<b>File Number</b>	<b>MV2014X0011</b>
<b>Type of Operation</b>	<b>MISC.</b>
<b>Location</b>	Well sites A-1, A-2, A-3, A-4, B-1, B-2, and the Plant Site.

An inspection of the above noted operation was conducted on July 24, 2018 by Resource Management Officer II Kyle Christiansen and Manager, Resource Management Jarret Hardisty.

ENVIRONMENTAL INSPECTION REPORT

Permittee:	Paramount Resources Ltd.	Permit Expiry Date:	June 04, 2019
Land Use Permit No.	MV2014X0011	Previous Inspection:	August 10, 2017
Quarrying Permit No.		Inspection Date:	July 24, 2018
Contractor:		Subcontractor:	
Location(s) Inspected:	Well sites A-1, A-2, A-3, A-4, B-1, B-2, and the Plant Site.		
Current Stage of Operation:	Reclamation/Remediation		
Program Modifications Approved:	Not applicable

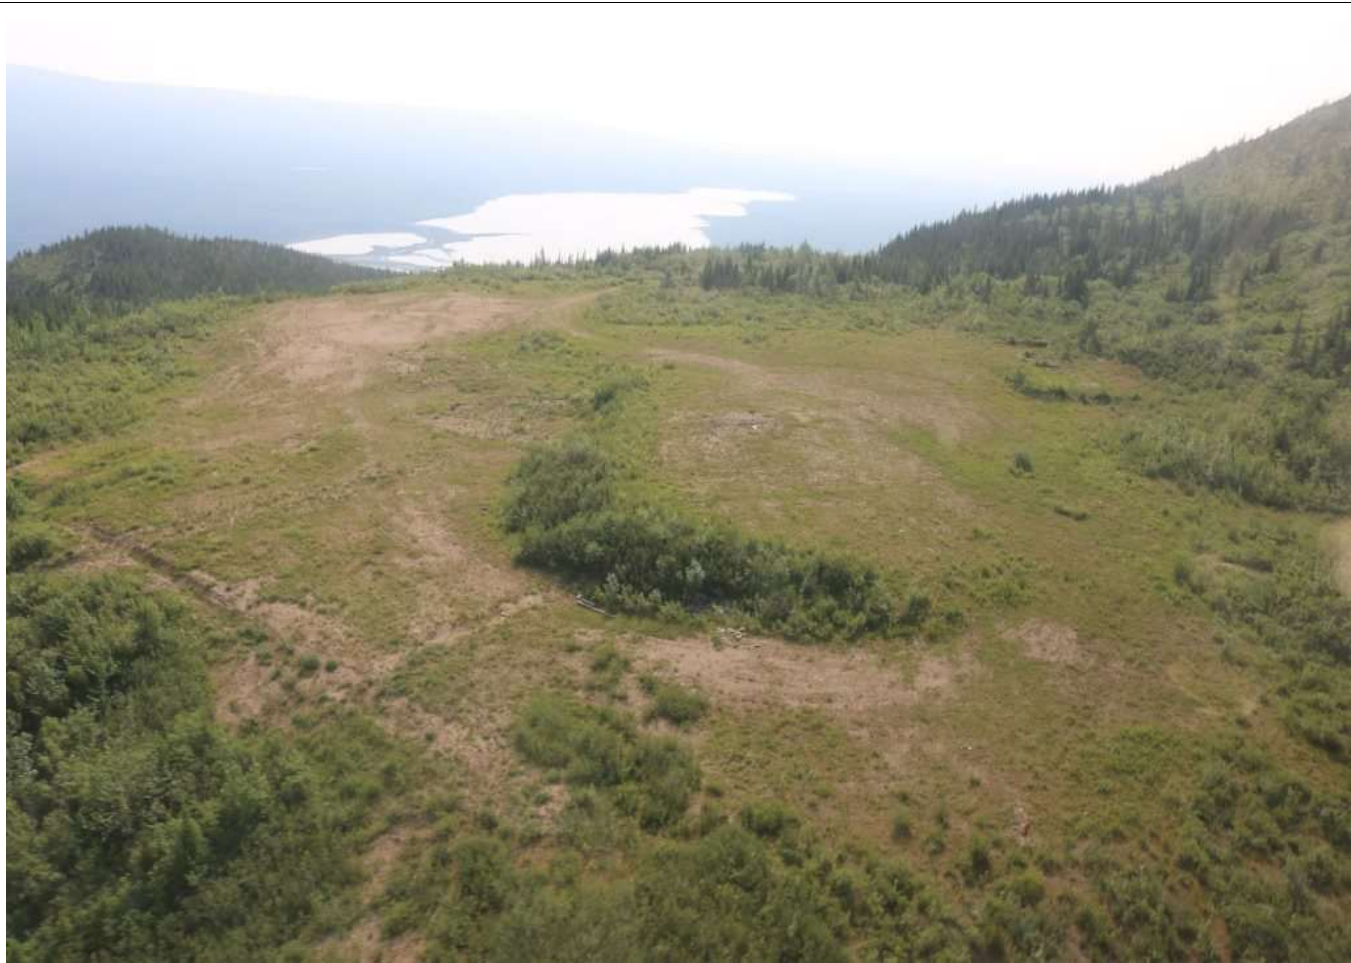
All above ground infrastructure has been removed from the A-1 well site except for ground water monitoring wells. Vegetation covered approximately 50% of the site. The soil that was replaced at the former wellhead location had settled out and the sign was still in place. Inspectors have no concerns with the A-1 well site and will continue to monitor the location.

Figure 1  
Aerial of the A-1 well site.

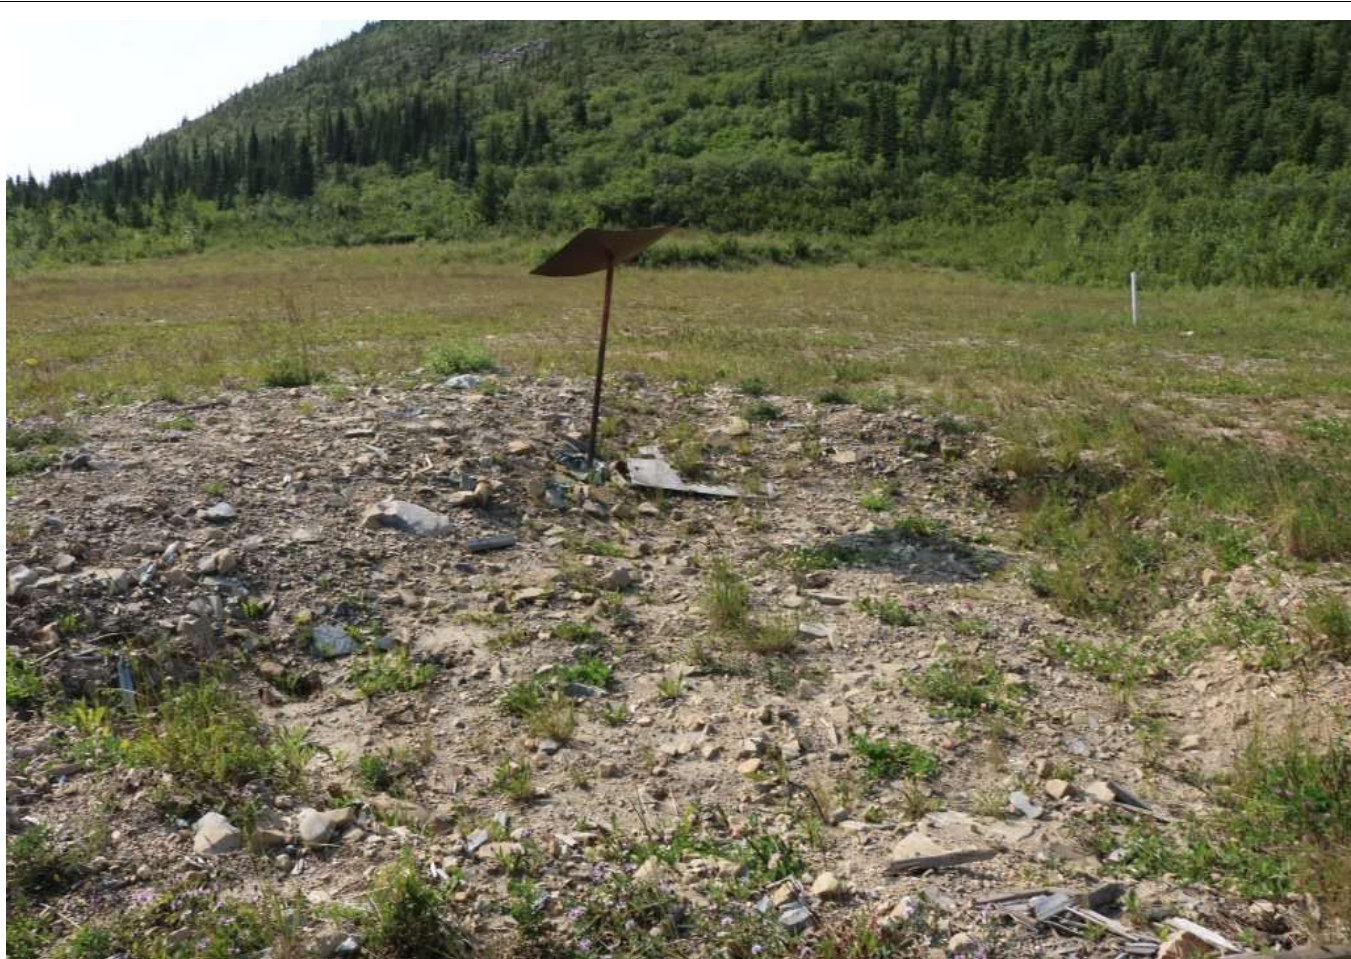
Figure 2  
Sign that was installed where wellhead was on A-1 well site.

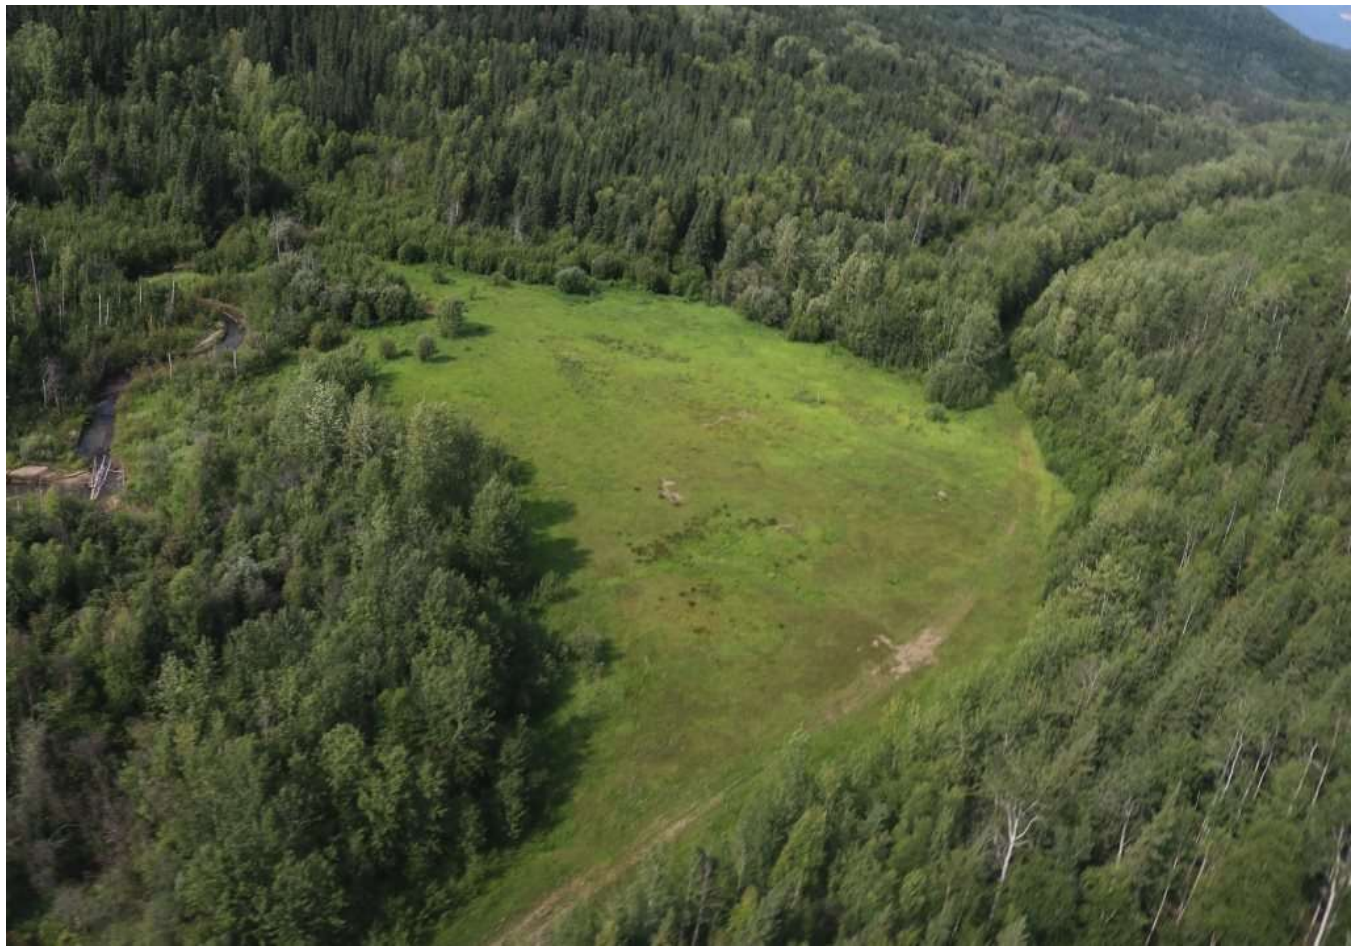
All above ground infrastructure has been removed from the A-2 well site except for ground water monitoring wells. Vegetation covered approximately 95% of the site. The soil settled where the wellhead was removed and the sign was installed. Inspectors have no concerns with the A-2 well site and will continue to monitor the location.

Figure 3  
Aerial of A-2 well site.

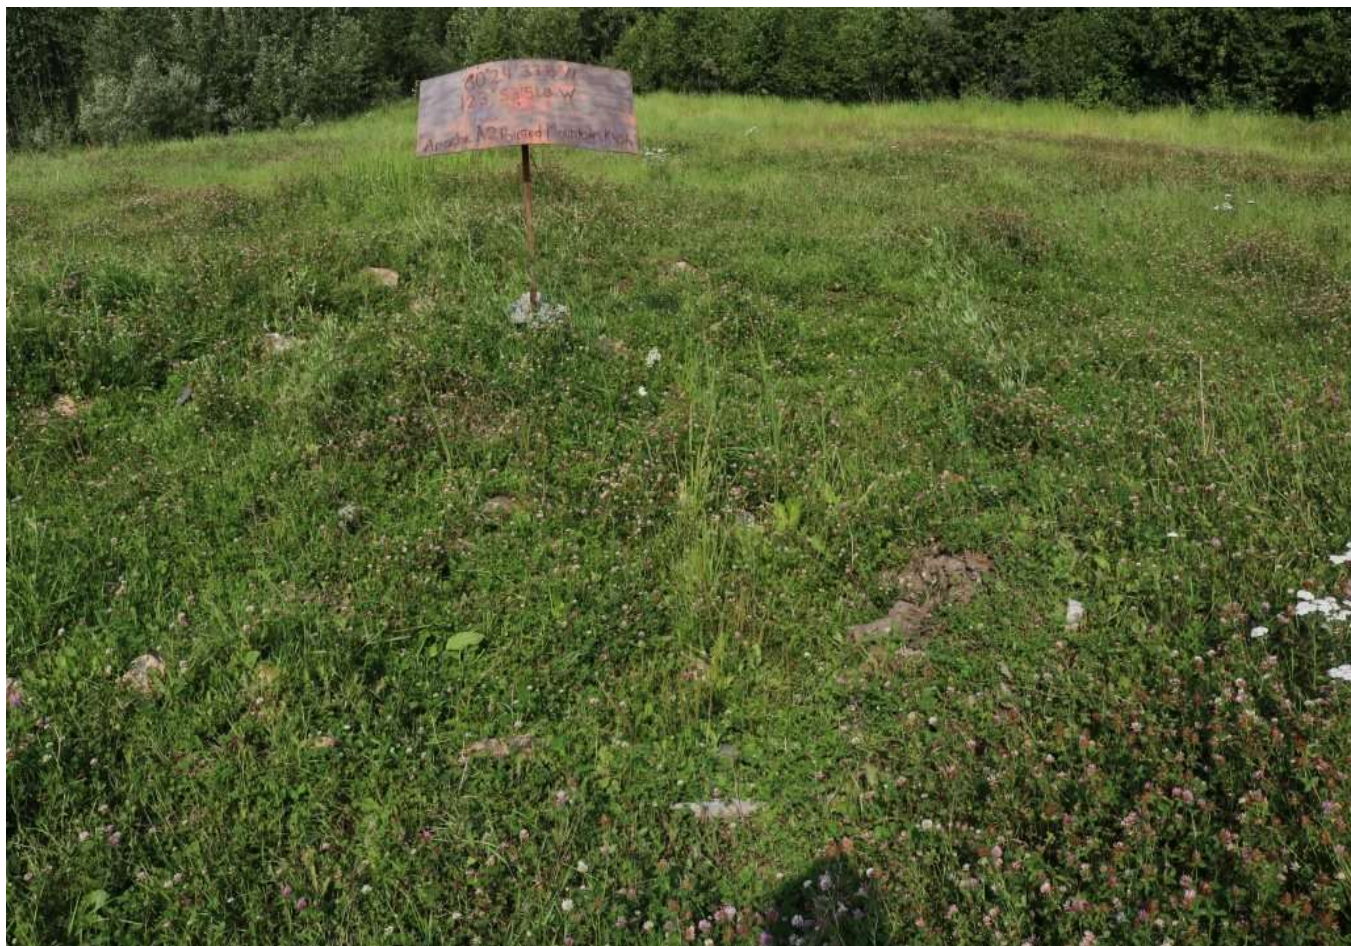
Figure 4  
Signage in place of wellhead on A-2 well site.

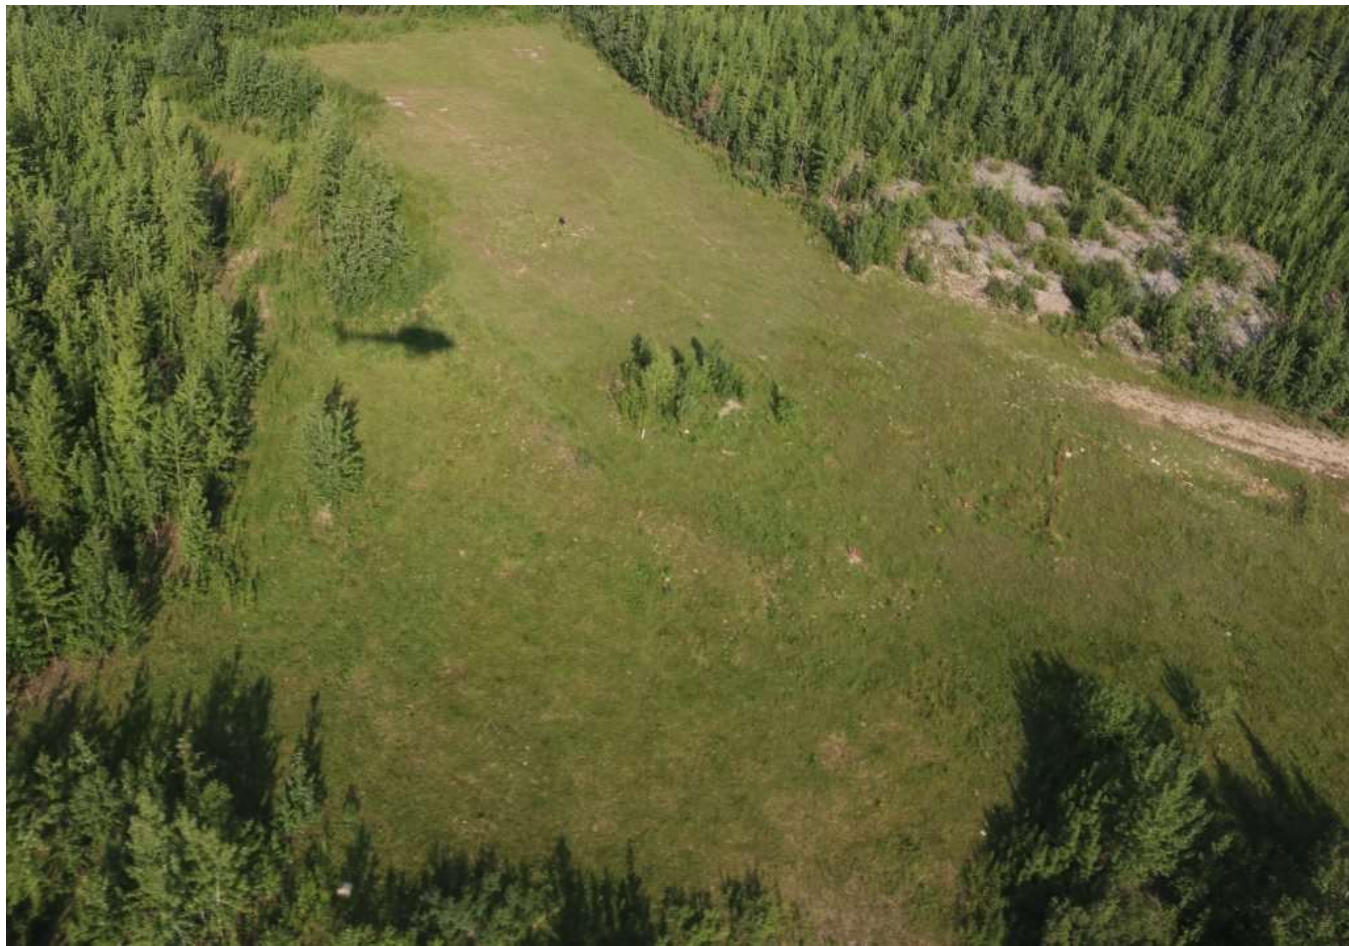
Most of the above ground infrastructure has been removed except for ground water monitoring wells and piping near the access entrance. Vegetation covered approximately 90% of the site with clover being one of the more prominent species noted by inspectors. The soil that was replaced once the wellhead was removed had settled around the sign that was installed. Inspectors have no concerns with the A-3 well site and will continue to inspect it in the future.

Figure 5  
Aerial of A-3 well site.

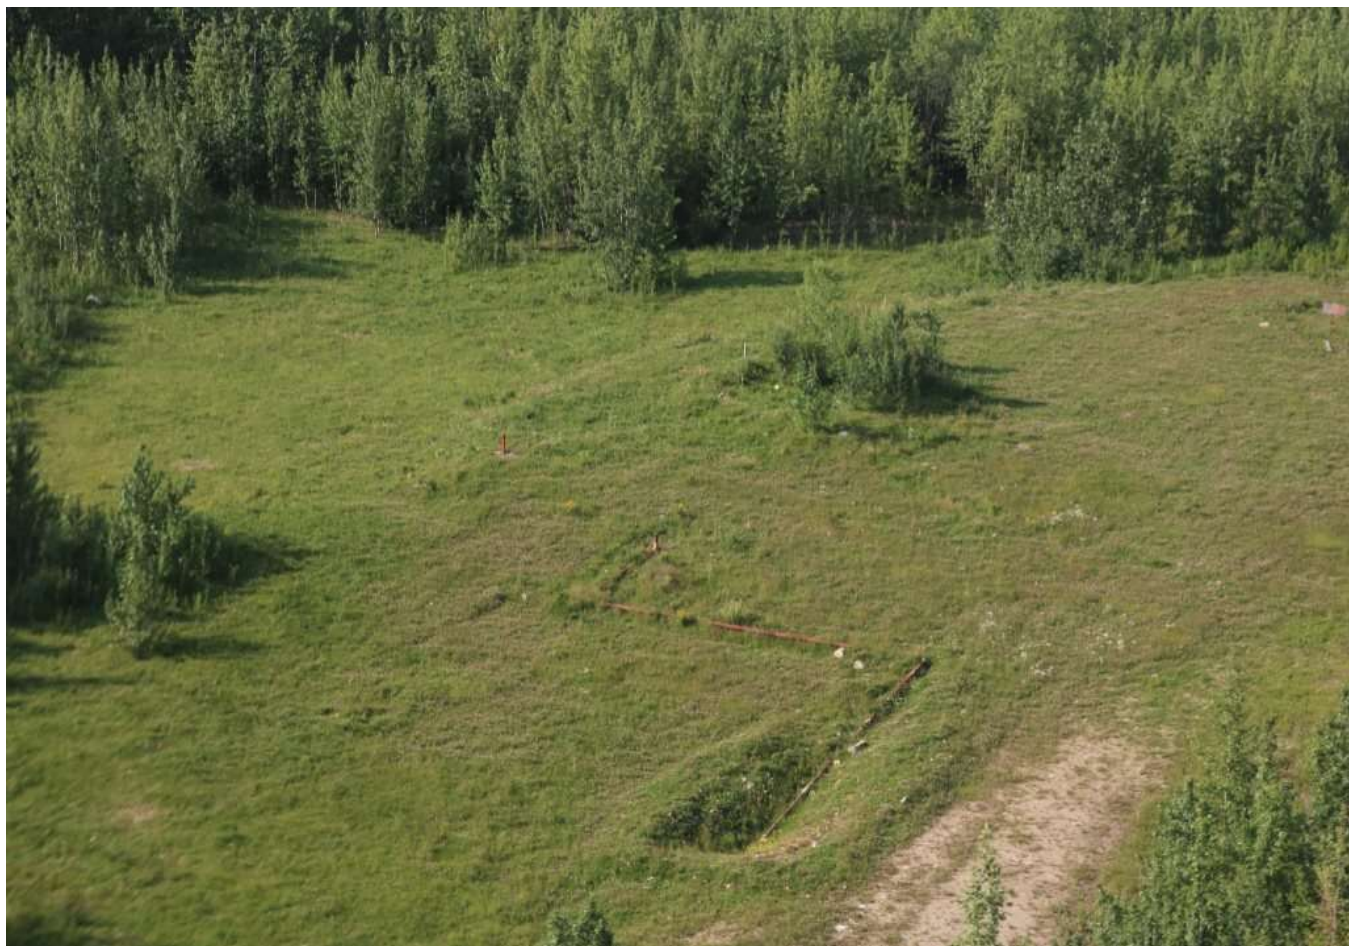
Figure 6  
Aerial with exposed piping on A-3 well site.

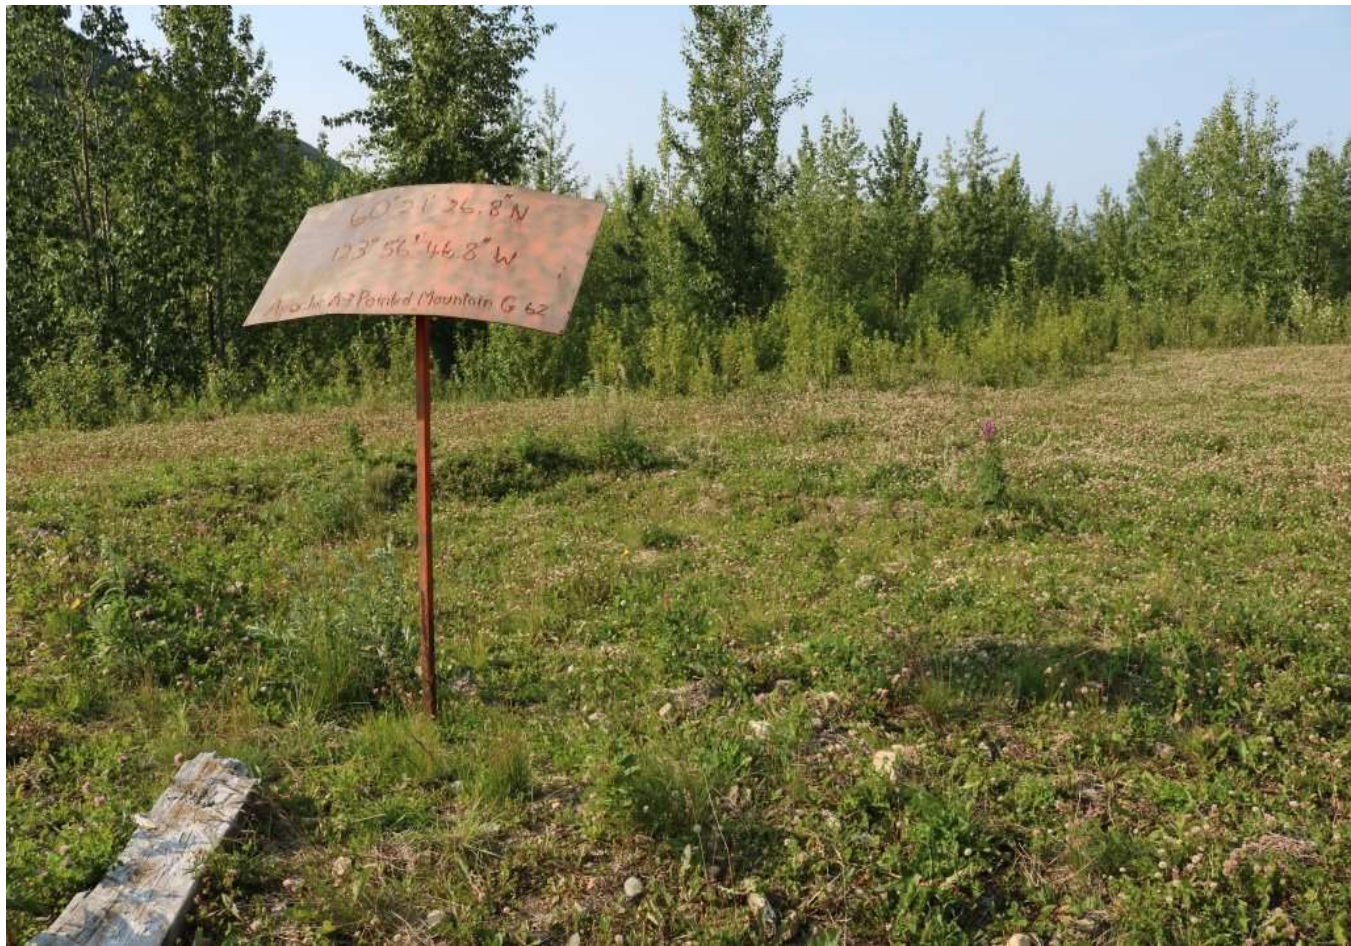
Figure 7  
Signage on A-3 well site.

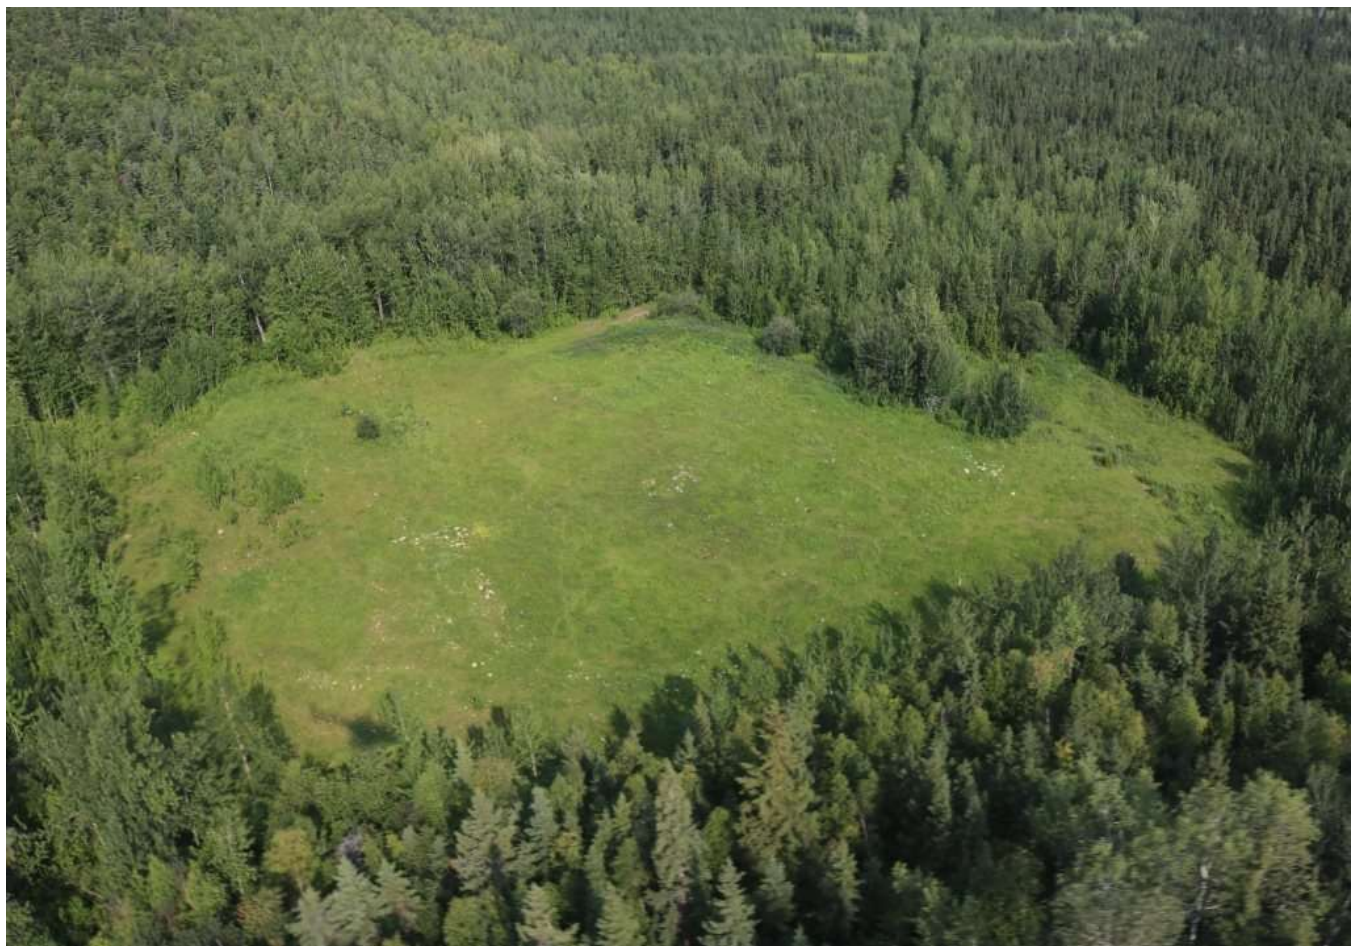
All above ground infrastructure except for the ground water monitoring wells was removed. Vegetation has established throughout the site with Inspectors noting that clover was prominent. The soil that was placed in the wellheads previous location had settled and the sign was still in place. Inspectors have no concerns with the A-4 well site and will continue to monitor the location.

Figure 8  
Aerial of A-4 well site.

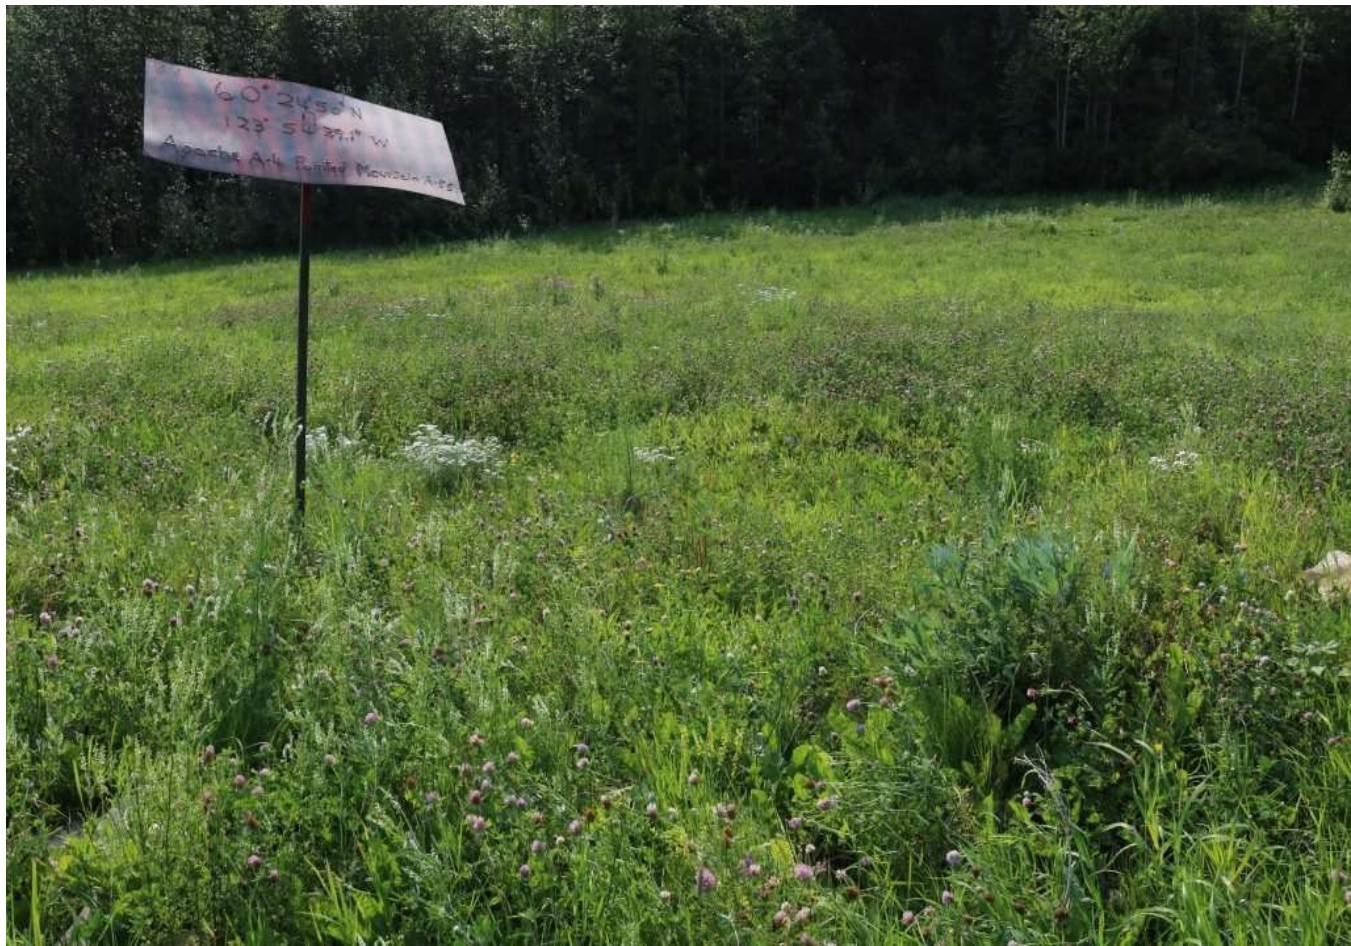
Figure 9  
Signage on A-4 well site.

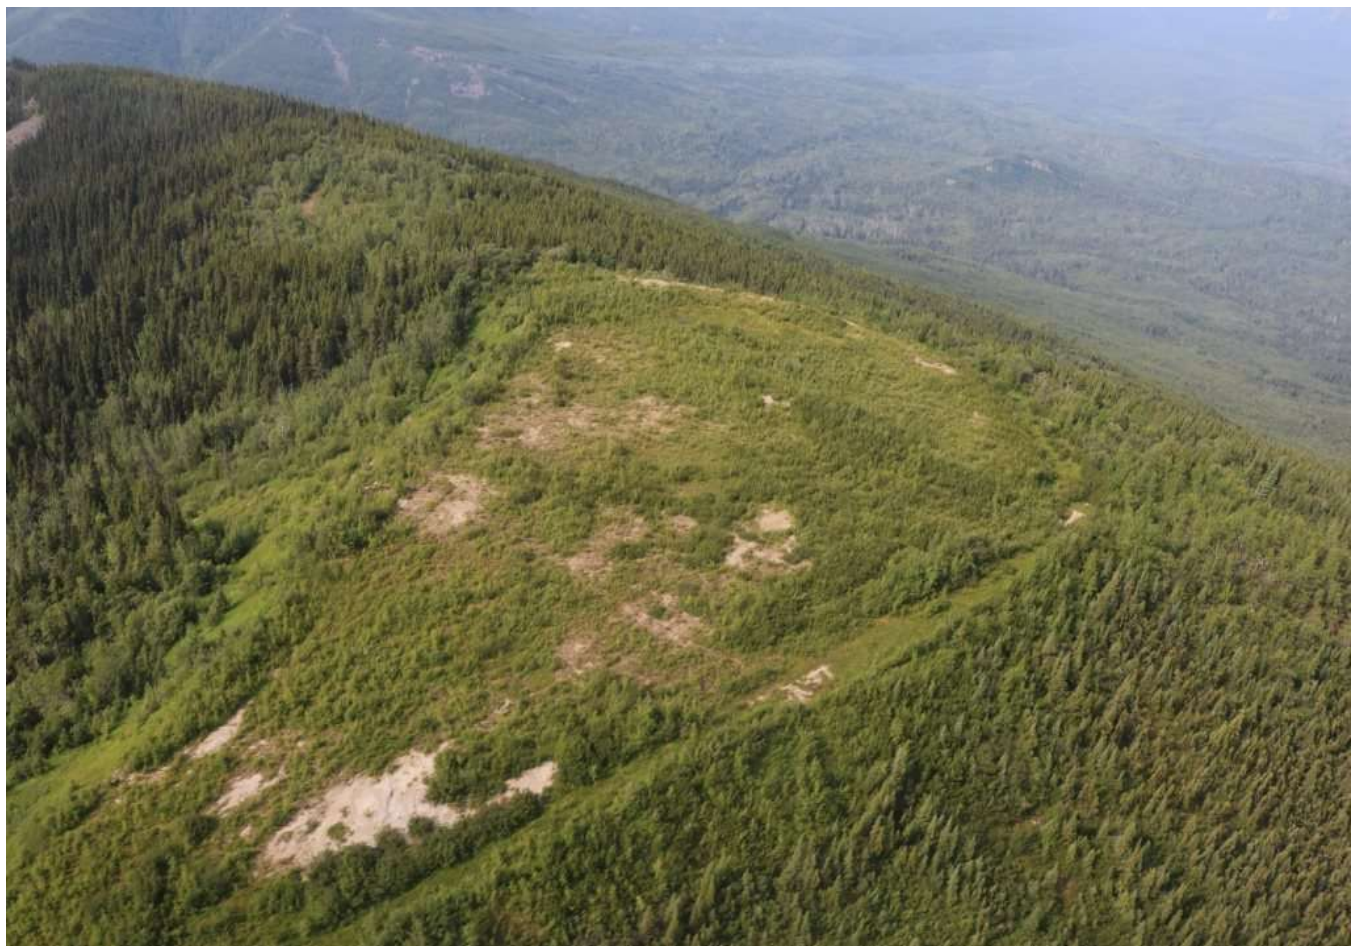
All above ground infrastructure was removed except for ground water monitoring wells. Vegetation has established on approximately 75% of the site. Pooling water was present on the site. The soil that replaced the wellhead had settled and the sign had fallen over. Brushing may be required in the future to ensure access via helicopter, if brushing occurs Inspectors request the sign be repaired at the same time. Inspectors have no concerns with the B-1 well site and will continue to monitor the location.

Figure 10  
Aerial of B-1 well site.

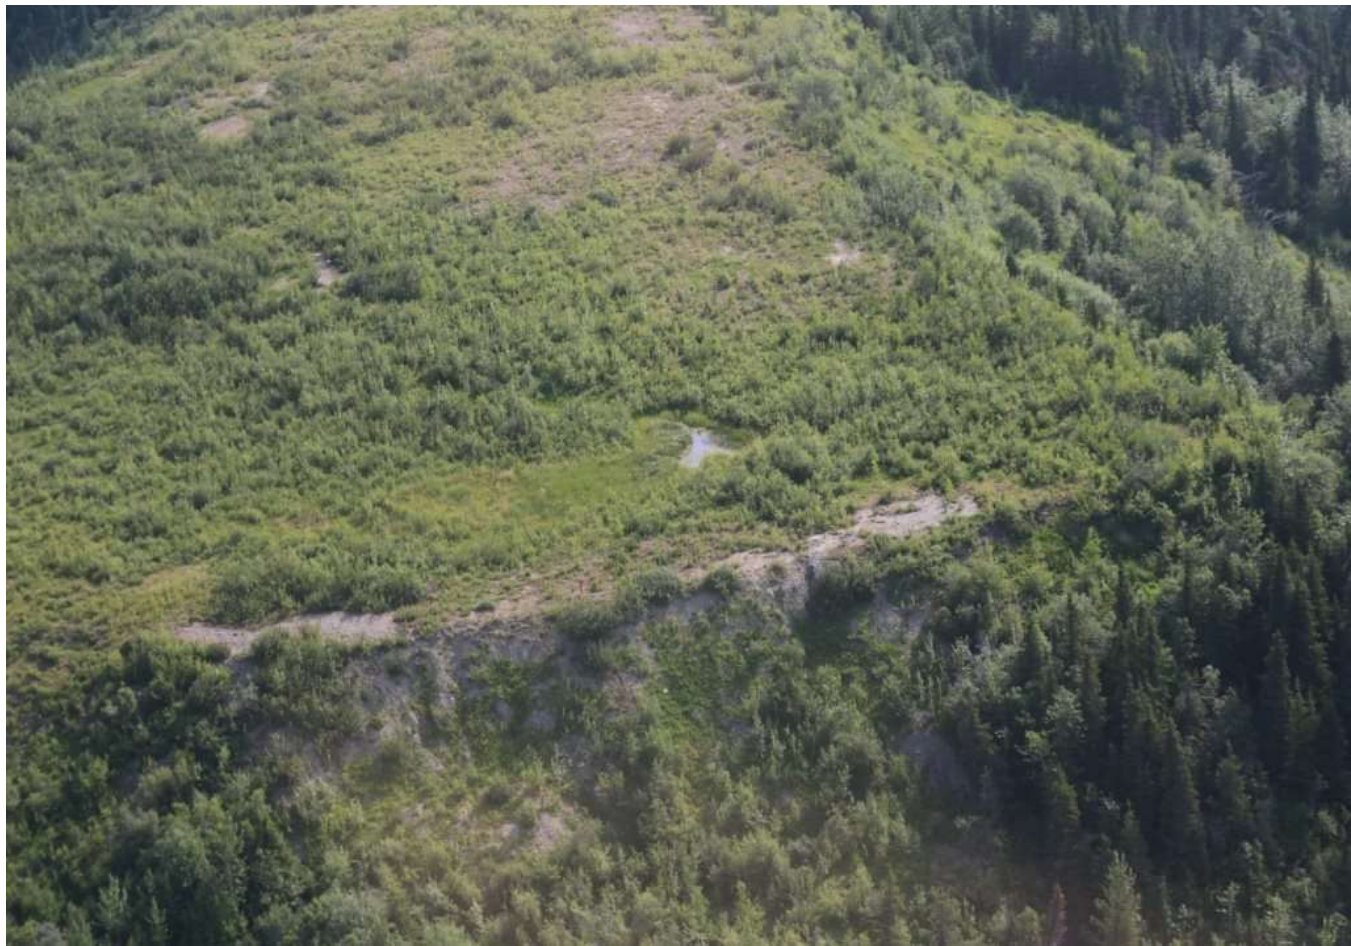
Figure 11  
Aerial of B-1 well site with pooling water.

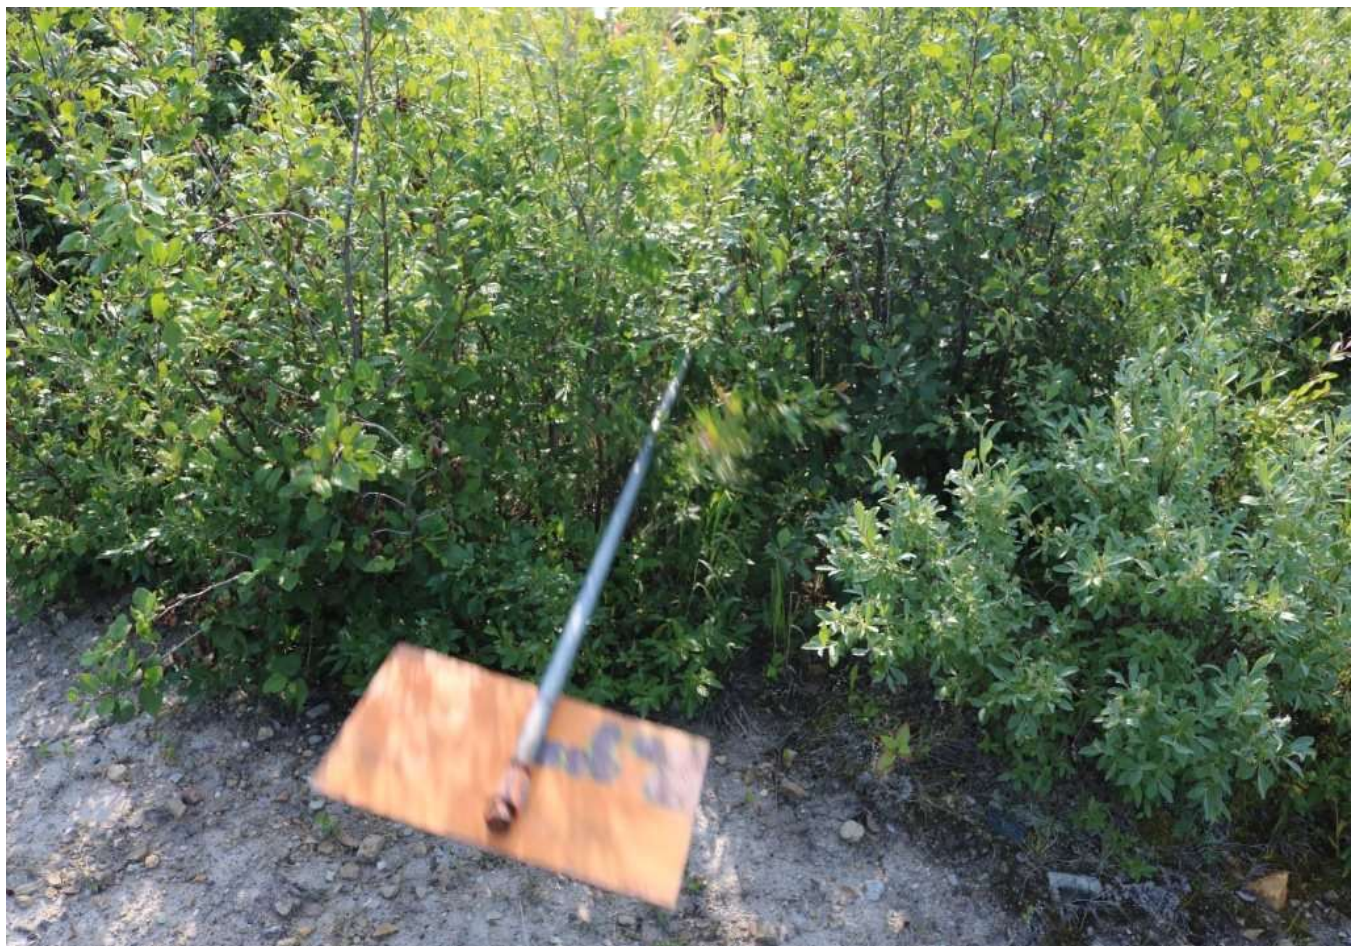
Figure 12  
Signage that fell over on B-1 well site.

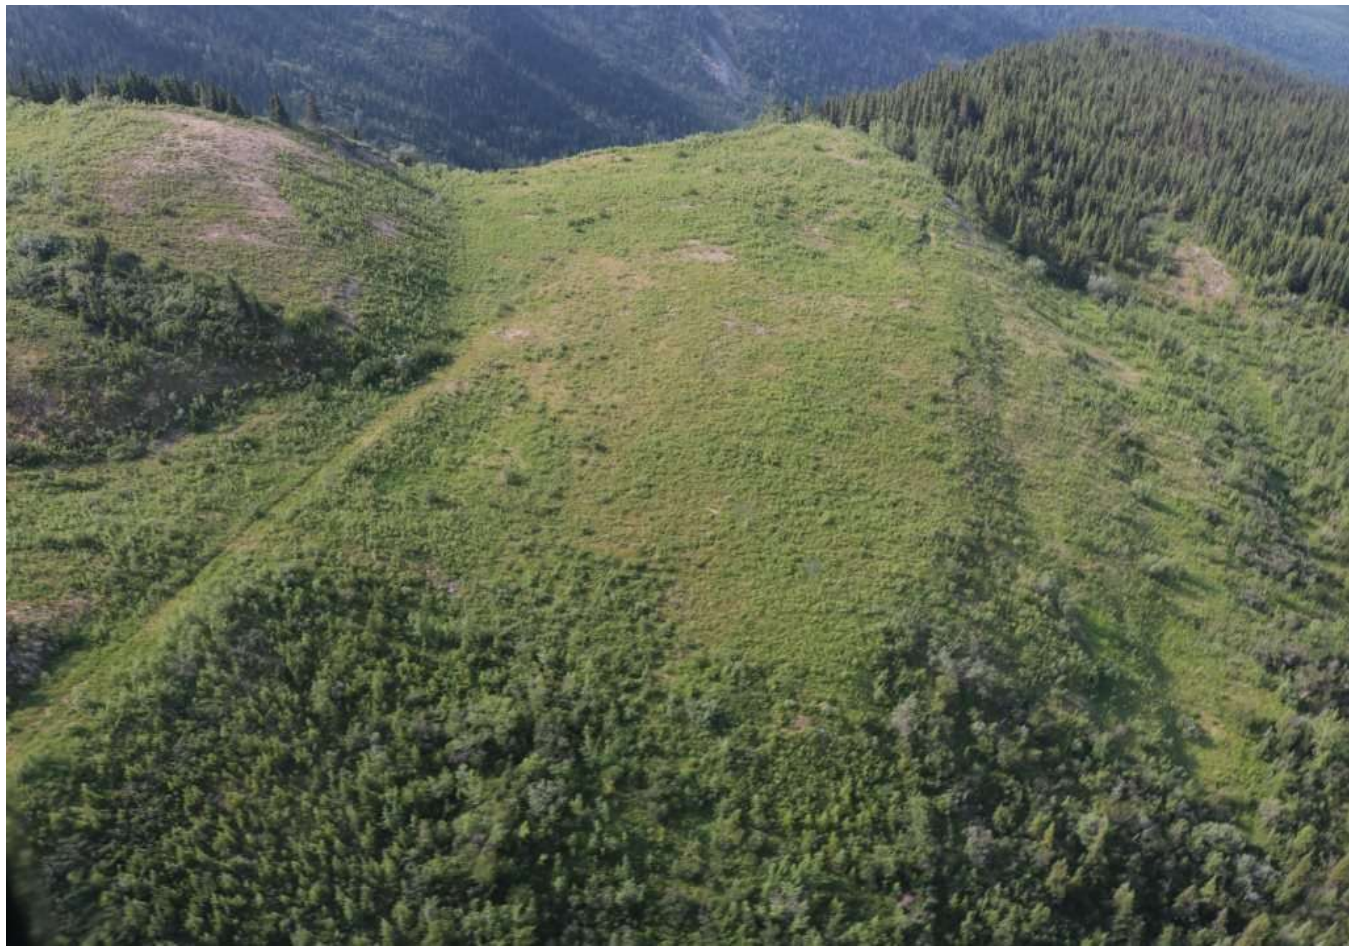
All above ground infrastructure except ground water monitoring wells has been removed. Vegetation covered approximately 85% of the site. The sign that was installed where the wellhead was located had fallen over. Inspectors have no concerns with the B-2 well site and will continue to monitor the location.

Figure 13  
Aerial of B-2 well site.

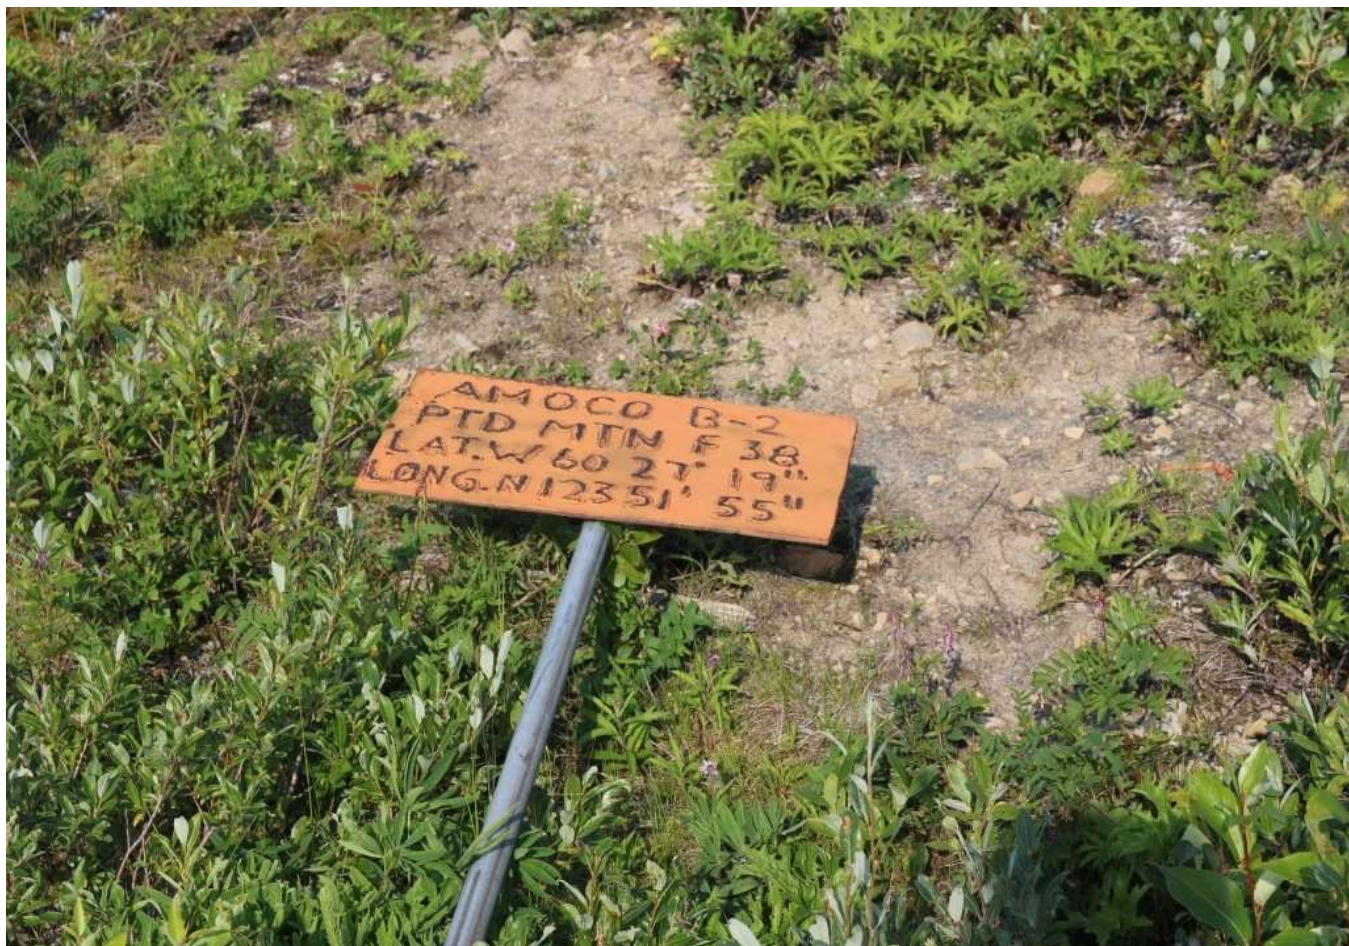
Figure 14  
Sign that fell over on B-2 well site.
