<b>File Number</b>	<b>MV2014X0011</b>
<b>Type of Operation</b>	<b>MISC.</b>
<b>Location</b>	Well sites A-1, A-2, A-3, A-4, B-1, B-2, and the Plant Site.

An inspection of the above noted operation was conducted on July 24, 2018 by Resource Management Officer II Kyle Christiansen and Manager, Resource Management Jarret Hardisty.

ENVIRONMENTAL INSPECTION REPORT

Permittee:	Paramount Resources Ltd.	Permit Expiry Date:	June 04, 2019
Land Use Permit No.	MV2014X0011	Previous Inspection:	August 10, 2017
Quarrying Permit No.		Inspection Date:	July 24, 2018
Contractor:		Subcontractor:	
Location(s) Inspected:	Well sites A-1, A-2, A-3, A-4, B-1, B-2, and the Plant Site.		
Current Stage of Operation:	Reclamation/Remediation		
Program Modifications Approved:	Not applicable

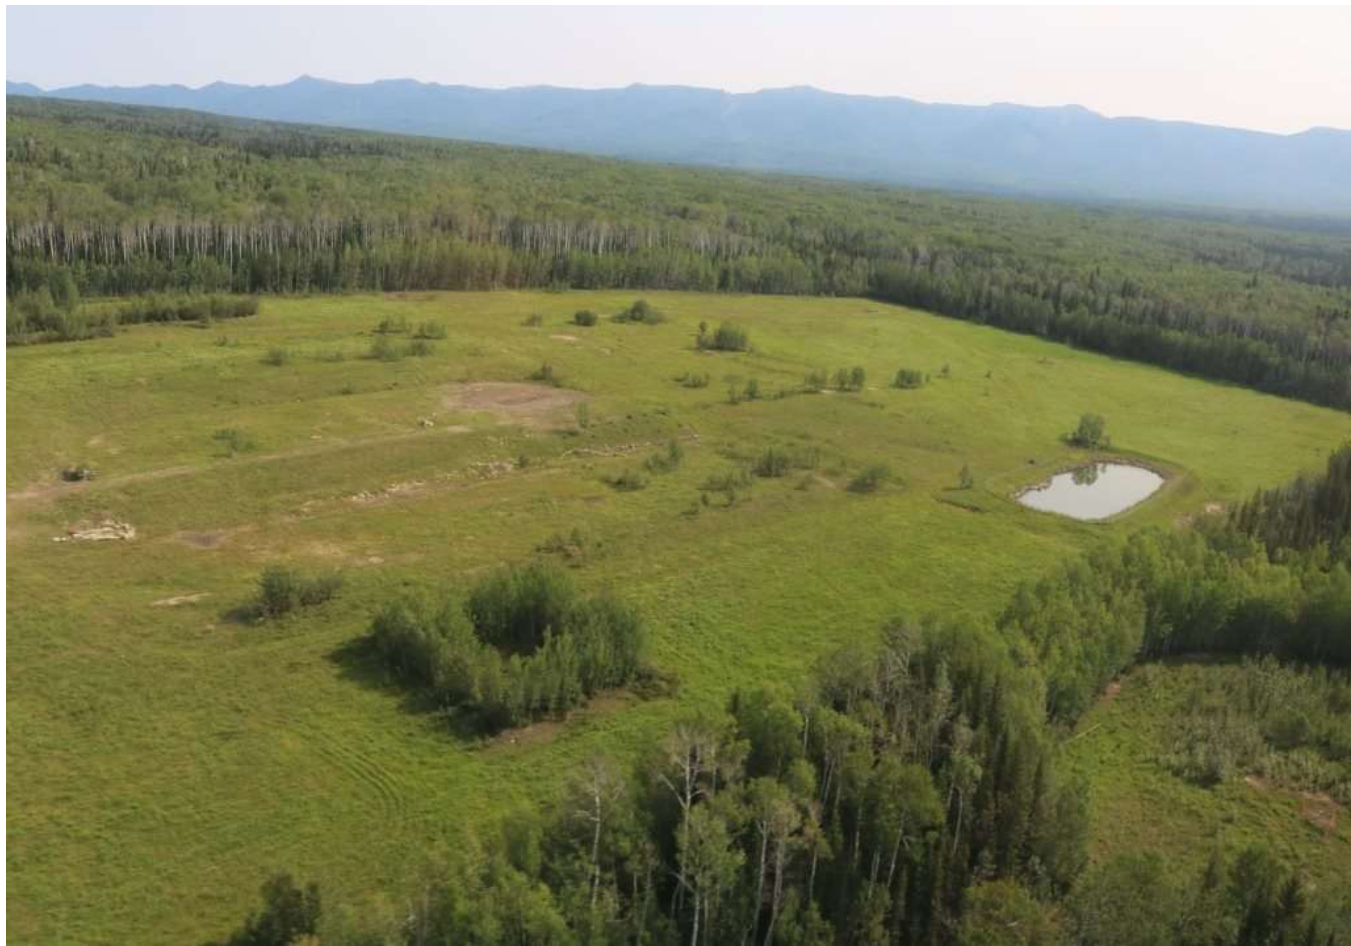
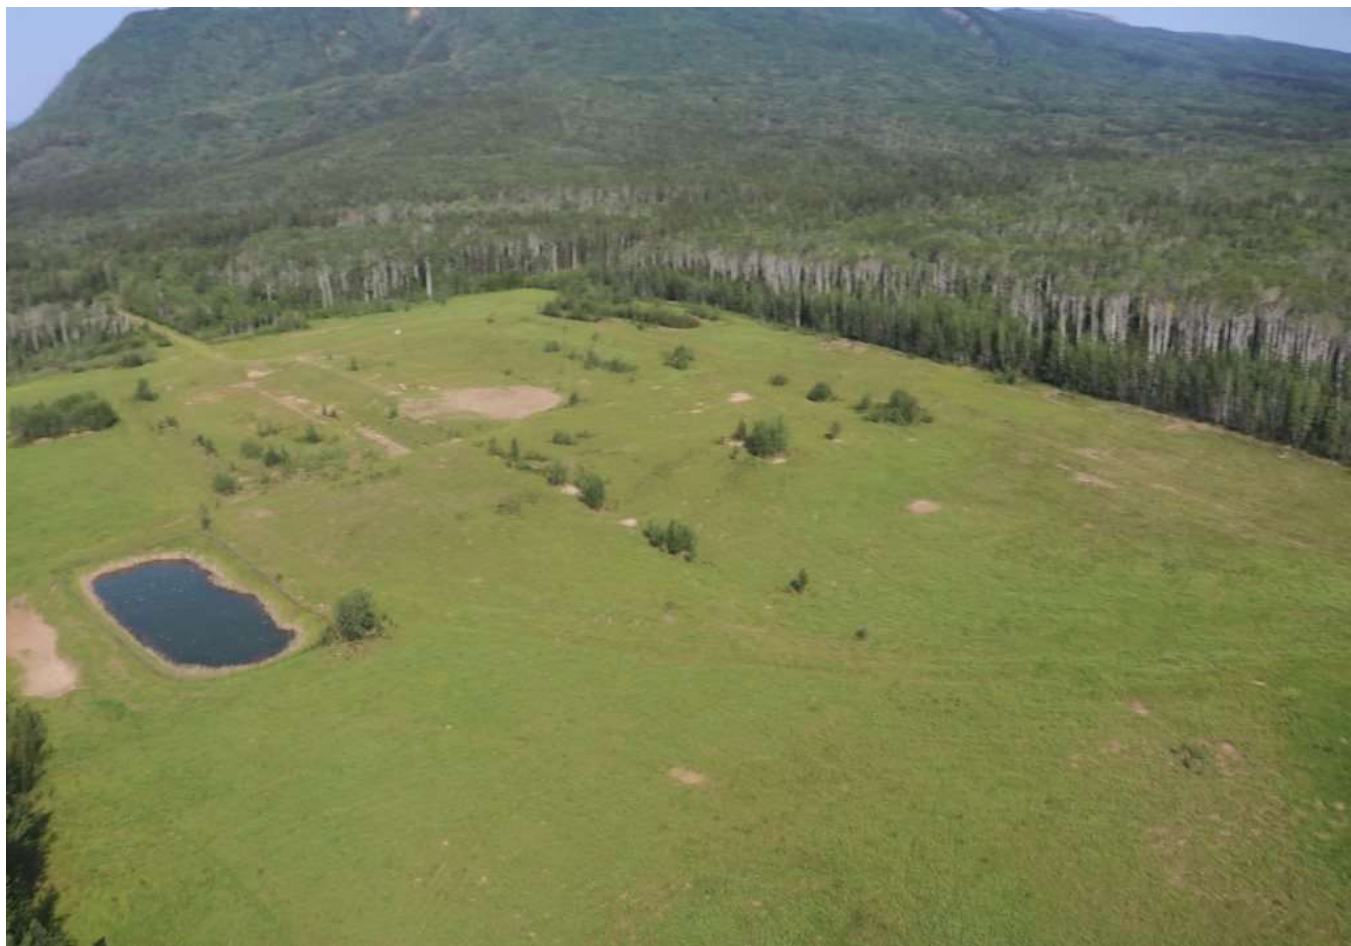
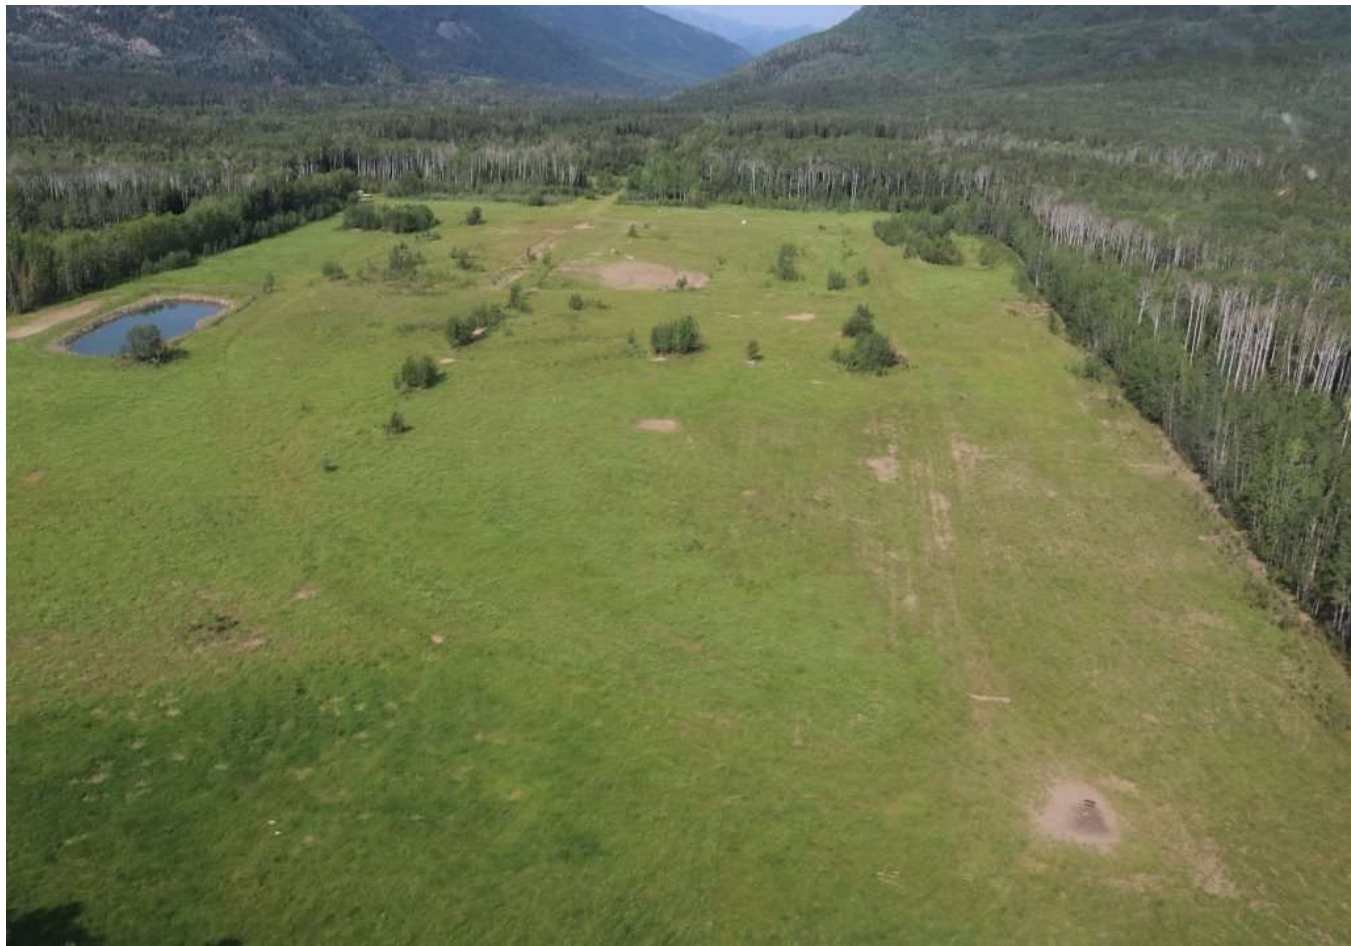
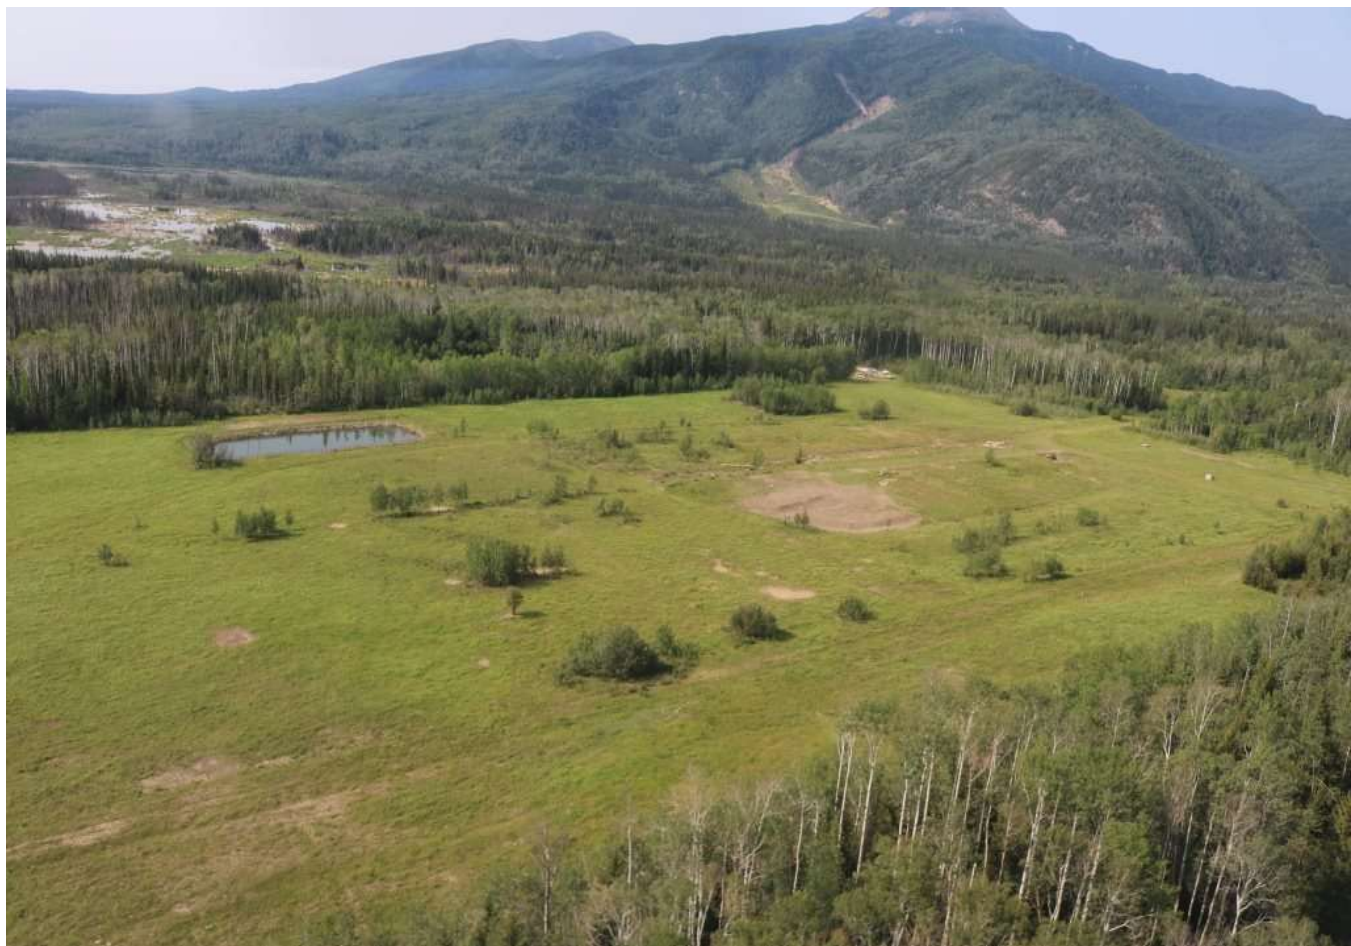
The Pointed Mountain Plant site was in a similar condition as the previous year’s inspection. Most of the above ground infrastructure has been removed from the site. The surge pond was holding water with new fencing that replaced the previous snow-fencing. Bird deterrents were also installed on the surge pond. Debris was noted on the site during the inspection which will be removed as remediation and reclamation progresses. Vegetation has established on approximately 90% of the site. Inspectors have no concerns with the activities under Land-Use Permit MV2014X0011 and will continue to inspect the location.

Figure 15  
Aerial of Plant Site.

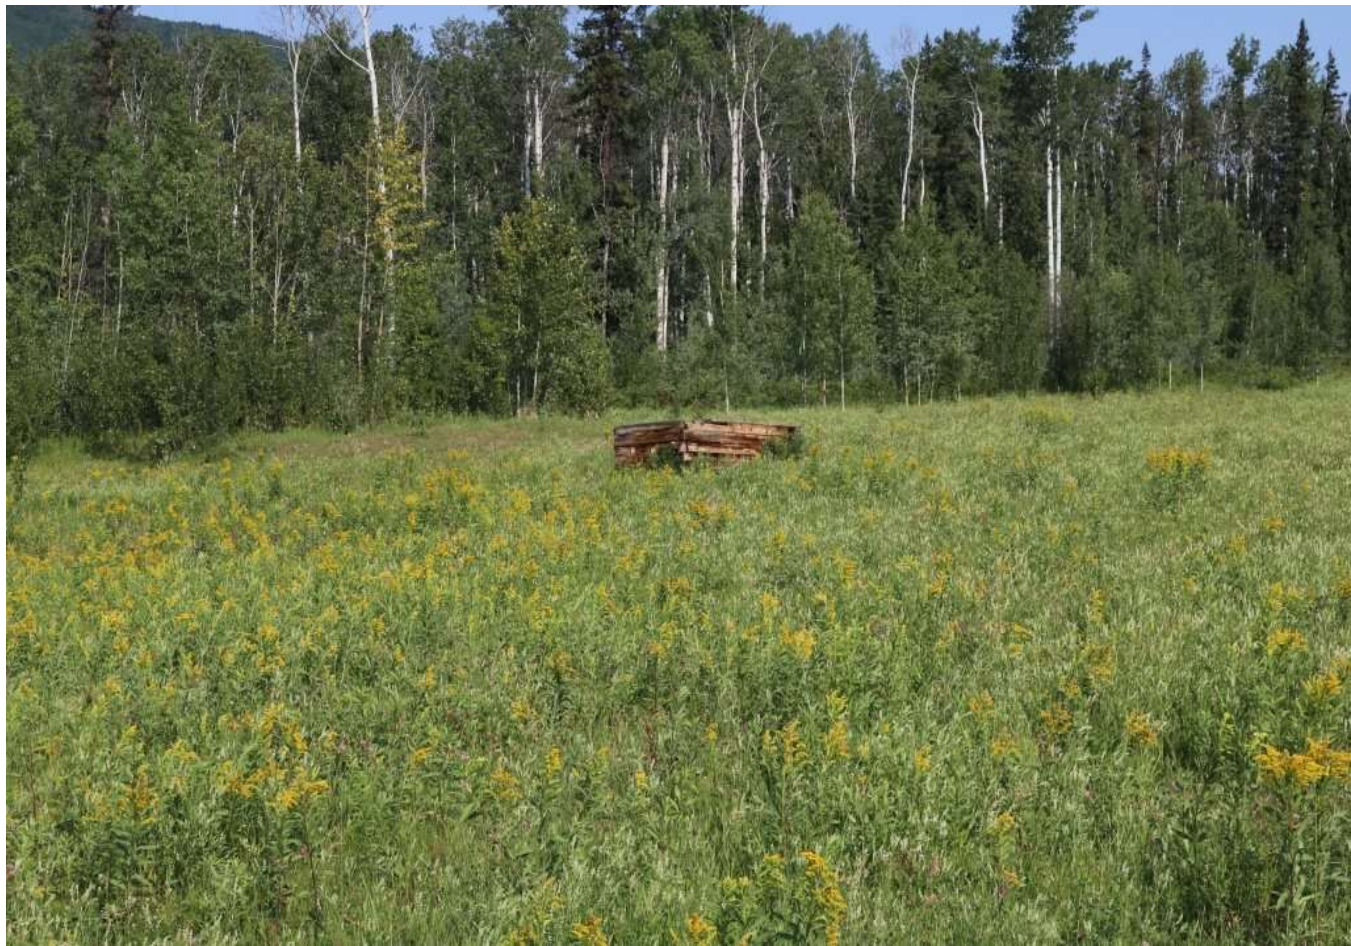
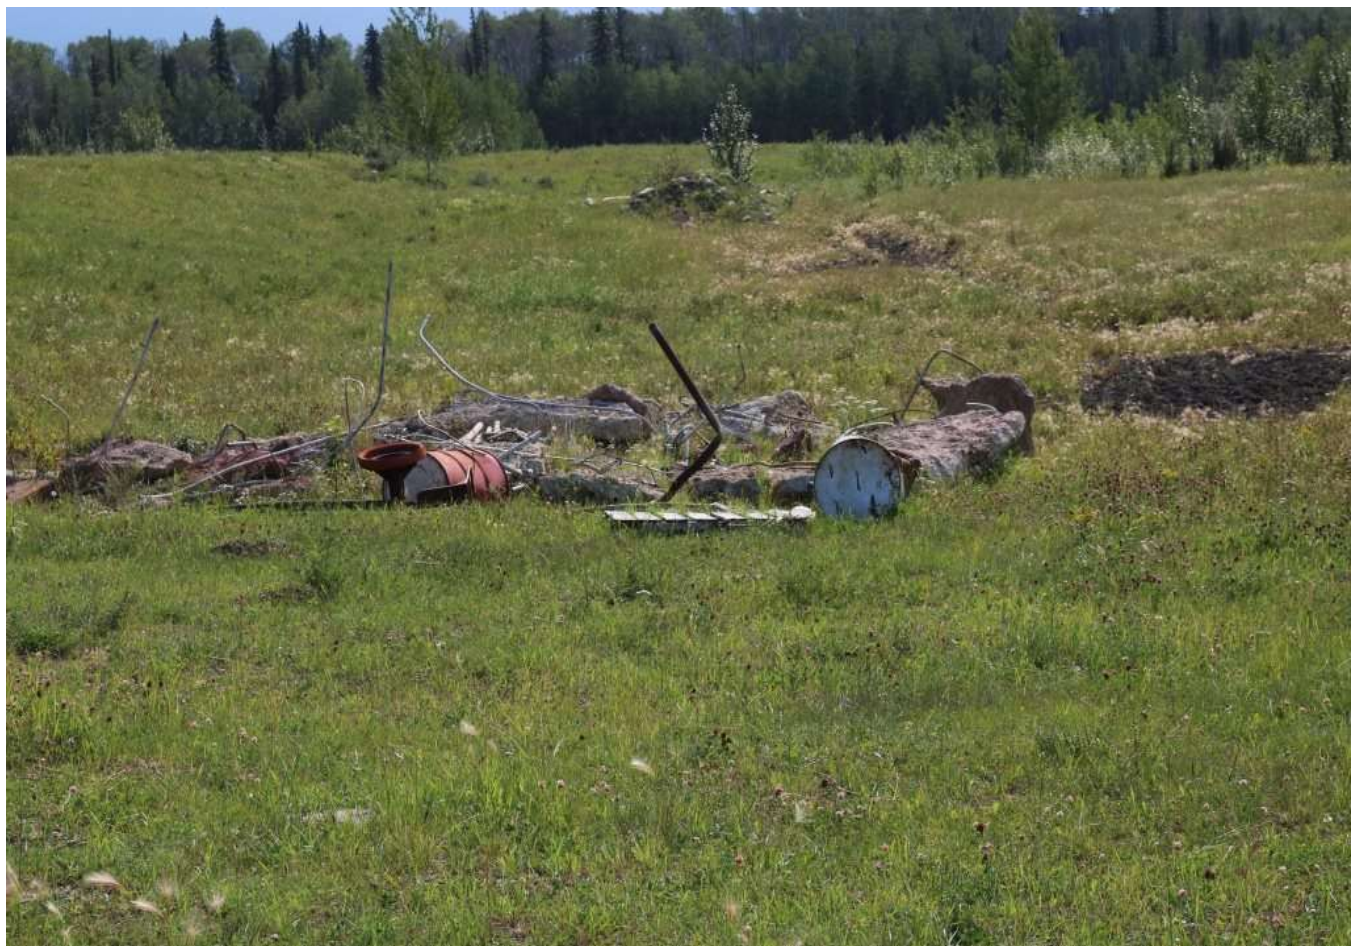
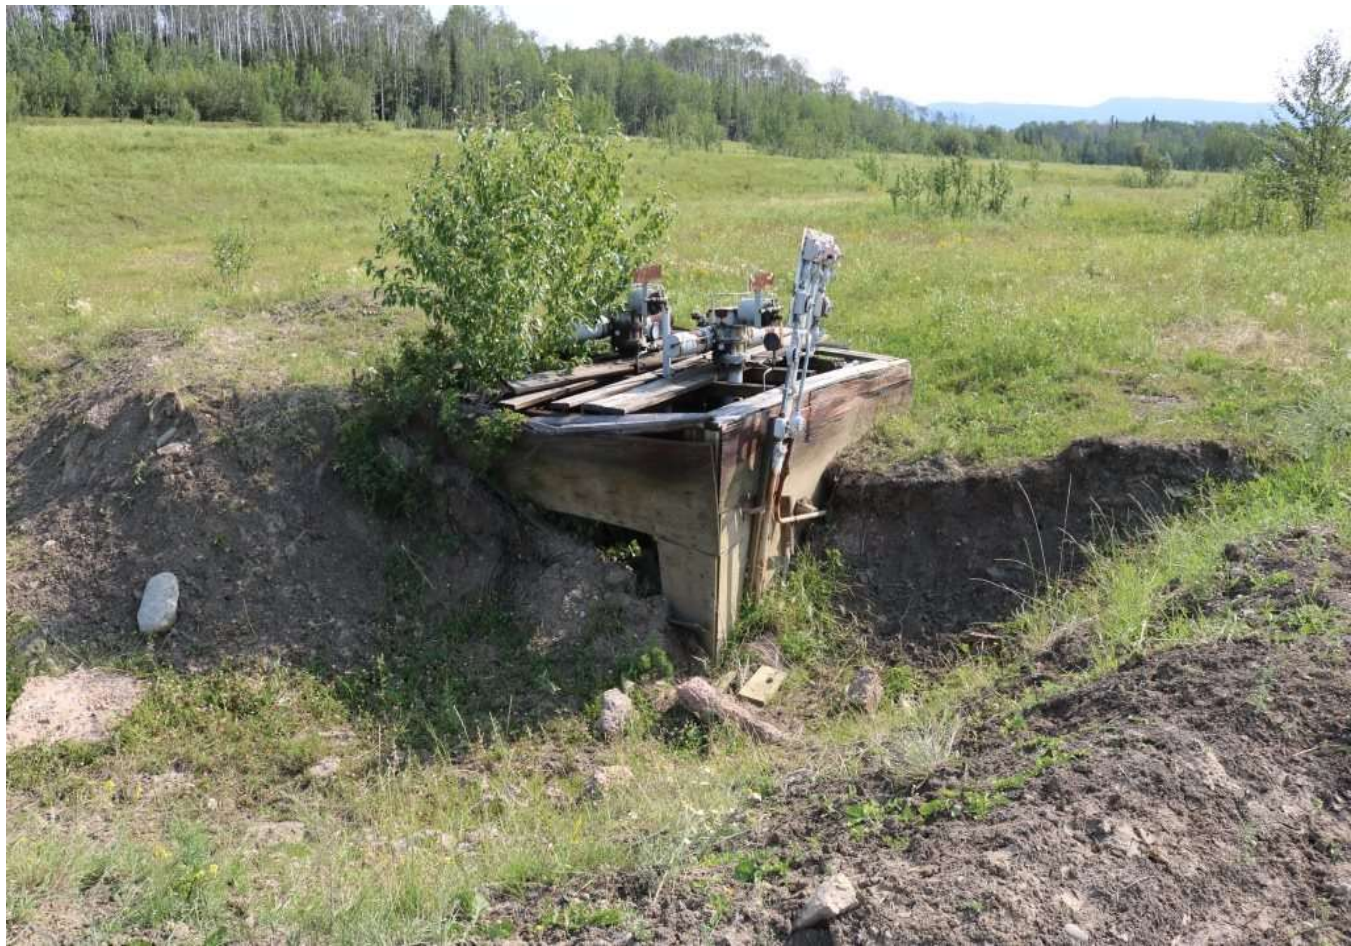
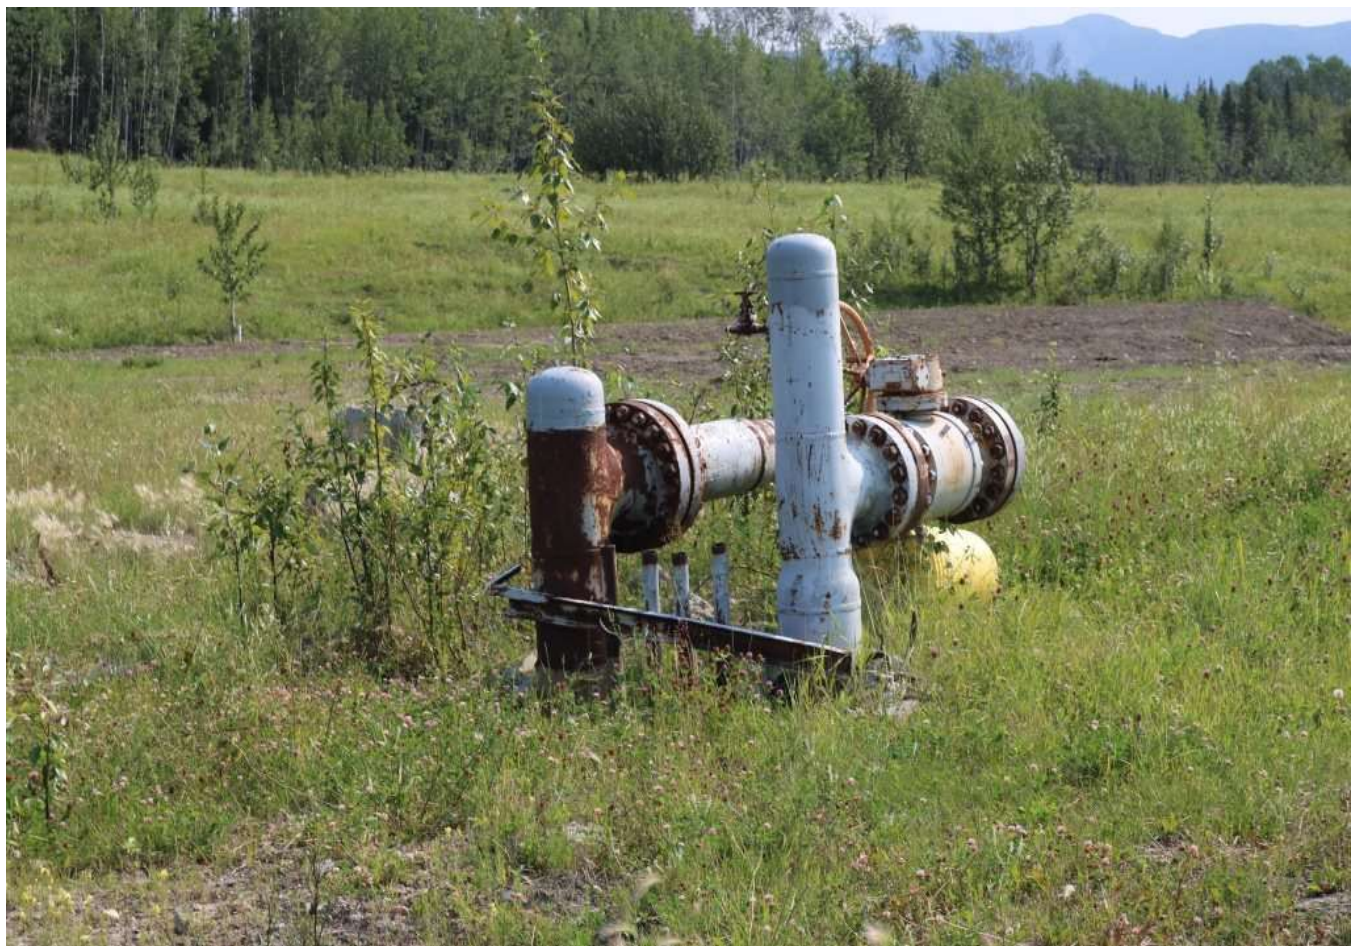
Figure 19  
Debris on Plant Site.

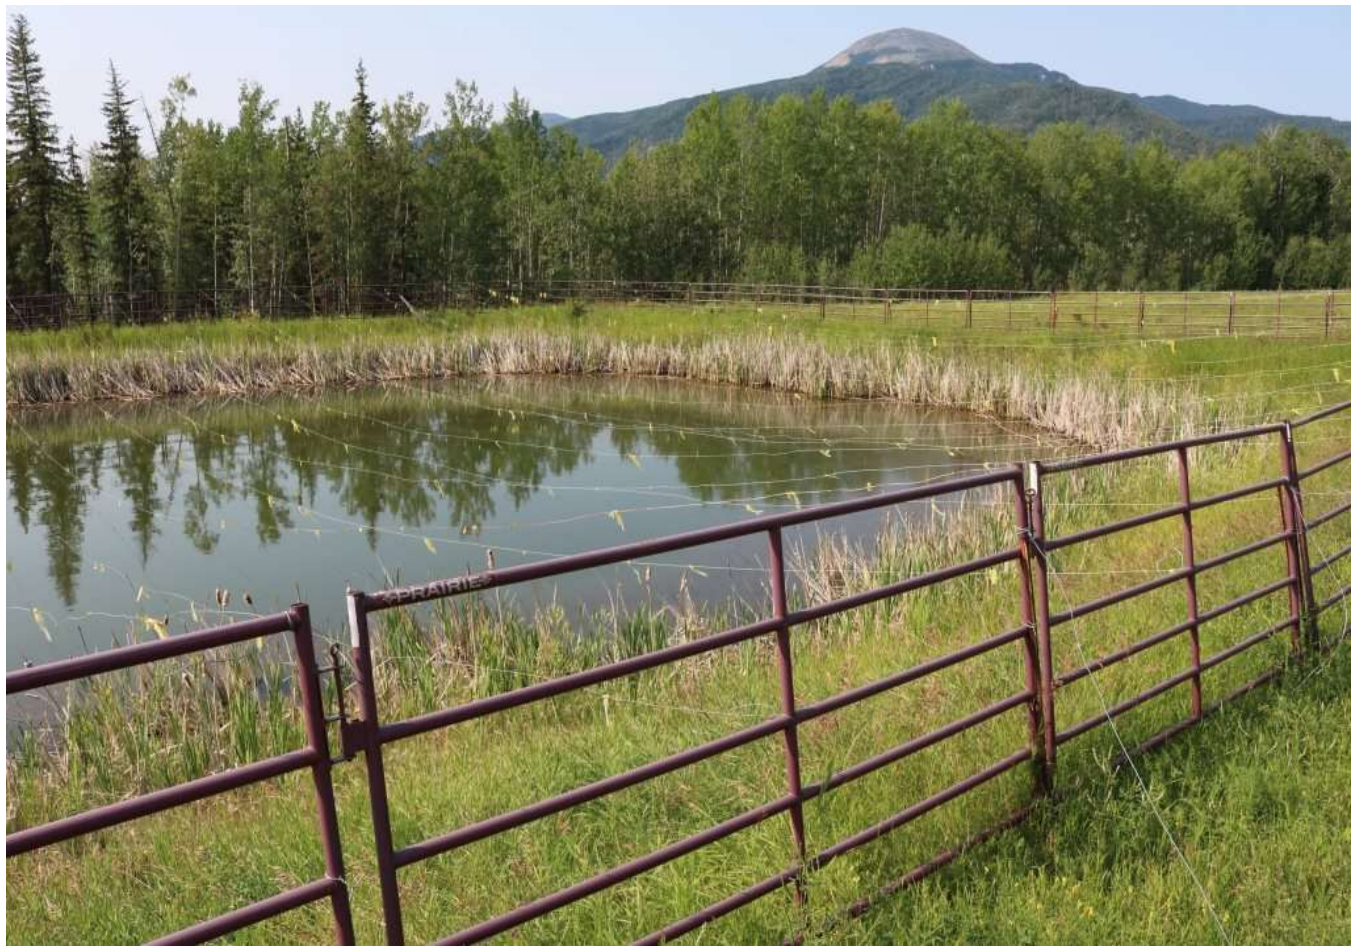
Figure 23  
New fencing around surge pond.

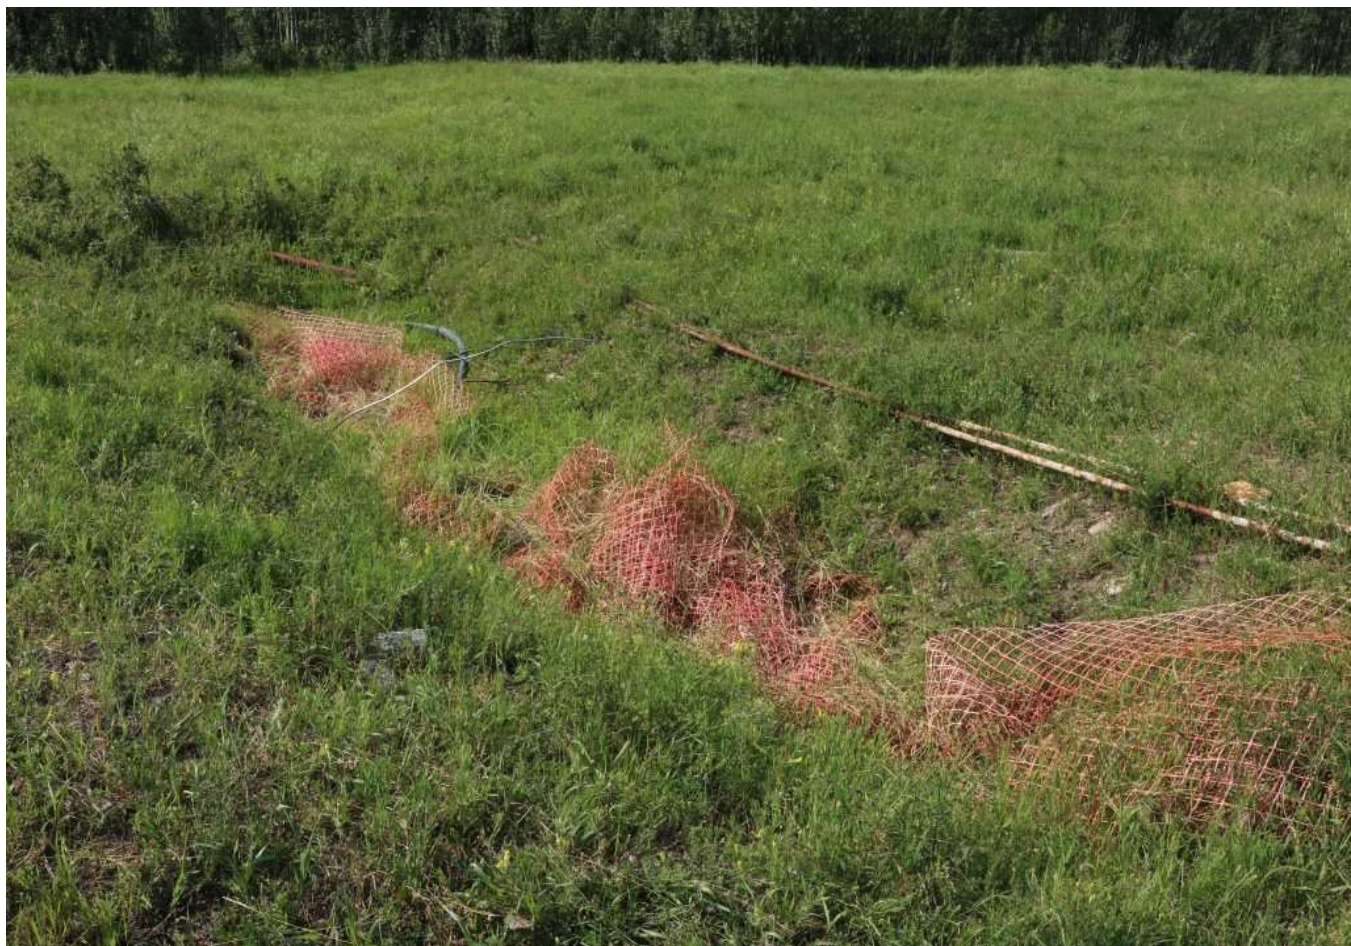
Figure 24  
Old snow-fencing that was around surge pond.
