File Number	MV2014X0011
Type of Operation	MISC.
Location	A-1, A-2, A-3, A-4, B-1, B-2 and Plant Site

ENVIRONMENTAL INSPECTION REPORT

Permittee:	Paramount Resources Ltd.	Permit Expiry Date:	June 04, 2021
Land Use Permit No.	MV2014X0011	Previous Inspection:	August 15, 2023
Quarrying Permit No.		Inspection Date:	September 25, 2024
Contractor:		Subcontractor:	
Location(s) Inspected:	A-1, A-2, A-3, A-4, B-1, B-2 and Plant Site		
Current Stage of Operation:	Abandonment and Reclamation		
Program Modifications Approved:	2023 Remedial Action Plan- NT Spill 202355

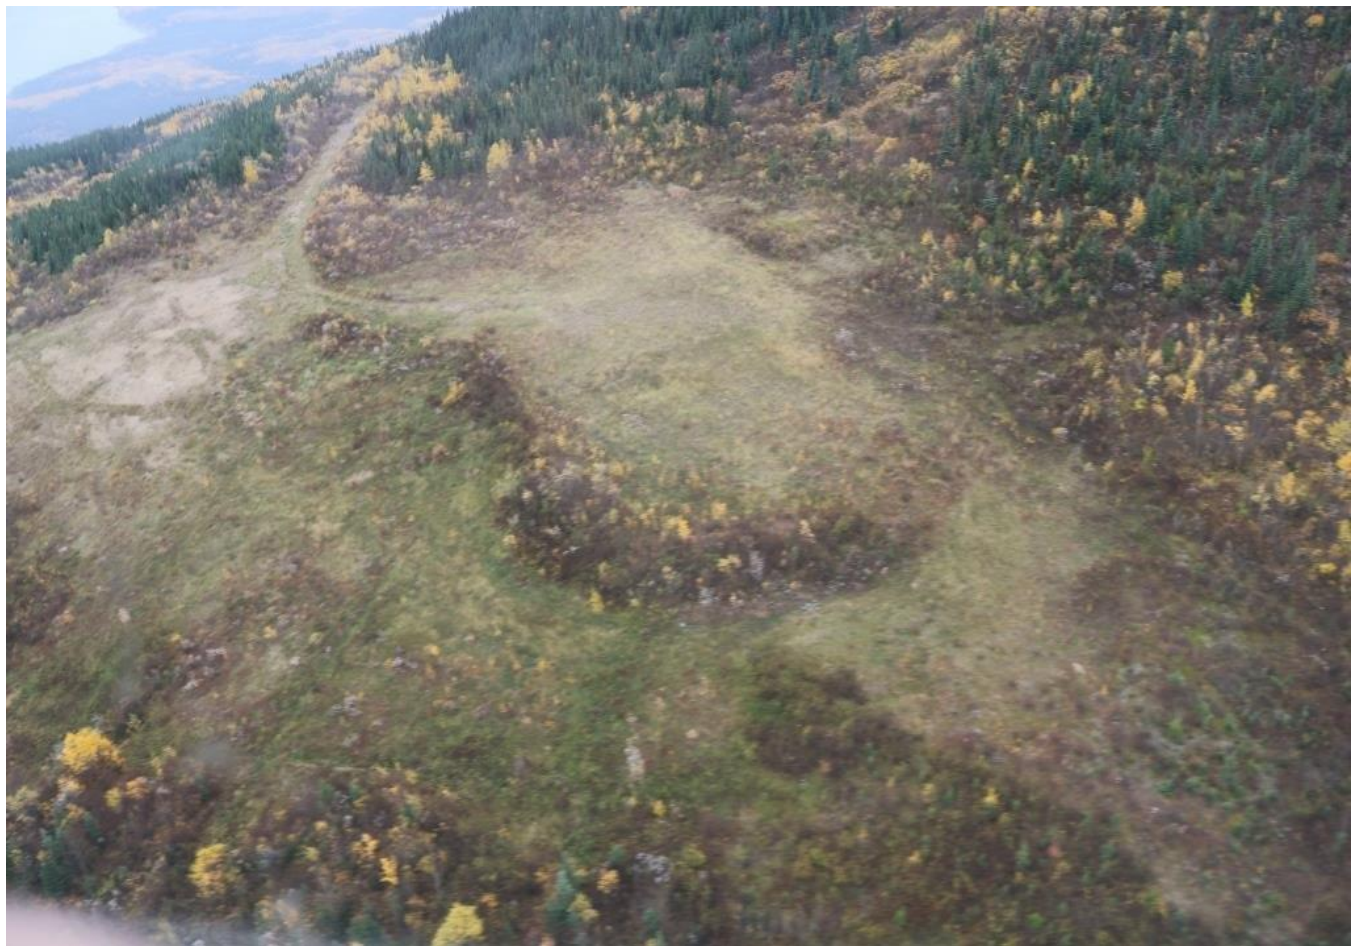
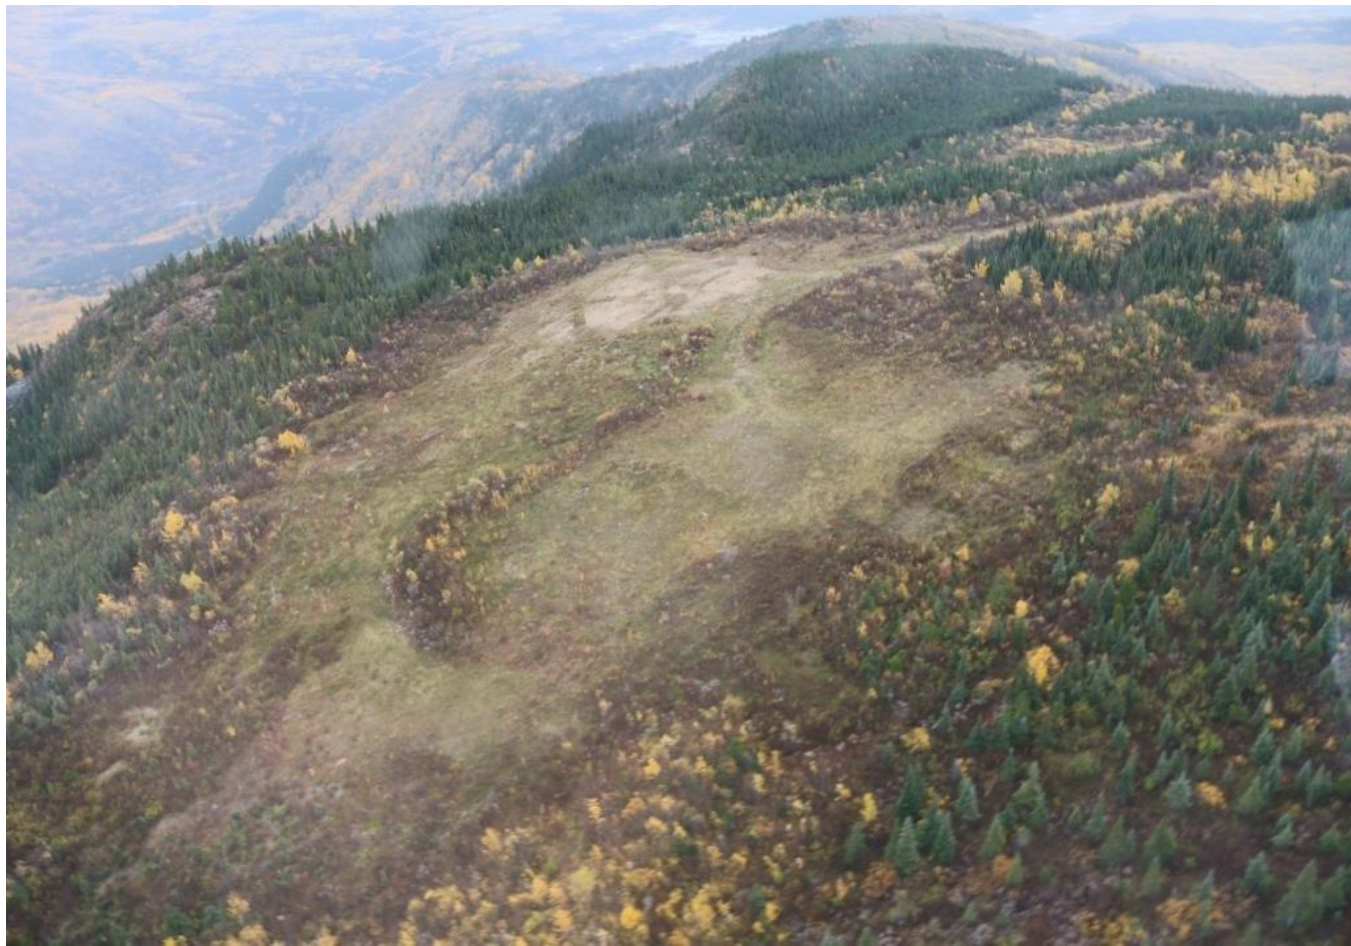
A-1: Vegetation growth was present. There was ground water monitoring wells and a sign. The Inspector has no concerns with this site.

Figure 1
A-1

Figure 2
A-1

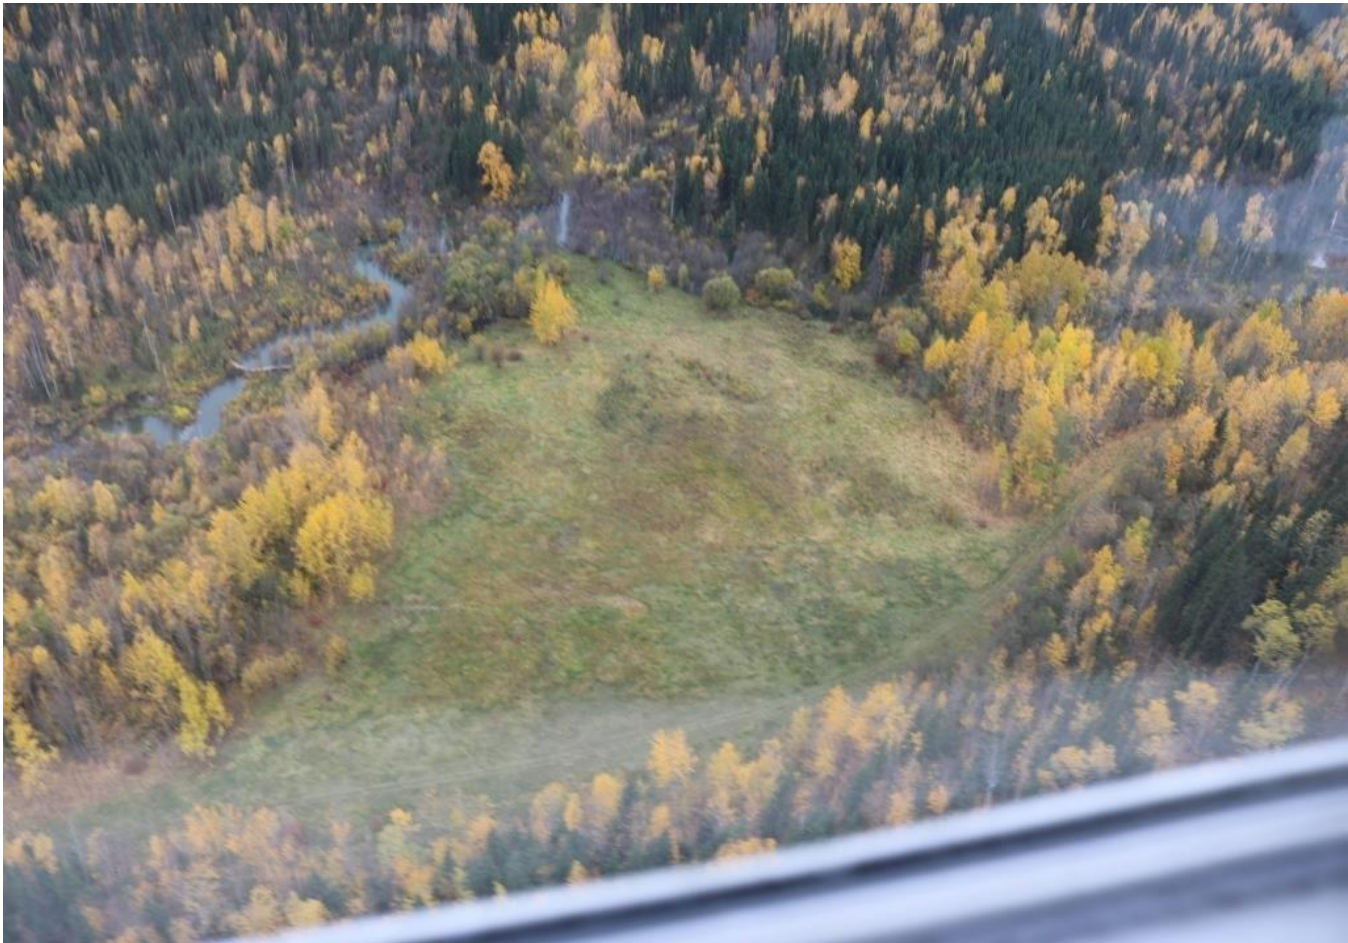
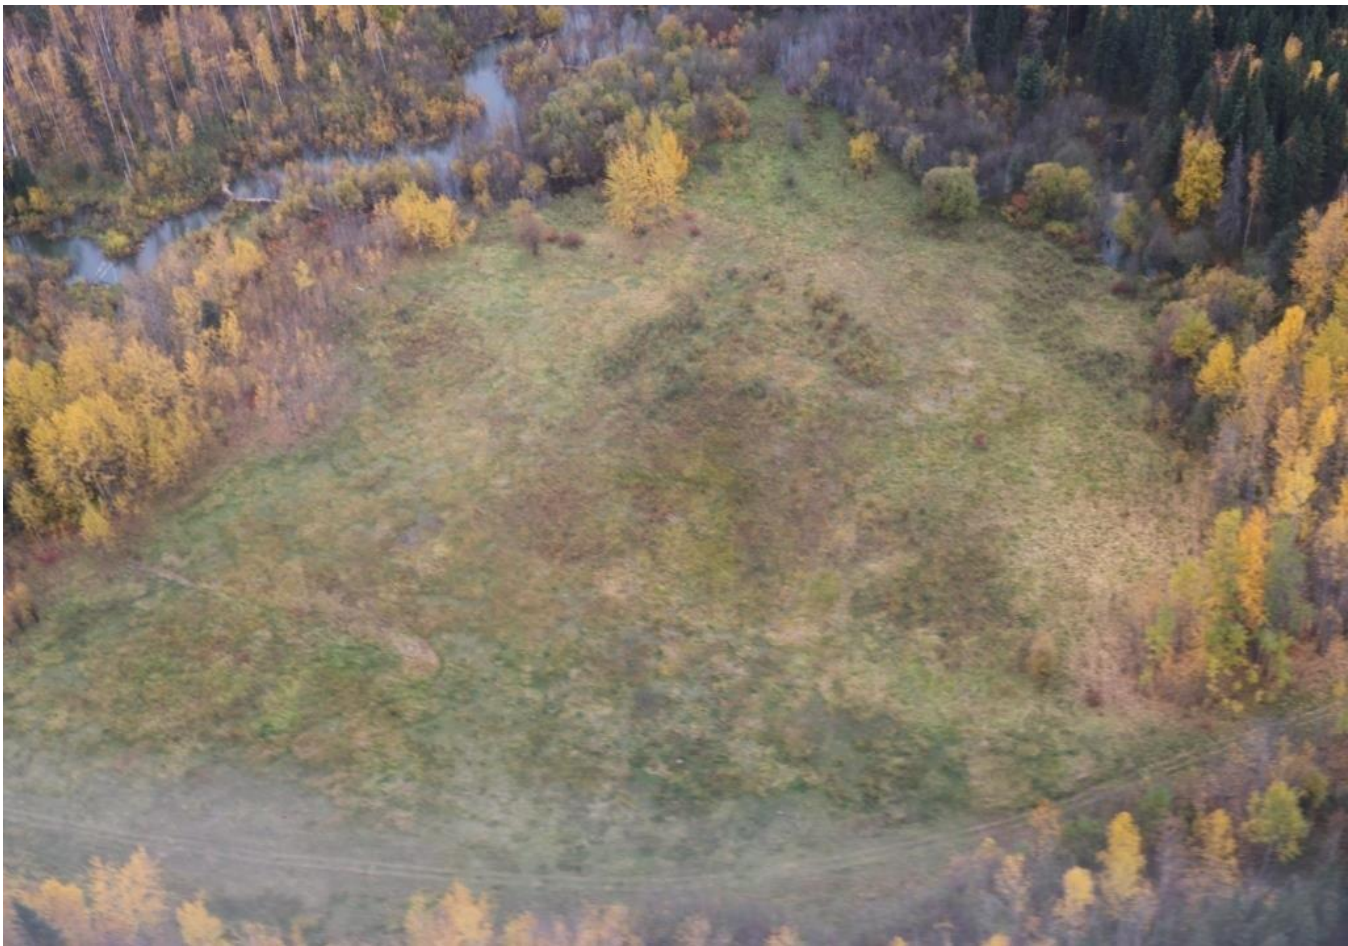
A-2: Vegetation growth was present. There was a ground water monitoring well and a sign. The Inspector has no concerns with this site.

Figure 3
A-2

Figure 4
A-2

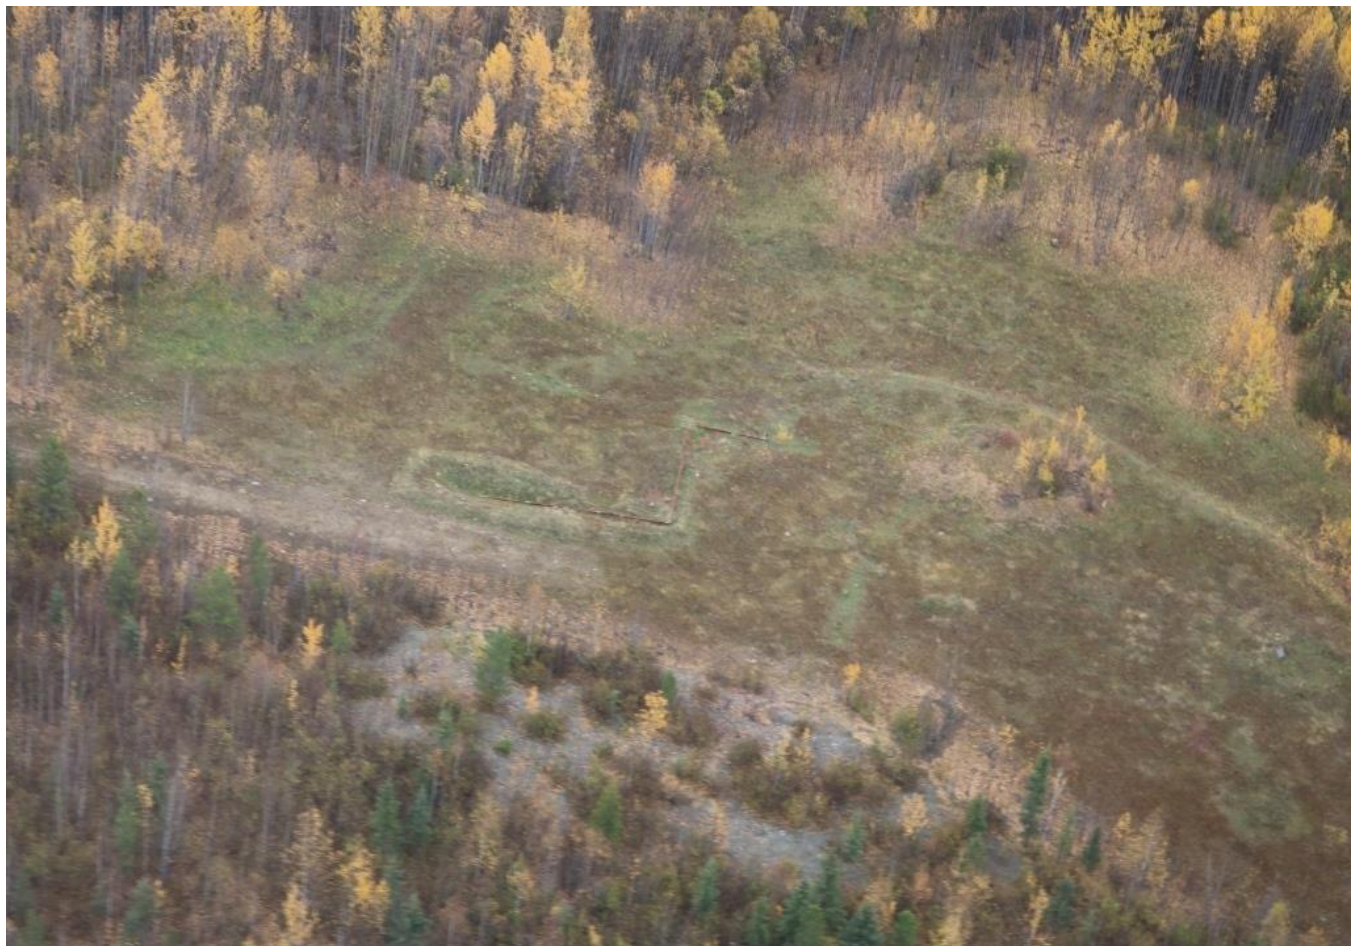
Figure 5
A-3

A-3: Vegetation growth was present throughout the site. There were pipes still present on the site.

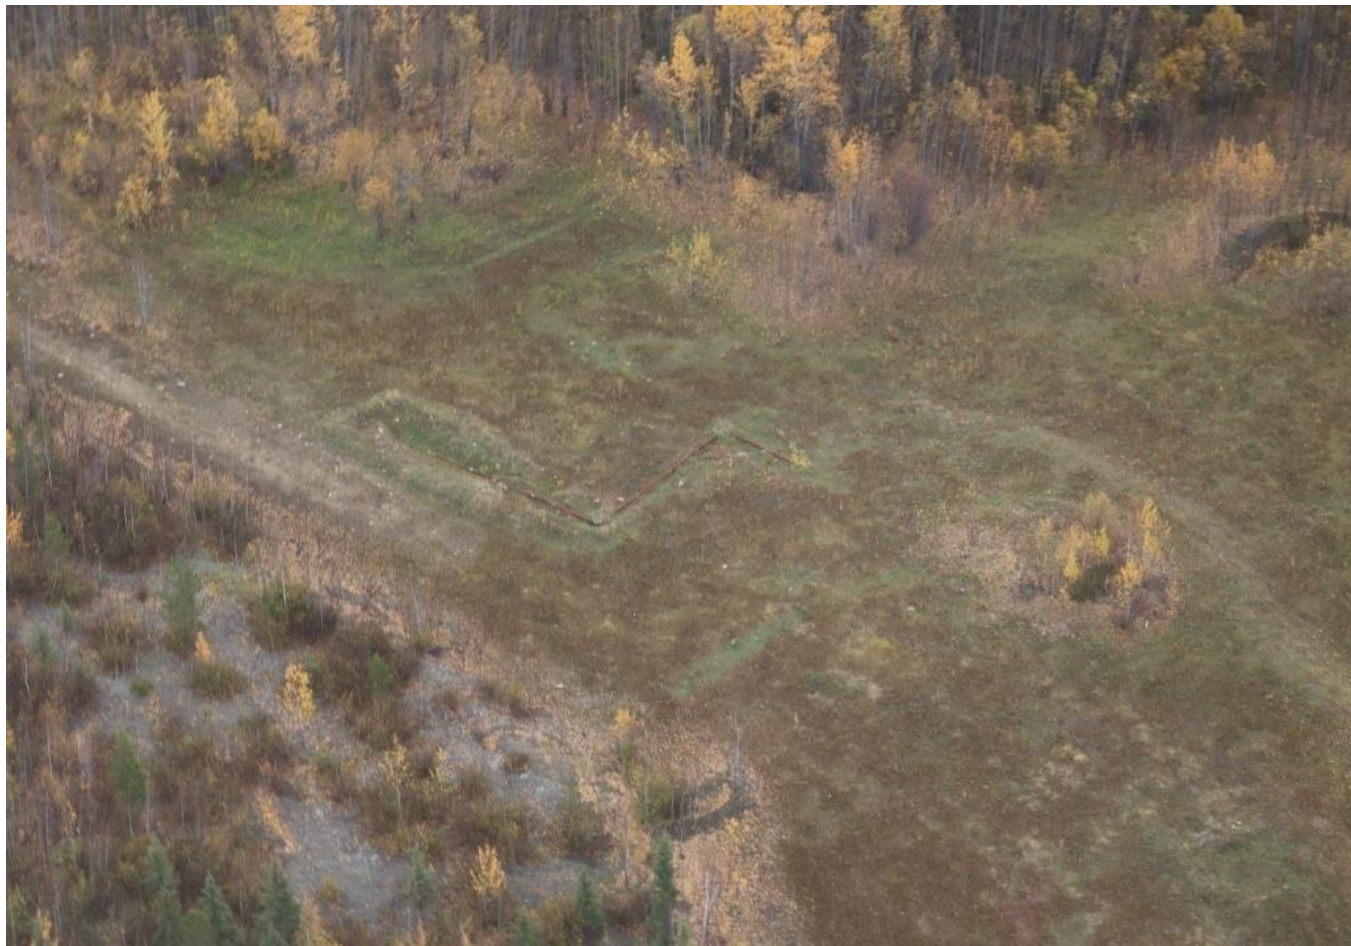
Figure 6
A-3- Note Pipes

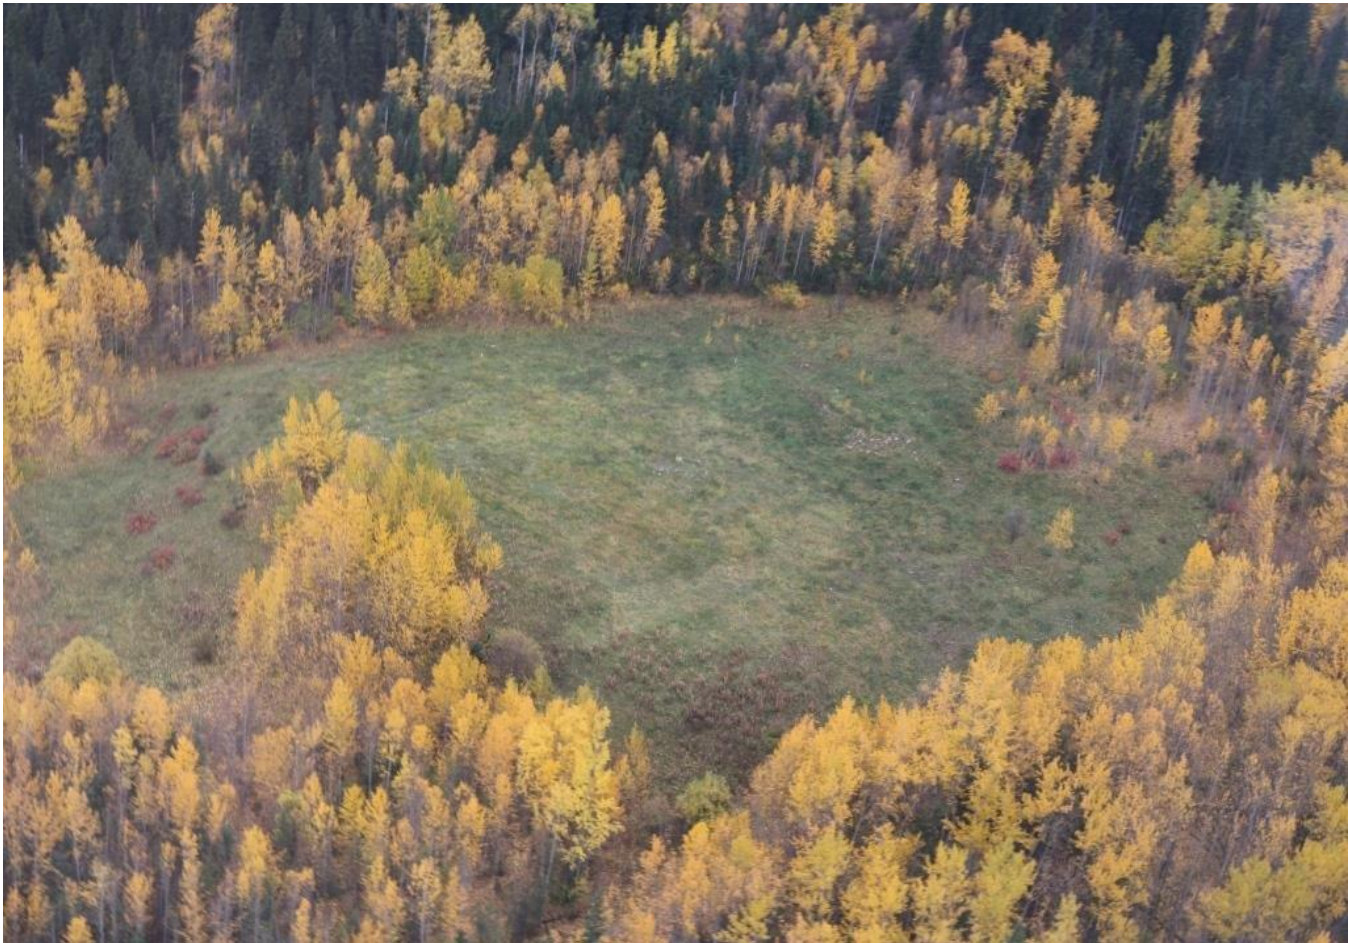
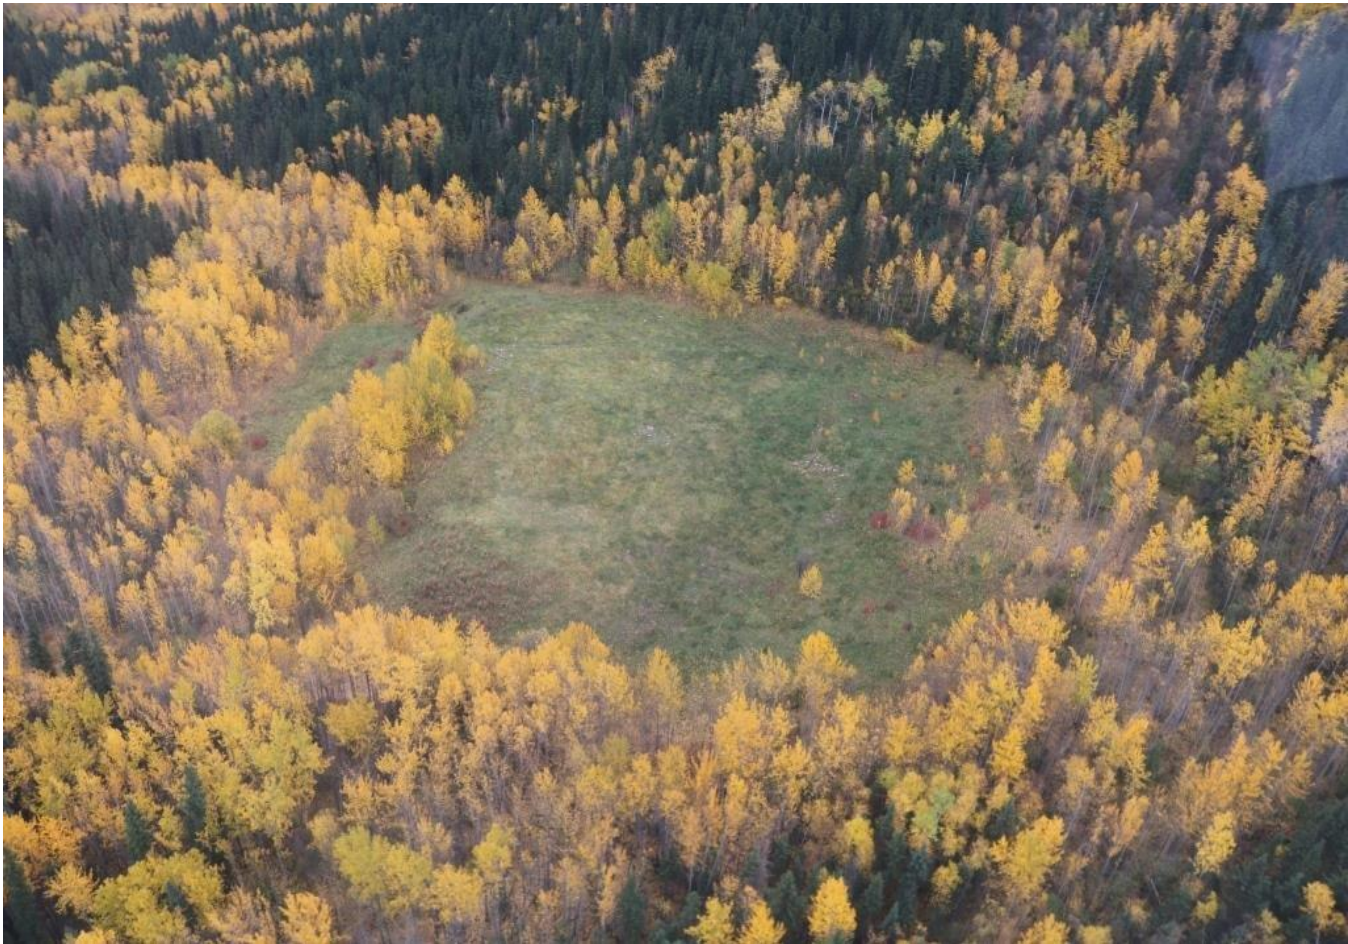
A-4: Vegetation growth was present throughout the site. There was a sign where the wellhead used to be. The Inspector has no concerns with this site.

Figure 7
A-4

Figure 8
A-4

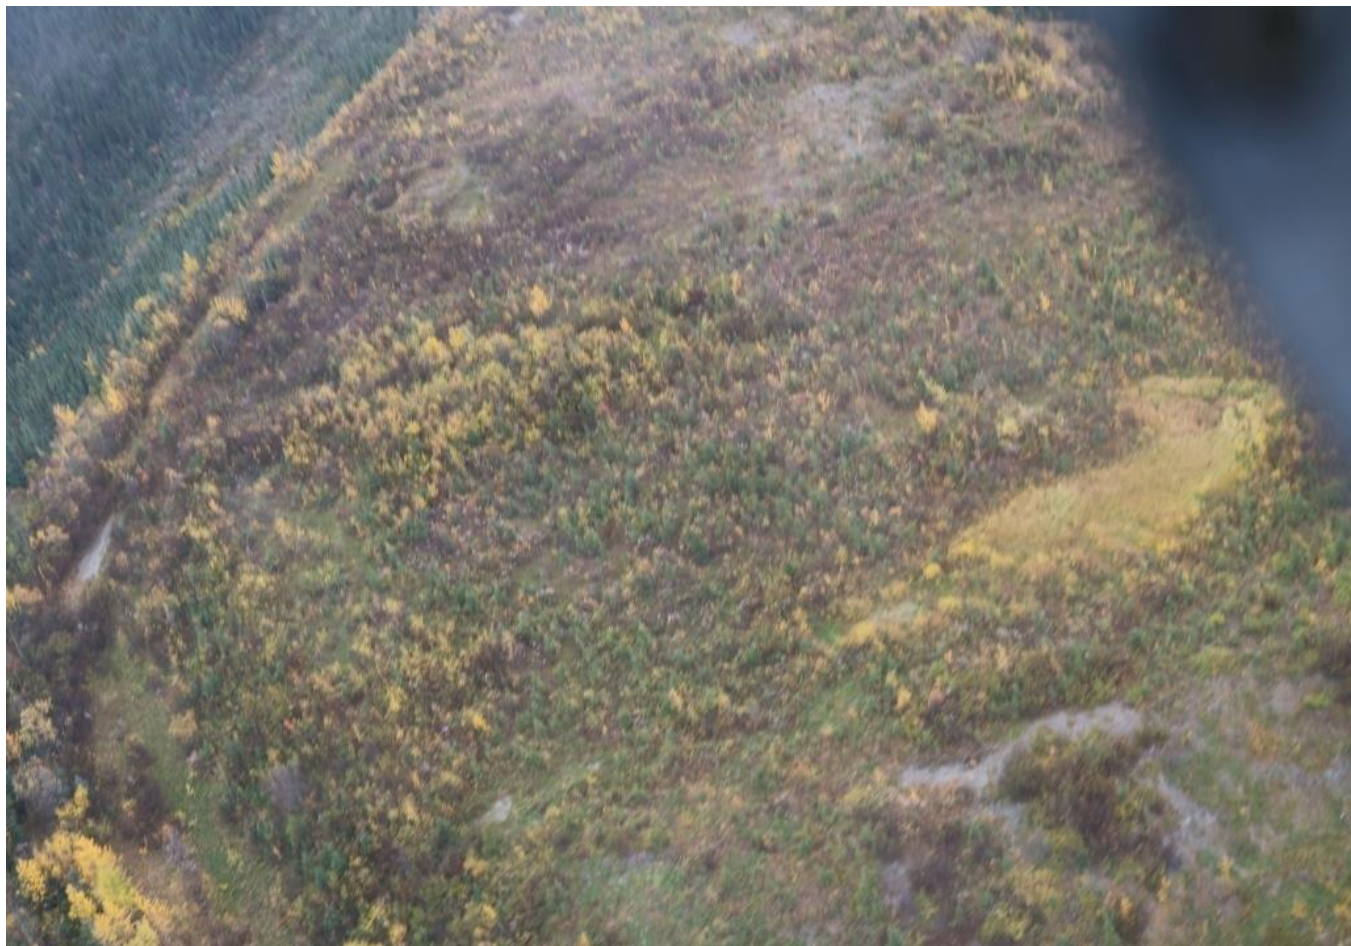
B-1: Vegetation growth was present throughout the site. There was a sign where the wellhead used to be. The Inspector has no concerns with this site.

Figure 9
B-1

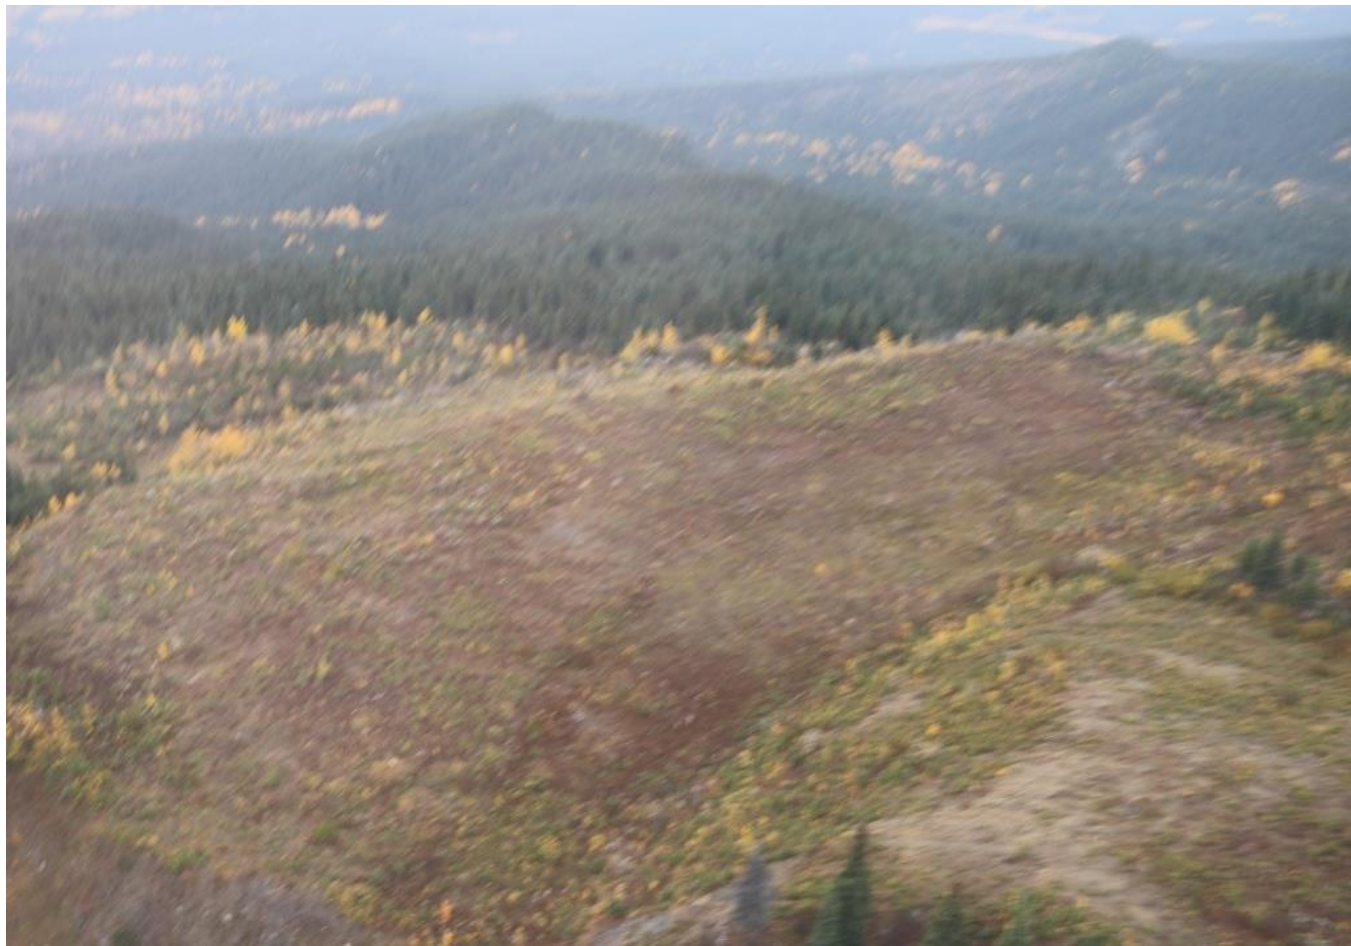
B-2: Vegetation growth was present throughout the site. There was a groundwater monitoring well. The Inspector has no concerns with this site.

Figure 10
B-2

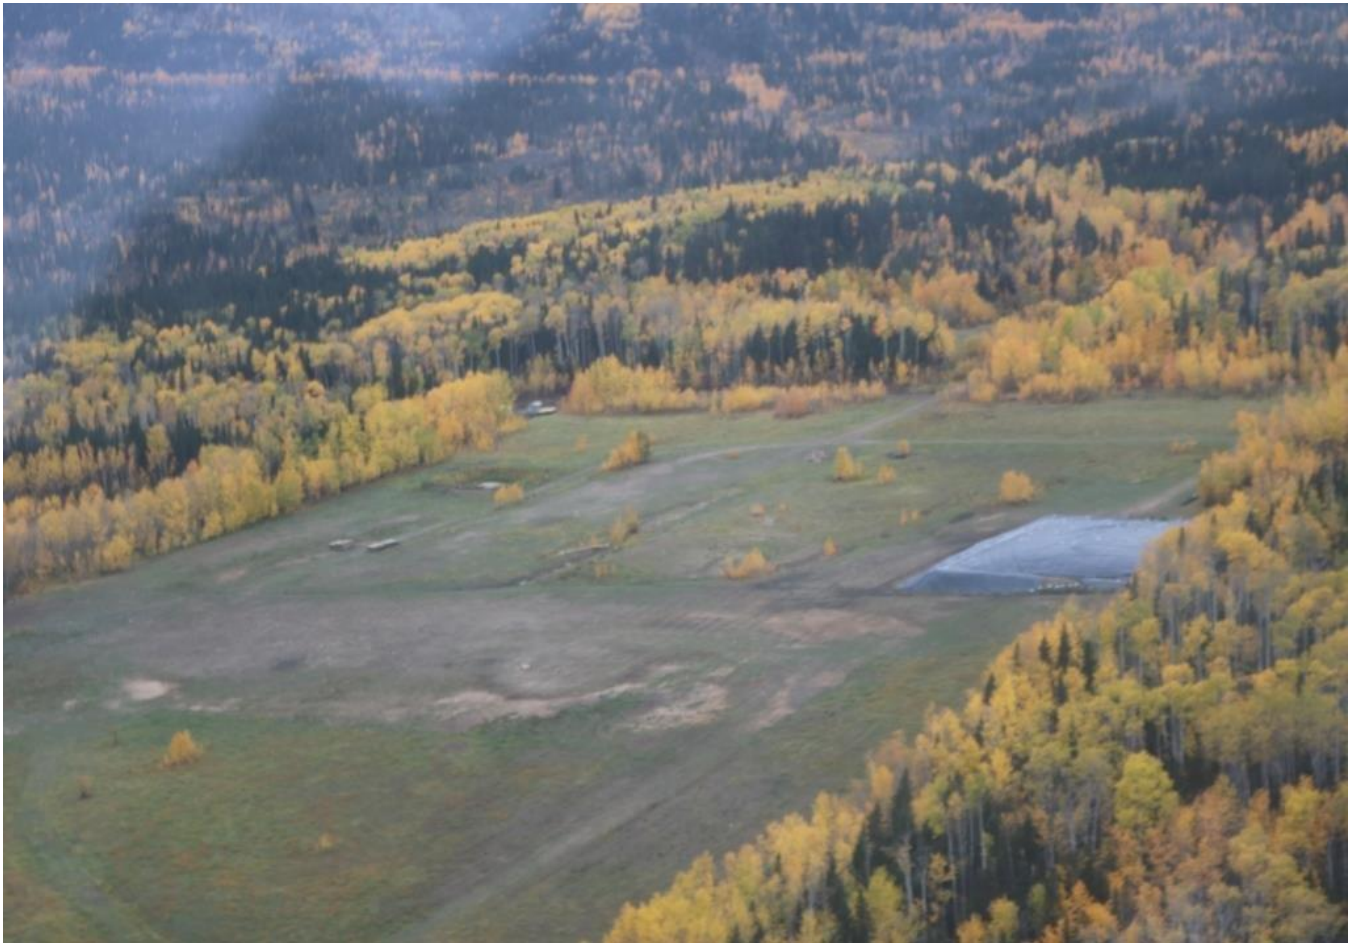
Figure 11
Plant Site

Plant Site: There was vegetation regrowth occurring where the surge pond, the cells and the clean backfill soil was removed from during last summers spill remediation. There was no ponding of water occurring, but the Inspector did note that there was erosion present throughout the remediated site. The fencing around the contaminated soil pile and the berm were intact at the time of the inspection. The Inspector did note that a section of the covering was not in place and was bunched up near the contaminated soil. This covering should be fixed as soon as possible to prevent any of the contaminated soil spreading to other areas of the site.

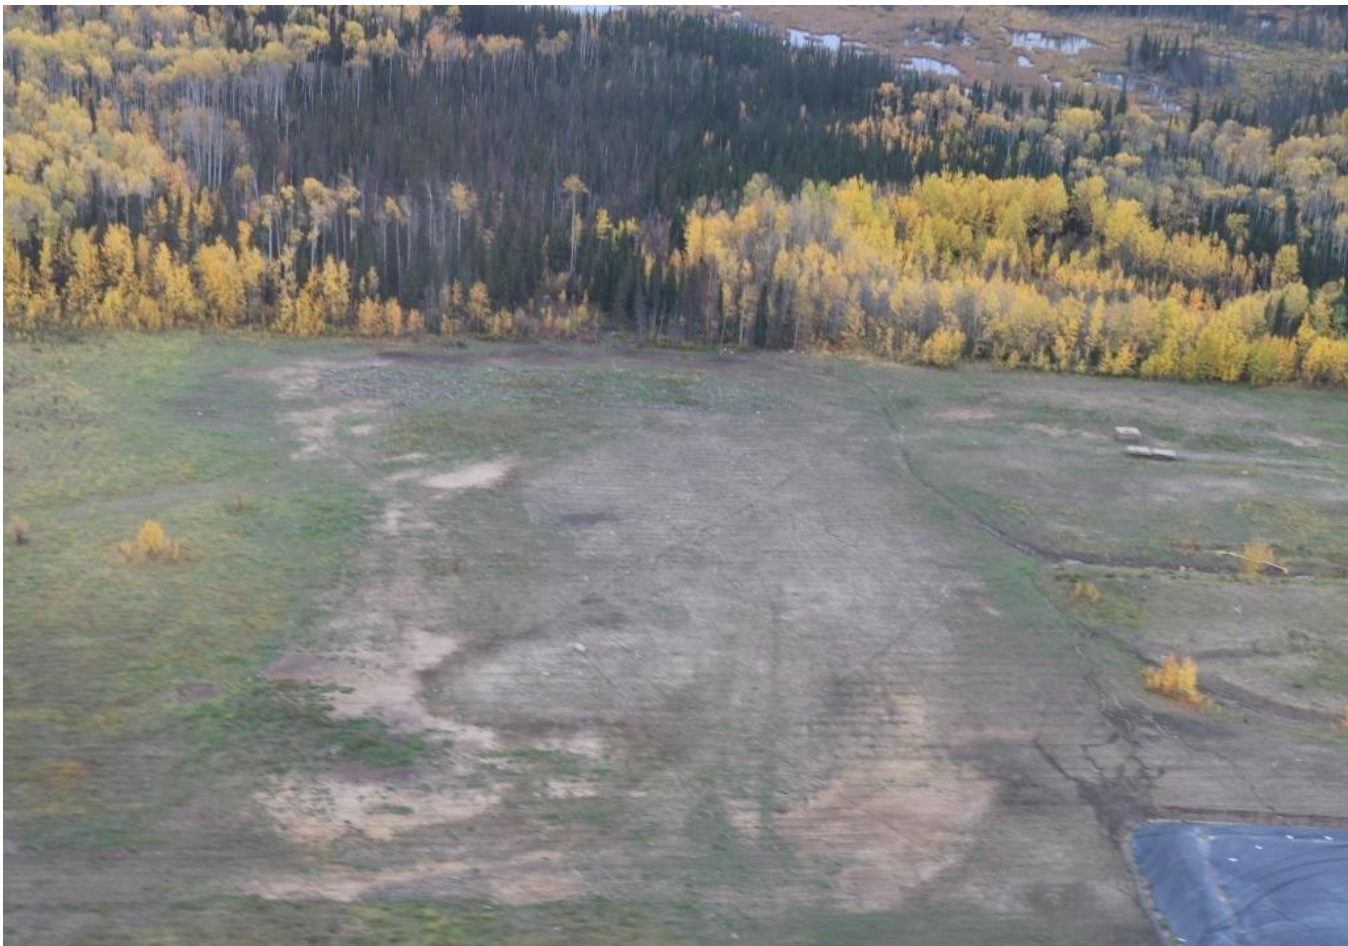
Figure 12
Plant Site- Note Erosion

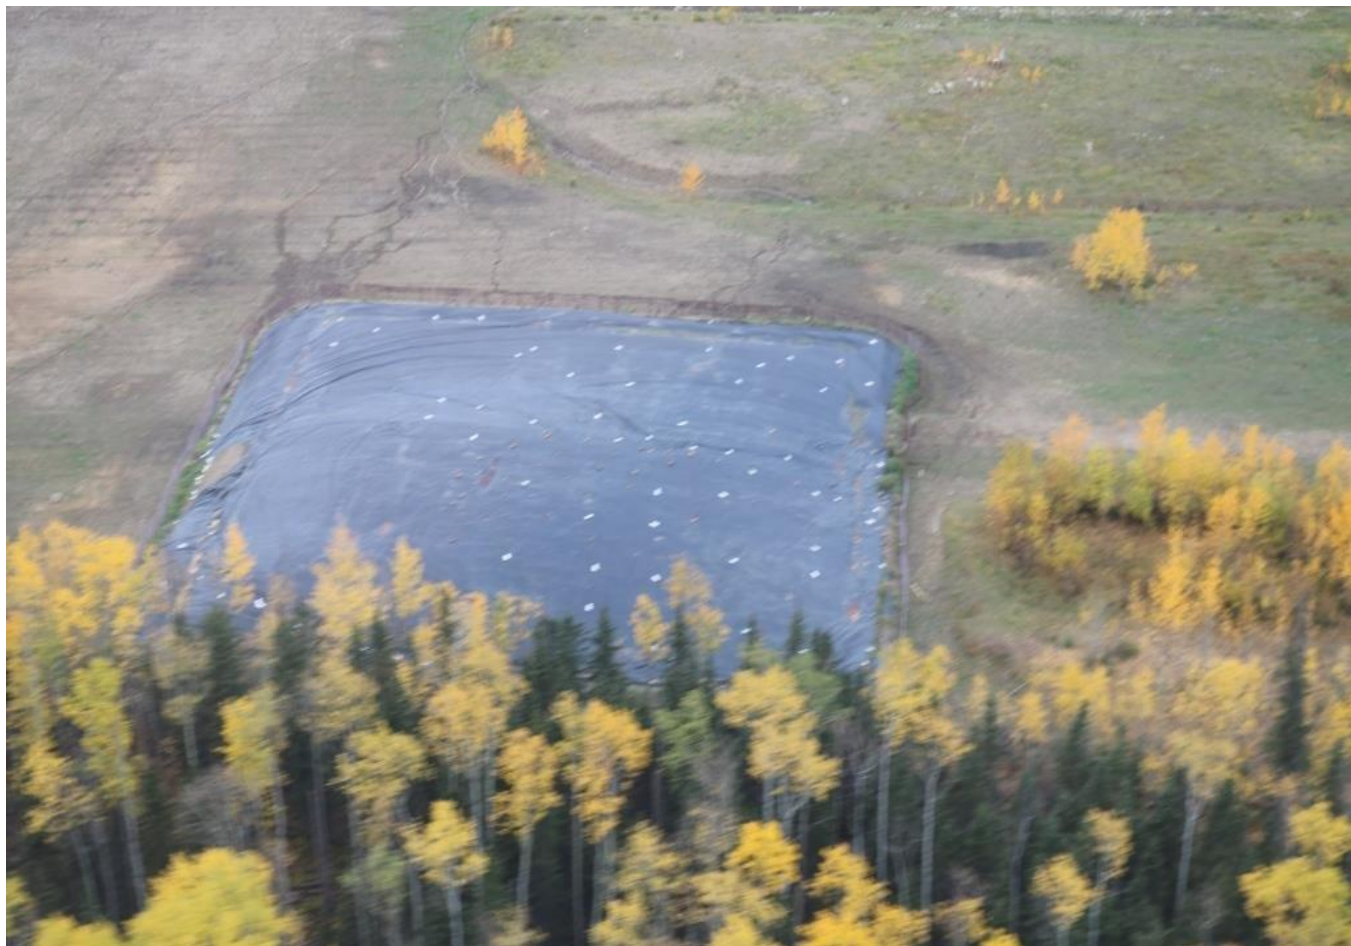
Figure 13
Plant Site- Note Erosion

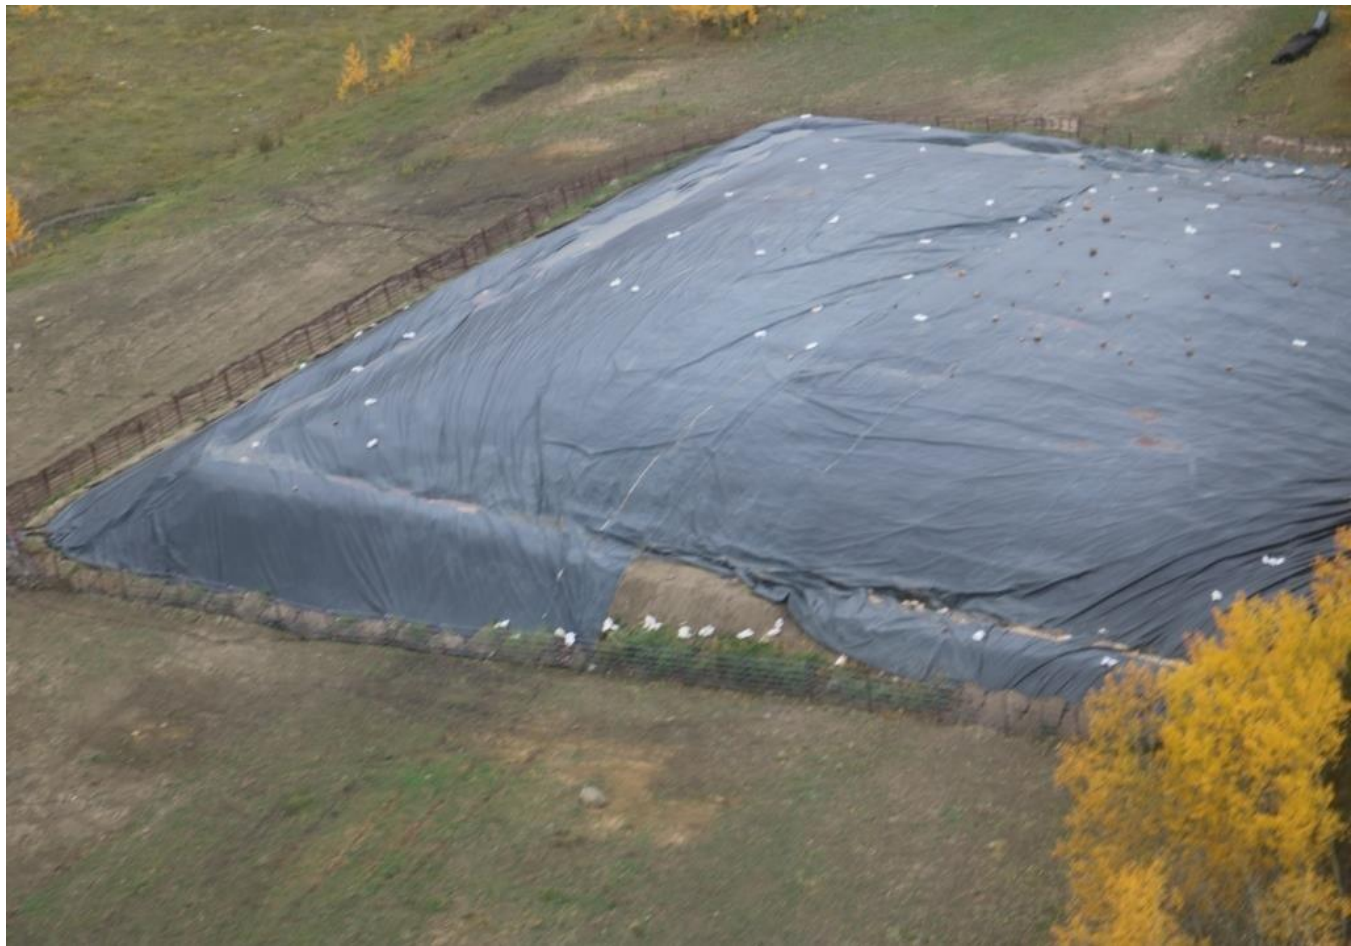
Figure 14
Plant Site- Note Cover
