<b>File Number</b>	<b>MV2014X0011</b>
<b>Type of Operation</b>	<b>MISC.</b>
<b>Location</b>	Plant Site- NT Spill 202355

ENVIRONMENTAL INSPECTION REPORT

Permittee:	Paramount Resources Ltd.	Permit Expiry Date:	June 04, 2021
Land Use Permit No.	MV2014X0011	Previous Inspection:	August 24, 2022
Quarrying Permit No.		Inspection Date:	July 14, 2023
Contractor:		Subcontractor:	
Location(s) Inspected:	Plant Site- NT Spill 202355		
Current Stage of Operation:	Reverse Osmosis of Surge Pond		
Program Modifications Approved:

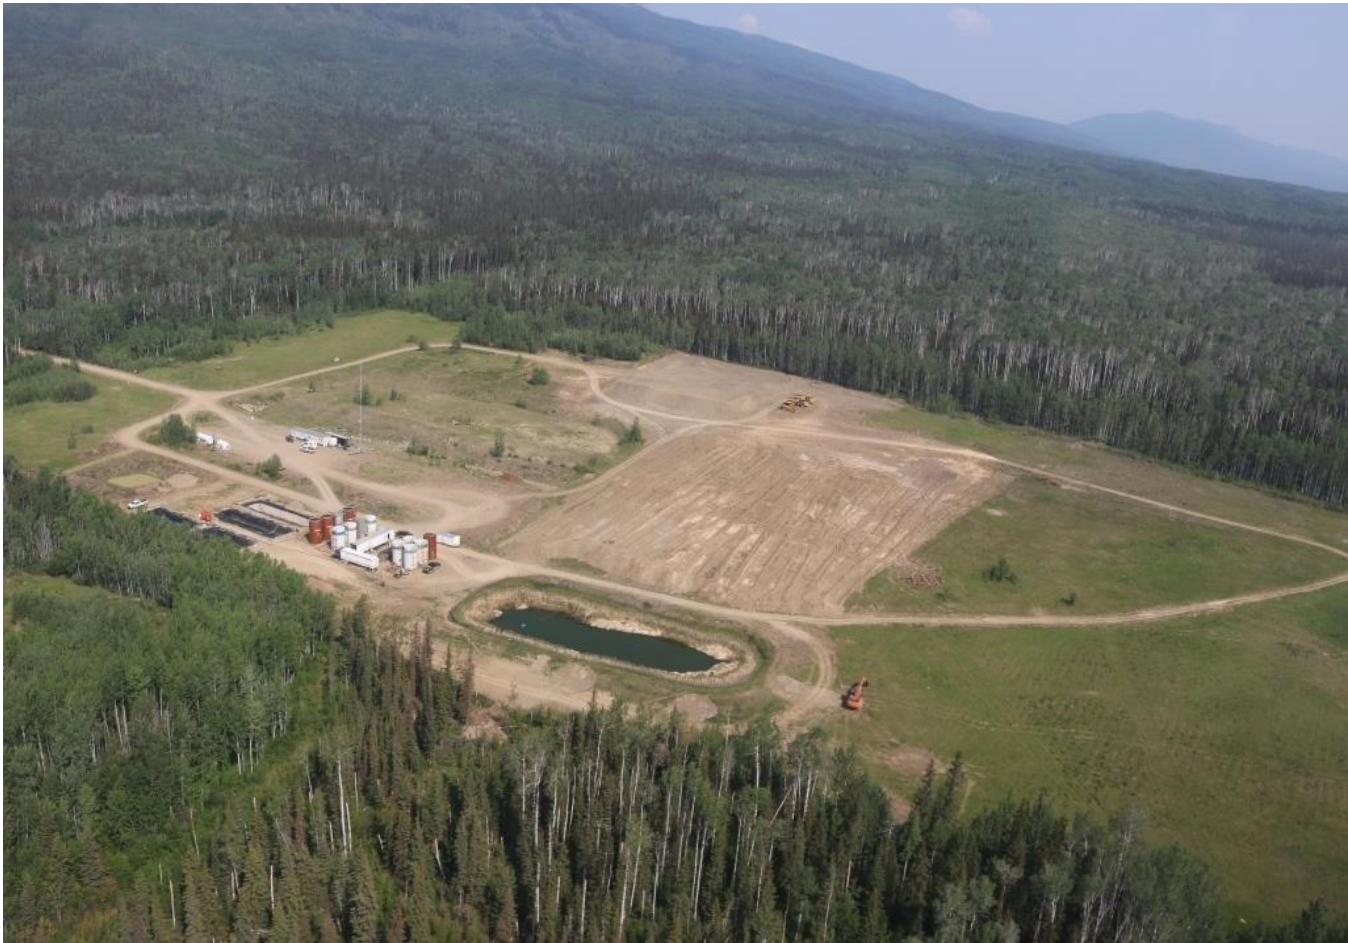
Figure 1  
Aerial of site

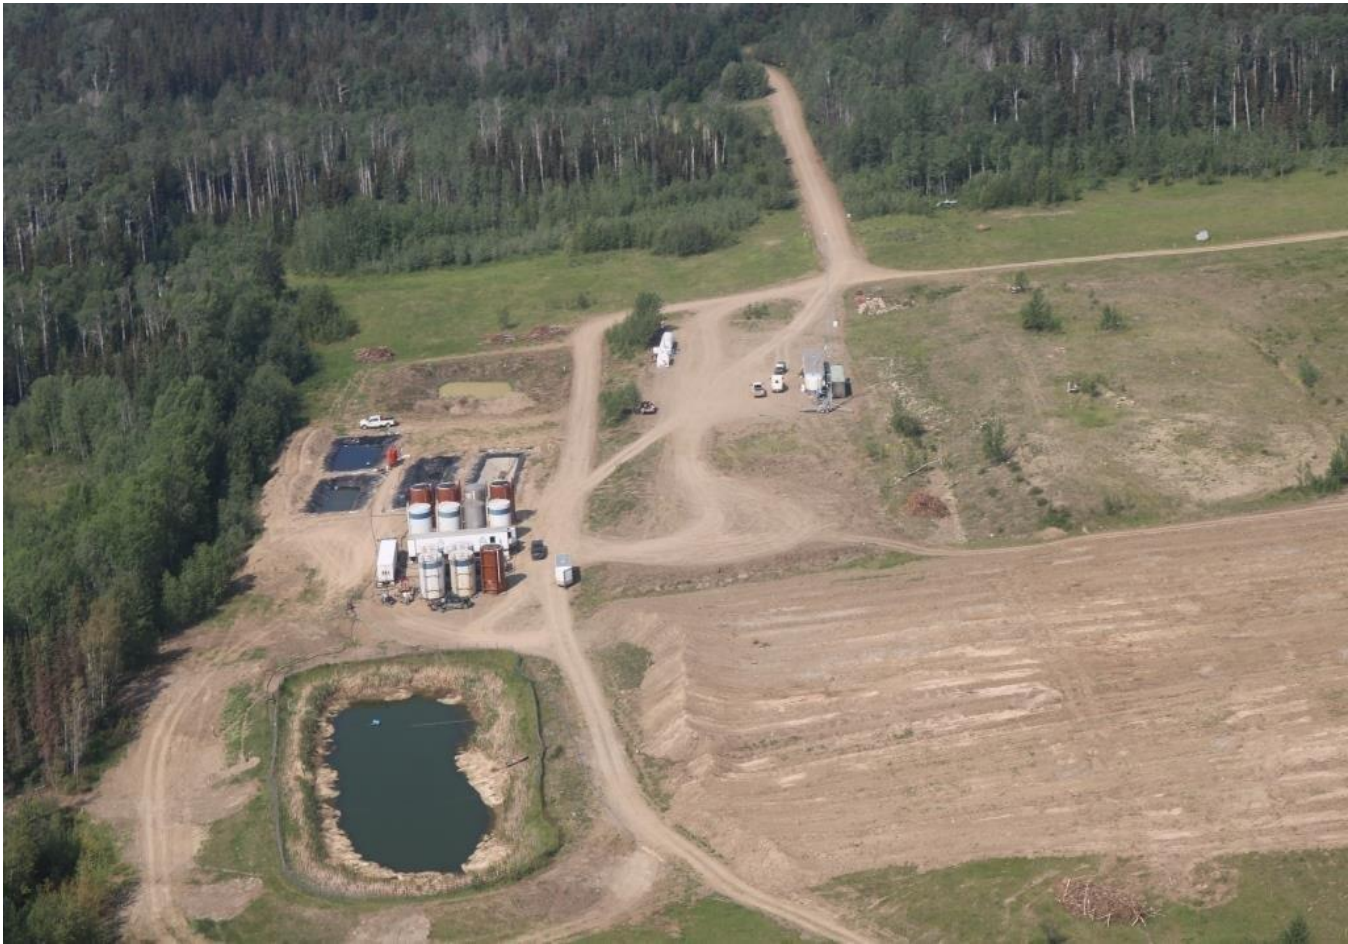
Figure 2  
Aerial of site

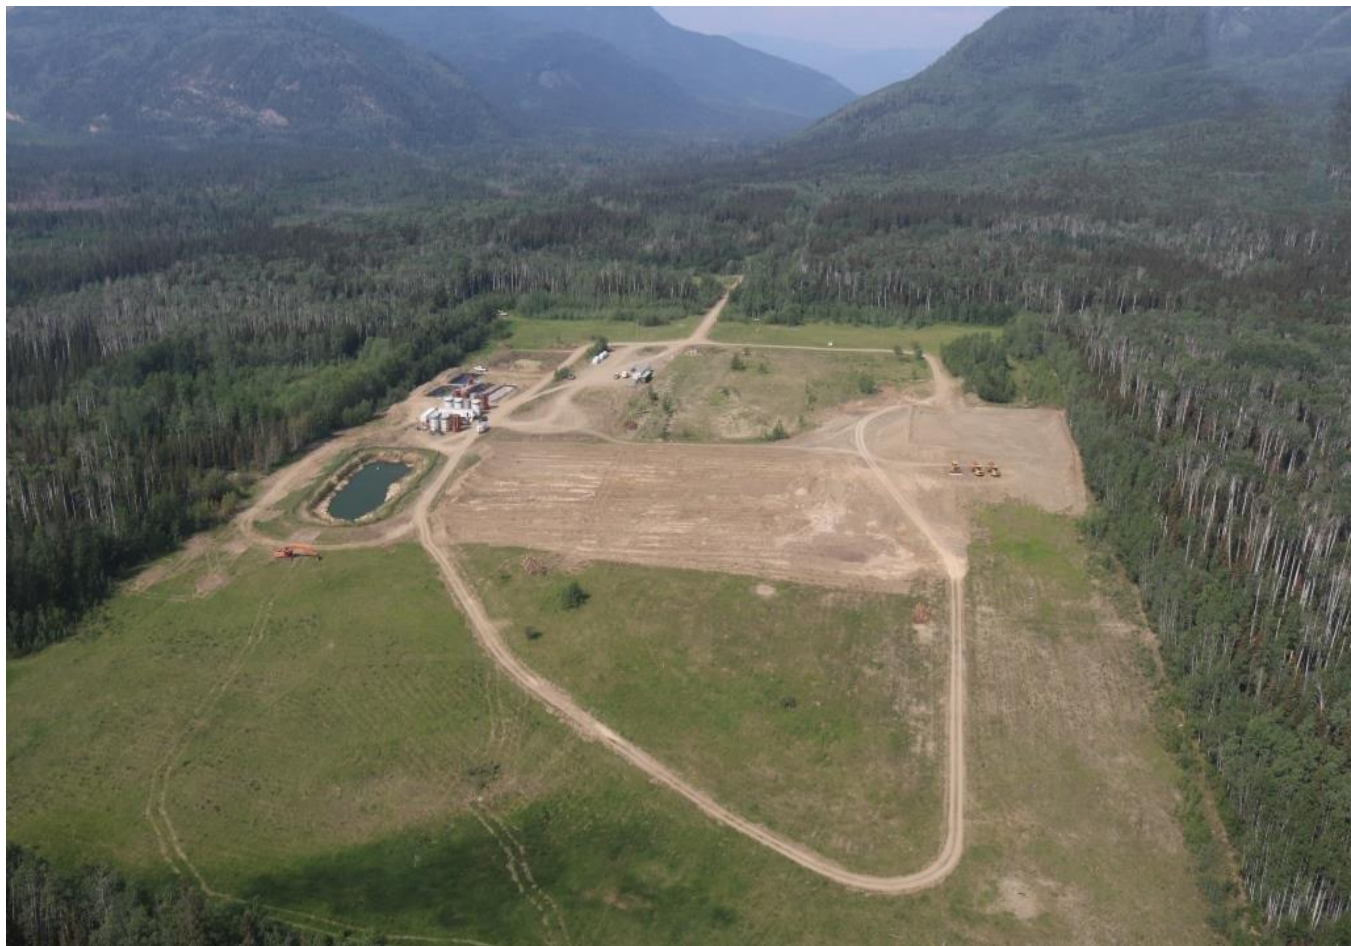
Figure 3  
Aerial of site

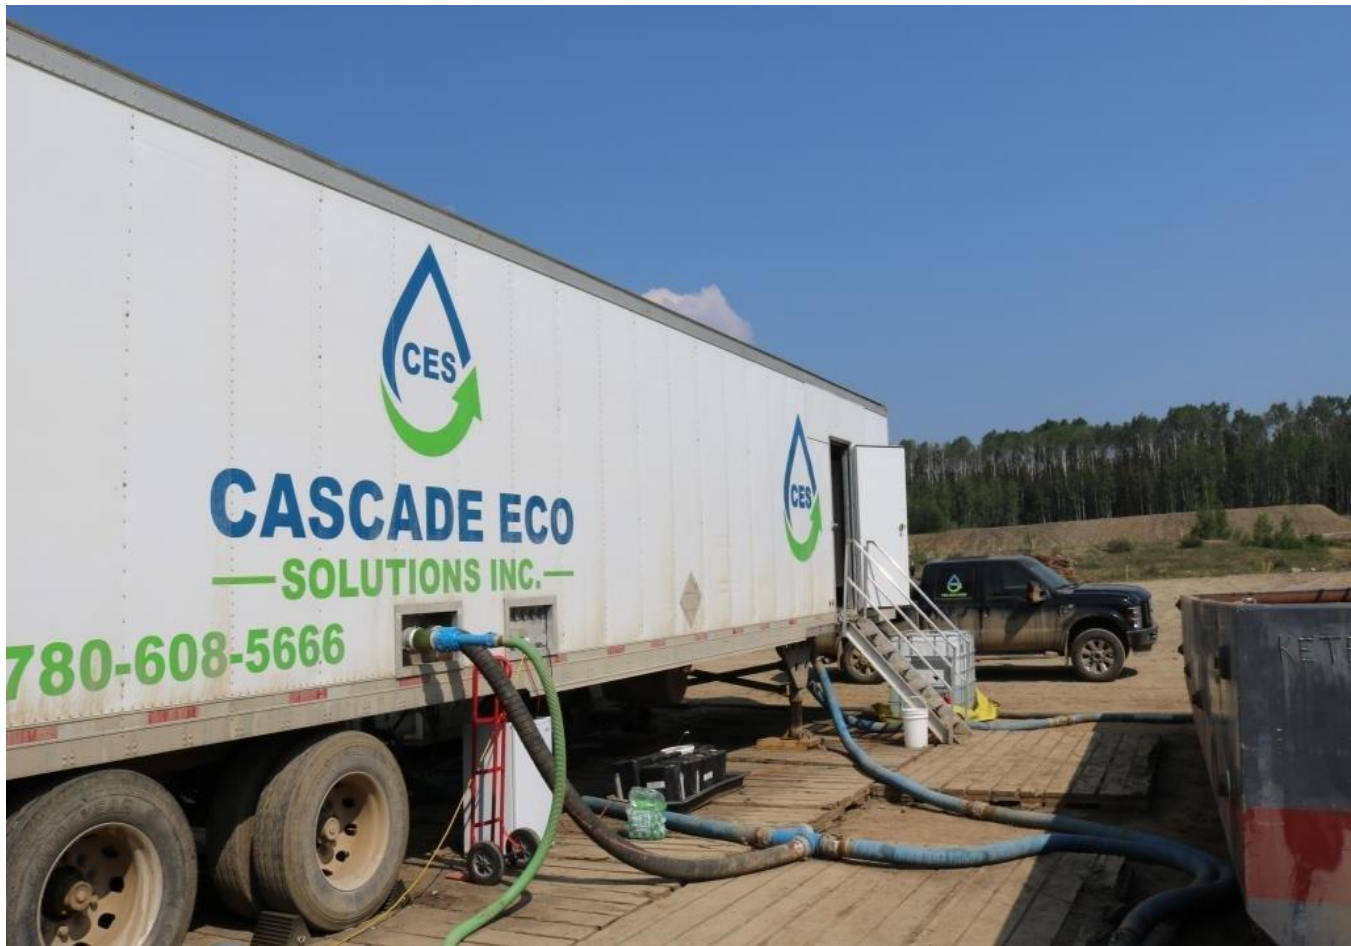
Figure 4  
Reverse osmosis trailer

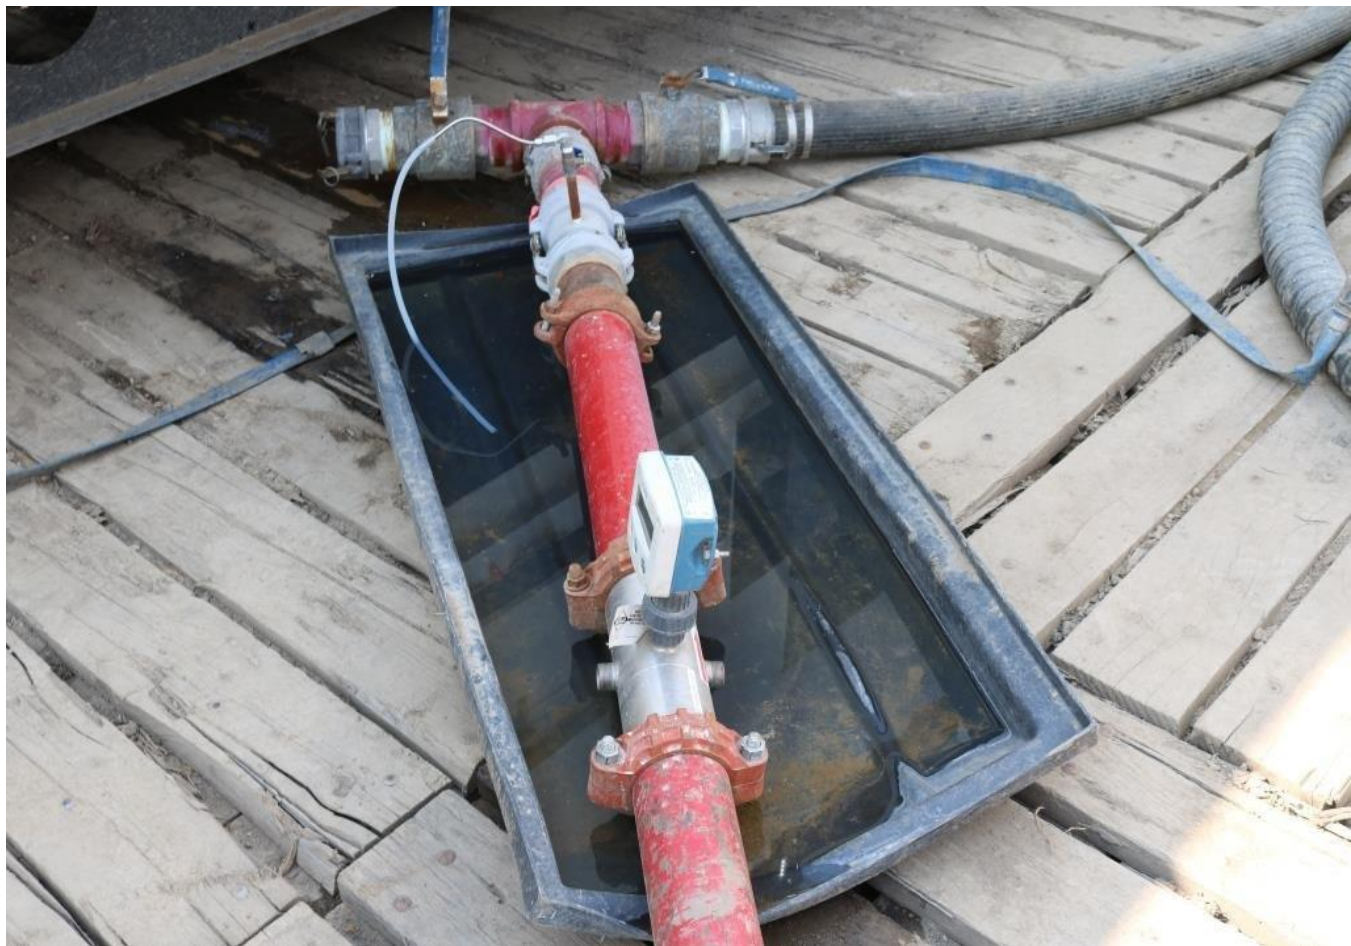
Figure 5  
Drip tray collecting leaking water

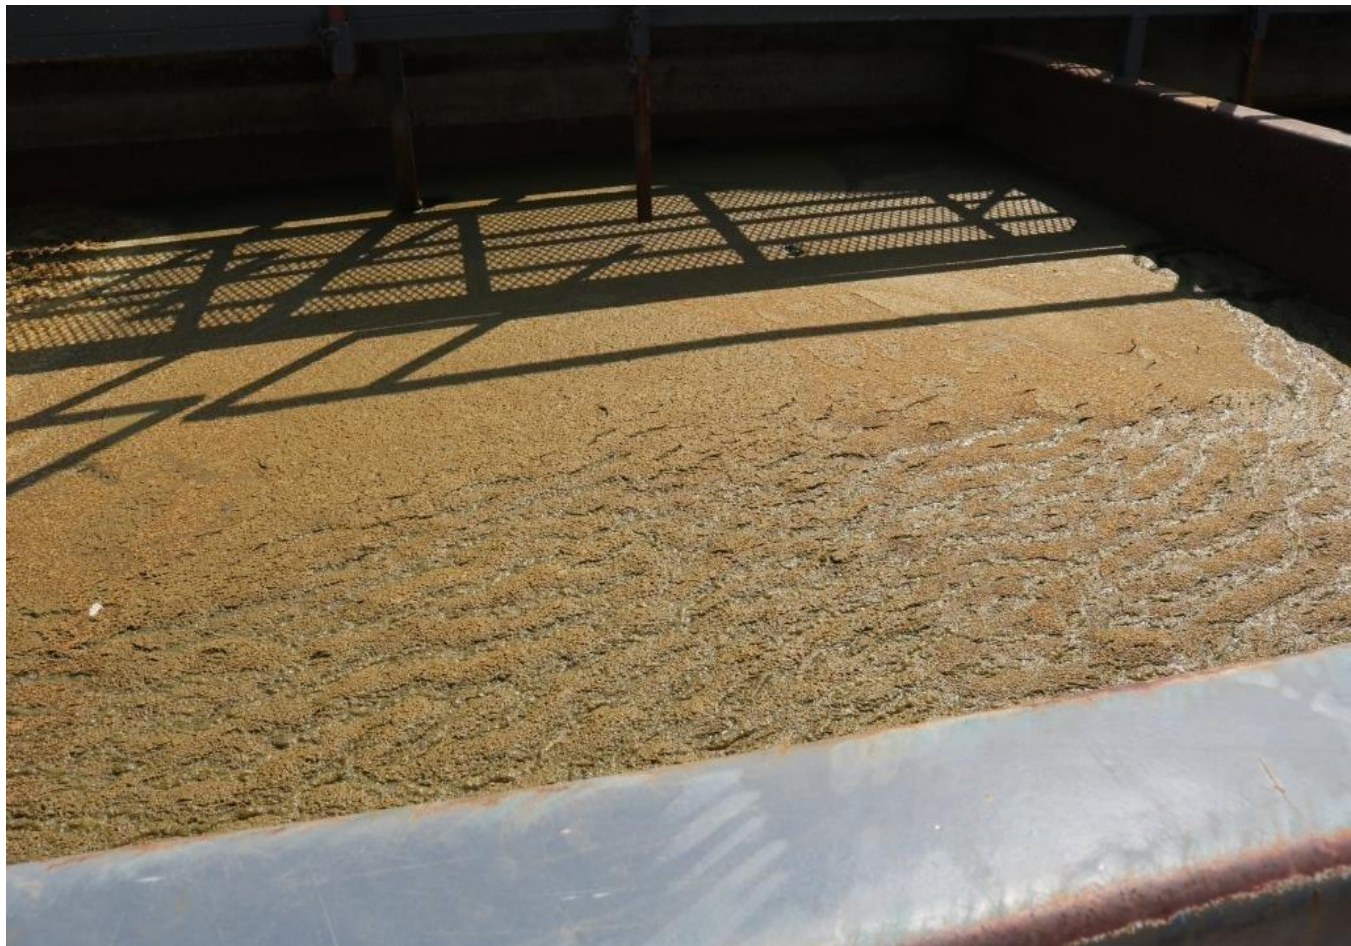
Figure 6  
Water from surge pond

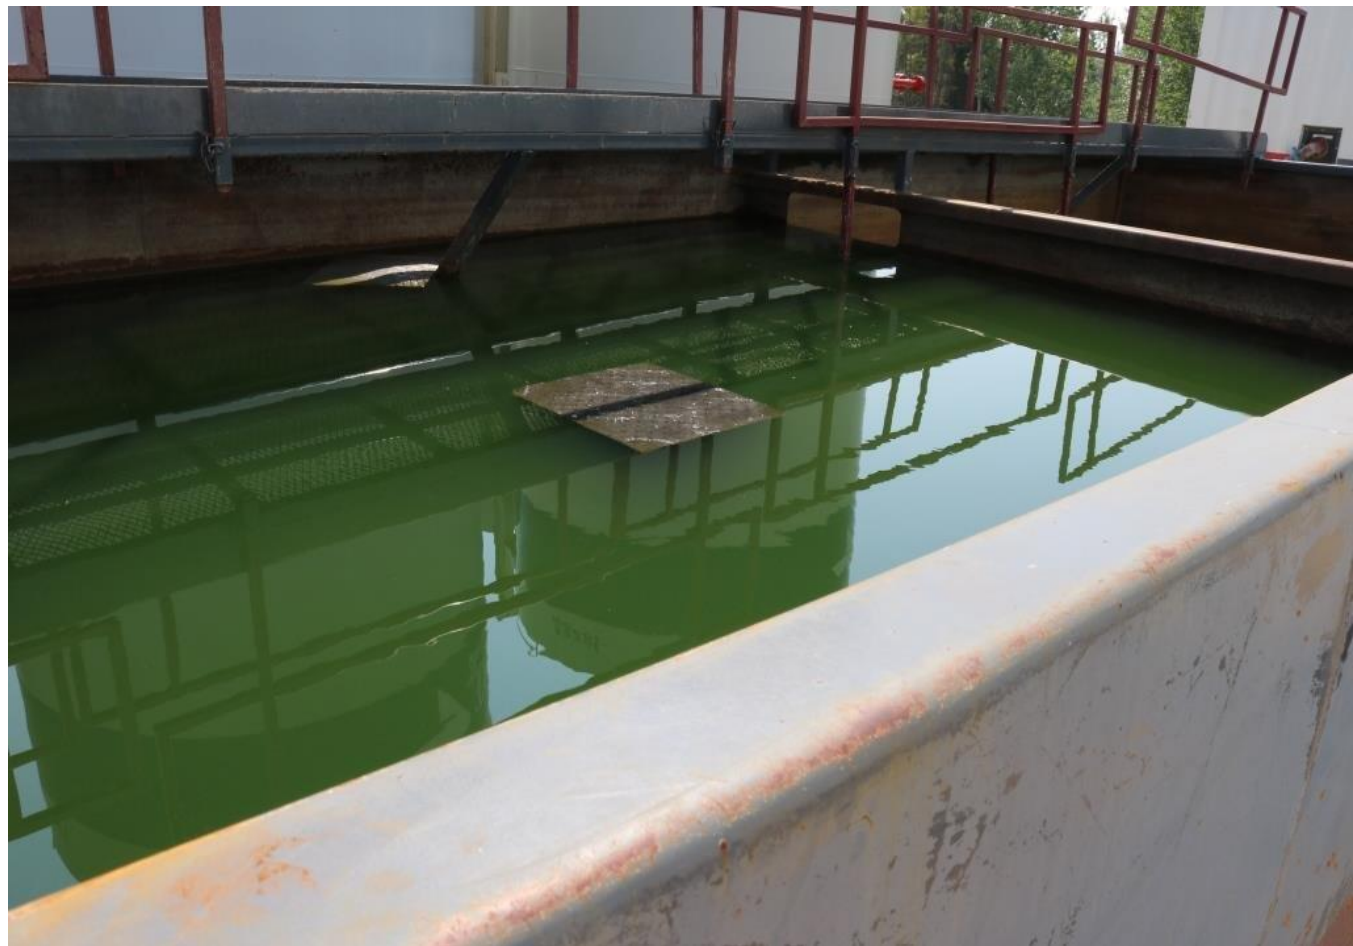
Figure 7  
First pass through filtration

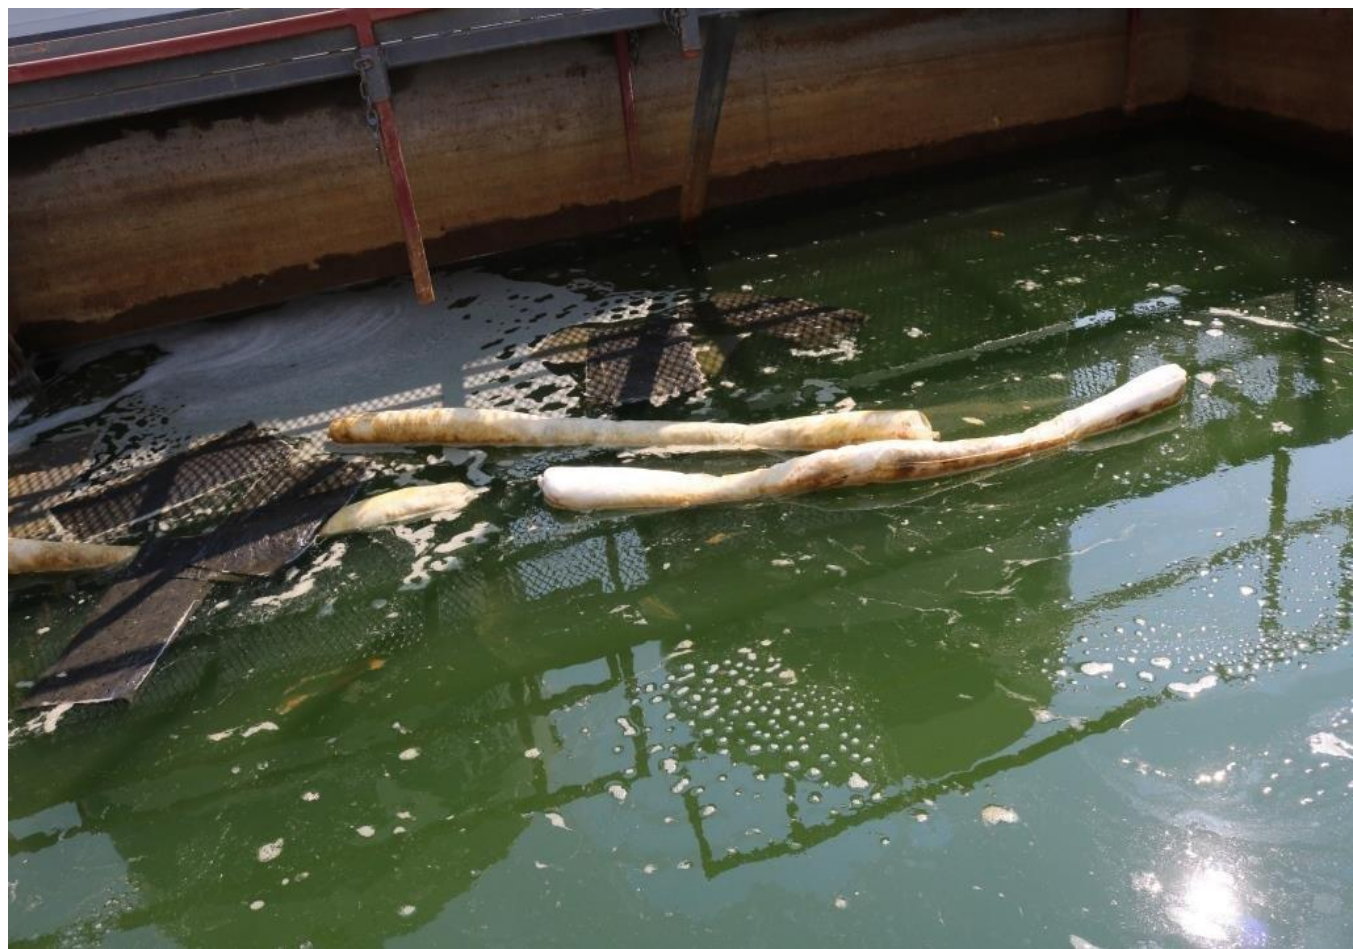
Figure 8  
Second pass through filtration

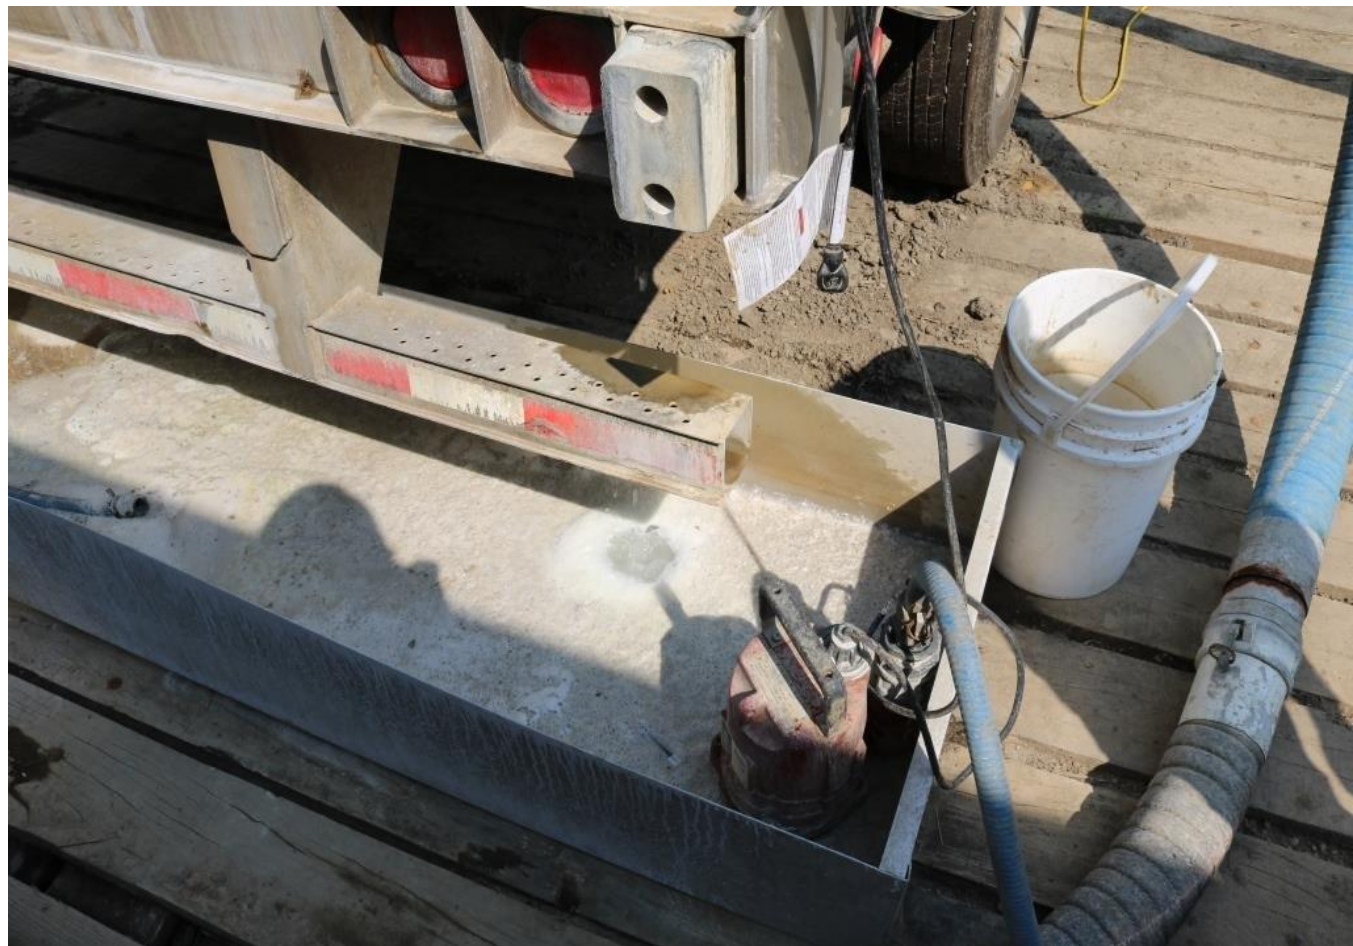
Figure 9  
Water collected from washing osmosis trailer floors

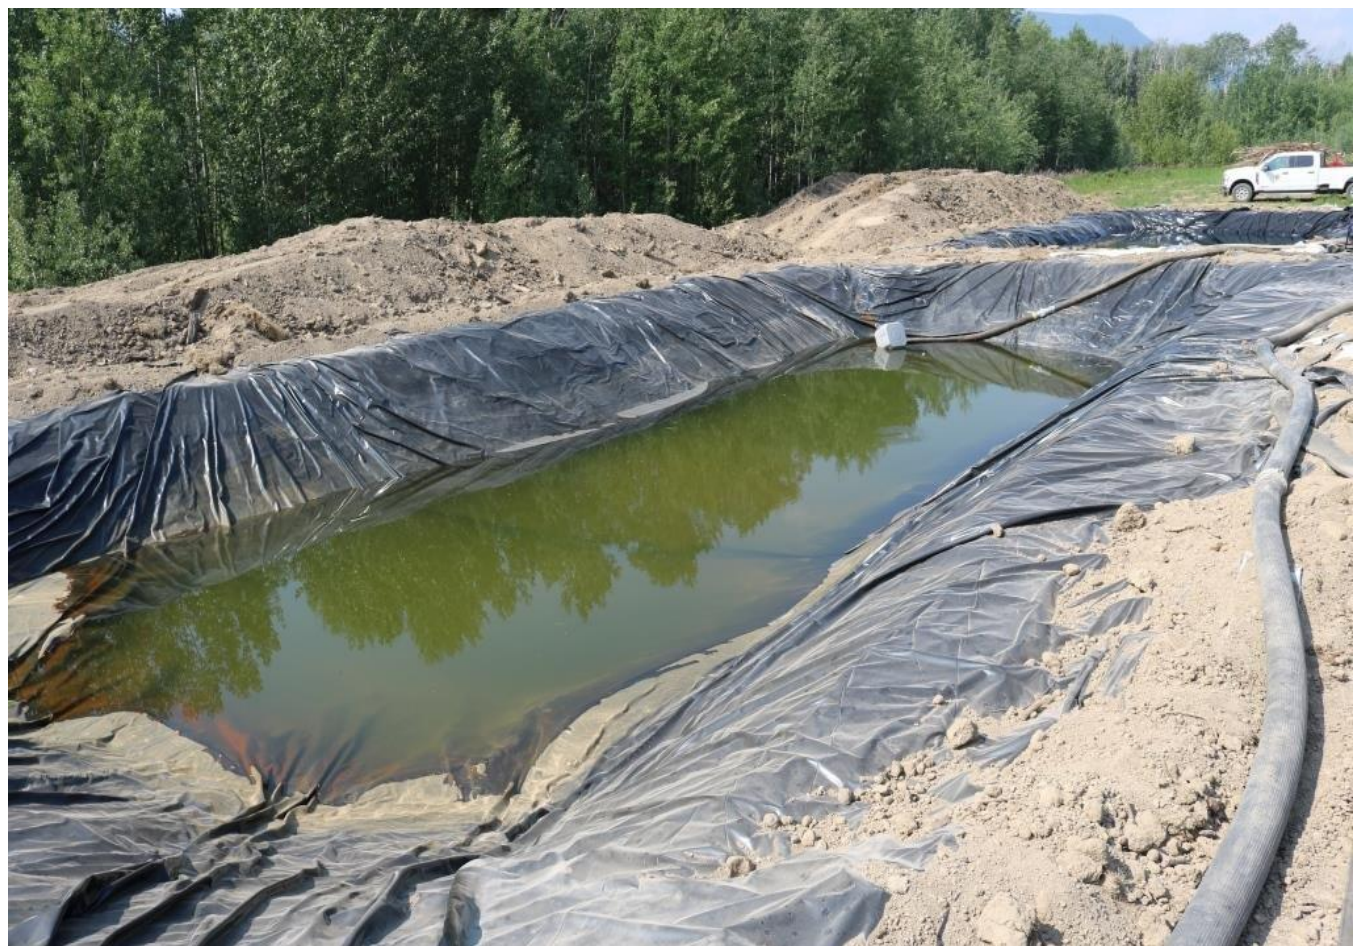
Figure 10  
Water stored in lined cell to go through reverse osmosis

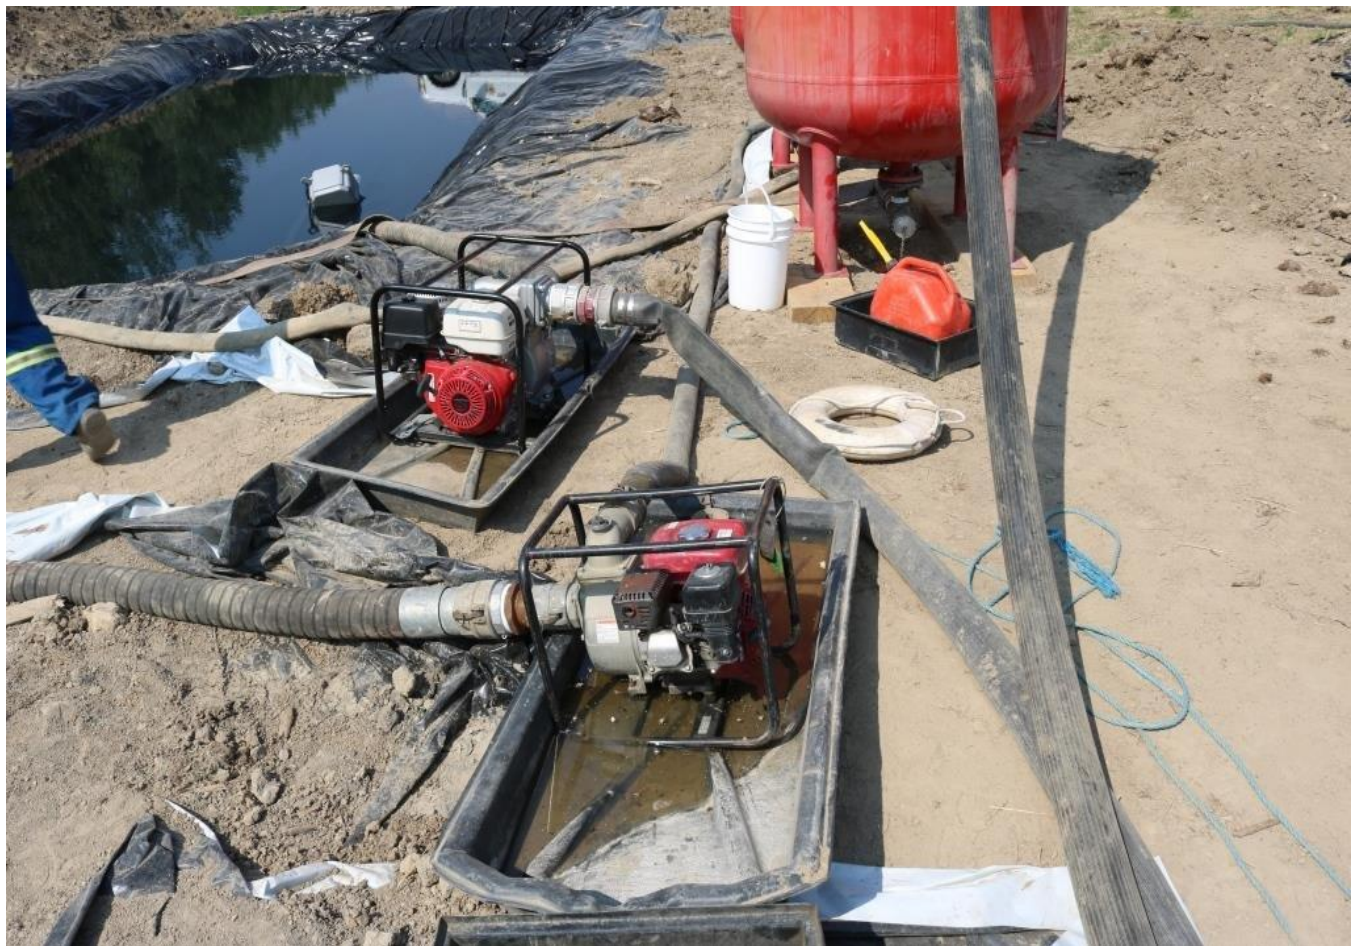
Figure 11  
Pumps in drip trays with two final tank filters in background

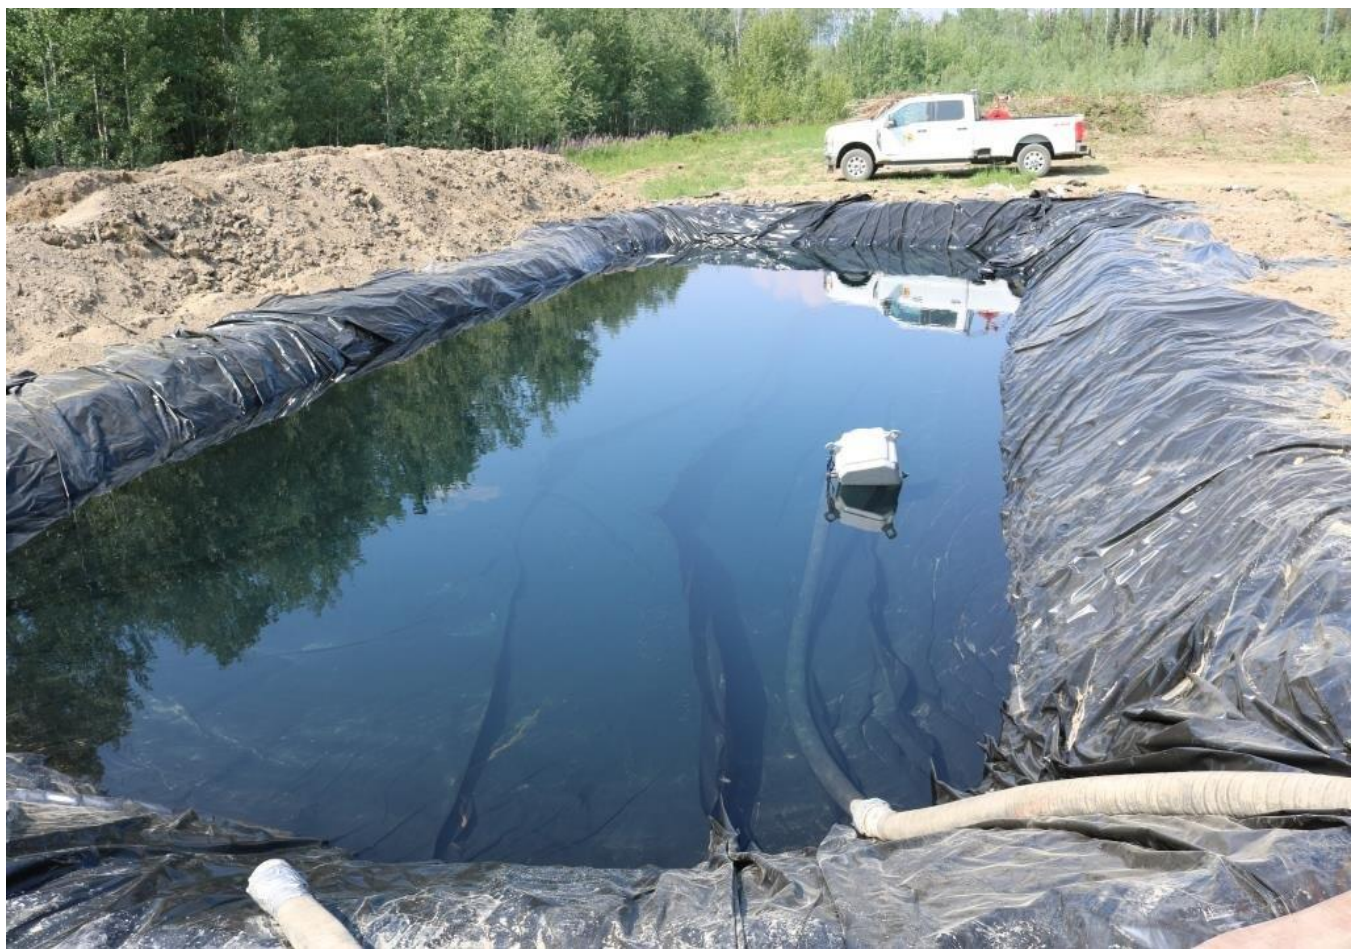
Figure 12  
Lined cell with final product- clean (treated) water

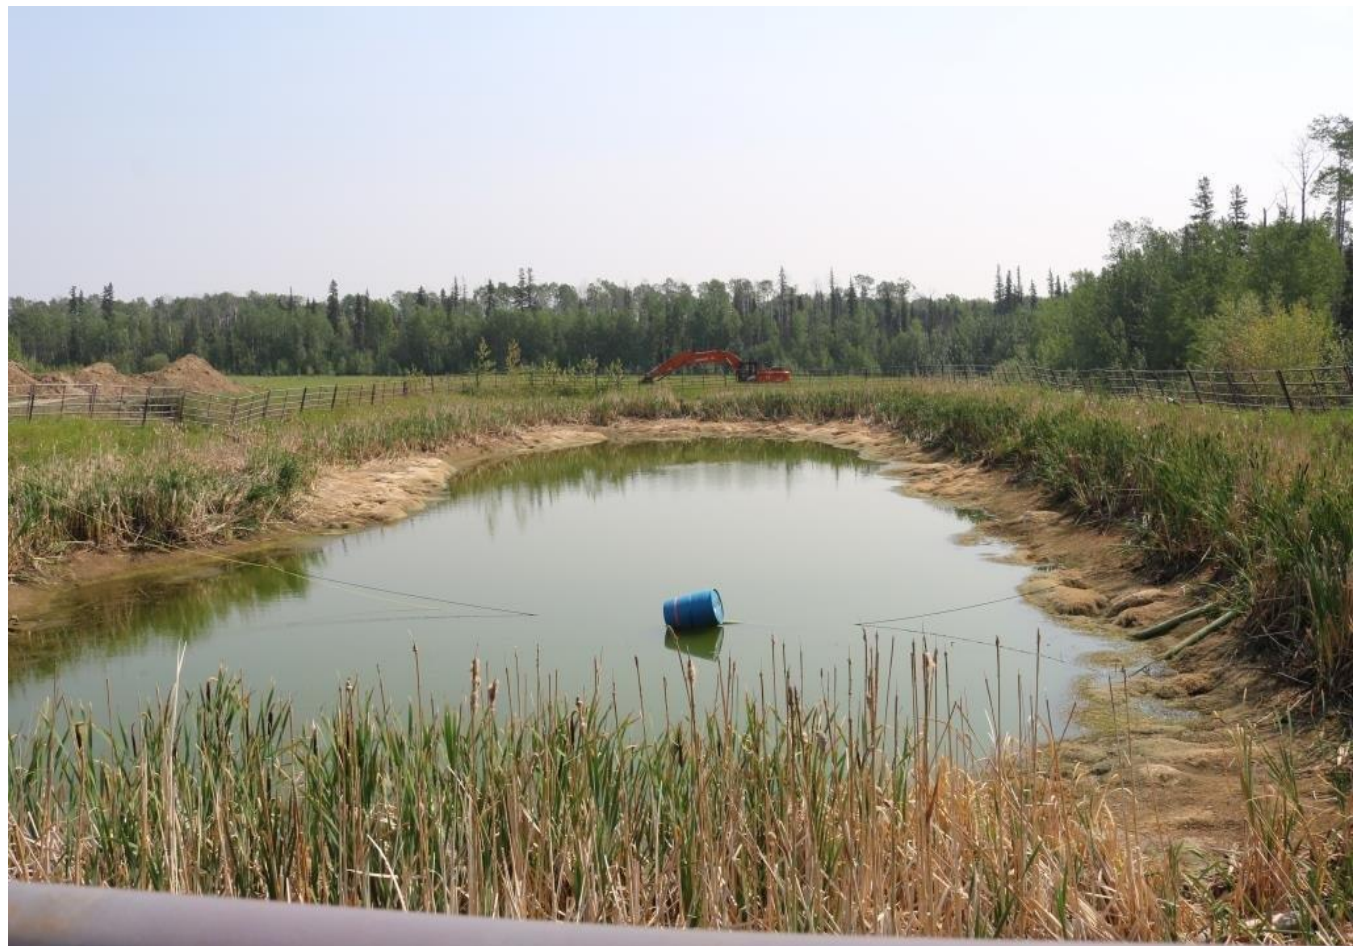
Mr. Arndt informed the Inspectors that they were waiting for the liner to come in for the contaminated soil area at the time of the inspection. Mr. Arndt also asked if they could mix soil with the sludge at the bottom of the surge pond when moving the sludge/contaminated

soil to the designated area to help solidify when moving. Inspectors informed Mr. Arndt that there was no concern with doing that.

Figure 13  
Surge Pond

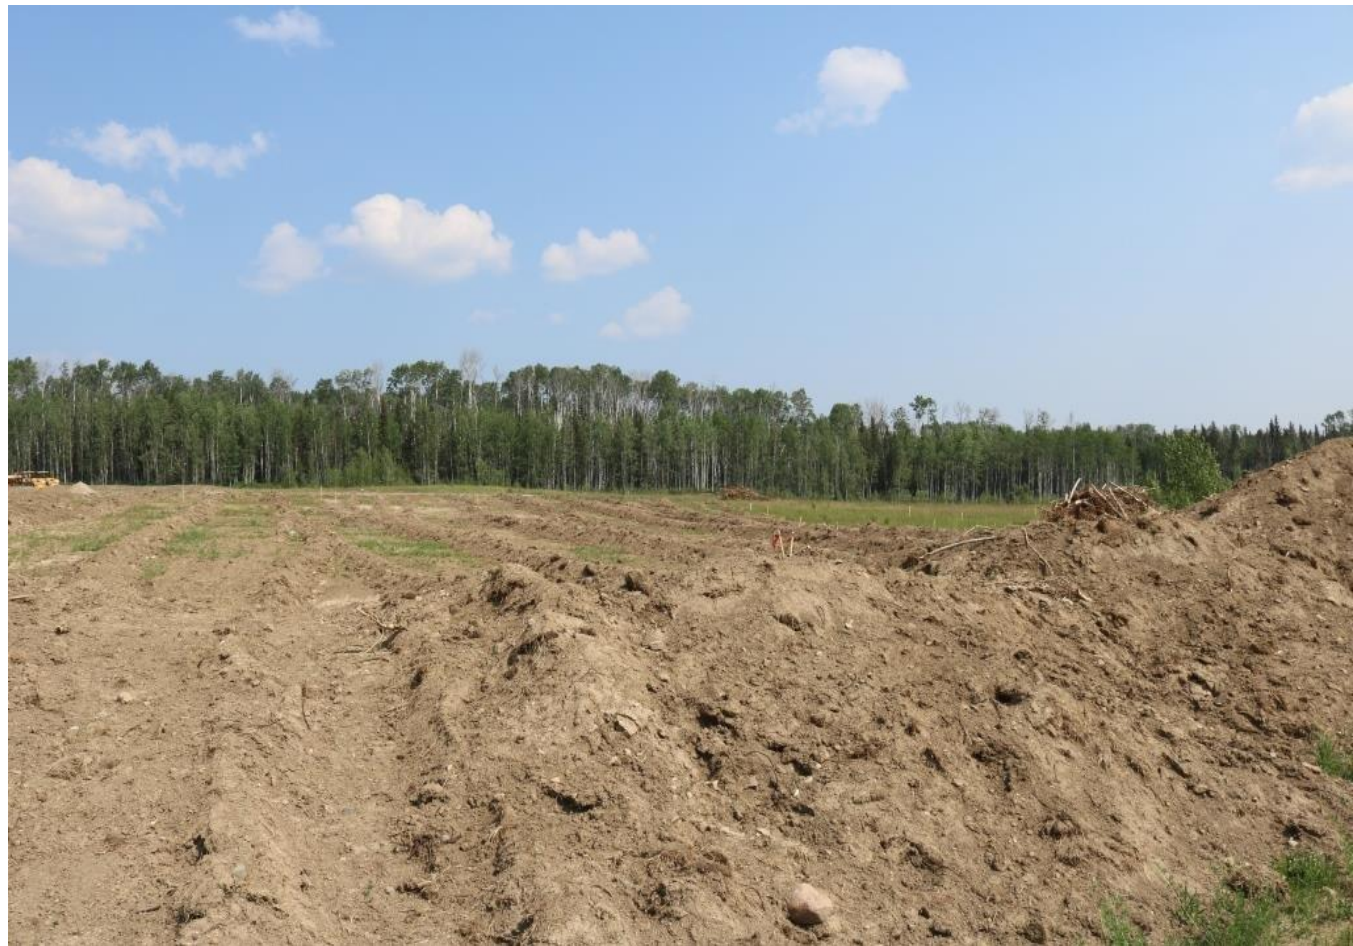
Figure 14  
Clean soil area for backfill operations

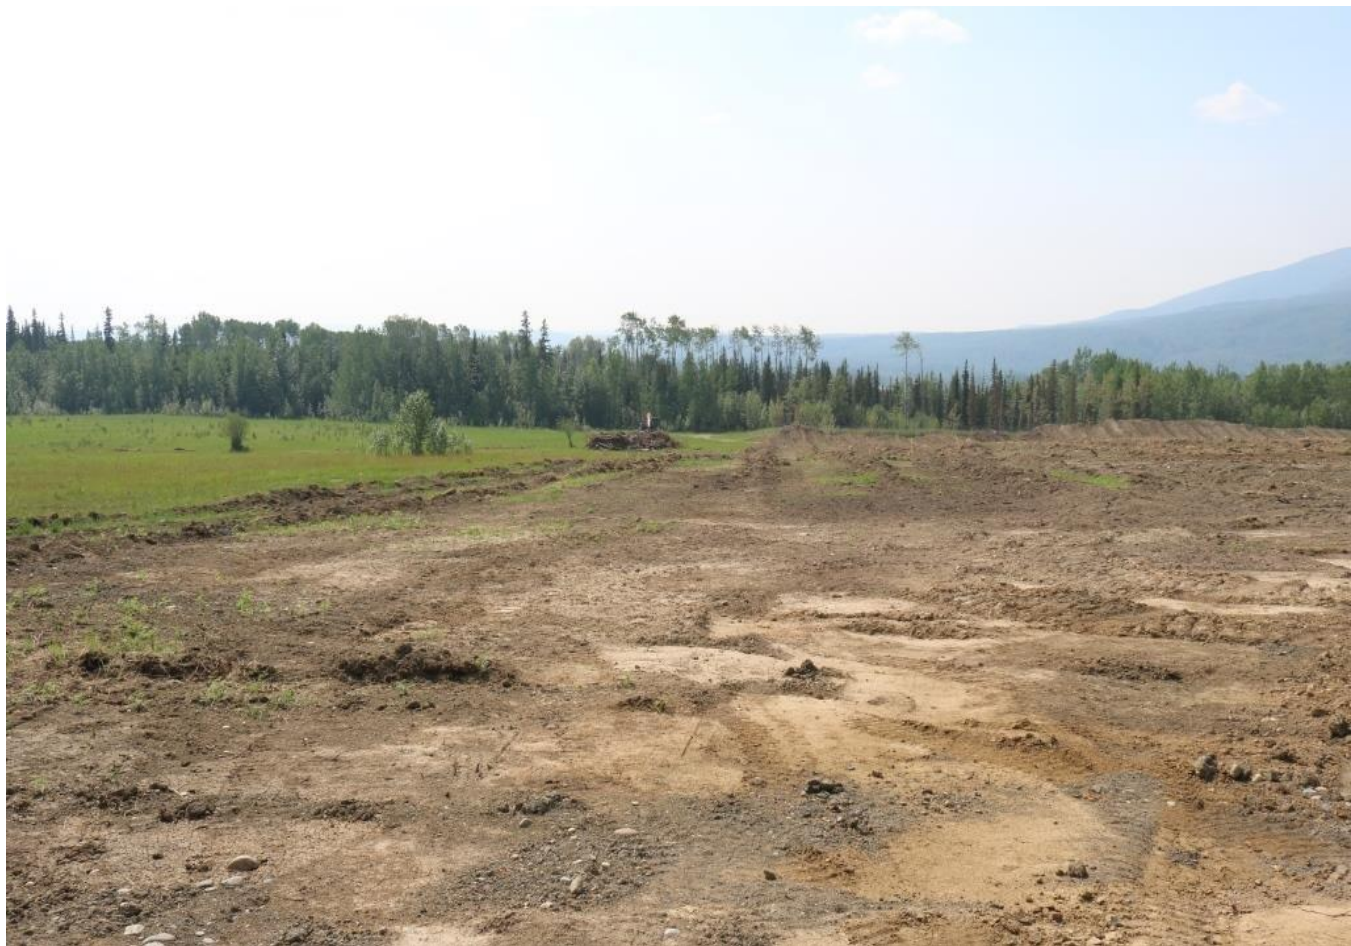
Figure 15

Different view of clean soil area for backfill operations

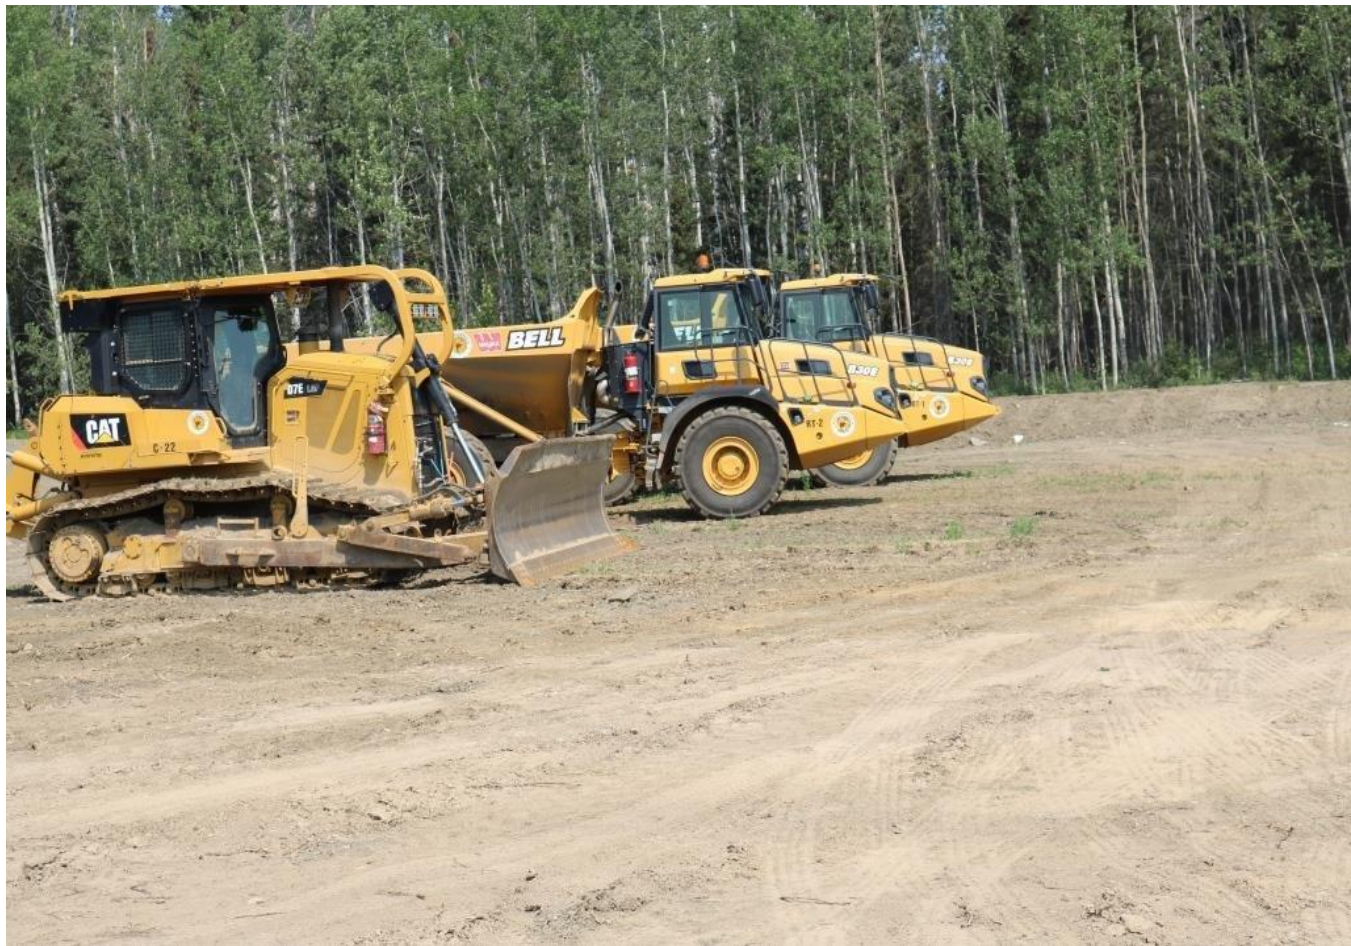
Figure 16

There were no drip trays under the heavy equipment and Inspectors informed Mr. Arndt at the time of the inspection that drip trays are required under all equipment to prevent spills.

Equipment

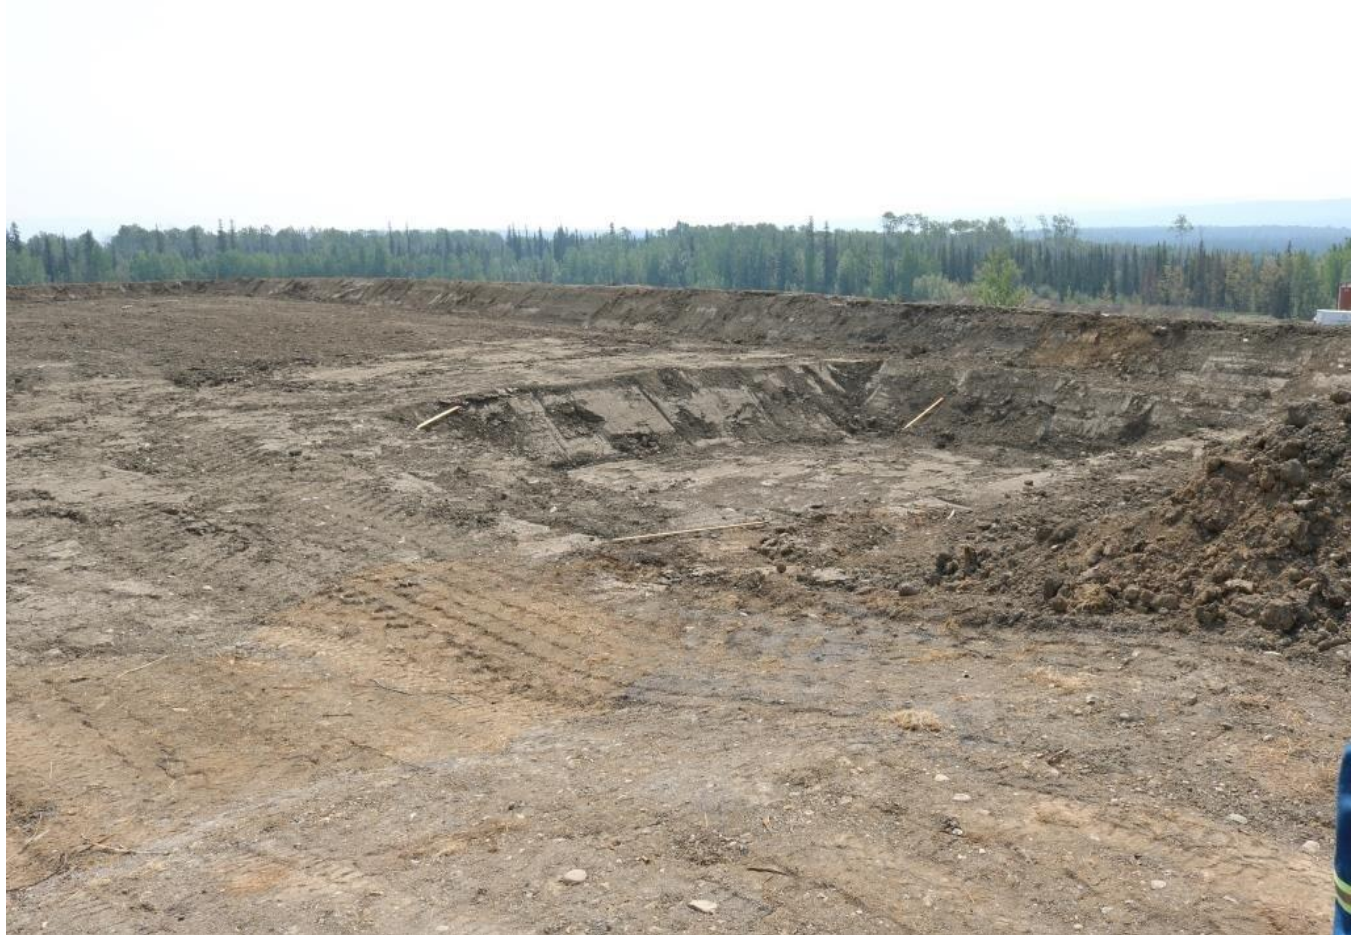
Figure 17

Prepped area for contaminated soil
