<b>File Number</b>	<b>MV2014X0011</b>
<b>Type of Operation</b>	<b>MISC.</b>
<b>Location</b>	Plant Site- NT Spill 202355

ENVIRONMENTAL INSPECTION REPORT

Permittee:	Paramount Resources Ltd.	Permit Expiry Date:	June 04, 2021
Land Use Permit No.	MV2014X0011	Previous Inspection:	August 24, 2022
Quarrying Permit No.		Inspection Date:	July 14, 2023
Contractor:		Subcontractor:	
Location(s) Inspected:	Plant Site- NT Spill 202355		
Current Stage of Operation:	Reverse Osmosis of Surge Pond		
Program Modifications Approved:

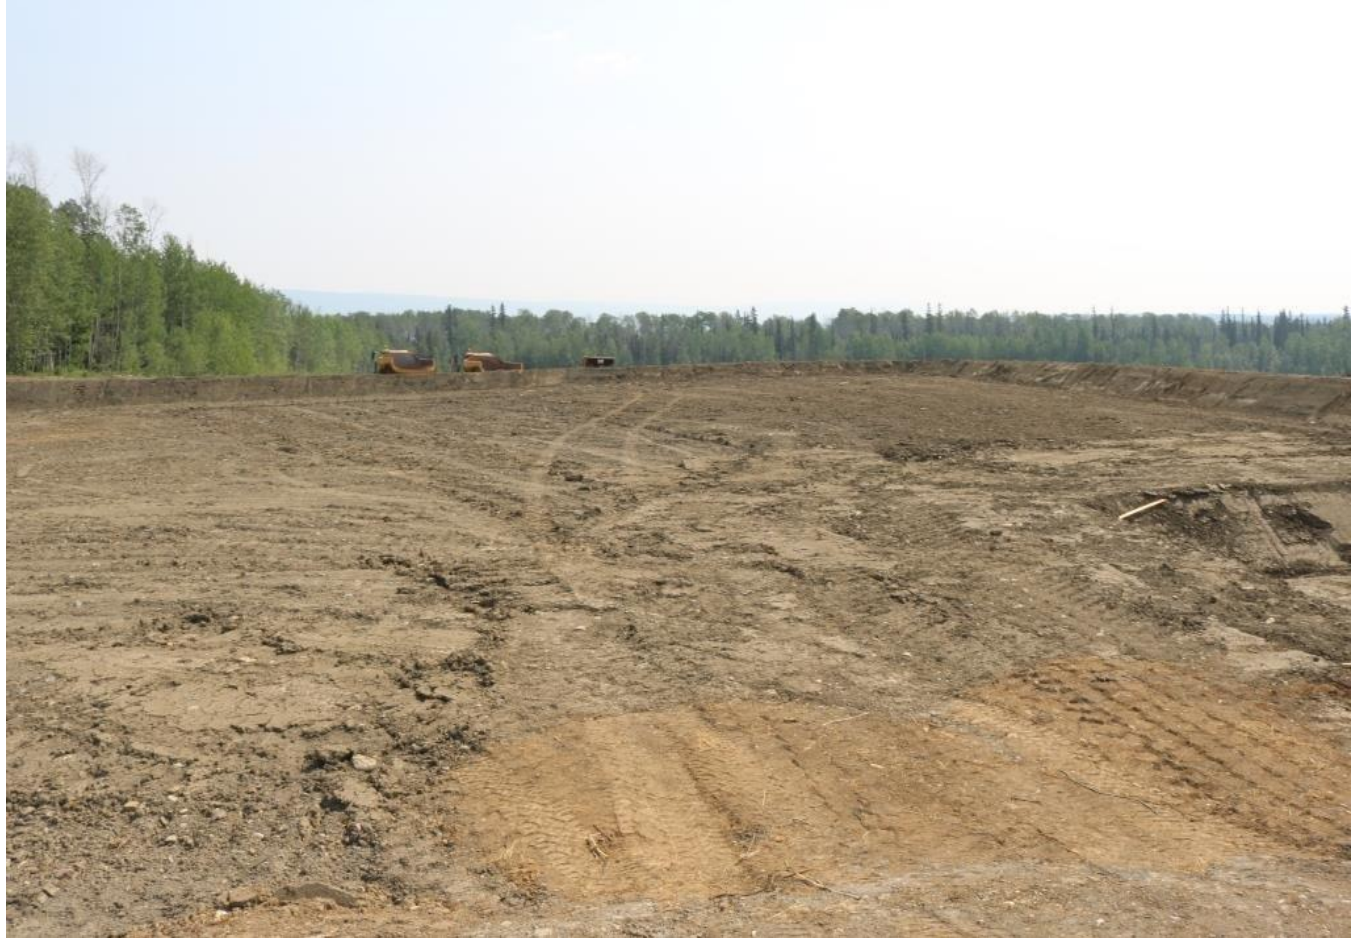
Figure 18

Prepped area for contaminated soil

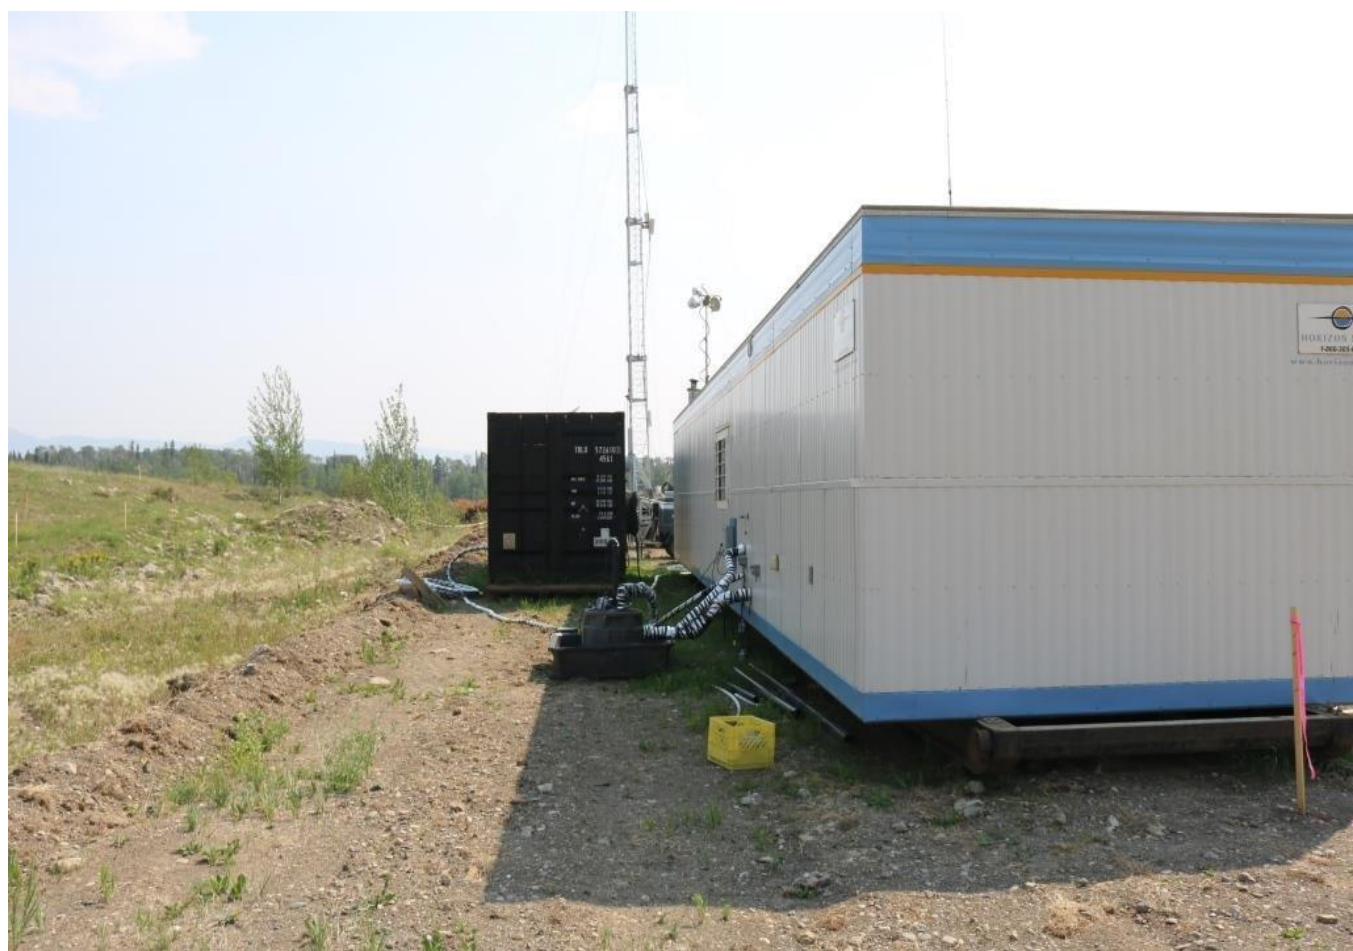
Figure 19  
Trailer on site

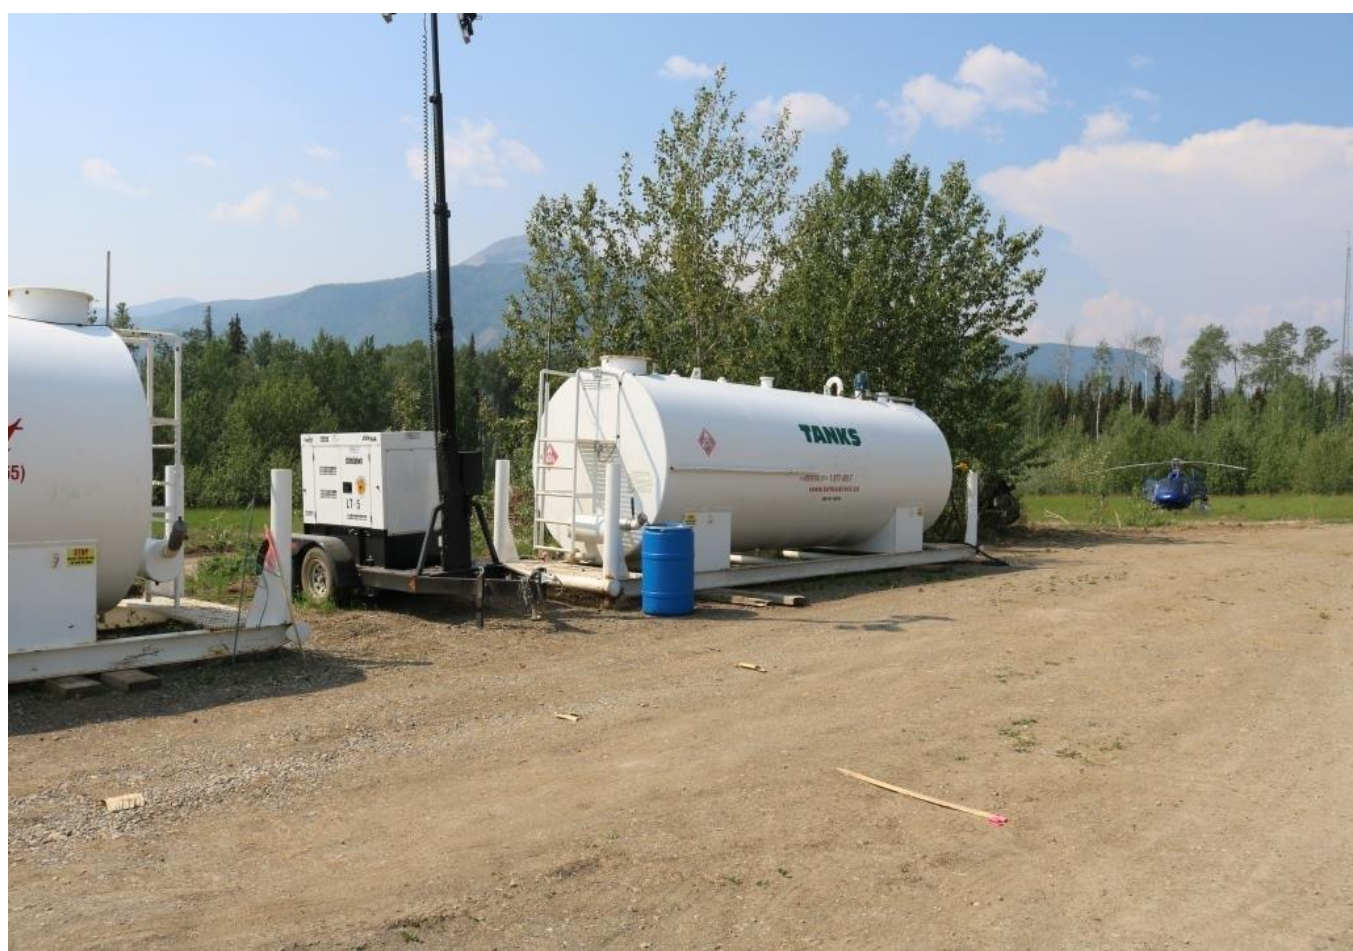
Figure 20  
Fuel tanks on site
