File Number	MV2014X0011
Type of Operation	MISC.
Location	Well Sites A-1, A-2, A-3, A-4, B-1, B-2, Plant Site and Airstrip

ENVIRONMENTAL INSPECTION REPORT

Permittee:	Paramount Resources Ltd.	Permit Expiry Date:	June 04, 2021
Land Use Permit No.	MV2014X0011	Previous Inspection:	July 29, 2020
Quarrying Permit No.		Inspection Date:	August 26, 2021
Contractor:		Subcontractor:	
Location(s) Inspected:	Well Sites A-1, A-2, A-3, A-4, B-1, B-2, Plant Site and Airstrip		
Current Stage of Operation:	Reclamation/Remediation		
Program Modifications Approved:	N/A

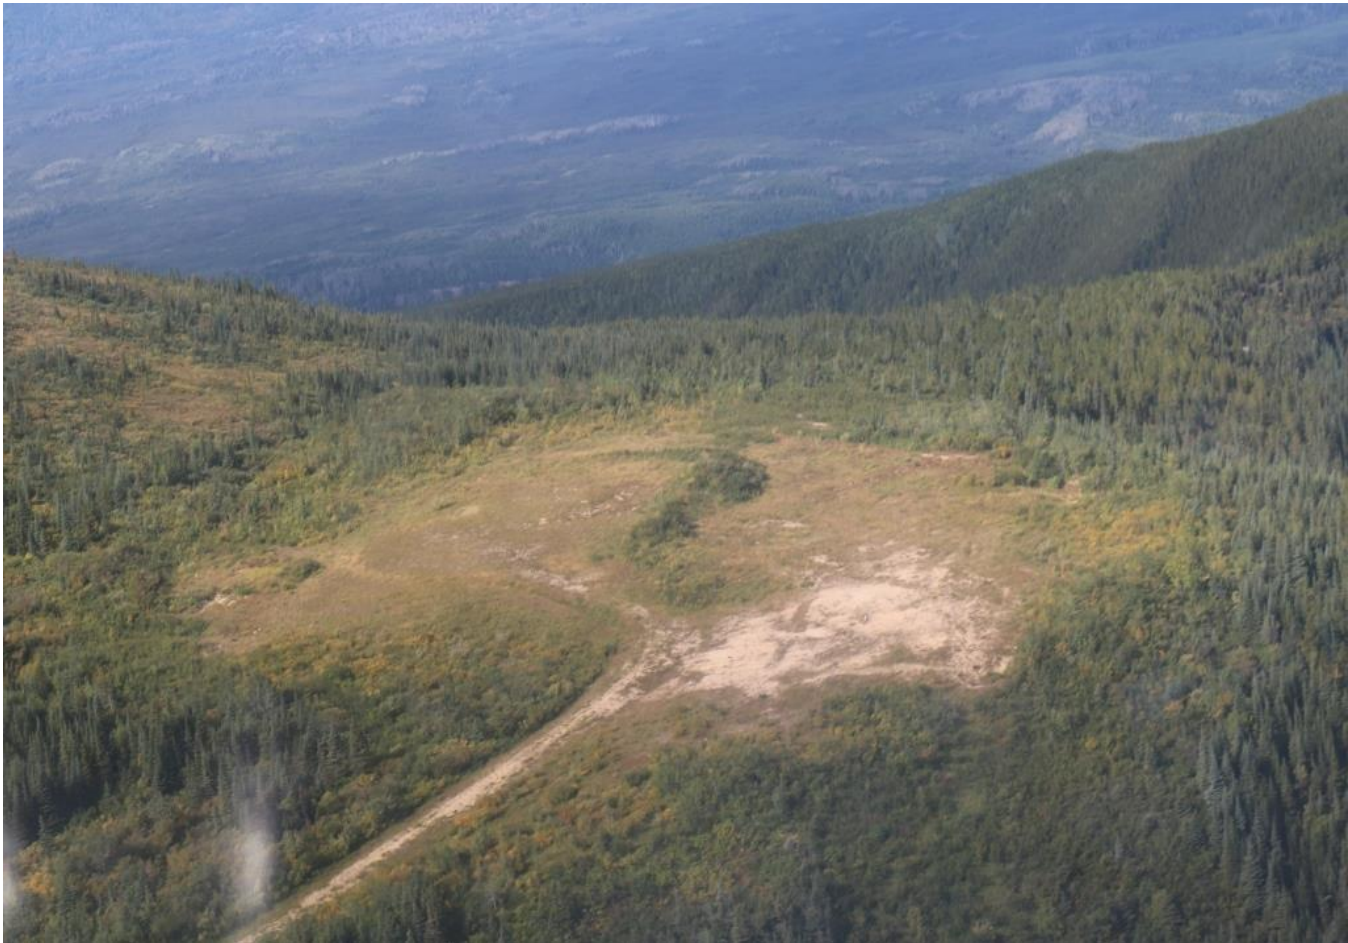
Figure 1
Aerial of A-1

Vegetation is established with limited bare soil present throughout the site. There was a sign in place where the wellhead used to be. Inspectors have no concerns with the A-1 well site and will continue to monitor the location.

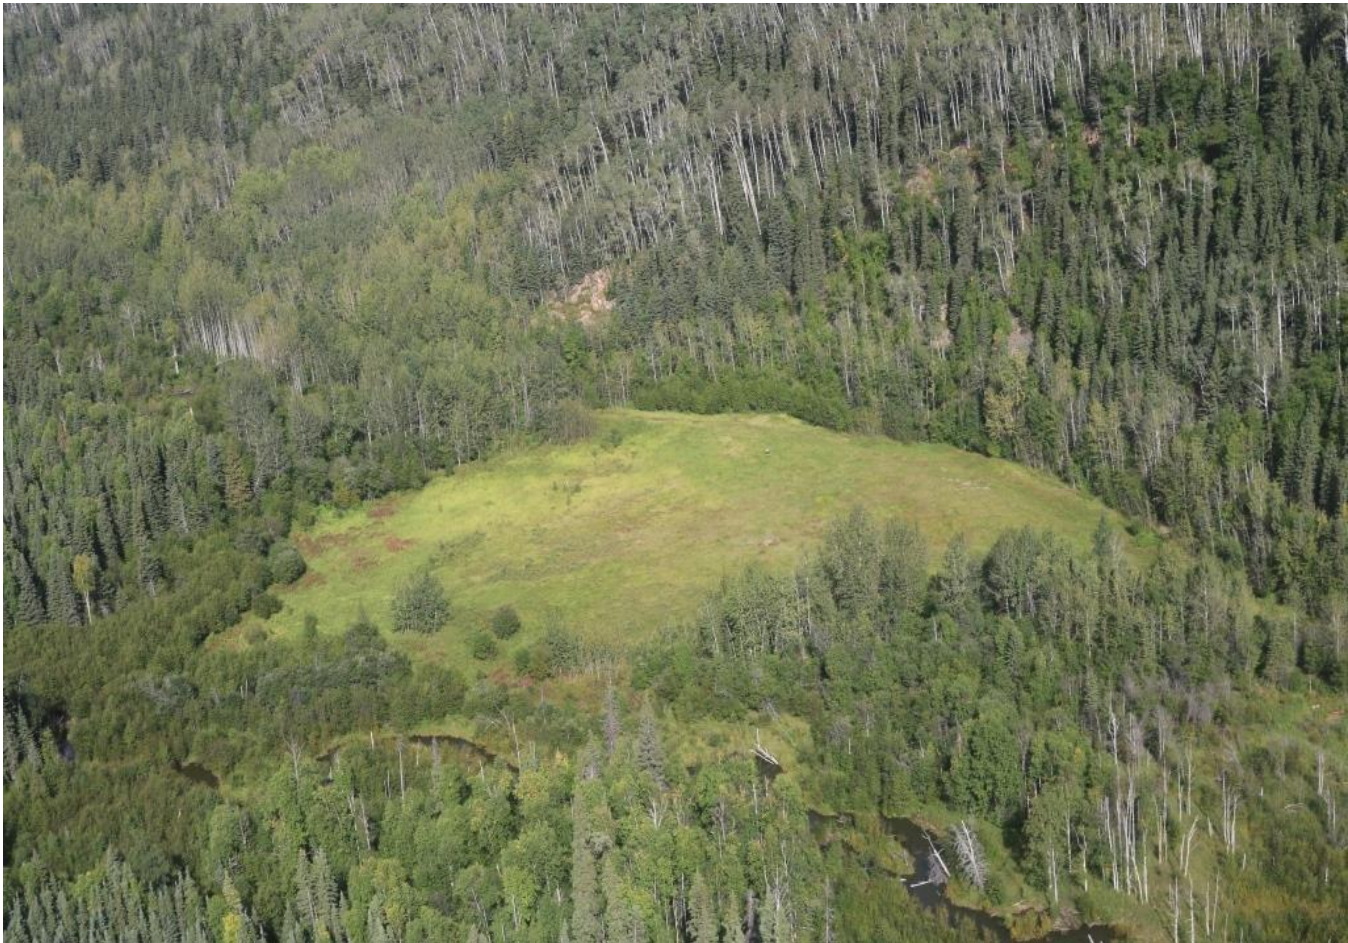
Figure 3
Aerial of A-2

Vegetation regrowth is adequate and Inspectors noted a white flowering species throughout the site. There was a sign in place where the wellhead used to be. Inspectors have no concerns with the A-2 well site and will continue to monitor the location

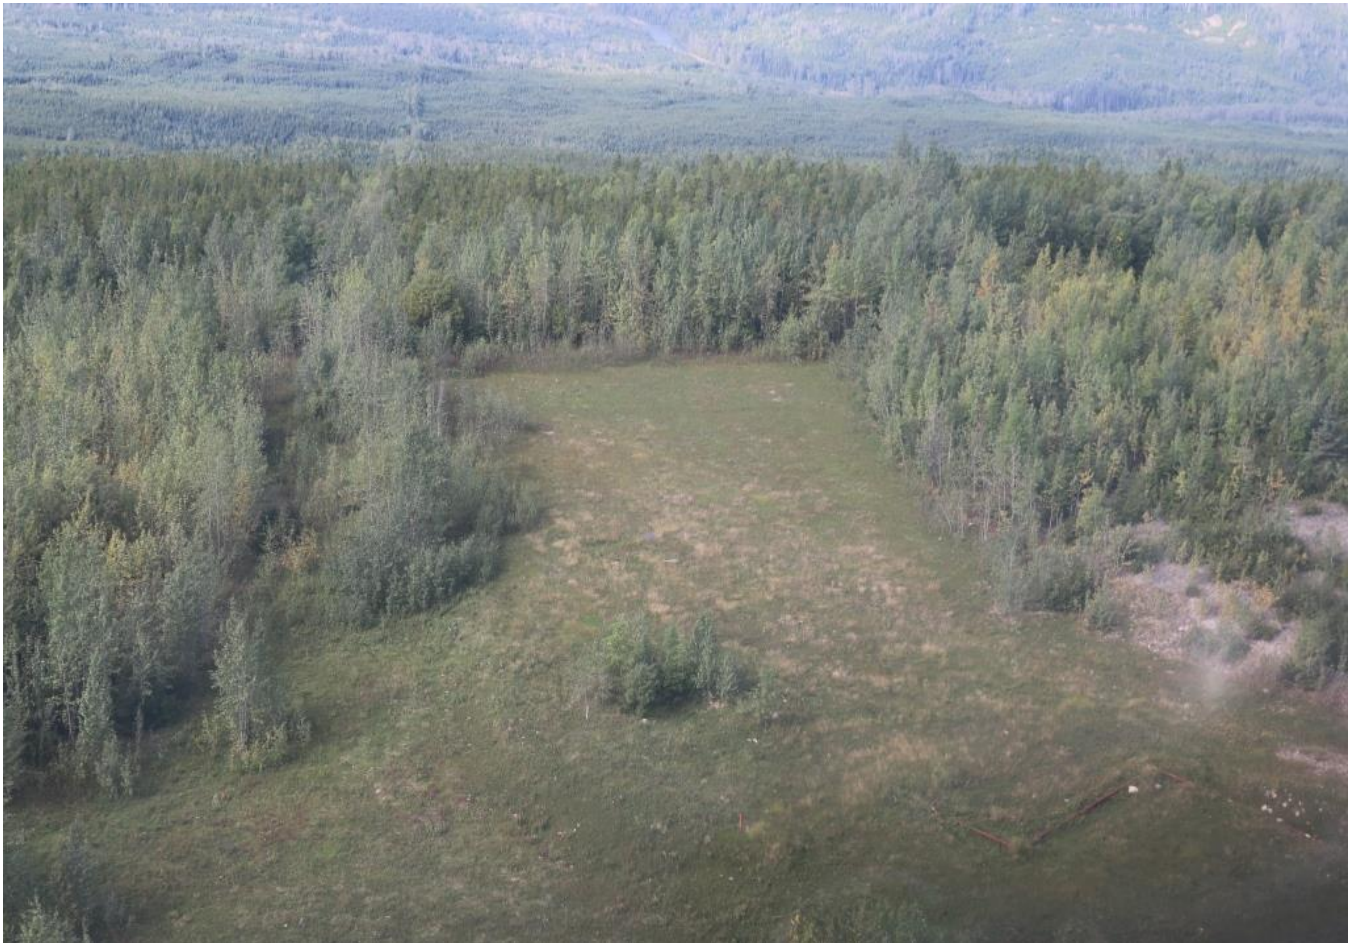
Figure 5
Aerial of A-3

A-3
Piping near the entrance was still on site. Vegetation regrowth is adequate. There was a sign in place where the wellhead used to be. Inspectors have no concerns with the A-3 well site and will continue to monitor the location.

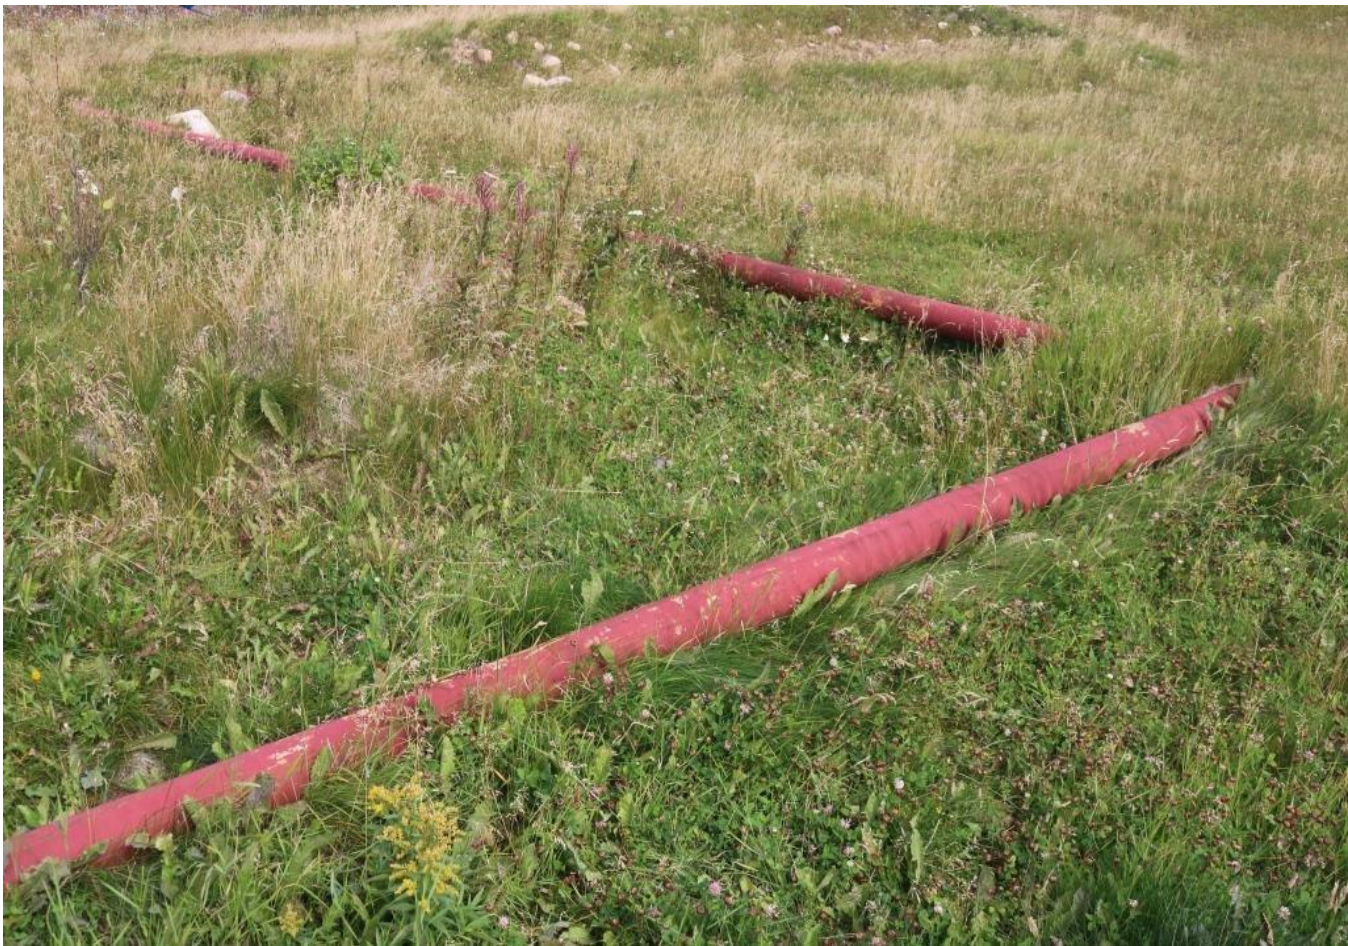
Figure 6
Pipes on A-3

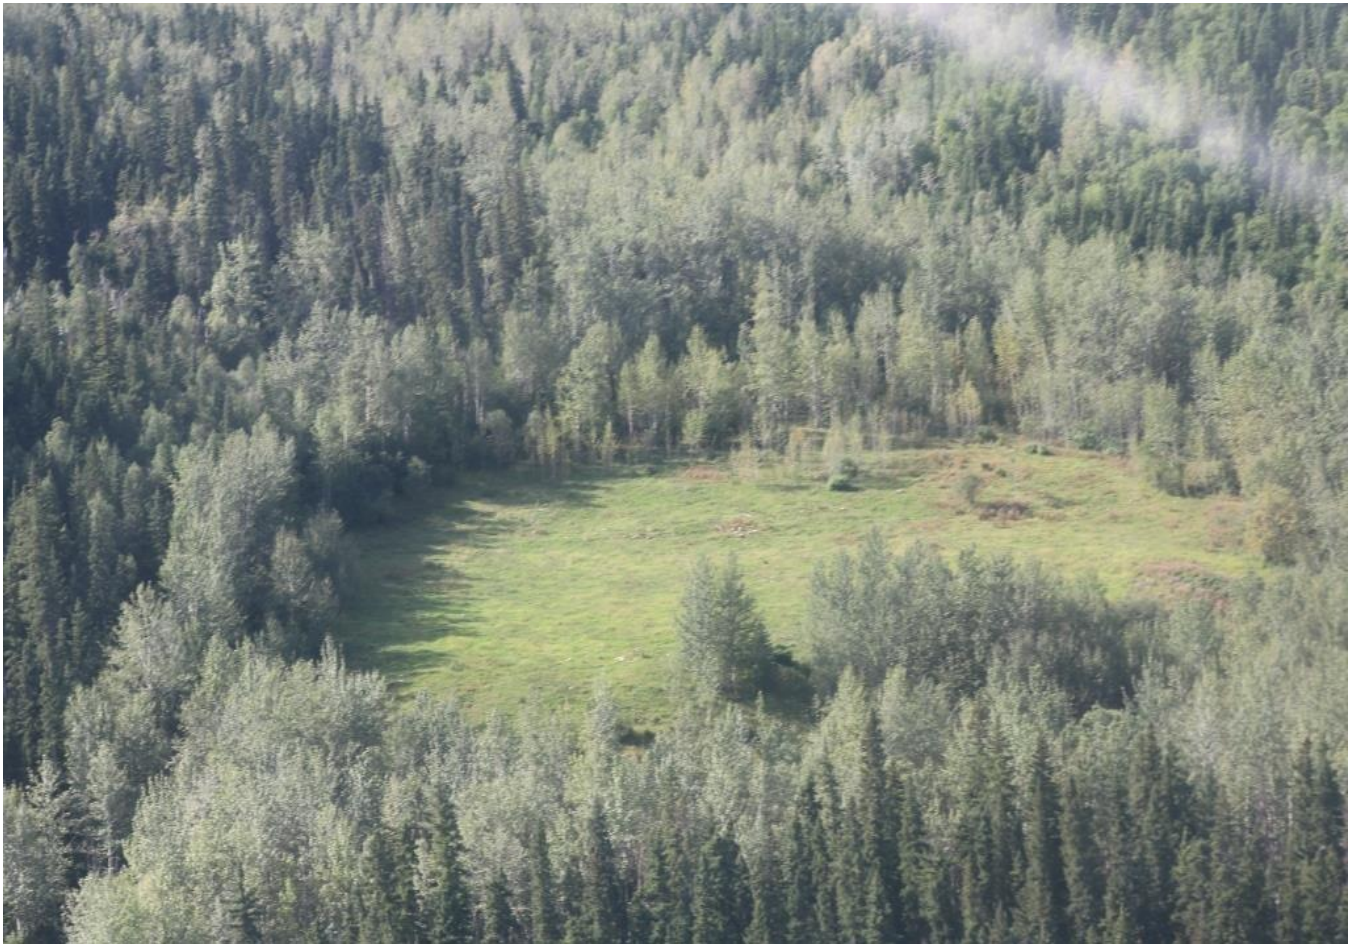
Figure 8
Aerial of A-4

A-4
Vegetation regrowth is adequate and Inspectors noted a white flowering species throughout the site. There was a sign in place where the wellhead used to be. Inspectors have no concerns with the A-4 well site and will continue to monitor the location.

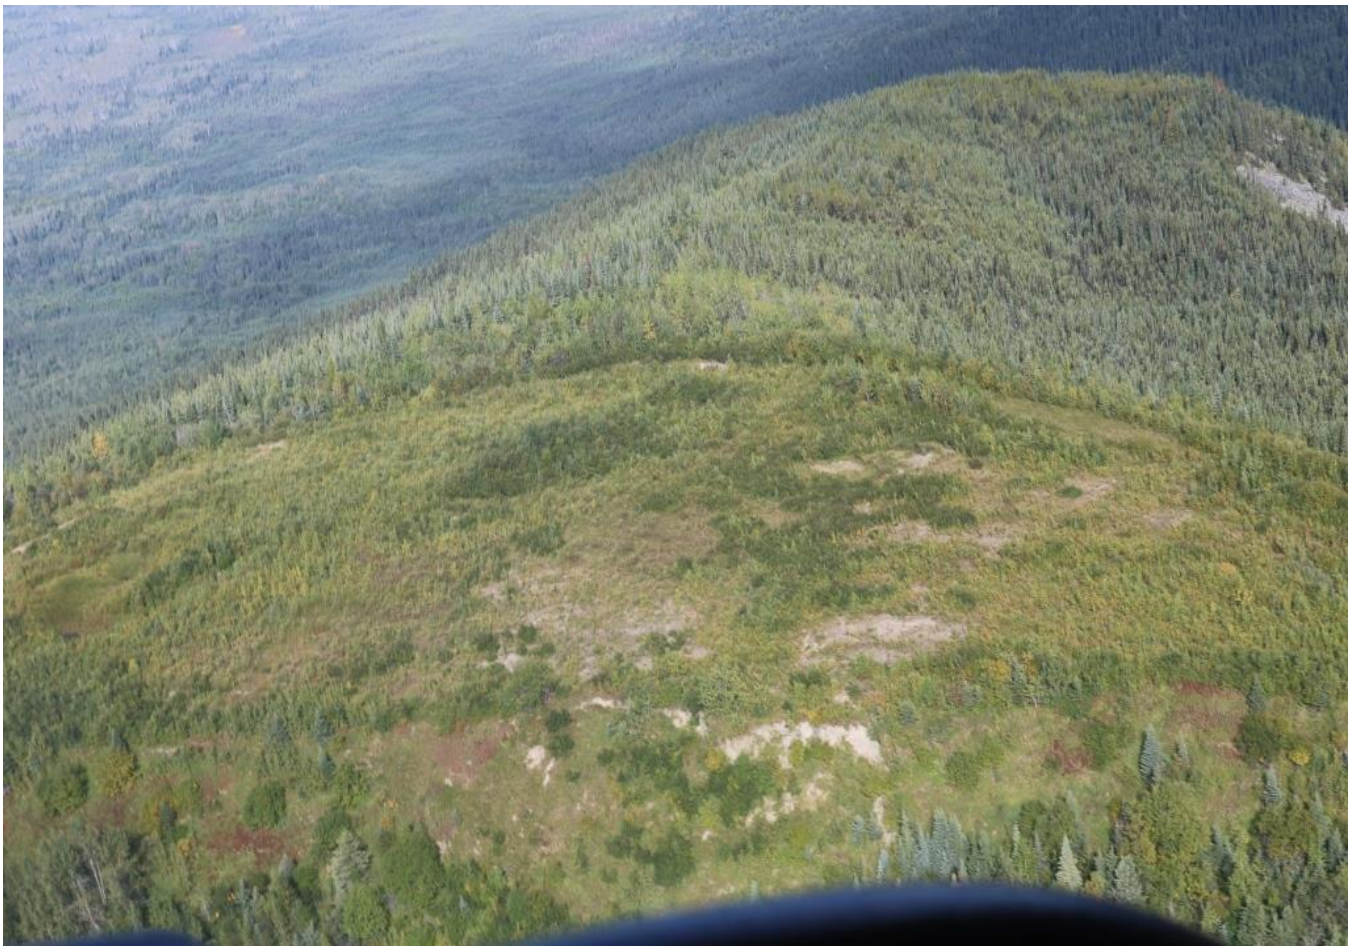
Figure 10
Aerial of B-1

B-1
Vegetation regrowth is adequate. There was a fallen down sign where the wellhead used to be. Inspectors have no concerns with the B-1 well site and will continue to monitor the location.

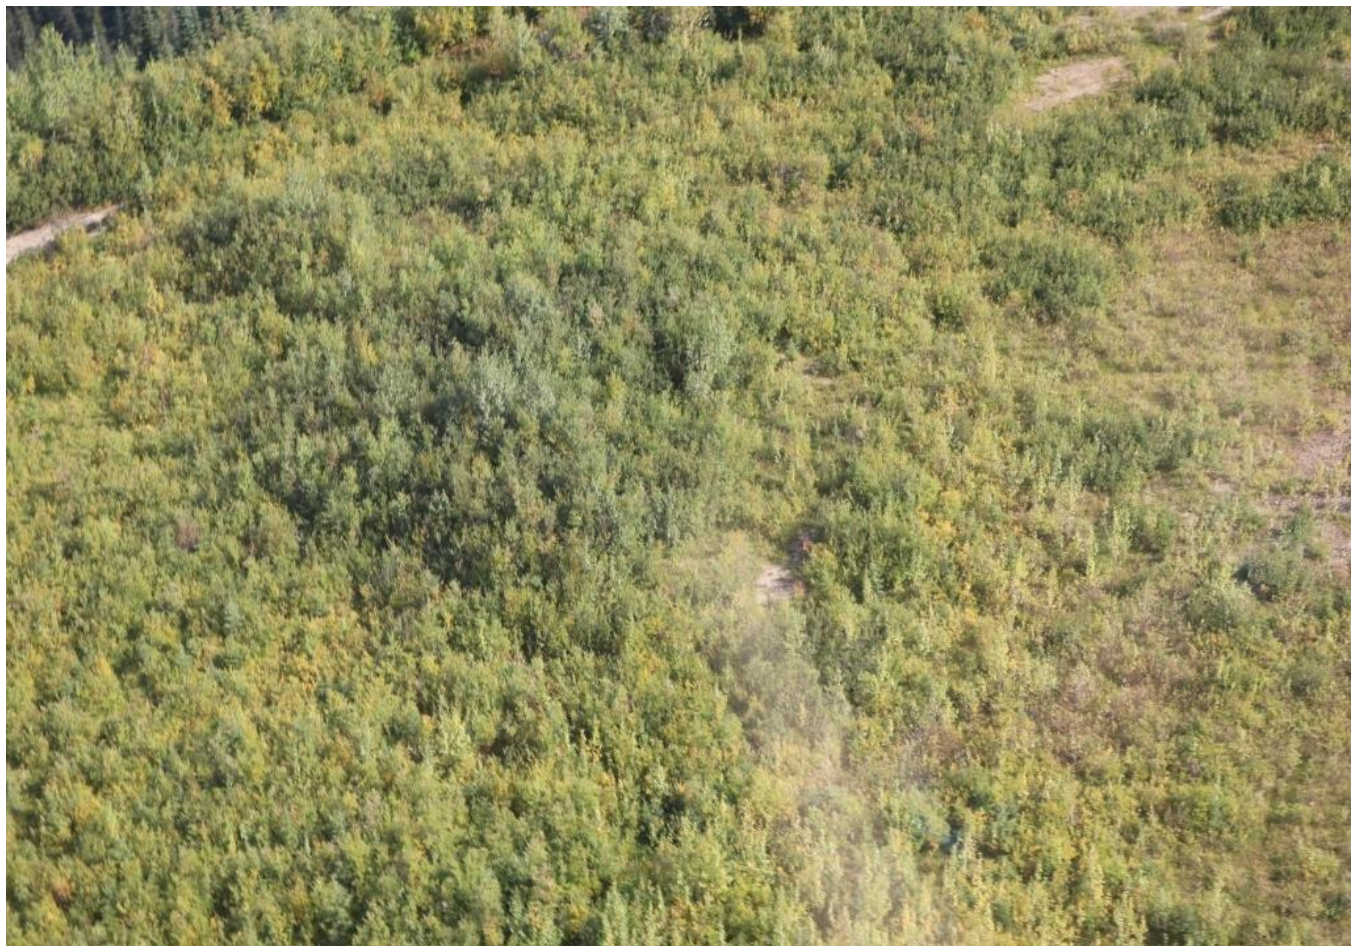
Figure 11
B-1 sign fallen

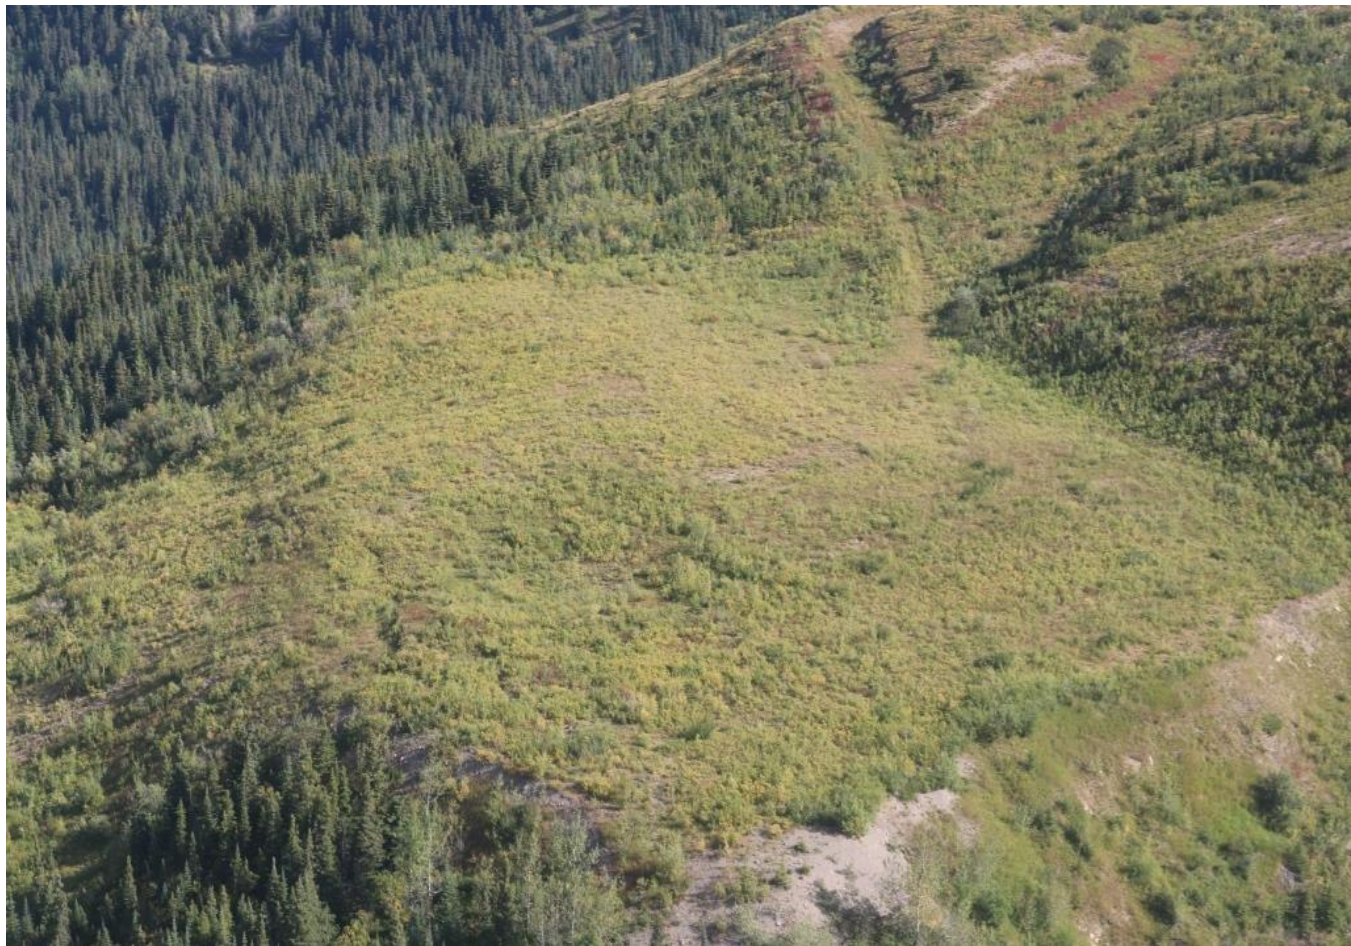
Figure 12
Aerial of B-2

B-2
Vegetation regrowth is adequate. The sign was fallen over where the wellhead used to be. Inspectors have no concerns with the B-2 well site and will continue to monitor the location

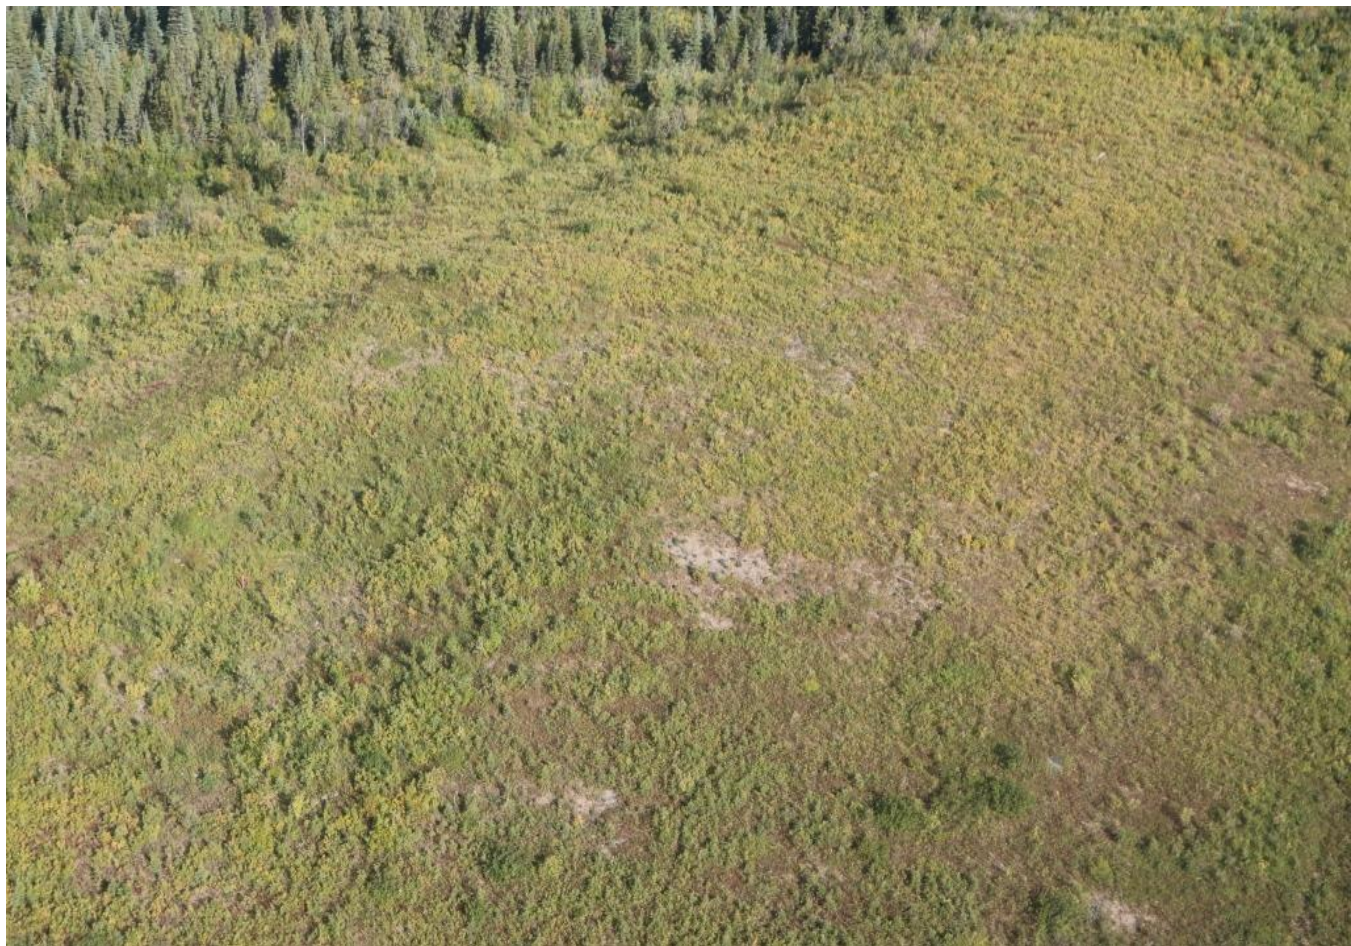
Figure 13
B-2 sign fallen

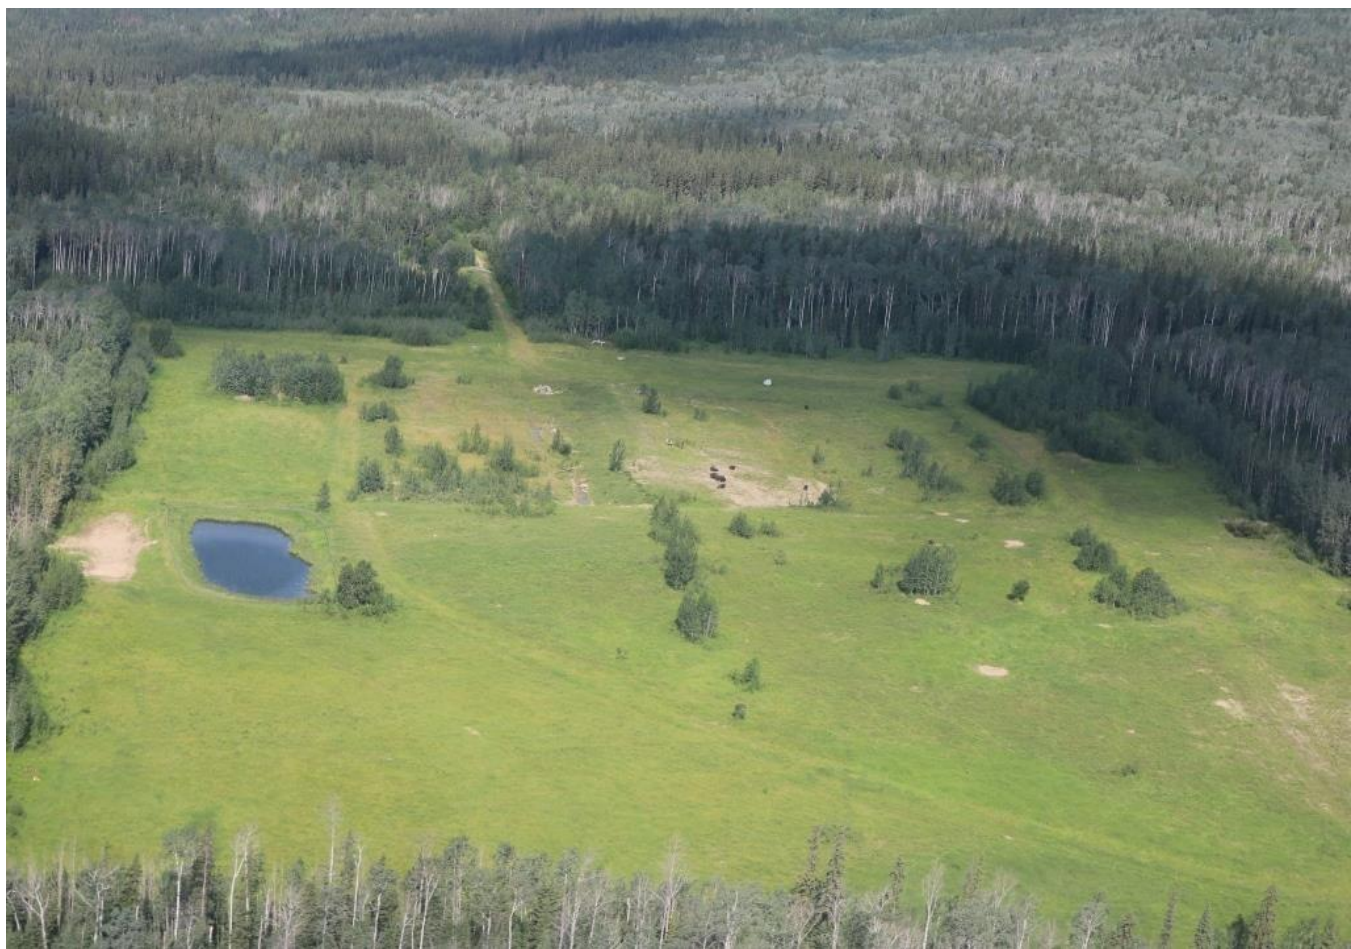
Figure 14
Aerial of plant site

Plant Site:
Most of the above ground infrastructure has been removed. The ponds on site were holding water with the surge pond having sturdy fencing with bird deterrents. Vegetation regrowth is adequate. There was bison present on site at the time of the inspection. Inspectors have no concerns with the Plant Site and will continue to monitor the location.

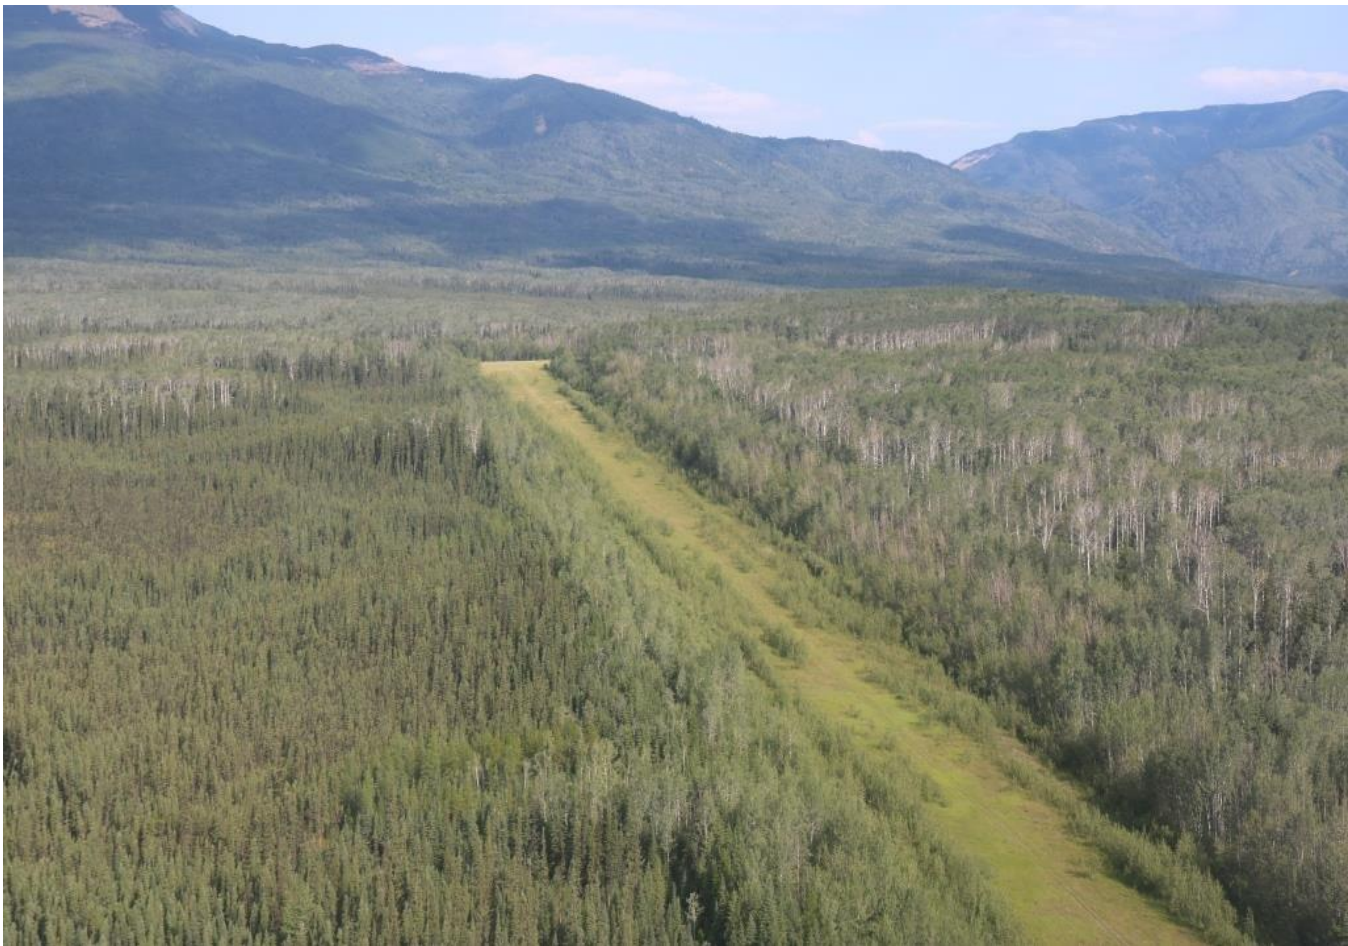
Figure 16
Aerial of airstrip

Airstrip:
The sea cans, totes and culverts were still on site. Vegetation is present throughout the site. Inspectors have no concerns with the airstrip and will continue to monitor the location.

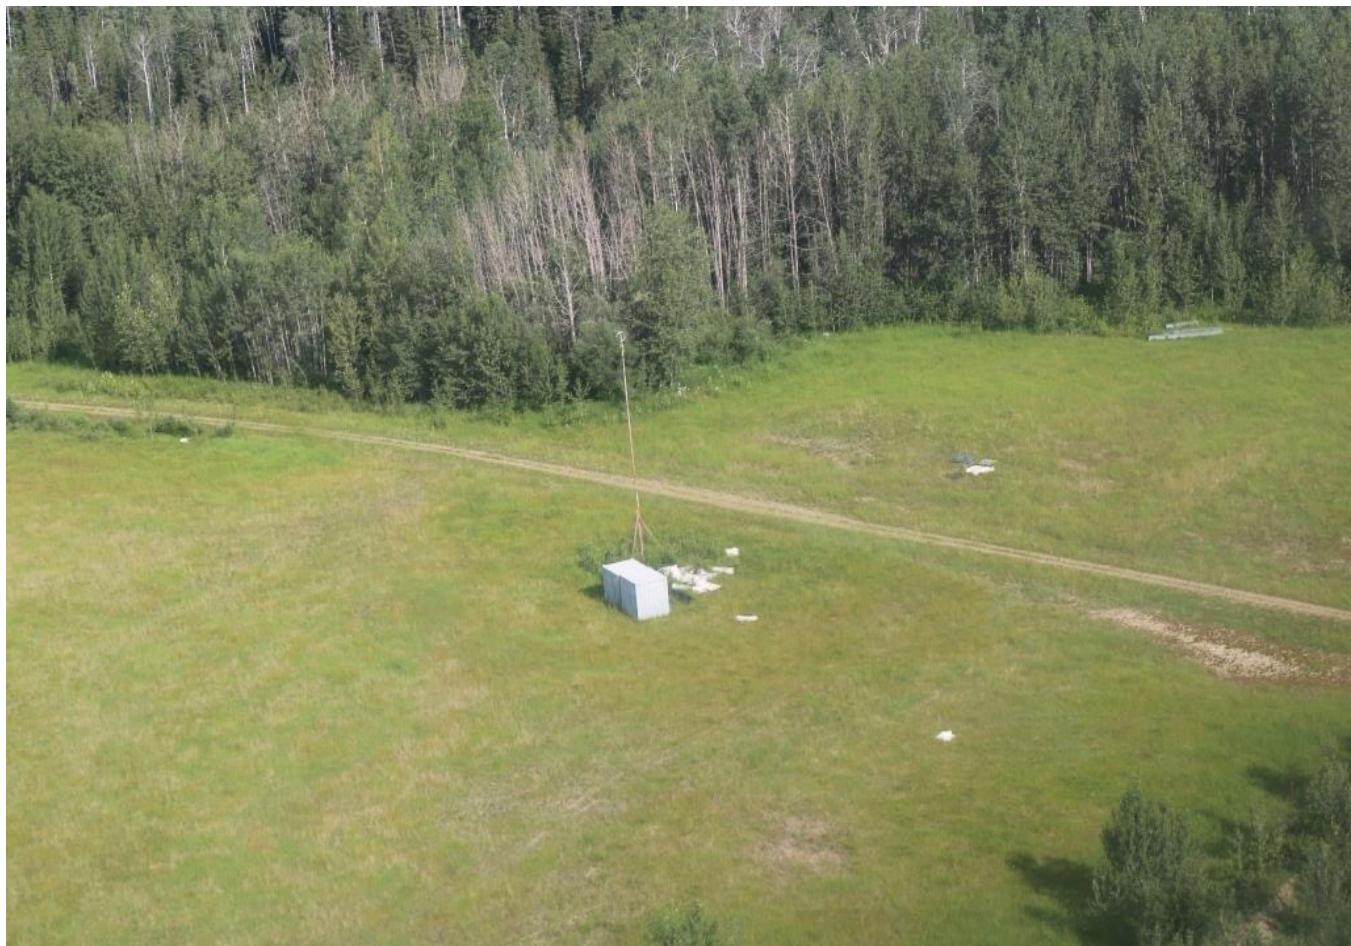
Figure 17
Aerial of seacans, totes and culverts
