File Number	MV2016Q0036
Type of Operation	QUARRY SITE - Existing
Location	Salt Mountain Quarry

An inspection of the above noted operation was conducted on April 23, 2024 by Resource Management Officer II Miles Barry and Resource Management Officer II Jarod Tuckey.

ENVIRONMENTAL INSPECTION REPORT

Permittee:	Fort Smith Const. NT. Ltd.	Permit Expiry Date:	December 03, 2024
Land Use Permit No.	MV2016Q0036	Previous Inspection:	July 14, 2023
Quarrying Permit No.	2023QP0013 Expires June 25, 2026	Inspection Date:	April 23, 2024
Contractor:	Rowe’s Construction Ltd.	Subcontractor:	N/A
Location(s) Inspected:	Salt Mountain Quarry		
Current Stage of Operation:	Active		
Program Modifications Approved:	N/A

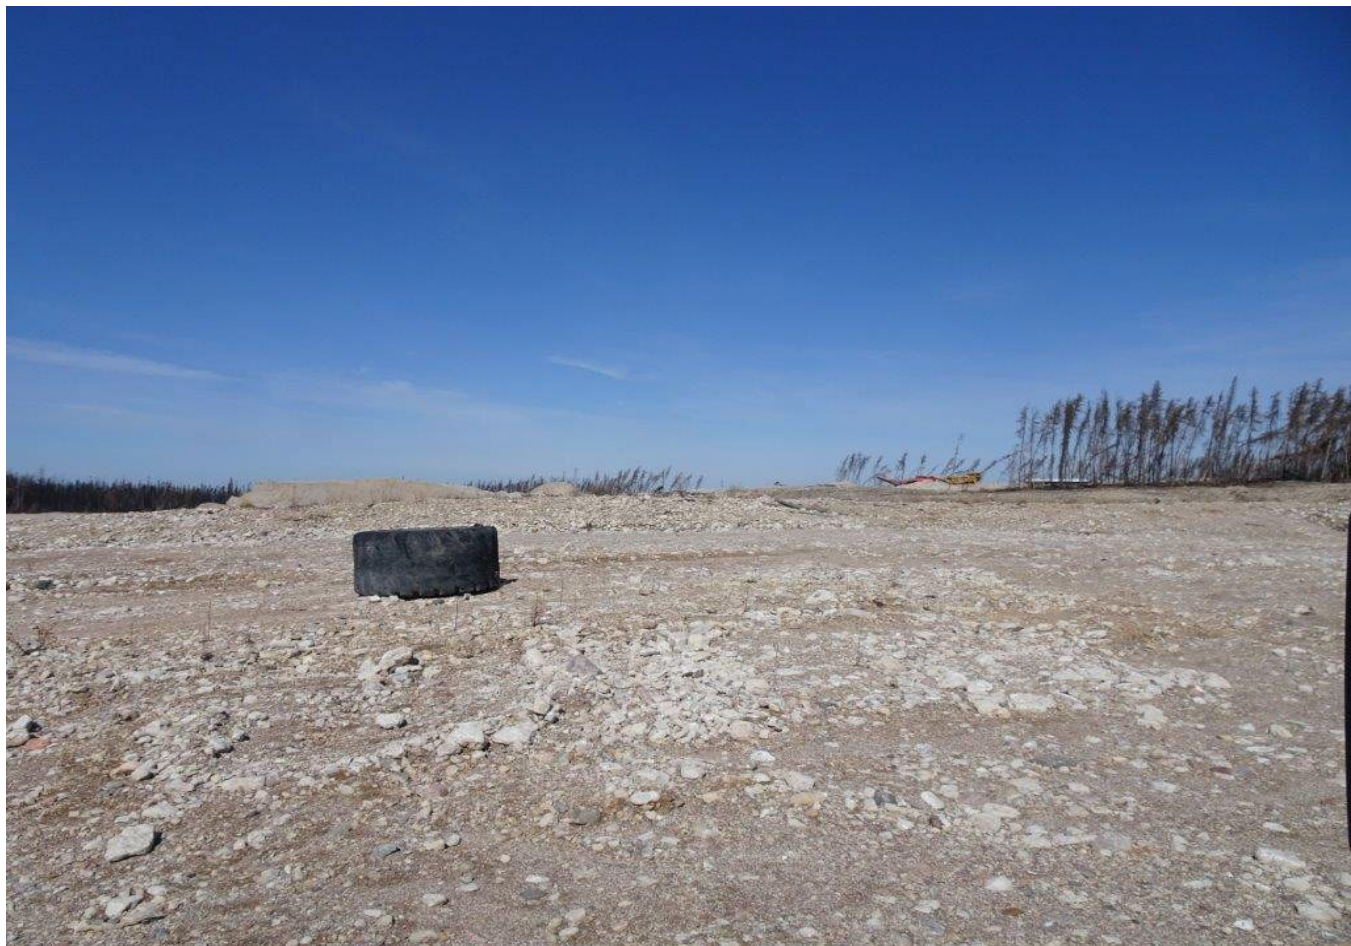
Figure 1

Inspectors observed various items stored in the northwest portion of the quarry (Figure 1-6). If any of these items are waste or not in use please remove them to an authorized waste facility.

Lone tire at the south end of quarry, facing north.

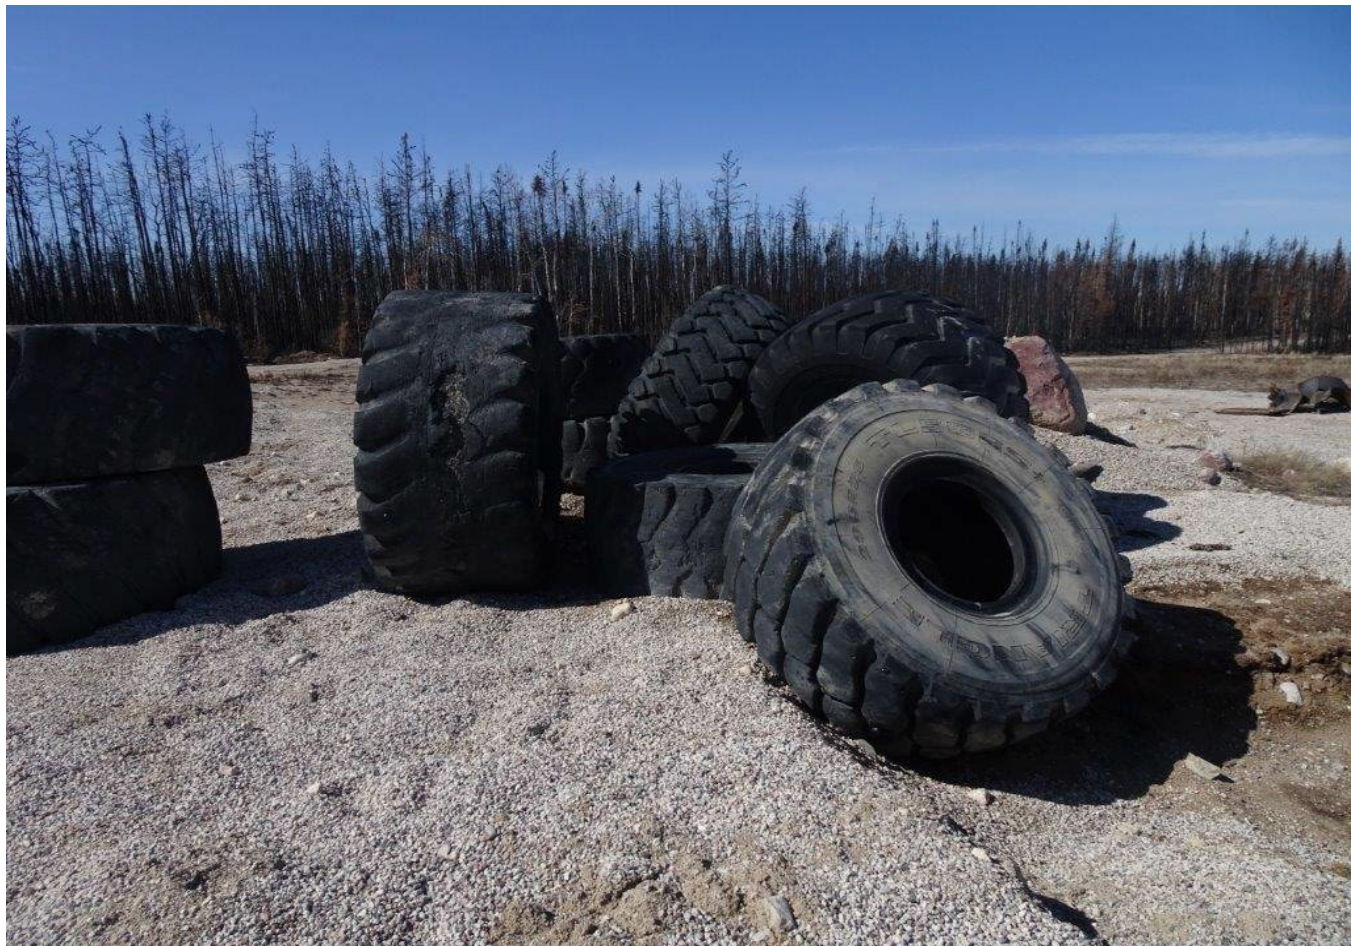
Figure 2

Ten large tires at the northwest portion of quarry.

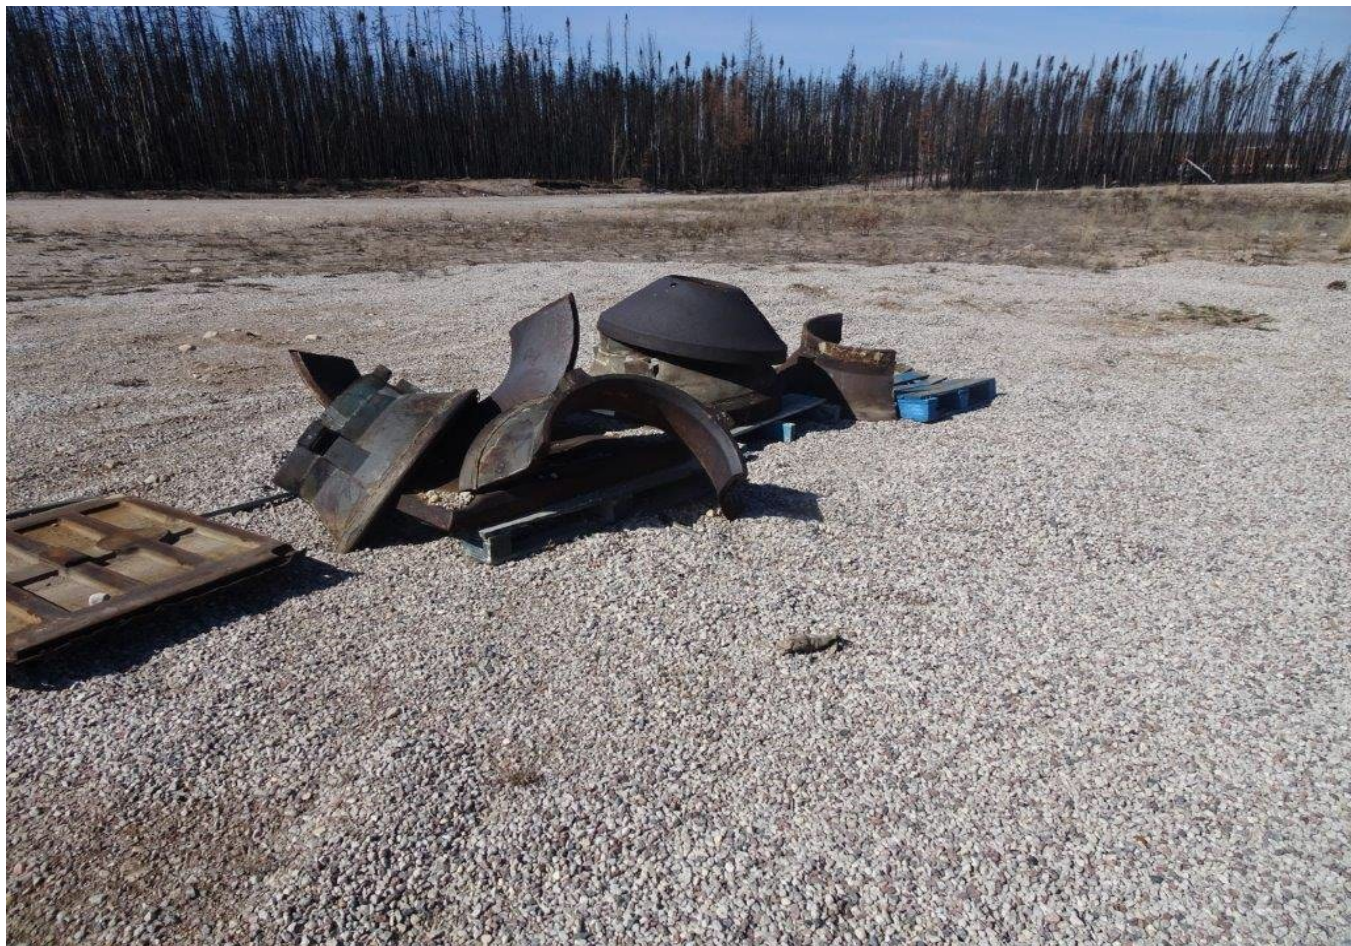
Figure 3

Scrap metal at the northwest portion of quarry.

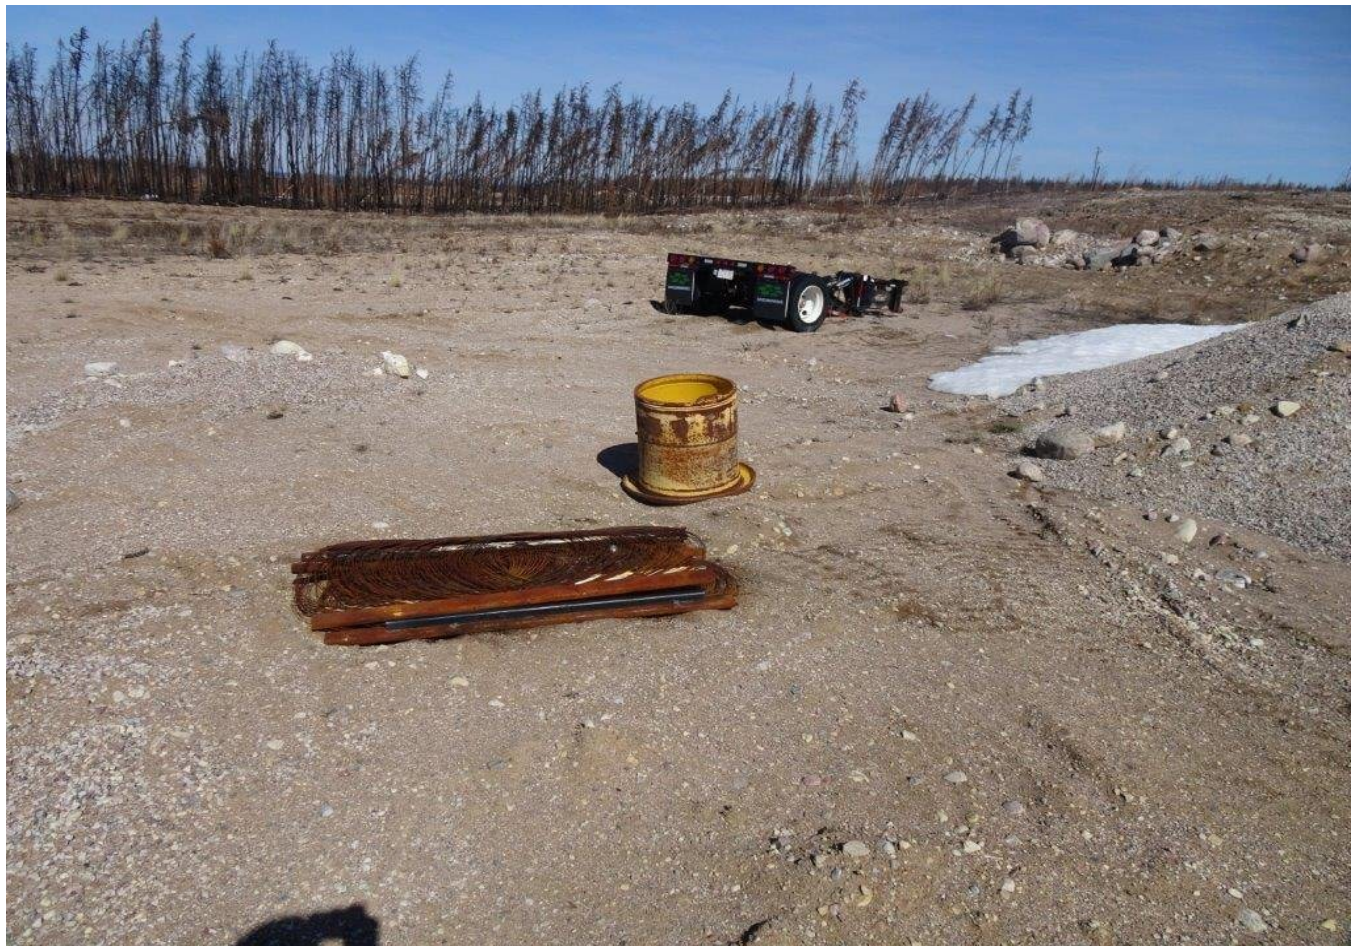
Figure 4

Scrap metal and a trailer extension at the northwest portion of quarry.

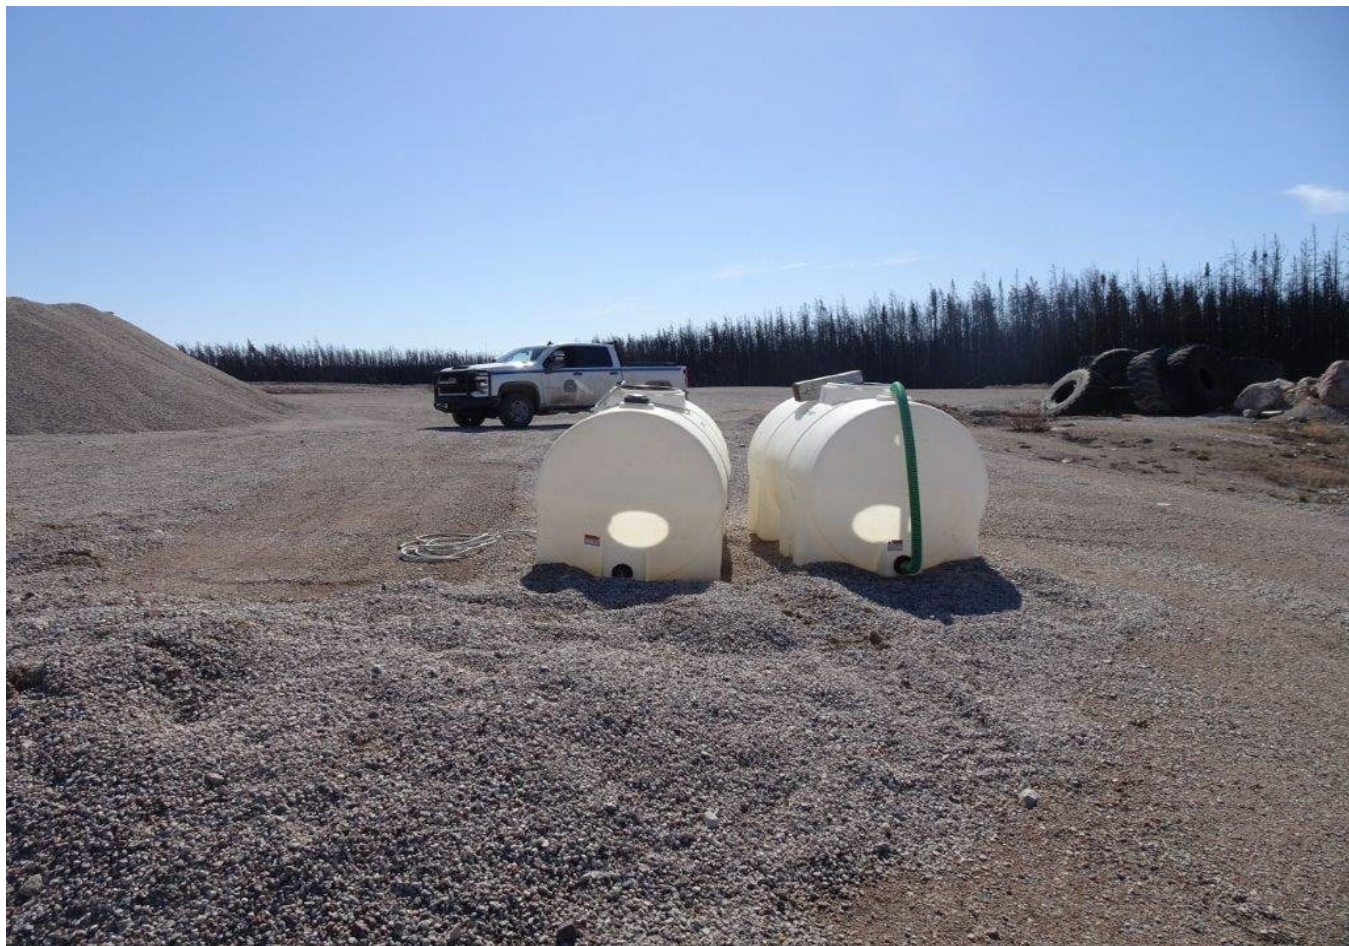
Figure 5

Two portable water tanks at the northwest portion of the quarry.

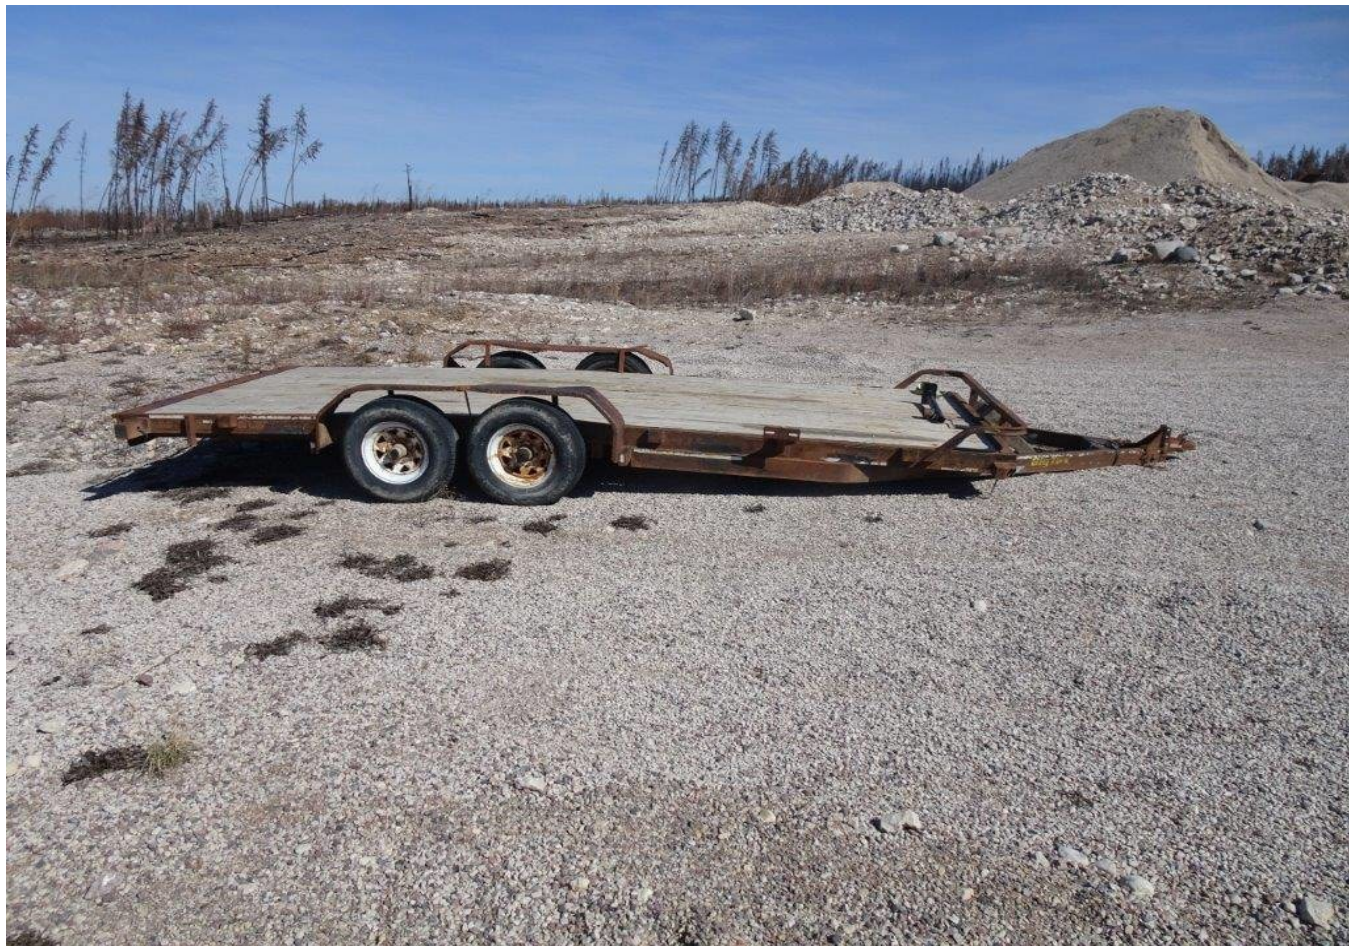
Figure 6

Flatdeck trailer at the northwest portion of the quarry.

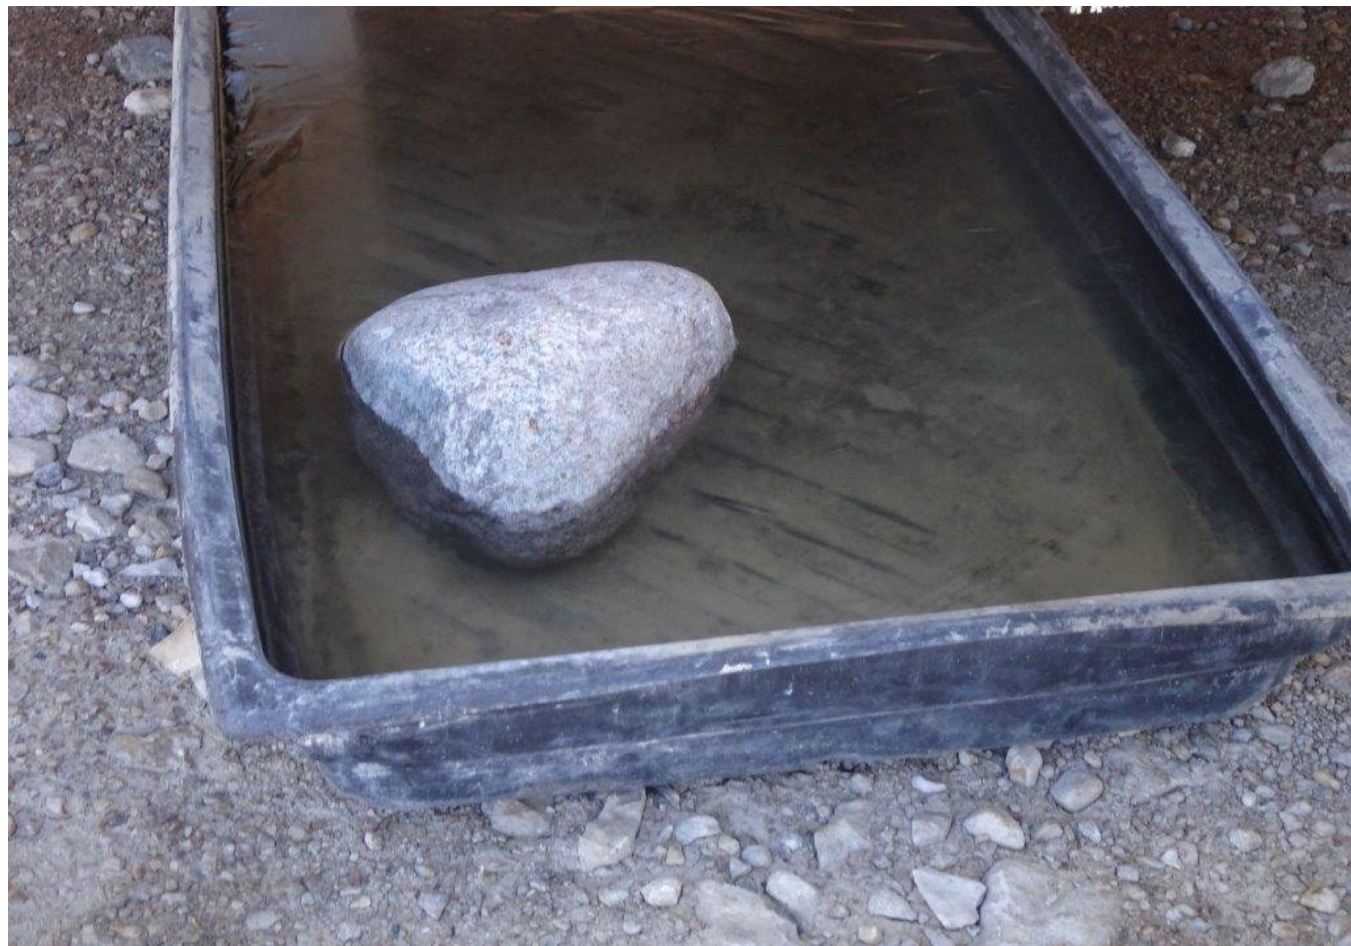
Figure 9

hydrocarbon staining (Figure 13-15, 18-20). And the yellow crusher was actively leaking what appeared to be hydraulic fluid (Figure 13-15). There were drip trays present under some of the parked equipment (Figures 9, 16, 17, 26). There were no drip trays under the three assembled crushing machines.

Drip tray full of water under the generator trailer.

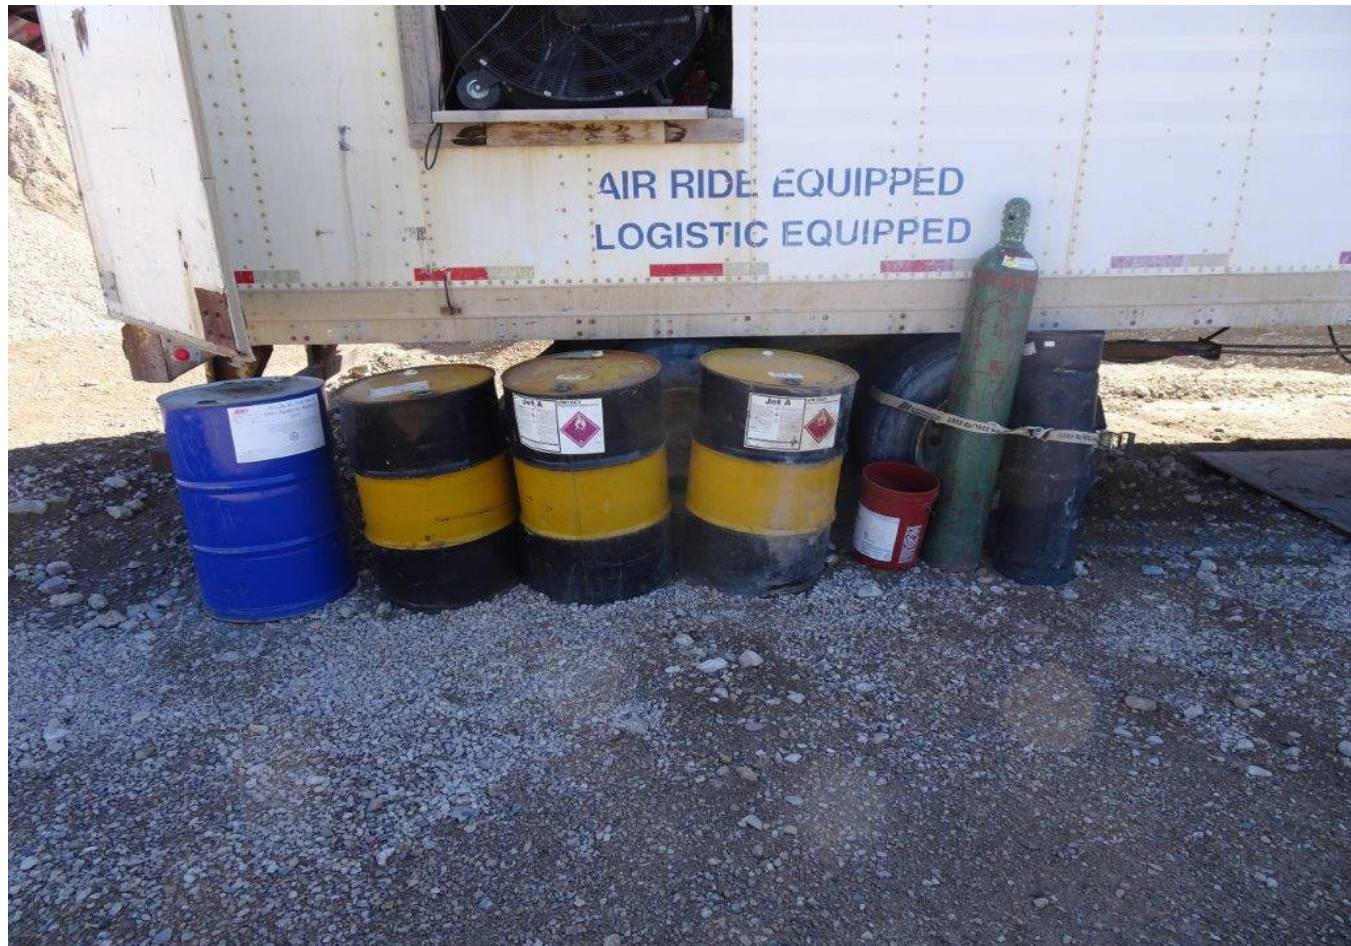
Figure 10

Inspectors observed several opened and exposed 5 gallon pails of hydraulic fluid/oil and two exposed tubes of grease (Figure 10, 19-22). There were several areas where there was visible

Fuel and chemical storage outside of the generator trailer.

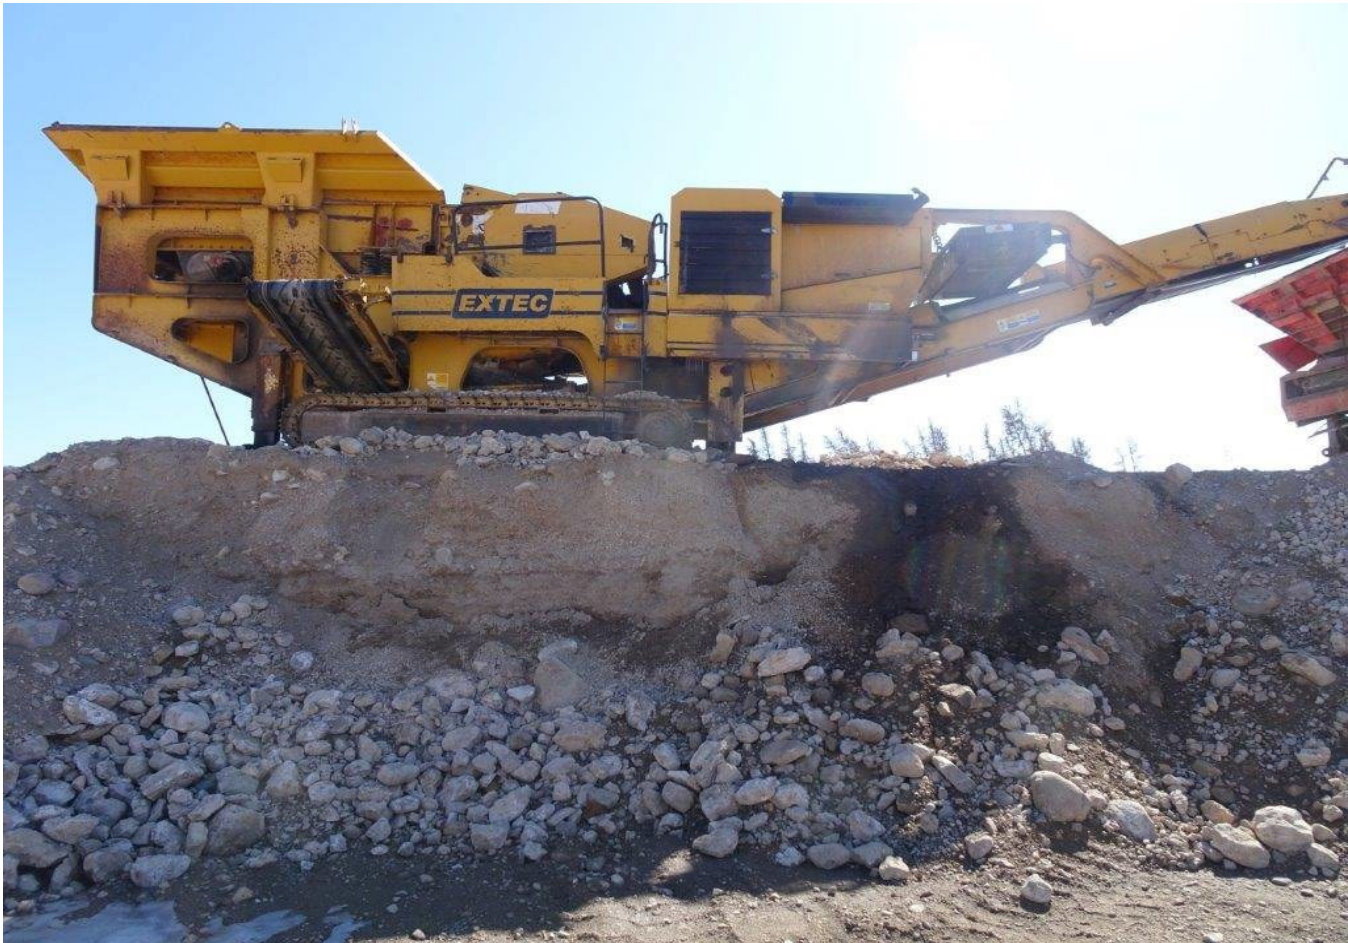
Figure 13
Yellow crusher and hydrocarbon staining.

As per permit condition # 31:
“All equipment that may be parked for two hours or more, shall have a hazmat/drip tray under it or be sufficiently diapered. Leaky equipment shall be repaired immediately.”

As per permit condition # 32:
“The Permittee shall clean up all leaks, spills, and contaminated material.”

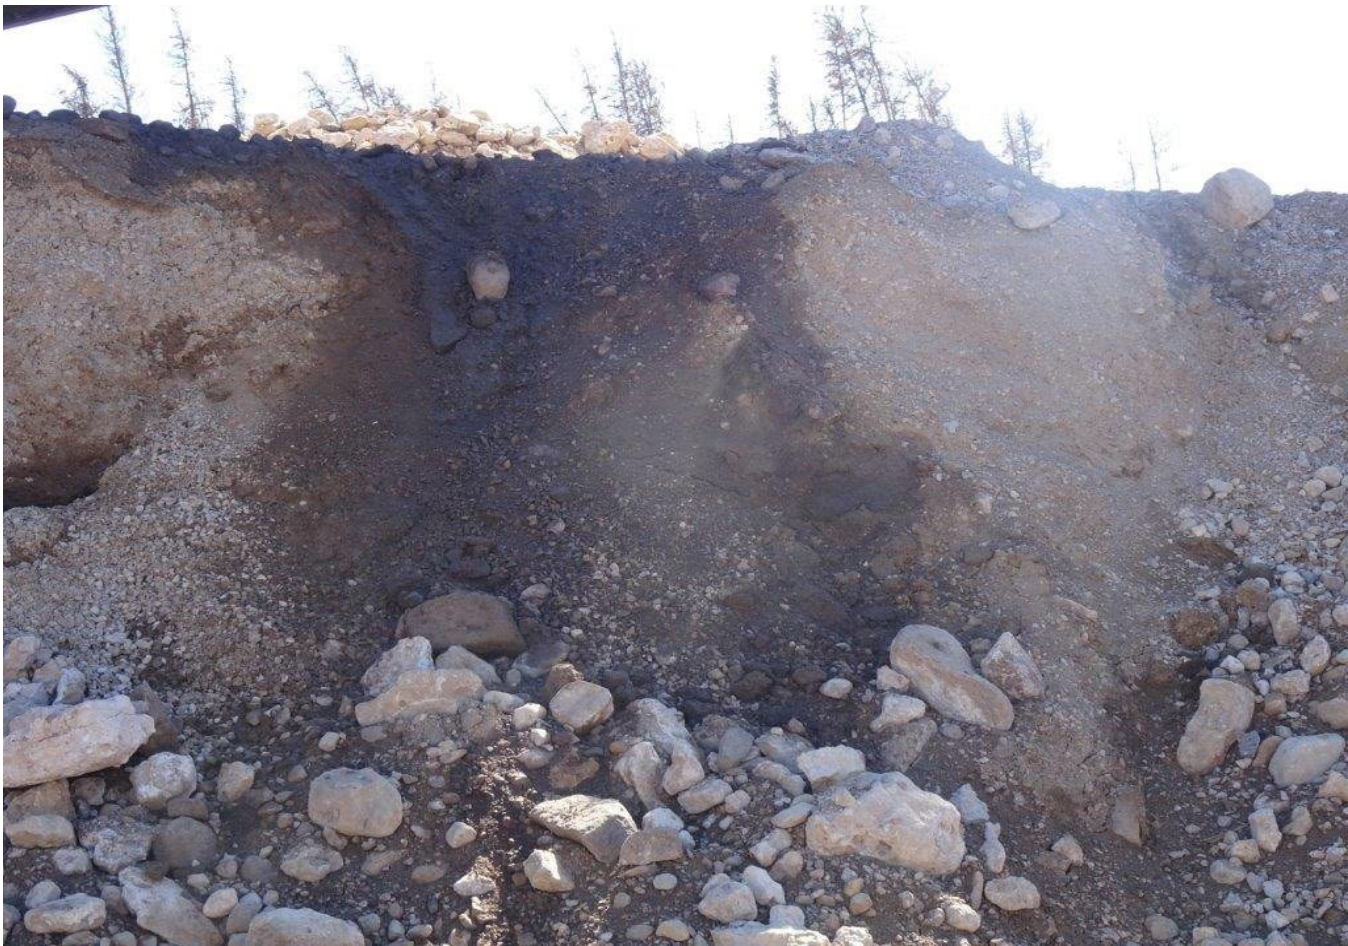
Figure 14
Closeup of hydrocarbon staining.

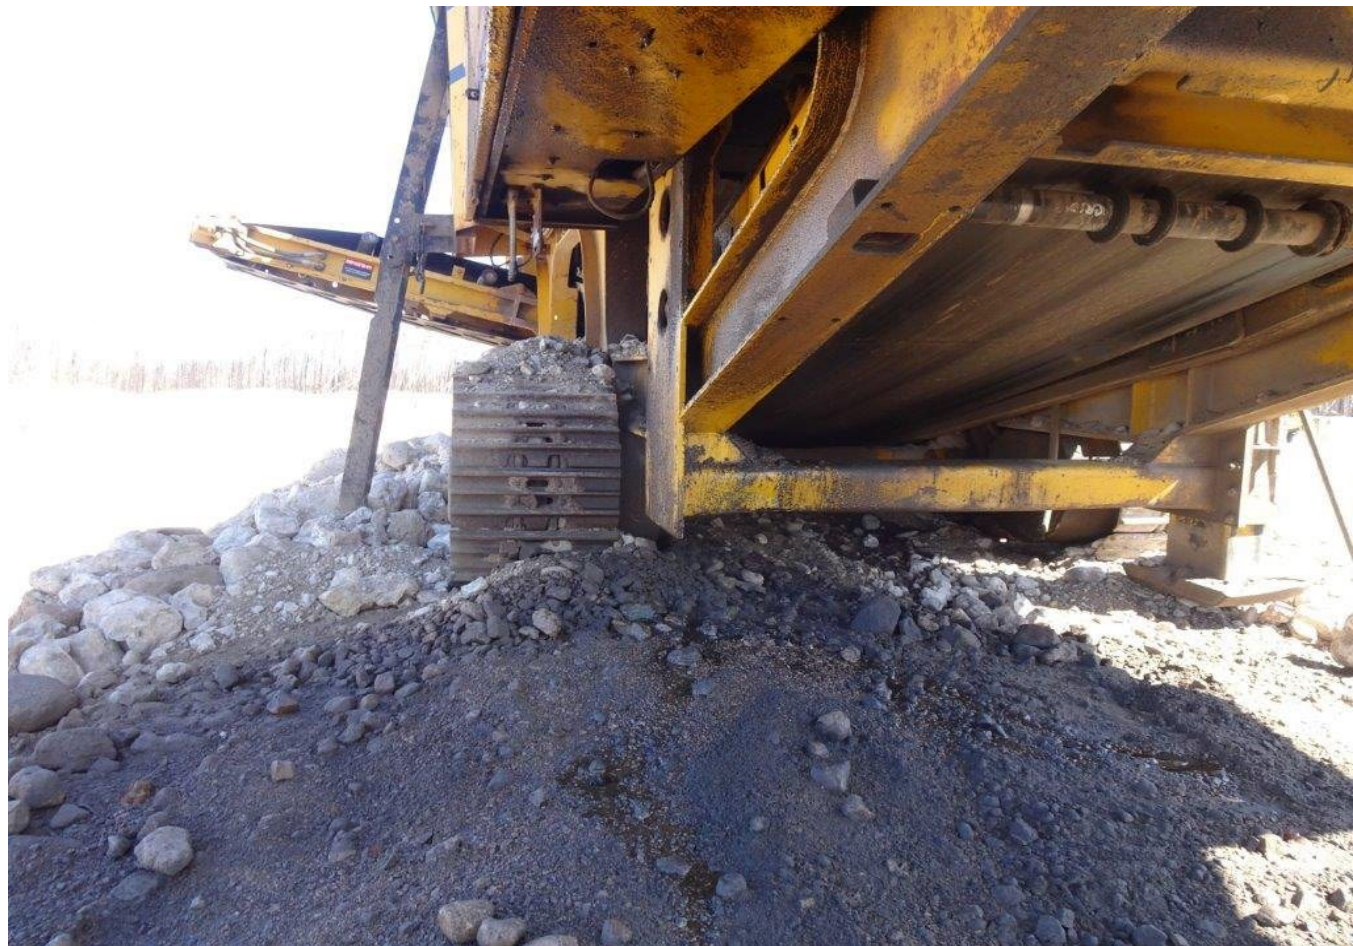
ENVIRONMENTAL INSPECTION REPORT

Hydrocarbon staining beneath yellow crusher, what appears to be hydraulic fluid is actively leaking.

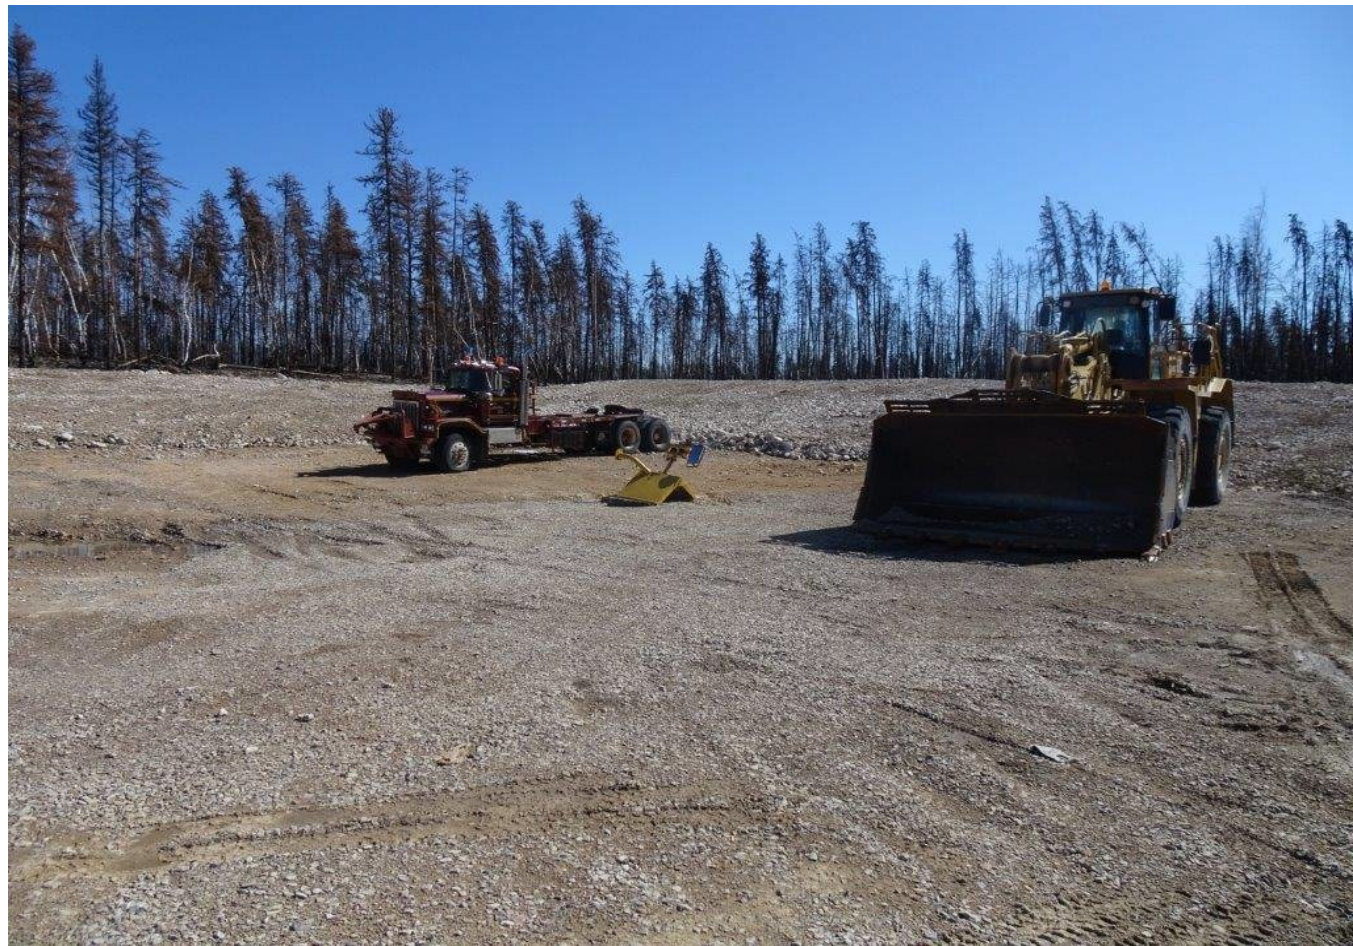
Figure 16

A loader and semi truck parked in the northeast portion of the quarry. Drip trays were present.

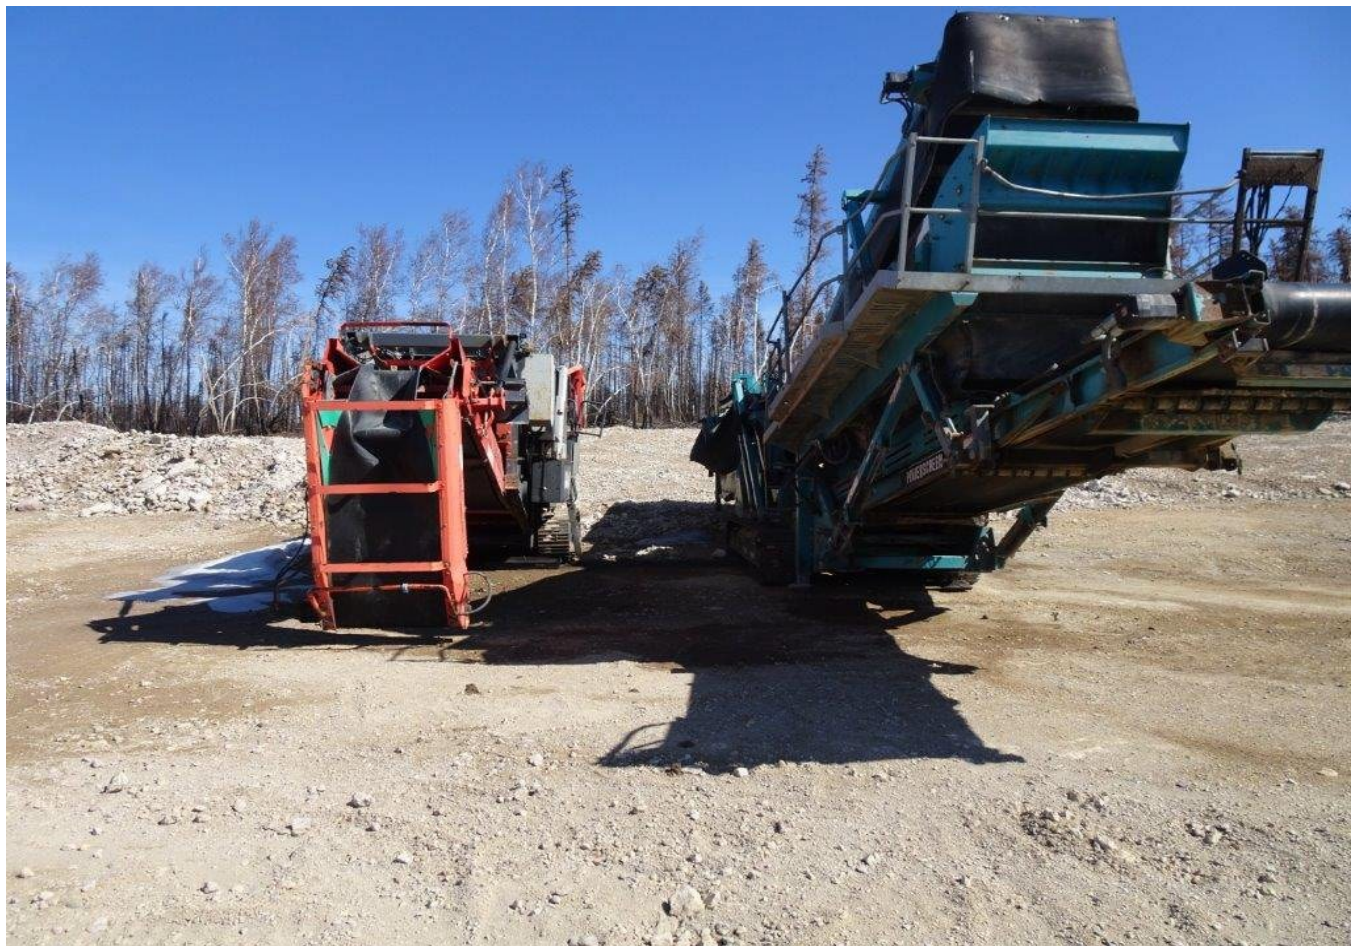
Figure 17

Two crushing machines parked in the northeast portion of the quarry. Drip trays were present.

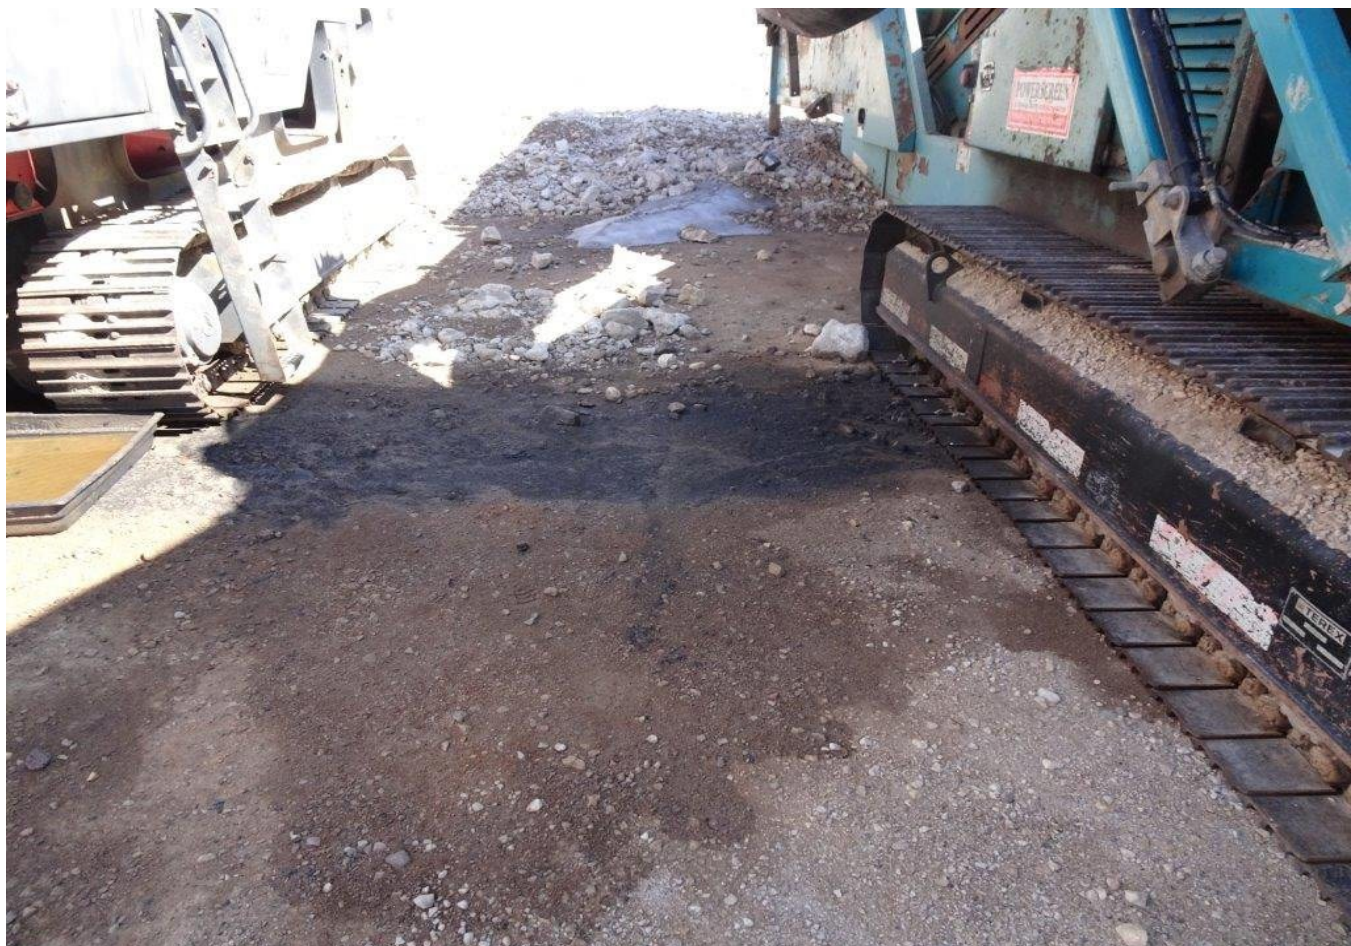
Figure 18

Hydrocarbon staining between the two parked crushing machines.

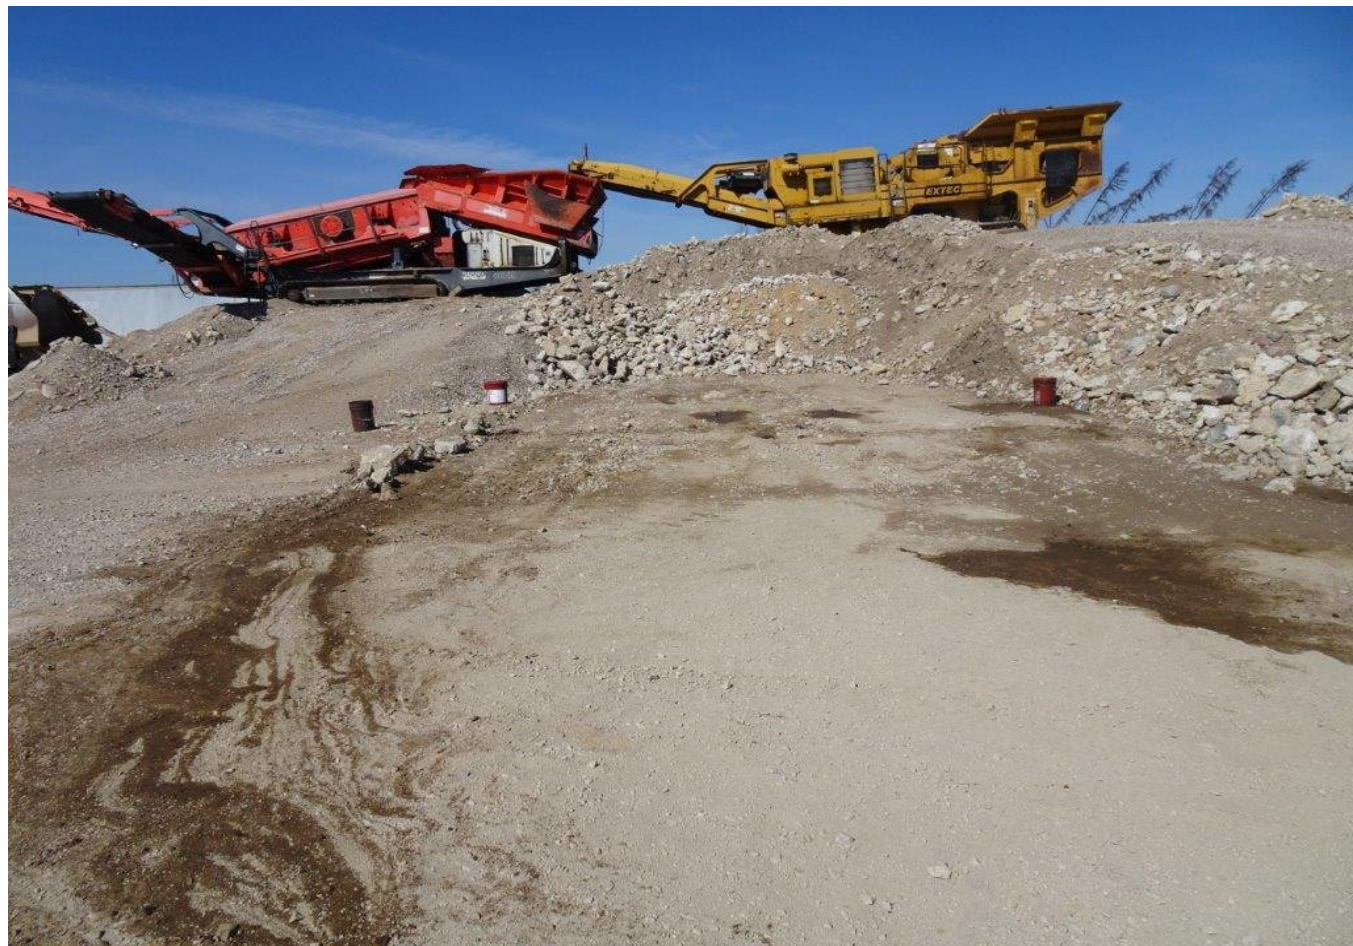
Figure 19

Two crushing machines and four 5 gallon pails of oil/hydraulic fluid. Visible hydrocarbon staining.

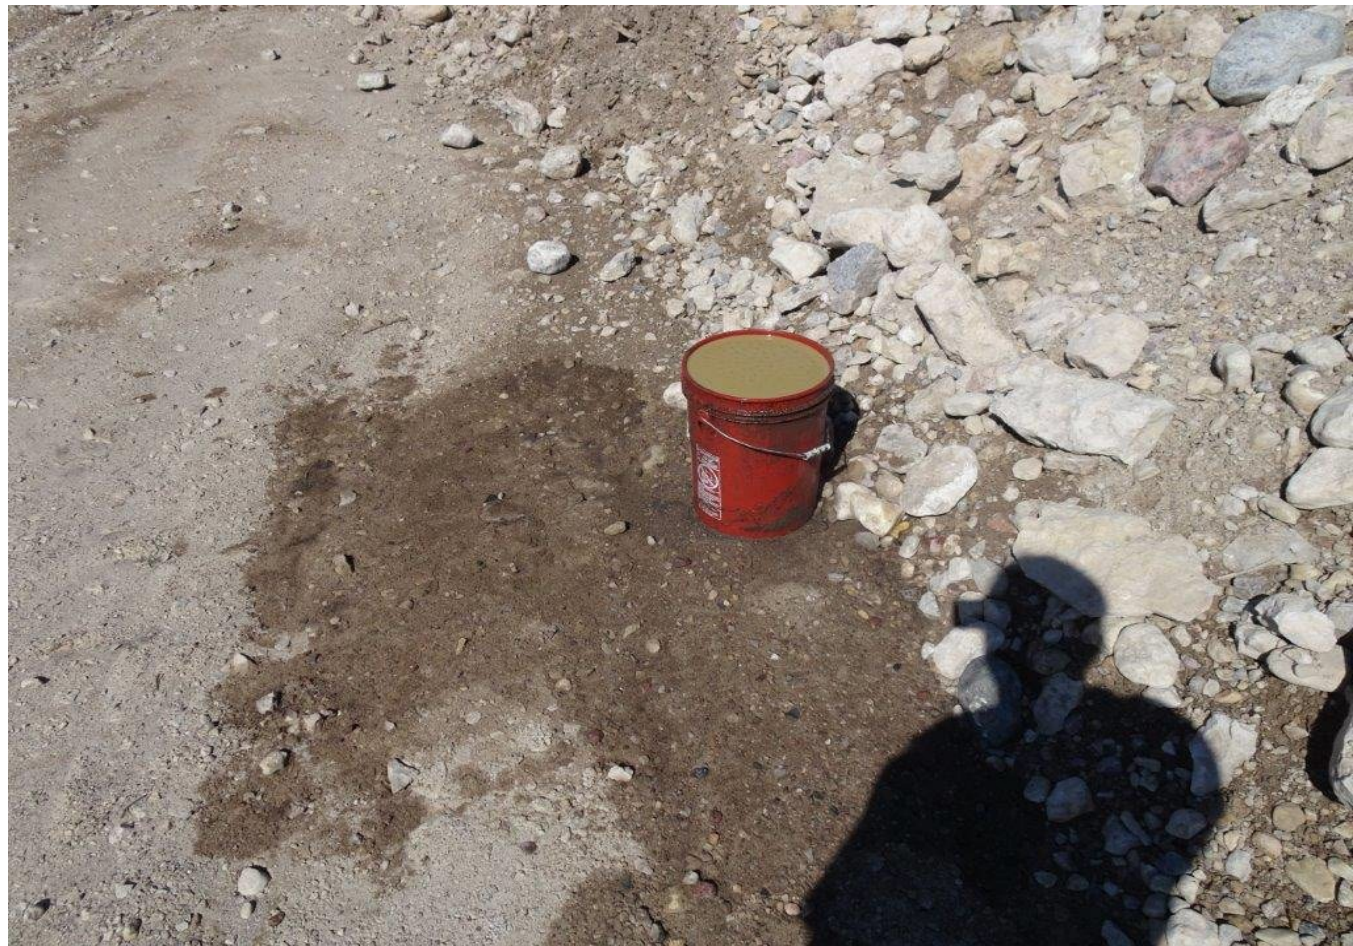
Figure 20

An opened pail of oil/hydraulic fluid and visible staining of sediments.

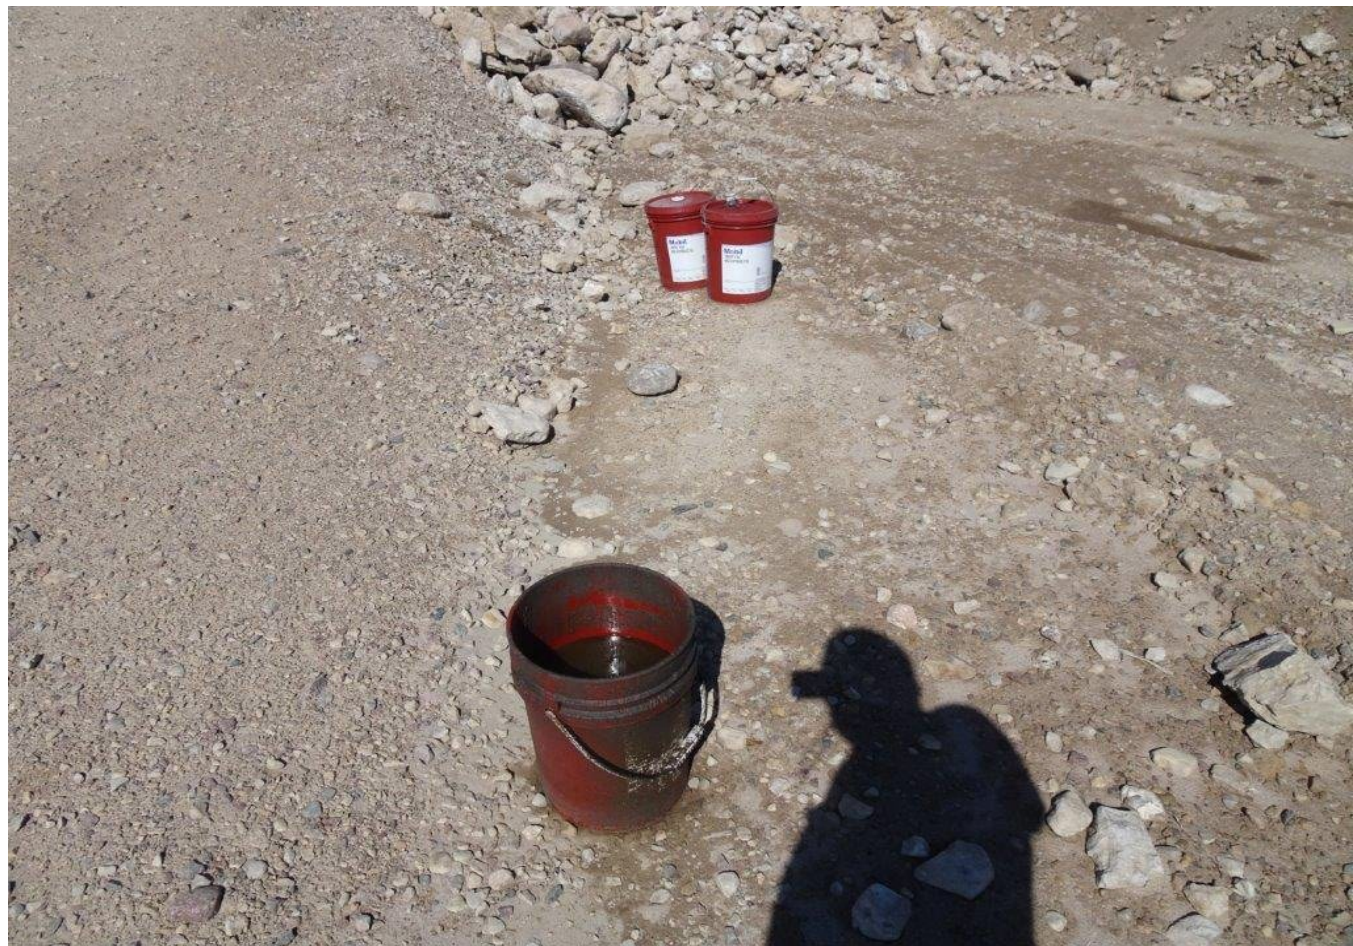
Figure 21

An opened pail of oil/hydraulic fluid.
