File Number	MV2016Q0036
Type of Operation	QUARRY SITE - Existing
Location	Salt Mountain Quarry

An inspection of the above noted operation was conducted on April 23, 2024 by Resource Management Officer II Miles Barry and Resource Management Officer II Jarod Tuckey.

ENVIRONMENTAL INSPECTION REPORT

Permittee:	Fort Smith Const. NT. Ltd.	Permit Expiry Date:	December 03, 2024
Land Use Permit No.	MV2016Q0036	Previous Inspection:	July 14, 2023
Quarrying Permit No.	2023QP0013 Expires June 25, 2026	Inspection Date:	April 23, 2024
Contractor:	Rowe’s Construction Ltd.	Subcontractor:	N/A
Location(s) Inspected:	Salt Mountain Quarry		
Current Stage of Operation:	Active		
Program Modifications Approved:	N/A

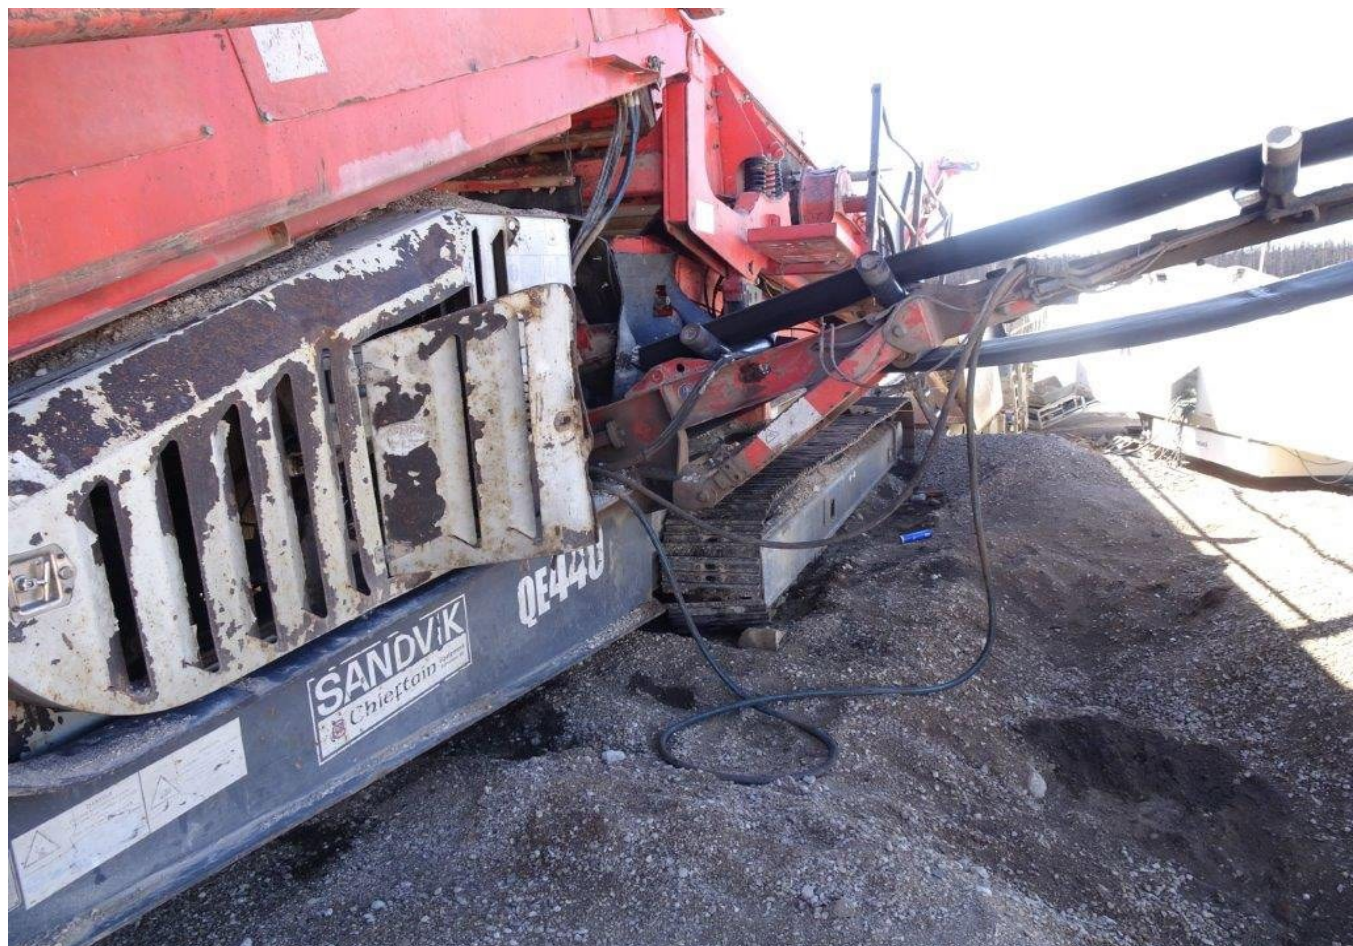
Figure 22

Inspectors observed several opened and exposed 5 gallon pails of hydraulic fluid/oil and two exposed tubes of grease (Figure 10, 19-22). There were several areas where there was visible

Two tubes of grease were visible behind the red crushing maching.

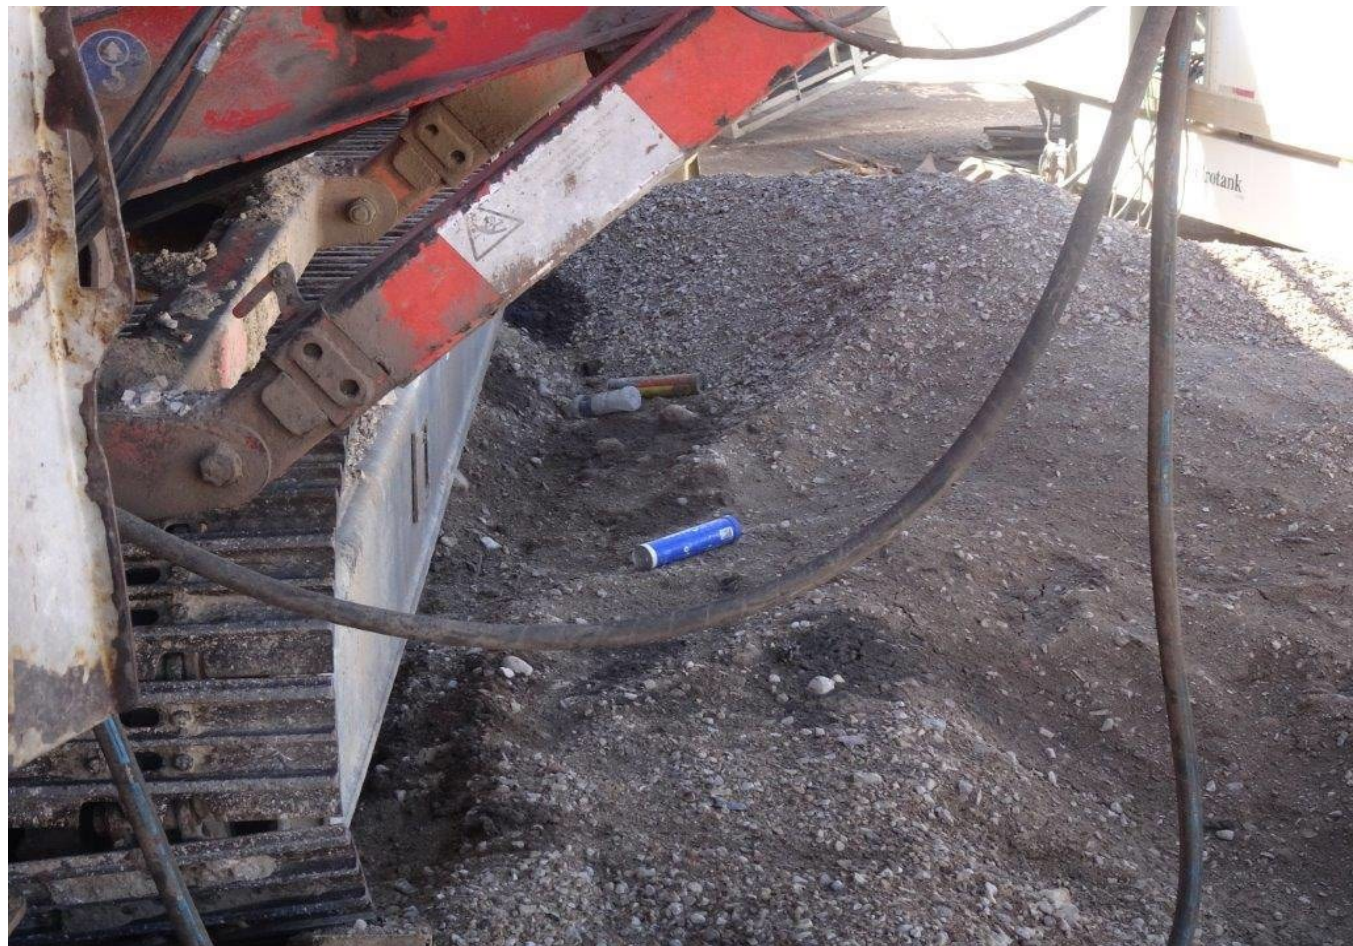
Figure 23
Two tubes of grease.

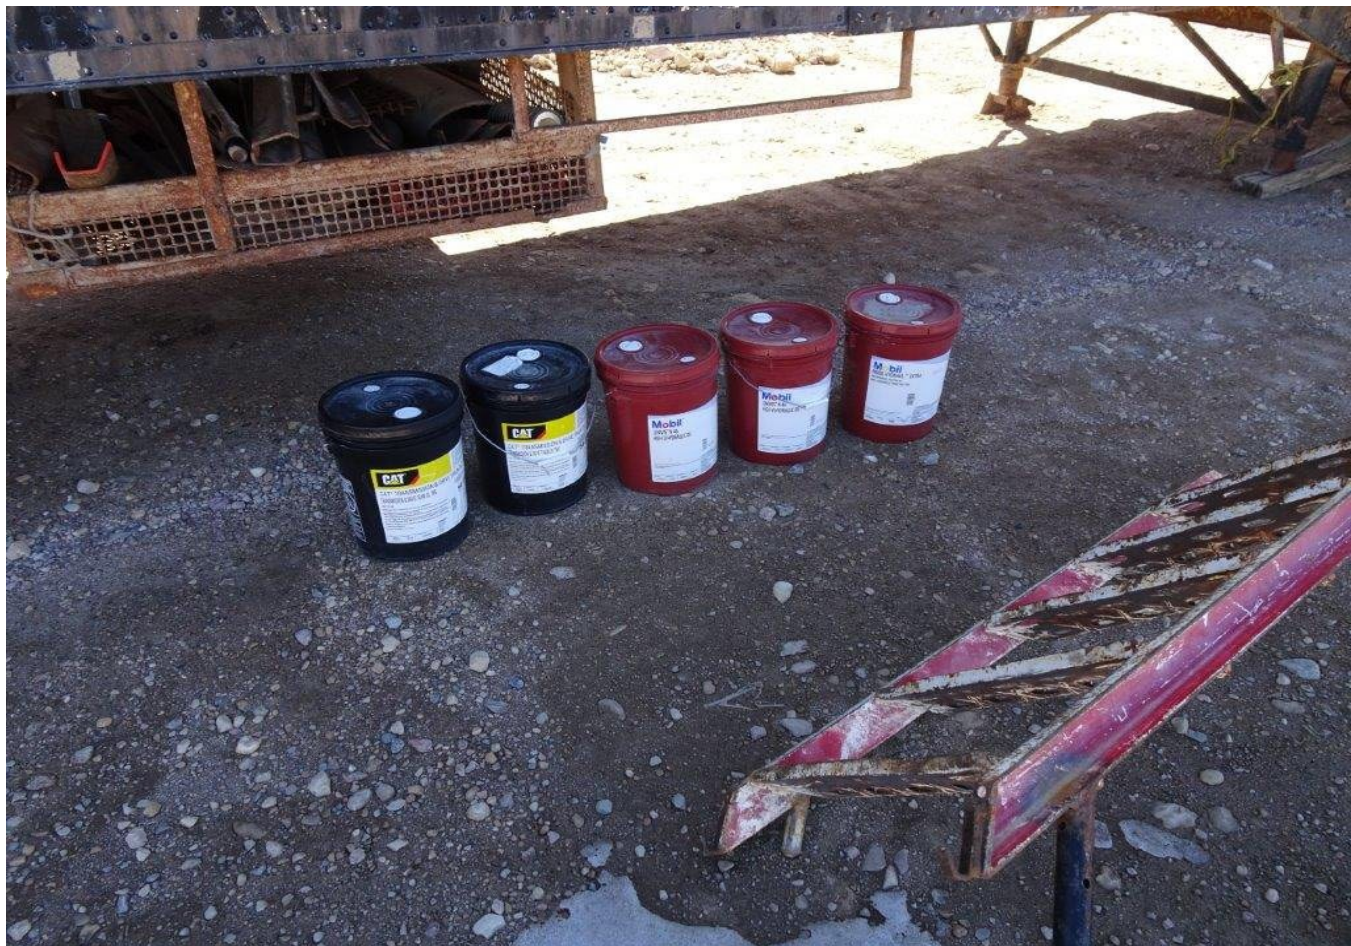
Figure 25

Five 5 gallon pails of oil and hydraulic fluid stored underneath the trailer.

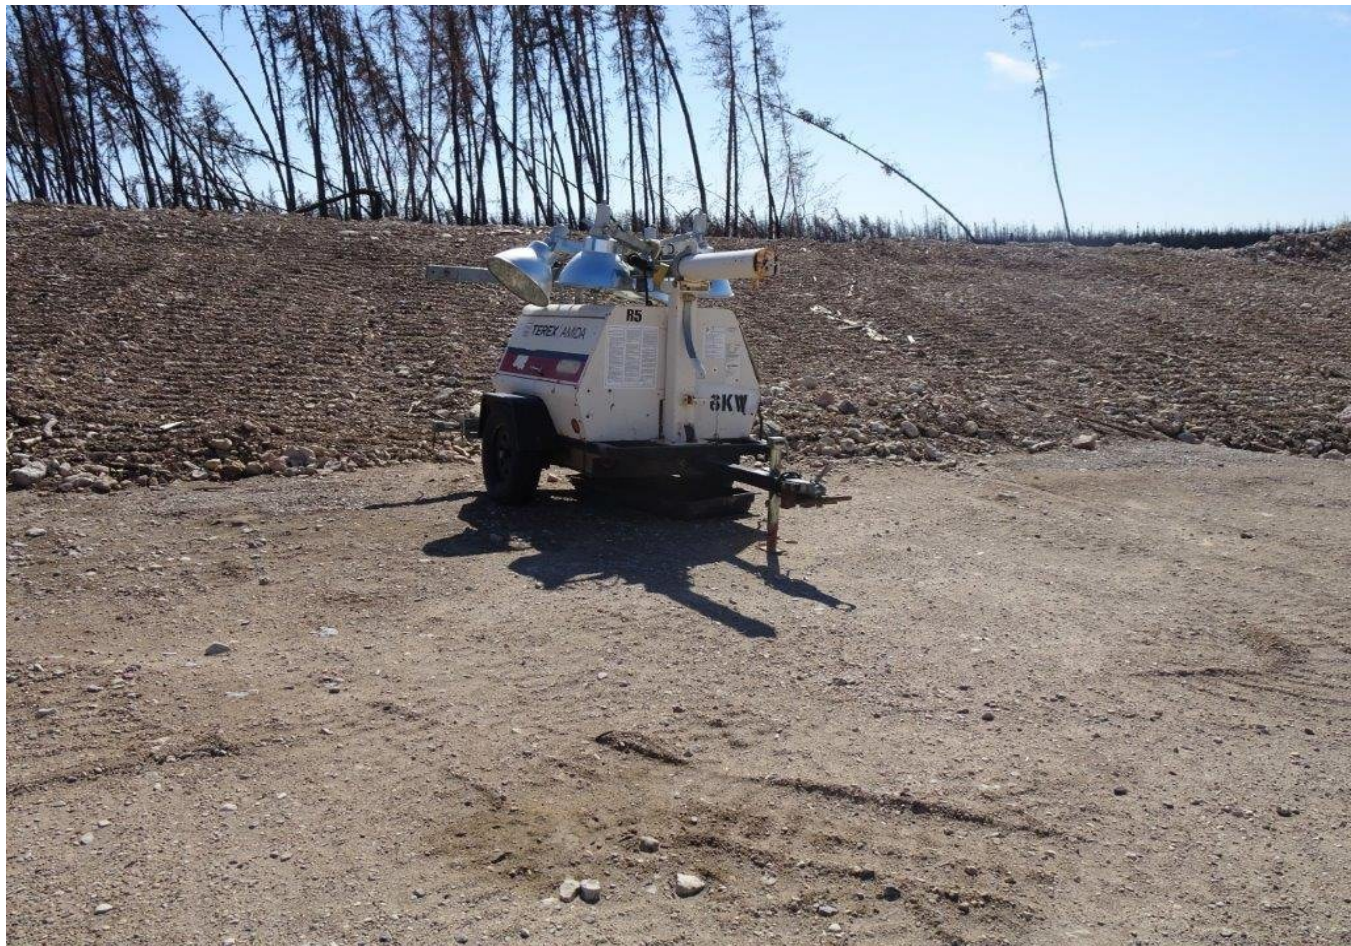
Figure 26

hydrocarbon staining (Figure 13-15, 18-20). And the yellow crusher was actively leaking what appeared to be hydraulic fluid (Figure 13-15). There were drip trays present under some of the parked equipment (Figures 9, 16, 17, 26). There were no drip trays under the three assembled crushing machines.

A mobile light plant with a drip tray.
