July 4, 2024

File Number	MV2016Q0036
Type of Operation	QUARRY SITE - Existing
Location	Quarry on Salt Mountain

ENVIRONMENTAL INSPECTION REPORT

Permittee:	Fort Smith Const. NT. Ltd.	Permit Expiry Date:	December 03, 2024
Land Use Permit No.	MV2016Q0036	Previous Inspection:	April 23, 2024
Quarrying Permit No.	2023QP0013	Inspection Date:	June 28, 2024
Contractor:	Rowes Construction	Subcontractor:	
Location(s) Inspected:	Quarry on Salt Mountain		
Current Stage of Operation:	Crushing		
Program Modifications Approved:	N/A

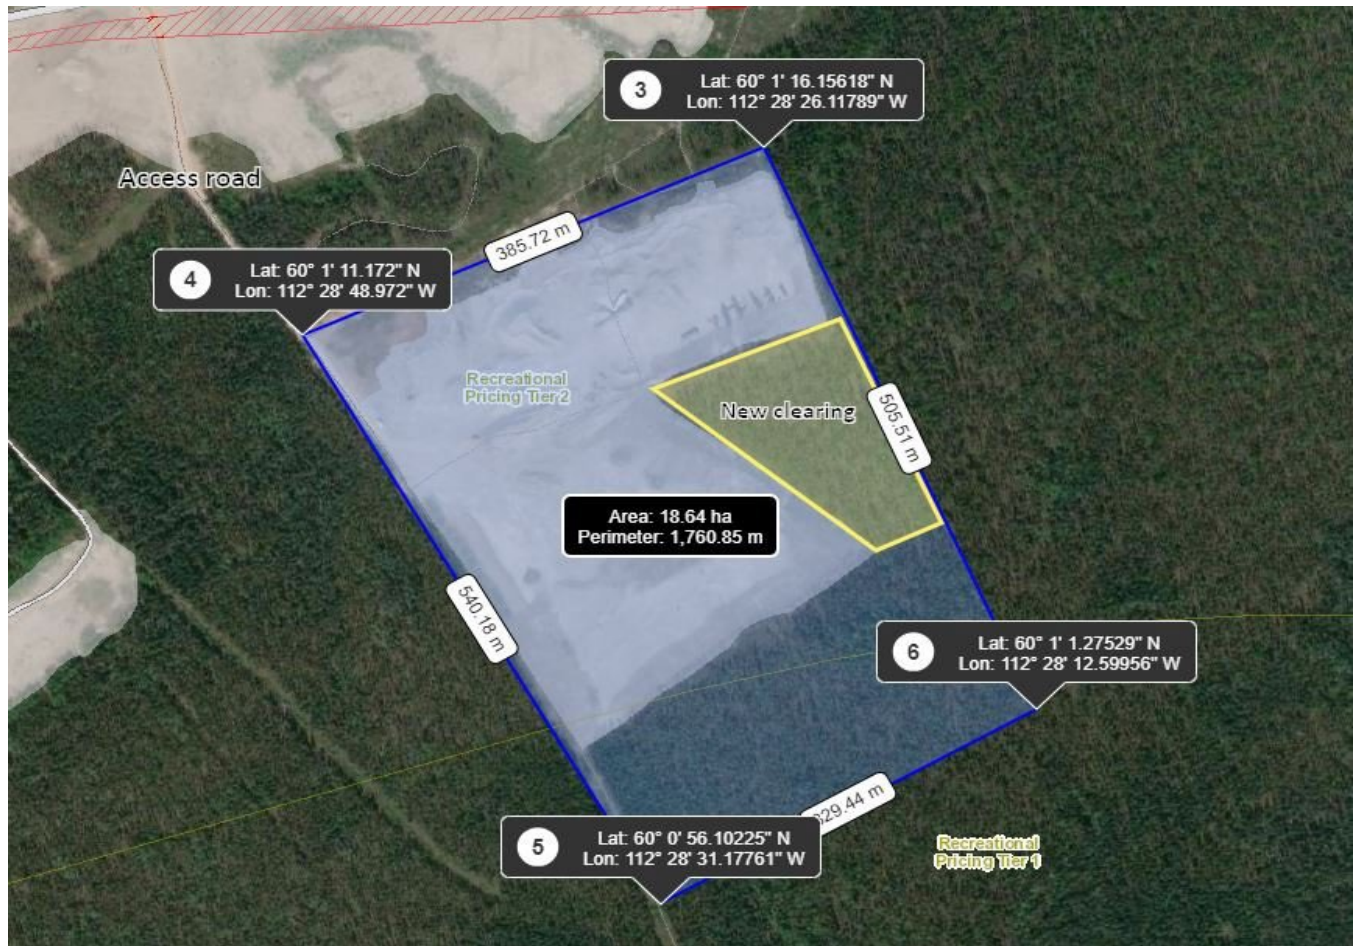
Figure 1

The area surrounding the quarry burned in the 2023 wildfires. The forest along the eastern boundary of the pit has been cleared and quarried in location as permitted (Figures 1 & 13). Crushed material is being stockpiled on site (Figures 14-15) and brush is being piled for burning as it is unsalvageable due to the intensity of wildfire (Figure 17).

Site map of quarry showing freshly cleared area.

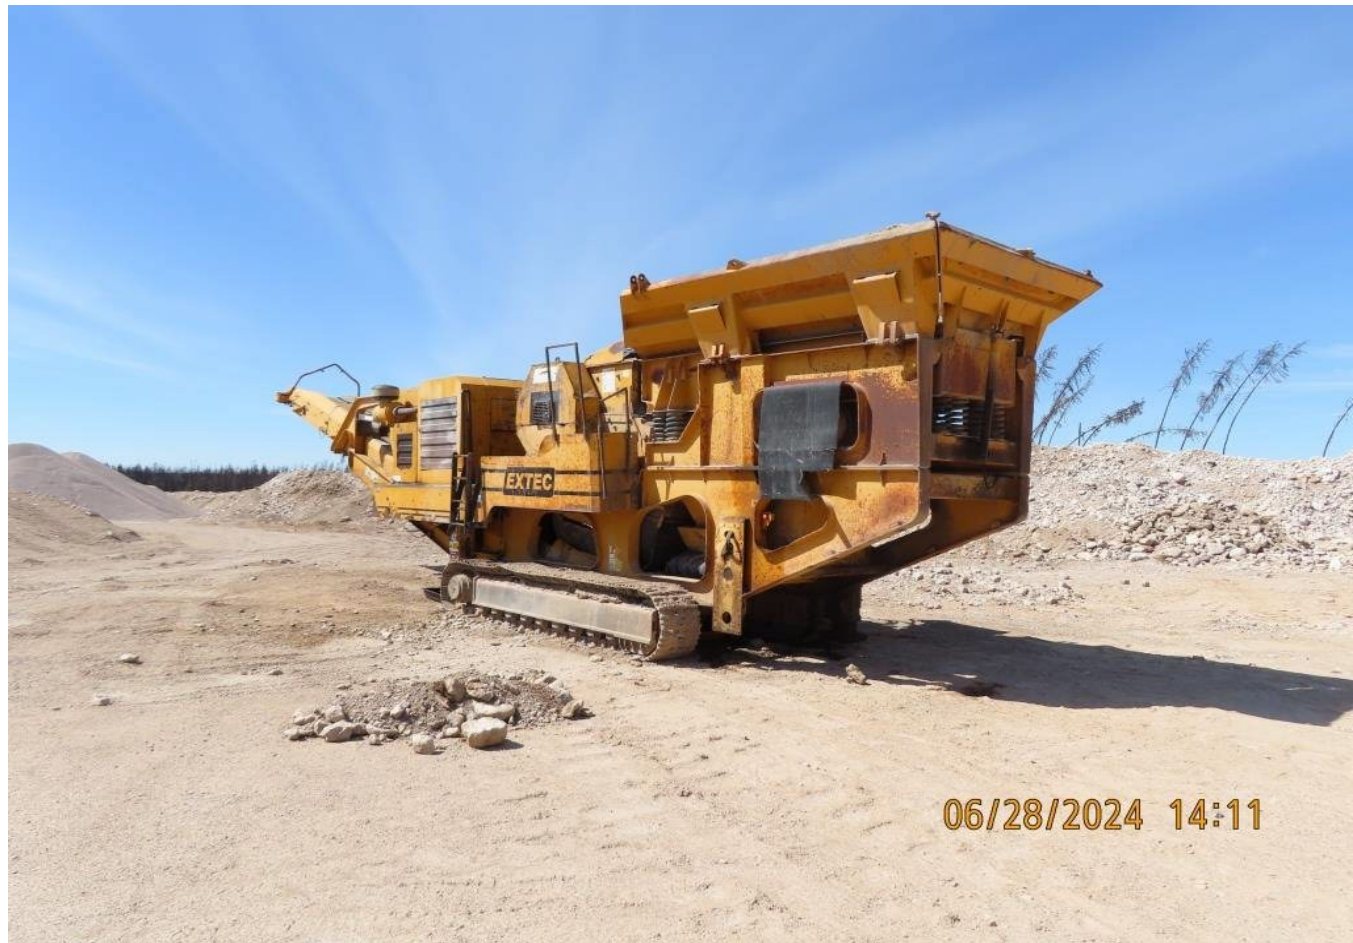
Figure 2

There is an unserviceable EXTEC crusher located in the northeast corner of the pit (Figure 2-3). The machine is leaking and has spilled over its drip trays (Figure 4).

Image of unserviceable EXTEC crusher located in the northeast corner of the pit.

Condition #31 requires:

"... Leaky equipment shall be repaired immediately."

The machine must be repaired immediately, or it needs to be removed from the quarry.

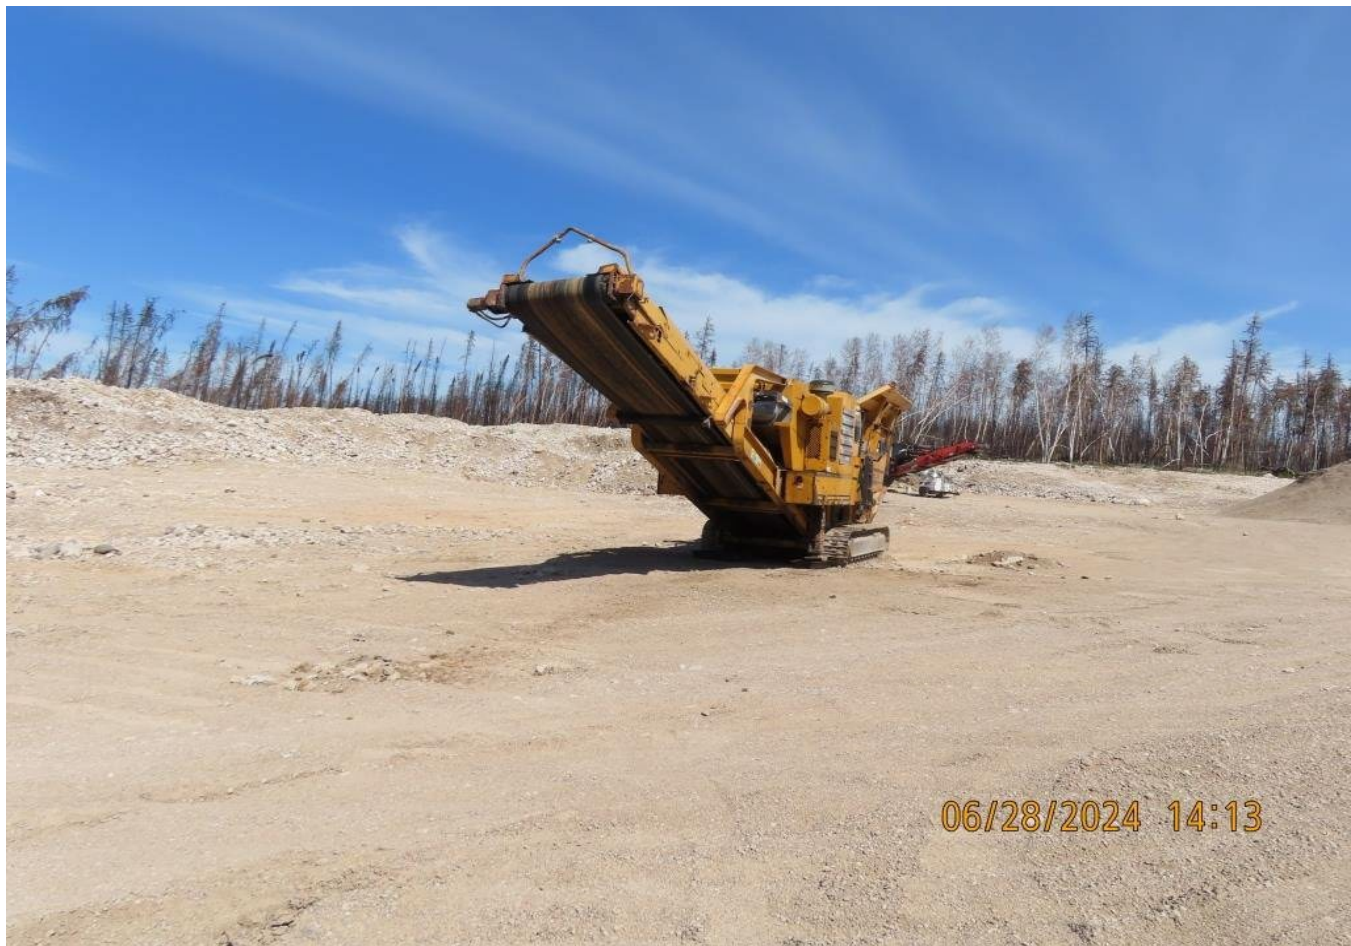
Figure 3
Unserviceable EXTEC crusher.

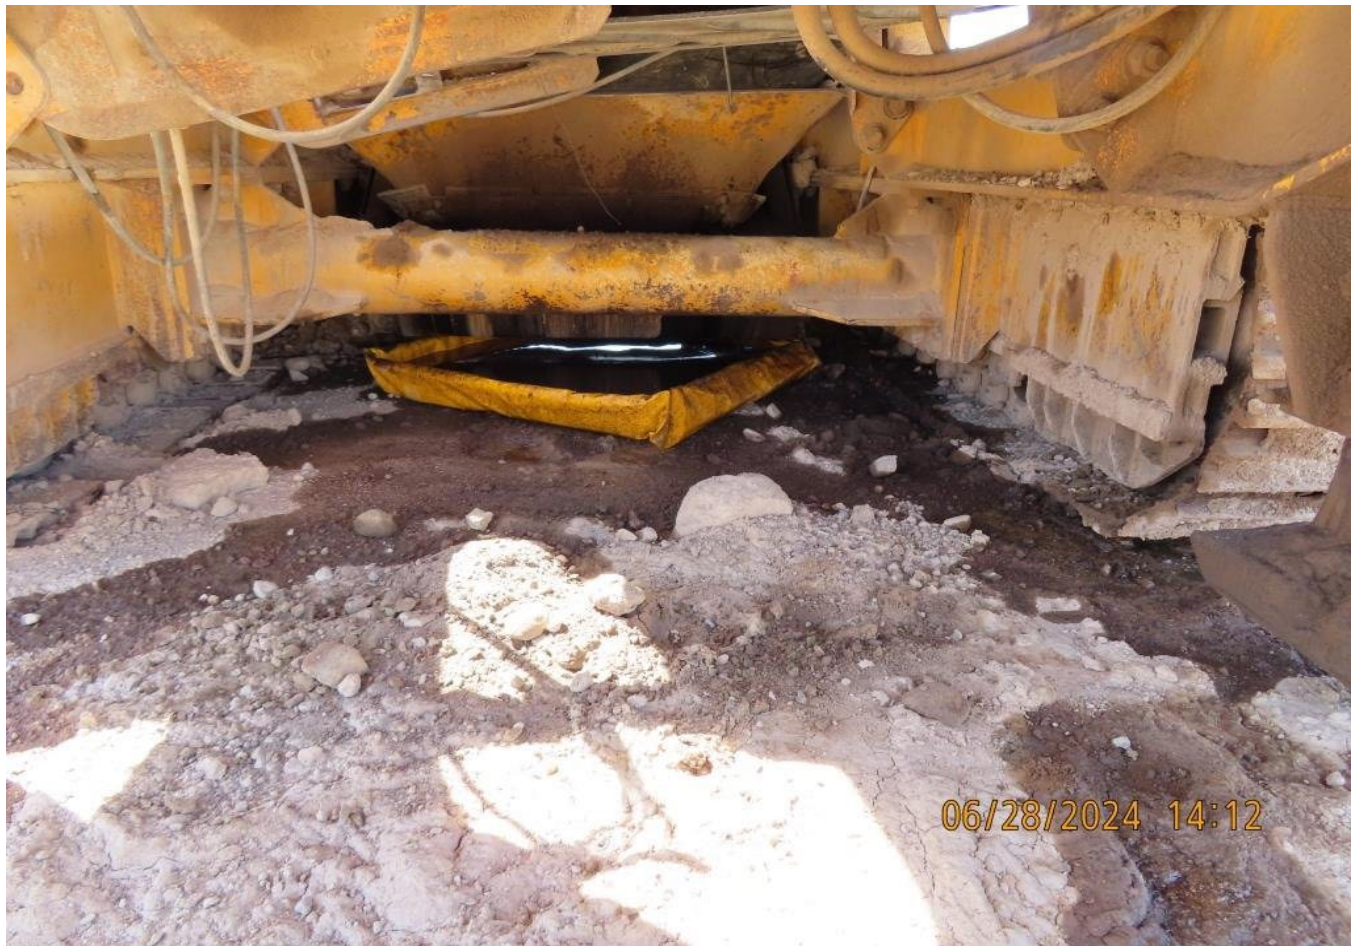
Figure 4
Close up image of leaks and spills

As per permit condition # 32:

"The Permittee shall clean up all leaks, spills, and contaminated material."

When contaminated soil is removed, please submit documentation to the Inspectors as per Condition #18.

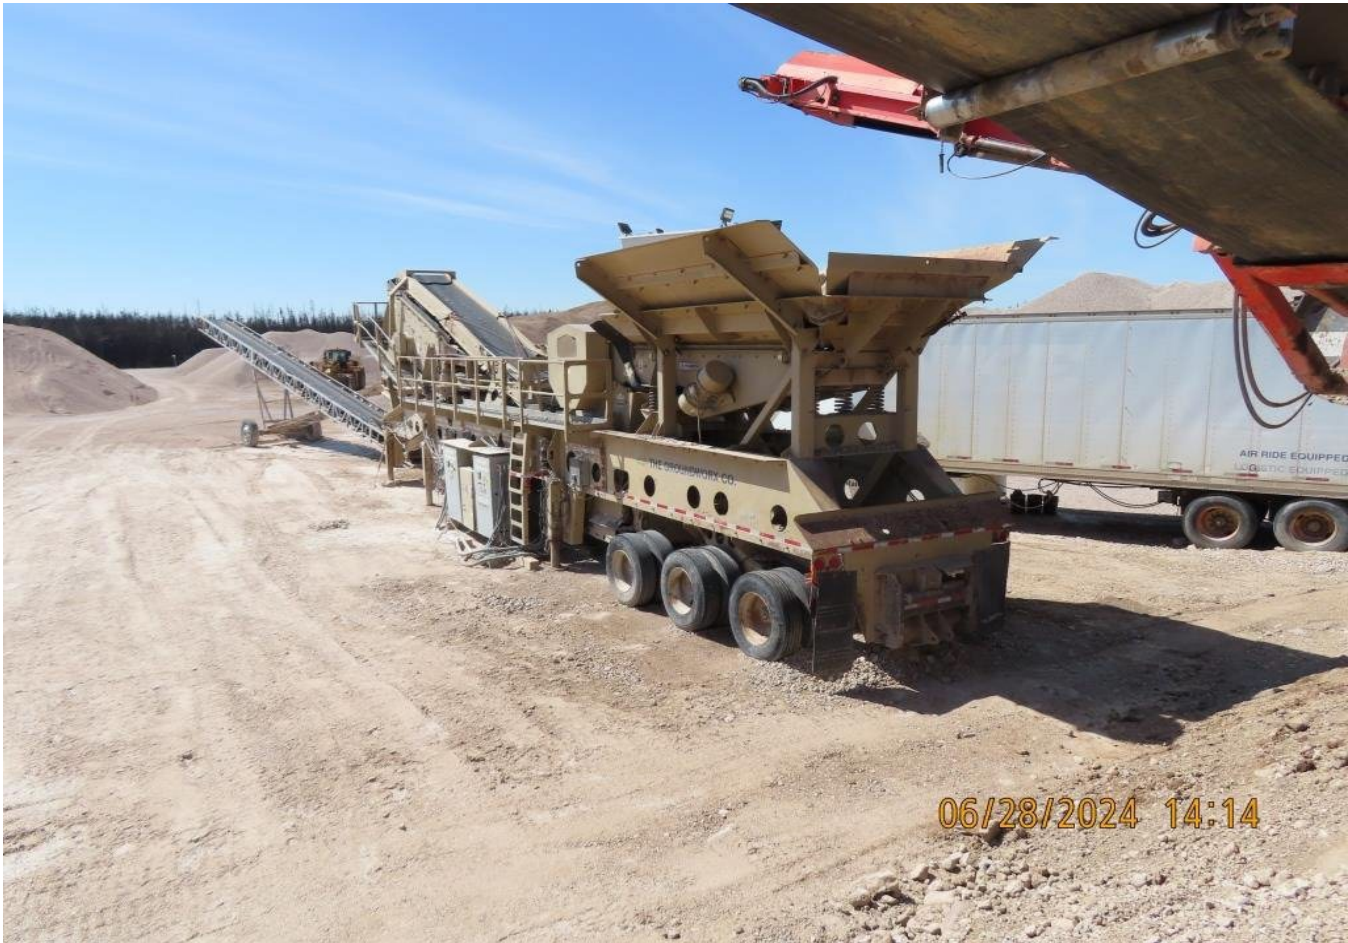
Other equipment documented included a GROUNDWORX crusher (Figure 5), two SANDVIK crushers (Figure 6-7), loader (Figure 8), enclosed trailer, utility trailer, crusher, and semi-trailer (Figure 9), semi-truck (figure 10), semi-trailer and skid-steer (Figure 11).

Figure 5
GROUNDWORX crusher in northeast corner of pit.

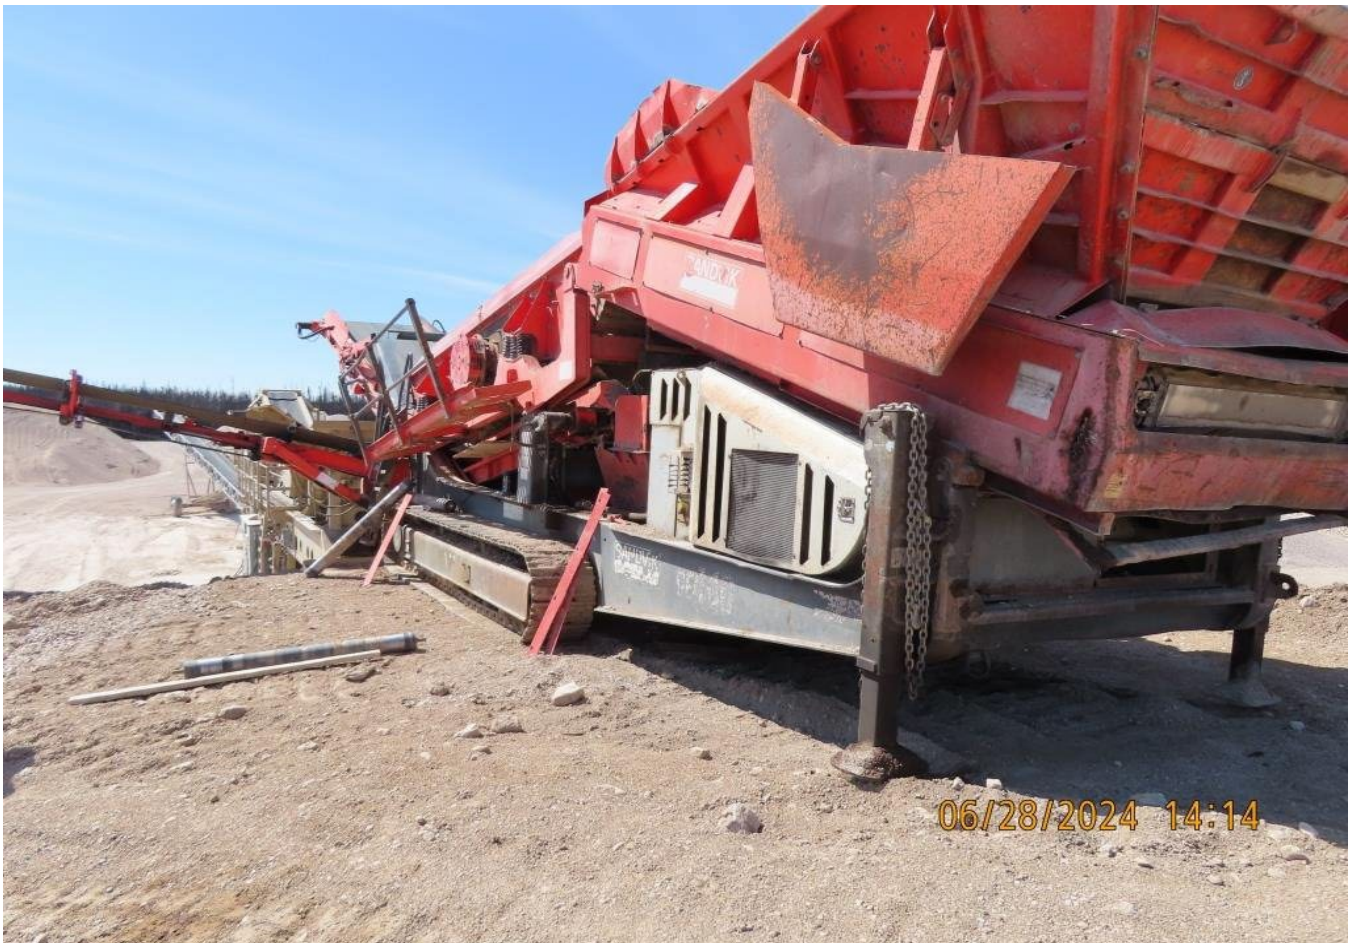
Figure 6
SANDVIK crusher staged in front of the GROUNDWORX crusher.

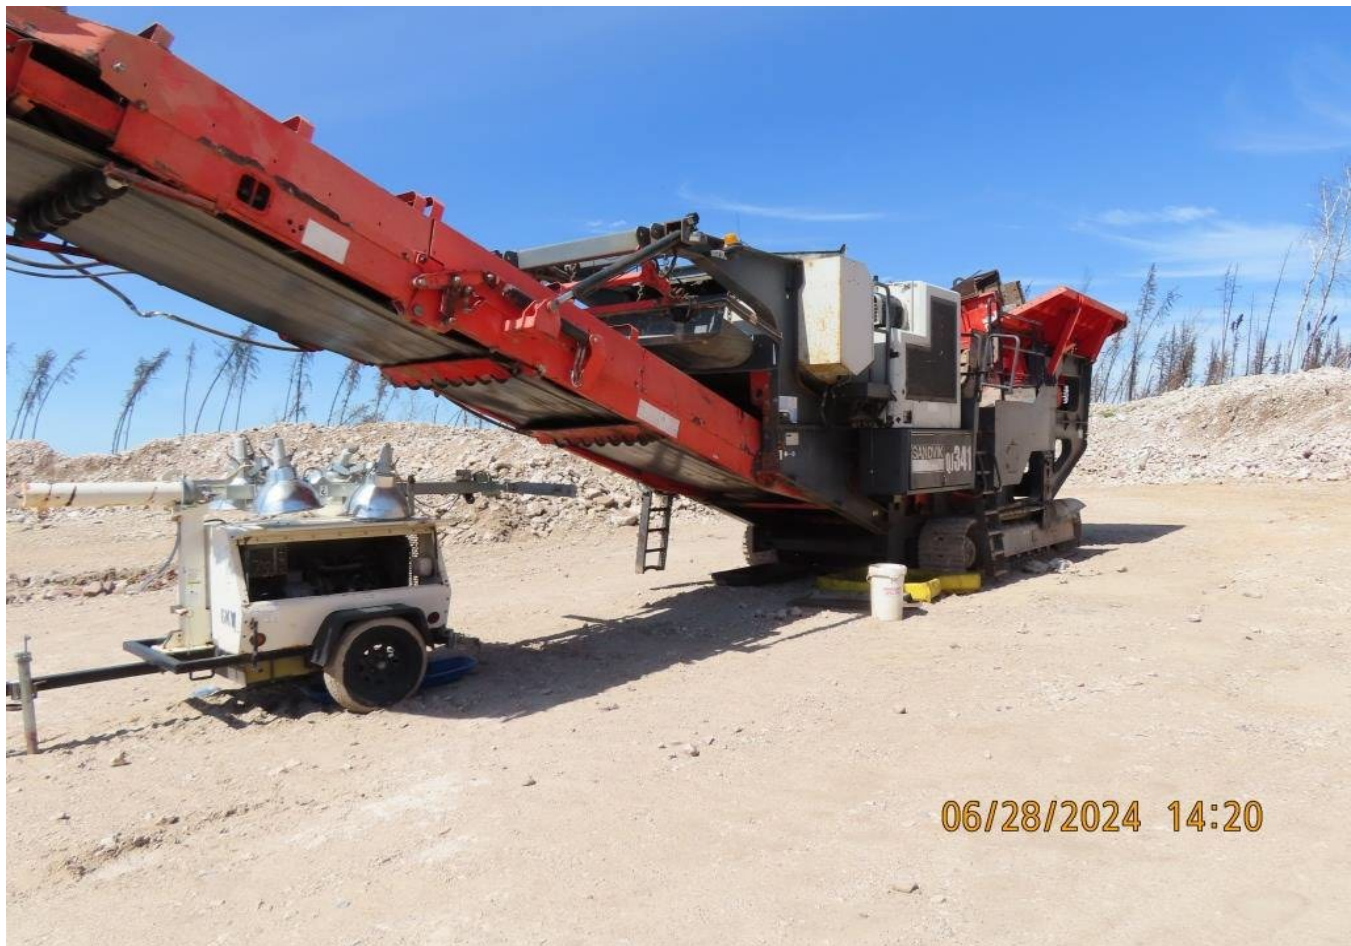
Figure 7
SANVIK crusher in northeast corner of the pit.

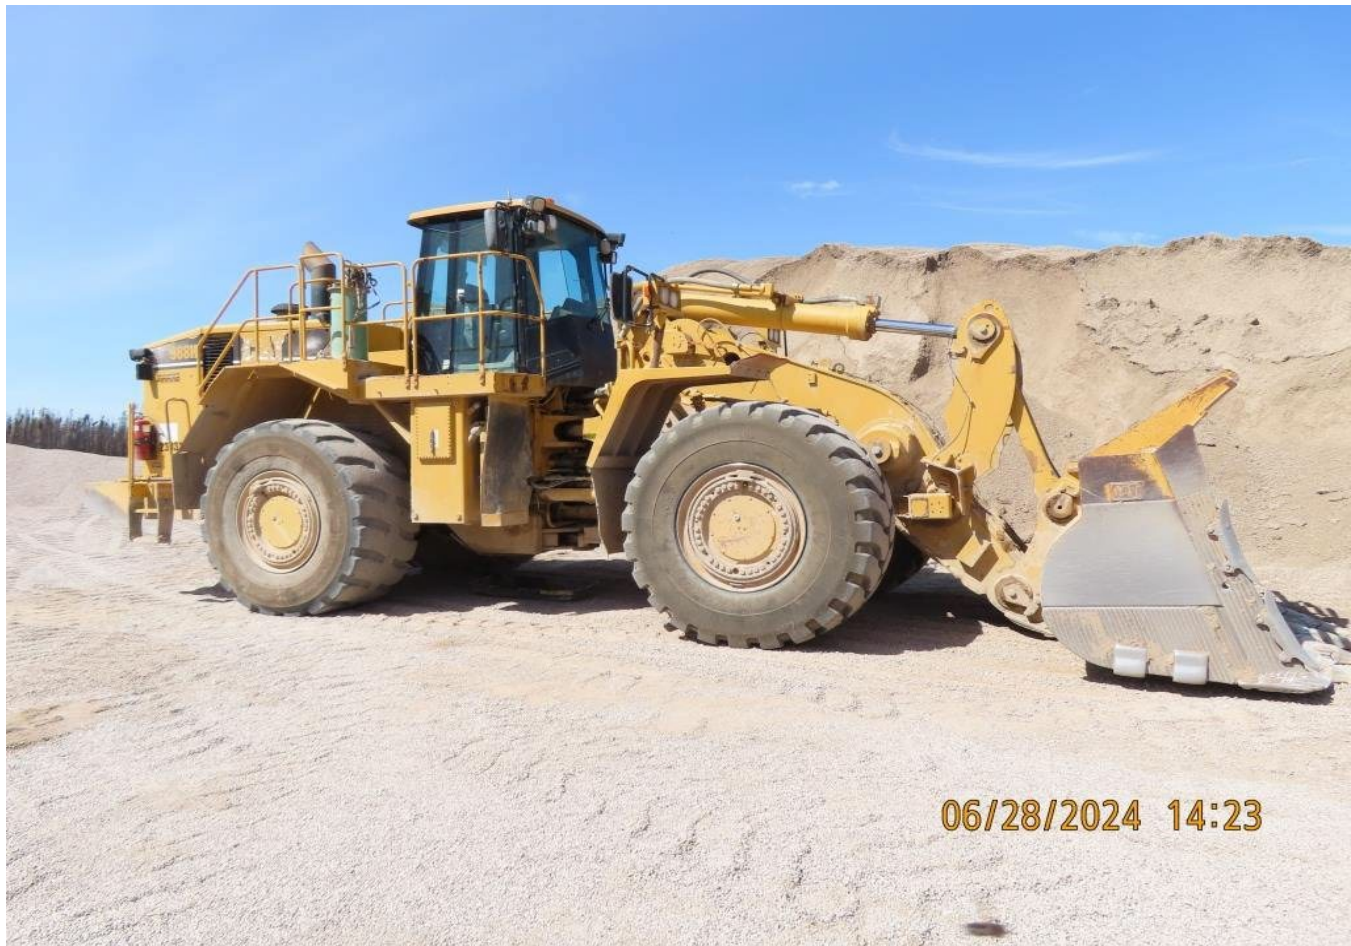
Figure 8
Loader with drip pan parked near stockpiles in northern portion of pit.

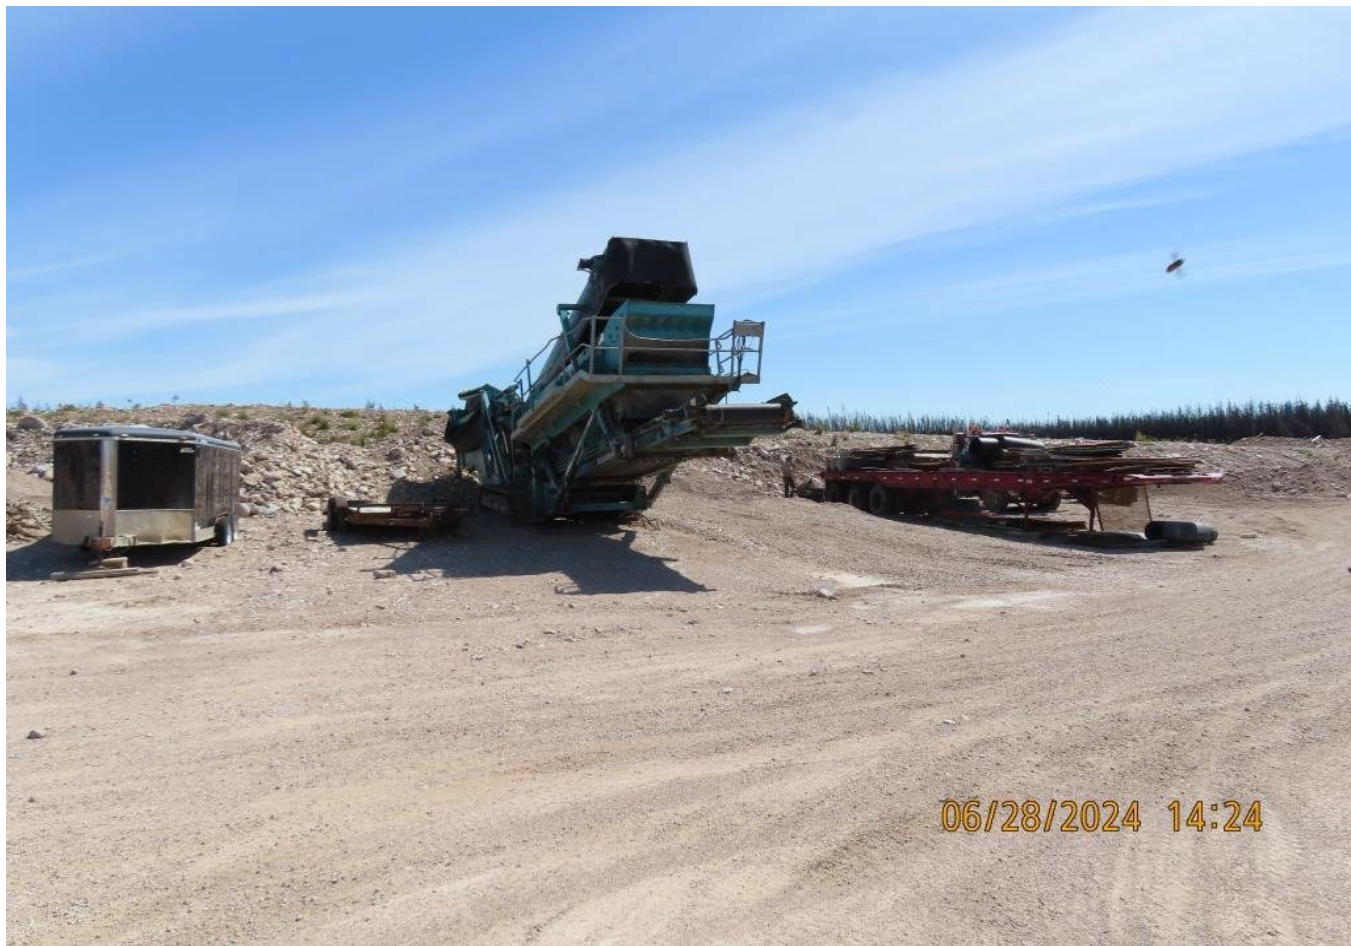
Figure 9
Enclosed trailer, utility trailer, crusher and semi-trailer with metal grating staged along north side of new clearing.

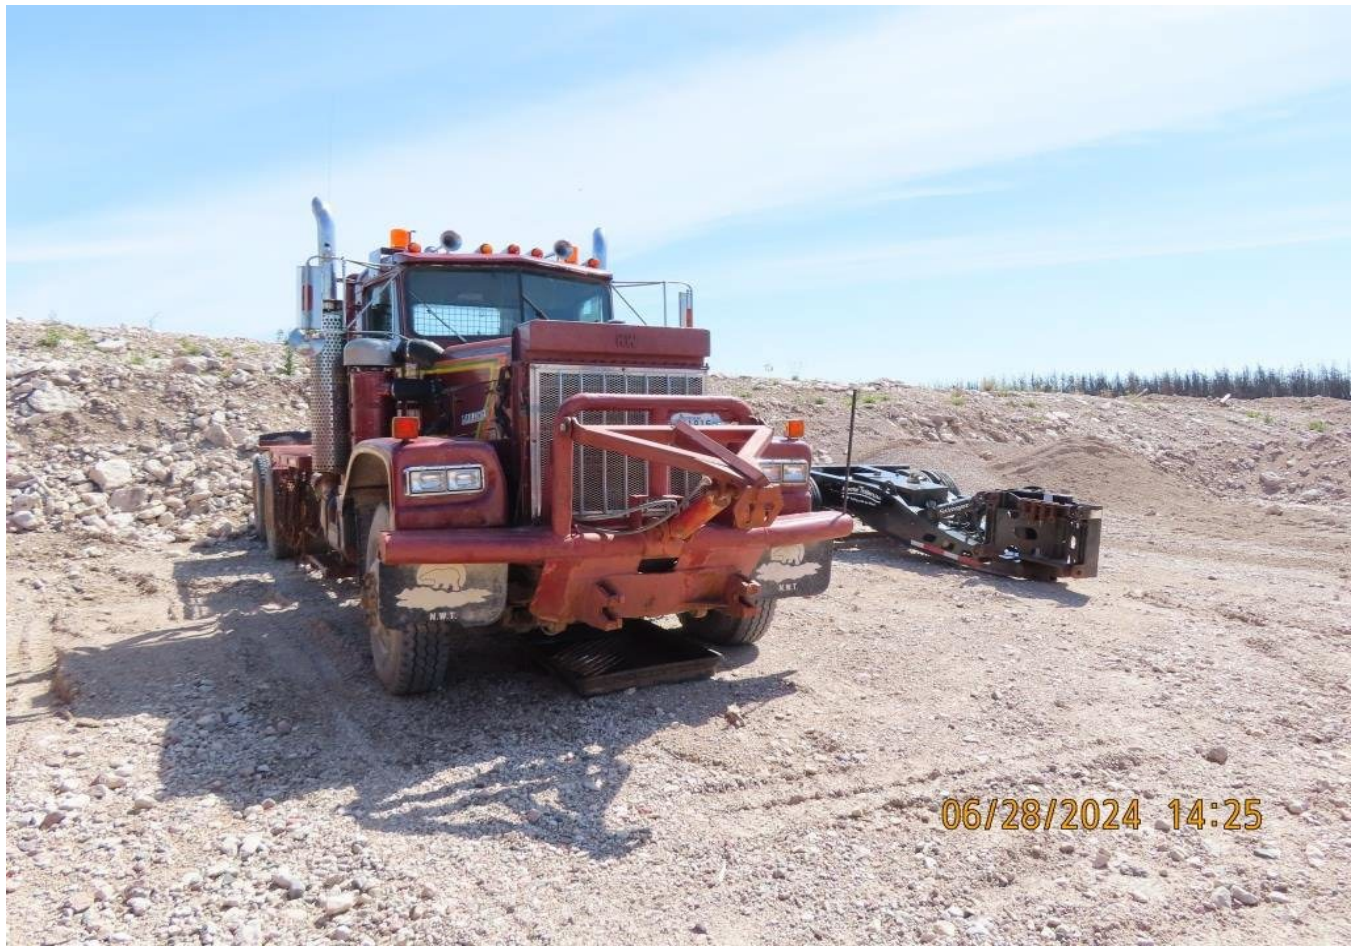
Figure 10
Semi-truck and attachment with drip pan.

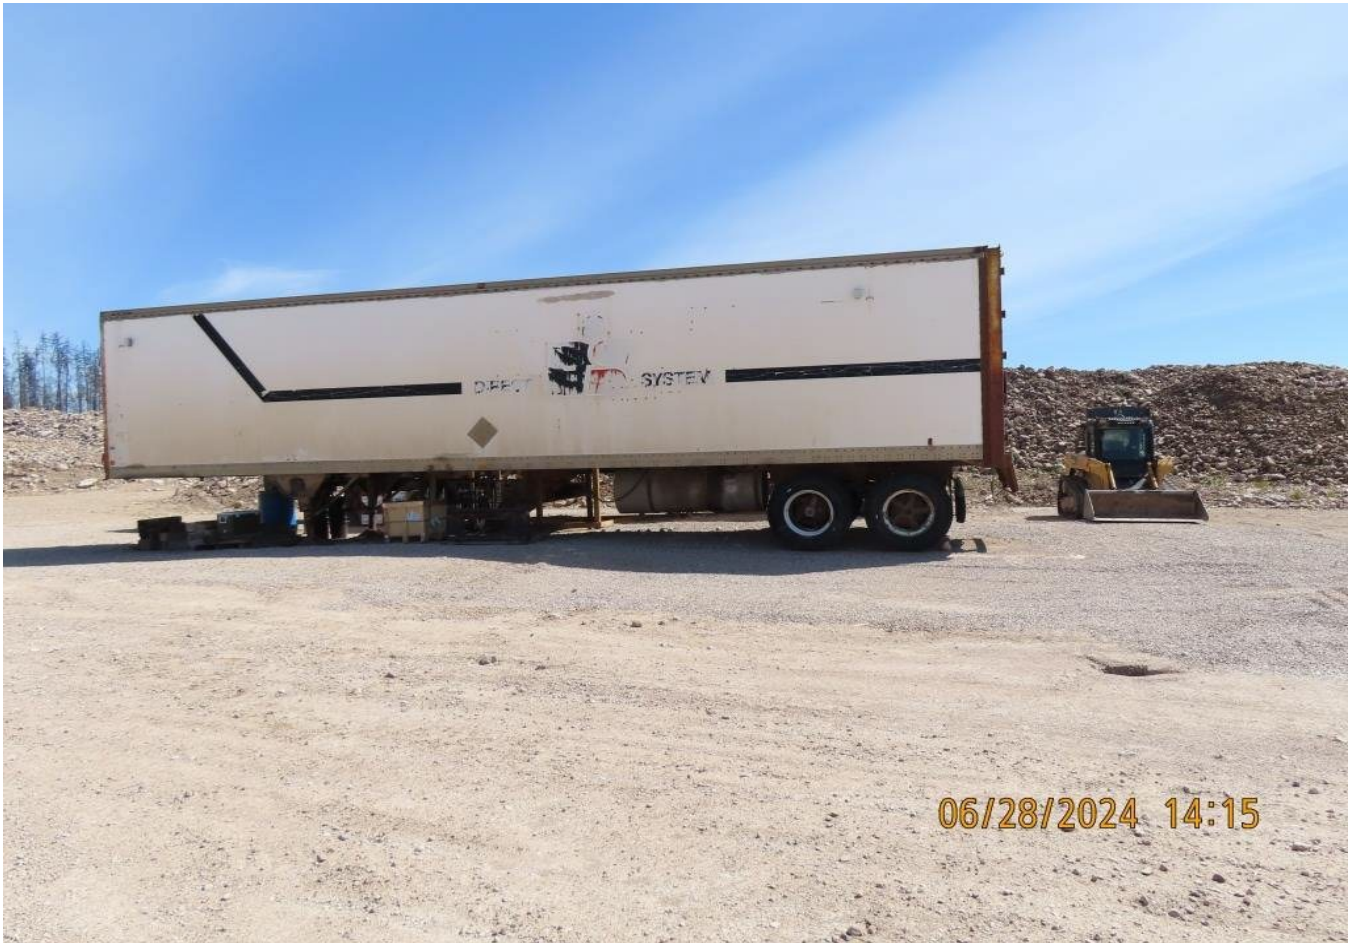
Figure 11
Semi-trailer and skid steer.

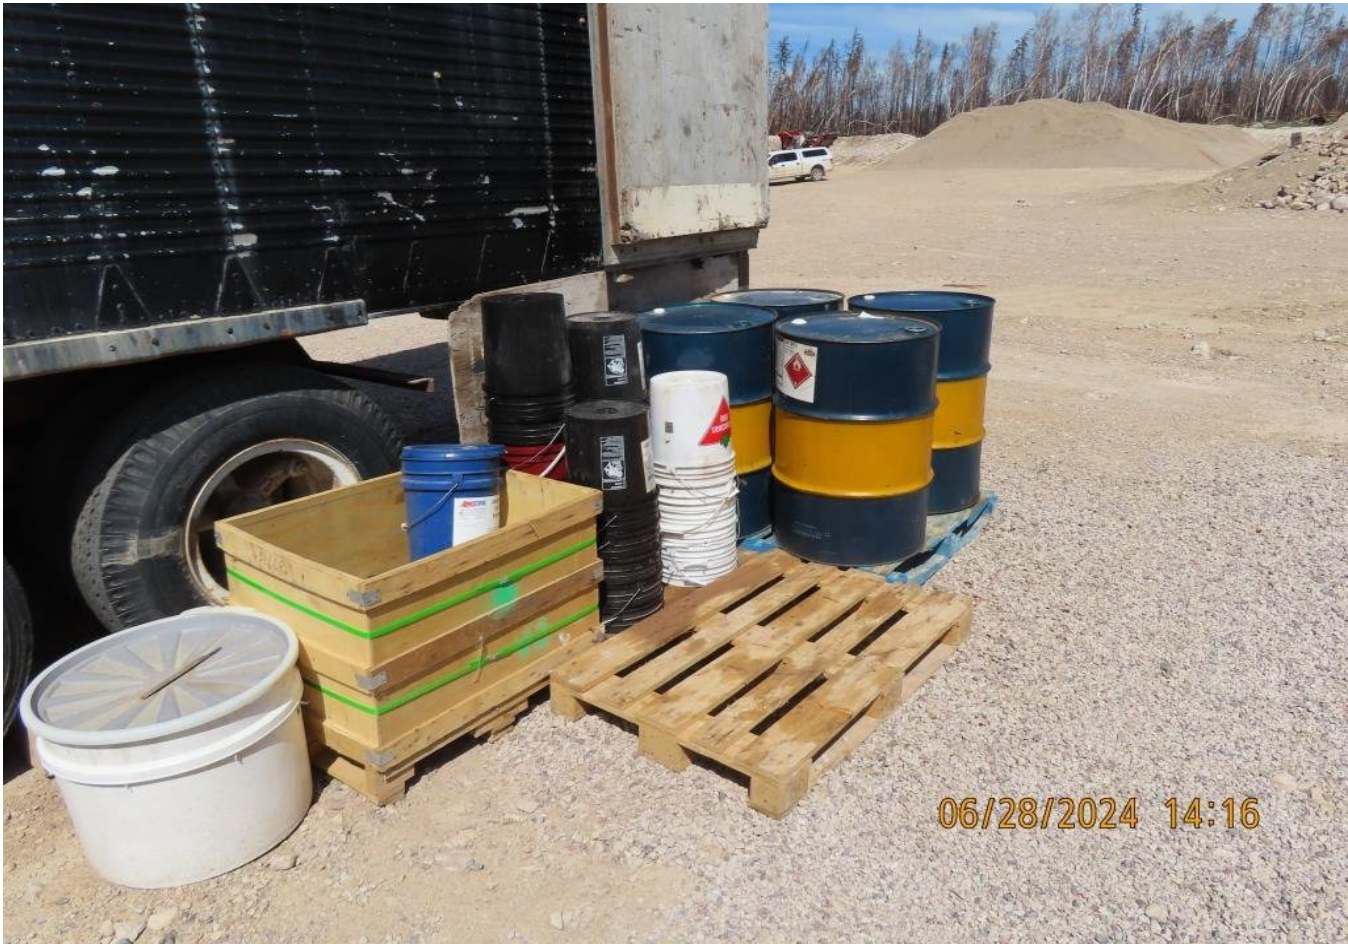
Figure 12
Fuel and chemical storage with spill kits.

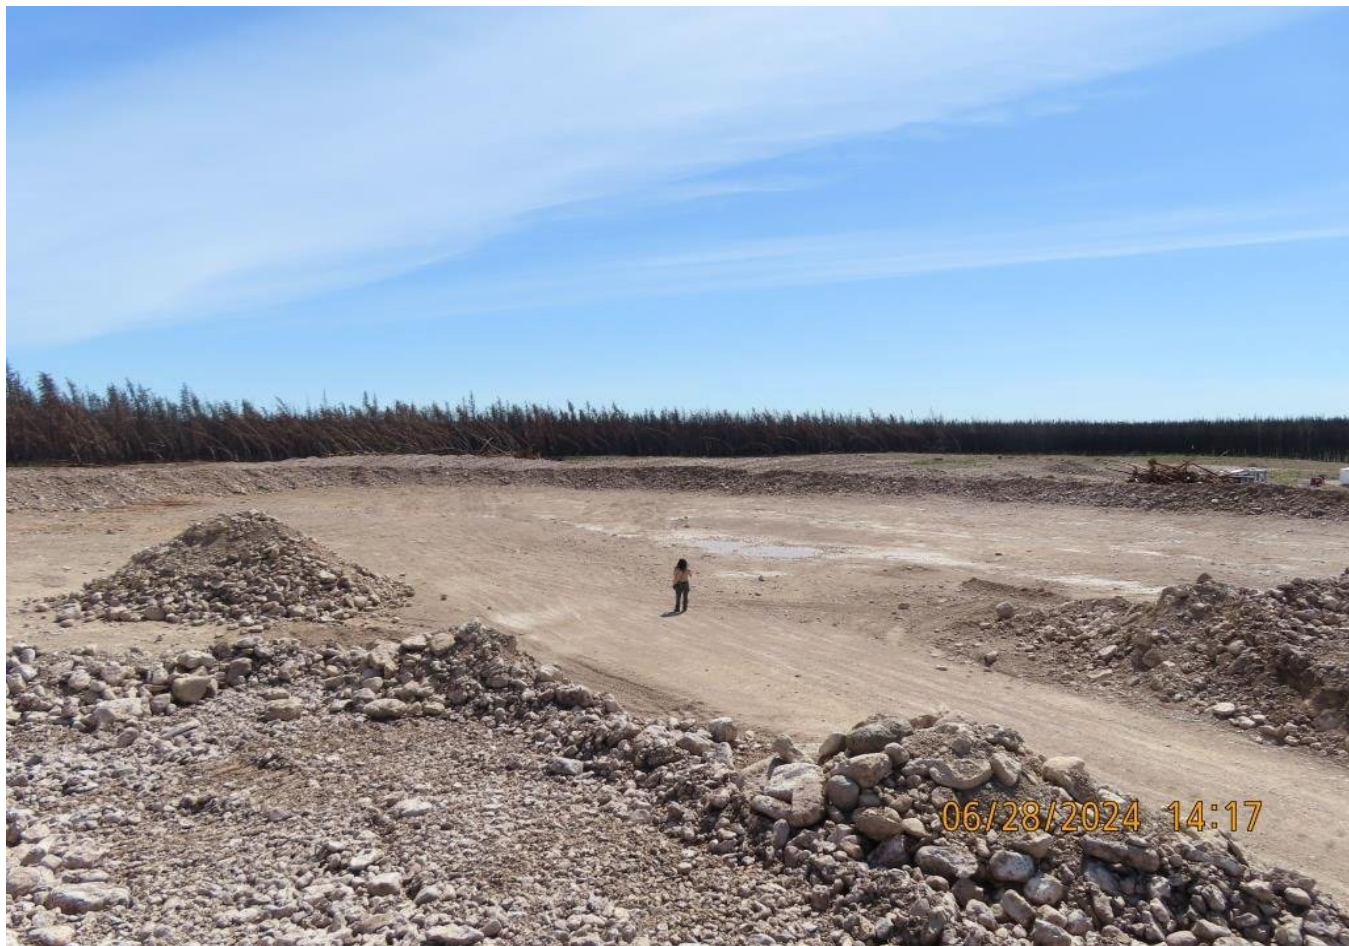
Figure 13

Image of freshly cleared and quarried area along the eastern boundary of the quarry.

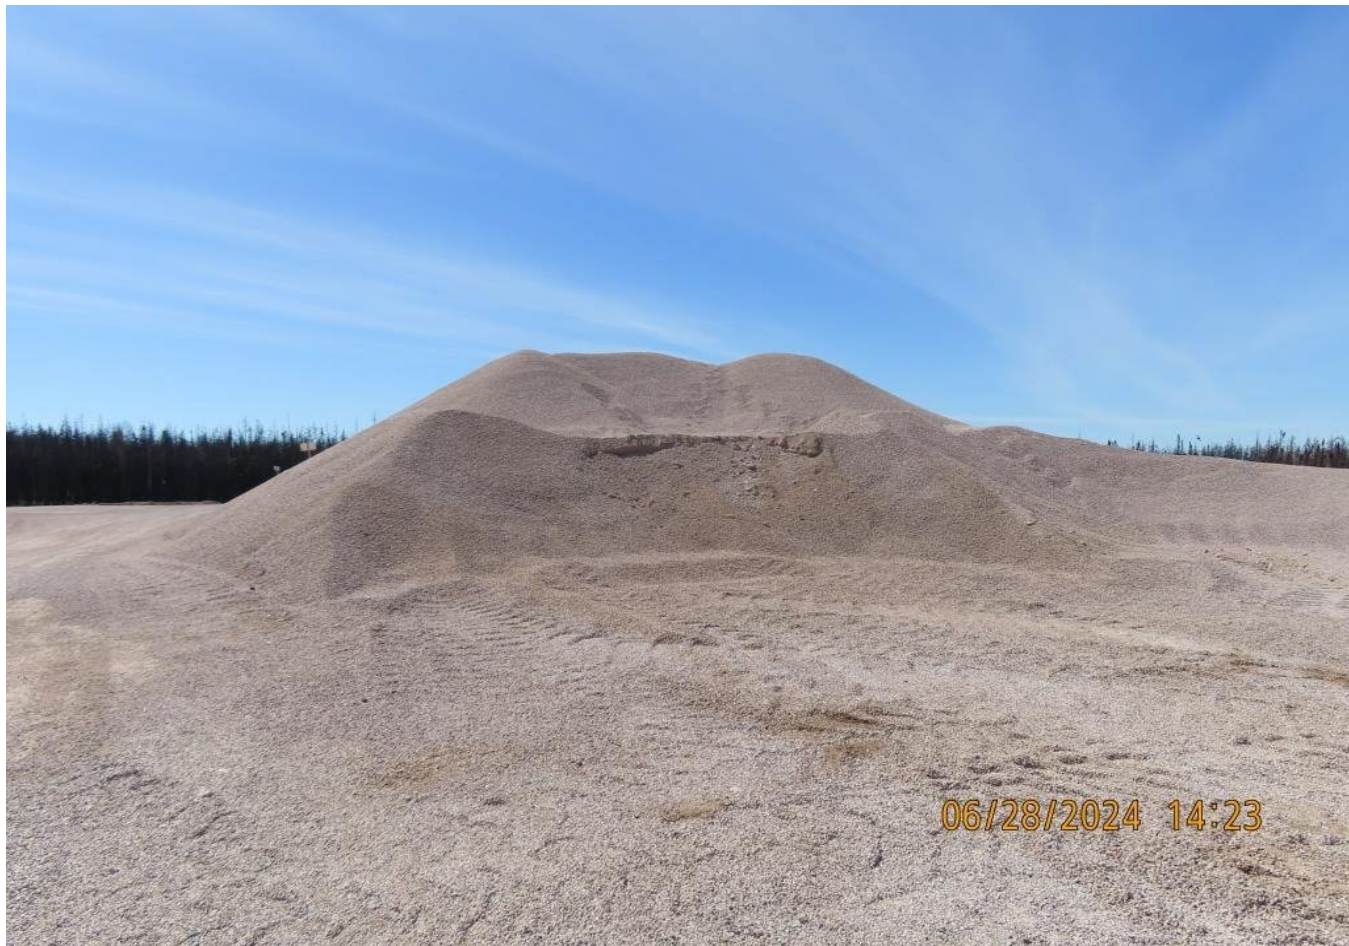
Figure 14

Stockpiles in norther portion of the pit.

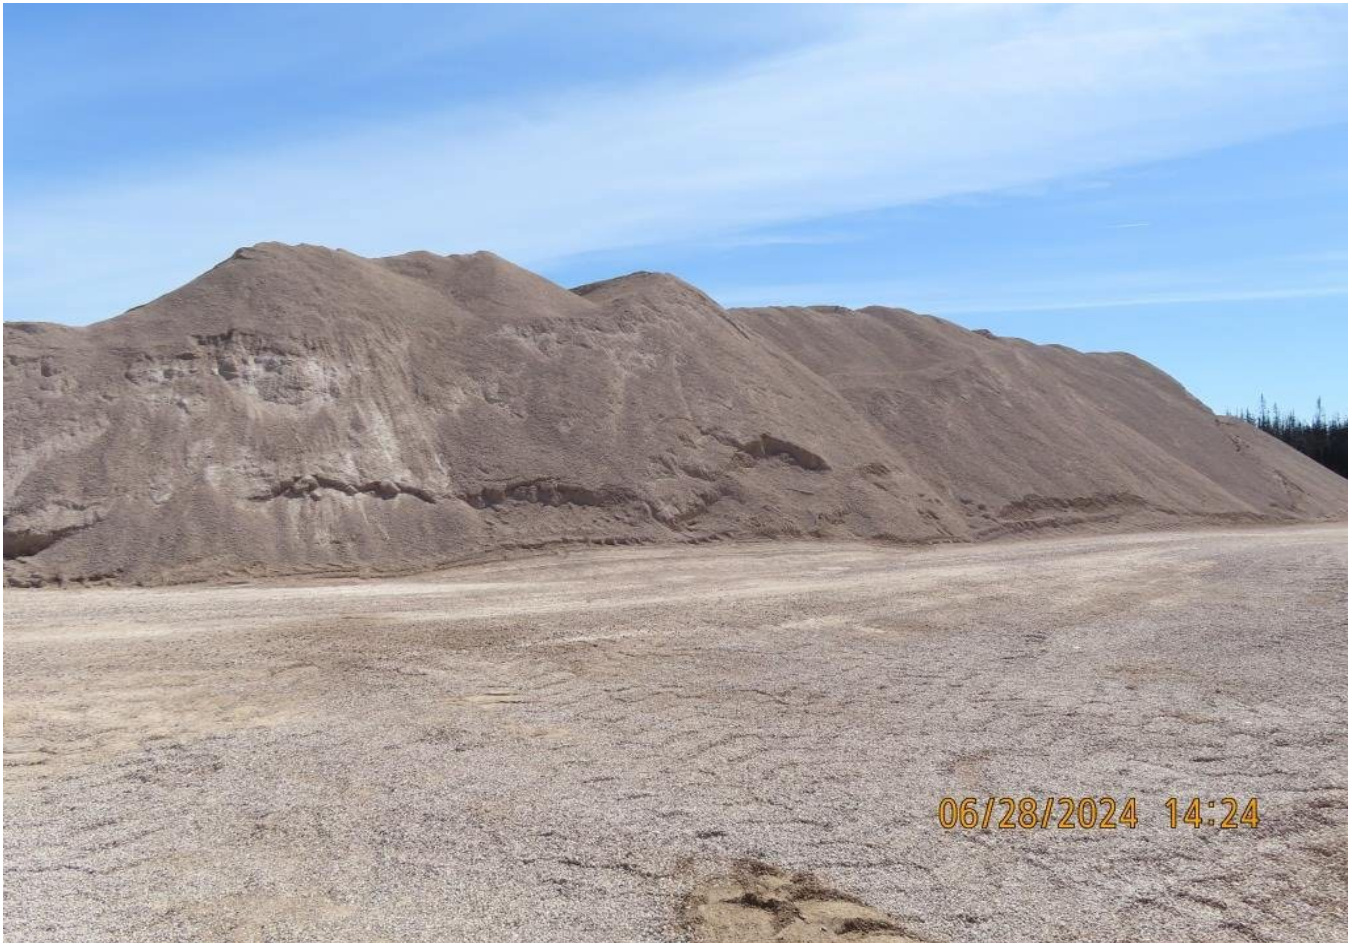
Figure 15
Stock piles in norther portion of the pit.

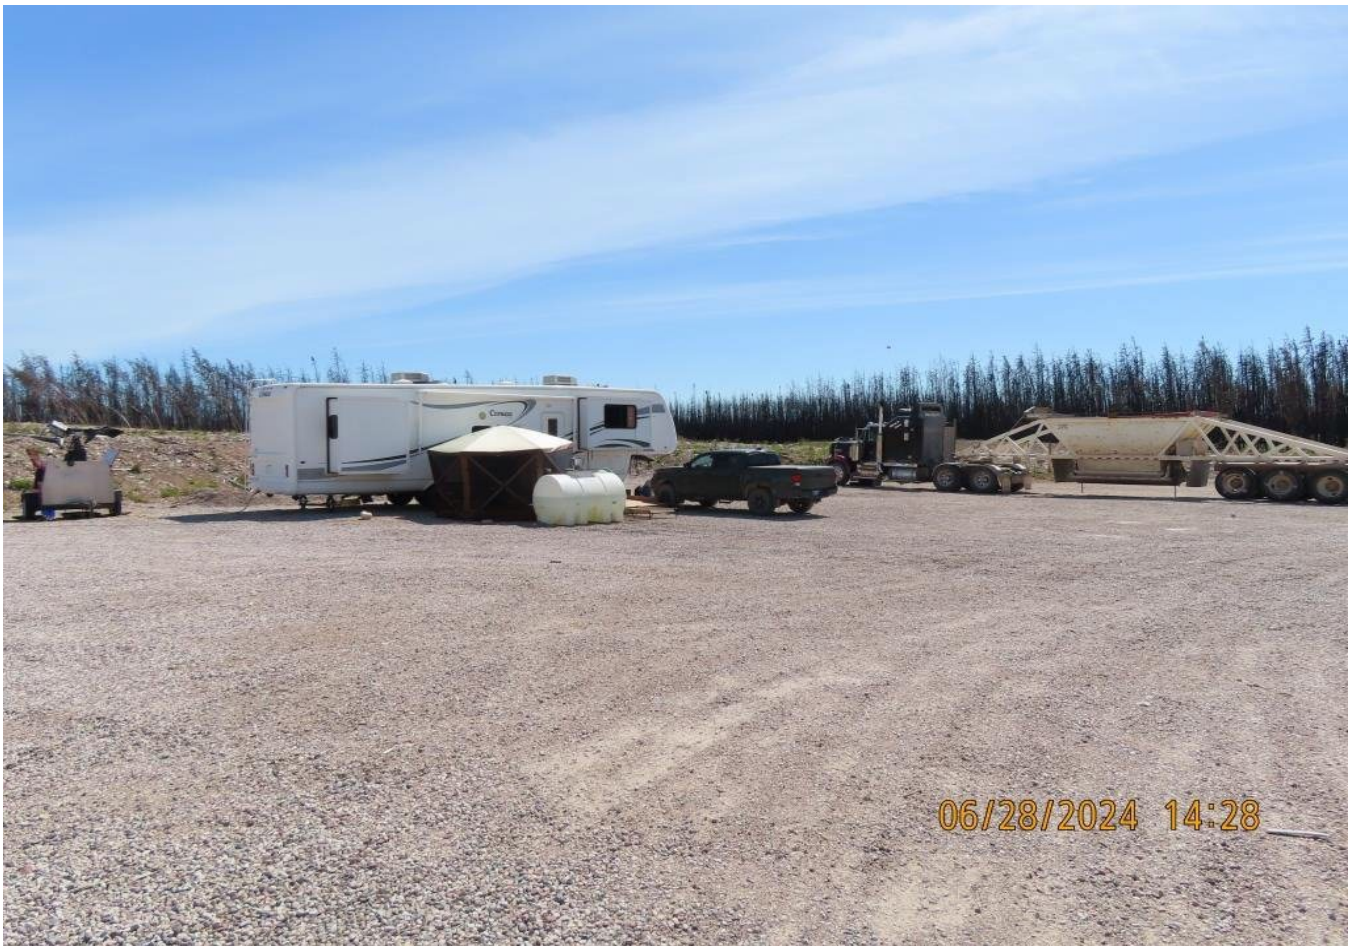
Figure 16
Two camper trailers and belly-up truck located near southern boundary the pit.

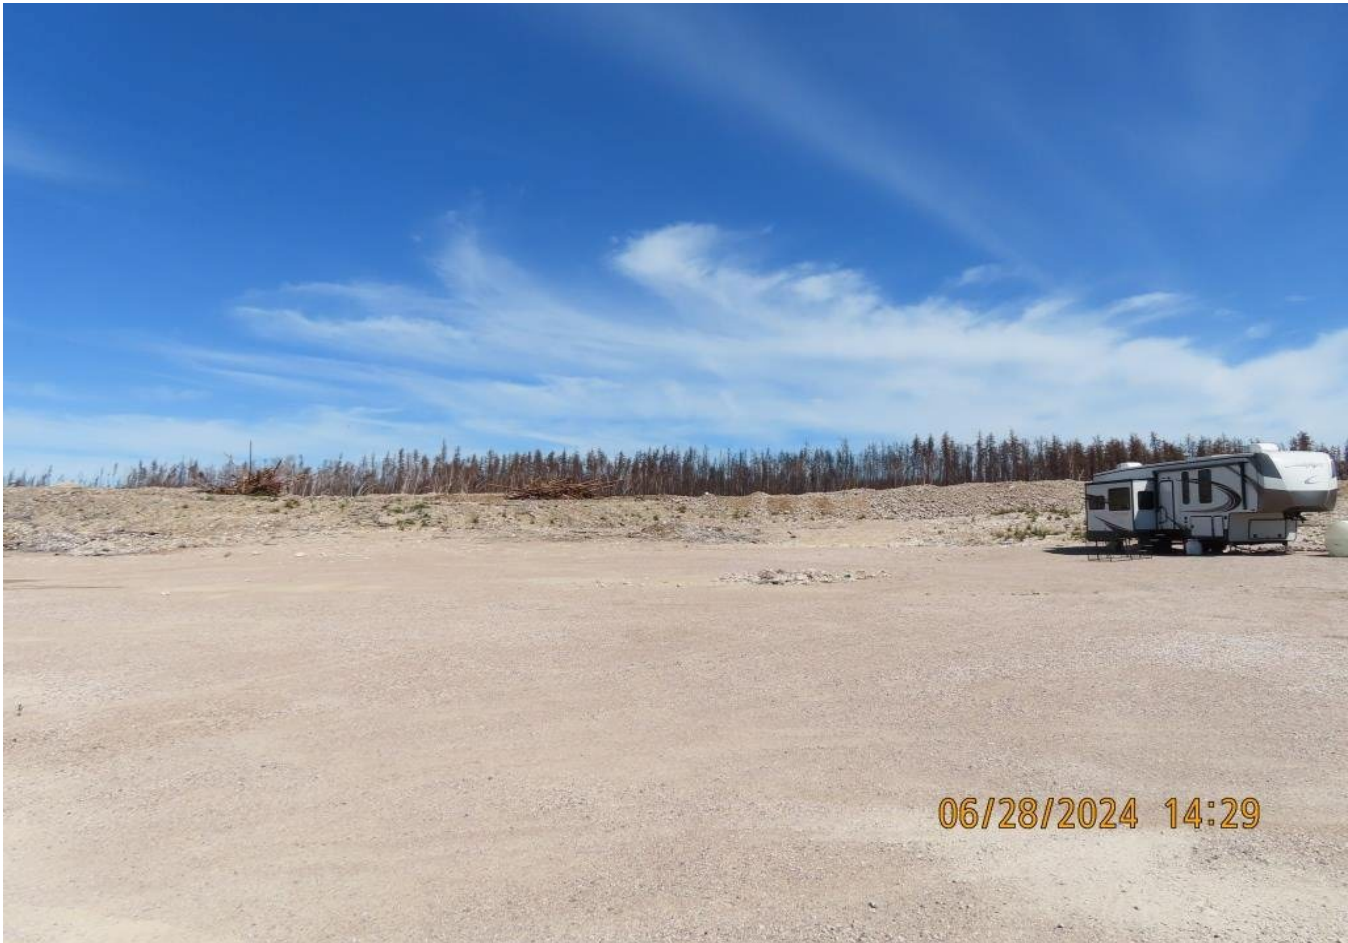
Figure 17
Image facing east, brush piles from new clearing visible.
