File Number	MV2016Q0036
Type of Operation	QUARRY SITE - Existing
Location	Quarry pit on Salt Mountain

ENVIRONMENTAL INSPECTION REPORT

Permittee:	Fort Smith Const. NT. Ltd.	Permit Expiry Date:	December 03, 2022
Land Use Permit No.	MV2016Q0036	Previous Inspection:	March 24, 2021
Quarrying Permit No.	2021QP0011	Inspection Date:	May 20, 2021
Contractor:	Rowe's Construction	Subcontractor:	
Location(s) Inspected:	Quarry pit on Salt Mountain		
Current Stage of Operation:	Crushing operation completed in 2020. Permittee currently removing processed granular materials from stockpiles located within project area.		
Program Modifications Approved:	N/A

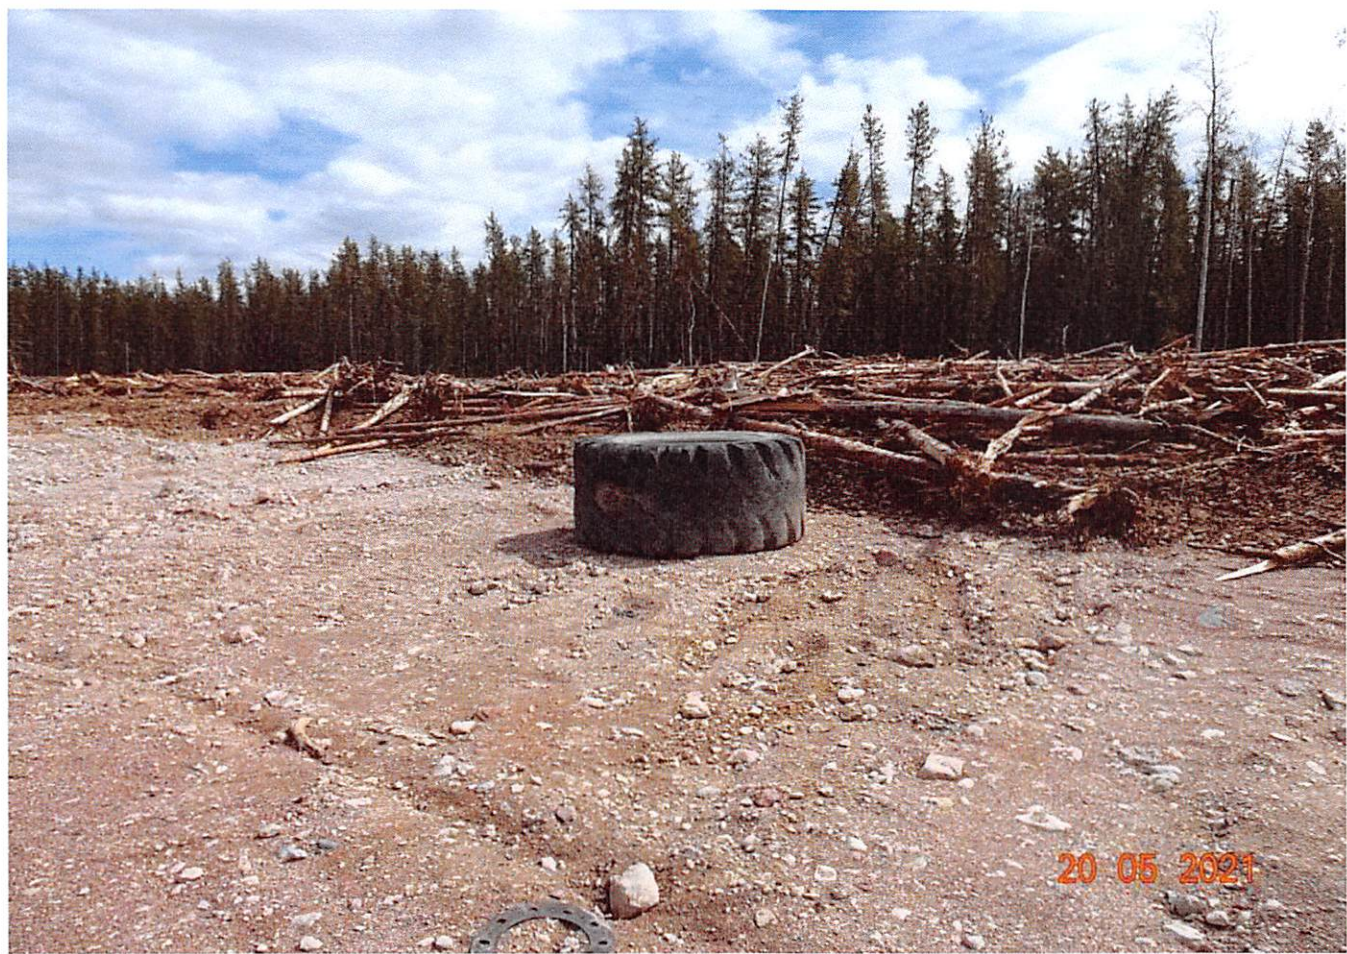
Heavy equipment tires, miscellaneous debris and camper trailer hoses that appear to be partially buried were noted on site (Figures 15-18). Conditions 13 & 21 under Land Use Permit MV2016Q0036 require the Permittee to keep the area clean and garbage in a designated container.

Figure 15
Heavy equipment tire stored along northern boundary.

- Non-serviceable equipment and debris need to be contained and removed.
- Leaky equipment must cease operation immediately and be repaired.
- Spills must be excavated and contaminated soil must be disposed of at an authorized facility.
- An adequate spill kit must be kept on site at all times and drip trays must be kept under all equipment parked for 2 or more hours.
- Brush spread over useable material needs to be cleaned and piled for burning. Salvageable trees must be stacked clean of overburden and gravel.
- Active faces cannot be mixed with brush and overburden.
- Restoration of the Permittee's old quarry pit to the northeast needs to be completed.

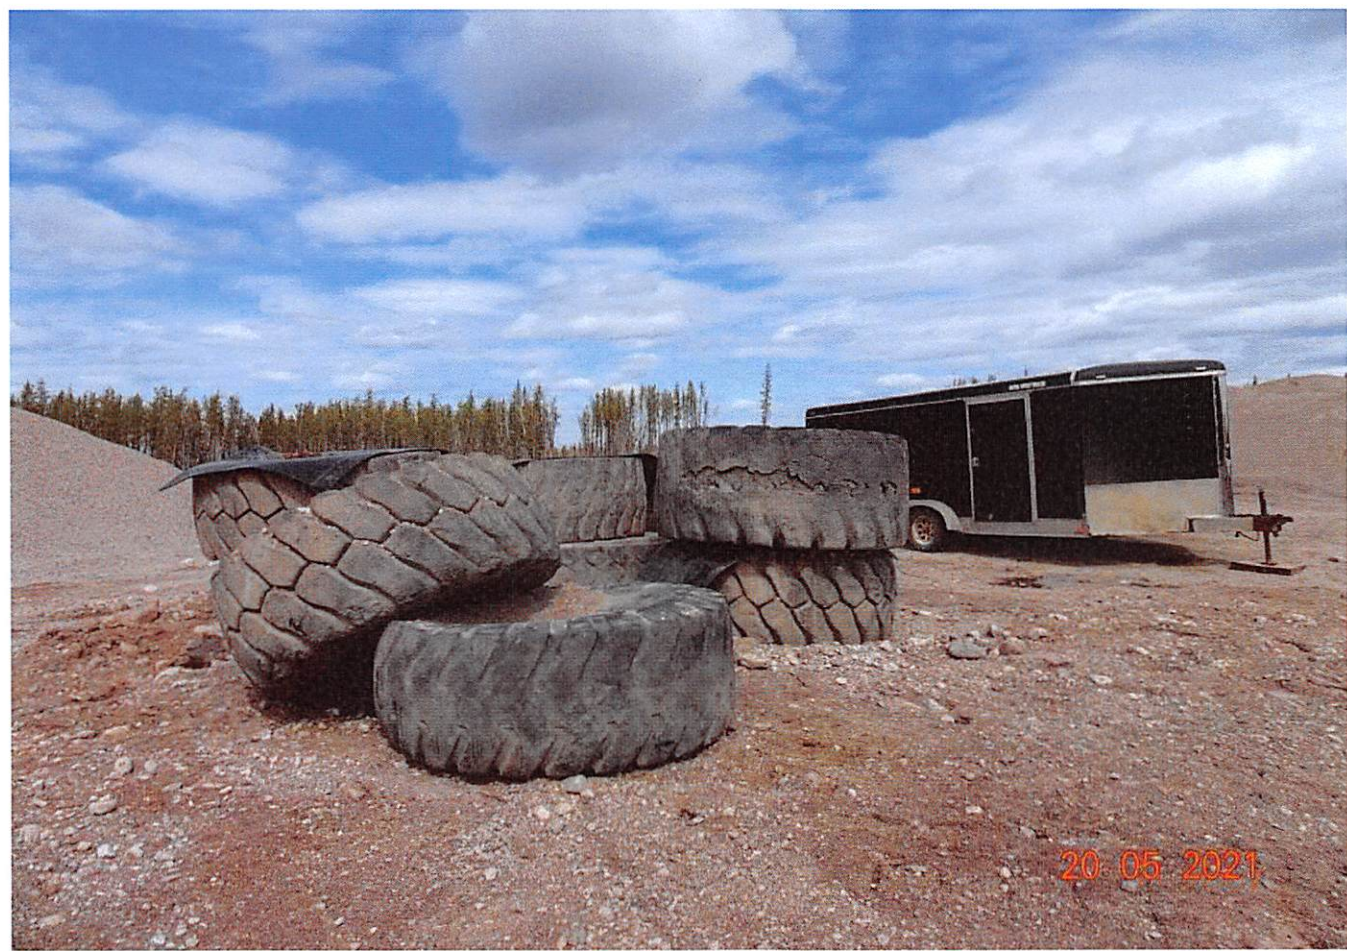
Figure 16
Heavy equipment tires and an enclosed trailer stored near the entrance of the pit.

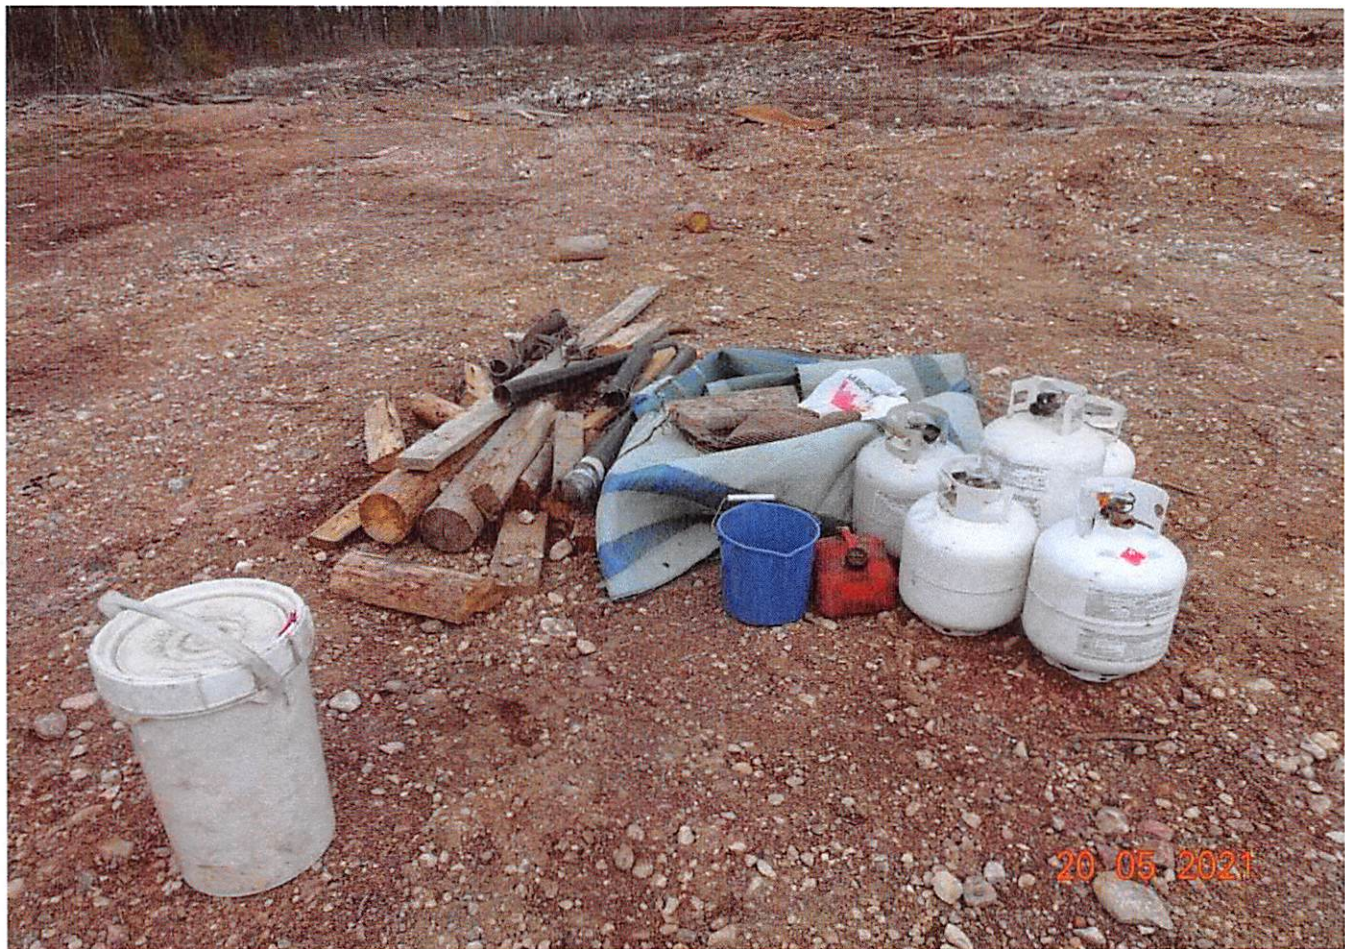
Figure 17
Miscellaneous items stored near the entrance of the pit.

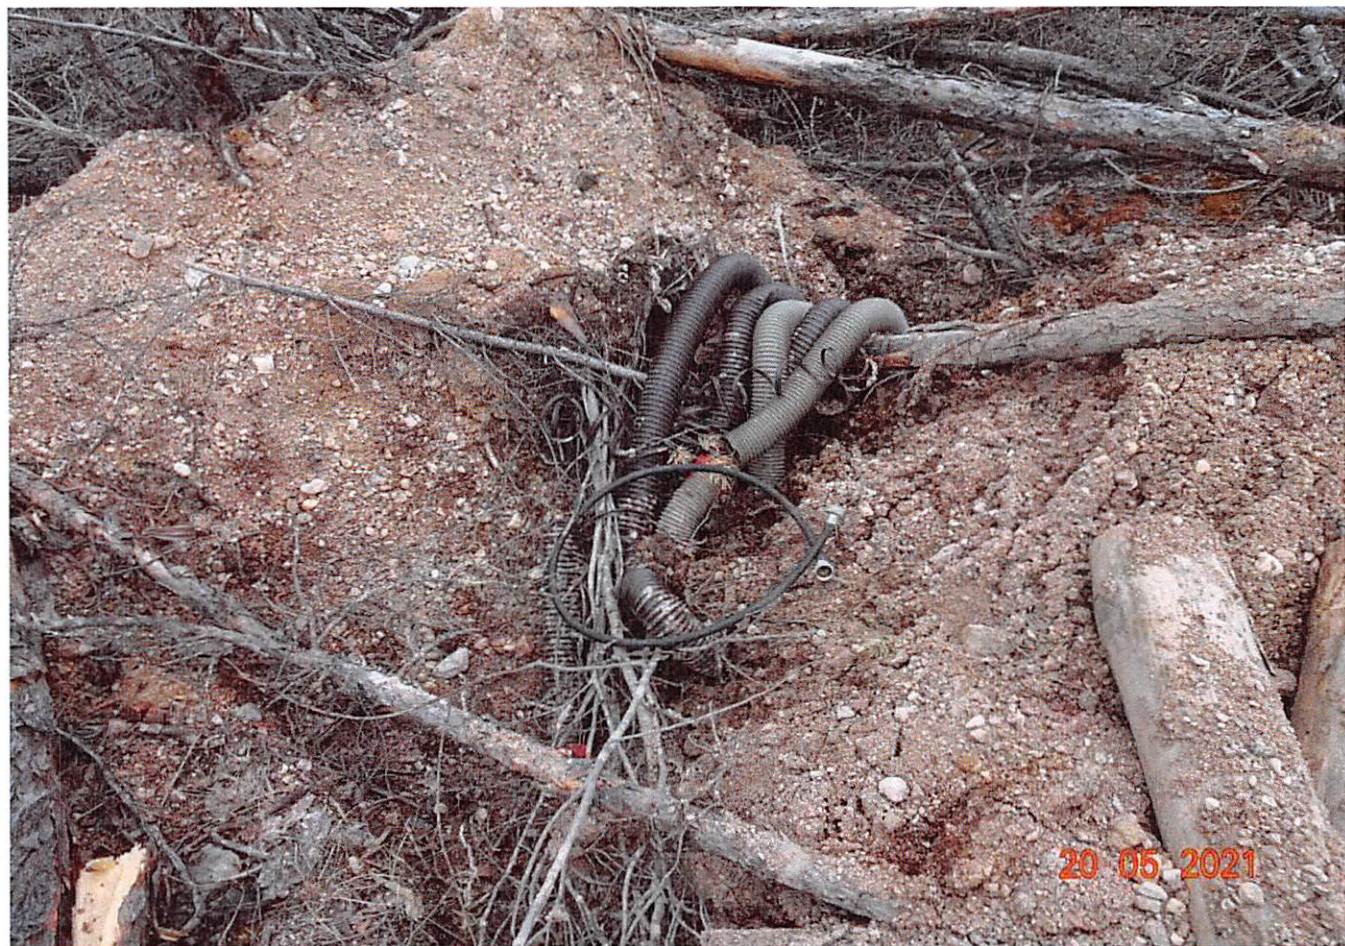
Figure 18
Camper trailer hoses left on site appear to be partially buried.

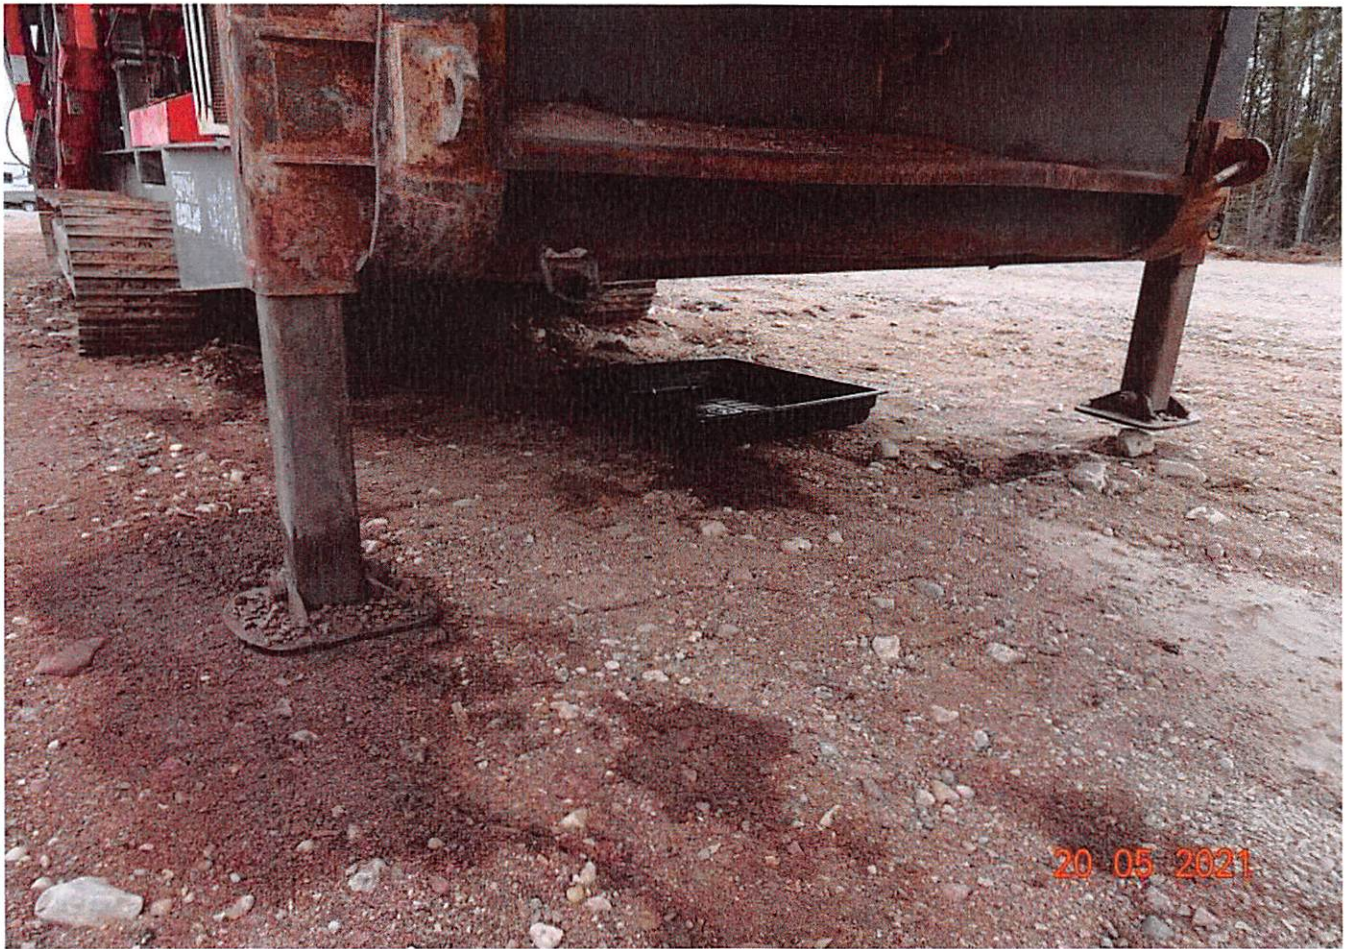
Figure 19

No adequate spill response kit was on site at the time of inspection and significant hydrocarbon stains were observed throughout the project area (Figures 19-25). A haul truck that came to the site had an oil leak and left numerous spills. Impacted soils must be

Spills observed under crusher.

removed and disposed of at an authorized facility. Inspectors went back to the site on May 28 and marked spills (Figures 41-51). Inspectors will be following up on site to document actions taken to rectify this issue.

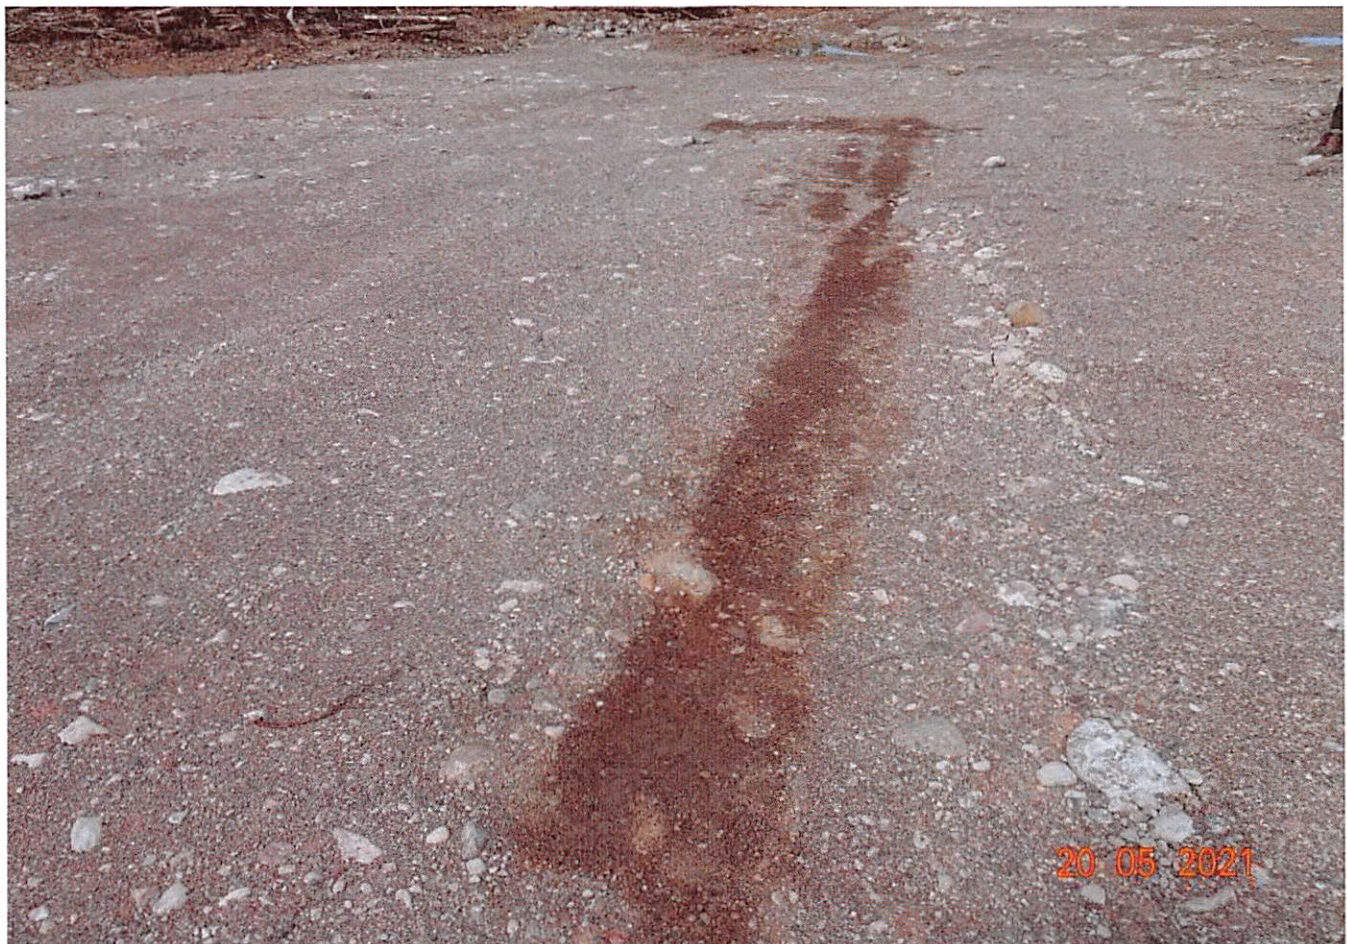
Figure 20

Spill measuring ~6.7m x 1.6m located near the southern boundary of the pit.

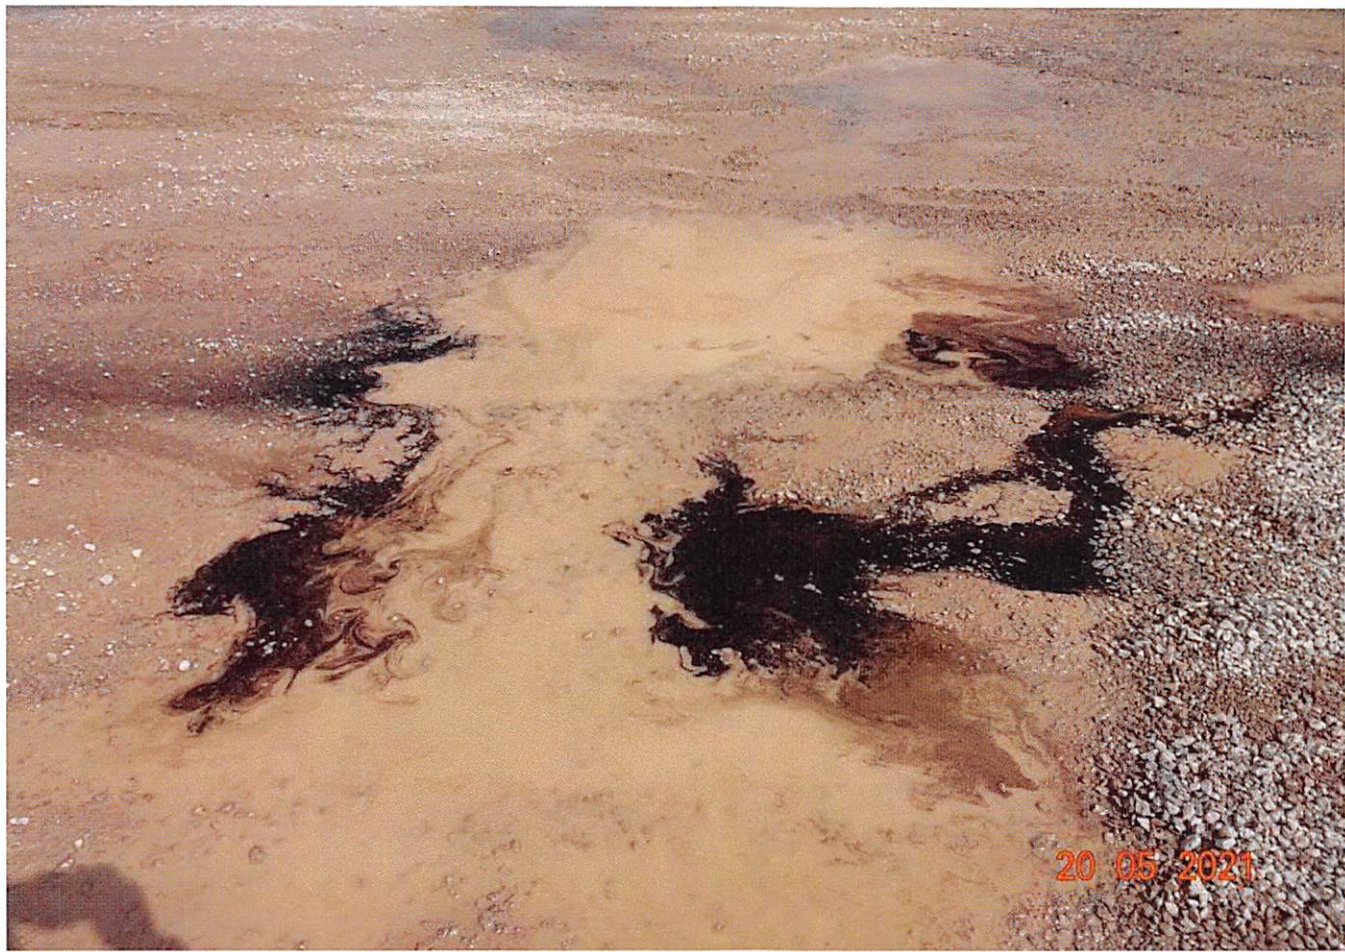
Figure 21
Oil spill observed after Fort Smith Construction haul truck was on site.

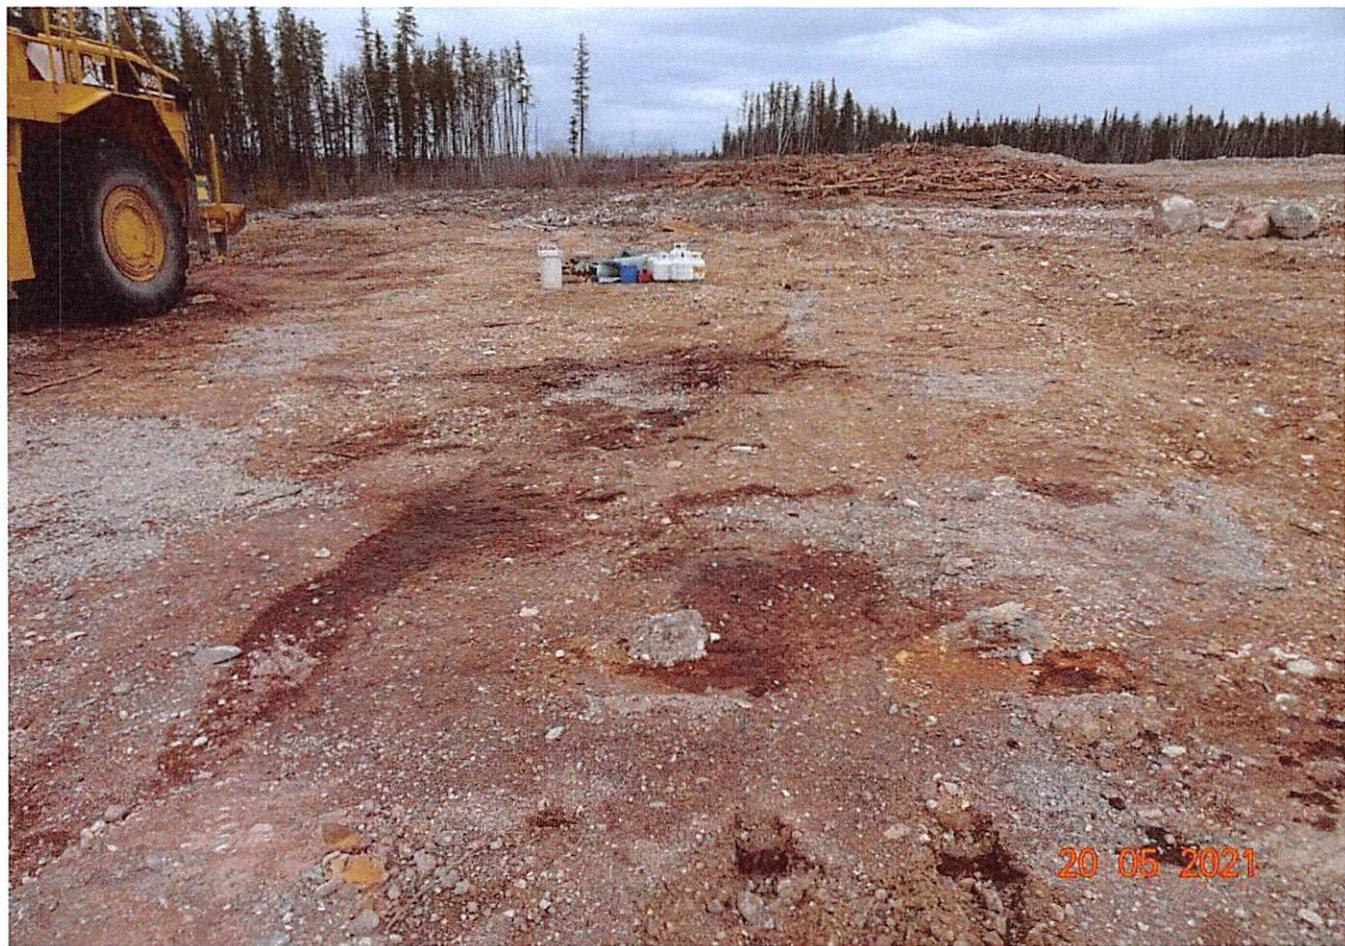
Figure 22
Numerous spills located near parked machinery.

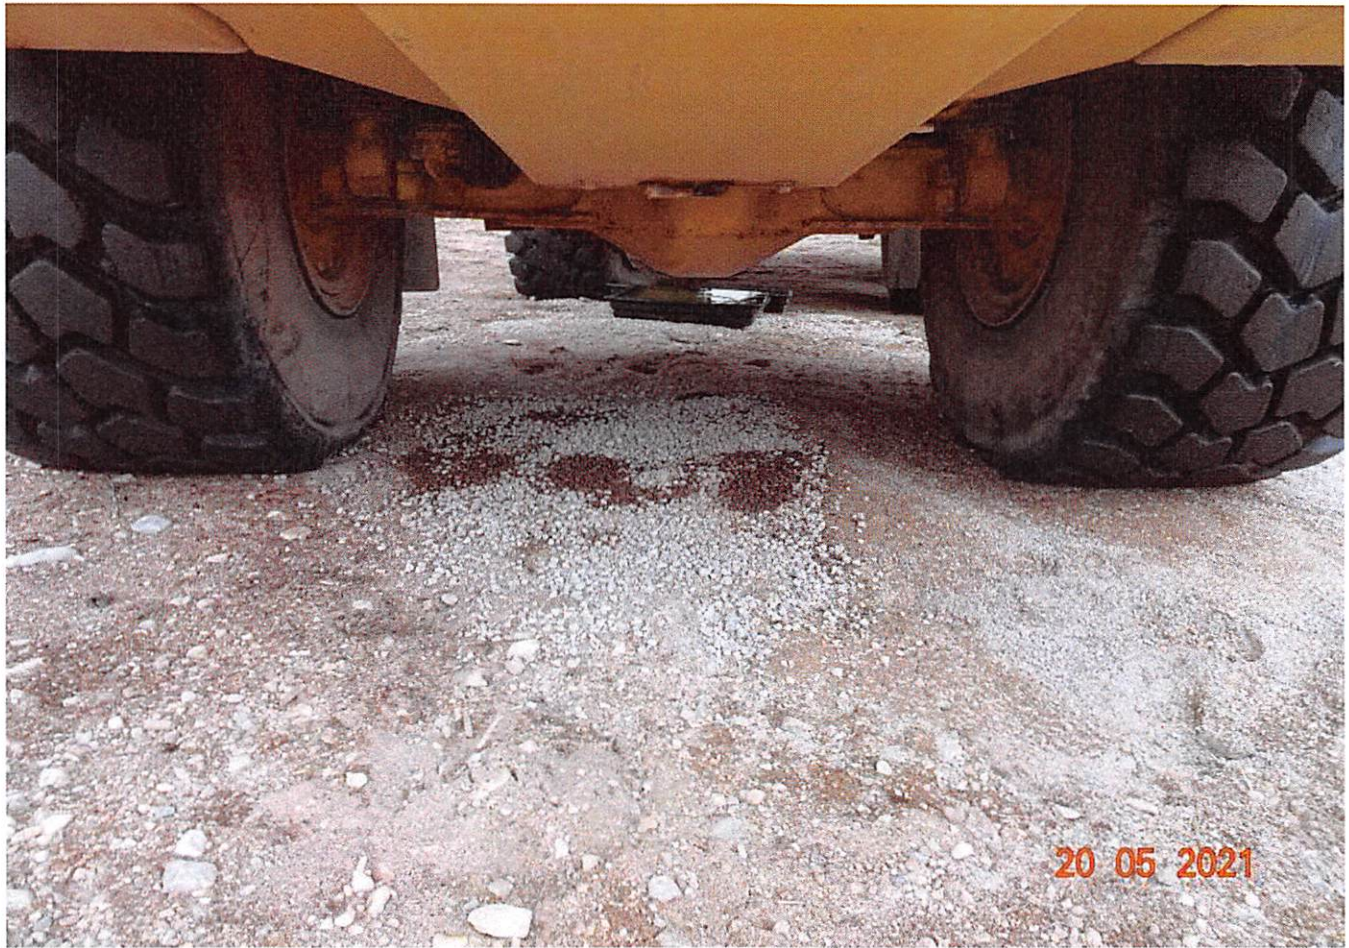
Figure 23

The Inspectors were disappointed to observe a number of fuel spills covered over by fresh gravel (Figures 23-24). In accordance with Permit Condition #32, the Permittee is required to clean up all fuel leaks, spills and contaminated material. The Inspectors note that the Permittee has made no effort to address this issue. The intent of this condition is to ensure that all fuel spills are immediately cleaned up.

Spill incorrectly covered with gravel under equipment.

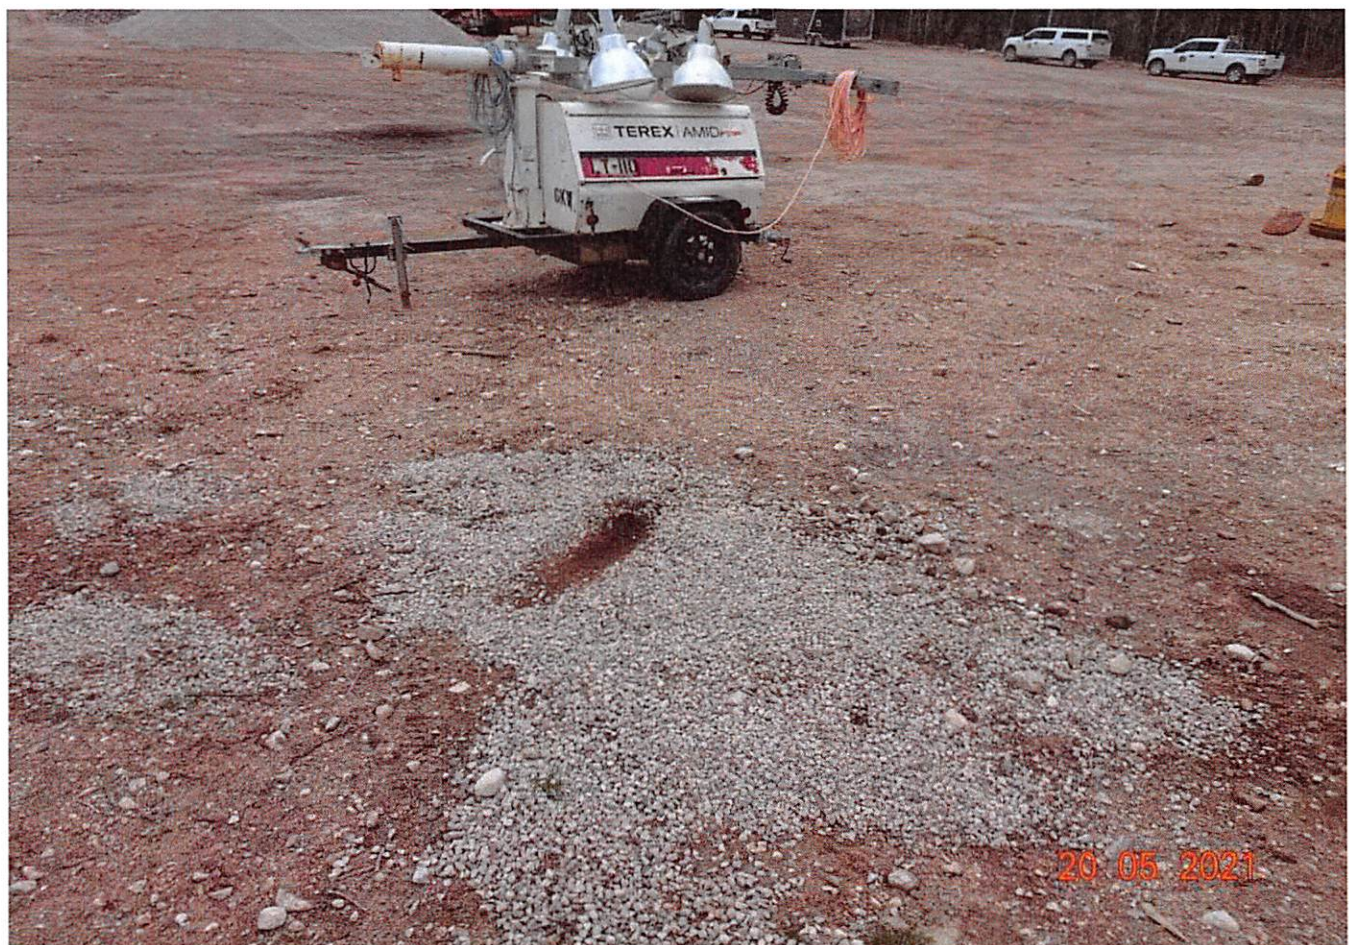
Figure 24

Spill covered with gravel near genset.

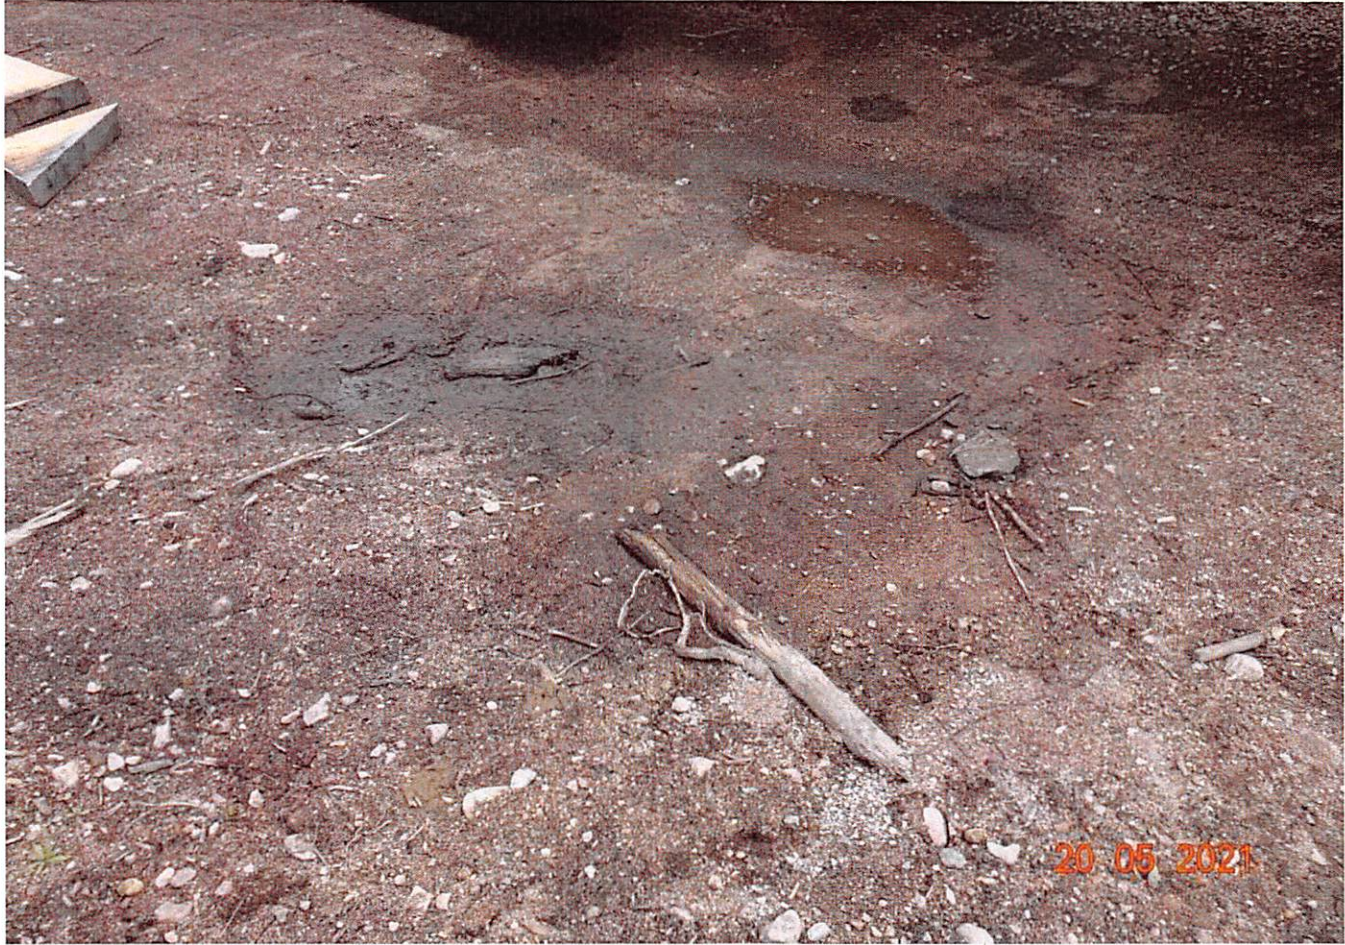
Figure 25

Spill located near equipment.

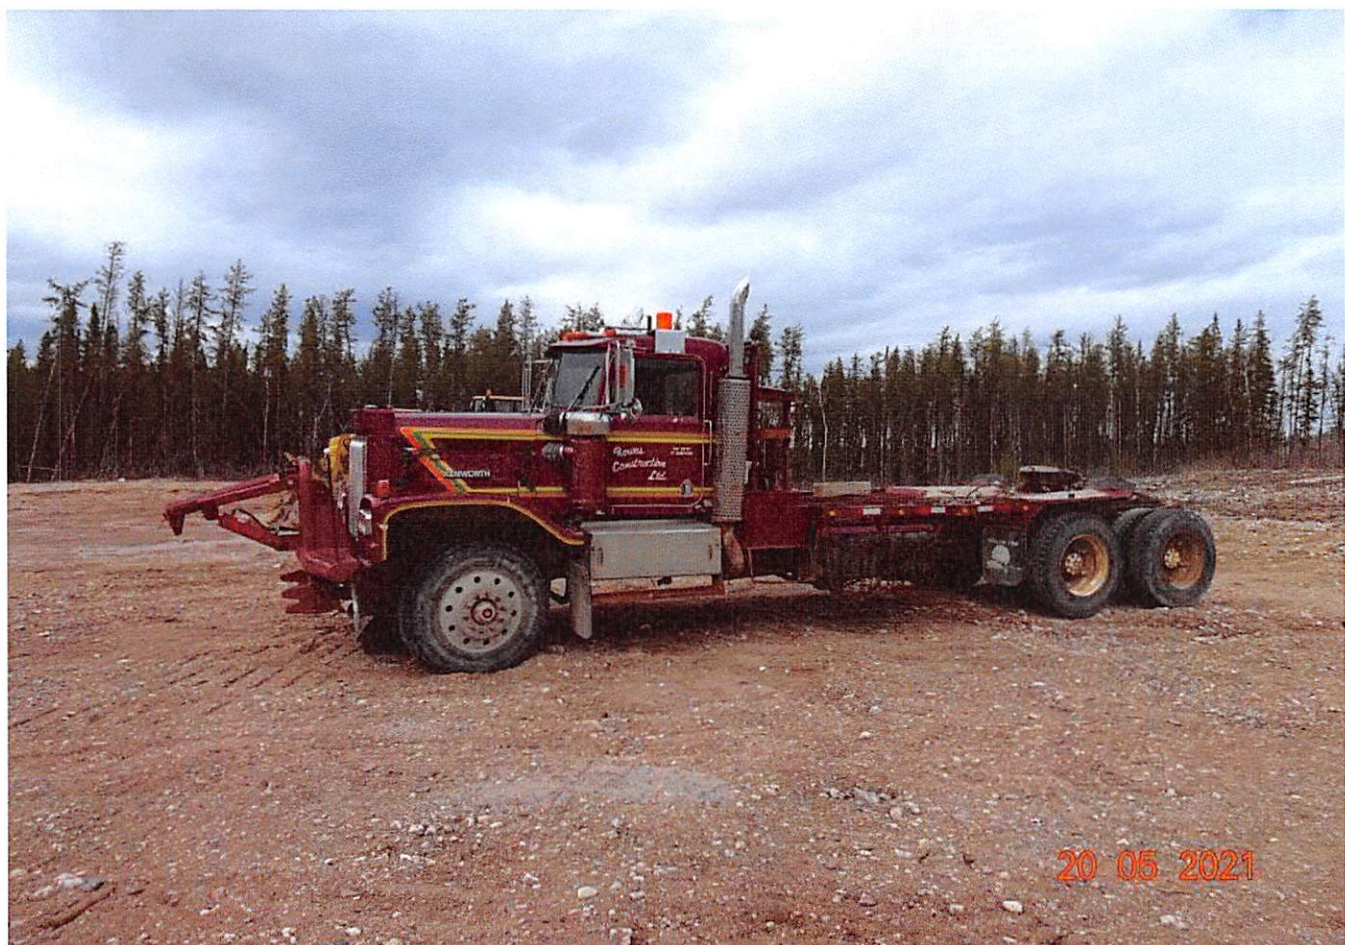
Figure 26

Drip trays were present but not under all equipment (Figures 26-33). Conditions 30-32 require sufficient spill response supplies and spill cleanup. All equipment parked for two hours or more must have drip trays in place. Fueling operations require secondary containment.

Rowe's Construction semi-truck with drip tray.

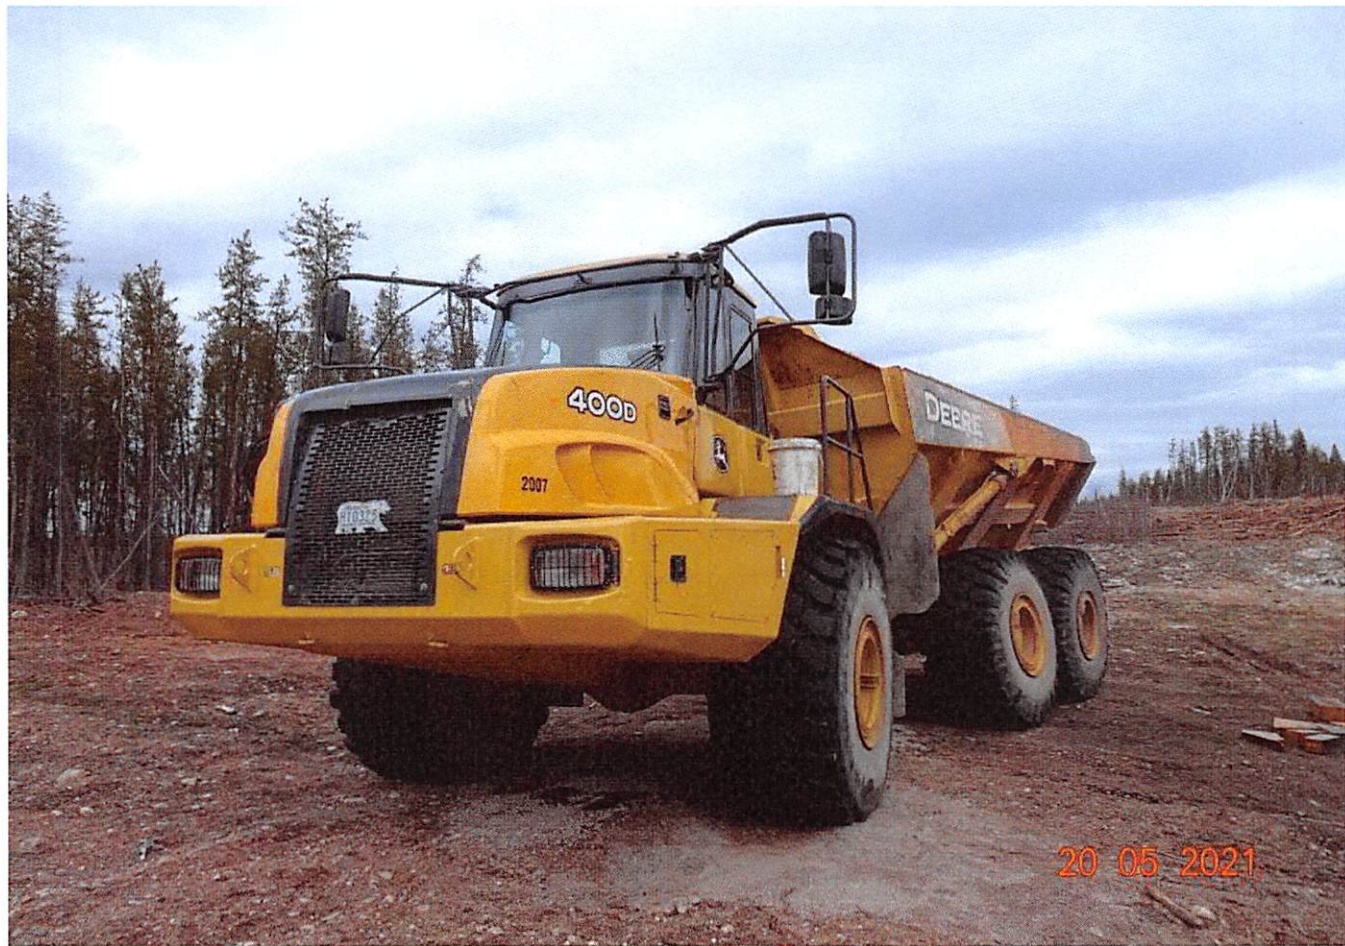
Figure 28
Haul truck with drip tray.

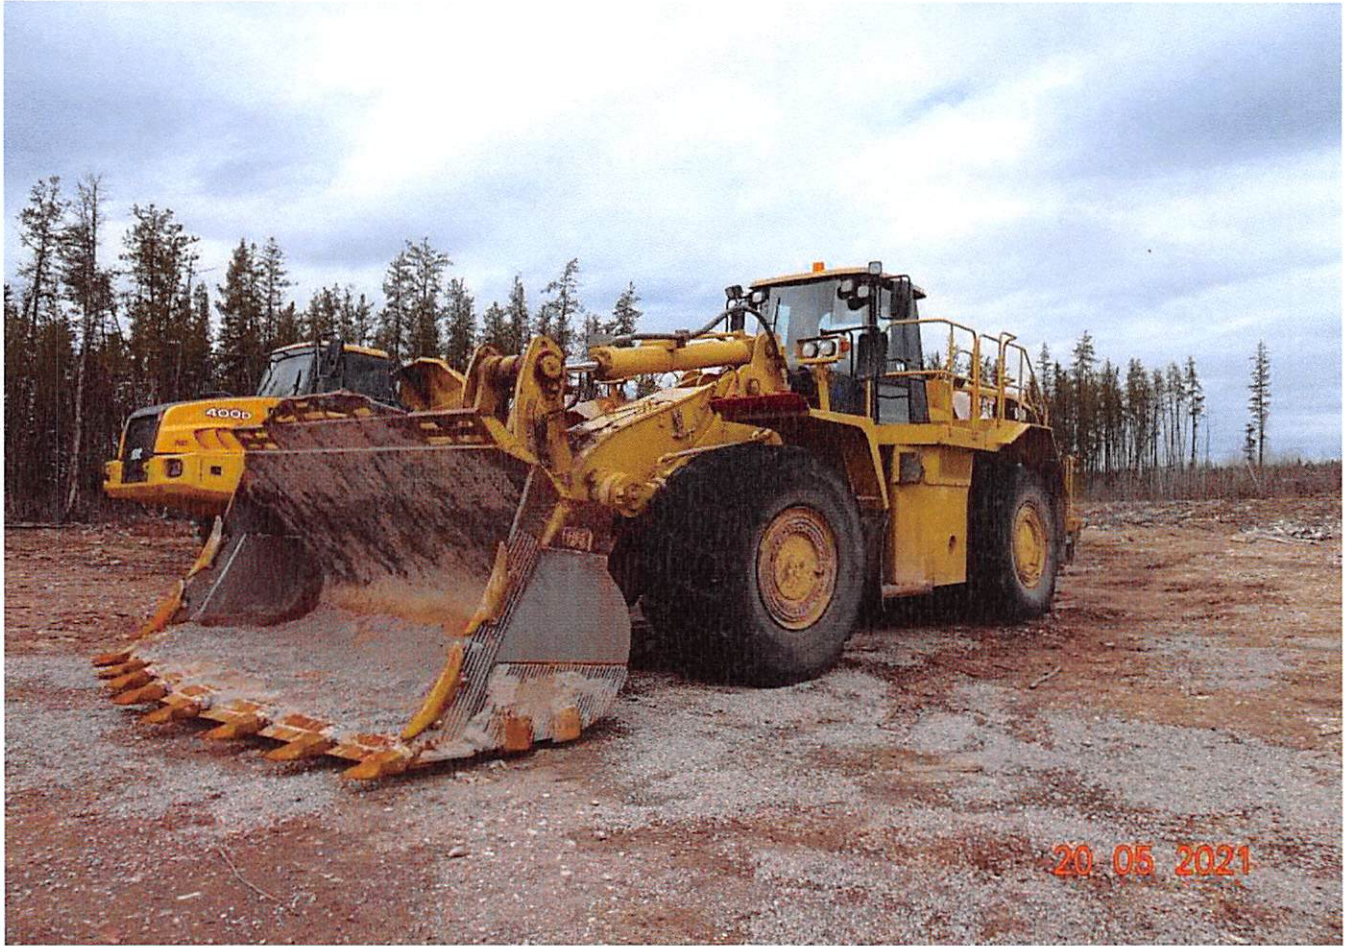
Figure 29

Front-end loader with drip tray.

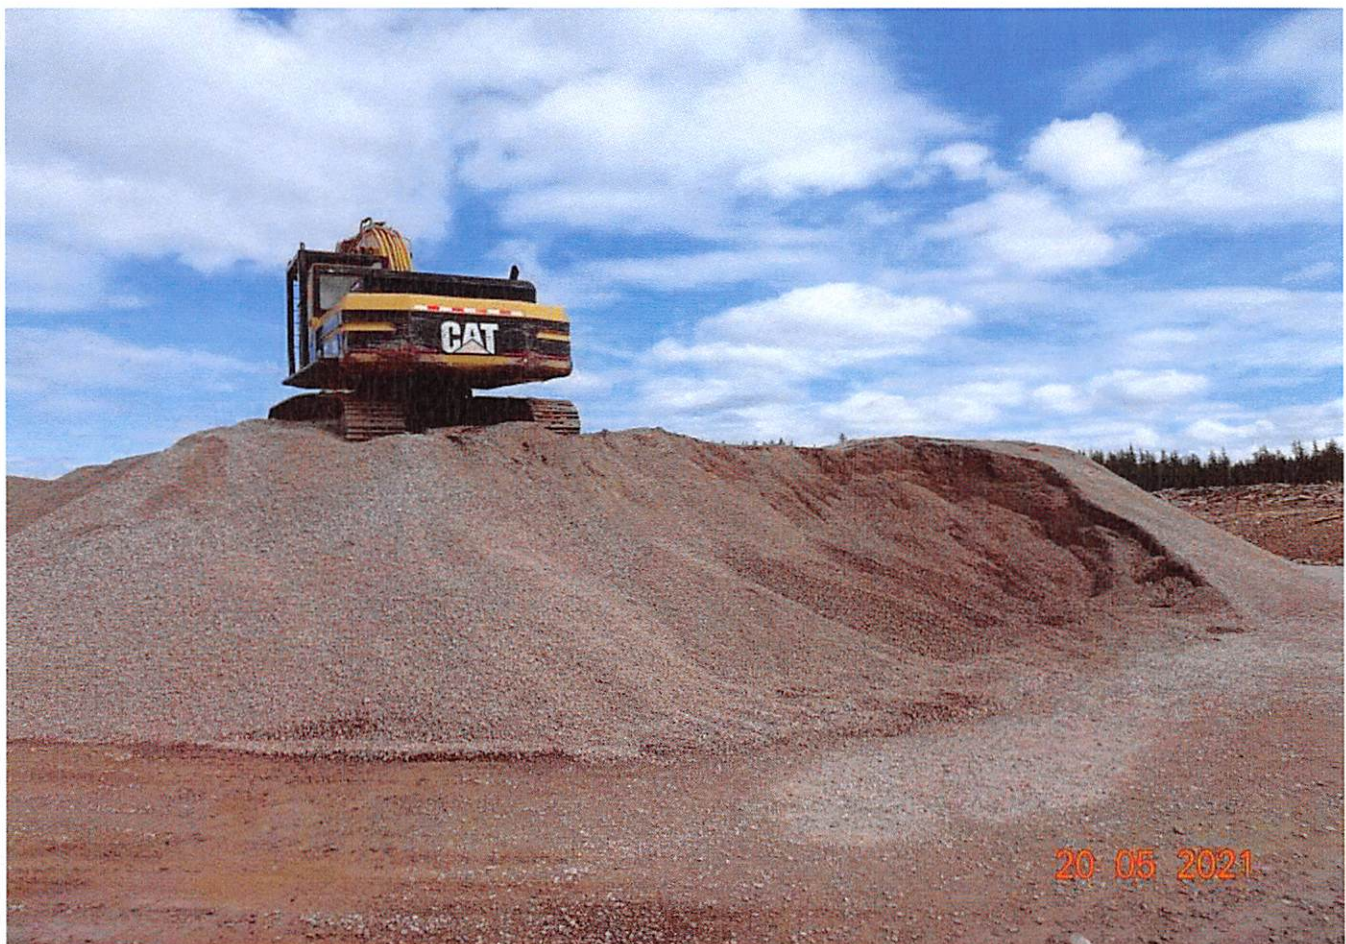
Figure 30

Excavator parked on stockpile A.

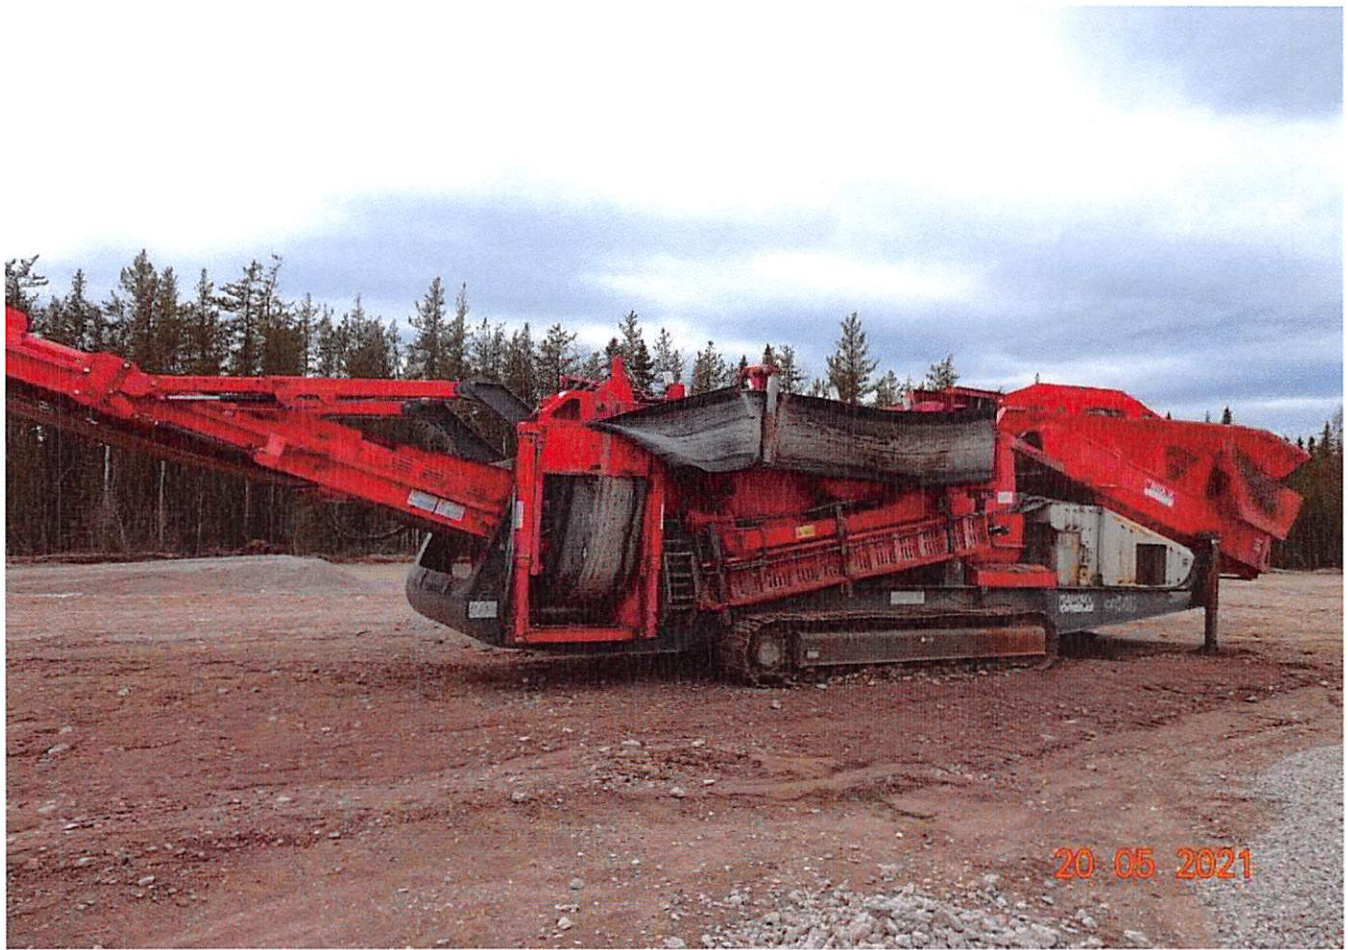
Figure 31

Rowe's Construction crusher.

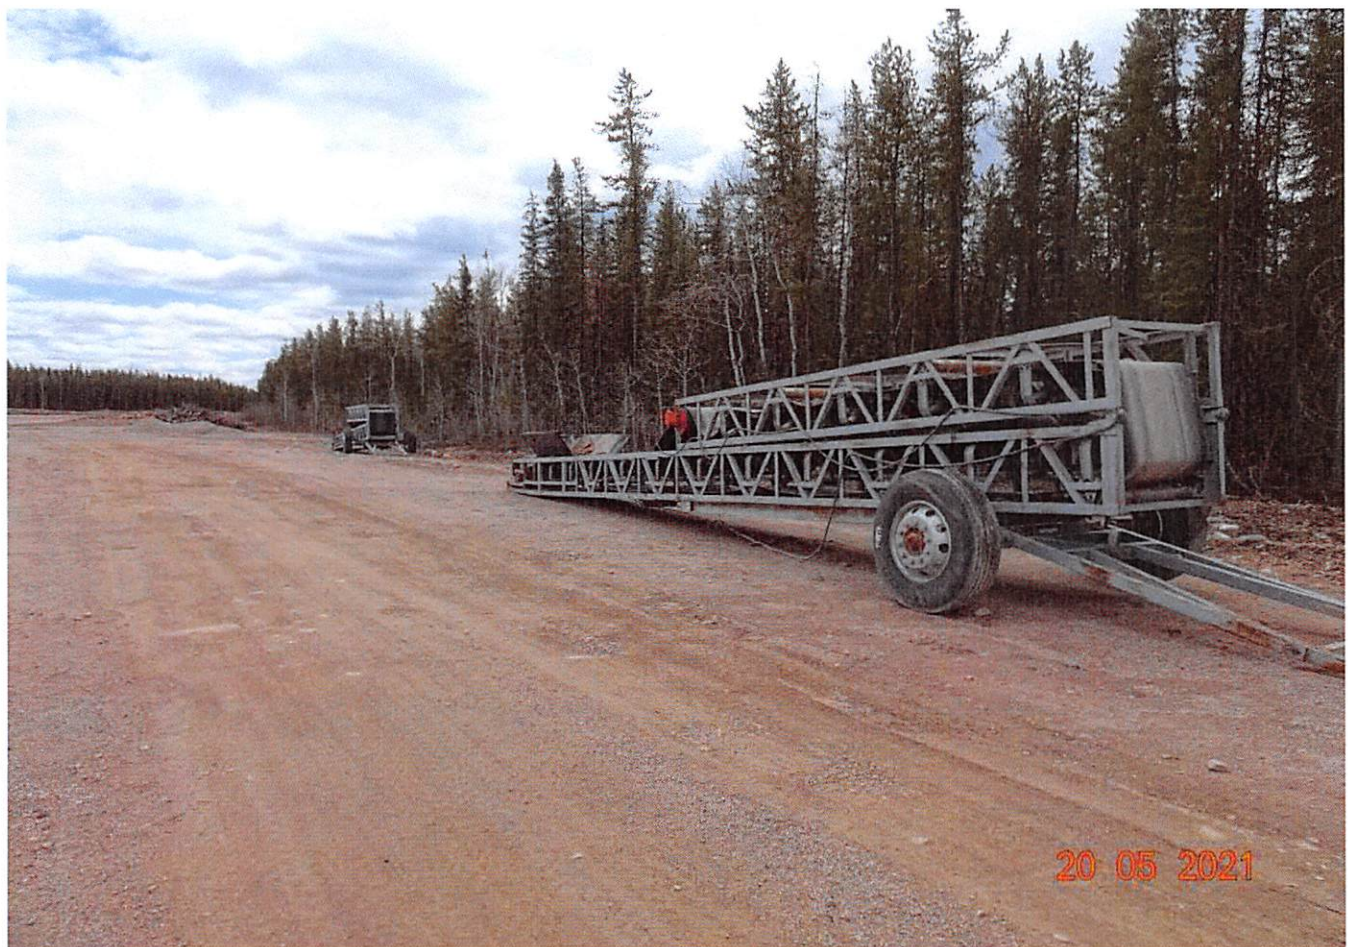
Figure 32

Conveyor belts on western boundary.
