File Number	MV2016Q0036
Type of Operation	QUARRY SITE - Existing
Location	Quarry pit on Salt Mountain

ENVIRONMENTAL INSPECTION REPORT

Permittee:	Fort Smith Const. NT. Ltd.	Permit Expiry Date:	December 03, 2022
Land Use Permit No.	MV2016Q0036	Previous Inspection:	March 24, 2021
Quarrying Permit No.	2021QP0011	Inspection Date:	May 20, 2021
Contractor:	Rowe's Construction	Subcontractor:	
Location(s) Inspected:	Quarry pit on Salt Mountain		
Current Stage of Operation:	Crushing operation completed in 2020. Permittee currently removing processed granular materials from stockpiles located within project area.		
Program Modifications Approved:	N/A

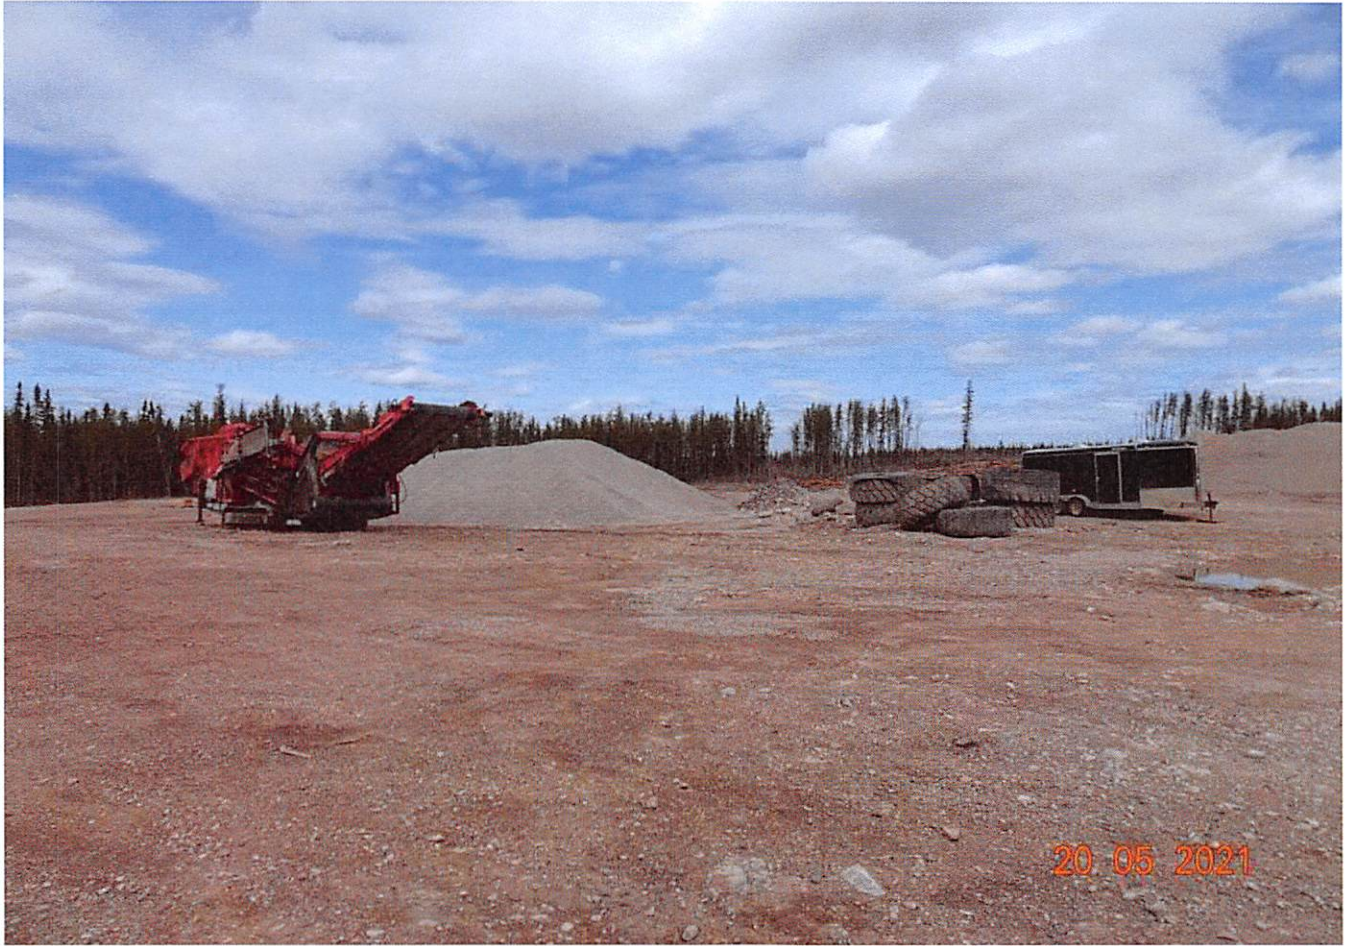
Figure 33

Drip trays were present but not under all equipment (Figures 26-33). Conditions 30-32 require sufficient spill response supplies and spill cleanup. All equipment parked for two hours or more must have drip trays in place. Fueling operations require secondary containment.

Equipment stored on-site near crushed rock stockpile.

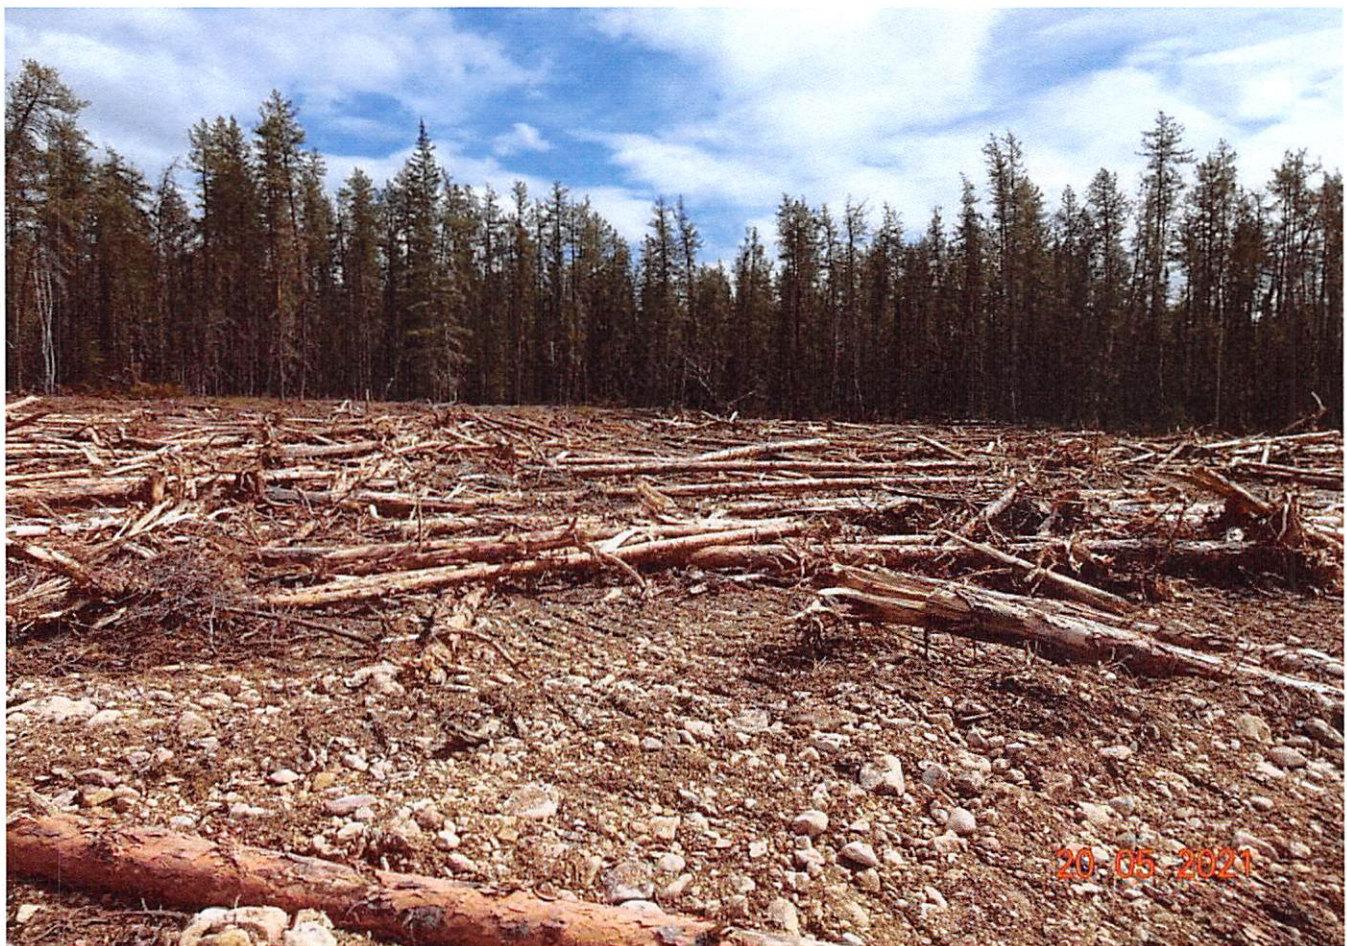
Figure 34

Progressive brush and overburden disposal has occurred over areas where granular material is still available (Figures 34-35). Fort Smith Construction stated in their quarry application that "non-salvageable timber disposal will be achieved through burning. Any timber cleared that is larger than 13cm in diameter will be piled and salvaged." The inspection notes that the Permittee made no effort to salvage timber larger than 13cm for firewood. This is especially disappointing considering the close proximity of the gravel pit to the Town of Fort Smith where residents utilize firewood for home heating.

Progressive brush disposal in the southern portion of the pit.

Timber greater than 13cm must be decked in a location accessible to the public for salvage. Decked timber must not be mixed with gravel and overburden.

In accordance with Permit Condition #37, overburden must be spread over the depleted portion of the pit and not used to recontour the active face.

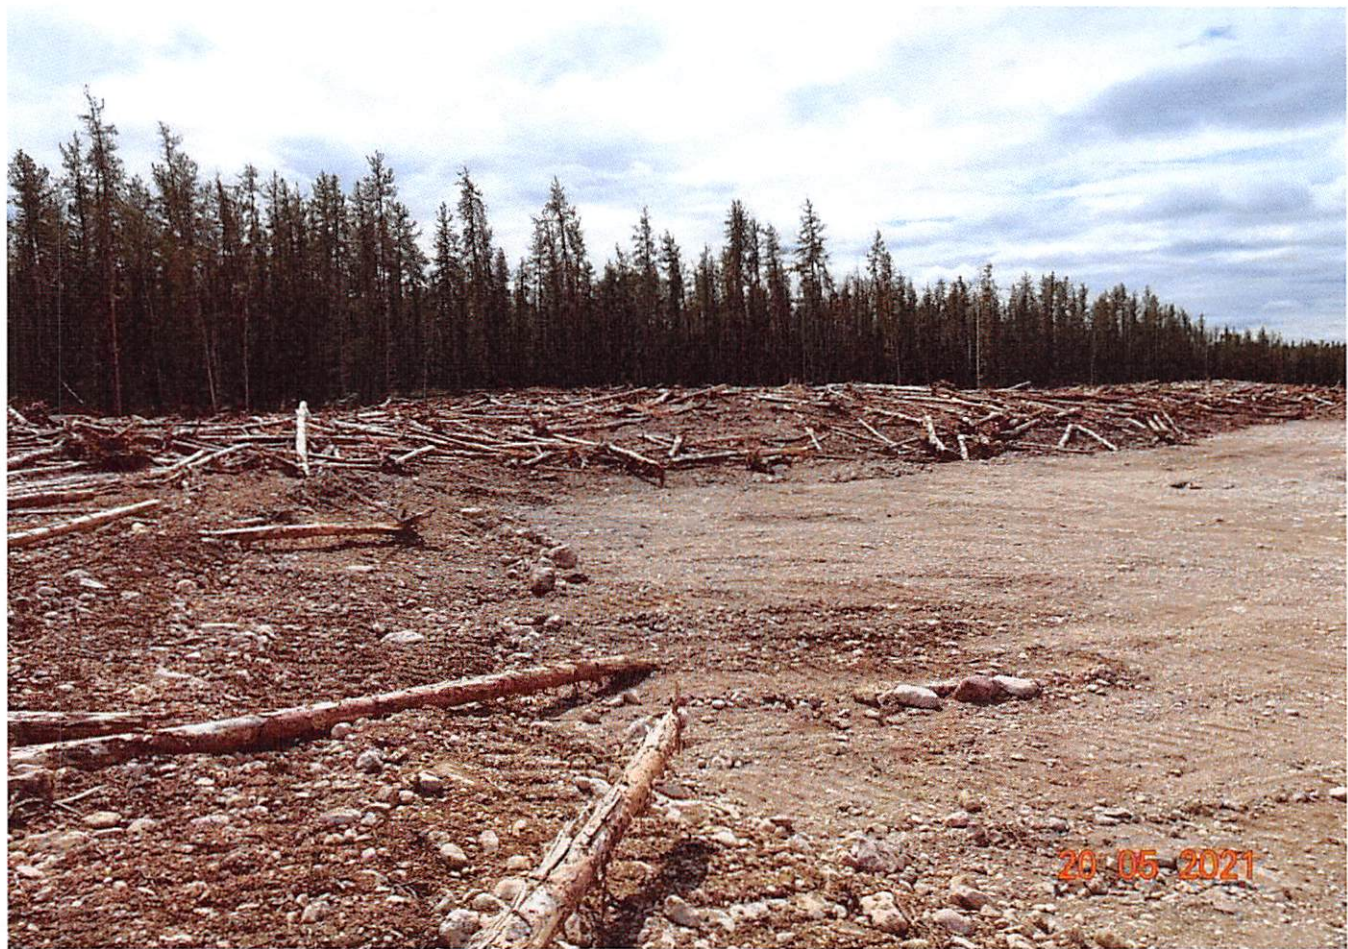
Figure 35
Progressive brush disposal in the southern portion of the pit.

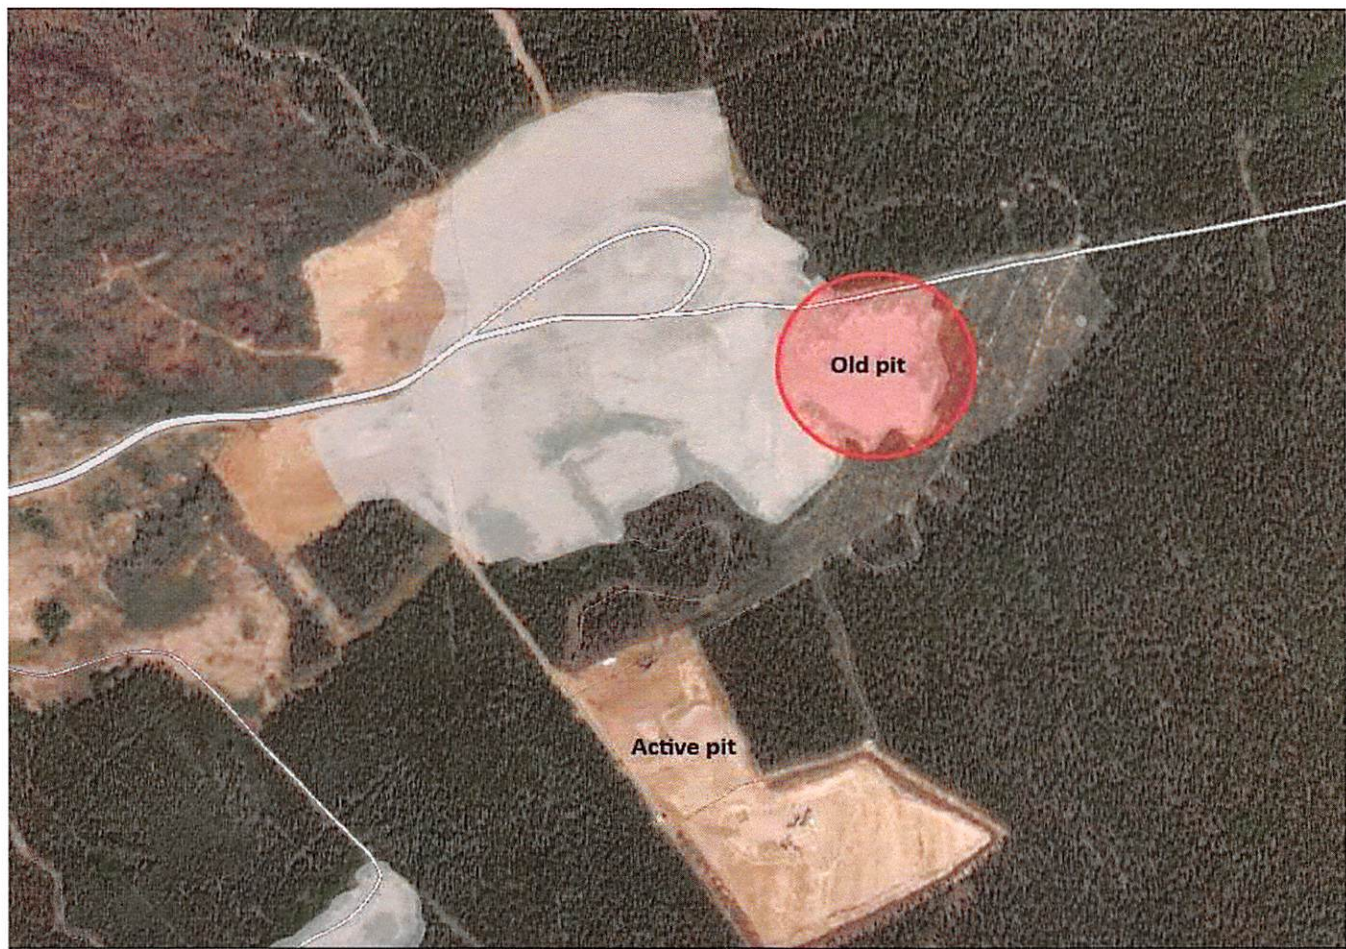
Final restoration has not been completed on the Permittee's old quarry pit to the north east (Figures 38-40). Condition 38 requires final cleanup and restoration. If the material is no longer needed the stockpiles need to be leveled and working faces should be sloped to a 2:1 ratio. A stockpile of processed material remains in the old quarry pit area.

Figure 38
Location of old quarry permit 2012QP0076 under LUP MV2010Q0056.

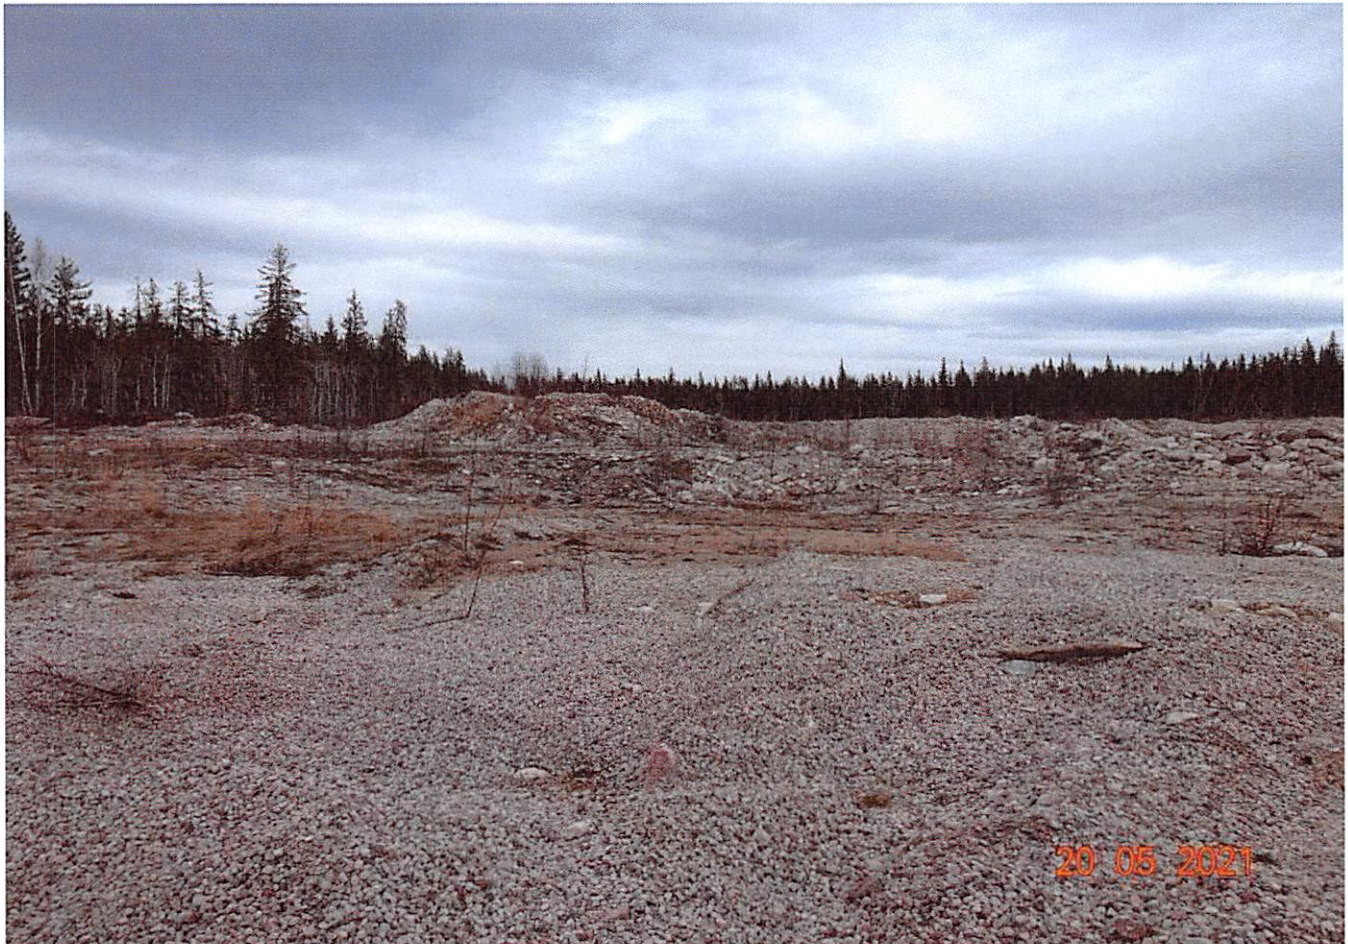
Figure 39

Image showing stockpiles in old Fort Smith Construction quarry pit that requires leveling.

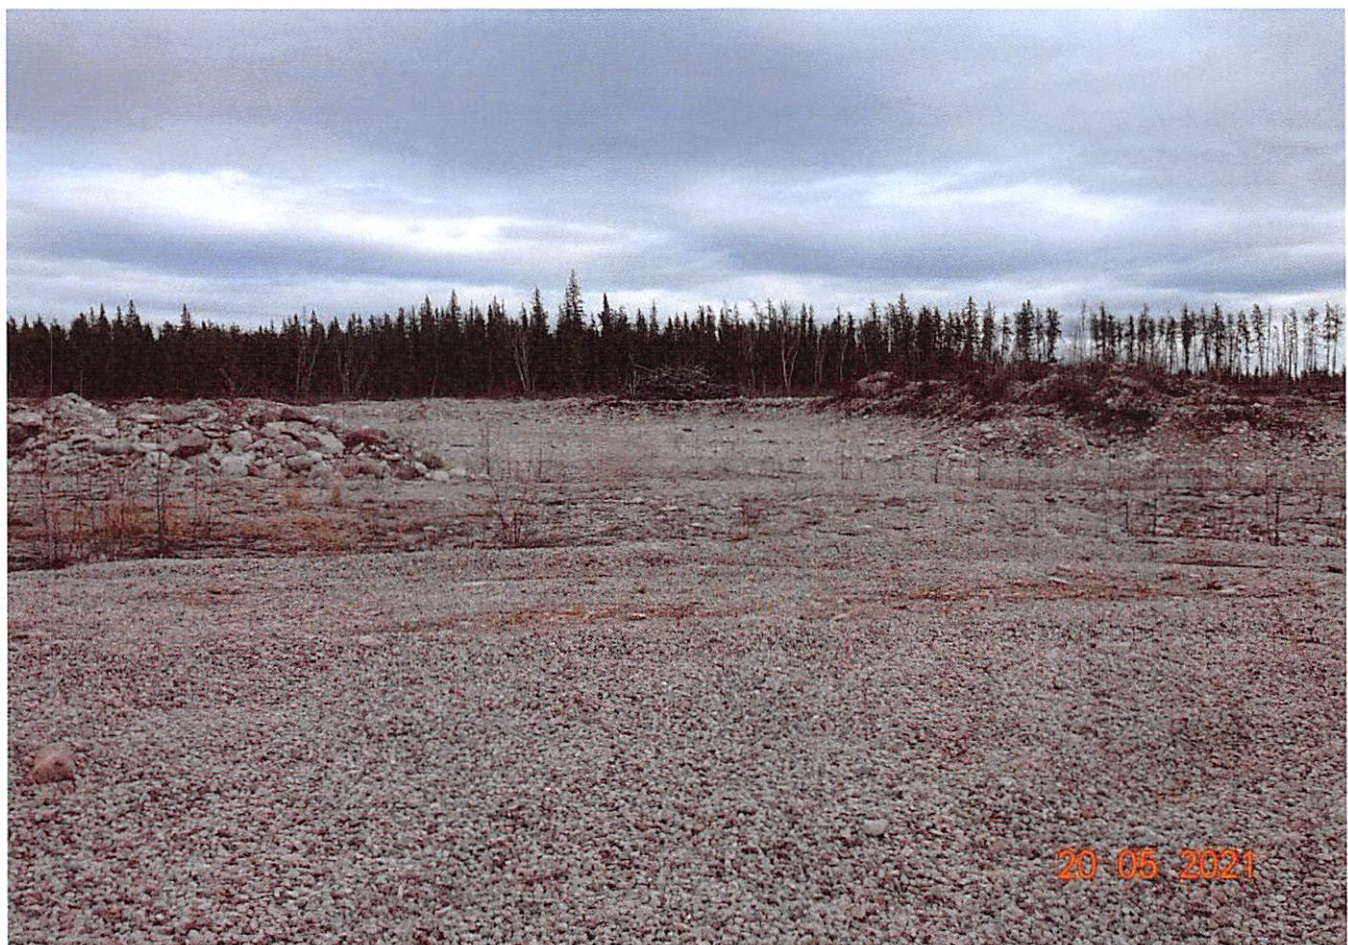
Figure 40

Image showing stockpiles in old Fort Smith Construction quarry pit that requires leveling.

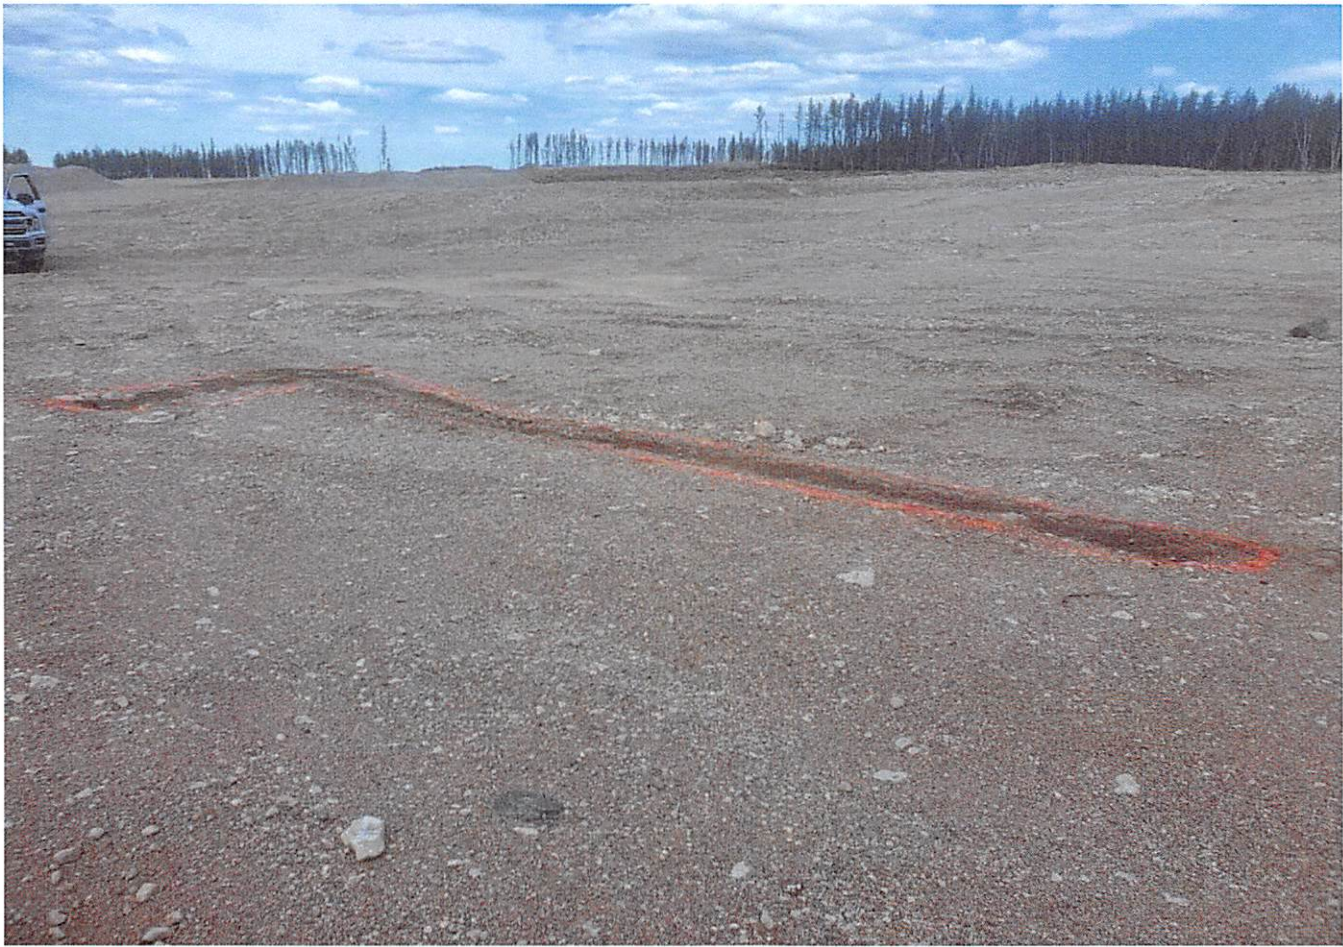
removed and disposed of at an authorized facility. Inspectors went back to the site on May 28 and marked spills (Figures 41-51). Inspectors will be following up on site to document actions taken to rectify this issue.

Figure 42
Marked spill.

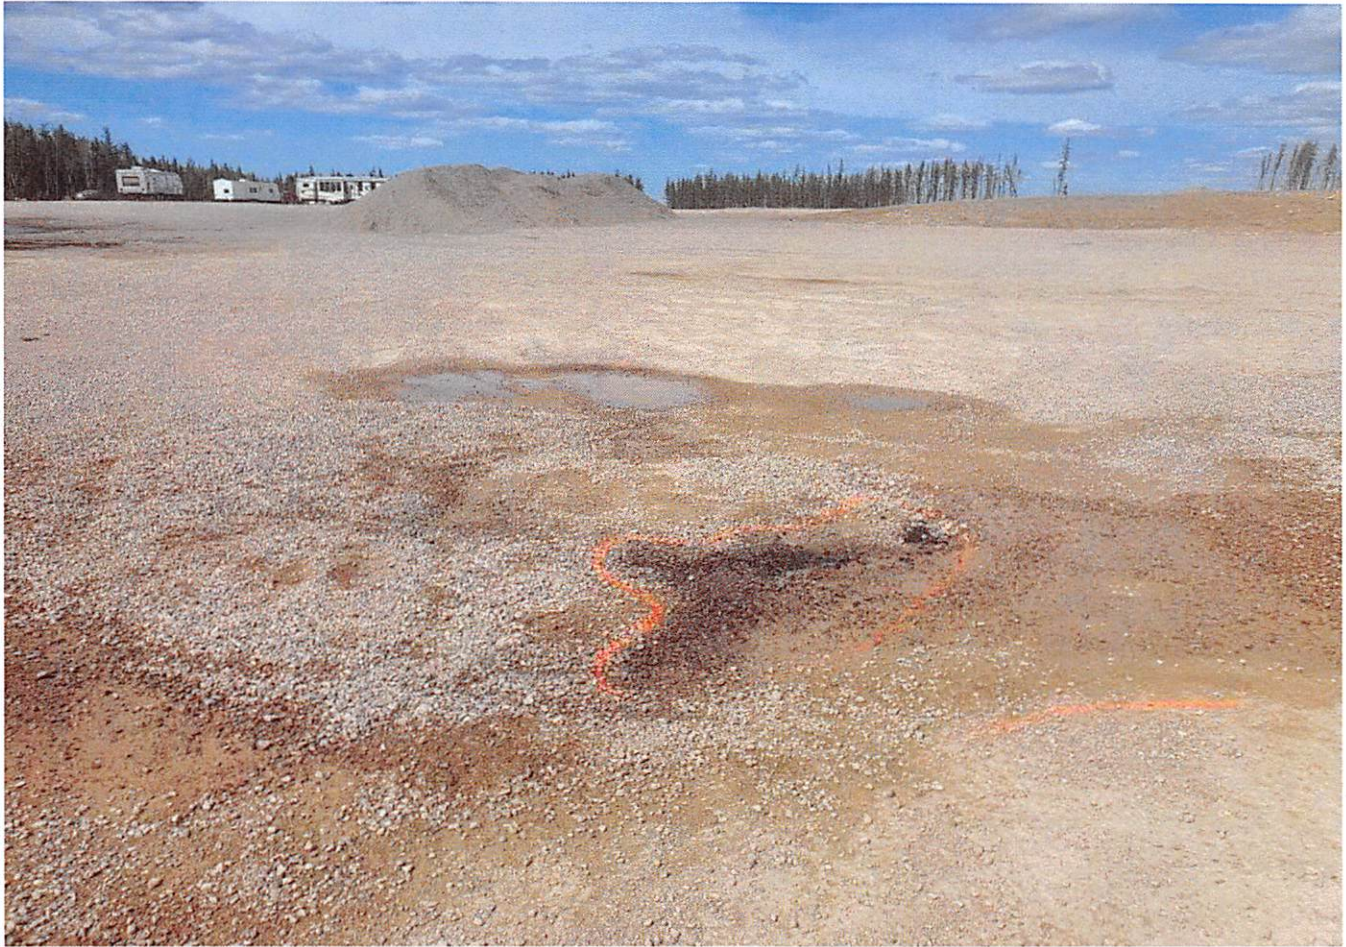
Figure 43
Marked spills.

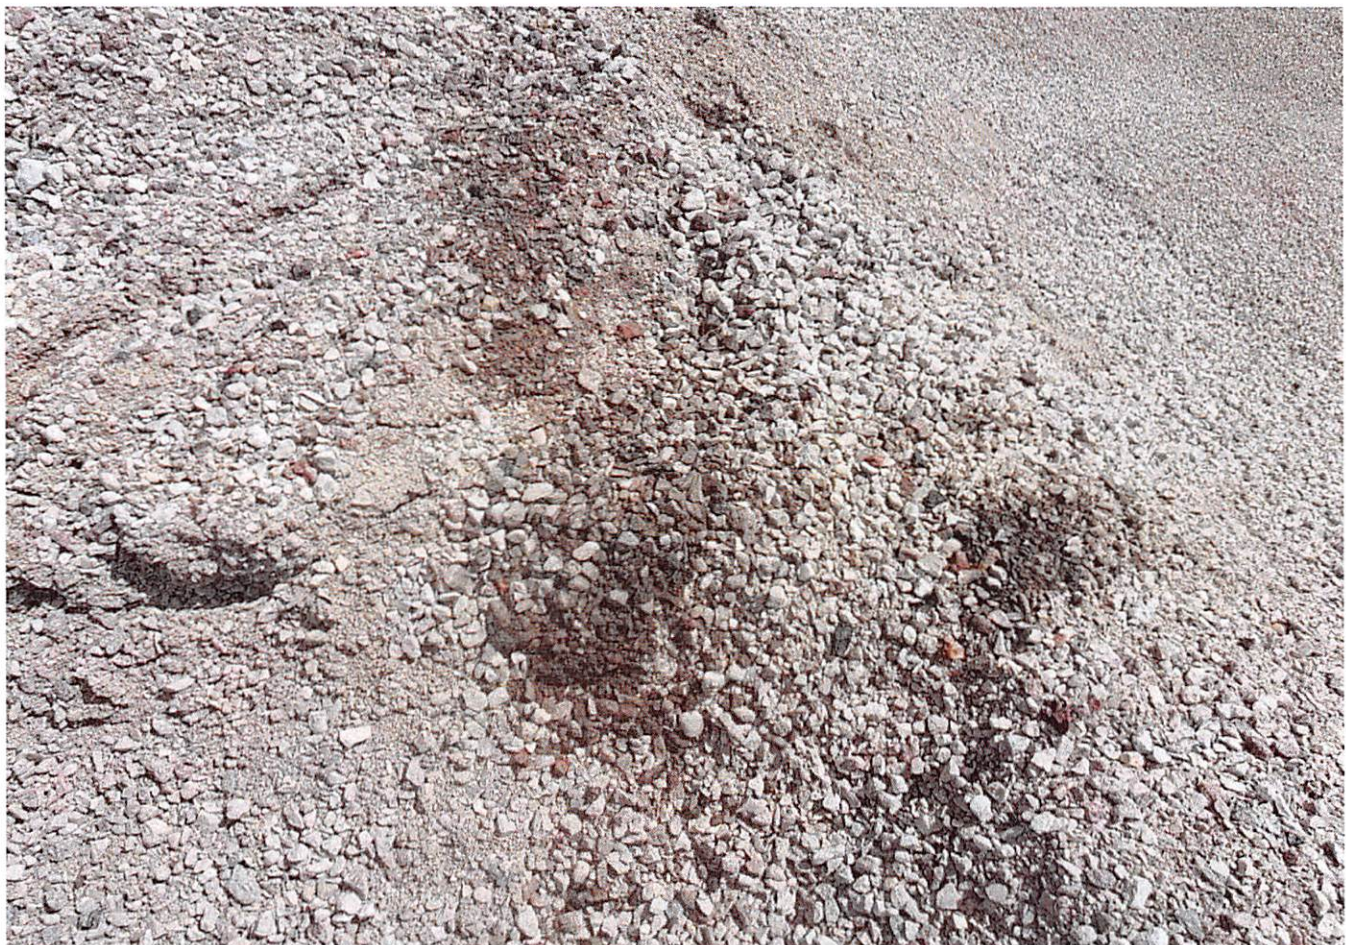
Figure 44
Spill on gravel pile.

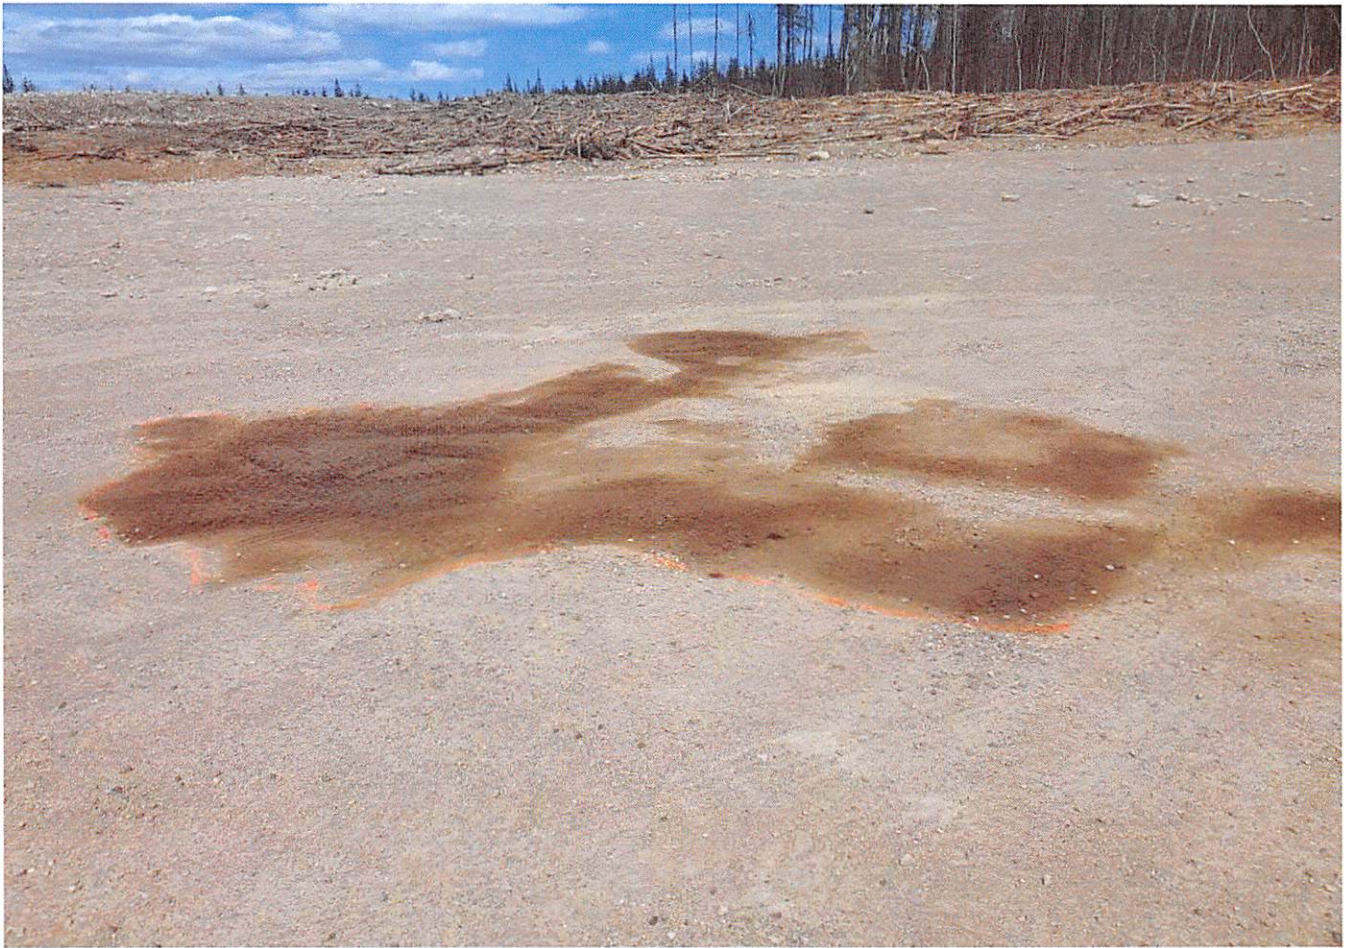
Figure 45
Marked spills.

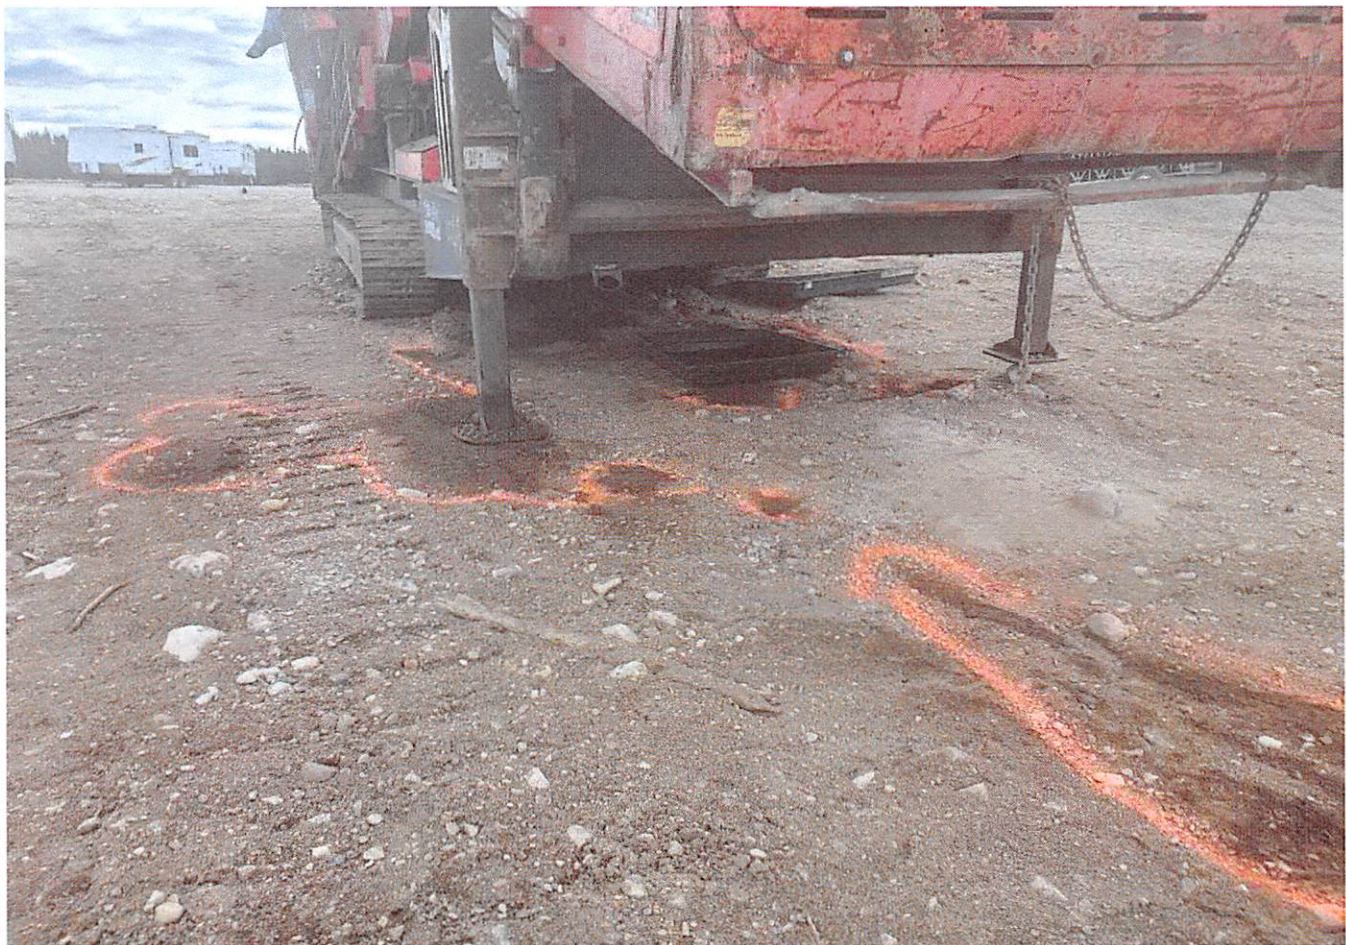
Figure 46
Marked spills.

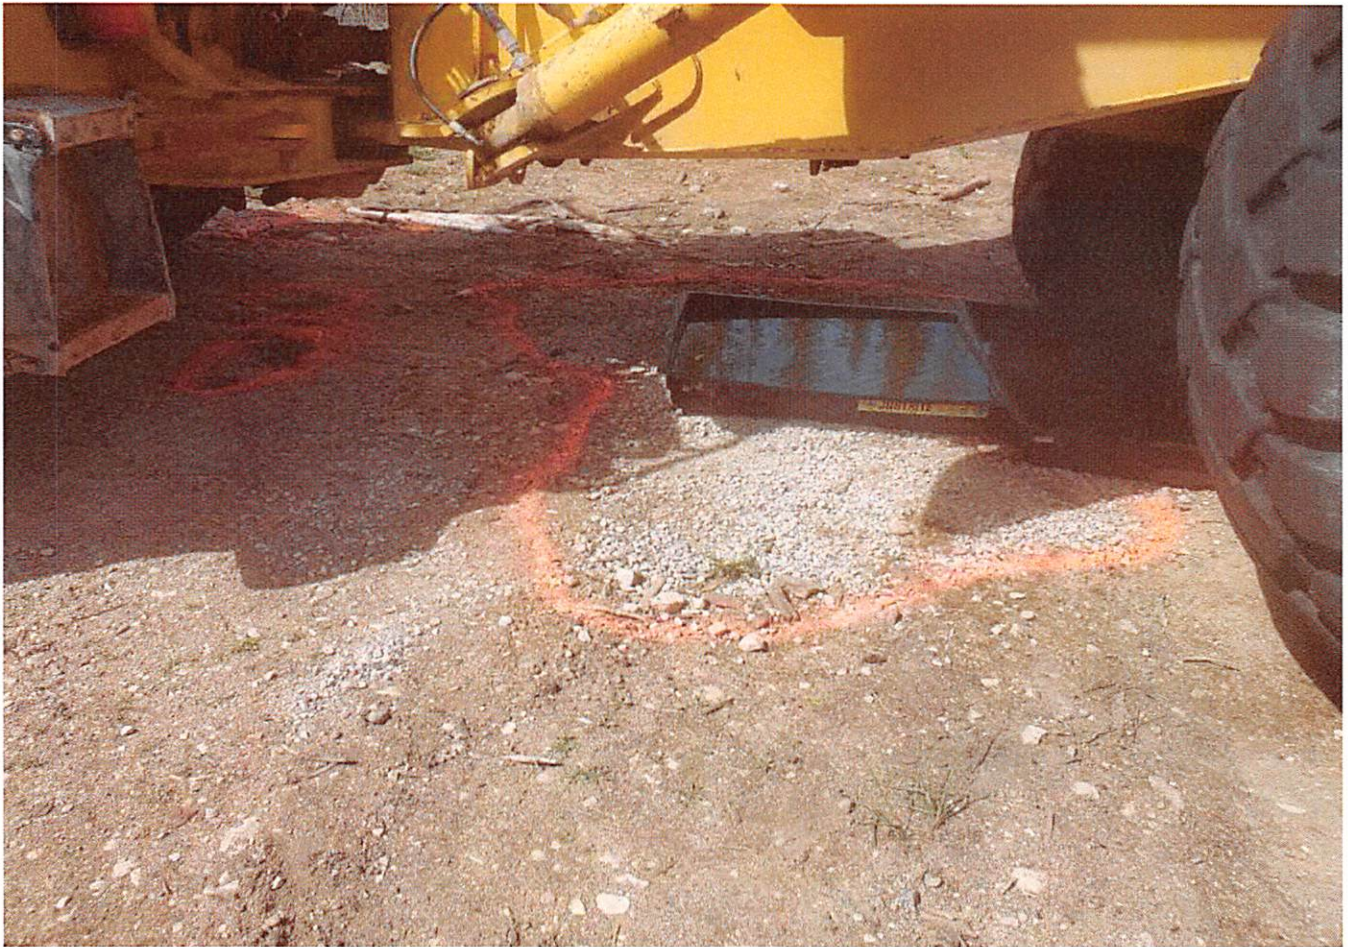
Figure 49
Marked spills.

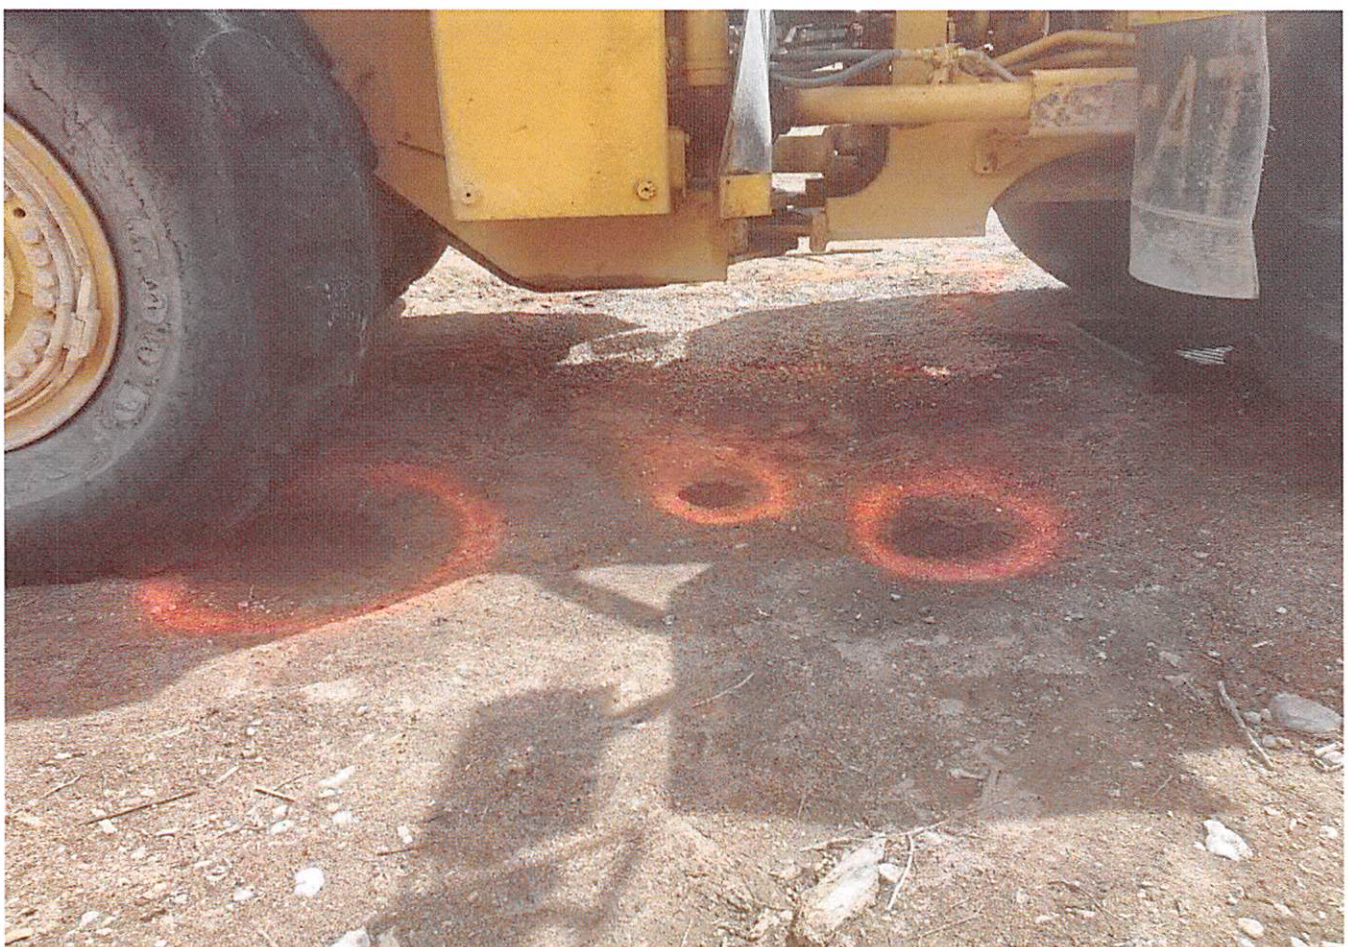
Figure 50
Marked spills.

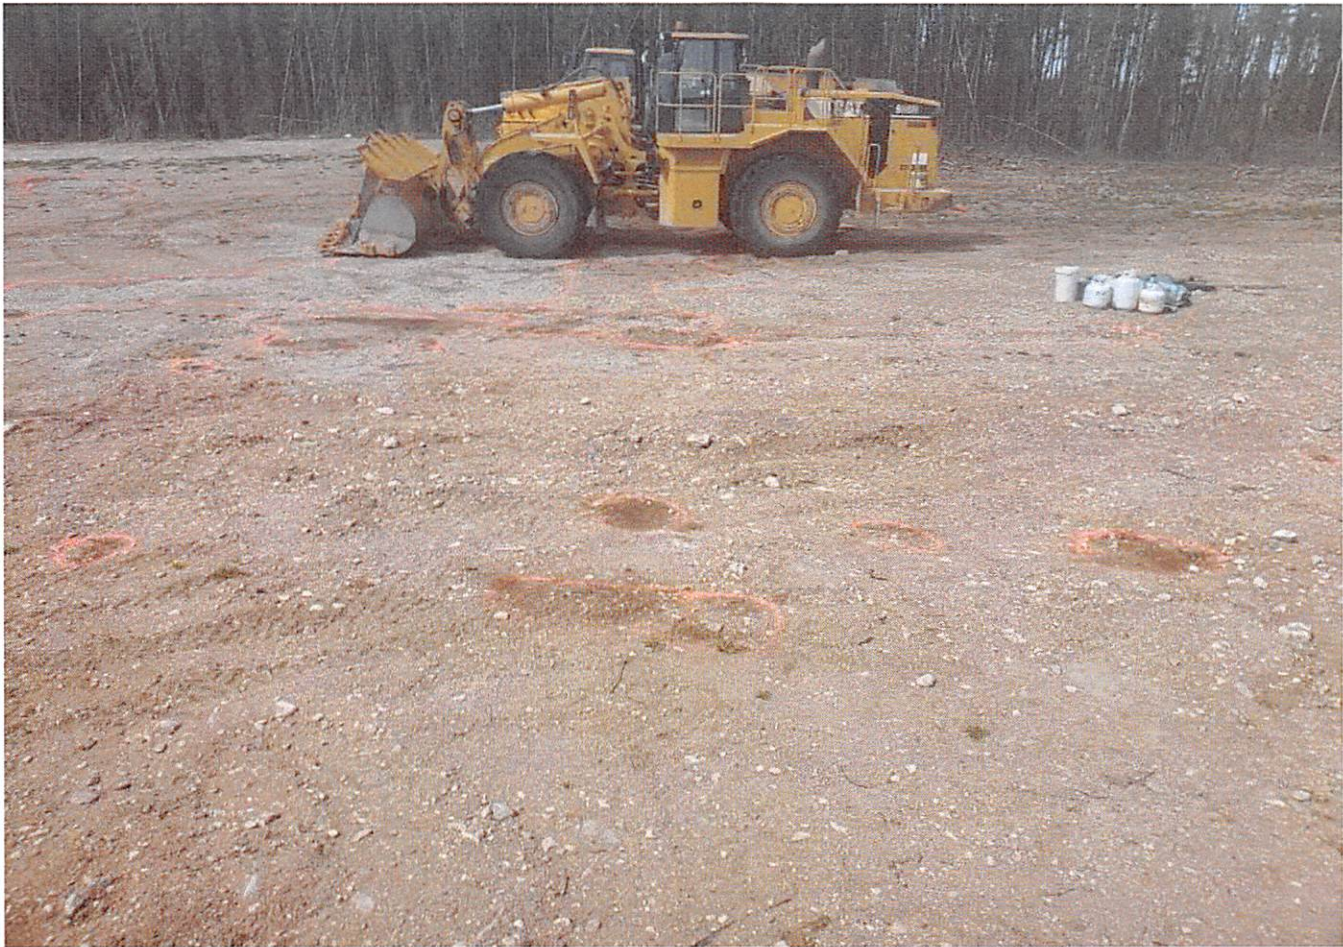
Figure 51
Marked spills.
