#### Reference: 2020 Annual Geotechnical Inspection – Water License MV2017L2-0007

• Pine Point Mine Tailings Impoundment Area 2020 Annual Inspection, dated December 16 2020 prepared by Golder Associates

Reference No. 20140895-279-R-Rev0-1000

16 December 2020

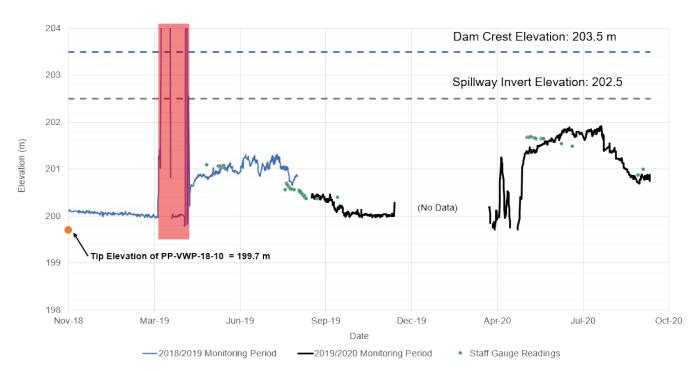
Illustration 5: Main Pond Level Measured by Vibrating Wire Piezometer (PP-VWP-2018-10)

Main pond levels were also recorded at VWP PP-VWP-2018-10, installed in the pond, from November 2018 to September 2020, as presented in Illustration 5 along with elevations recorded at the staff gauge. Large increases in pressure over short periods are interpreted as errors, rather than rapid raising or lowering of the pond level and are partly attributed to freeze/thaw of the instrument. Point measurements of pond elevation at the staff gauge differed from readings at PP-VWP-2018-10 by up to 2.06 m. As a result, the data from PP-VWP-2018-10 are not considered to accurately reflect the level of the pond. Additional instruments were installed in September 2020 to monitor the pond level, including a vibrating wire piezometer in a deeper section of the pond near the dogleg, and a remote camera (webcam) with a view of the pond staff gauge.

Note: Readings corrected for barometric pressure. Red shading indicates errors attributed to freeze/thaw. Data in green from staff gauge readings.

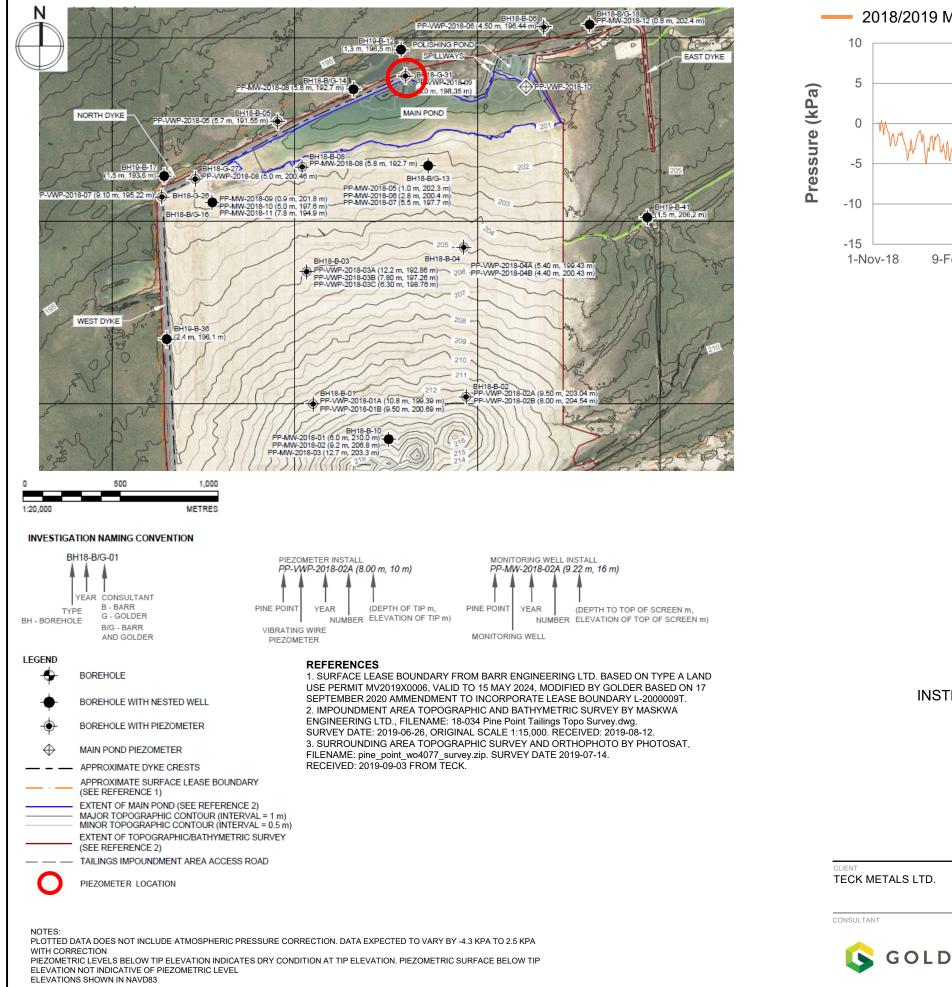
TAILINGS IMPOUNDMEN _ INSPECTION NT	NT AREA	
TITLE BOREHOLE E VIBRATING V	3H18-B-31 VIRE PIEZOMETER PP-\	/WP-2018-09	
PROJECT NO. 20140895	PHASE/TASK/DOC 1000/1006/279	REV.	FIGUR

Readings from PP-VWP-2018-01B, 02A, 02B, 05, 08 and PP-VWP-2018-09 were considered unreliable due to possible malfunction. The instruments are planned to be reviewed and trigger-action-response-plans (TARPs) developed for the TIA. Any malfunctioning instrument required for a TARP shall be repaired or replaced.

### **INSTRUMENT REQUIRES CHECK FOR FUNCTIONALITY / CALIBRATION**

### DATA INDICATES VWP IS DRY AT ELEVATION 198.35 m
