# 2017 Dam Safety Inspection Pine Point Tailings Impoundment Area Pine Point, NT

**Submitted to:**  
Teck Metals Ltd.  
601 Knighton Road  
Kimberley, BC  
V1A 1C7

**Reference Number:** 1776943-003-R-Rev1-1600

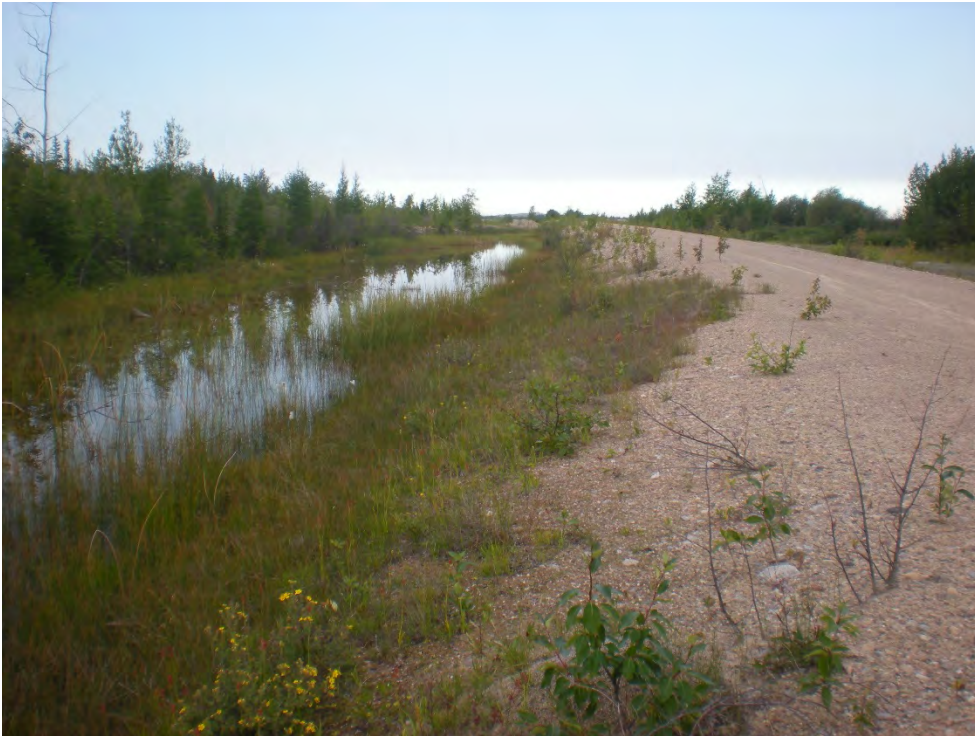
*Photograph 1: South Dyke – Downstream Face at East End, Looking West. 27 July 2017*

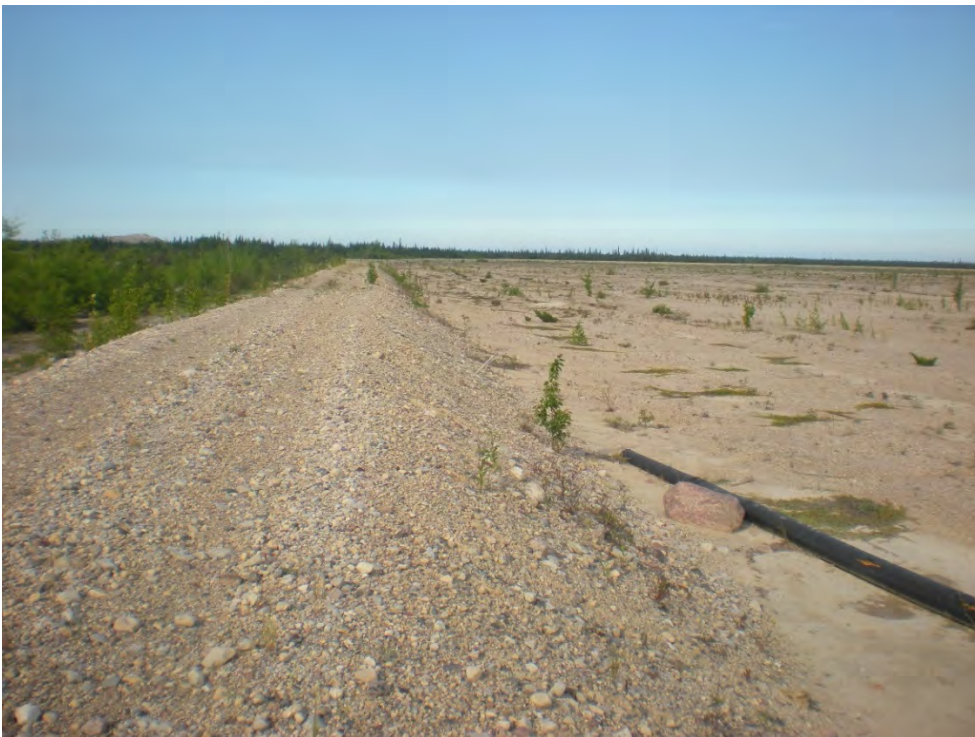
*Photograph 2: South Dyke – Upstream Face of Central Portion, Looking West. 27 July 2017*

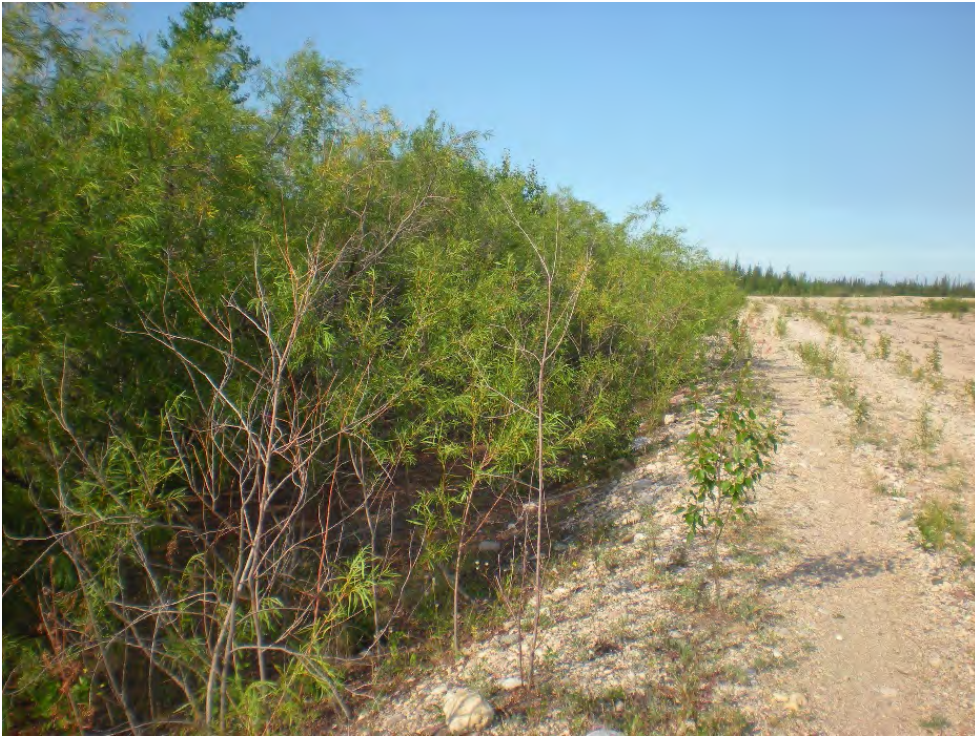
- Clearing of vegetation should continue in accordance with the OMS manual. Vegetation regrowth will be an ongoing issue. Priority should be given to the western portion of the south dyke, where some of the densest vegetation was observed. Teck has indicated that spraying and vegetation clearance was completed in summer 2017.

*Photograph 3: South Dyke – Downstream Face of West End with Vegetation, Looking West. 27 July 2017*

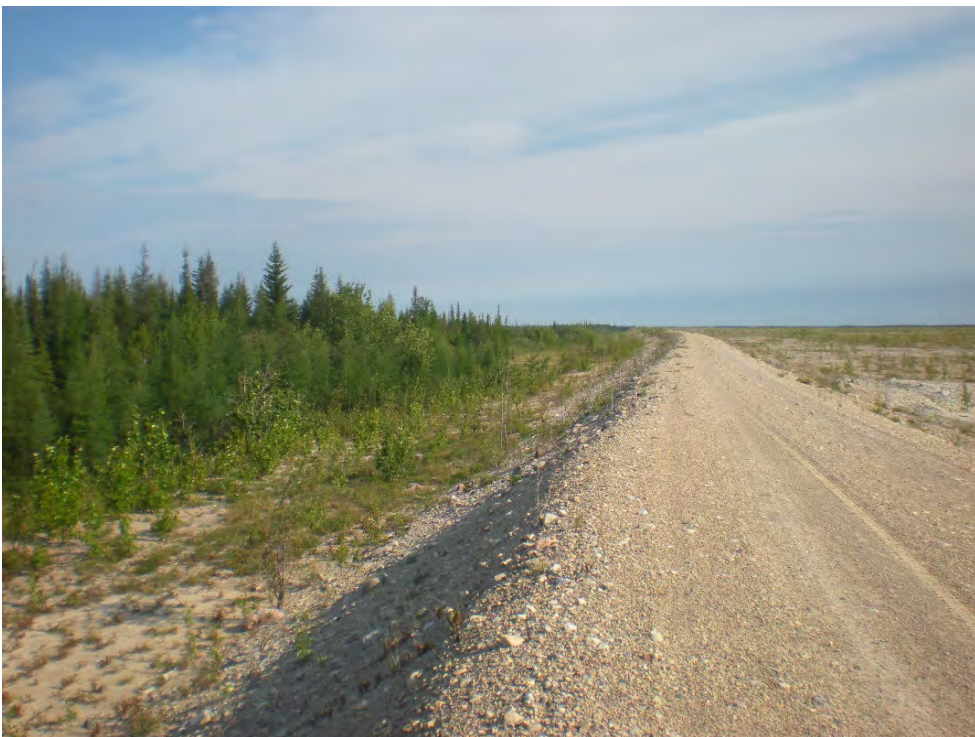
*Photograph 4: West Dyke – Downstream Face, Looking North. 27 July 2017*

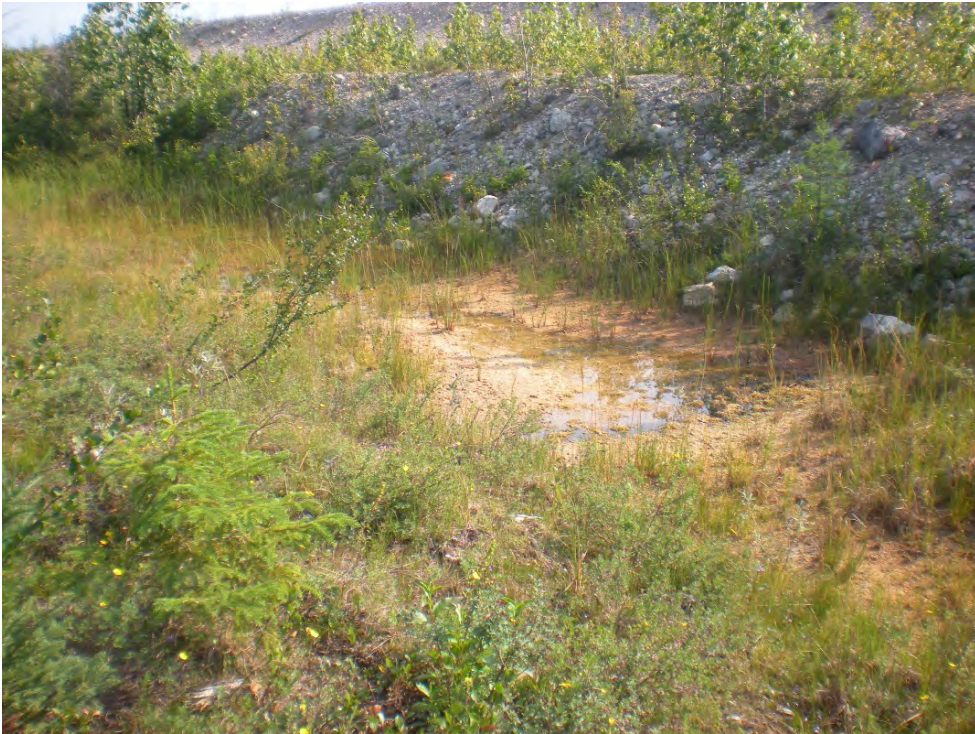
There were no visible signs of seepage through the dykes, although the healthy growth of some bushes or small trees at the outside toe of portions of the north, west, and south dykes is considered indicative of soil moisture in these areas. Ponded water at the toe of the dykes may or may not be indicative of seepage through the dykes. Some of the wet areas beyond the perimeter of the disposal area are due to naturally ponded water, and are not indicative of seepage.

*Photograph 5: West Dyke, South End. Ponded Water Downstream Of Toe, Looking North. 27 July 2017*

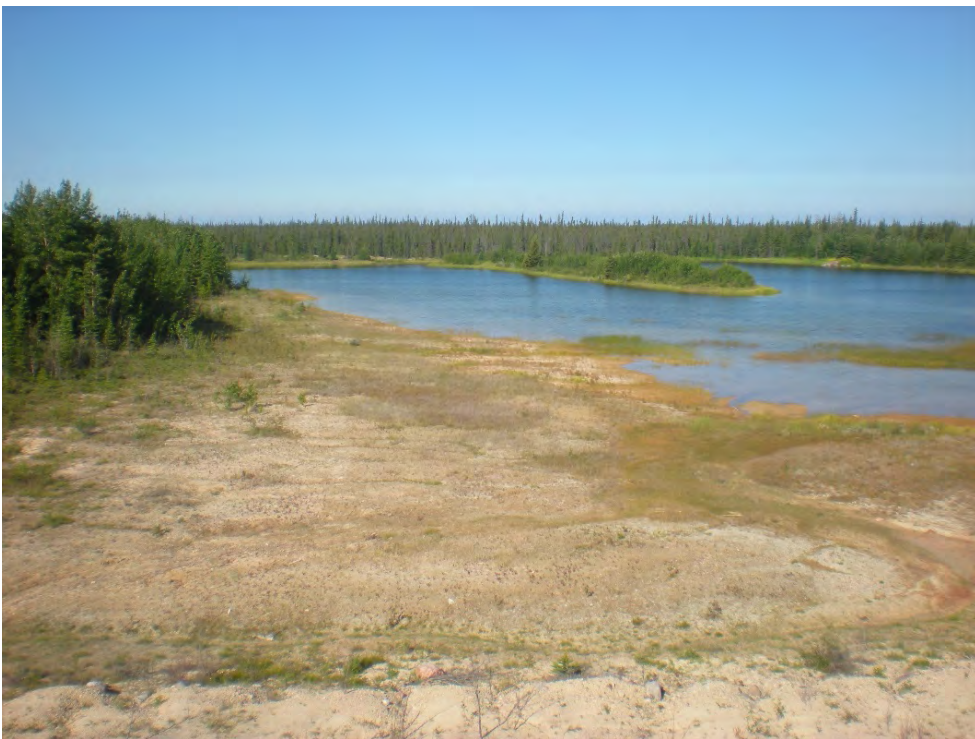
*Photograph 6: West Dyke – Downstream Drainage Course near North End - Dry. 27 July 2017*

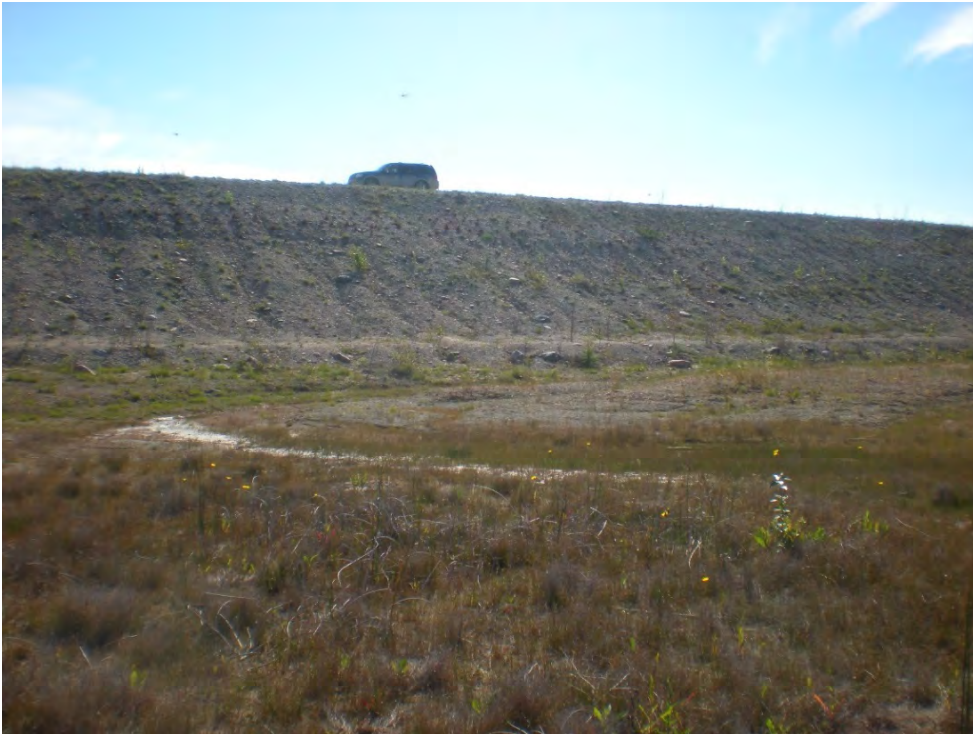
- Other than the ongoing clearing of vegetation, there is no other maintenance noted for 2017.
- The formation of erosion gullies on the downstream slopes of the south, west, and east dykes has been observed during previous site inspections. In the last seven years of inspections, including 2017, the degree of erosion has not been observed to increase significantly.

*Photograph 7: West Dyke, Downstream Side – Looking East, Stable Erosion Features. 27 July 2017*

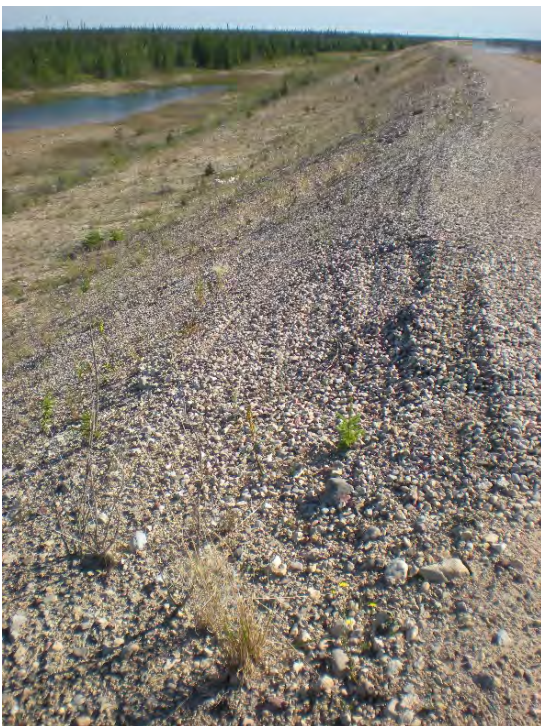
- Dykes are in overall good condition. Repairs made to a number of minor erosion features, by placing dam fill on the downstream side of the north dyke in 2016 were observed to be in place and intact. Minor erosion rills in other portions of the north dyke, including a 4 to 5 m section at the ramp remnant, do not appear to have grown significantly and do not impact dam integrity.

*Photograph 8: North Dyke – Downstream Slope (left side of photo) with 2016 Patch on Erosion Feature in Place, Looking East. 27 July 2017*

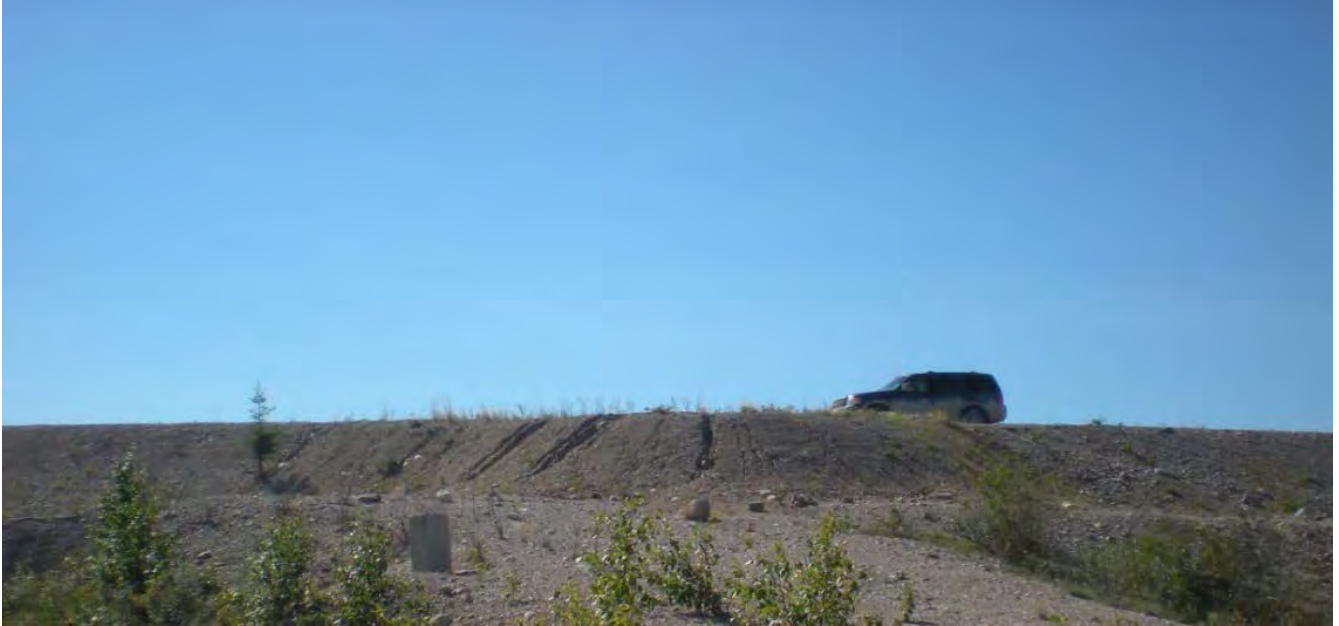
*Photograph 9: North Dyke – Erosion Feature on Downstream Slope (former ramp, non-structural), Near Center (dogleg), Looking South. 27 July 2017*

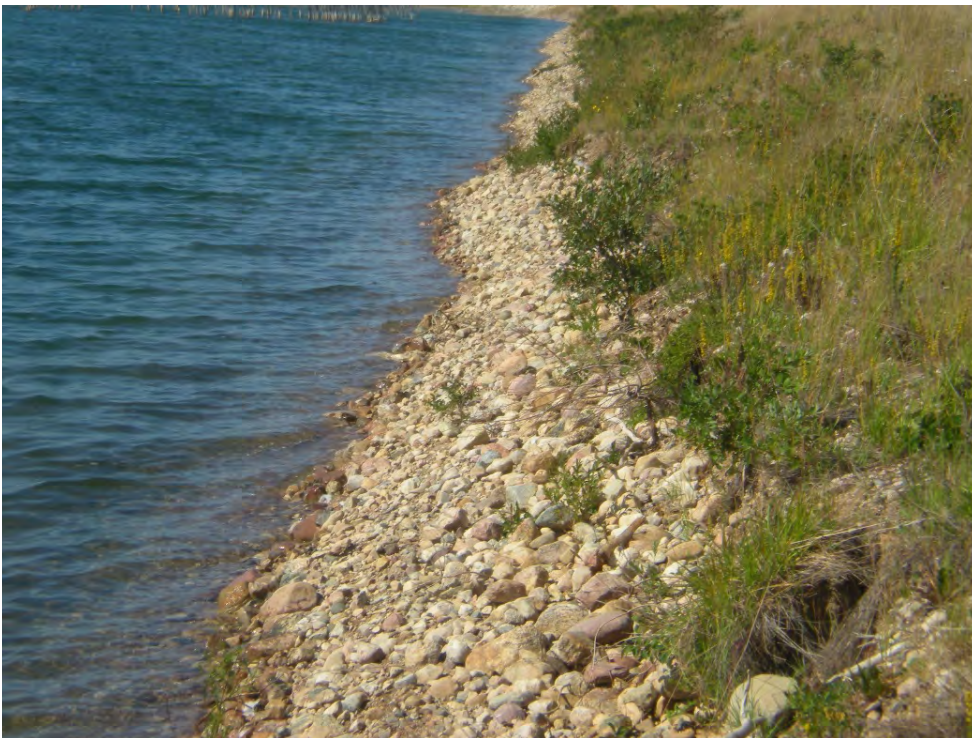
- Wave cut erosion—During the 2014 and 2015 inspections, erosion was observed at the central section of the north dyke at or just above the water level. In 2016 repairs were made to a test section of the north dyke to evaluate if coarser fill is necessary for restoration. These repairs were in good condition at the time of the inspection. The erosion in areas that had not been repaired in 2016 did not increase significantly between 2016 and 2017.
- Surface erosion rills (gullies)—Some relatively shallow rills were observed during the 2017 inspection. Areas of rilling which have been repaired were observed to be in good condition.
- None of the observed erosion extended into the dyke crest, and the erosion is not believed to compromise dam safety.

*Photograph 10a: North Dyke Upstream Face, Gravel and Cobbles at Pond Waterline. 27 July 2017*

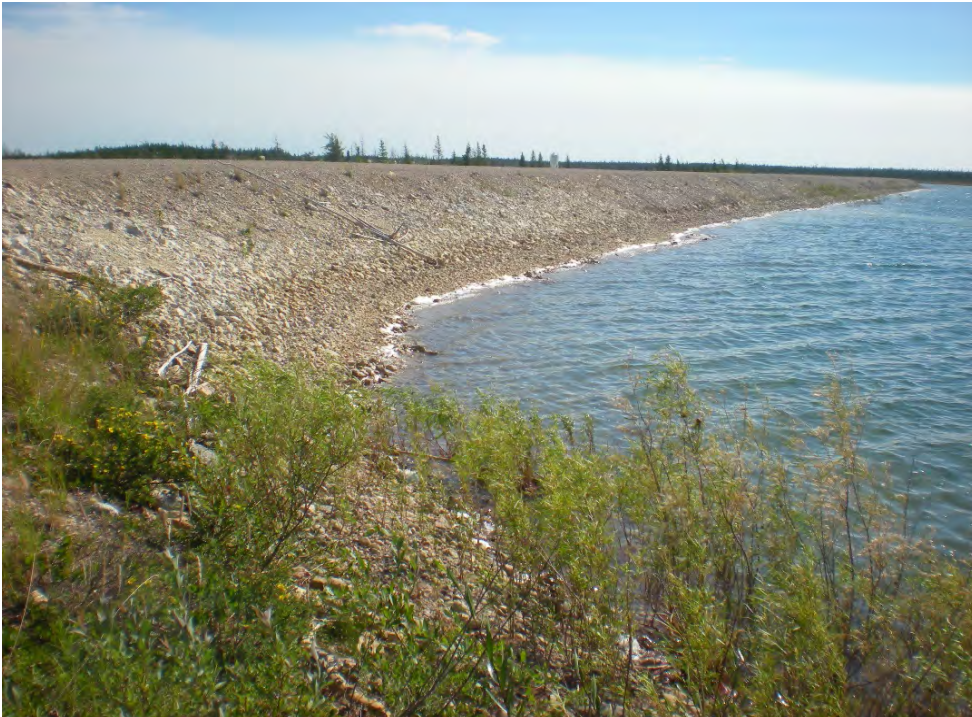
*Photograph 10b: North Dyke Upstream Face, Gravel and Cobbles at Pond Waterline, at Dogleg Looking East. 27 July 2017*

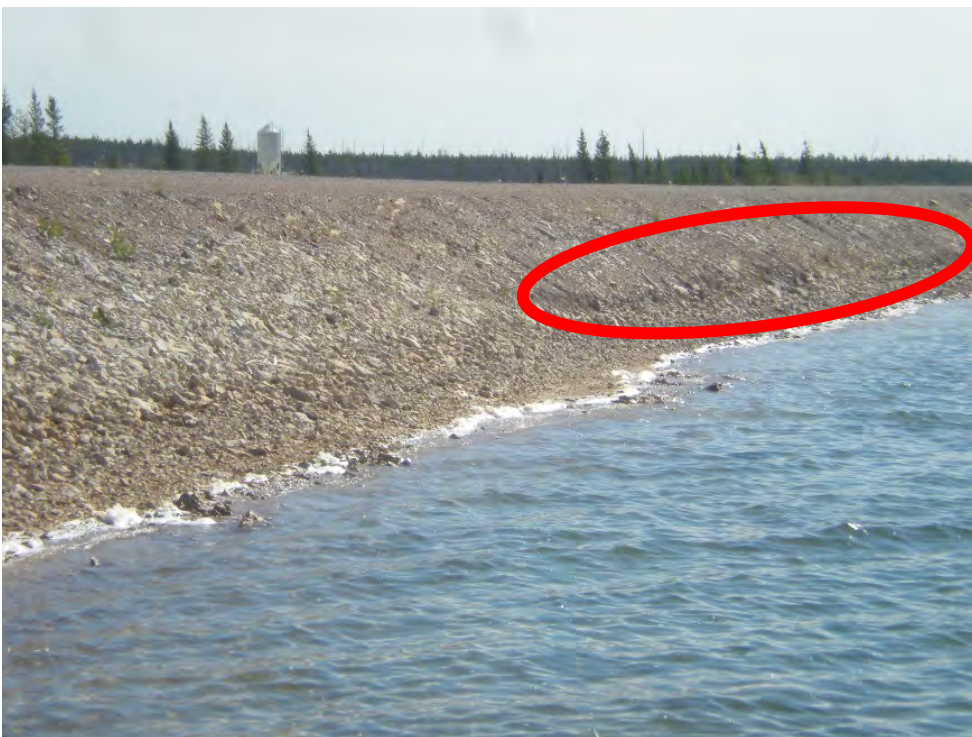
There is the potential for ongoing erosion of the upstream face of the north dyke. Historical erosion in this area has previously been repaired and may require additional maintenance in the future. The upstream slope is inspected annually to confirm that erosion does not compromise stability in the future.

*Photograph 10c: North Dyke Upstream Face, Gravel and Cobbles at Pond Waterline, at Dogleg Looking East. Detail Showing Possible Sloughing of Previous Repair. 27 July 2017*

Structure	ID Number	Deficiency or Non-conformance	Applicable Regulation or OMS Manual Reference	Recommended Action	Priority	Recommended Deadline/Status
North dyke	2014-01	Erosion observed on the pond side of the north dyke with potential to cause dyke instability.	OMS manual Section 5.5.2	Continue observation and evaluation of replacement fill placed in 2016 throughout 2018 monitoring period.  Should restored area indicate adequate performance, repair the remaining sections of observed erosion in 2019 with the same fill material used in the trial.  Should significant erosion occur within the test section during 2018, complete a new test restoration using coarser fill in 2019, or evaluate alternative approaches such as periodic repair work on the fill.	3	end of Q2 2019

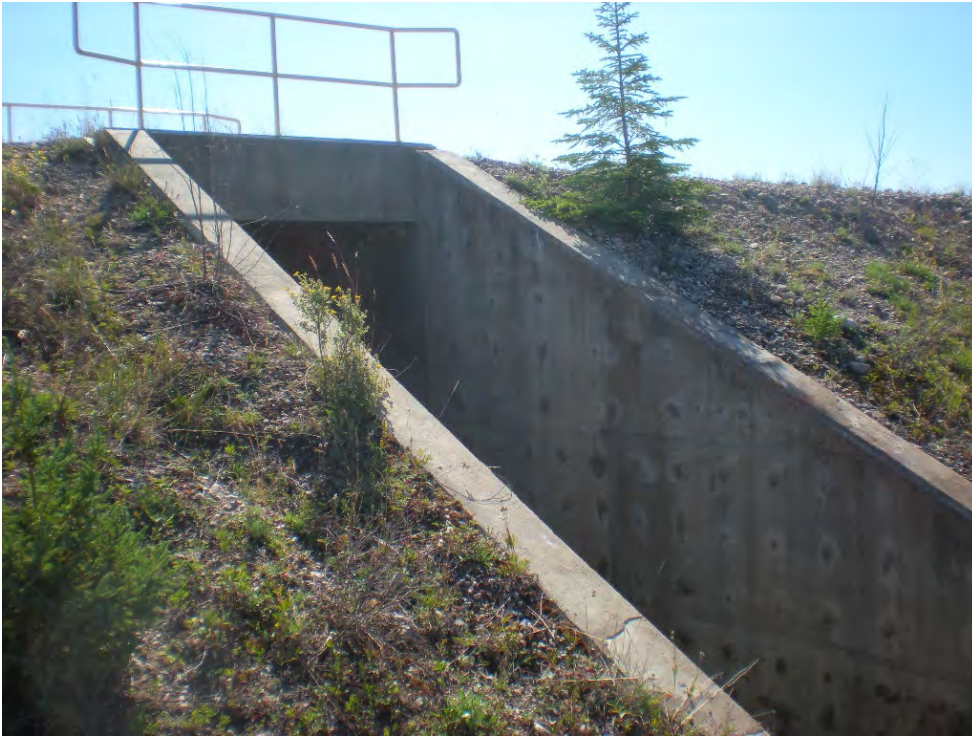
*Photograph 11a: Main Pond Spillway (Spillway No. 1). 27 July 2017*

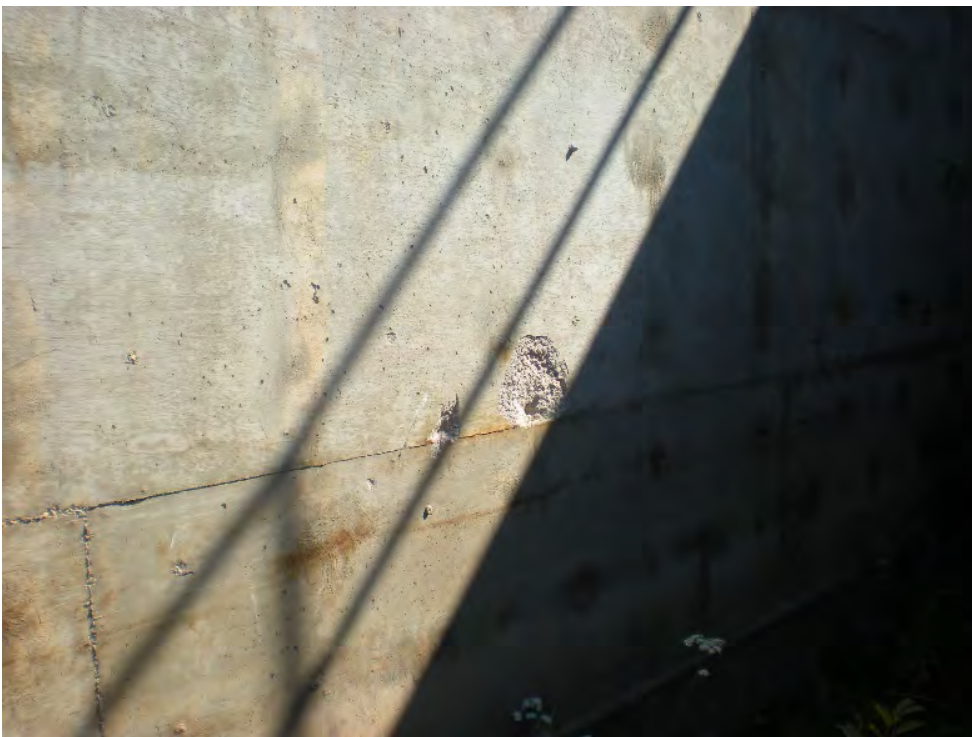
*Photograph 11b: Main Pond Spillway (Spillway No. 1). Detail of Limited Spalling 27 July 2017*

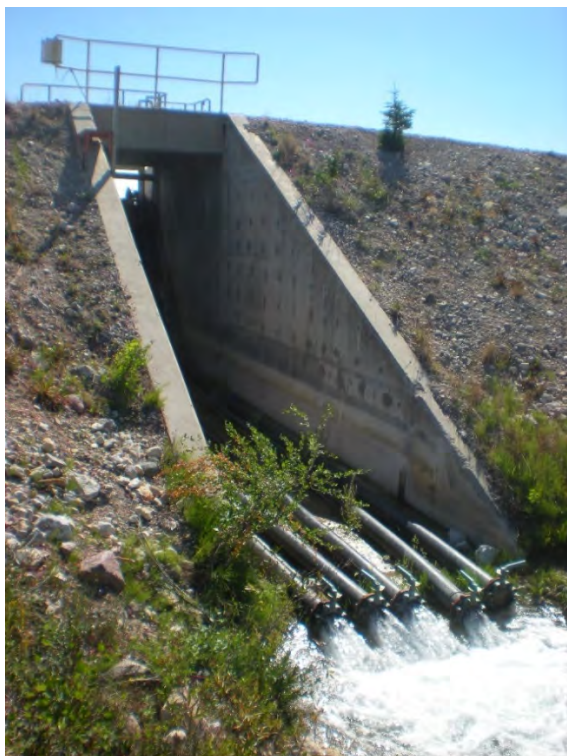
*Photograph 12: Settlement Pond Spillway (Spillway No.2) – Syphon Piping Discharge at Outlet. 27 July 2017*

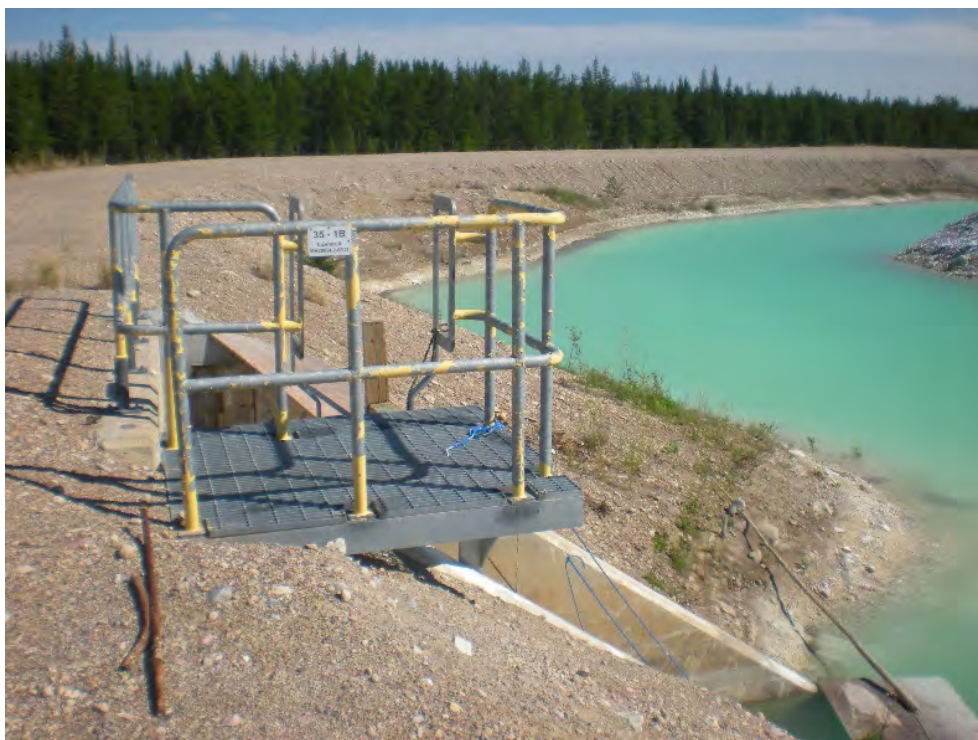
*Photograph 13: Settlement Pond Spillway (Spillway No.2) – Settling Pond Side. 27 July 2017*

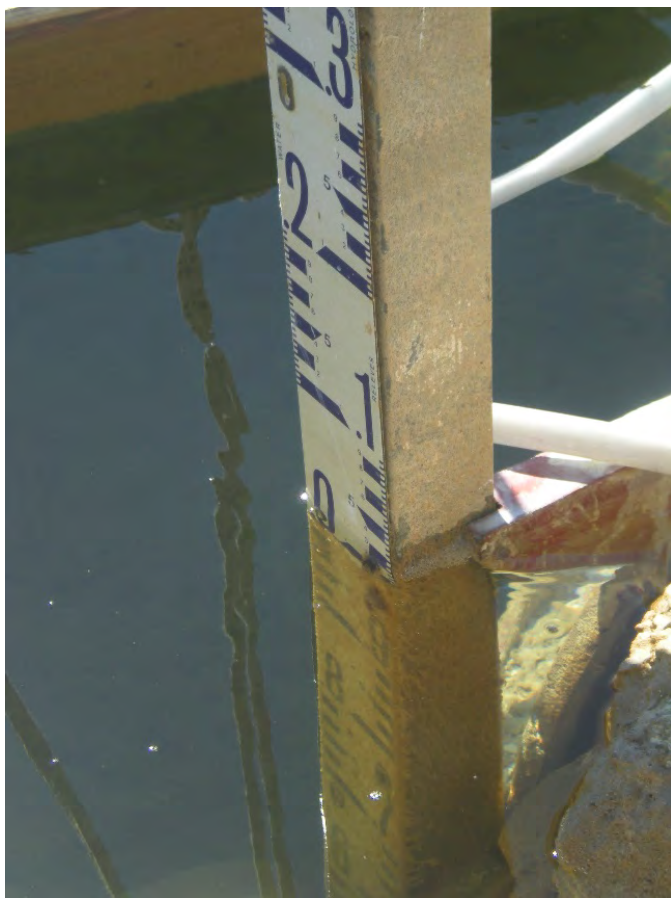
*Photograph 14: Main Pond Water Level at Culvert Intake to Settling Pond (201.03 m). 27 July 2017*

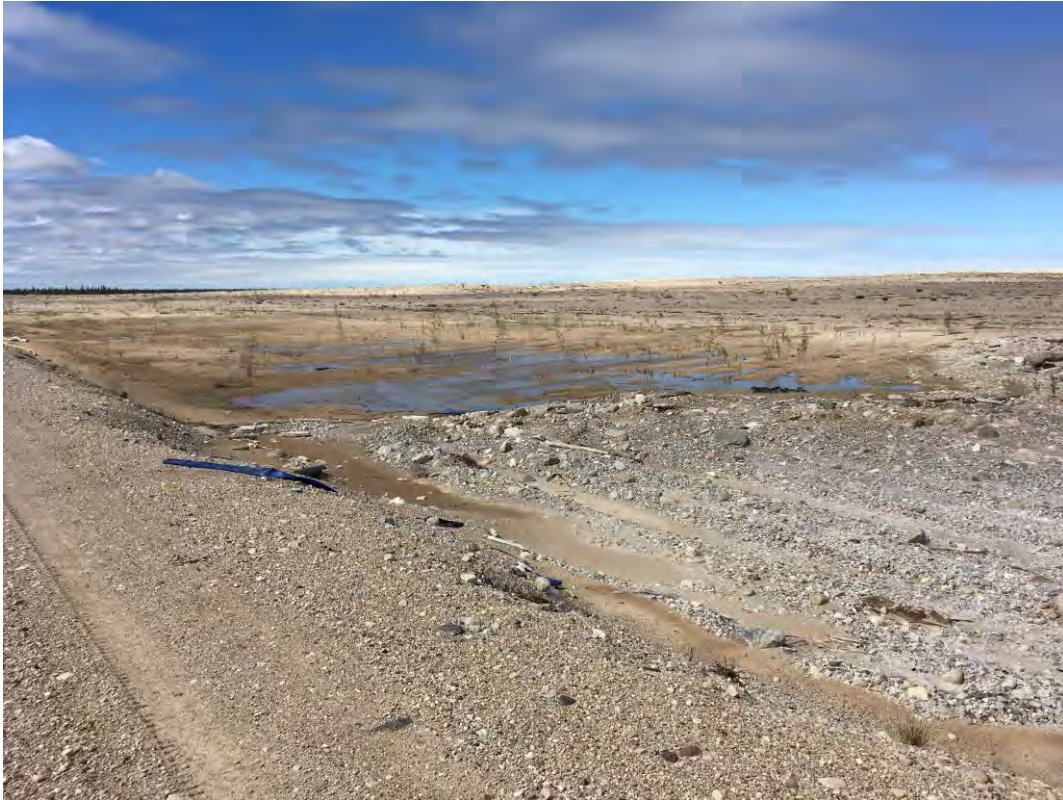
South Dyke, Central Area, minor seasonal water upstream side

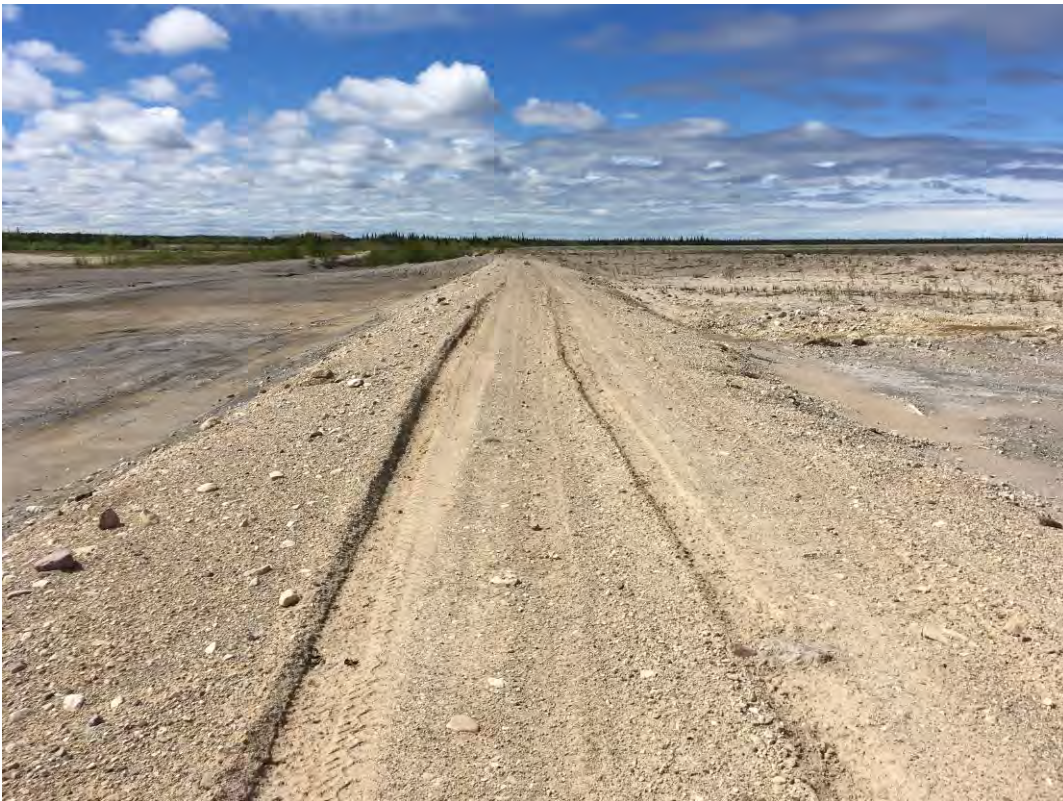
South Dyke, Central area facing east, minor vehicle rutting

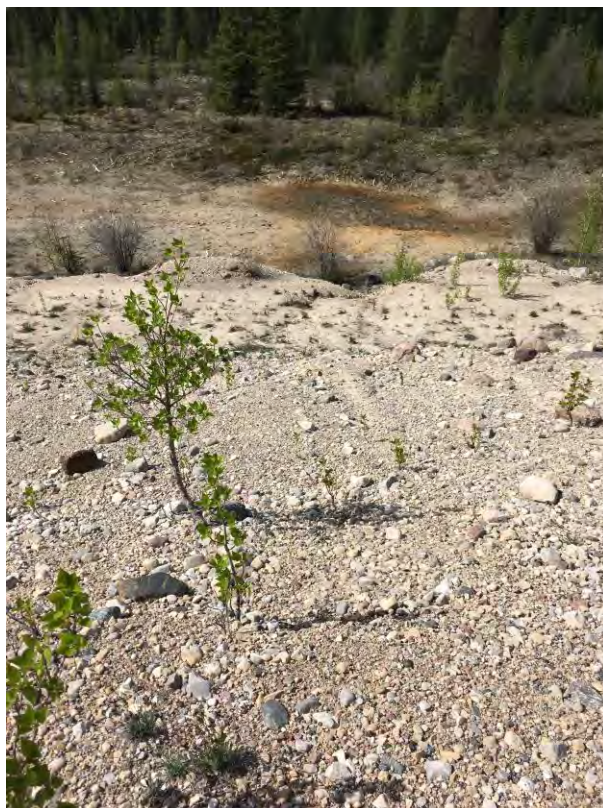
West Dyke, minor staining near toe, Approximate Station 19+00

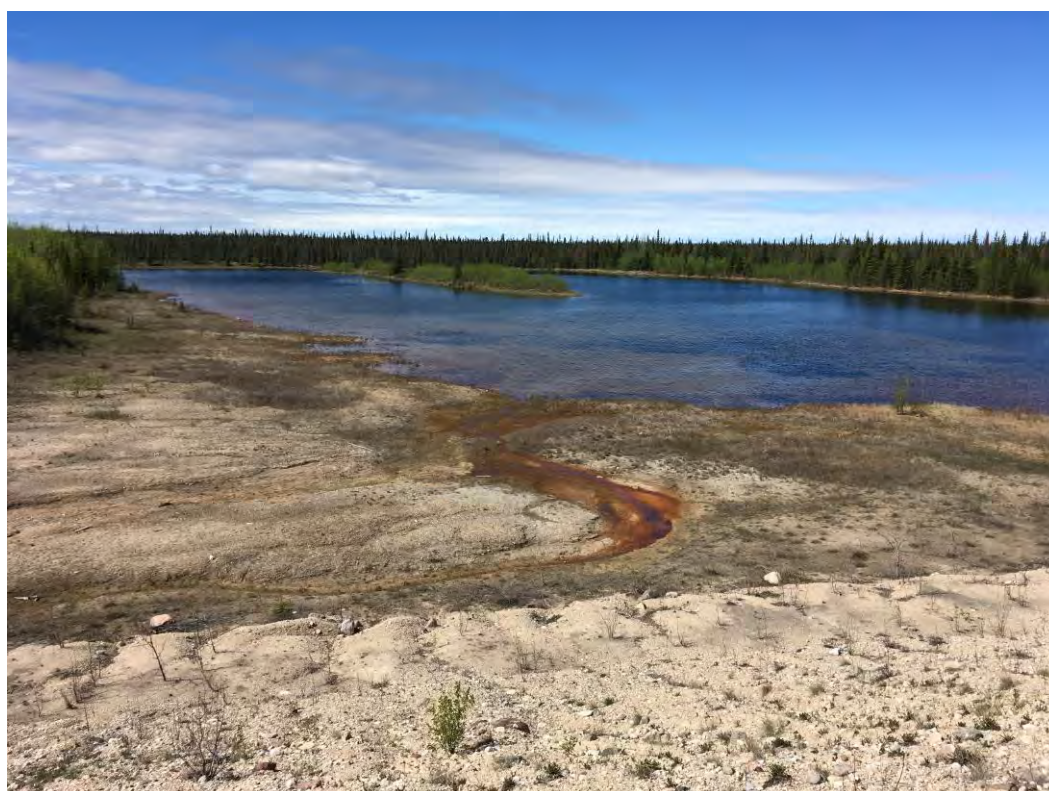
West Dyke, staining near toe.

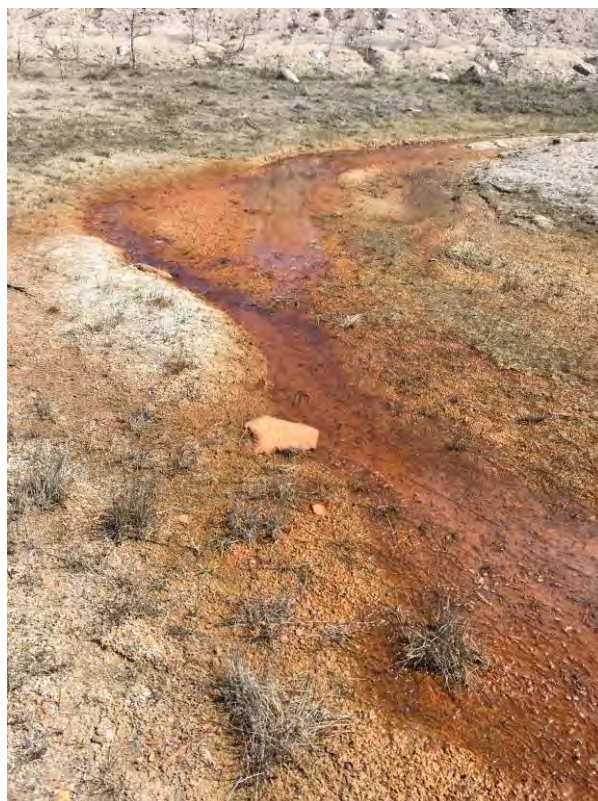
West Dyke, Previously Observed Boil Area, Staining near toe, facing East.

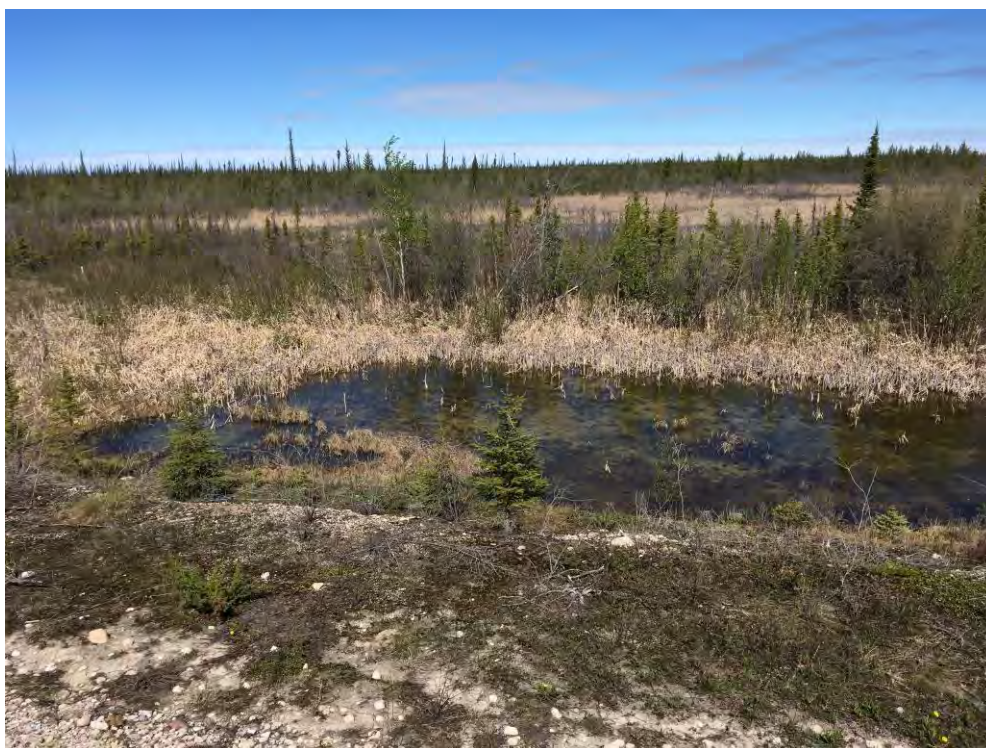
North Dyke, dog leg section, facing north, staining at toe.

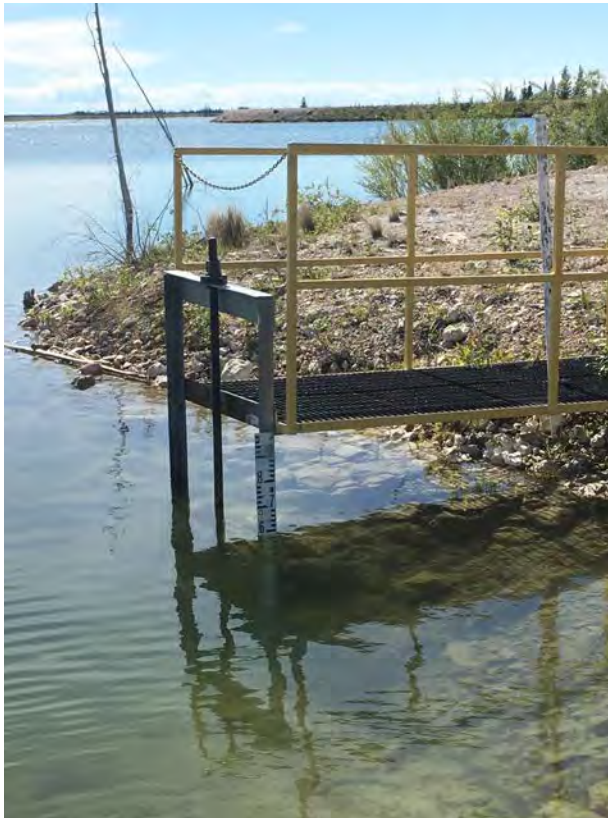
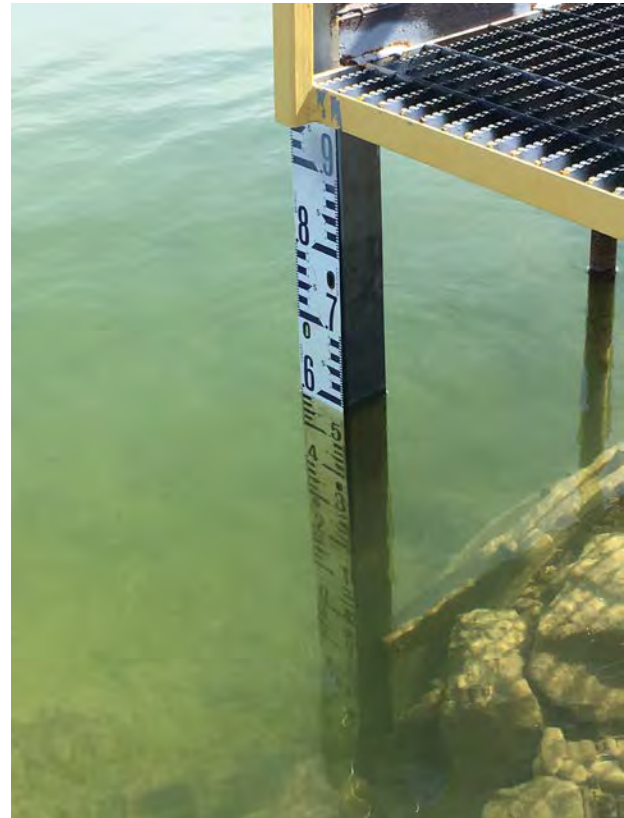
Main Pond to Polishing Pond Water Level Check

- Main Pond Water Elevation: 201.62 metres – Elevation taken on mine waste side near culvert inlet to polishing pond.
