Reference: 2019 Annual Geotechnical Inspection – Water License MV2017L2-0007

REPORT

2019 Dam Safety Inspection

Reference No. 18114183-209-R-Rev0-3000

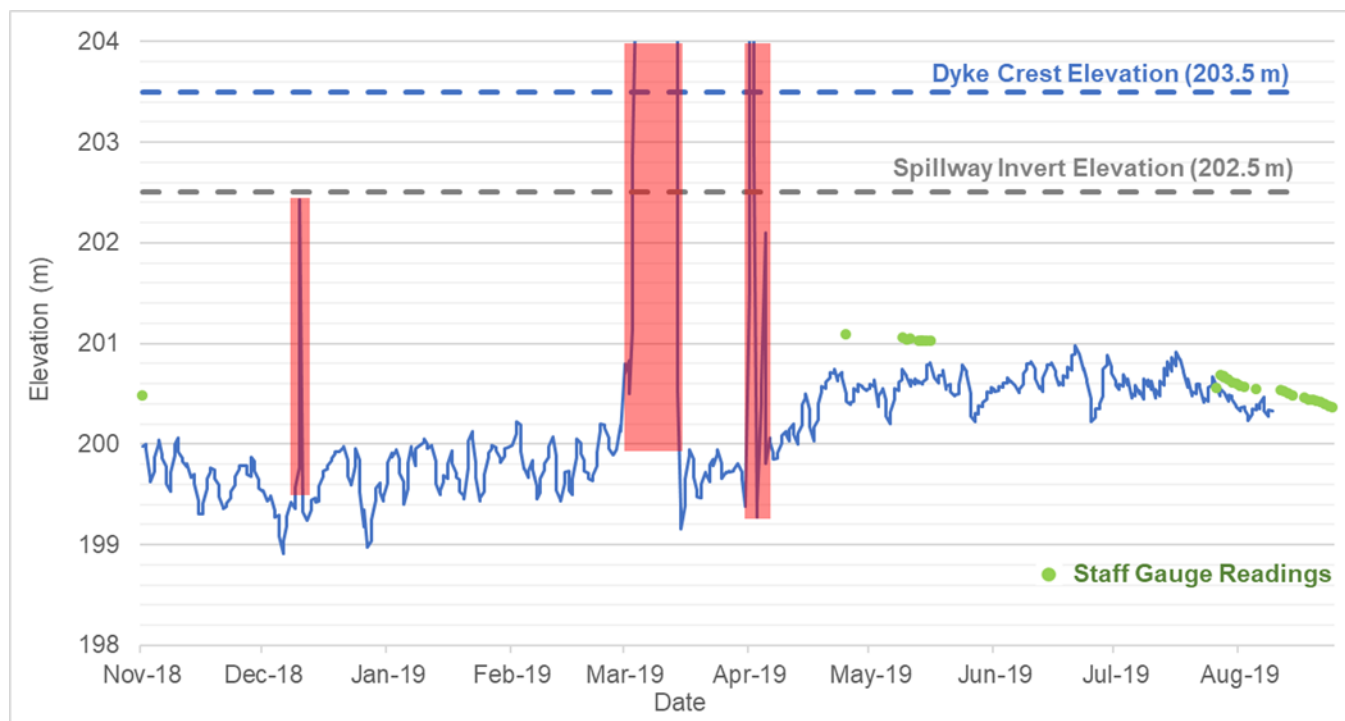
Point measurements of pond elevation at the staff gauge differed from readings at PP-VWP-18-10 by up to 0.6 m. Development of a calibration was in progress at the time of reporting.

Notes: Readings corrected for barometric pressure up to 15 August 2019; data not available after 15 August 2019.

Red shading indicates errors attributed to freeze/thaw.

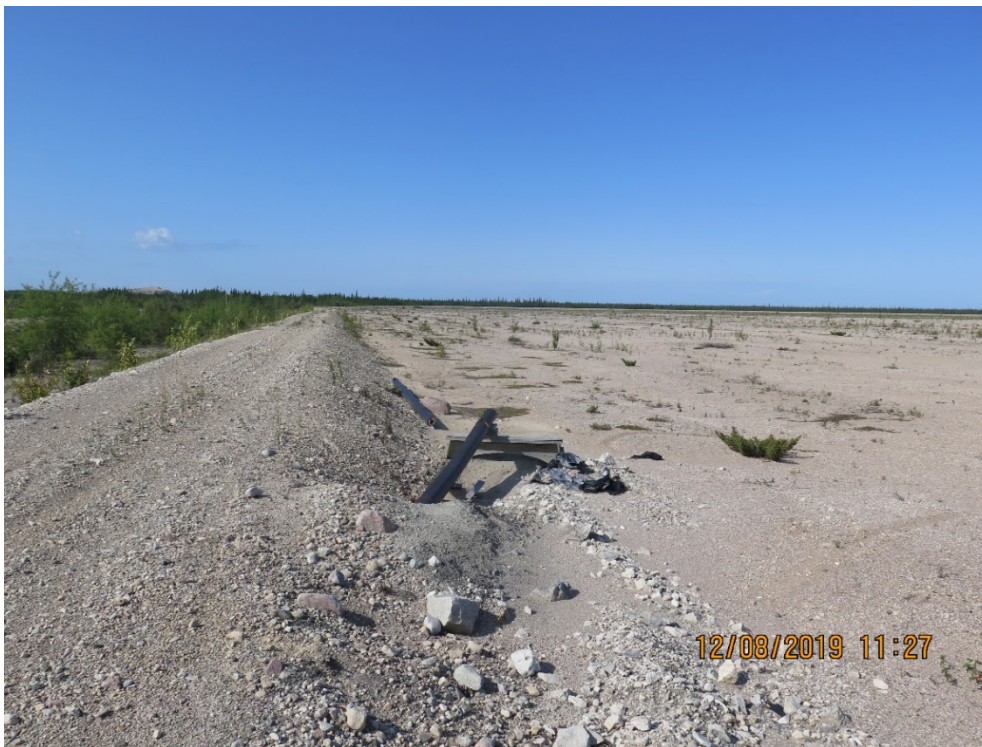
Photograph 2: South Dyke – Upstream Slope of Central Portion, and Debris in Impoundment Area, Looking West, 12 August 2019

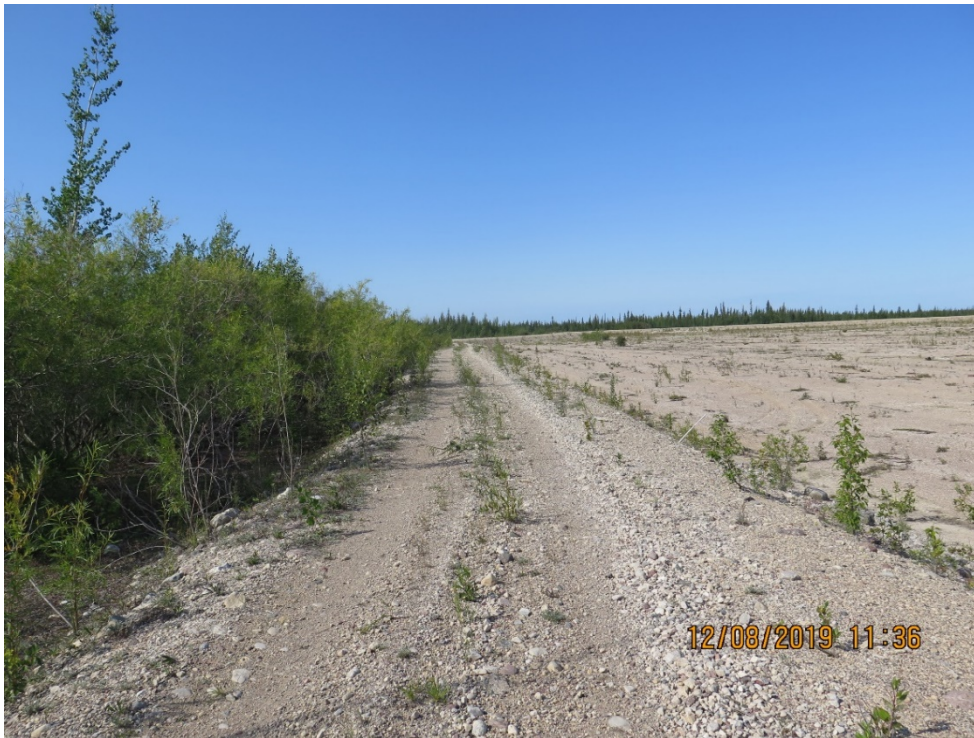
- Vegetation was observed on the downstream slope of the south dyke, at the west end.
- Minor vegetation was observed on upstream and downstream slopes of the north dyke.

Photograph 3: South Dyke – Crest at West End with Vegetation on Downstream Slope, Looking West, 12 August 2019

Structure	ID Number	Deficiency or Non-conformance	Applicable Regulation or OMS Manual Reference	Recommended Action	Recommended Deadline/Status
south dyke	2018-1	Vegetation encroaching on downstream face of south dyke	OMS Manual Section 5.5.2	Remove vegetation at west end of south dyke as per OMS manual. The south dyke is outside the Teck lease boundary and permission from land owner will be required to complete vegetation removal.	Completed October 2019.
polishing pond	2018-2	No written procedure for sludge removal	none	Update water treatment manual to include written maintenance procedure for removal of sludge from polishing pond including dewatering operations.	Three (3) months prior to scheduled maintenance of polishing pond (previously stated as 2019 (Golder 2019b))

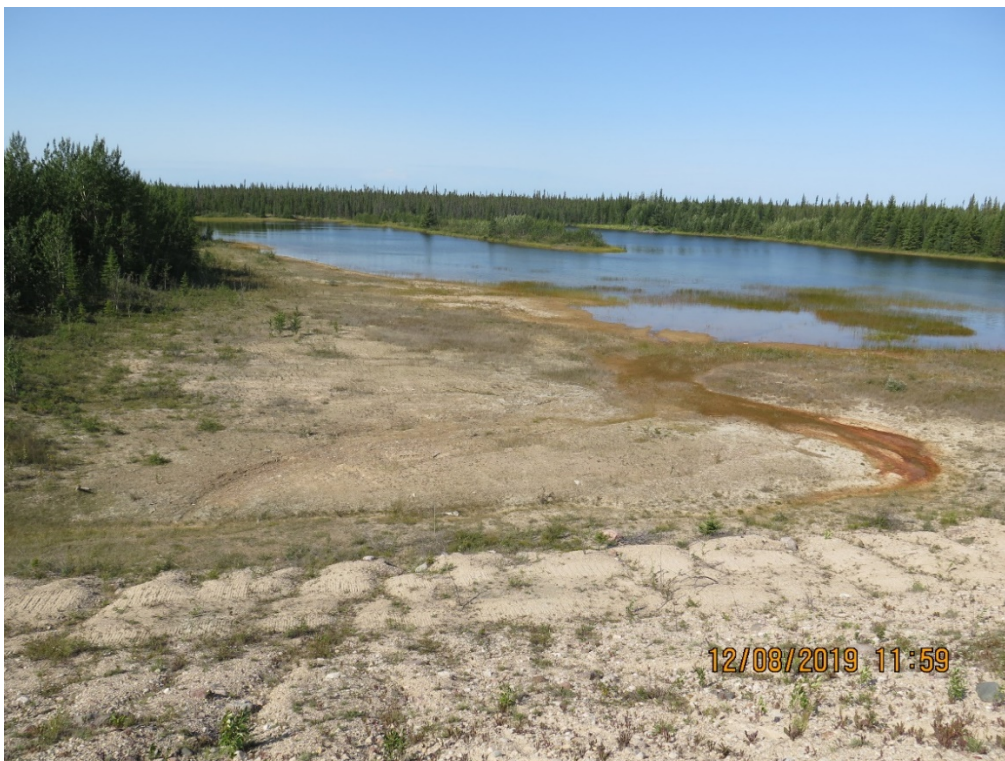
Photograph 6: West Dyke – Downstream Toe Area with Staining Along Drainage Near Former Seep Location, North End, Looking West, 12 August 2019

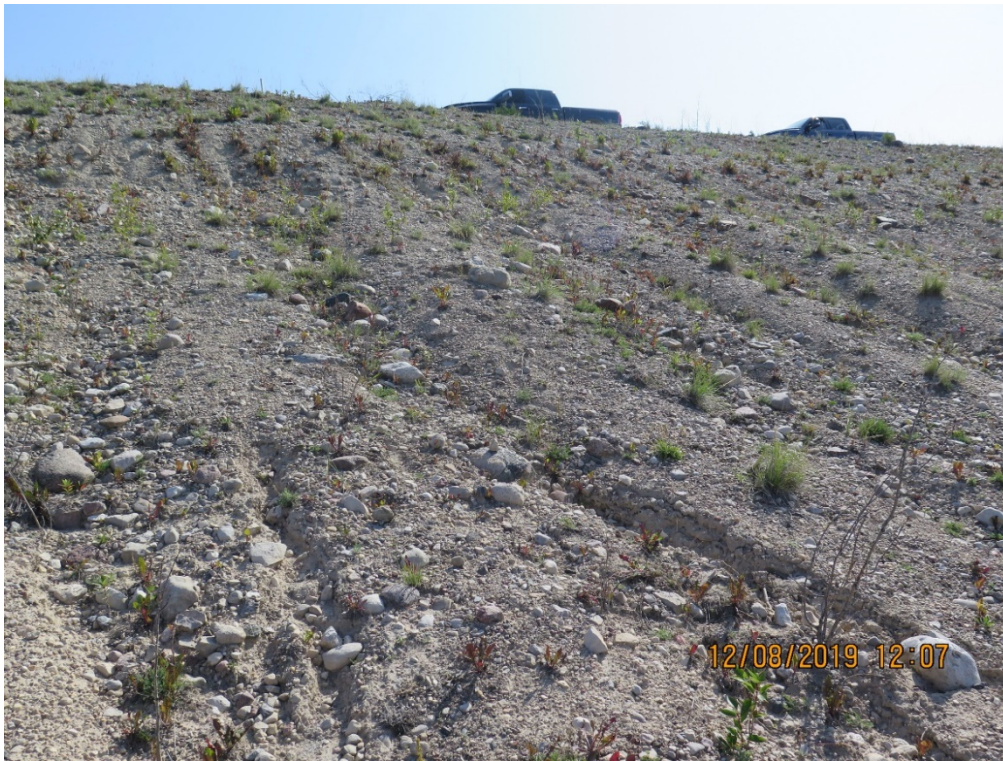
Photograph 7: West Dyke – Downstream Toe and Slope Near North End, Looking East, Minor Erosion Rills, 12 August 2019

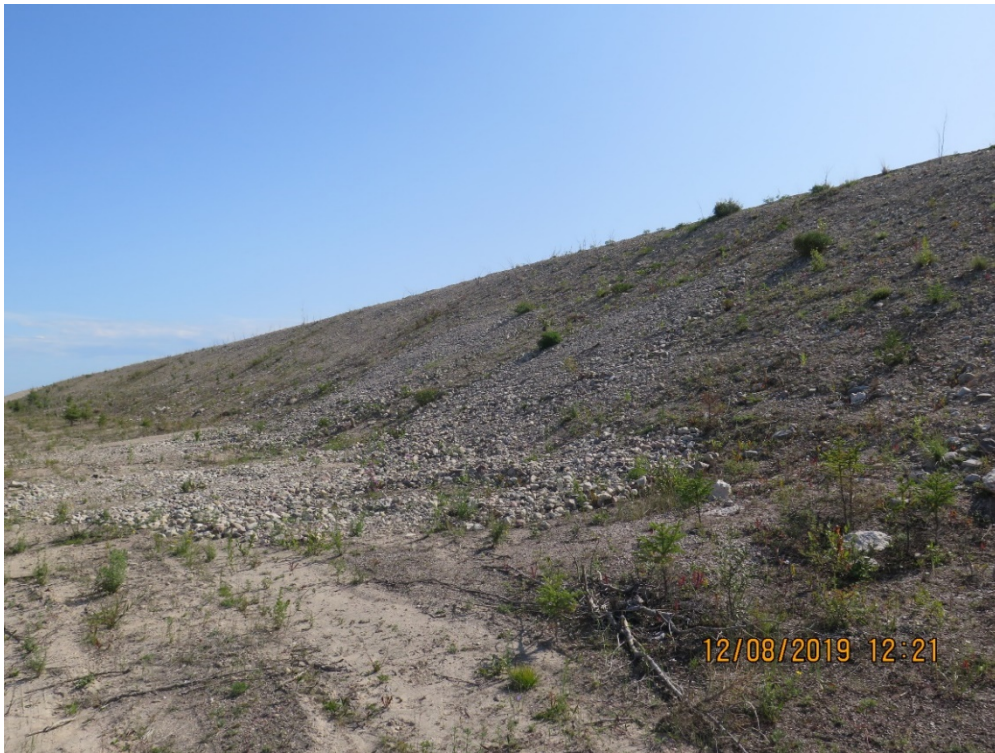
- No rills were observed to extend into the dyke crest, crest width was intact
- Large rills on the downstream slope of the north dyke observed during 2018 had been repaired using coarse gravels and cobbles. Repairs were in good condition.

Photograph 9: North Dyke – Repaired Erosion Rills on Downstream Slope Near West End, Looking Southeast, 12 August 2019

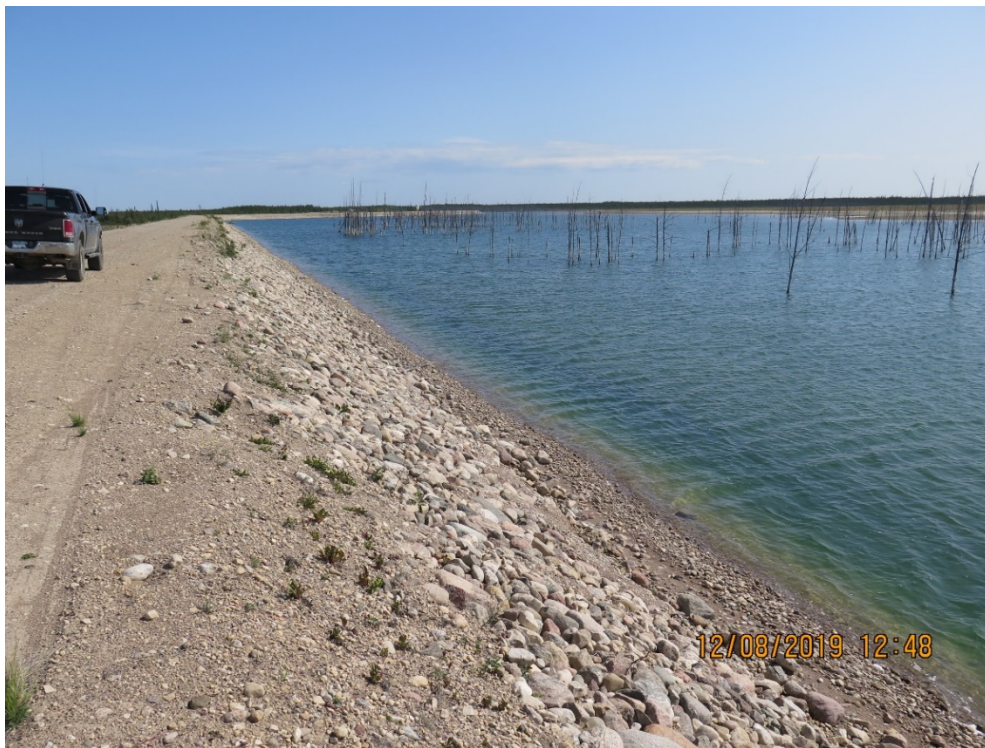
- maintenance repair by placement of geotextile and riprap fill on upstream face of the north dyke between 10 and 15 October 2018, reported in Golder (2019a) and inspected in 2019

Photograph 11: North Dyke – Upstream Slope, Repaired with Riprap, Looking Northeast, 12 August 2019

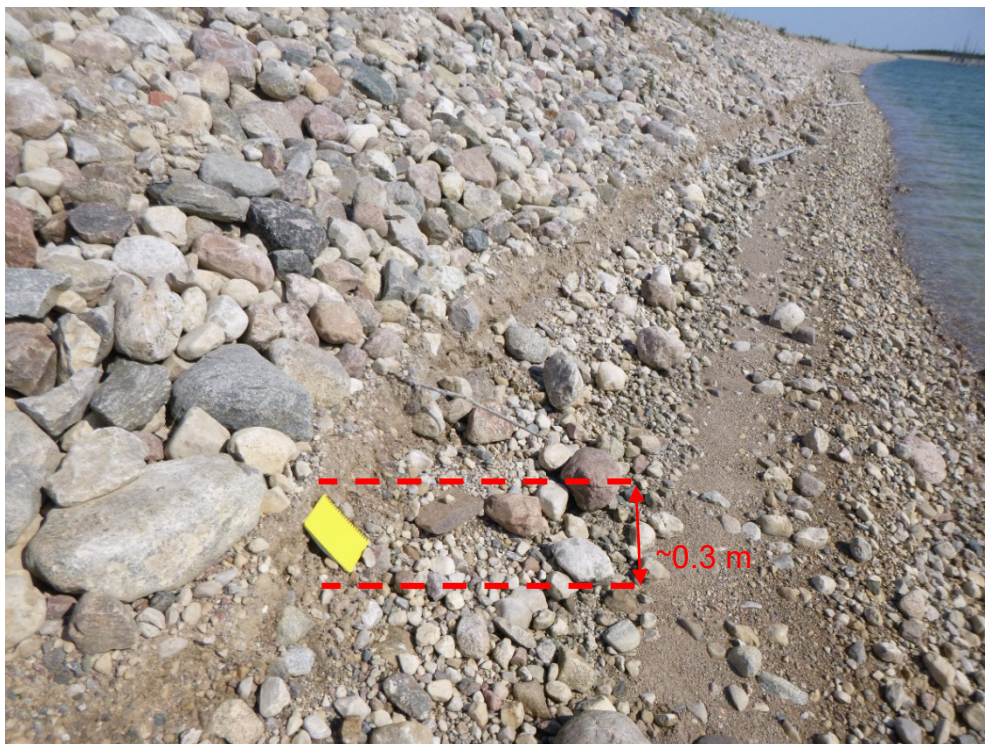
- Wave cut erosion
 - An erosion bench or scarp approximately 0.3 to 0.5 m high was observed on the upstream face of the north dyke, over a 700 m long section west of the dogleg. This erosion was immediately below the riprap placed on the slope in 2018 and above a bench in the slope. The erosion was attributed to wave and/or ice action. The maintenance repairs made in 2018 otherwise appeared to be in good condition, and should continue to be monitored.

- An erosion scarp approximately 300 to 500 mm in height was observed over a 700 m section of the upstream face of the north dyke, below the riprap placed in 2018 as part of a maintenance repair, and above a bench in the slope. The 2018 repairs were otherwise in good condition.

Photograph 12: North Dyke – Upstream Slope, ~0.3 m Scarp Below Riprap Placed In 2018, Looking Northeast, 12 August 2019

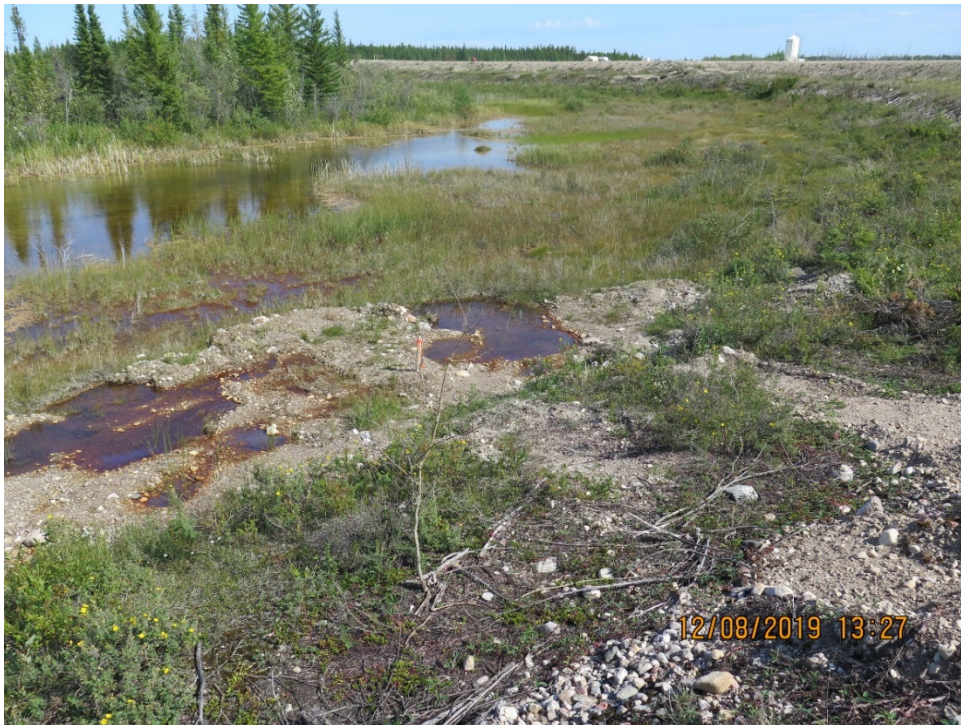
Photograph 14: North Dyke – Downstream Toe Area at Dogleg, Red Staining, Looking East, 12 August 2019

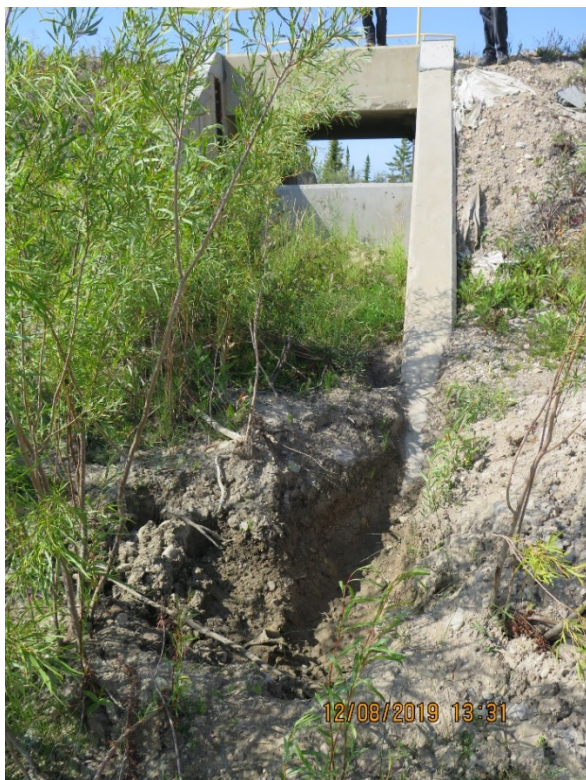
Photograph 16: Main Pond Spillway – Excavation Near Toe of Wall on Upstream Side, Looking East, 12 August 2019
