**Re: Land Use Permit MV2018C0023  
Mineral Exploration  
Yellowknife, NT**

ENVIRONMENTAL INSPECTION REPORT

Permittee:	Gold Terra Resource Corp.	Inspection Date – January 31 <sup>st</sup> , 2025
------------	---------------------------	---

Location(s) Inspected:	Foraco diamond drill.
------------------------	-----------------------

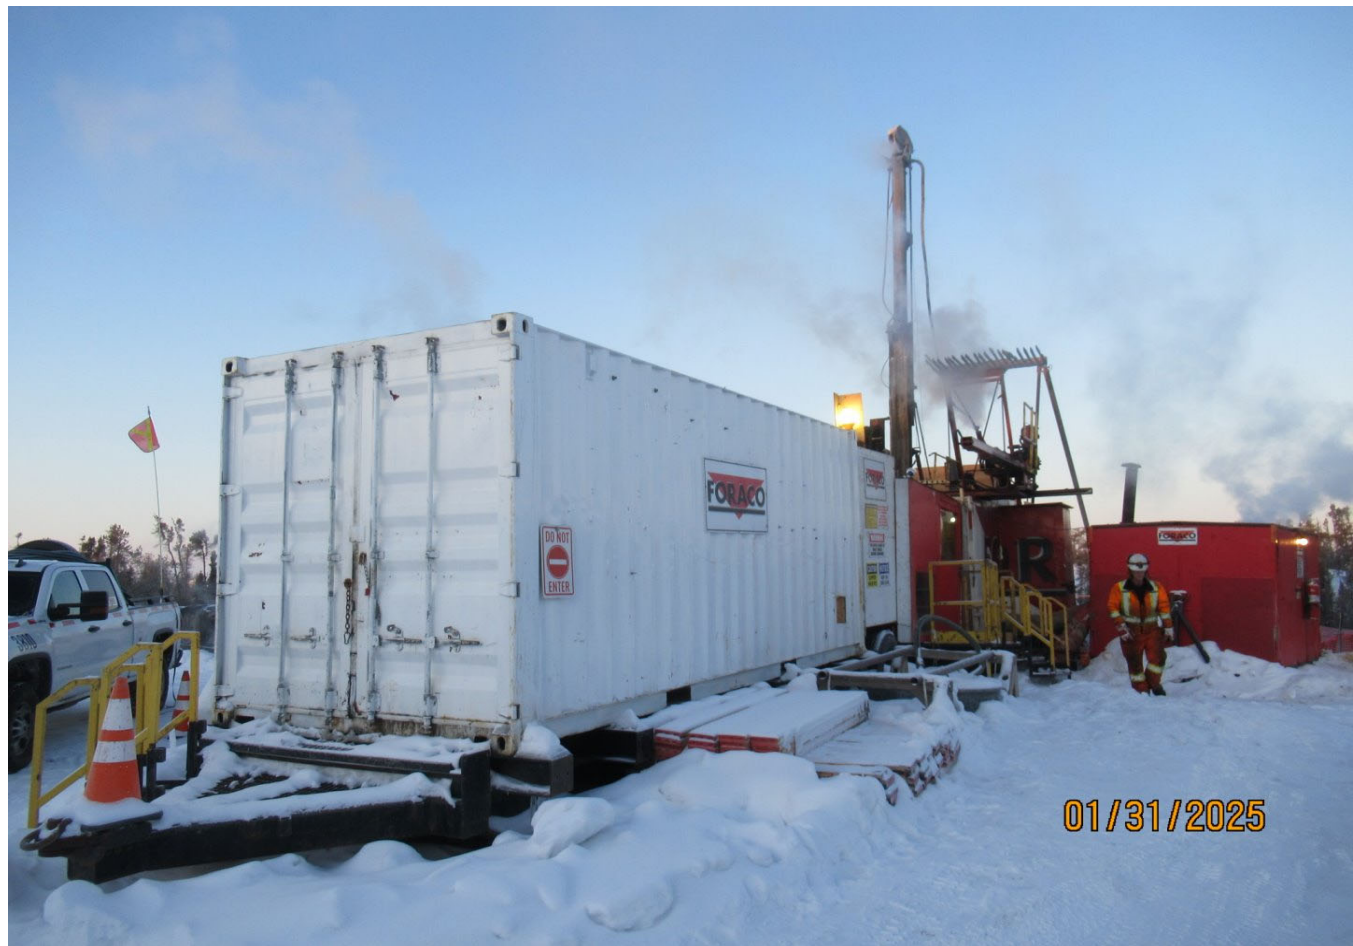
The Inspectors were provided notification that drilling on the Con Mine Property was scheduled to re-commence on January 9<sup>th</sup>, 2025 and at the time of the inspection, the Foraco diamond drill was active on target GTCM24-0056 (Figure 1). No concerns were noted during the inspection since the following was observed.

Figure 1  
The Foraco Val d'Or VD8000 diamond drill on target GTCM24-0056.

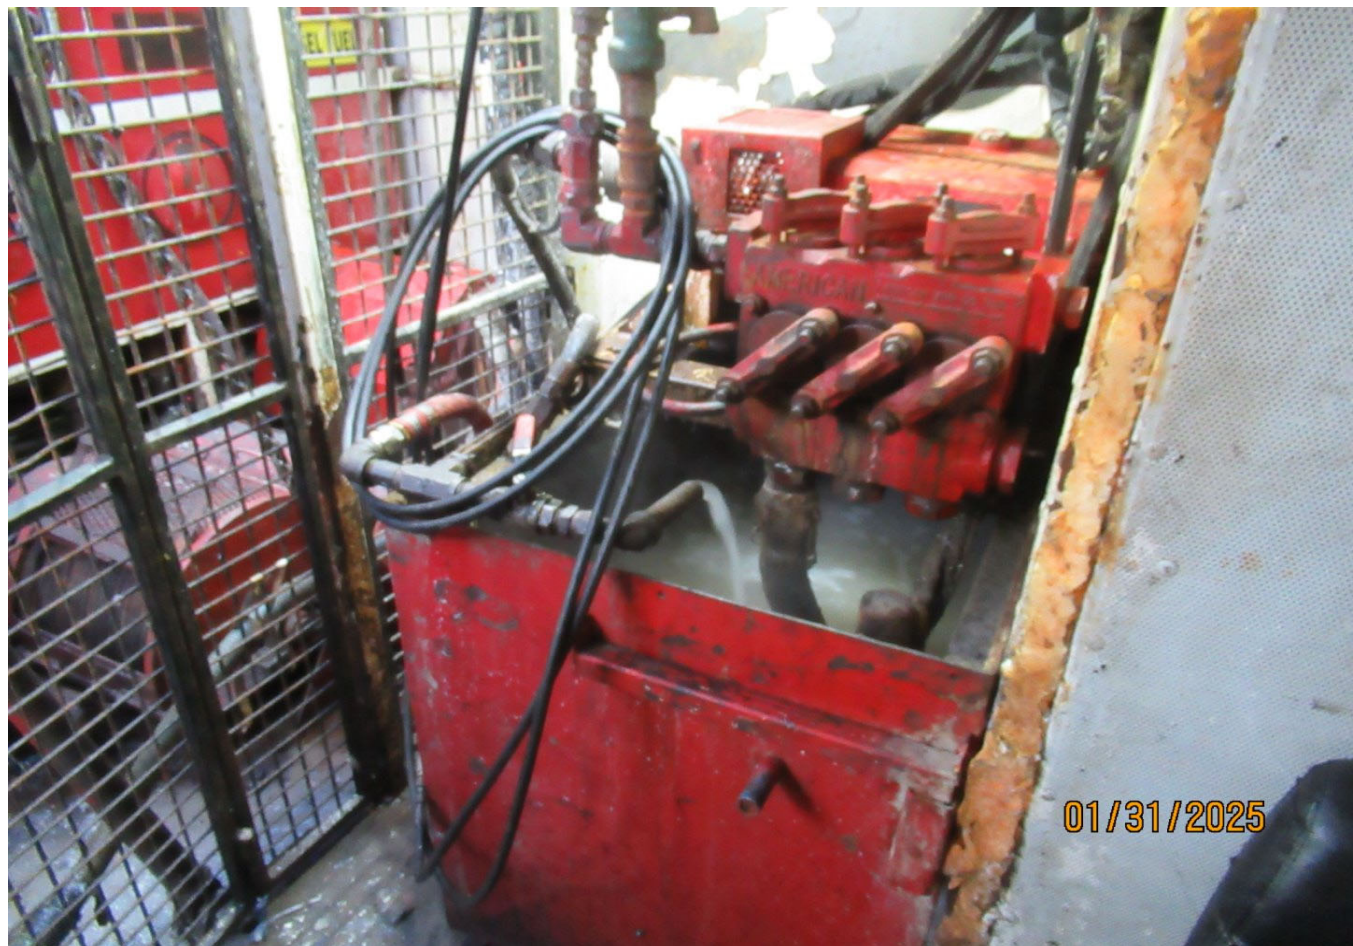
- The Permittee/Contractor is minimizing the volume of water used for this land use operation by employing a closed circuit system. Water reports to the mud tank viewed in Figure 2 and once full, water is directed into the “cellar” at the collar for re-circulation.

Figure 2  
Mud tank inside the drill shack. Water volumes are being minimized since a closed circuit system is in use.

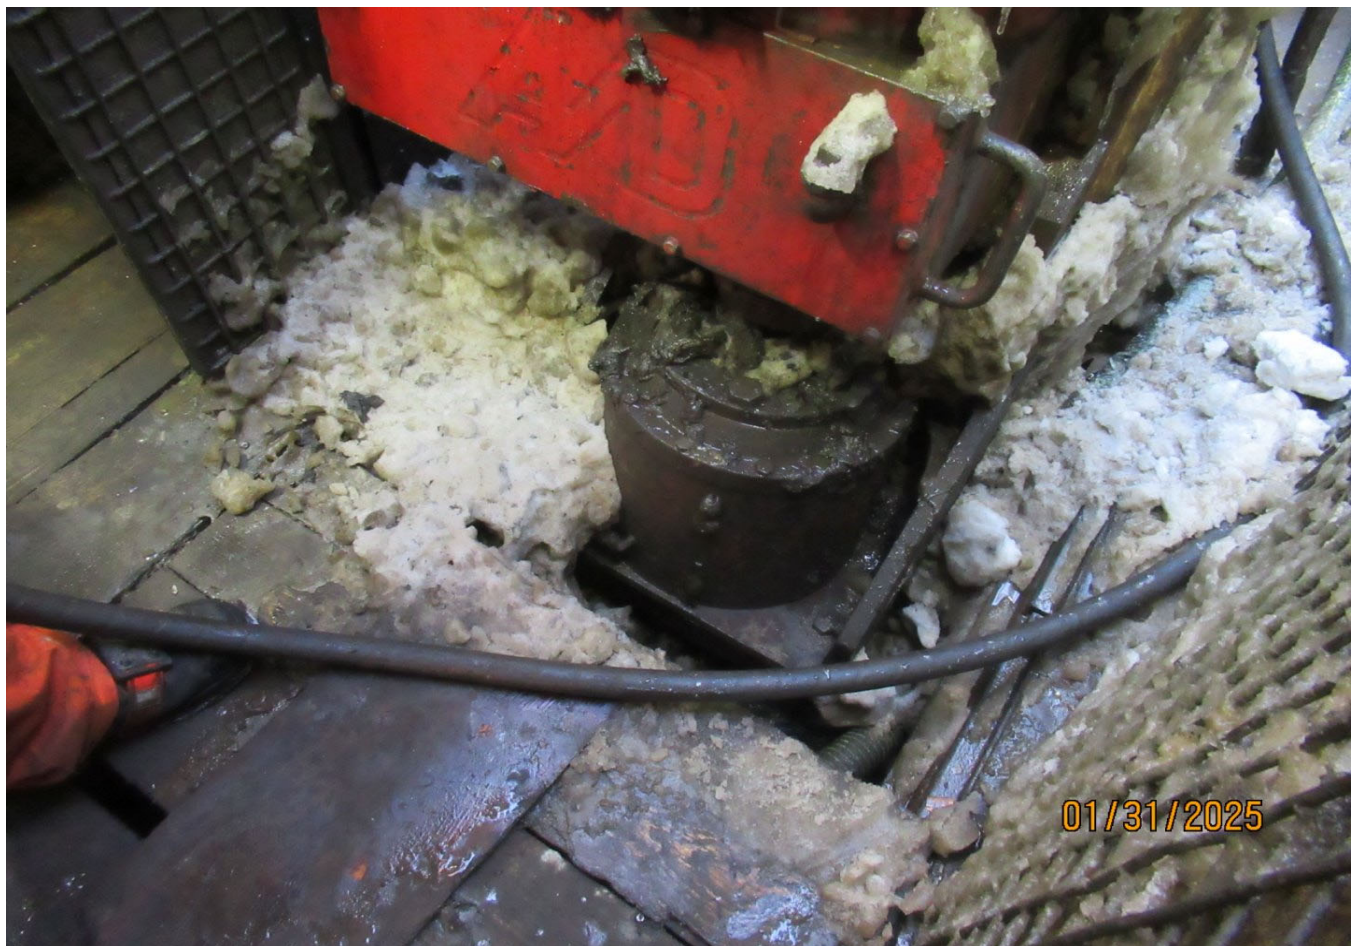
- All drill waste is being captured at the collar (Figure 3) and pumped into the settling tank viewed in Figure 4 & 5. Any make up drill water is being sourced from the City of Yellowknife and once required, cuttings will be removed by vacuum truck and deposited in Middle Pud for proper disposal.

**Figure 3**  
**Cellar below the collar collects all drill waste for pumping to a large metal settling tank for reuse.**

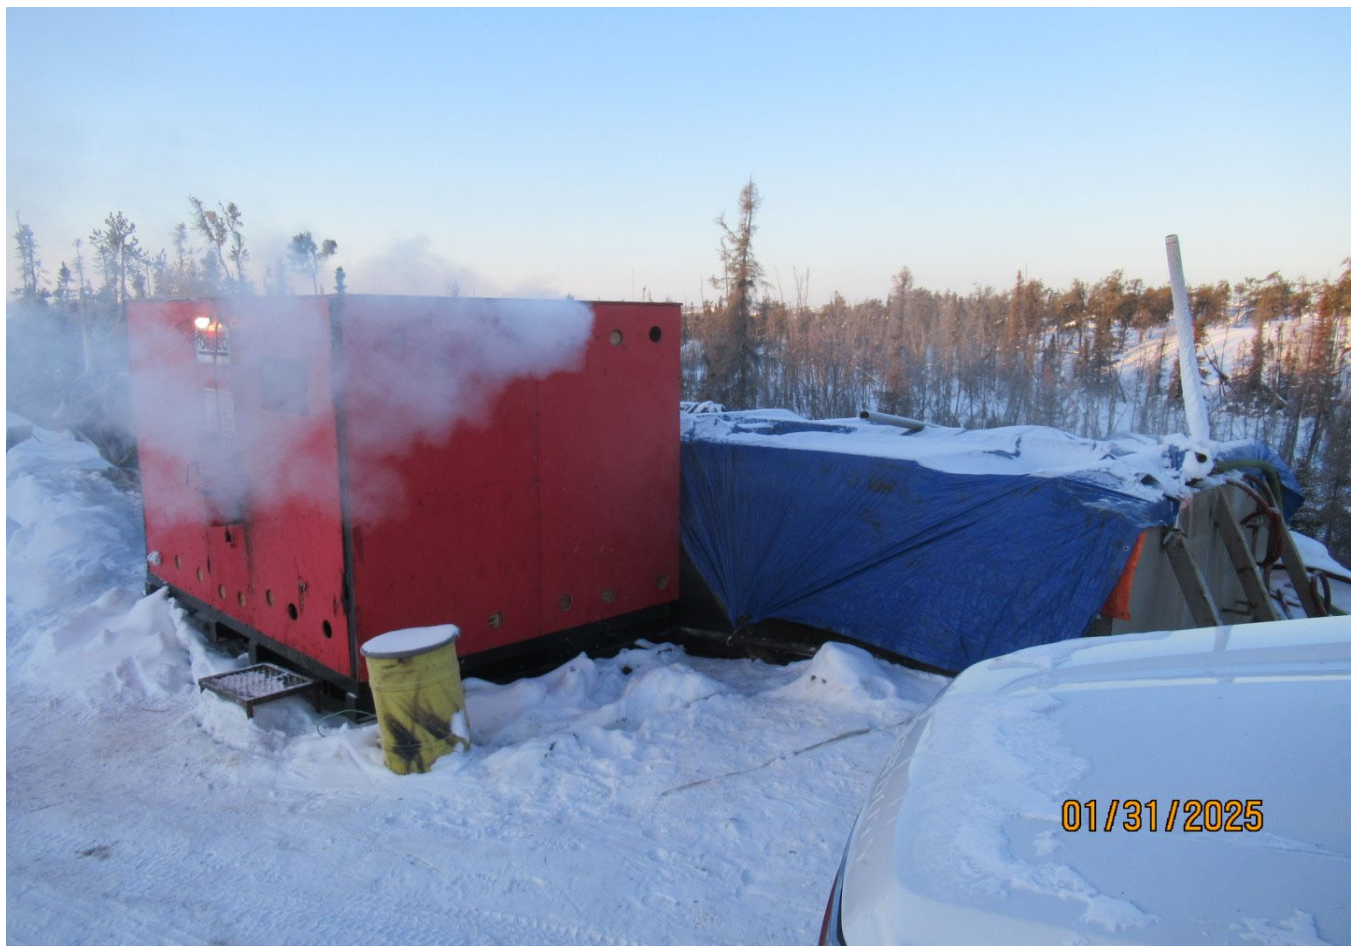
**Figure 4**  
**Coil stove in the red building is being used to heat the water in the settling tank.**

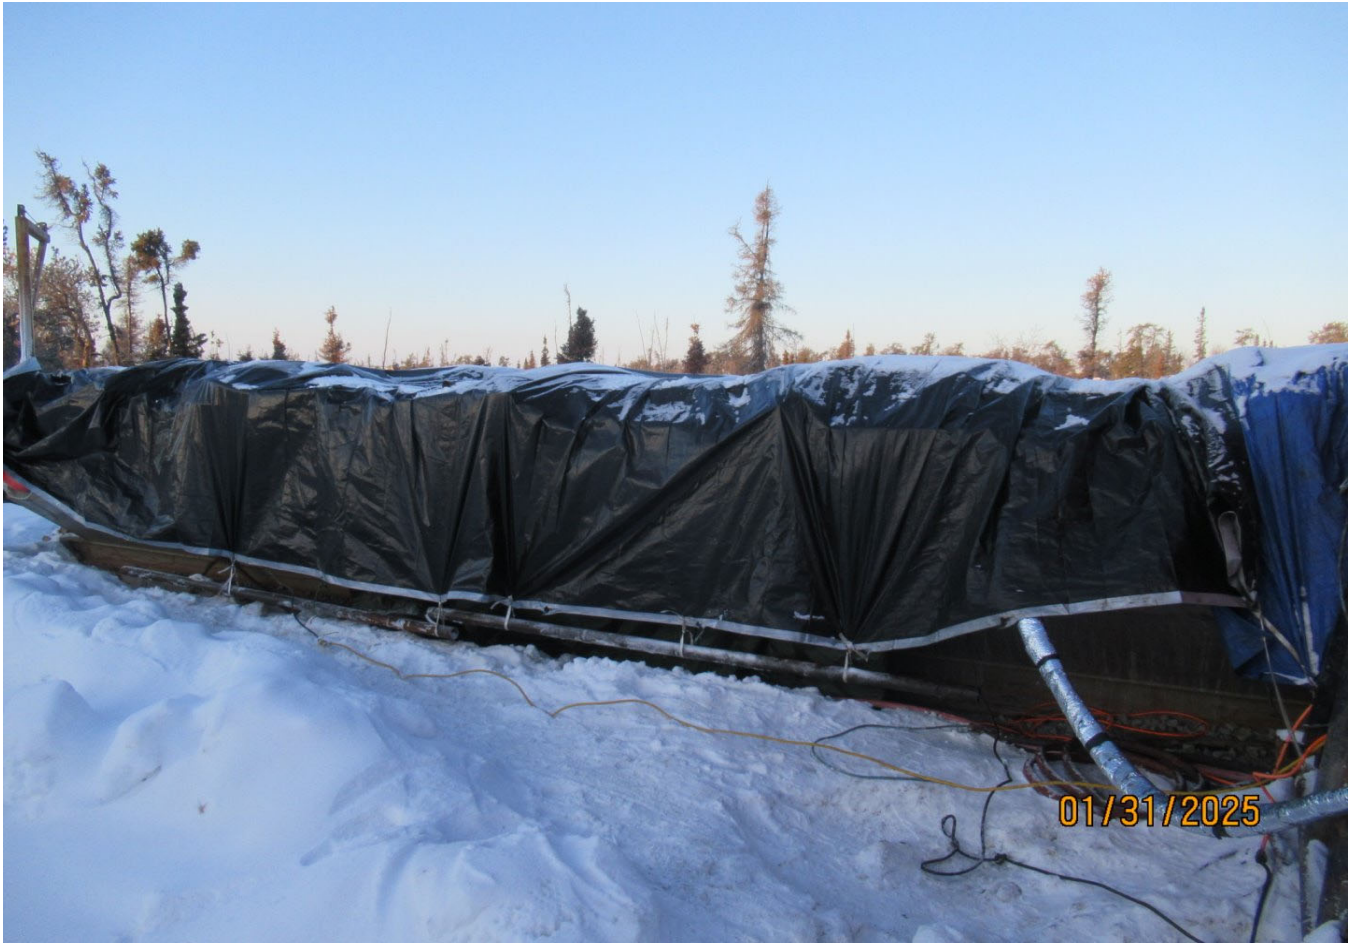
**Figure 5**  
All drill waste is reporting to this settling tank. No flocculants are currently in use.

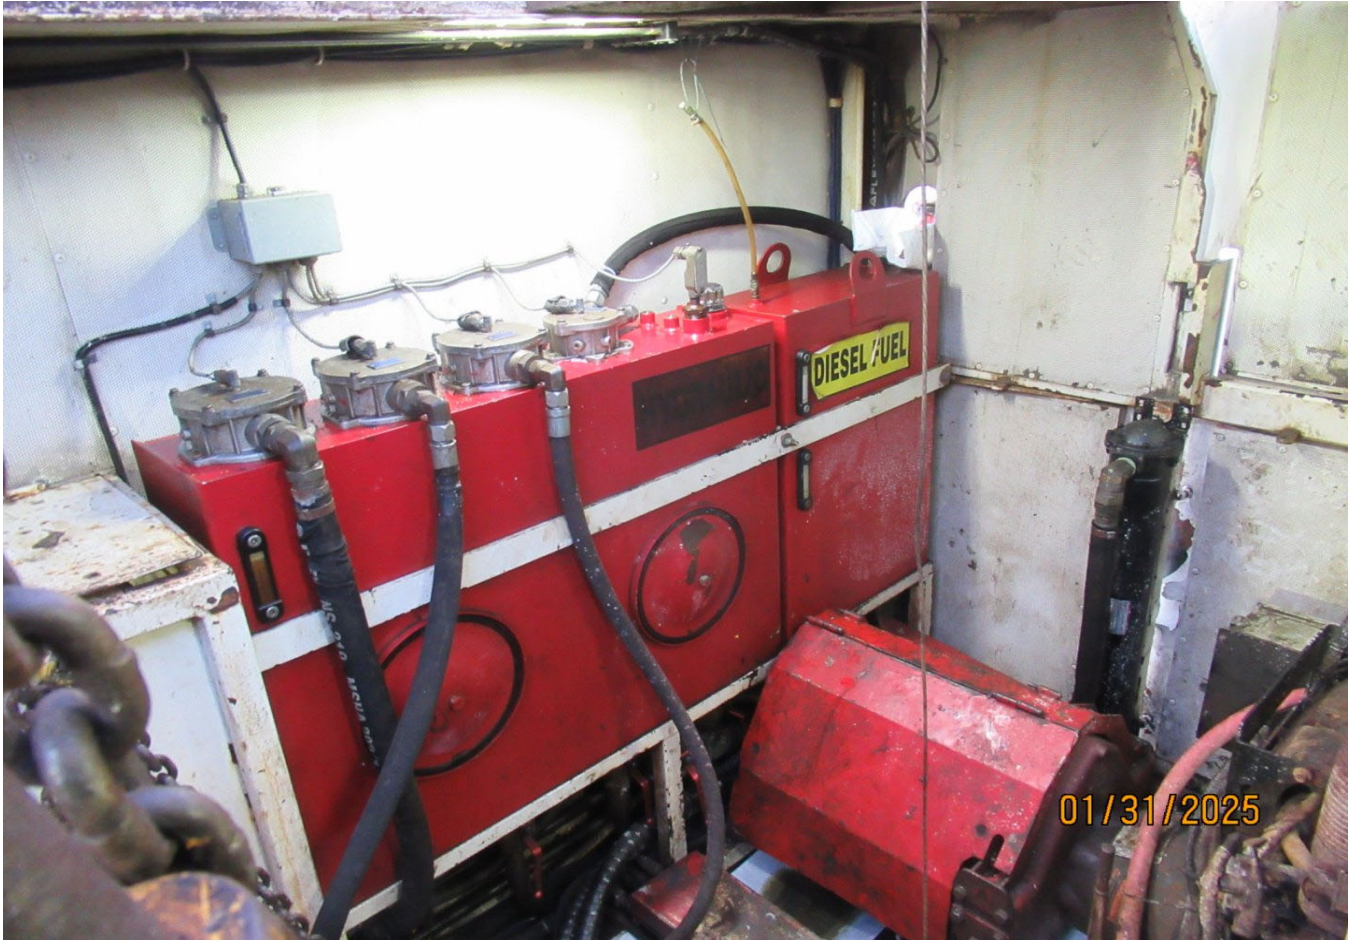
- The fuel tank for the drill can be viewed in Figure 6. No concerns were noted with fuel storage or handling (Figure 7).
- Spill kits and hydrocarbon absorbent matting are present in strategic locations throughout the land use area (Figure 8 & 9).

**Figure 6**  
Fuel tank for the drill. No concerns with fuel handling were noted.

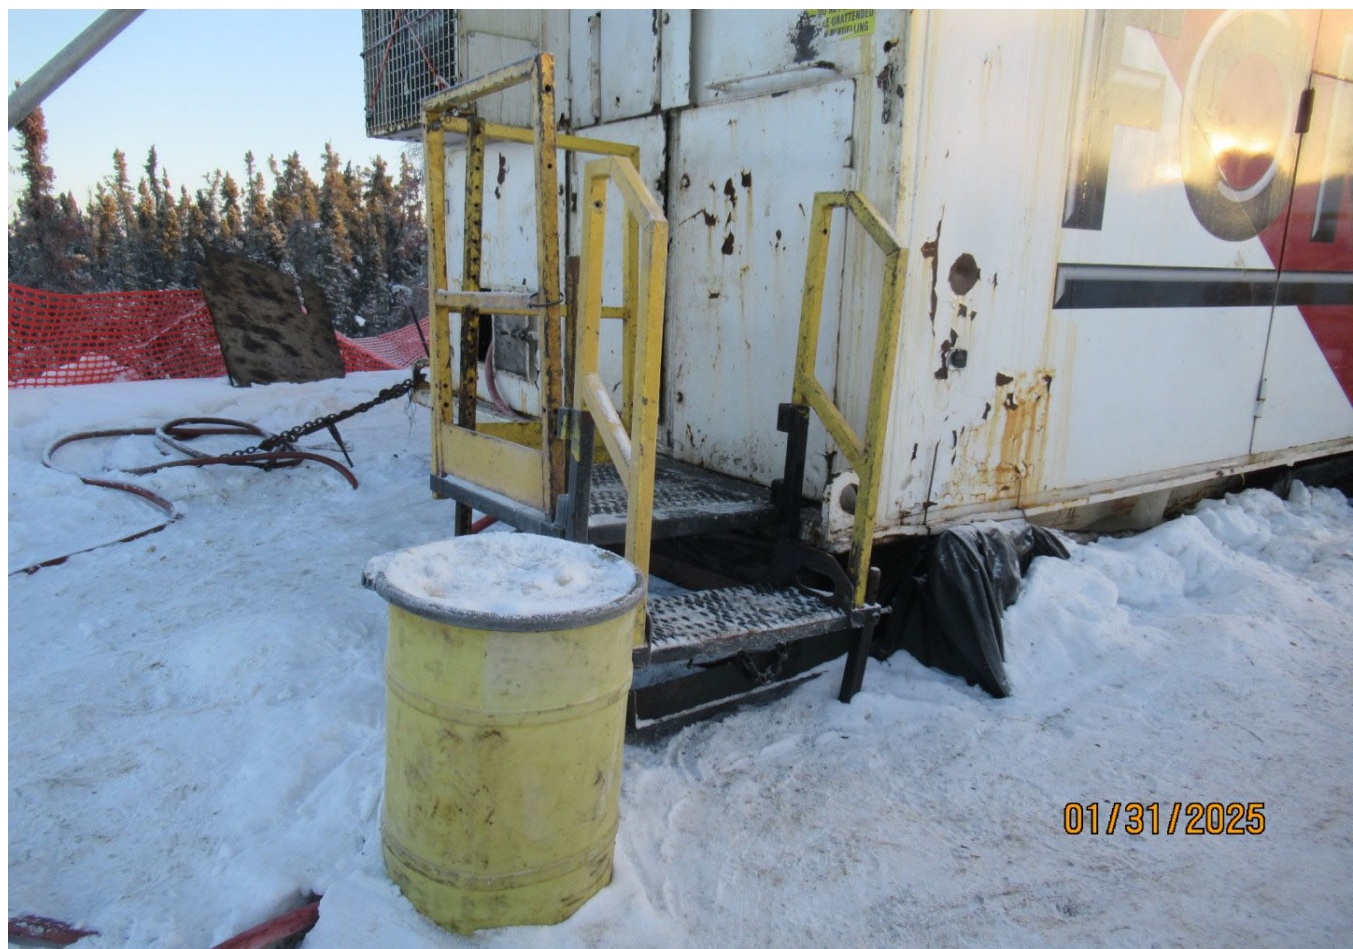
**Figure 7**  
Drip tray below the fuel spout for the fuel tank on the drill and a spill kit is present. No concerns with fuel handling were noted.

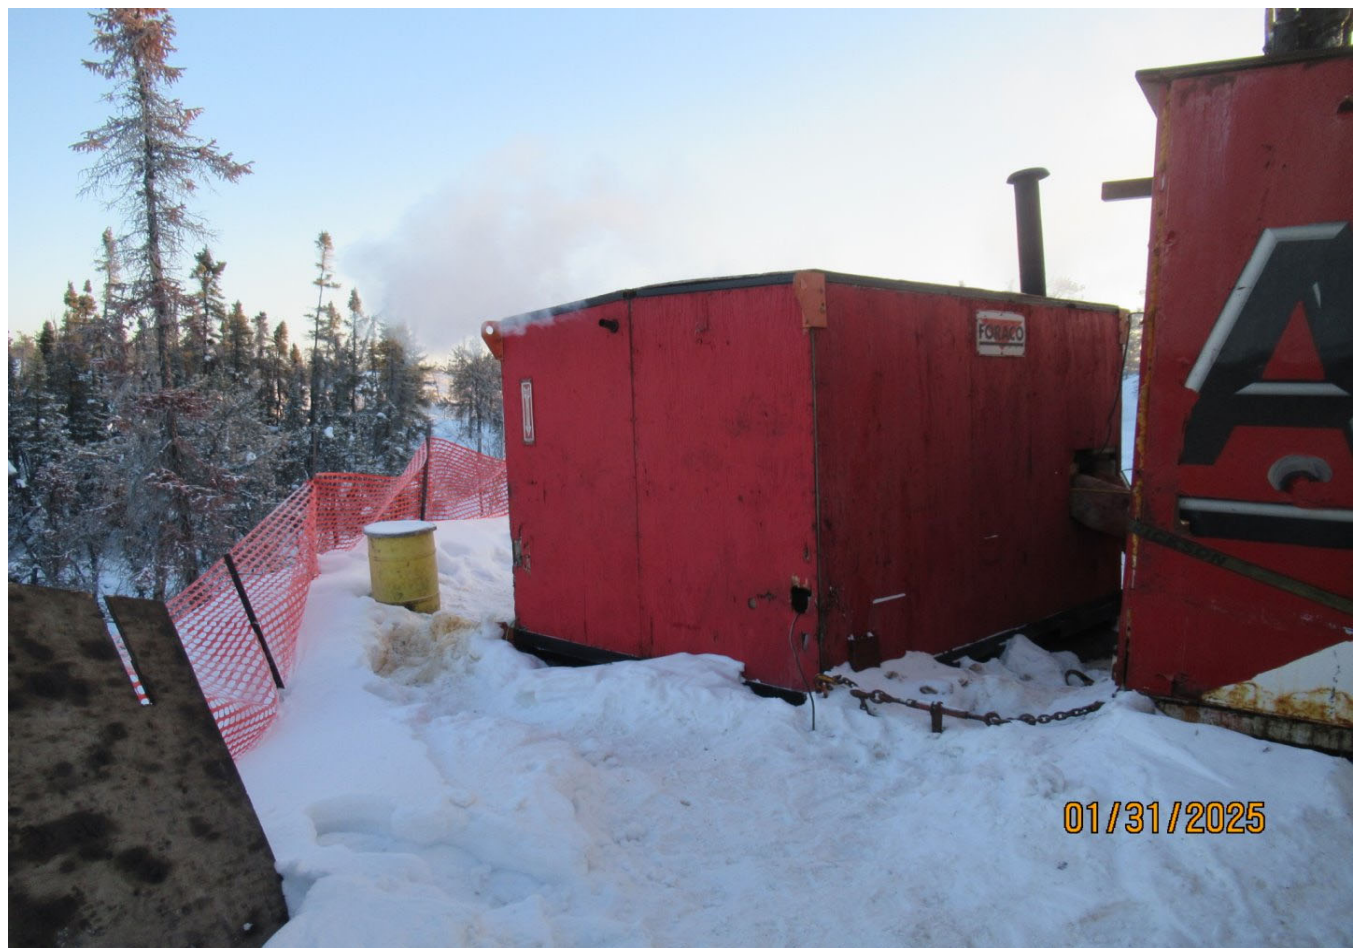
**Figure 8**  
Spill kit located in a highly visible location at the second pump shack.

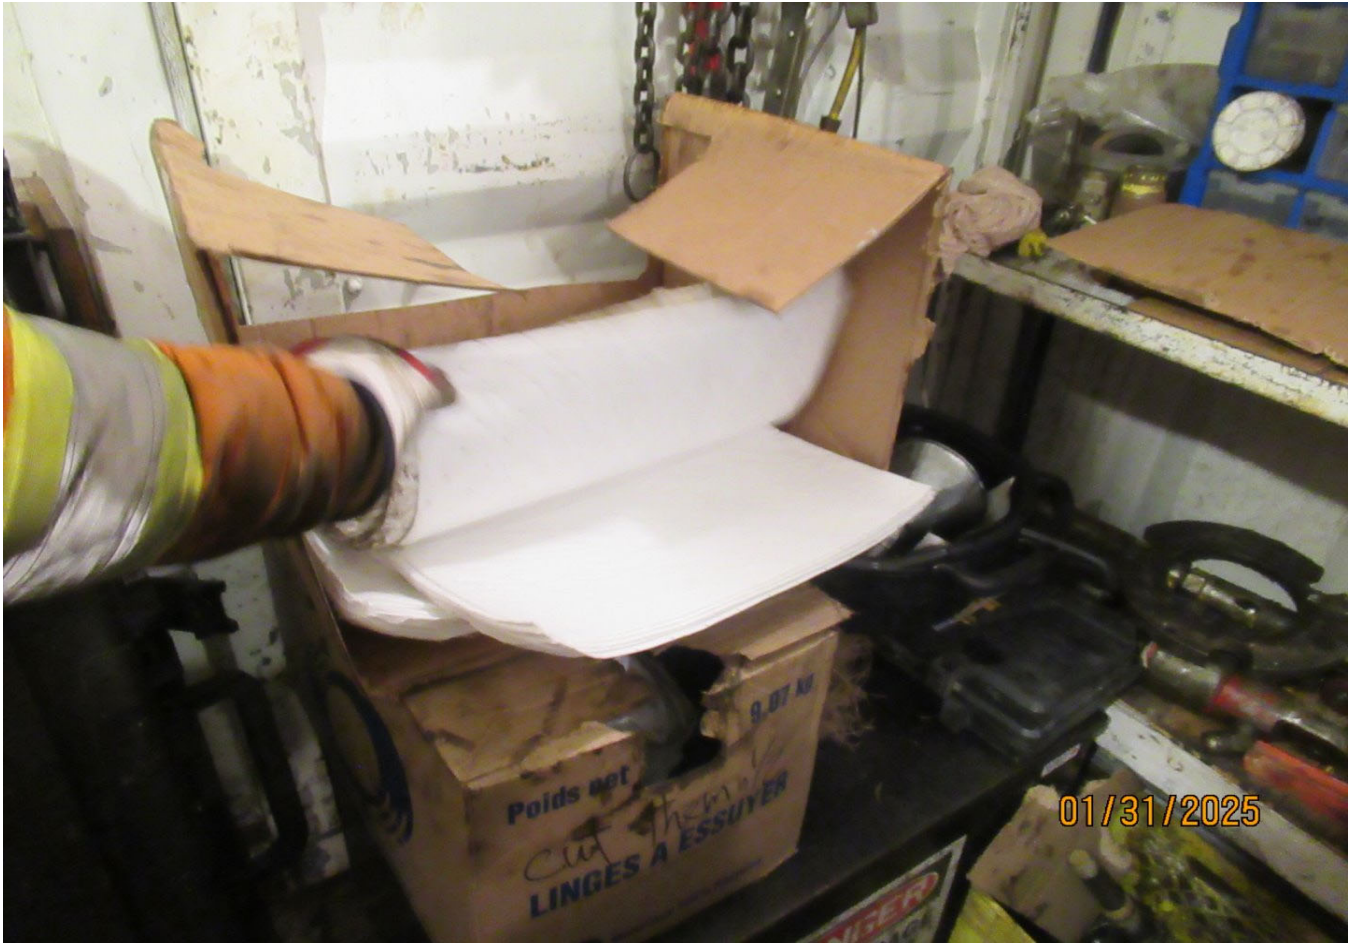
Figure 9  
Hydrocarbon absorbent matting is present inside the seacan adjacent to the drill shack.

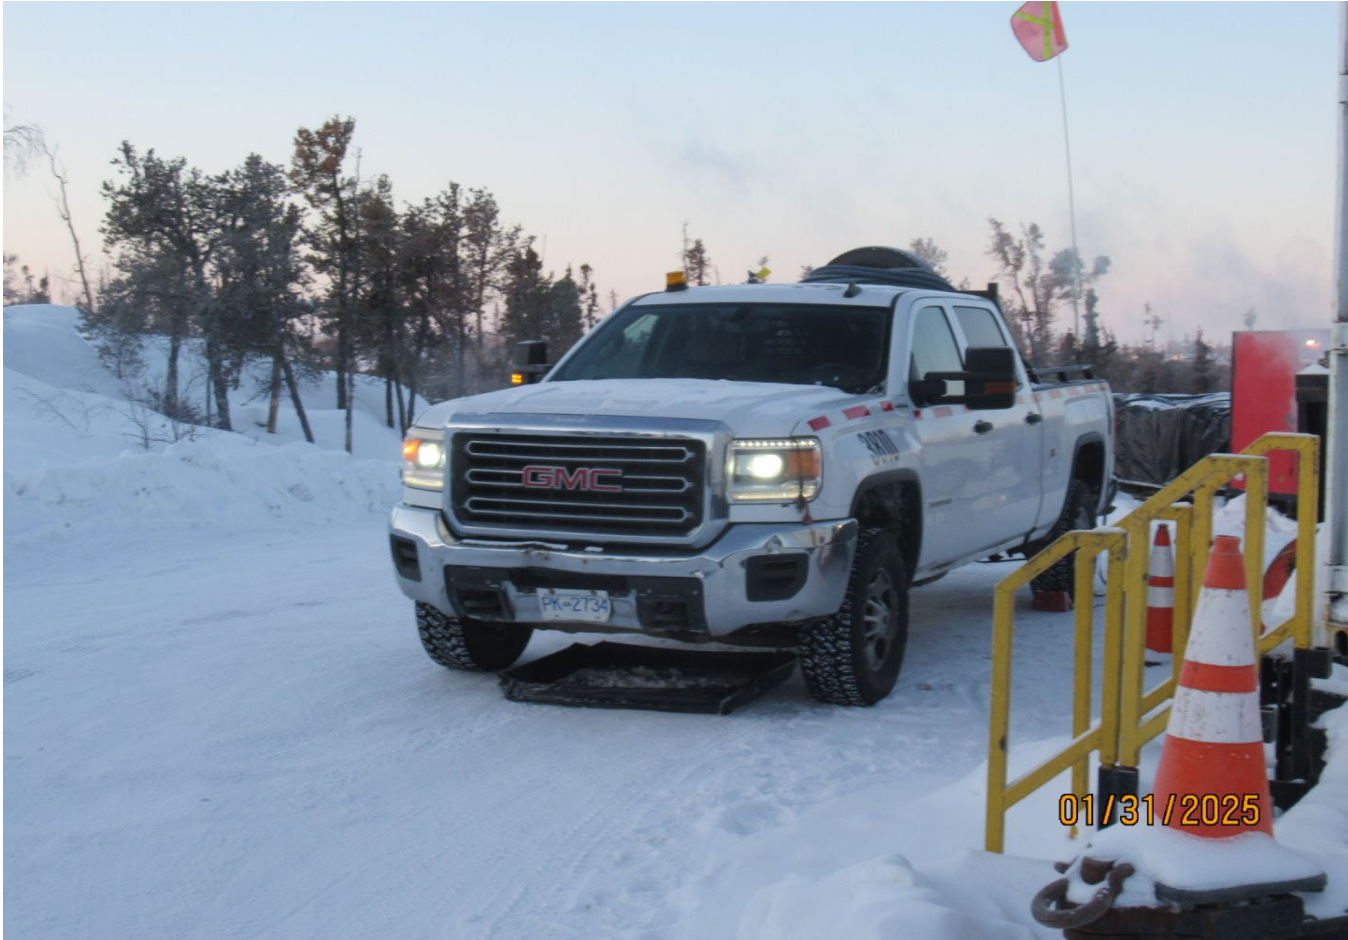
- All parked vehicles had drip trays placed beneath the engine compartments (Figure 10).
- Containers of oils & lubes are being stored in the metal box viewed in Figure 11 to reduce the likelihood of a container from becoming damaged or a spill occurring.

Figure 10  
All parked vehicles had drip trays present.

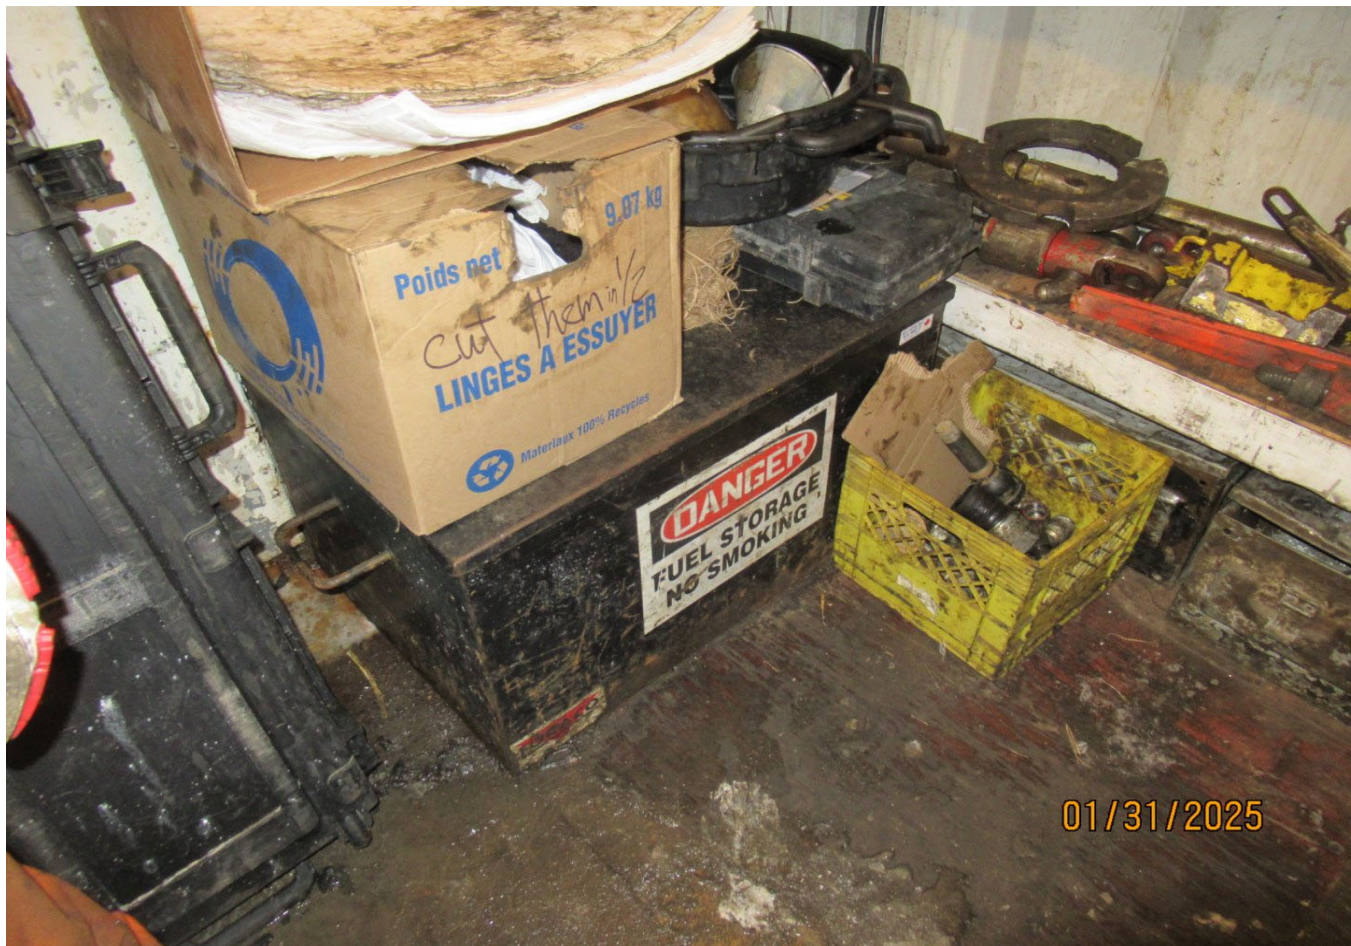
**Figure 11**  
Oil and other hydrocarbons are stored inside this metal box to reduce the likelihood of damage to a container or a spill.

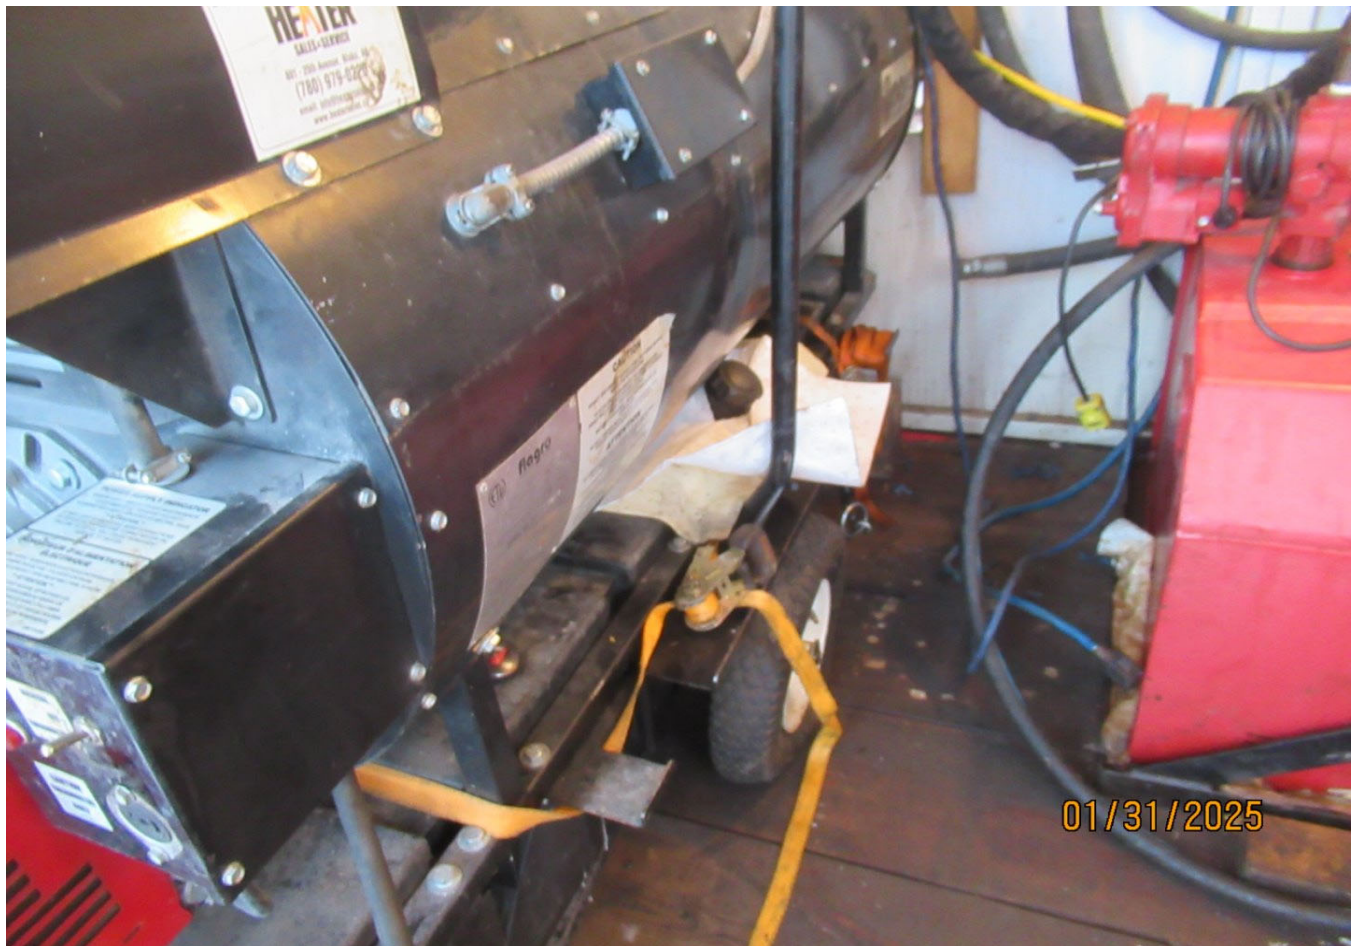
- All fuel spouts of the ancillary equipment have hydrocarbon absorbent matting present (Figure 12) and adequate secondary containment was present (Figure 13 & 14).

**Figure 12**  
Hydrocarbon absorbent matting is present on all ancillary equipment fuel spouts.

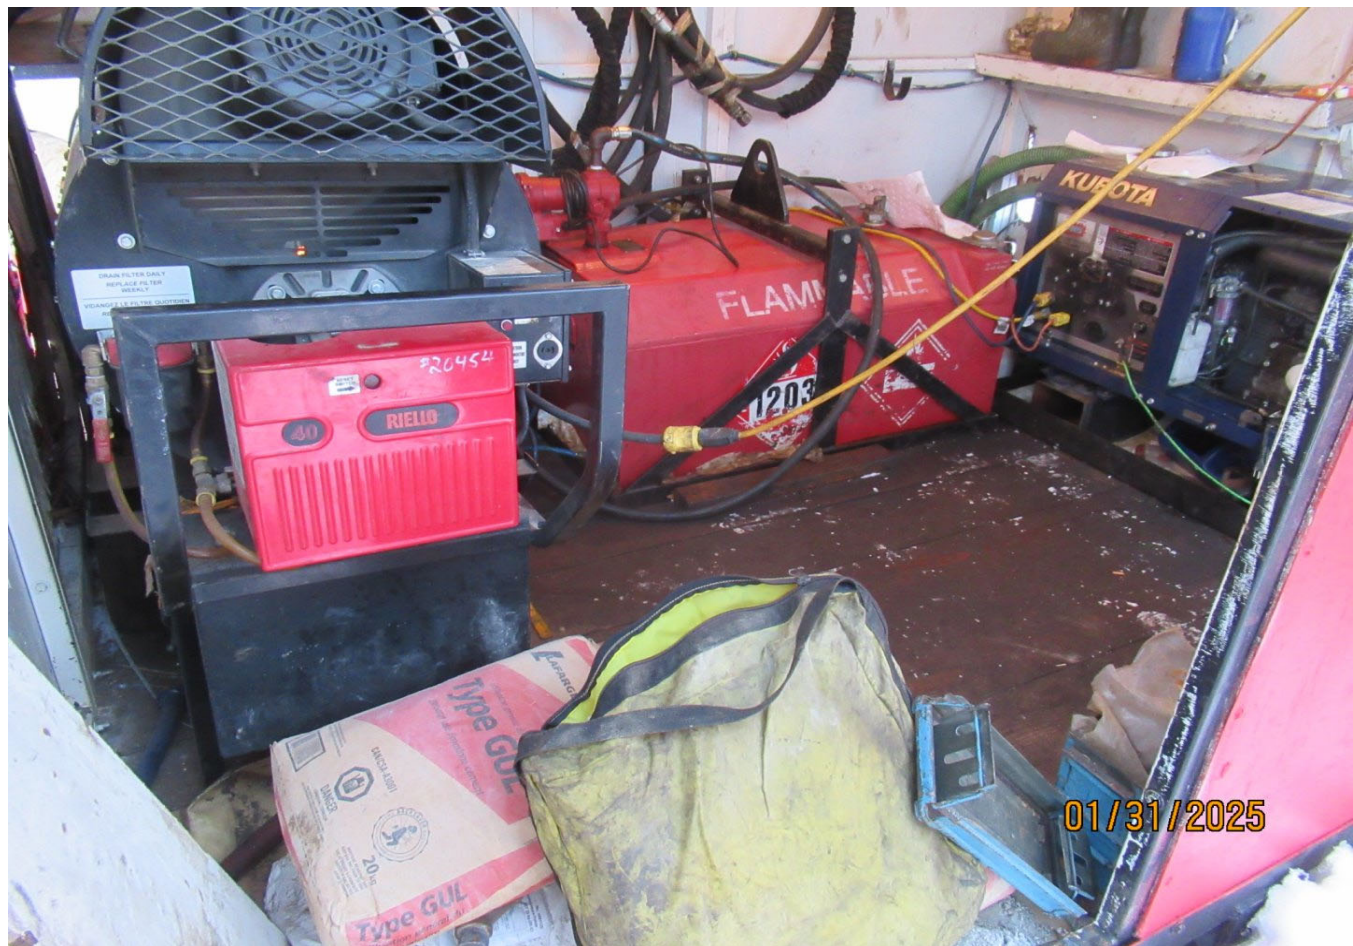
Figure 13  
Ancillary equipment with secondary containment.

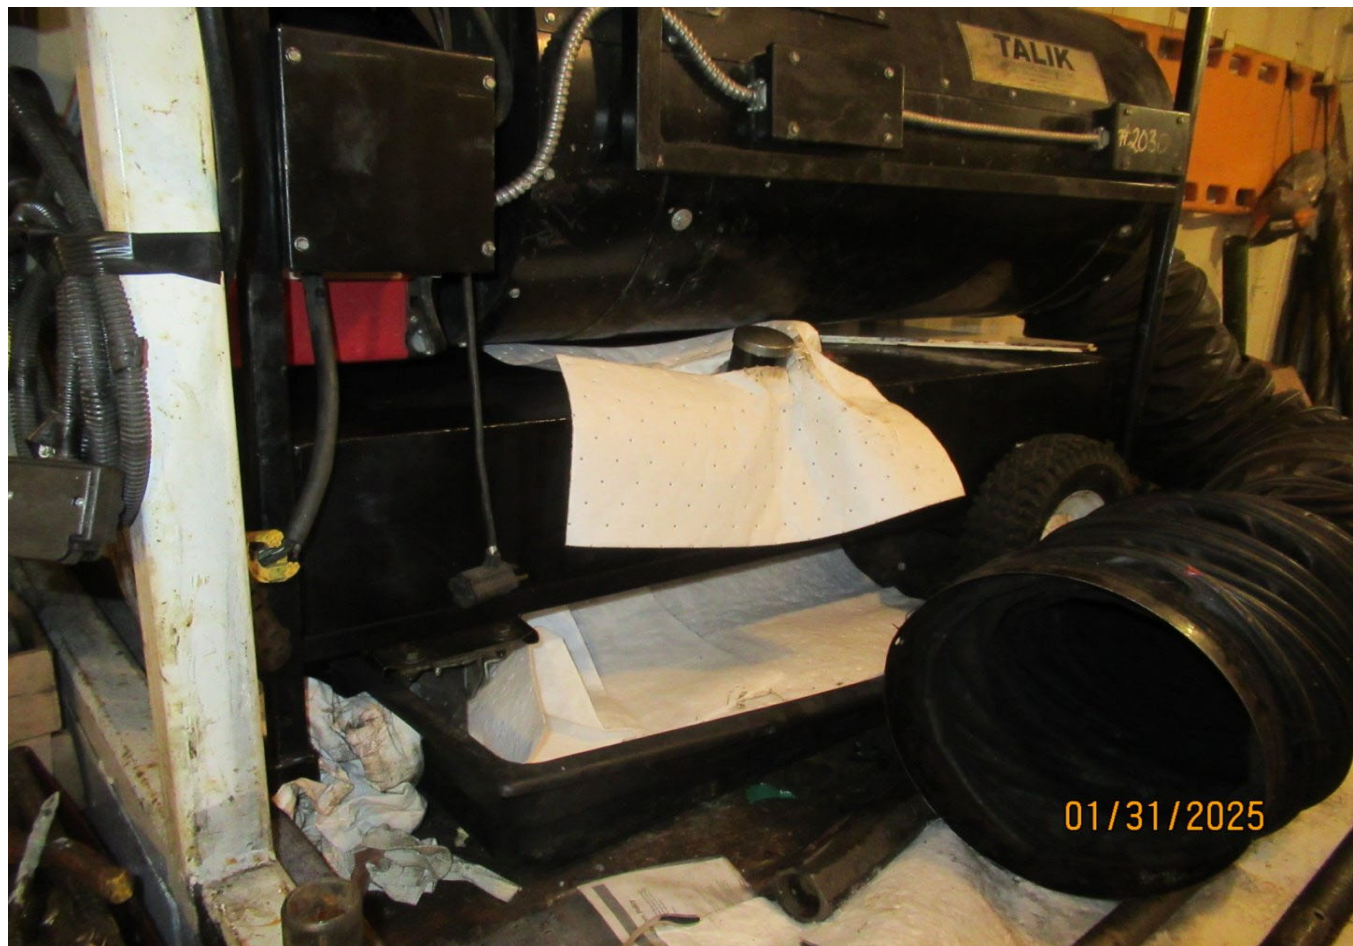
Figure 14  
Secondary containment and absorbent matting on a frost fighter.

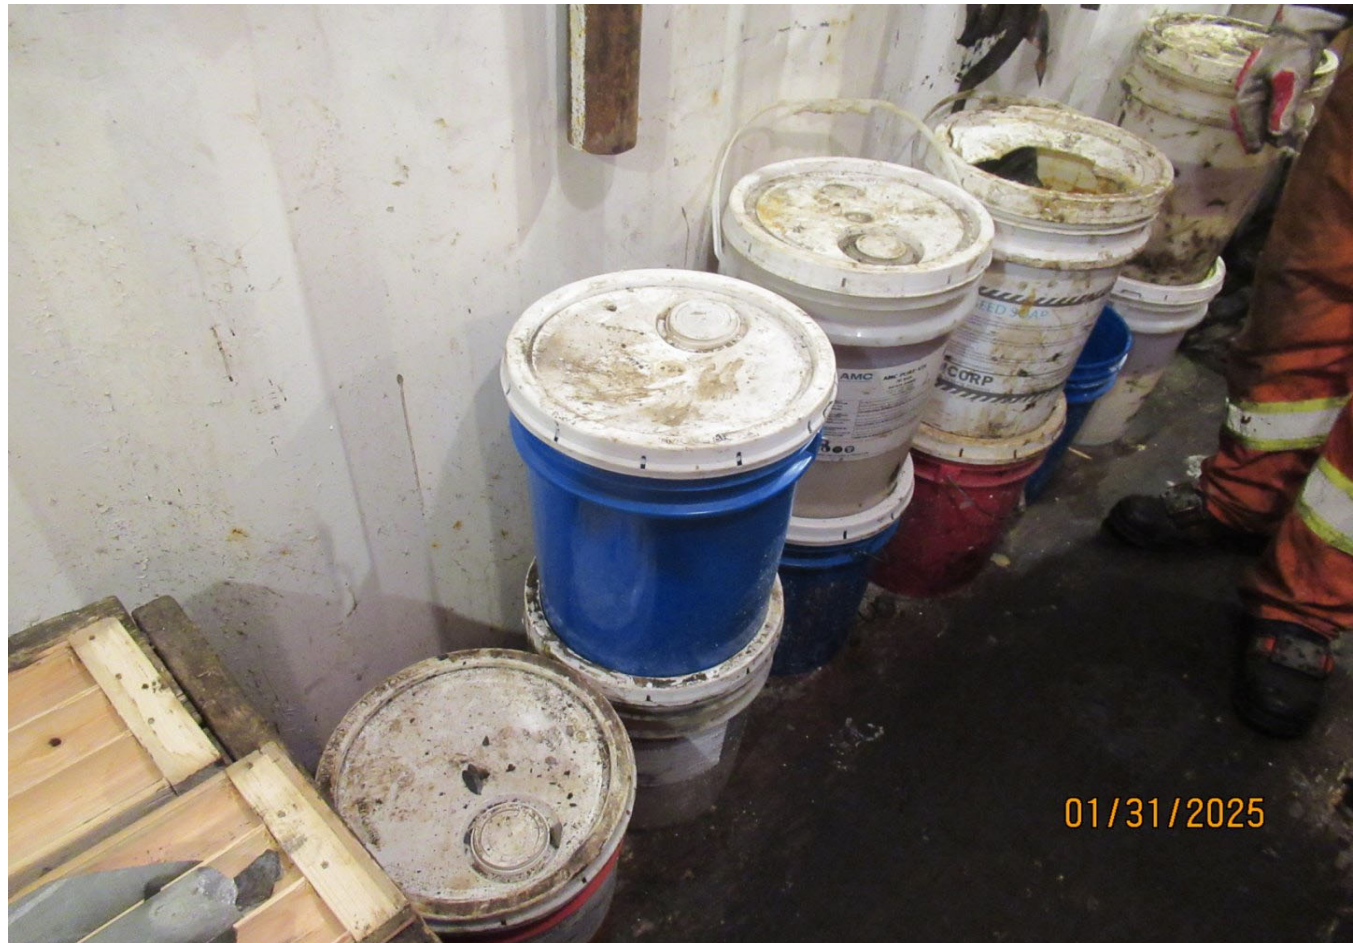
Figure 15

- The Contractor currently isn’t using any drill additives. All containers inside the drill were inspected (Figure 15) and the Permittee has previously provided Safety Data Sheets (SDS) so their use is approved if they are needed as drilling advances.

All drill additives stored on site are approved for use if they are required as drilling progresses.

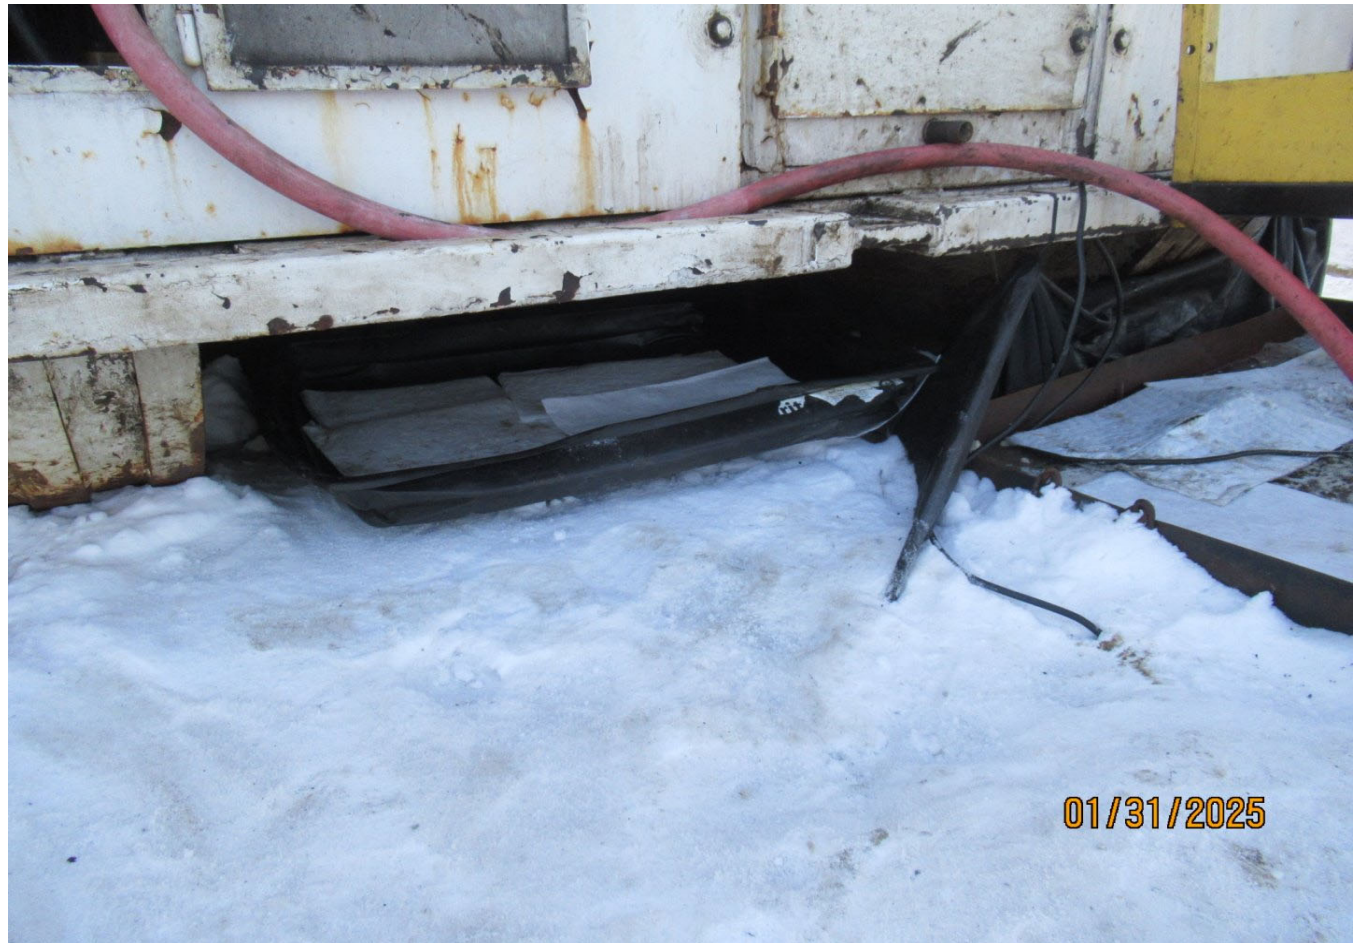
Figure 16

- The entire drill has secondary containment beneath it (Figure 16).

The entire drill shack has secondary containment (tarp) beneath it.
