**Re: Land Use Permit MV2018C0023
Mineral Exploration
Yellowknife, NT**

ENVIRONMENTAL INSPECTION REPORT

Location(s) Inspected:	Active diamond drill operations on the Con Mine Property.
------------------------	---

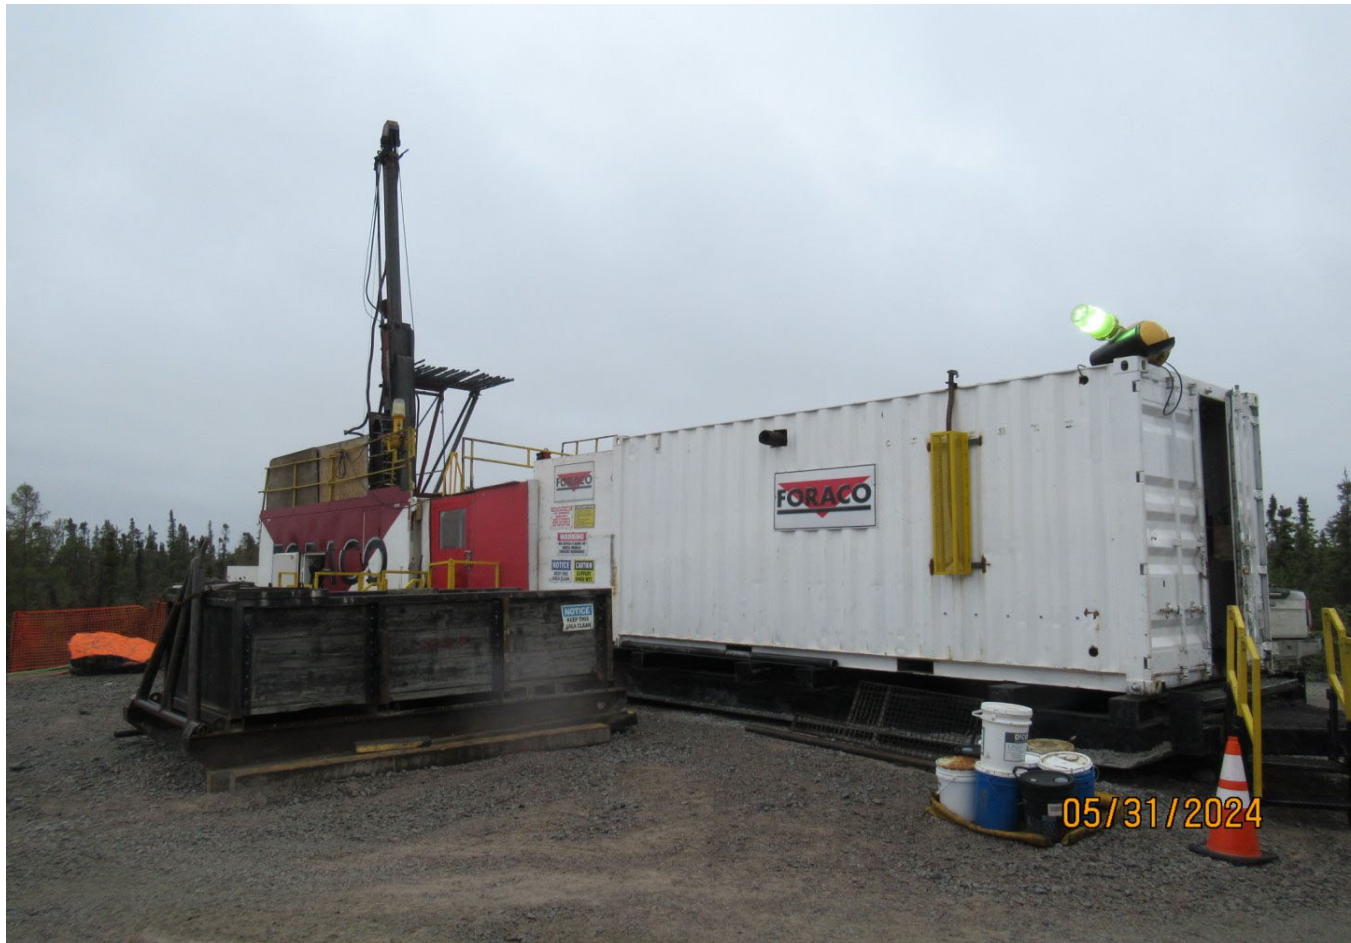
The drilling of target GTCM24-056 on the Con Mine Property commenced on approximately February 11th, 2024 and at the time of the inspection, the Foraco Val-d’Or VD8000 diamond drill (Figure 1 & 2) was at approximately 2406 metres. The Inspector is pleased to report that no major concerns were noted and the following was observed;

Figure 1
Foraco Val-d’Or VD8000 diamond drill on target GTCM24-056.

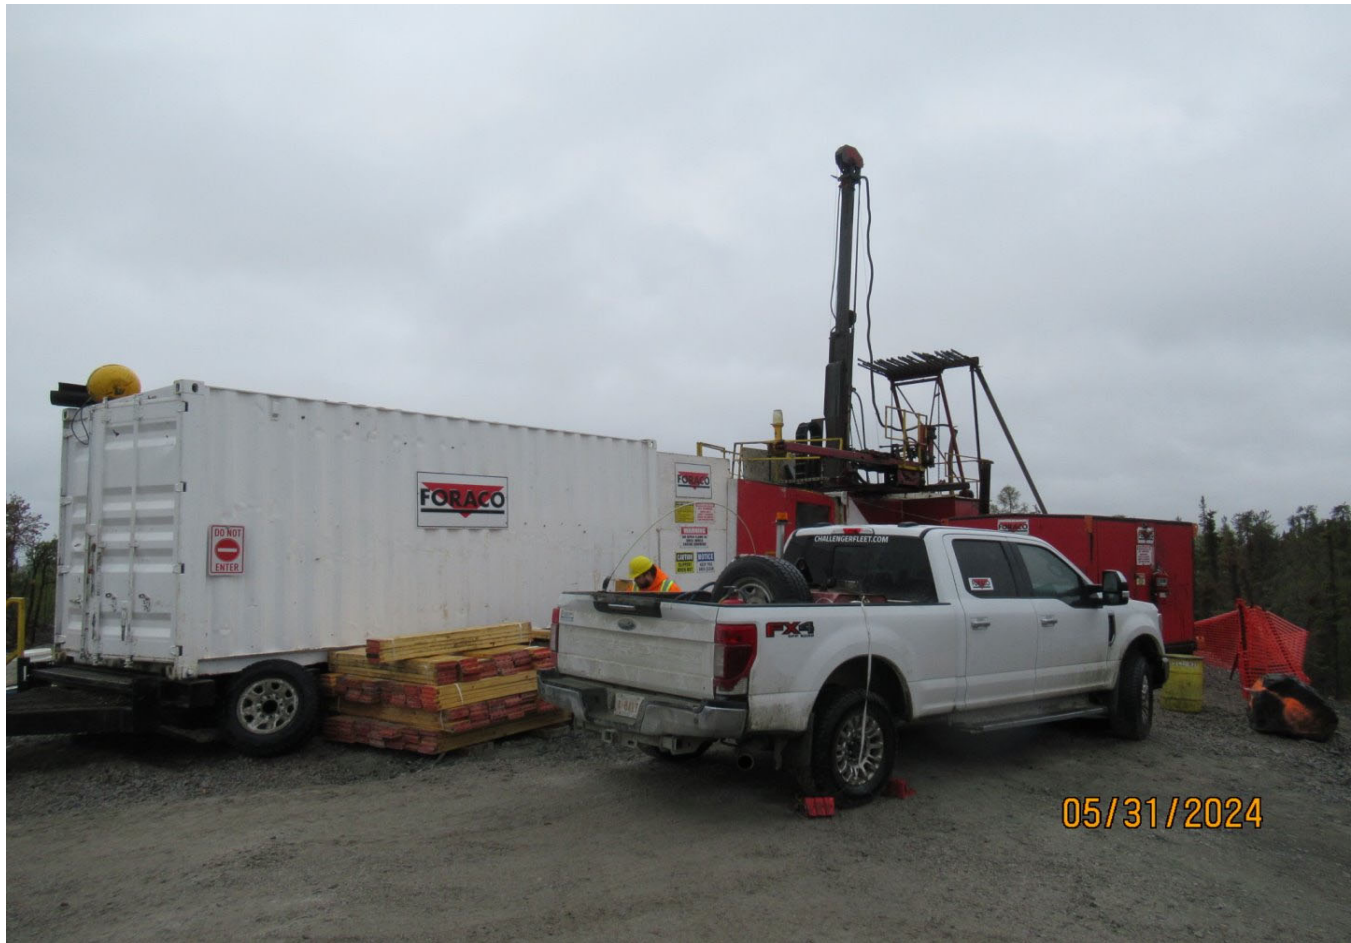
Figure 2
Another view of the active diamond drill.

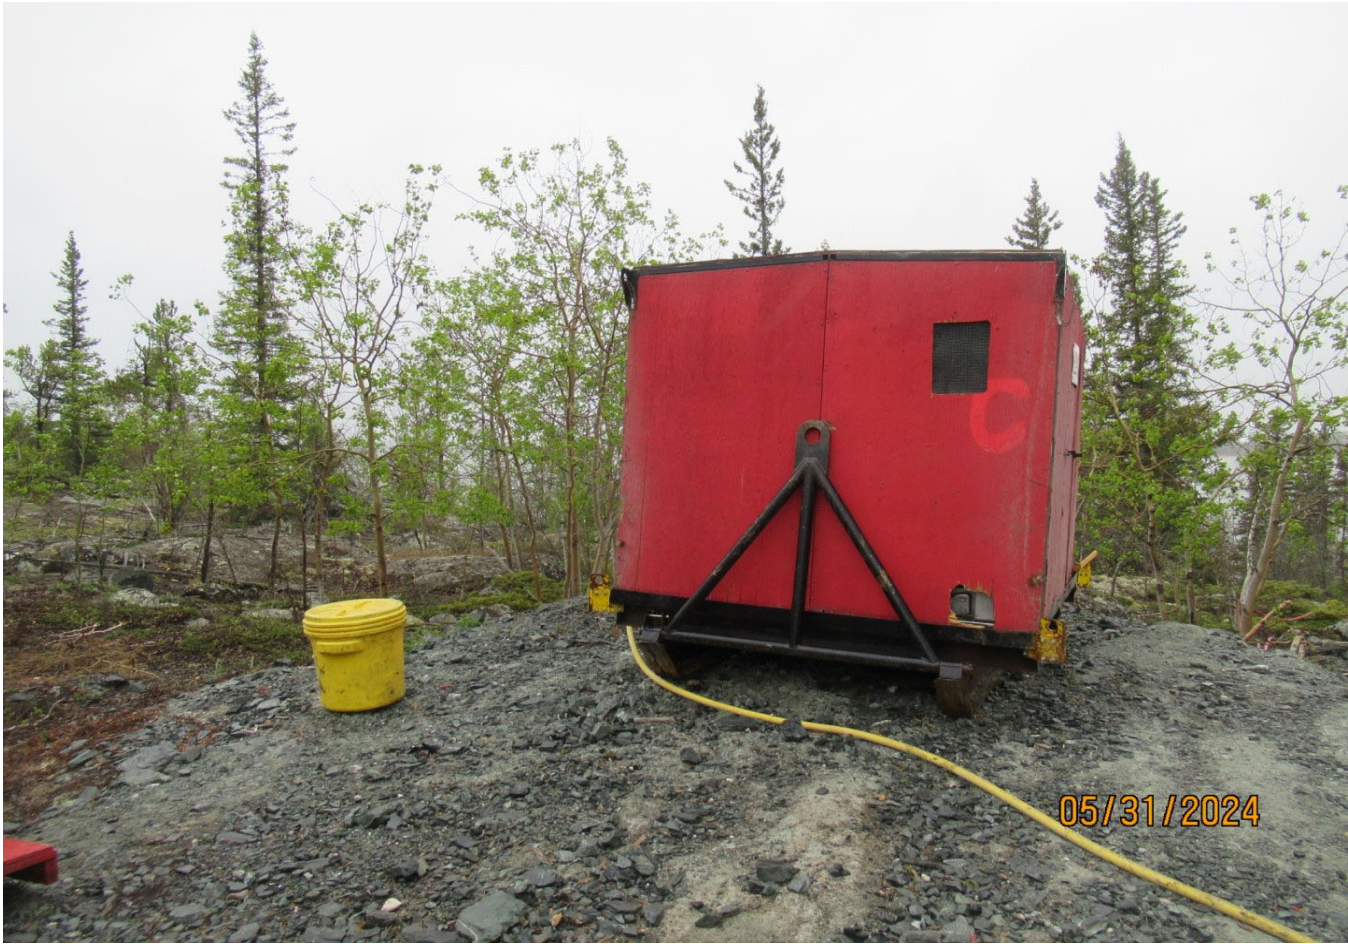
- Spill response materials were readily available at the drill, outside the shack that houses the generator & pump shack (Figure 3) and in various other locations throughout the land use area.

Figure 3
Spill kit is present at the Kam Lake pump shack.

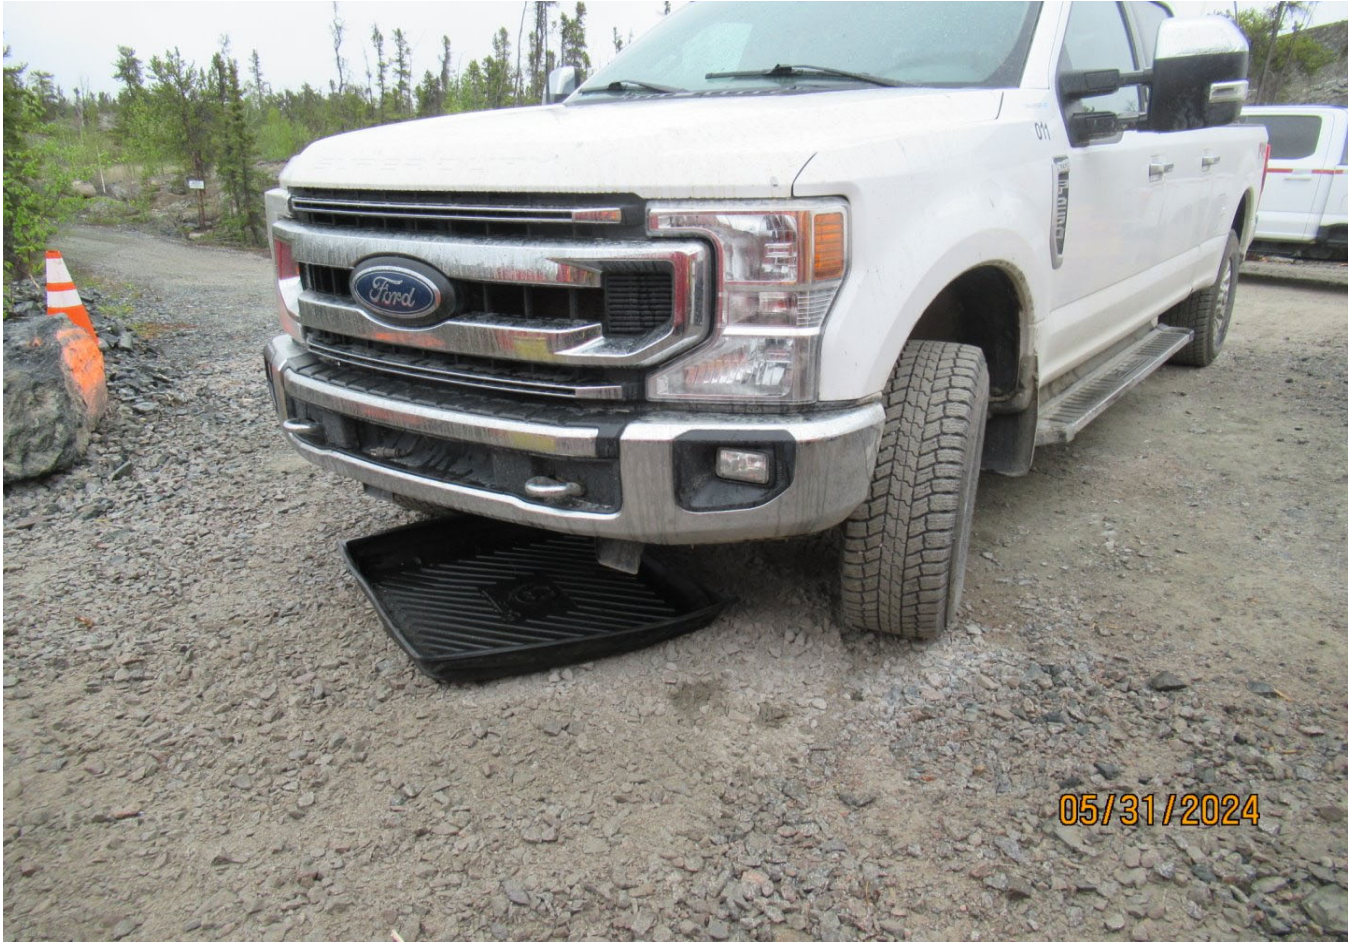
- Parked vehicles, equipment and ancillary equipment for the drill had drip trays (Figure 4).
- Secondary containment was observed below the feed frame (Figure 5) and power pack (Figure 6) of the drill.

Figure 4
Parked vehicles had drip trays present.

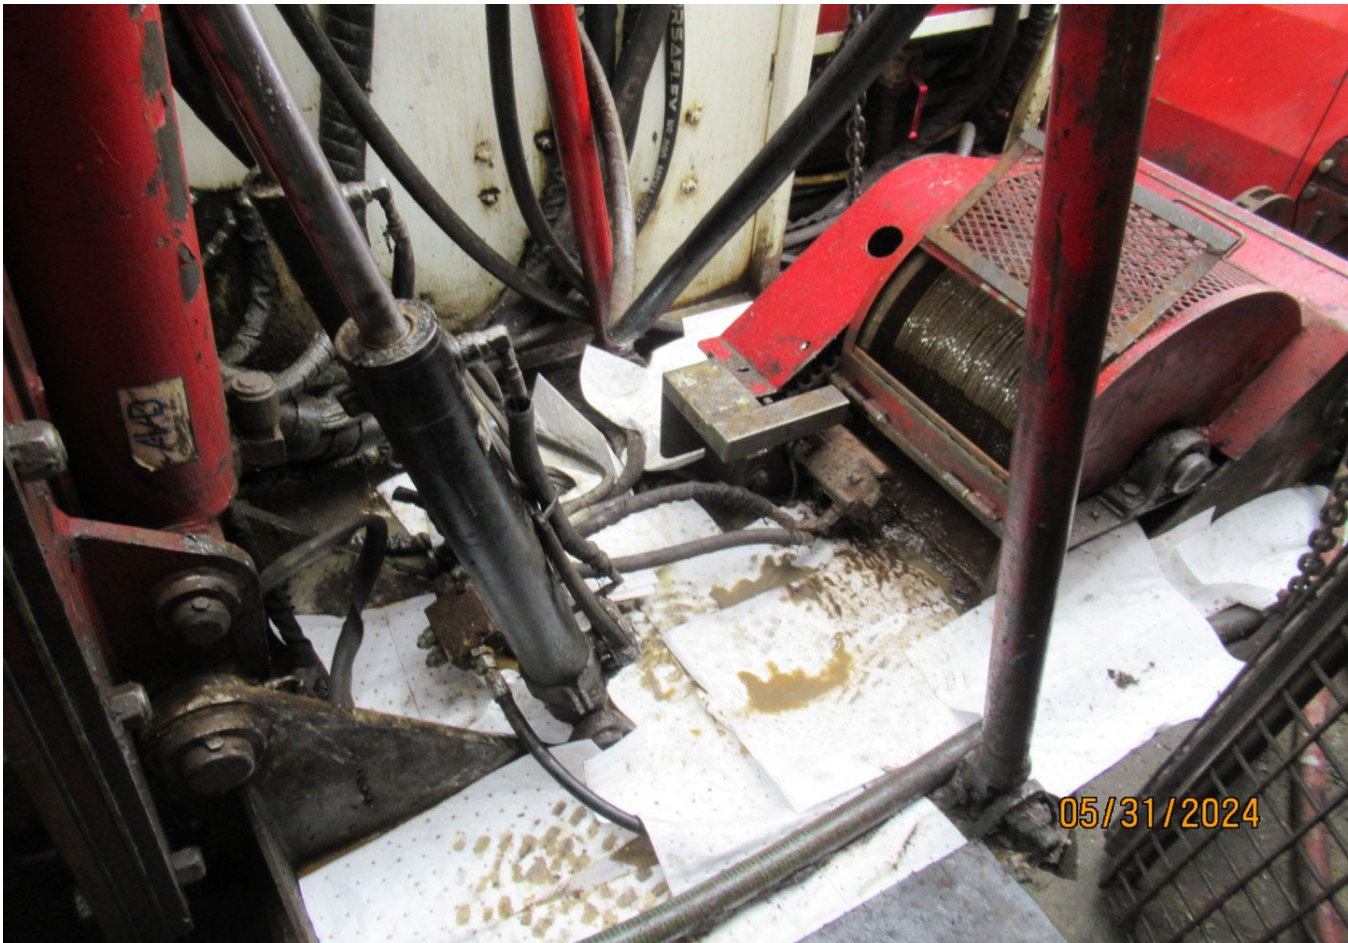
Figure 5
Hydrocarbon absorbent matting below the feed frame of the drill.

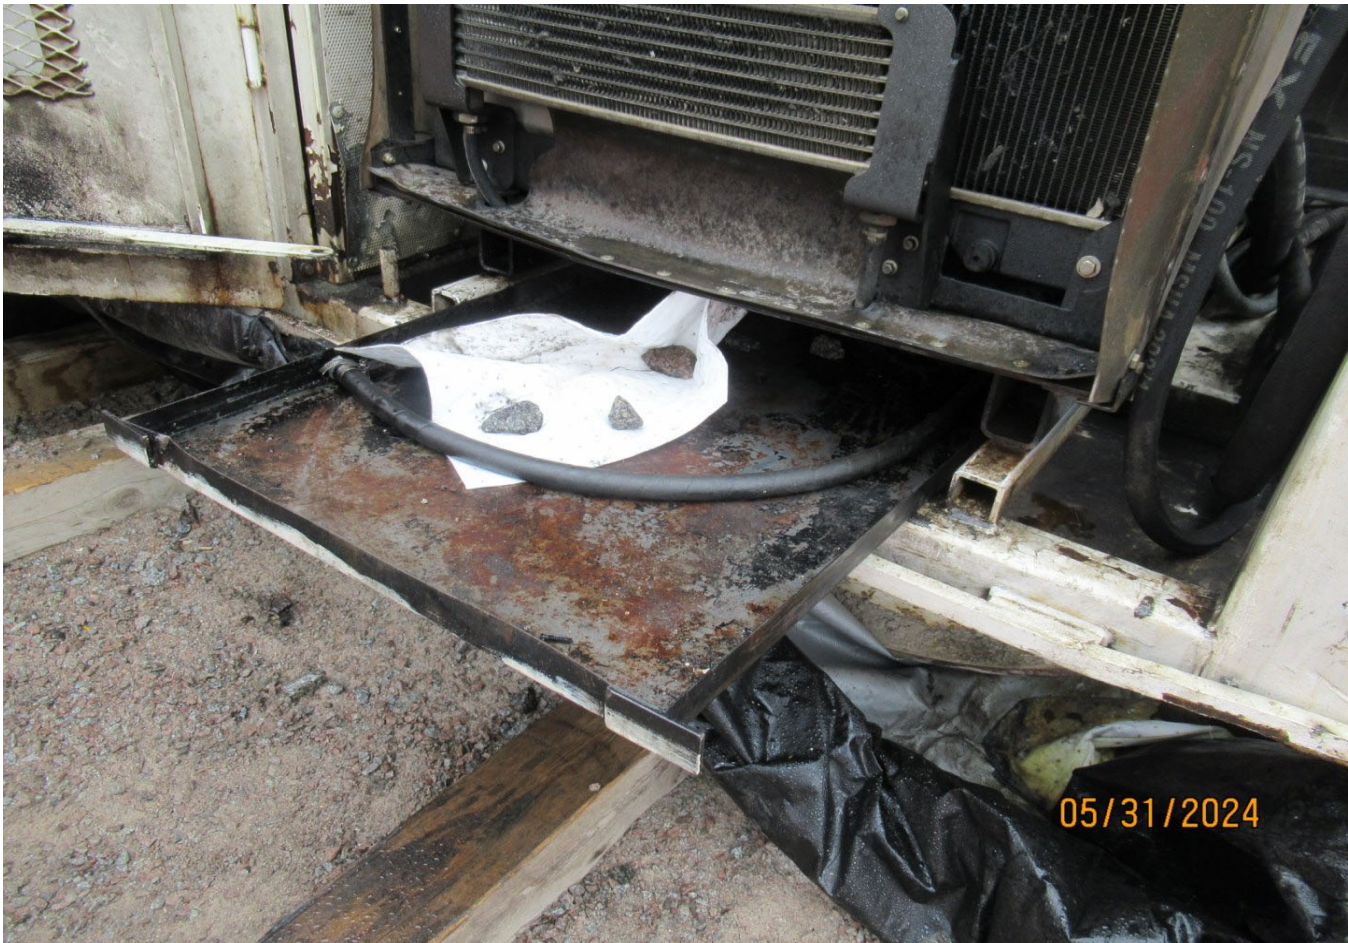
Figure 6
Secondary containment tray below the power pack of the drill.

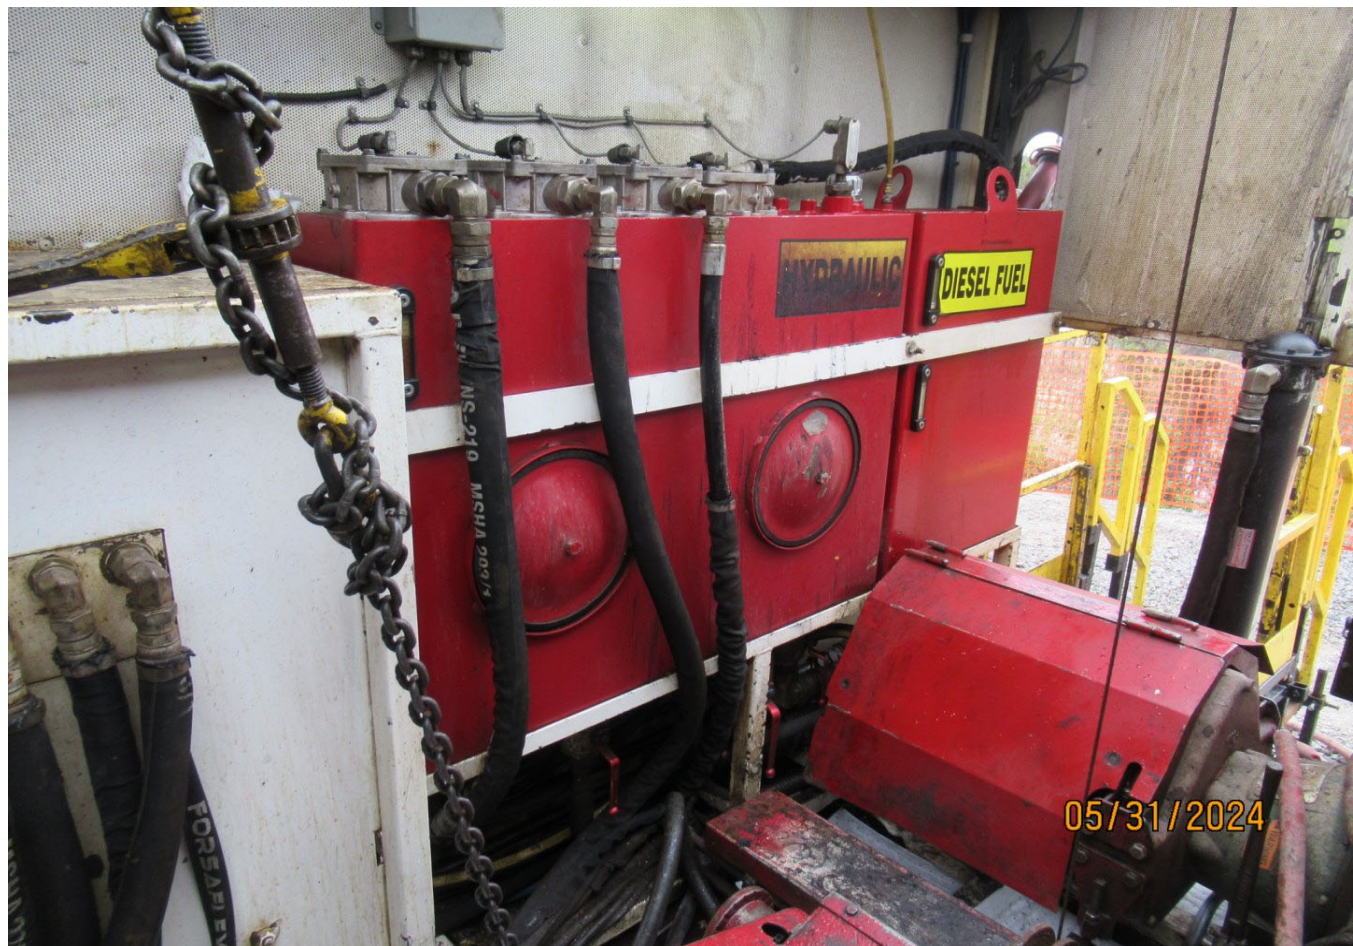
- No fuel handling concerns were noted at the fuel tank for the drill (Figure 7) or generator tidy tank in the pump shack (Figure 8).
- SDS (Safety Data Sheets) for all the drill additives on hand have been provided to the Inspectors and Mr. Mattie informed Inspectors that additives currently in use are Pure Vis, Flock Block, 133X, G Stop, and Rod Grease (Figure 9 & 10).

Figure 7
Fuel and hydraulic tanks inside the drill shack. No concerns were noted with fuel handling.

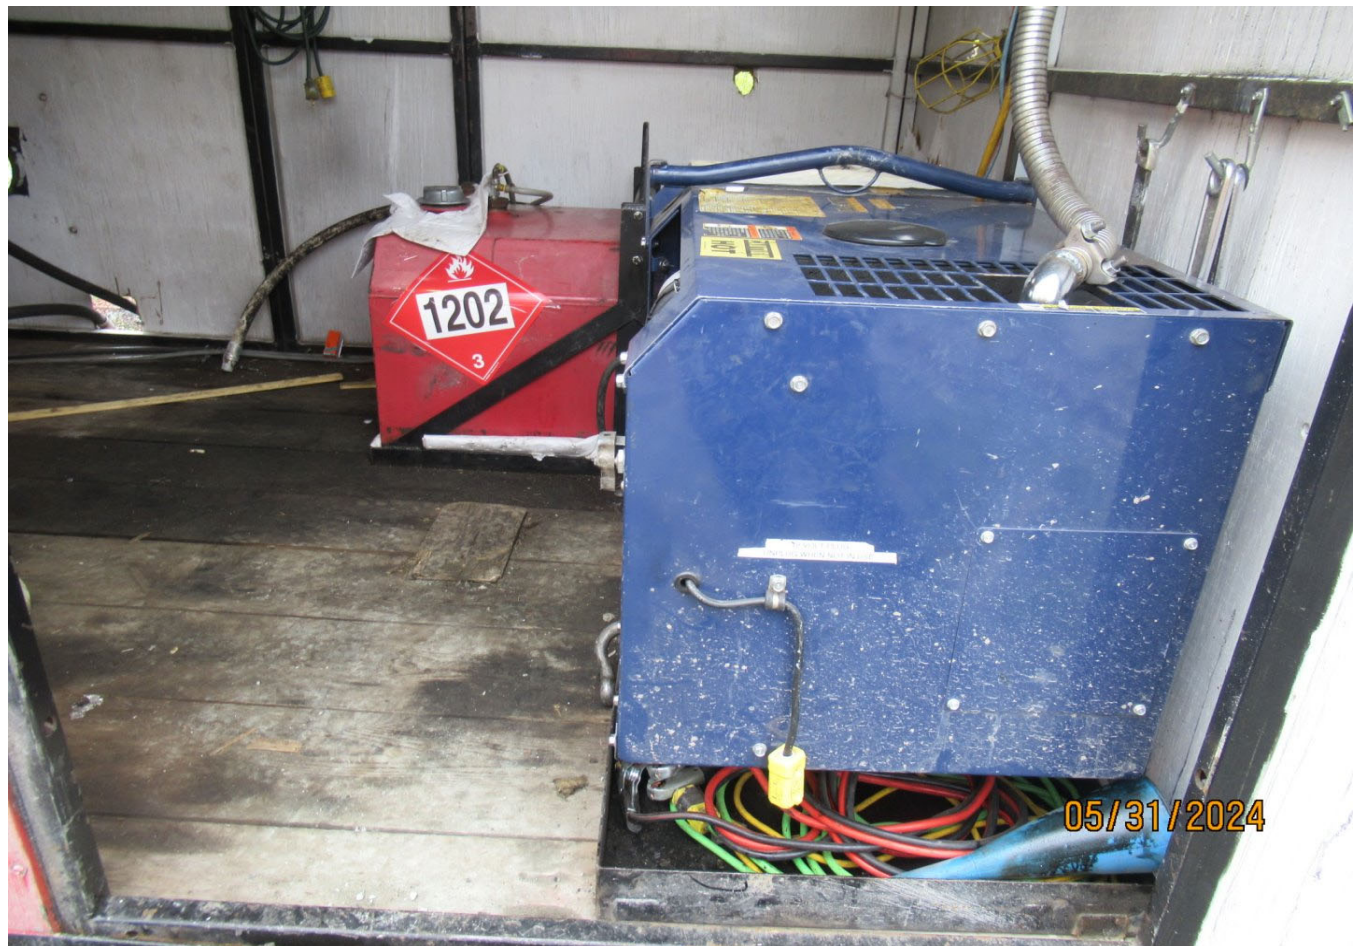
Figure 8
No obvious spills or concerns were noted with fuel handling at the generator or tidy tank inside the pump shack.

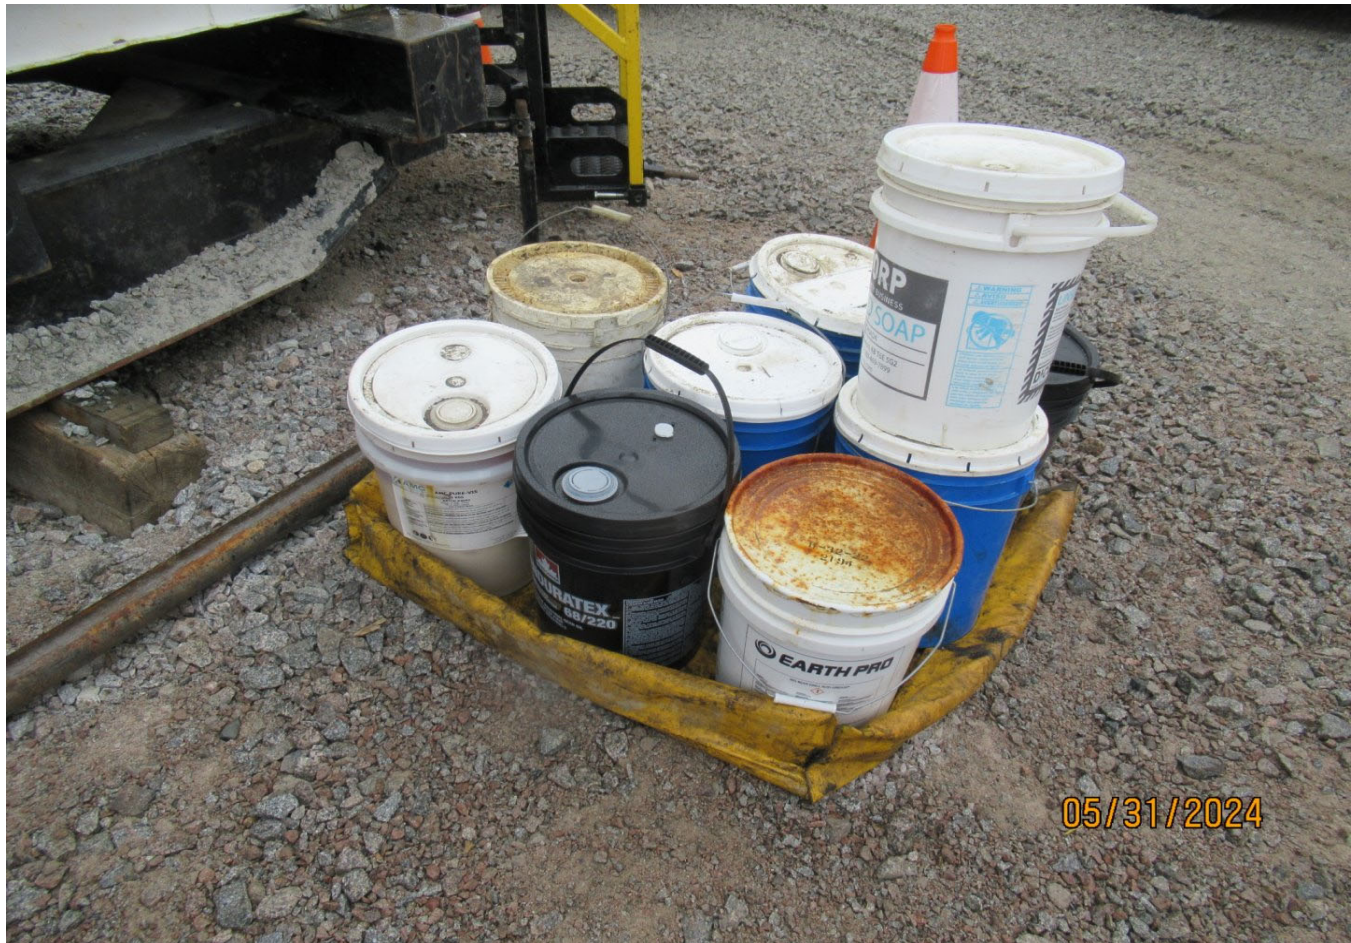
Figure 9
Acceptable drill additives are being stored within secondary containment.

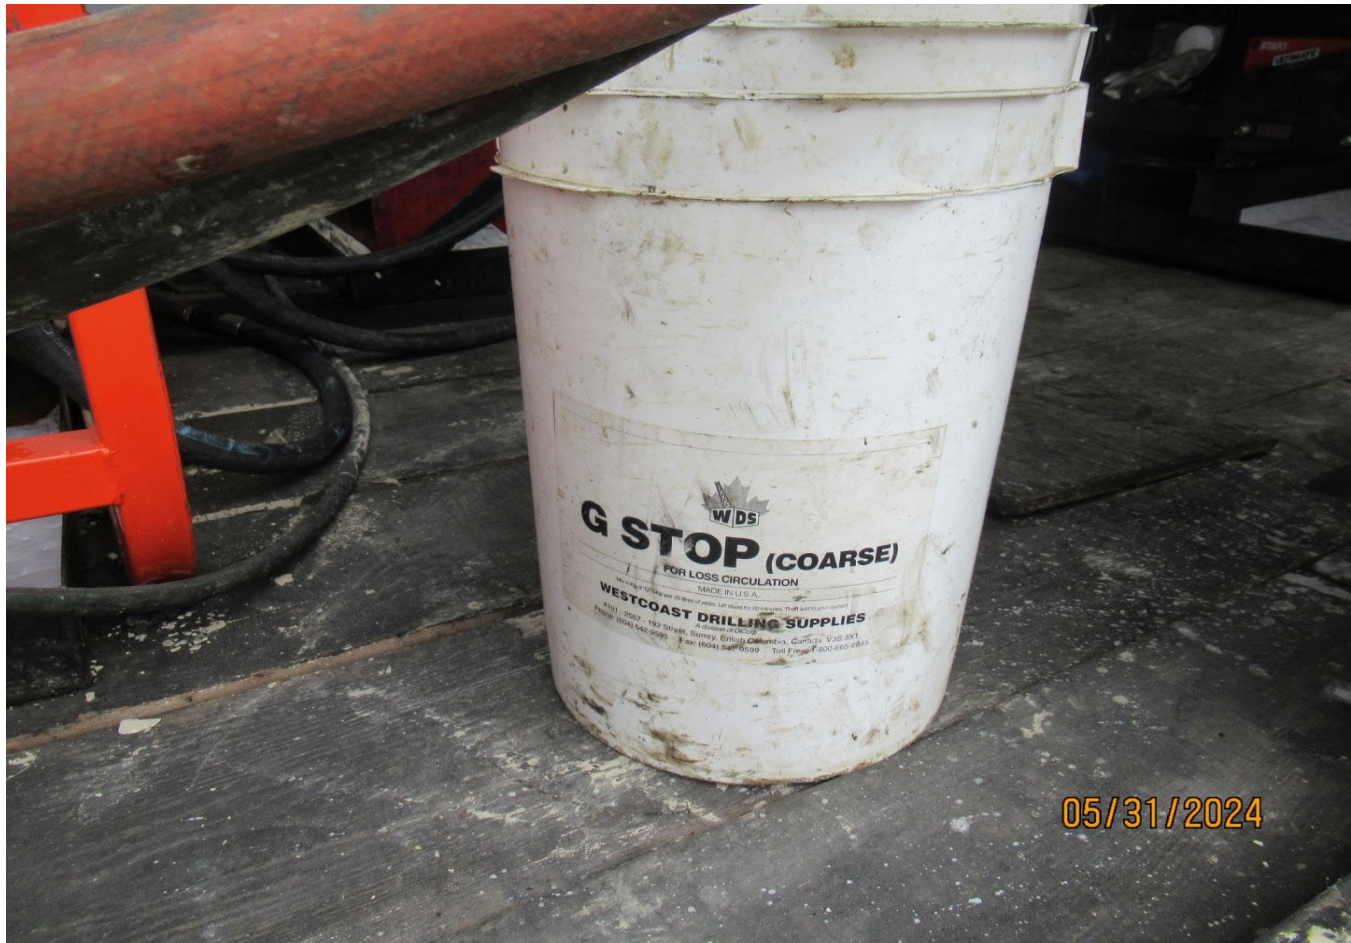
Figure 10
Another drill additive on site.

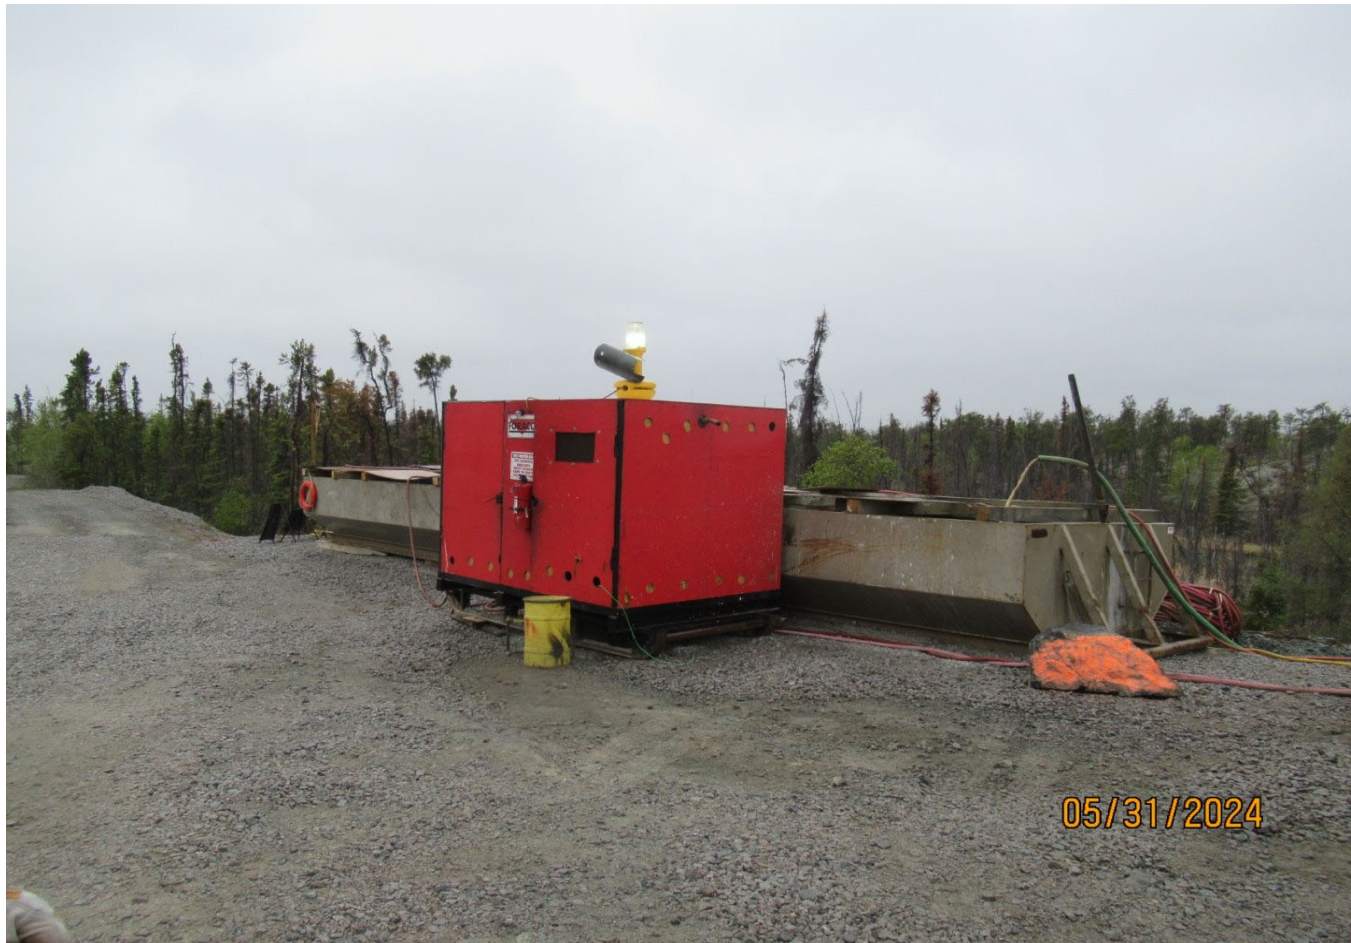
- Water meters have been installed on the large settling tank (Figure 11 & 12) and water use is being diligently tracked.
- Rod grease is being skimmed off the water surface in the settling tank (Figure 13) and drill rods as they are pulled.

Figure 11
Water settling tank has four compartments and forms part of the closed circuit drilling system.

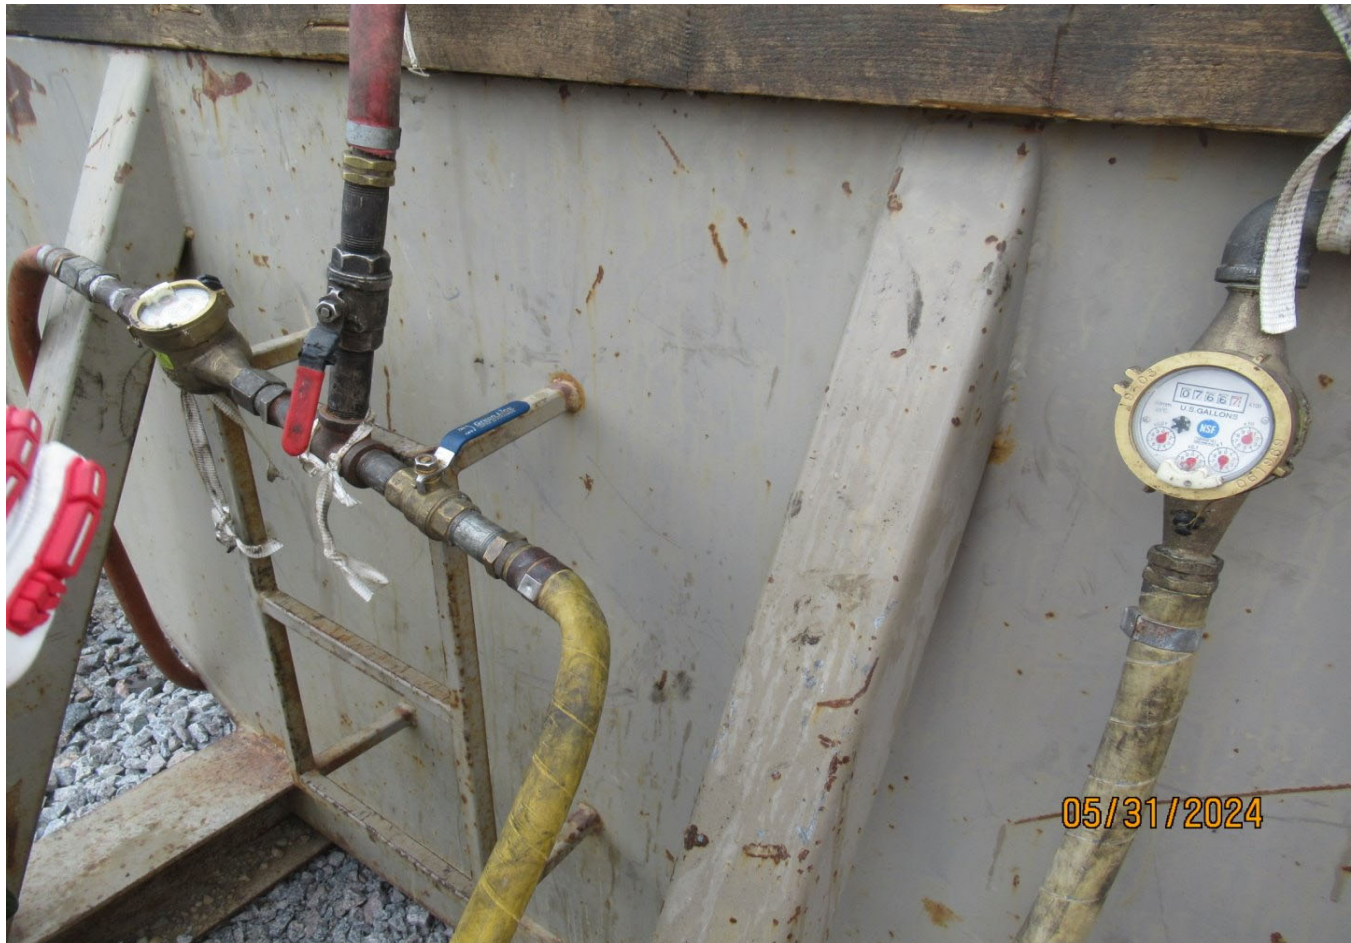
Figure 12
Water meters on the side of the settling tank.

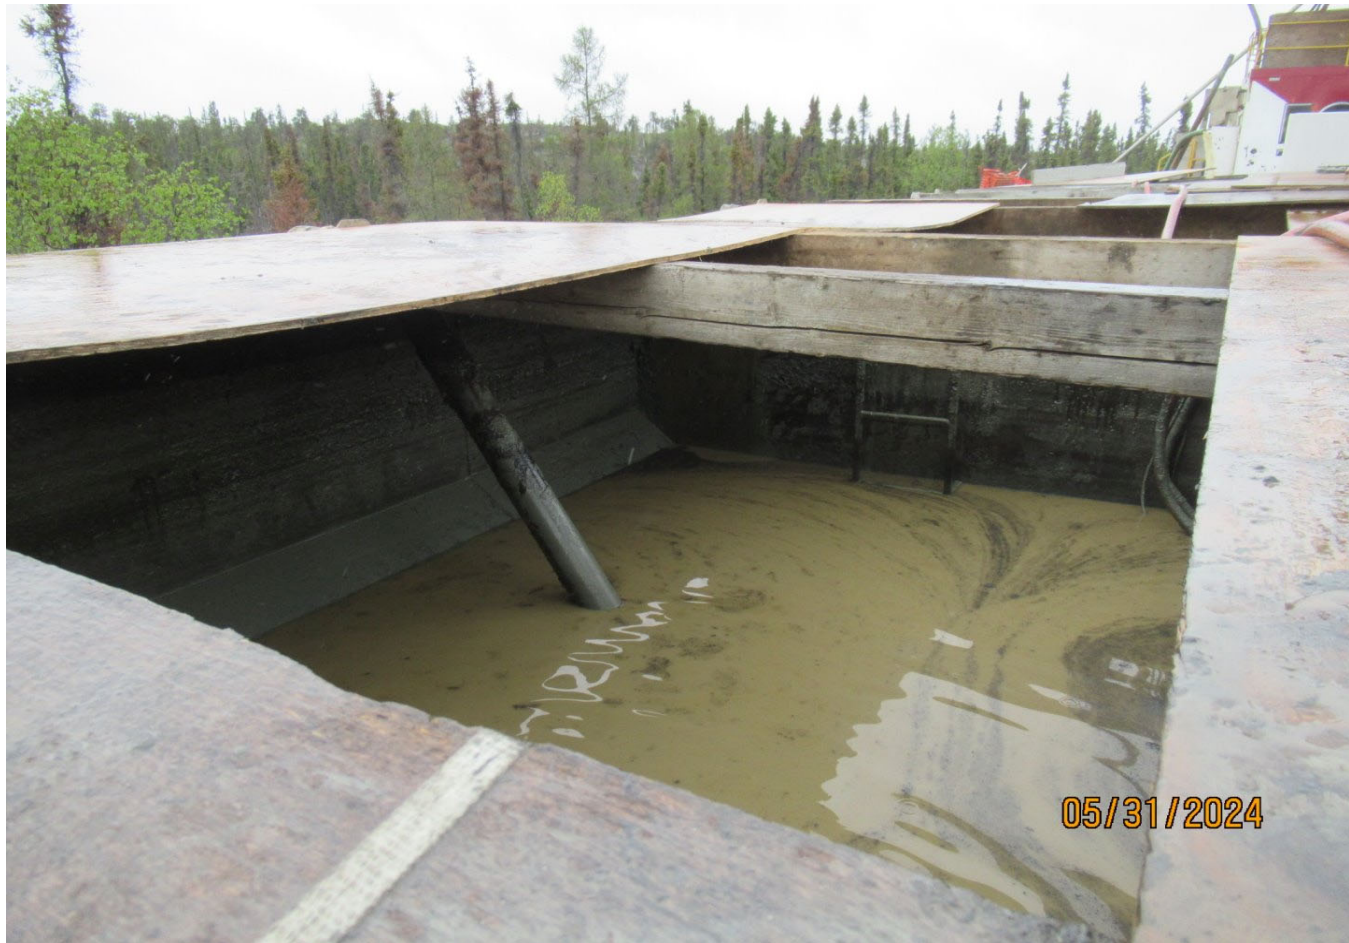
Figure 13
Drill water is being skimmed prior to removal and disposal in middle Pud.

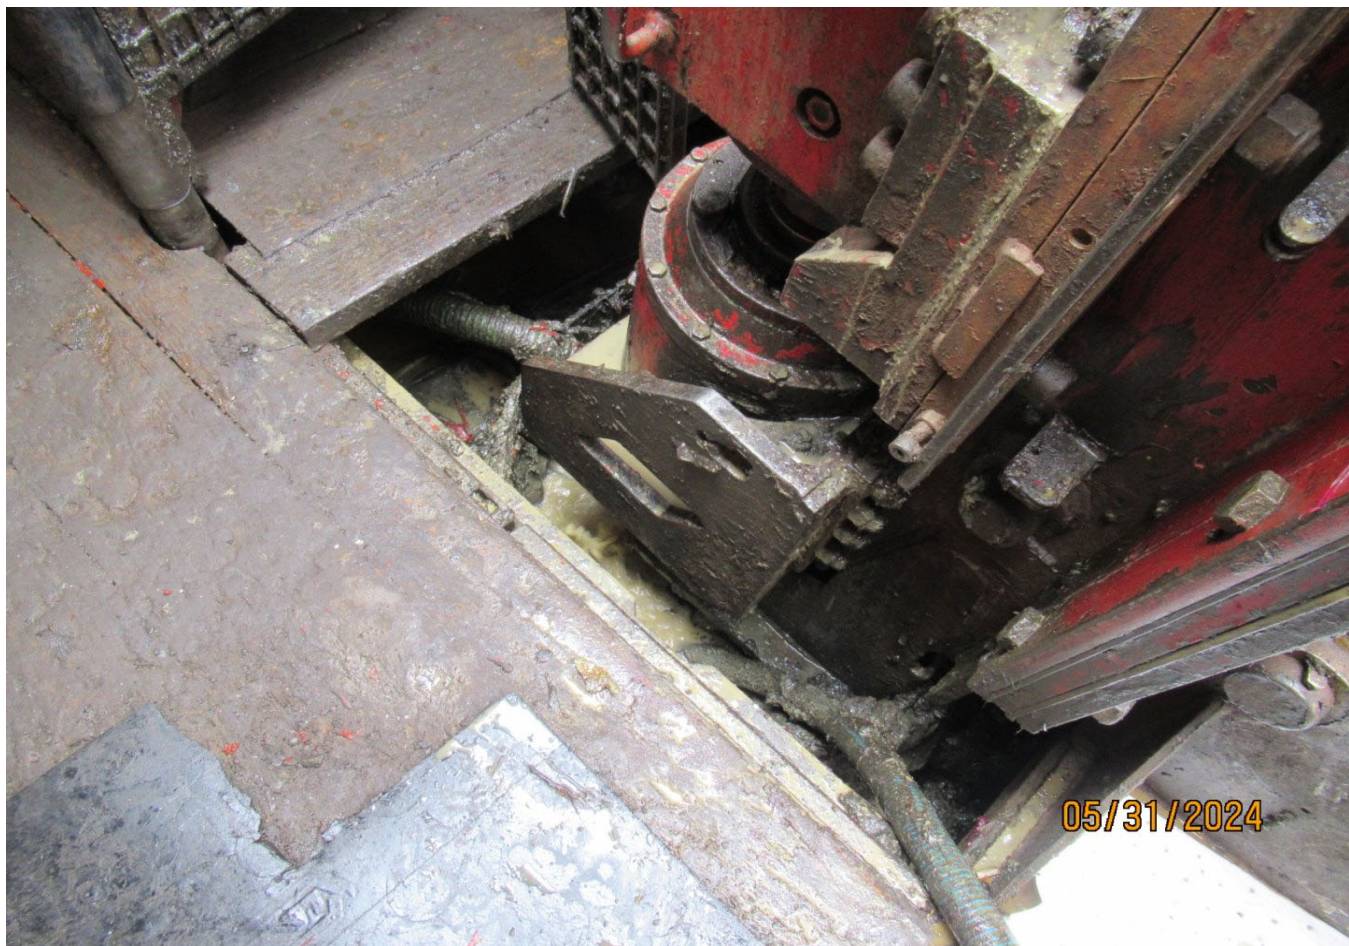
- A cellar (Figure 14) has been installed at the collar to collect all drill waste prior to pumping to the drill cuttings settling tank.
- A true closed circuit system is being utilized to manage drill waste & water consumption.

Figure 14
Cellar at the collar of the drill site for the collection of drill waste.

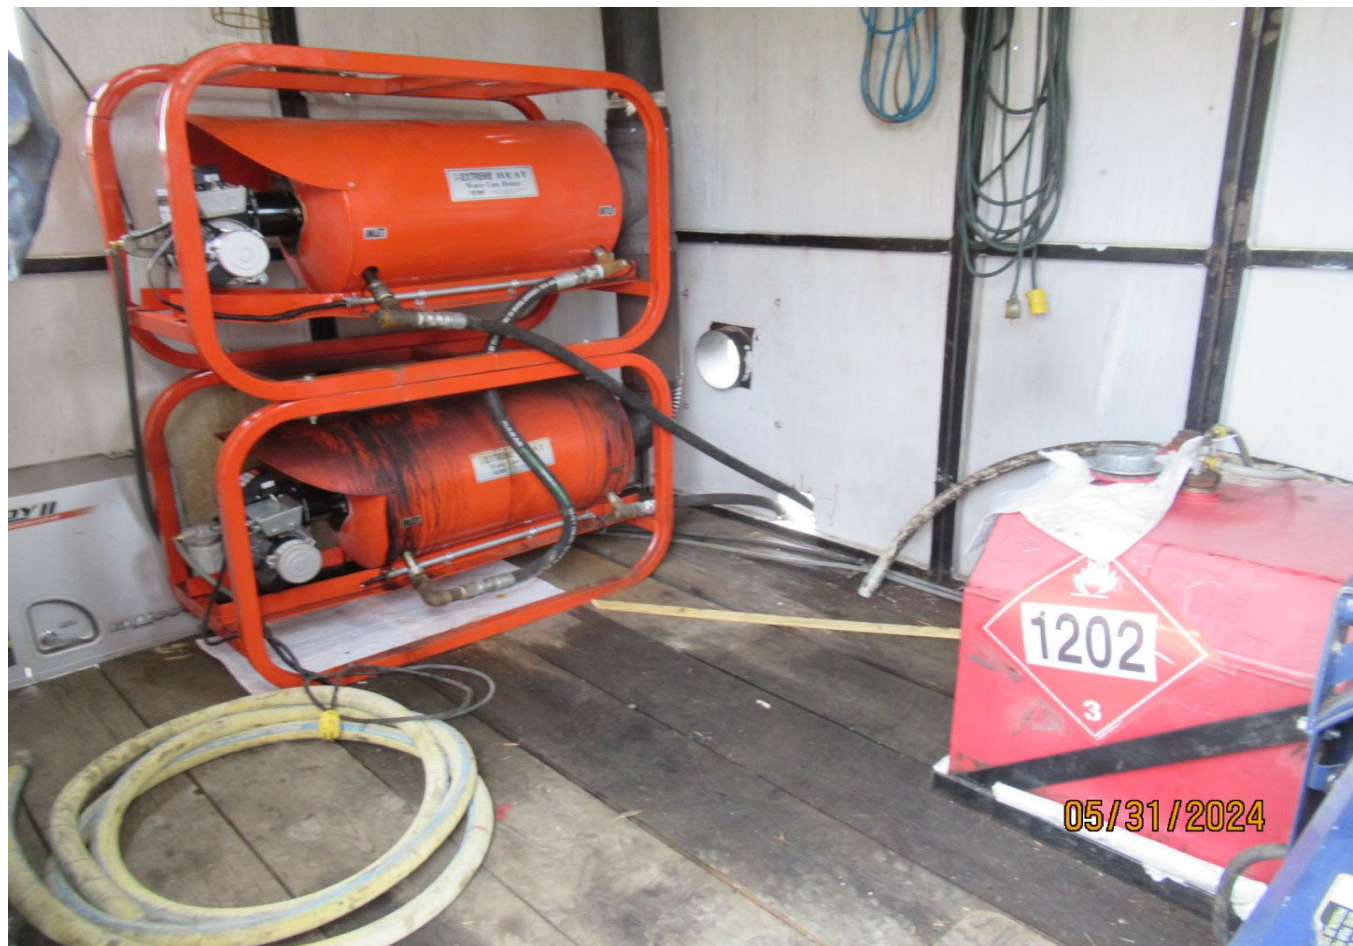
- All ancillary equipment had a form of secondary containment present (Figure 15-17).
- A secure container is in use for the segregation of garbage at the drill site until final disposal occurs (Figure 18).

Figure 15
Ancillary containment and fuel tank have a form of secondary containment present.

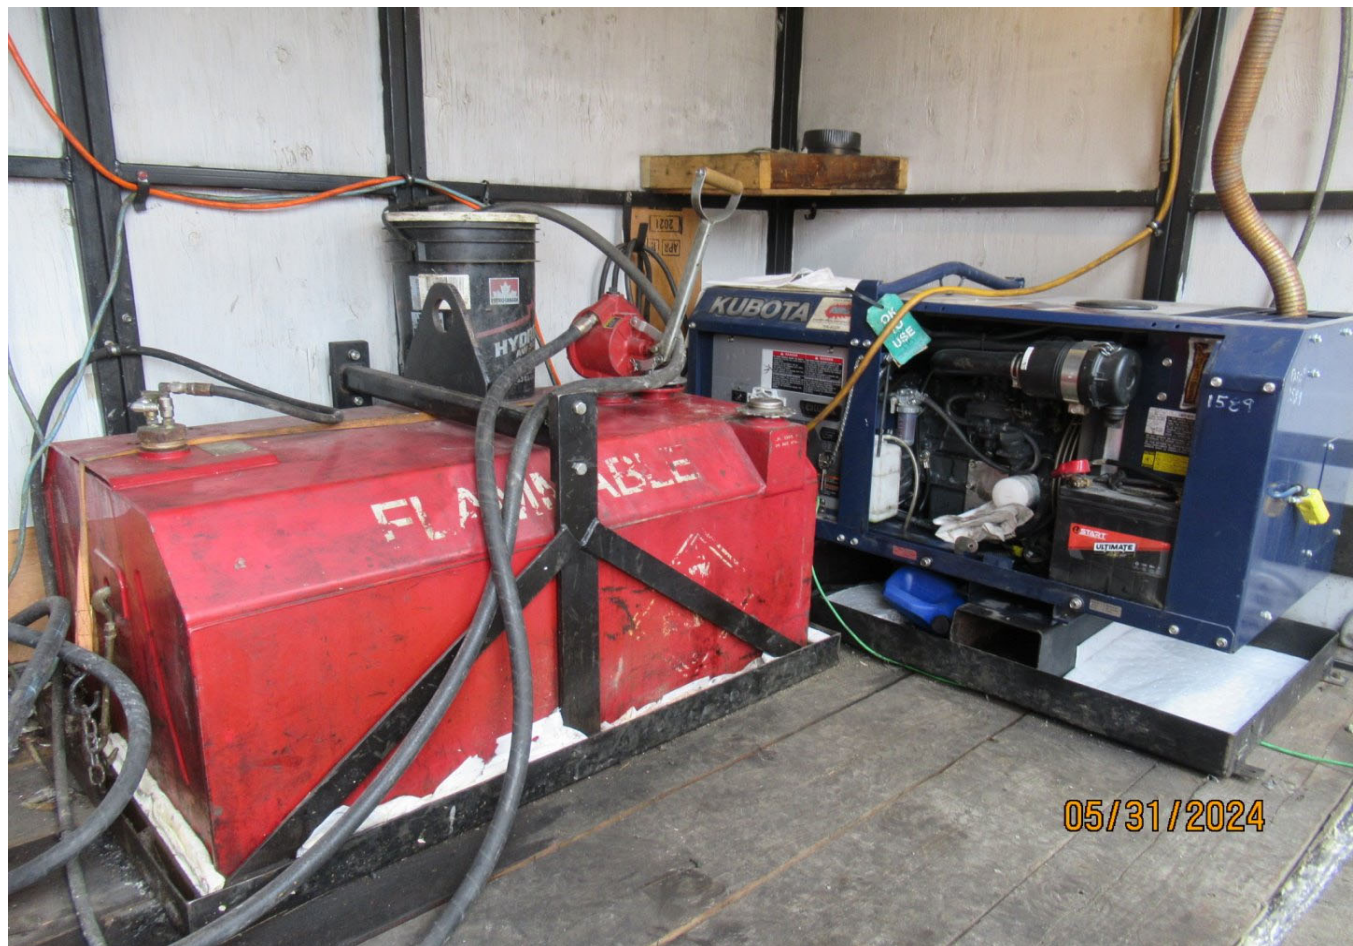
Figure 16
Secondary containment under other ancillary equipment in the land use area.

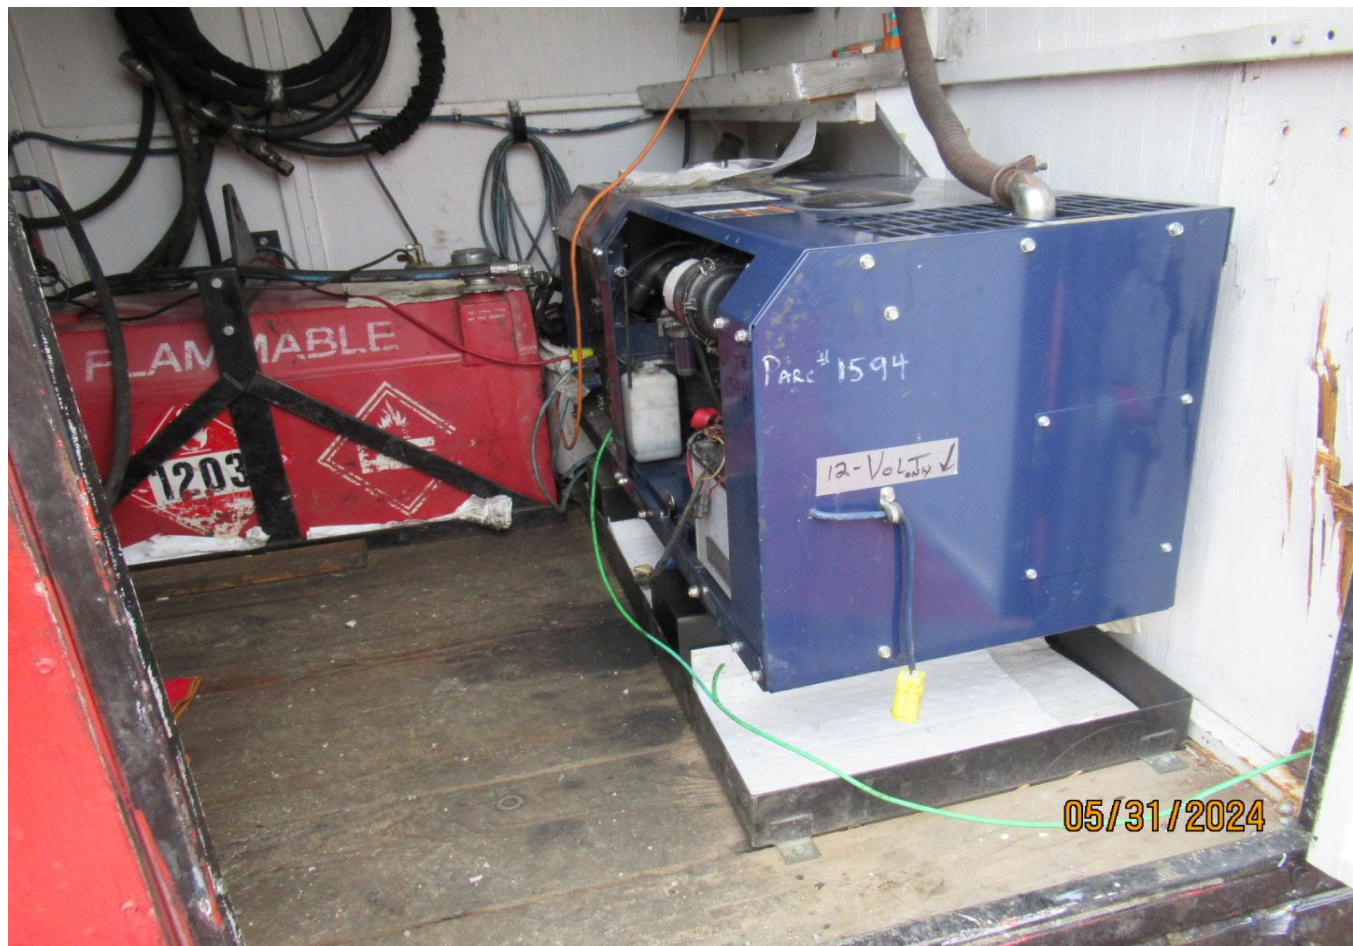
Figure 17
Drip trays and absorbent matting below another generator.
