**Re: Land Use Permit MV2018C0023
Mineral Exploration
Yellowknife, NT**

ENVIRONMENTAL INSPECTION REPORT

Location(s) Inspected:	Active diamond drill operations on the Con Mine Property.
------------------------	---

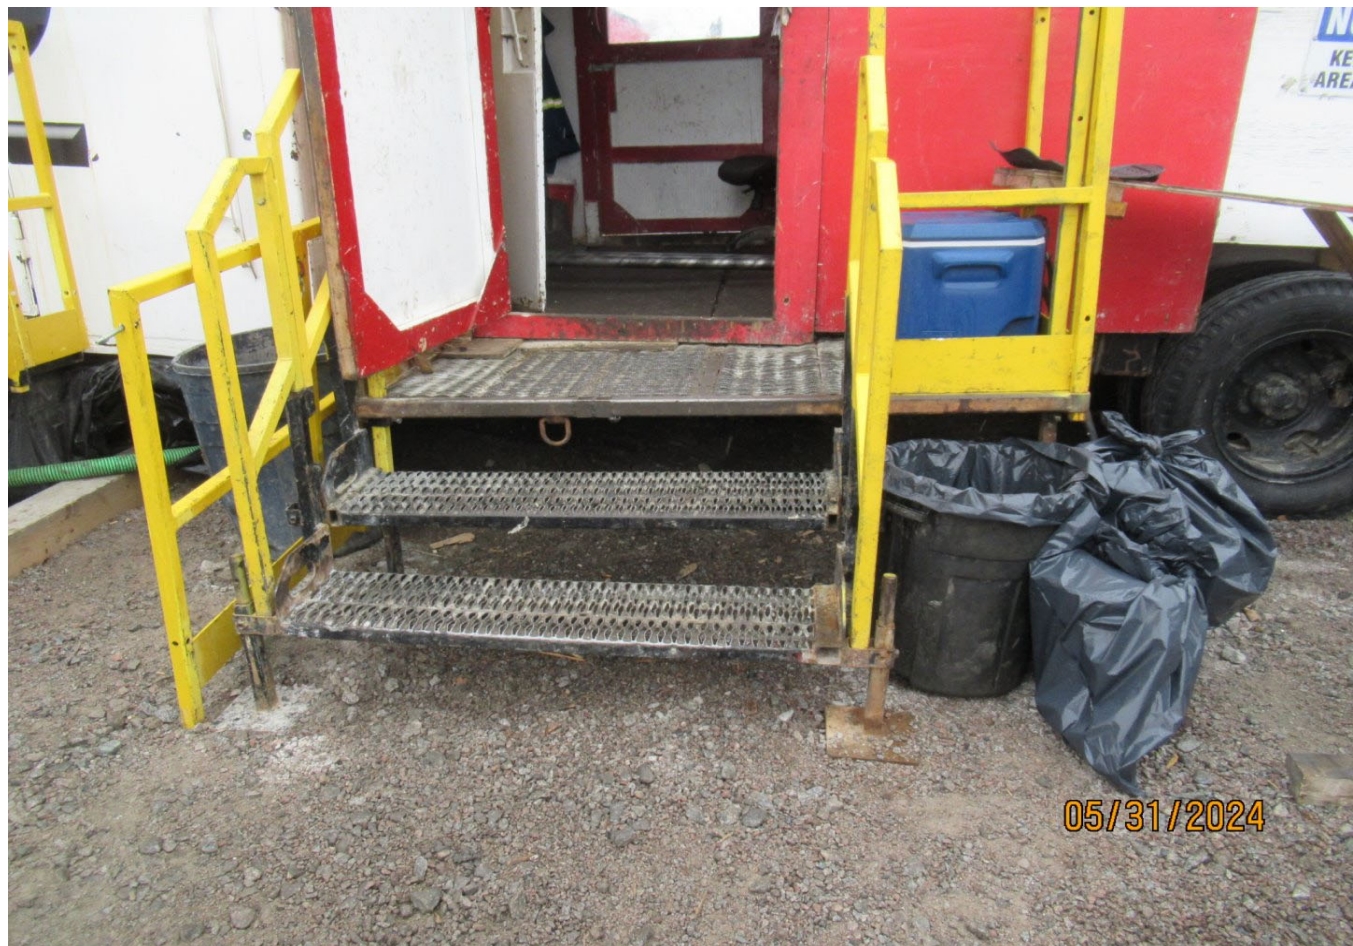
Figure 18
Garbage is being segregated and removed from site for proper offsite disposal.

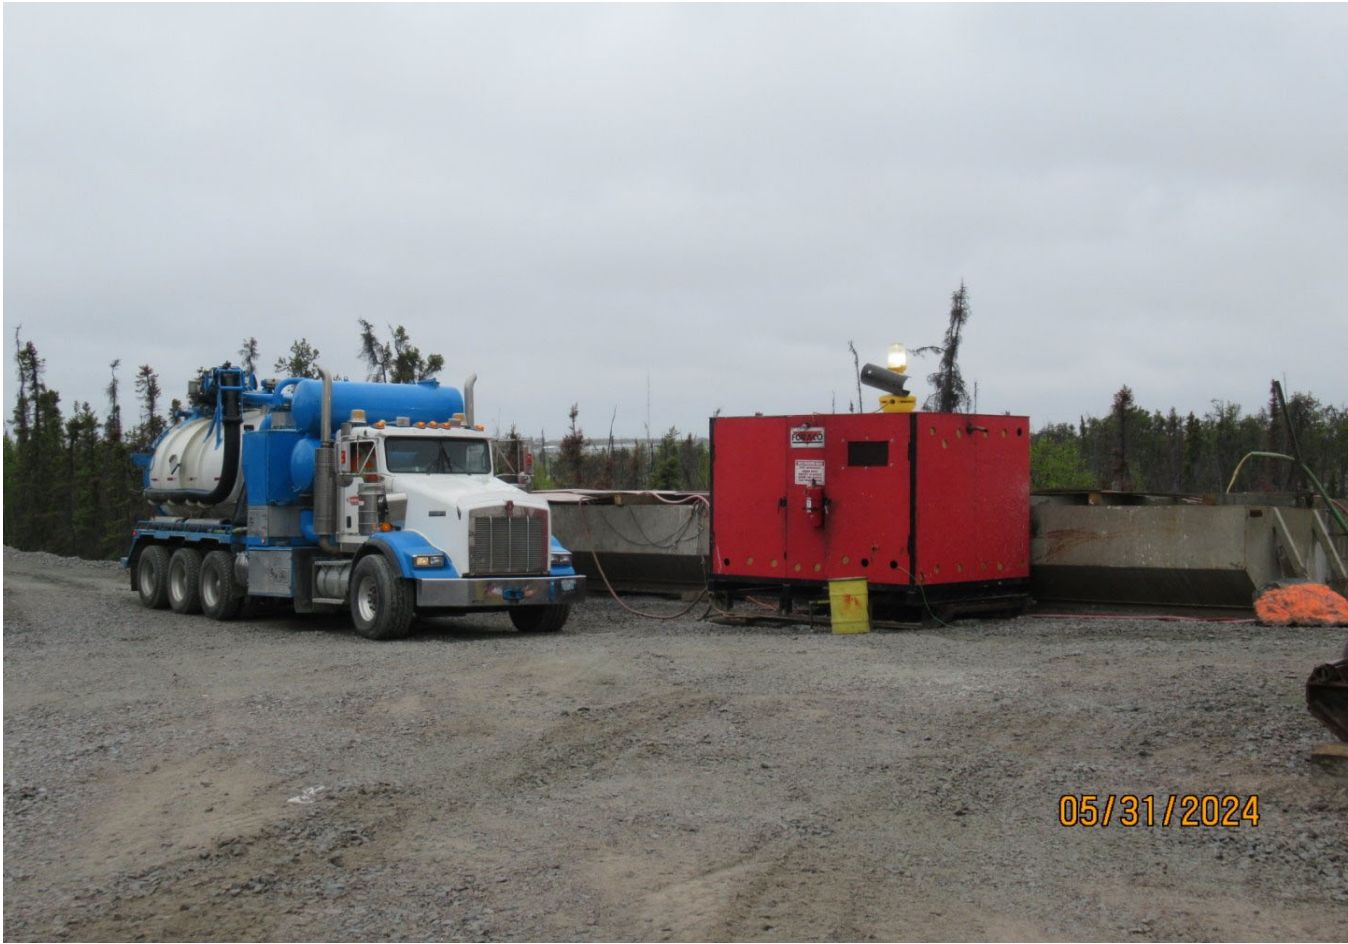
- A vacuum truck is being used to pump out the settling tank for final disposal of cuttings into middle Pud (Figure 19 & 20). Only a minor amount of rod grease was noted at the disposal location which is a drastic improvement from the previous inspection.

Figure 19
Vacuum truck for the pumping of drill waste and removal to Middle pud.

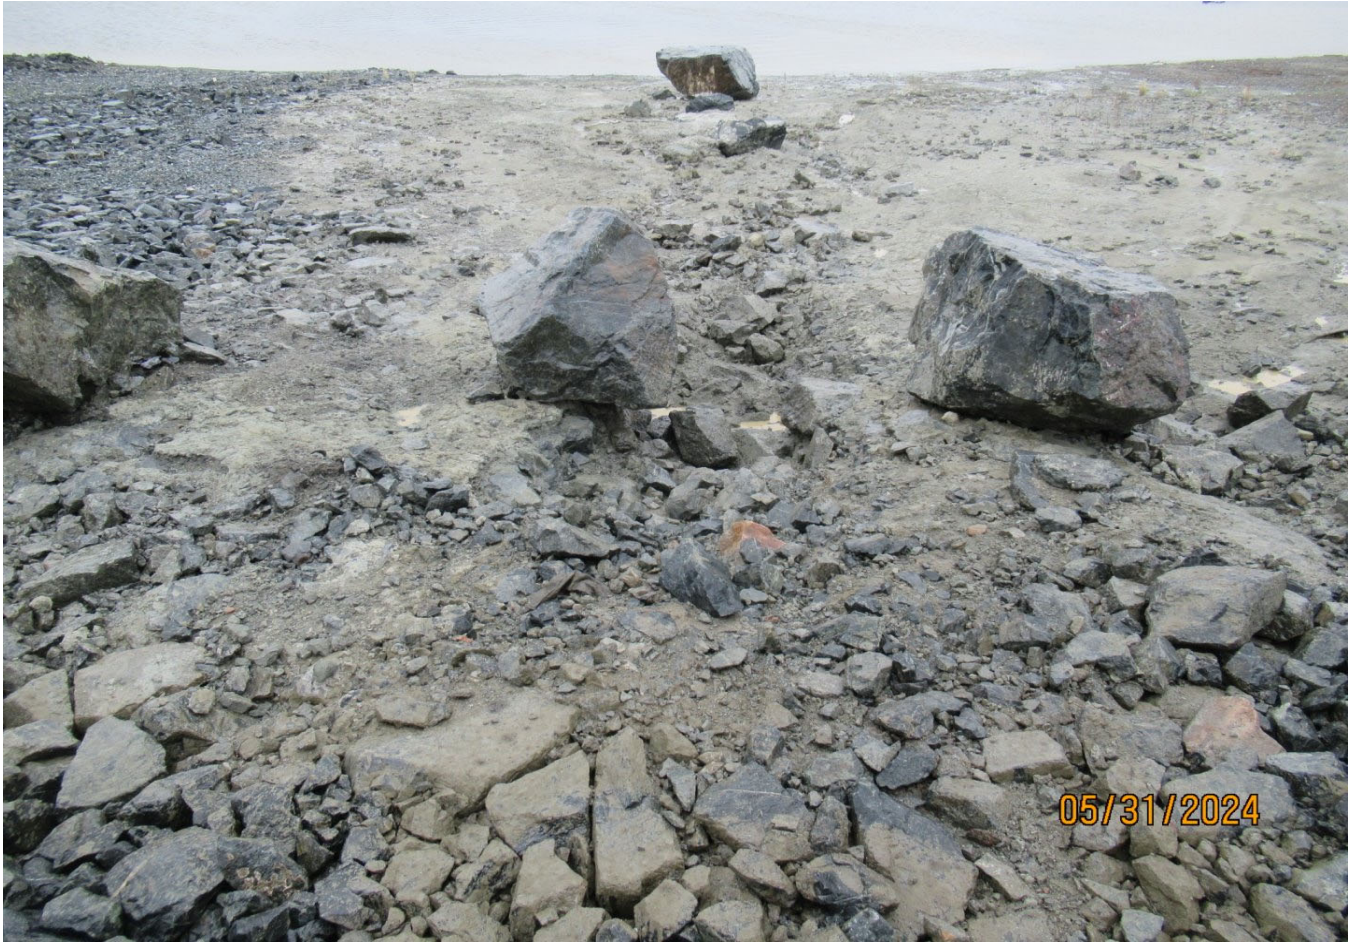
Figure 20
Vacuum truck disposal location at Middle Pud.

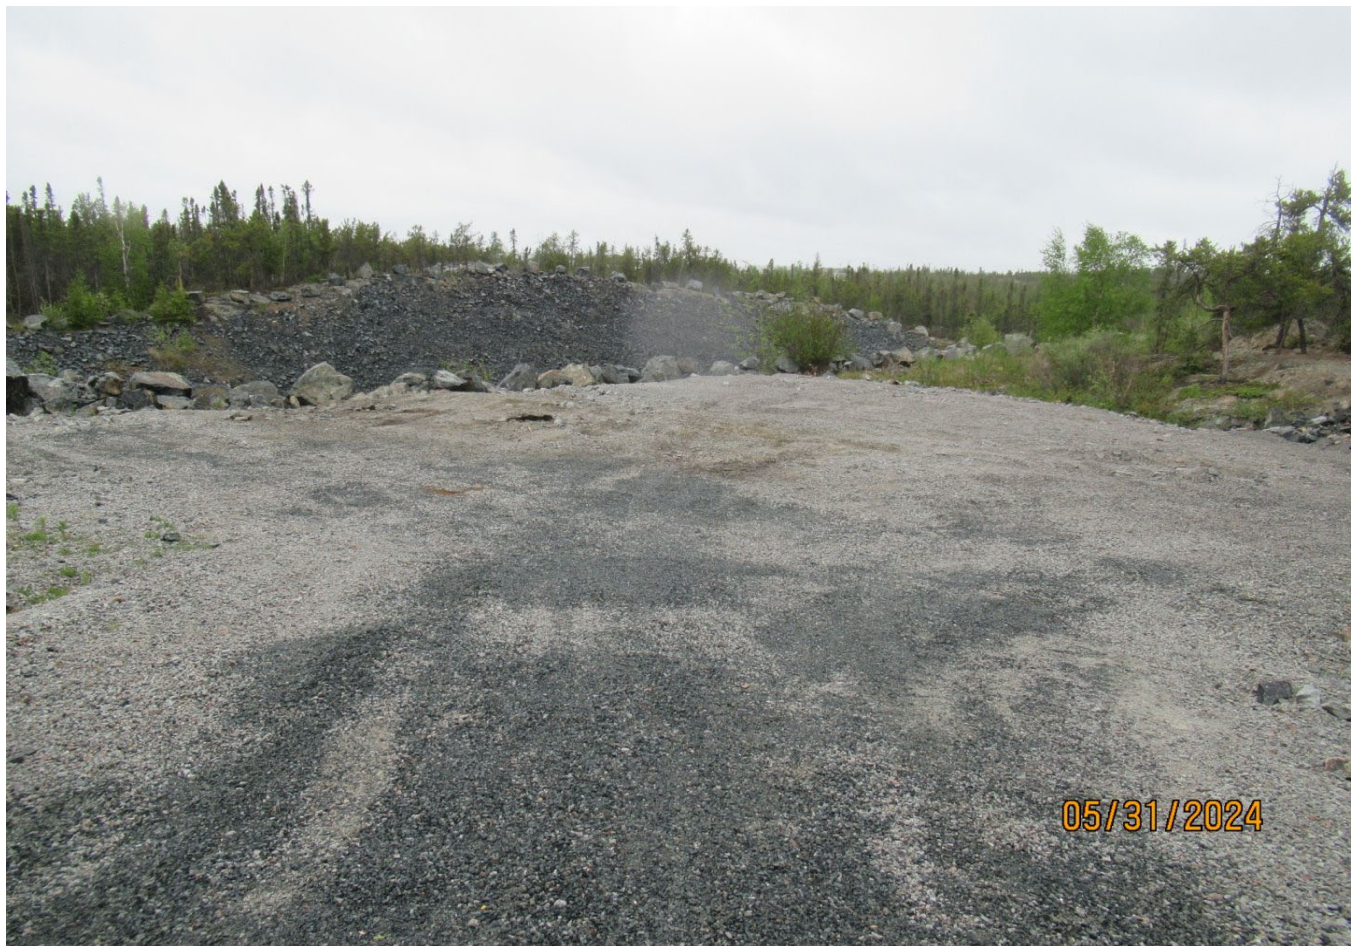
Figure 21
Completed drill site GTCM23-055. A minor amount of hydrocarbon impacted soils must be cleaned up for proper offsite disposal.

- Completed drill site GTCM23-055 can be viewed in Figure 21 and once a final decision is made on whether this hole will be re-entered, remediation will be conducted.

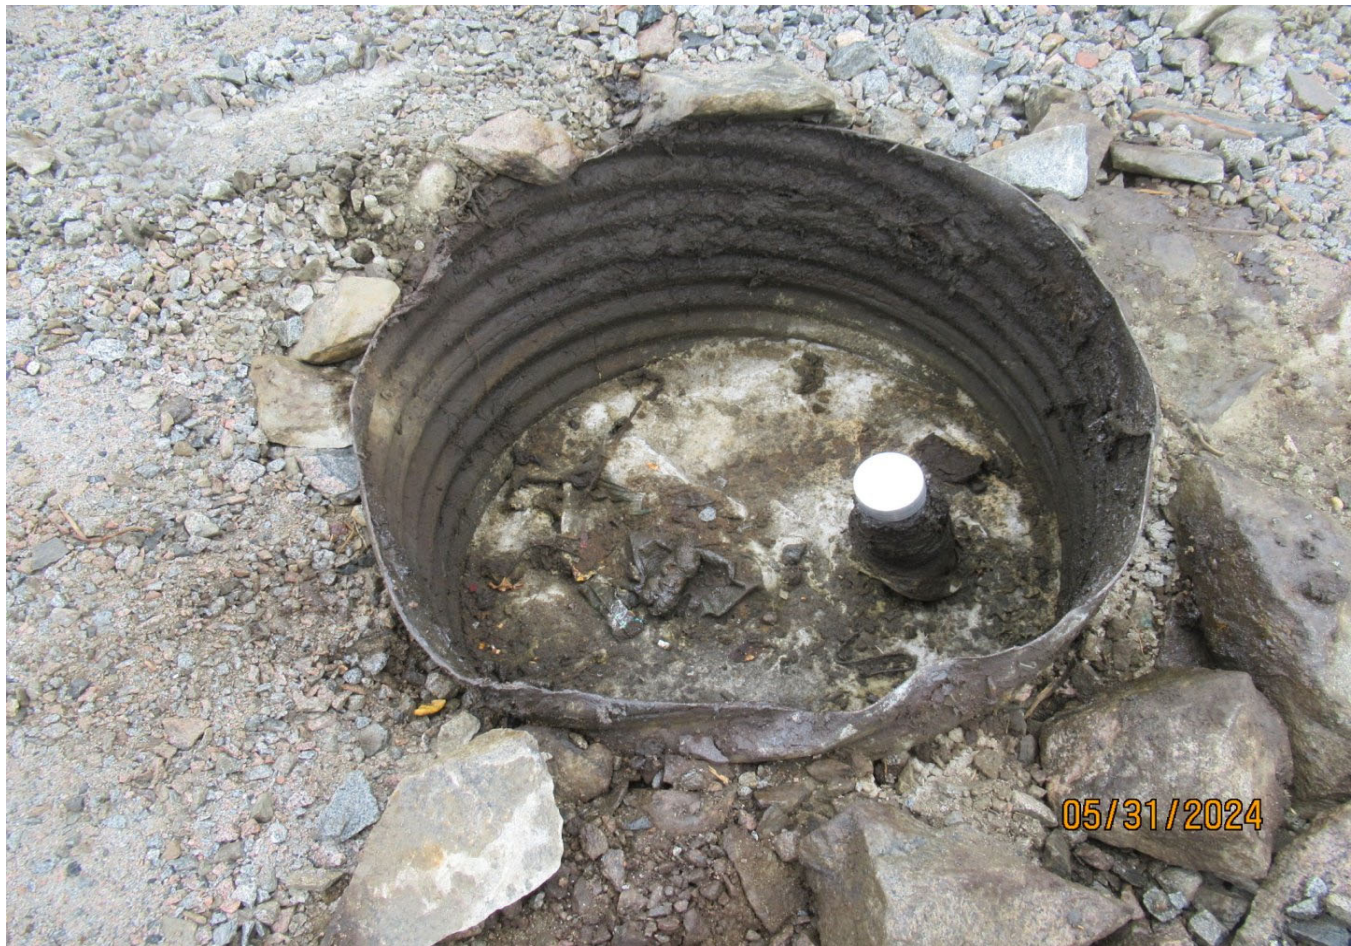
- The top portion of drill site GTCM23-055 was cemented and cap installed (Figure 22).

Figure 22
Cellar at the completed drill site. It will be removed once a final decision is made on the re-entry of this drill hole.
