<b>File Number</b>	<b>MV2019X0027</b>
<b>Type of Operation</b>	<b>MISC.</b>
<b>Location</b>	<b>KM 6 Camp, KM 184, 236 and 238 Dempster Highway #8</b>

ENVIRONMENTAL INSPECTION REPORT

Permittee:	Yukon Gov. Dept. of Highways and Public Works	Permit Expiry Date:	August 30, 2025
Land Use Permit No.	MV2019X0027	Previous Inspection:	September 18, 2023
Quarrying Permit No.		Inspection Date:	September 27, 2023
Contractor:		Subcontractor:	
Location(s) Inspected:	KM 6 Camp, KM 184, 236 and 238 Dempster Highway #8		
Current Stage of Operation:	On-going		
Program Modifications Approved:

Dempster Fibre Project:

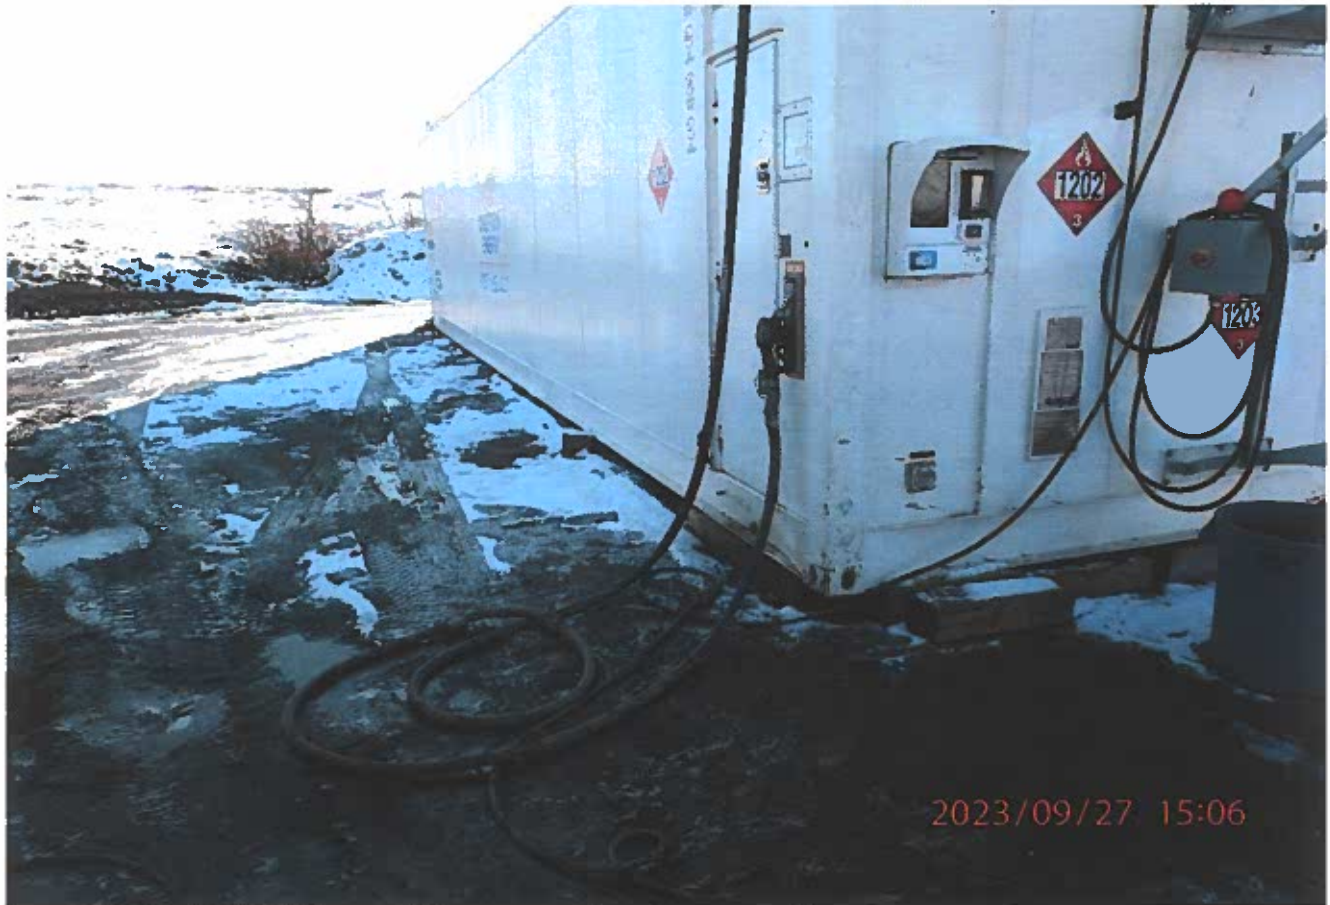
**Figure 1**

The refueling location, used for filling auxiliary tanks on the pickup trucks. There are spill trays in the vehicles.

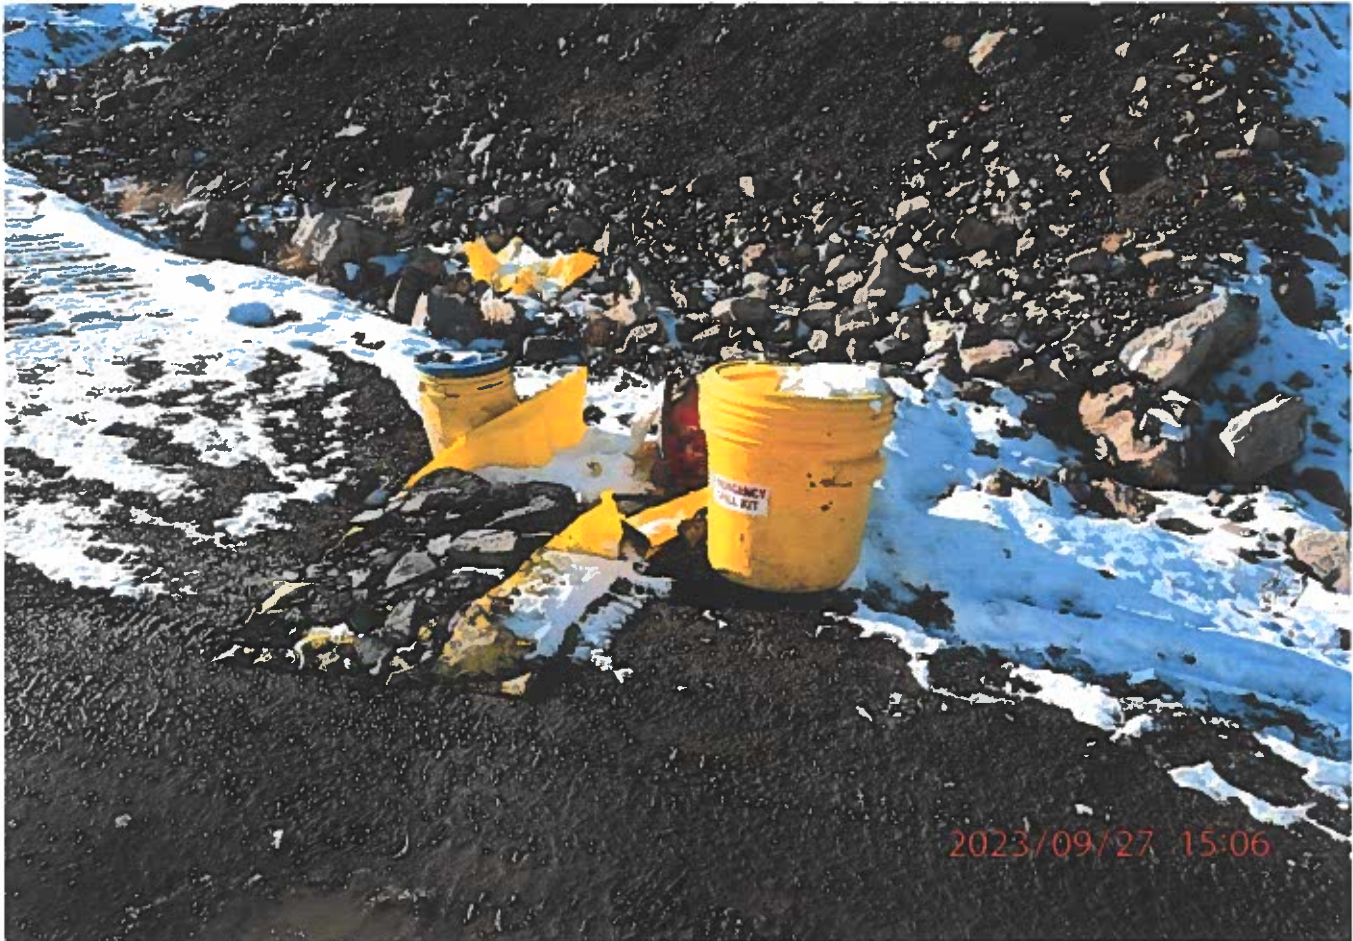
**Figure 2**

Some hazardous waste that will be stored with other hydrocarbon impacted material while they wait for transport to an approved waste facility.

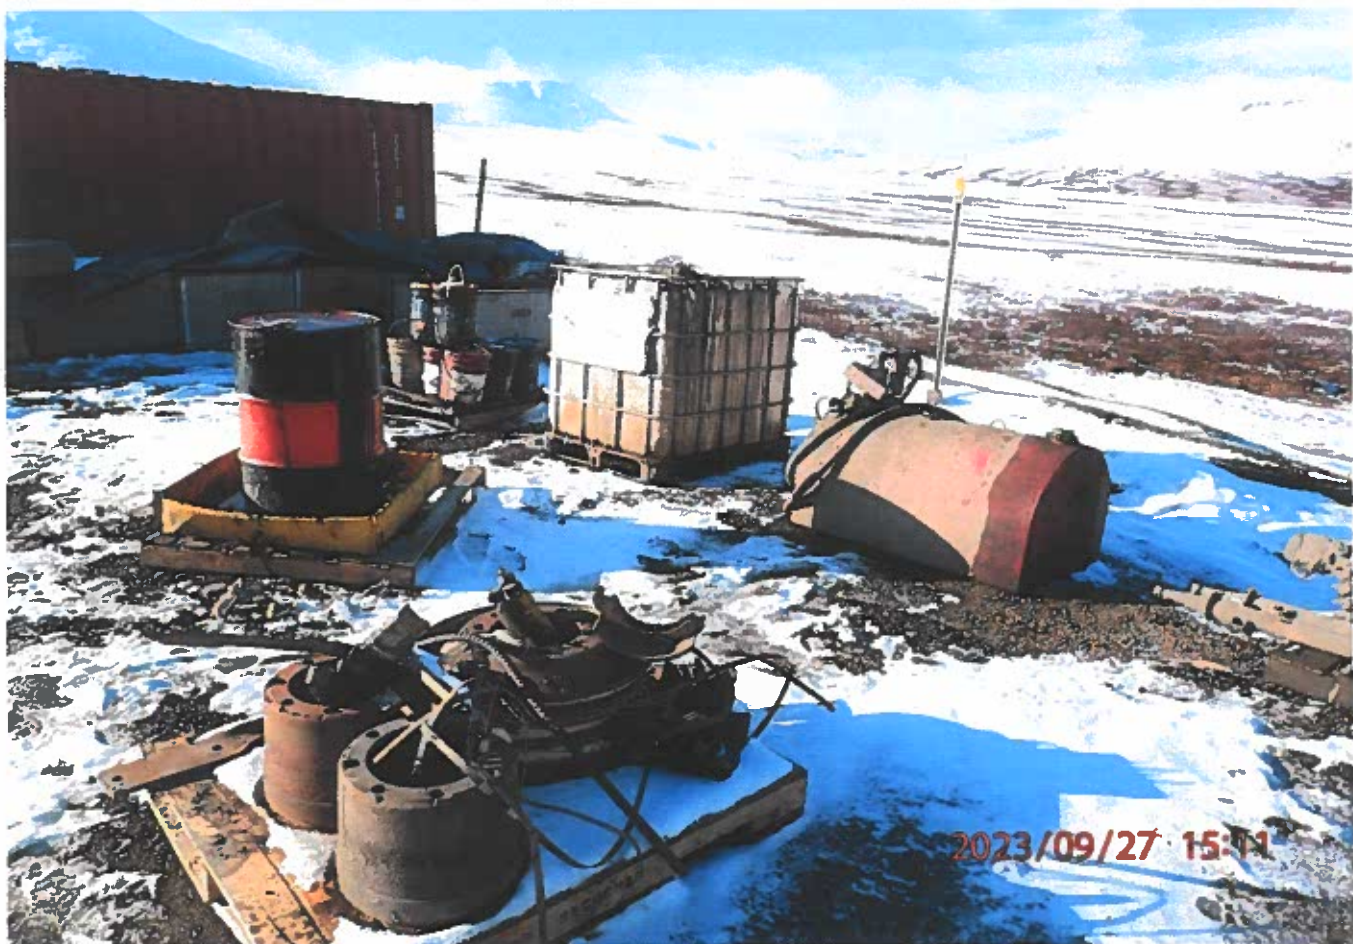
**Figure 3**

Some waste oil that was placed in secondary containment and will be labeled.

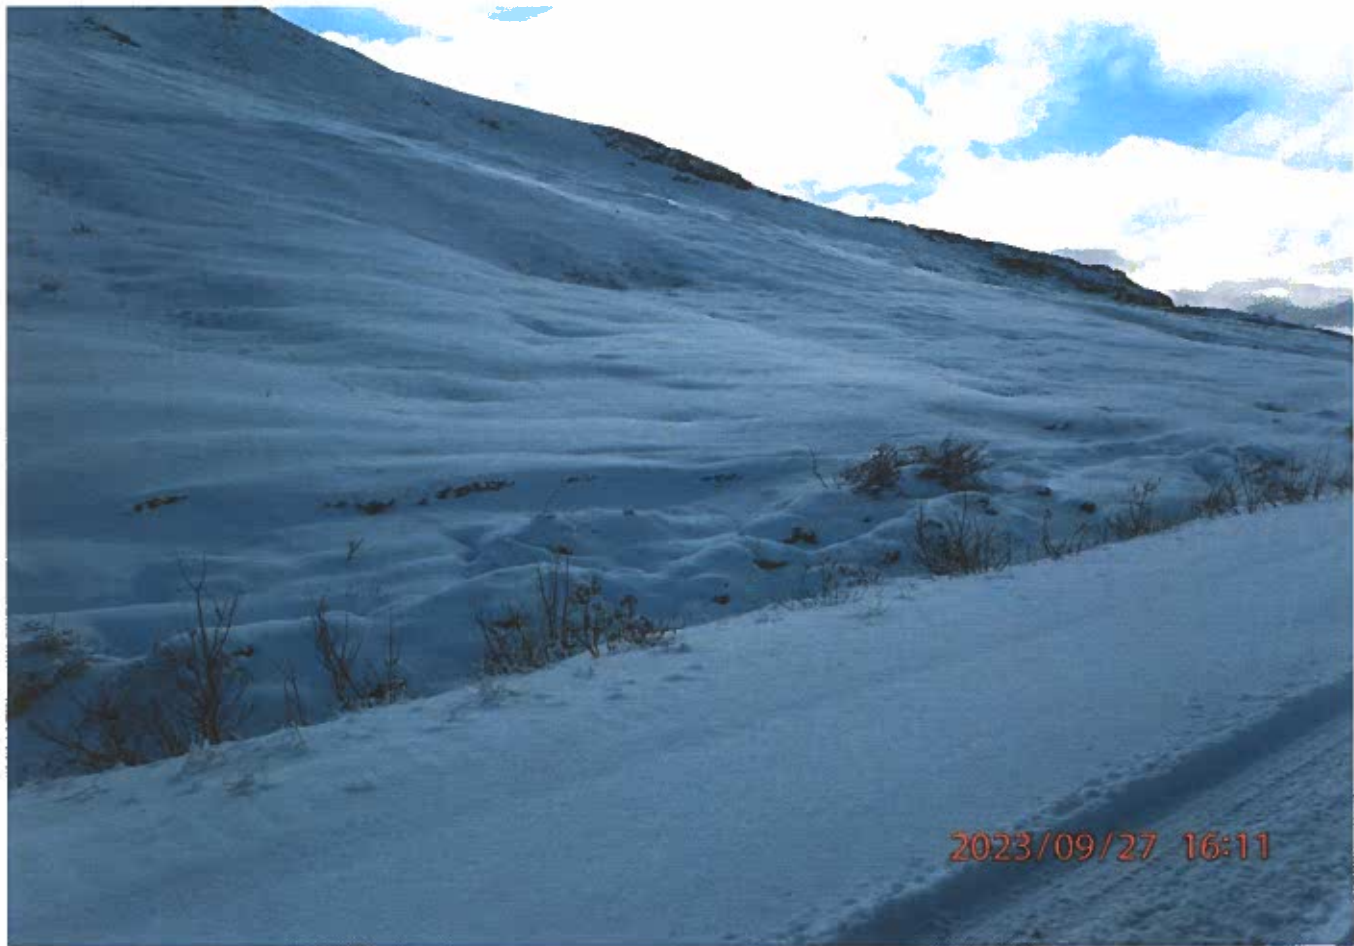
The inspector did a walk-around at the KM 6 campsite with Mr. Gary Seed from Rohl and observed the concerns around the campsite have been corrected. However, the inspector subsequently drove north along Dempster Highway #8 and observed the rutting issue at KM 24 had not yet been dealt with.

Figure 4  
The rutting at KM 24, now completely covered with snow.

Remediation to surface rutting at:

- KM 24
- KM 184
- KM 238

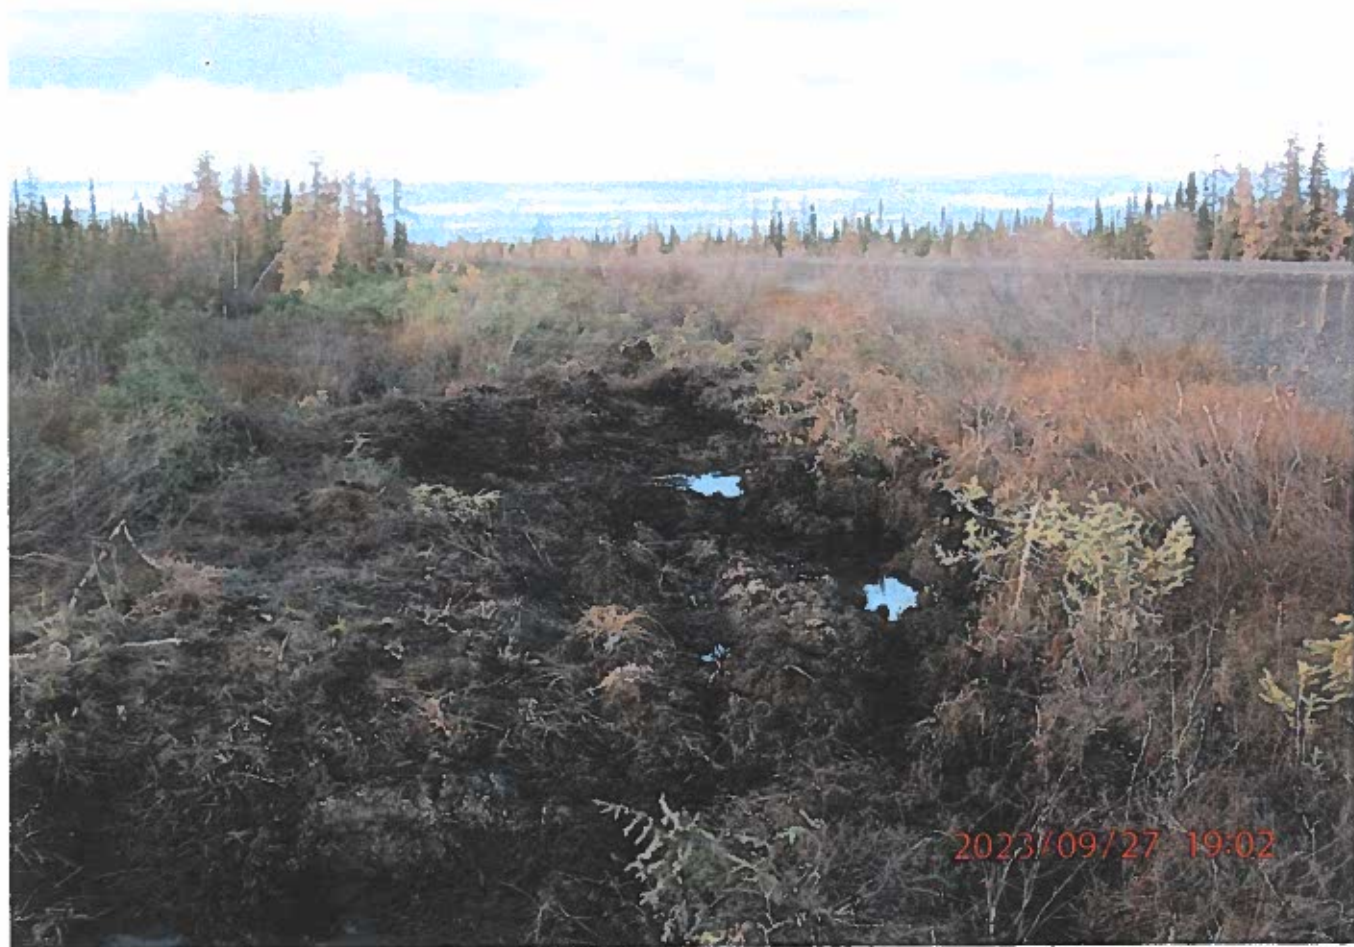
Figure 5  
Some rutting at KM 184.

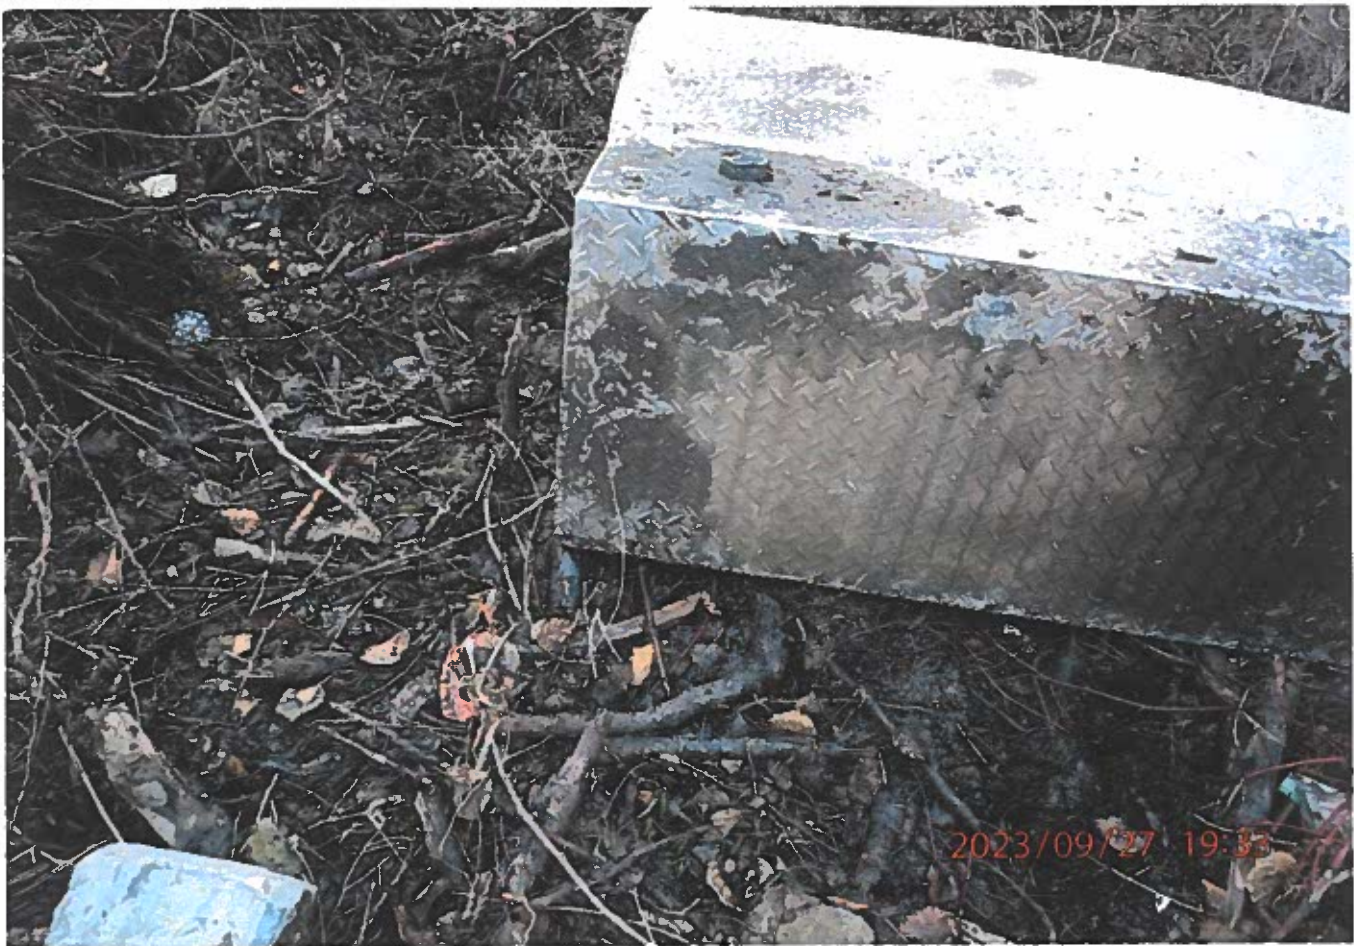
**Figure 6**

The source of the spill at KM 236.

Hydrocarbon spill clean-up at:

- KM 236

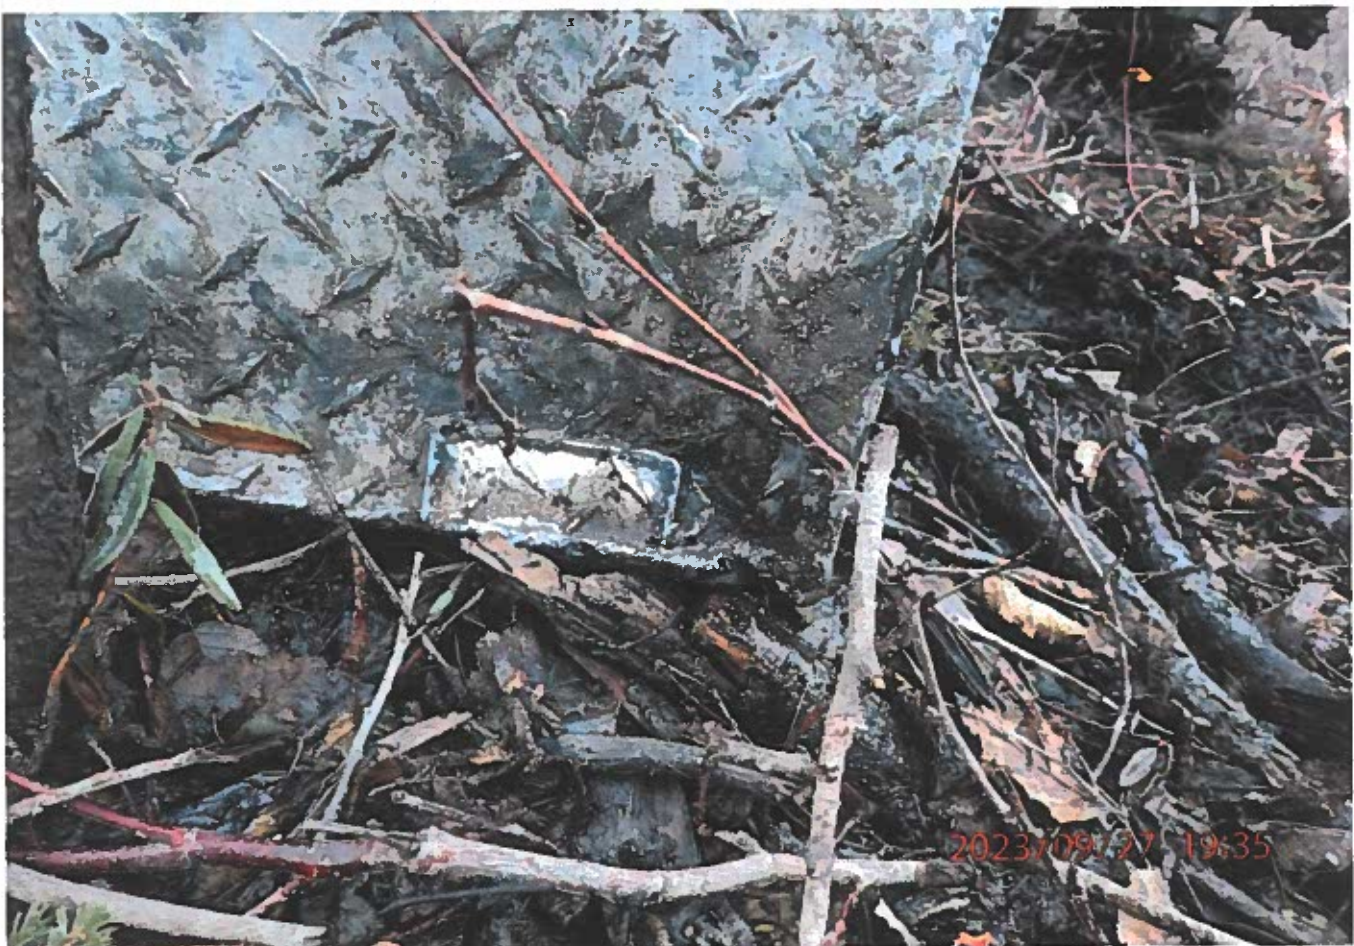
**Figure 7**

A close-up image of the damage at the bottom of the tank in the previous photo.

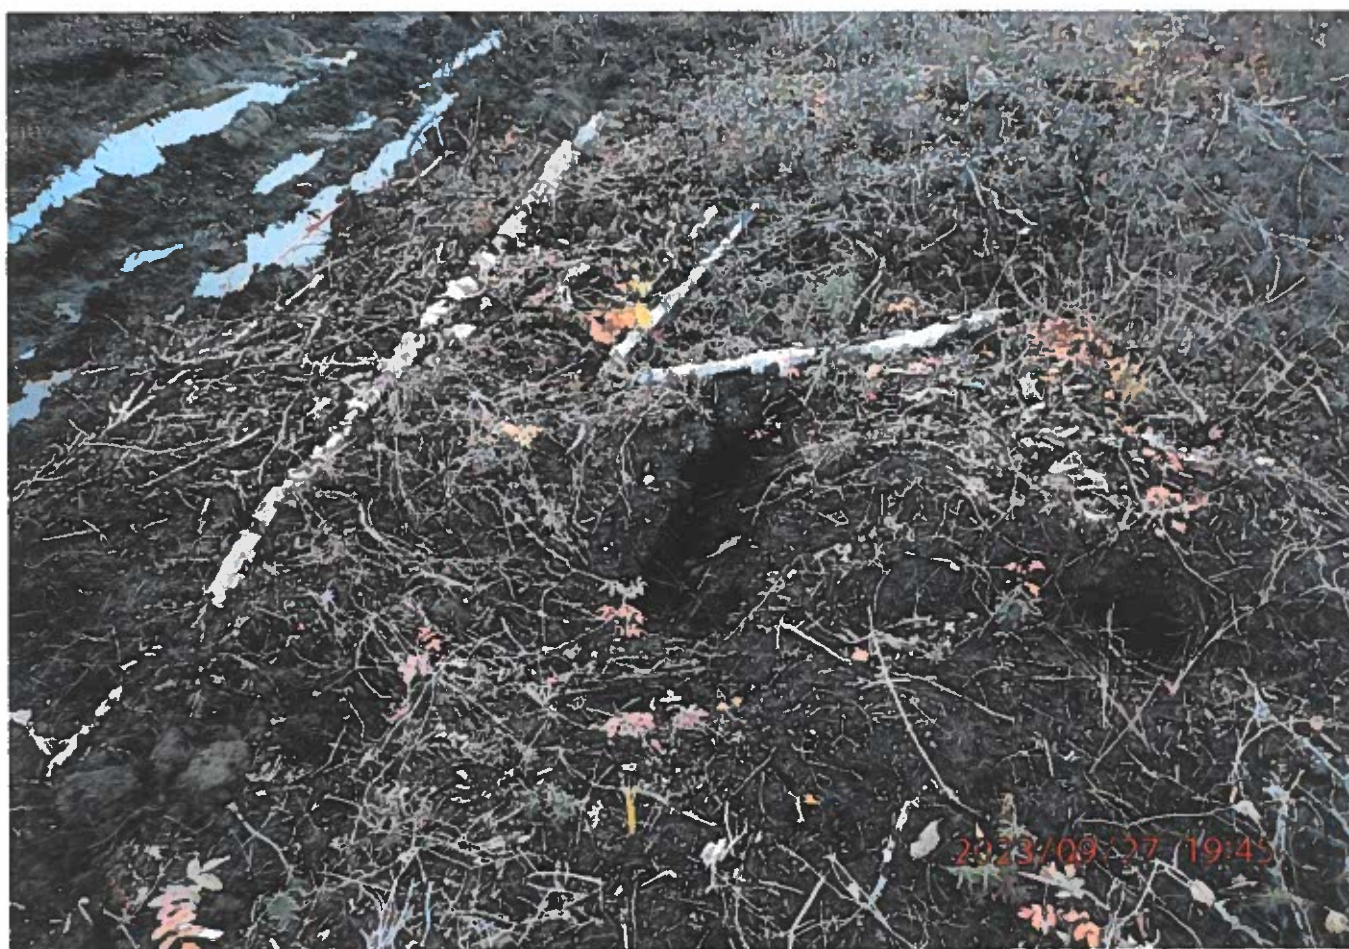
**Figure 8**

The surface damage at KM 238.

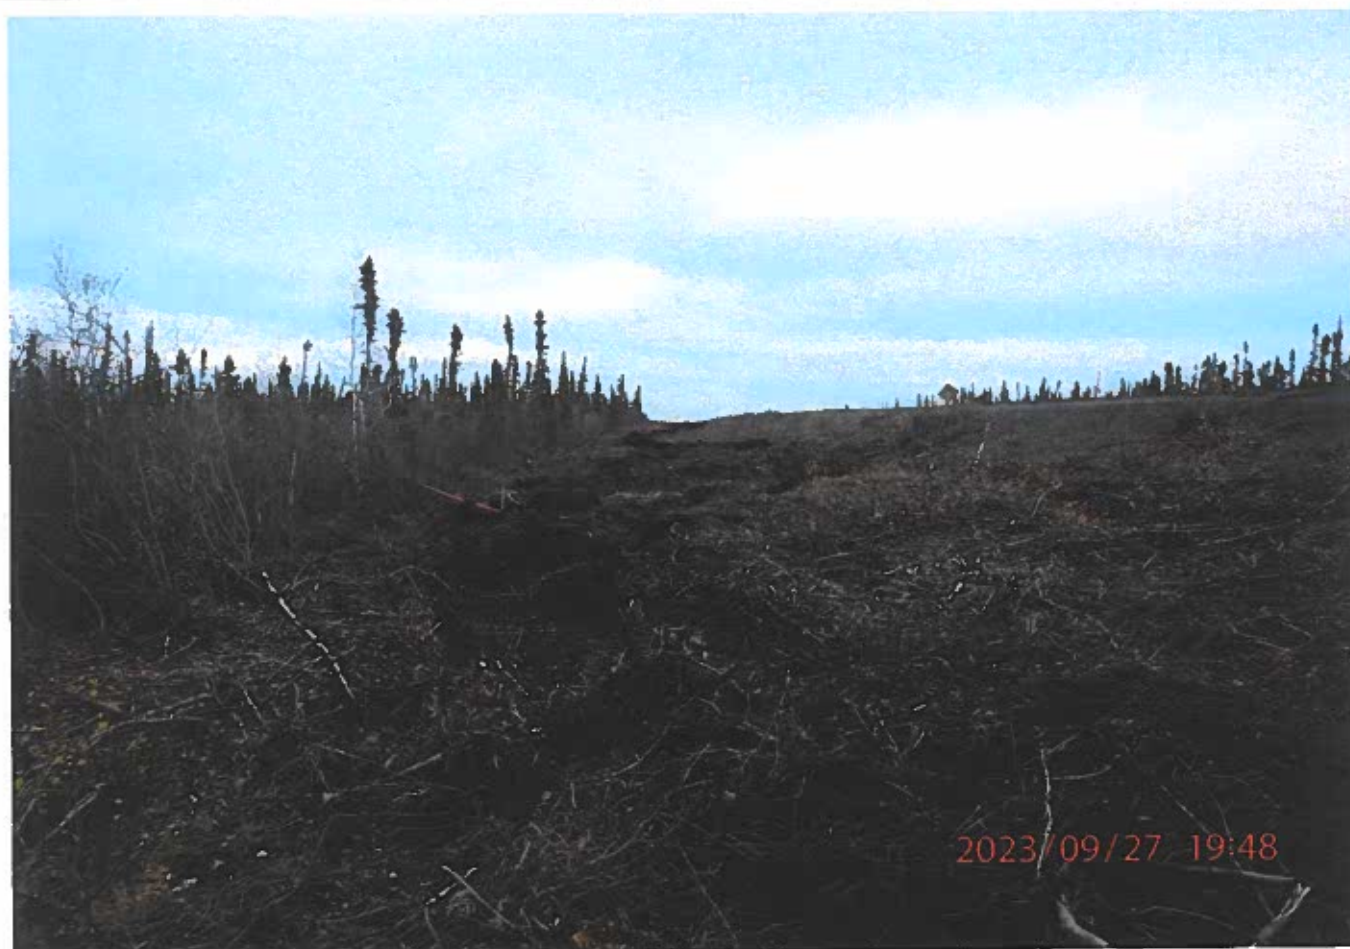
**Figure 9**

Another photo of the damage near KM 238.

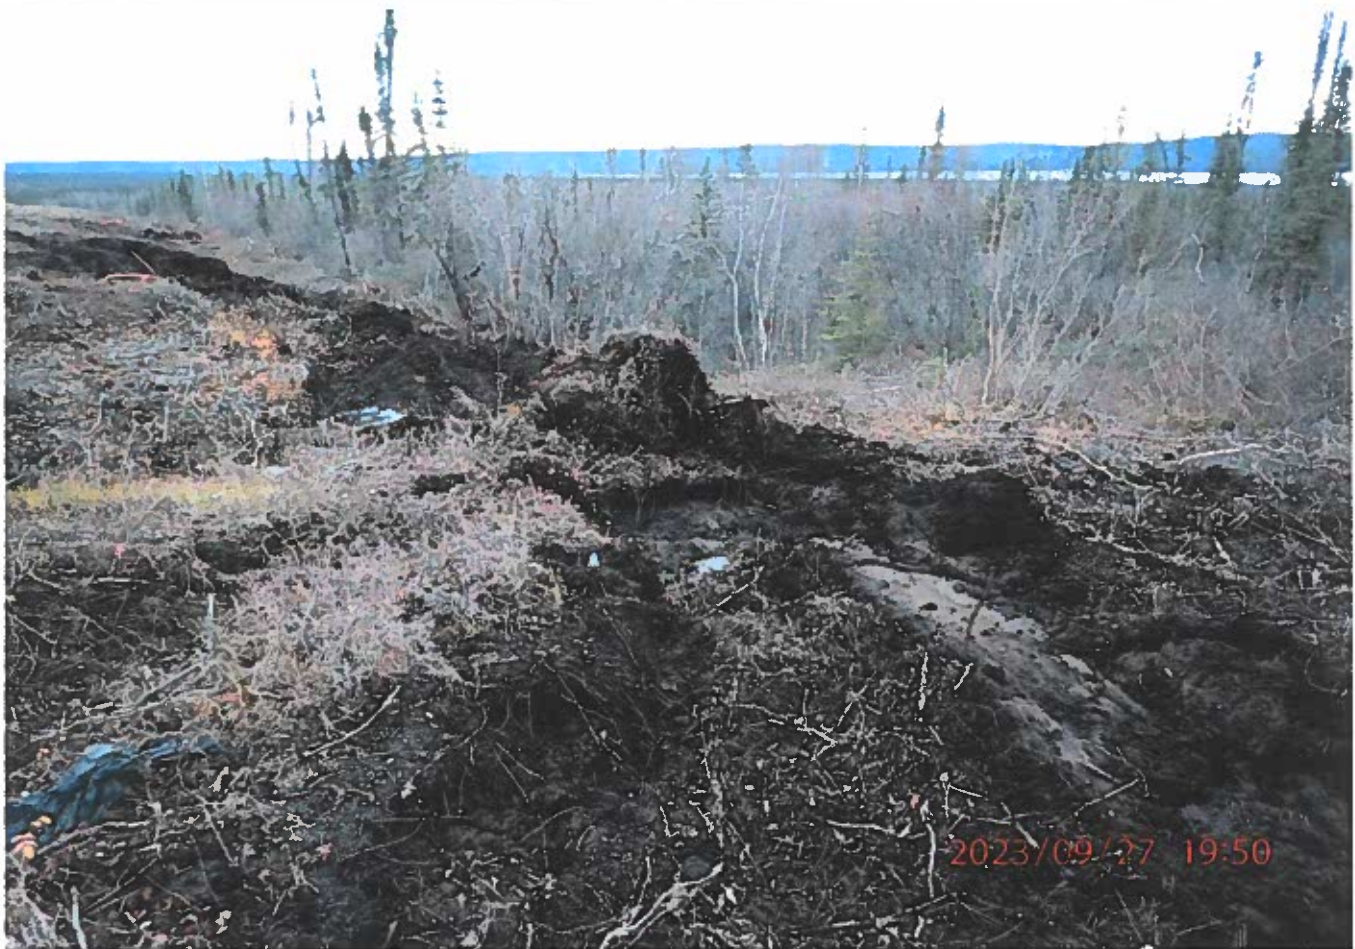
**Figure 10**

**Another photo of the extensive damage near KM 238.**
