# OROGO Site Decommissioning Inspection Summary Report

Facility: Liard West	Location: West of Fort Liard, NT
OA#: POA-2620-D-12-9 (Liard West Field)	H <sub>2</sub> S site? <input checked="" type="checkbox"/> Yes <input type="checkbox"/> No
Operator: Paramount Resources Ltd.	Facility status: Shut In
Site Representative (if applicable): D.Rock Oilfield Consulting & Contracting	Details: Crews were actively pigging and decommissioning pipelines, disconnecting above ground pipelines from buildings, and removing associated debris from site.
Name: Rocky Arndt Title: Construction Foreman	
Associated Well(s): Facilities decommissioning at K-29, M-25, F-25, and O-80 See Well Inspection Report Form dated: 2023-08-01

Date of inspection: 2024-07-30	OROGO Inspectors: Brandon Bradbury and Mike Martin
Access method: Vehicle

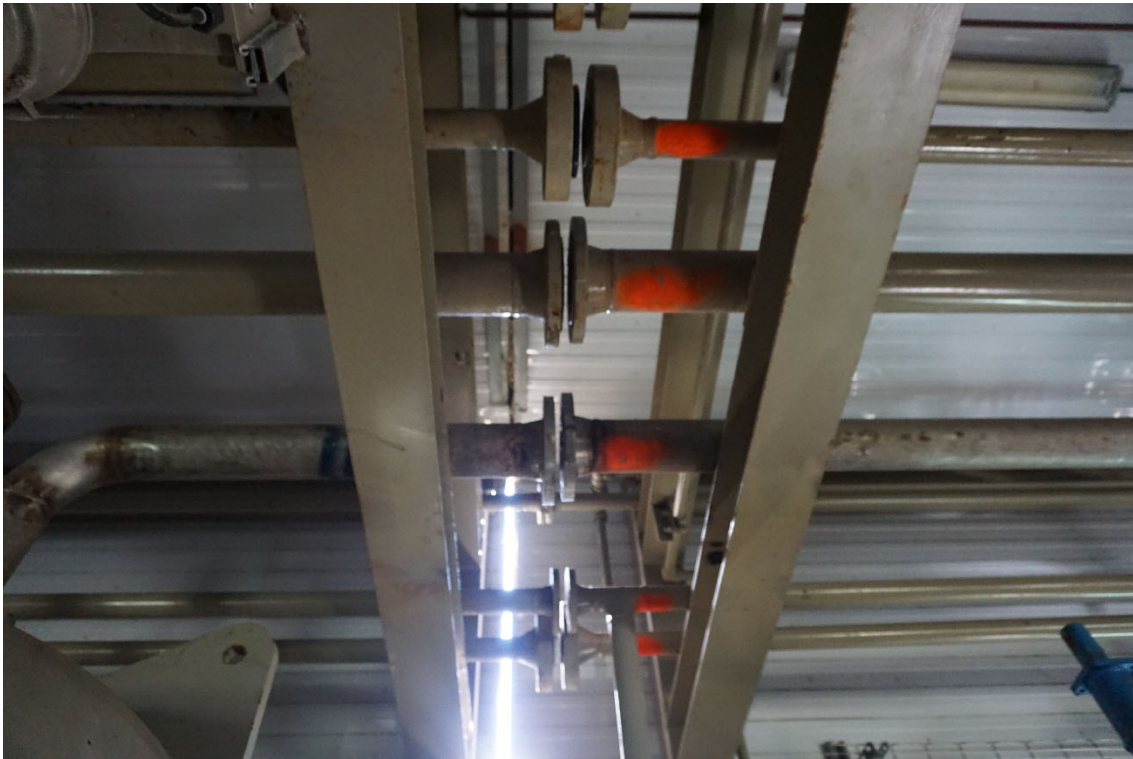
Structures	Status: Being separated and disconnected from gas lines & electrical lines for offsite removal. Buildings have also been cut with a torch from all pilings so they can be hoisted and staged for removal. (Photo #1)
Pilings	Status: Some pilings have been removed to allow access to the buildings on site but the majority have been left in the ground until final reclamation of the land use area (Photo #2).
Above ground lines	Status: Actively being dismantled, insulation being removed from pipelines, and all above ground pipelines are being cut to an appropriate length with an excavator mounted shear. All above ground pipelines are being containerized into metal bins which are being actively removed on an ongoing basis to prevent accumulation on site (Photos #3 & #4).
Oil and gas processing equipment	Status: Equipment is being disconnected from above ground lines, and all electrical lines are being wrapped and safely secured inside the buildings (Photos #5 & #6). Equipment not purged to the facilities structure is being collected and staged for backhaul. Equipment attached to the structures have been emptied/purged and labeled and will remain in place until they reach the salvage location in Fort Nelson (Photo #7).

Photo #1: Pipelines inside buildings have been disconnected along with the walls and floor of the building.

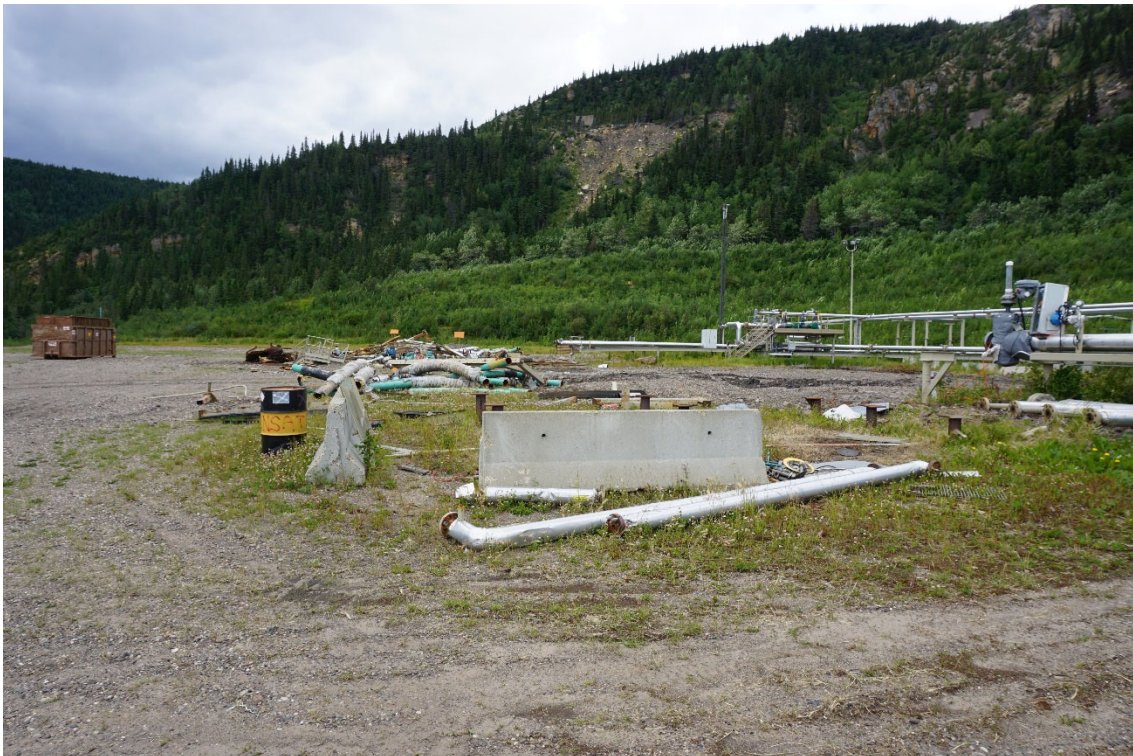
Photo #2: Waste items have been consolidated on site until waste bins arrive for proper offsite disposal. Remaining Pilings can be seen in place for future removal.

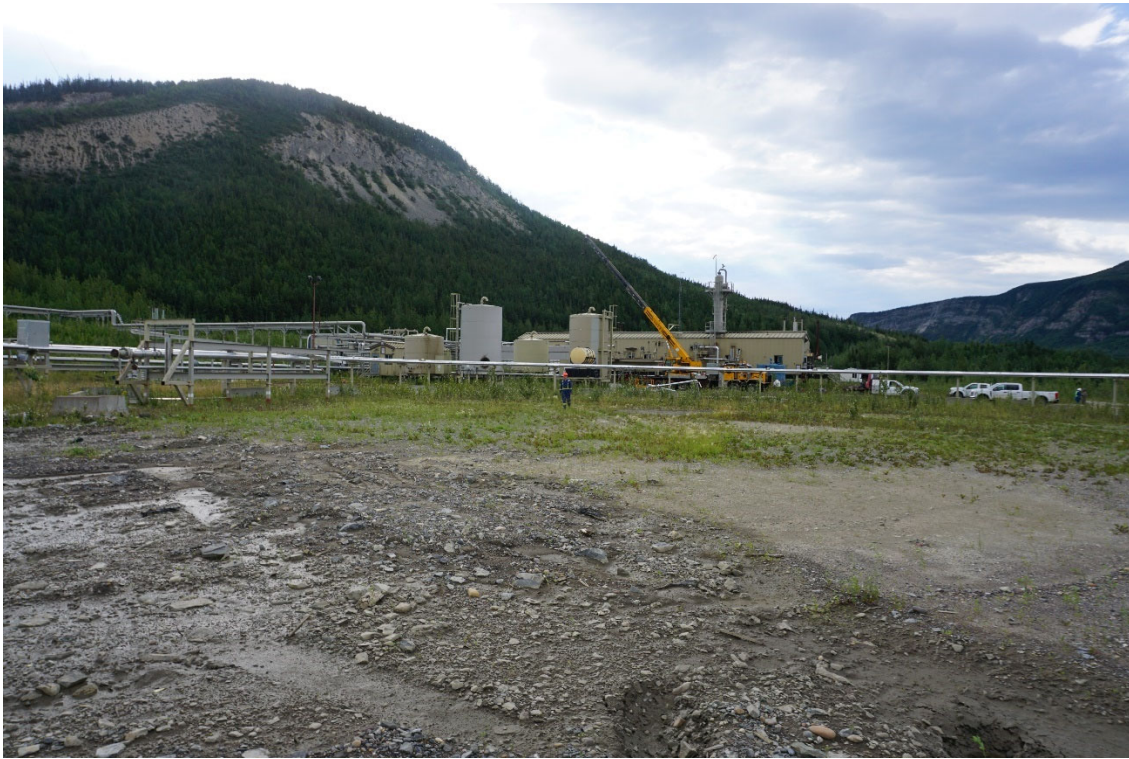
Photo #3: Above ground pipelines are being dismantled.

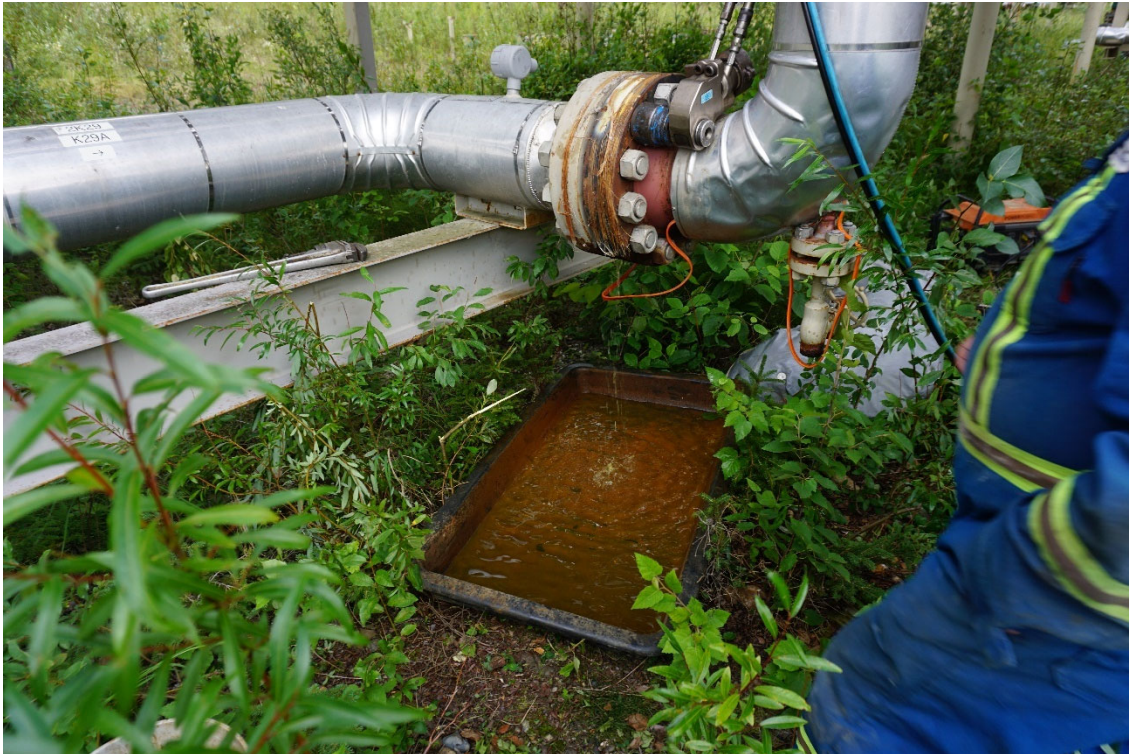
Photo #4: Drip trays were present underneath disconnected lines to prevent impacts to the underlying soils.

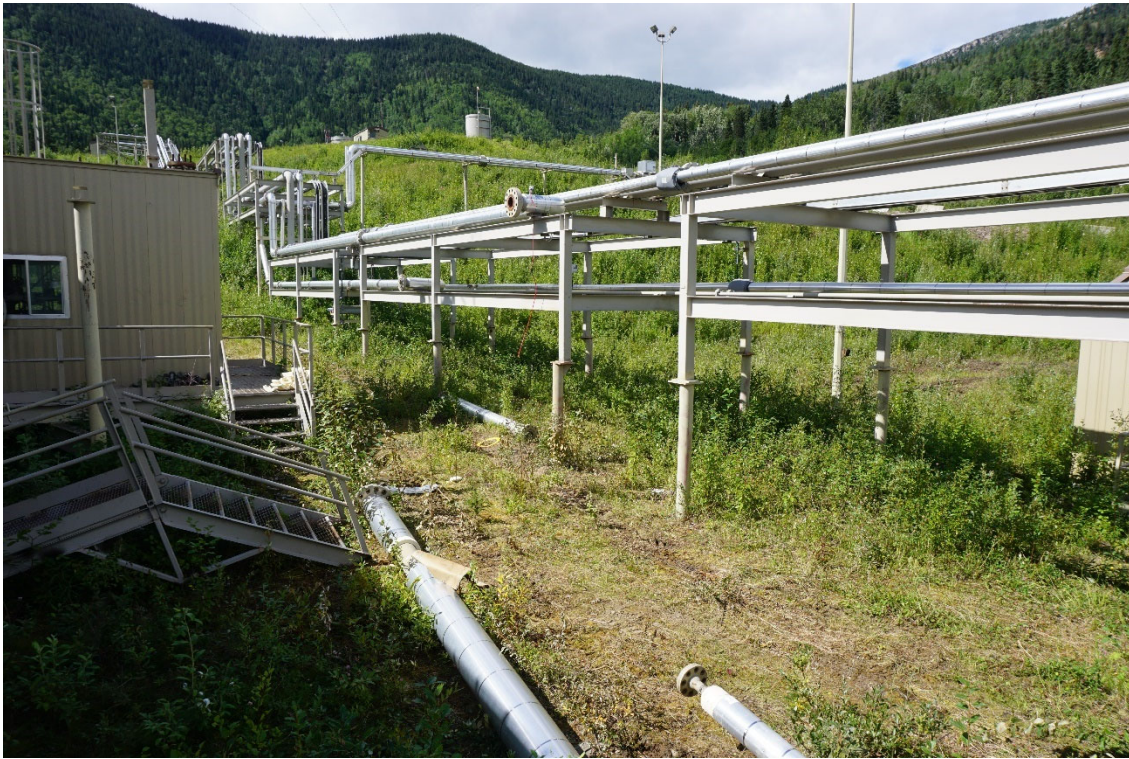
Photo #5: Above ground lines at the F-25 site have been disconnected from the separator buildings.

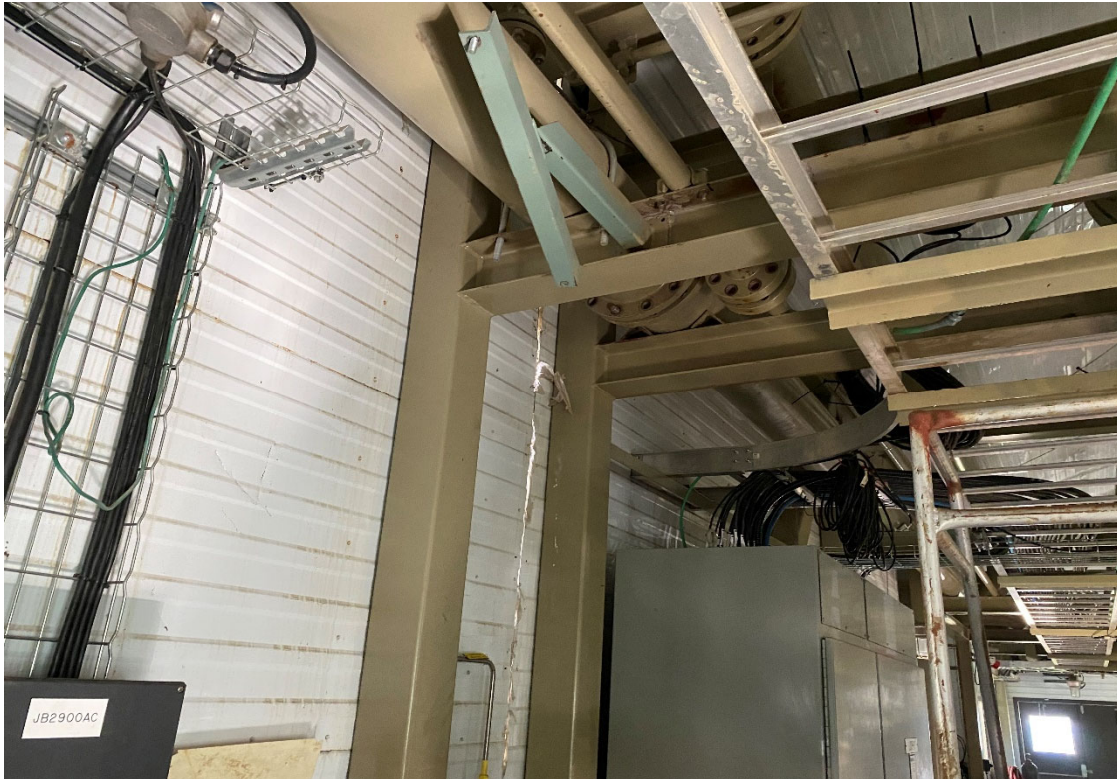
Photo #6: Electrical lines are disconnected and wrapped neatly inside the buildings.

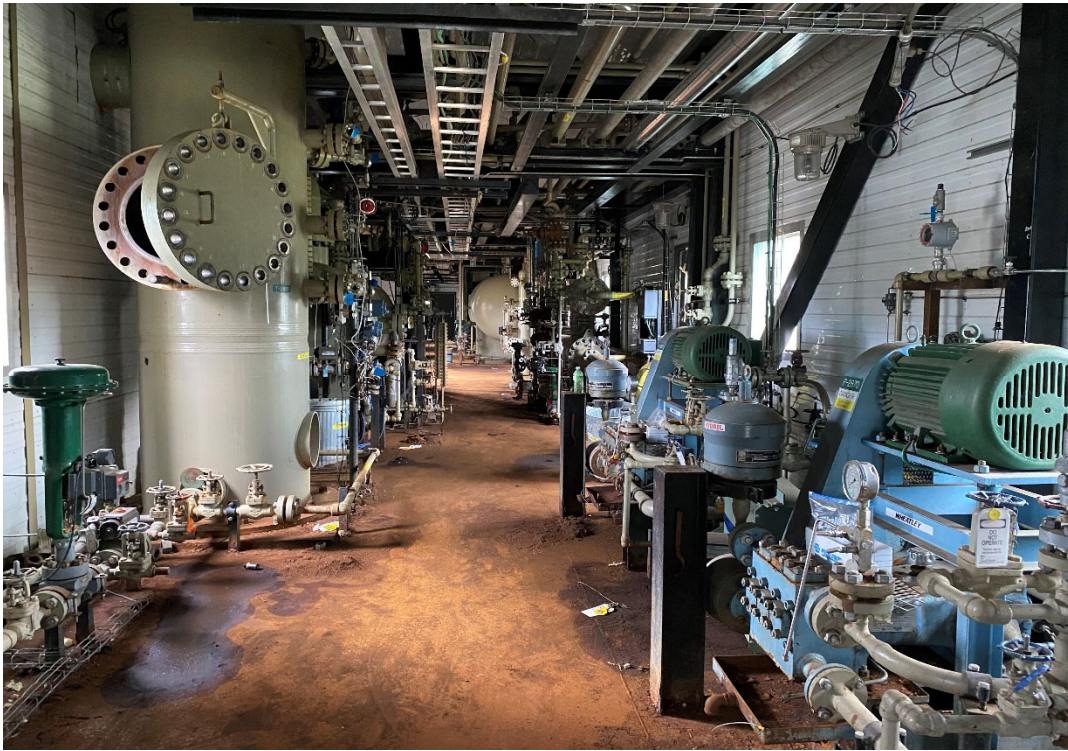
Photo #7: View of the inside of a purged and plugged building that has been disconnected from the outside above ground pipelines.

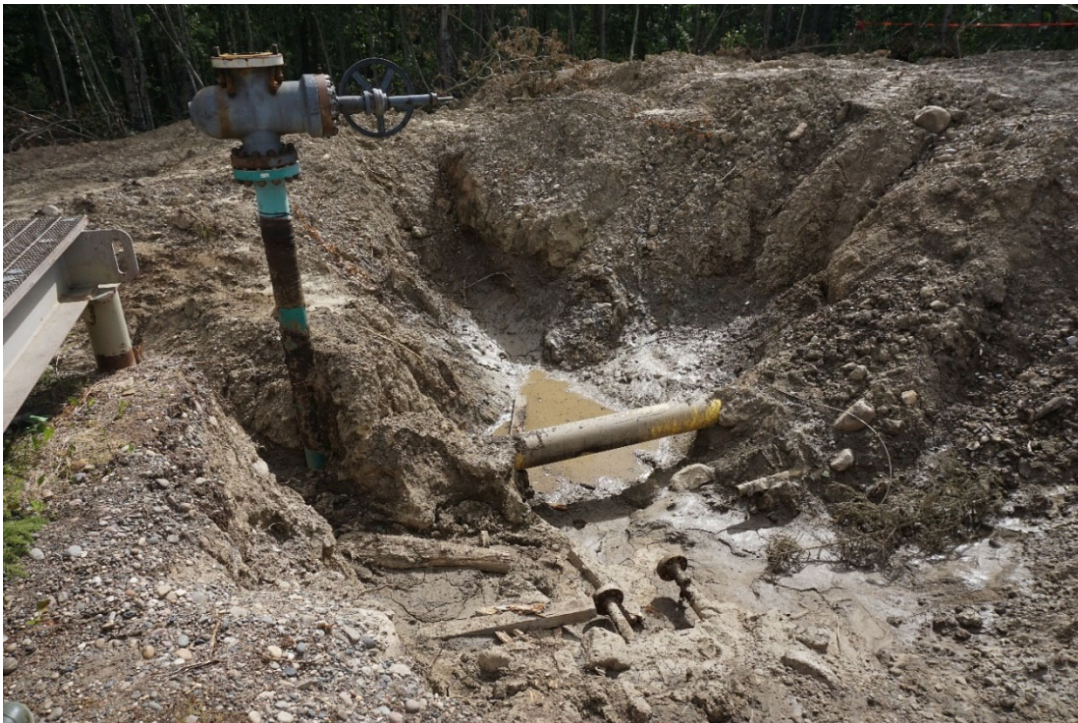
Purging	Status:
Pigging	Status: Pipelines from all facilities (K-29, M-25, F-25) have been pigged to the junction (Photo #8), along with the pipeline from the junction point in Liard West to the Pointed Mountain Transboundary Pipeline (Photo #9). Waterlines have also been pigged to the O-80 water injection well. (Photo #10)
Plugging	Status: upon completion of pigging and confirmation that all product has been removed, pipelines are being cut where they turn in a horizontal direction and plugged and backfilled in place.
Burying	Status: No debris is being buried on site and capped pipelines are being backfilled. Ongoing backfilling and mounding is proposed for all capped pipelines below ground surface.
Overall pipelines decommissioning is:	Comments:
<input checked="" type="checkbox"/> Acceptable <input type="checkbox"/> Unacceptable <input type="checkbox"/> Unacceptable but corrected onsite <input type="checkbox"/> Not applicable

Photo #8: Waterlines at the junction that leads to the O-80 Injection well. And Pipelines from the Liard West field that lead to the South Pointed Mountain pig receiver. This hole will be refilled and mounded to prevent the ponding of water.

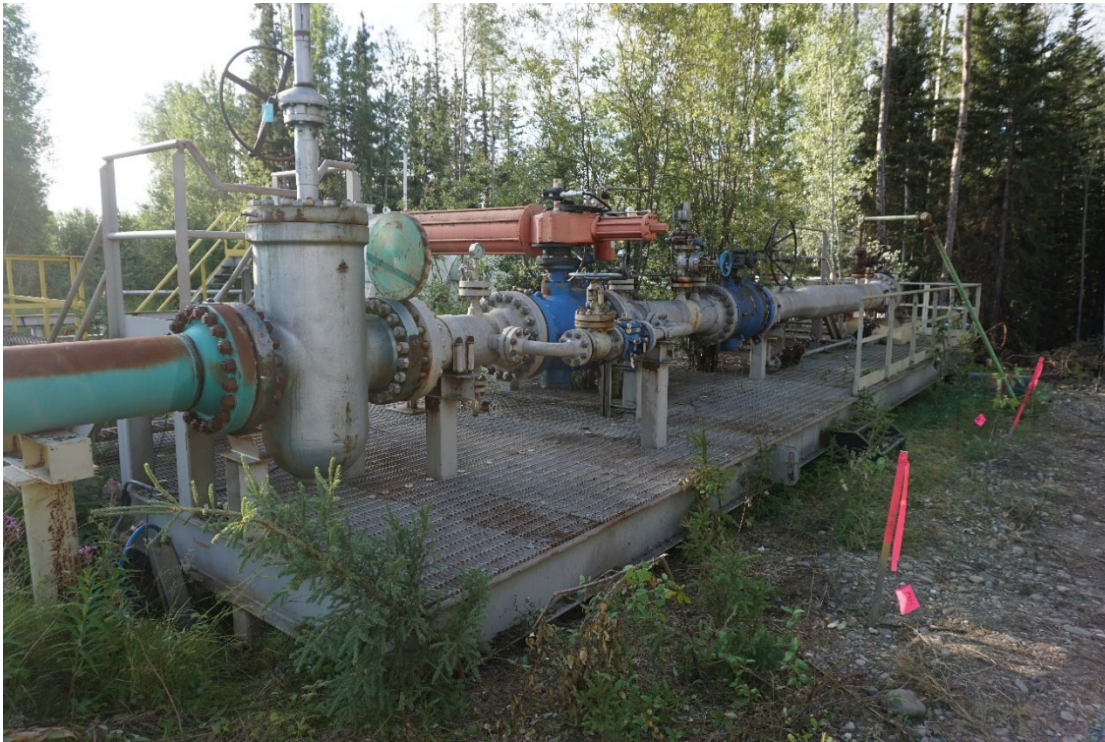
Photo #9: View of the South Pointed Mountain pig receiver. The pipeline from the Liard West Field ties into the South Pointed Mountain transboundary pipeline at this location.

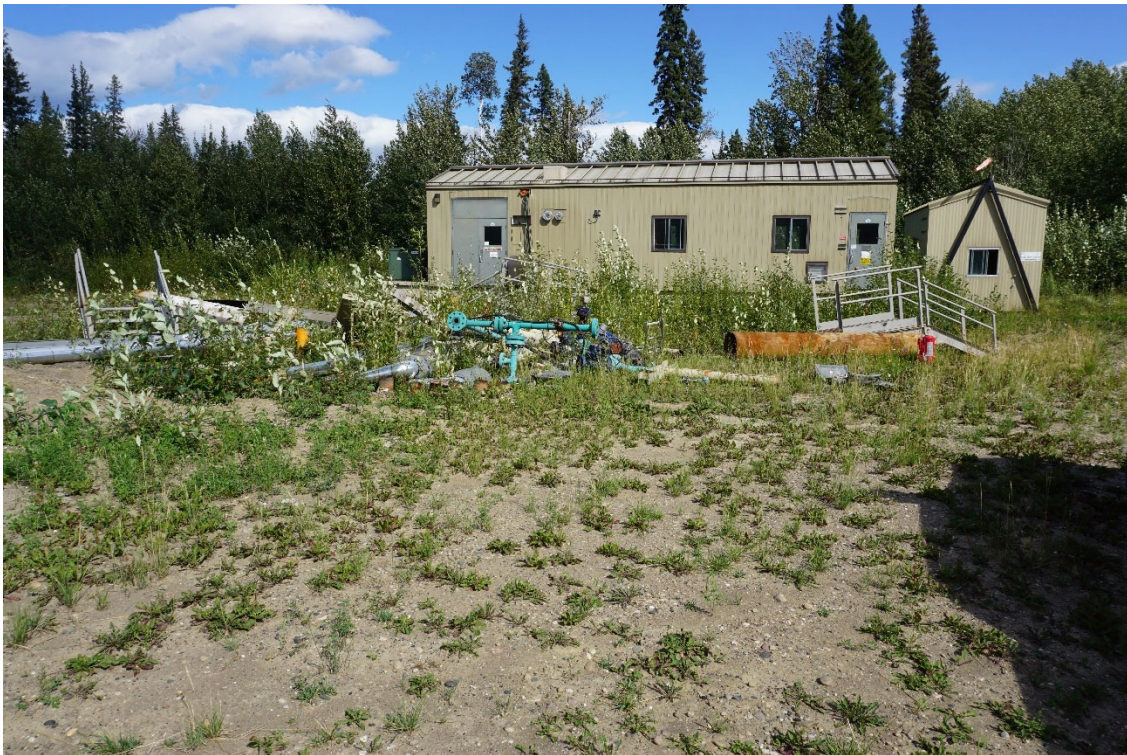
Photo #10: View of the consolidated waste at the O-80 water injection well that will be removed.

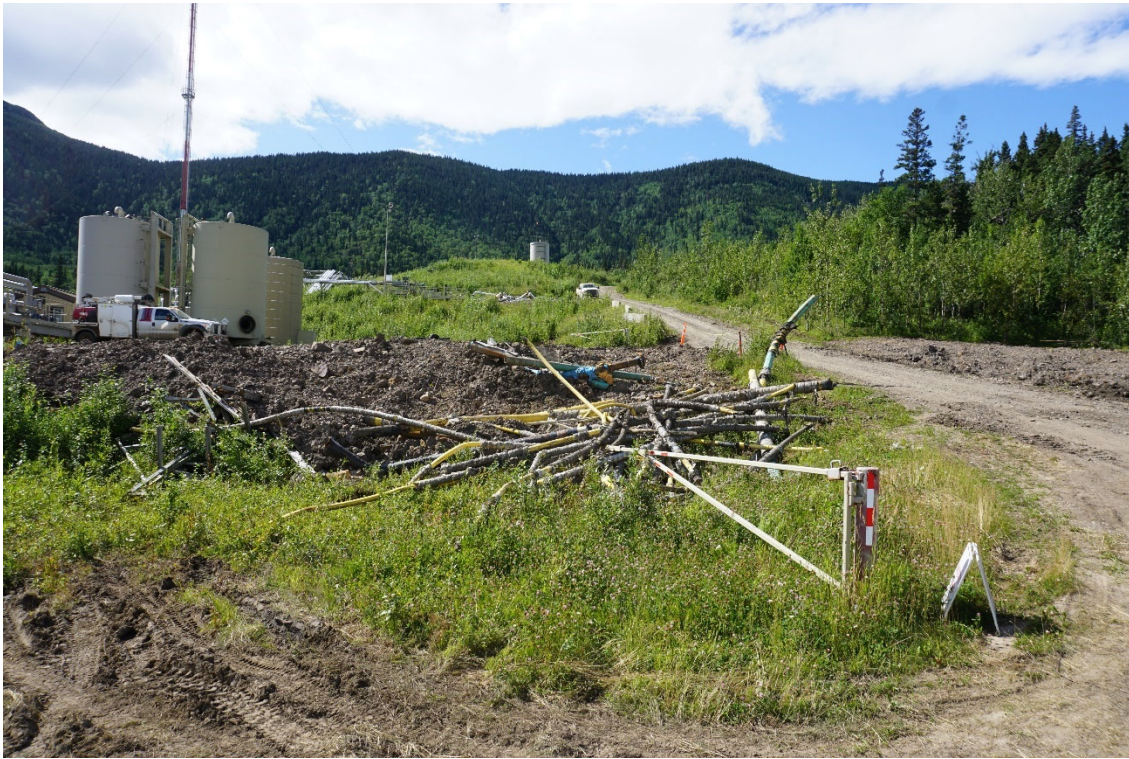
Photo #11: Waterline was removed from the ground and staged at the F-25 site.

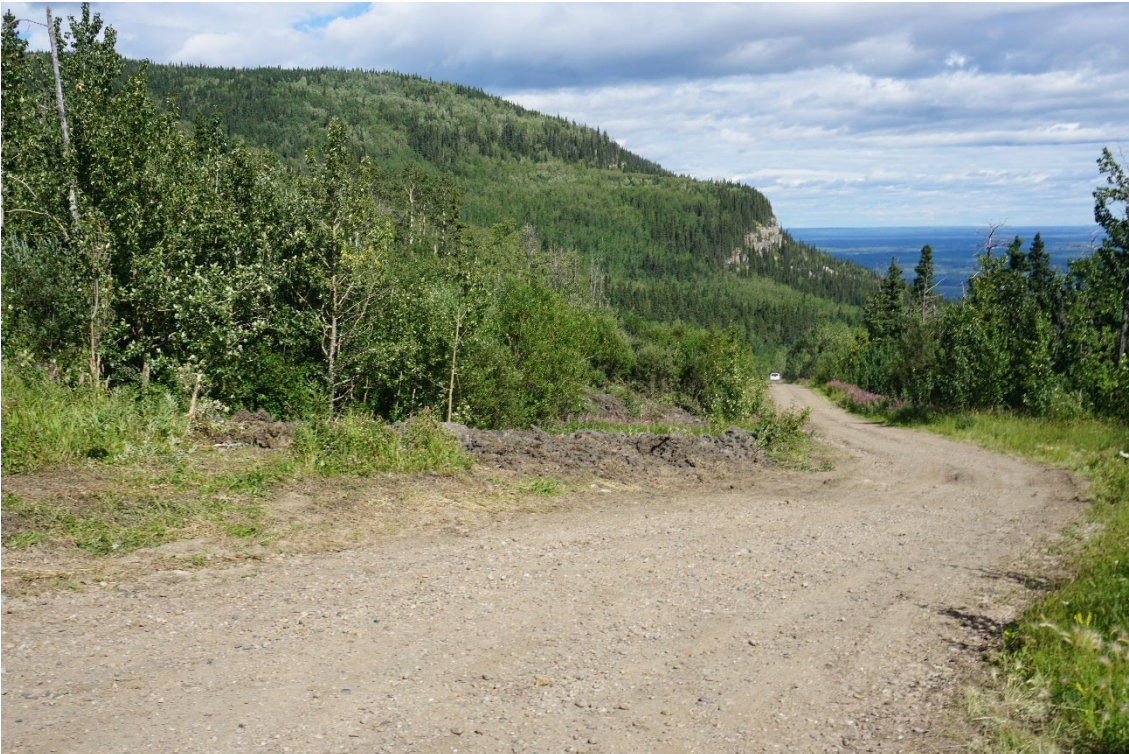
Photo #12: Water pipeline was removed laterally in sections to minimize ground disturbance.

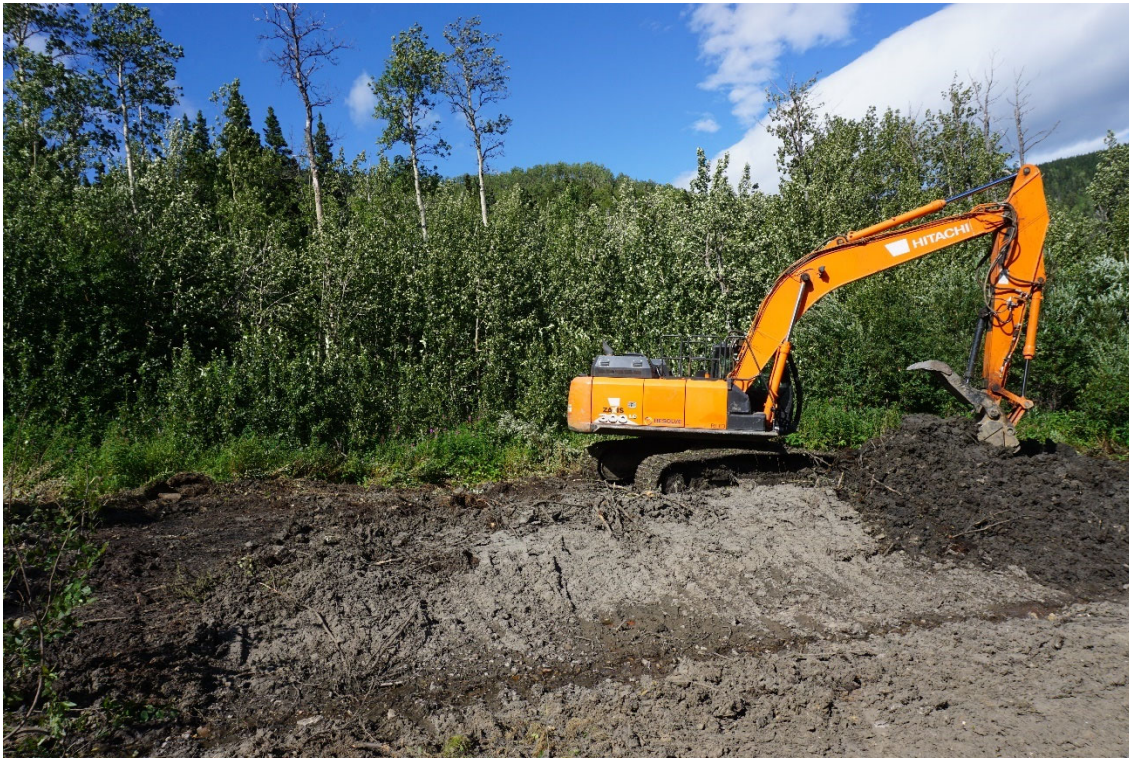
Photo #13: The areas under the waterline extraction points were re-contoured.

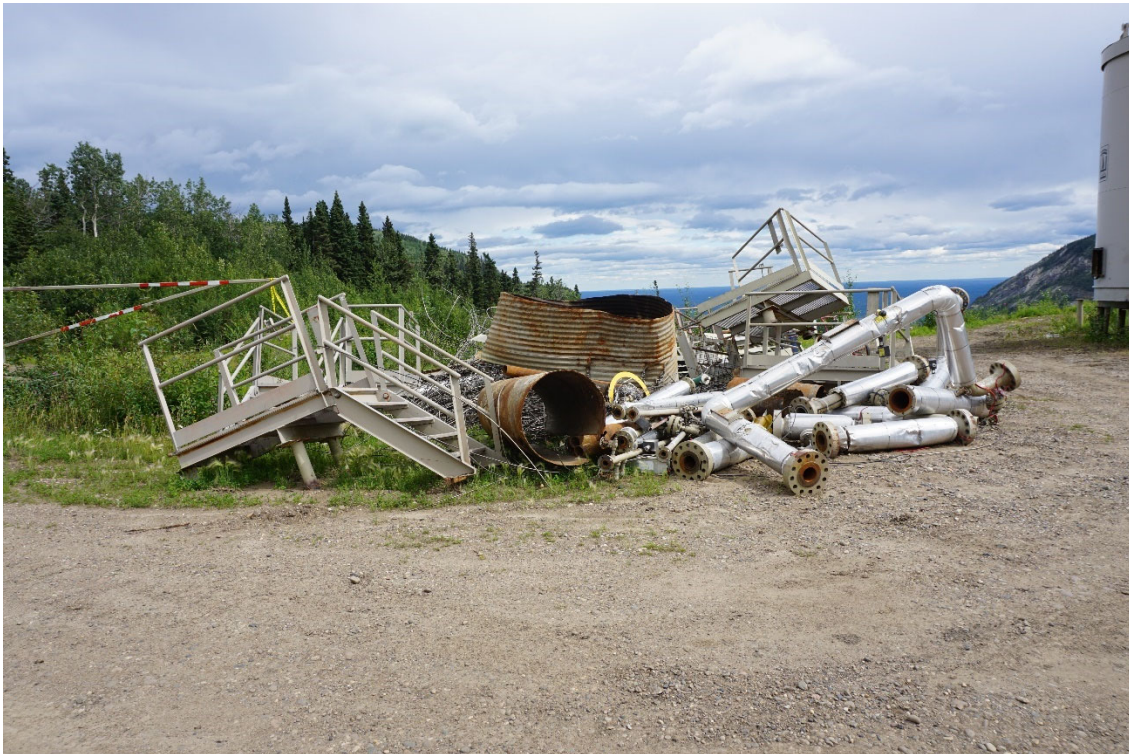
Status: Waste metals and sections of above ground pipelines are being cut into appropriate lengths (Photo #14) and stored in metal bins (Photo #15), all other waste on site is being consolidated on the ground surface until the appropriate waste bin arrives on site for removal (Photo #16).

Photo #14: Waste metals staged on the F-25 site awaiting metal bins for proper offsite disposal.

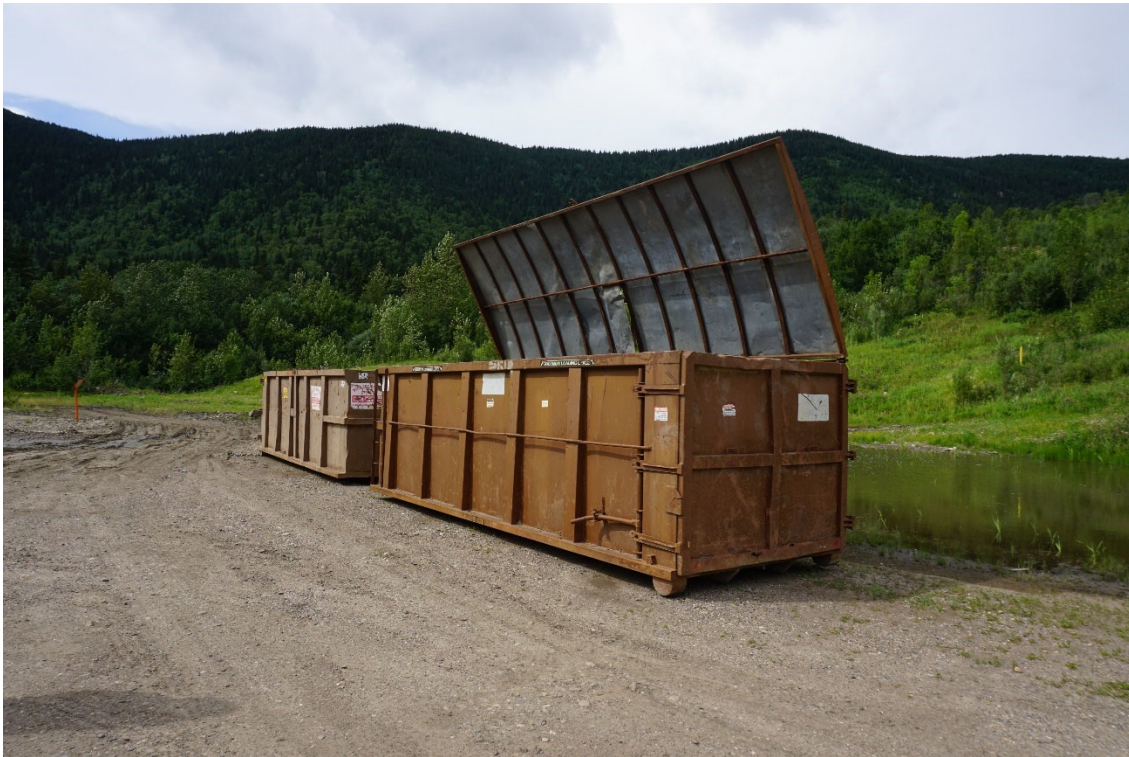
Photo #15: Metal bins staged on the F-25 site for the proper disposal of various waste metals on site.

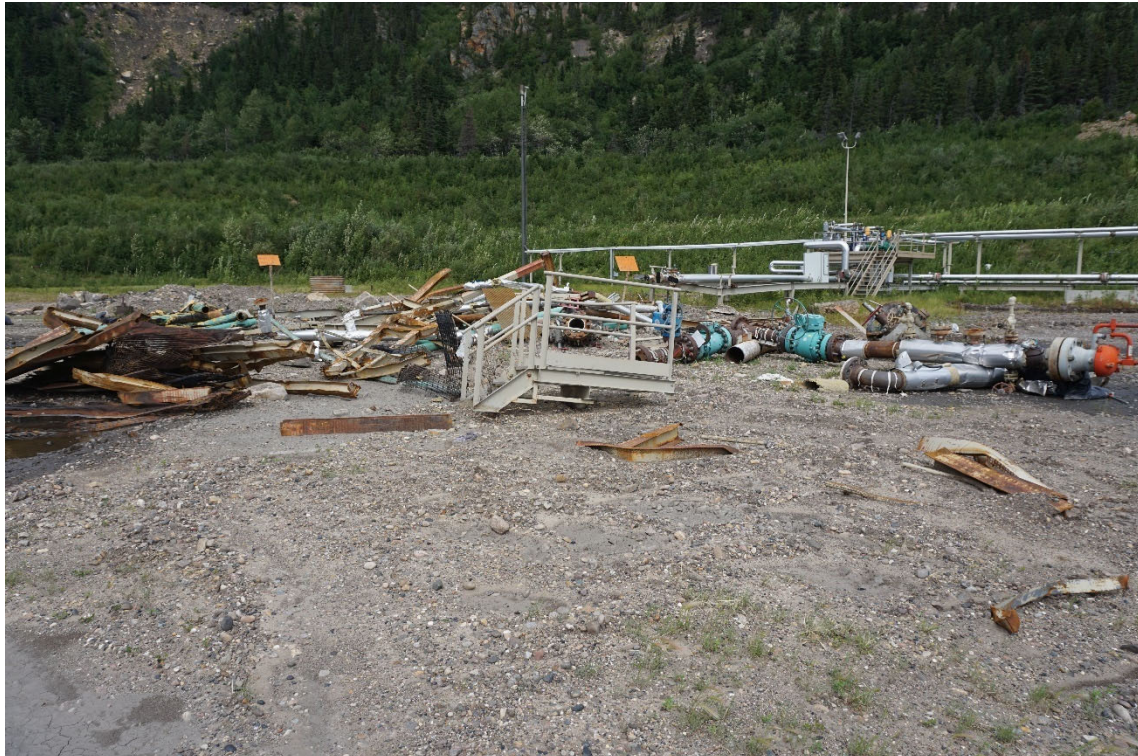
Photo #16: Waste is scattered around on the M-25 site but is planned to be placed into metal bins and removed as soon as they arrive on site.

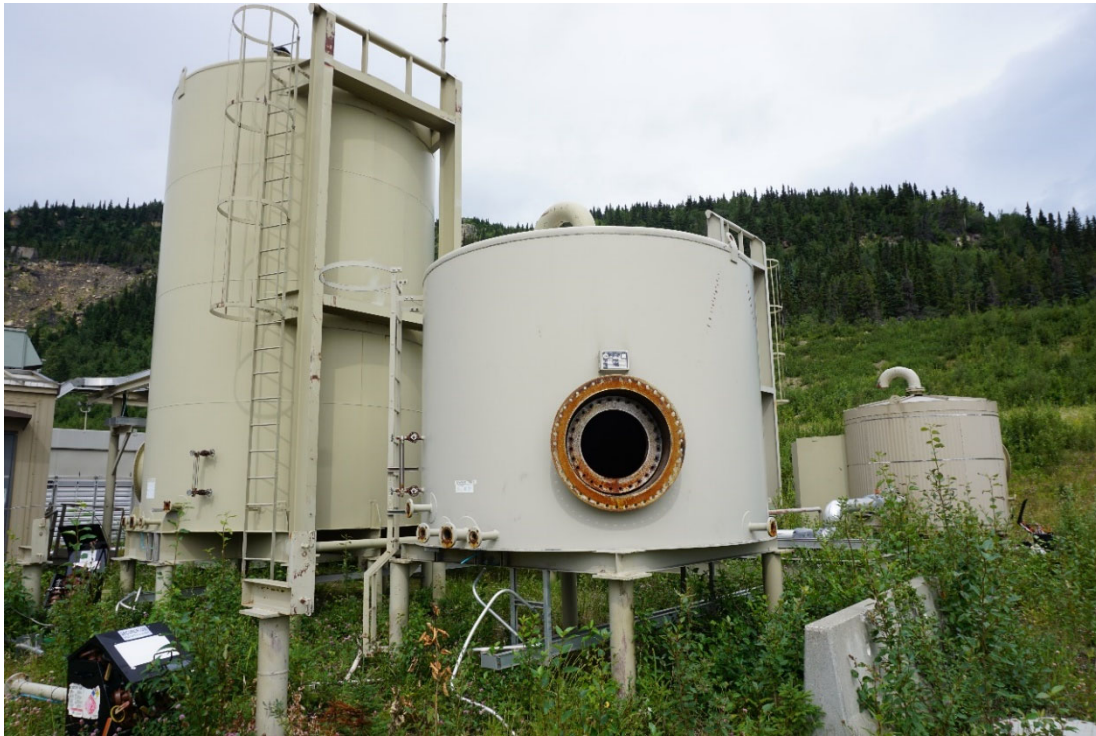
Photo #17: Vertical tanks containing Methanol, Diesel, etc have been emptied with a vac truck and access hatches opened to ensure all fluids have been removed.

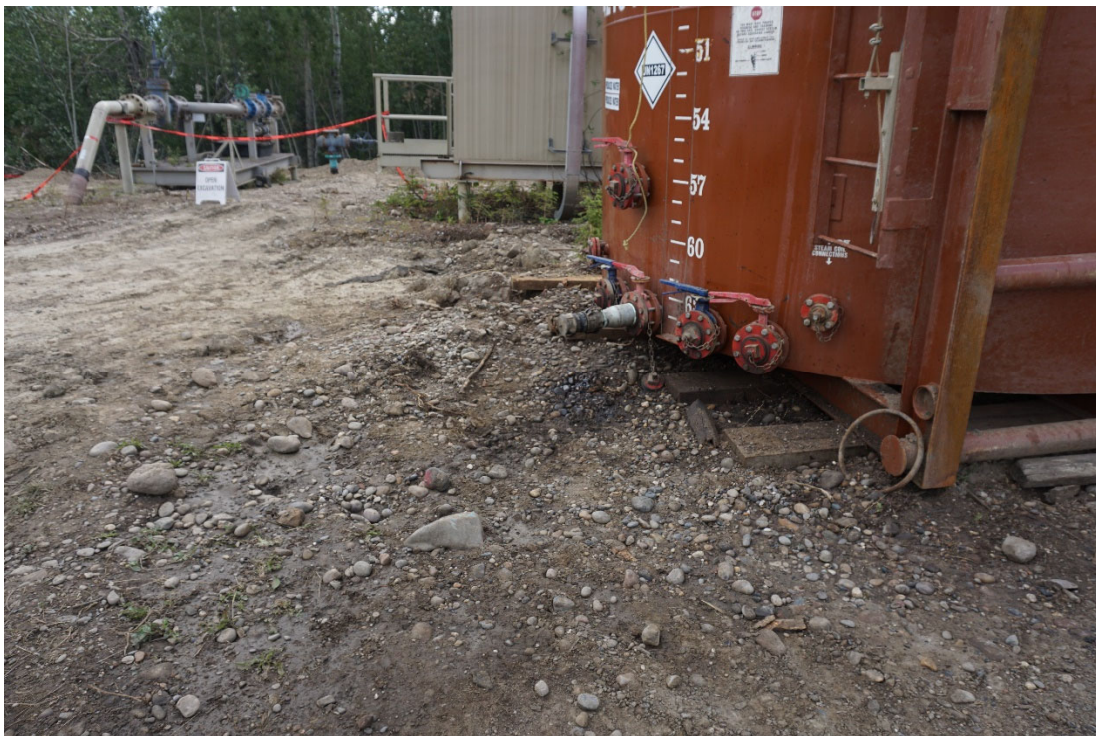
Evidence of improper containment of waste (for ex., staining, spills)	Status: During the pigging and containment of fluids from the waterlines at the junction. The 60m3 vertical tank viewed in Photo #18 was overtopped and hydrocarbons (<100L) spilled into the underlying soils. This concern was identified on site by the Inspectors along with residual staining directly underneath the connection point to empty the tank (Photo #19). The near-miss summary report (NM-2024-001-PAR-POA-2620-D-12-9) submitted on August 12, 2024 details steps that must be followed to remediate impacts and prevent this from occurring during future operations.
Debris consolidated, staged, and disposed of	Status: No concerns were noted with the consolidation of staged debris since it was being removed for proper offsite disposal on a regular basis to prevent accumulation on site.
Overall site cleanliness is: <input checked="" type="checkbox"/> Acceptable <input type="checkbox"/> Unacceptable <input type="checkbox"/> Unacceptable but corrected onsite <input type="checkbox"/> Not applicable	Comments: Personnel were actively removing debris, waste metals, and drip trays were placed under fittings while being disconnected.

Photo #18: Vertical tank containing water and hydrocarbons from pigging operations was overtopped and hydrocarbons have impacted the underlying soils. This concern was discussed on site and contaminated soils will be excavated, containerized, and removed for proper offsite disposal prior to the end of operations.

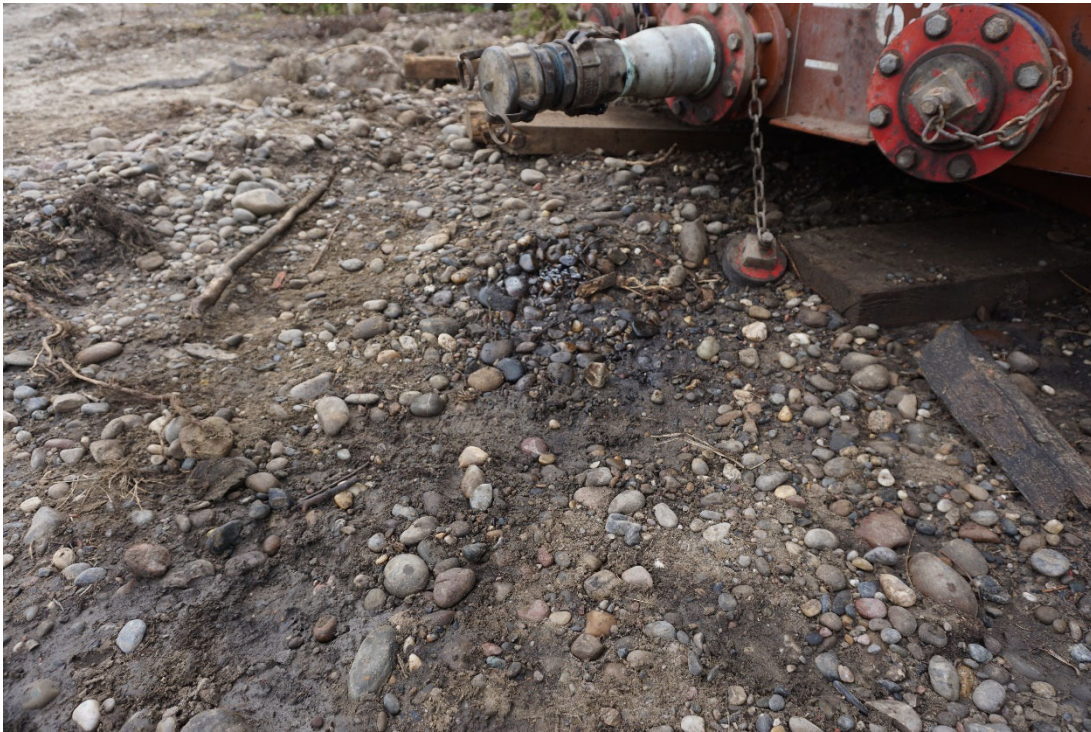
Photo #19: Drip trays must be utilized under all fluid transfer points to reduce the likelihood of hydrocarbon impacts to the underlying soils.

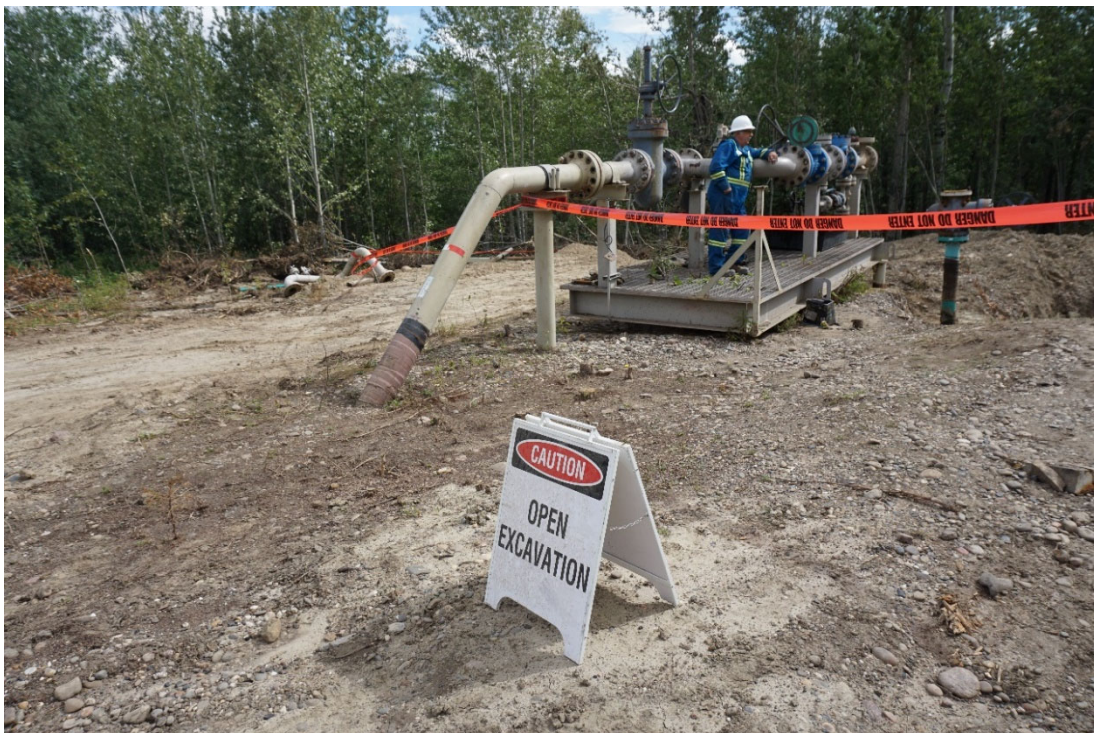
Photo #20: Hazard identifiers were present during the inspection.
