**REPORT**  
**on**  
**2024 ANNUAL INSPECTION**  
**of**  
**NTPC DAMS**  
**at**  
**BLUEFISH, TALTSON & SNARE**  
**HYDROELECTRIC DEVELOPMENTS**

August 2024

COURAGE PROJECTS LTD.  
30 Meadowlark Crescent SW Calgary Alberta T2V 1Z2  
Ph 403-875-5583  
[courageprojects@shaw.ca](mailto:courageprojects@shaw.ca)

## FINAL

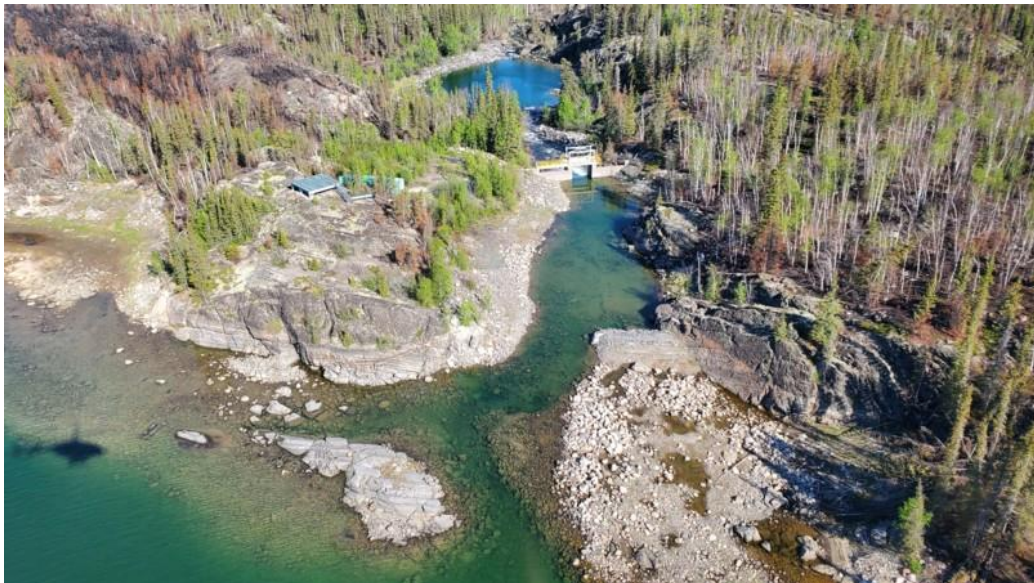
Photo 1. Shows Duncan Dam located in a protected inlet on Duncan Lake.

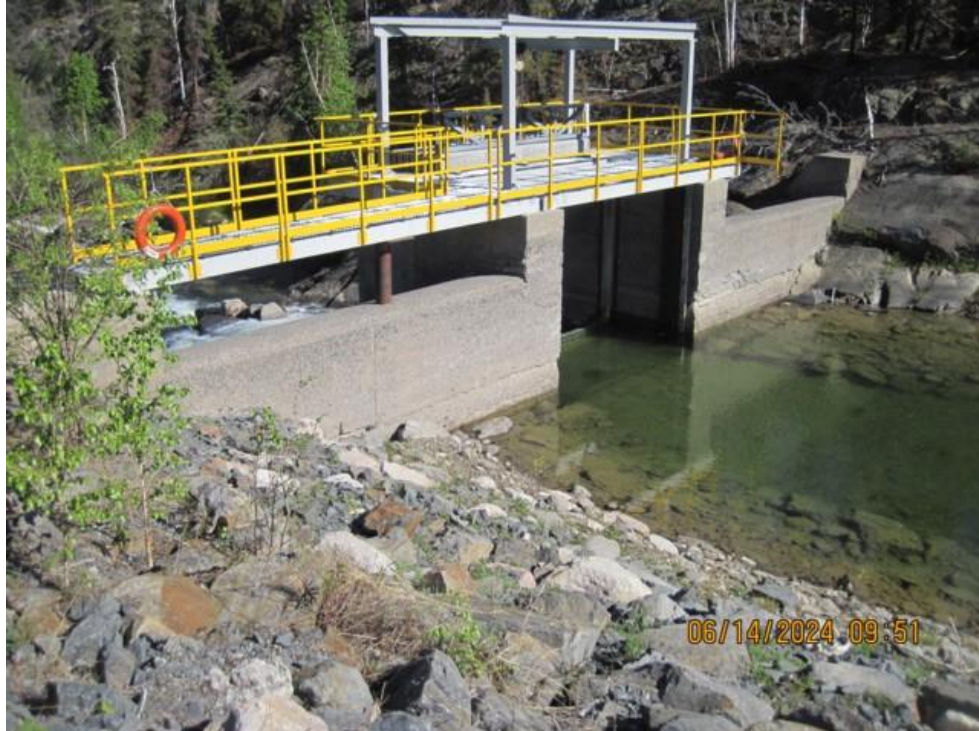
Weathered concrete on the downstream faces of the Dam were repaired in early summer of 2017. Weathered concrete on the upstream face could not be repaired in 2017 since the area requiring repair extended below lake level. High water levels have been experienced in recent years especially in 2020 & 2021. Low water is being experienced in 2023-2024 and repairs to the upstream face were completed in 2024. Cracks in the face of the concrete were also sealed.

Photo 2. View of the upstream face of the Dam at low water level. The concrete and steel work is in good condition. There is some surface erosion of the concrete above the water level that was repaired this year, 2024. The Dam is structurally sound.

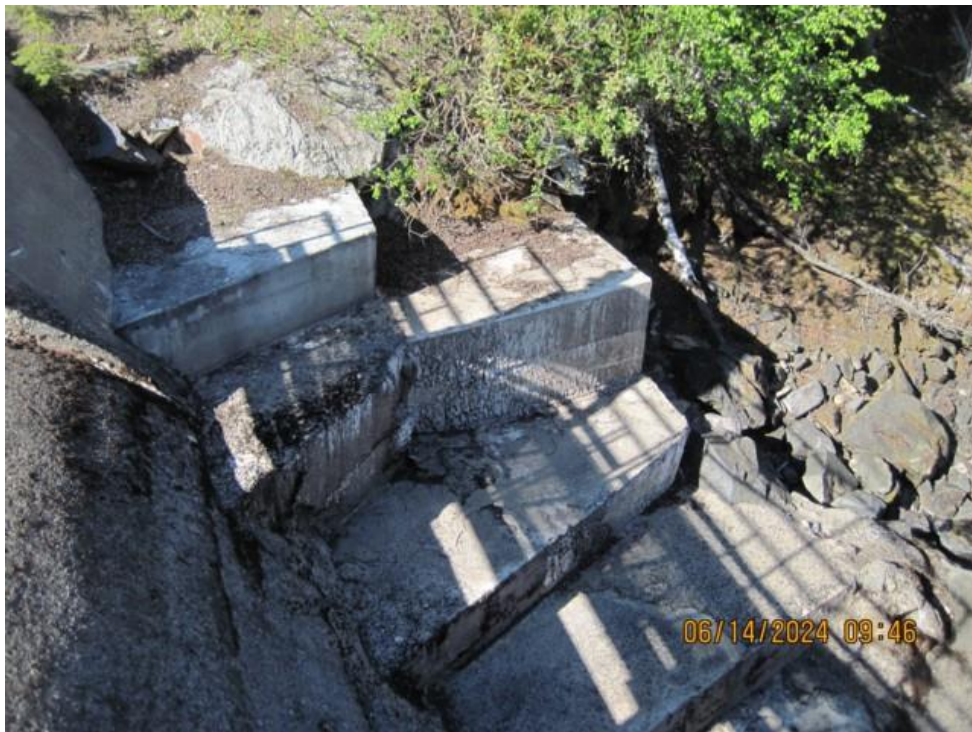
Photo 3. Shows view of the benched concrete repairs done in 2007. In good condition.

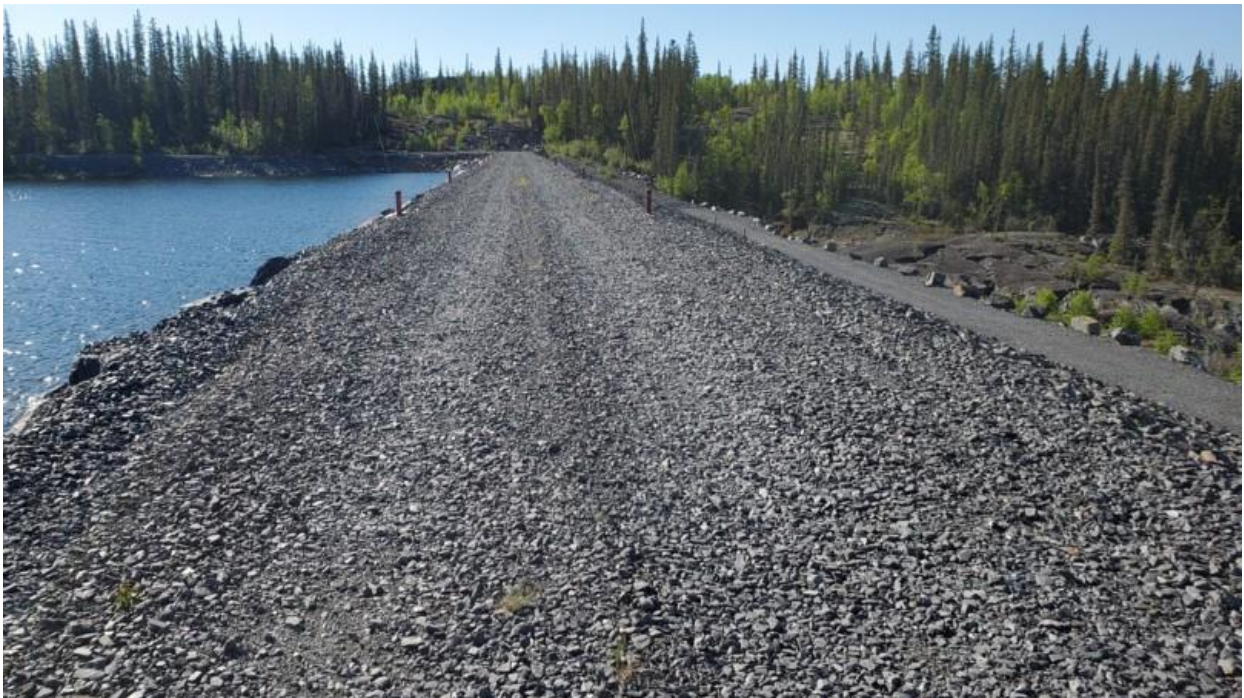
The Crest is firm and has a gravel surface without any evidence of cracks or signs of significant settlement.

Photo 6. View of crest looking towards the left abutment. No sign of instability.

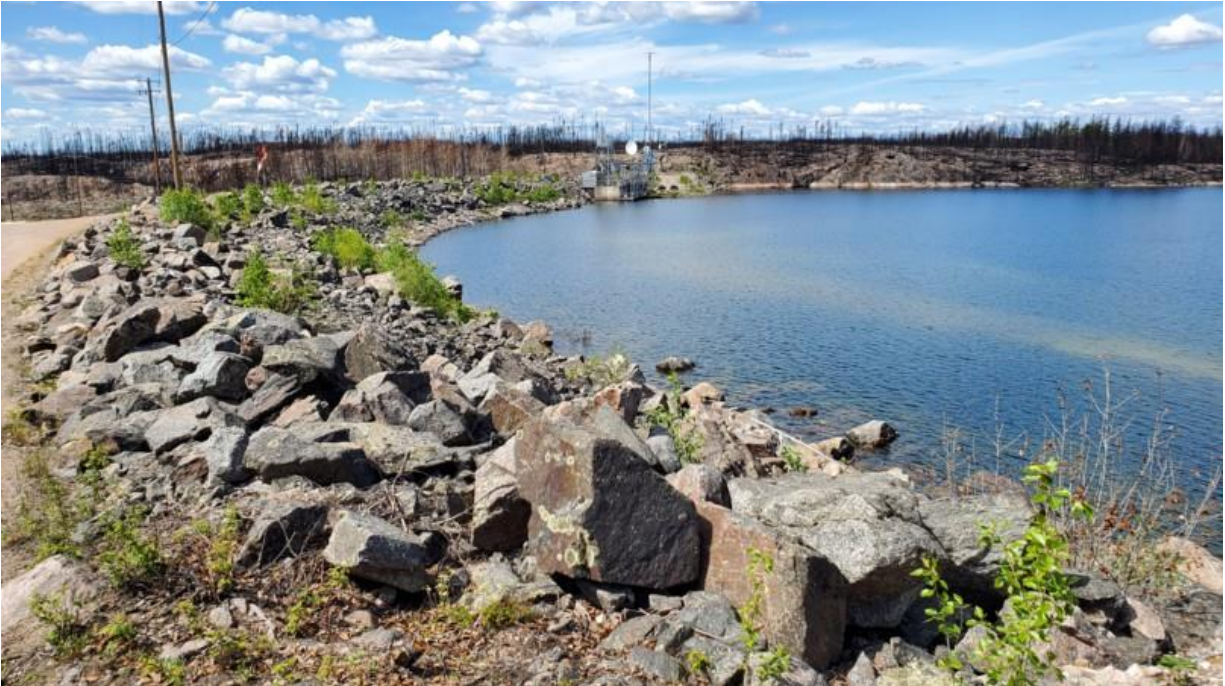
Photo 12. View of Taltson Dam seen from the left abutment. The riprap erosion protection is satisfactory except at the intake where improvement is recommended, as shown in Photo 13.

- Enhancement of the riprap to the left of the Intake Structure is recommended.
- Readings be recorded monthly from the well drain located to the right of the powerhouse which collects leakage from the North Gorge.

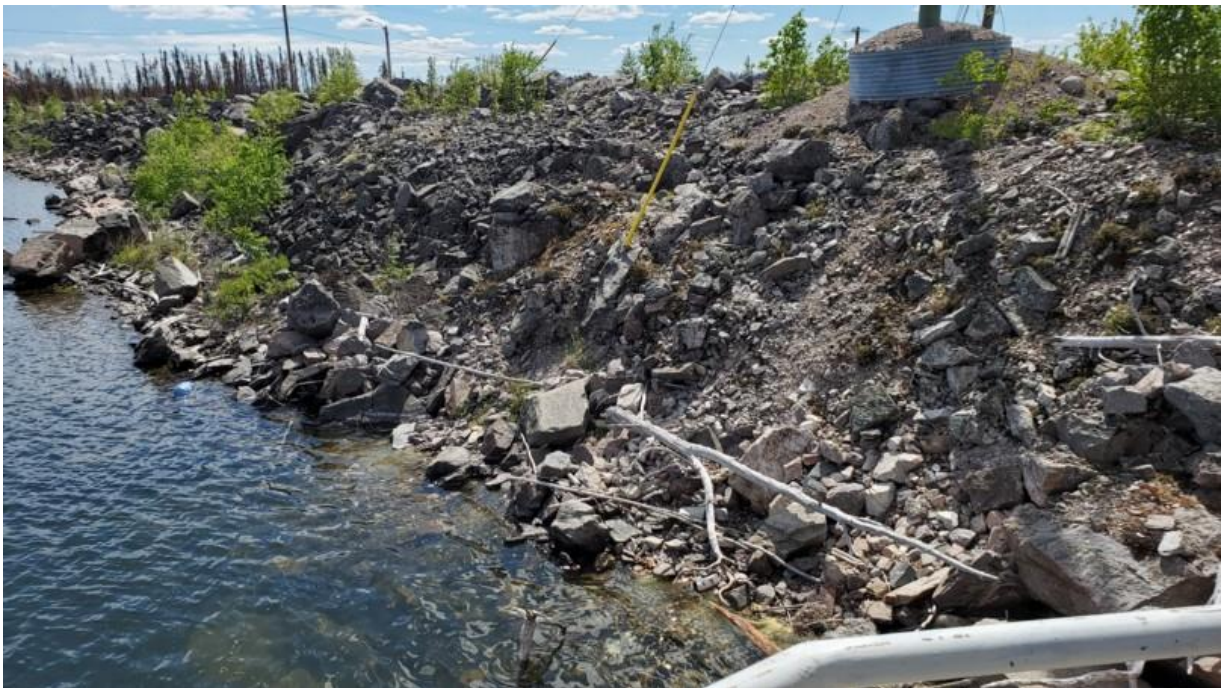
Photo 13. Shows the upstream face of the dam left of the intake. The slope is steep and without adequate erosion protection. The power pole caisson is also undermined. It is recommended that riprap improvements be carried out and the power pole be adequately supported.

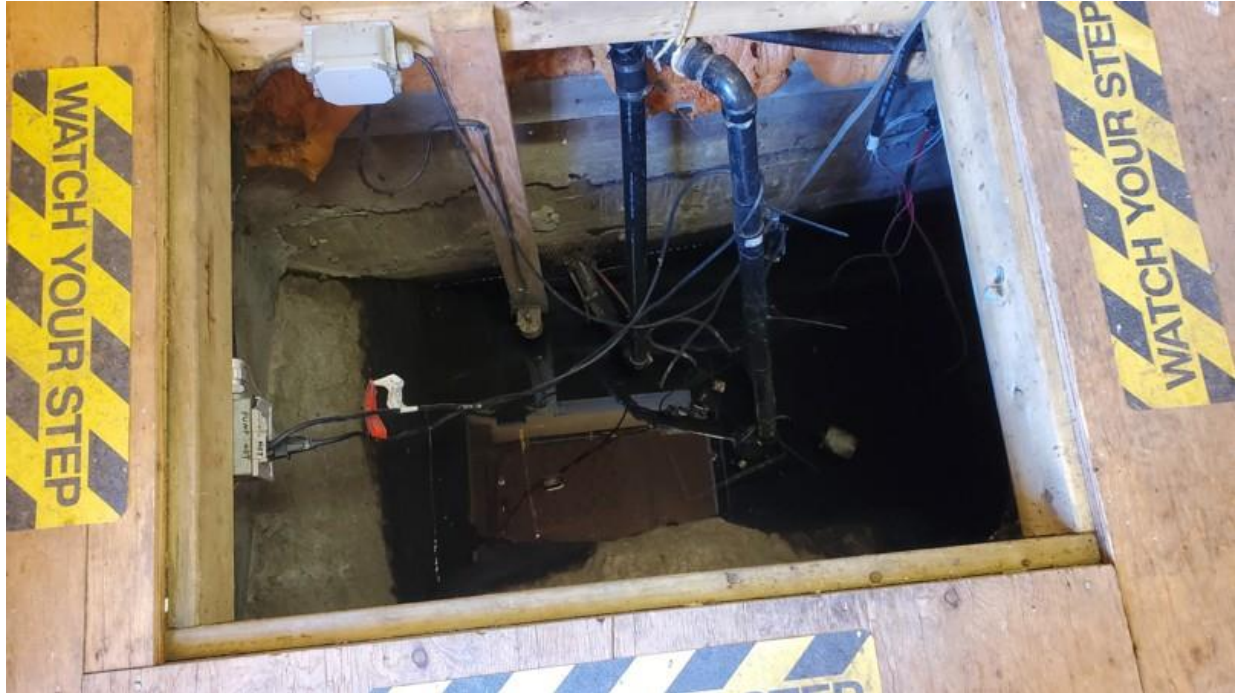
Photo 14. Shows the Well, right side, above Switchyard & Powerhouse. Stagnant water. No flow in drainpipe at the right side of the Powerhouse, where flow is measured.

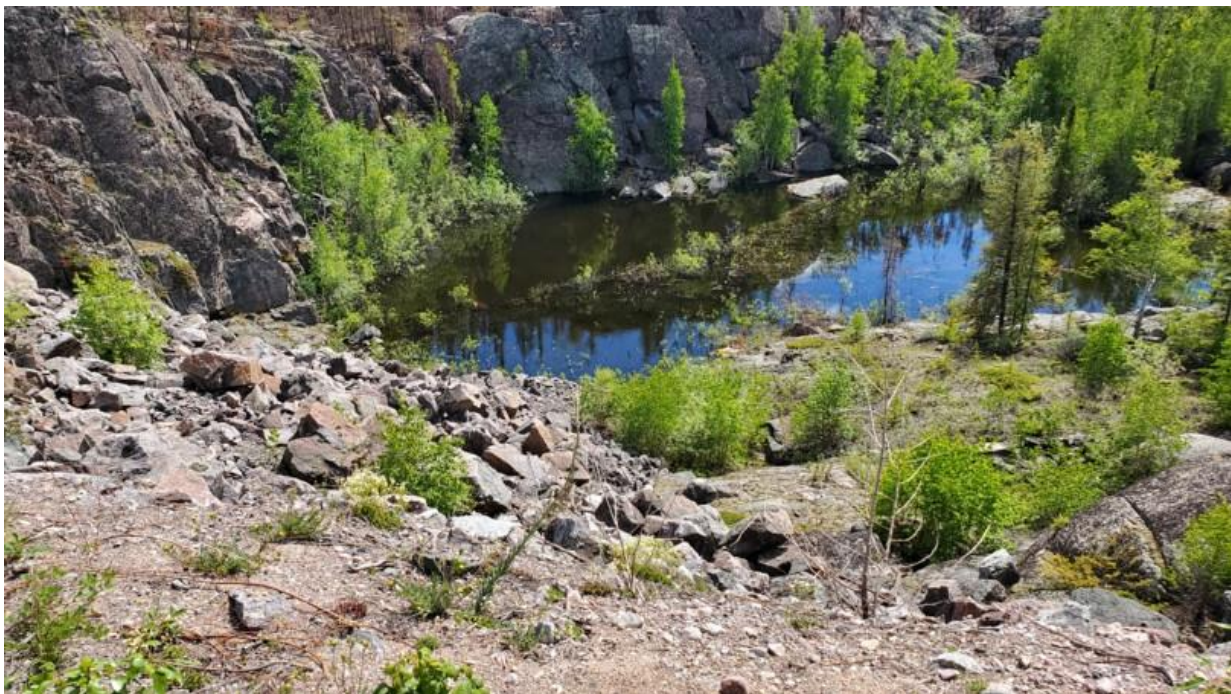
Photo 15. View of the Dam at the South Gorge. The level of the pond at the downstream toe is recorded by a camera and calibrated rod (gage). No indication of leakage flow in the pool.

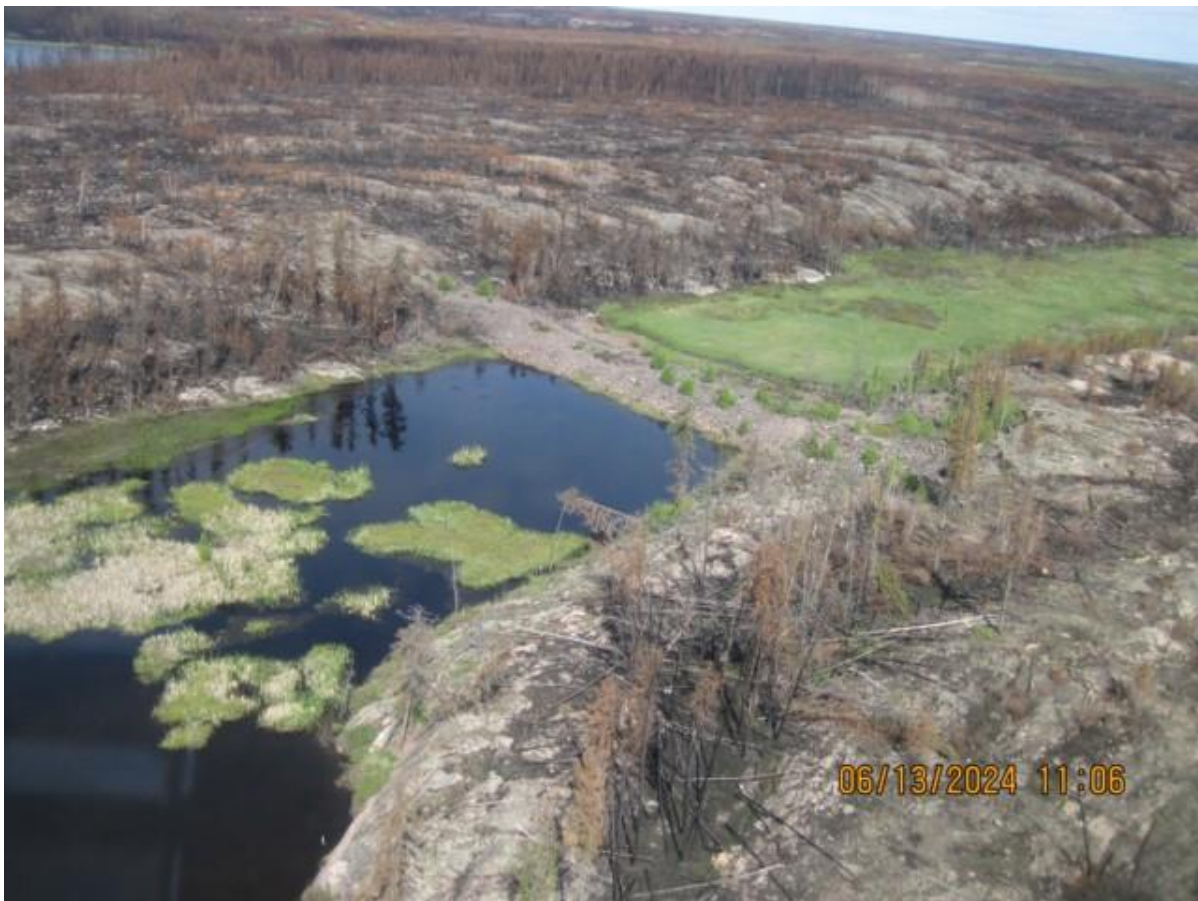
The embankment has no signs of instability however the crest has settled about 1.2m (4ft) since construction. At the time of construction (1963-65) the dam foundation was sounded to hard bottom (Figure 10) and is indicated to be built on about 12 feet of swamp (muskeg) which is compressible and accounts for the settlement over the years. The dam was overbuilt to allow for settlement of the foundation. The dam currently has adequate freeboard for both normal and Design Flood (IDF) inflows The dam is shown on the following Photo.

Photo 16. View of the Taltson North Valley Dam.

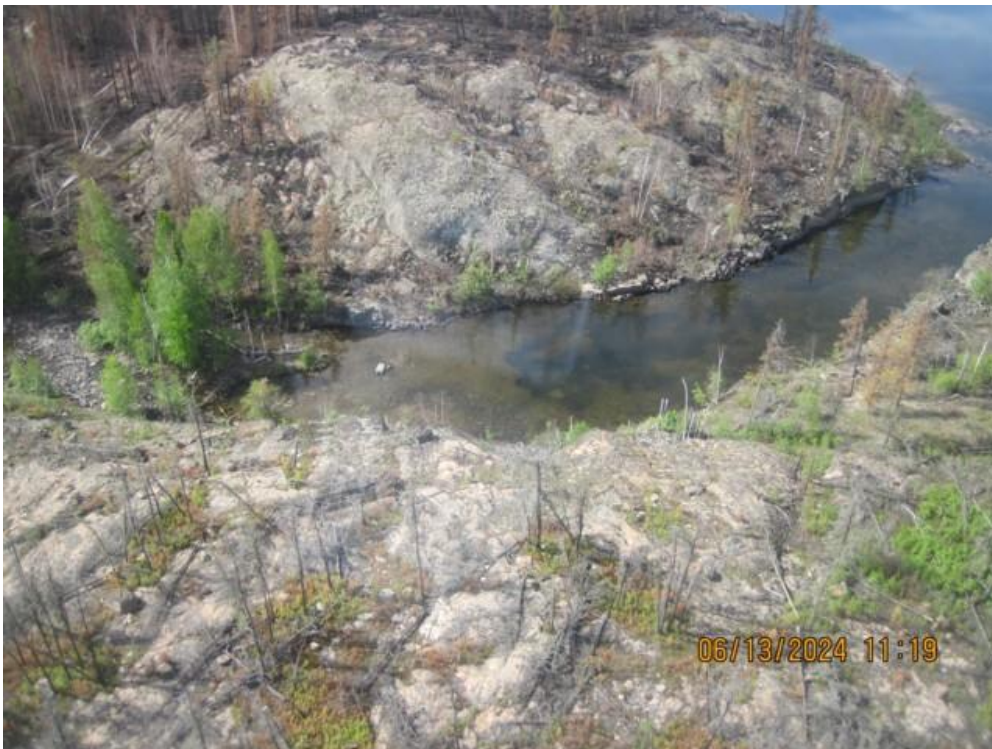
Photo 18. Shows the spillway channel at location 2. There is no concrete sill.

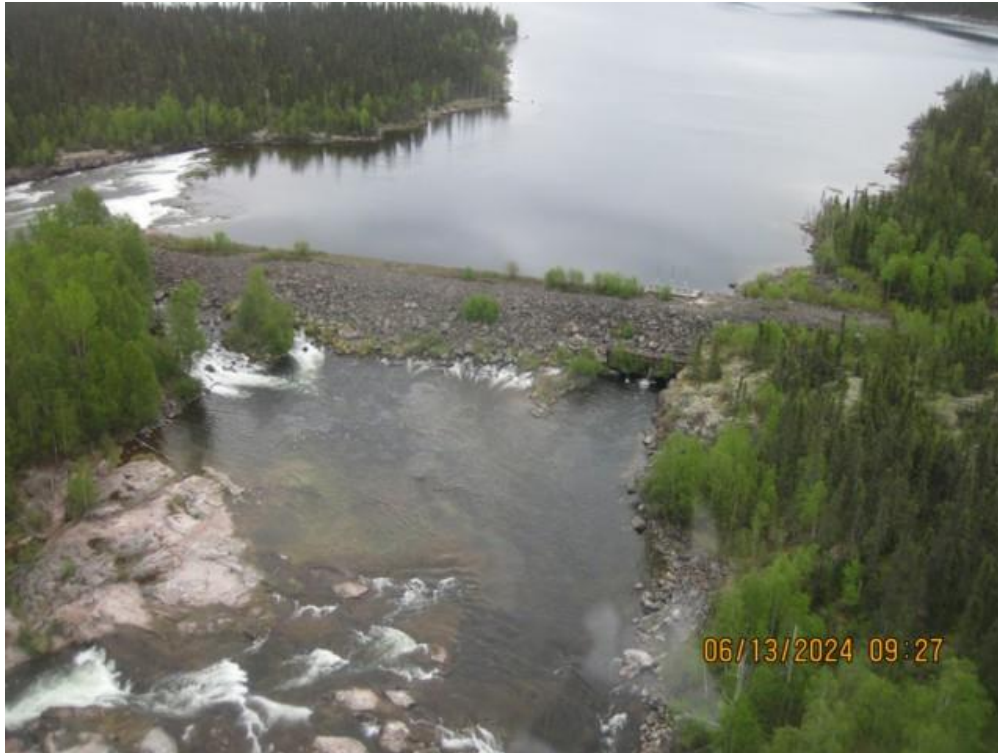
Photo 20. Shows the Nonacho Dam, Spillway & Control Structure with Ro-torque Operators (3). It is a rockfill dam designed to accommodate leakage. About 300mm of settlement of the crest occurred shortly after 1968 construction where leakage is high at the right abutment, and has remained stable since. Inspection reports over the years, based on visual assessments, have stated no change in condition. Pins have now been installed for survey and to verify the stability of the structure.

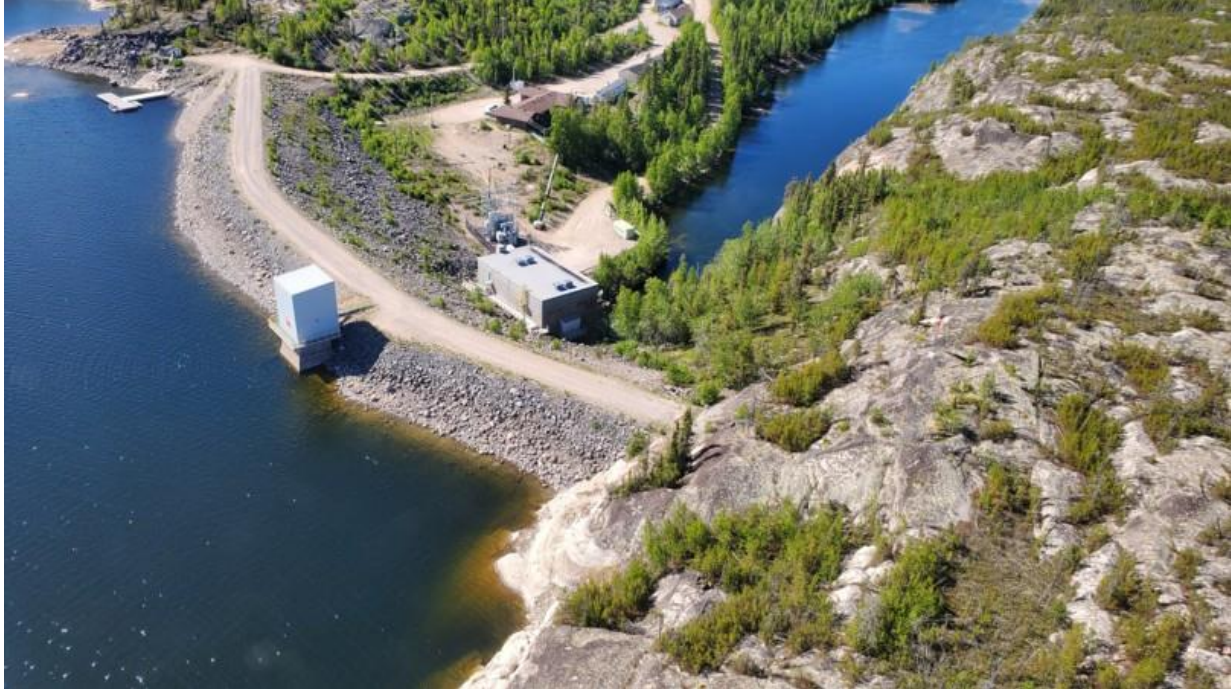
Photo 21. Upstream view of Rapids Dam. Variable riprap. No beaching. Satisfactory.

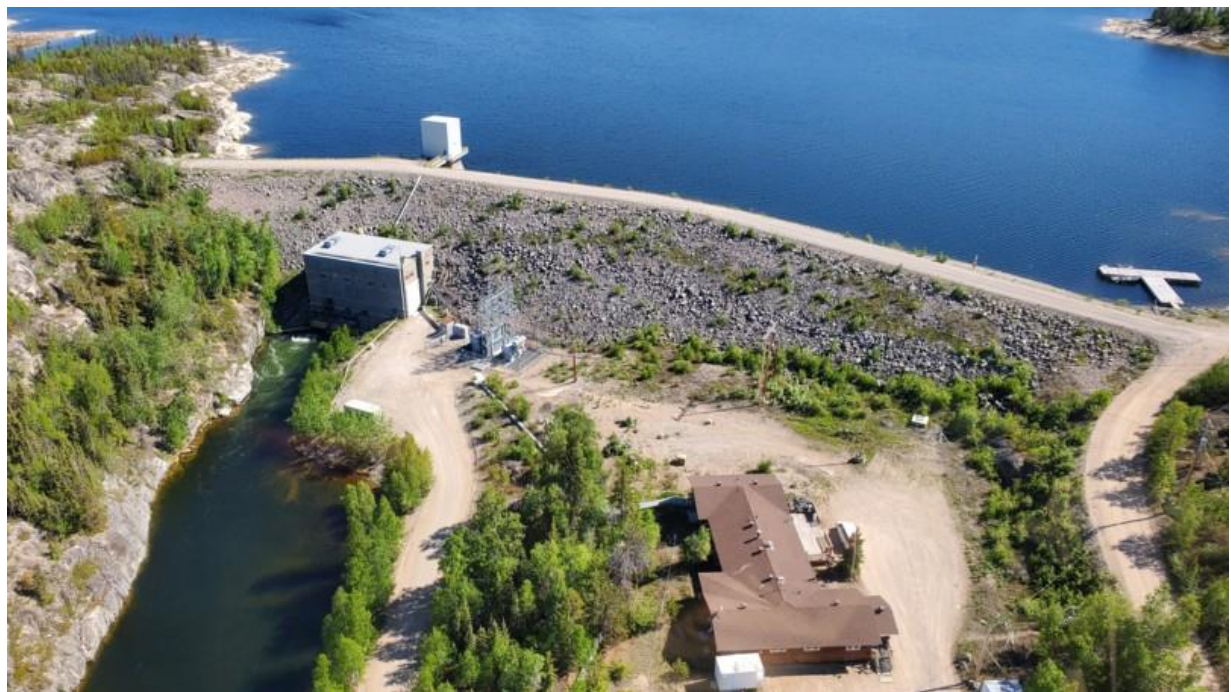
Photo 18. View of Rapids Dam and downstream area. Stable. Minor leakage, monitored.

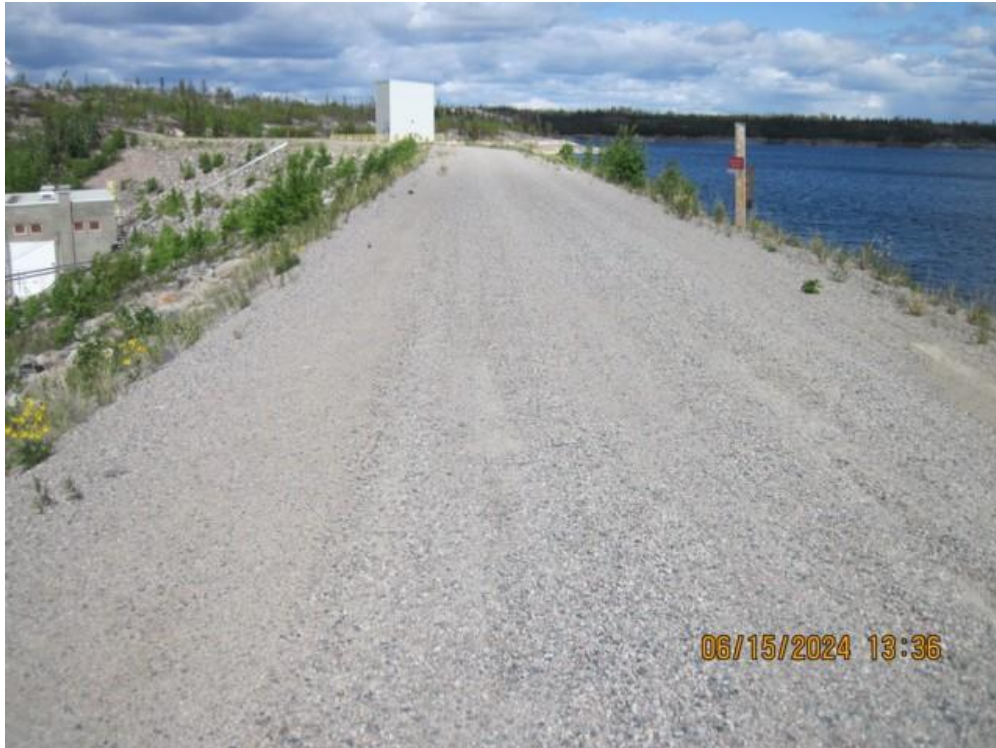
The crest, upstream slope, downstream slope, toe area, and seepage locations downstream of the Dam were inspected. The reservoir was at El 717.9 ft at the time of the site visit. In past years there was evidence of considerable frost heave and cracking about one (1) metre deep parallel to the axis of the Dam along the shoulders of the crest extending from the intake to the left abutment. The cause is attributed to poor compaction when the top of the dam was excavated and rebuilt to raise the core in 2002. It is likely that cracks occur due to frost heave and difference in moisture content and compaction occurring in the center compared to the material at the shoulders. The cracks parallel the contact between the original and new poorly compacted backfill material. There are no cracks transverse to the Dam Axis and consequently no added risk to Dam Safety. Continue to grade, compact and monitor the crest. The cracks which parallel the dam axis are not considered to be a dam safety issue.

Photo 19. Rapids Dam. View of crest. Some minor cracking evident.

- Annually fill the crest cracks, grade and compact forming a crown to drain towards the shoulders and maintain design crest elevation.
- Continue with the established monthly leakage monitoring.

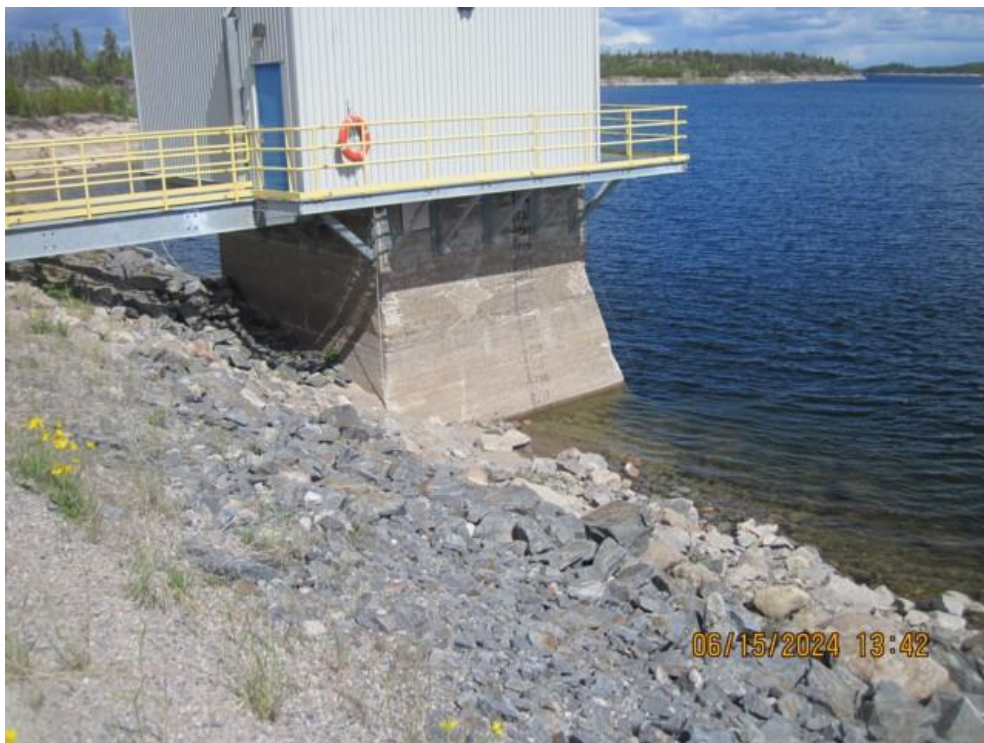
Photo 20. Intake at Rapids Dam. Some surface weathering of the concrete.

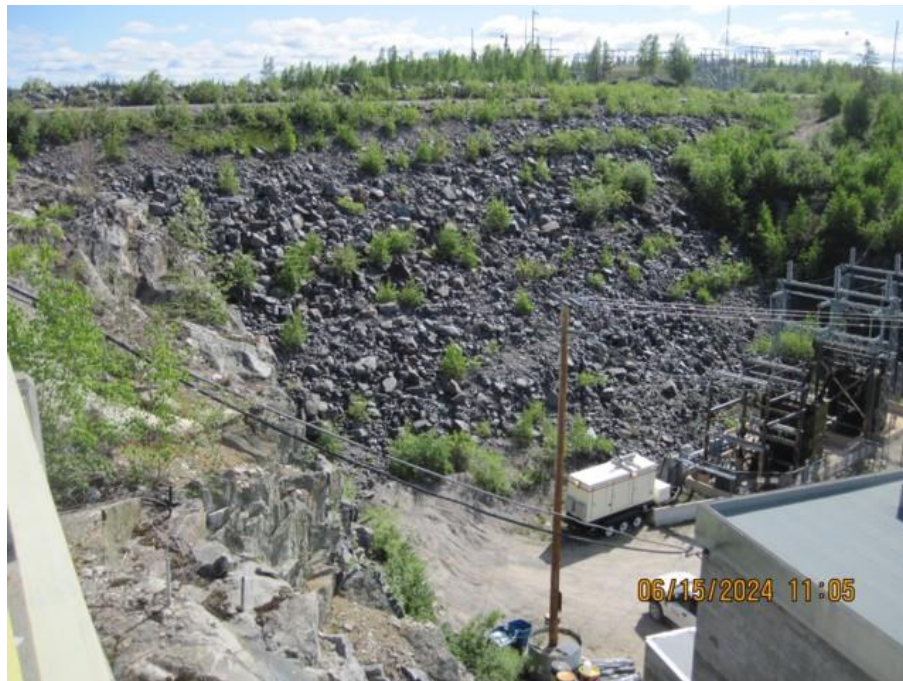
Photo 25 Shows the downstream face of the Main Dam. Stable. No visible leakage.

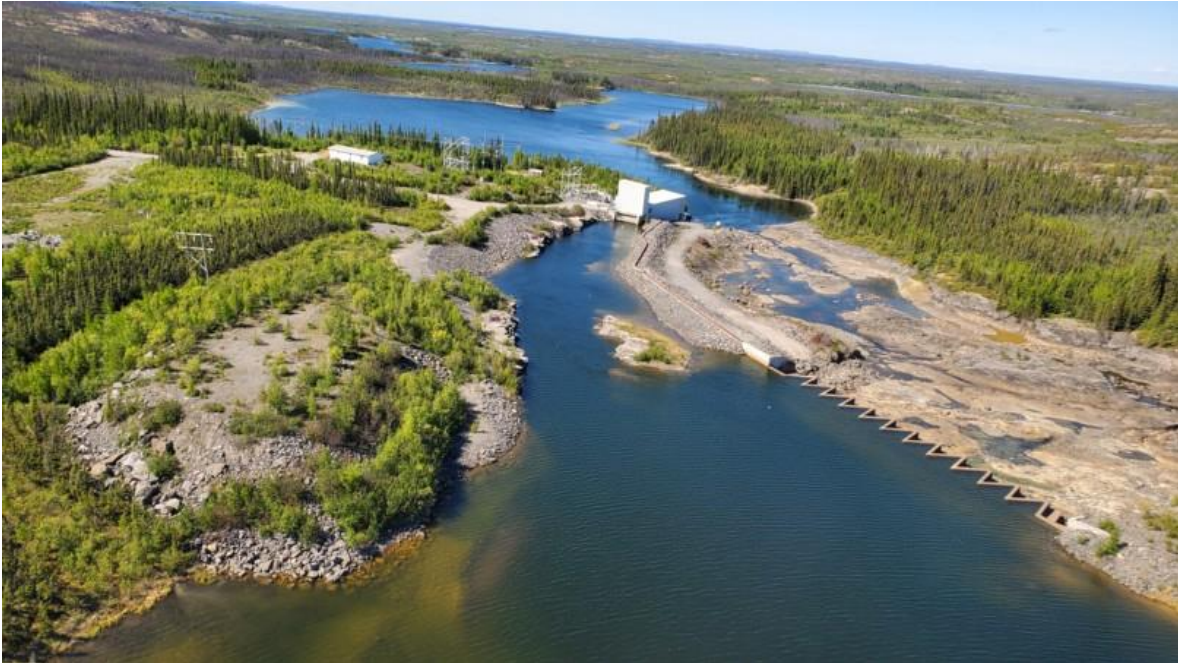
Photo 26. Shows the Cascades Development, ie: Powerhouse, Rockfill Dyke with Cutoff Wall, Spillway & Earthfill Dyke. The top of the Dyke Cutoff Wall was raised in 2023 to El 185m by installation of a 0.5m high steel membrane.

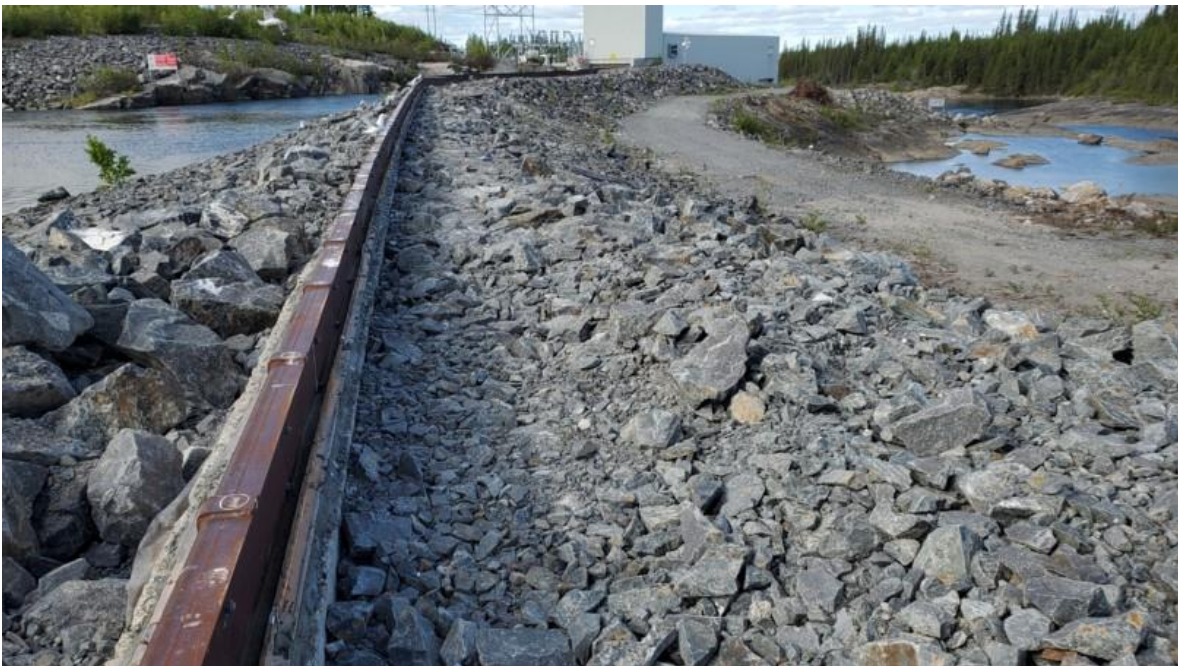
Photo 27 Shows the steel membrane, on top of Cut Off Wall. The wall provides free board protection against potential overtopping by wave action in the event of the design flood.

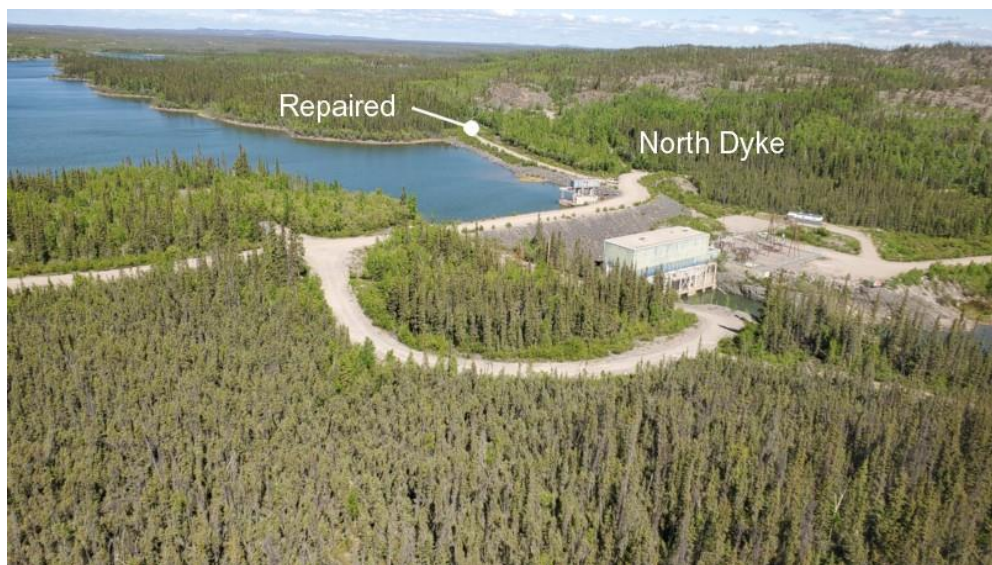
Photo 29. Shows location of 2024 repair to the North Dyke to prevent overtopping and wash-out of the main access road in event of the design flood.

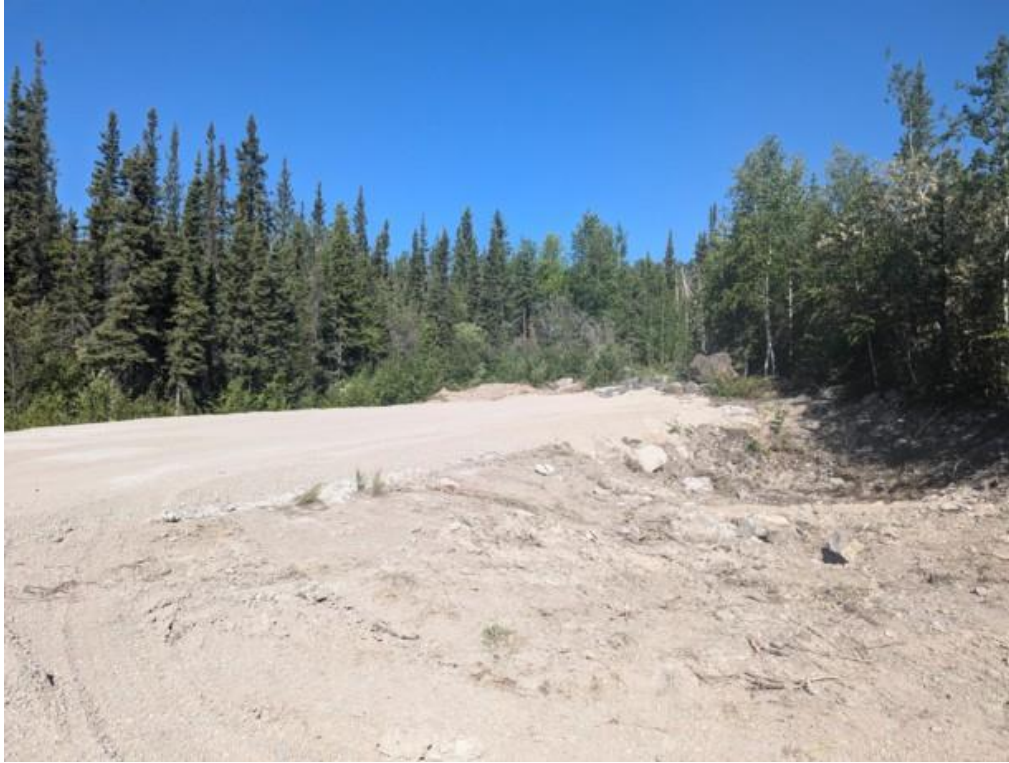
Photo 29. Shows repair to the far end of North Dyke near the Quarry. Crest raised to design grade tied to high ground.

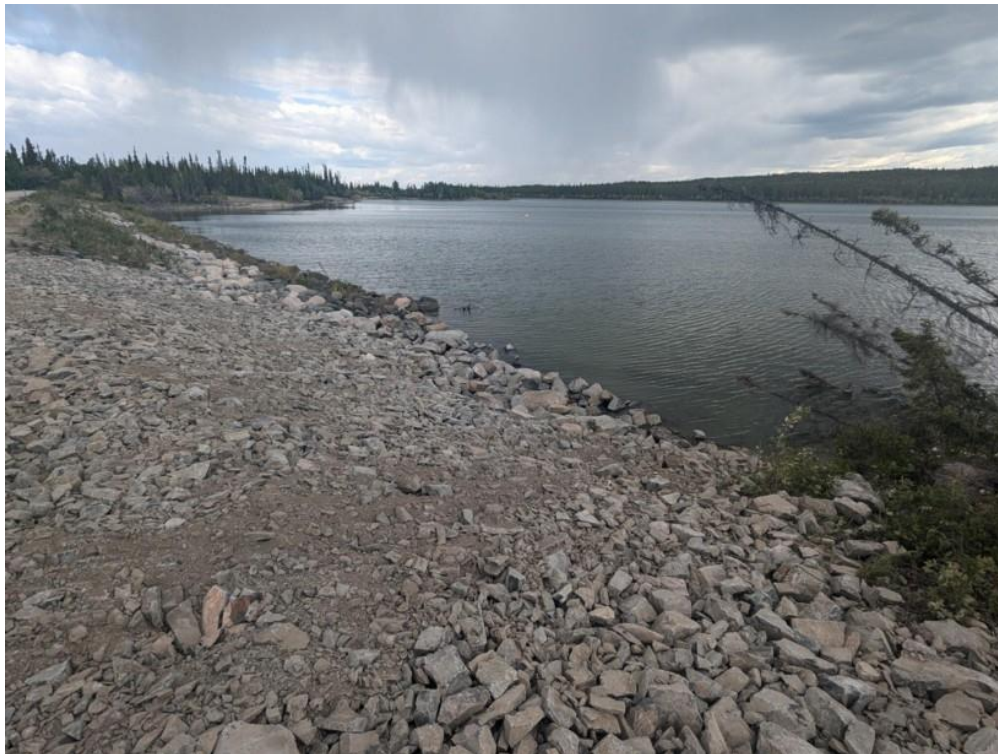
Photo 30. View of riprap repair at left abutment of Dyke 2.

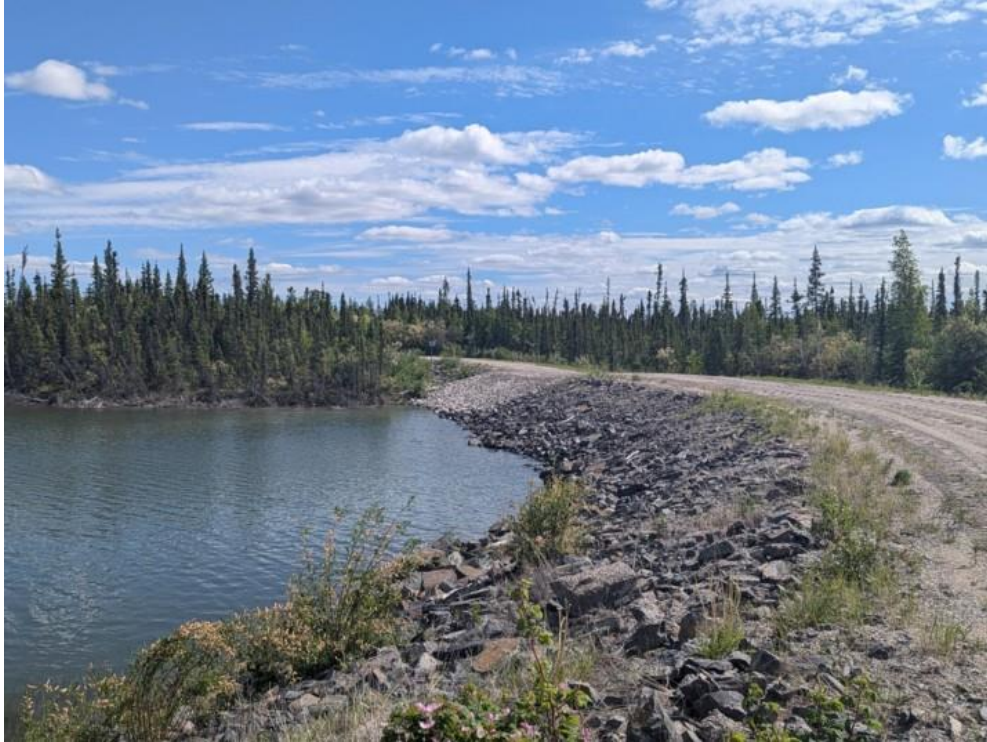
Photo 31. Shows the riprap repair to the left abutment of Dyke 3.

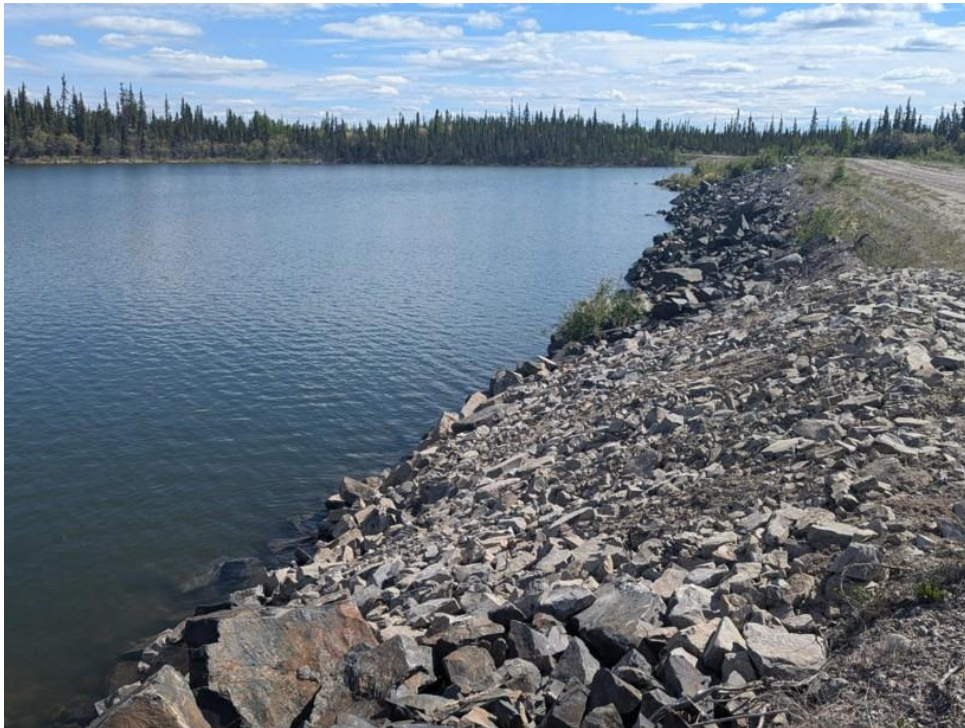
Photo 32. Shows enhancement to riprap at Forks Main Dam.

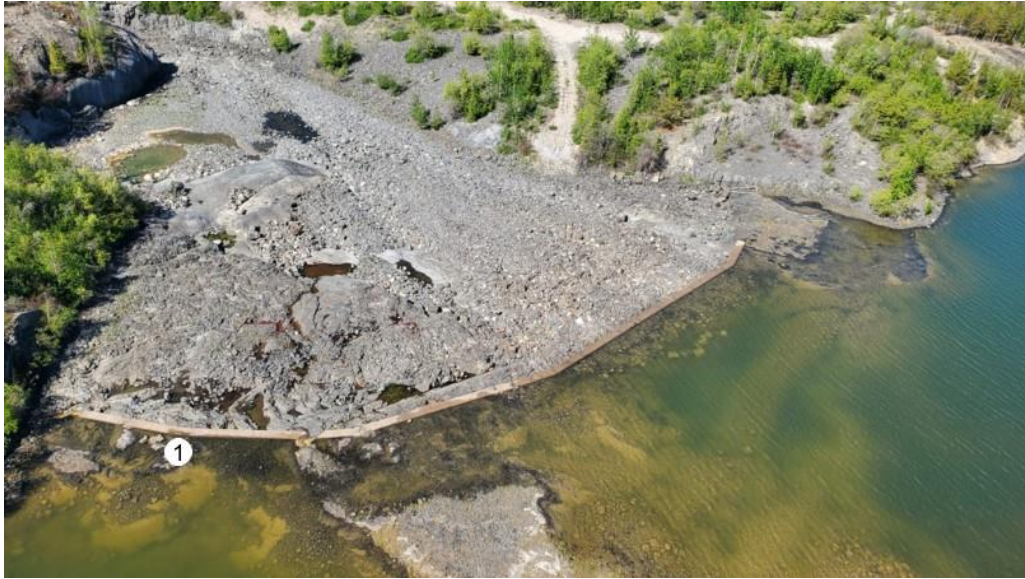
Photo 33. Shows the Forks Overflow Spillway Weir. Repair to weathered concrete at the crest was carried out in 2024 at location (1)

- Inspect the rockfill area immediately downstream of the weir after periods of high overflow. Some reworking of the rock erosion protection may be required if movement occurs. Now satisfactory.
- Status: Spalled concrete along the sill had occurred and reinforcing steel was exposed. This repair was carried out in 2024.
