# Bluefish Hydro Comprehensive Dam Safety Review

Northwest Territories Power Corporation  
January 2017  
Project: 159100263

Final Report

Prepared by:  
Stantec Consulting Ltd.

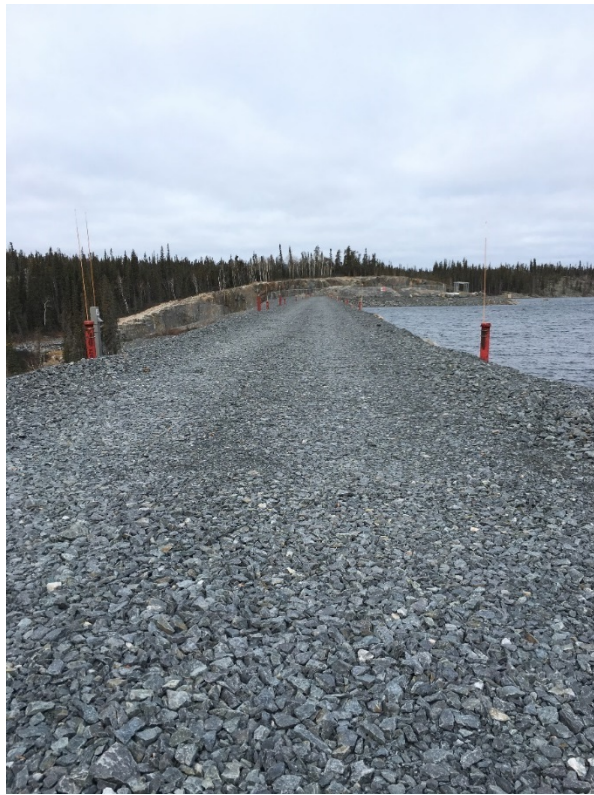
Along the dam crest, minor grading issues were noted resulting in the vehicle path being slightly lower in elevation than the areas of the crest immediately up and downstream, where the instrumentation stick-ups are located. This grading issue is likely due to snow clearing activities, as it is understood that the crest is regularly plowed during winter months to allow for continuous access across the dam. Figure 5.3 shows the condition along dam crest during the site inspection.

Figure 5-3: Condition of the dam crest during site inspection.

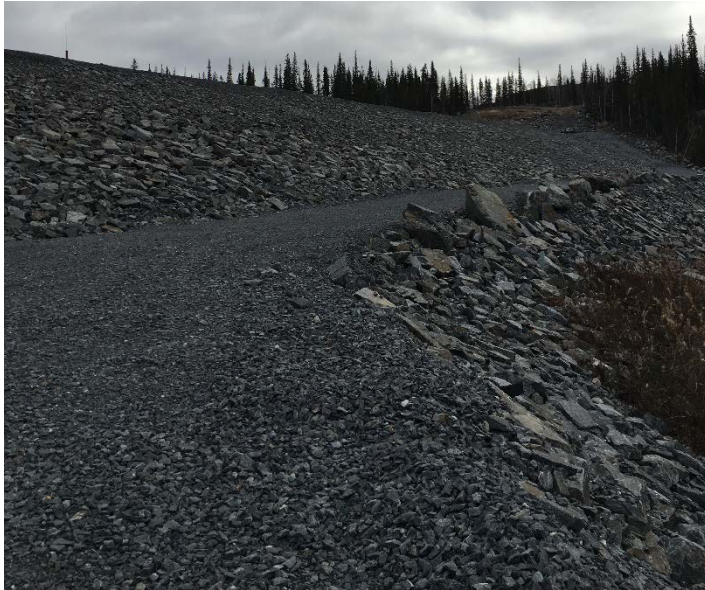
**Figure 5-4: Condition of the dam downstream slope during site inspection.**

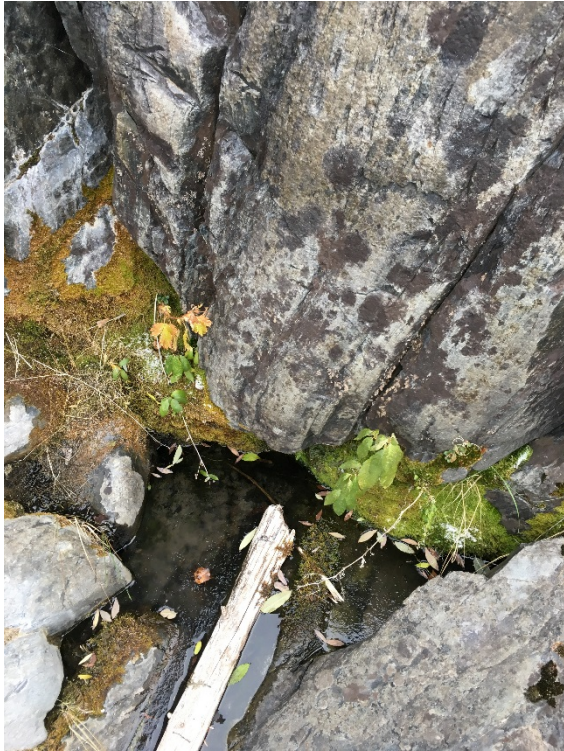
At the very base of the of dam toe, at the location of the former river channel, a small amount of clear seepage was observed to be flowing between the large native bedrock outcrops and the placed rockfill boulders. The flow was estimated at less than 10 l/min, based on a simple visual assessment. It is understood that this seepage has been observed since the commissioning of the dam. This area has been observed to form a significant ice dam in the winter, whereby ice advances up the downstream face with continuous flowing seepage below.

Figure 5-5: Observed seepage from base of dam at former river channel location.

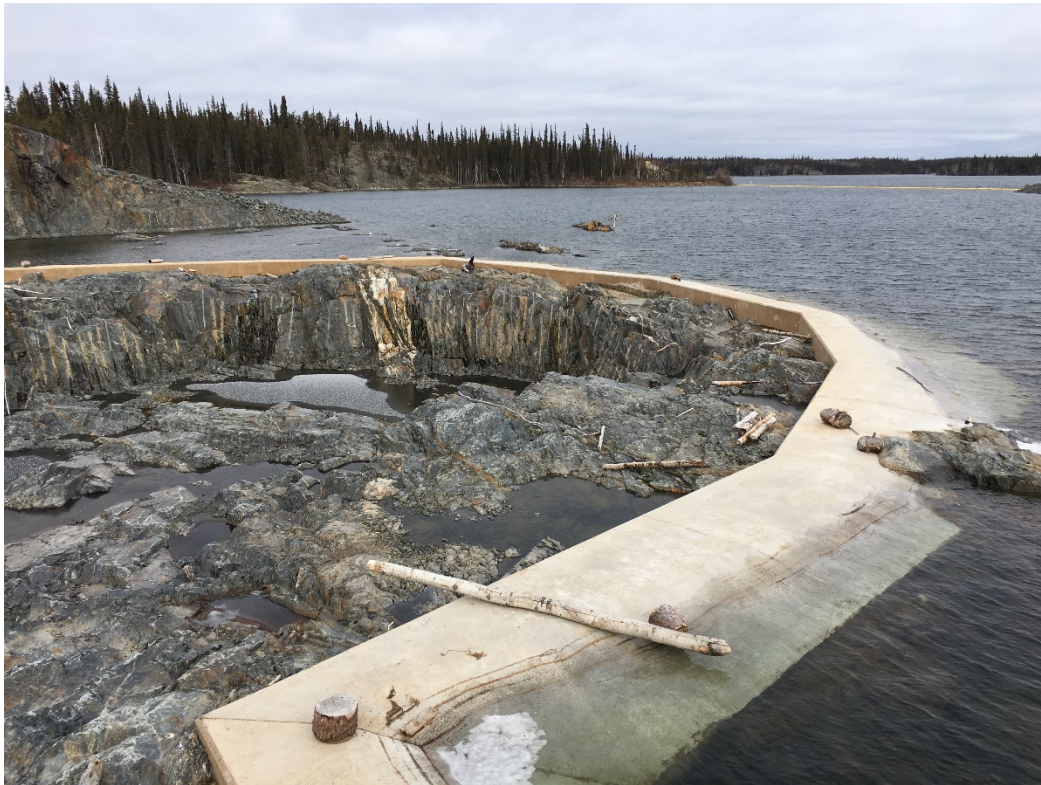
Some minor seepage was observed to be occurring in the vertical rock face below the sill elevation at two discrete locations. As the distance was relatively far from where the observations were made, it was not possible to assess the water clarity or flow rate, though it was not immediately obvious that water was flowing, suggesting that the amount was very small. As noted in previous reports by others, the concrete sill poured to correct the over blast of the rock along the spillway could provide an area of concern where water between the rock and concrete could subject to freeze thaw cycles could result in additional seepage paths below the concrete. Sealing of the voids is recommended in order to avoid accelerated degradation. Periodical survey of the elevation of the sill is recommended in order to monitoring displacement over time. The conditions observed at the spillway during the site inspection are shown in Figures 5.7 and 5.8.

Figure 5-7: Condition of upstream spillway vertical rock face.

5.2	Possible additional seepage below the concrete sill along the spillway.	Seal of the voids to avoid accelerated degradation.	M
5.2	No displacement monitoring of the spillway sill	Perform periodical survey of the elevation of the sill.	M

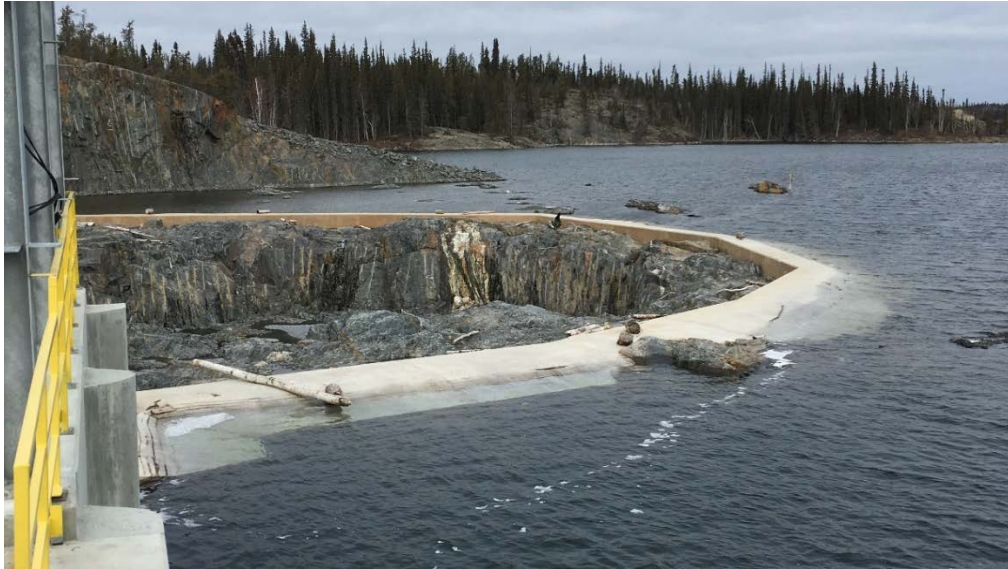
**Figure 5-8: Condition of right side of spillway vertical rock face.**

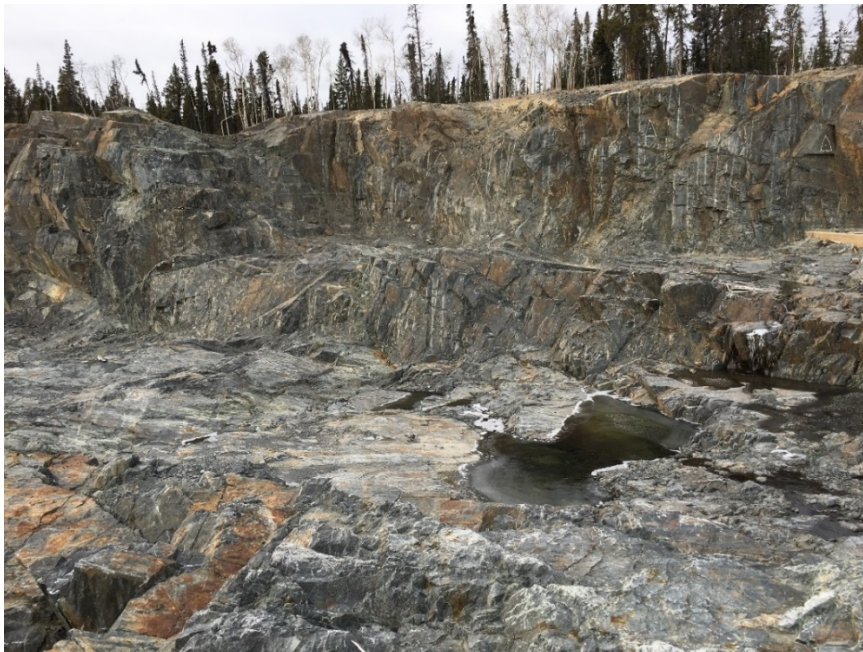
The near vertical excavated rock walls for the spillway and low level outlet channel appeared to be in stable condition. Again, observations were limited, as it was only safe to view these areas from the control structure platform. Rock anchors along the left side of the low level outlet wall (also the right abutment for the dam) were visible, however due to their height and flowing water conditions, no detailed inspection of this area was completed. The observed conditions of the spillway outlet channel and the low level outlet channel are shown in Figures 5.9, 5.10 and 5.11.

**Figure 5-9: Spillway outlet channel right wall.**

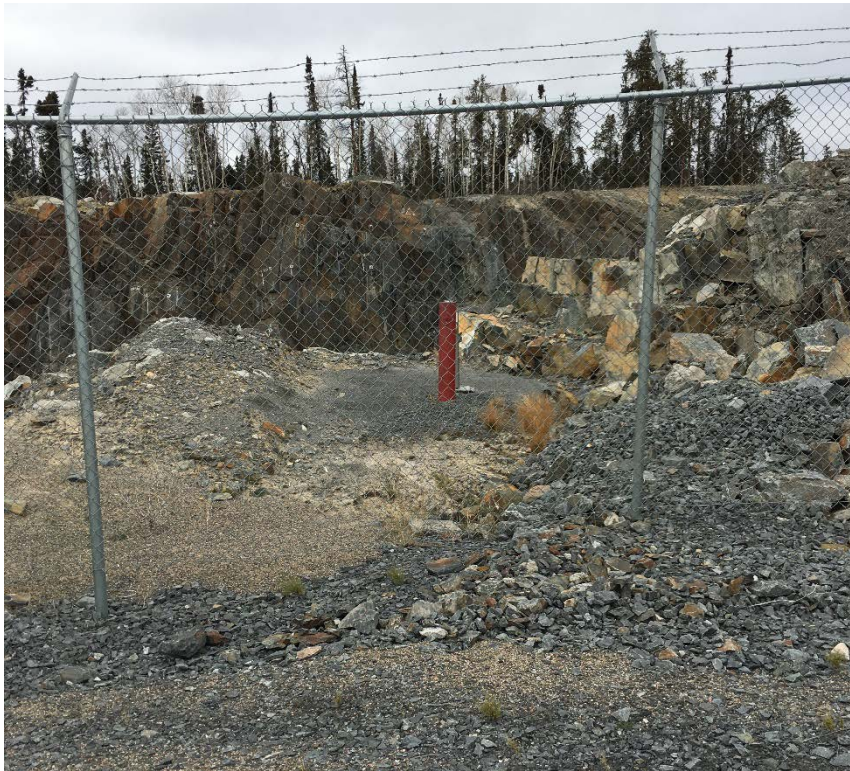
At this time, there is no indication in the OMS manual to outline the monitoring frequency for the piezometers, though they are typically monitored monthly, nor has any analysis been completed to assess the threshold water level (water level at a piezometer at which the stability of the dam is sufficiently impacted that additional monitoring or action is required) for each of the piezometers. It is critical that a series of analyses be completed to determine what the threshold water level is for each piezometer and the results of this analysis be incorporated into the OMS manual and ERP such that appropriate action is taken when the piezometers are monitored. The collected data should also be processed in a timely manner such that any potential errors or anomalies can be corrected immediately.

**Figure 5-12: Piezometer SP01 shown outside of the perimeter fence, restricting access which has less led to the instrument not being monitored**

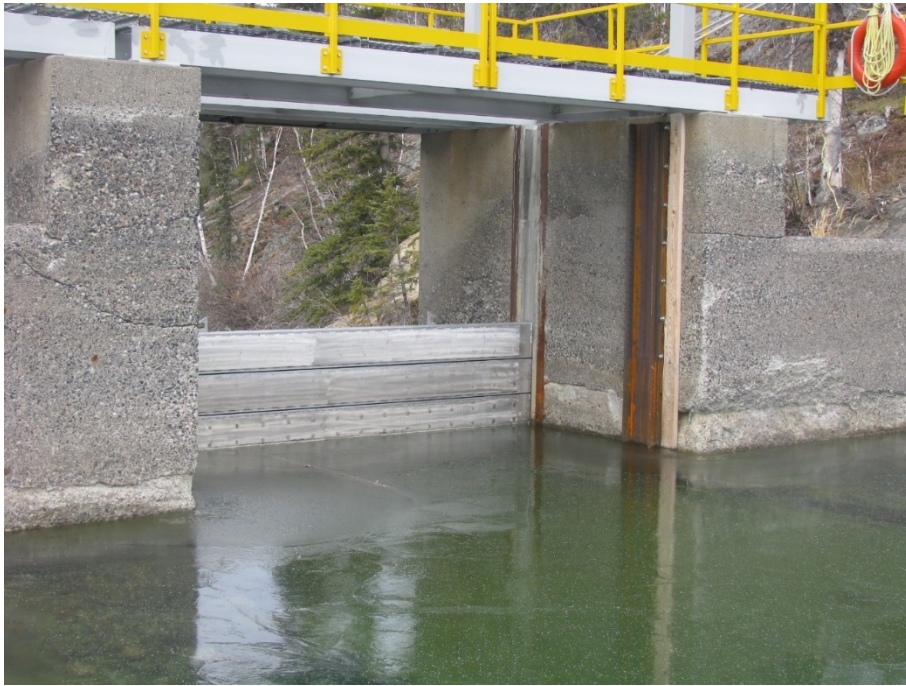
Figure 6-3: Freezing damage/spawling at waterline

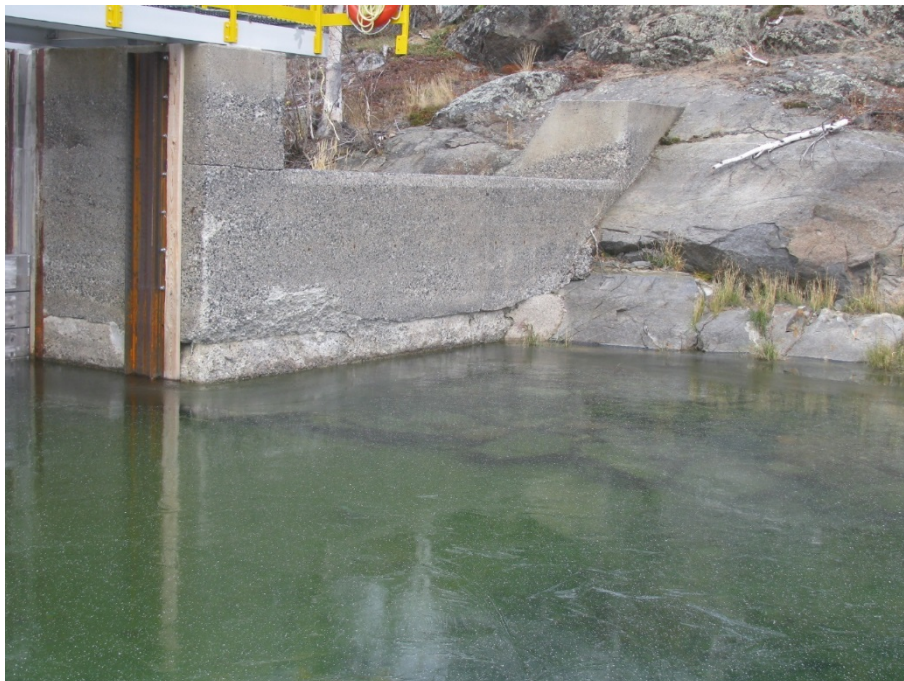
Figure 6-4: Abutment/overflow section appears to be in good condition. Interface between rock and concrete appears to be tight.

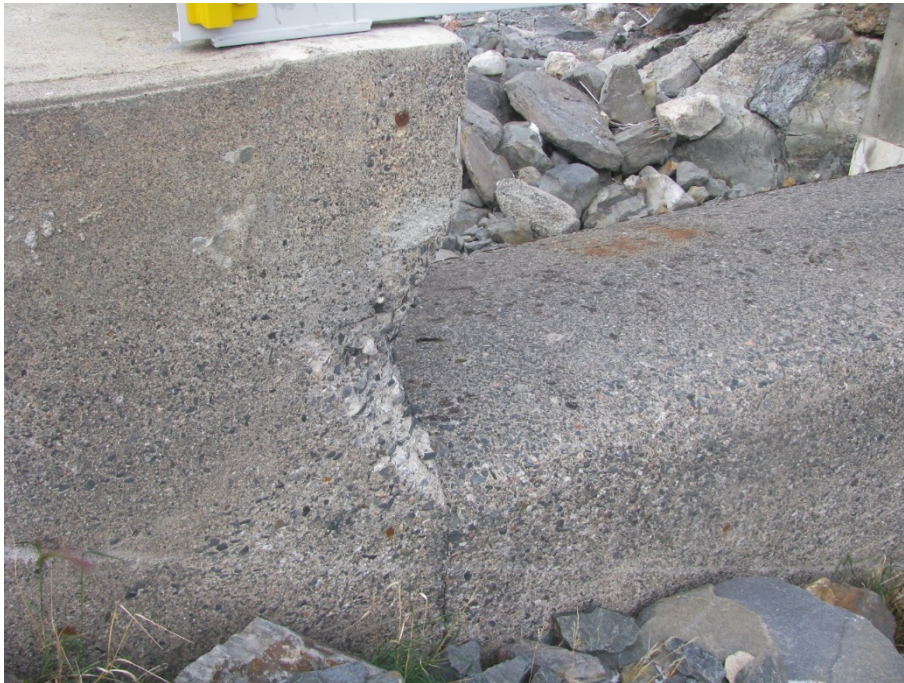
Figure 6-5: Eroded concrete at abutment upstream corner at rollway. Concrete should be rebuilt to protect from further damage.

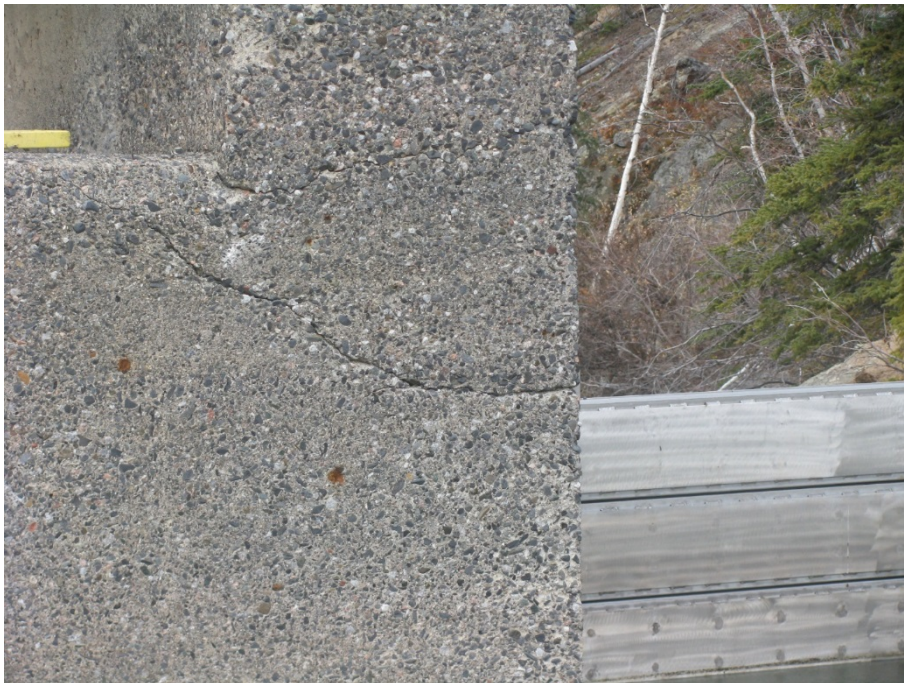
Figure 6-6: Large cracks (2 cracks) at pier to rollway interface. Cracks should be epoxy injected

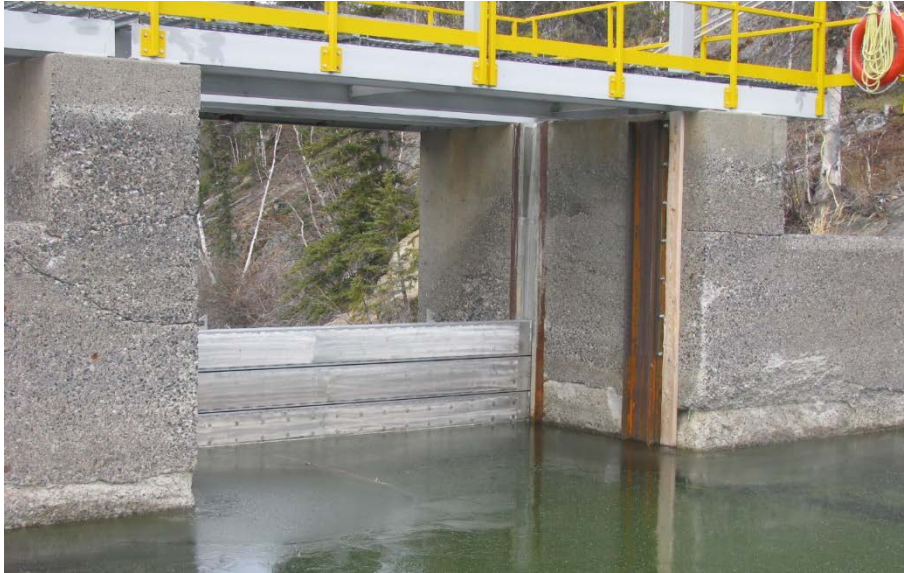
Figure 6-7: Crack visible on upstream side of both piers near rollway crest on both piers. Cracks to be epoxy injected

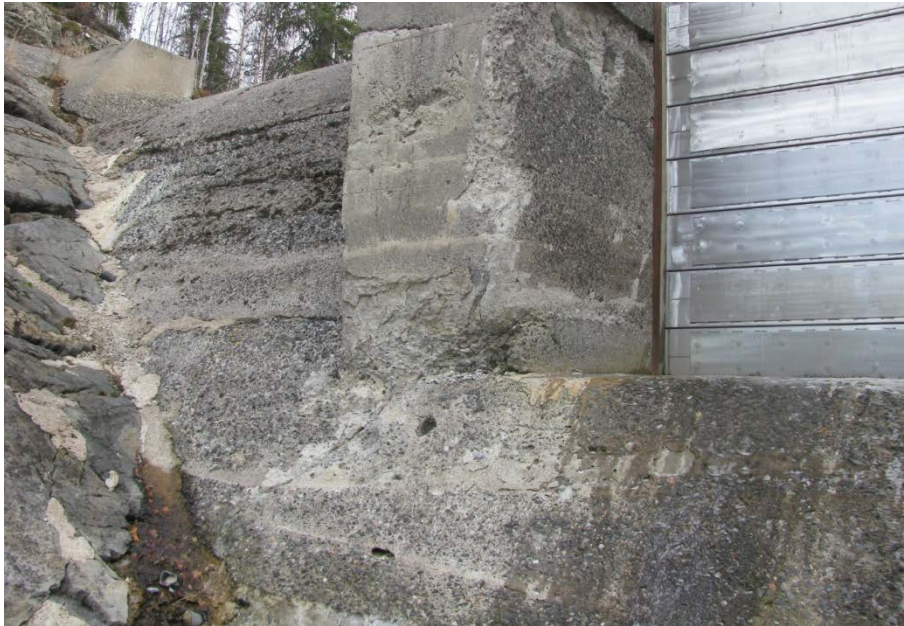
Figure 6-8: Downstream side of piers and side face shows signs of freeze-thaw damage. Eroded concrete zone should be patched to reinstate concrete cover

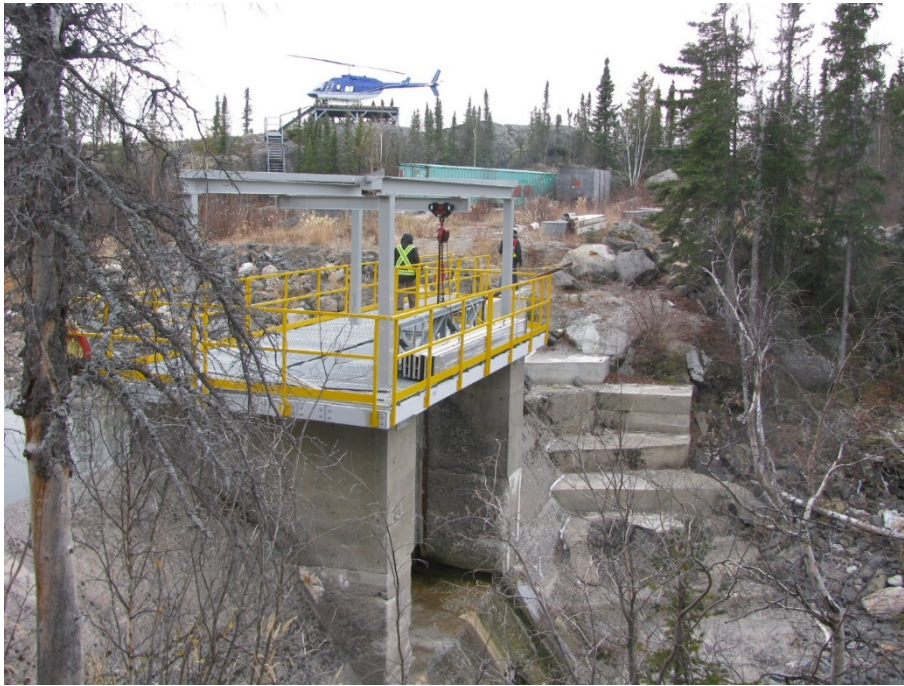
Figure 6-9: Stepped concrete added to downstream side of dam. Concrete appears to be in good conditions

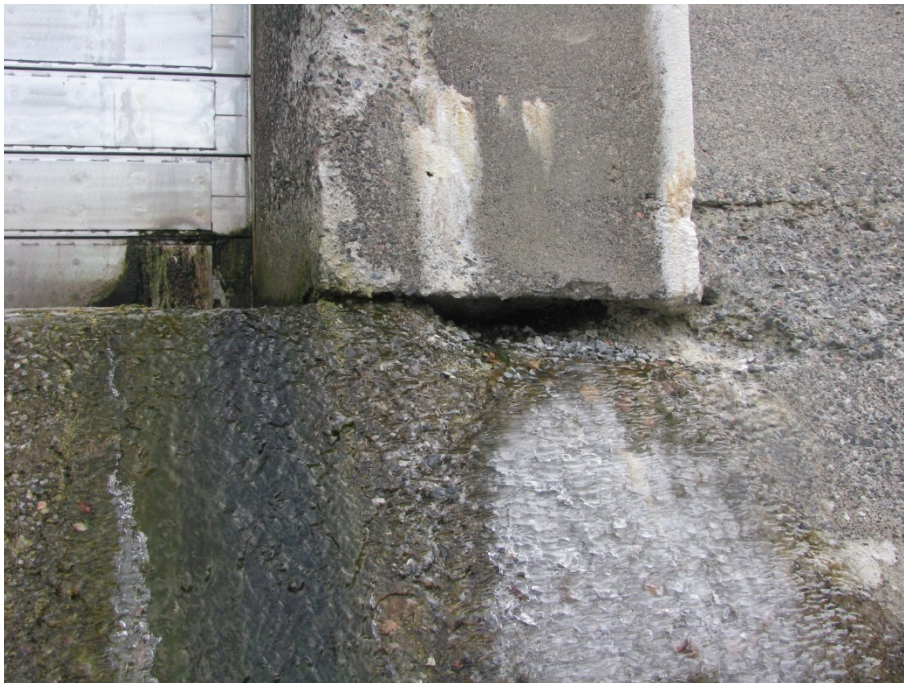
Figure 6-10: Downstream pier base has eroded and some leakage is evident. Toe of pier should be repaired

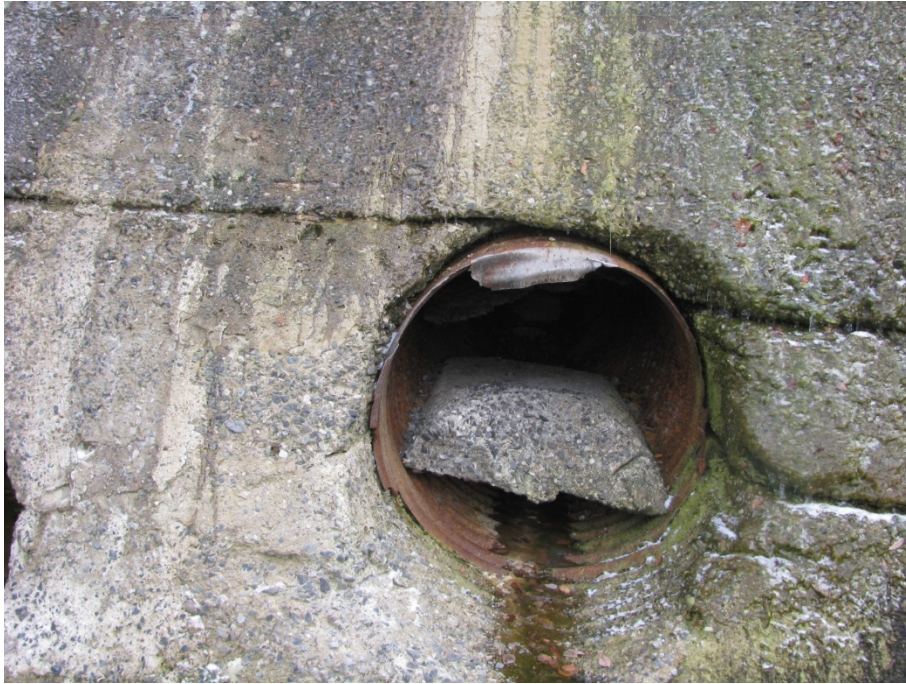
Figure 6-11: Abandoned low level conduit appears to be in fair condition

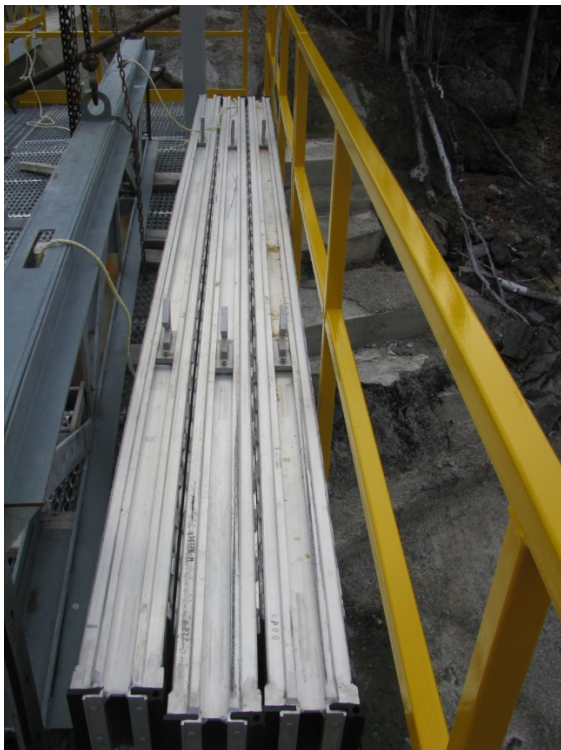
Figure 6-12: Metal stoplogs on operational platform appear to be in good condition.

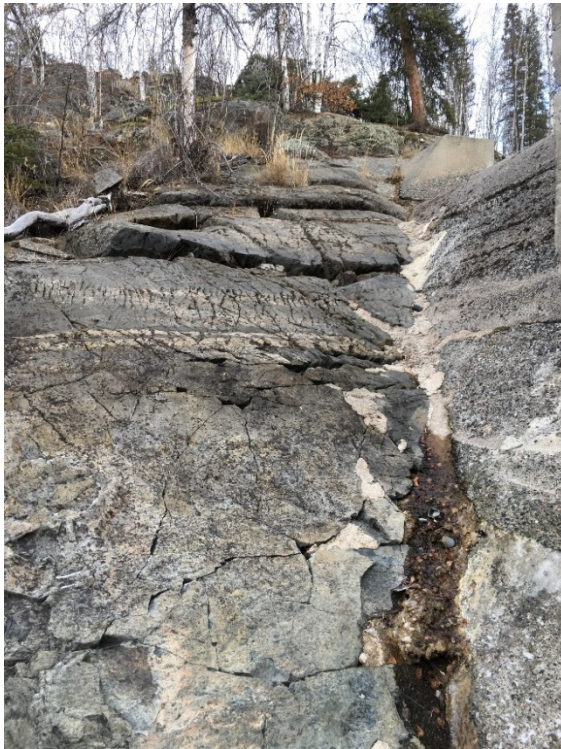
Figure 6-13: Minor seepage observed along the rock/concrete contact of the right abutment

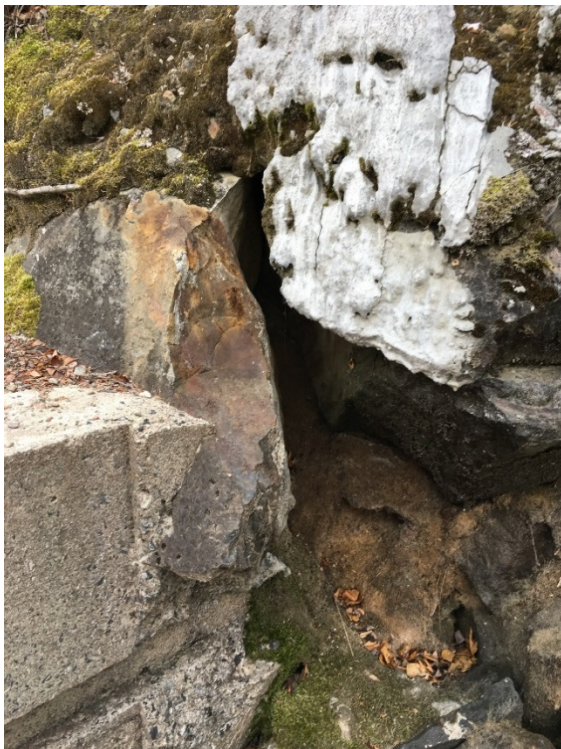
Figure 6-14: Example of voids in blast rock/rubble of the left abutment.

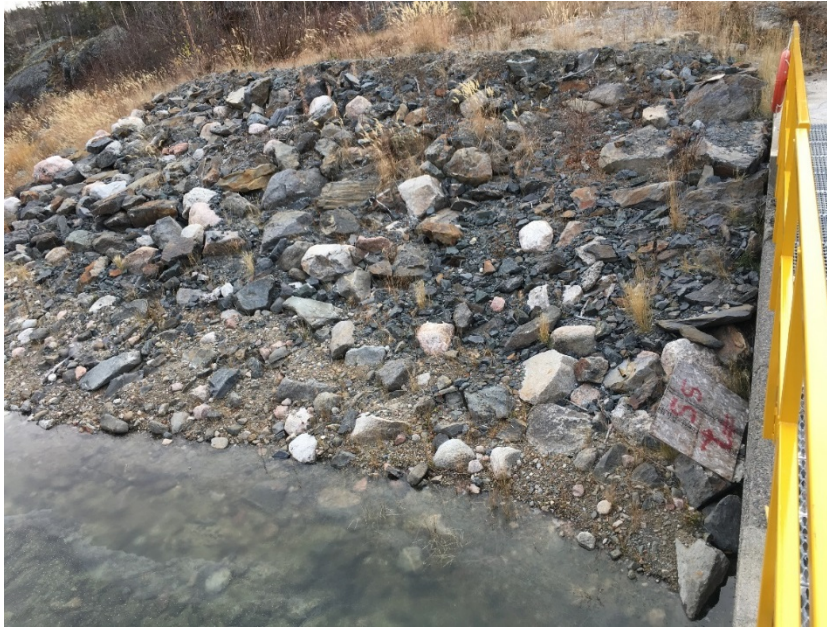
**Figure 6-15: Upstream left abutment conditions – exposed fine grained soils within water flow areas could be eroded at higher water elevations.**

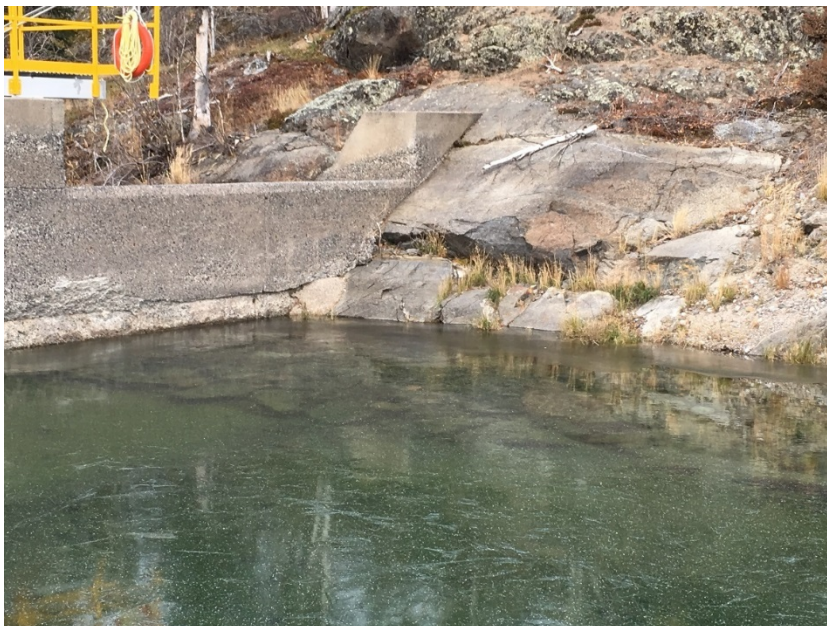
Joints and fractures in the rock on the upstream side of the right abutment are parallel to the direction of water and could also present an opportunity for seepage beneath the concrete contact at higher water elevations. This condition is shown in Figure 6.16.

**Figure 6-16: Joints/fractures parallel to the direction of water flow present an opportunity for seepage to pass beneath the concrete during higher water elevations.**
