File Number	MV2020X0004
Type of Operation	Miscellaneous
Location	Taltson Dam

ENVIRONMENTAL INSPECTION REPORT

Permittee:	Northwest Territories Power Corporation (NTPC)	Permit Expiry Date:	July 01, 2025
Land Use Permit No.	MV2020X0004	Previous Inspection:	May 26, 2022
Quarrying Permit No.	2022QP0006	Inspection Date:	July 13, 2023
Contractor:	Litostroj Hydro	Subcontractor:	DB Consultant
Location(s) Inspected:	Taltson Dam		
Current Stage of Operation:	Active – Overhaul Construction		
Program Modifications Approved:	N/A

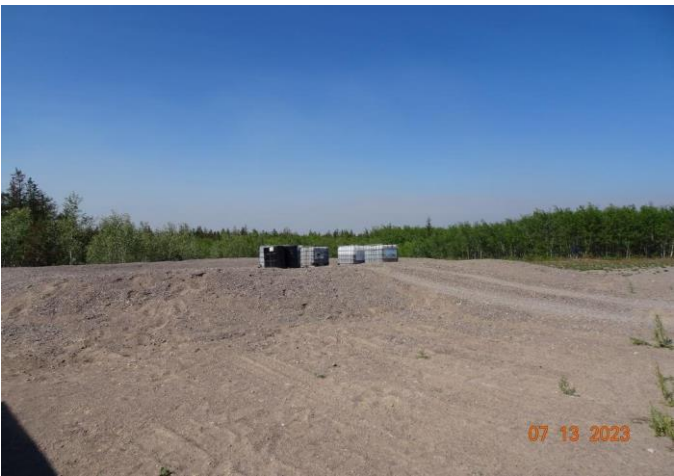
At the airstrip, there is a newly developed gravel pad with a berm southwest of the fuel shed; there are five 1000L totes and seven 45G drums that contain waste products such as used oil, concrete water, and diesel (Figures 2-3). Please inform the Inspectors whether the gravel pad with berm is lined, if not please store waste containers in secondary containment.

Figure 3
Waste products in containers at the south end of the airstrip.

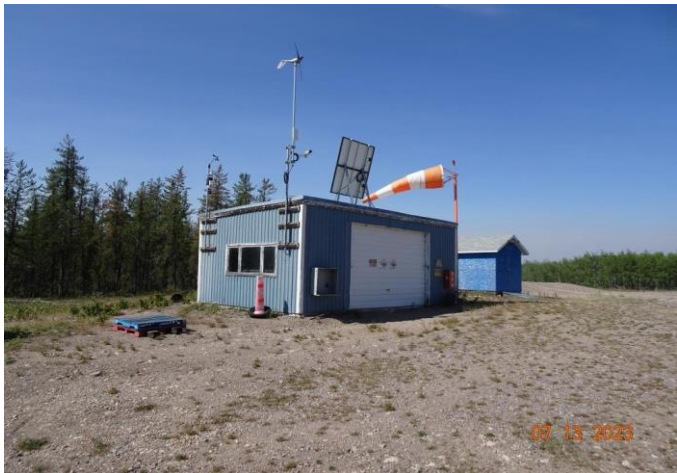
There are 32 x 45G fuel drums located inside the fuel shed (Figures 4-5). There are 24 empty 45G drums located along the southeast side of the runway (Figures 6-7). It is recommended that empty 45G drums be stored on pallets and hauled out during the next winter road season (2023/24) and disposed of to an authorized waste facility.

Figure 5
32 x 45G fuel drums stored inside the fuel shed at the airstrip.

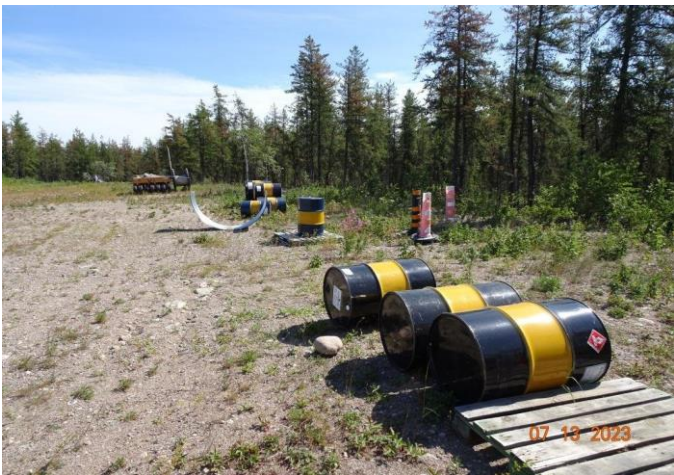
Figure 7
Empty 45G fuel drums along the southeast side of the airstrip.

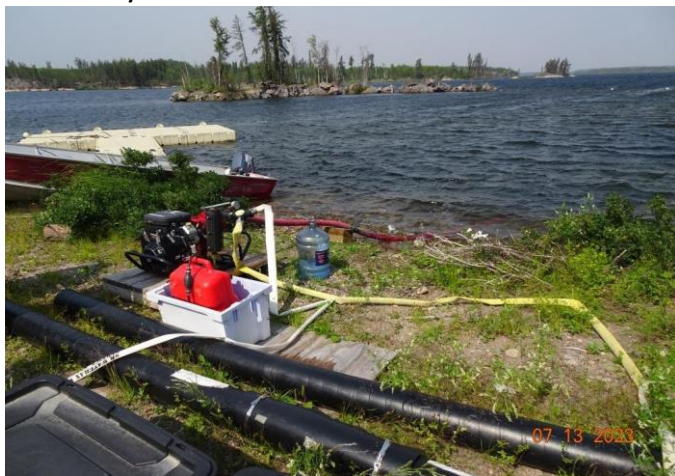
There are two emergency water pumps with 25L jerry cans set up along the shore of the Twin Gorges Forebay; one is located near the water intake shed and one located near the head gate (Figures 12-13). It is recommended that the 25L jerry cans be stored in secondary containment.

Figure 13
Emergency water pump and 25L jerry can without secondary containment located at the head gate.

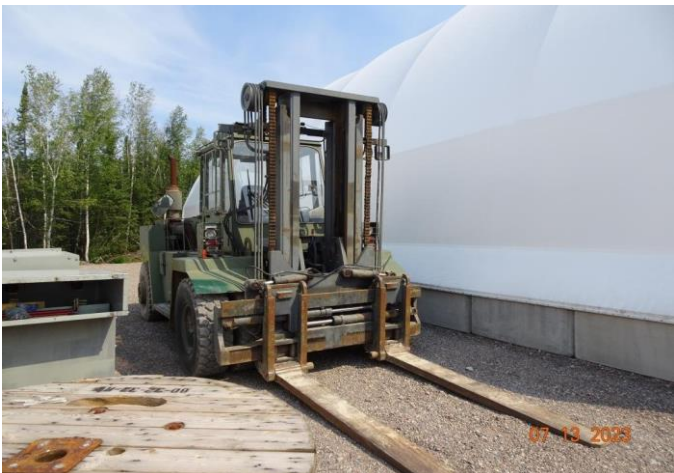
Storage area A across from the new camp facility has two large Quonsets (Figures 21-23). There is a Velmet TD 1612 HS forklift parked in between the Quonsets without a drip tray (Figures 24-25).

Figure 25
No drip tray underneath the Velmet TD 1612 HS forklift.

Equipment parked for 2 hours or greater must have a drip tray underneath it. Leaky equipment needs to be repaired immediately, and full drip trays need to be emptied into a labelled waste container to be hauled out and disposed of to an authorized waste facility.

Permit Condition #59 *“All equipment that may be parked for two hours or more, shall have a haz-mat/drip tray under it or be sufficiently diapered. Leaky equipment shall be repaired immediately.”*

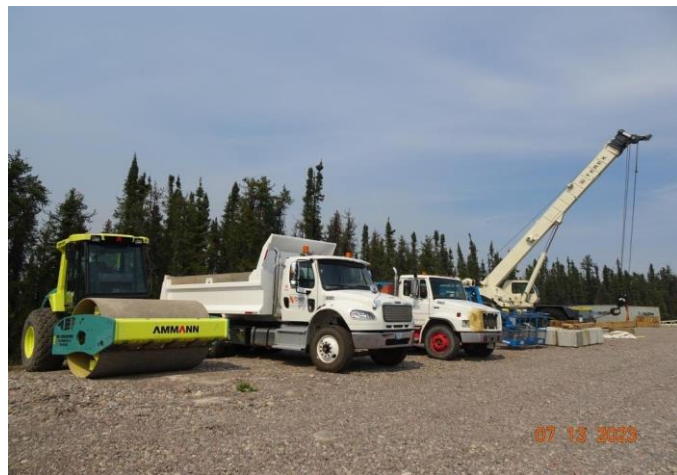
Storage area B has a gravel pad and is being used to store material and heavy equipment for the overhaul (Figures 26-39). Hydrocarbon staining and full drip trays were observed under the AMMANN single drum roller (Figures 26-27) and the old NTPC dump truck #3027 (Figures 26-29). The new NTPC dump truck #3081, Genie articulating boom lift, RT780 Terex crane, and Freightliner semi-truck did not have drip trays underneath them (Figures 26, 28, 30 & 36-37).

Figure 27
Hydrocarbon staining and full drip tray underneath the AMMANN single drum roller.

Permit Condition #36 *“The Permittee shall dispose of all combustible waste petroleum products by removal to an approved disposal facility.”*

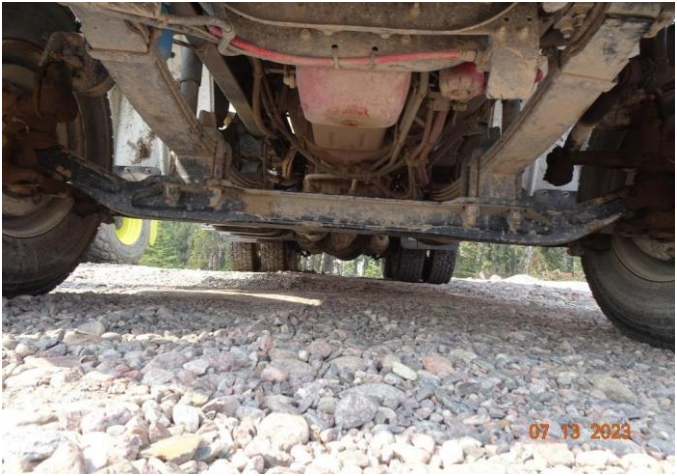
Figure 29
Hydrocarbon staining and drip tray underneath NTPC dump truck #3027.

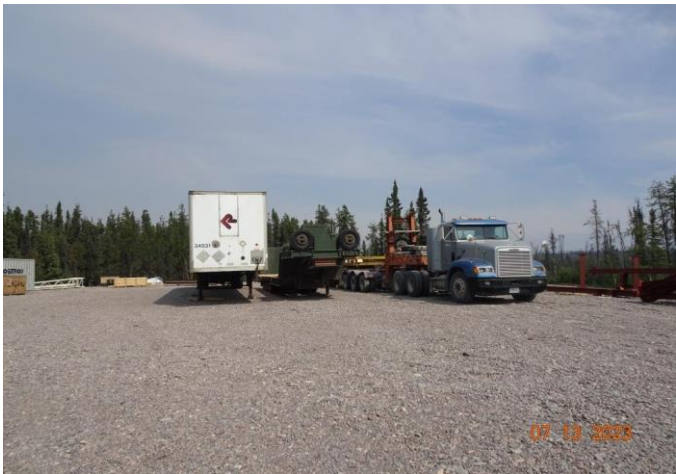
Figure 37
No drip tray underneath Freightliner semi-truck.

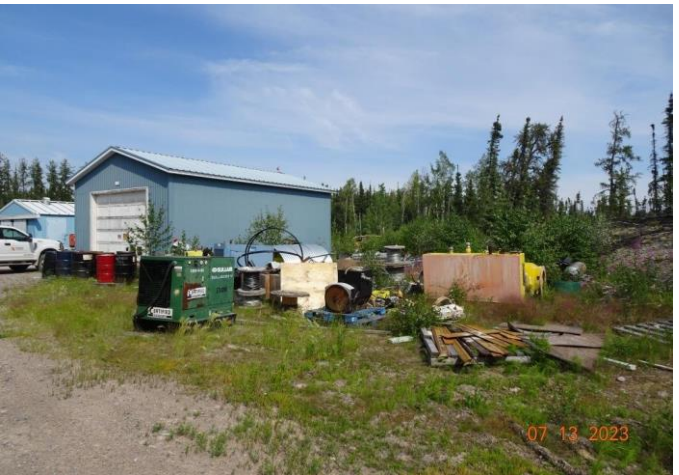
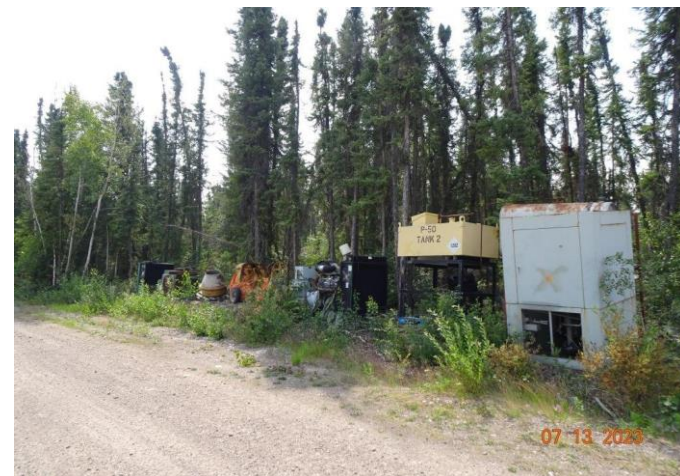
The boneyard has two storage sheds and miscellaneous items throughout the area (Figures 40-55). It is recommended that items be pulled out from the tree line and sorted through; items that are no longer of use need to be hauled out during the 2023/24 winter road and disposed of at an authorized waste facility.

Figure 41
Miscellaneous items are stored along the south tree line of the boneyard.

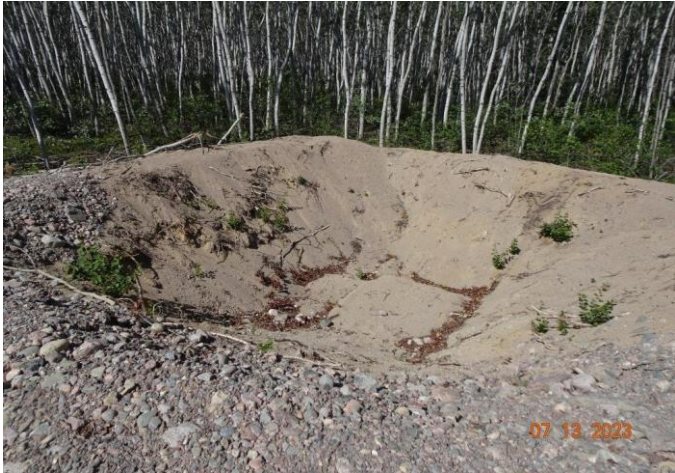
The new septic field is operational (Figures 59-61). A temporary sewage lagoon for dumping porta-potti waste has been developed along the spillway access road (Figures 62-63). The grease trap from the kitchen was dumped on the berm of the pit (Figure 64). Domestic waste cannot be dumped in the pit. Please clean up contaminated granular material by shoveling it into the pit and covering it with fresh granular material.

Figure 64
Kitchen grease trap waste dumped on berm.

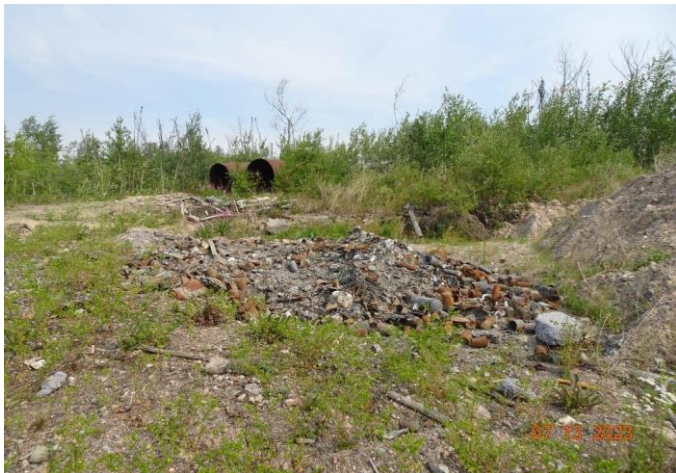
As mentioned in the May 26, 2022, inspection report it is recommended that the incinerator ash (Figure 67) be stored in a container and removed from site when possible; the ash contains traces of heavy metals and dioxins.

Figure 67
Incinerator ash pile located at the dump.

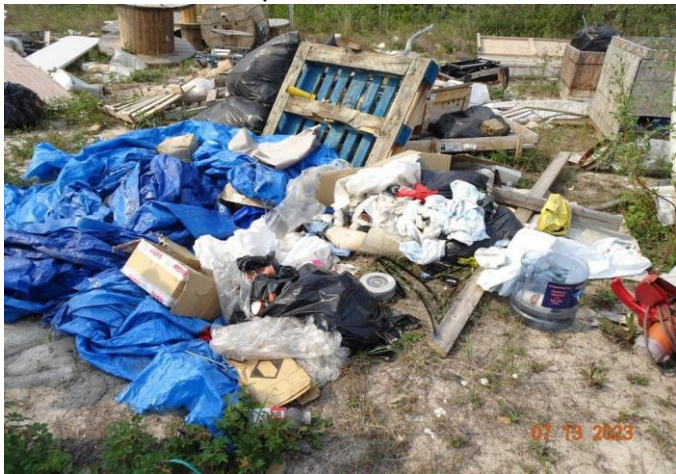
The dump is well organized with signage and a spill response kit (Figures 65-72). There was a bag of domestic garbage in the general section of the dump (Figure 72). Please do not dump domestic garbage at the dump as this attracts wildlife; domestic garbage should be stored in a secure container until it is disposed of.

Figure 72
Bag of domestic garbage located in the general section of the dump.

Permit Condition #40 *“The Permittee shall keep all garbage and debris in a secure container until disposal.”*

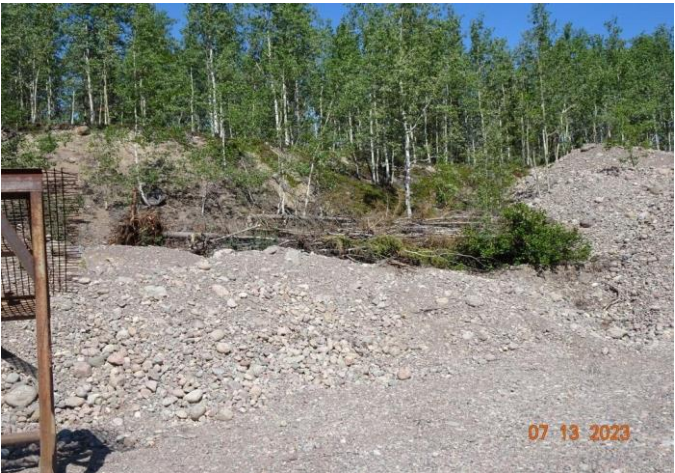
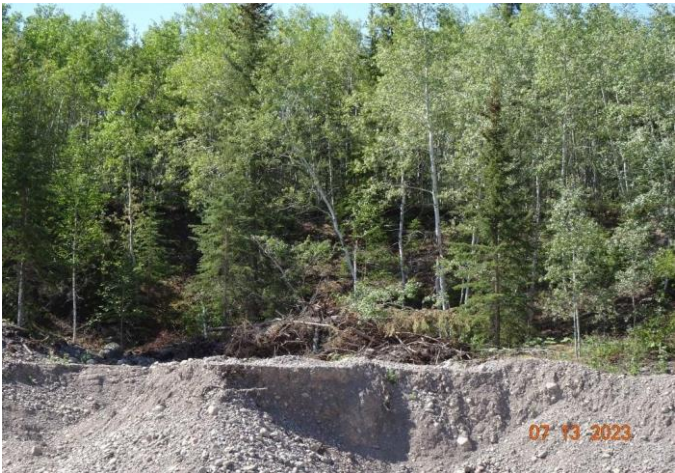
Pit W is an active gravel quarry northwest of the airstrip. Pit run material has been stockpiled in the northwest portion of the pit (Figure 80). An EZ Screen 1000XL and manual metal screener are located along the west side of the pit (Figure 79). There are two small brush piles along the west side of the pit, it is recommended that brush/tree piles be burned when weather conditions are acceptable.

Figure 81
Piled trees along the west side of Pit W.

Figure 82
Piled trees located in the southwest side of Pit W.

Permit Condition #62 *“The Permittee shall progressively dispose of all brush and trees; all disposal shall be completed prior to the end this land use operation.”*
