<b>File Number</b>	MV2020X0004
<b>Type of Operation</b>	Construction of Replacement Facilities
<b>Location</b>	Taltson Dam

ENVIRONMENTAL INSPECTION REPORT

Permittee:	Northwest Territories Power Corporation	Permit Expiry Date:	July 25, 2025
Land Use Permit No.	MV2020X0004	Previous Inspection:	New
Quarrying Permit No.	2020QP0019	Inspection Date:	July 29, 2021
Location(s) Inspected:	Taltson Dam Hydroelectric Facility		
Current Stage of Operation:	Preparing for shutdown and overhaul

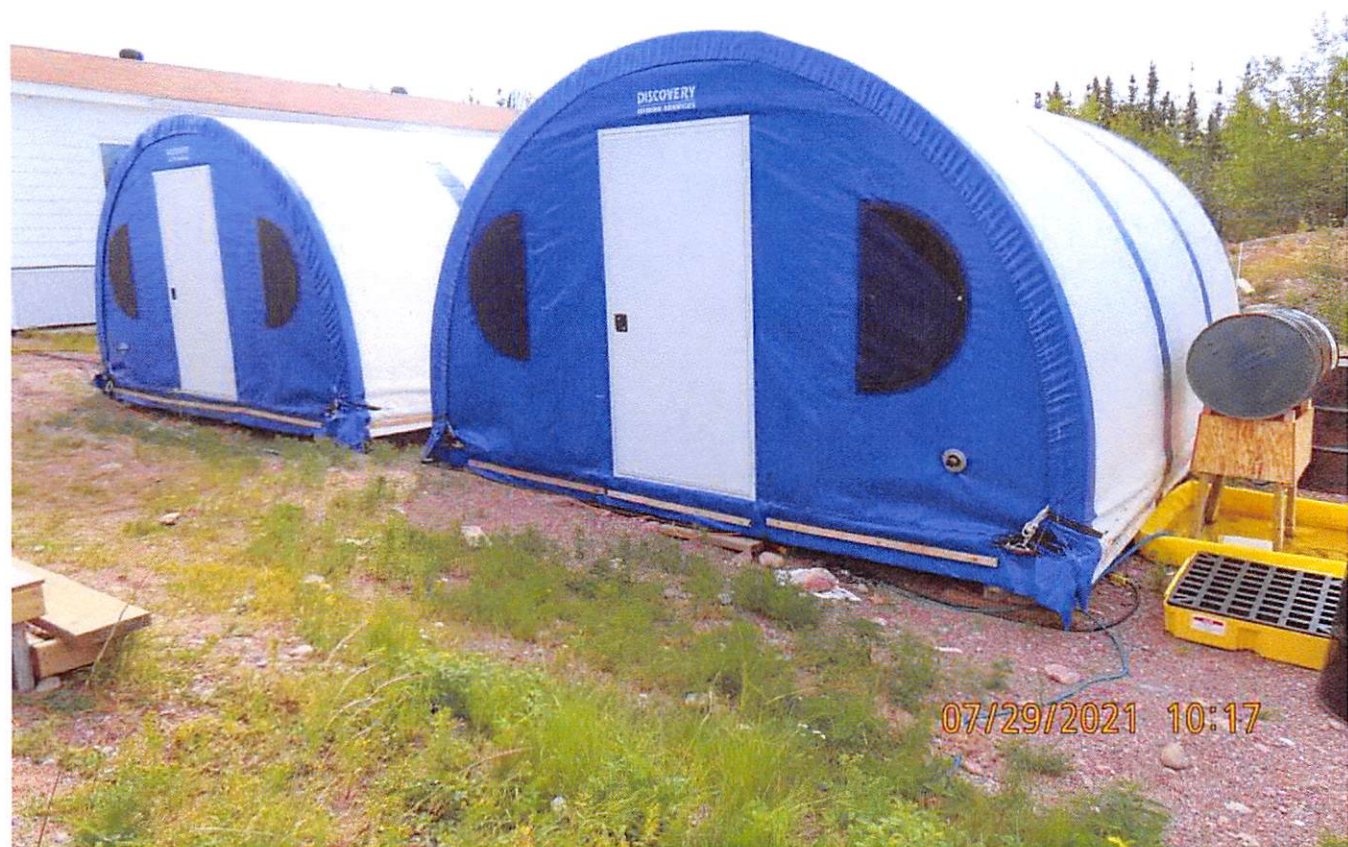
Figure 2  
Image of temporary accommodations.

There are four temporary staff tents staged below the existing camp facilities (Figure 2). There are six 45G fuel drums for heating the tents (Figure 3). The drums are secure on wooden stands with secondary containment. Water was observed in the containment trays (Figure 4). Inspectors discussed draining the water in situ if no hydrocarbon sheen was present or containing (pumping) it into a barrel if contaminated. Connections between the drums and tents were flexible and leak free.

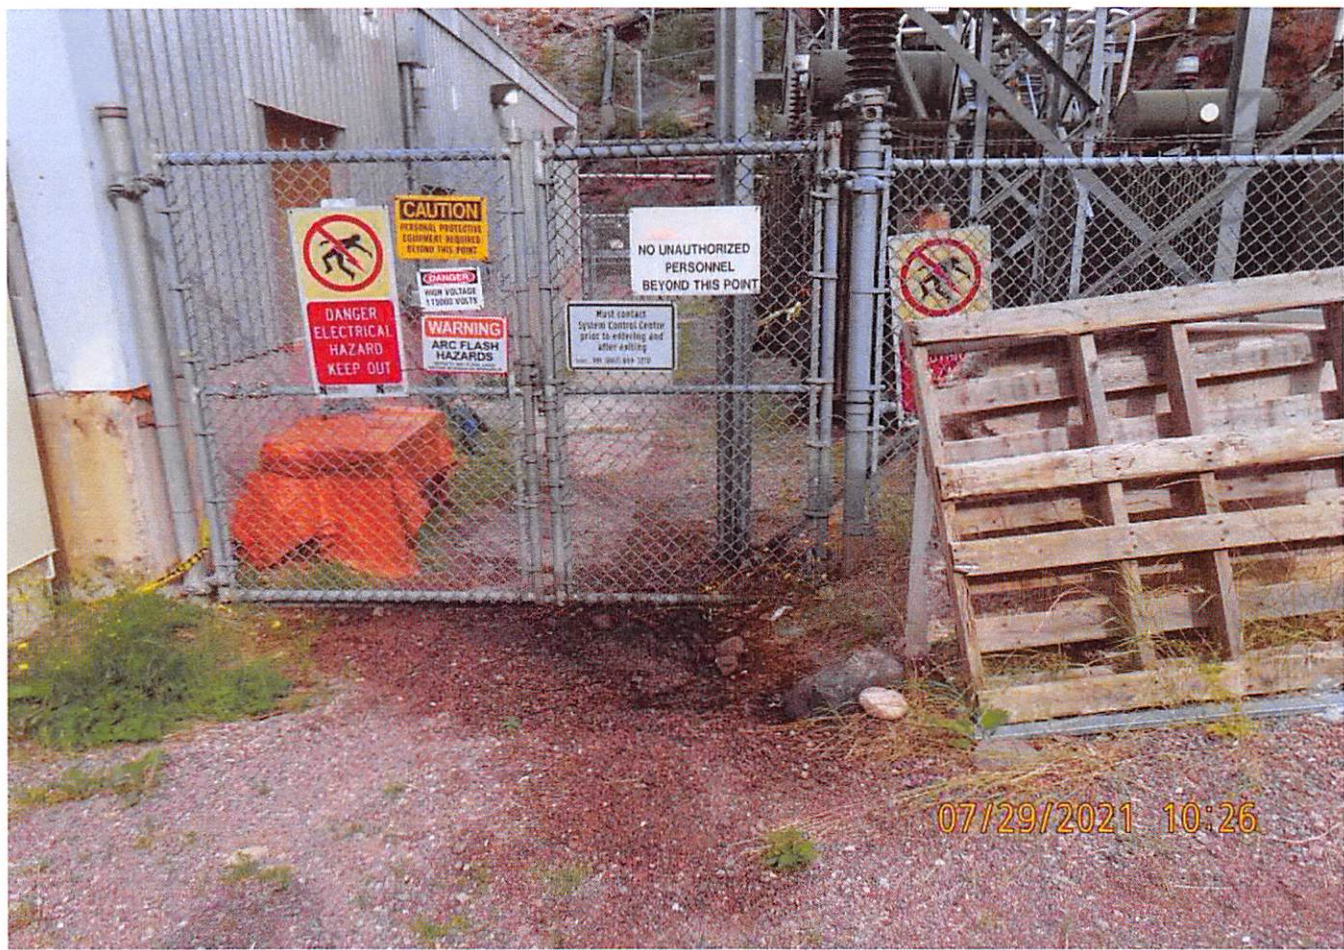
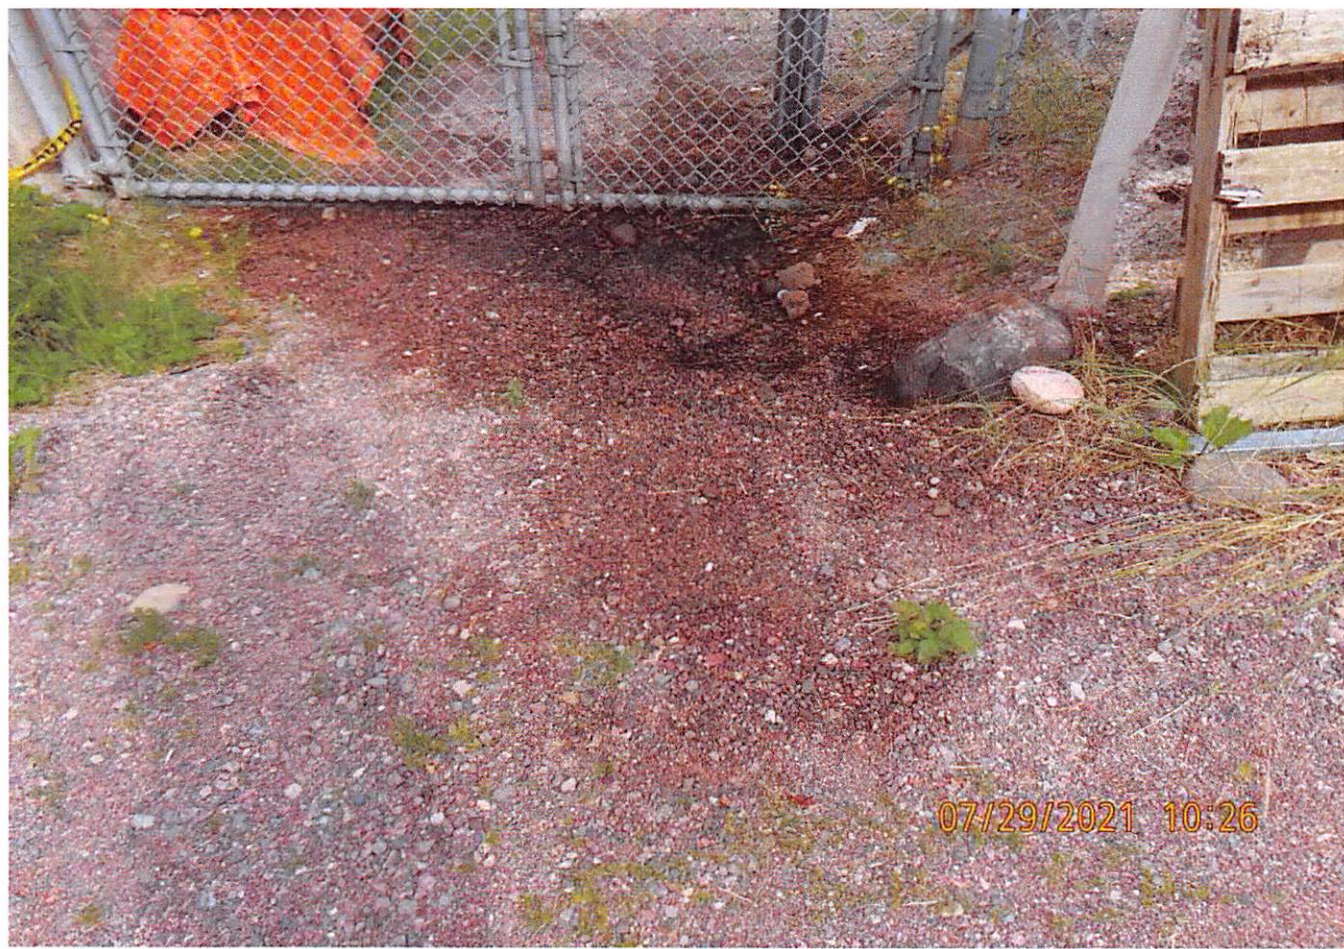
There is a 30L transformer oil spill (Spill #: 2021261) located at the gate to the substation as reported to Inspectors on June 24, 2021 (Figures 5-6). Clean up of the spill will occur during the 2021 shutdown (Aug.16-31) as per the spill report. Contaminated soil will be shipped off site and disposed of at an authorized solid waste facility. Confirmation of cleanup will be sent

Figure 5  
Image of reported fuel spill near substation.

Figure 6  
Image of reported fuel spill near substation.

to Inspectors as per post-inspection discussions on August 6, 2021.

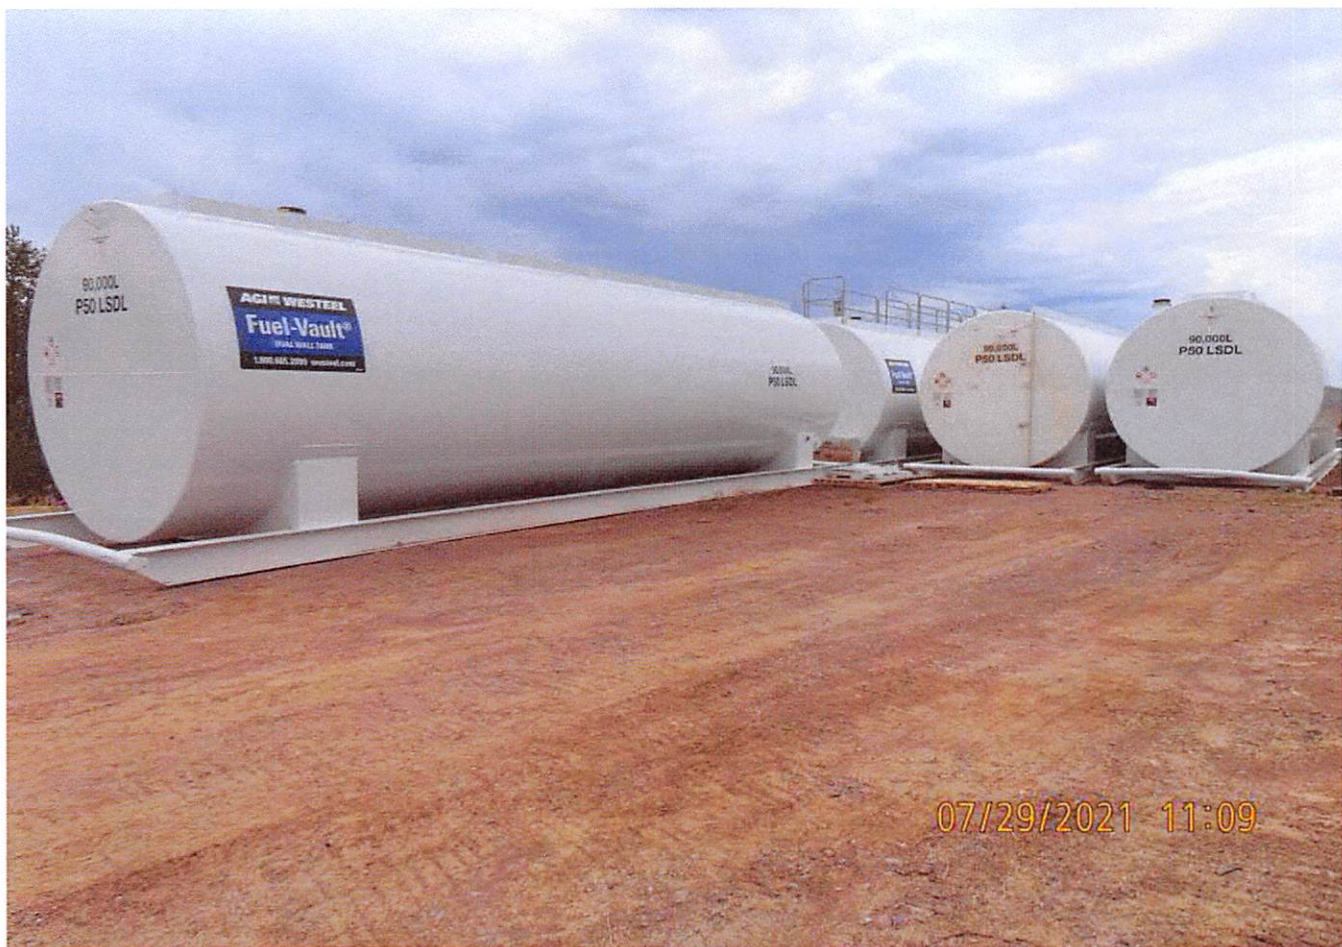
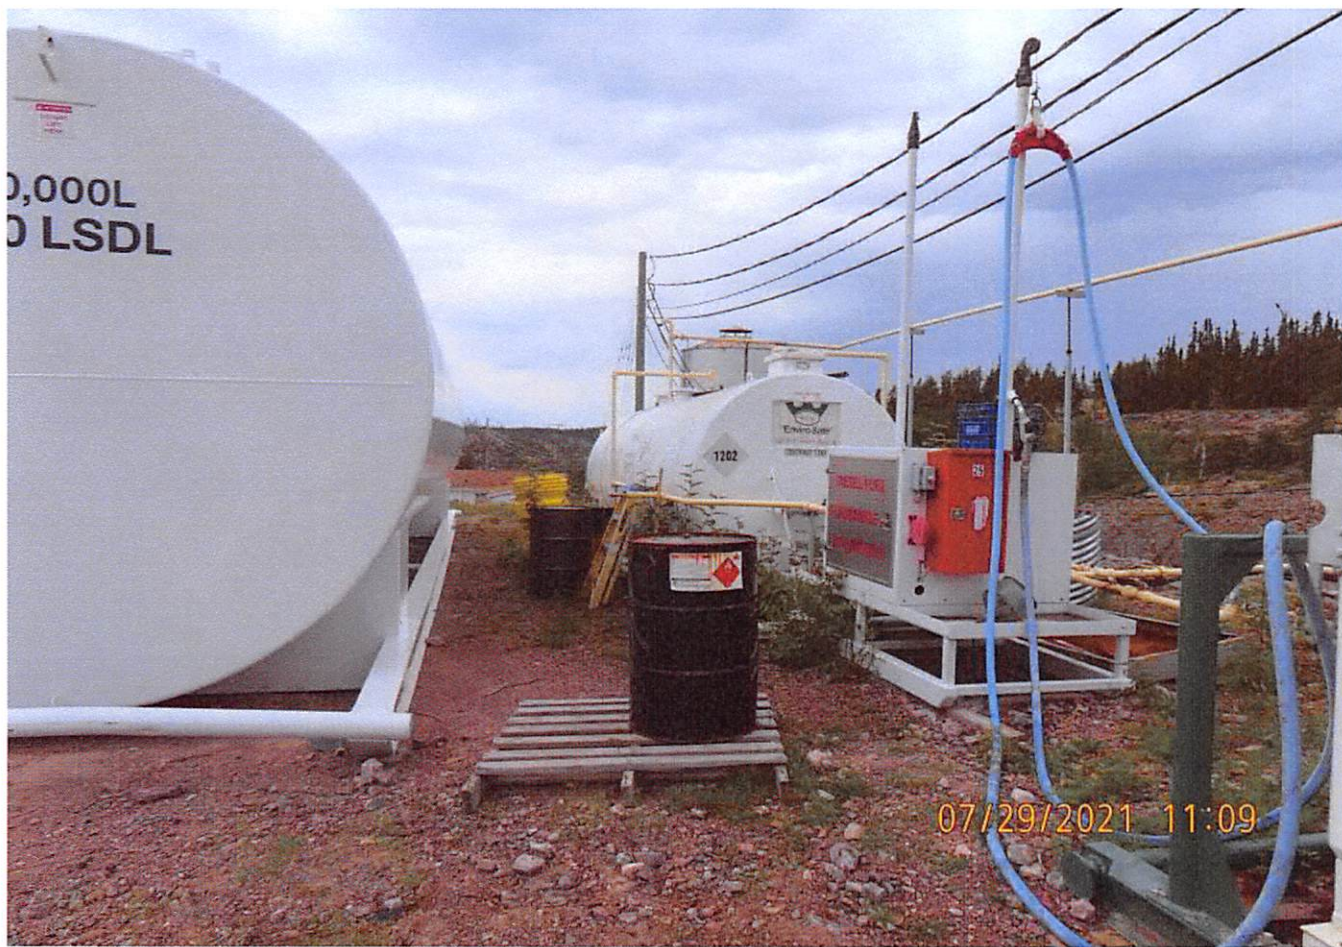
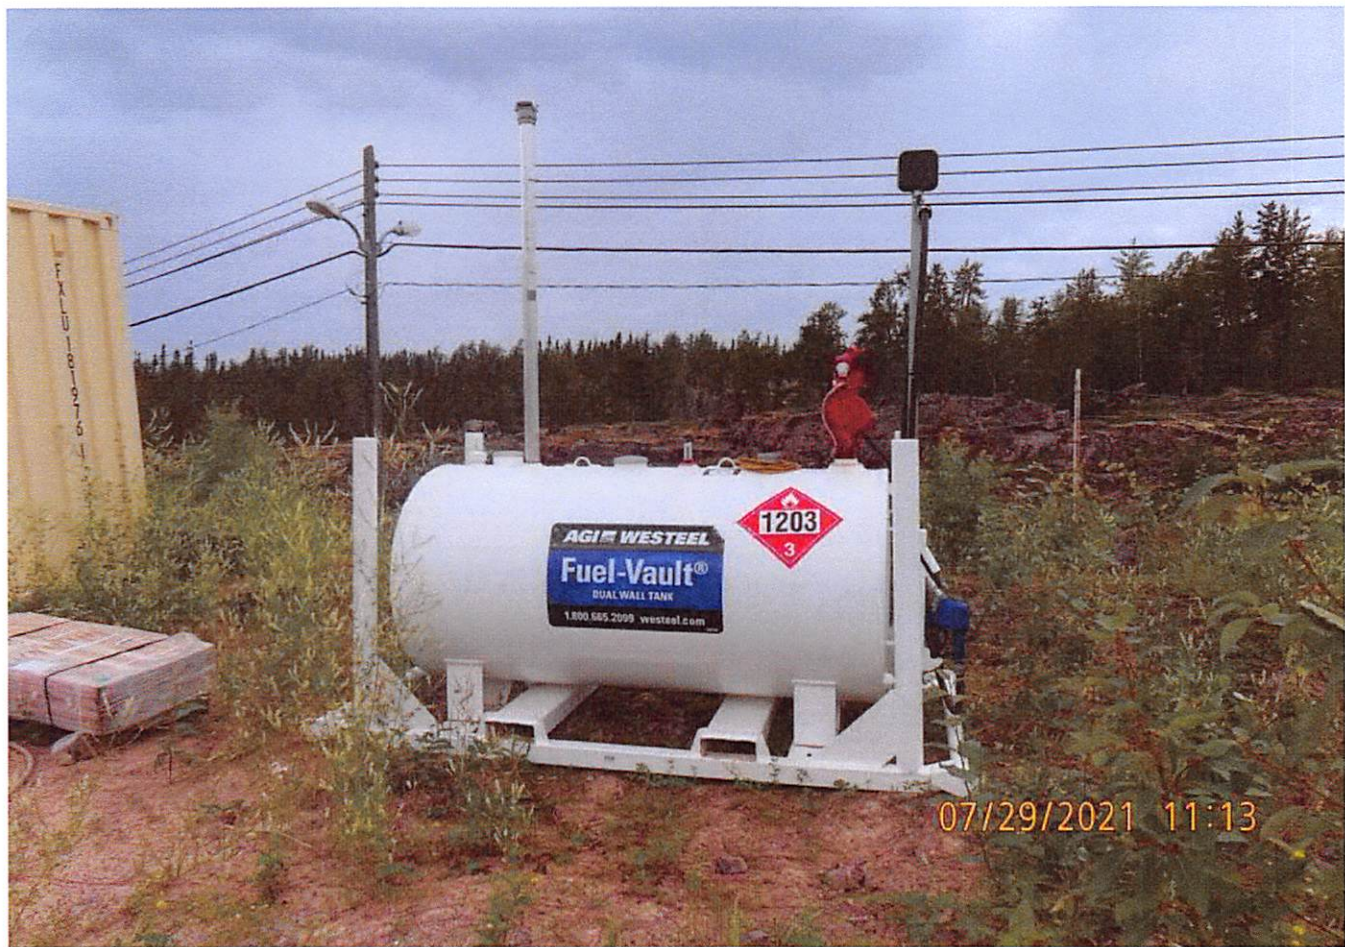
The temporary fuel storage and distribution area is located up hill and south of the penstock (Figures 7-9). The area is clean of leaks and staining. There were ten 45G drums of diesel fuel stored adjacent to the new backup generator facility in a secondary containment tray (Figure 10). Water was also observed in this tray. Water should be drained immediately following rain if no hydrocarbon sheen is present.

Figure 7  
Image of temporary fuel (diesel) storage.

Figure 8  
Image of fuel distribution system.

Figure 9  
Image of fuel (gas) storage & distribution.

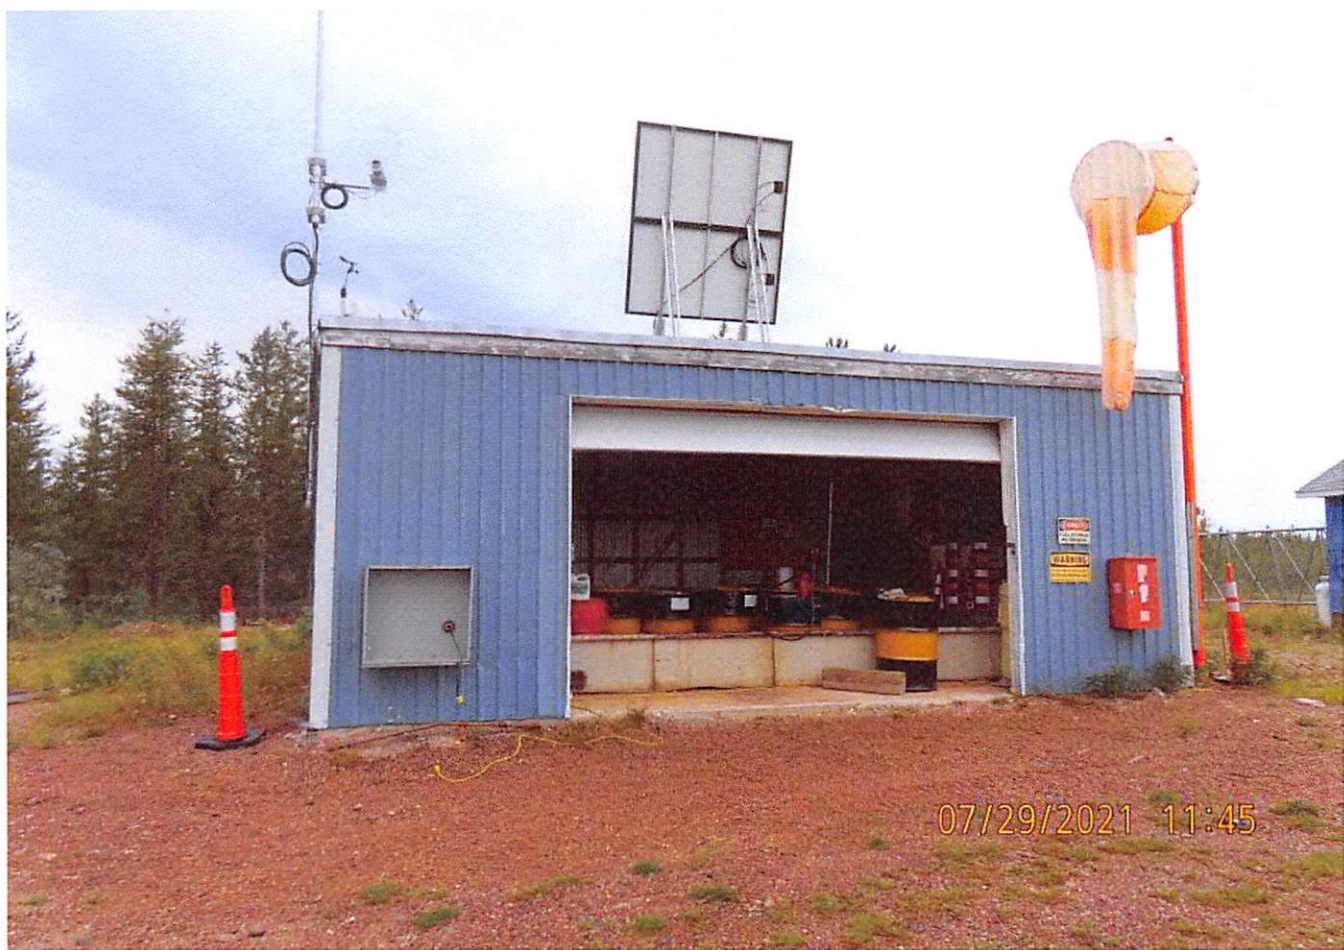
Figure 11  
Fuel storage shed located at the airstrip.

There is a fuel storage shed in the southwest corner of the airstrip containing ~33 fuel drums (Figure 11). The drums are undercover and well contained.

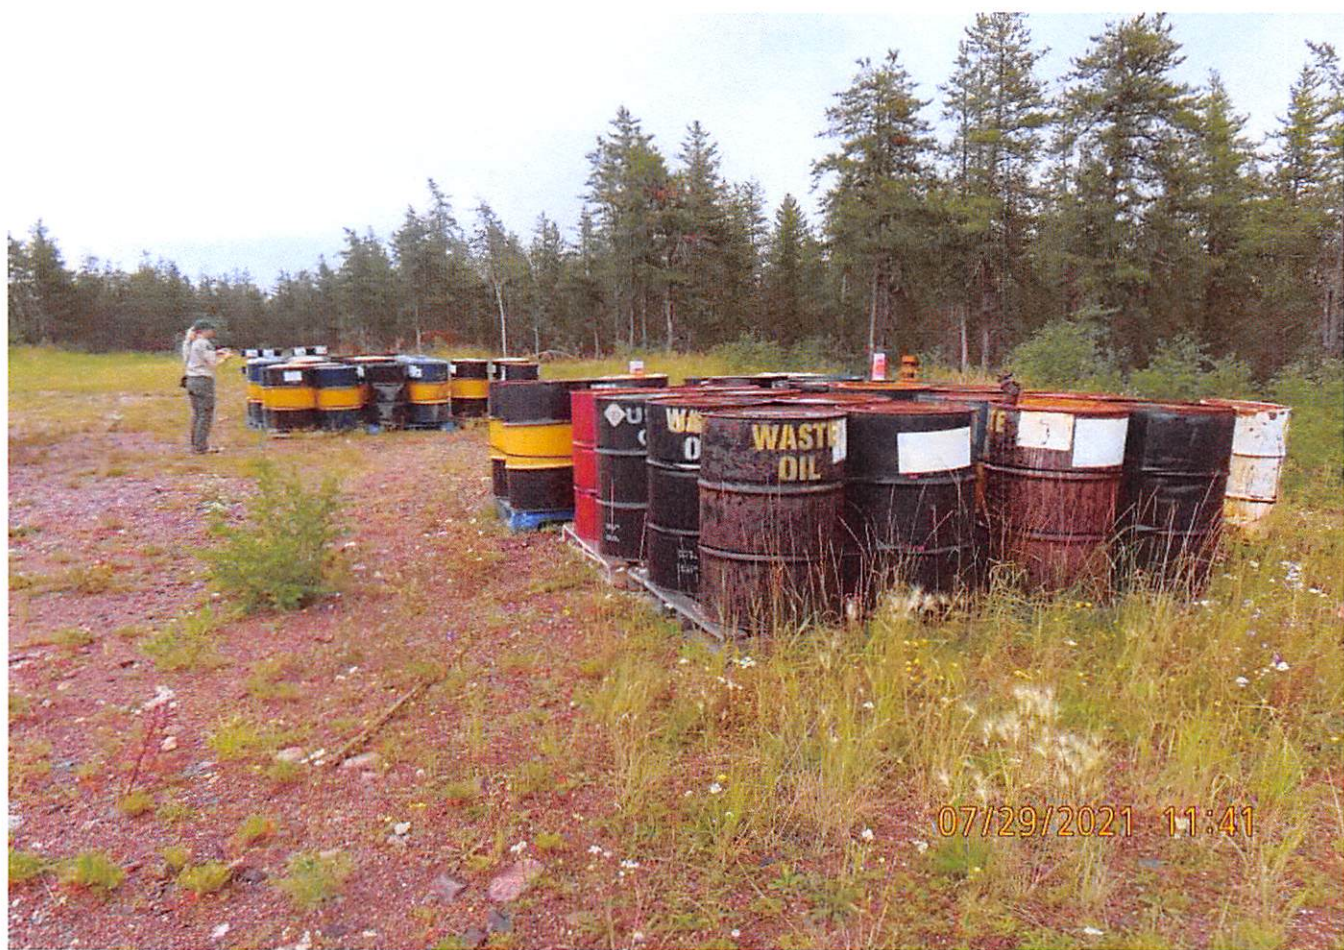
Figure 12  
Image of fuel drum storage adjacent to the airstrip.

There were multiple 45G drums (8 x Jet A fuel, 24 x waste barrels & 27 x diesel) temporarily being stored on pallets adjacent to the runway (Figure 12). The barrels are mostly empty and are all marked adequately for removal from site. Storage of these barrels is temporary. If barrels are to be stored long term please note permit condition #49 requires “The permittee shall ensure that all fuel caches have adequate Secondary Containment.”

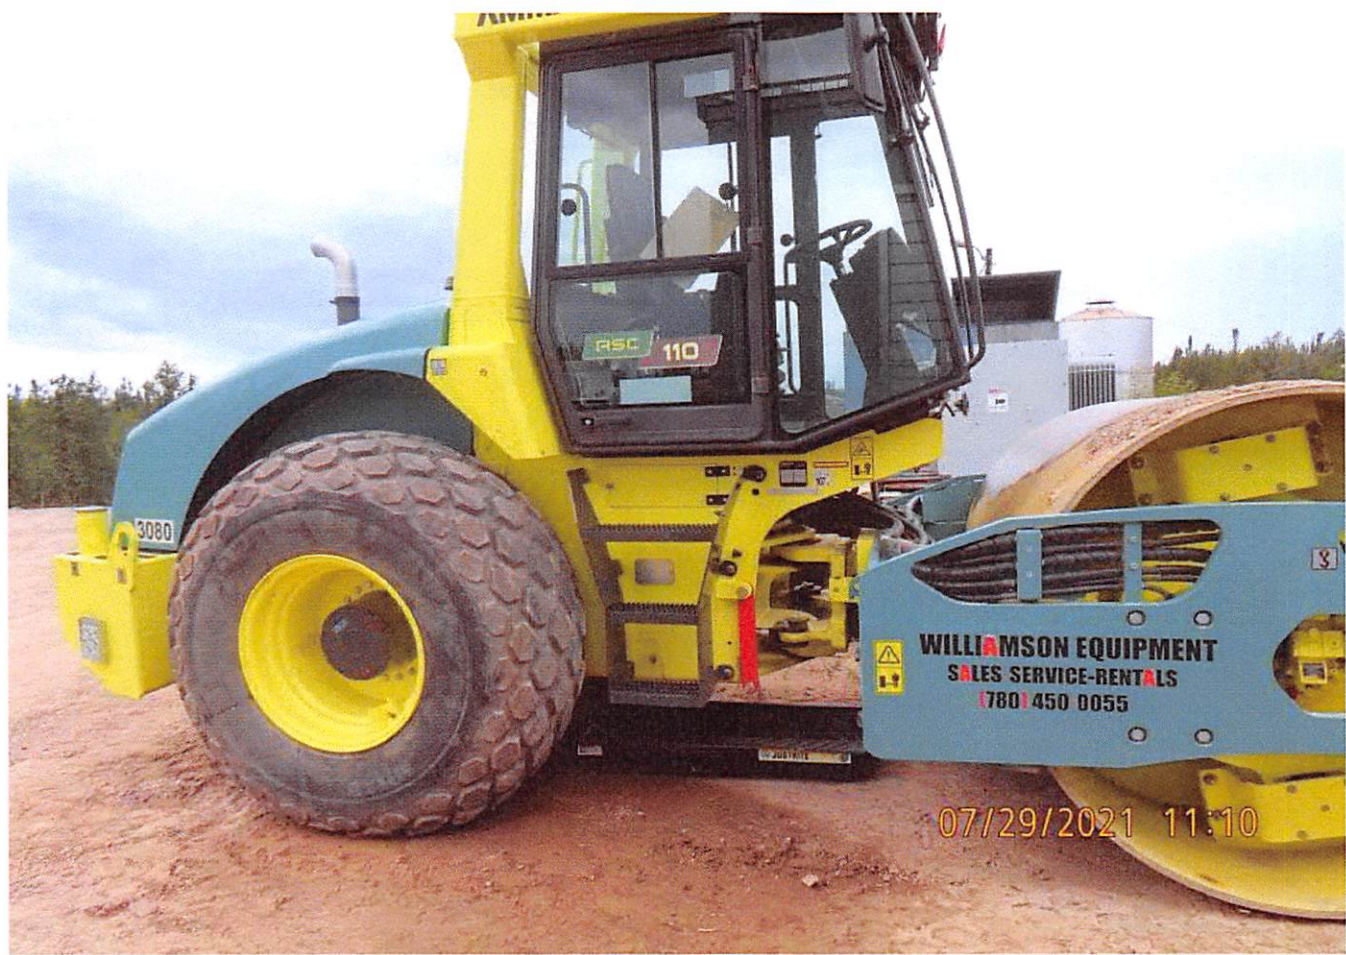
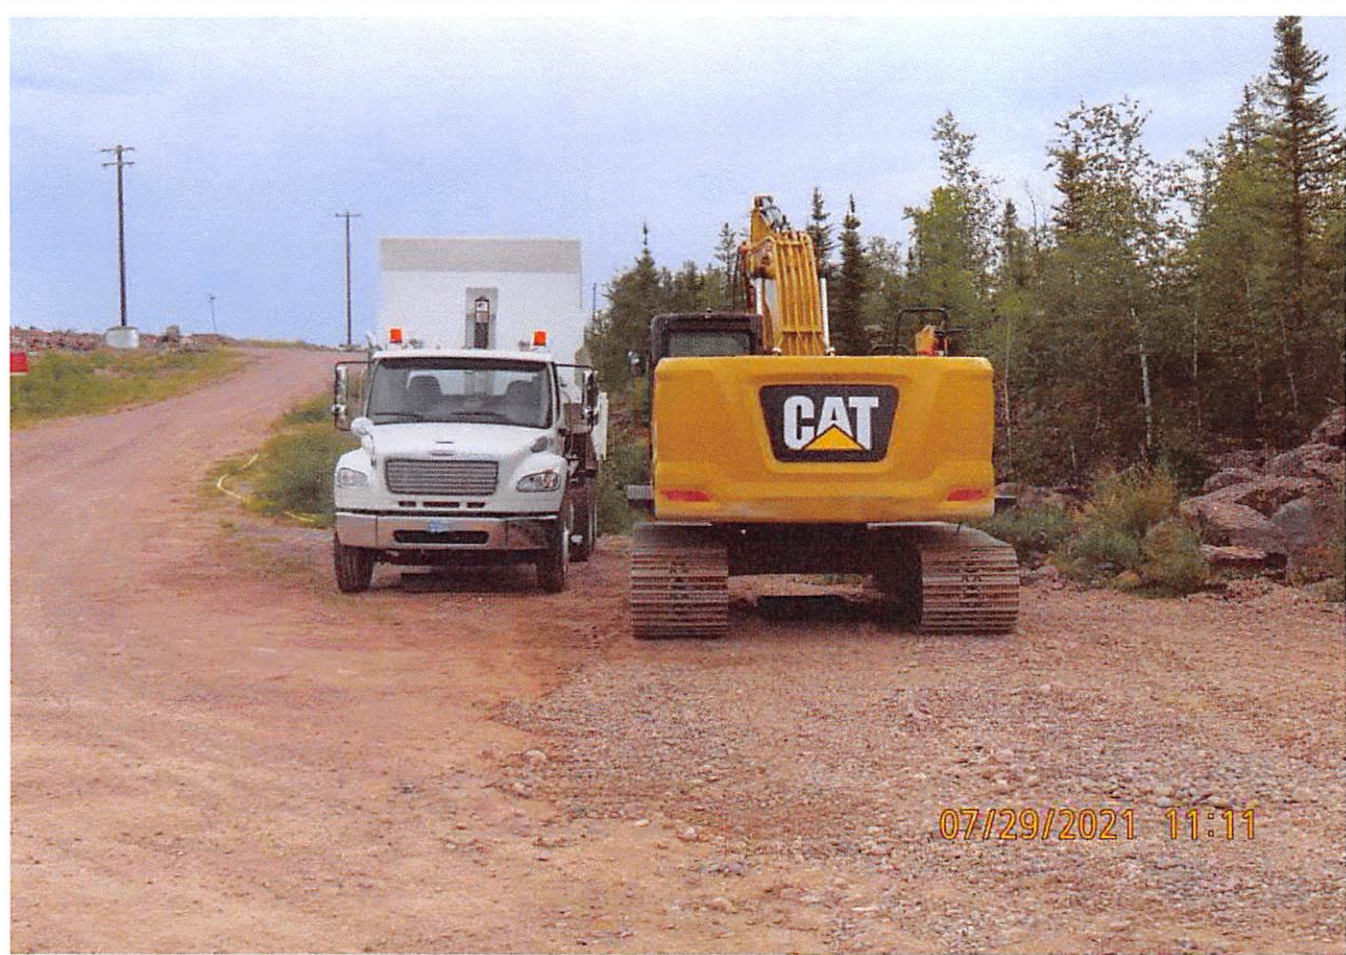
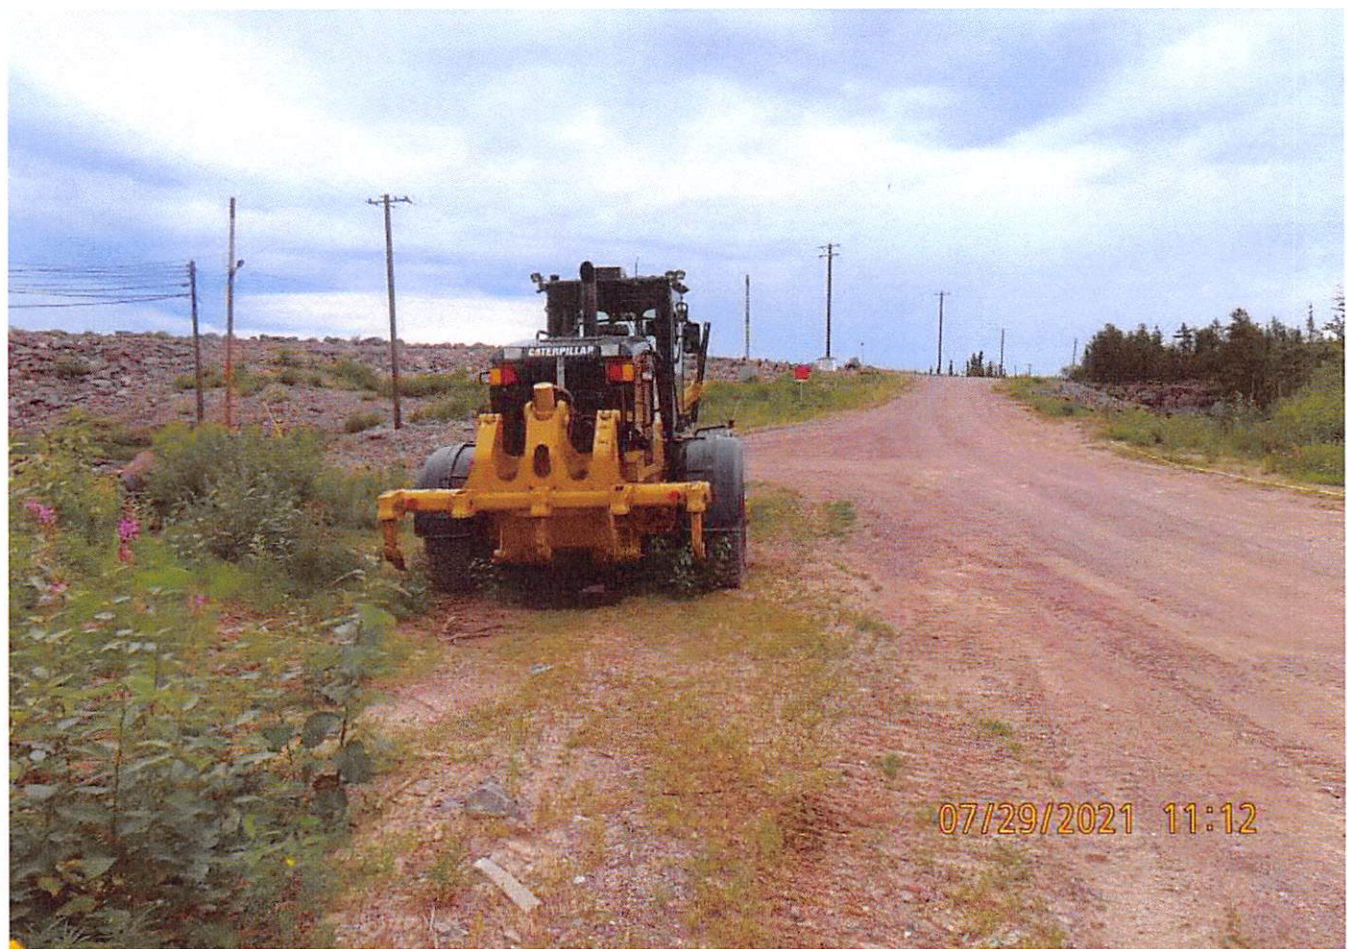
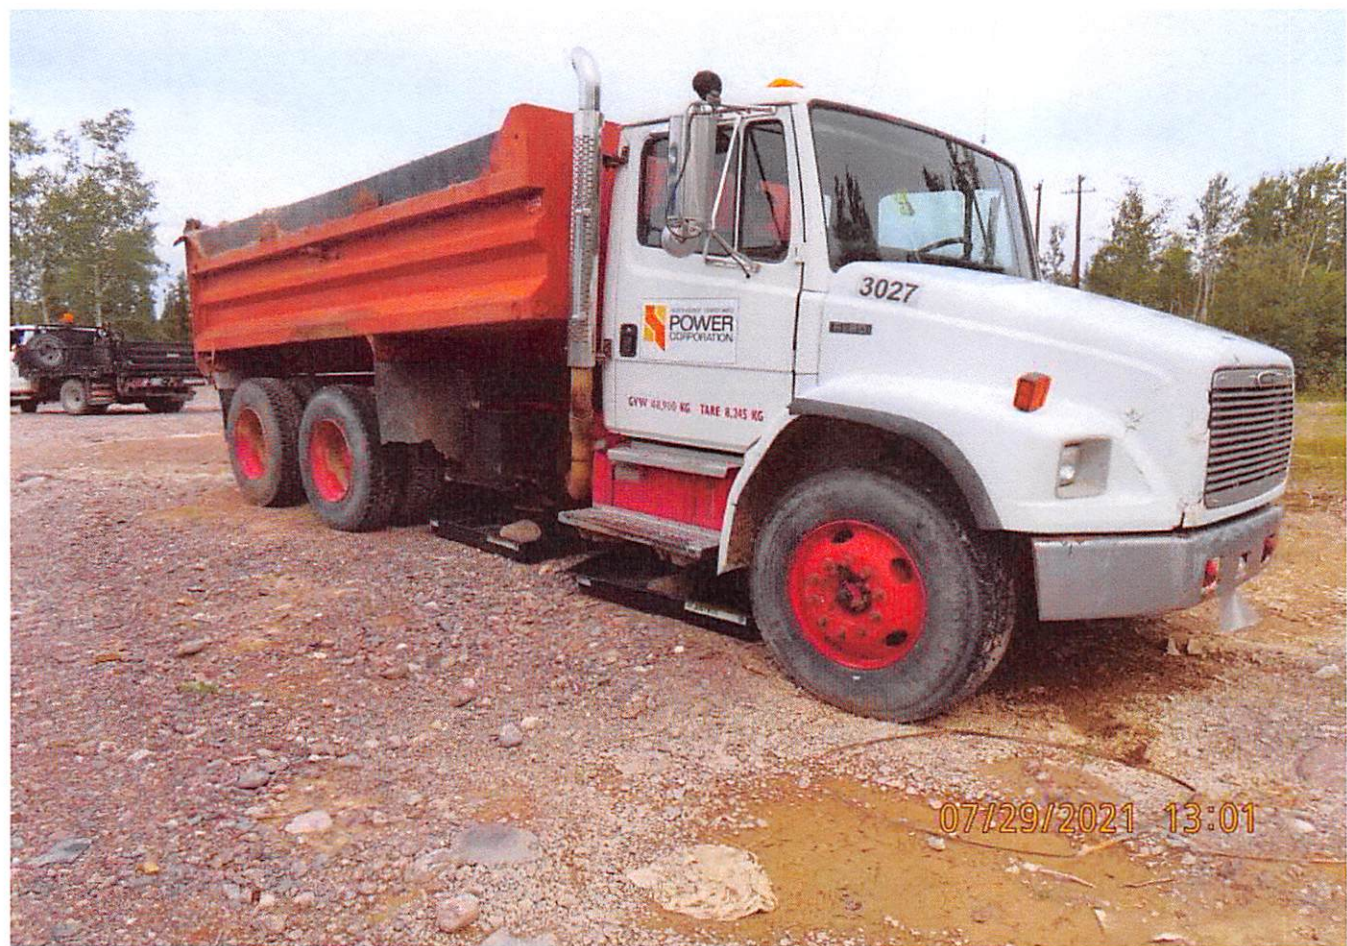
Drip trays were present under equipment (Figures 13-16). As with other containment trays water from recent rains was present and should be drained accordingly.

Figure 13  
Image of equipment stored with drip tray.

Figure 14  
Image of equipment stored with drip trays.

Figure 15  
Image of equipment stored with drip tray.

Figure 16  
Image of a dump truck stored with drip trays.

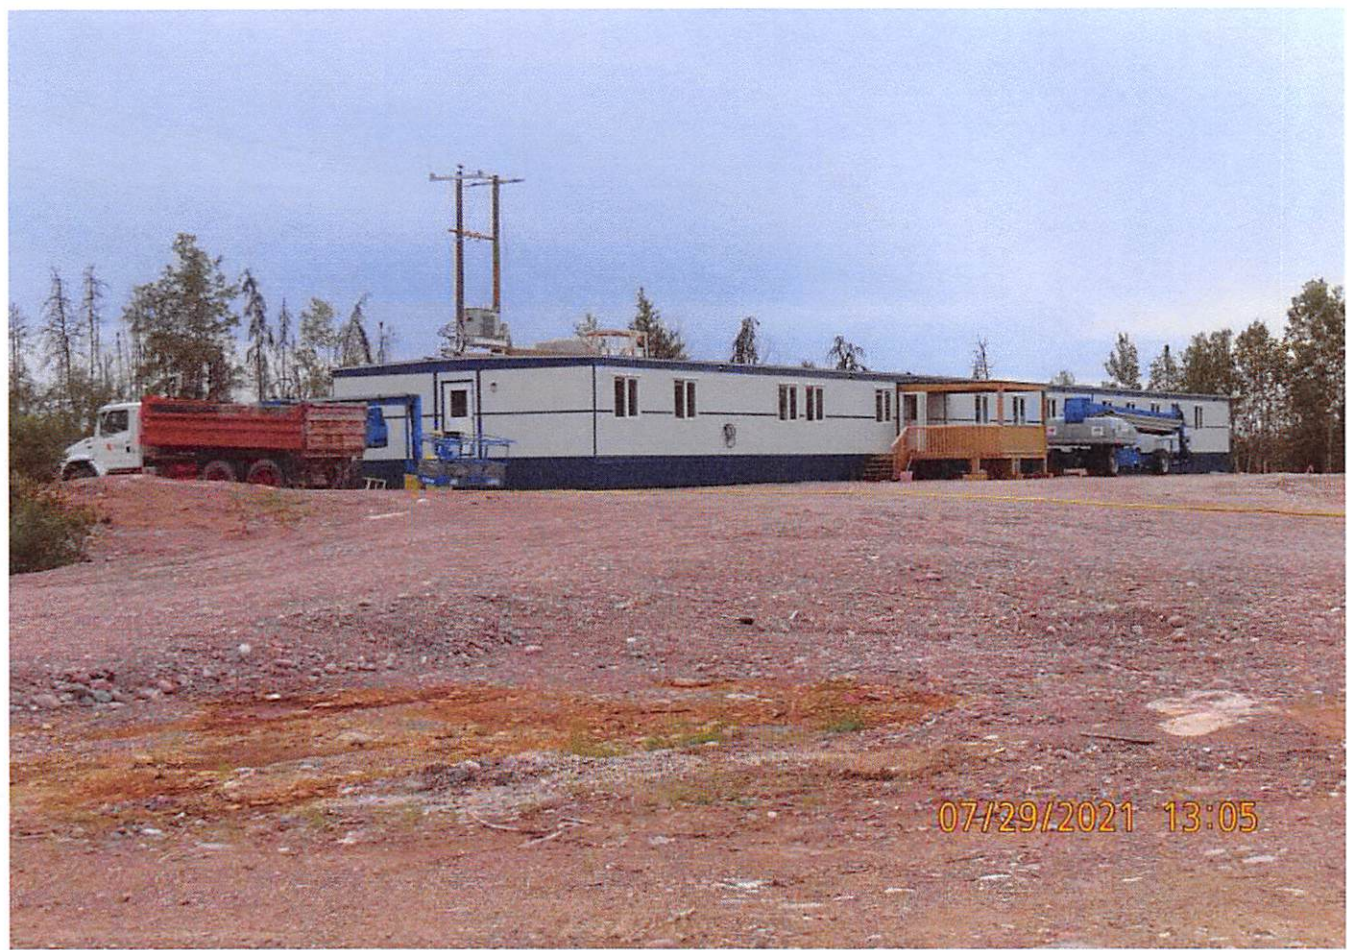
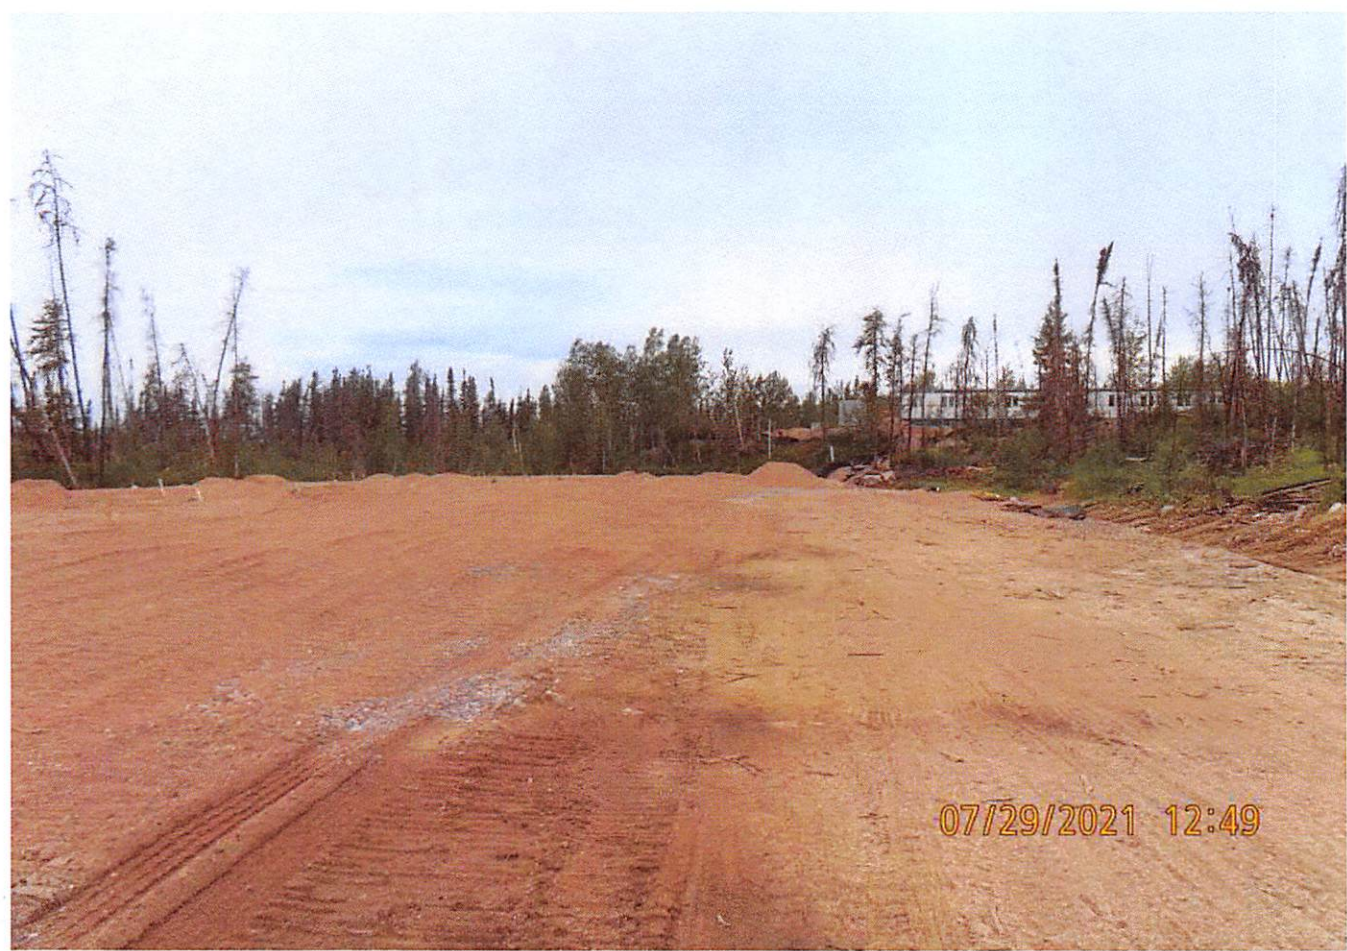
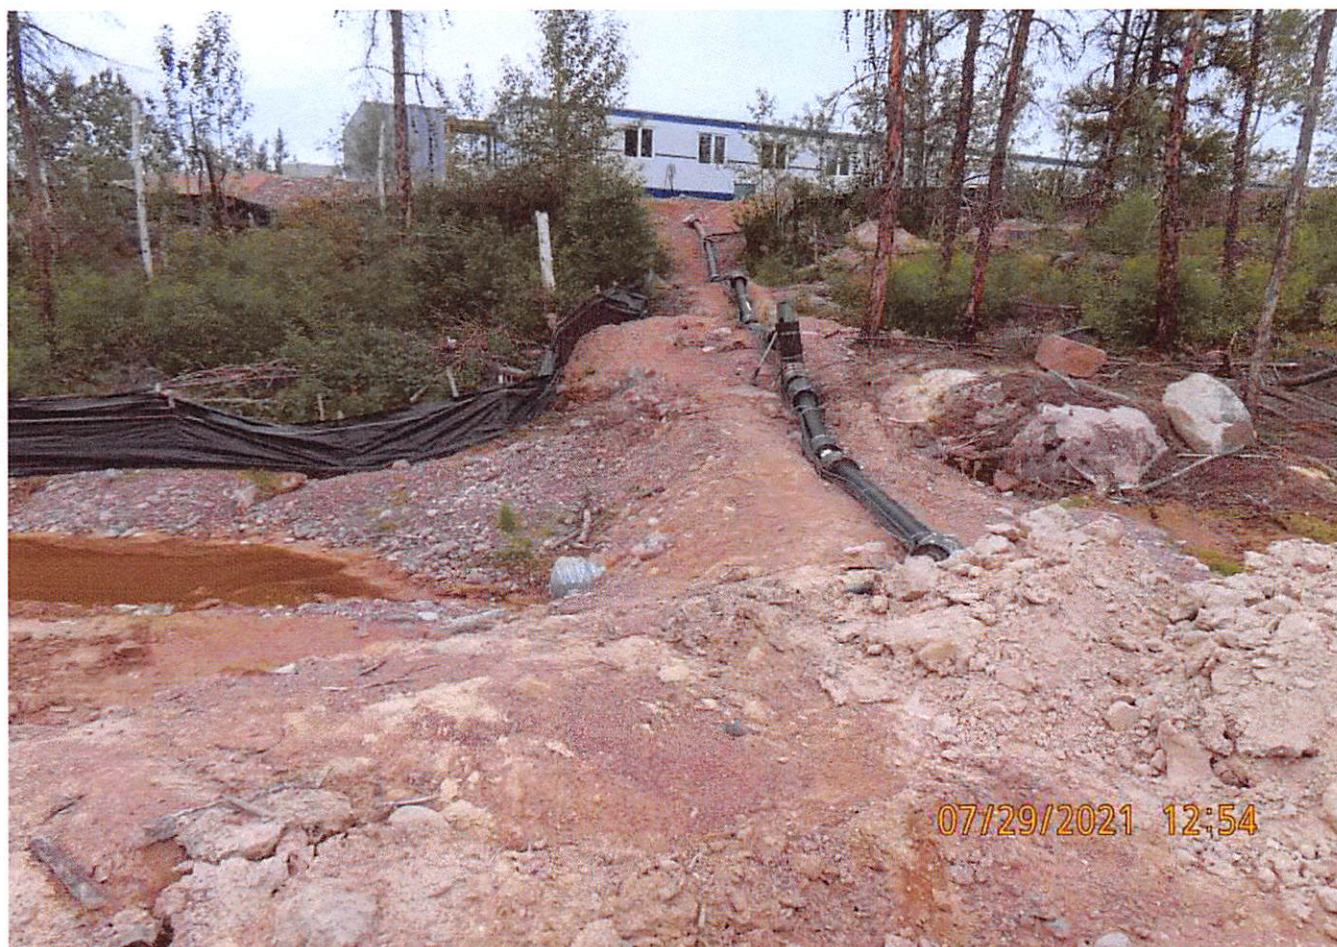
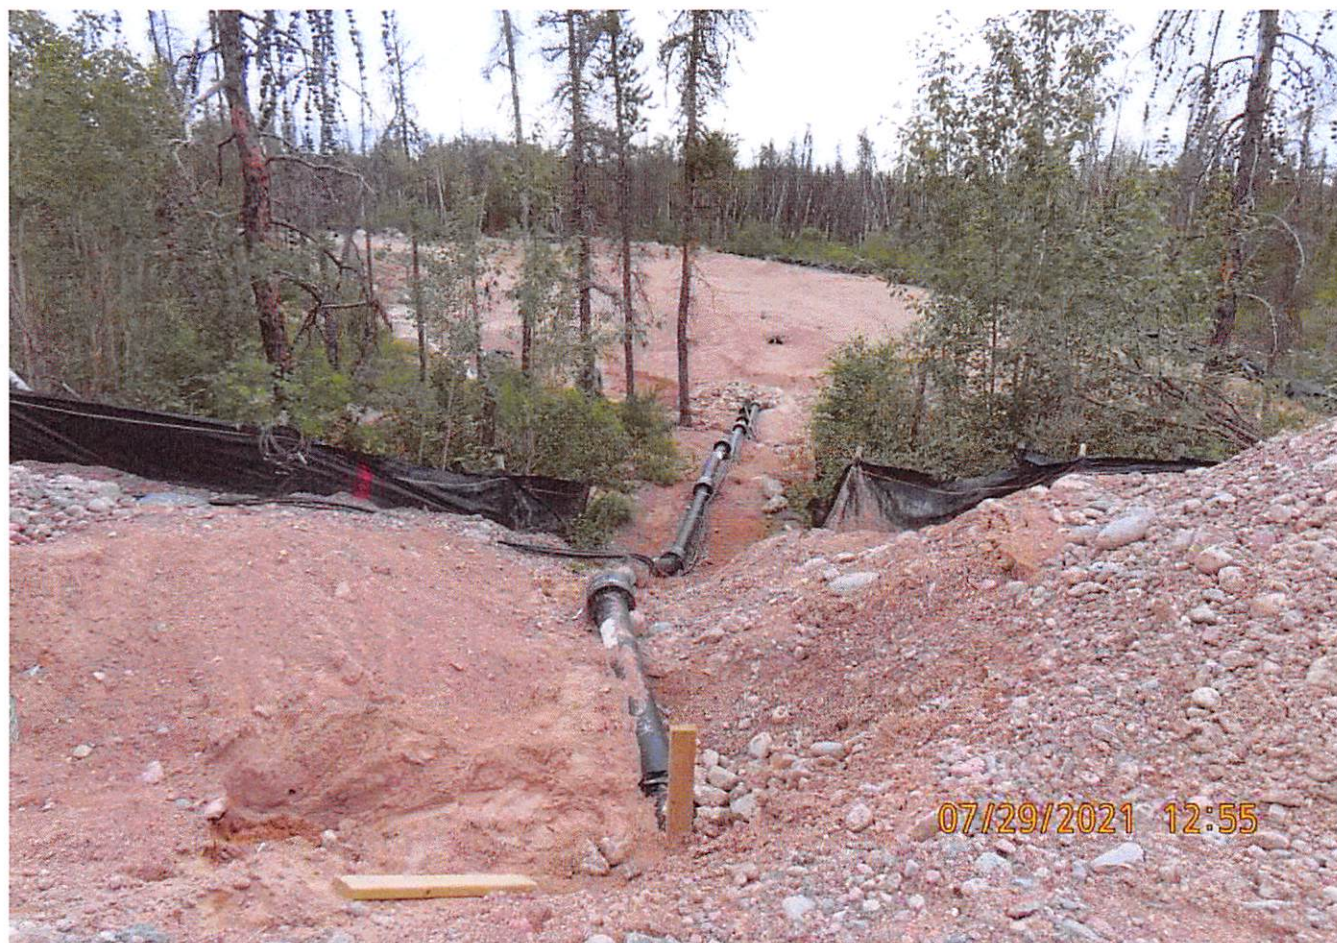
The new 40 person camp facility is located across the road and south of the dock (Figure 17). The septic field to service the new building was under construction at the time of inspection (Figures 18-20). Erosion and sediment control measures were well established and installed in an effective manner. There were no concerns with the new facilities.

Image showing the new staff lodging not in use at the time of inspection.

Image of the new septic field under construction at the time of inspection.

Image of the septic line leading from the new staff lodging.

Image of the septic line leading to the septic field.
