<b>File Number</b>	MV2020X0004
<b>Type of Operation</b>	Construction of Replacement Facilities
<b>Location</b>	Taltson Dam

ENVIRONMENTAL INSPECTION REPORT

Permittee:	Northwest Territories Power Corporation	Permit Expiry Date:	July 25, 2025
Land Use Permit No.	MV2020X0004	Previous Inspection:	New
Quarrying Permit No.	2020QP0019	Inspection Date:	July 29, 2021
Location(s) Inspected:	Taltson Dam Hydroelectric Facility		
Current Stage of Operation:	Preparing for shutdown and overhaul

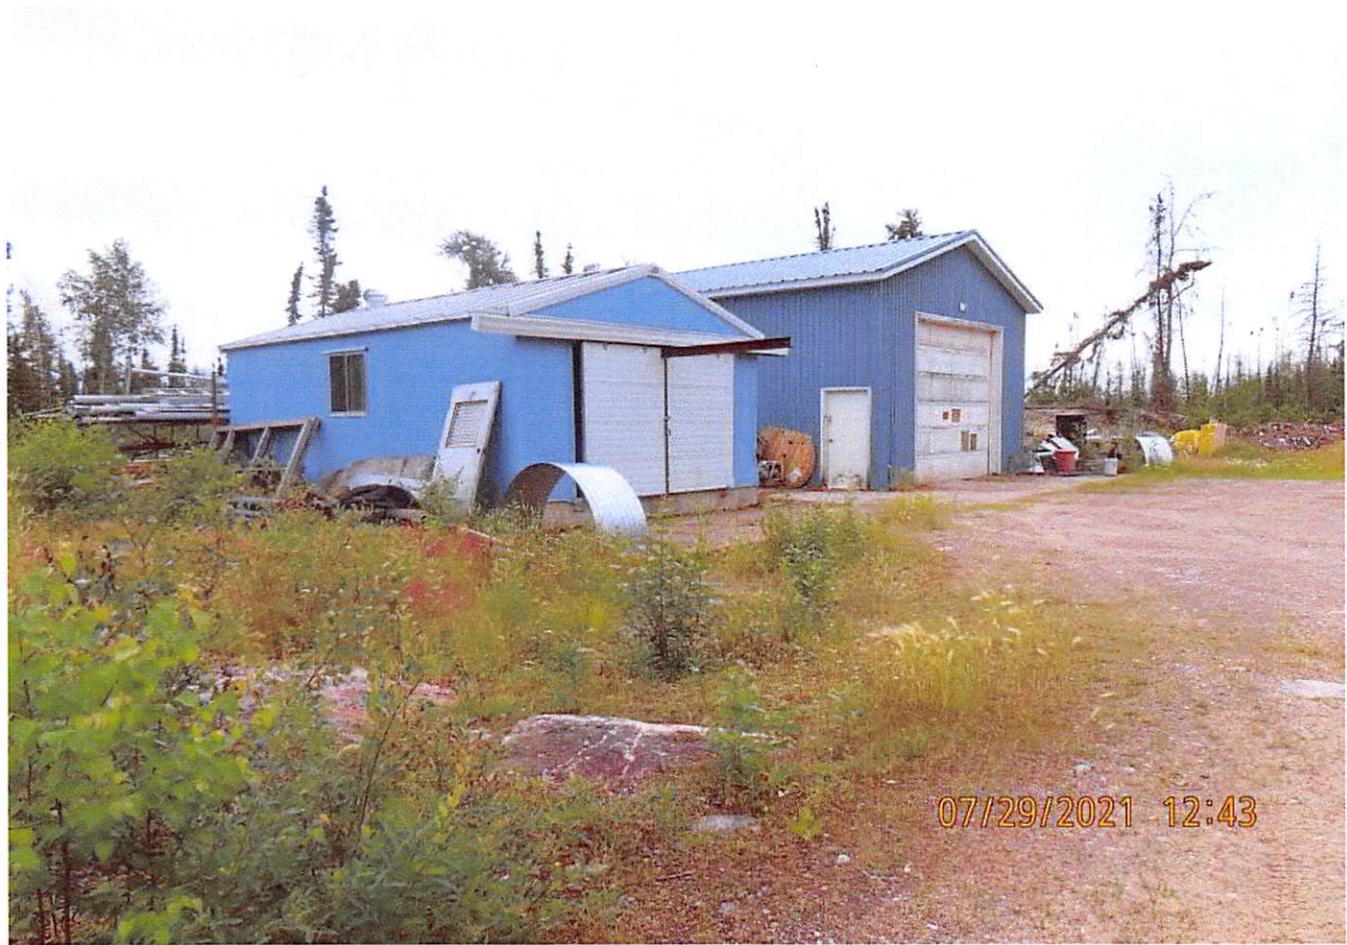
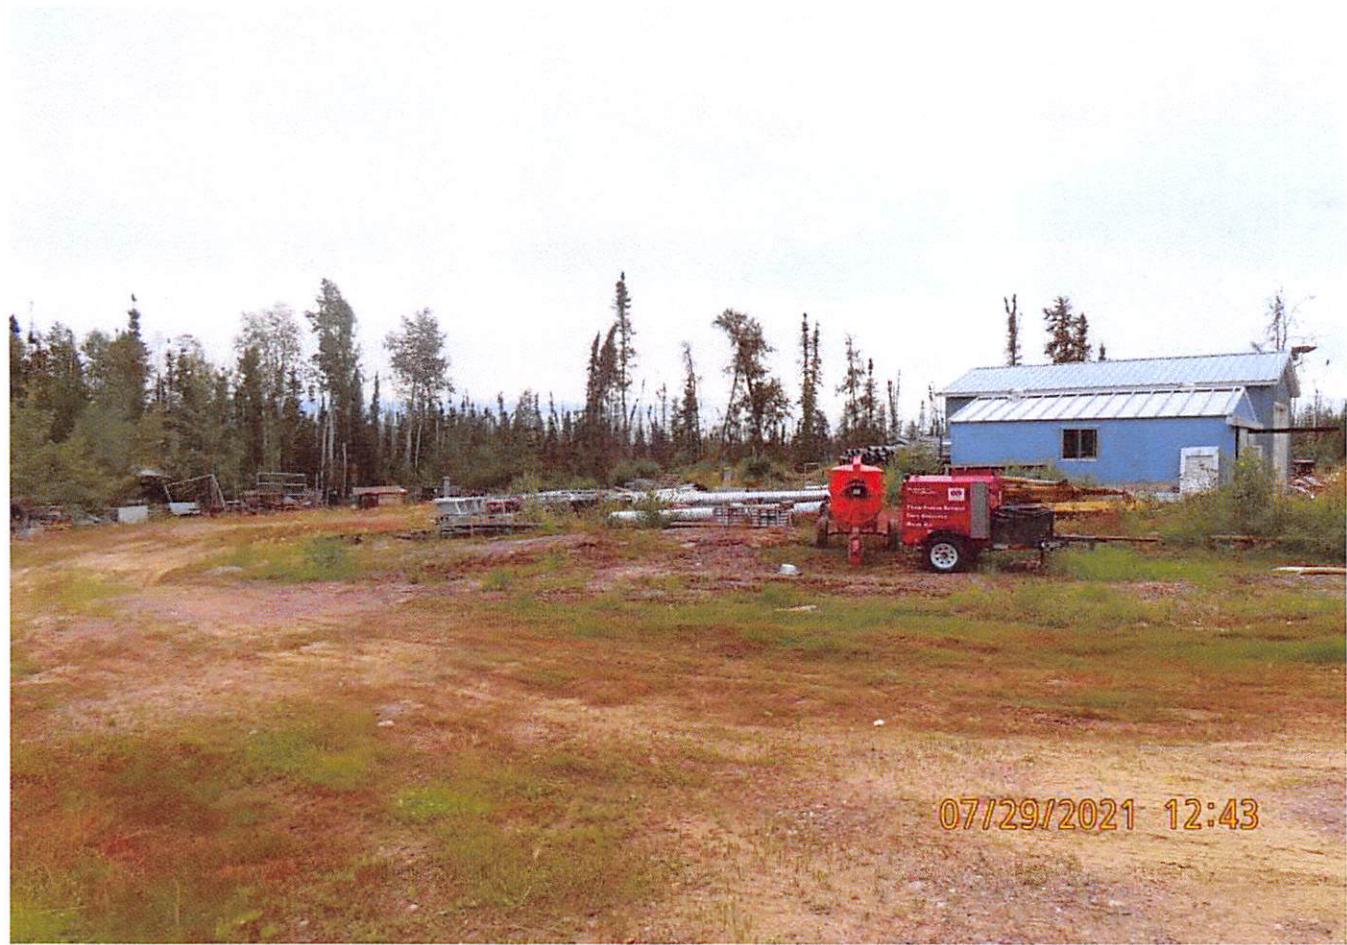
The Additional Storage Area is located northeast of the hydroelectric facility (Figures 21-22). There are two storage sheds on site and miscellaneous items in the yard. It was recommended that items that are no longer in use should be removed to an authorized solid waste facility as time and access permits.

Figure 21  
Image of the "boneyard" storage buildings.

Figure 22  
Overview image of the "boneyard".

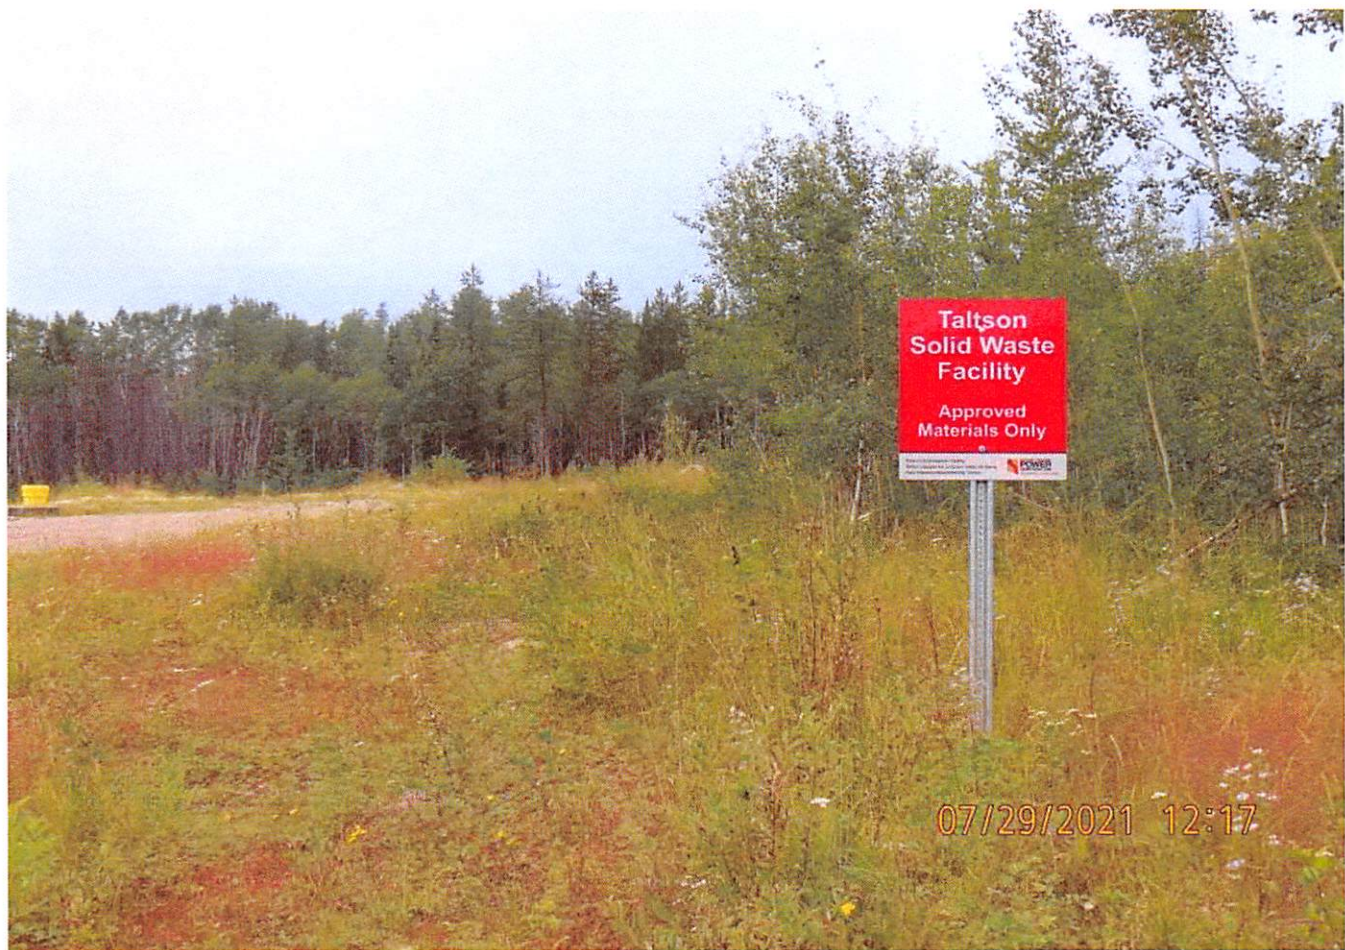
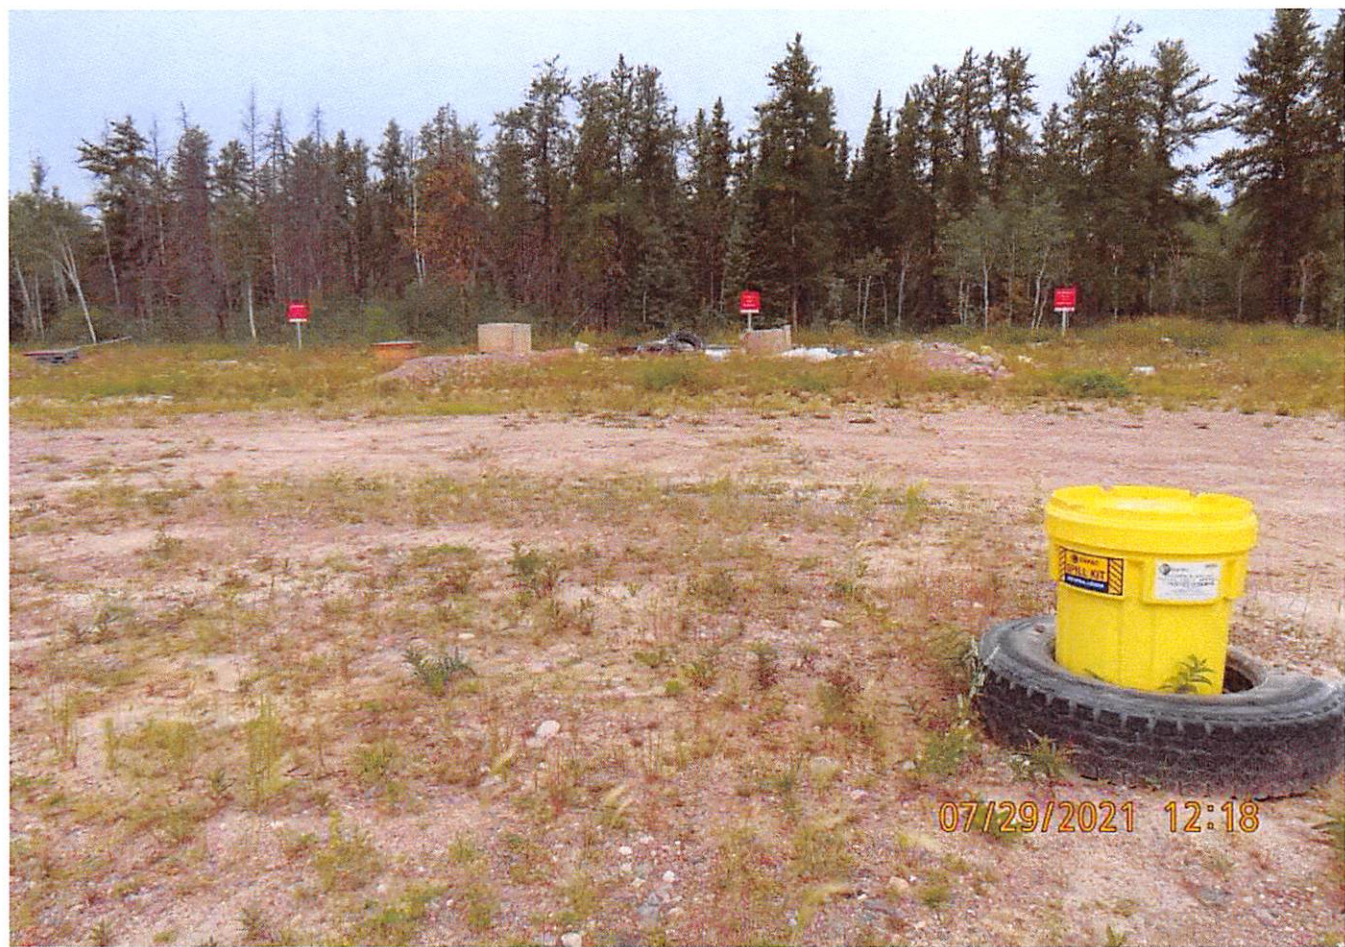
Recent waste facility upgrades included signage and berms for supporting the proper sorting of materials including waste meant to be shipped off site (Figures 23-24). One wooden crate in the “General” waste area contained metals from the incinerator. Inspectors discussed stockpiling waste material left by the incinerator and removing them from site when the winter road is open.

Figure 23  
Image of new signage leading to waste facility.

Figure 24  
Image showing modifications to waste facility and spill kit in foreground.

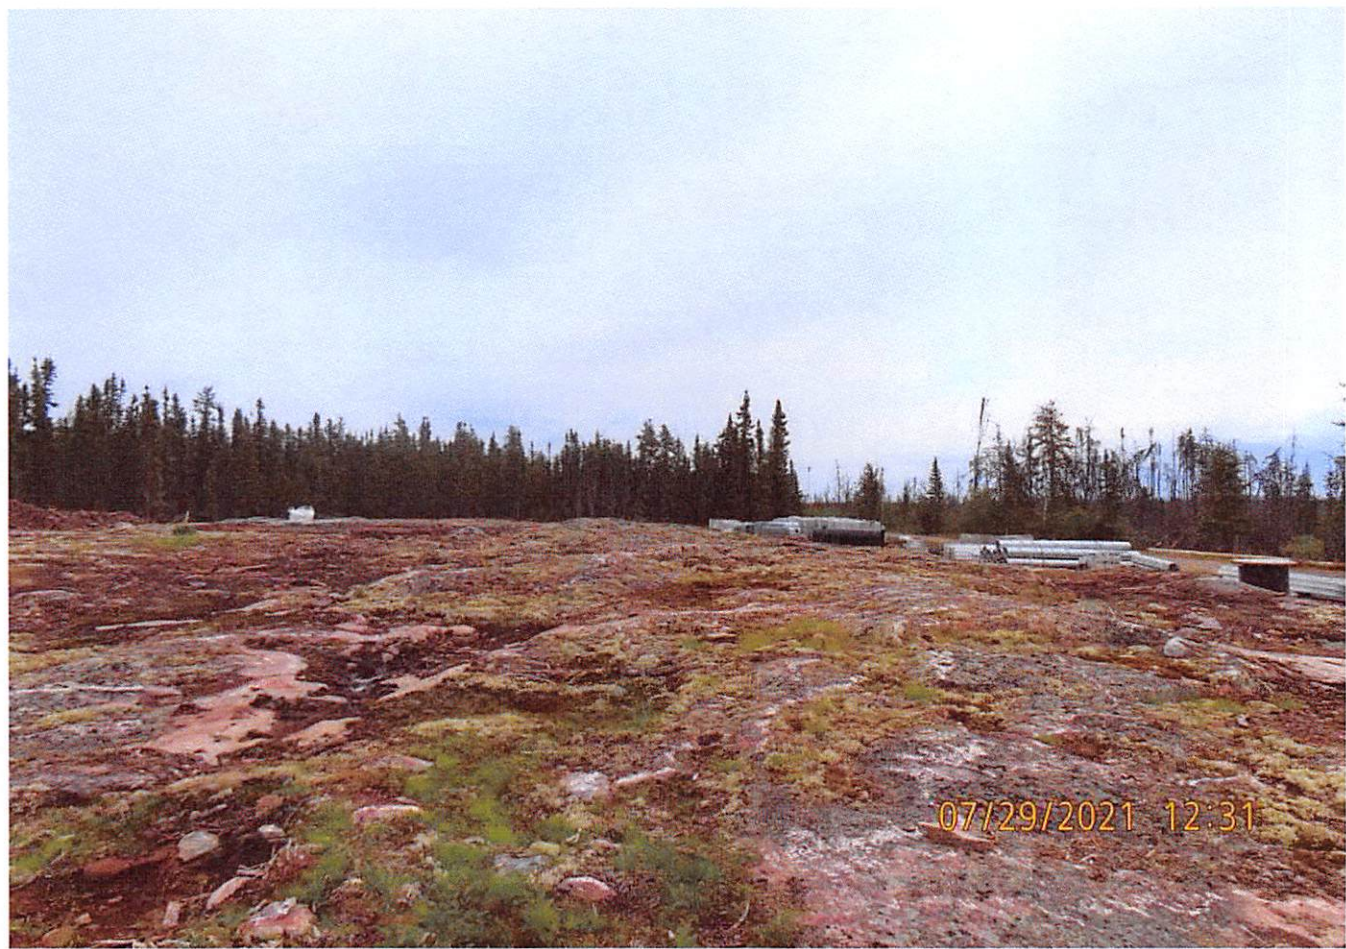
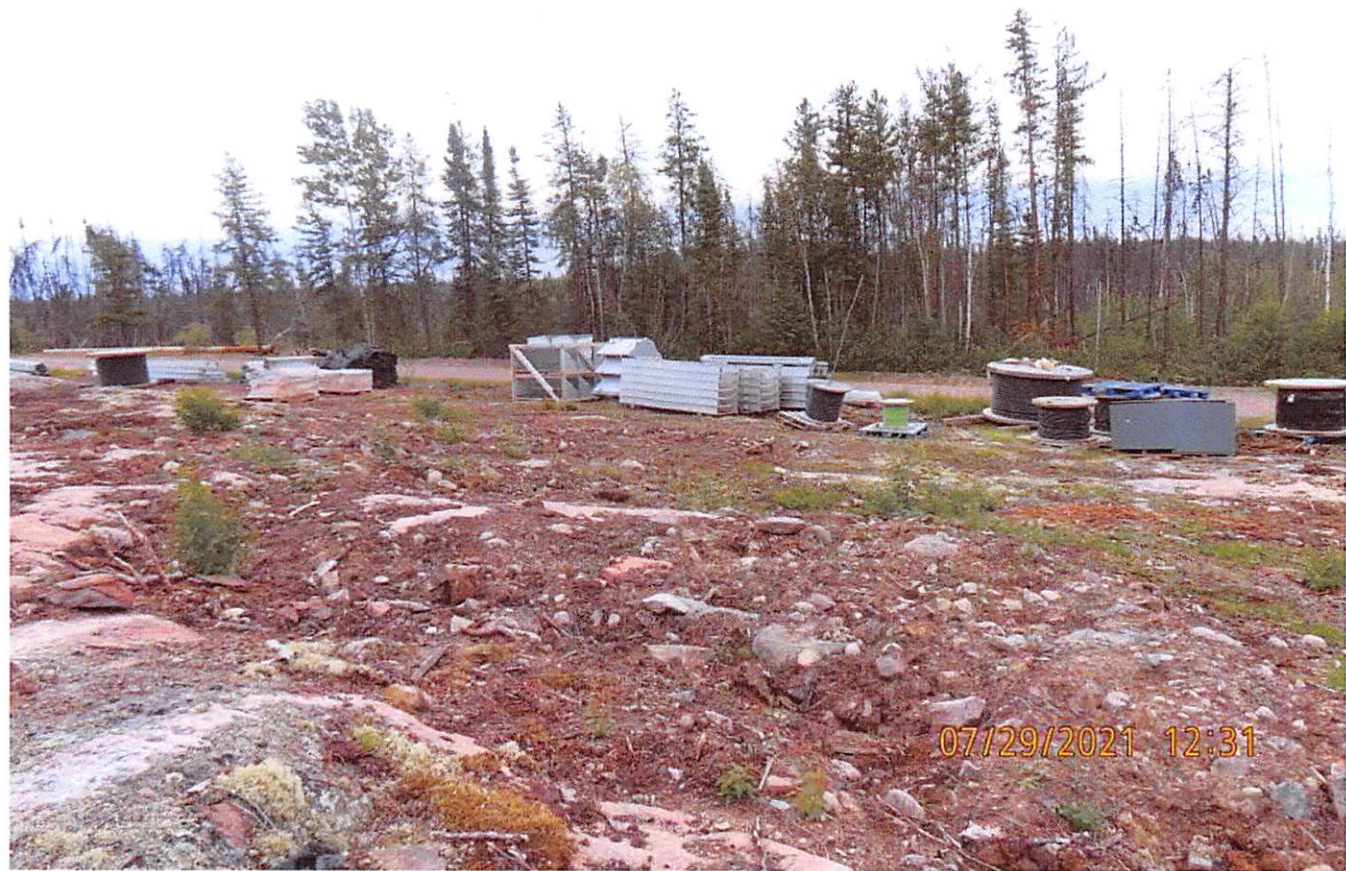
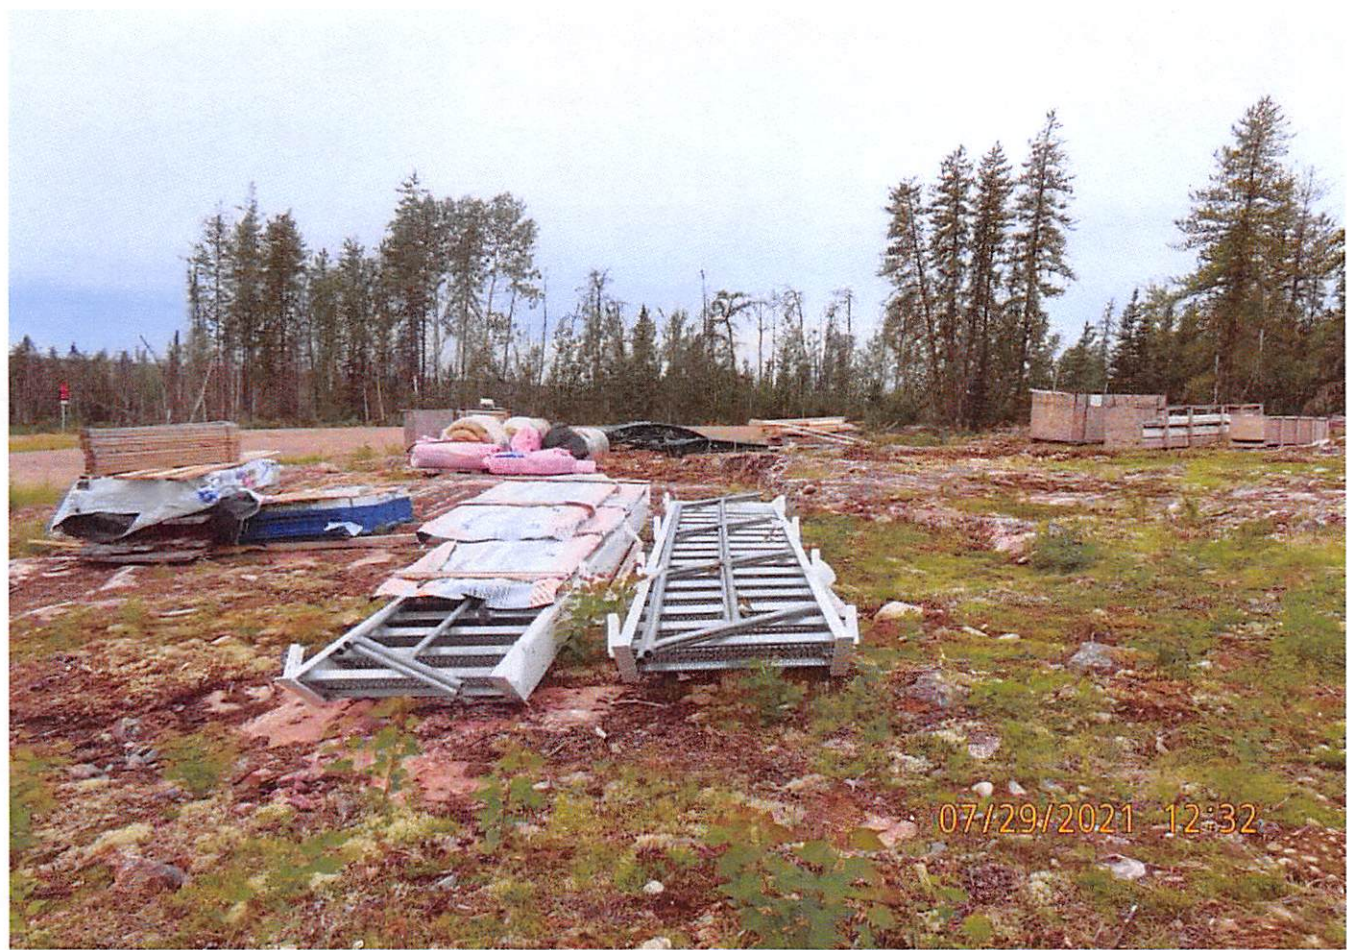
The new storage/laydown area referred to as “Additional Storage B” is located across the road from the new camp septic field (Figures 25-27). Larger items for the overhaul operation are stored here on a cleared rock outcrop (culverts, cinder blocks, lumber, insulation, straw wattle rolls, fencing, piping, etc.). There were no concerns with this staging area at the time of inspection.

Figure 25  
Image of "Additional Storage B" area facing east.

Figure 26  
Image of "Additional Storage B" area facing southeast.

Figure 27  
Image of "Additional Storage B" area facing southwest.

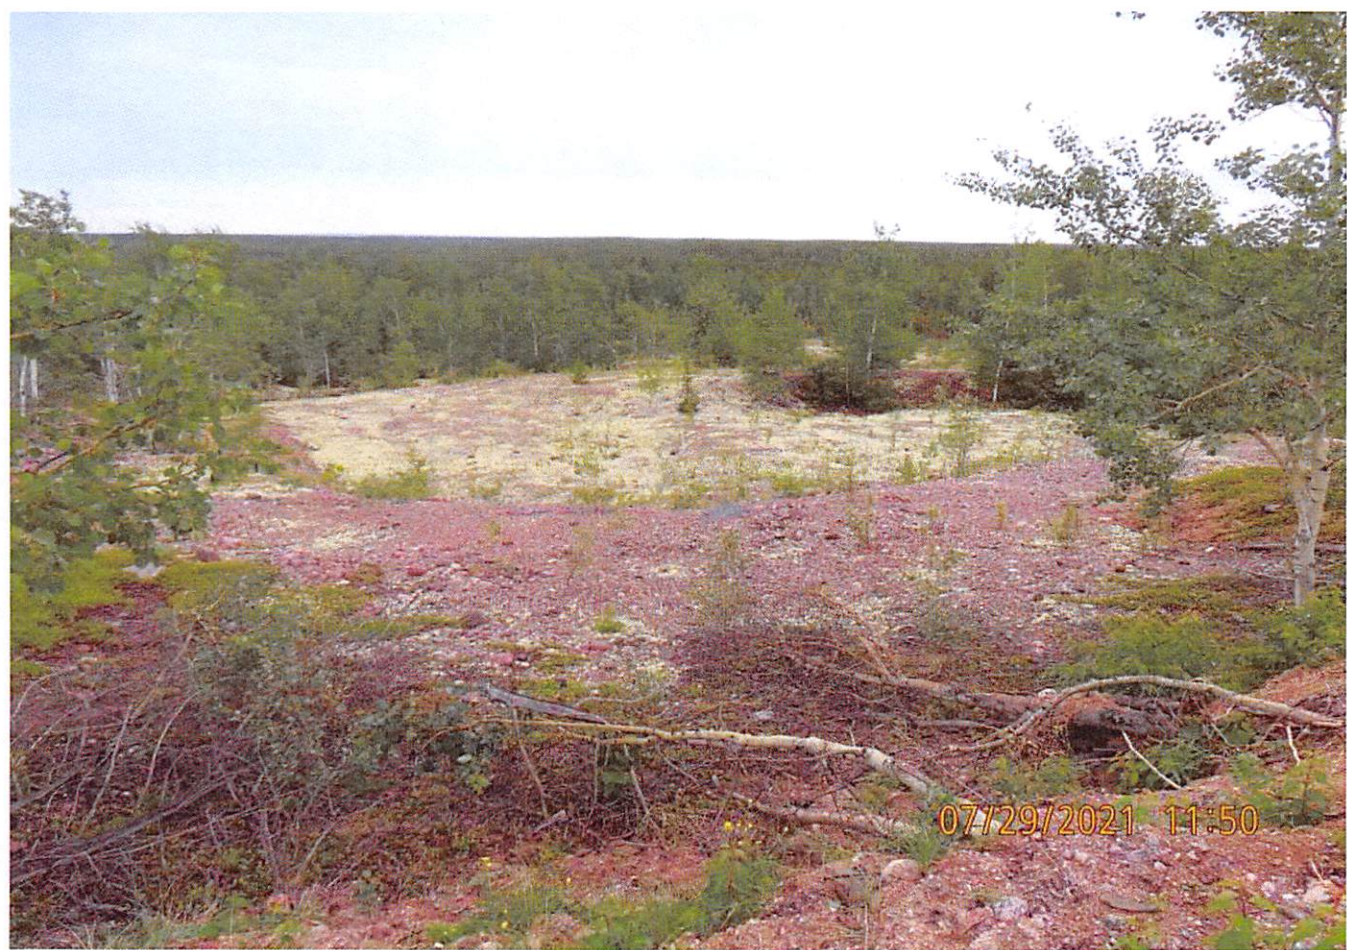
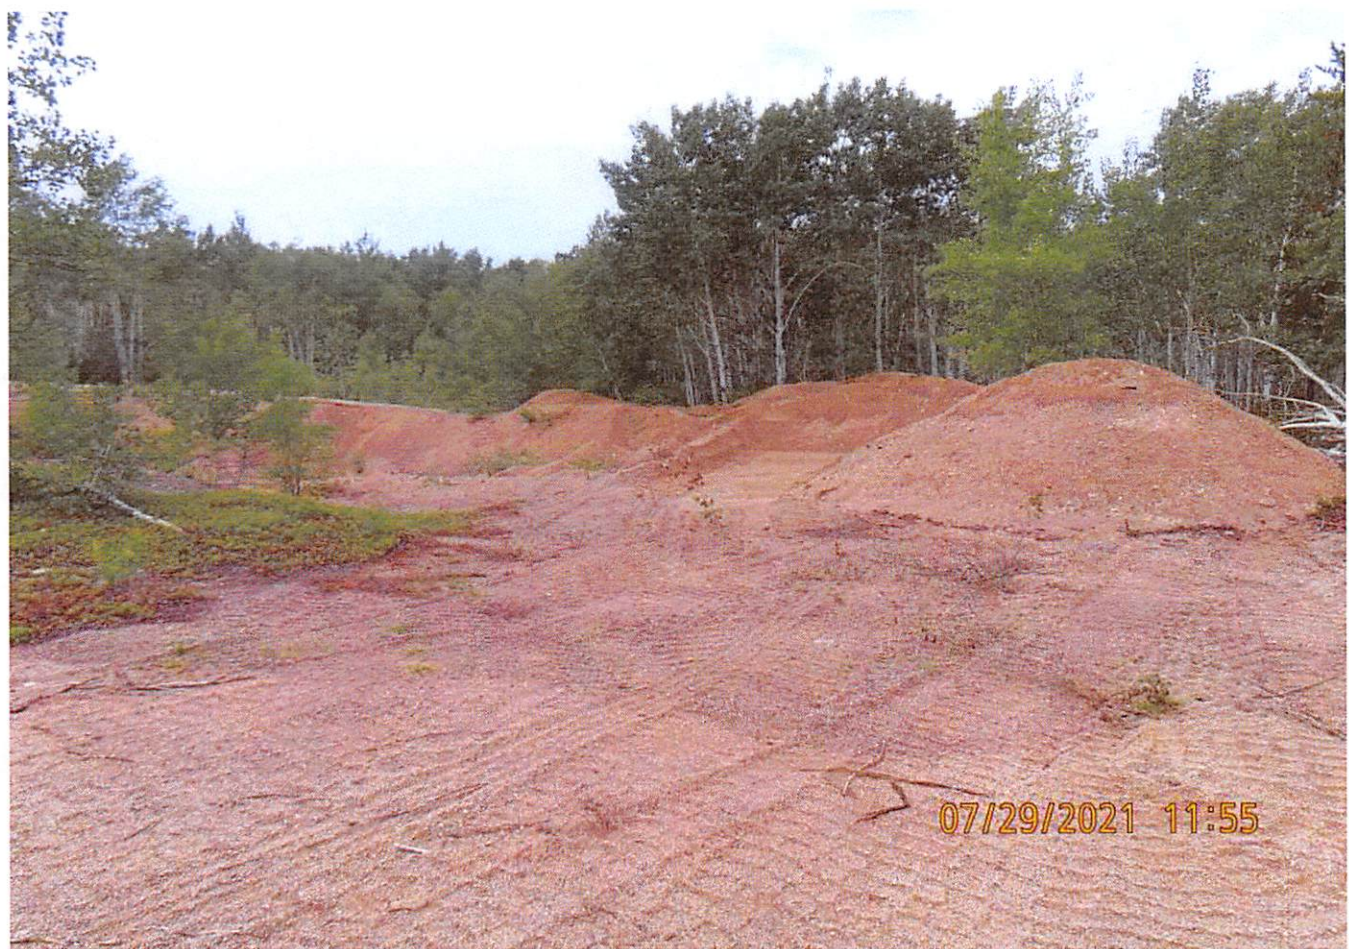
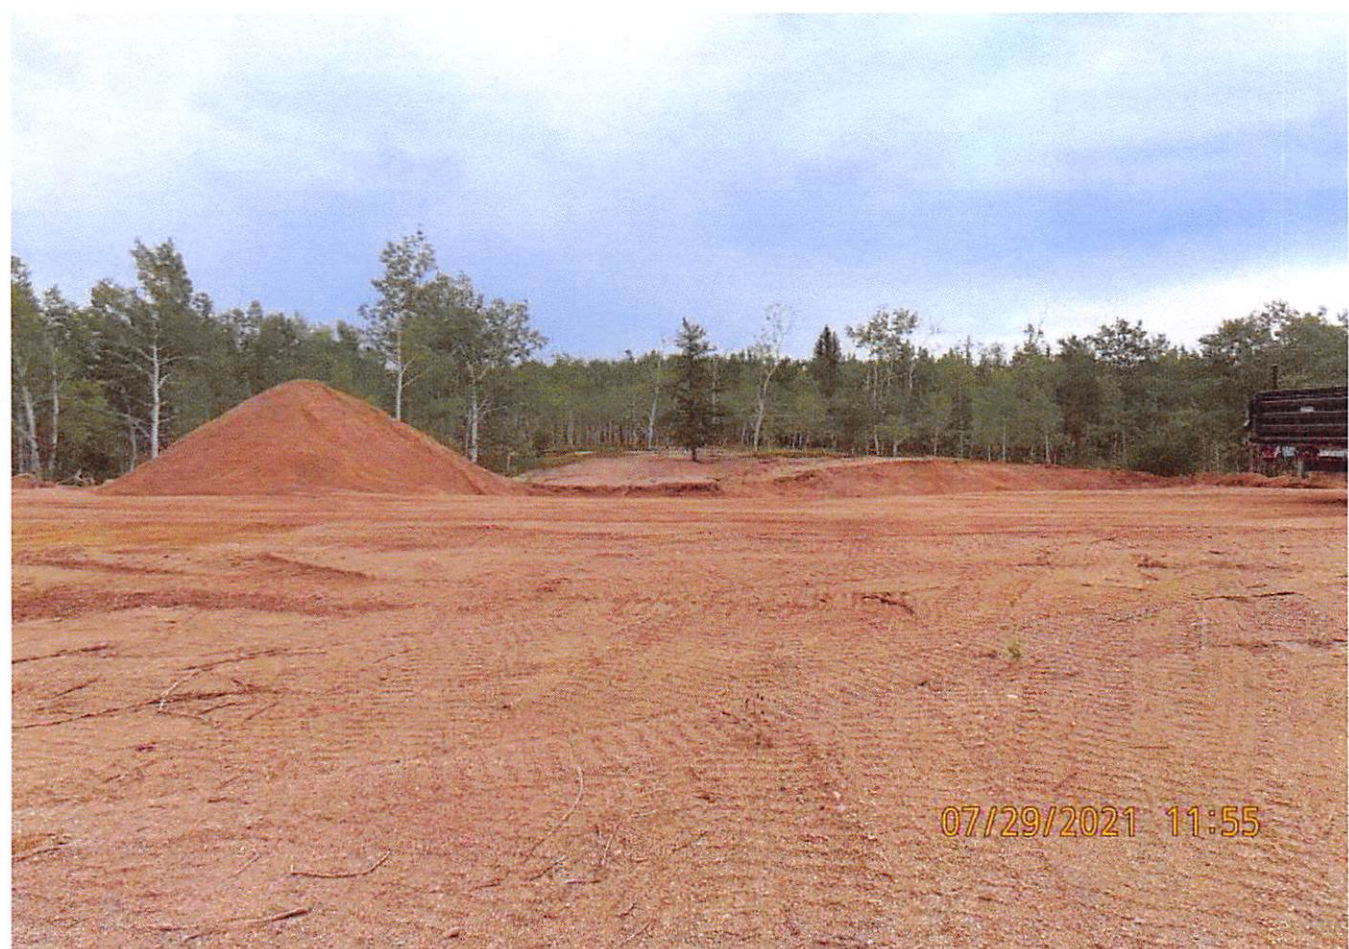
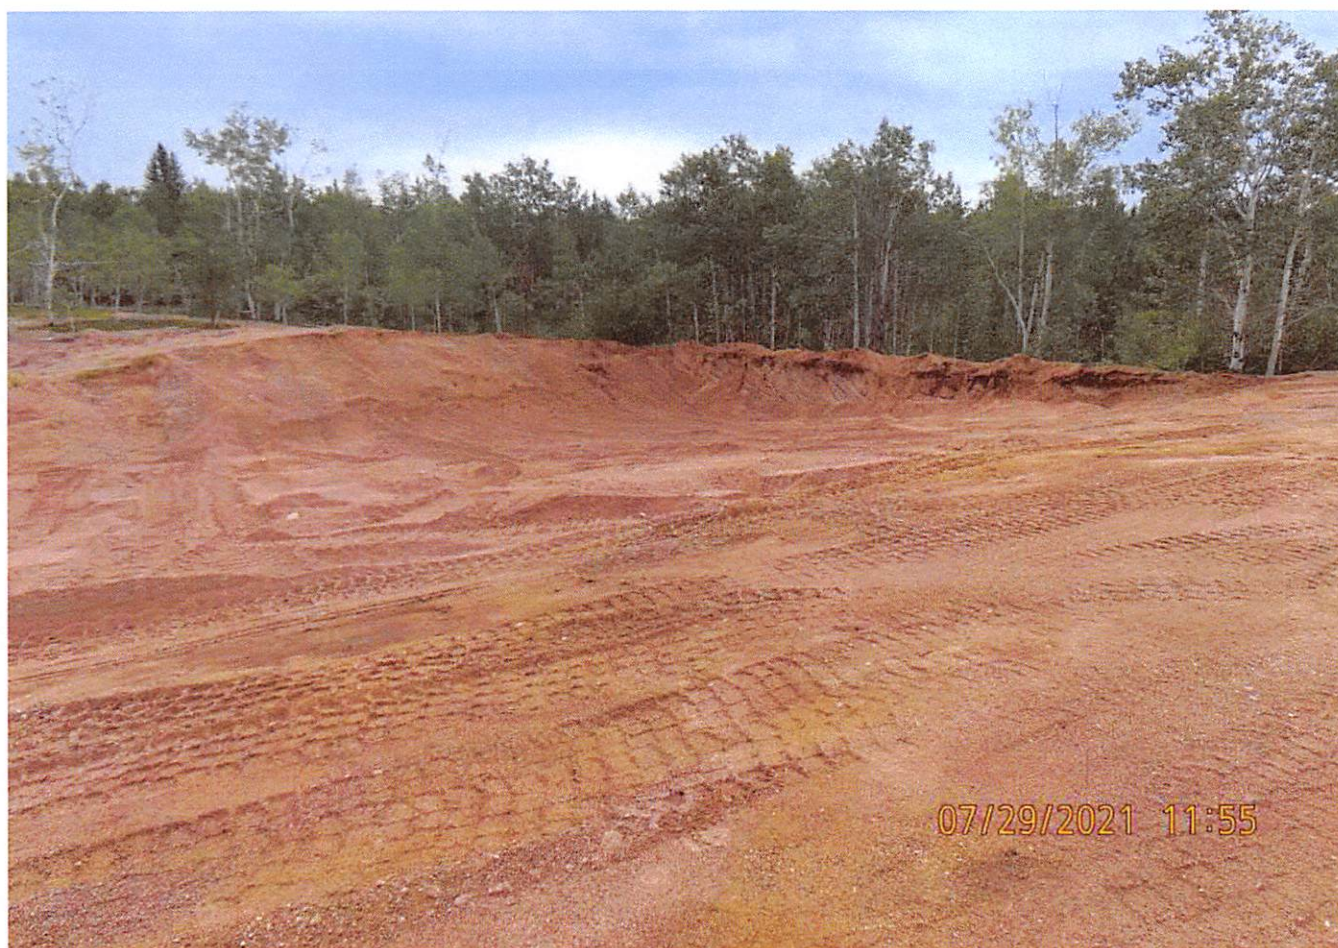
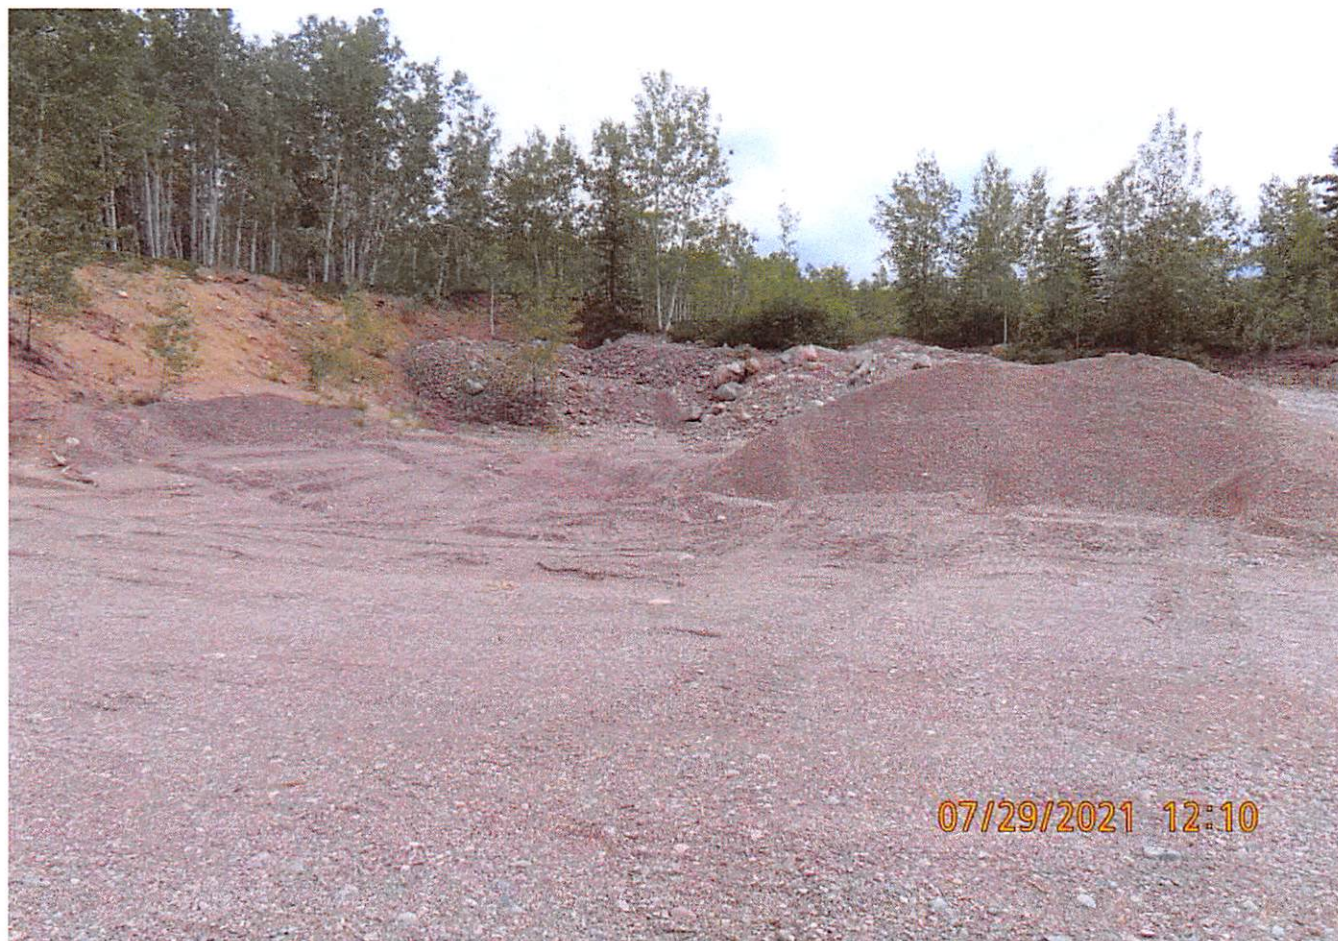
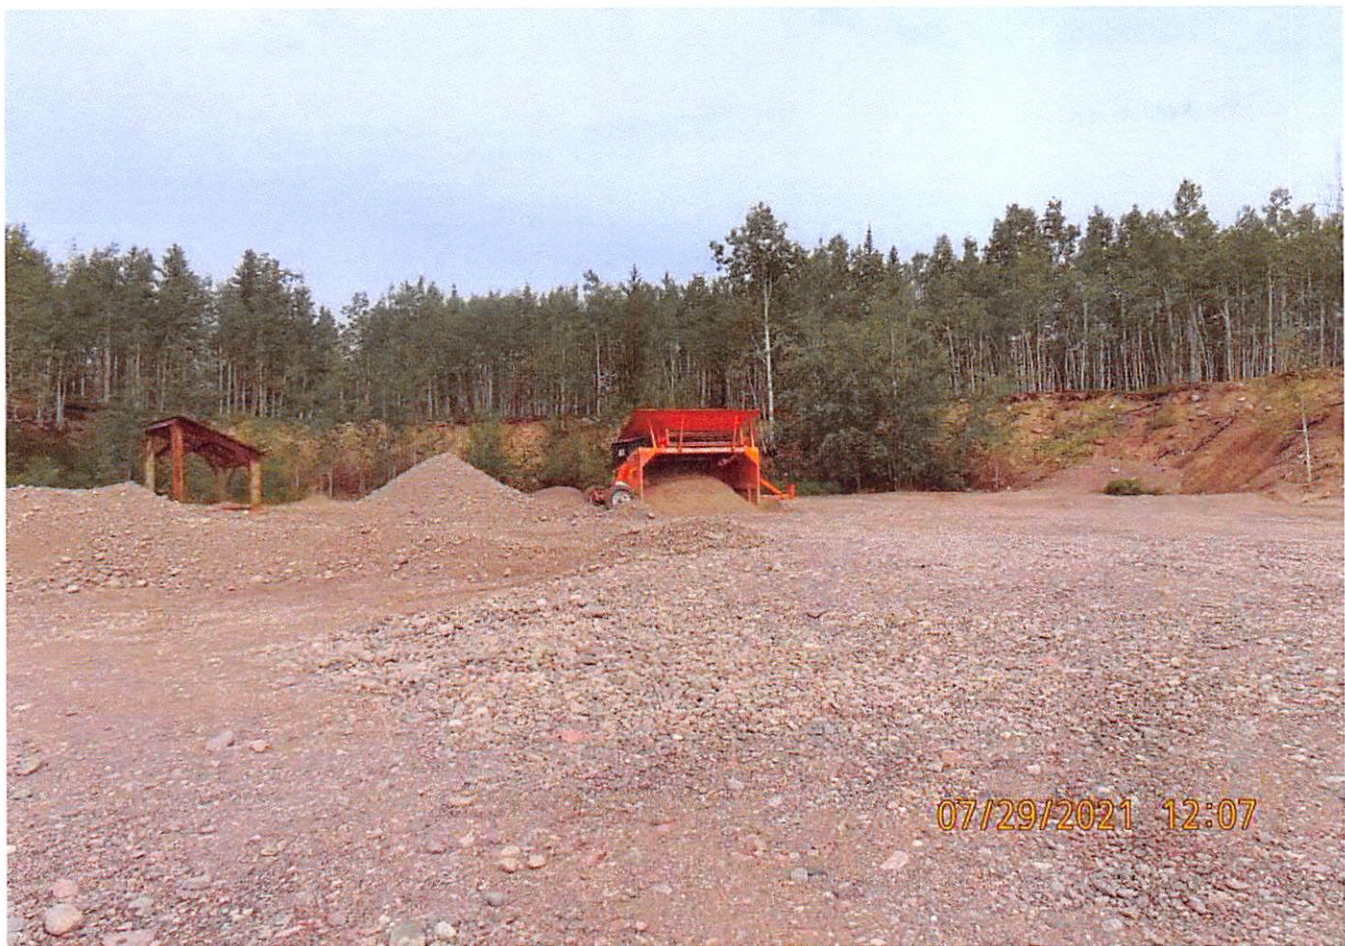
Pit Z was observed at the southeastern end of the airstrip but was not actively being quarried at the time of inspection (Figure 28). Pit D is an active gravel quarry north of the airstrip at the western end (Figures 29-31). A crusher and screen were on site and some small stock piles were present. Pit W is an active sand quarry north of the airstrip (Figures 32-36). Some small stock piles were present. As per Quarry Permit 2020QP0019 condition #11 please

Figure 28  
Image of "Pit Z" inactive quarry located at the northeast end of the airstrip.

Figure 29  
Image of “Pit D” active sand quarry north of the airstrip.

Figure 30  
Image of stockpiled material at “Pit D” active sand quarry.

Image of "Pit D" active sand quarry facing southwest.

Image of "Pit W" active gravel quarry located north of the airstrip at the southwest end.

Image of crusher & screen located at "Pit W".

submit monthly reports stating amounts quarried. There were no concerns with quarrying operations.

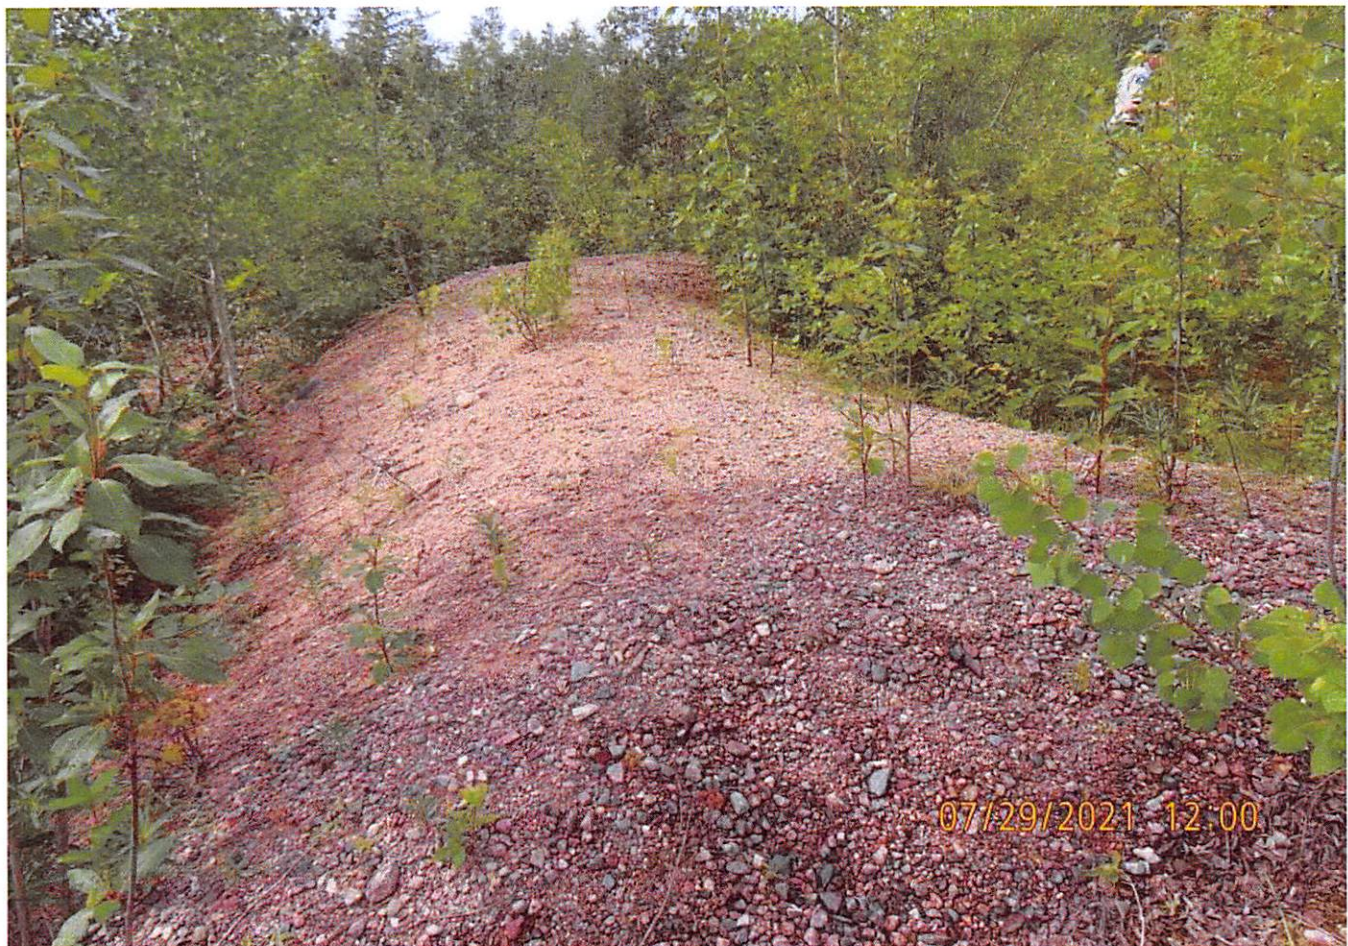
Figure 37

The existing Contaminated Soil Containment area was inspected (Figure 37). Inspectors discussed possible reuse of the bermed area by excavating the decontaminated material and checking the condition of the HDPE liner. If the lining is in satisfactory condition, the area could be used for future needs and a new bermed containment area may not have to be established.

Image of bermed Contaminated Soil Containment area located near “Pit V” north of the airstrip.
