File Number	MV2020X0004
Type of Operation	MISC.
Location	Taltson Dam

ENVIRONMENTAL INSPECTION REPORT

Permittee:	NTPC Northwest Territories Power Corp	Permit Expiry Date:	July 01, 2025
Land Use Permit No.	MV2020X0004	Previous Inspection:	February 20, 2024
Quarrying Permit No.	2022QP0006 Expires April 11, 2024	Inspection Date:	September 05, 2024
Contractor:	Listostroj Hydro	Subcontractor:	DB Consultant
Location(s) Inspected:	Taltson Dam		
Current Stage of Operation:	Active		
Program Modifications Approved:	N/A

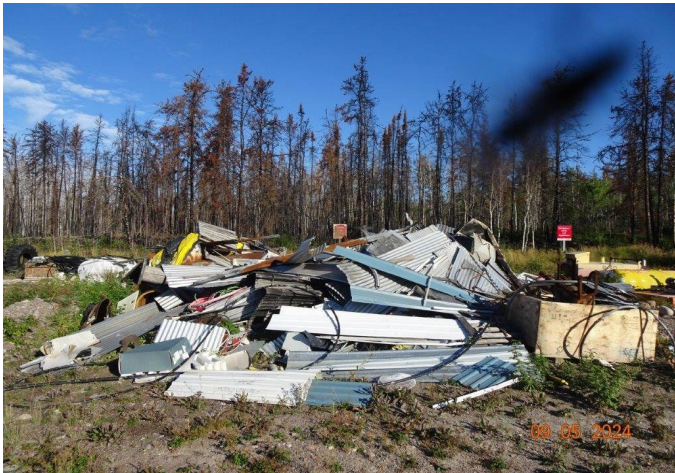
Figure 13

The dump was well organized (Figure 5-14). A significant amount of noncombustible material had been removed by the winter road since the last inspection. There were some large brush piles pushed up on the southeast side of the dump (Figure 6). Please continue to progressively burn brush piles as per permit condition #62.

Sorted waste items on the north side of the dump.

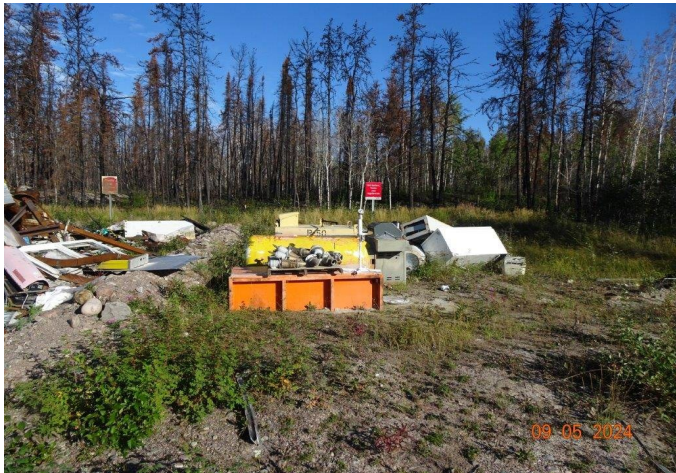
Figure 14

Sorted waste items on the north side of the dump.

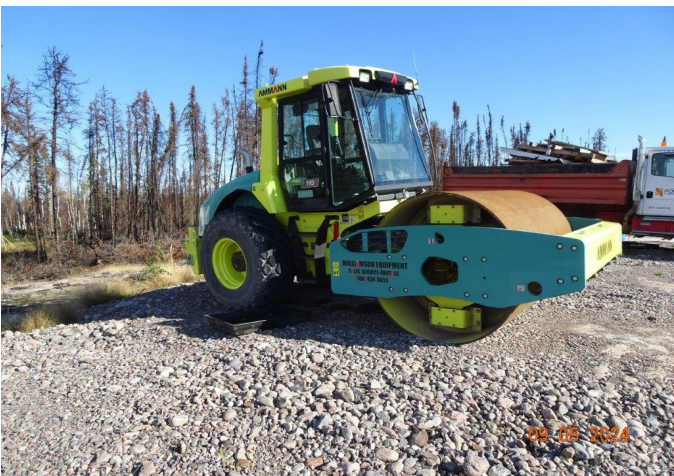
Figure 22

Storage area B continues to be used for the storage of materials and equipment for use in the overhaul (20-22, 24). A roller compactor parked on site was leaking and hydrocarbon staining was observed on sediments underneath the vehicle (Figure 22-23).

Roller compactor parked at storage are B.

Please ensure leaking equipment is repaired, contaminated soil is cleaned/removed, and drip trays are in place.

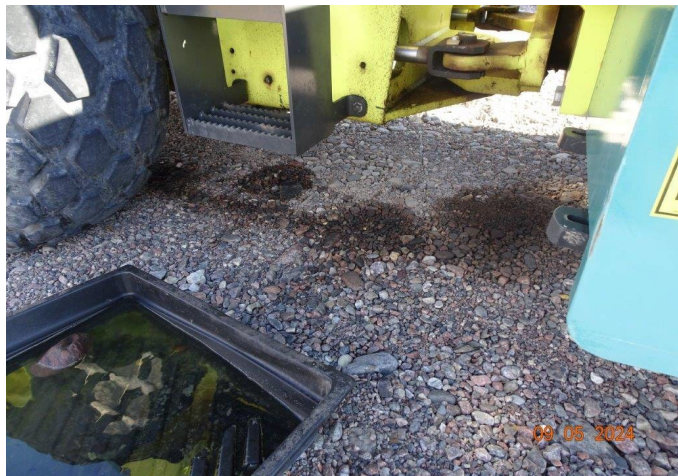
Figure 23

Permit Condition #59: *“All equipment that may be parked for two hours or more shall have a haz-mat/drip tray under it or be sufficiently diapered. Leaky equipment shall be repaired immediately.”*

Permit Condition #60: *“The permittee shall clean up all leaks, spills, and contaminated material immediately.”*

Hydrocarbon staining under the roller compactor.

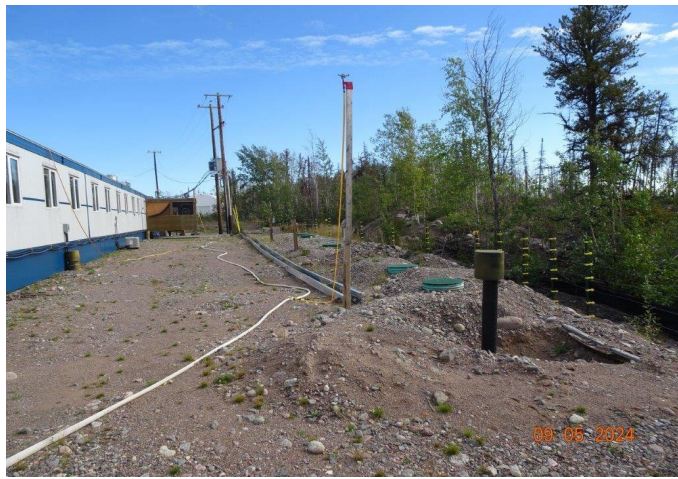
Figure 35

The new camp facility and water intake was operational and the sites were clean and orderly (Figure 28-34). There were some repairs made to the electric fence and septic outlet due to damage caused by a bear (Figure 35-36). Bear boards were laid down as an additional wildlife deterrent.

The septic outlet.

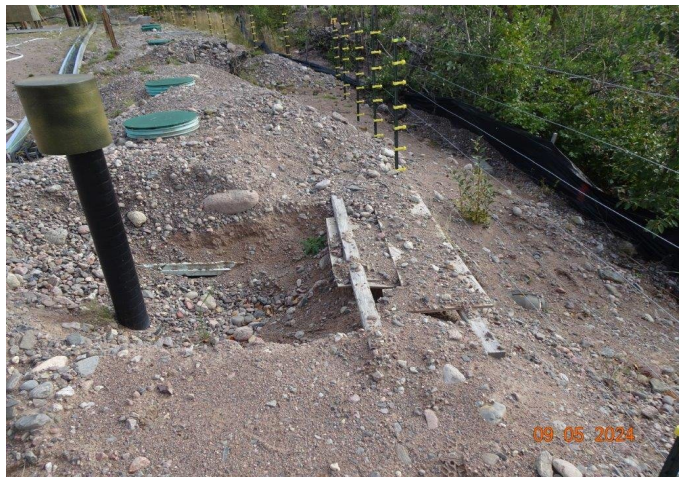
Figure 36

Repairs made at the septic outlet.

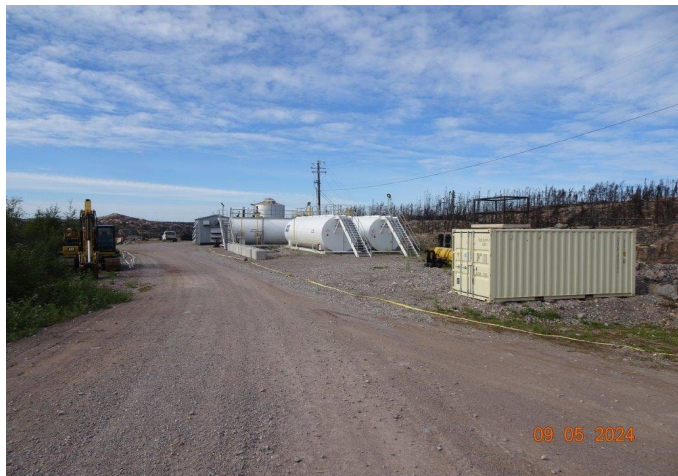
Figure 41

There were three 90’000L diesel fuel tanks, a 13’600L diesel tank, a 1295L gas tank, a 1000L fuel tote, and 10x 54G fuel drums stored at the dam site (Figure 41-44). One 90’000L diesel fuel tank had been removed from site since the previous inspection.

Bulk fuel and generators at the dam site.

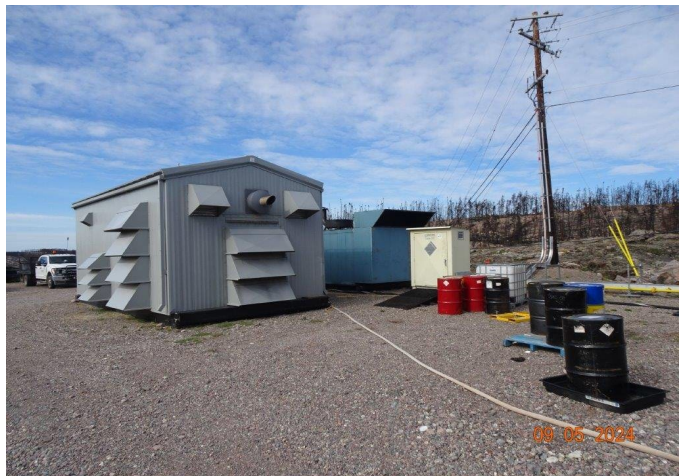
Figure 42

Generator units and fuel.

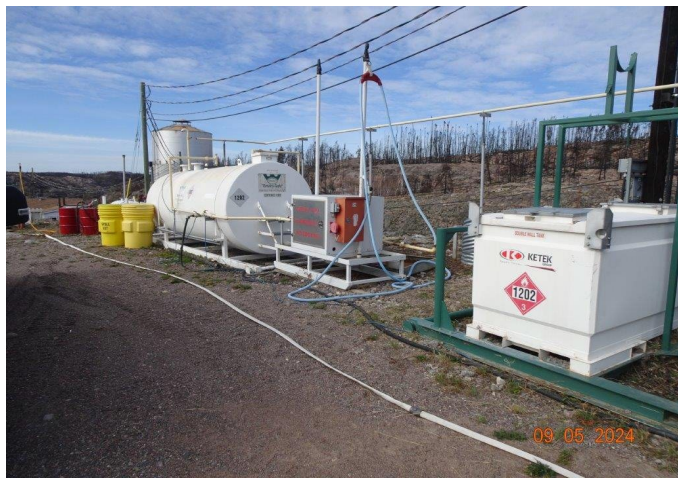
Figure 43

Fuel storage at the dam site.

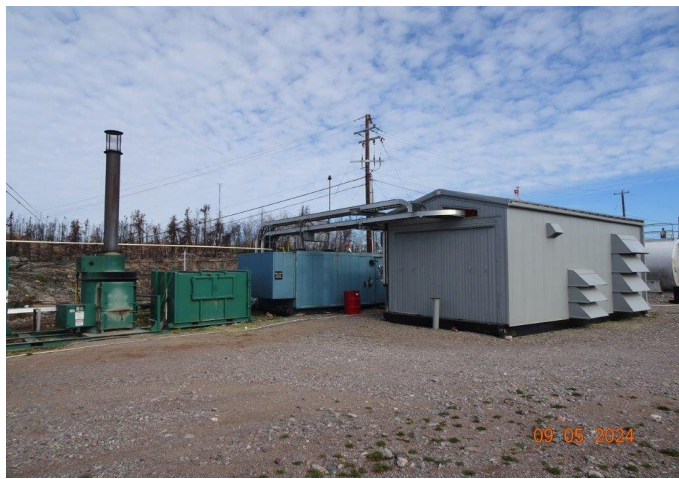
Figure 44

Incinerator and generators.

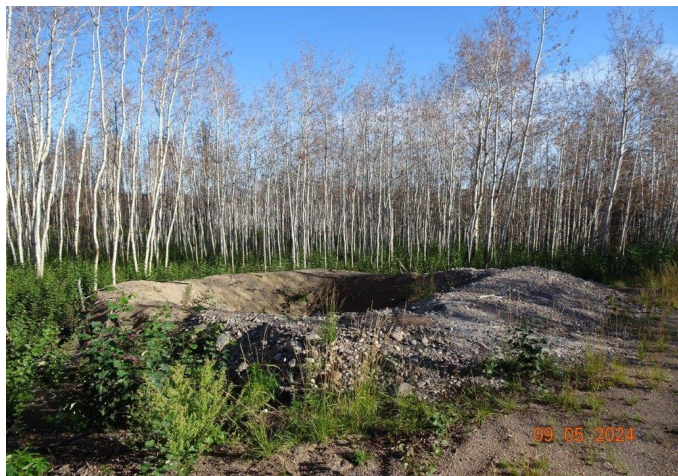
Figure 51

The septic field was operational (Figure 37). The temporary sewage lagoon for dumping portable outhouse waste on the spillway road appears to still be in operation (Figure 51). There was some spillage observed on the berm of the lagoon (Figure 52). Please ensure sewage is deposited in the lagoon and spillage is cleaned up immediately after occurrence.

Additional sewage lagoon.

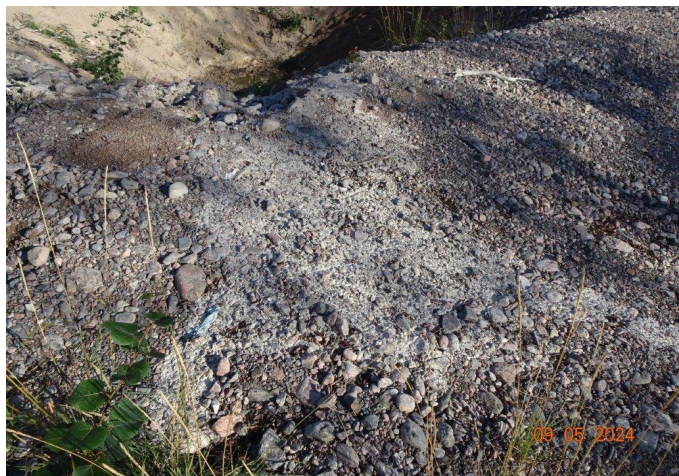
Figure 52

Spilt sewage staining on the berm of the lagoon.

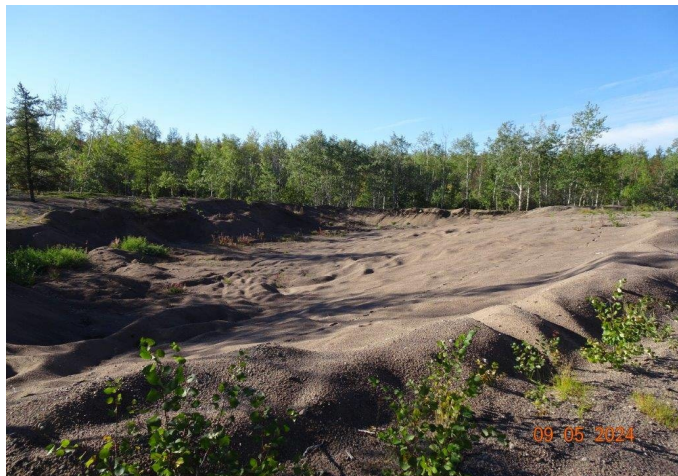
Figure 53

At the time of inspection there was active gravel quarrying occurring at Pit W (Figure 55-56). Sand quarries at Pit C and D appear to be infrequently used (Figure 53-54).

Sand quarry in Pit B.

Be advised that all material removed must be reported in a monthly quarry report as per Quarry Permit Condition #10.

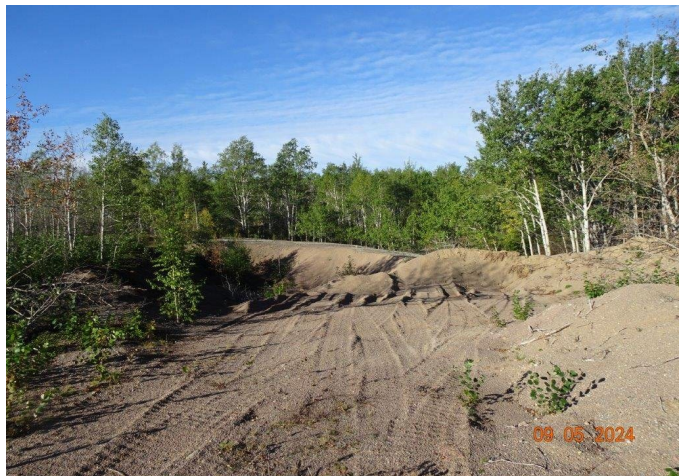
Figure 54

Sand quarry in Pit D.

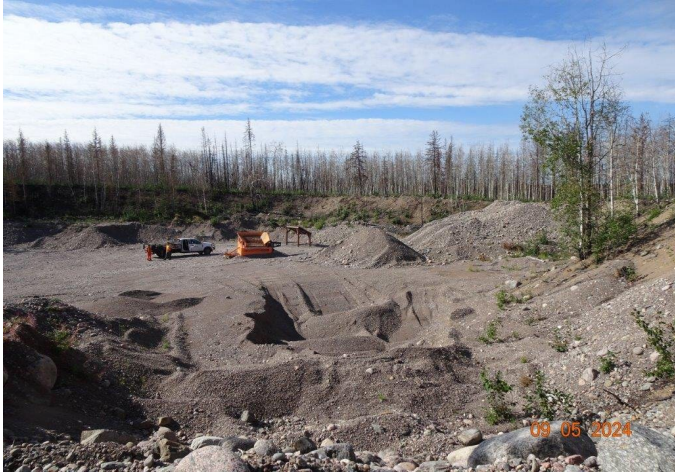
Figure 55

Gravel quarry in Pit W.

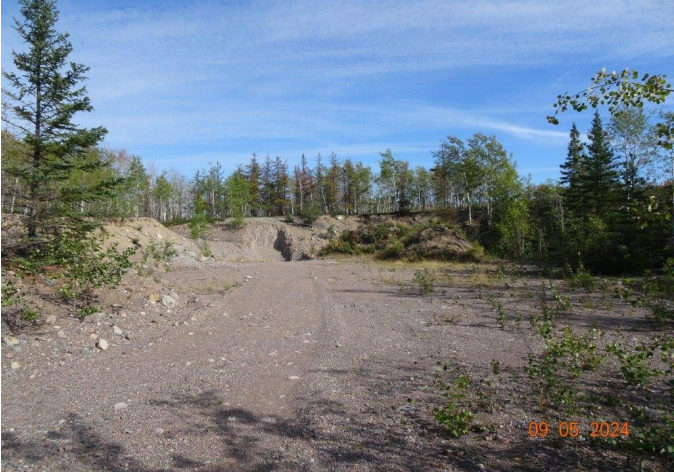
Figure 56

Gravel quarry in Pit W.
