File Number	MV2021A0006
Type of Operation	OIL AND GAS DRILLING - WELLSITE
Location	I-02, F-36, N-01, O-35

ENVIRONMENTAL INSPECTION REPORT

Permittee:	Paramount Resource Ltd.	Permit Expiry Date:	July 27, 2026
Land Use Permit No.	MV2021A0006	Previous Inspection:	August 18, 2022
Quarrying Permit No.		Inspection Date:	August 16, 2023
Contractor:		Subcontractor:	
Location(s) Inspected:	I-02, F-36, N-01, O-35		
Current Stage of Operation:	Monitoring		
Program Modifications Approved:	N/A

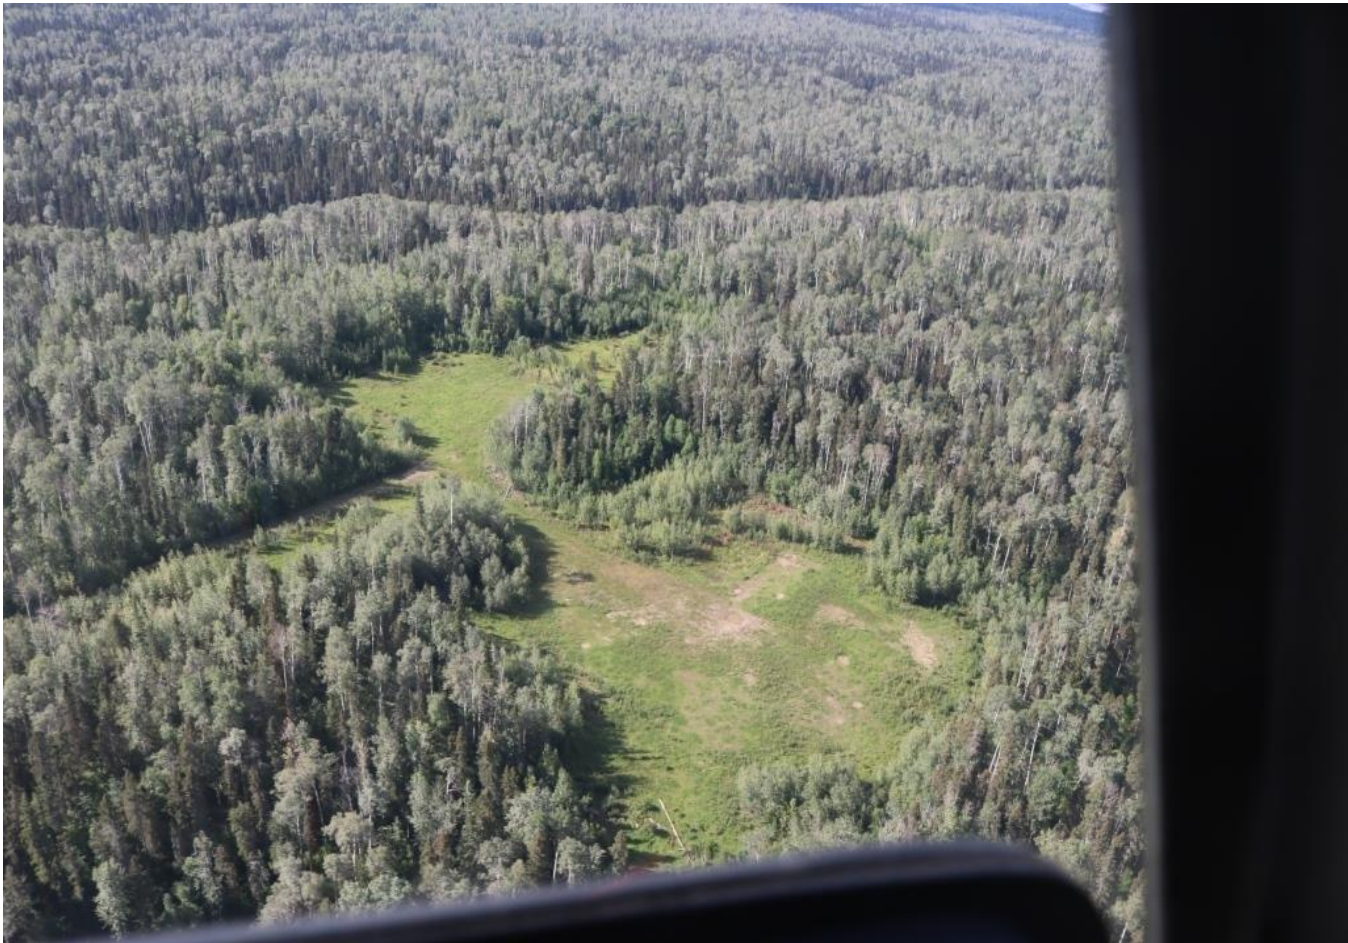
Figure 1
I-02

I-02: Vegetation growth is present throughout the site. The area around the sign that was noted in the previous inspection report, had a bit more vegetation present. There was water ponding at the time of the inspection. There were no signs of erosion but it was evident that bison have been present.

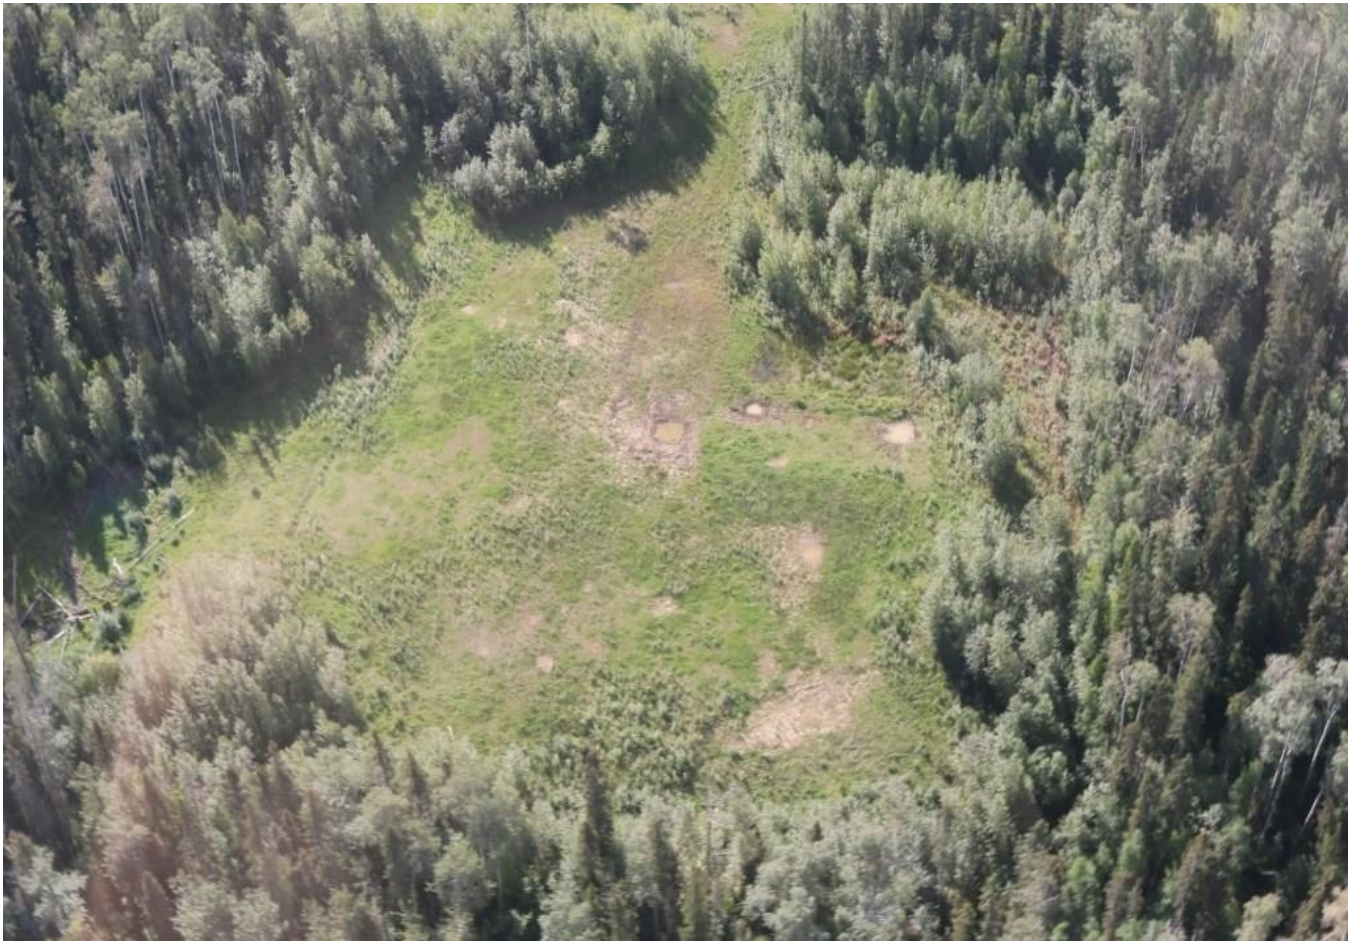
Figure 2
I-02- note ponding water

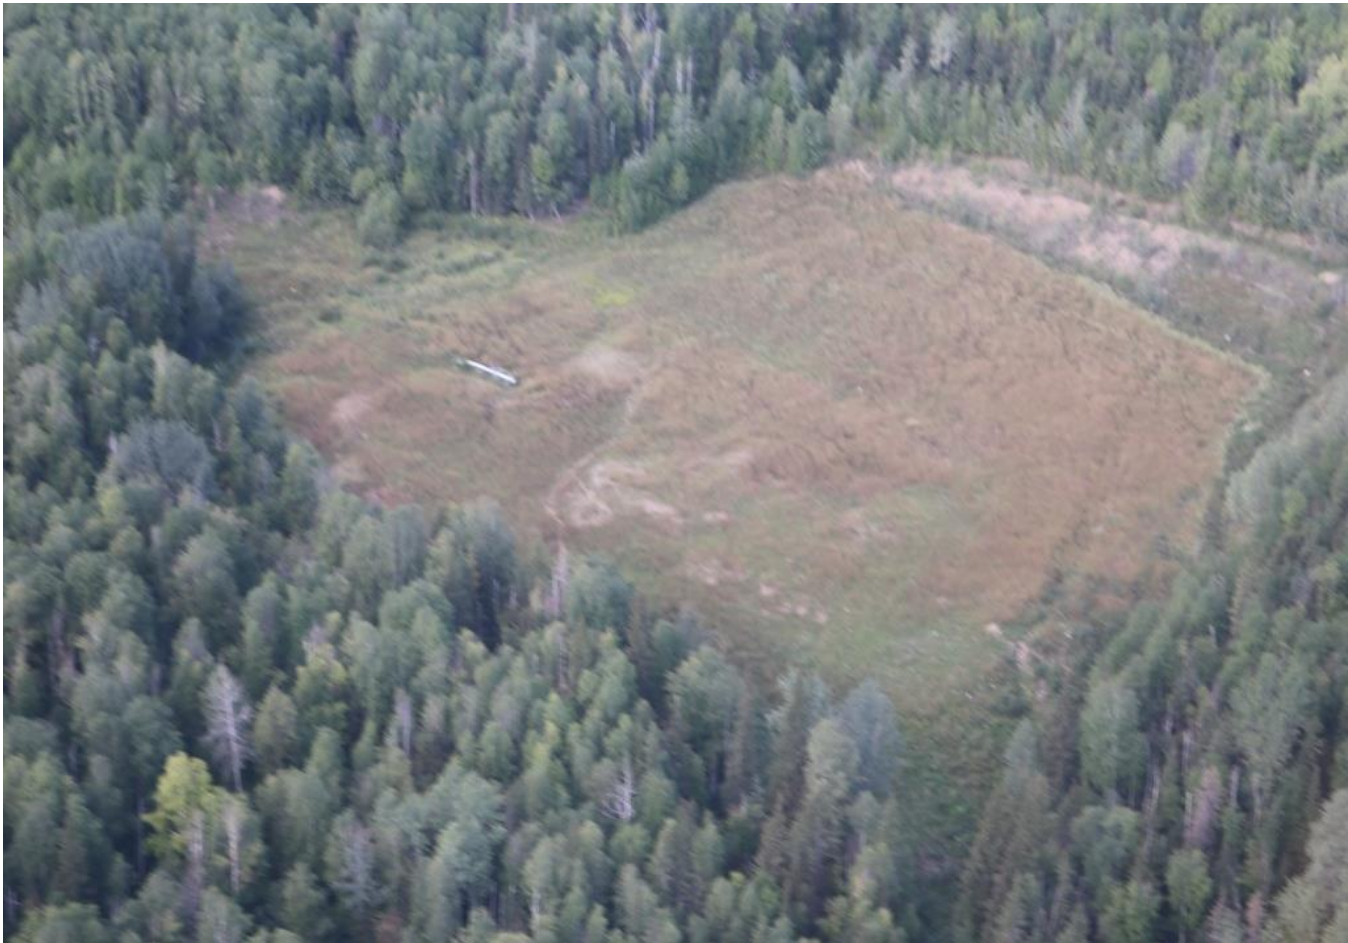
Figure 3
F-36

F-36: Vegetation growth was present throughout the site. The erosion that was noted in the previous inspection report was less noticeable but still present at the time of the inspection. There was still a riser on site.

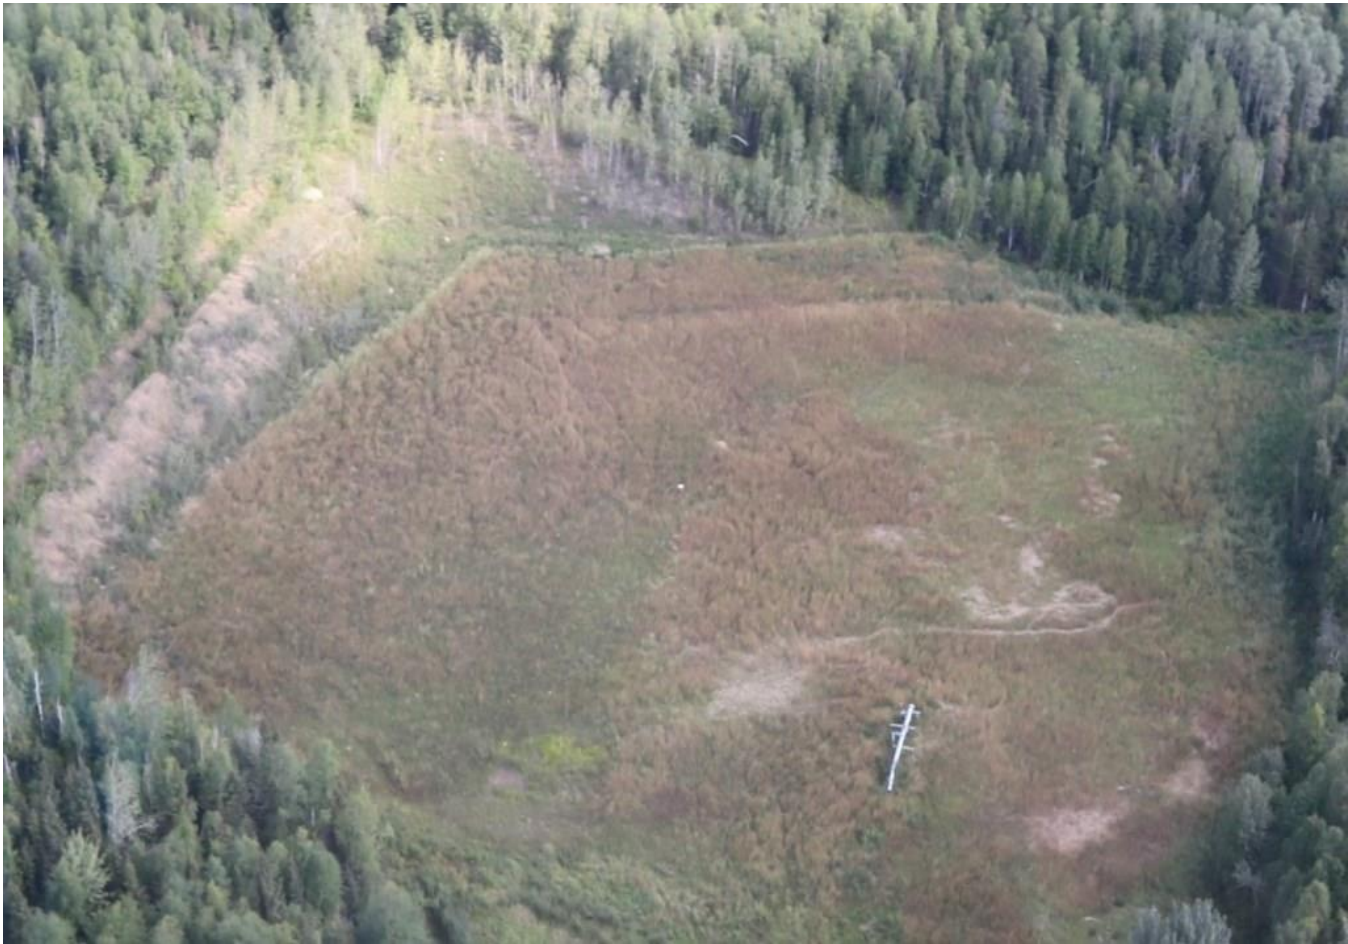
Operating Condition	Aspect Inspected				
	Wellsites				
Location as Permitted	A				
Time as Permitted	A				
Equipment as Approved (Type & Size)	A				
Methods & Techniques	A				
Facilities	A				
Erosion (Control or Prevention)	U (F-36)	28.			
Chemicals	A				
Wildlife and Fisheries Habitat (Protection)	A				
Wastes	A				
Fuel Storage	A				
Brush Disposal	A				
Restoration of Lands	A				
Permits	A

Figure 4
F-36- note erosion channel

28. **Repair Erosion:** The Permittee shall apply appropriate mitigation at the first sign of erosion.

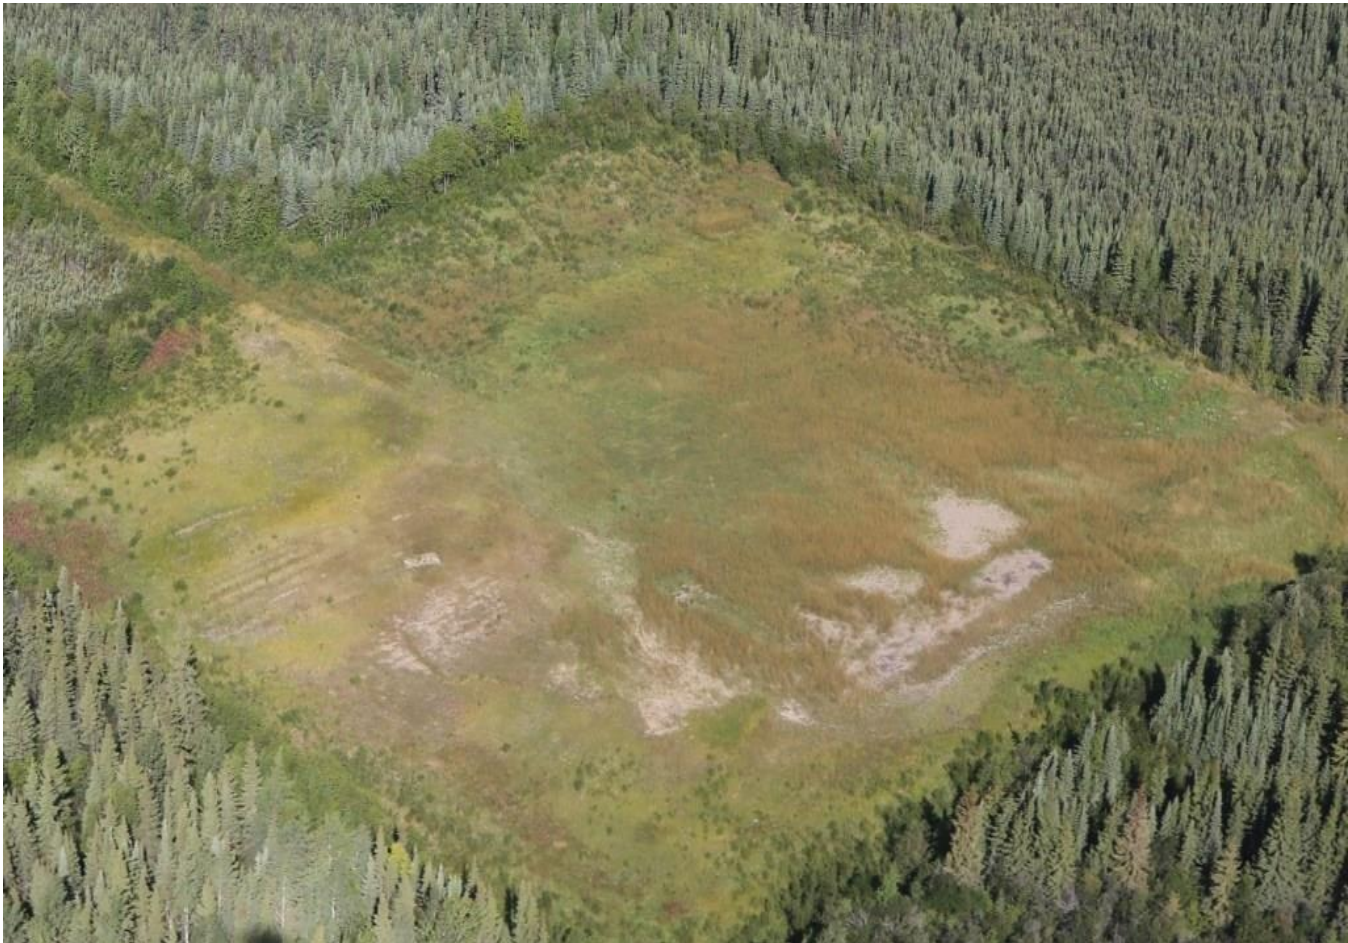
Figure 5
N-01

N-01: Vegetation is present throughout the site. There were a few bare areas with little vegetation. The wellhead was removed and a sign was in its place.

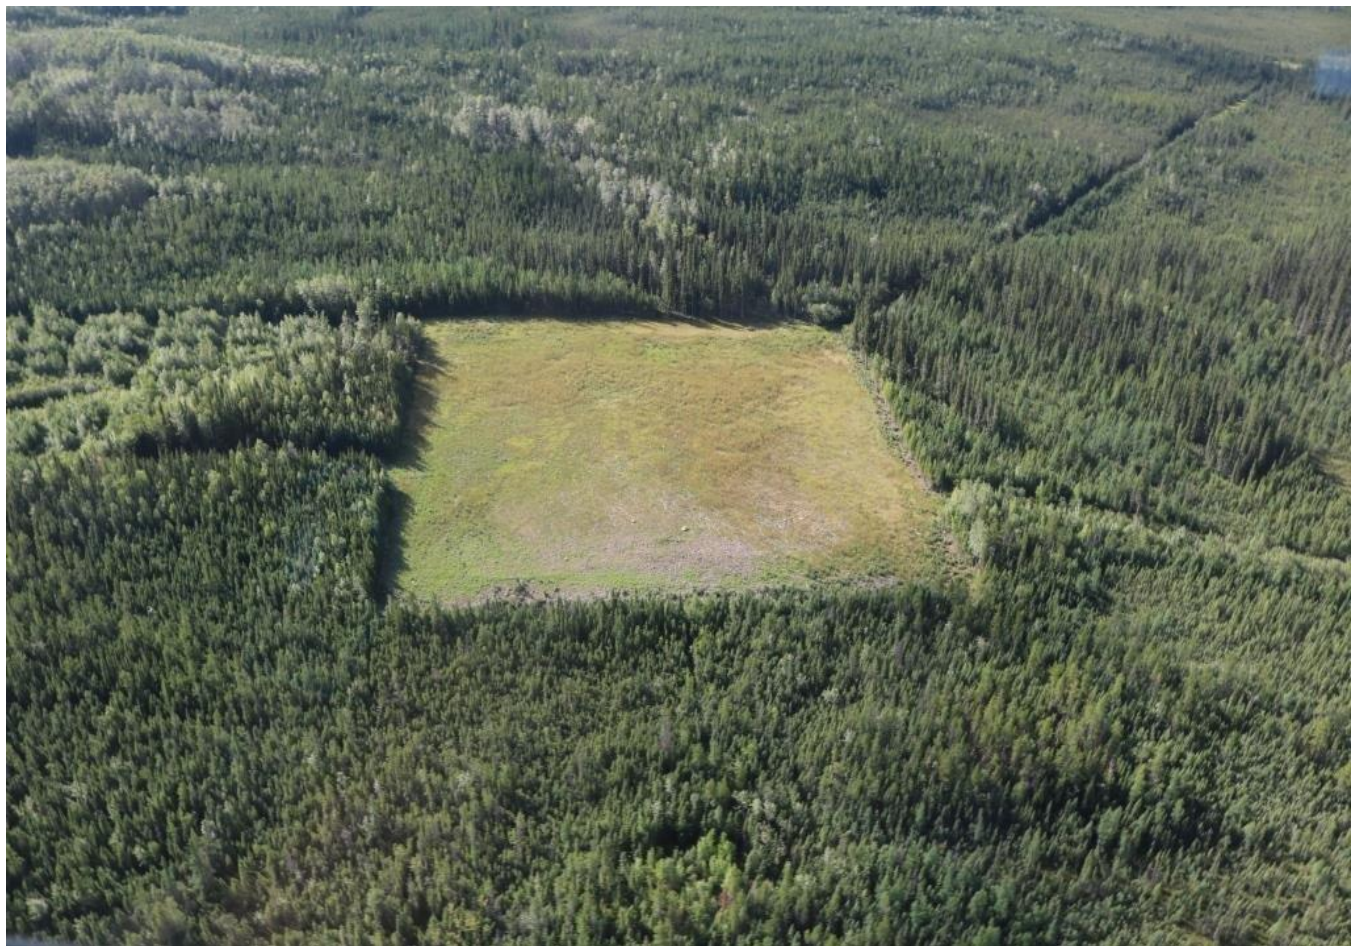
Figure 7
O-35

O-35: Vegetation was present throughout the site. There was a sign in place where the wellhead was.
