**File: MV2021D0009**

**Re:      Land Use Permit MV2021D0009  
         Margaret Lake Camp  
         Kennady Lake, NT**

ENVIRONMENTAL INSPECTION REPORT

Permittee:	De Beers Canada Inc. – Margaret Lake Camp	Inspection Date: June 17, 2025
------------	---	--------------------------------

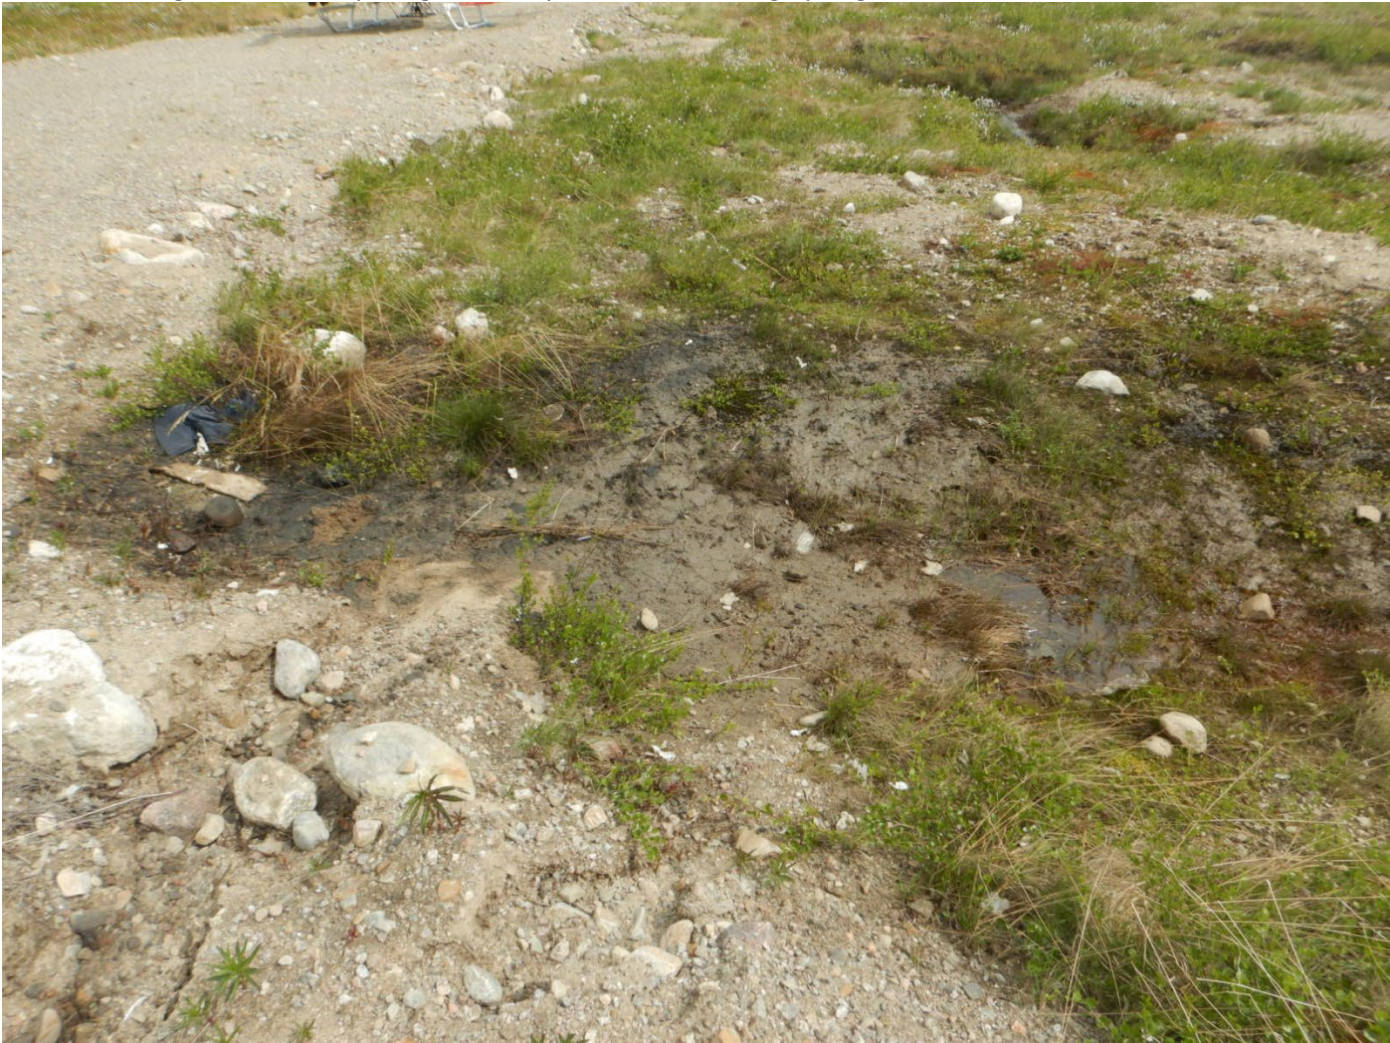
Photo 1 – Margaret Lake Camp – Significant hydrocarbon staining/spillage.

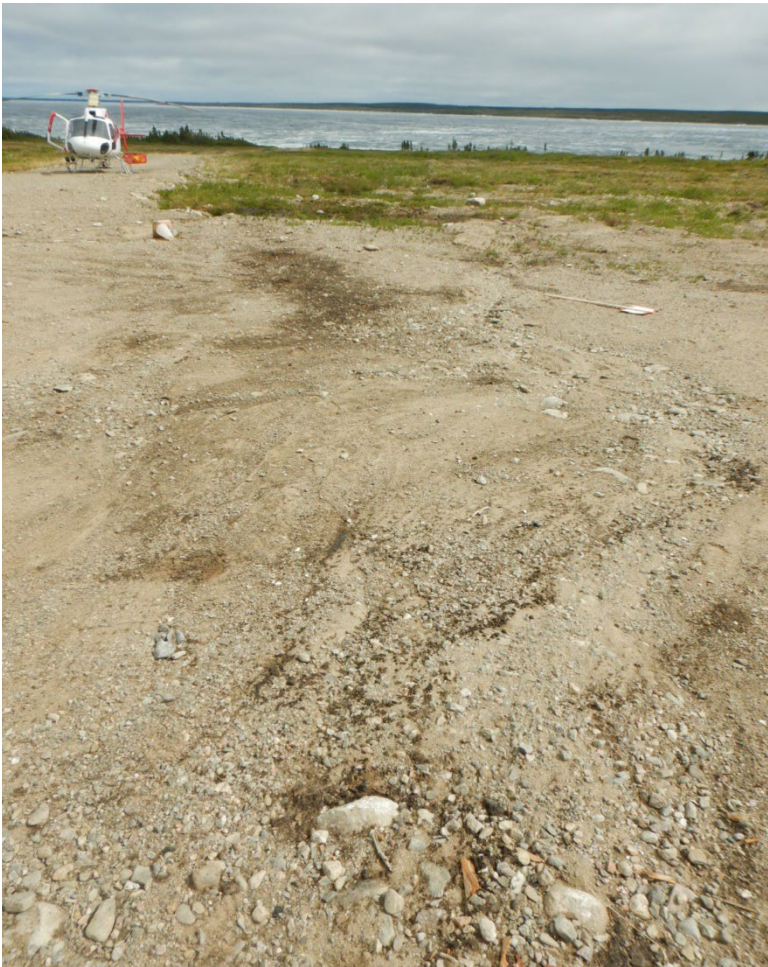
Photo 2 – Margaret Lake Camp – Same spill looking toward spur road from camp.

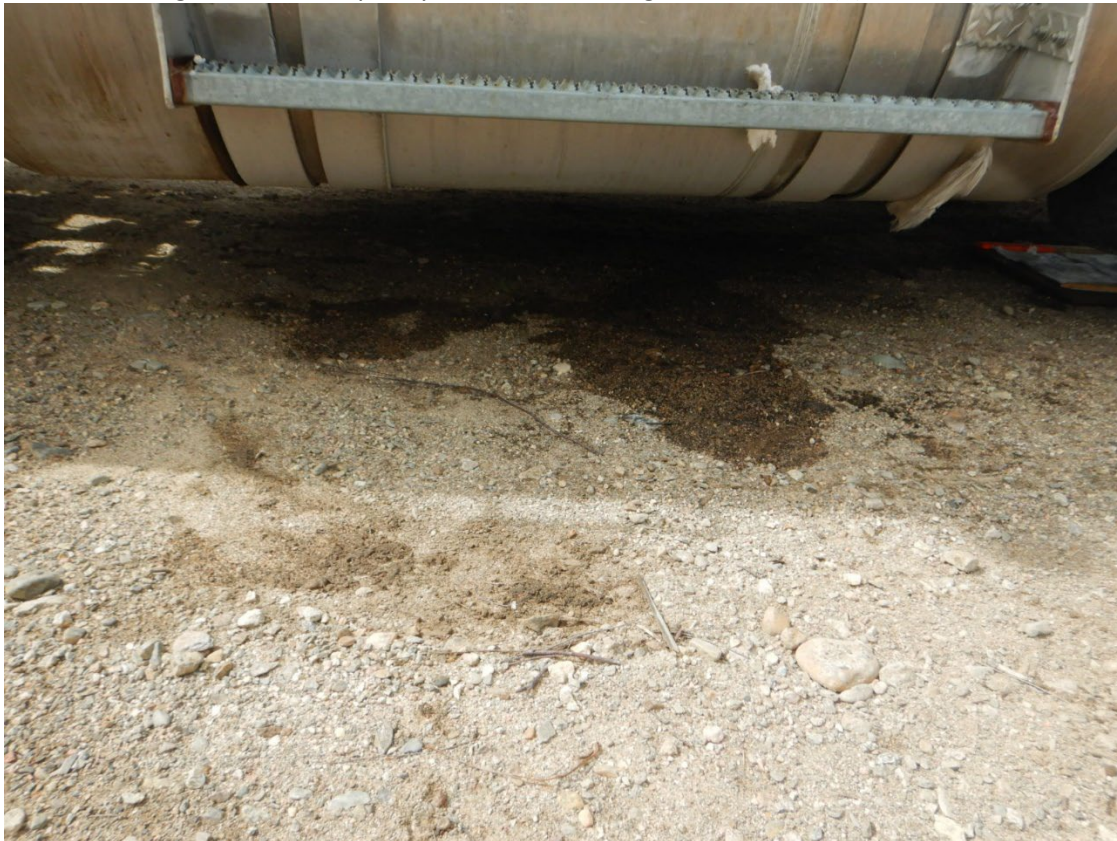
Photo 3 – Margaret Lake Camp – Hydrocarbon staining under vehicle (1).

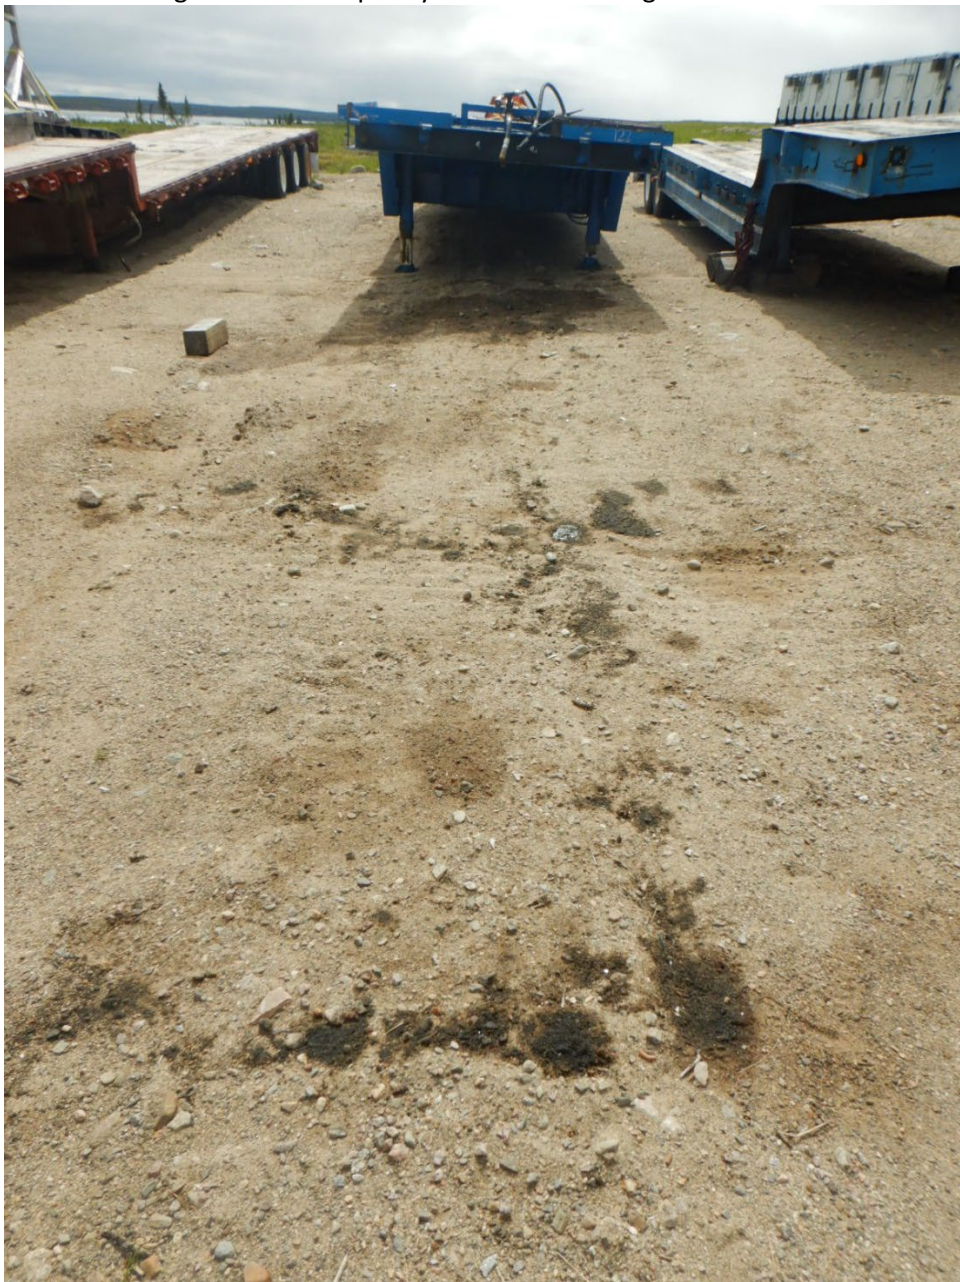
Photo 4 – Margaret Lake Camp – Hydrocarbon staining under and around flatbed (2).

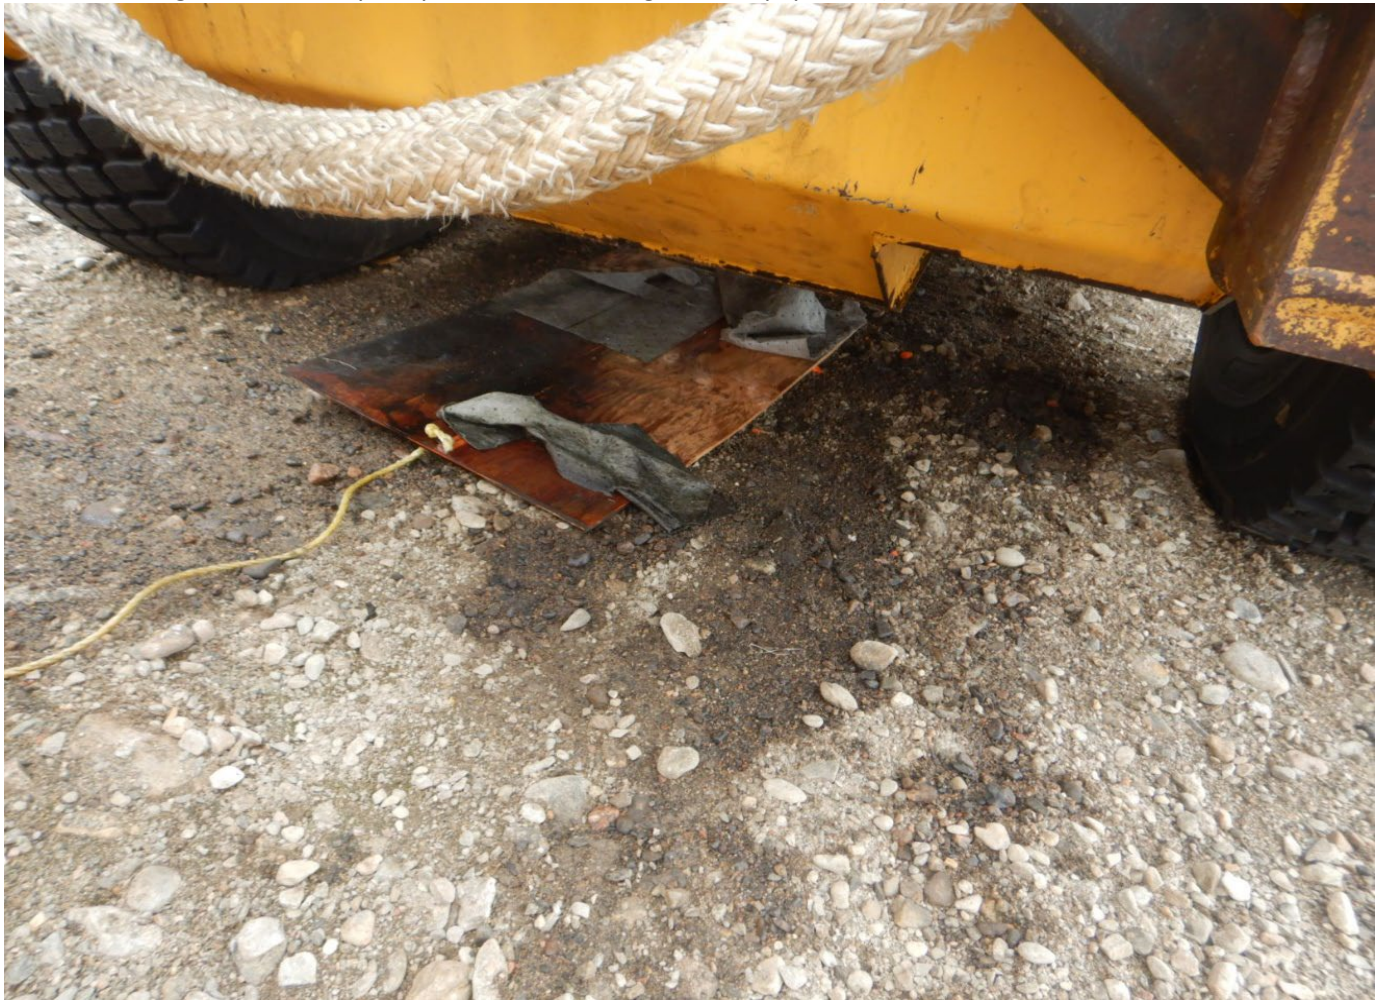
Photo 5 – Margaret Lake Camp – Hydrocarbon staining under equipment (3).

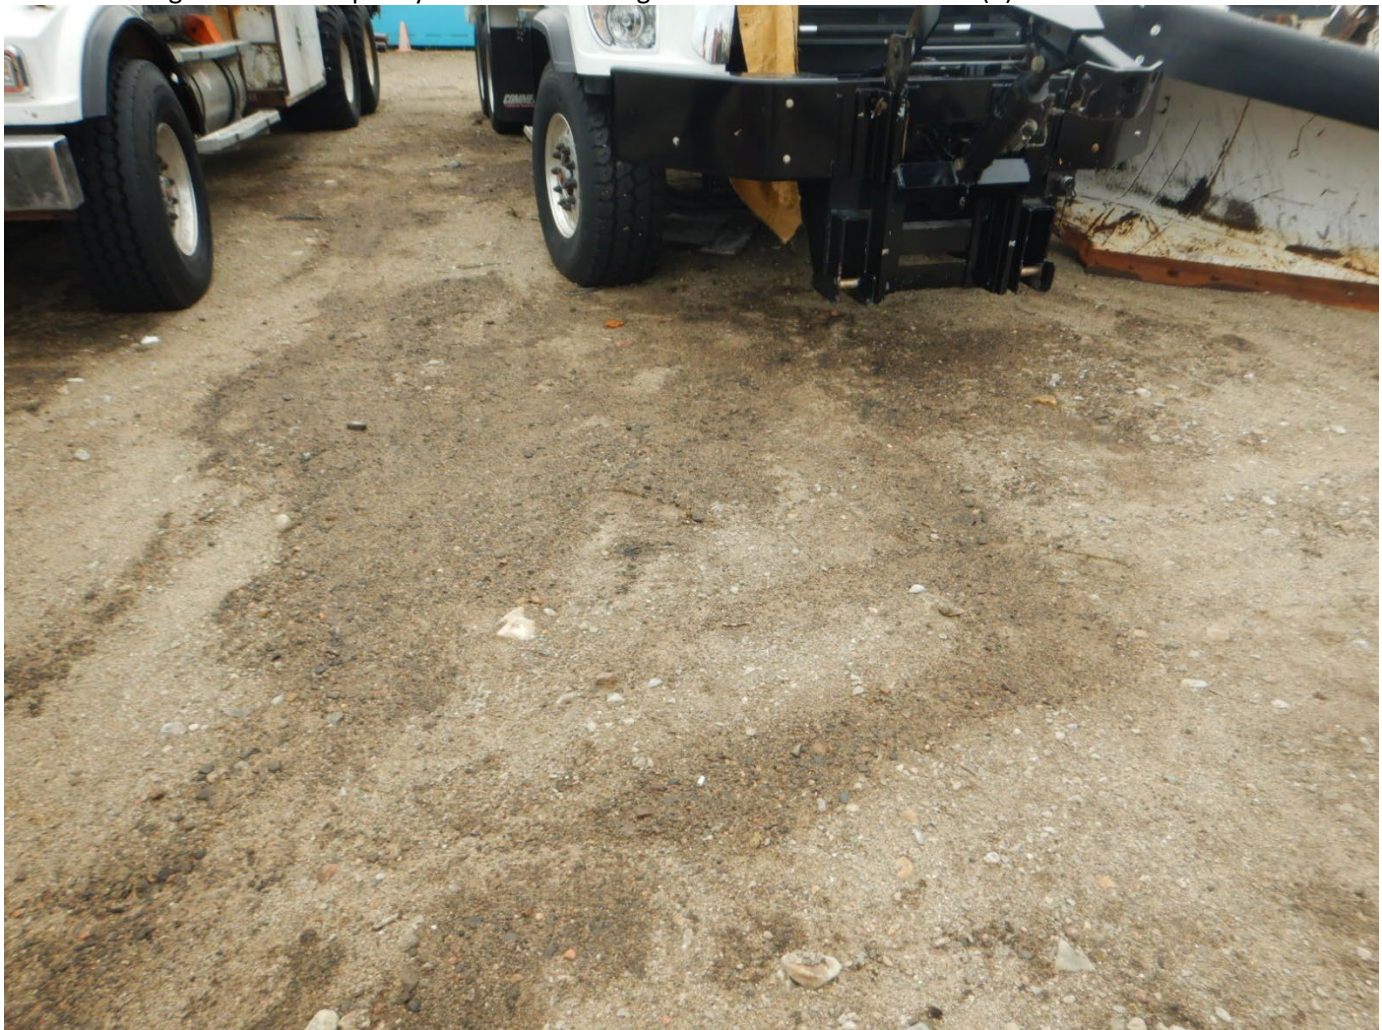
Photo 6 - Margaret Lake Camp – Hydrocarbon staining under and around vehicles (4).

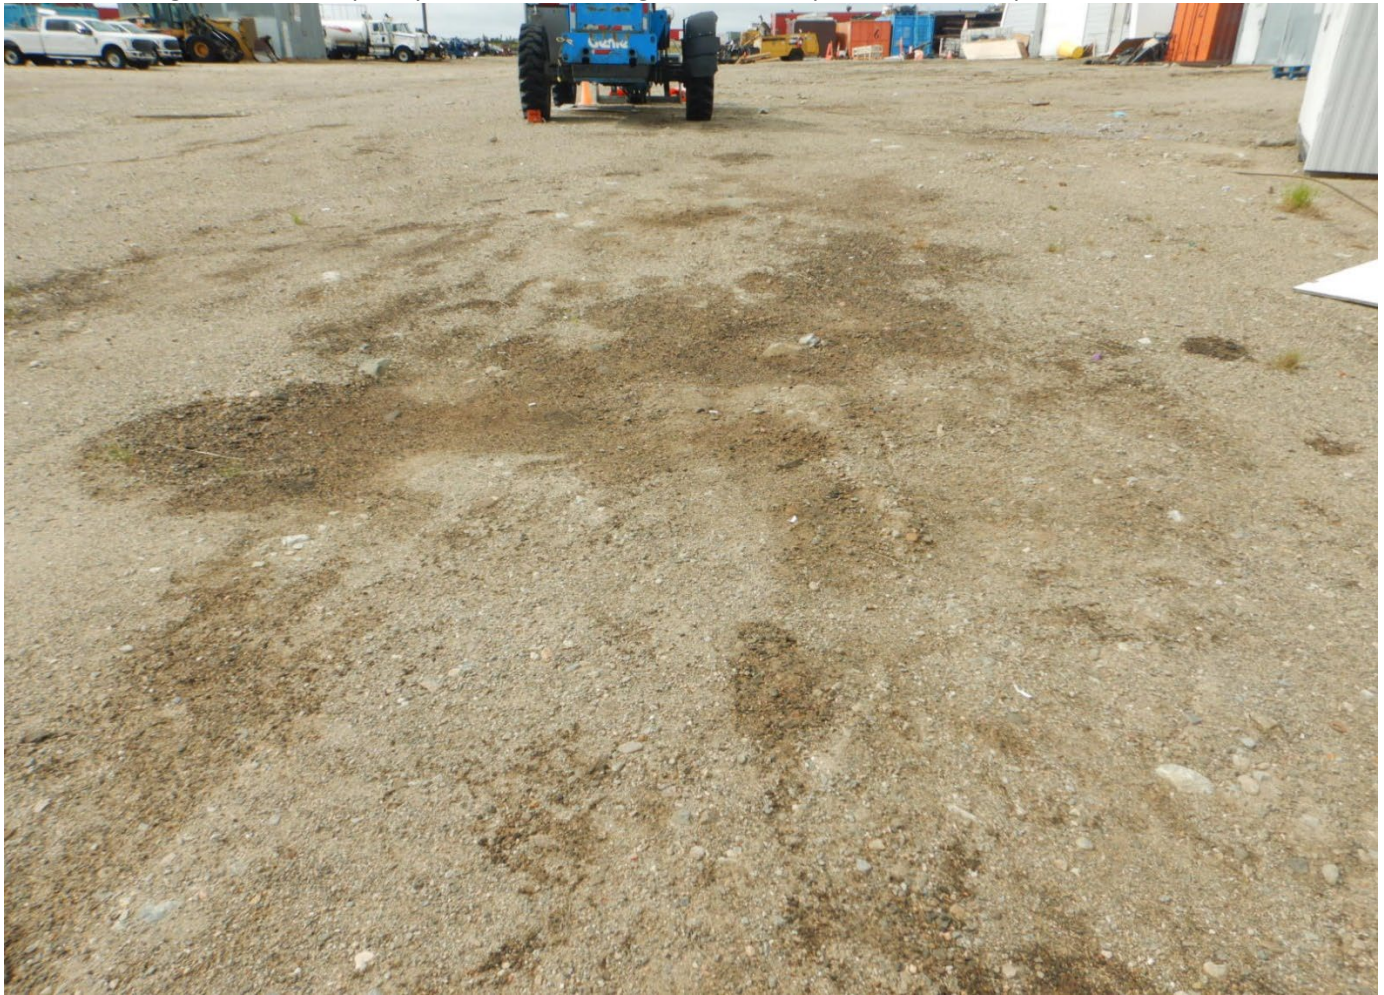
Photo 7 - Margaret Lake Camp – Hydrocarbon staining between shops and main camp.

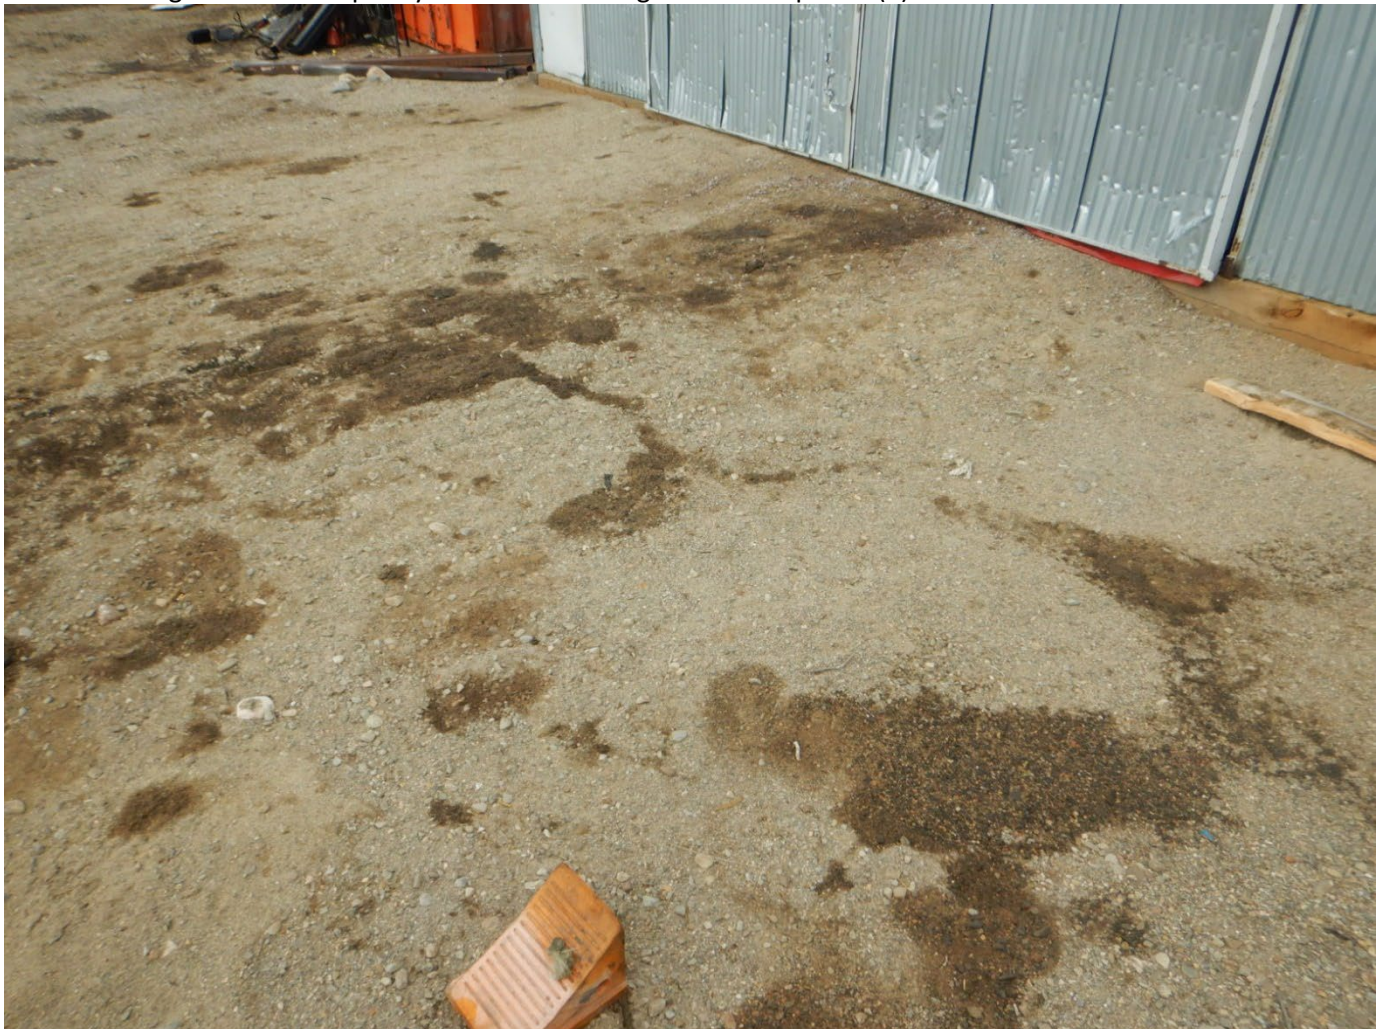
Photo 8 - Margaret Lake Camp – Hydrocarbon staining outside shop area (1).

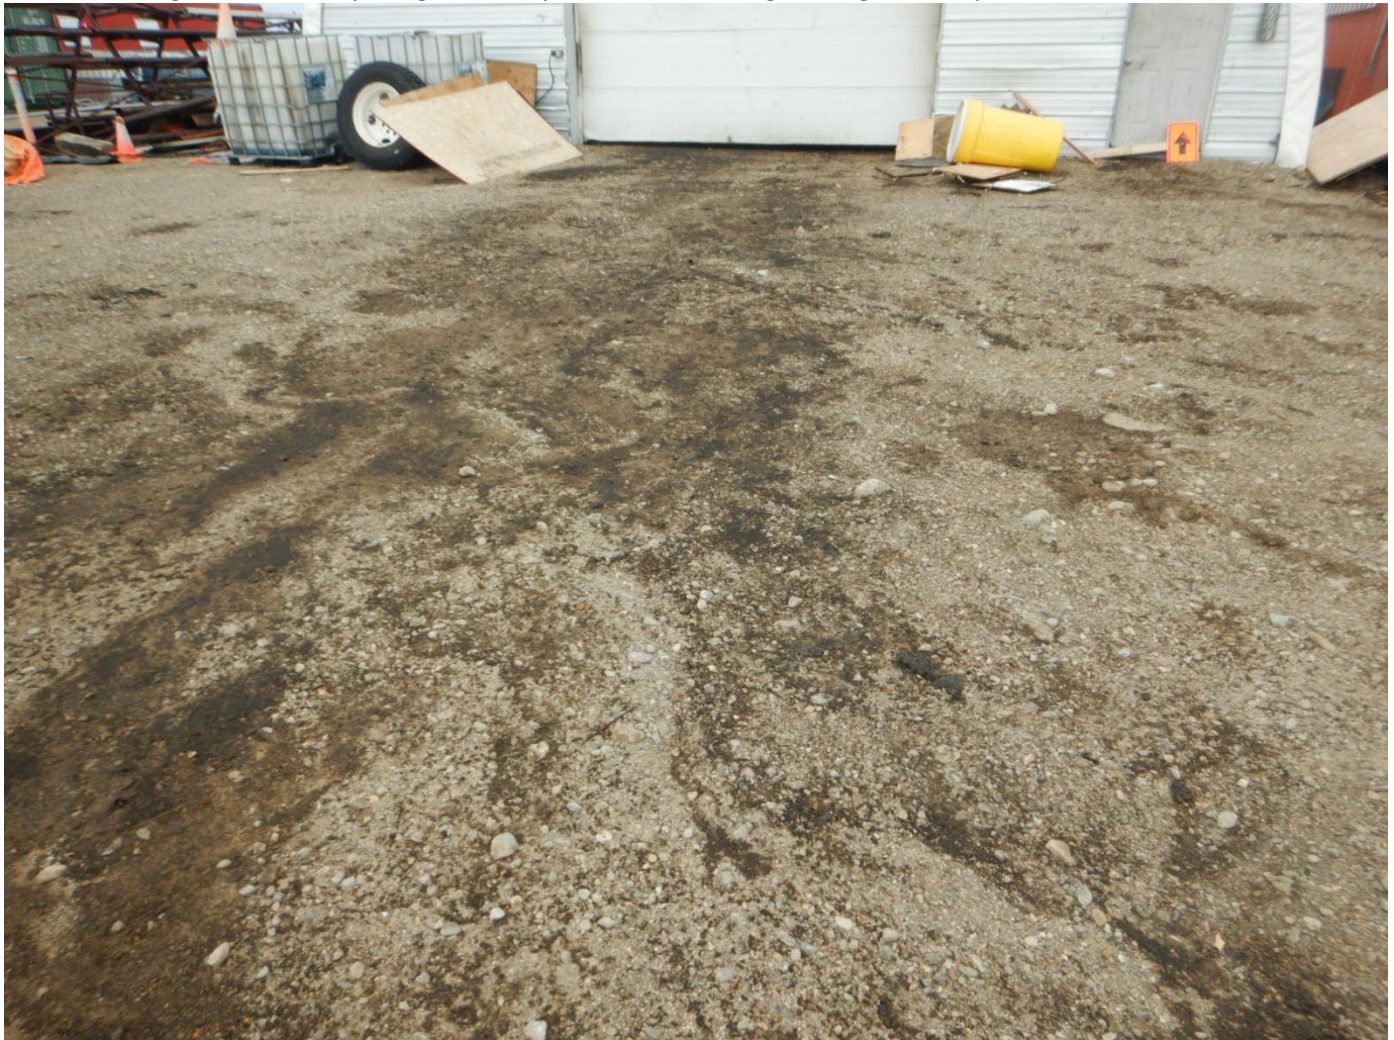
Photo 9 - Margaret Lake Camp – Significant hydrocarbon staining leading into shop area.

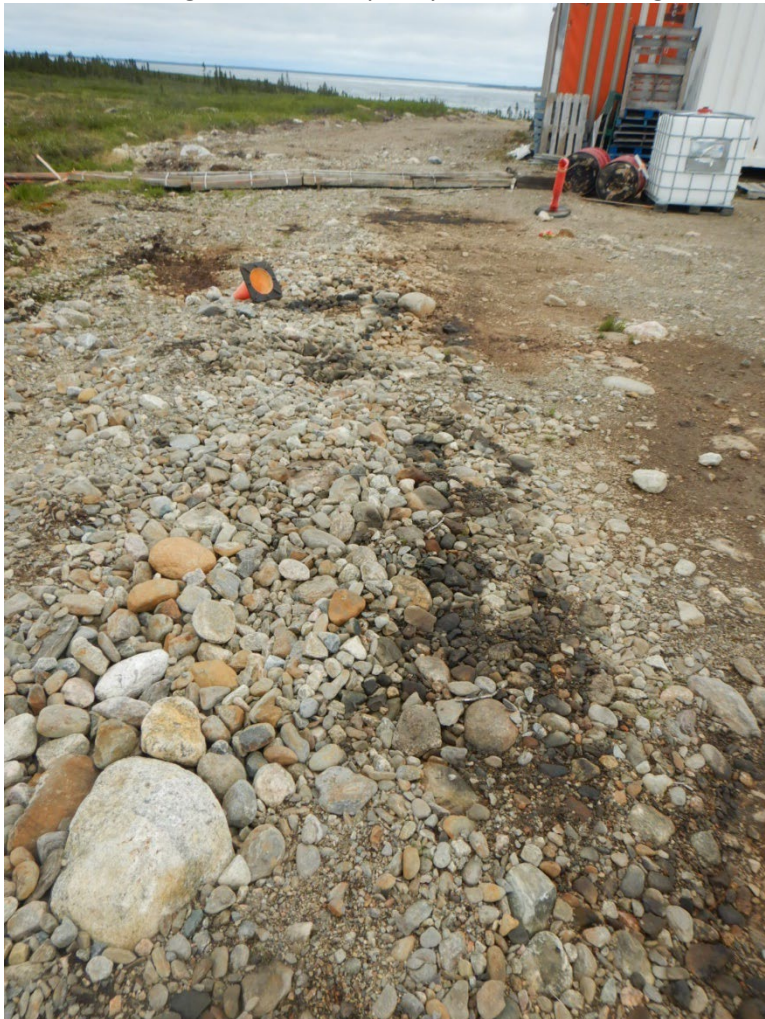
Photo 10 - Margaret Lake Camp – Hydrocarbon staining behind shops.

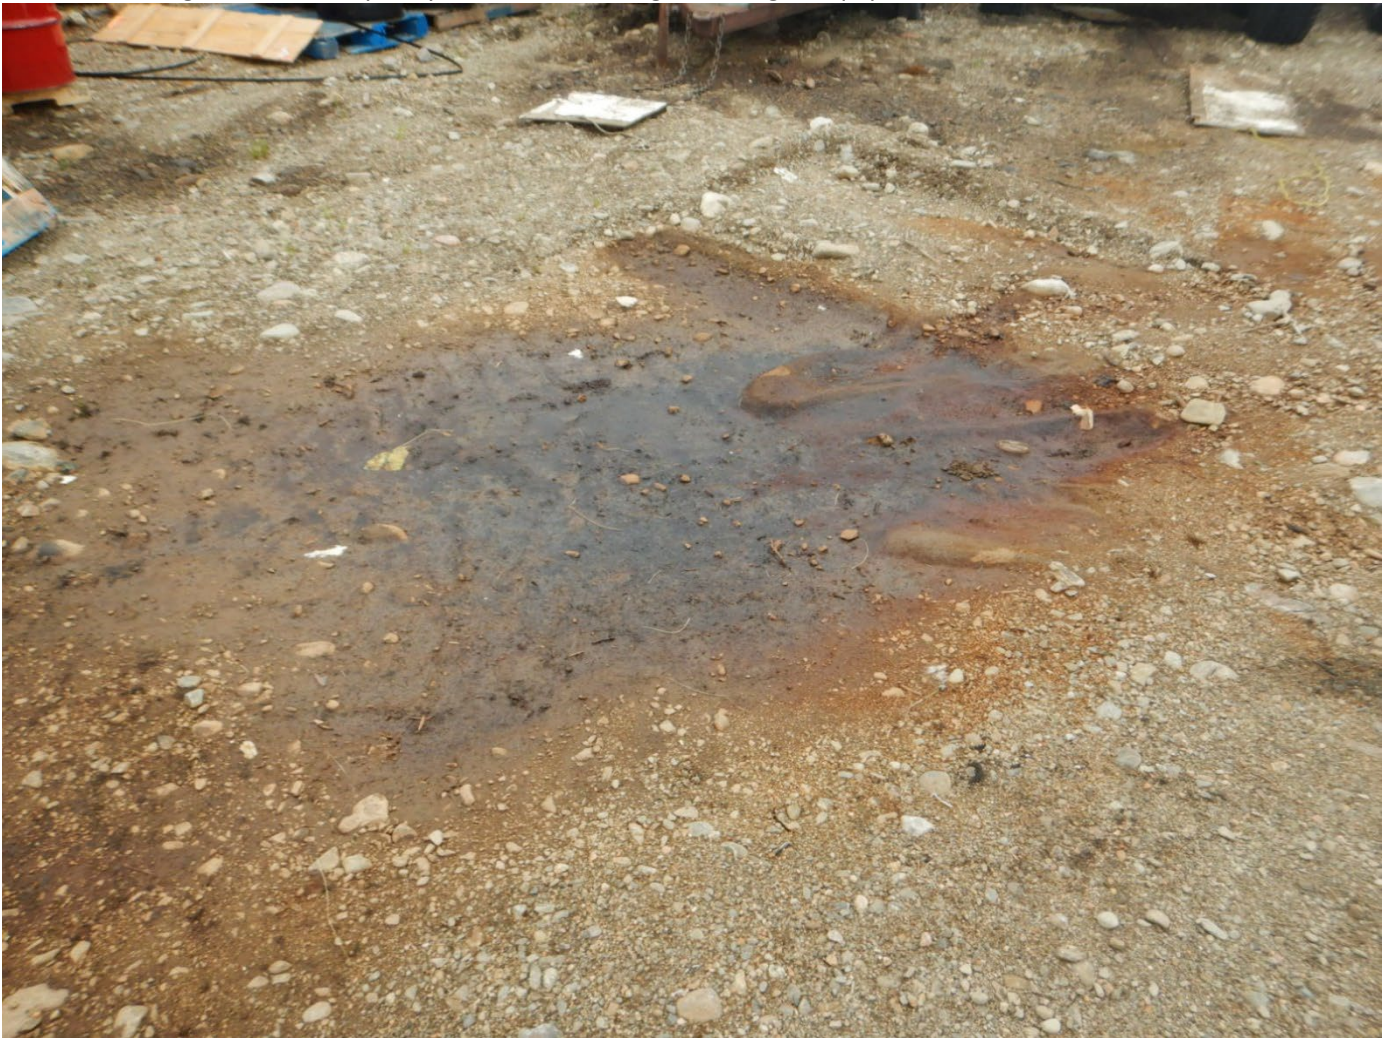
Photo 11 - Margaret Lake Camp – Hydrocarbon staining near staged equipment area.

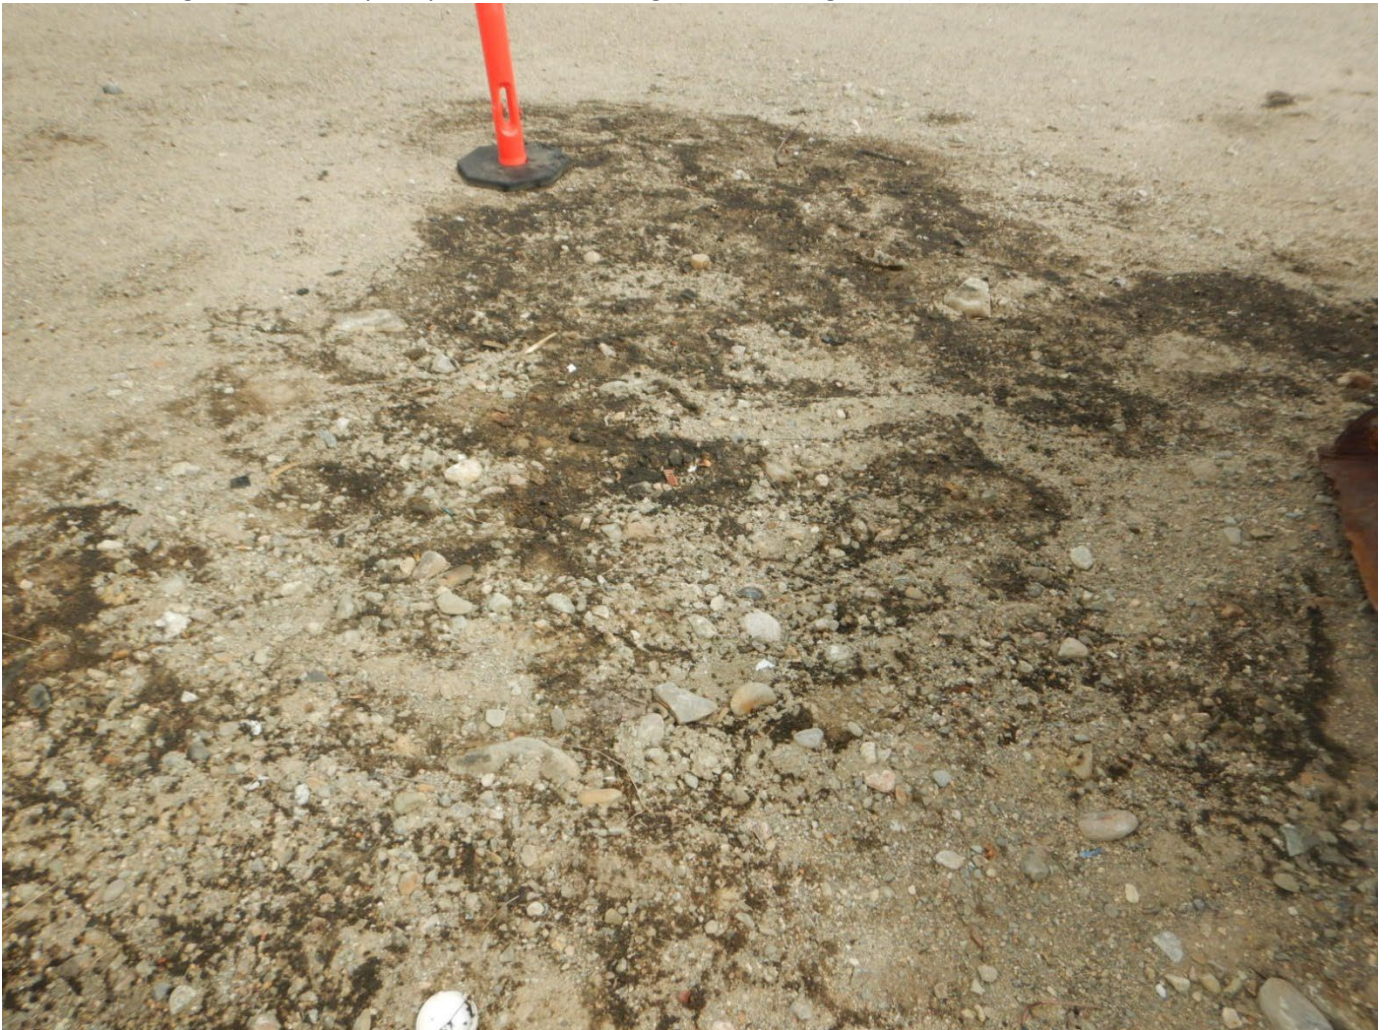
Photo 12 - Margaret Lake Camp – Hydrocarbon staining near refueling area (1).

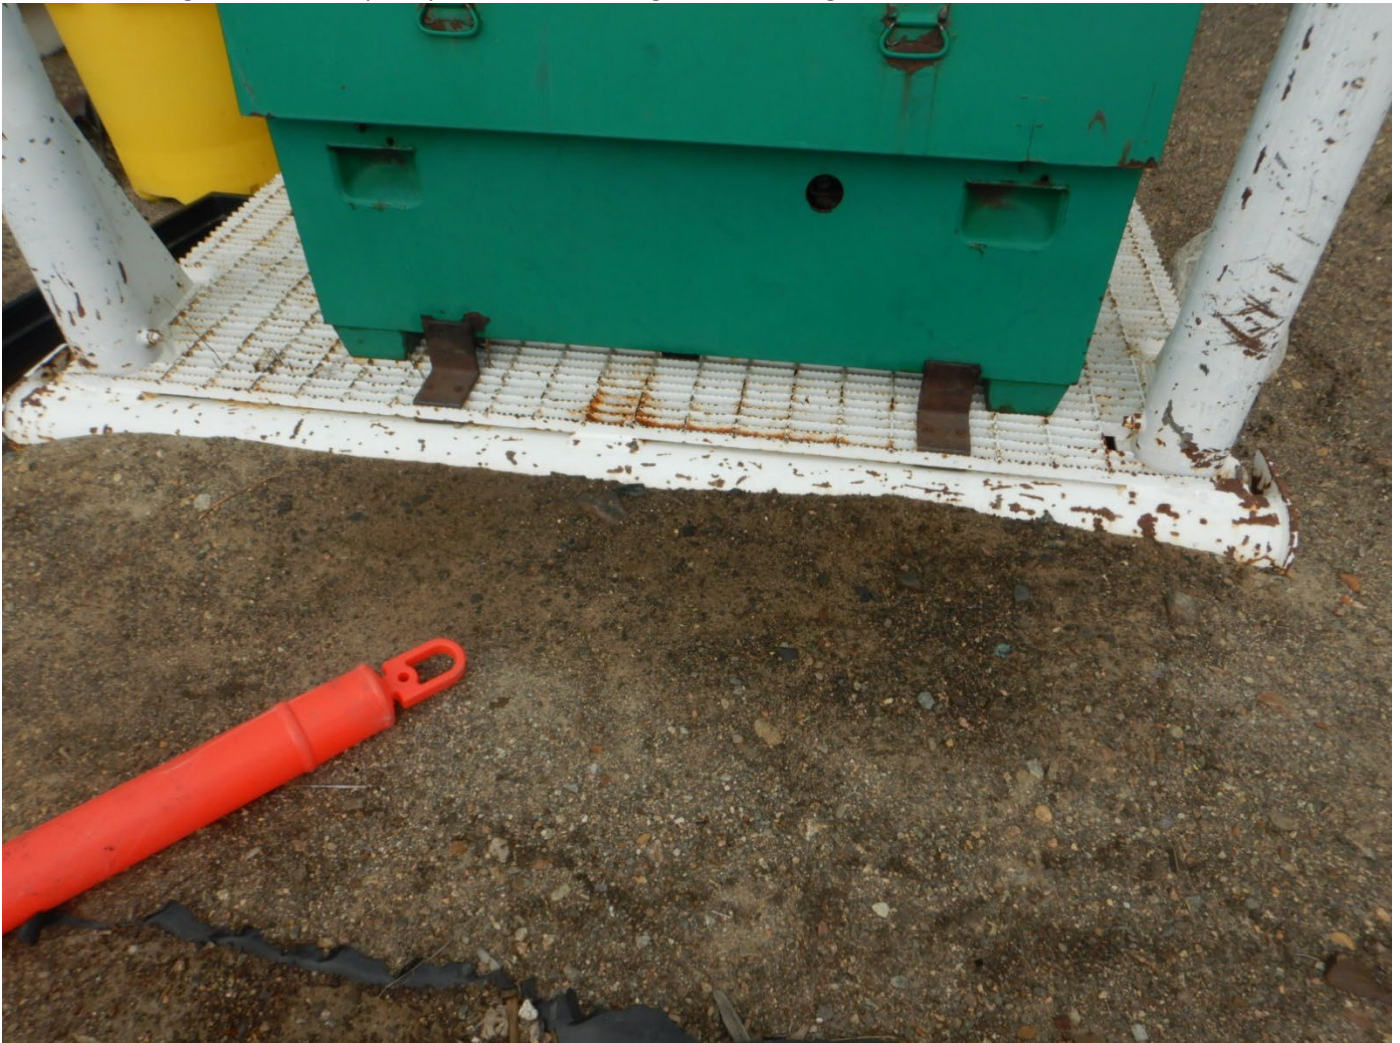
Photo 13 - Margaret Lake Camp – Hydrocarbon staining near refueling area (2).

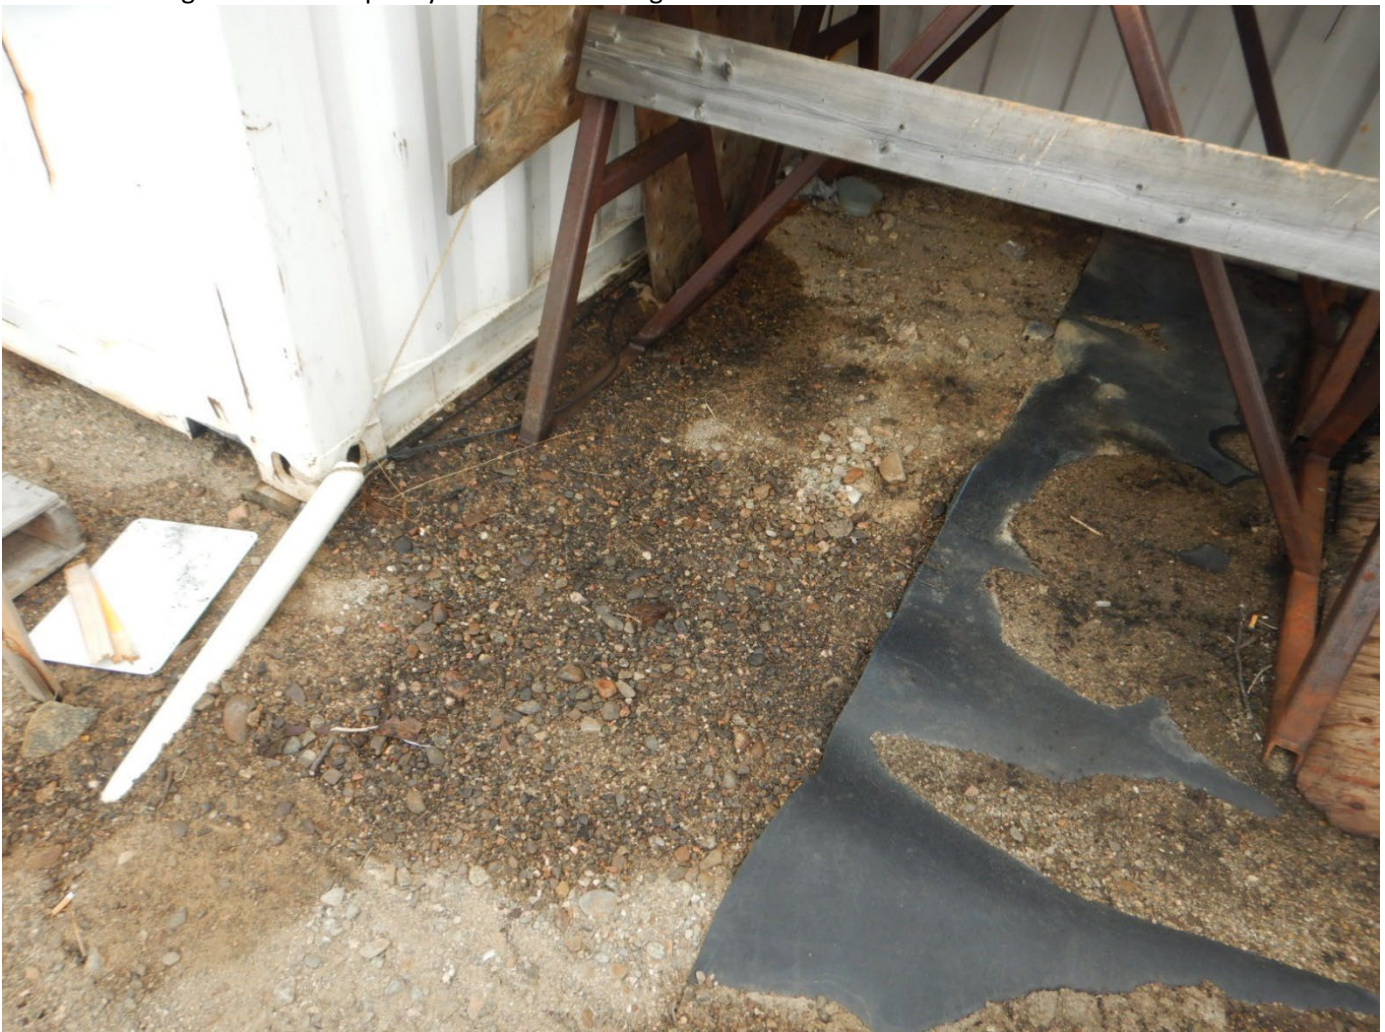
Photo 14 - Margaret Lake Camp – Hydrocarbon staining underneath raised fuel tank.

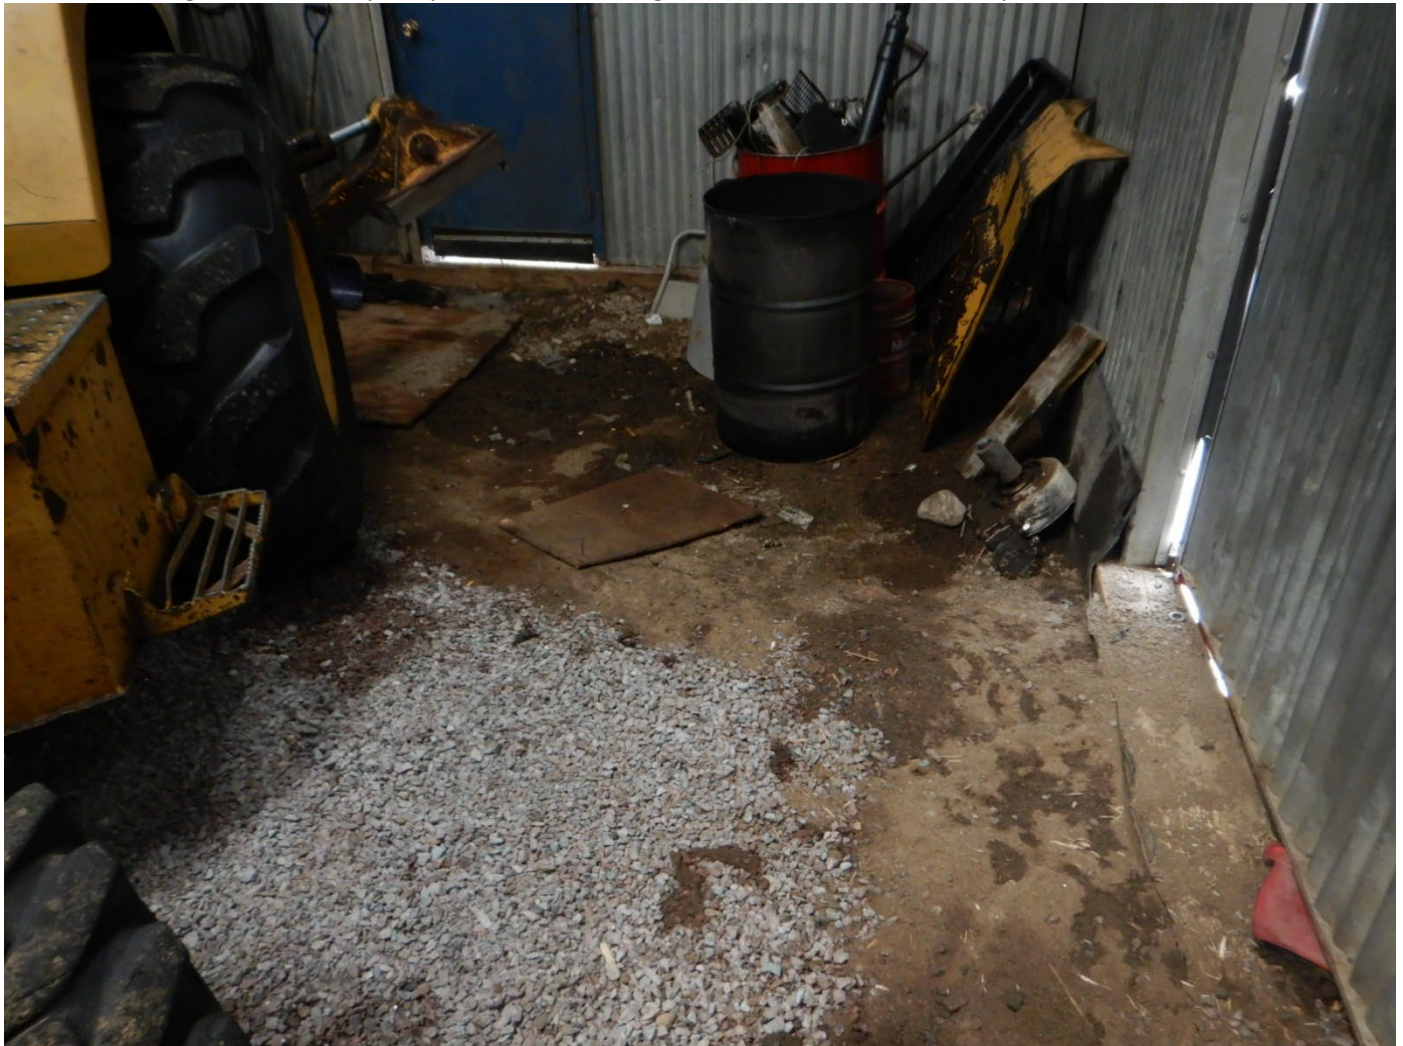
Photo 15 - Margaret Lake Camp – Hydrocarbon staining inside the maintenance shop.

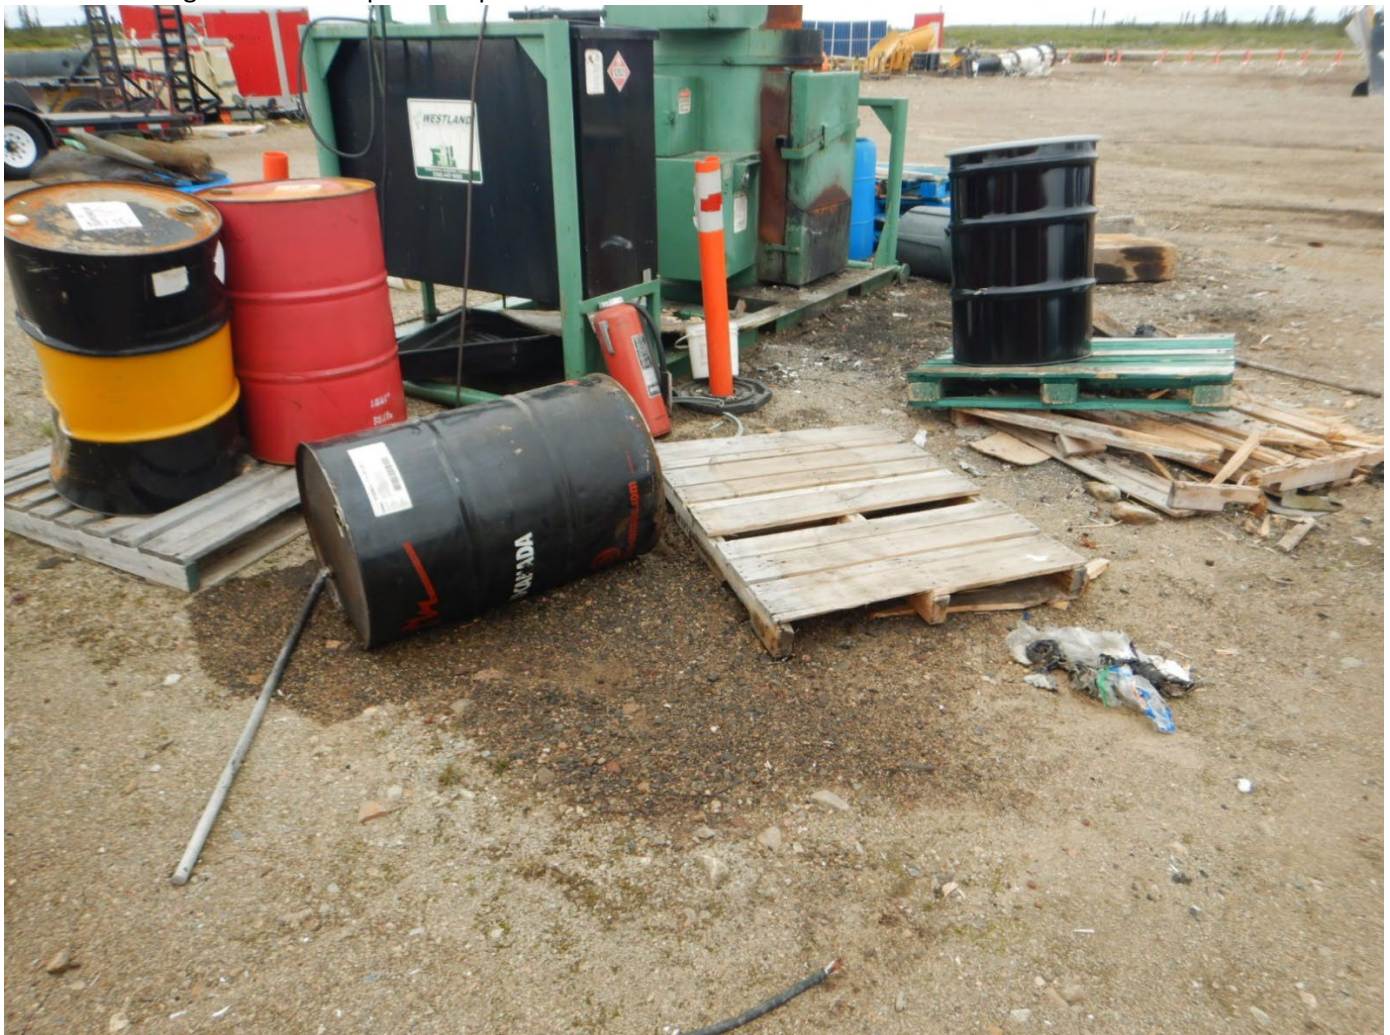
Photo 16 - Margaret Lake Camp – Fuel spill from overturned drum.

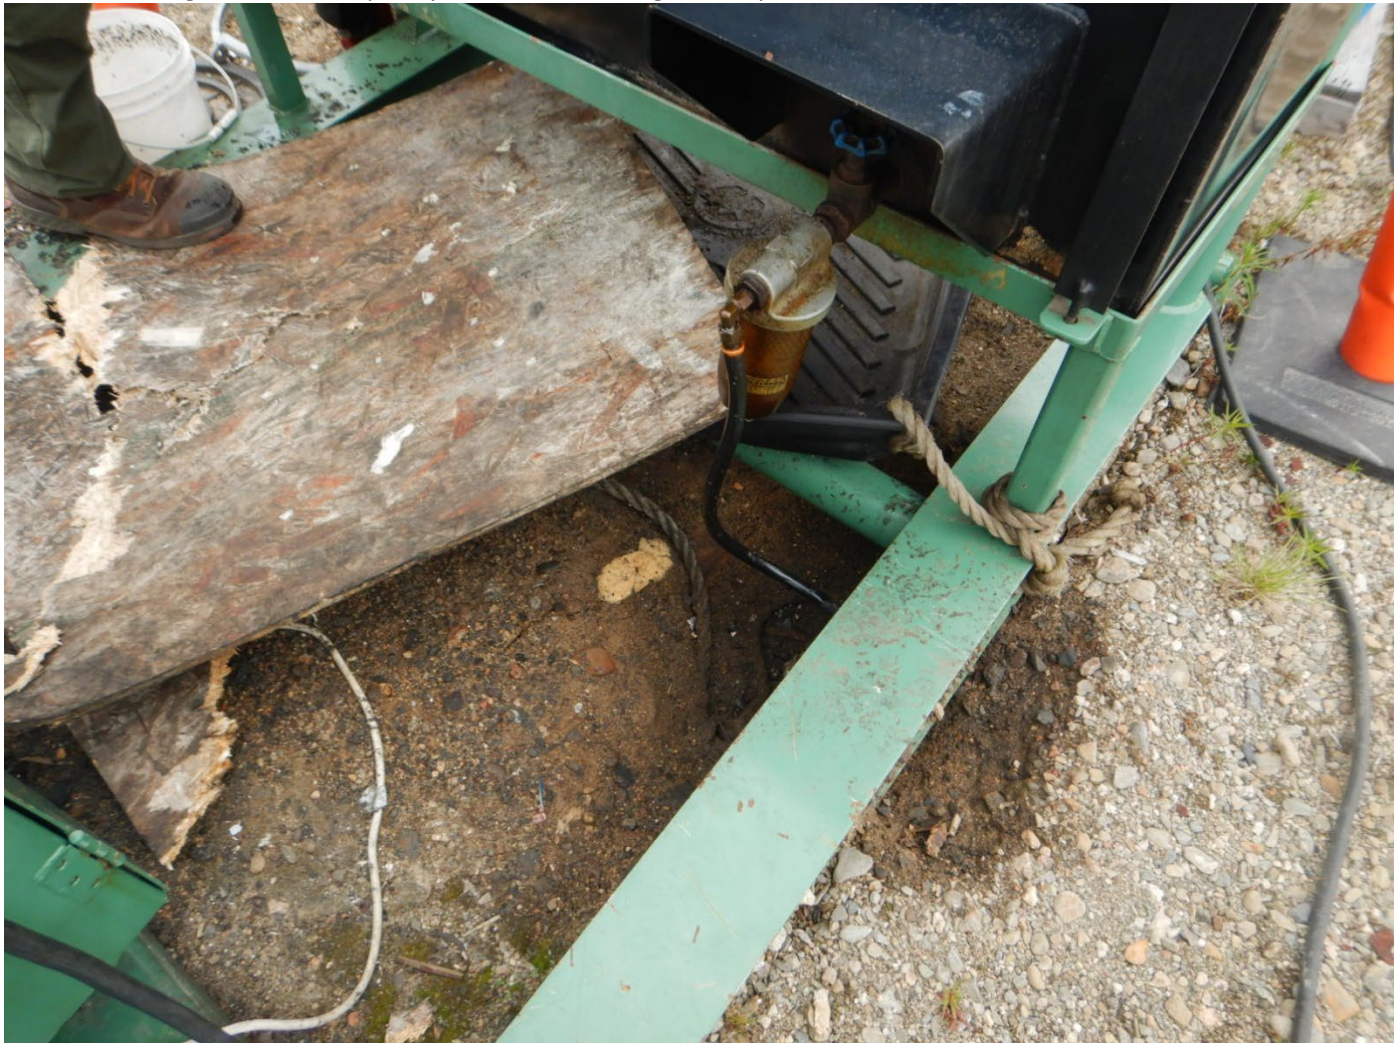
Photo 17 - Margaret Lake Camp – Hydrocarbon staining from a potential fuel line leak.
