**File: MV2021D0009**

**Re:      Land Use Permit MV2021D0009  
         Margaret Lake Camp  
         Kennady Lake, NT**

ENVIRONMENTAL INSPECTION REPORT

Permittee:	De Beers Canada Inc. – Margaret Lake Camp	Inspection Date: June 17, 2025
------------	---	--------------------------------

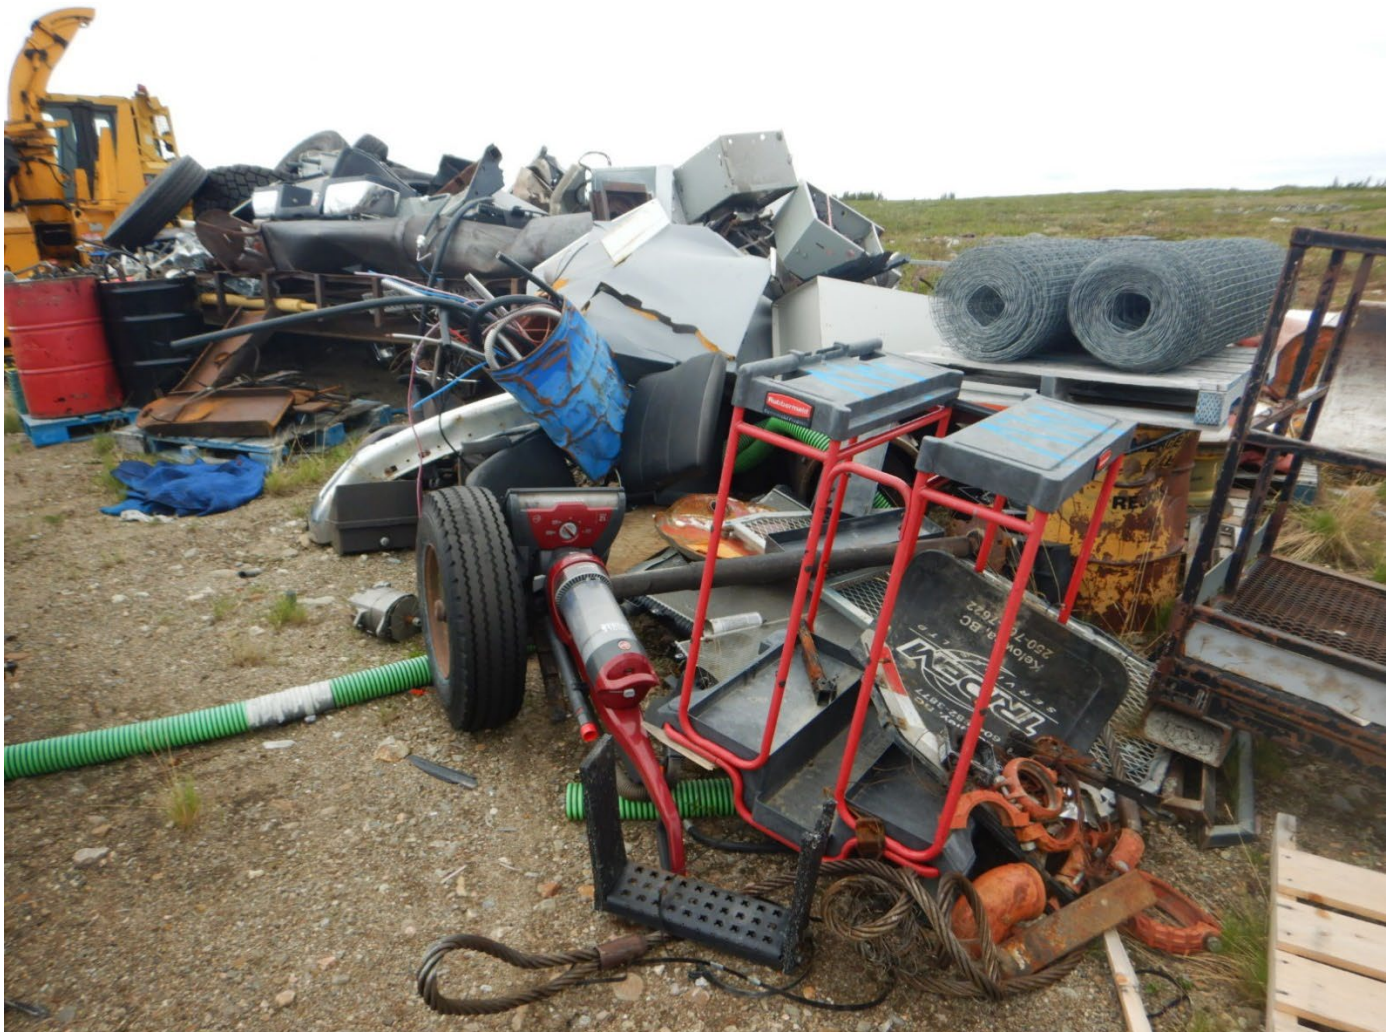
Photo 18 - Margaret Lake Camp – Historical accumulation of scrap material.

In previous inspections there was dialogue between the Inspector and De Beers and its contractor to take a staged approach regarding the removal of waste which has accumulated on site. There was some progress made in the removal of old vehicles and materials during the 2025 winter road season, however, given the state of the site during the most recent inspection, the Inspector must see all scrap materials that have accumulated be removed on the upcoming winter road, and there is to be no further accumulation of materials from year to year. This would include all the material observed in the scrap metals/miscellaneous waste pile (Photo 18). A number of drums with scrap material (Photo 19) was also observed, which should have been shipped out while the winter road was open. The remainder of derelict vehicles must also be prioritized for shipment off site in 2026.

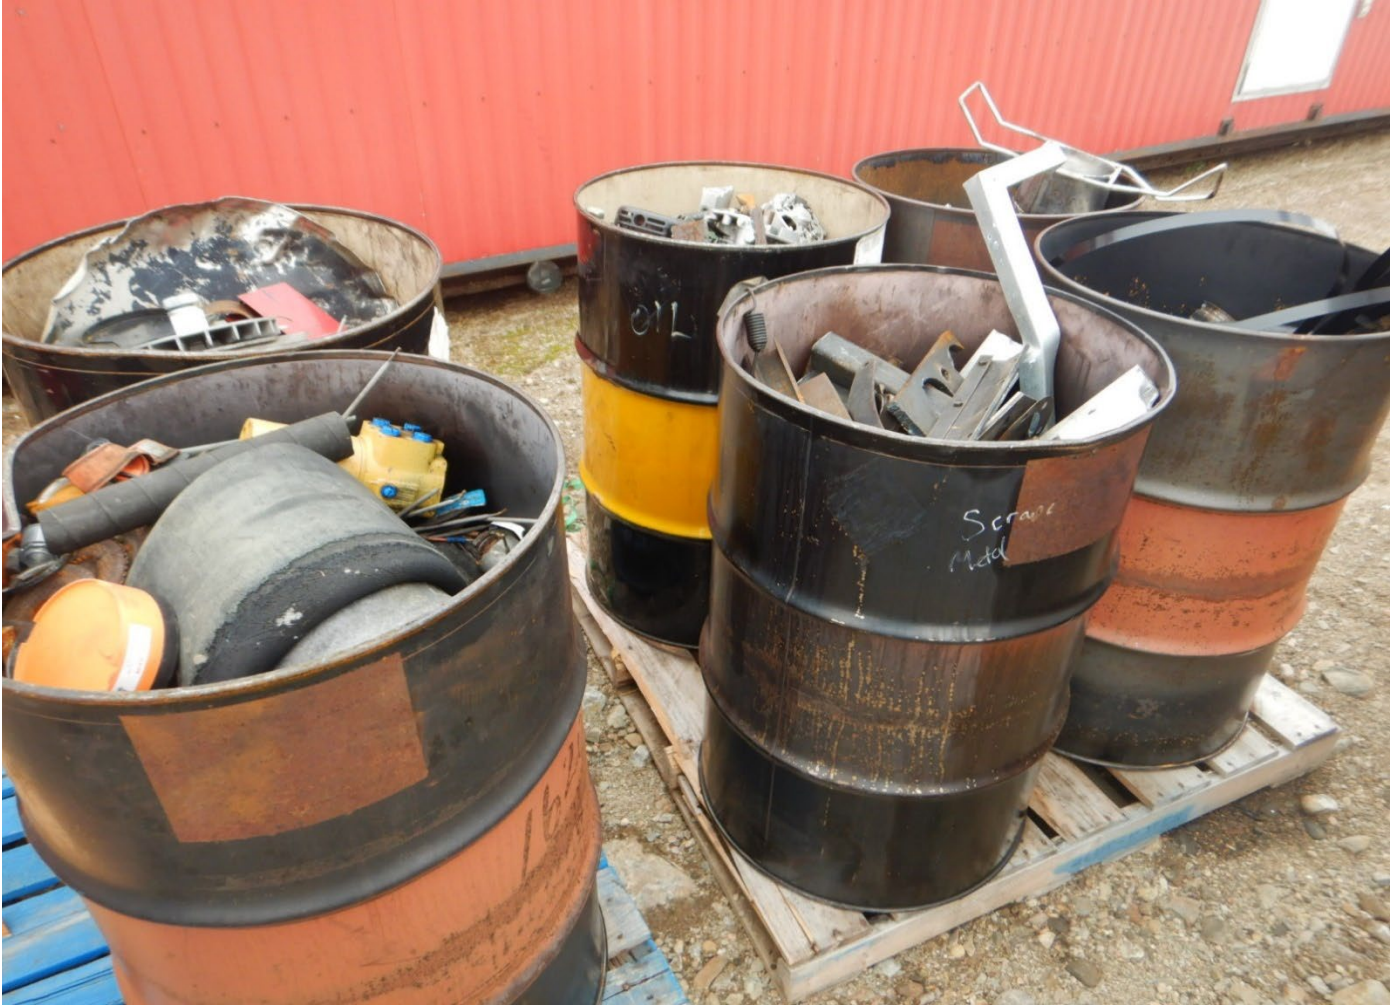
Photo 19 - Margaret Lake Camp – Scrap material in drums requires shipment off site.
