Re: MV2021L2-0004: Annual Geotechnical Inspection Report Submission, Prairie Creek Mine, NT

2024 ANNUAL GEOTECHNICAL INSPECTION PRAIRIE CREEK MINE, NORTHWEST TERRITORIES					
WATER STORAGE POND PLAN					
PROJECT NO. ENG.EARC03183-06		DWN EL	CKD TB	REV IFU	FIGURE 3
OFFICE EDMONTON		DATE NOVEMBER 2024

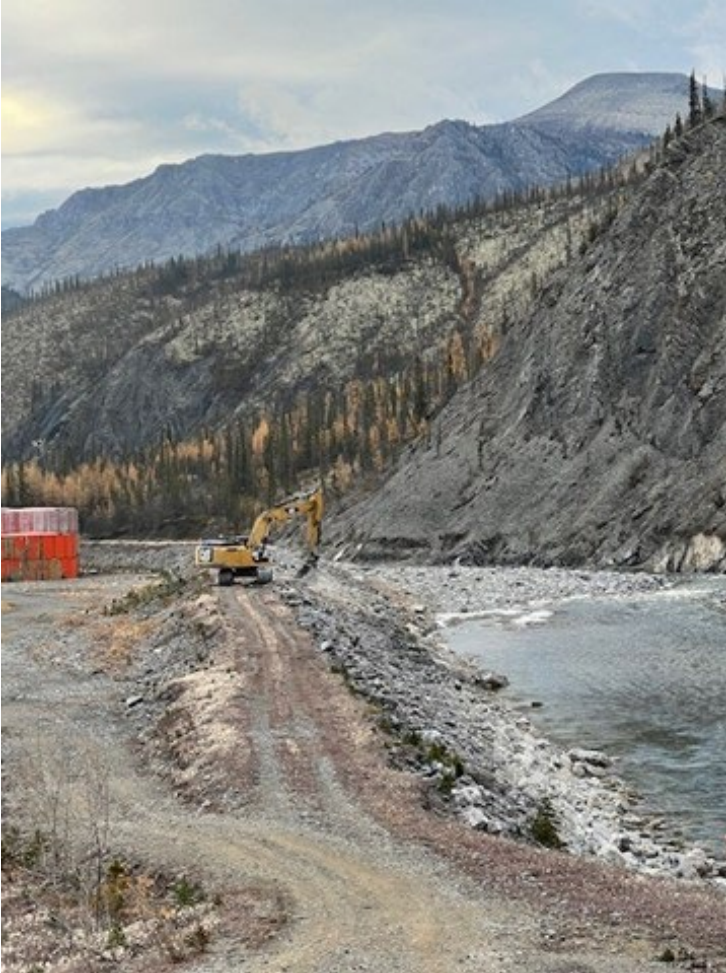
Flood Protection Berm repair and regrade work between Monitoring Sites NHC-02 and NHC-05, 2024.

Photo 1 – South view of the berm.

- Repair and regrade of the creek side slope of the berm between Monitoring Sites NHC-02 and NHC-05 was completed in 2024 in areas where erosion and oversteepening was identified.

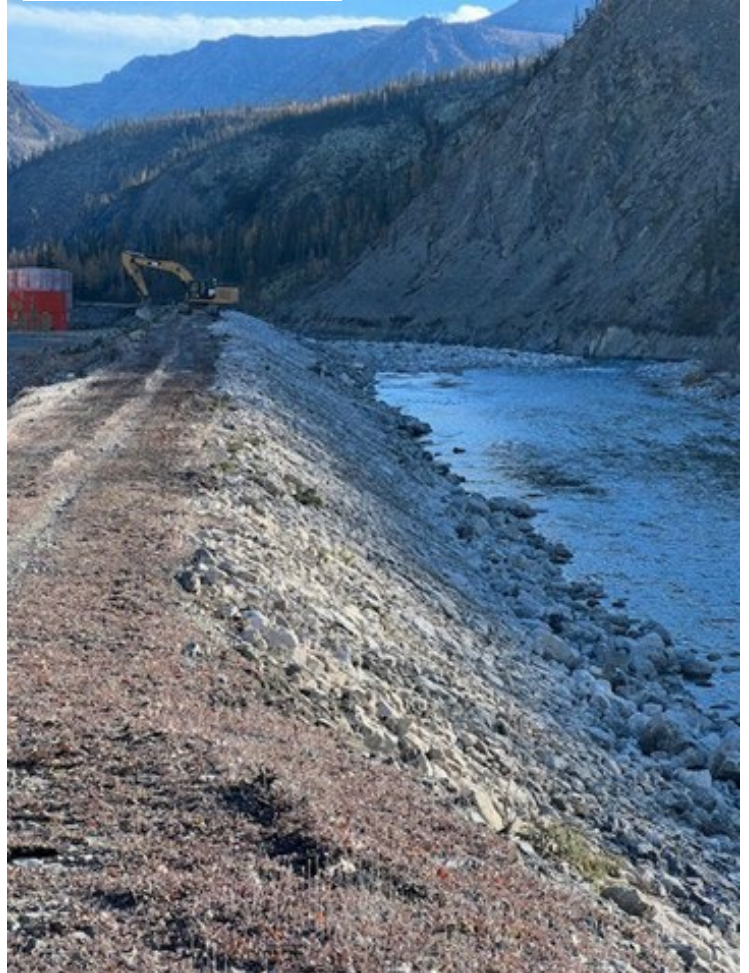
Photo 2 – South view closer up to show berm repair work.

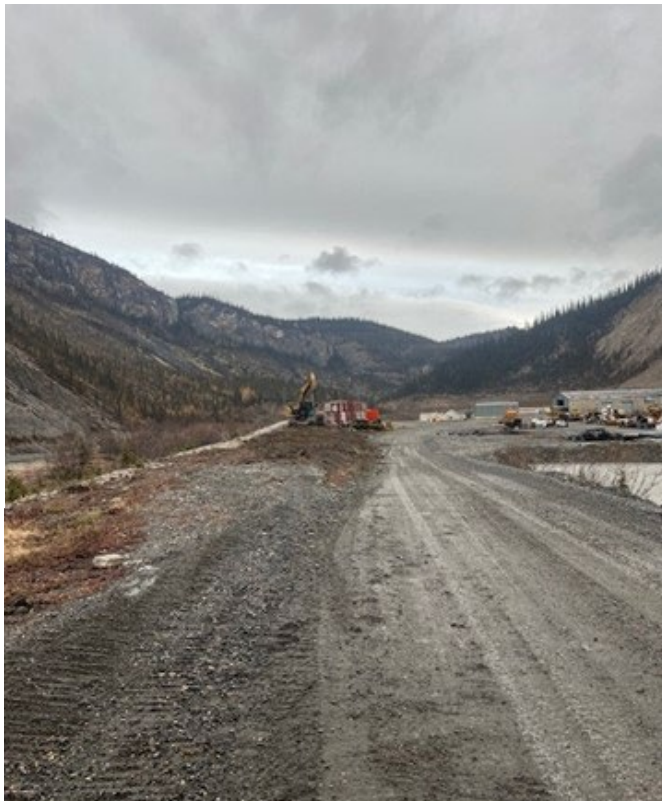
Photo 3 – North view (taken near the catchment pond looking towards the airport location).

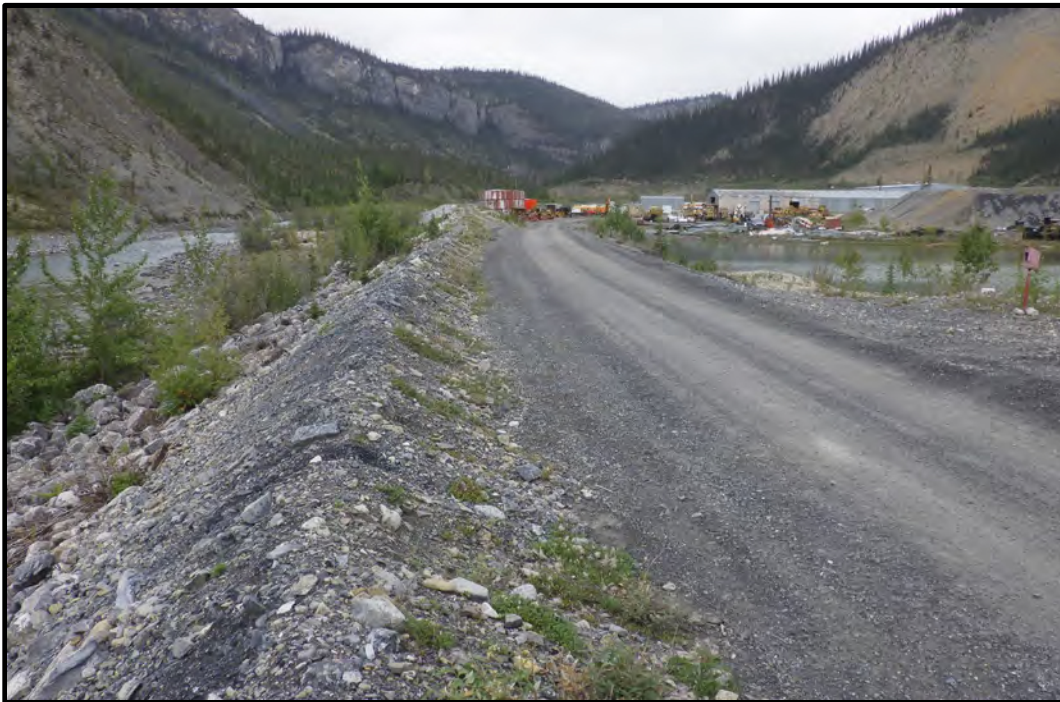
- The creek side slope was armoured with riprap and well-graded in most areas between the berm's deflection point and the Harrison Creek culverts. Ground vegetation and trees up to 8 m high were observed on the slope (Photo A2);

Photo A2: Flood Protection Berm
Crest of creek side slope looking upstream from Harrison Creek culverts.
(photo taken August 20, 2024)

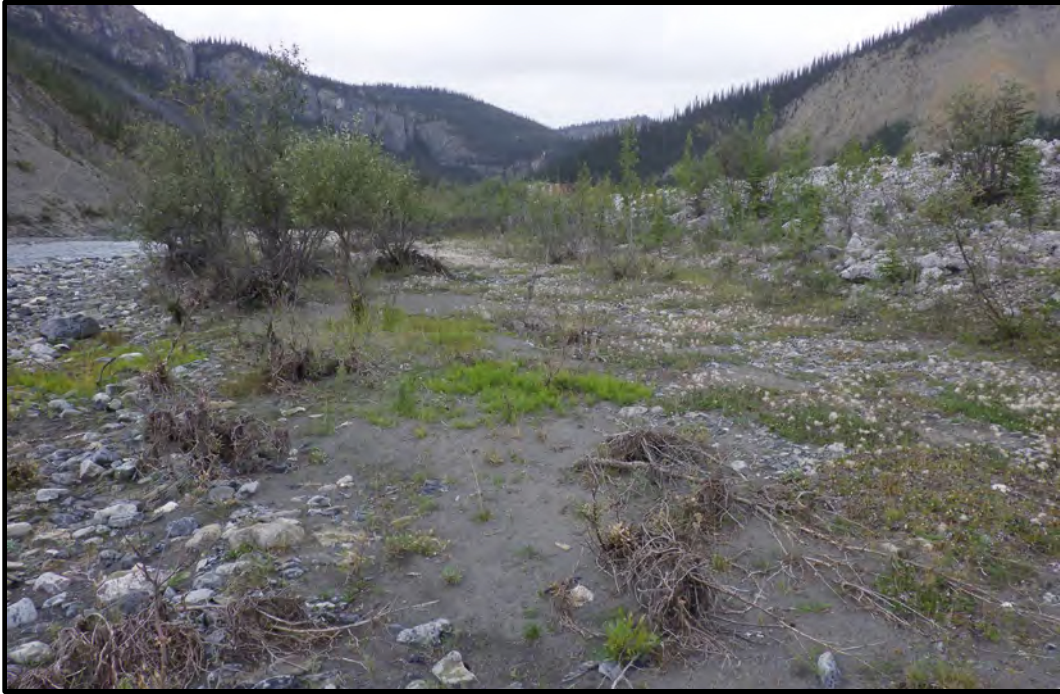
- No new flood debris was observed along the floodplain between the berm's deflection point and the Harrison Creek culverts (Photo A3);
- The mine side slope was lightly vegetated with grasses, lichens, and spruce treelings (Photos A4, A6, A10, and A13);

Photo A3: Flood Protection Berm
Creek side floodplain looking upstream from near Harrison Creek culverts.
(photo taken August 20, 2024)

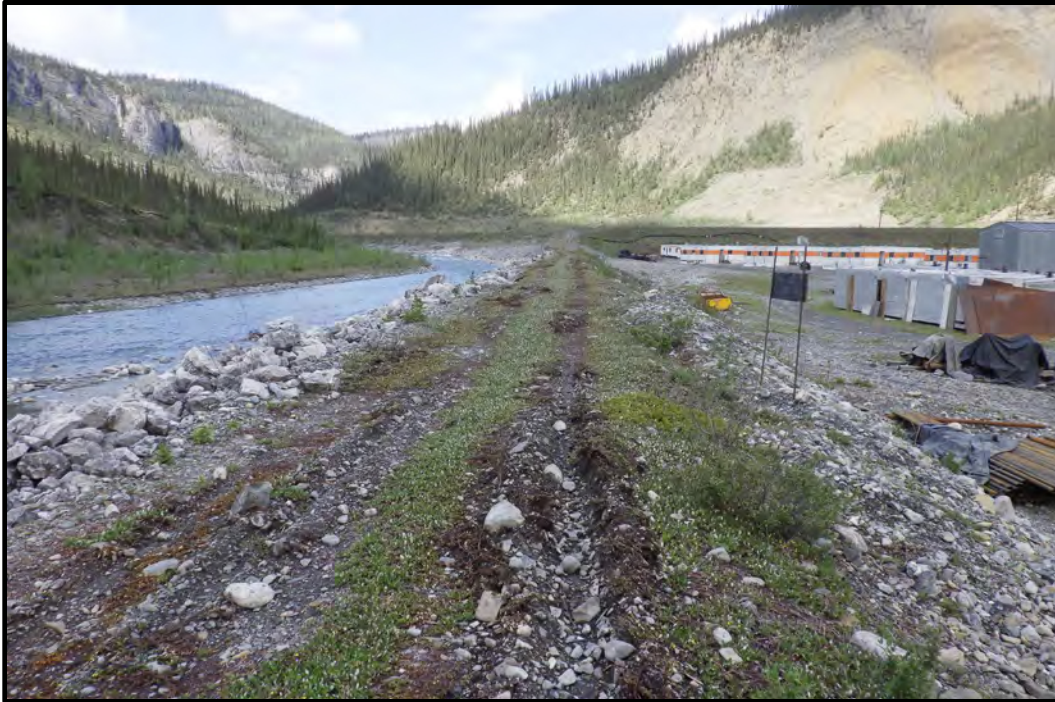
- Minor rutting was observed along the top of the berm which was lightly vegetated with grasses and lichens (Photos A5 and A20);
- Minor riprap settlement was observed along the creek side crest of the berm for approximately 35 m between the berm's deflection point and the Harrison Creek culverts;

Photo A5: Flood Protection Berm
Top of berm looking upstream from near Monitoring Site NHC-01.
(photo taken August 20, 2024)

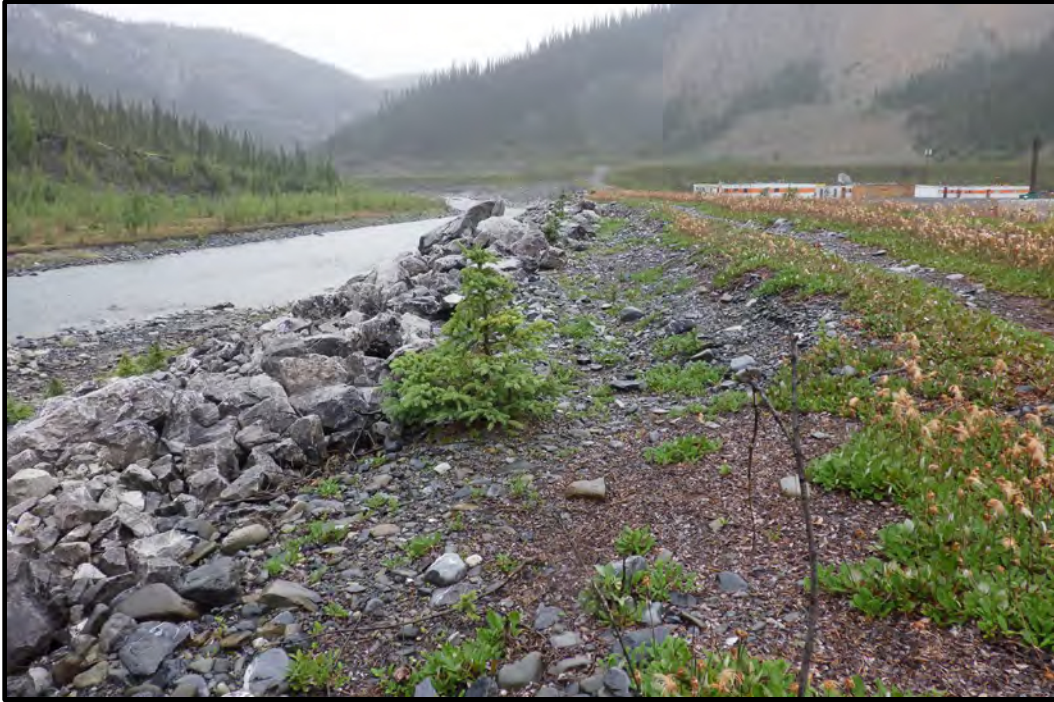
- Riprap settlement was observed along the crest of the creek side slope near Monitoring Site NHC-01 for approximately 23 m. This localized area appeared to be stable and in similar condition to what was previously noted in the 2023 AGI (Photo A7);

Photo A7: Flood Protection Berm, crest of creek side slope looking upstream from near Monitoring Site NHC-01. Riprap settlement shown along crest of berm.
(photo taken August 20, 2024)

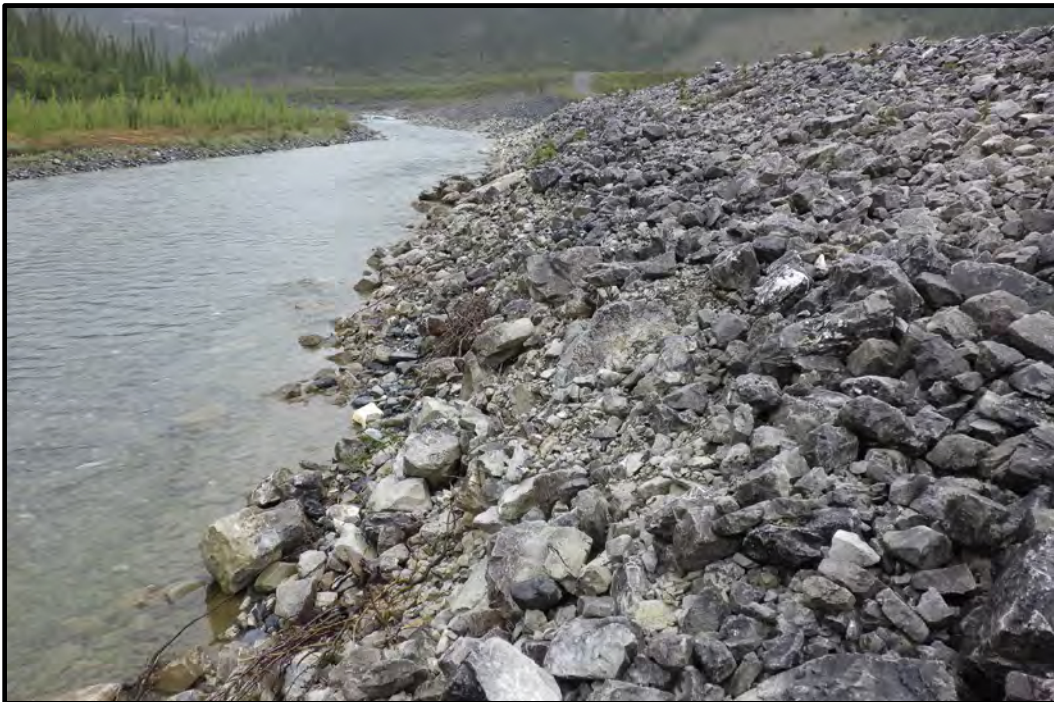
- Animal burrow was observed along the mine side slope near Monitoring Site NHC-02;
- Riprap on the creek side slope was eroded and oversteepened from toe to midslope between Monitoring Sites NHC-03 and NHC-05. No exposed berm core material was observed along eroded segments of the berm (Photos A8, A12, A14, and A17);

Photo A8: Flood Protection Berm, toe of creek side slope looking upstream from near Monitoring Site NHC-03. Riprap erosion and oversteepening shown along slope.
(photo taken August 20, 2024)

- Repair and regrade the creek side slope of the berm between Monitoring Sites NHC-02 and NHC-05, where erosion and oversteepening have occurred, to a slope gradient of 1.5H:1V or flatter. It is recommended that any suitable riprap along the upper bank of the berm be removed and reused after correcting the slope;

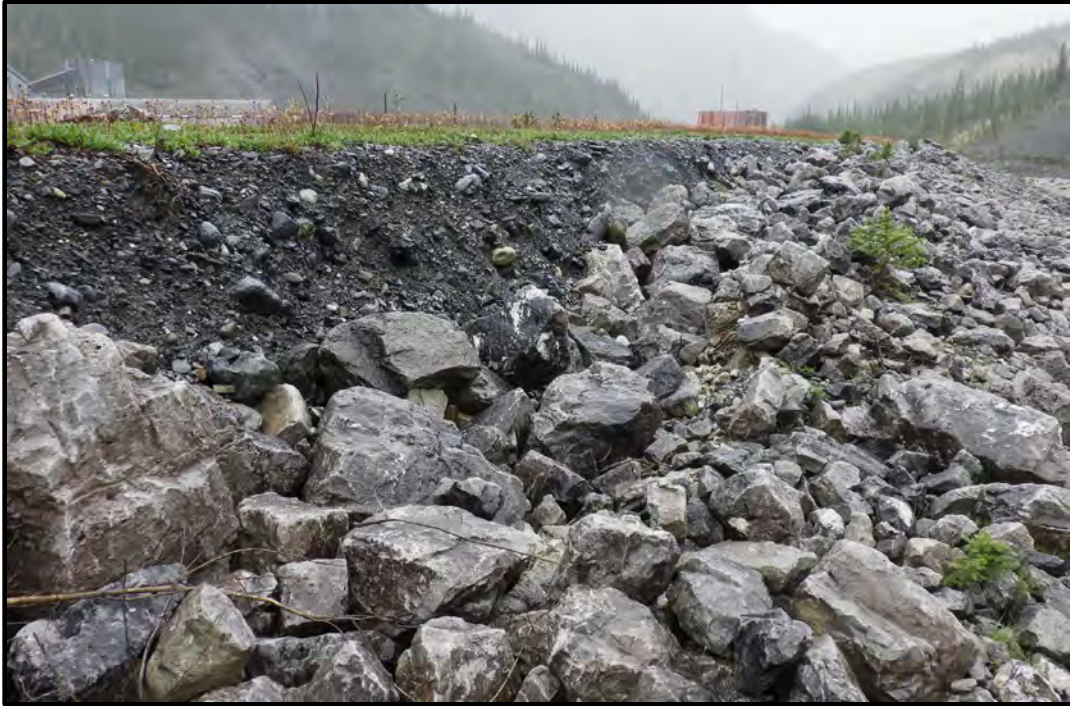
- Riprap settlement was observed along the crest of the creek side slope near Monitoring Site NHC-03 for approximately 25 m. This localized area appeared to be stable and in similar condition to what was previously noted in the 2023 AGI (Photo A9);

Photo A9: Flood Protection Berm, crest of creek side slope looking downstream from near Monitoring Site NHC-03. Riprap settlement shown along crest of berm.
(photo taken August 20, 2024)

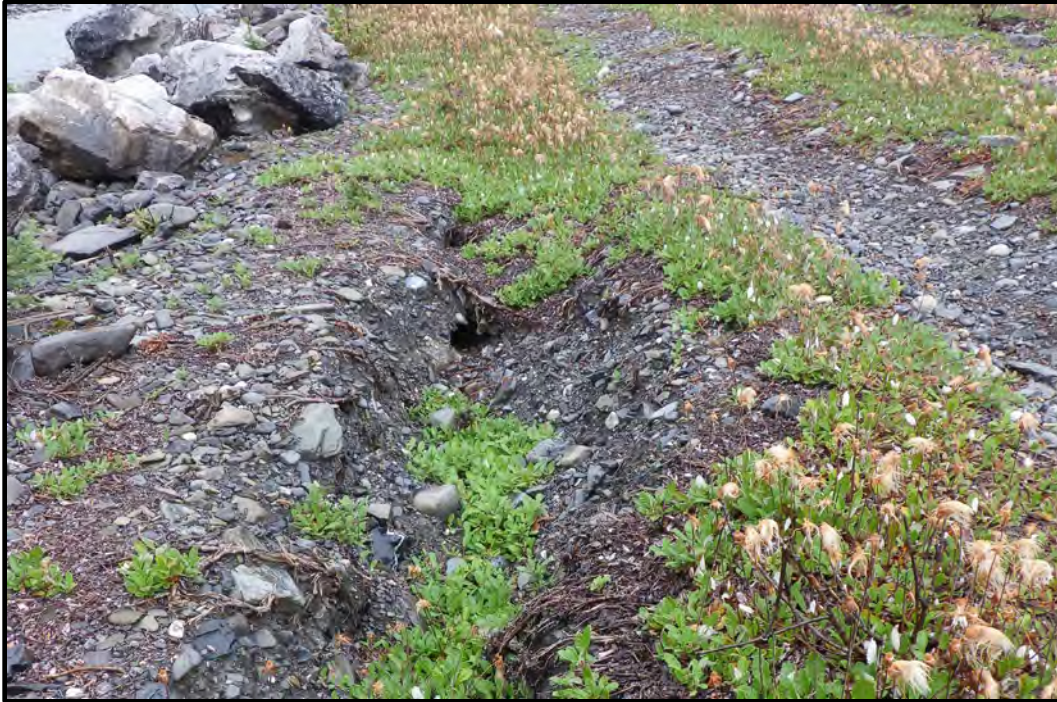
- Old animal burrow and tension crack between Monitoring Sites NHC-03 and NHC-04 appeared to be inactive and were infilled with ground vegetation (Photo A11);

Photo A11: Flood Protection Berm, crest of creek side slope looking upstream from between Monitoring Sites NHC-03 and NHC-04. Old animal burrow and tension crack shown. (photo taken August 20, 2024)

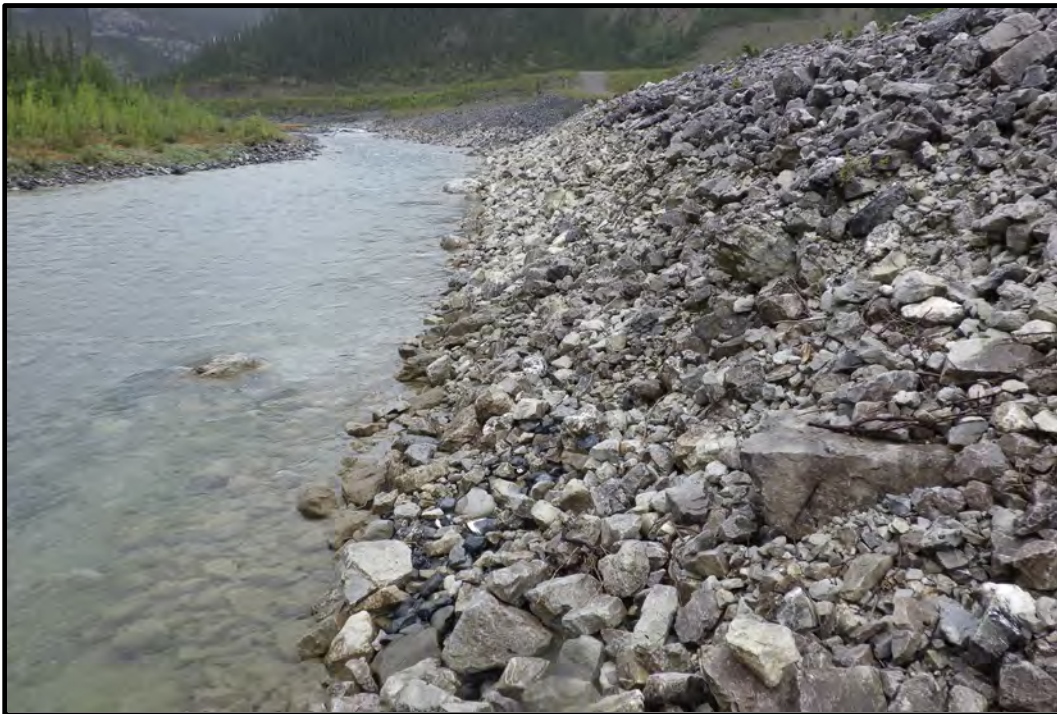
Photo A12: Flood Protection Berm, toe of creek side slope looking upstream from near Monitoring Site NHC-04. Riprap erosion and oversteepening shown along slope. (photo taken August 20, 2024)

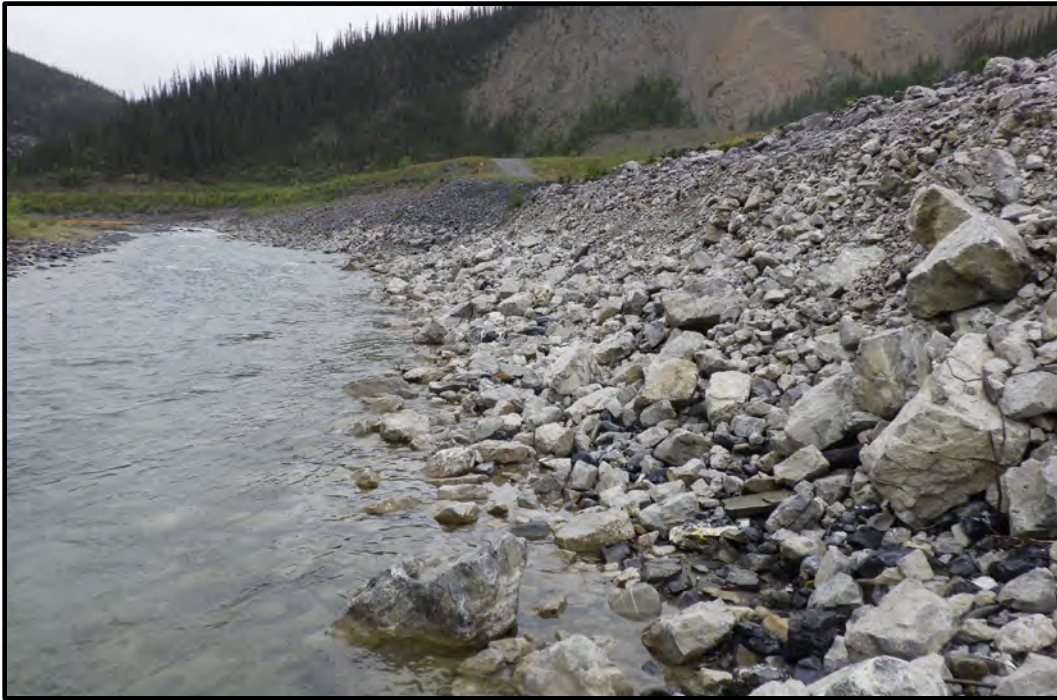
Photo A14: Flood Protection Berm, toe of creek side slope looking upstream from between
Monitoring Sites NHC-04 and NHC-05. Riprap erosion and oversteepening shown.
(photo taken August 20, 2024)

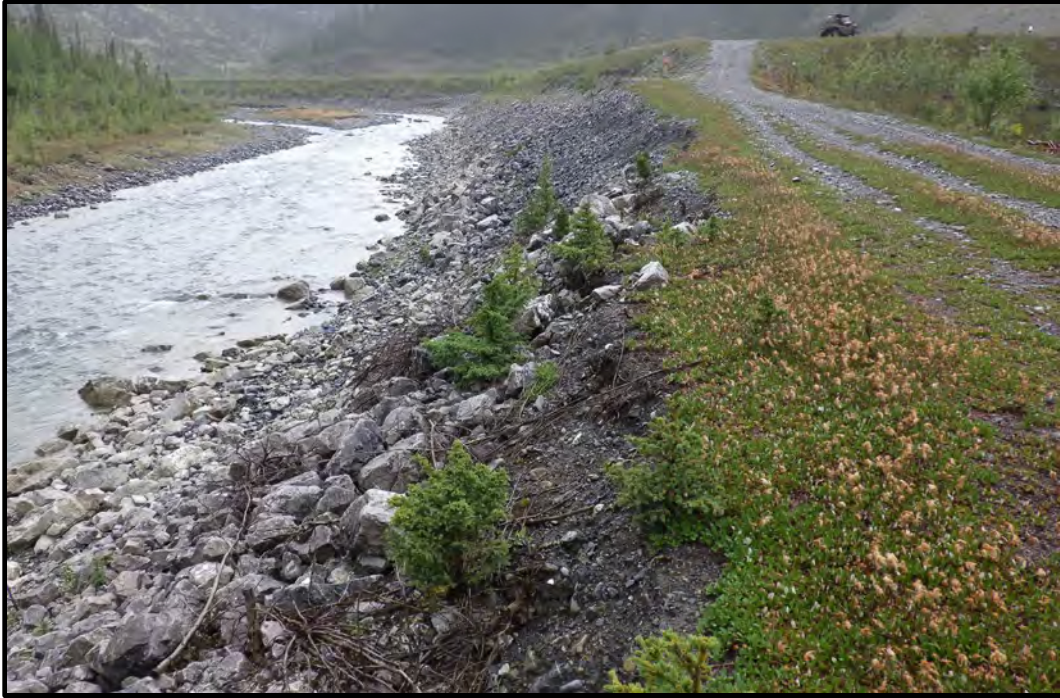
- Riprap settlement was observed along the crest of the creek side slope near Monitoring Site NHC-05 for approximately 12 m. This localized area appeared to be stable and in similar condition to what was previously noted in the 2023 AGI (Photo A15); and

Photo A15: Flood Protection Berm, crest of creek side slope looking upstream from near Monitoring Site NHC-05. Riprap settlement shown along crest of berm.
(photo taken August 20, 2024)

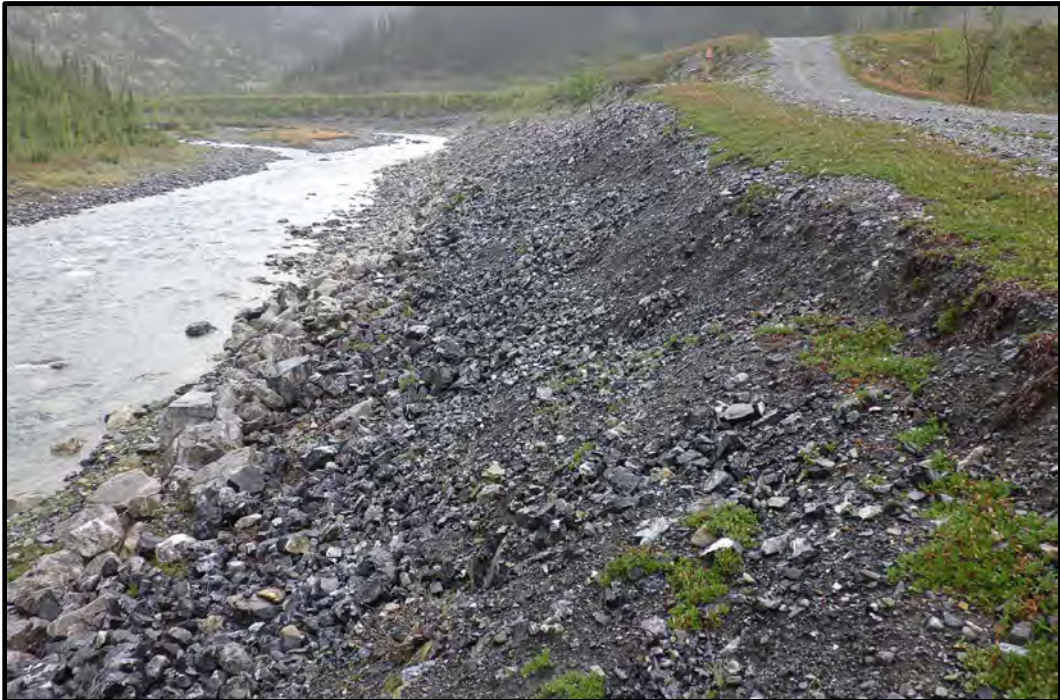
- Riprap on the creek side slope was sparse and low along a 38 m-long section of the slope between Monitoring Site NHC-05 and the WSP. This area was previously identified in 2009 as a location where riprap repairs were undertaken (NHC 2009, Repair Site “C”). At the time of inspection, suitable armouring only covered the lower quarter (i.e., 1/4th) of the creek side slope in this section. The remainder of the slope was observed to have exposed berm core material with limited riprap coverage (Photos A16, A18, and A19).

Photo A16: Flood Protection Berm, crest of creek side slope looking upstream from location of 2009 riprap repairs (NHC 2009, Repair Site "C").
(photo taken August 20, 2024)

- Place additional riprap on the creek side slope of the berm, where armouring is sparse and low, for the 38 m long section identified between Monitoring Site NHC-05 and the WSP (i.e., NHC 2009, Repair Site “C”). Riprap is recommended to meet the elevation and gradation requirements that are outlined in the *Flood Protection Berm and Water Storage Pond Southern Dyke Evaluation Report* (Tetra Tech 2023a).

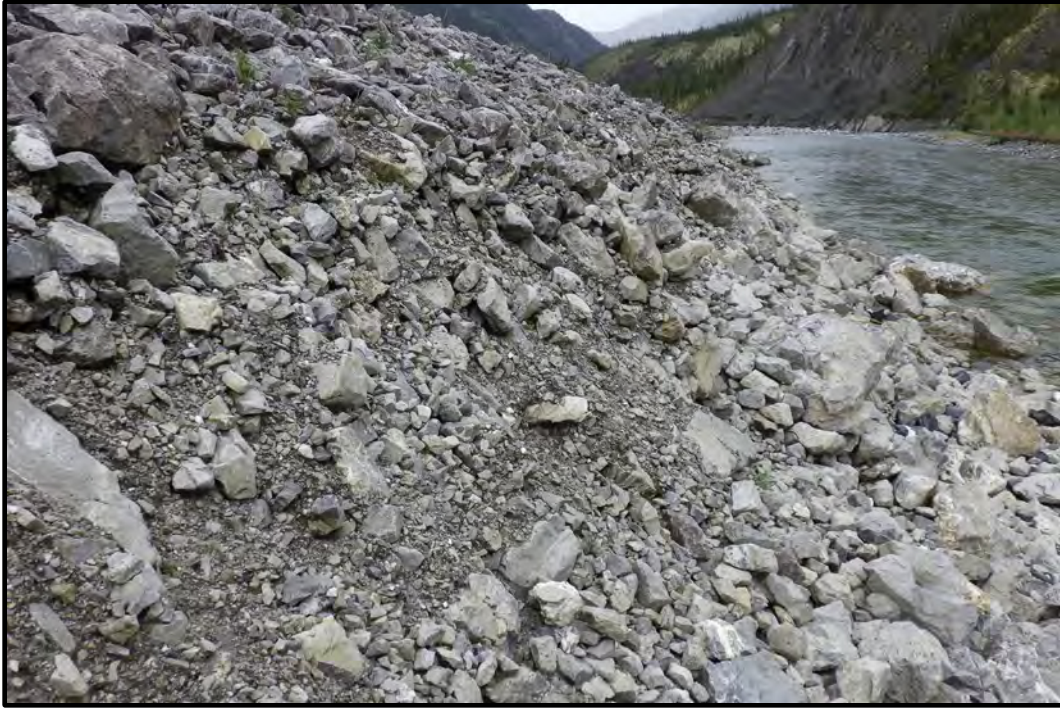
Photo A17: Flood Protection Berm, middle of creek side slope looking downstream near Monitoring Site NHC-05. Riprap erosion and oversteepening shown.
(photo taken August 20, 2024)

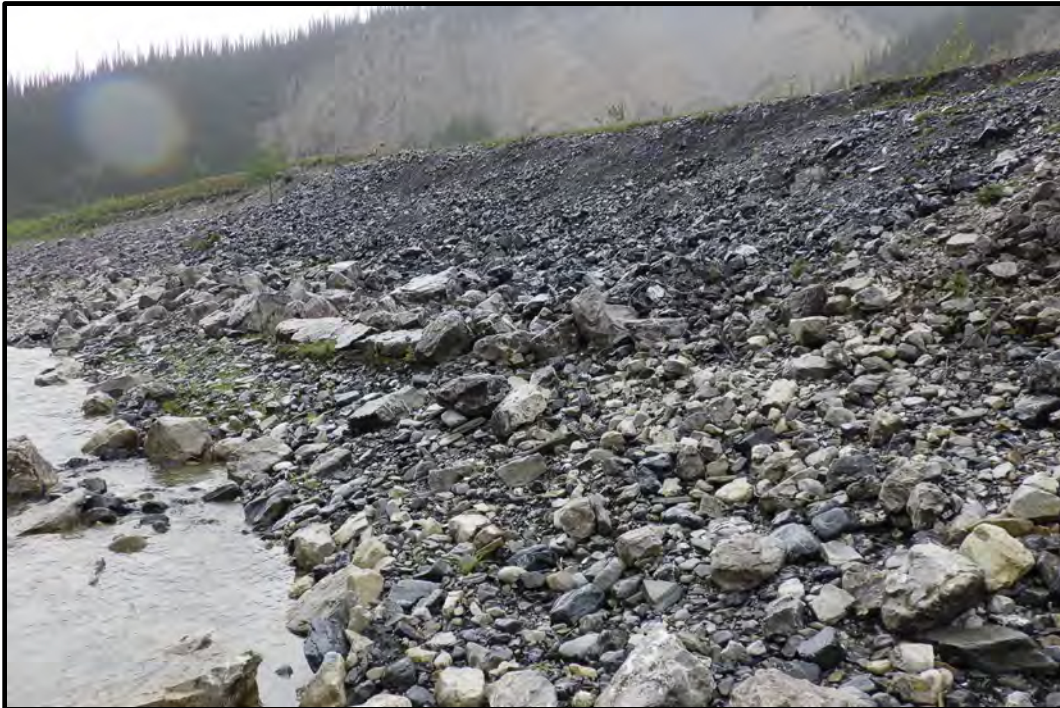
Photo A18: Flood Protection Berm, toe of creek side slope looking upslope (camp to the right) from location of 2009 riprap repairs (NHC 2009, Repair Site "C").
(photo taken August 20, 2024)

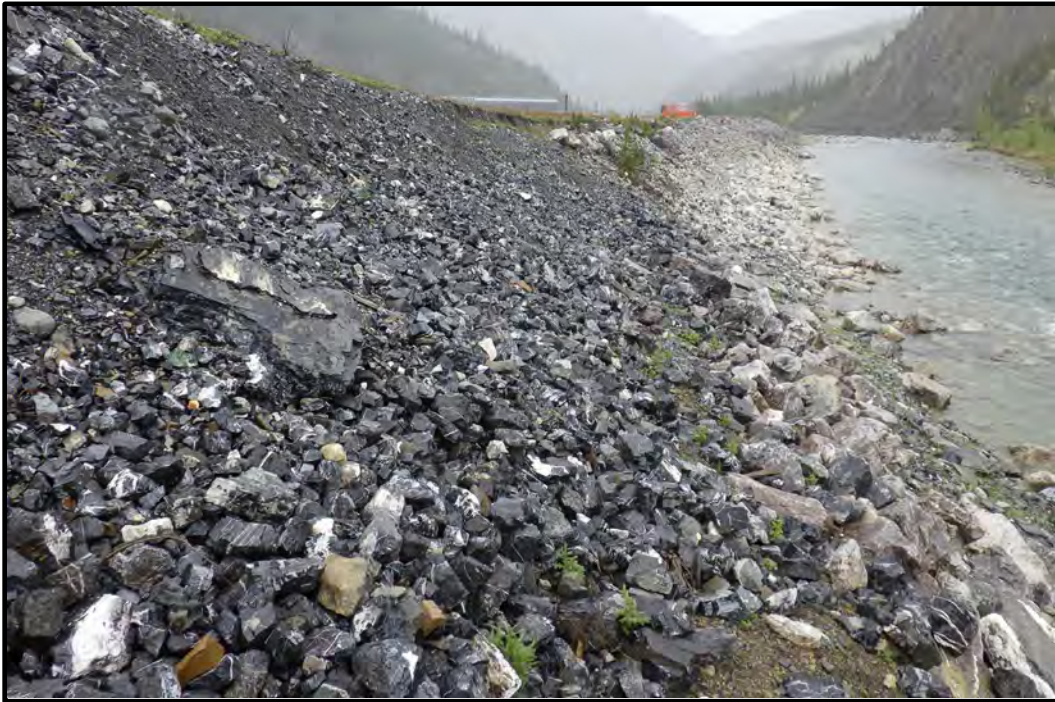
Photo A19: Flood Protection Berm, toe of creek side slope looking downstream from location of 2009 riprap repairs (NHC 2009, Repair Site “C”).
(photo taken August 20, 2024)

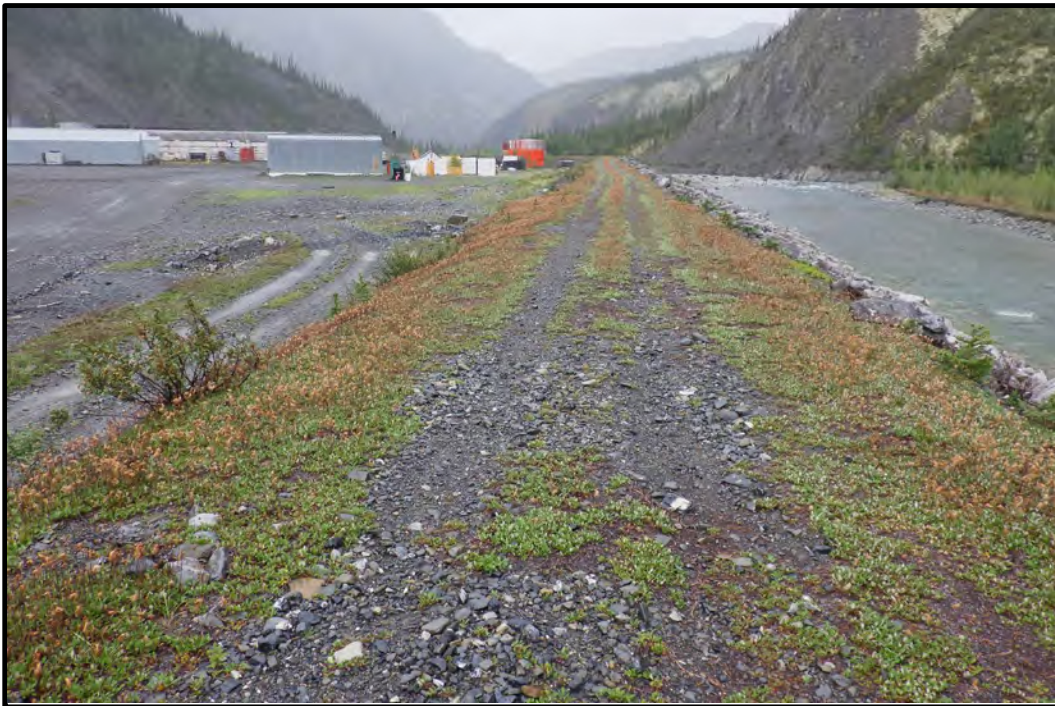
Photo A20: Flood Protection Berm
Top of berm looking downstream from connection with Water Storage Pond.
(photo taken August 20, 2024)
