File Number	MV2021Q0021
Type of Operation	QUARRY SITE - Existing
Location	HR33, Km 44.5, NWT Highway No. 5

ENVIRONMENTAL INSPECTION REPORT

Permittee:	Rowe's Construction	Permit Expiry Date:	January 21, 2026
Land Use Permit No.	MV2021Q0021	Previous Inspection:	July 20, 2023
Quarrying Permit No.	2023QP0004	Inspection Date:	October 19, 2023
Contractor:		Subcontractor:	
Location(s) Inspected:	HR33, Km 44.5, NWT Highway No. 5		
Current Stage of Operation:	Permittee is crushing gravel under the authority of quarry permit #2023QP0004.		
Program Modifications Approved:

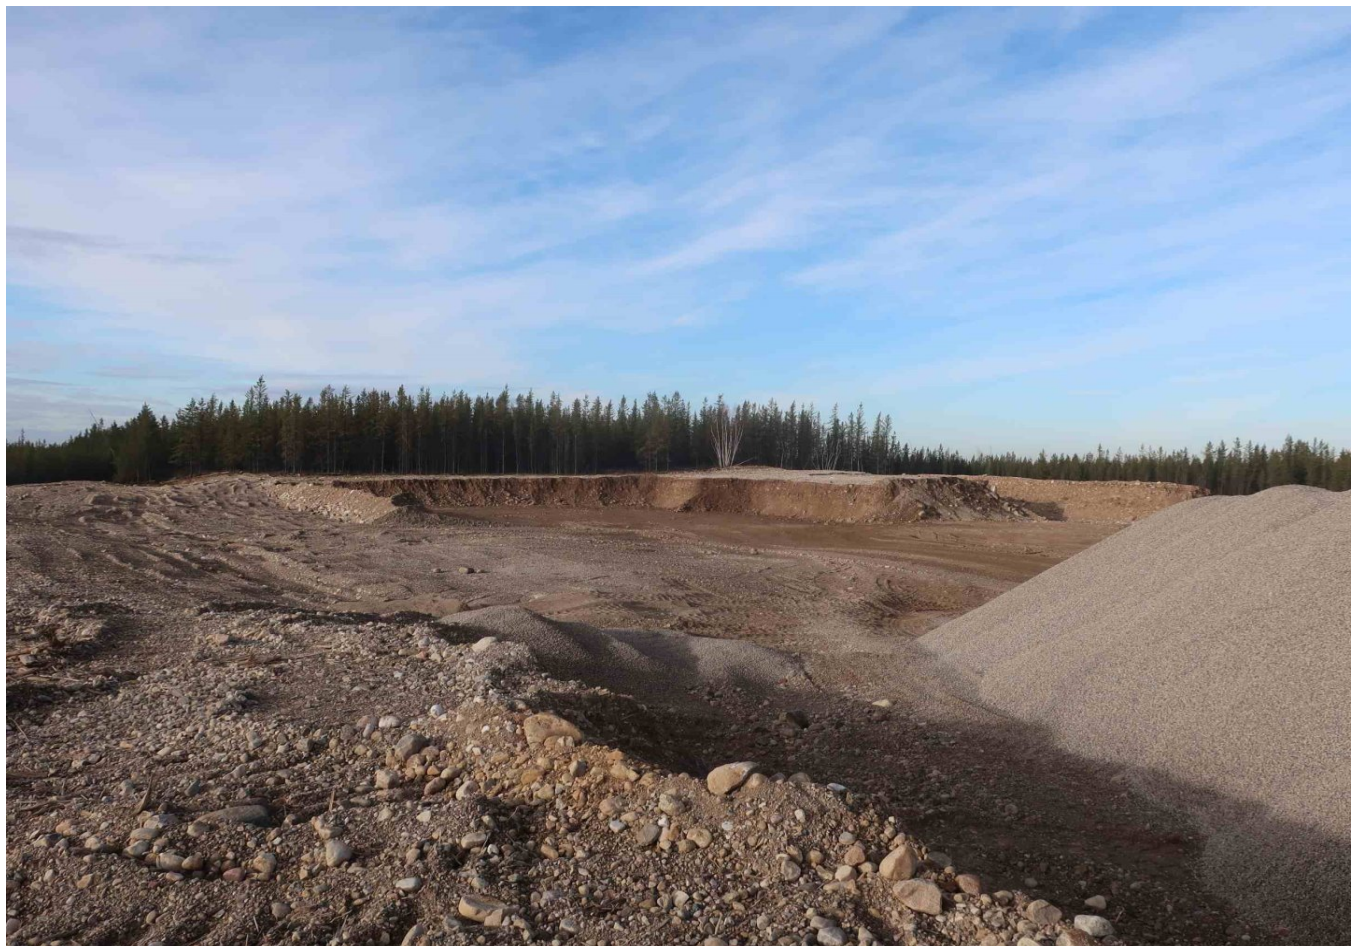
There has been a large pit expansion to the south and west side of the deposit. This area has been quarried and a large volume of granular material has been removed this season.

Figure 1
Southwest expansion of the pit.

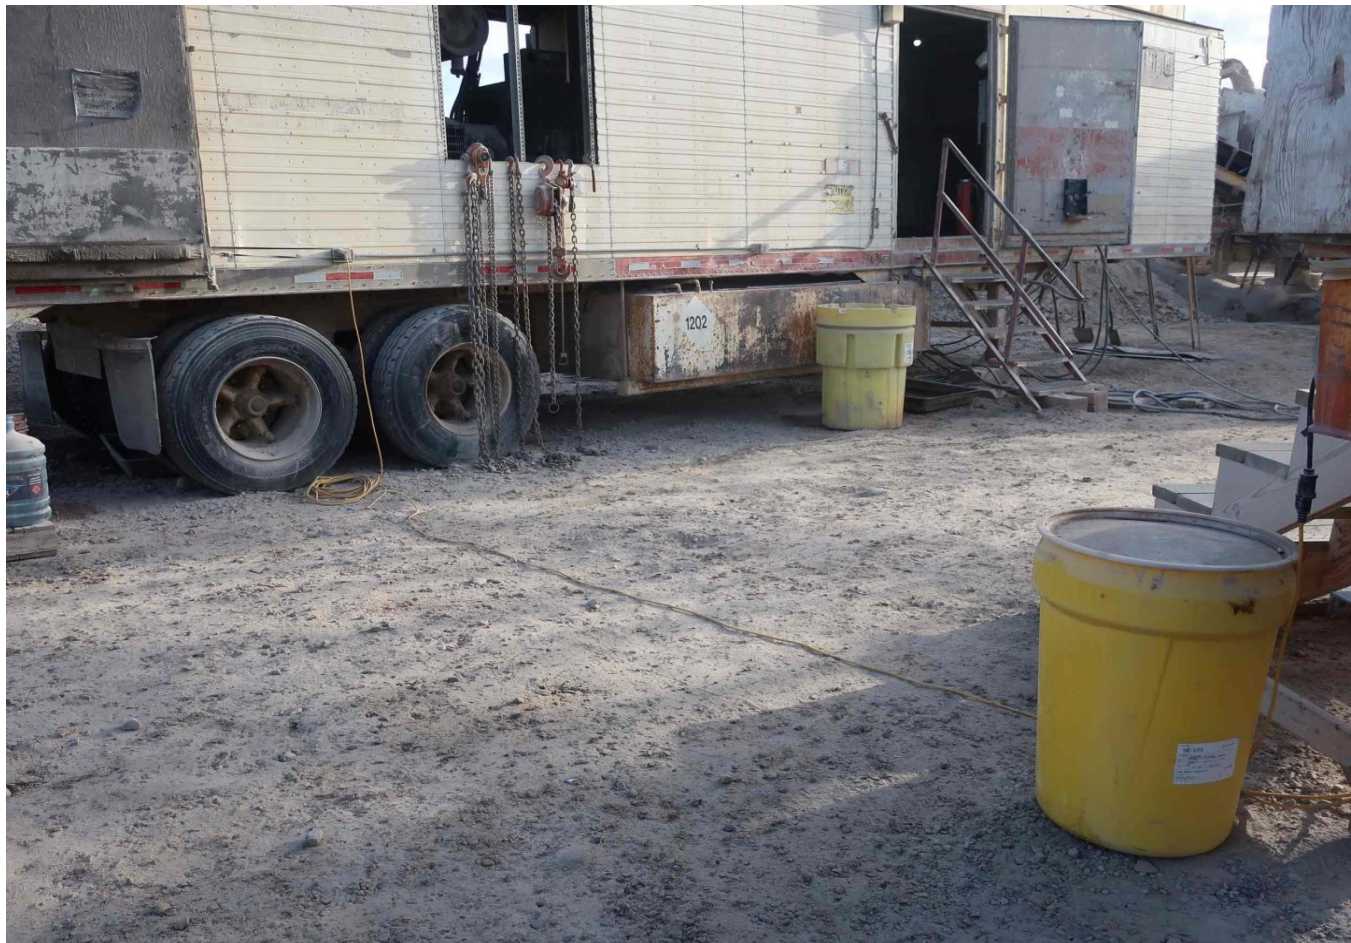
The Inspectors were pleased to see the Permittee is using drip trays under parked equipment on the site and has spill kits available for use.

Figure 2
Spill kits located at the crushing operation.

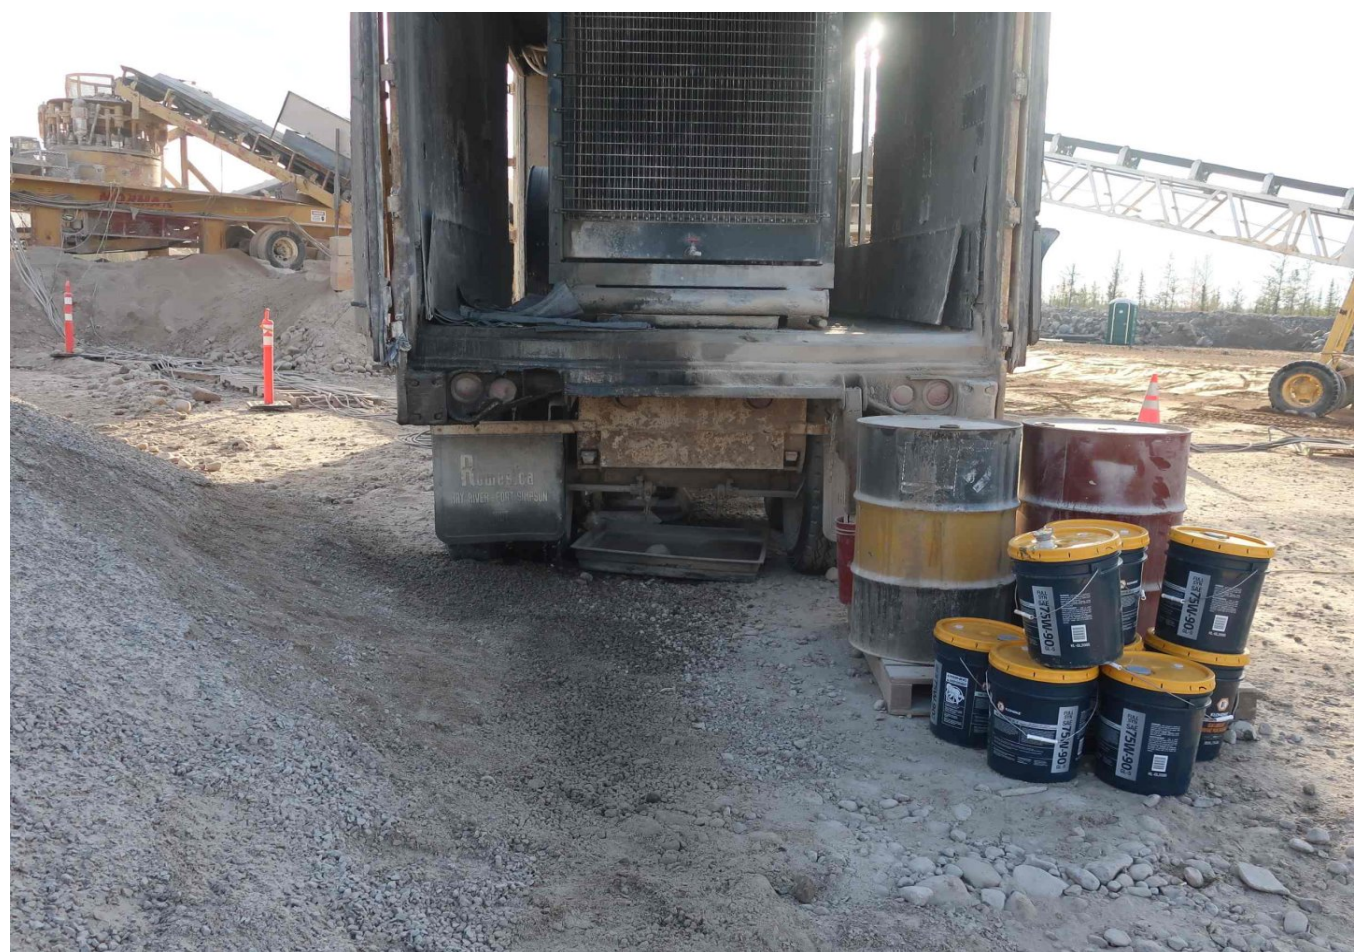
Glycol was observed to be leaking from the crusher generator out the back of the trailer and onto the ground. Spill pads were placed on the glycol in the trailer however were not sufficient in preventing the product from reaching the ground. The leak must be repaired and the contaminated soil be cleaned up as per **Condition 27 - CLEAN UP SPILLS**. All other spills under the generator trailer must be cleaned up as well.

Figure 3
Generator trailer with glycol leaking onto the ground. Glycol impacted soils must be cleaned up.

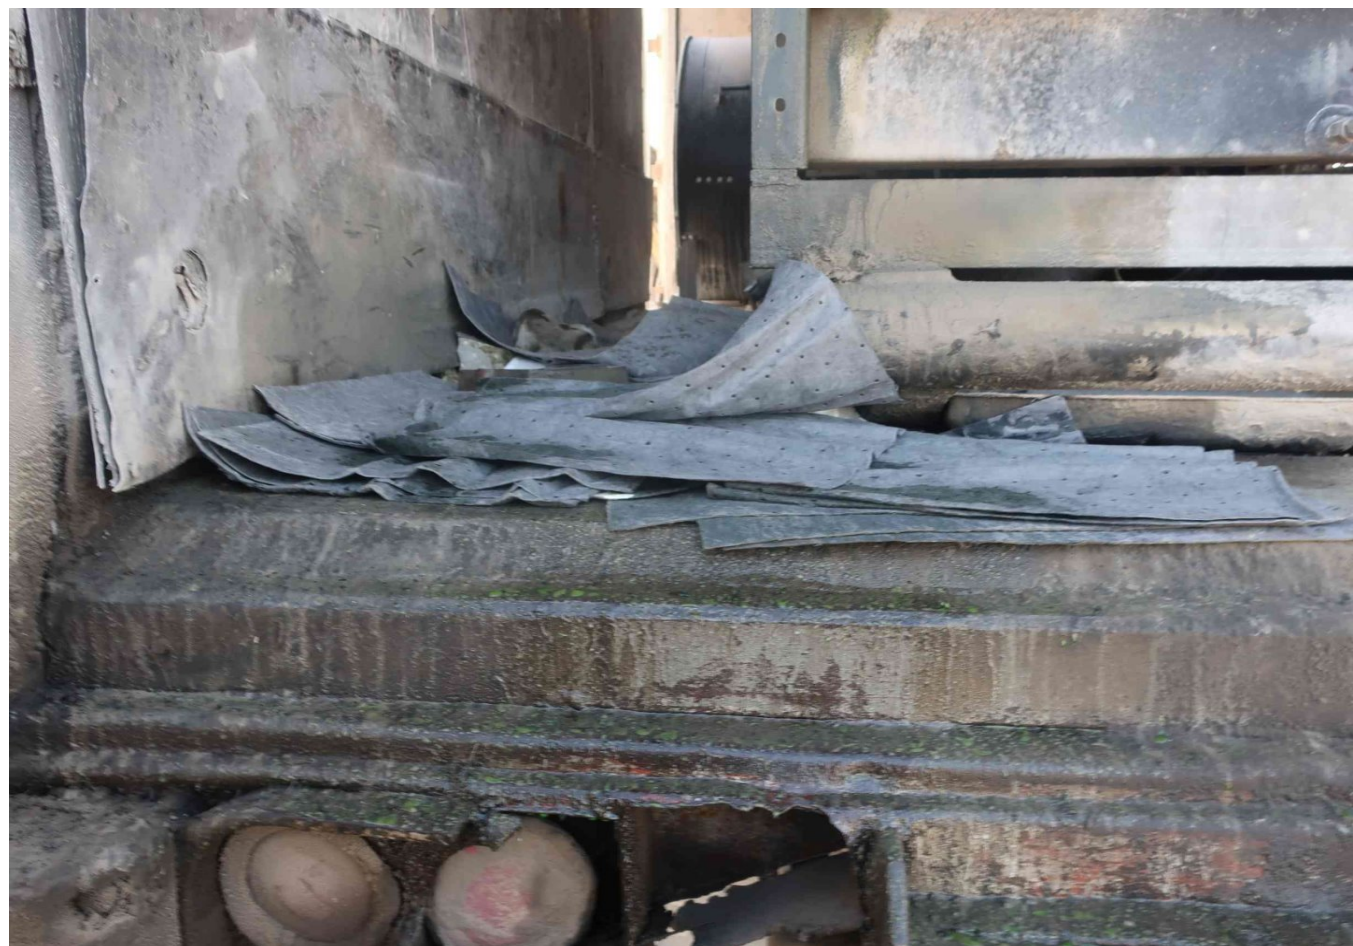
Figure 4
Glycol leaking out the back of the crusher generator trailer.

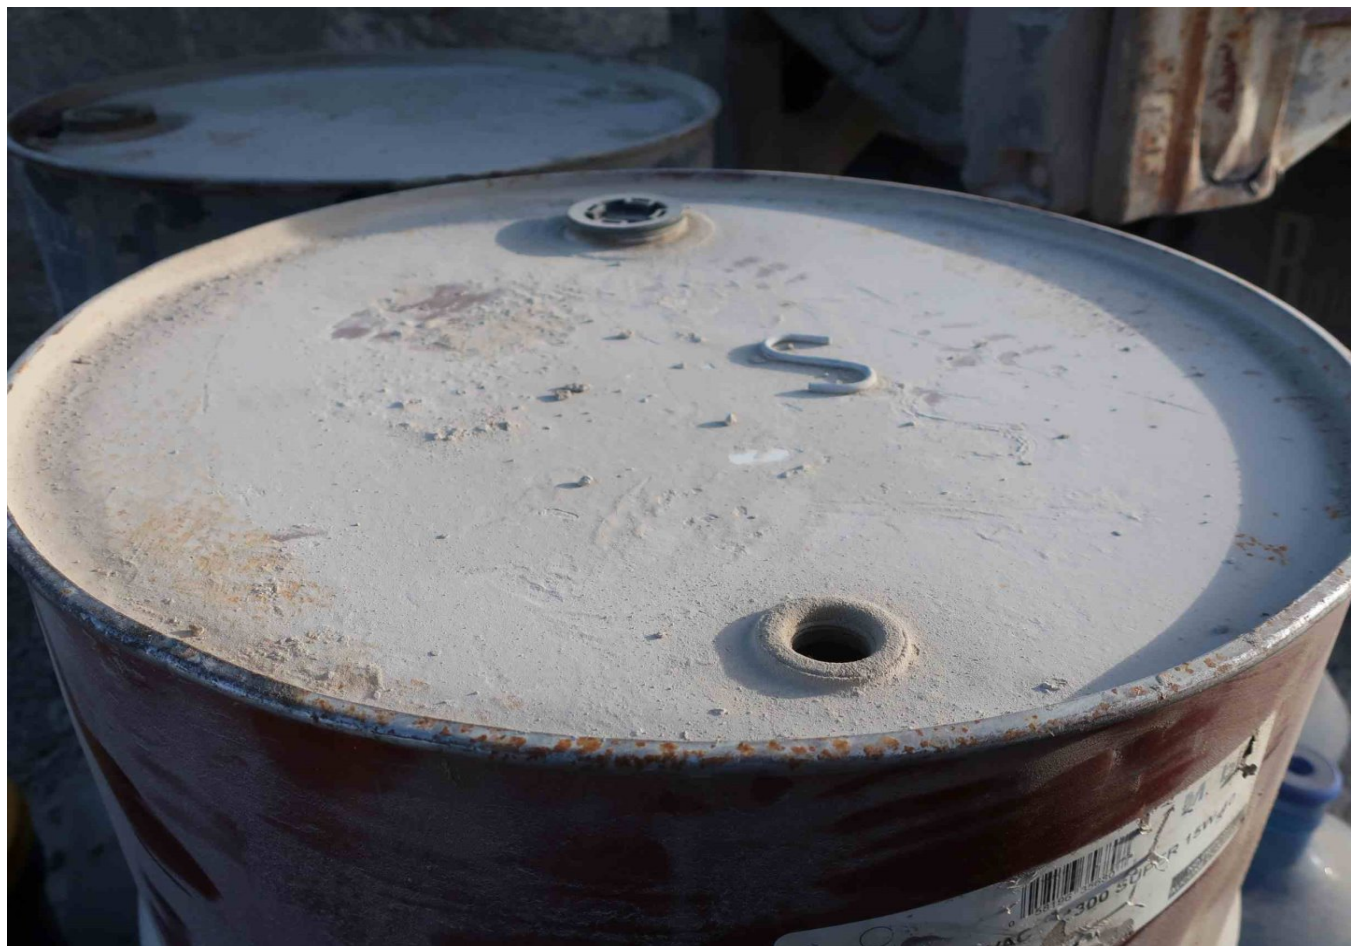
Figure 5

A 205L drum of 15W-40 Oil was observed near the generator trailer with no bung on it. This is not proper storage of hydrocarbons (**Condition 24 - SPILL CONTINGENCY PLAN**). A proper bung must be put in place immediately or remove the drum from territorial lands.

Drum of 15W-40 Oil with missing bung is located next to the generator trailer.

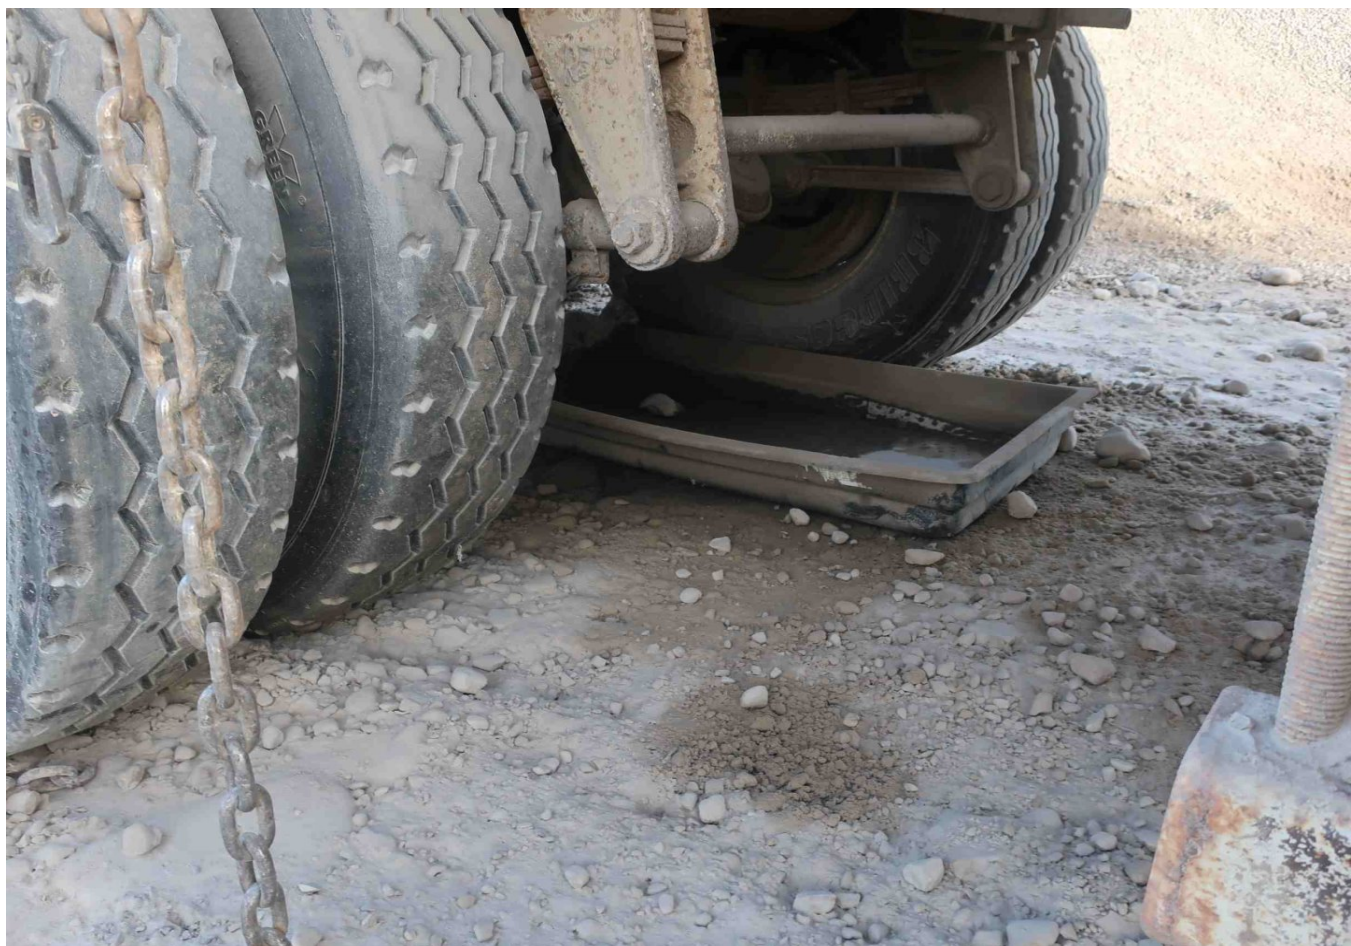
Figure 6

Hydrocarbon and/or glycol impacted soils under the engine trailer must be cleaned up.

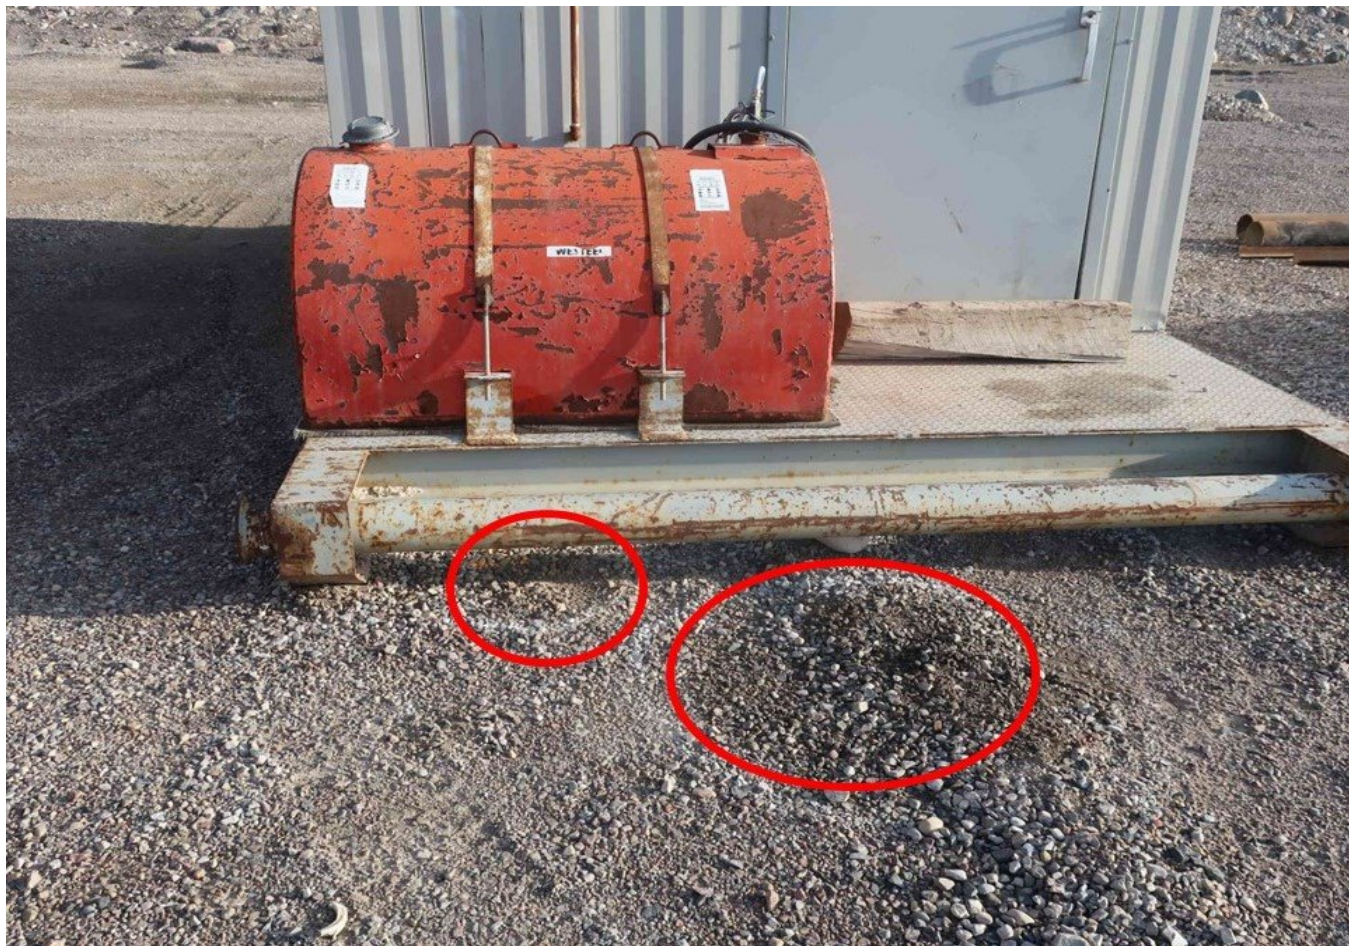
The single wall fuel tank attached to the generator shack stored on the east side of the pit must be replaced with a double walled tank before the generator shack is put into service again. There is also a spill in front of the fuel tank that requires cleanup. This spill was noted in the July 2023 inspection.

Figure 7
Spills (circled in red) by generator shack stored on north side of pit have not been cleaned up. Single wall fuel tank on the building skid.

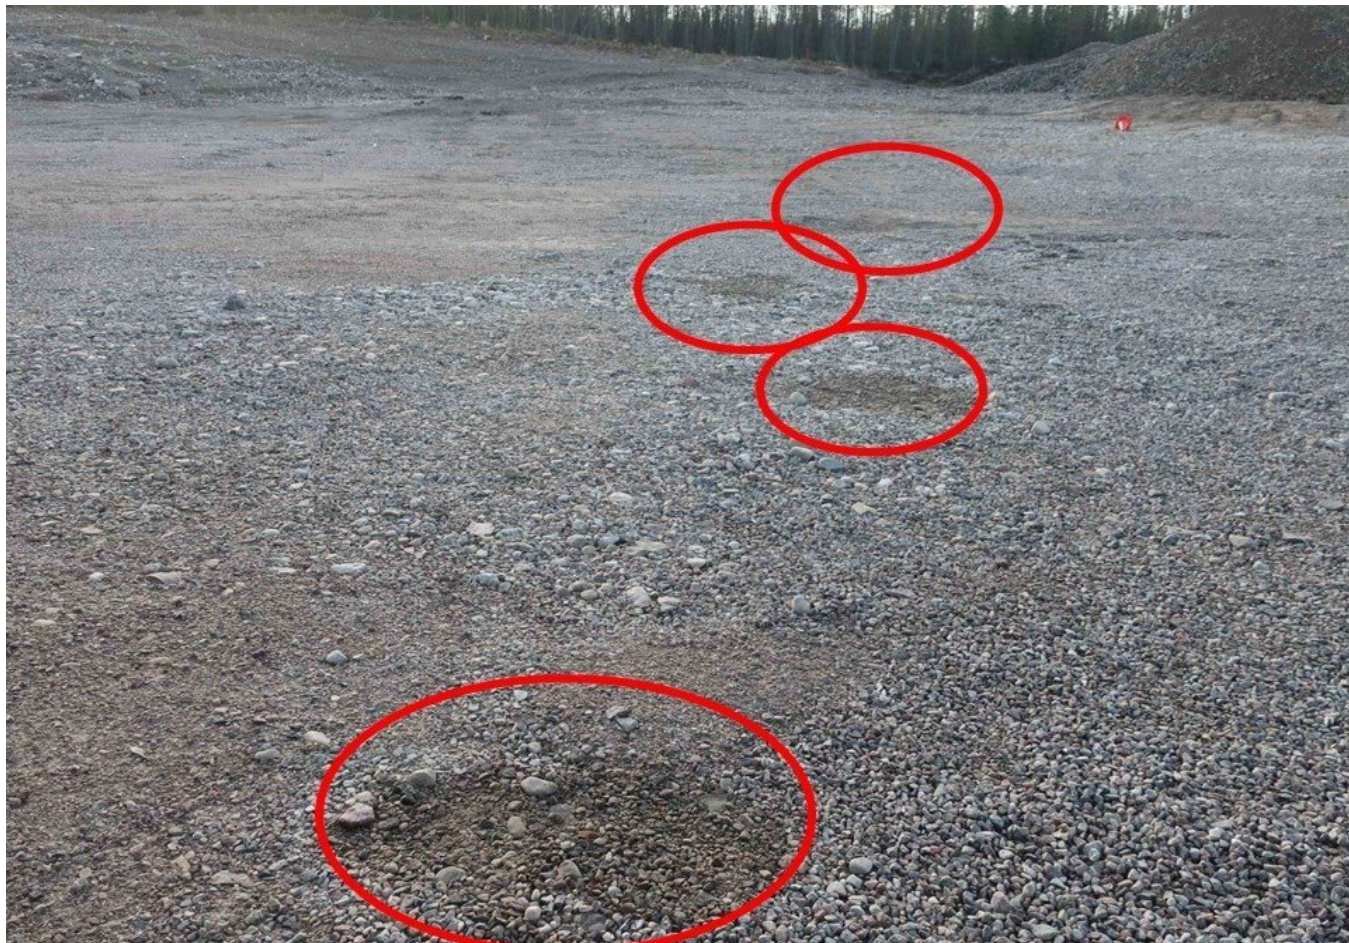
The Permittee has made some effort to cleanup spills on the south and east sides of the pit as documented in the previous inspection report in July, however more cleanup of spills is required. The Inspector does note that the town of Hay River was evacuated on August 13th due to Wildfire SS052 for 5 weeks. This evacuation may have impacted the Permittee's ability to complete the cleanup of the spills previously noted. As the site is now snow covered, any remaining cleanup will have to occur in the spring under snow free conditions.

Figure 8
Spills (circled in red) on the east side of the pit previously noted that require cleanup.

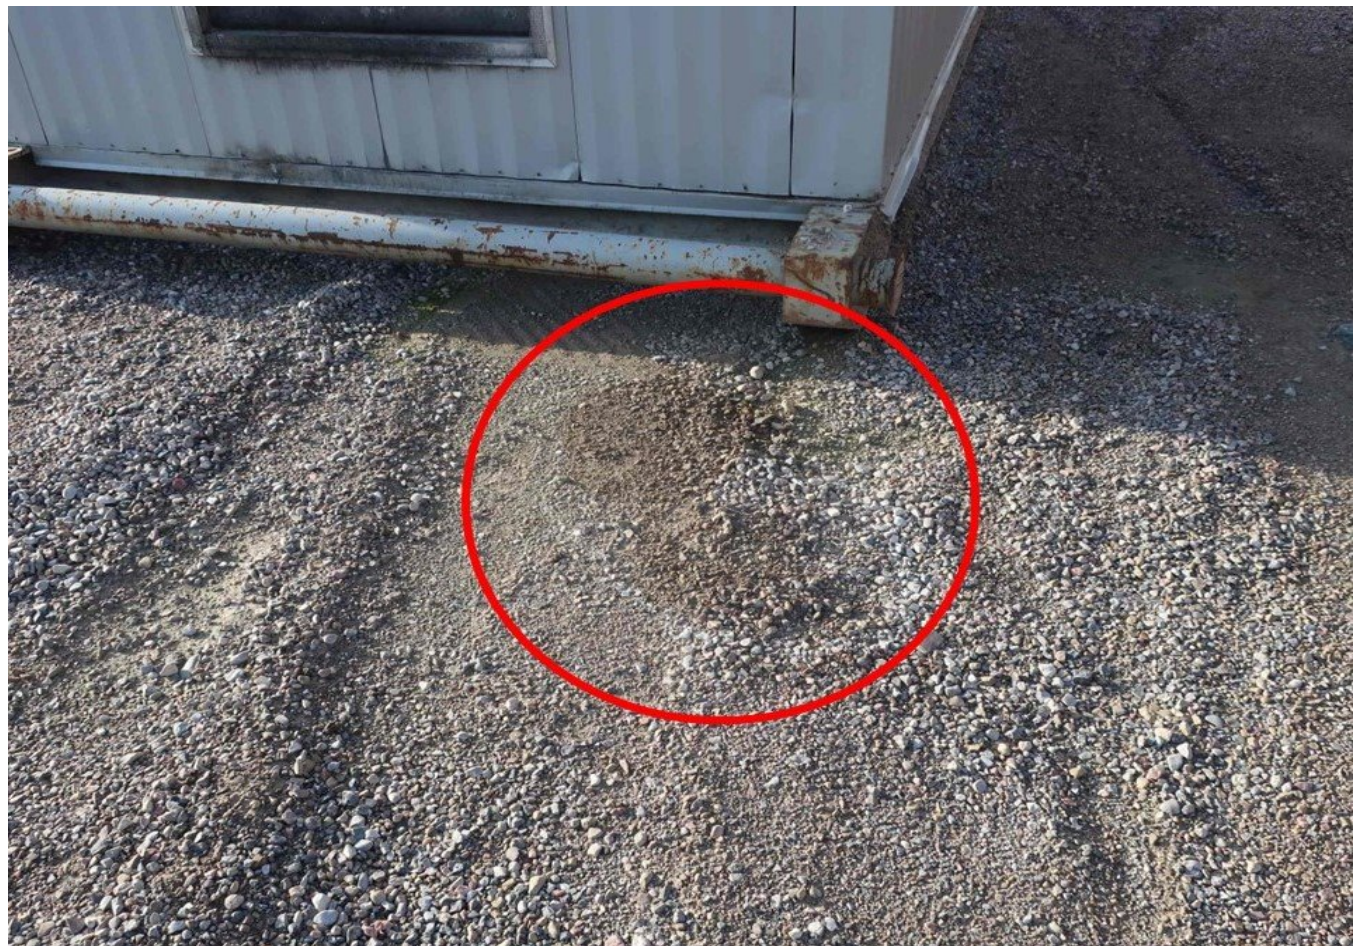
Figure 9
Spill (circled in red) requires cleanup.

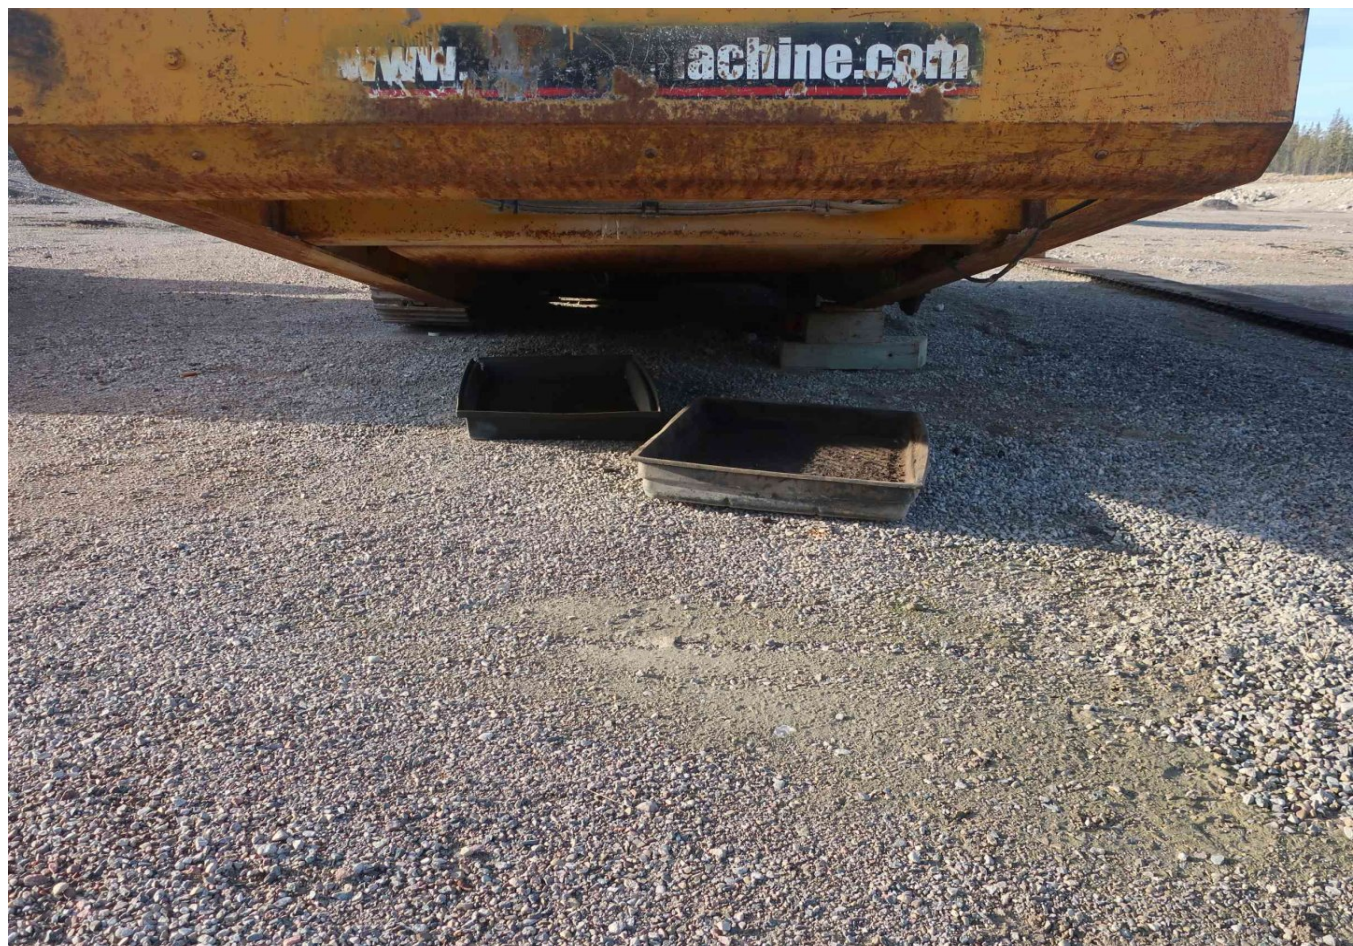
Figure 10
Drip tray in place under crusher stored on the north side of the pit.

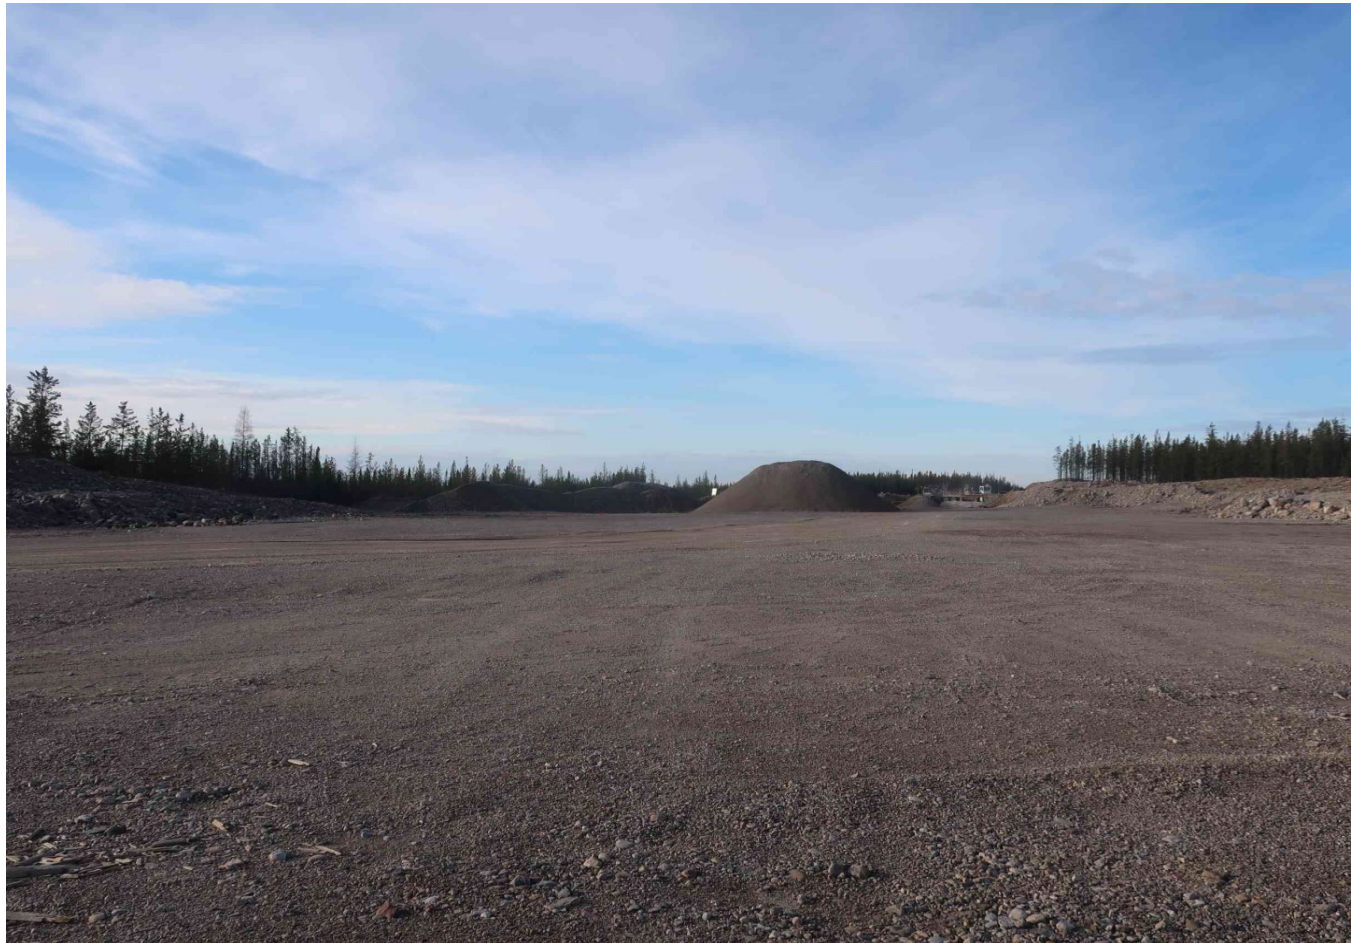
Figure 11

Permittee has several large stockpiles of processed granular material in the south area of the pit.
