File Number	MV2021Q0021
Type of Operation	QUARRY SITE - Existing
Location	Granular Deposit HR33

ENVIRONMENTAL INSPECTION REPORT

Permittee:	Rowe's Construction	Permit Expiry Date:	January 21, 2026
Land Use Permit No.	MV2021Q0021	Previous Inspection:	New
Quarrying Permit No.	2021QP0018	Inspection Date:	June 23, 2022
Contractor:		Subcontractor:	
Location(s) Inspected:	Granular Deposit HR33 at Km 44.5, NWT Highway No. 5		
Current Stage of Operation:	Active crushing operation. Granular materials being processed and removed from HR33 under the authority of Quarry Permit 2021QP0018.		
Program Modifications Approved:

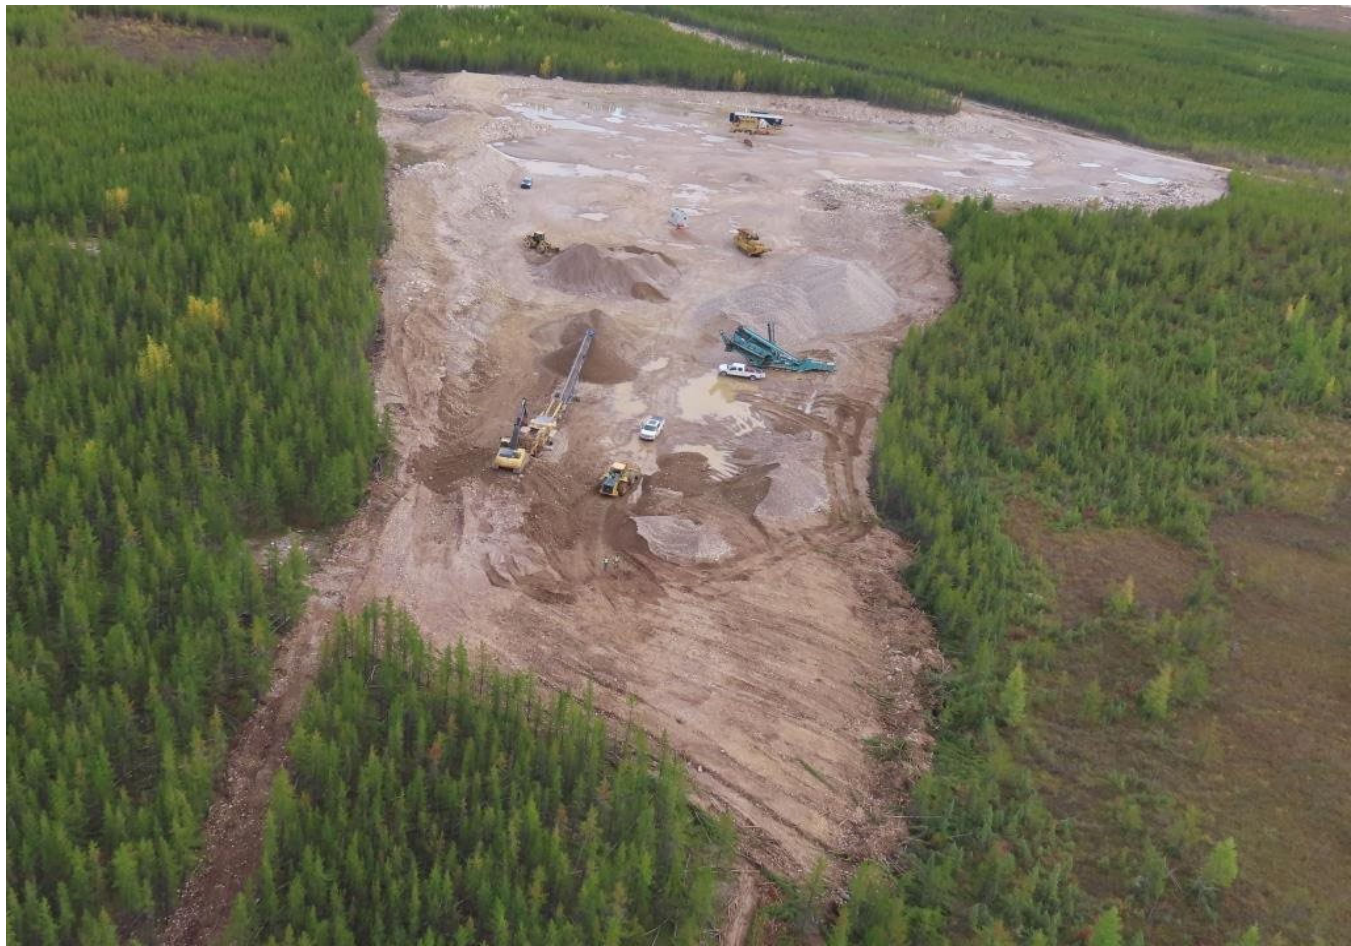
Figure 1

Aerial view of the HR33 Deposit facing east. Photograph was taken by the Department of Lands on September 17, 2021.

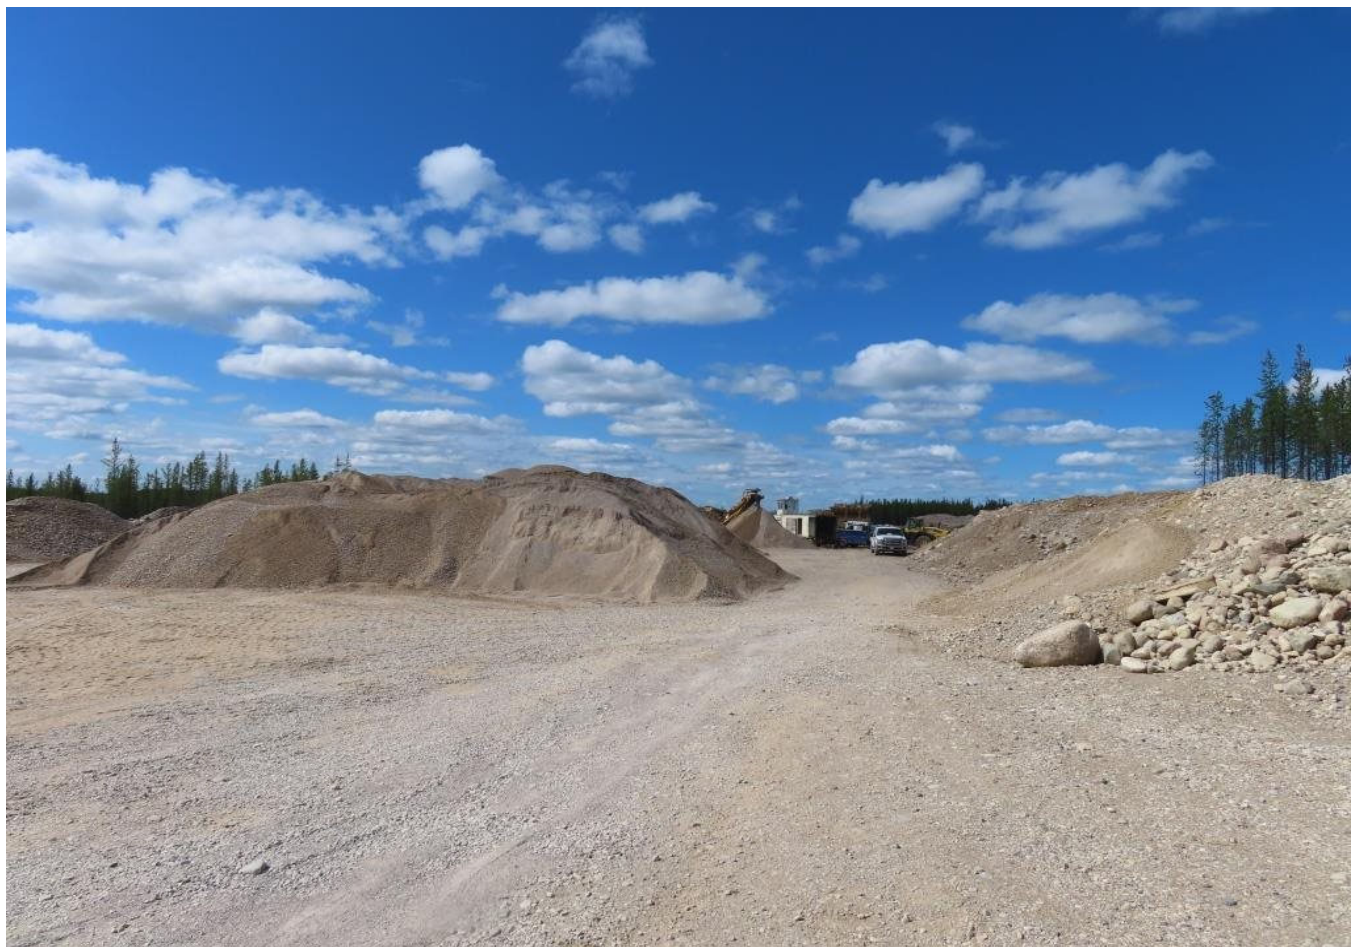
Figure 2

Facing west showing the stockpiles of processed materials and active crushing operation in progress.

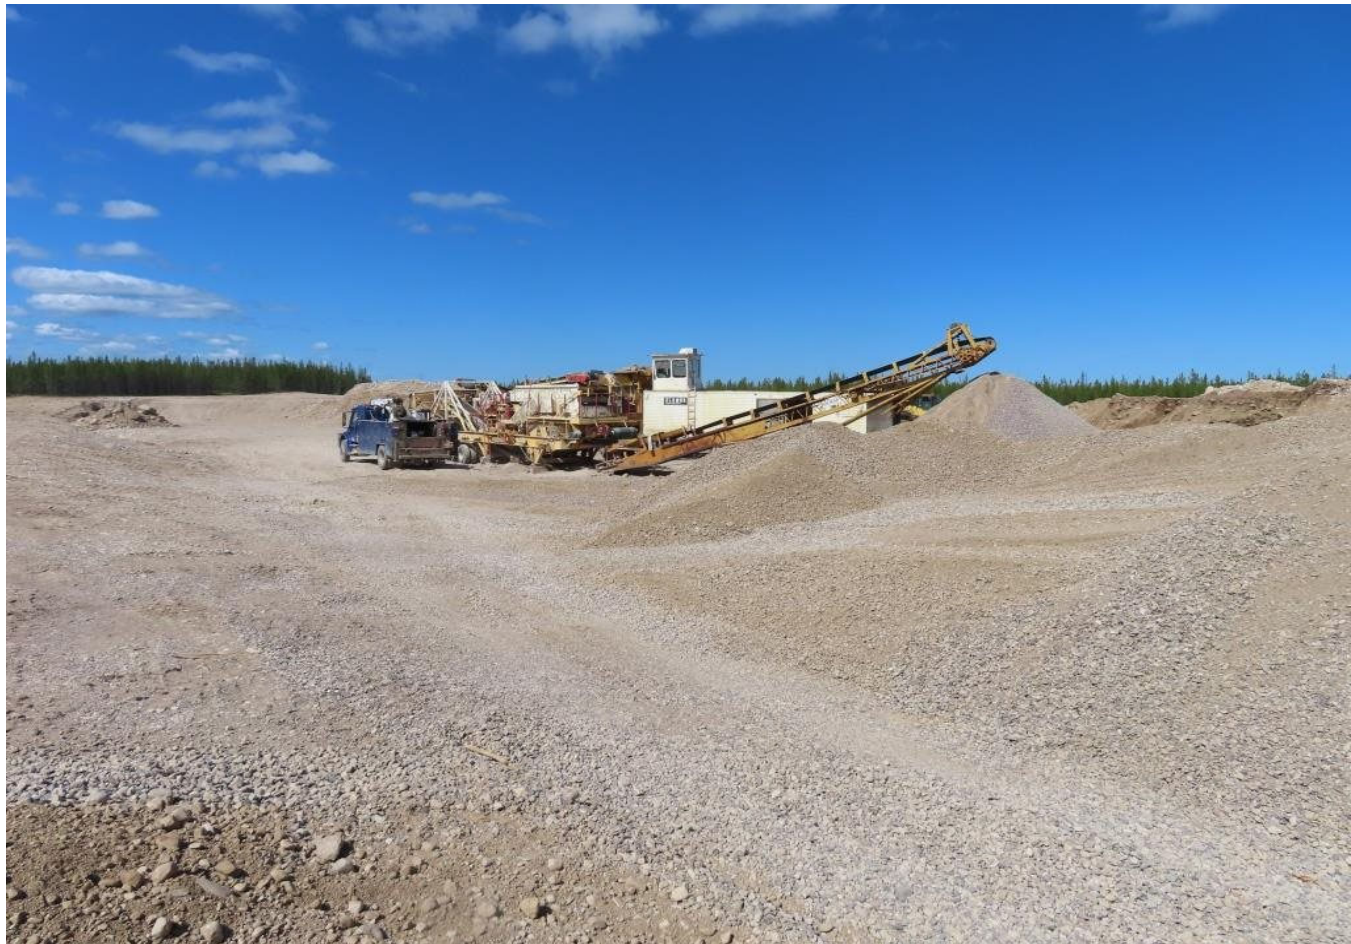
Figure 3
Crusher and stockpiles of processed material.

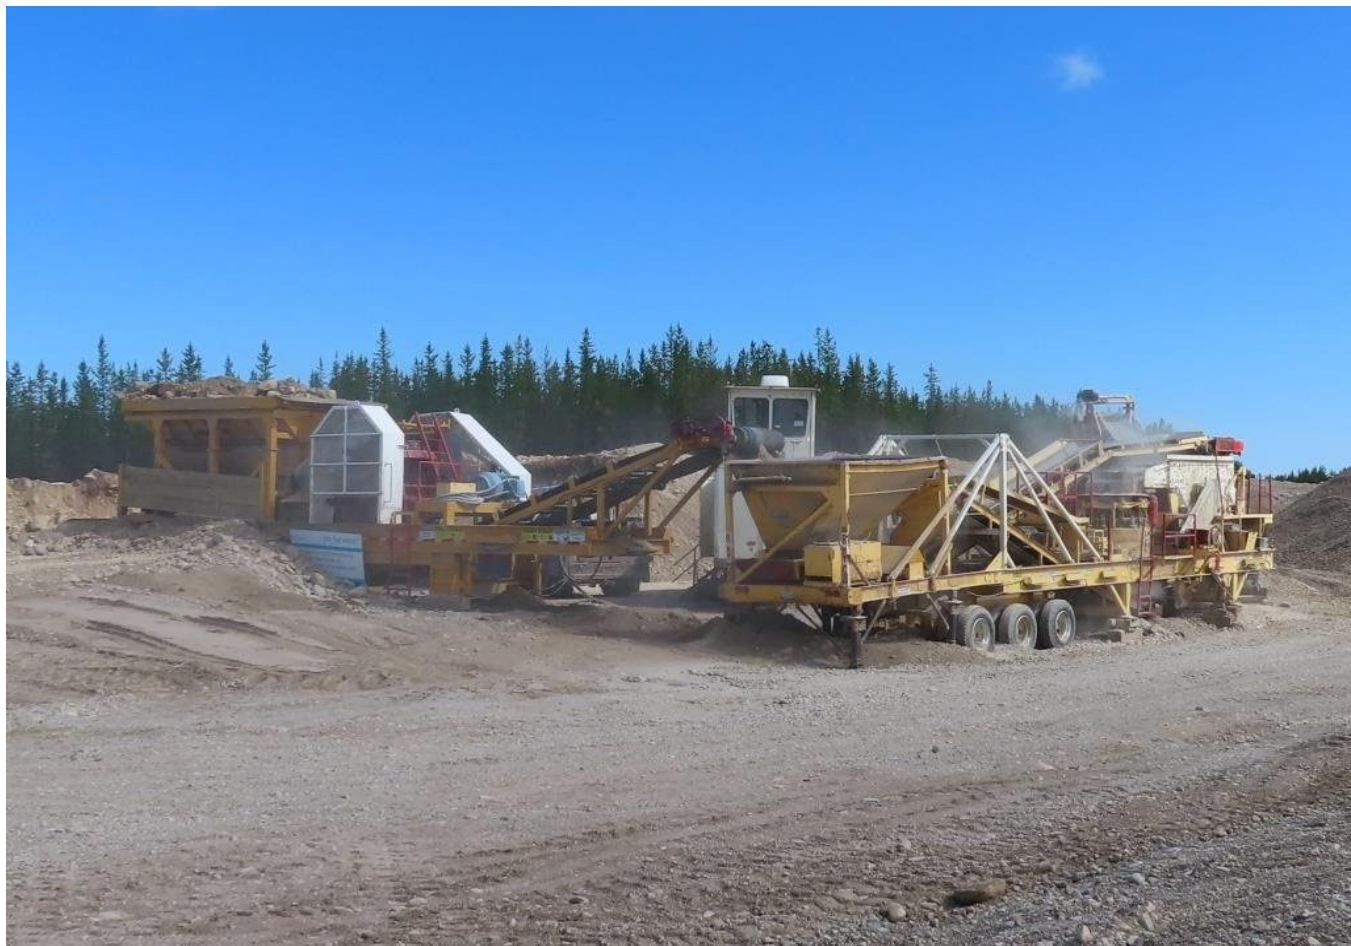
The crusher set-up was inspected and found to be in full compliance with the permit conditions. The grounds around the crusher were organized, clean of garbage and waste. Spill-response equipment was available to respond to any potential spills. Crushing operations were progressing well with processed 2" and ¾" being stockpiled.

Figure 4
No concerns noted with the crusher set-up.

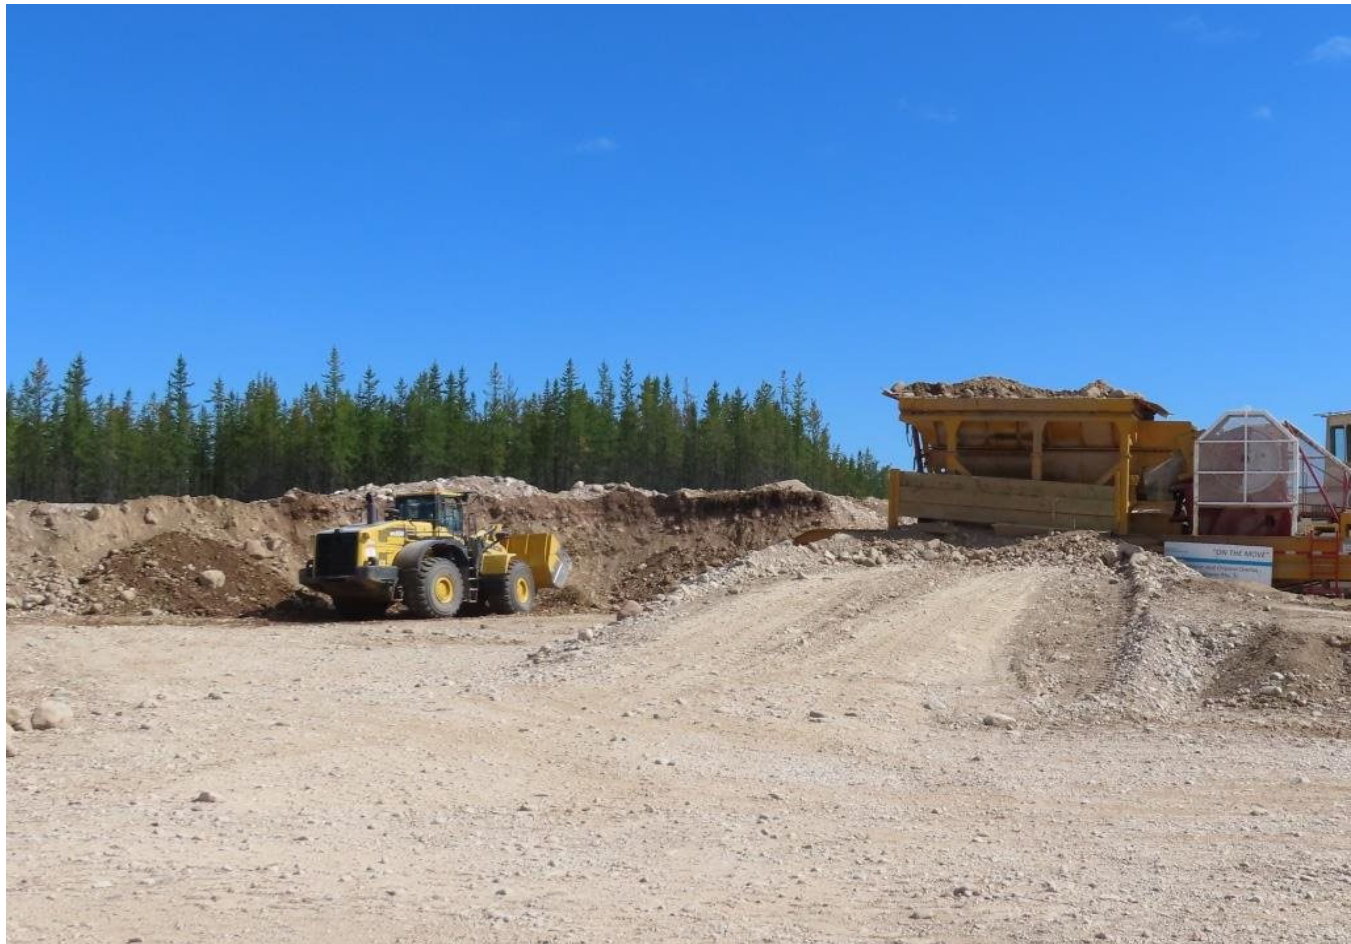
Figure 5

Pit run gravel being excavated from the active face on the north side of the pit.

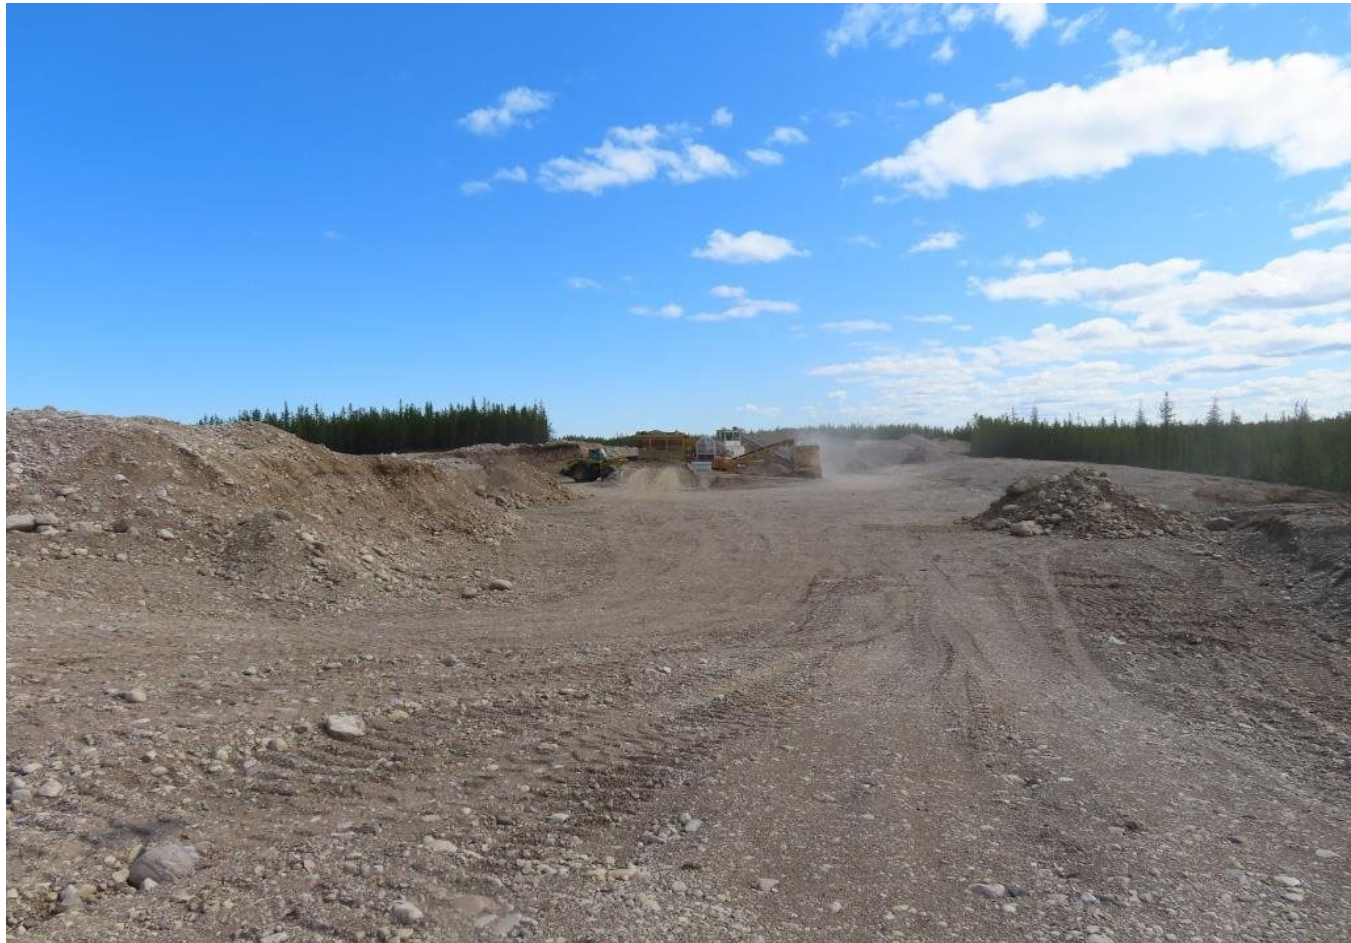
Figure 6

Facing east from the expanded section of the pit facing the crusher set-up.

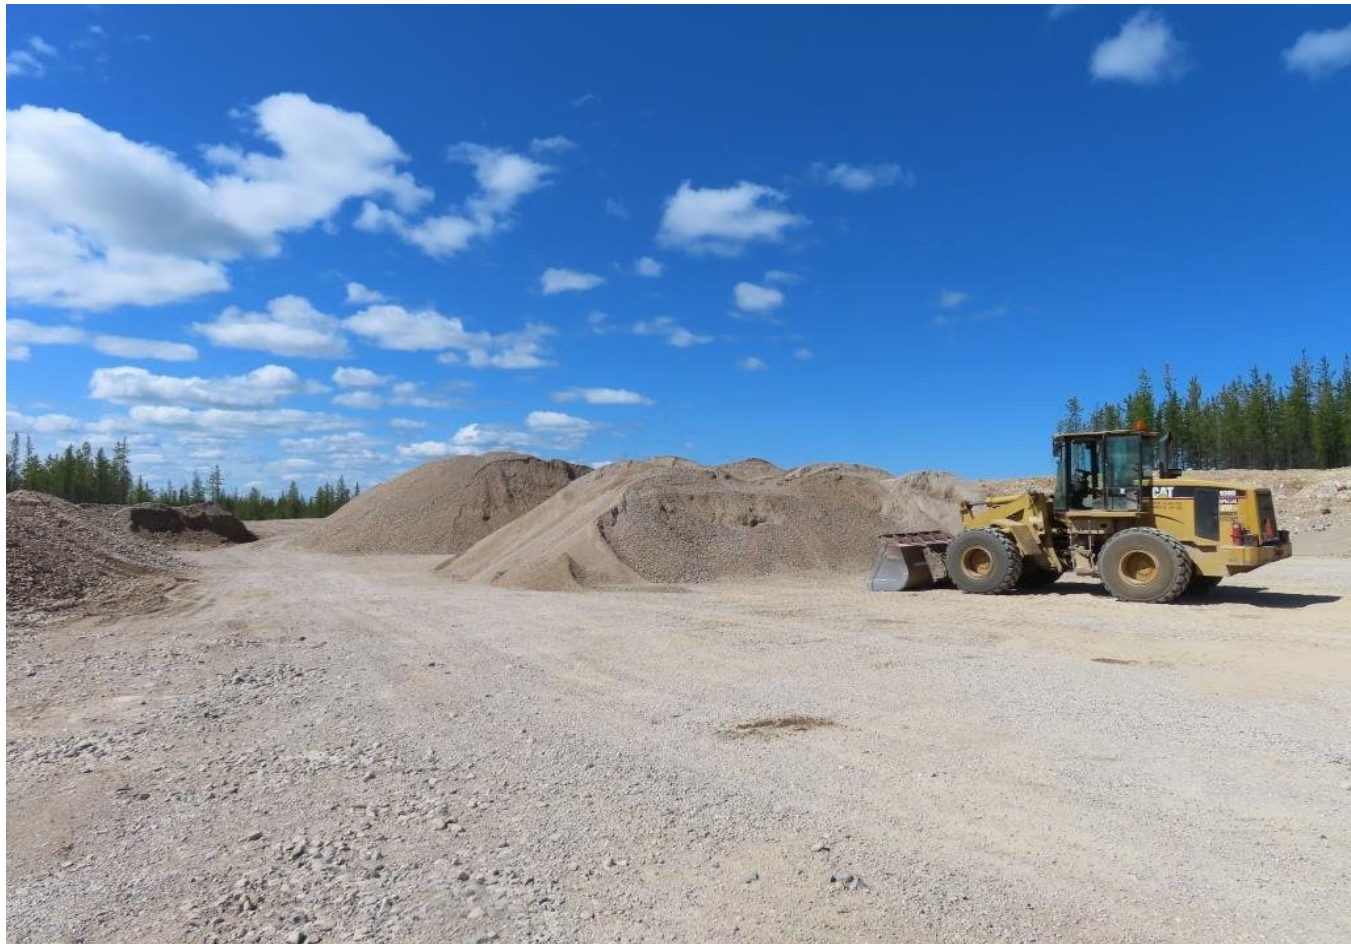
Figure 7
Processed material being hauled from site.

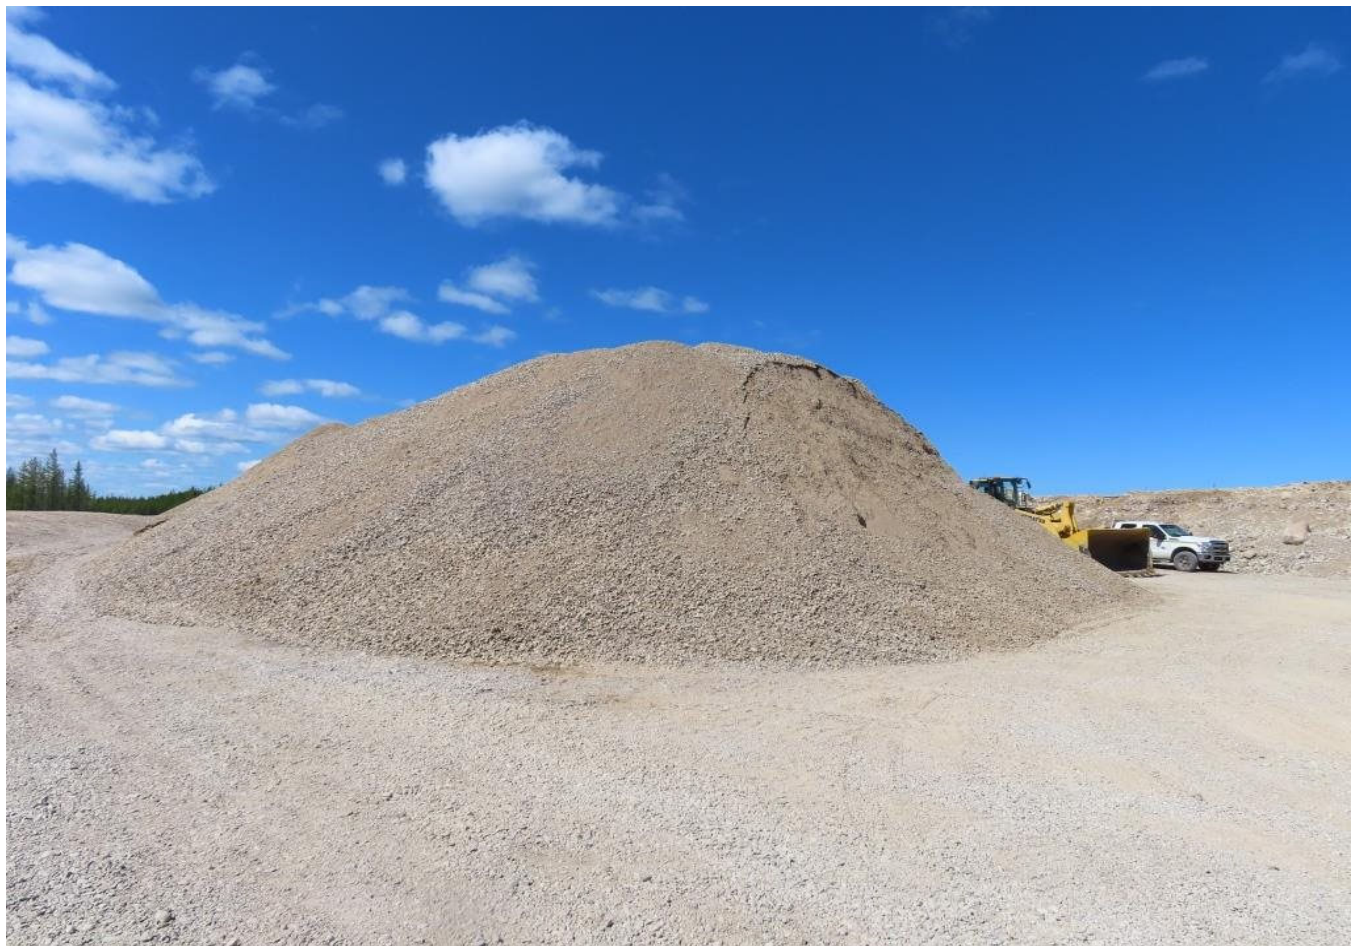
Figure 8
Stockpile of 2 inch minus processed this season.

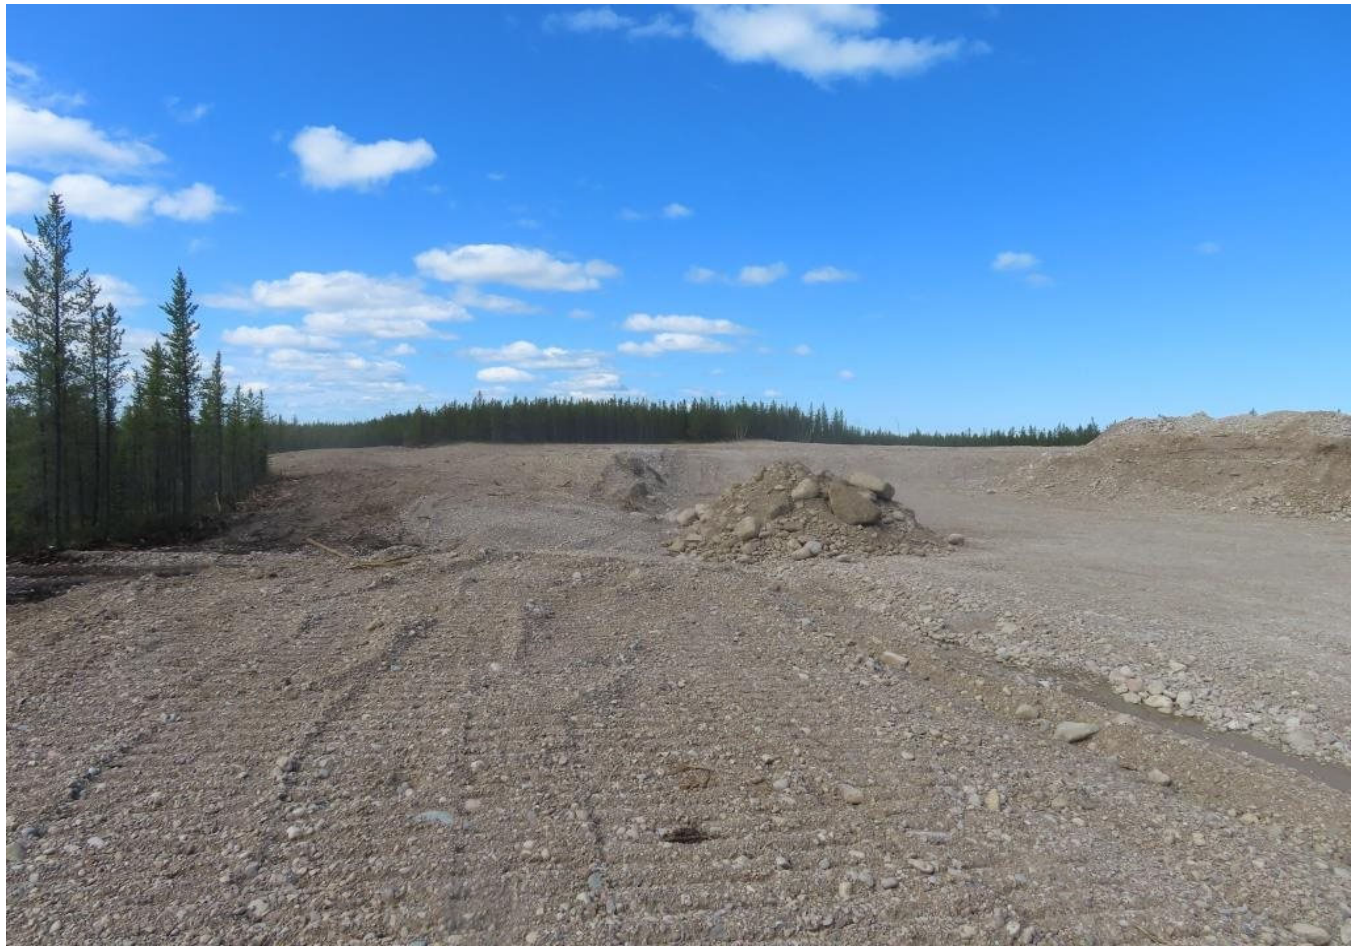
Figure 9

Facing west towards the east side of the expanded pit.

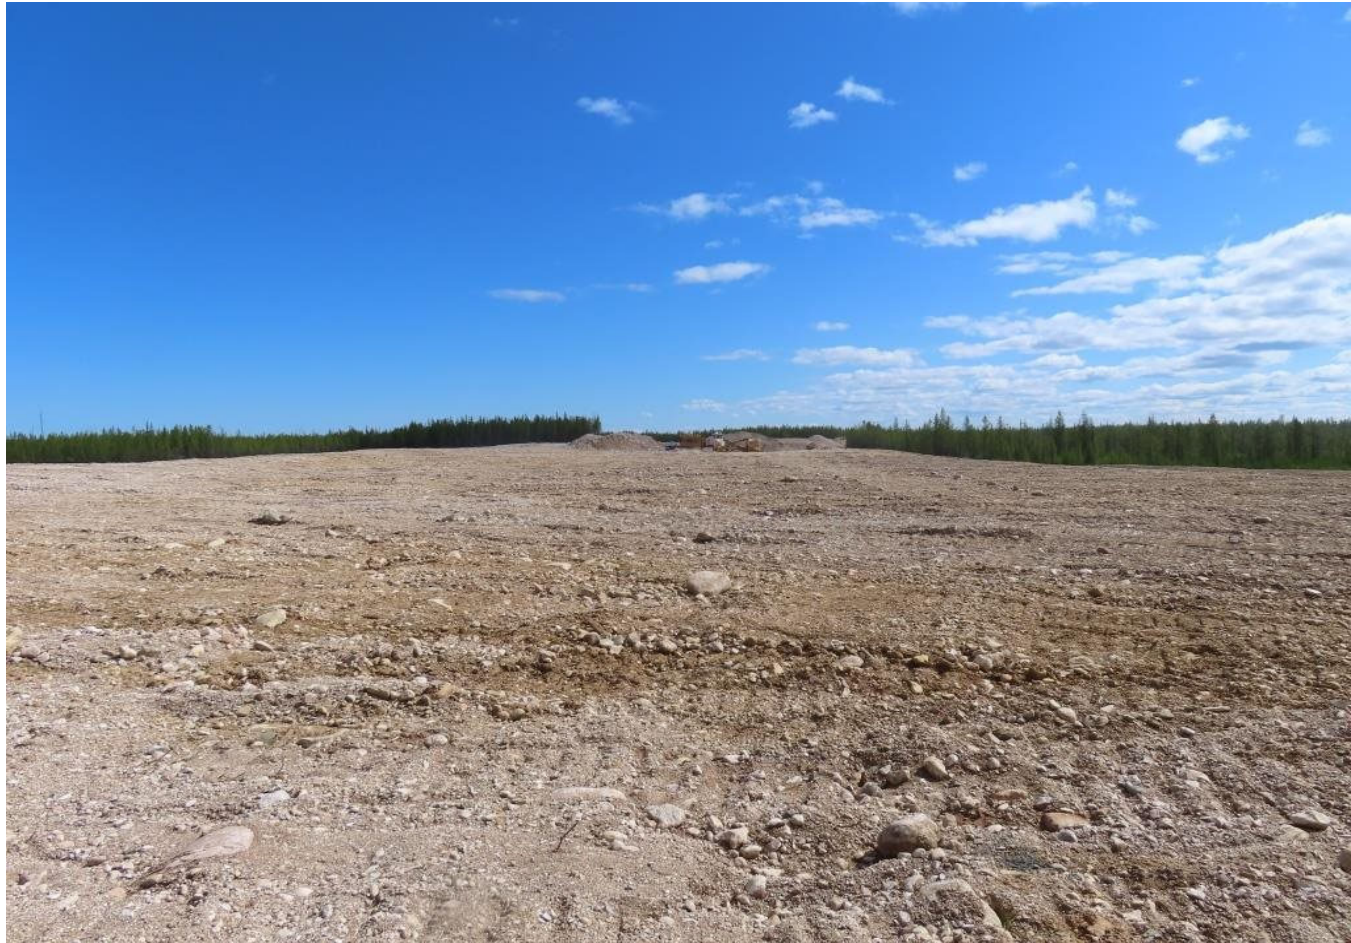
Figure 10

Gravel pit has been expanded to the west. Permittee has done a very good job with brush and overburden disposal.

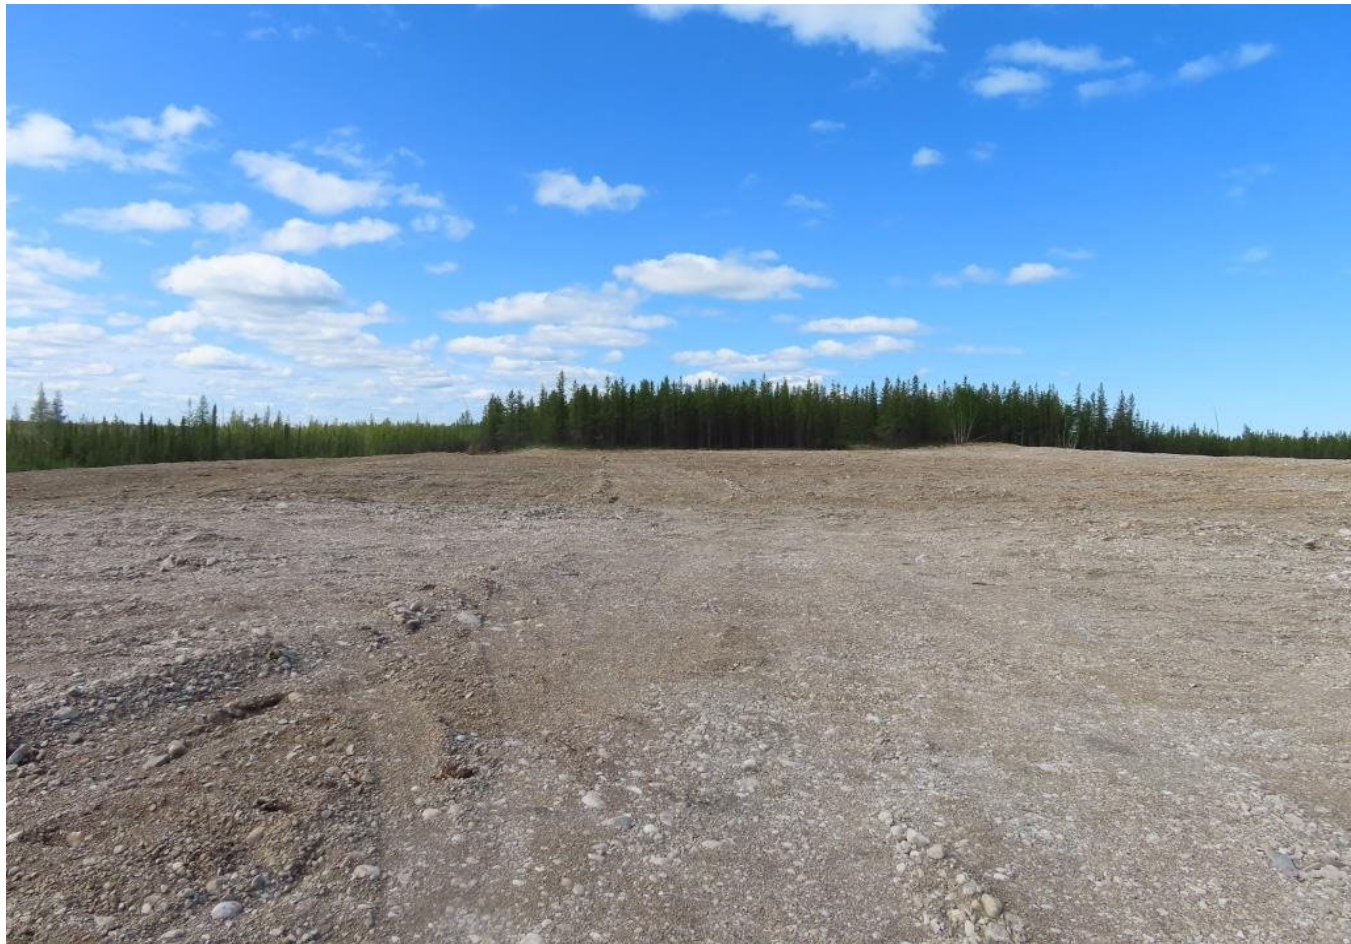
Figure 11

Facing west showing the area expanded for future quarry operations.

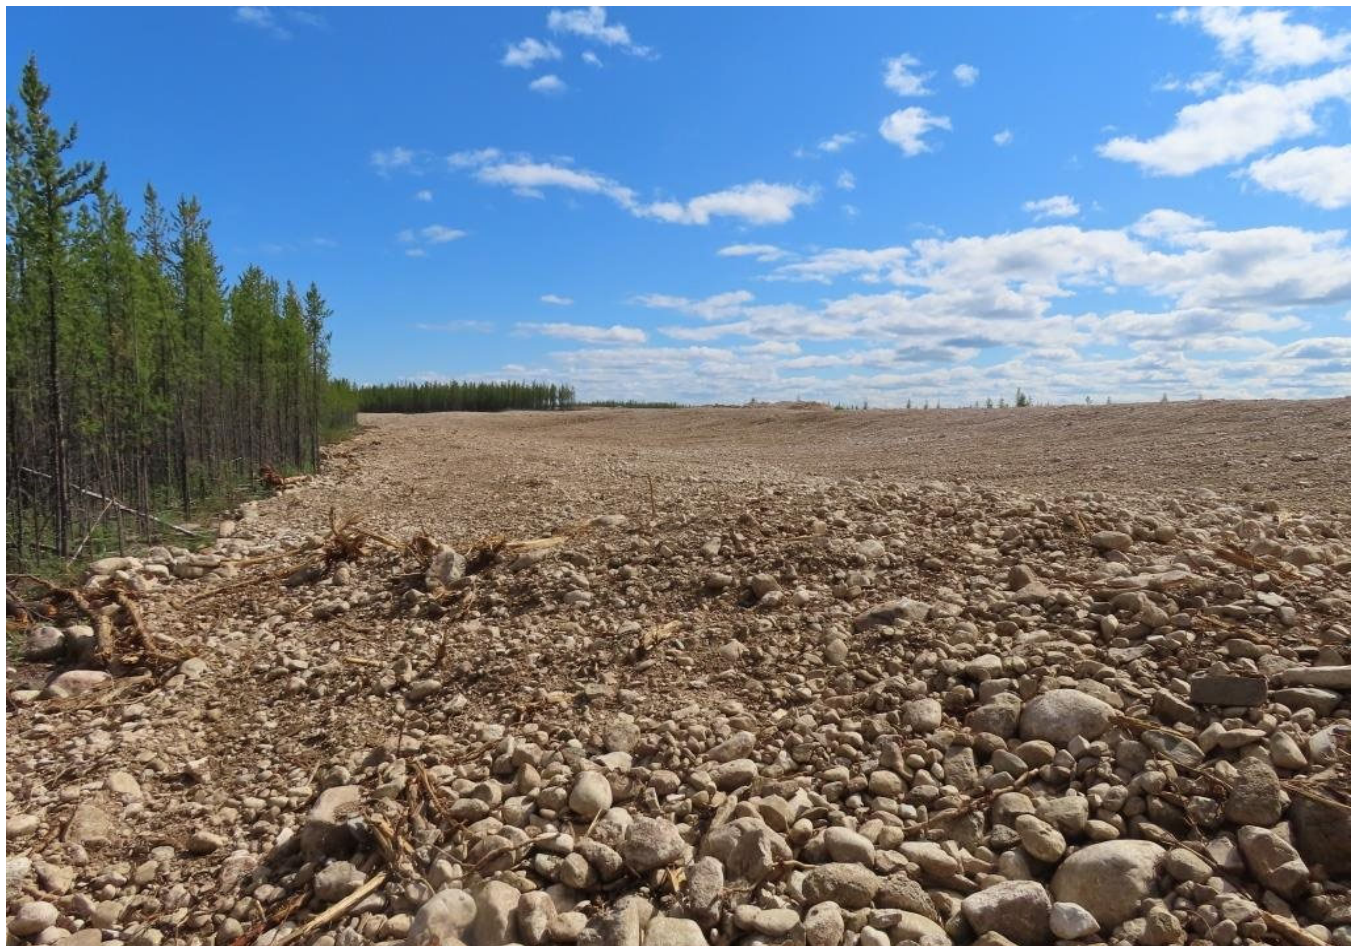
Figure 12

Facing east from the northwest corner of the expanded pit.

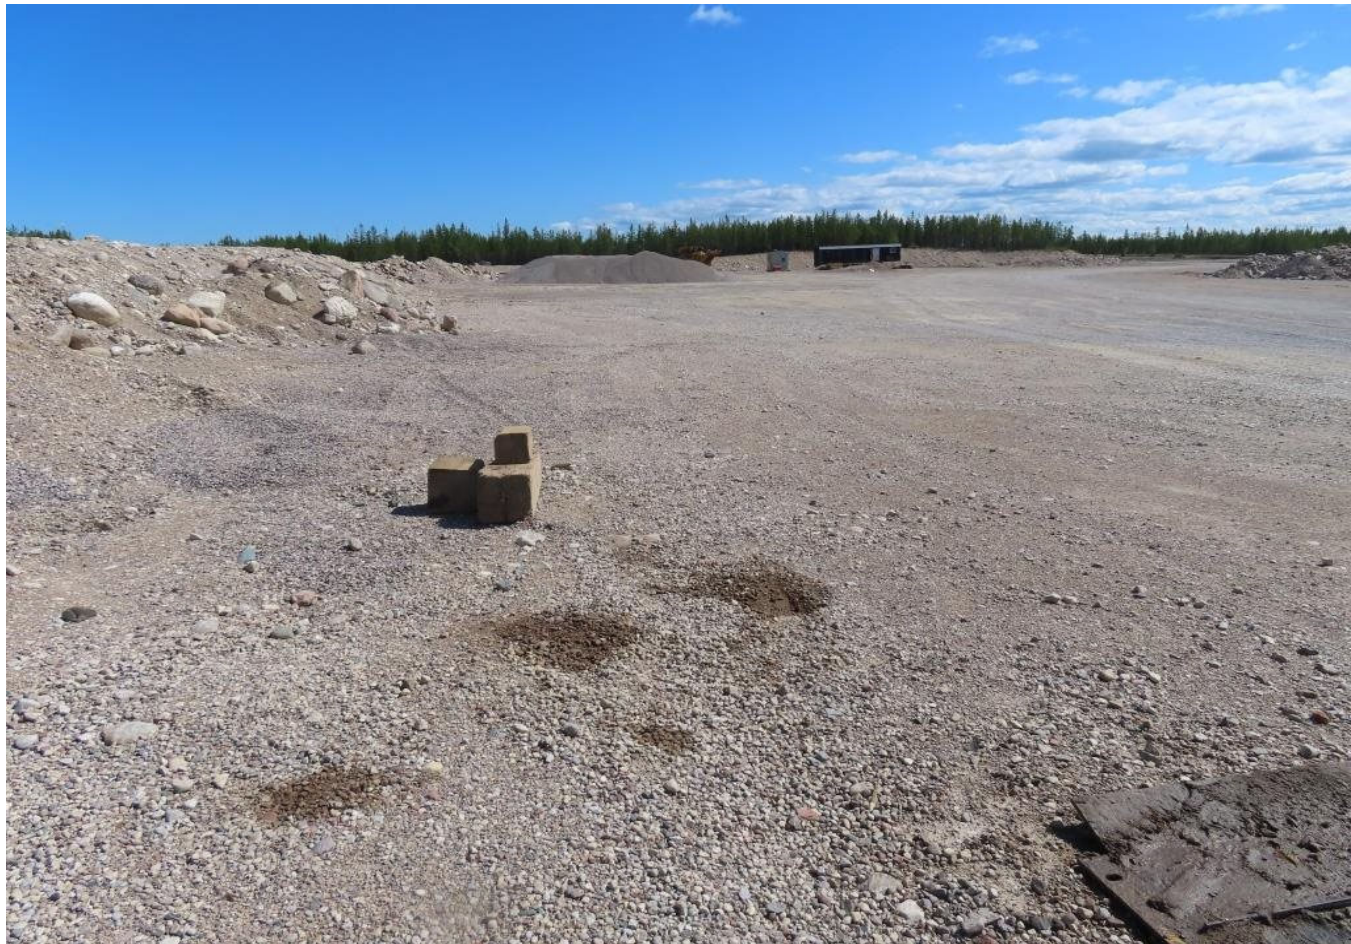
Figure 13

The only environmental concern noted during the inspection was a number of hydrocarbon spills observed on the north and east side of the gravel pit as shown in Figures 13 through 17. The Inspector was disappointed to see that these spills had not been immediately cleaned-up in contravention of Permit Condition #27 which states *"The Permittee shall clean up all leaks, spills, and contaminated material immediately."*

The hydrocarbon spills are noted to be less than 100 litres. As the volume of the spills was less than 100 litres, the Permittee is not required to report the spills to the spill line as required by Permit Condition #28 (Report Spills).

Small hydrocarbon spills on the north side of the pit requiring clean-up.

The larger hydrocarbon spill was observed on the west side of the "Muster Station" trailer located on the east side of the gravel pit. The coordinates of the spill are 60°41'48.1"N 115°05'37.7"W. Additional hydrocarbon spills were observed on the north side of the crusher. All hydrocarbon impacted soils must be clean-up and hauled to an authorized disposal site in accordance with the Spill Contingency Plan. A small amount of garbage was scattered around the east side of the pit which also must be cleaned-up.

Rowe's Construction must comply with their Spill Contingency Plan and ensure all spills are immediately cleaned-up (Condition #24). Permit Condition #24 states *"The Permittee shall comply with the Spill Contingency Plan, once approved, and shall annually review the plan and make any necessary revisions to reflect changes in operations, technology, chemicals, or fuels, or as directed by the Board. Revisions to the plan shall be submitted to the Board for approval."*

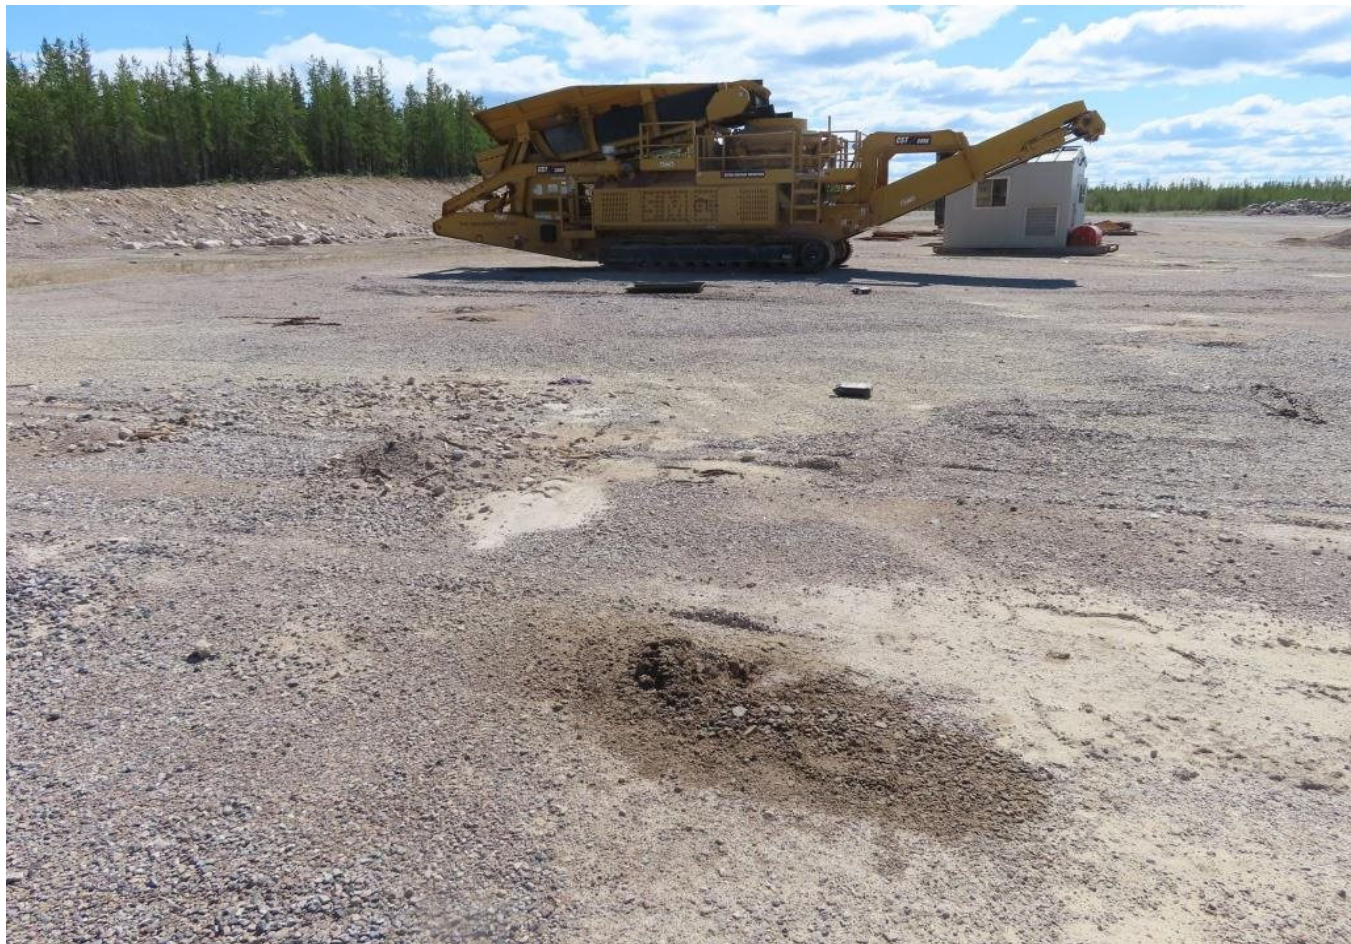
Figure 14

A hydrocarbon stain was observed under the parked Groundworx tracked crusher located on the east side of the pit. It is noted that there was no drip tray under the crusher in contravention of Permit Condition #26 which states *"All equipment that may be parked for two hours or more, shall have a hazmat/drip tray under it or be sufficiently diapered. Leaky equipment shall be repaired immediately."*

Hydrocarbon staining observed on the north side of the parked crusher. Crusher was parked on the east side of the pit.

It is required that the hydrocarbon impacted soils under the crusher be clean-up and a drip tray placed underneath to capture all leaks and drips. Repairs must be made to the crusher to prevent the spill from continuing.

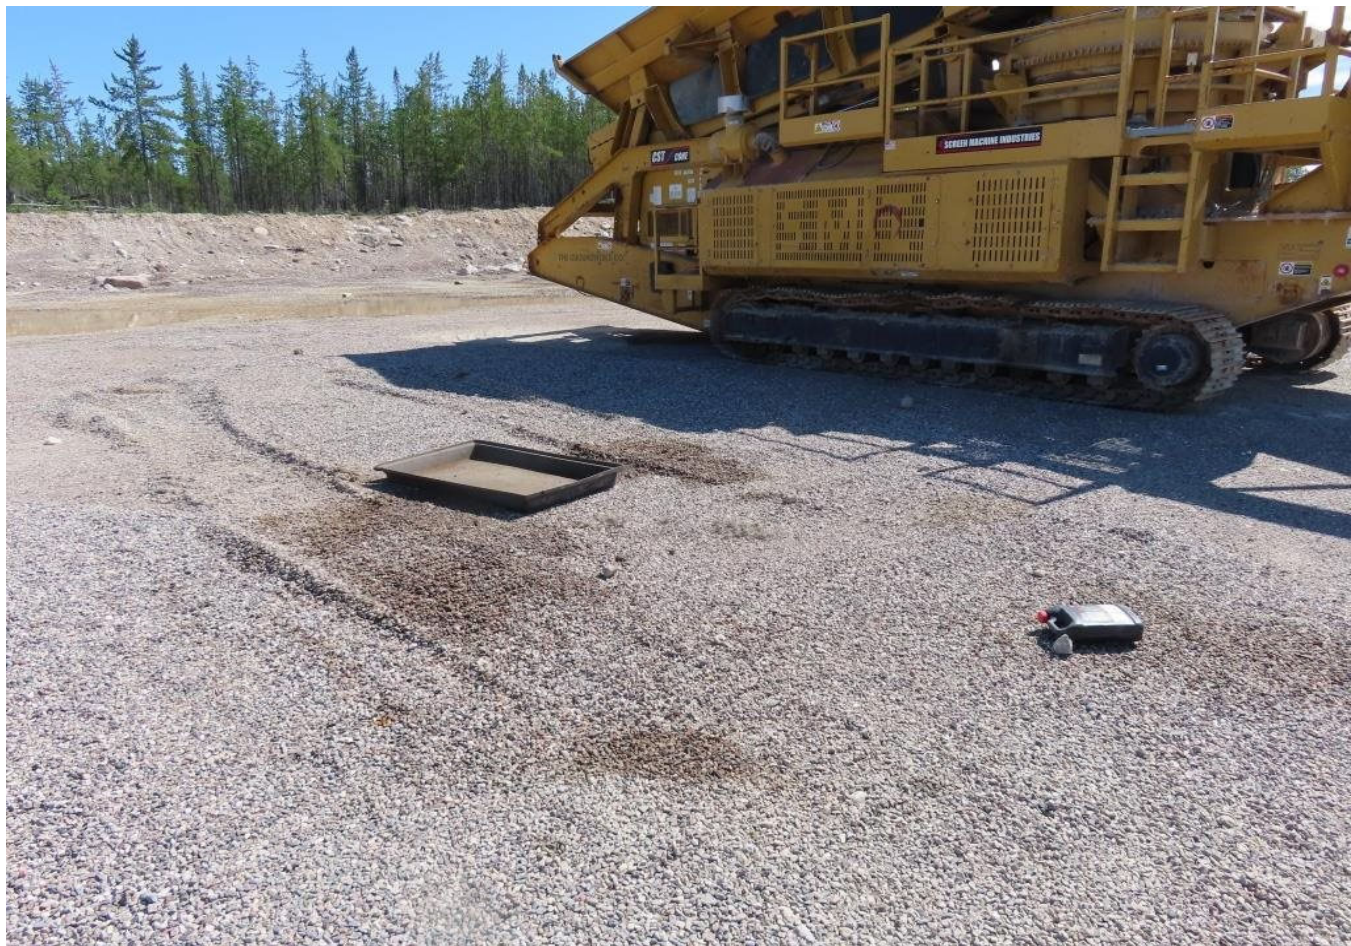
Figure 15
Hydrocarbon staining observed on the immediate north side of the crusher.

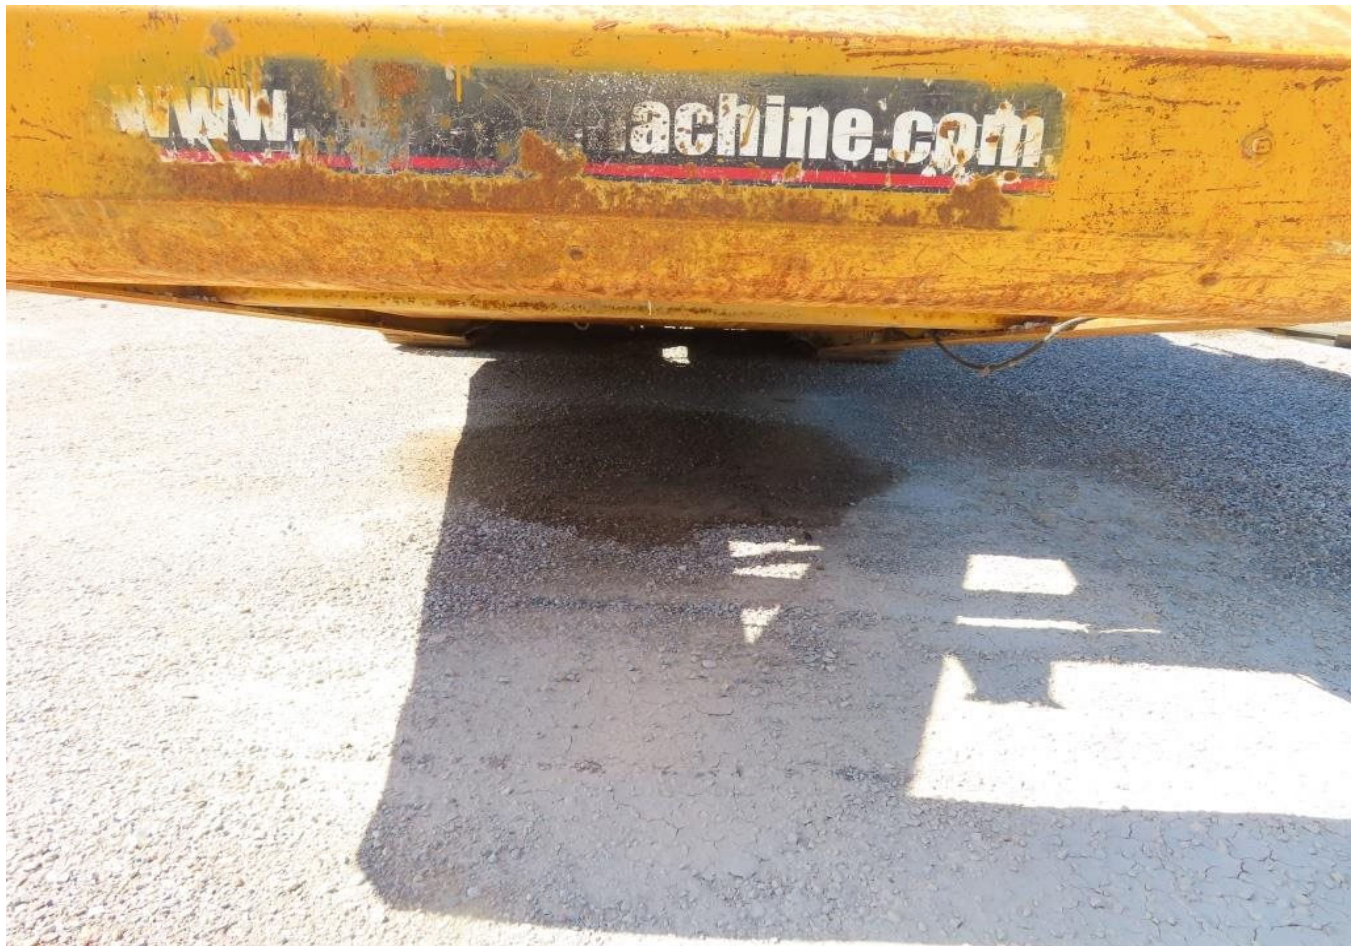
Figure 16
Hydrocarbon staining observed under the crusher. No drip tray was located under the parked equipment.

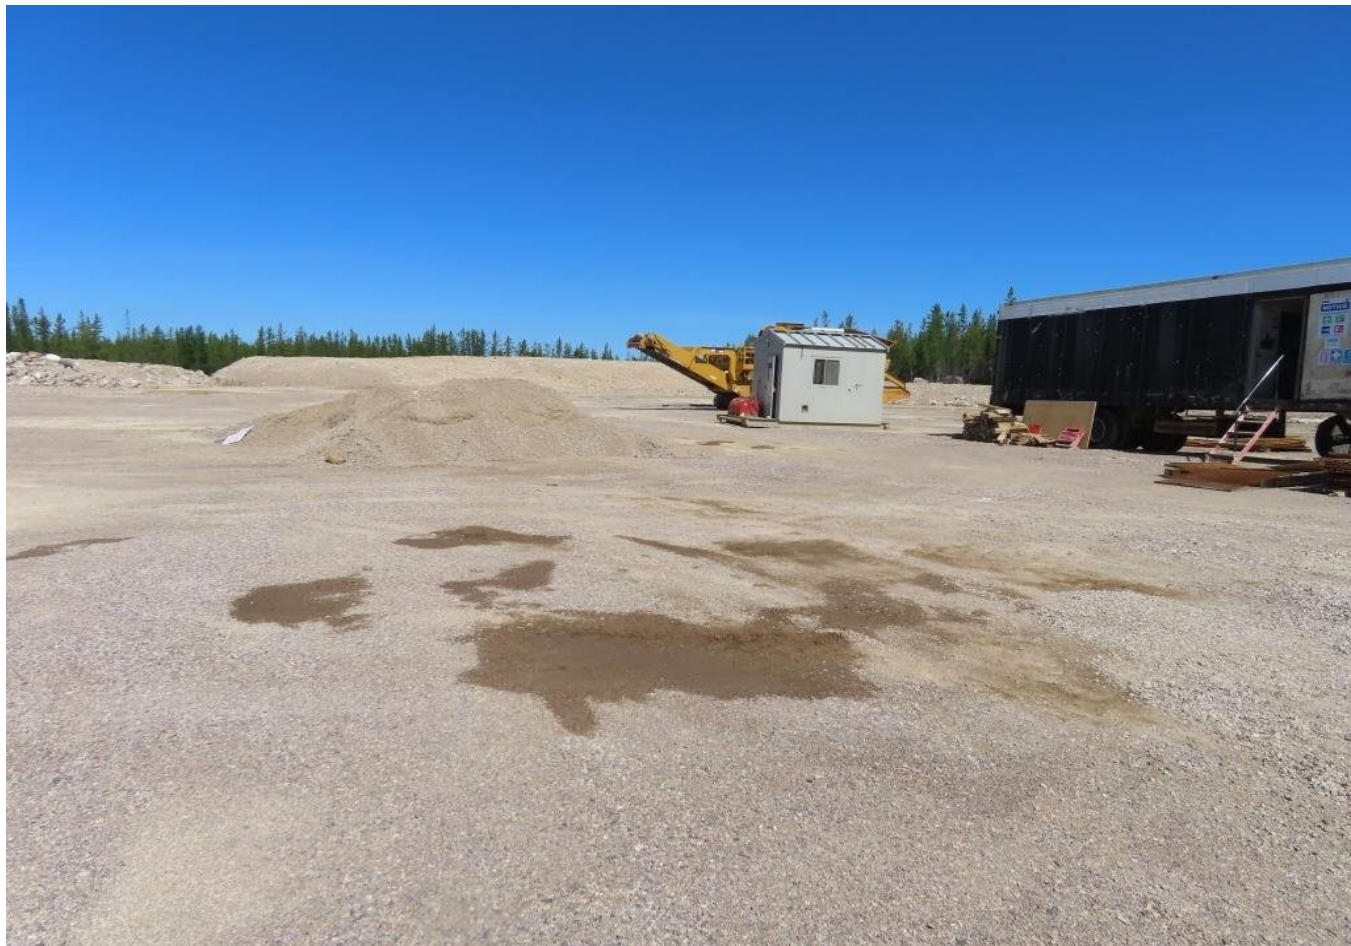
Figure 17
Hydrocarbon spills observed on west side of the "Muster Station" trailer.
