File Number	MV2021Q0021
Type of Operation	QUARRY SITE - Existing
Location	Granular Deposit HR33

ENVIRONMENTAL INSPECTION REPORT

Permittee:	Rowe's Construction	Permit Expiry Date:	January 21, 2026
Land Use Permit No.	MV2021Q0021	Previous Inspection:	New
Quarrying Permit No.	2021QP0018	Inspection Date:	June 23, 2022
Contractor:		Subcontractor:	
Location(s) Inspected:	Granular Deposit HR33 at Km 44.5, NWT Highway No. 5		
Current Stage of Operation:	Active crushing operation. Granular materials being processed and removed from HR33 under the authority of Quarry Permit 2021QP0018.		
Program Modifications Approved:

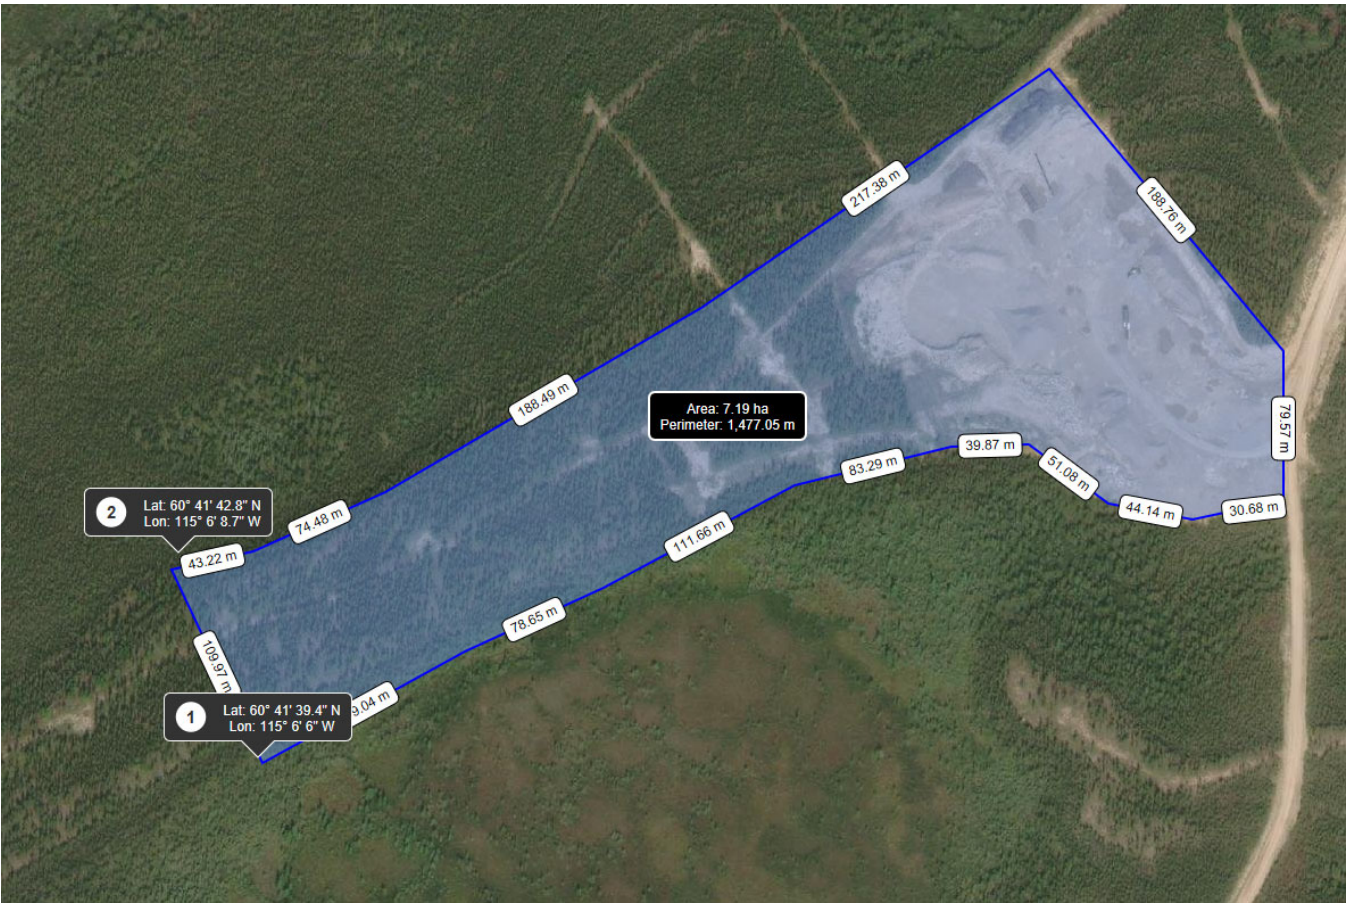
At time of inspection, crushing operations were active on the west side of the pit that was expanded in the fall of 2021 under the authority of MV2014Q0025. Total area of HR33 that has been developed is 7.19 ha. NW corner: 60°41’42.8”N 115°06’8.7”W; SW corner: 60°41’39.4”N 115°06’06.0”W (Figure 18).

Figure 18
Developed area of HR33.
