**Re: Land Use Permit MV2022C0021
Mineral Exploration
Yellowknife Lithium Project, NT**

ENVIRONMENTAL INSPECTION REPORT

Permittee:	EREX International Ltd.	Inspection Date – February 12 th & 13 th , 2024
------------	-------------------------	---

Location(s) Inspected:	Bighill Lake winter road, Echo Camp, and the ECHO Diamond Drill Program.
------------------------	--

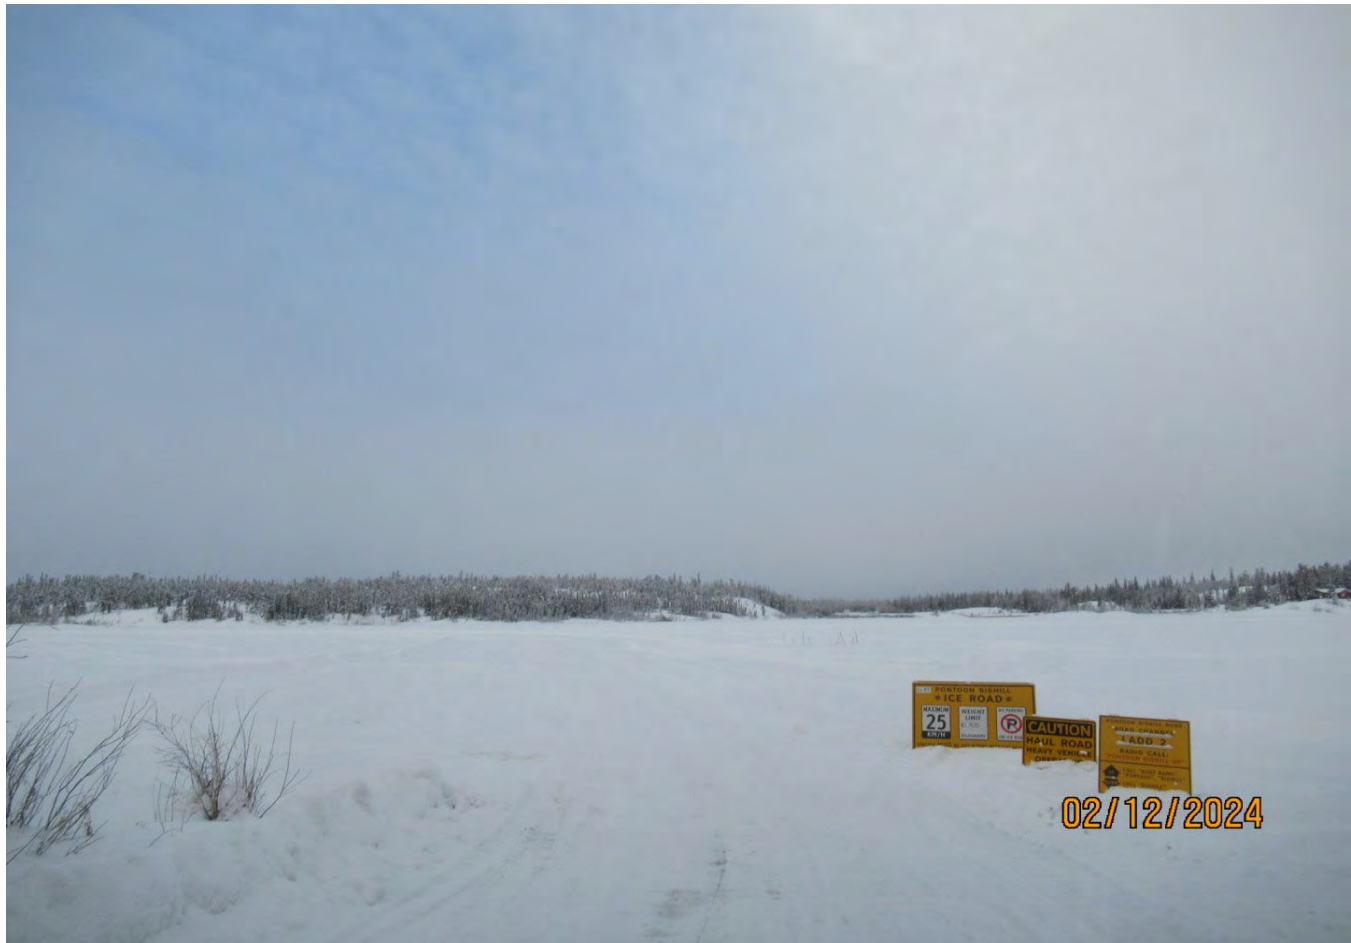
Figure 1

Looking southwest at the start of the winter road on the ice surface of Pontoon Lake.

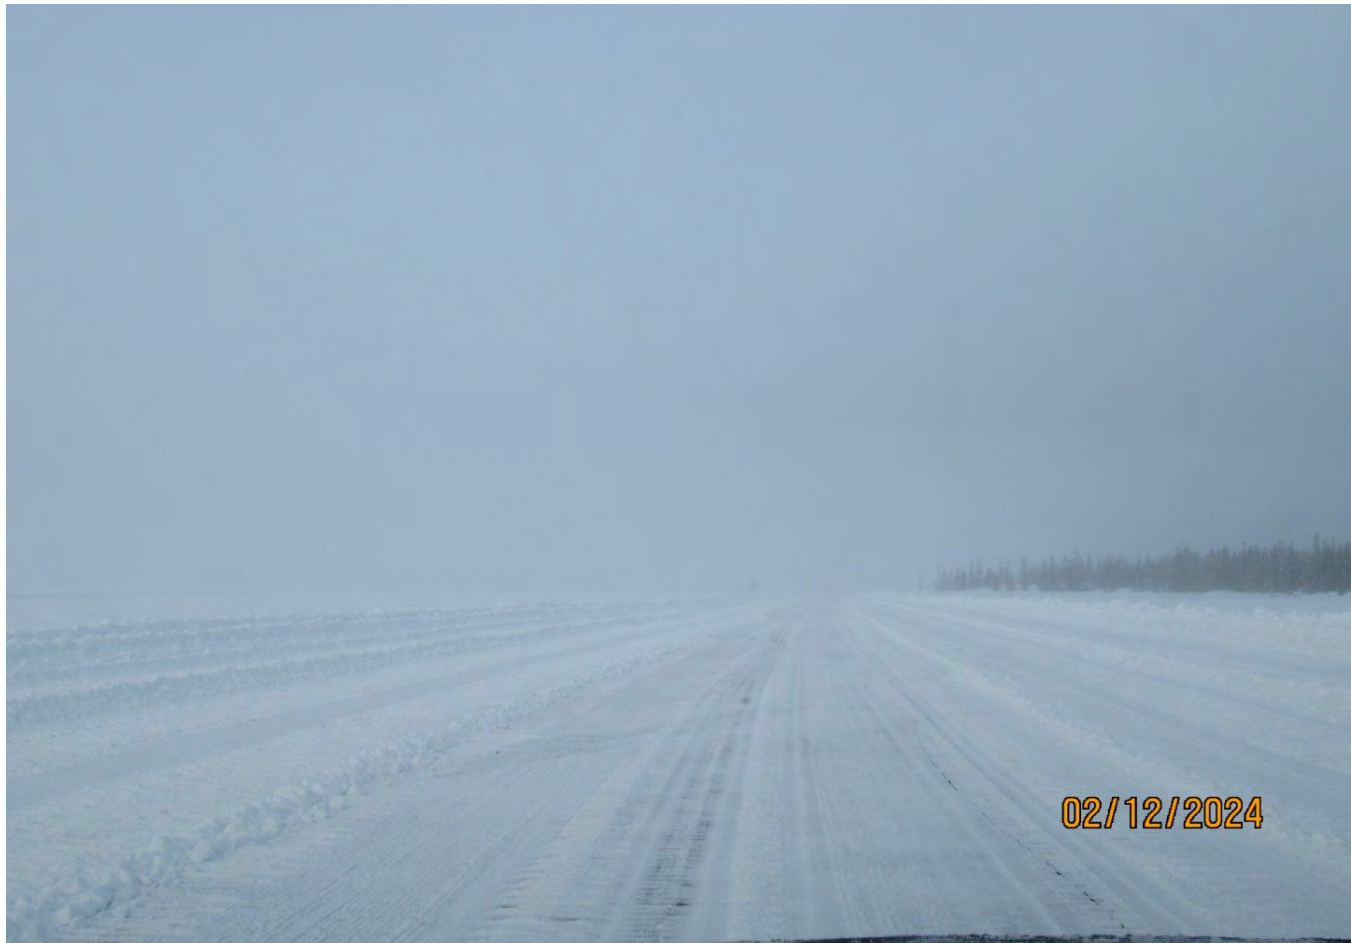
Figure 2

Looking northwest at the cleared ice surface on Bighill Lake.

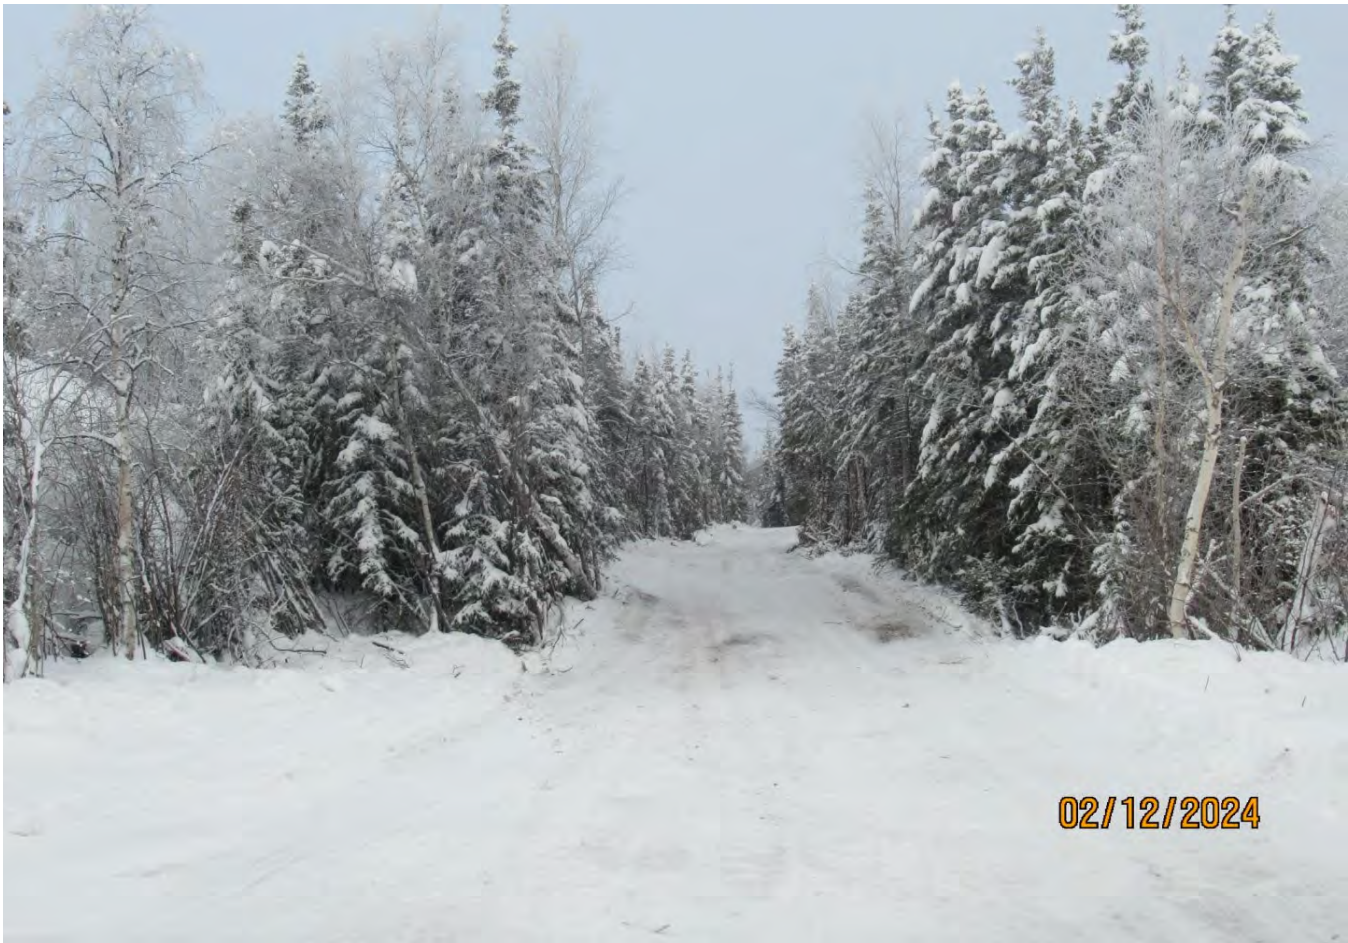
Figure 3
Portage 1 of the Bighill winter road. Looking south.

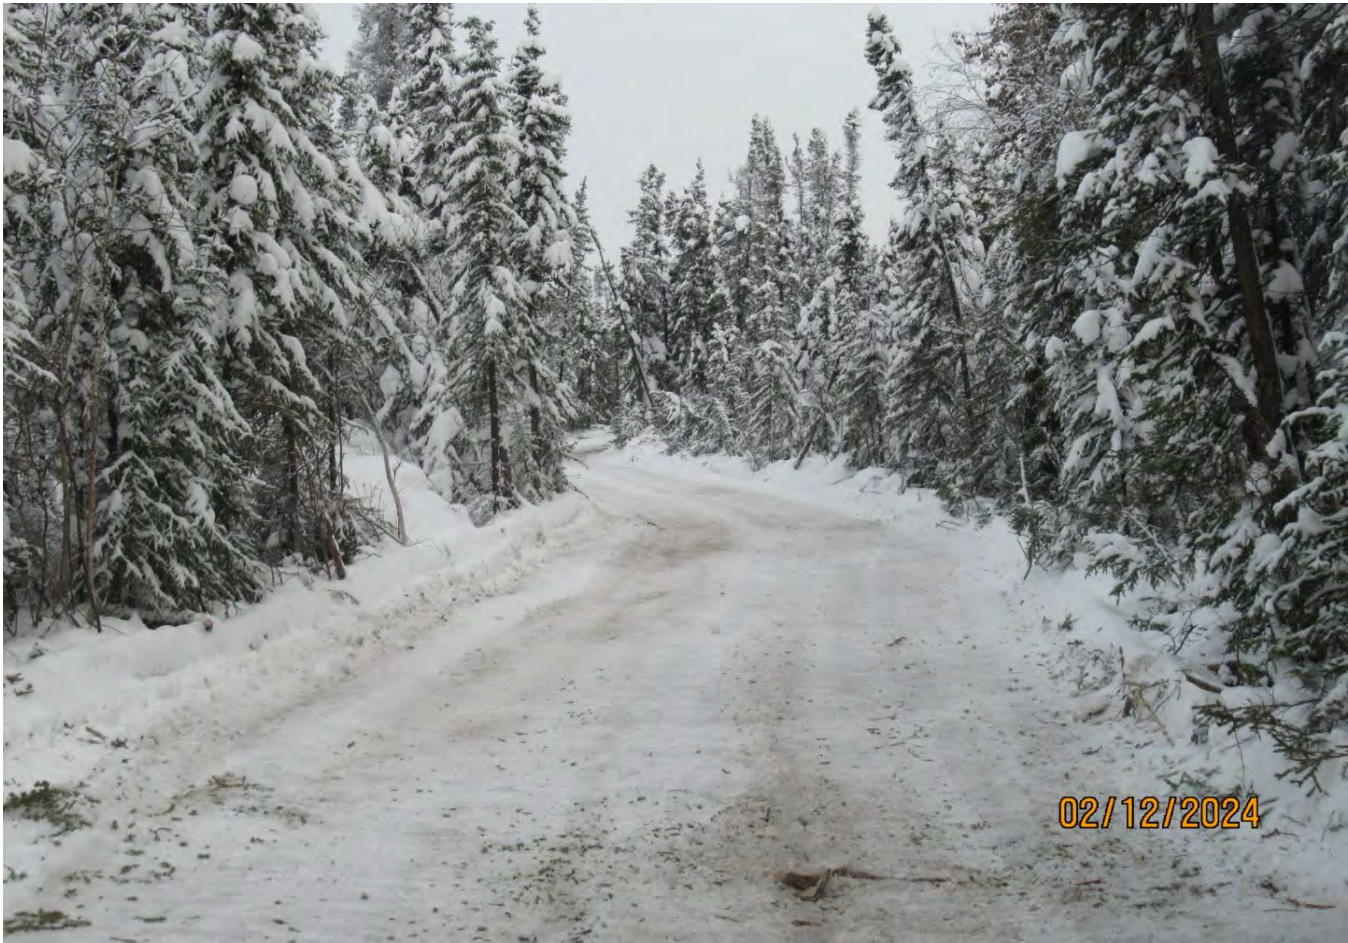
Figure 4
Initial icing of the portages is underway. As a reminder the portages must be iced in from shoulder to shoulder to comply with Condition #18 of the land use permit.

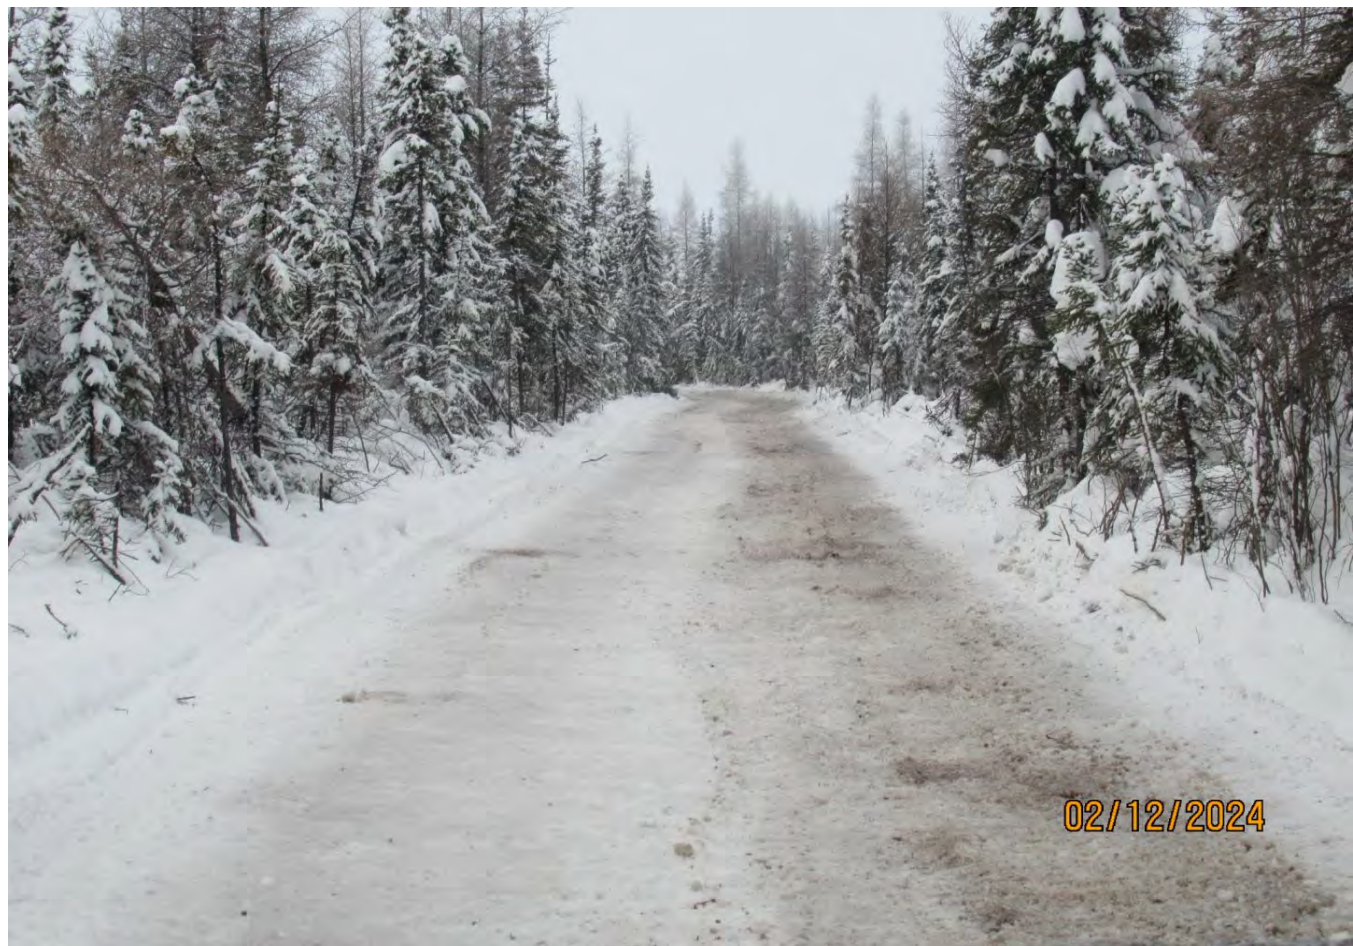
Figure 5
Another example of a portage in the early stages of construction.

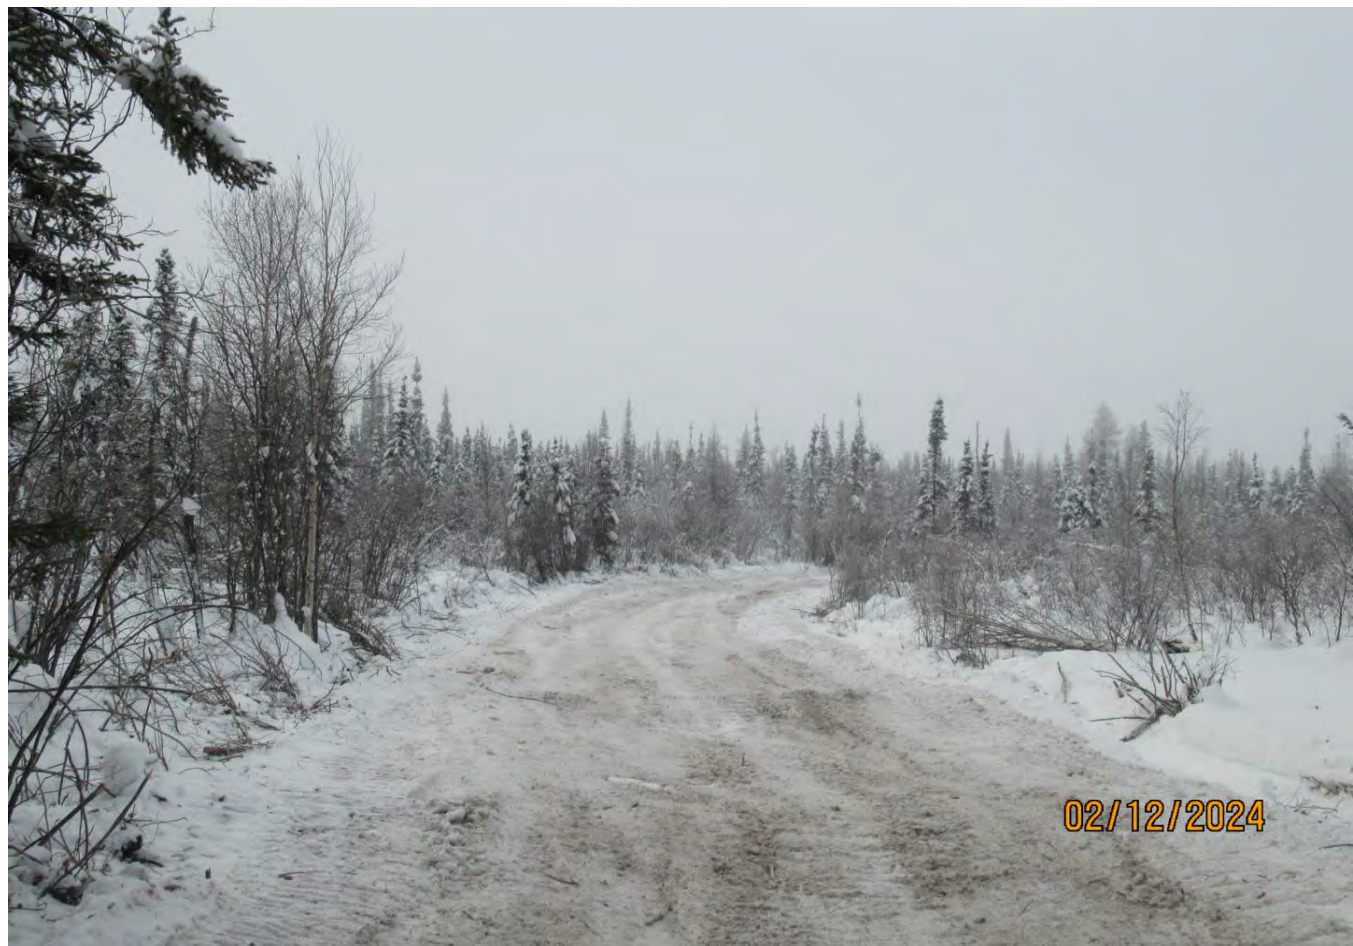
Figure 6
Another example of a portage under construction.

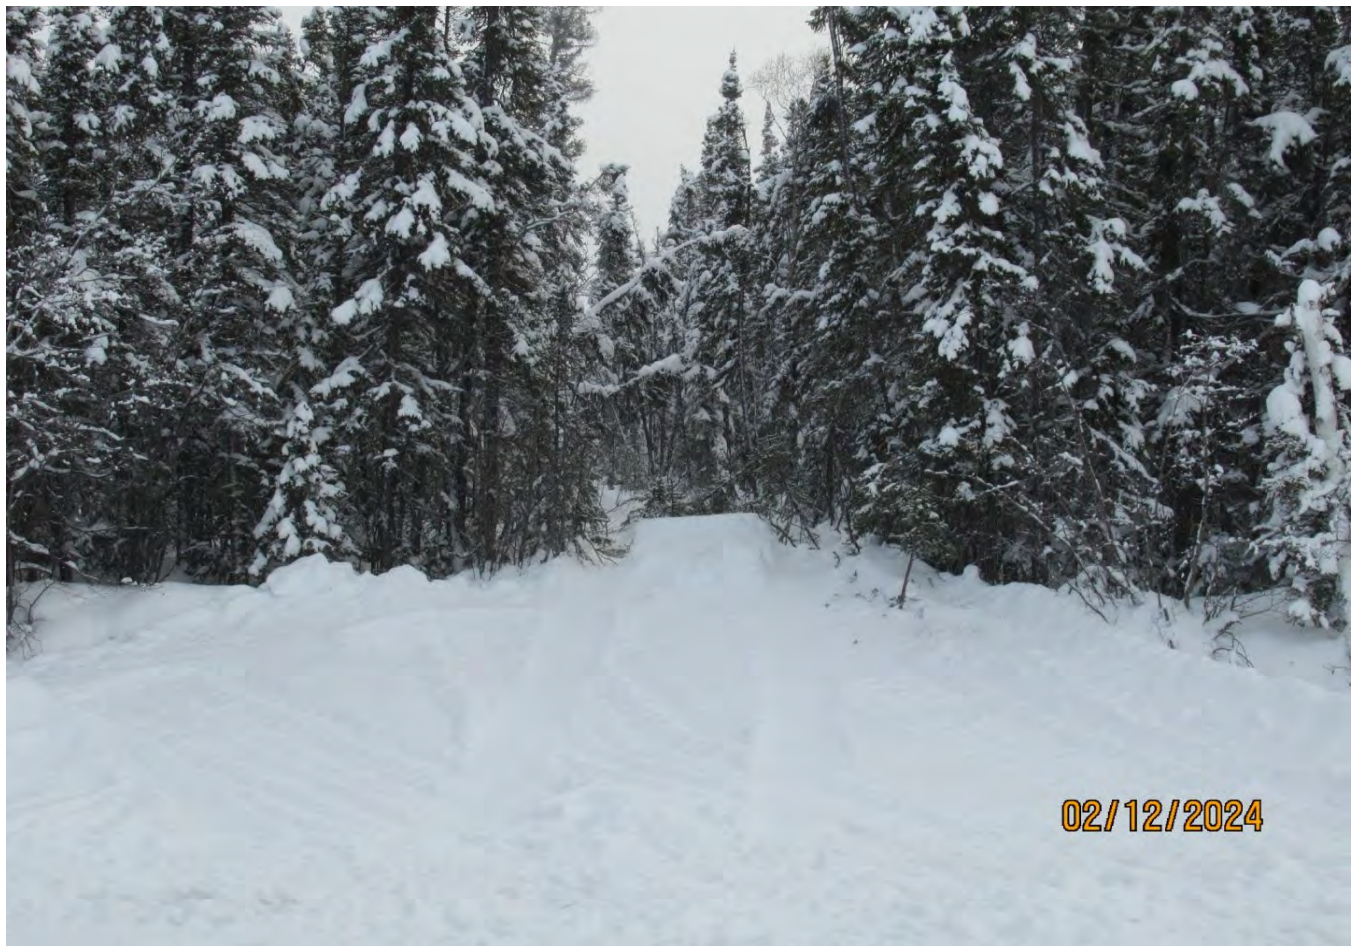
Figure 7
Portage on the east side of Bighill Lake. Initial reconnaissance was completed but no construction at the time of the inspection.

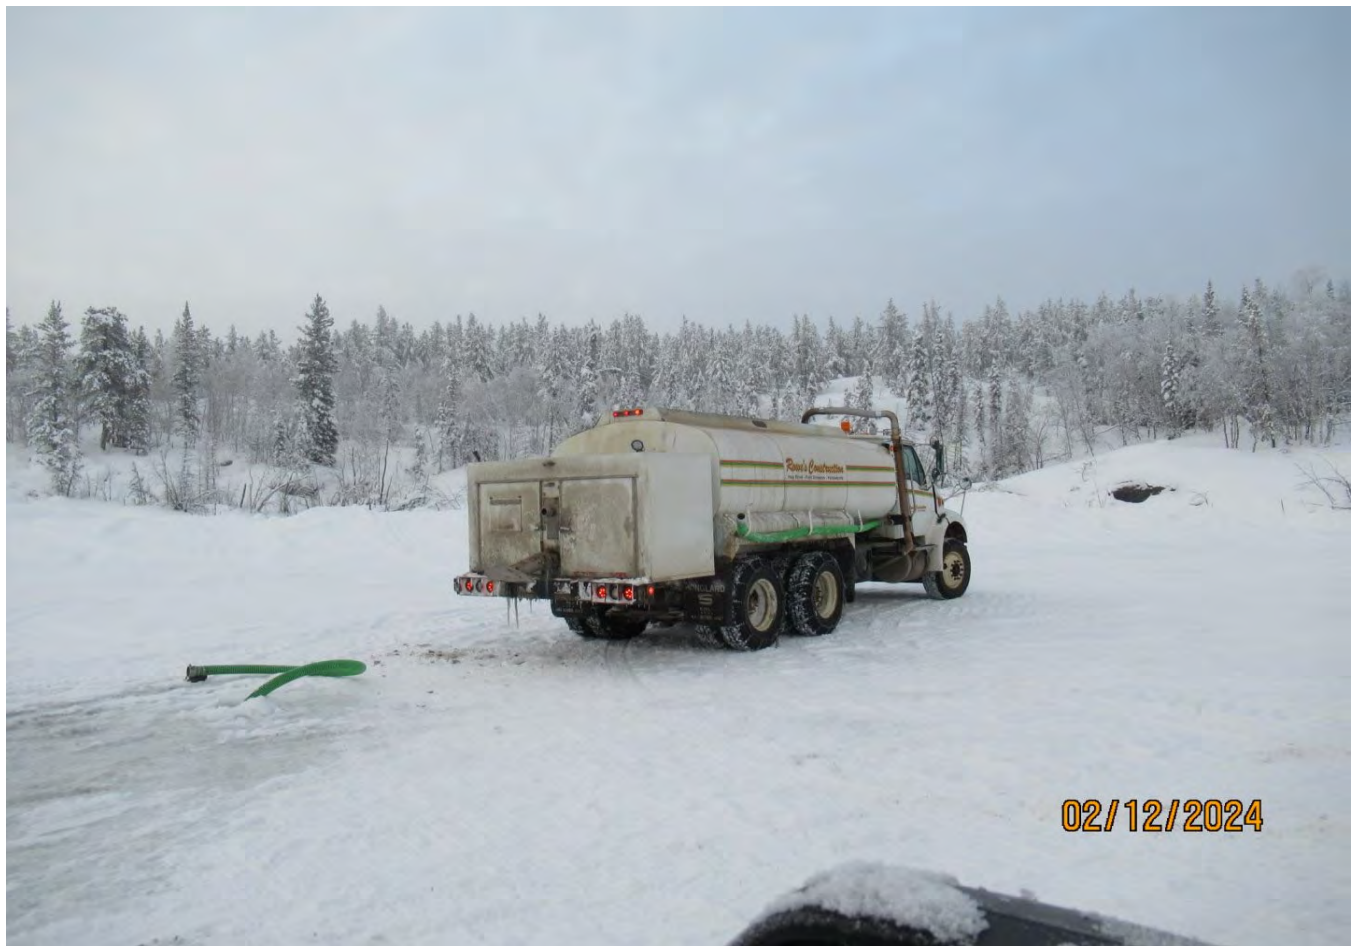
Figure 8
One of two water trucks being used for portage construction.

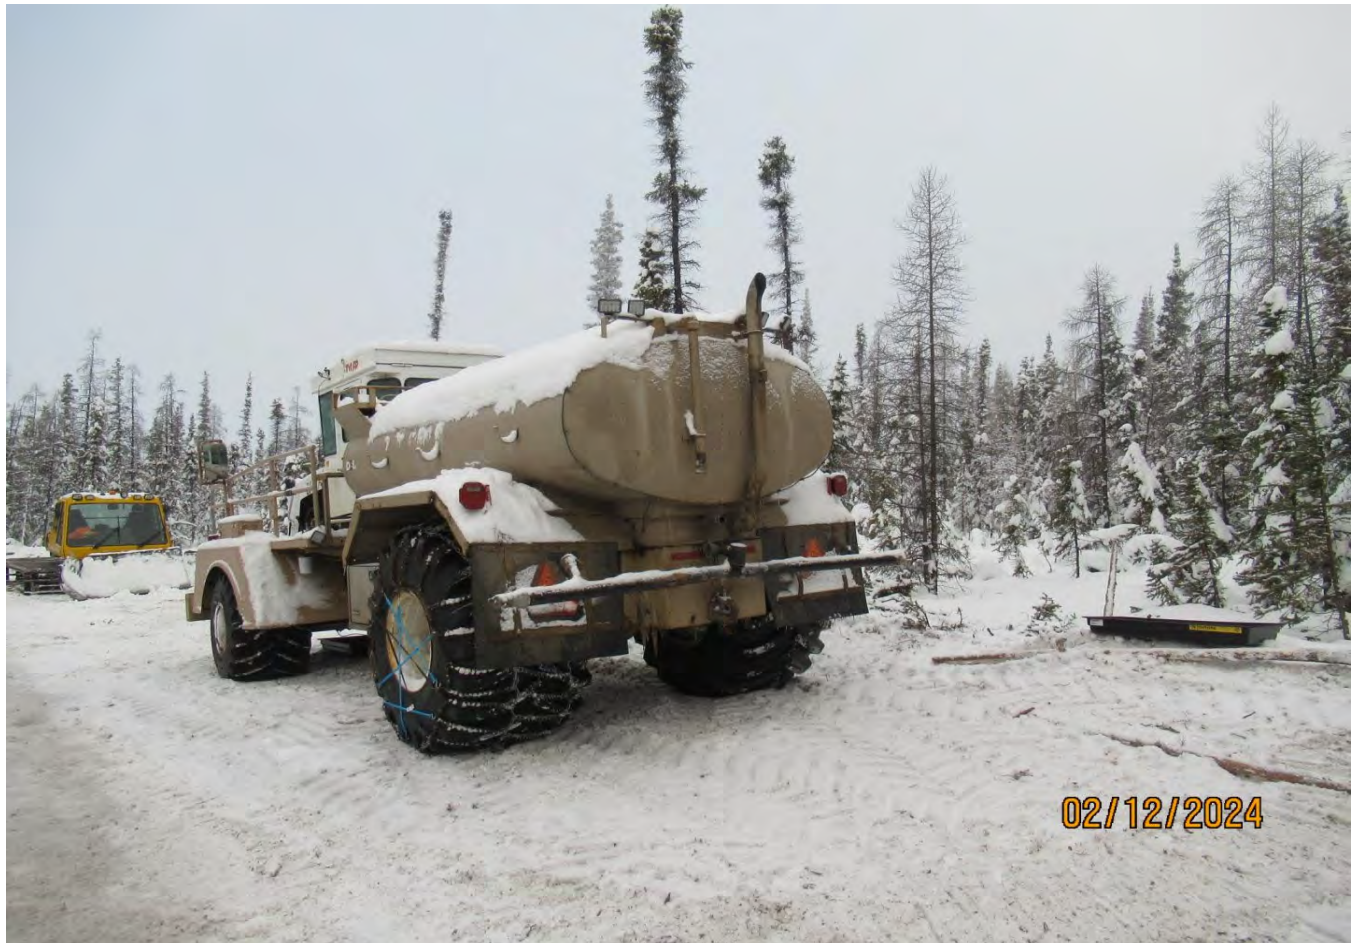
Figure 9
Second water truck in the land use area. Drip tray was present beneath the engine compartment.

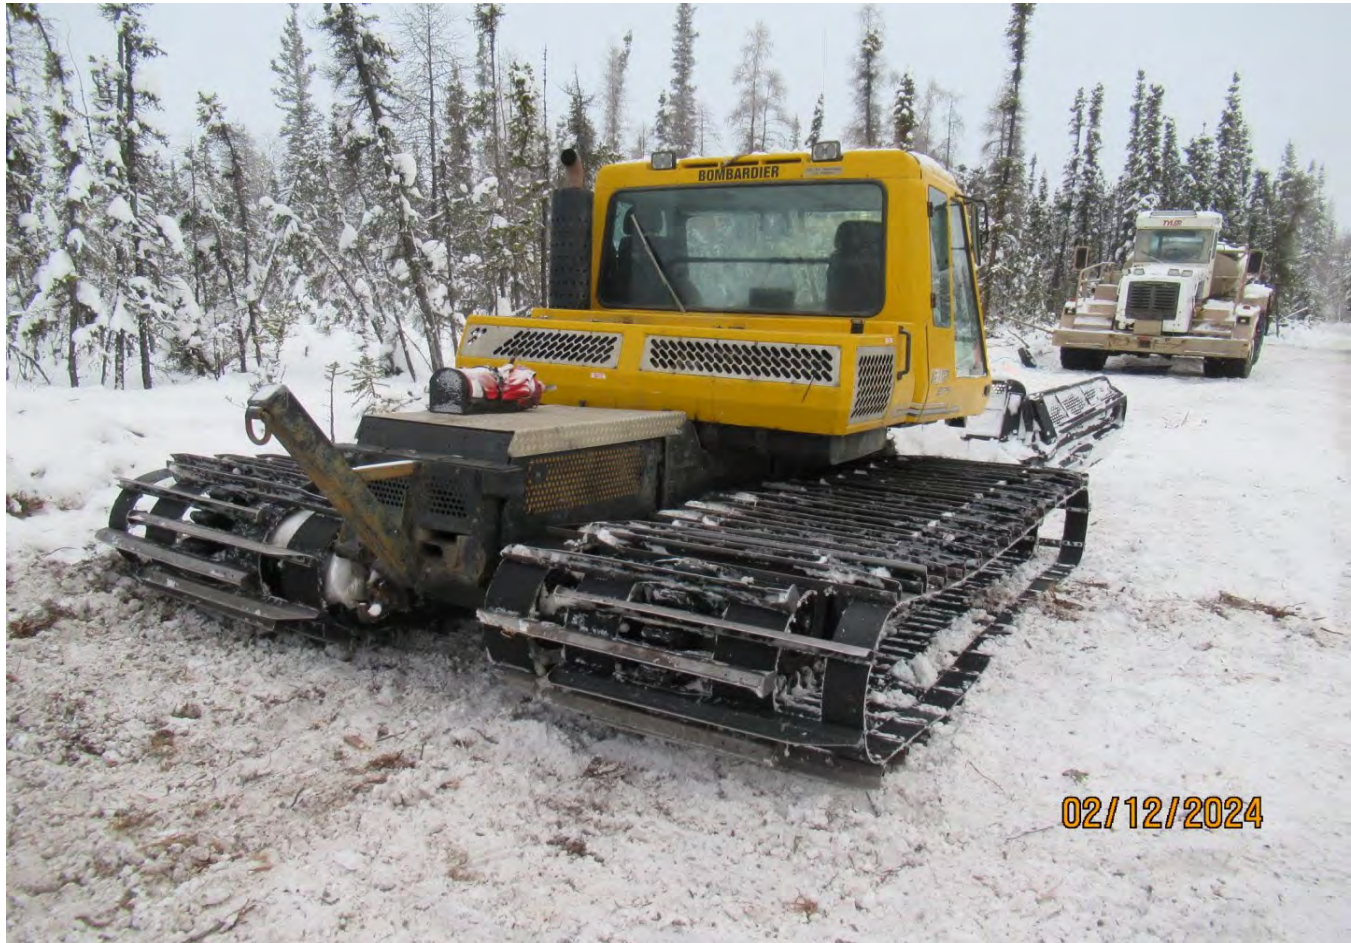
Figure 10
Snowcat parked adjacent to the portage. All parking areas on land must be watered in to protect the ground surface from damage and potential spills.

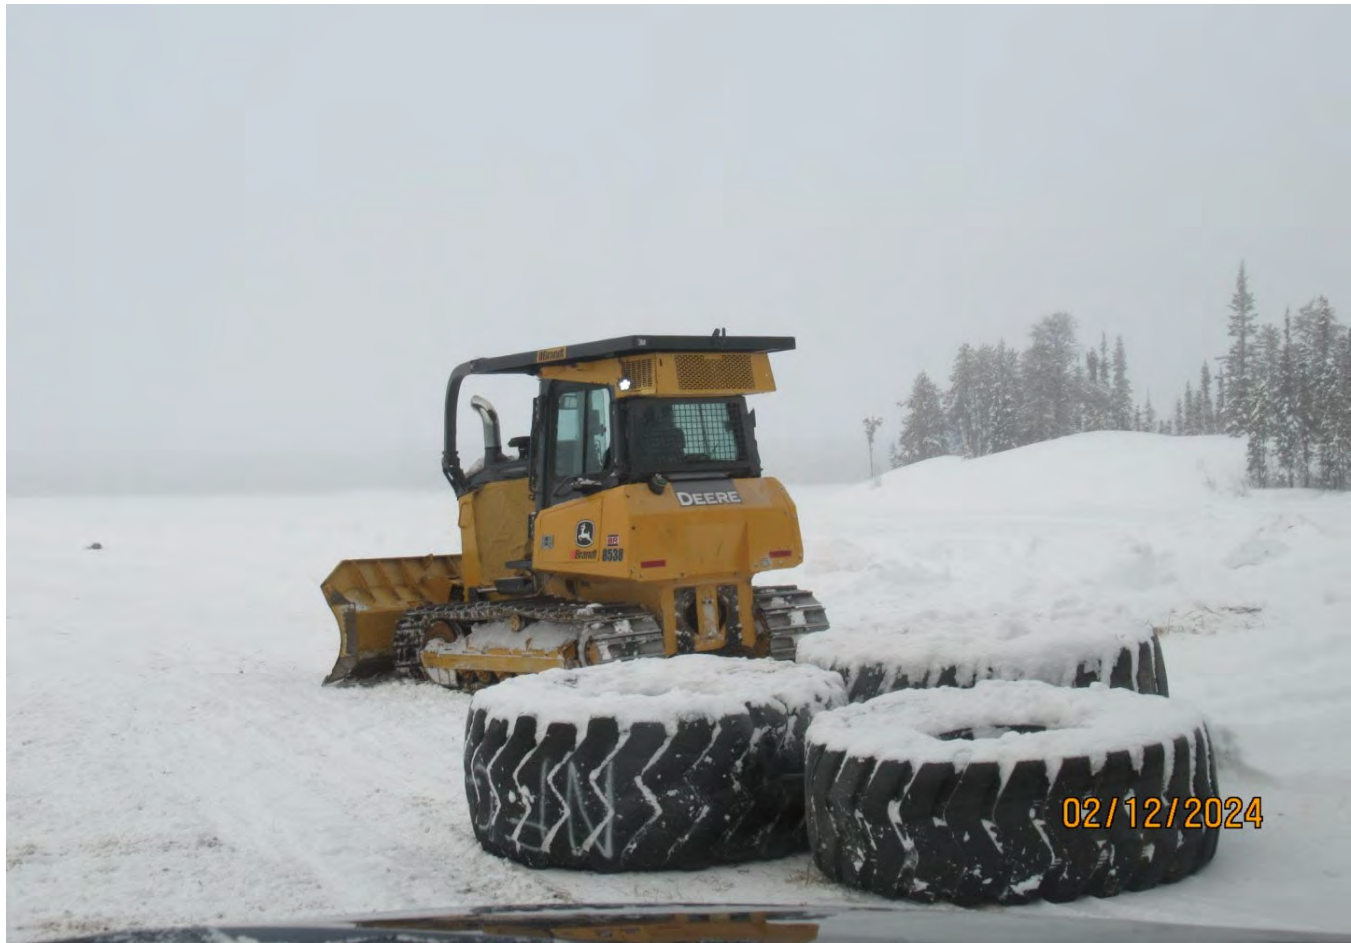
Figure 11
Small dozer is being used for initial tree clearing and the dragging of portages.

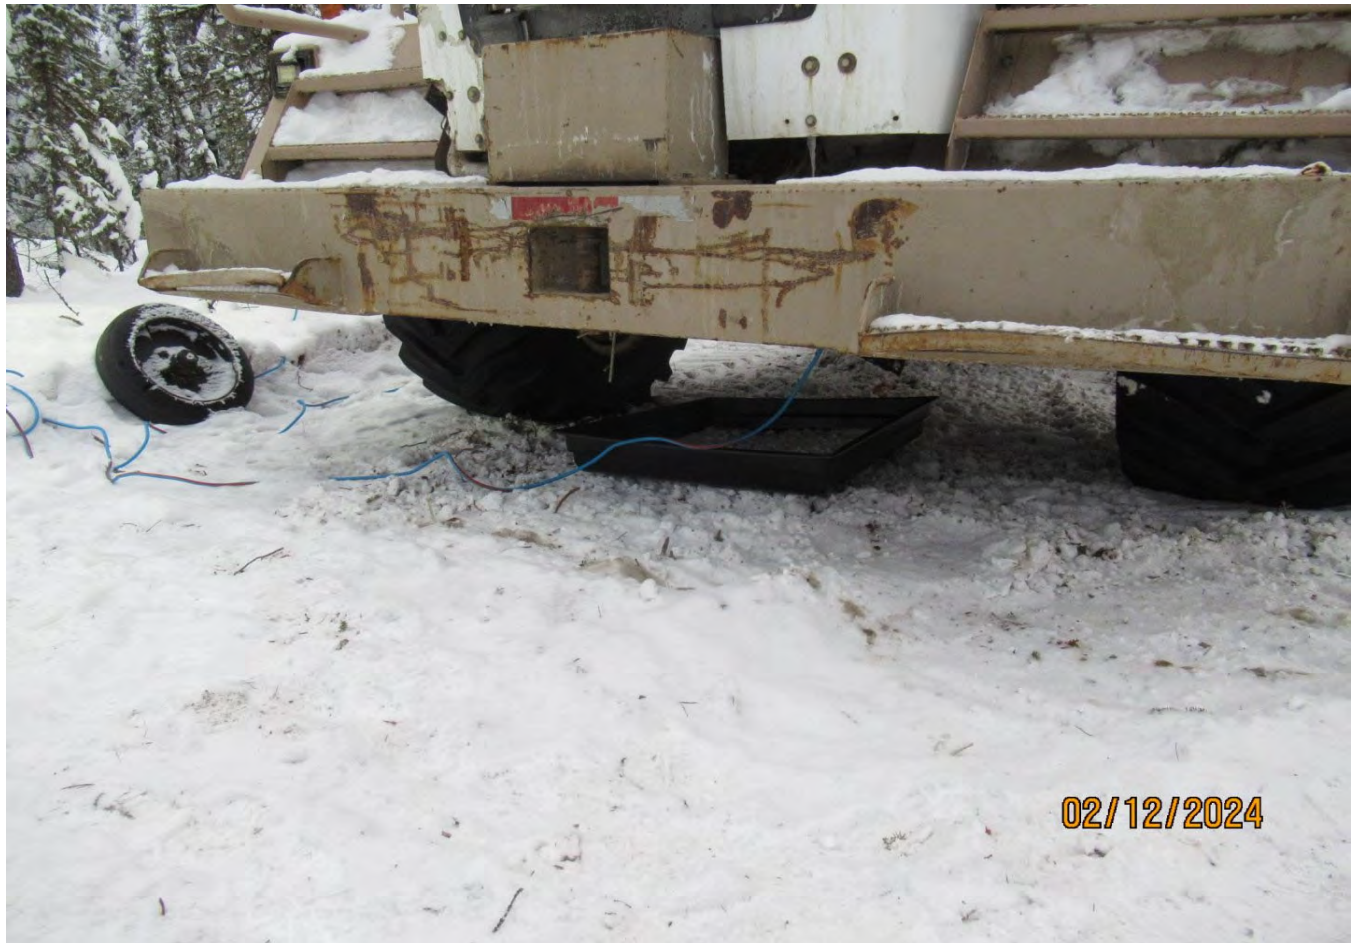
Figure 12
Drip tray was present below the one parked water truck.

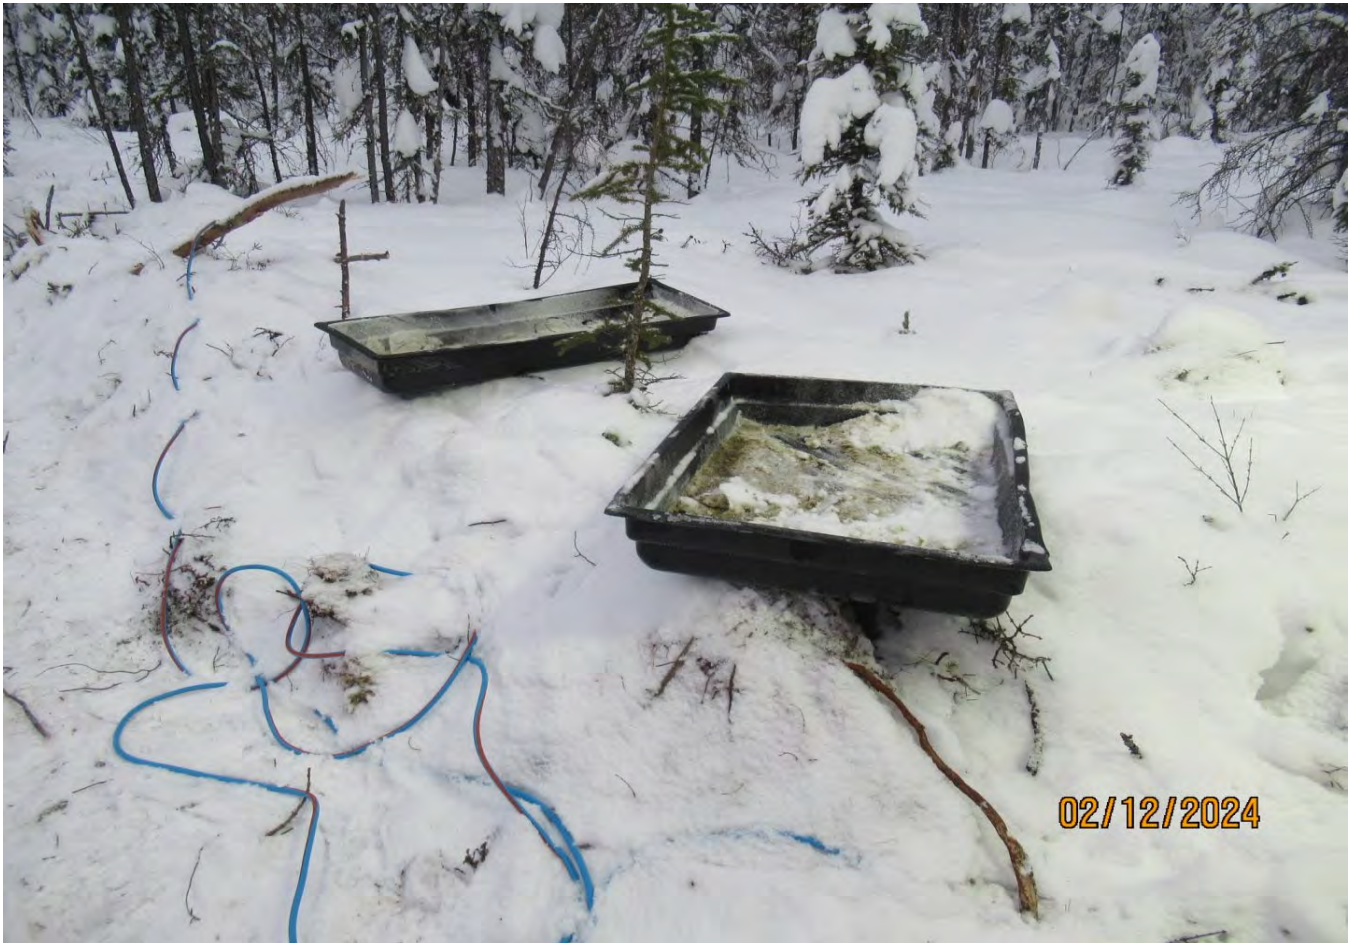
Figure 13
Drip trays for equipment are present. The Contractor must containerize hydrocarbon impacted snow for proper offsite disposal at a licensed facility in Yellowknife.

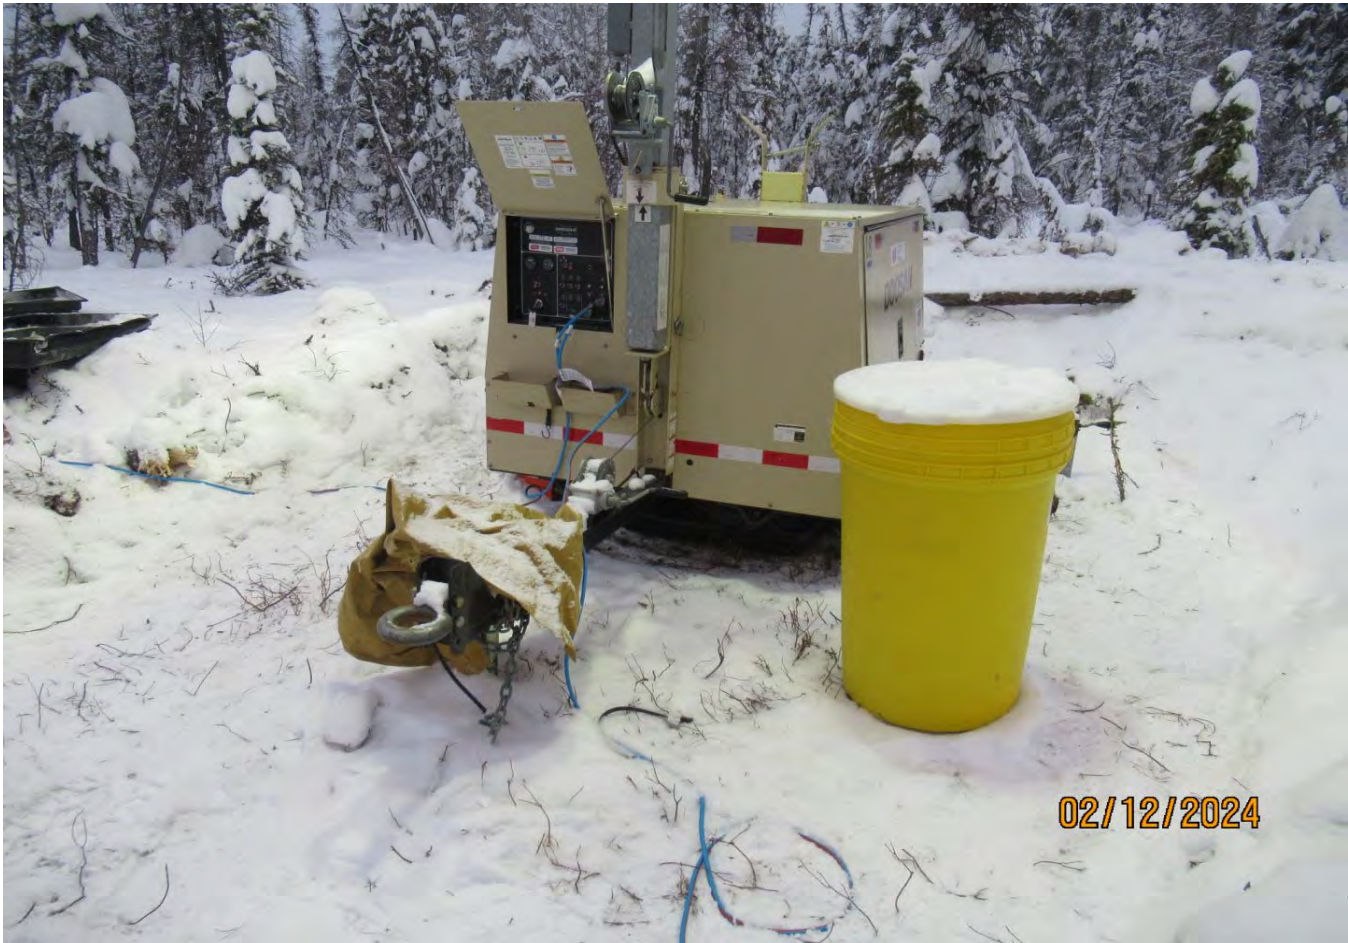
Figure 14
Light plant in the equipment laydown had a drip tray and a spill kit is present.

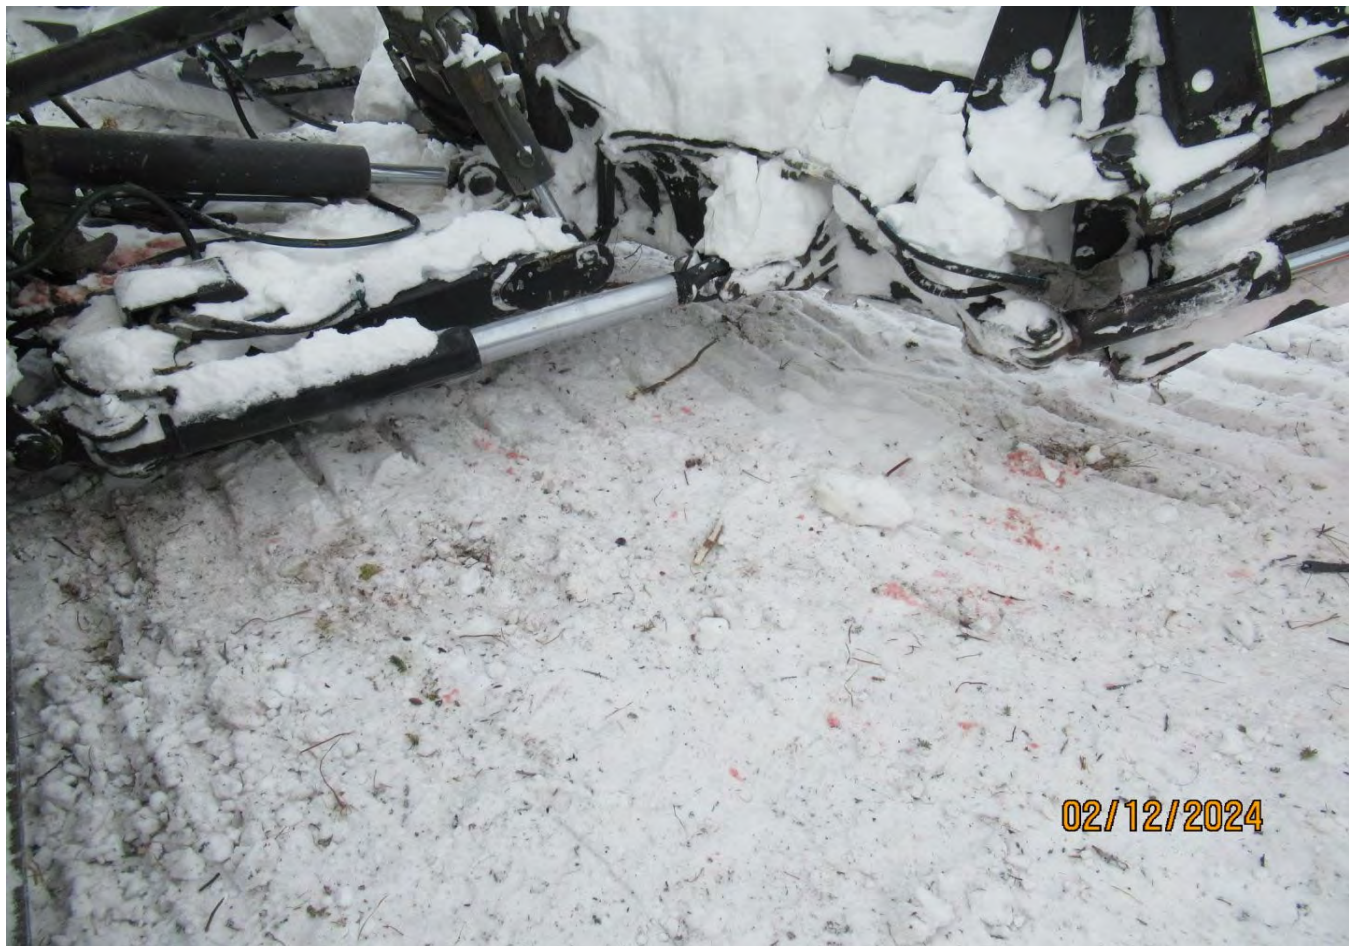
Figure 15
The fittings on the Snowcat are weeping. Hydraulic fluid was observed on the ground surface and requires cleanup for offsite disposal.

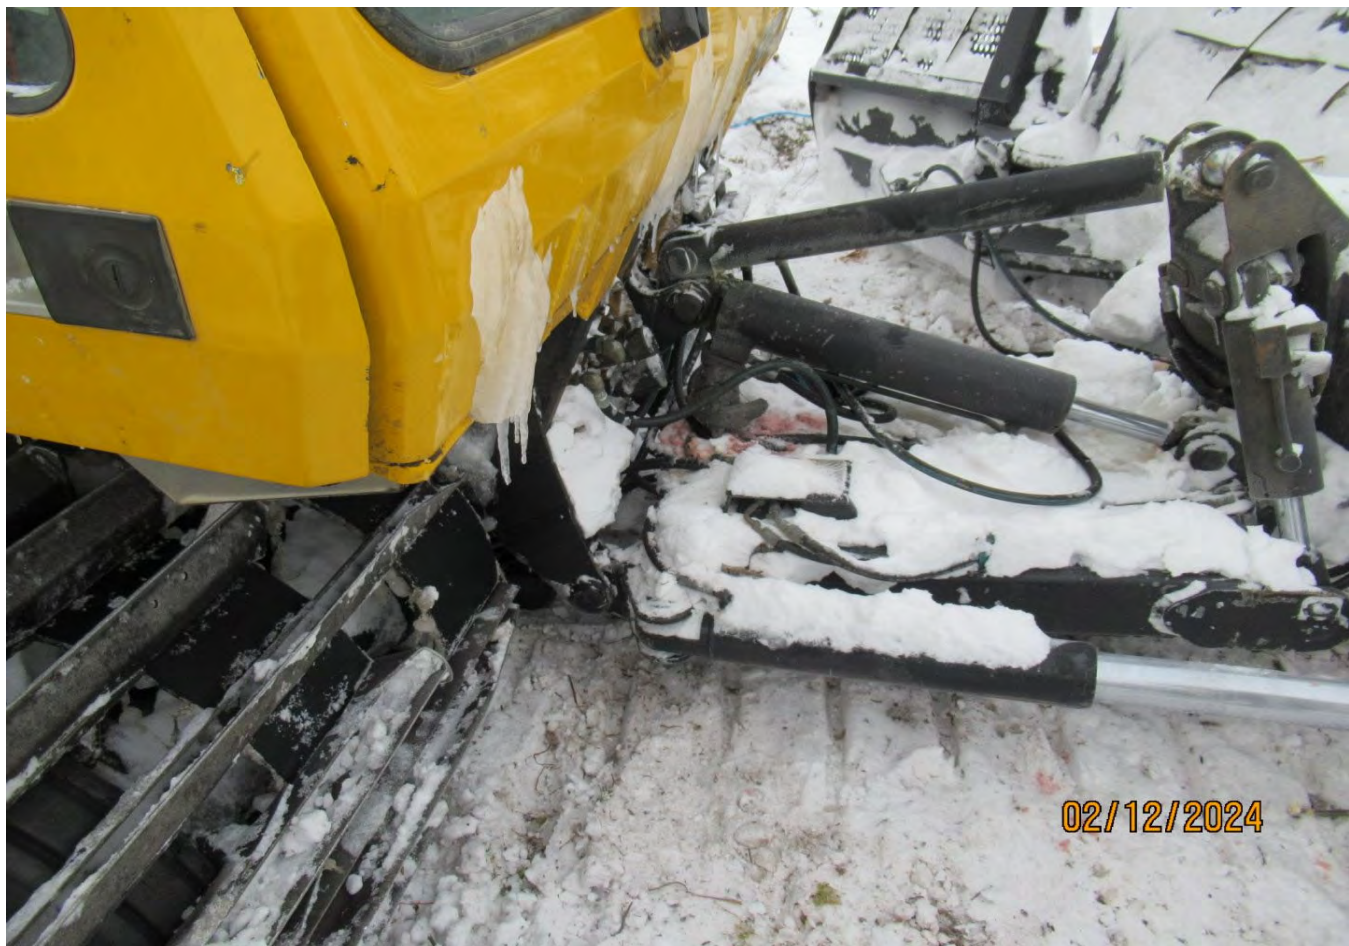
Figure 16
Personnel were wrapping fittings with absorbent matting to prevent further loss to the receiving environment. Persistent leaks must be repaired at the earliest opportunity.

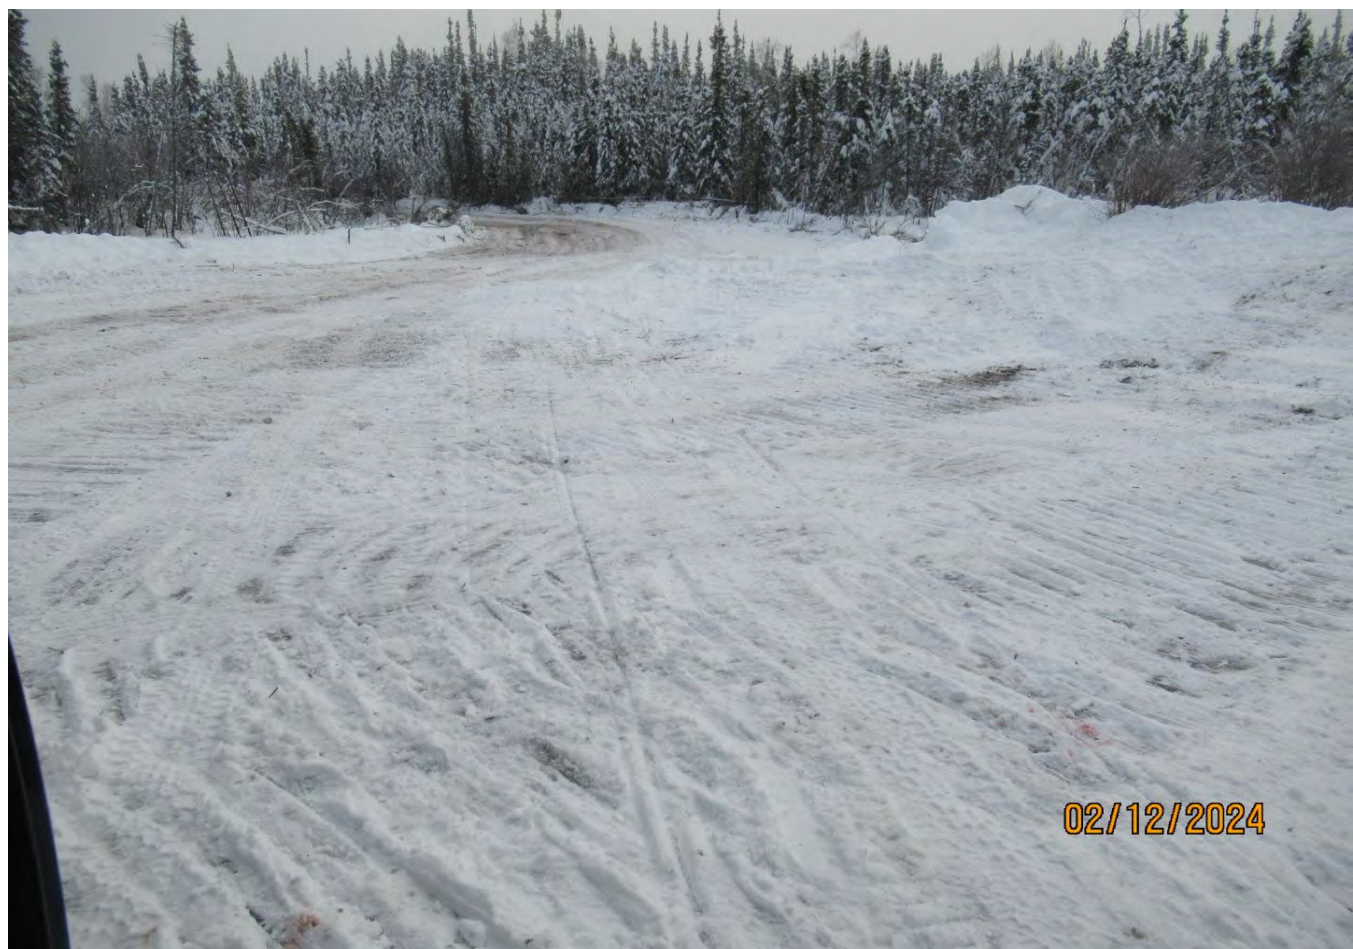
Figure 17

Small amount of hydraulic fluid was seen at the north end of Bighill Lake and a thorough cleanup is required.
