**Re: Land Use Permit MV2022C0021
Mineral Exploration
Yellowknife Lithium Project, NT**

ENVIRONMENTAL INSPECTION REPORT

Permittee:	EREX International Ltd.	Inspection Date – February 12 th & 13 th , 2024
------------	-------------------------	---

Location(s) Inspected:	Bighill Lake winter road, Echo Camp, and the ECHO Diamond Drill Program.
------------------------	--

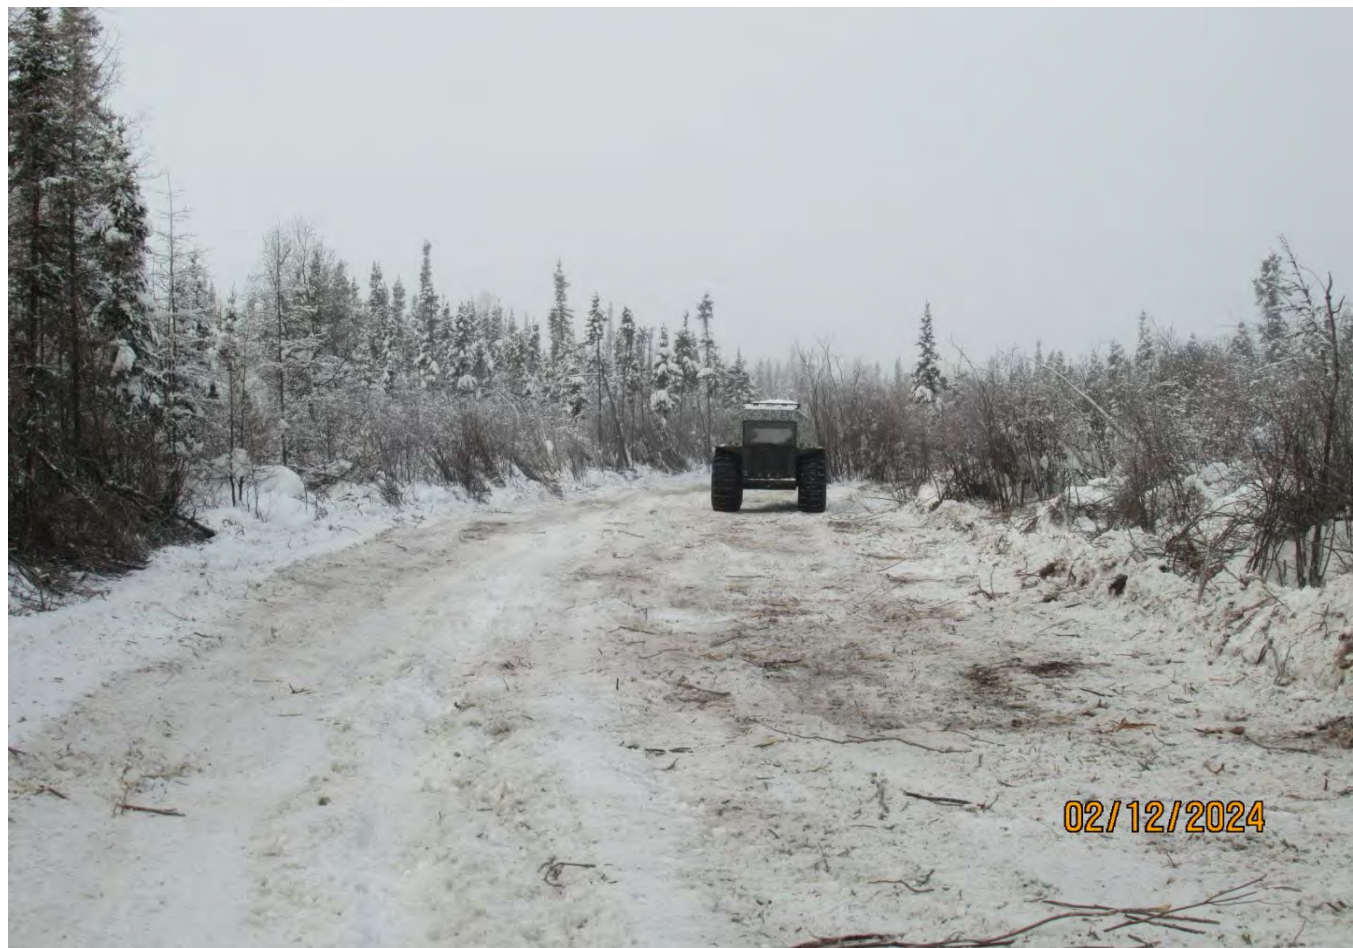
Figure 18

Section of a portage that has been widened. The Permittee is restricted to 10 metre width on portages and must minimize the amount of tree clearing that occurs.

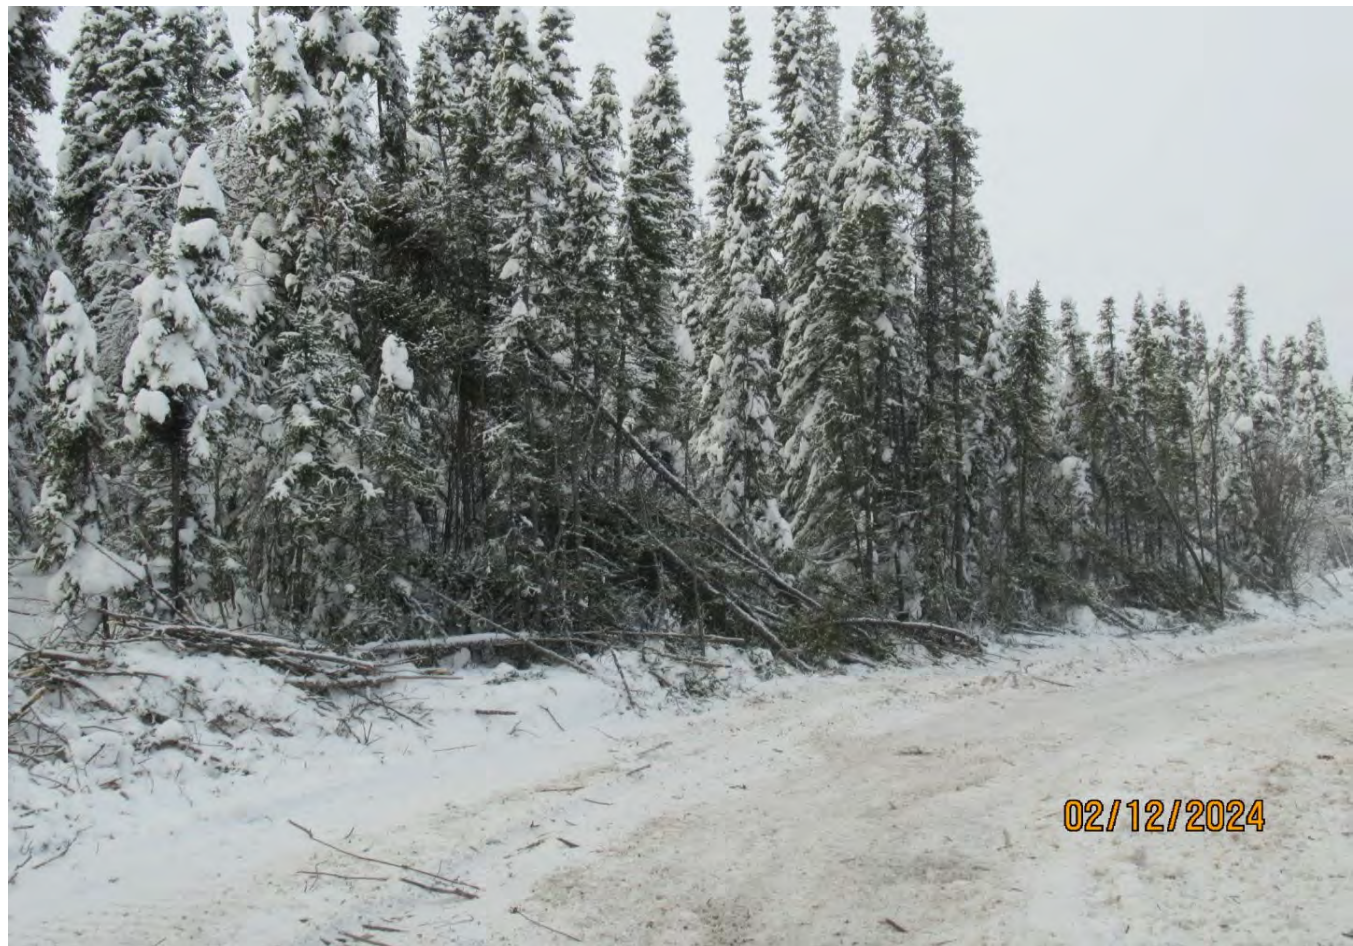
Figure 19
Leaners and displaced trees require proper disposal prior to the demobilization of the winter road contractor.

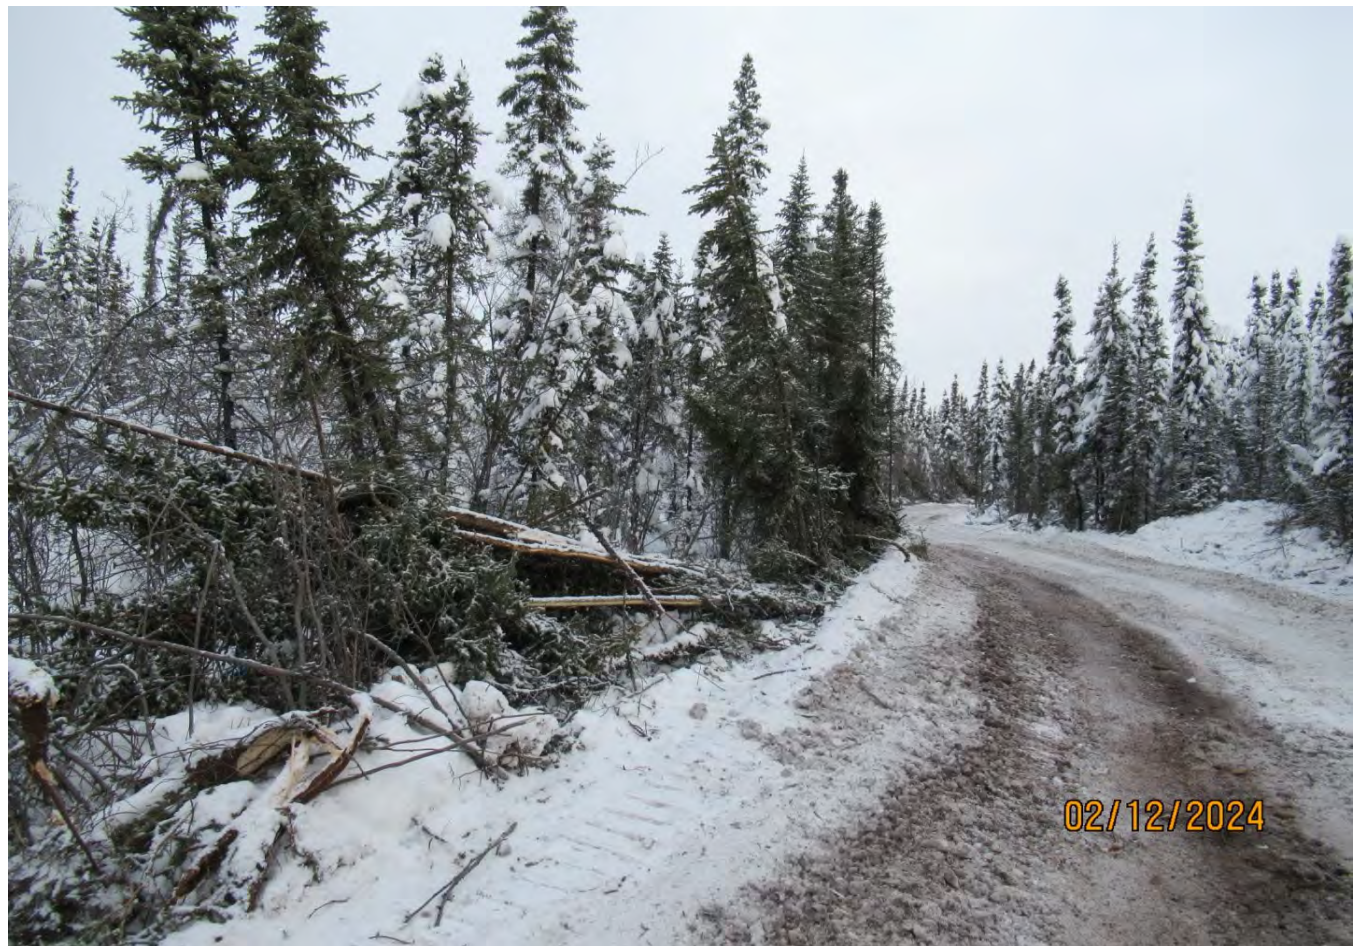
Figure 20
Another example of trees requiring proper disposal.

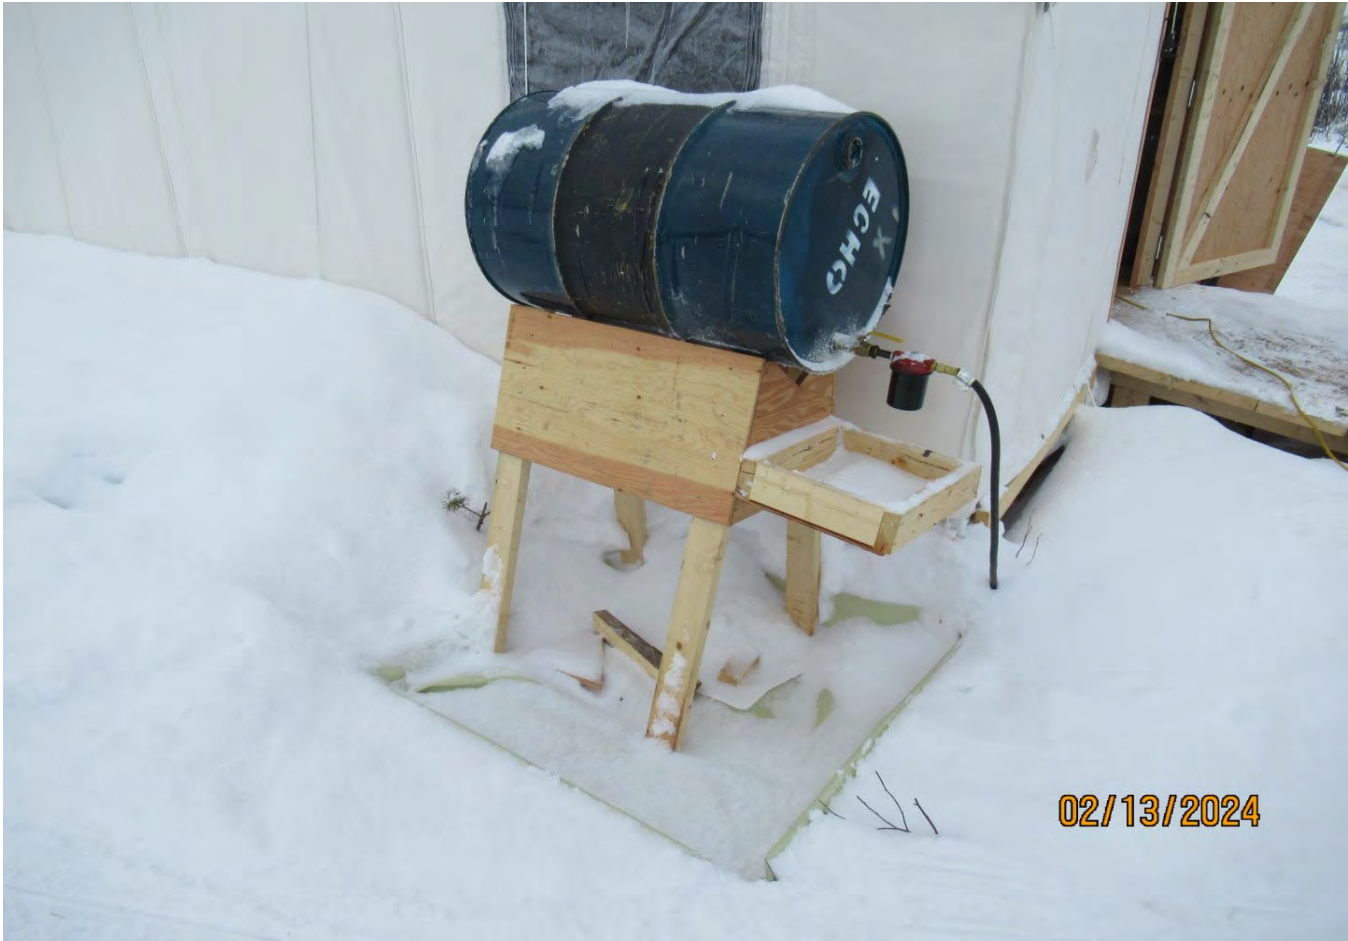
Figure 23
All active fuel drums have secondary containment below the fittings.

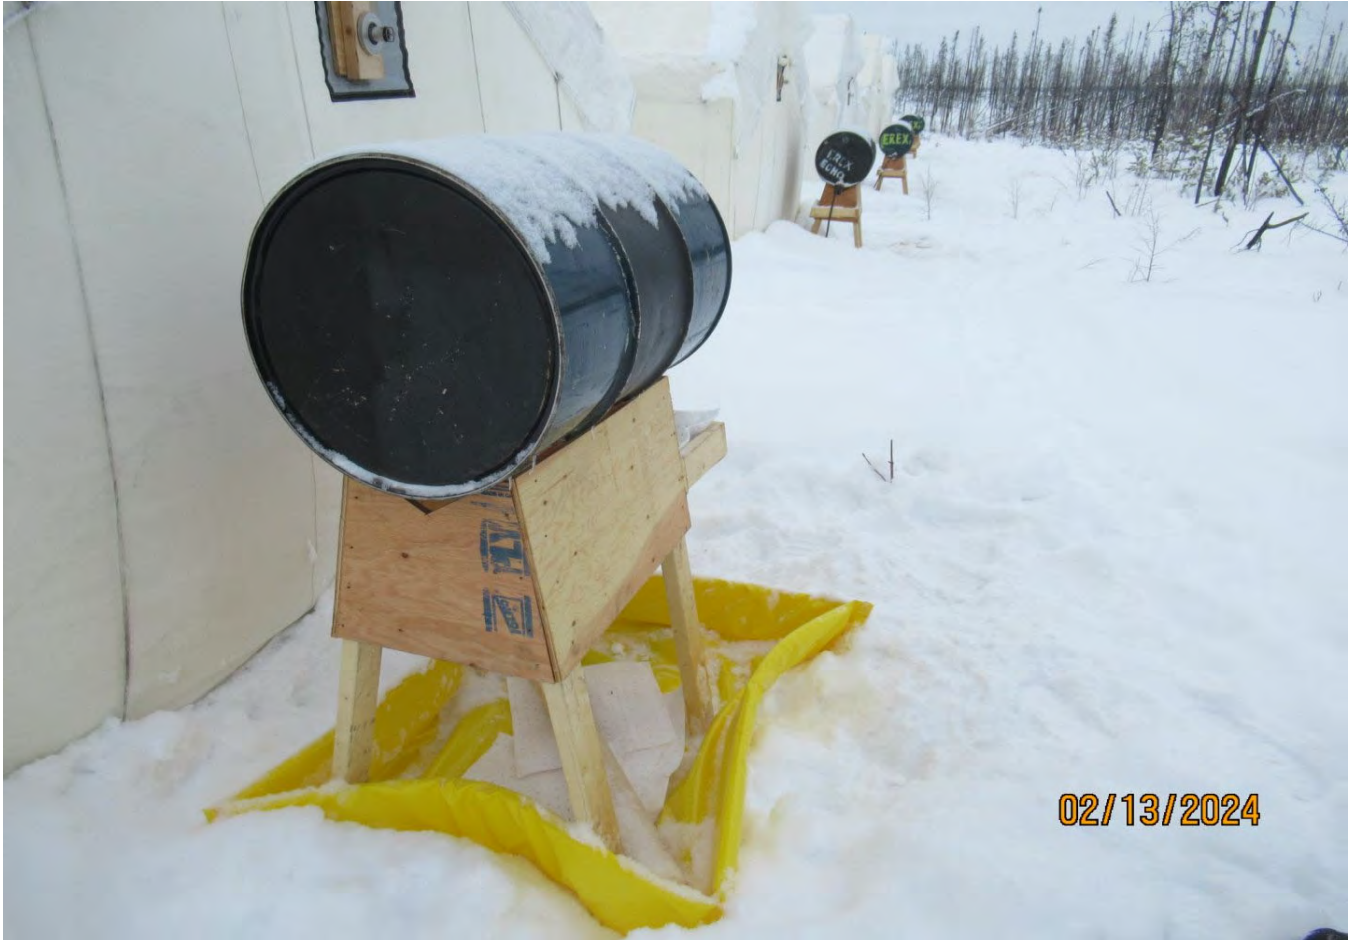
Figure 24
Another view of active drums behind sleeper tents in the Echo Camp.

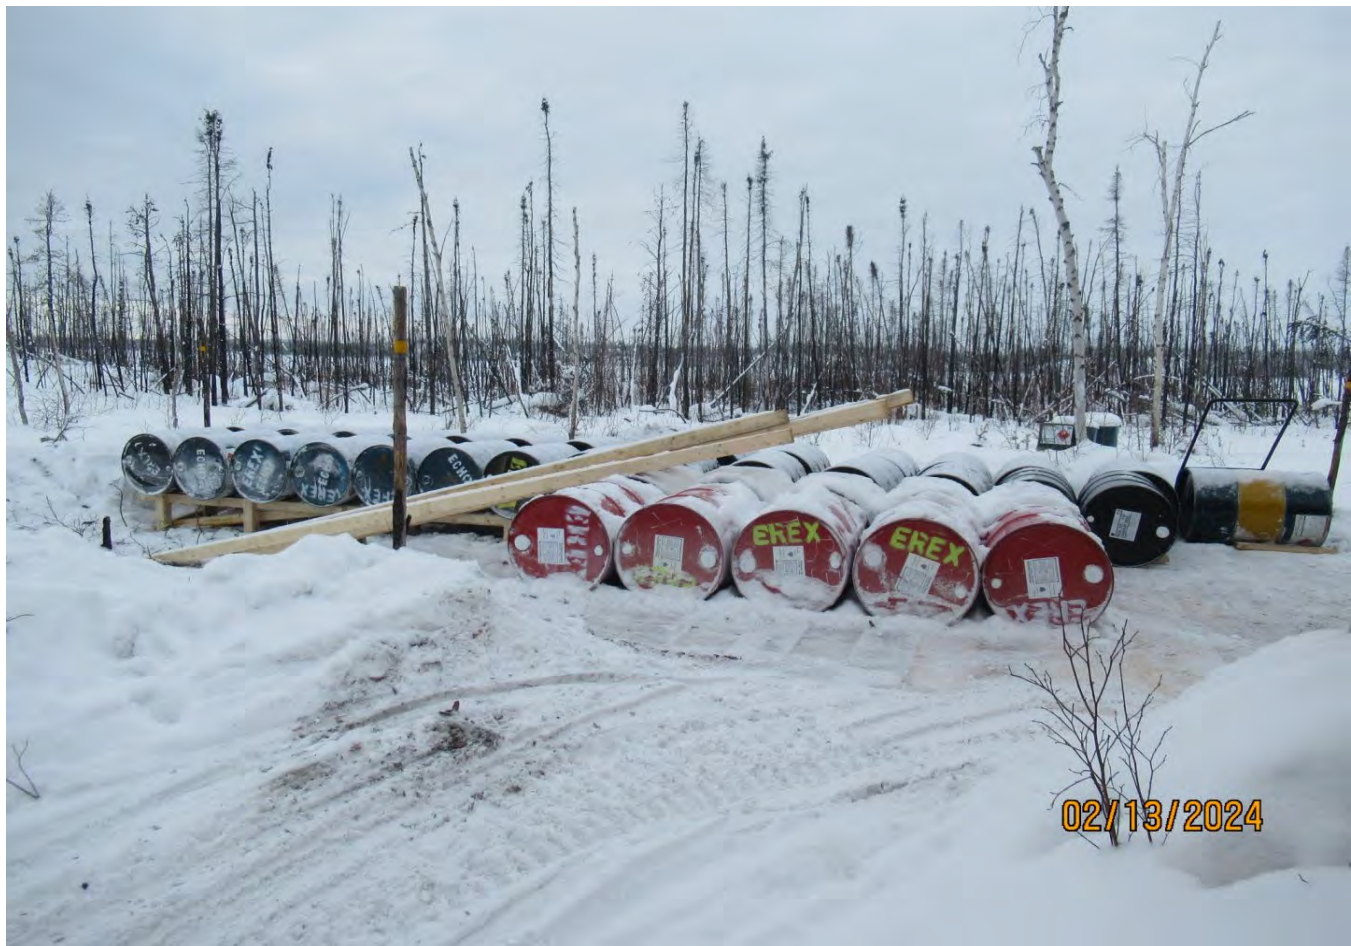
Figure 25
Camp fuel cache south of the generator building. Drums have the Permittee’s name and bungs are positioned at 3 and 9 o’clock.

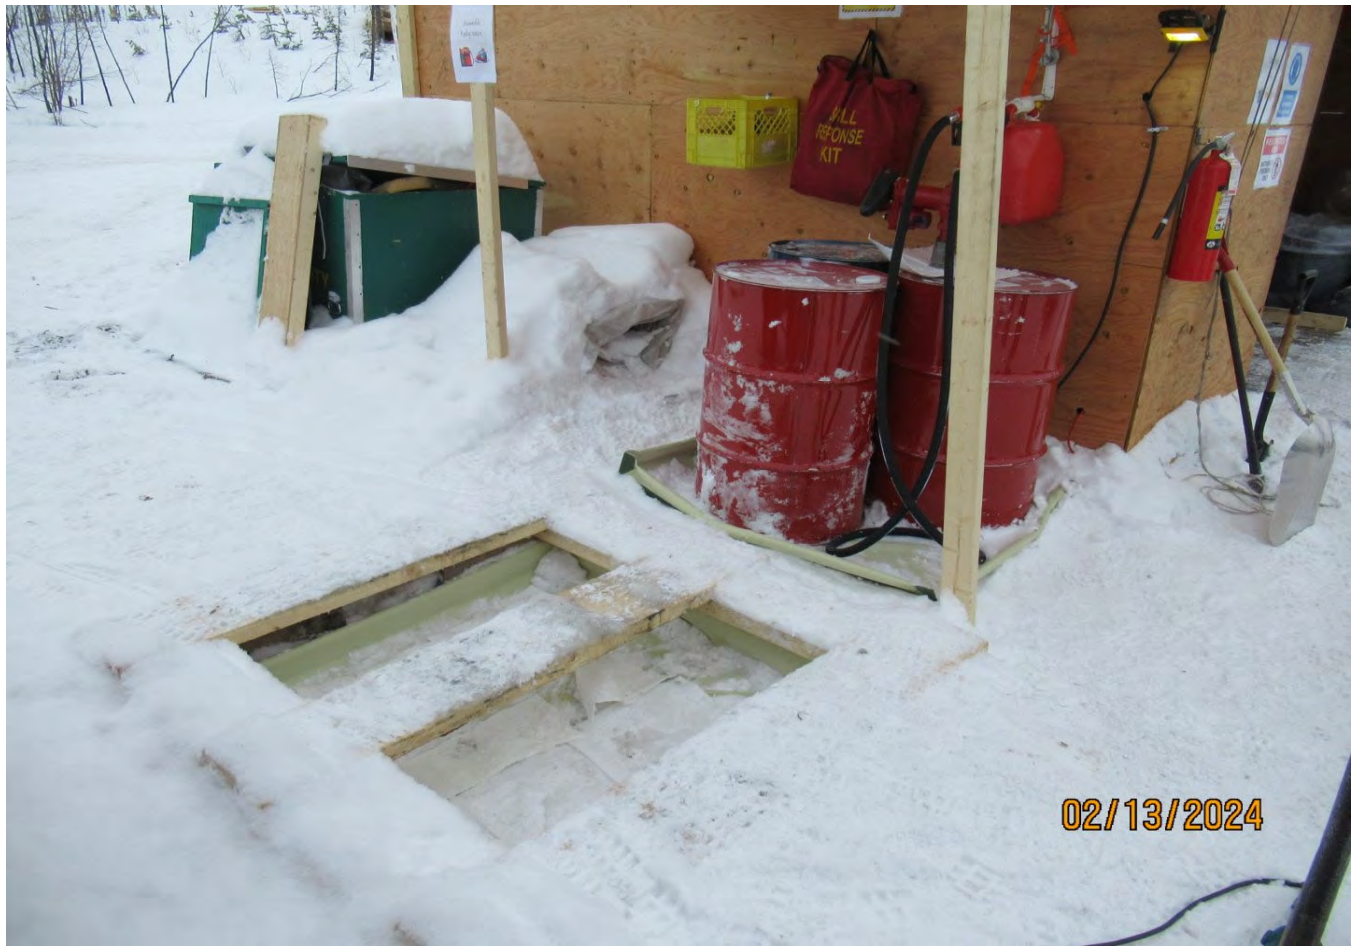
Figure 26
Gasoline drums have been placed in secondary containment and snowmobiles are being fueled overtop of this secondary containment structure.

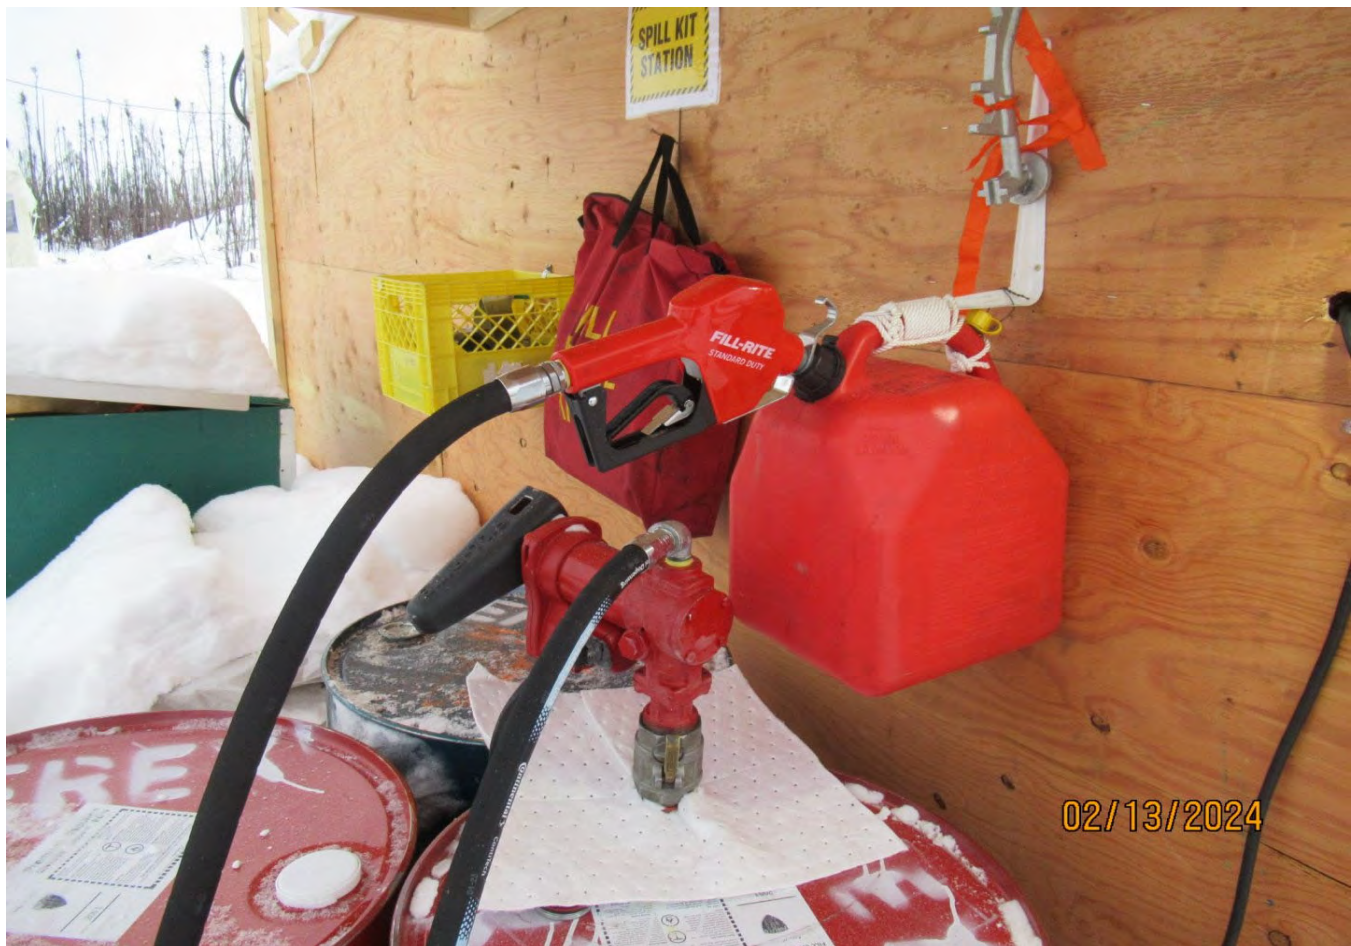
Figure 27
Fuel nozzles are being stored in secondary containment.

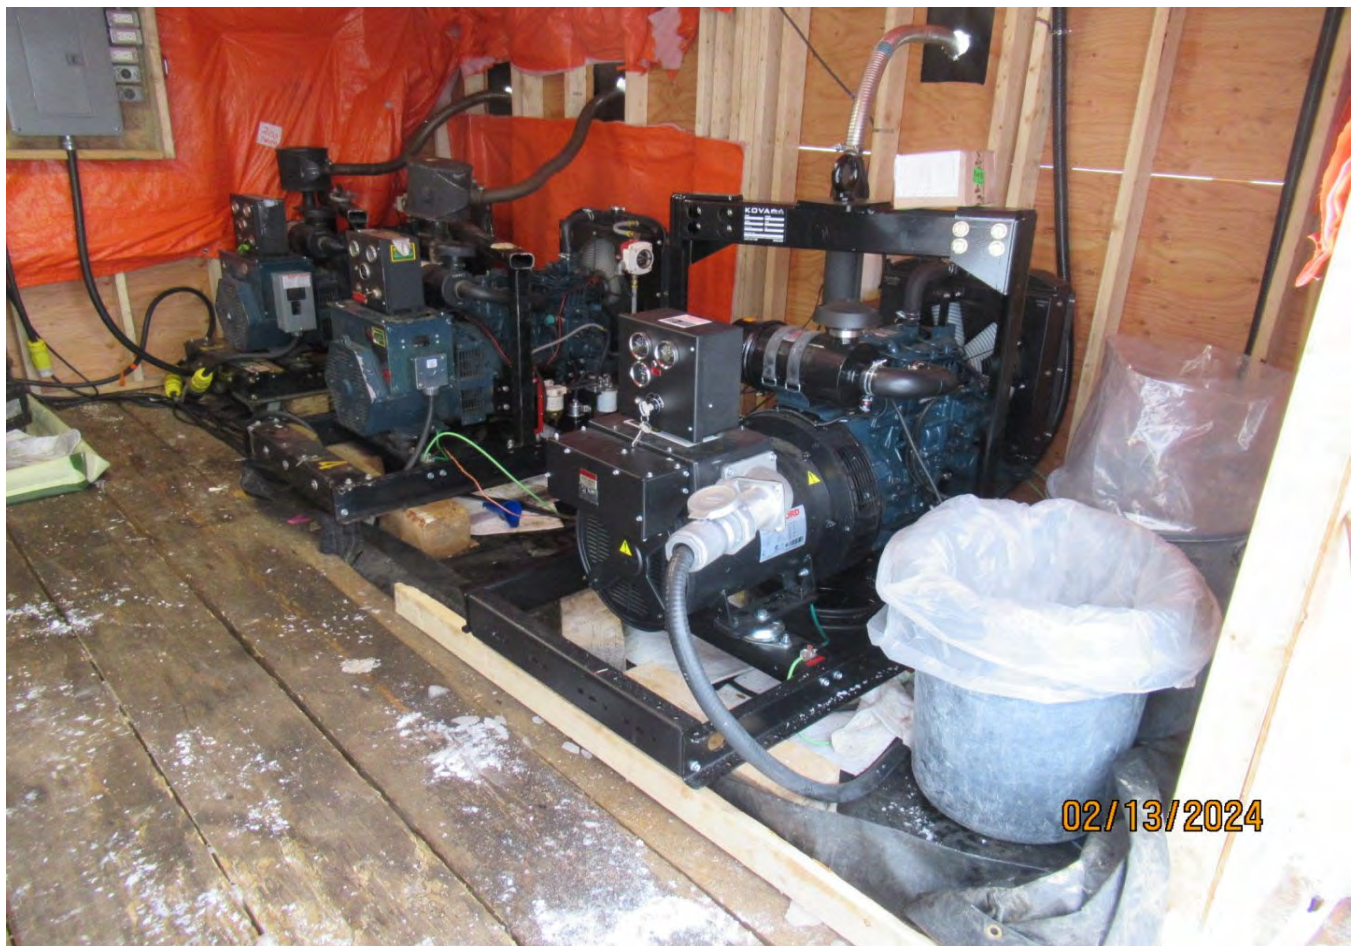
Figure 28
Camp generators have secondary containment present.

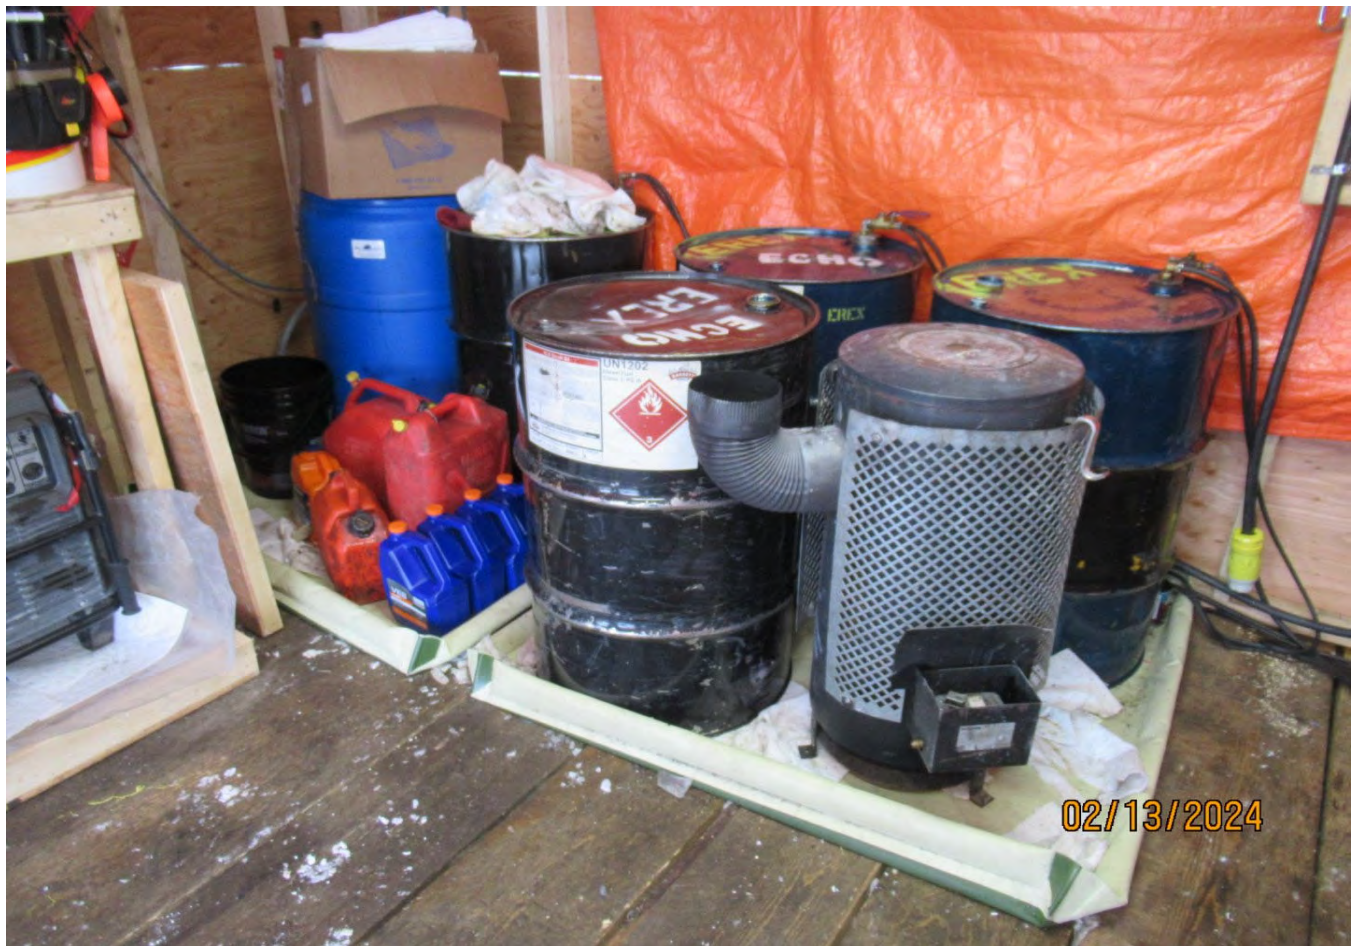
Figure 29
Hydrocarbon containers are stored in secondary containment. Spill kit in the back must be relocated to a more visible and accessible location.

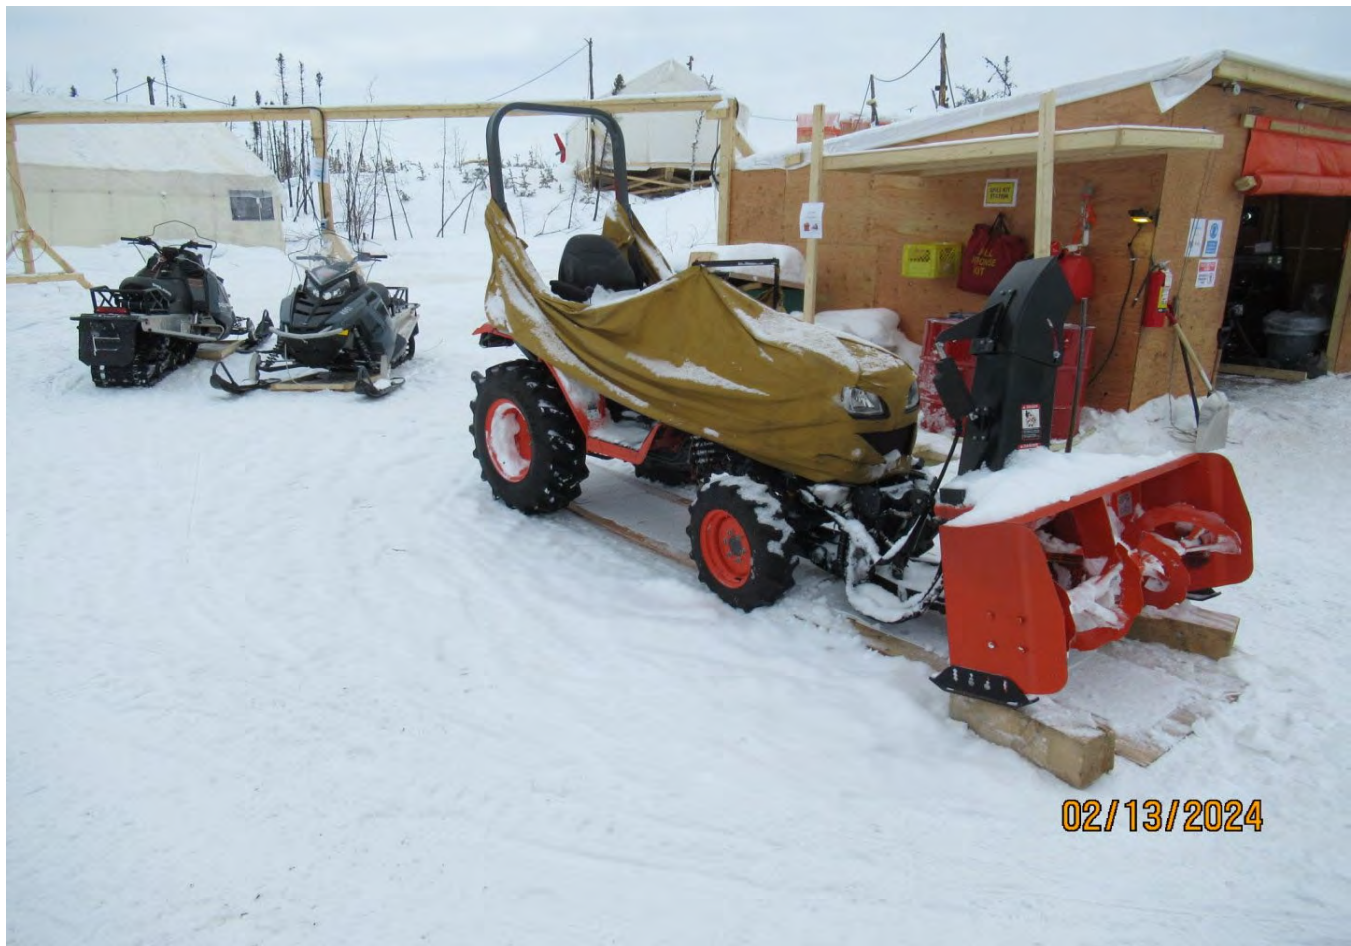
Figure 30
Drip boards are present below all parked vehicles.

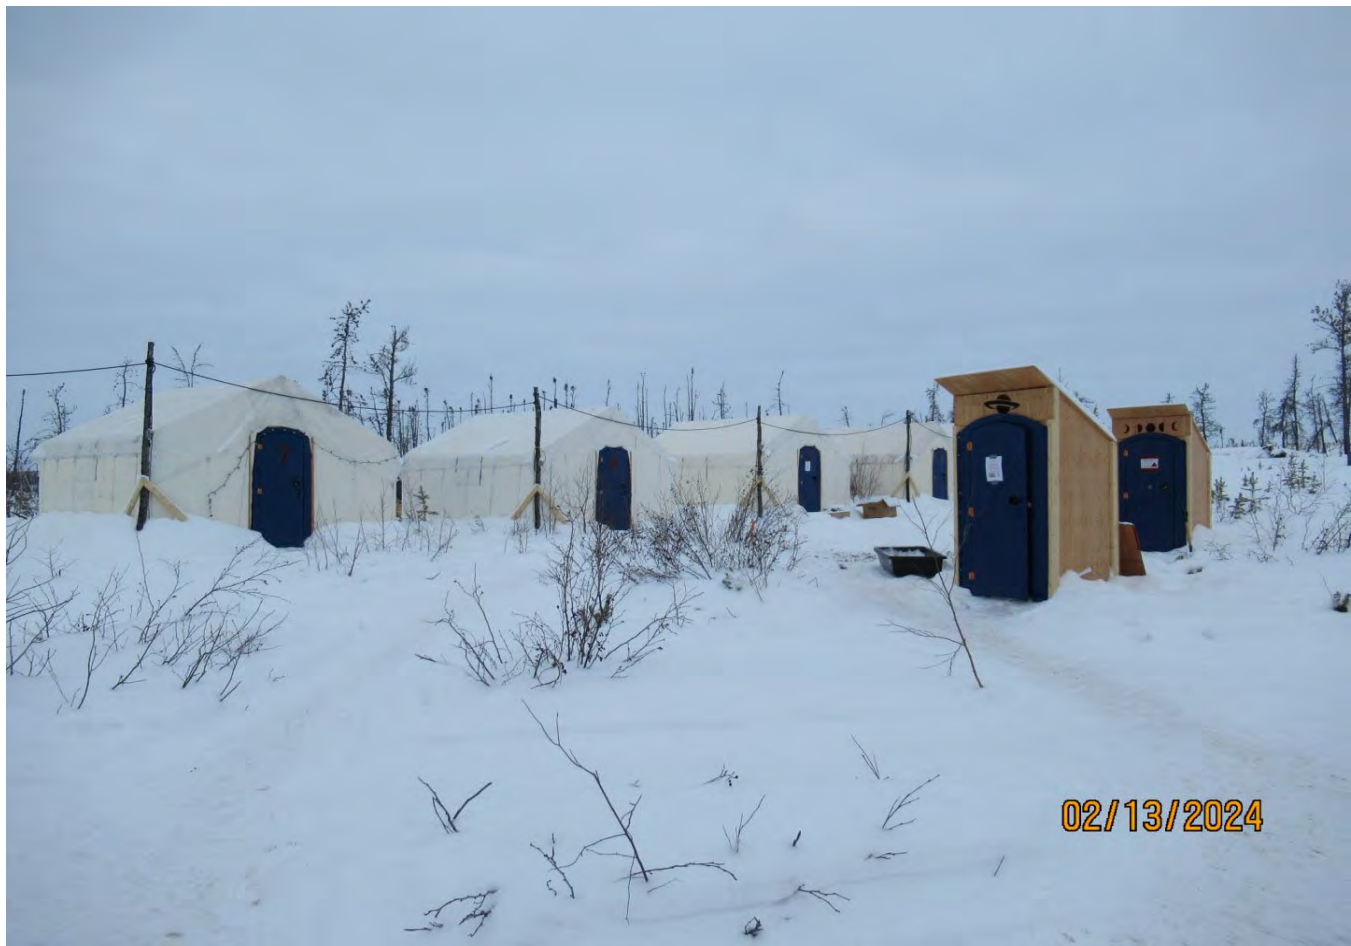
Figure 31
Pit privies are in use for black water disposal. Sump capacity is being diligently monitored and new sumps dug when required.

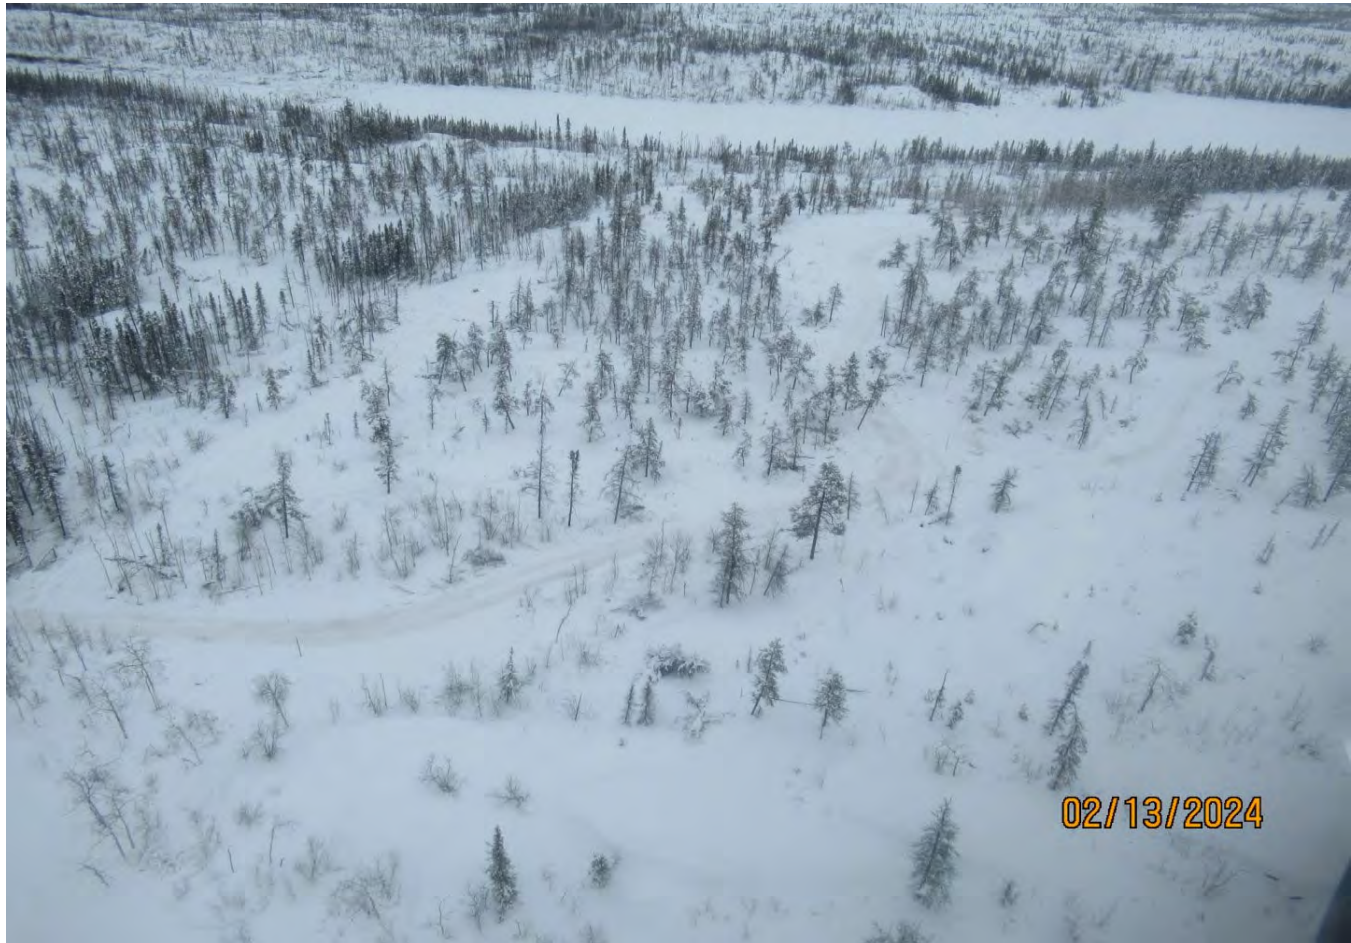
Figure 36
Drill access trails on the south side of Echo Lake. There appeared to be sufficient snow pack to protect the ground surface but diligent monitoring must occur.

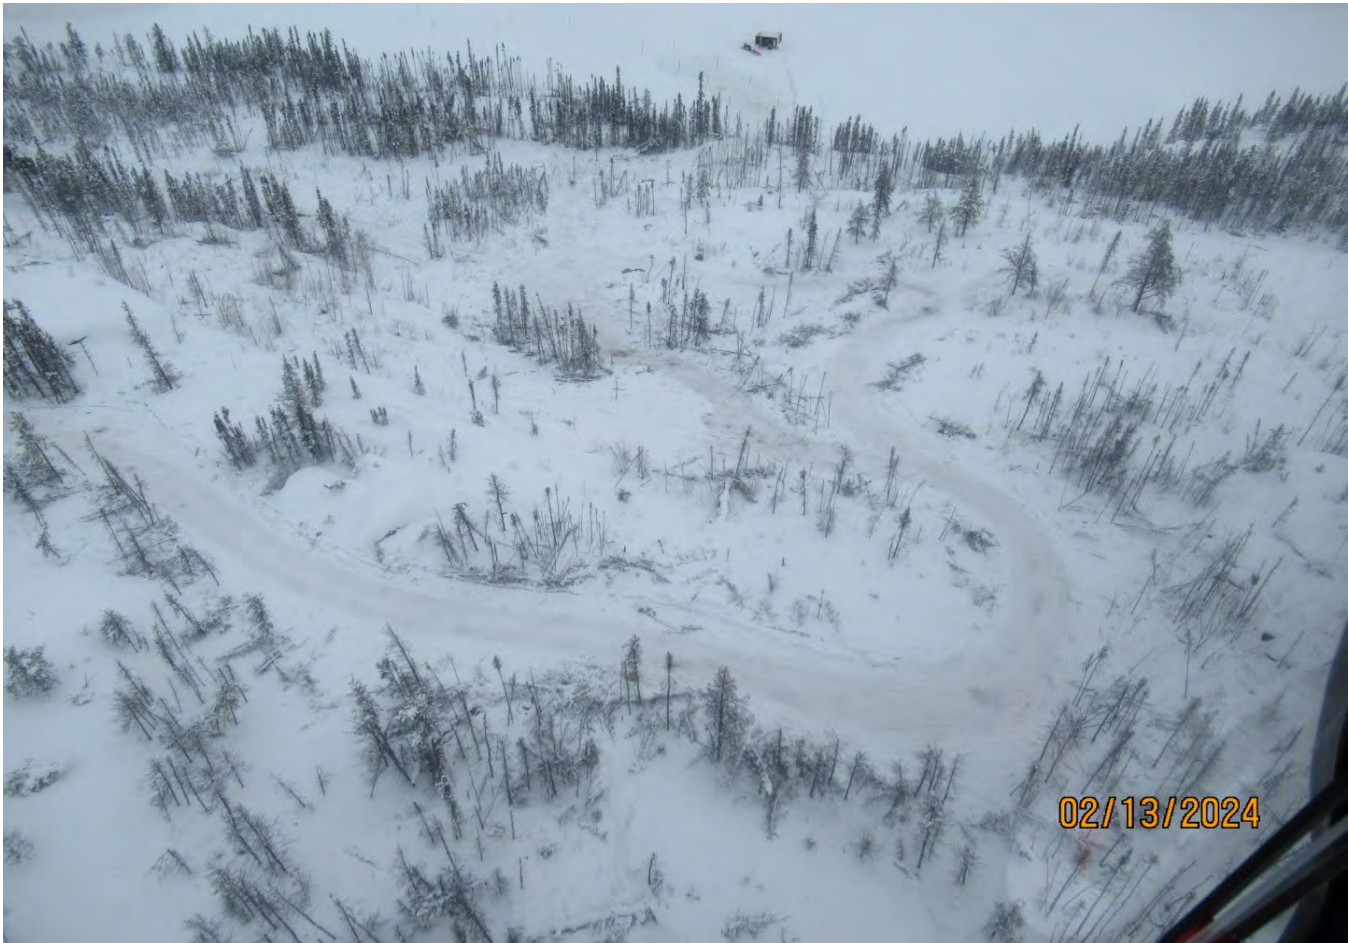
Figure 37
Another example of drill trails. The Contractor must ensure that routes are ground truthed prior to tree removal to prevent unnecessary clearing from occurring.

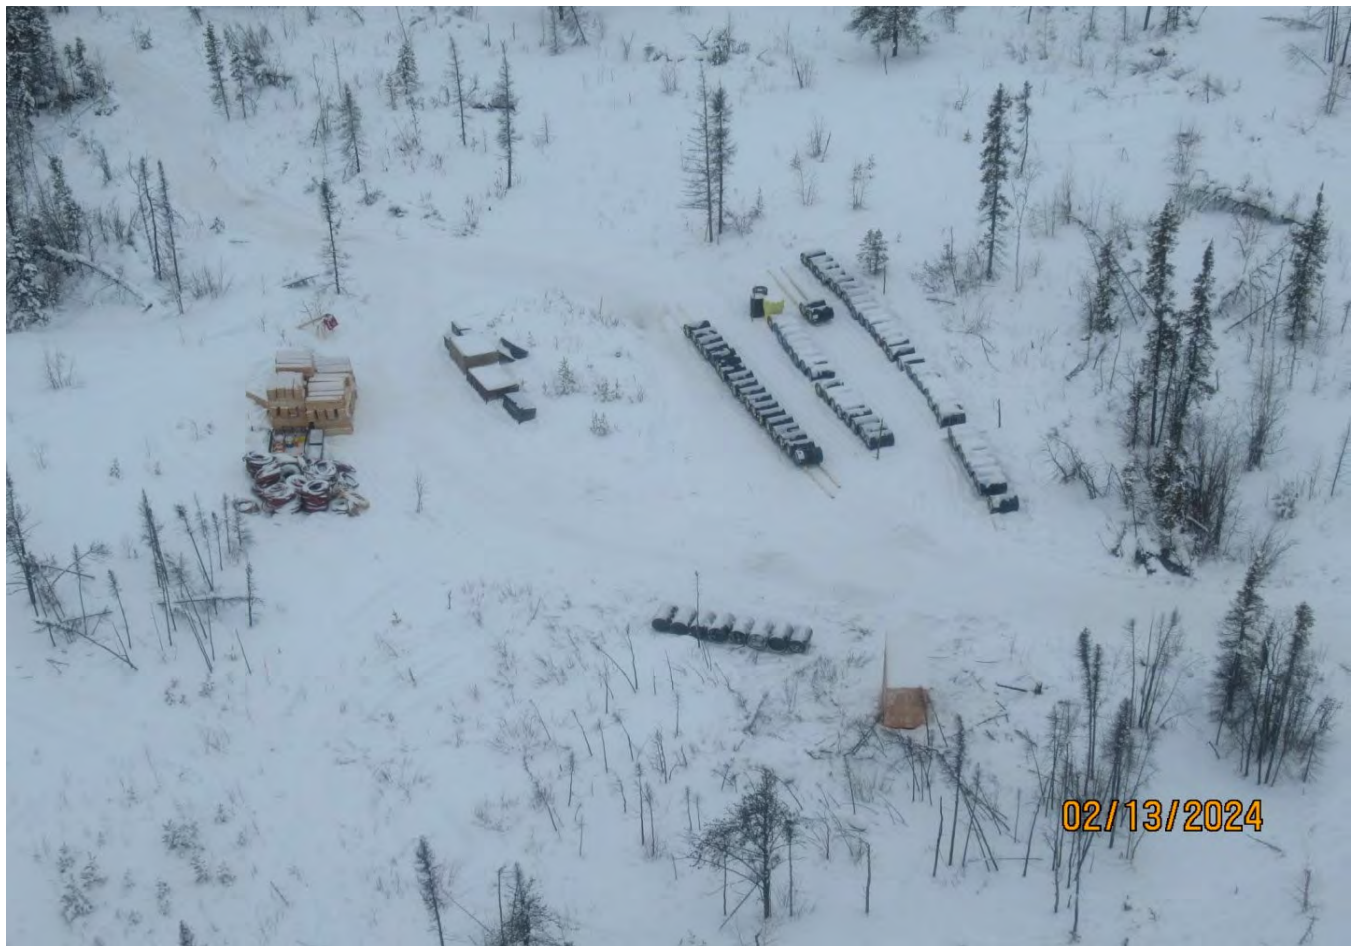
Figure 39

Fuel cache on the east side of Tanco Lake is setback a sufficient distance from OHWM of the lake and walkways are present to allow for diligent monitoring & ease of inspection.

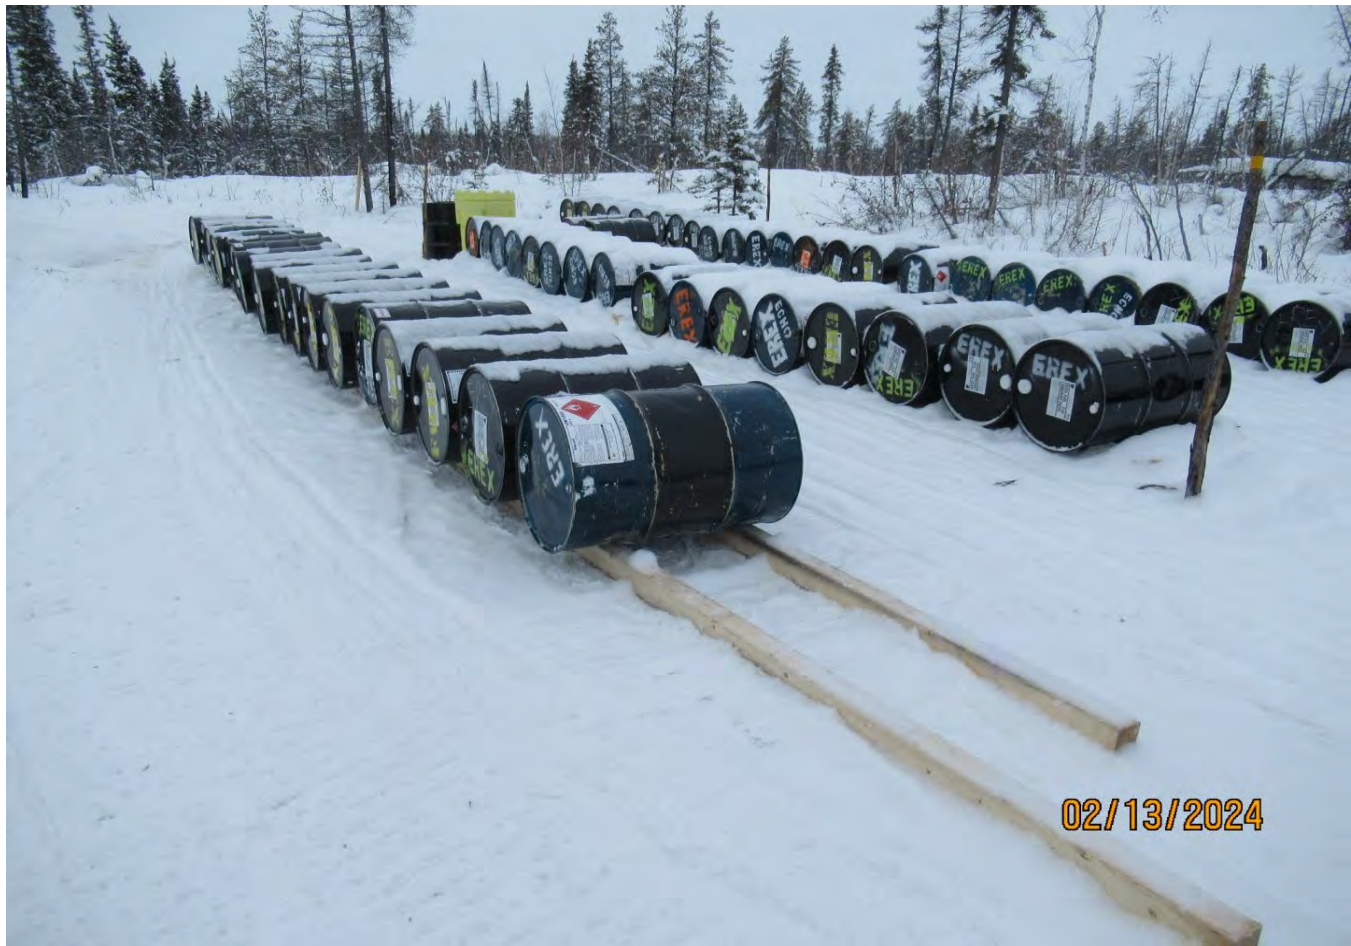
Figure 40

Names are on the drums, delineators are marking the corners of the fuel cache, and bungs are positioned at 3 and 9 o'clock.

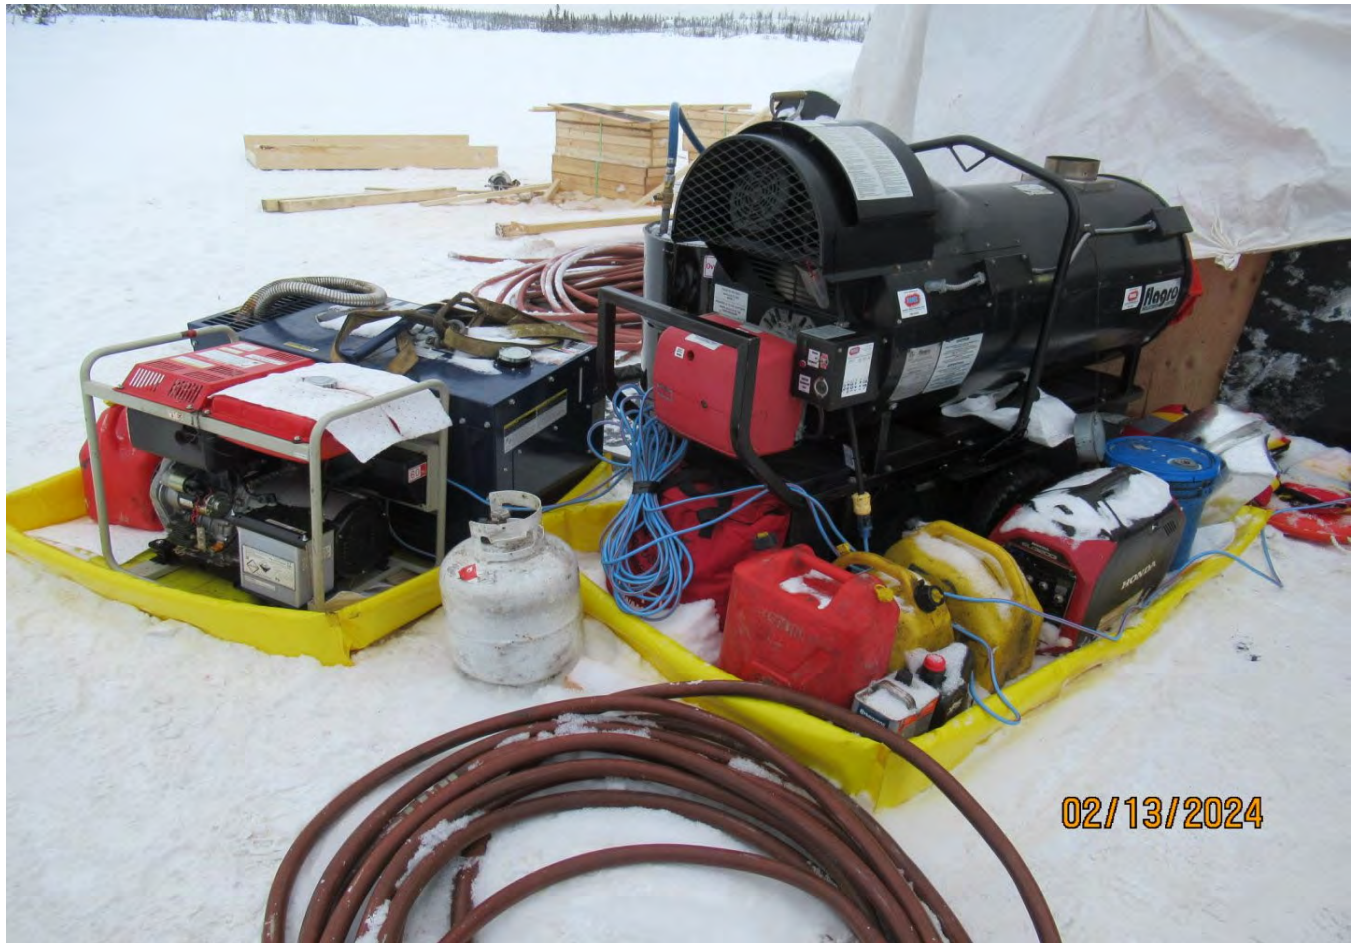
Figure 41
All ancillary equipment and hydrocarbon containers are stored in secondary containment.
