**Re: Land Use Permit MV2022C0021
Mineral Exploration
Yellowknife Lithium Project, NT**

ENVIRONMENTAL INSPECTION REPORT

Permittee:	EREX International Ltd.	Inspection Date – February 12 th & 13 th , 2024
------------	-------------------------	---

Location(s) Inspected:	Bighill Lake winter road, Echo Camp, and the ECHO Diamond Drill Program.
------------------------	--

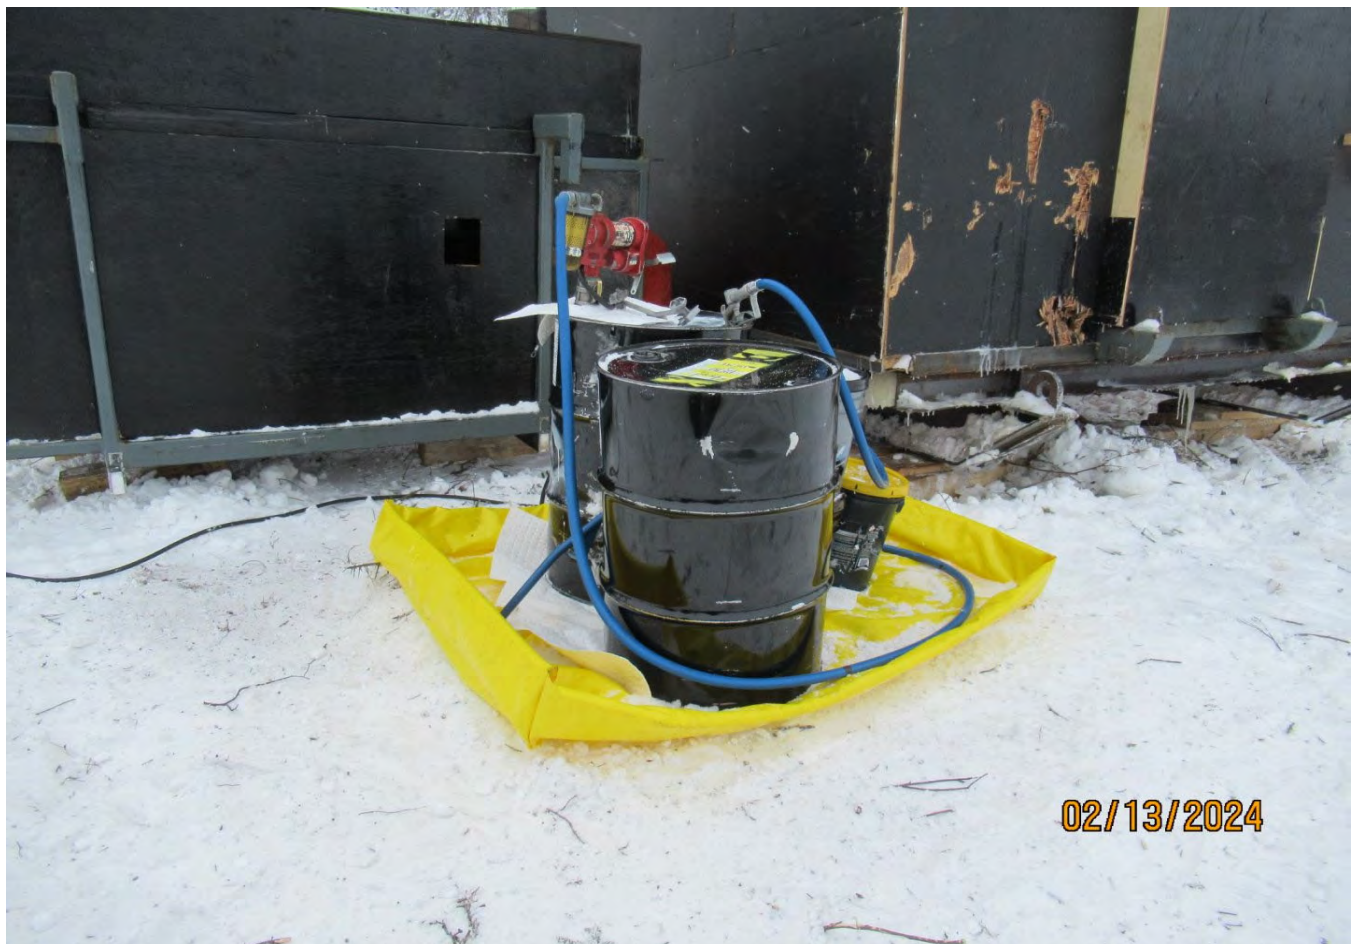
Figure 42
Fuel drums and the nozzle at the diamond drill are stored in secondary containment.

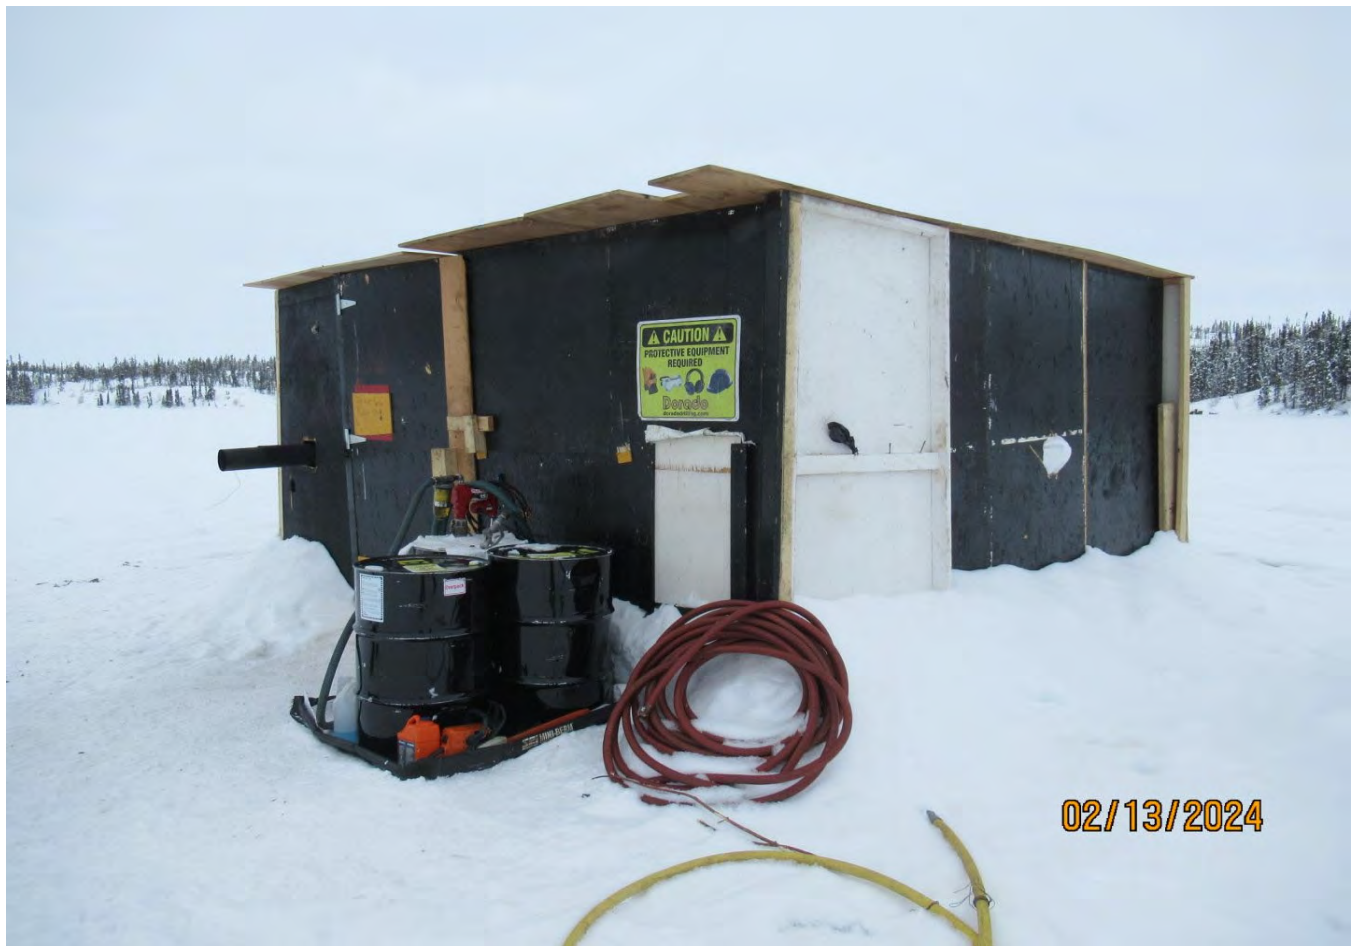
Figure 43
Pump shack on the ice surface of Echo Lake. Fuel and hydrocarbon containers are in secondary containment.

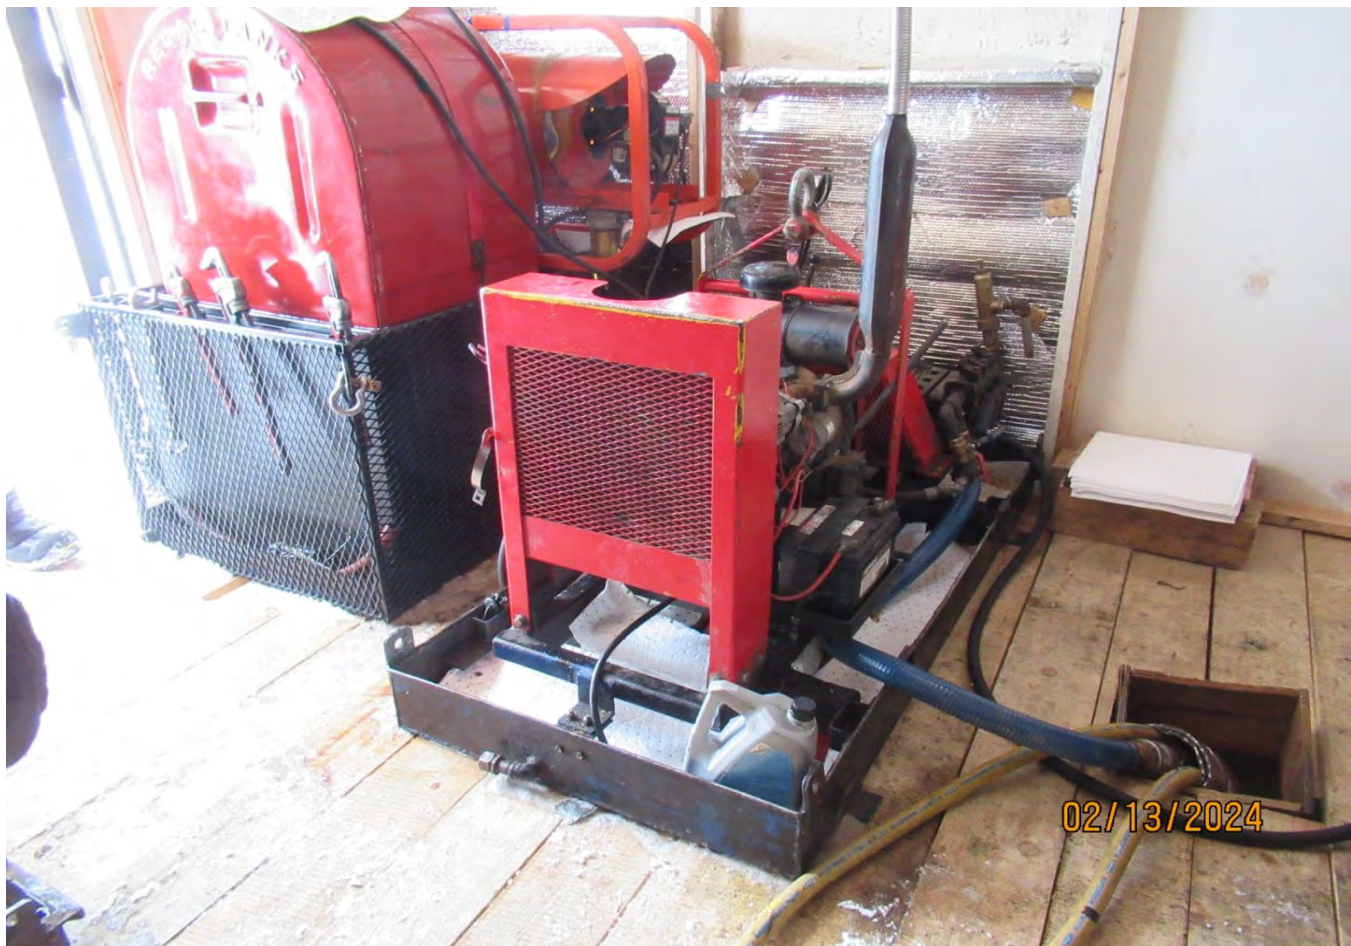
Figure 44
Ancillary equipment in the pump shack has secondary containment and fuel containers tertiary containment.

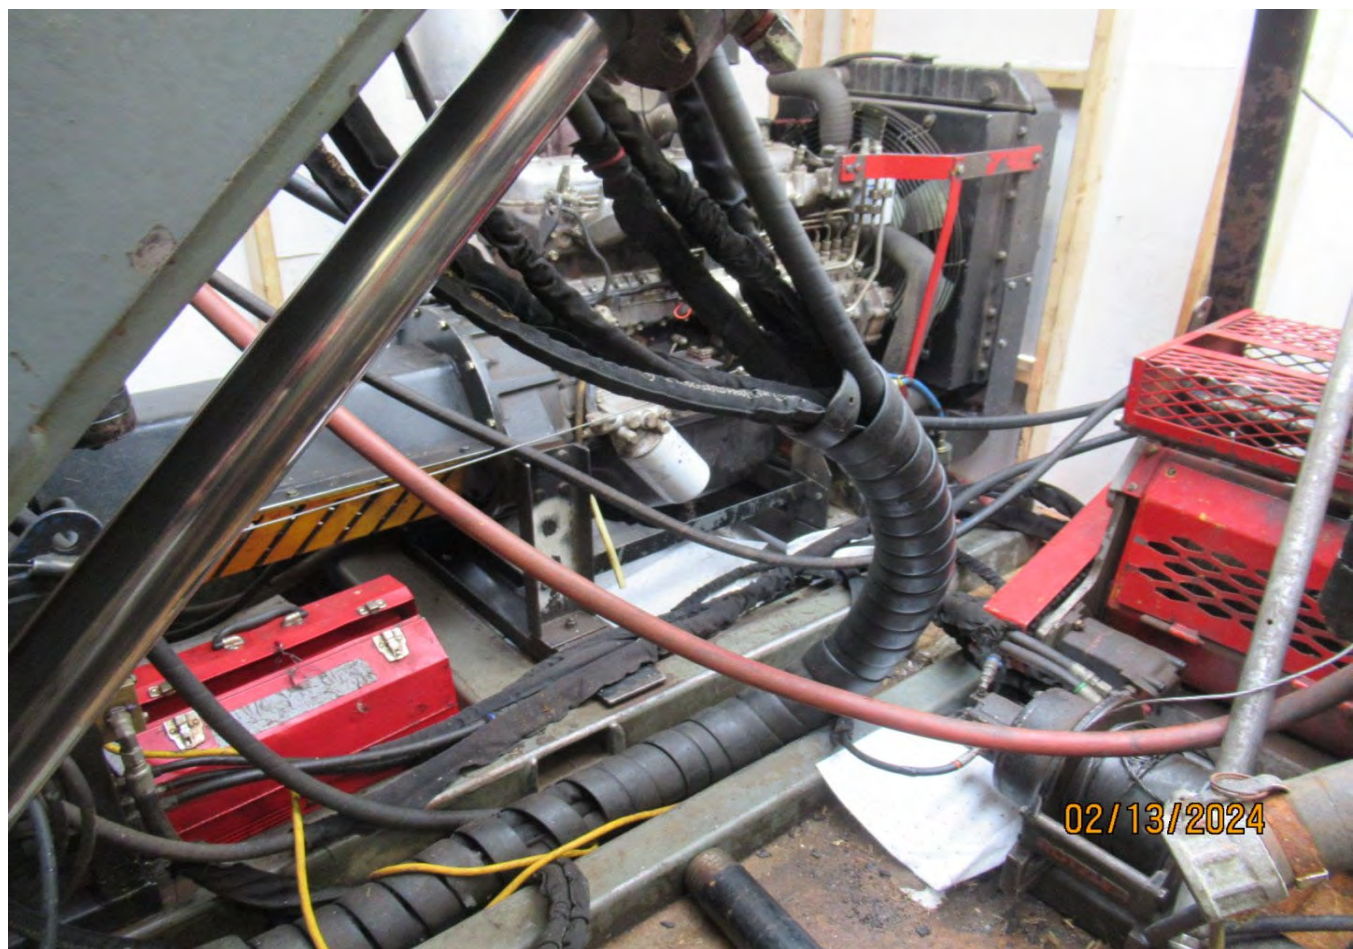
Figure 45
Secondary containment is present below the power pack, hydraulic tank, and feed frame of the diamond drill.

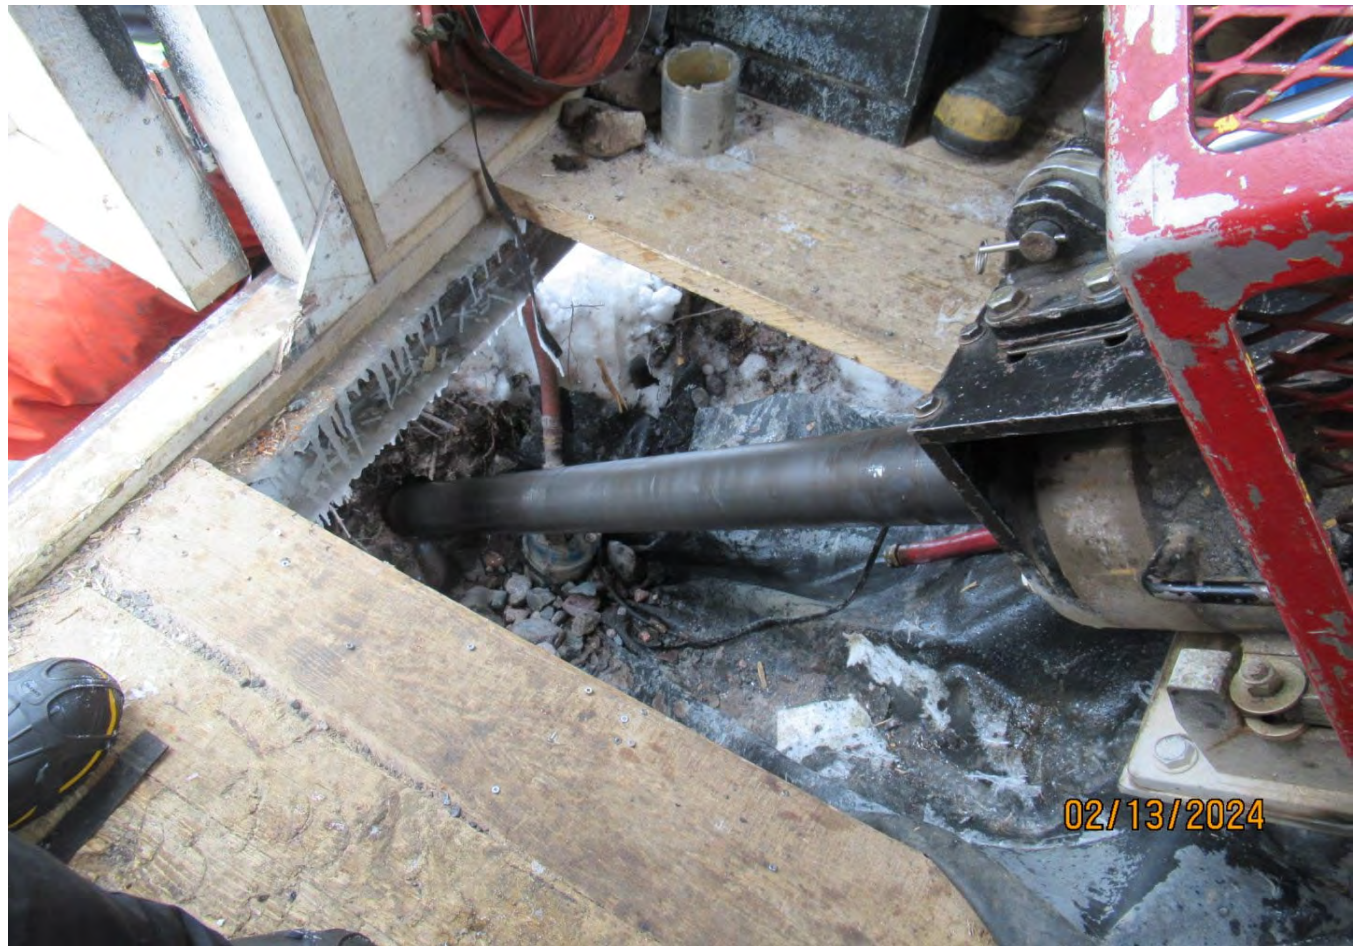
Figure 46
A pond liner and submersible pump are being used to collect drill waste for pumping to a natural depression when setting casing.

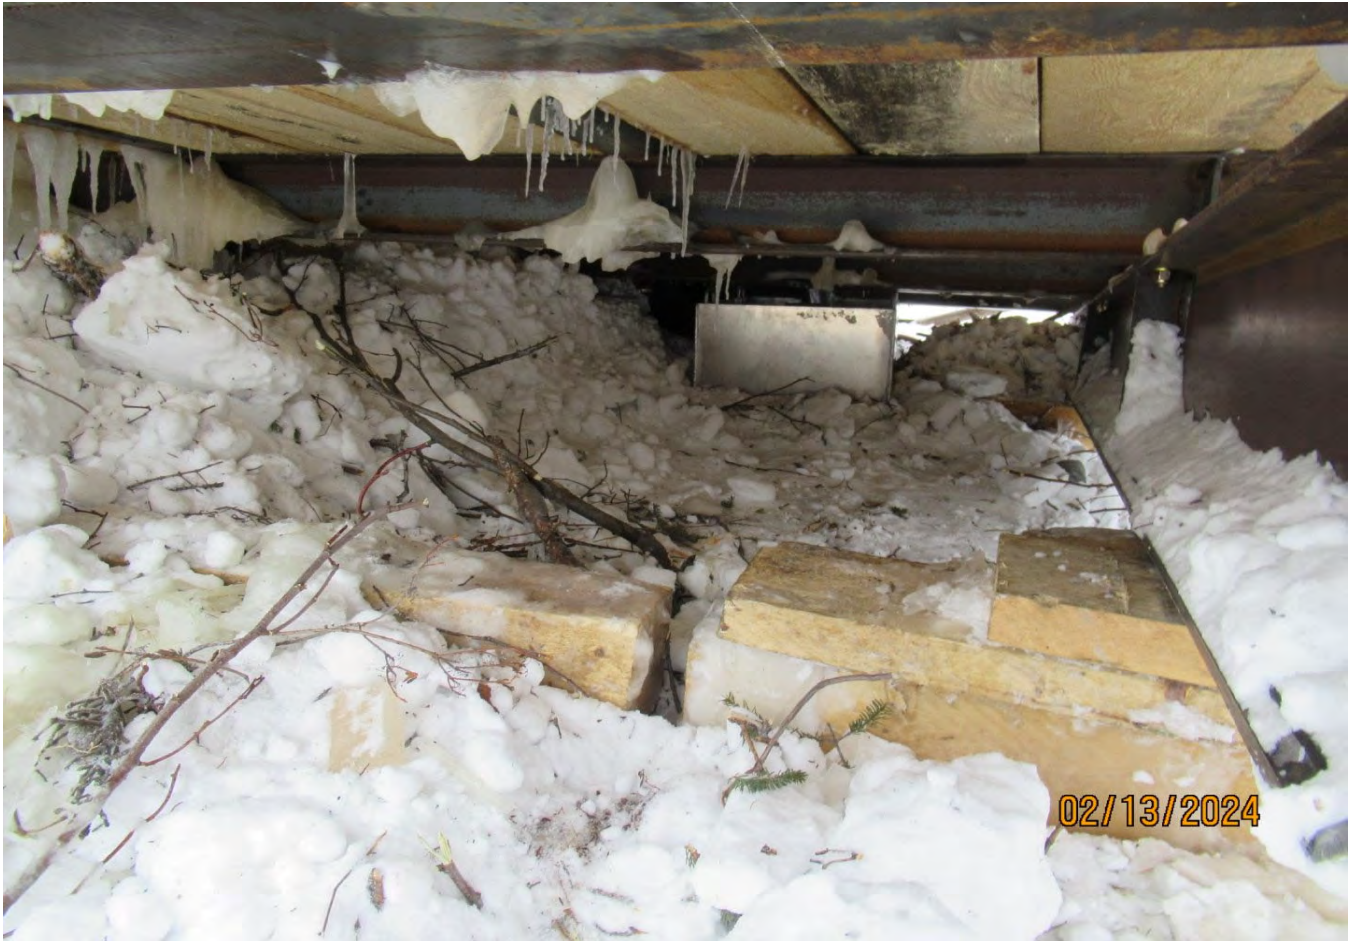
Figure 47
A catch can will be used when drilling commences to ensure full containment of drill waste at the collar.
