**Re: Land Use Permit MV2022C0021
Mineral Exploration
Yellowknife Lithium Project, NT**

ENVIRONMENTAL INSPECTION REPORT

Permittee:	EREX International Ltd.	Inspection Date – June 14 th , 2023
------------	-------------------------	--

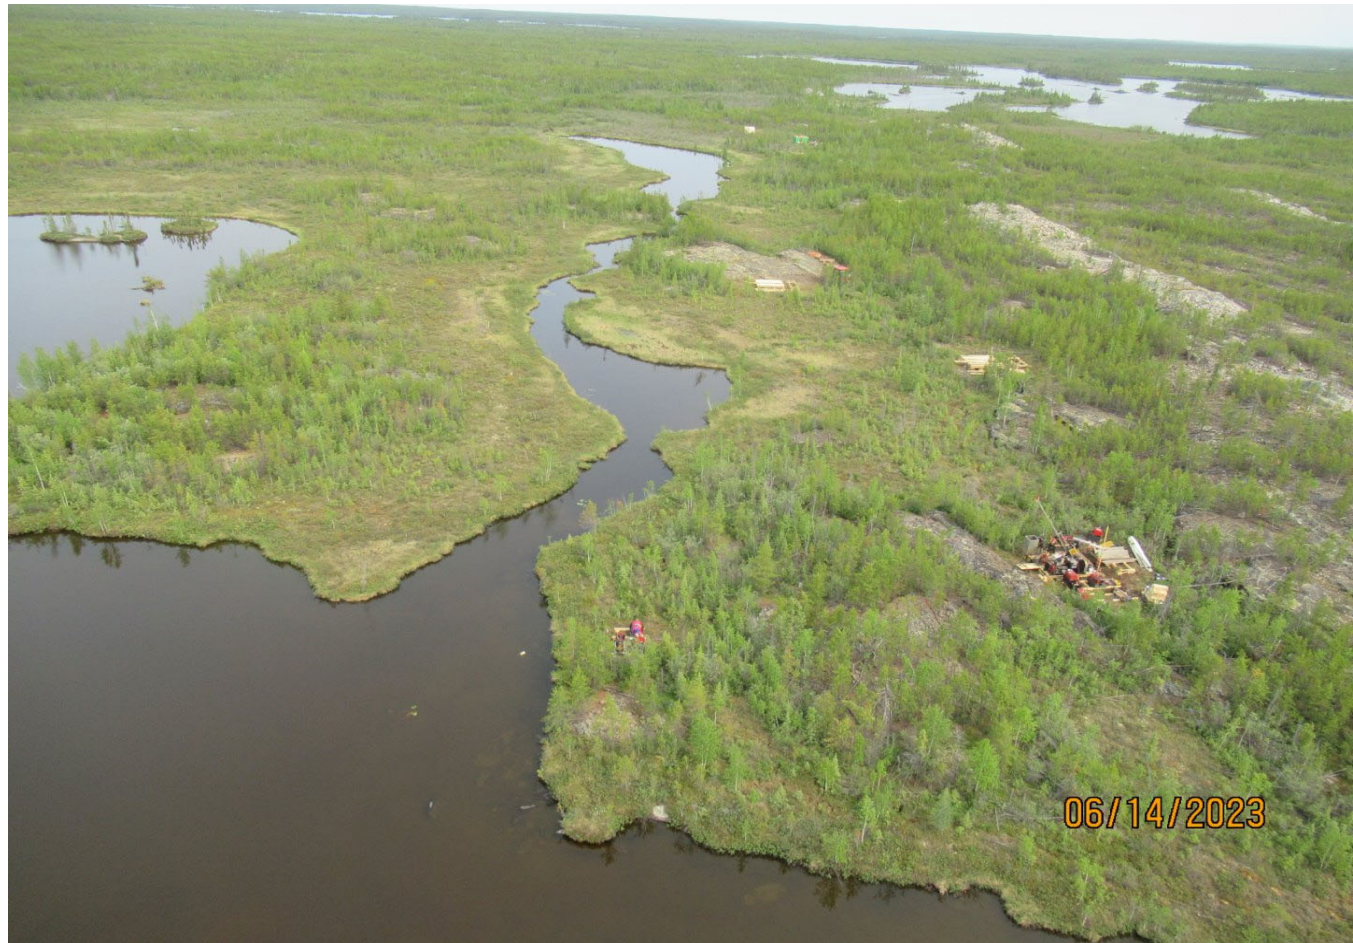
Figure 1
Looking north at the current area of drilling on the Fi Mineral tenure. Two drills were active at the time of the inspection.

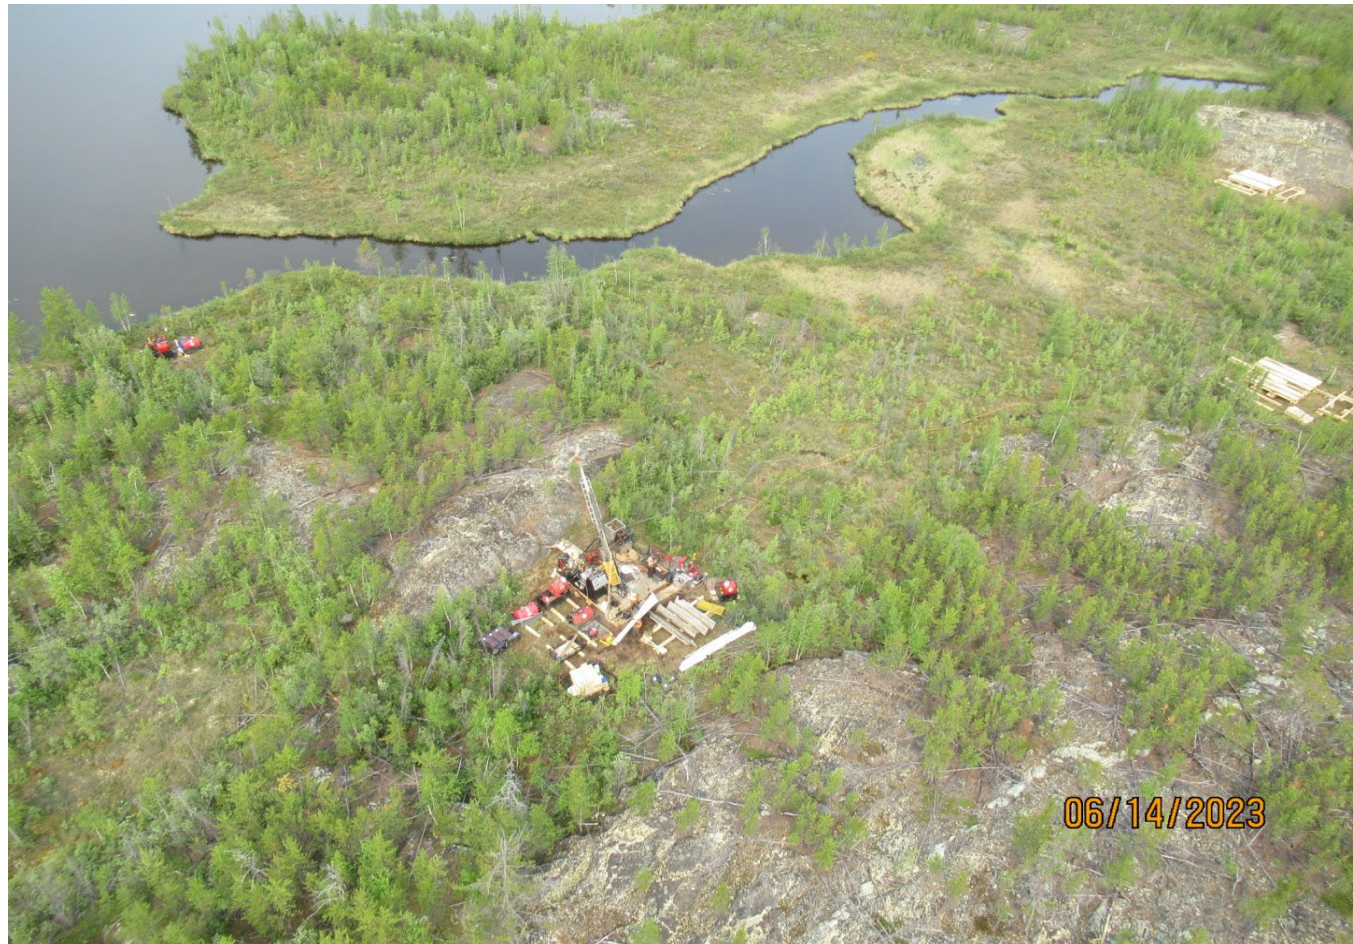
Figure 2
The Dorado diamond drill just completed this target and was preparing for a move.

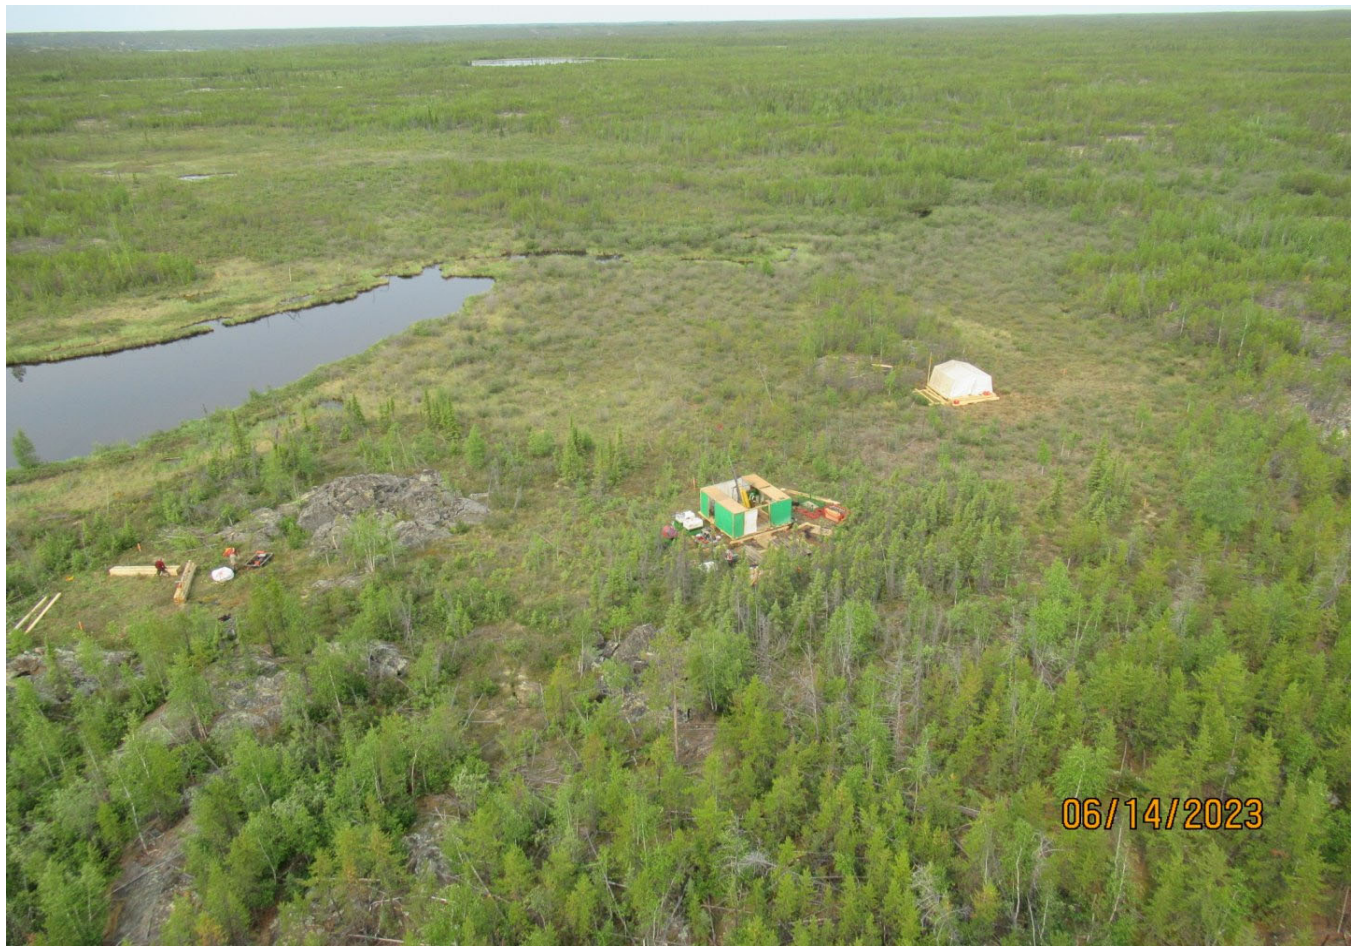
Figure 3
Looking northwest at the Northtech diamond drill.

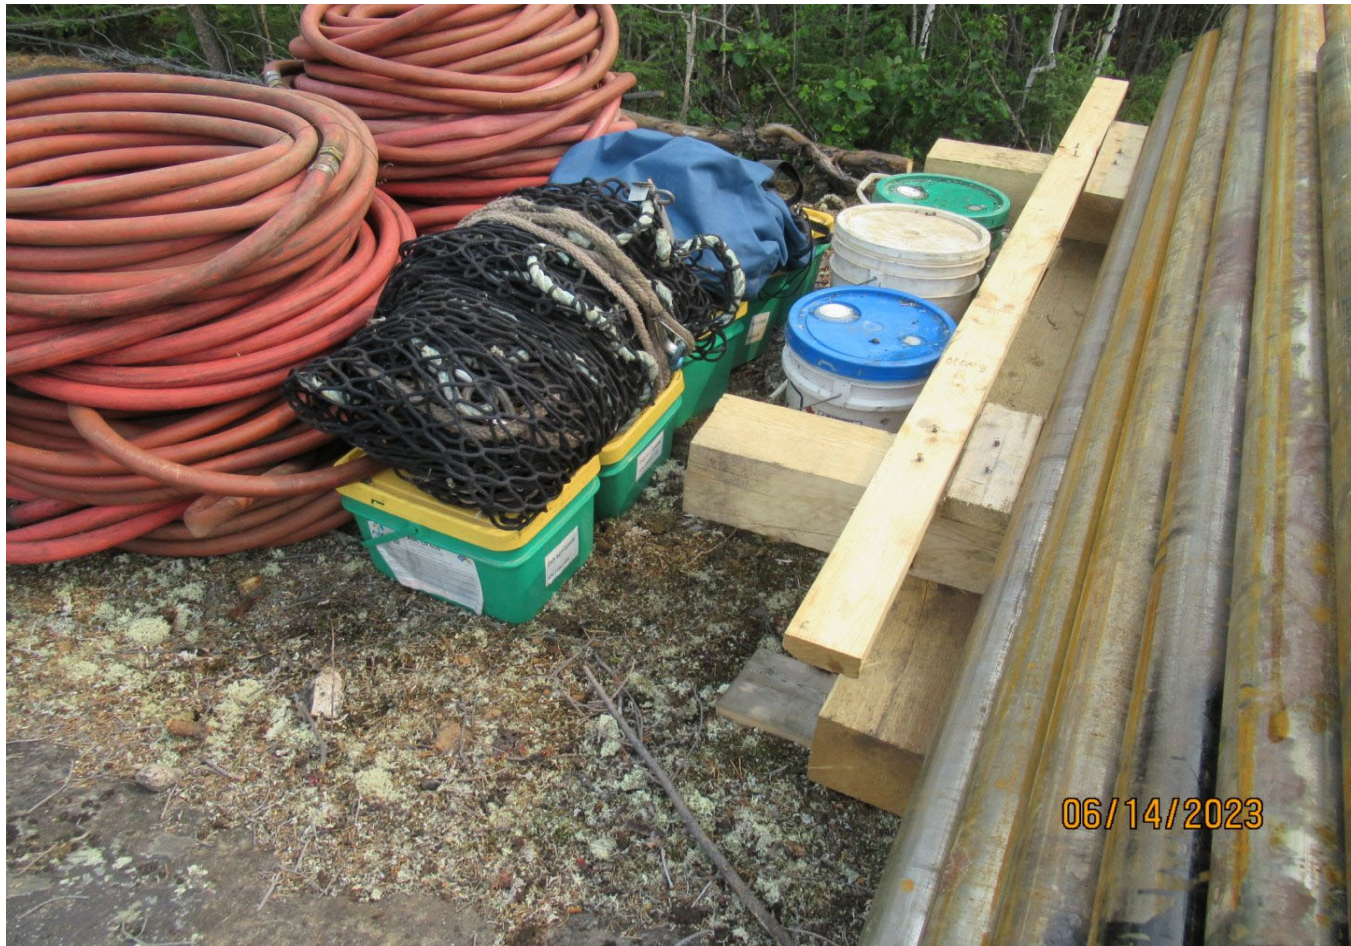
Figure 4
SDS for drill additives for both drill contractors have been provided to the Inspectors. Minimal use is currently occurring since holes are relatively short.

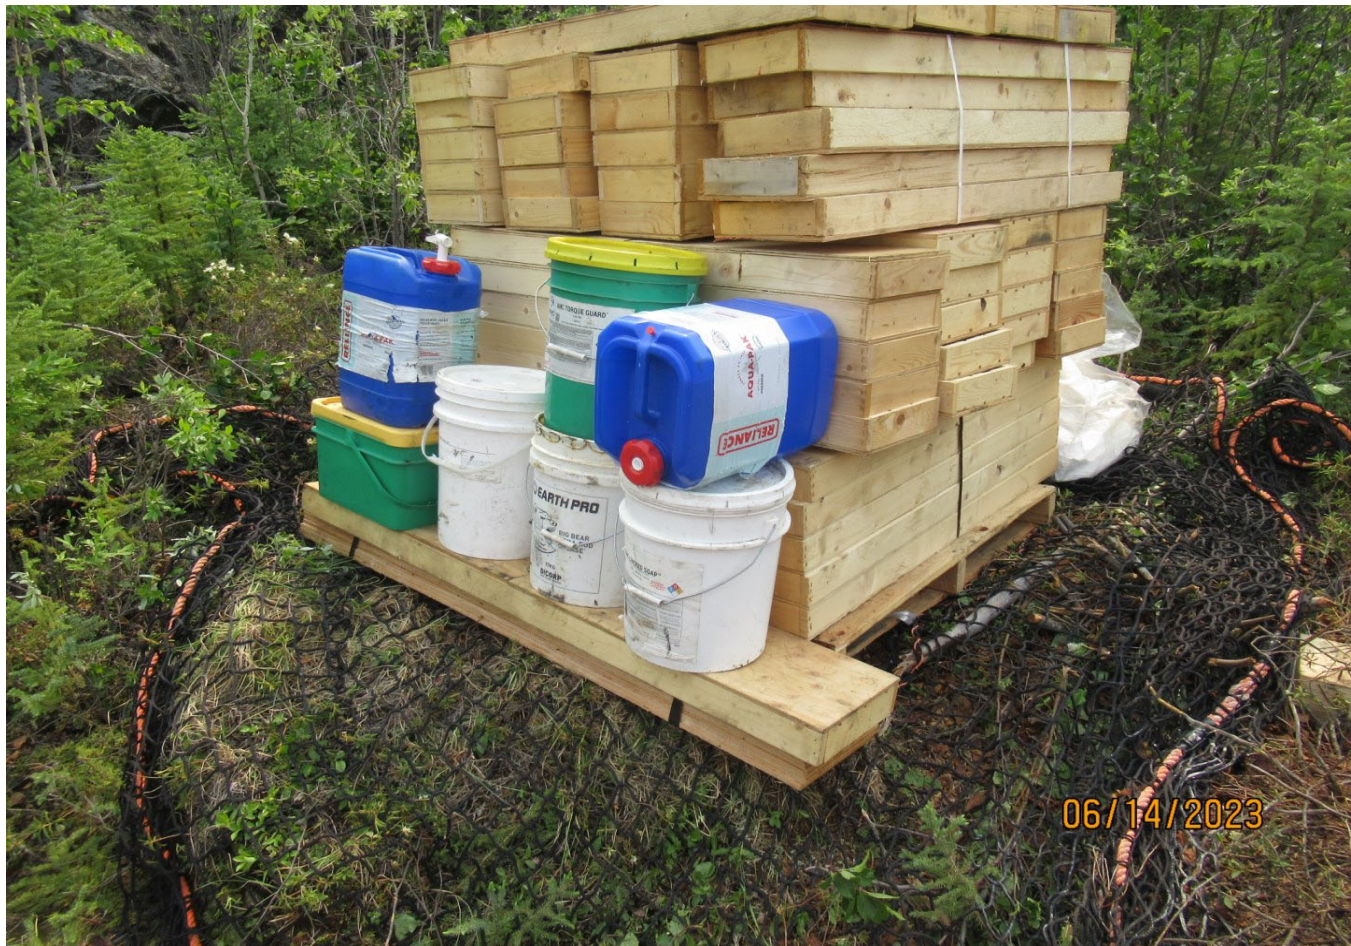
Figure 5
Other pails of drill additives at the Dorado drill.

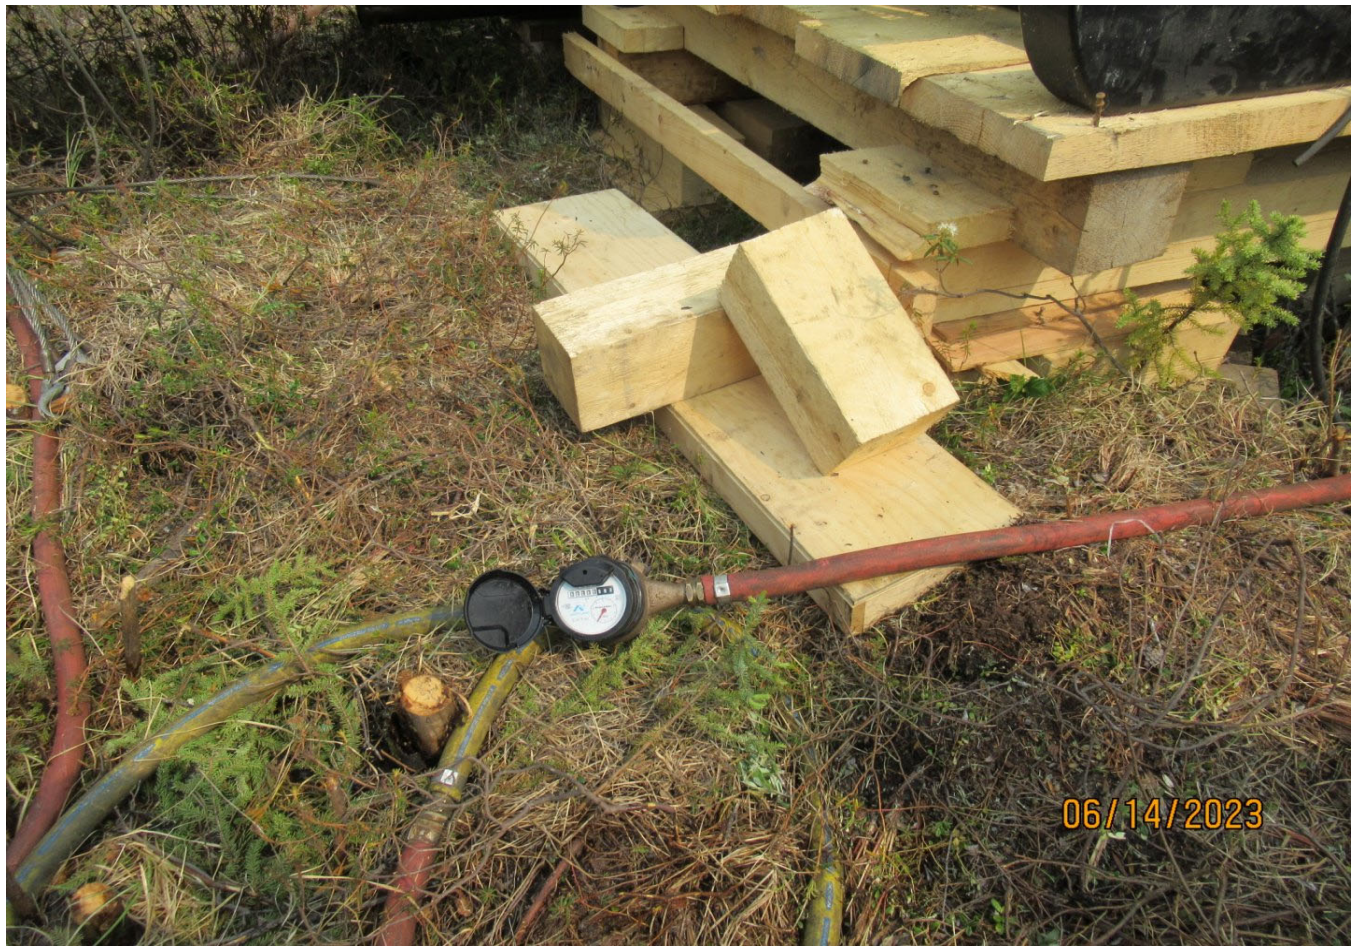
Figure 6
Water use is being metered at the Dorado drill. Volumes are being recorded daily.

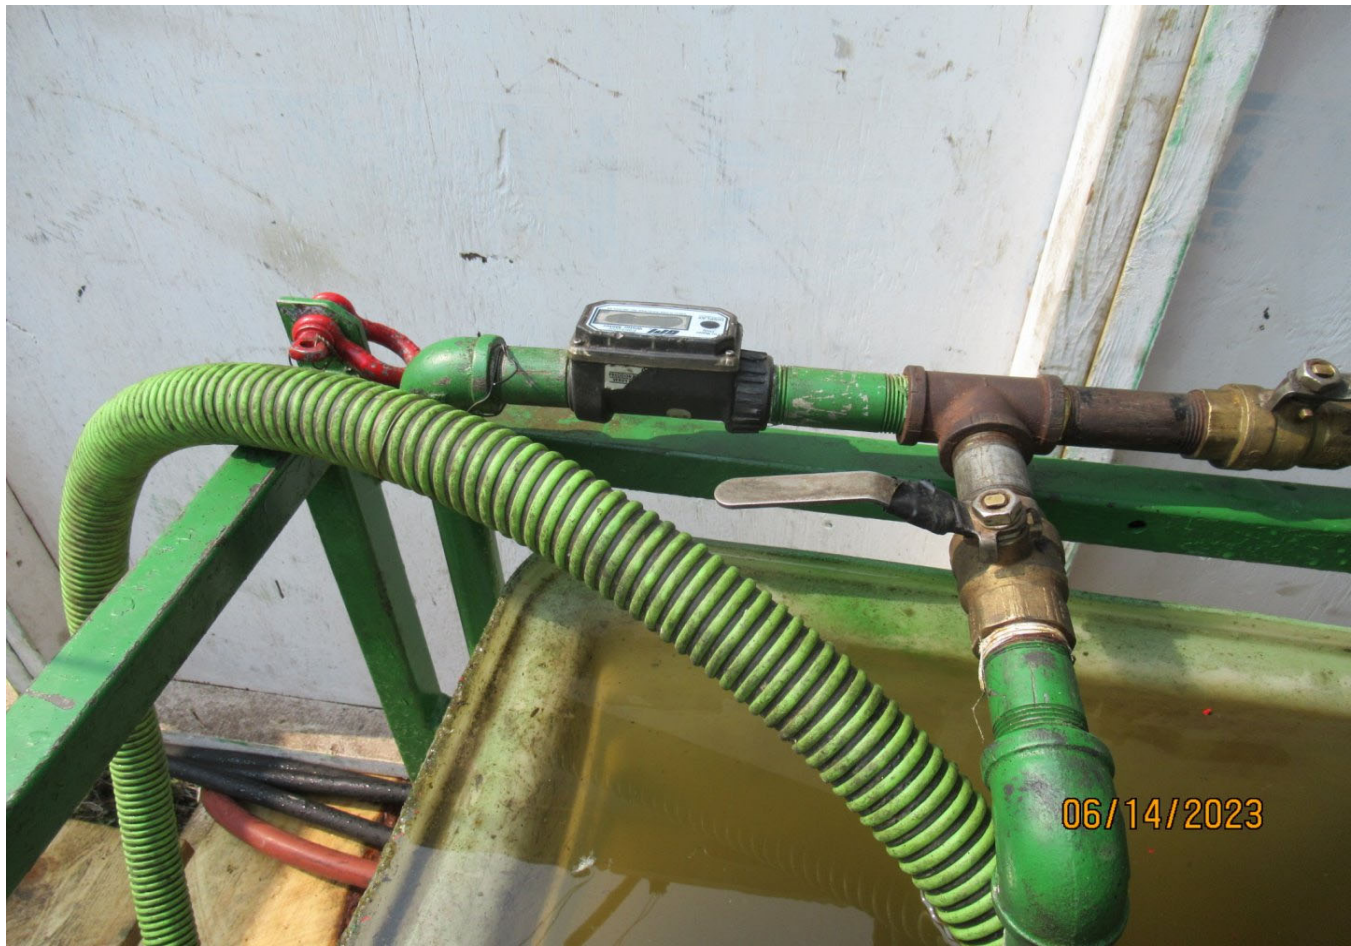
Figure 7
Water meter on the mud tank of the Northtech drill.

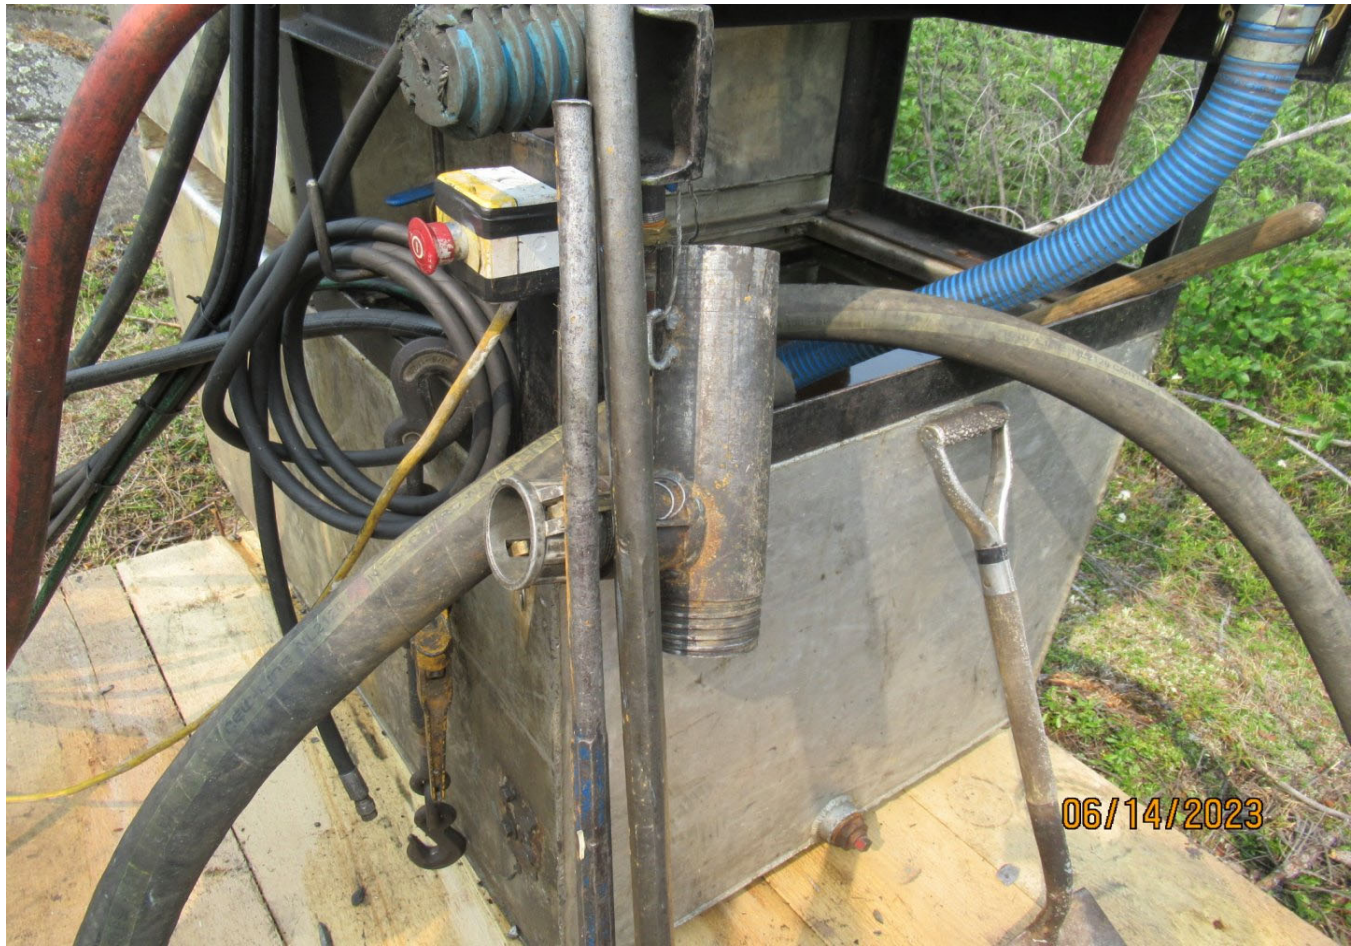
Figure 8
Water funnel is being used at the Dorado drill when pulling the core barrel. Water is directed back into the mud tank.

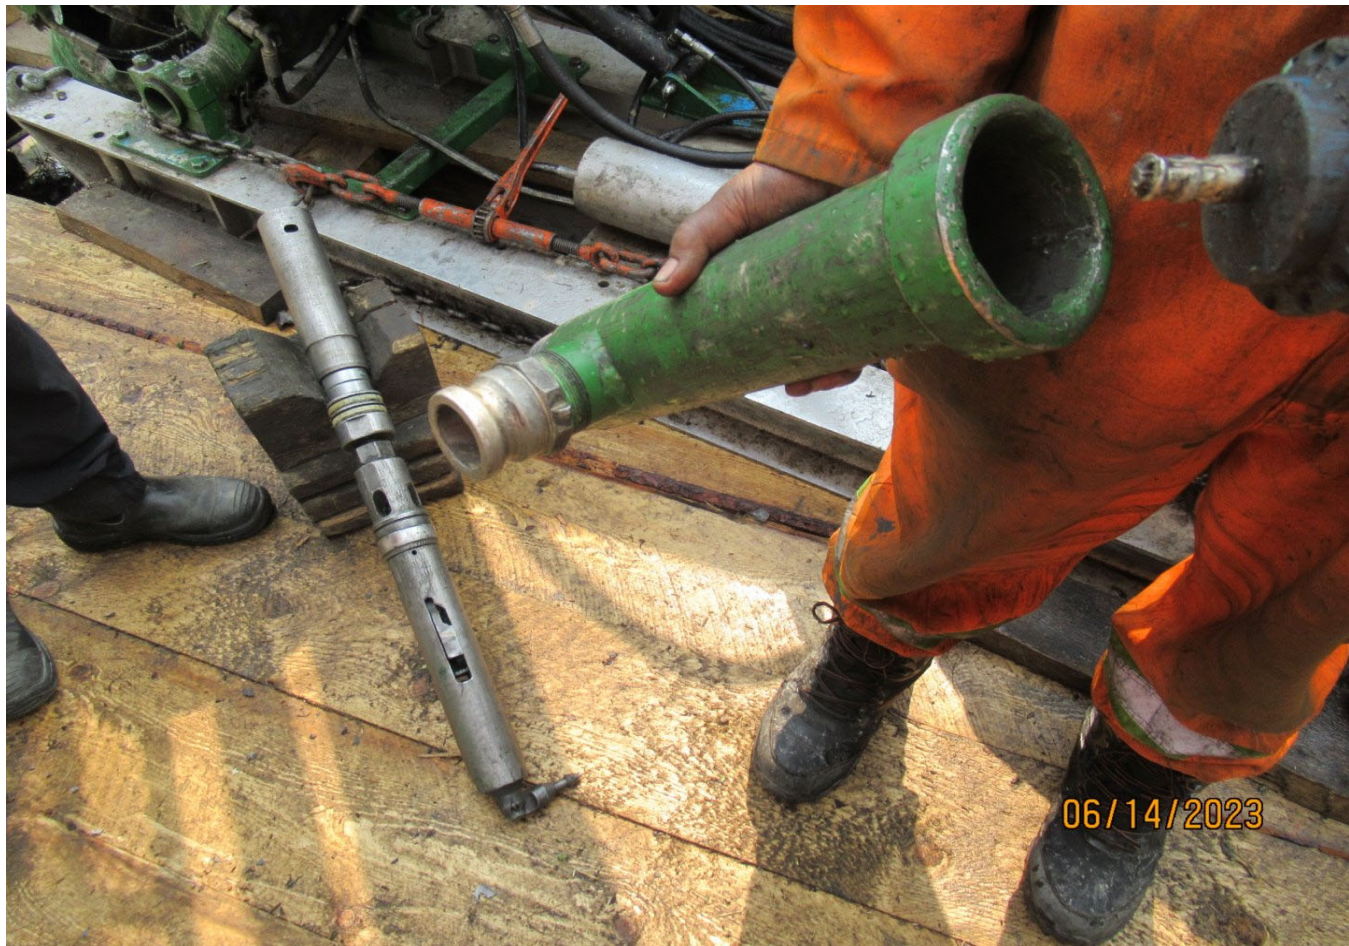
Figure 9
Funnel at the Northtech drill that is being used when pulling the tube.

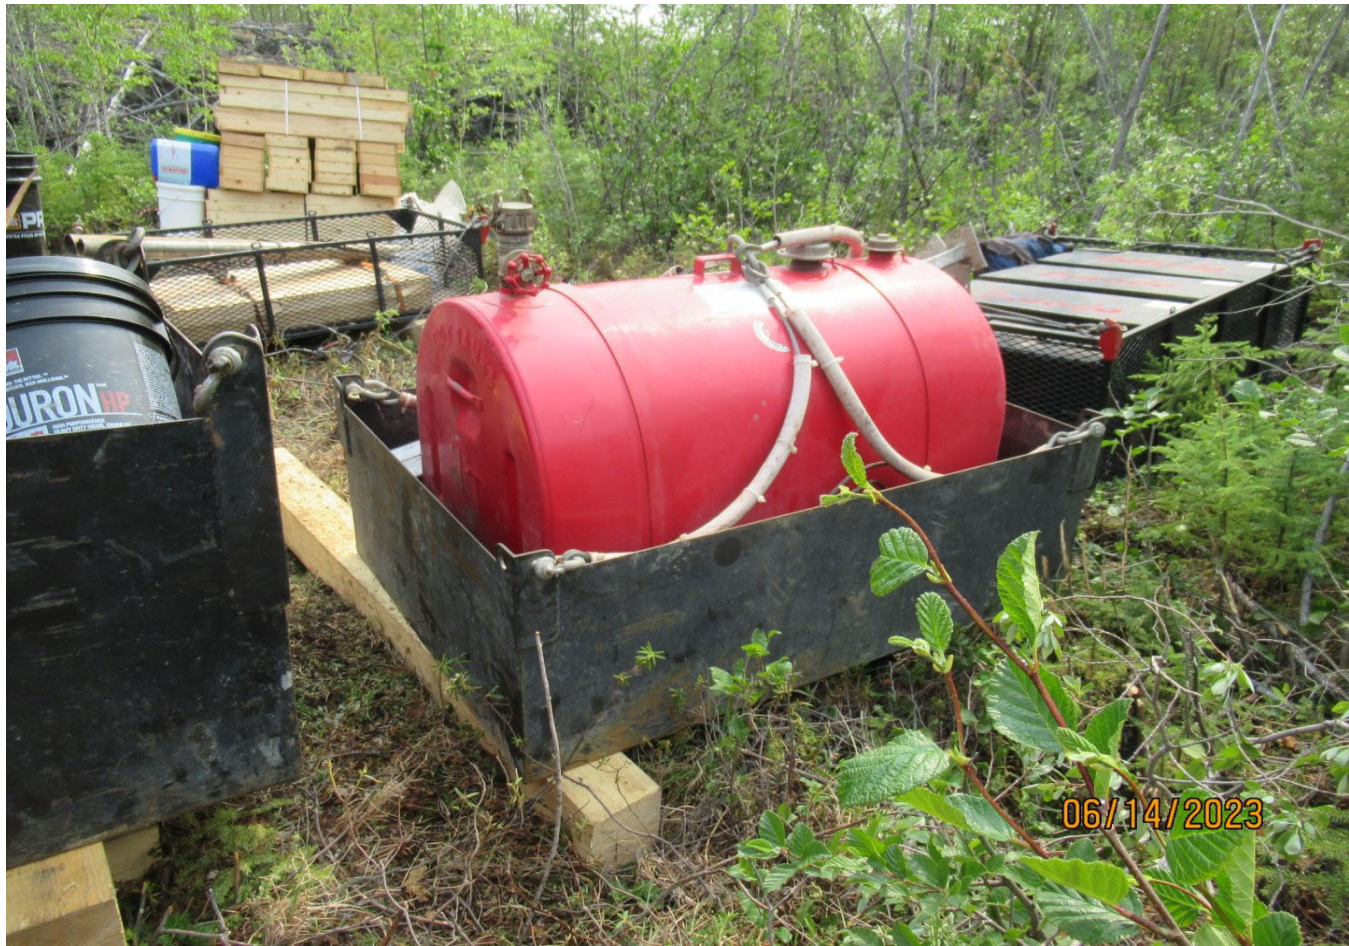
Figure 10
All of the Dorado fuel containers are being stored in secondary containment. Hydrocarbon absorbent matting must be placed on the water surface within the containment structure.

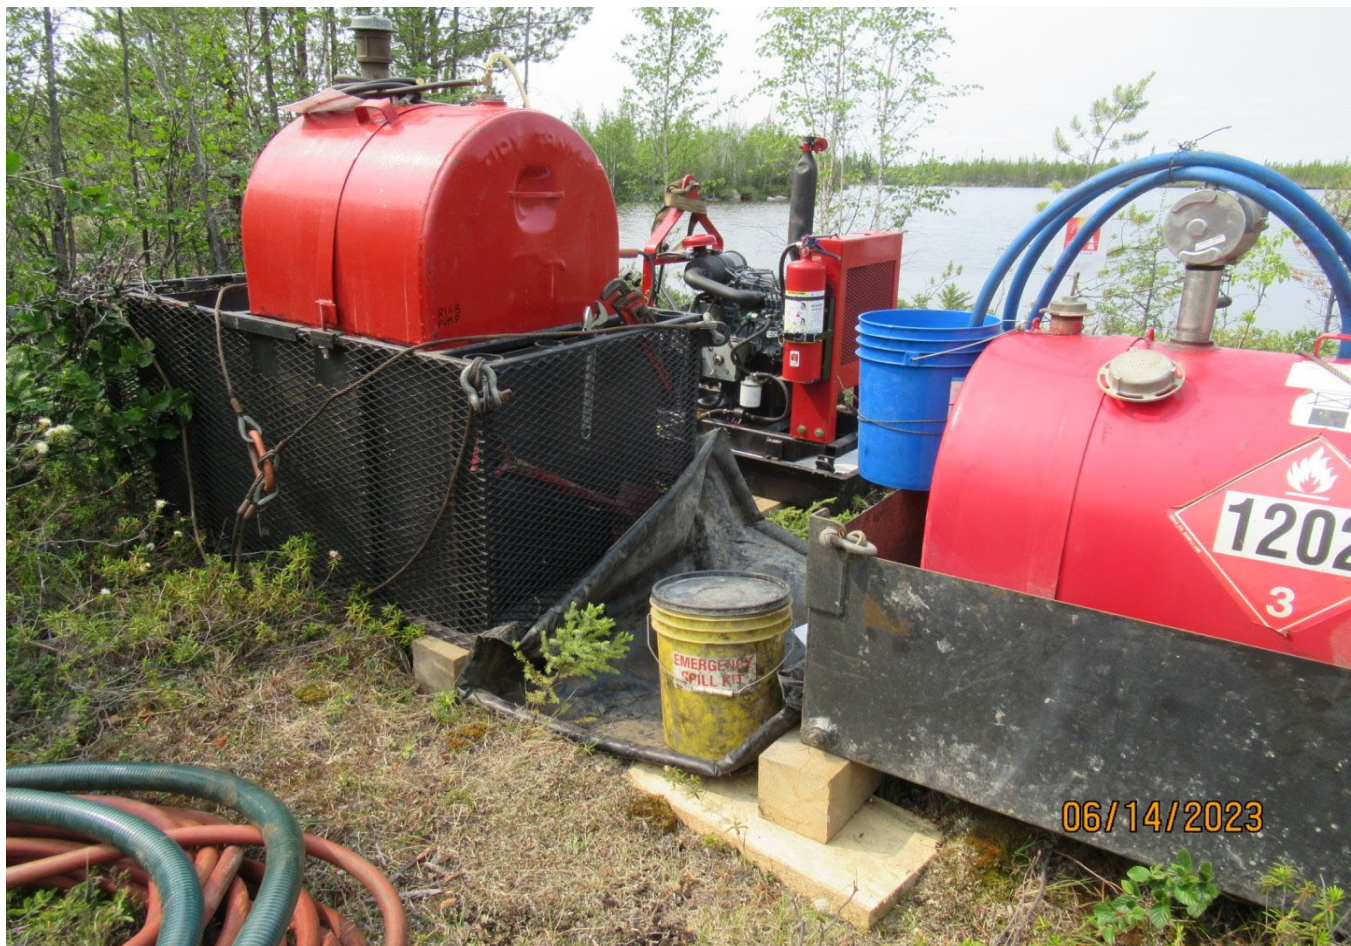
Figure 11
Fuel tanks at the Dorado water pump spill kit is present and fuel nozzles are being stored in containment with matting.

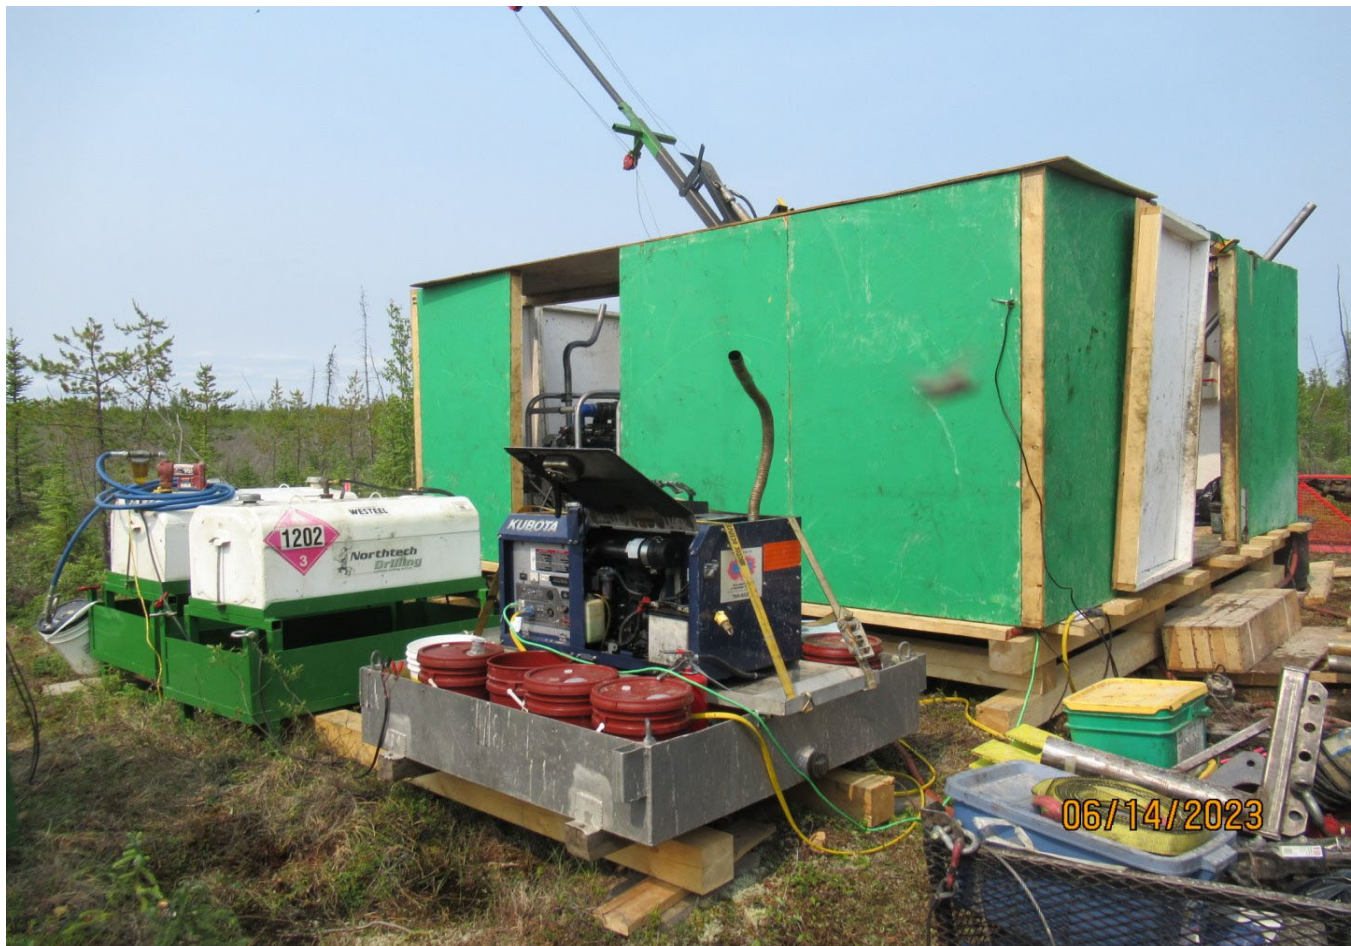
Figure 12
Top feed, double walled fuel tanks stored in tertiary containment at the Northtech drill. Generator and hydrocarbon pails are also being stored in secondary containment.

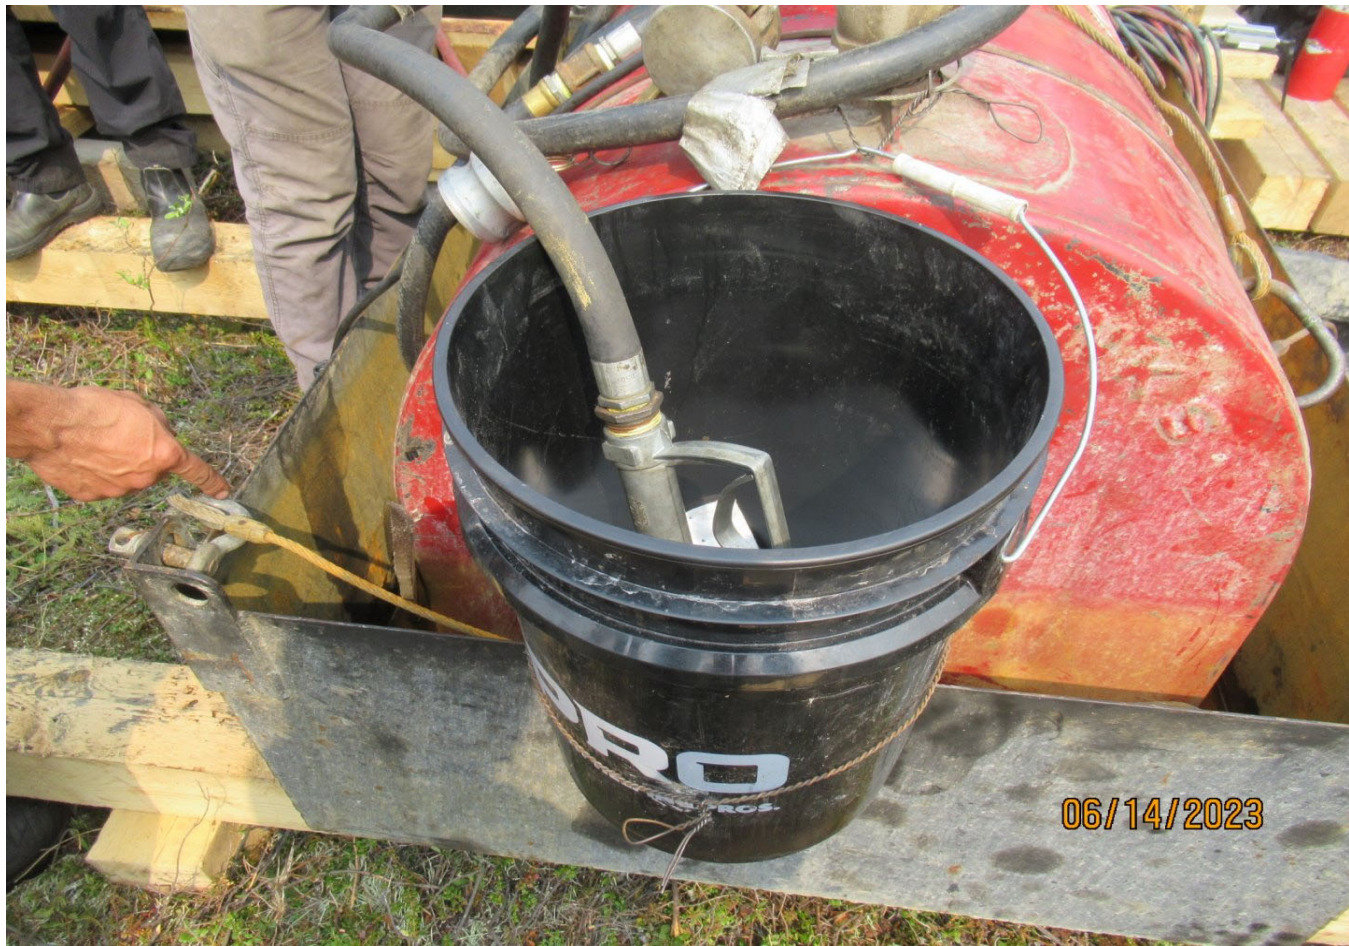
Figure 13
All fuel nozzles are being stored in 5 gallon pails after each use.

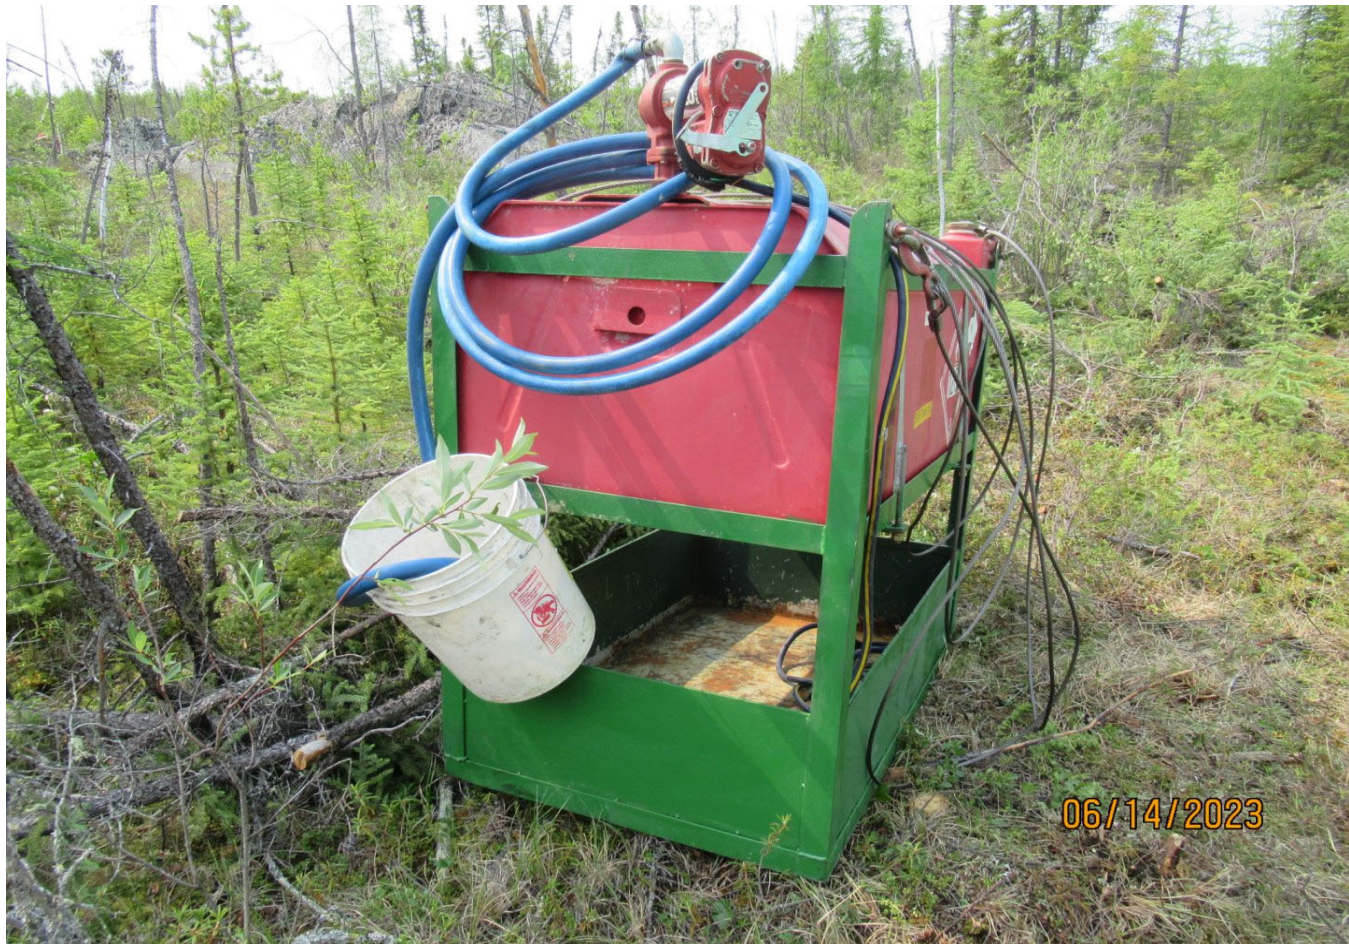
Figure 14
Fuel nozzle in a 5 gallon pail at the Northtech drill.

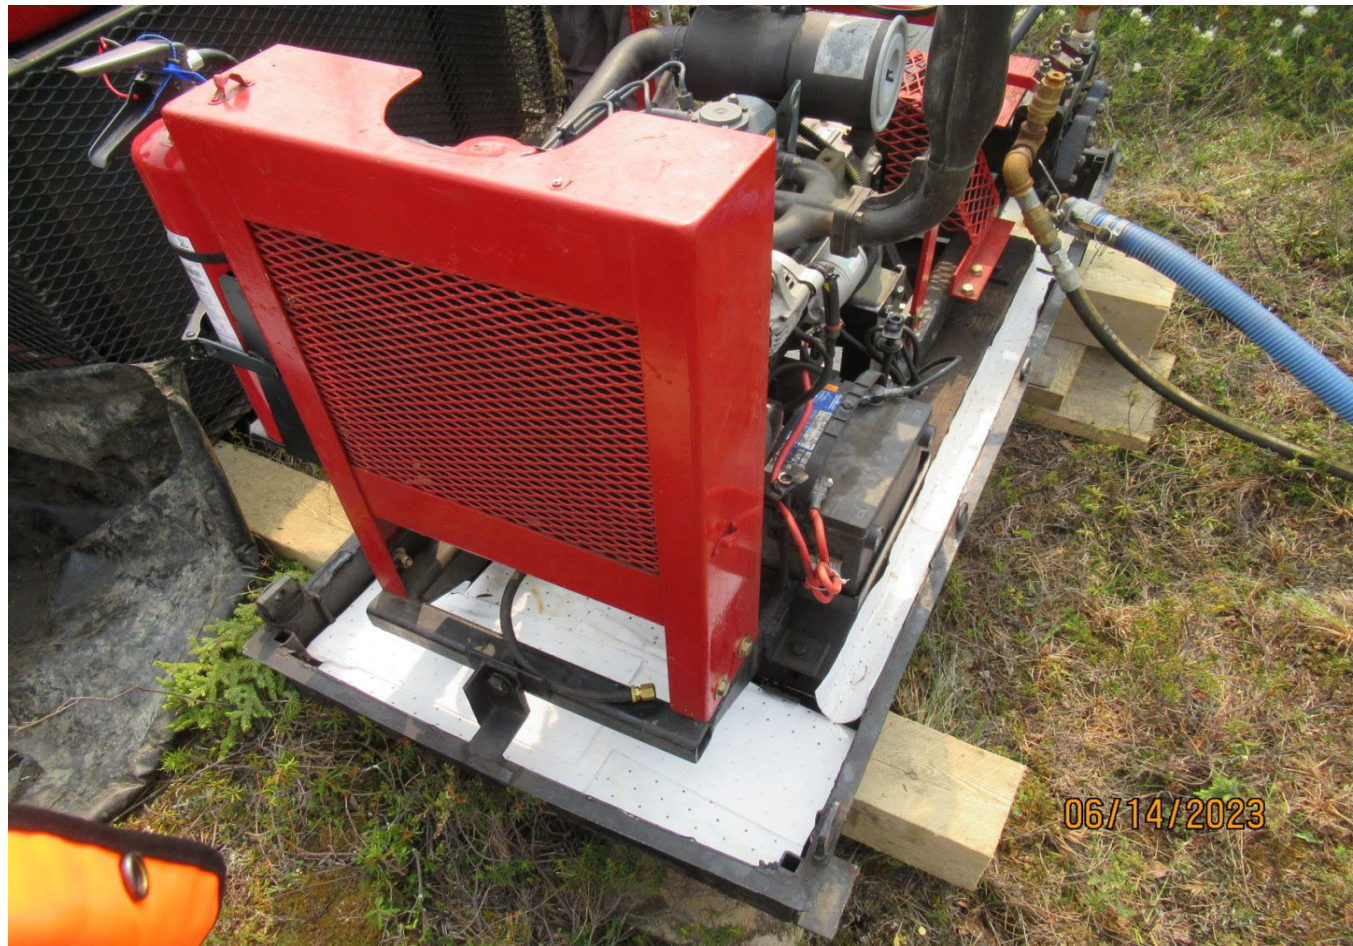
Figure 15

Ancillary equipment is being stored in containment with hydrocarbon absorbent matting lining.

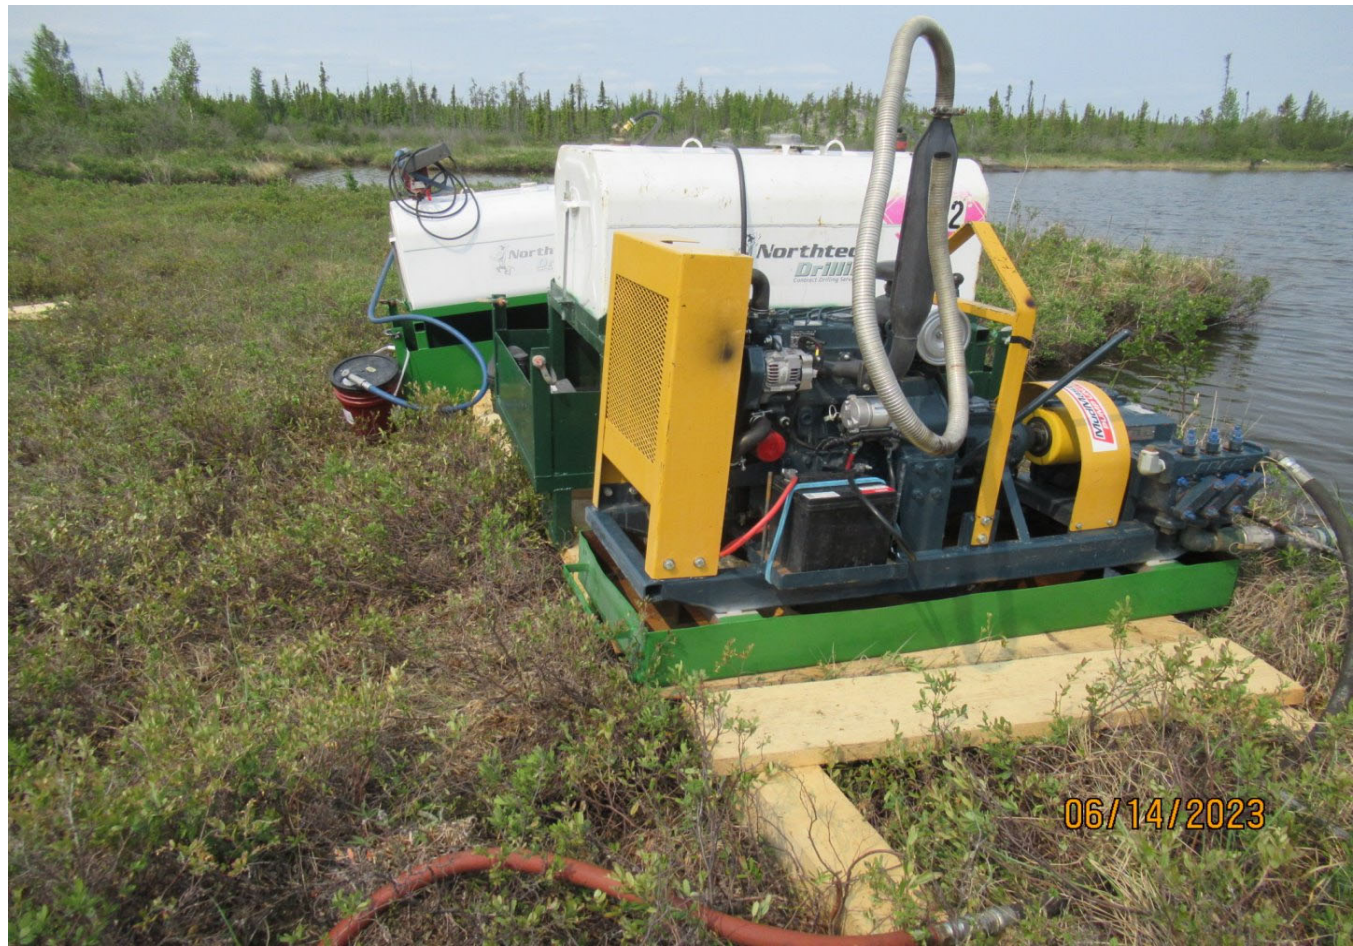
Figure 16

Secondary containment and tertiary containment at the Northtech water pump.

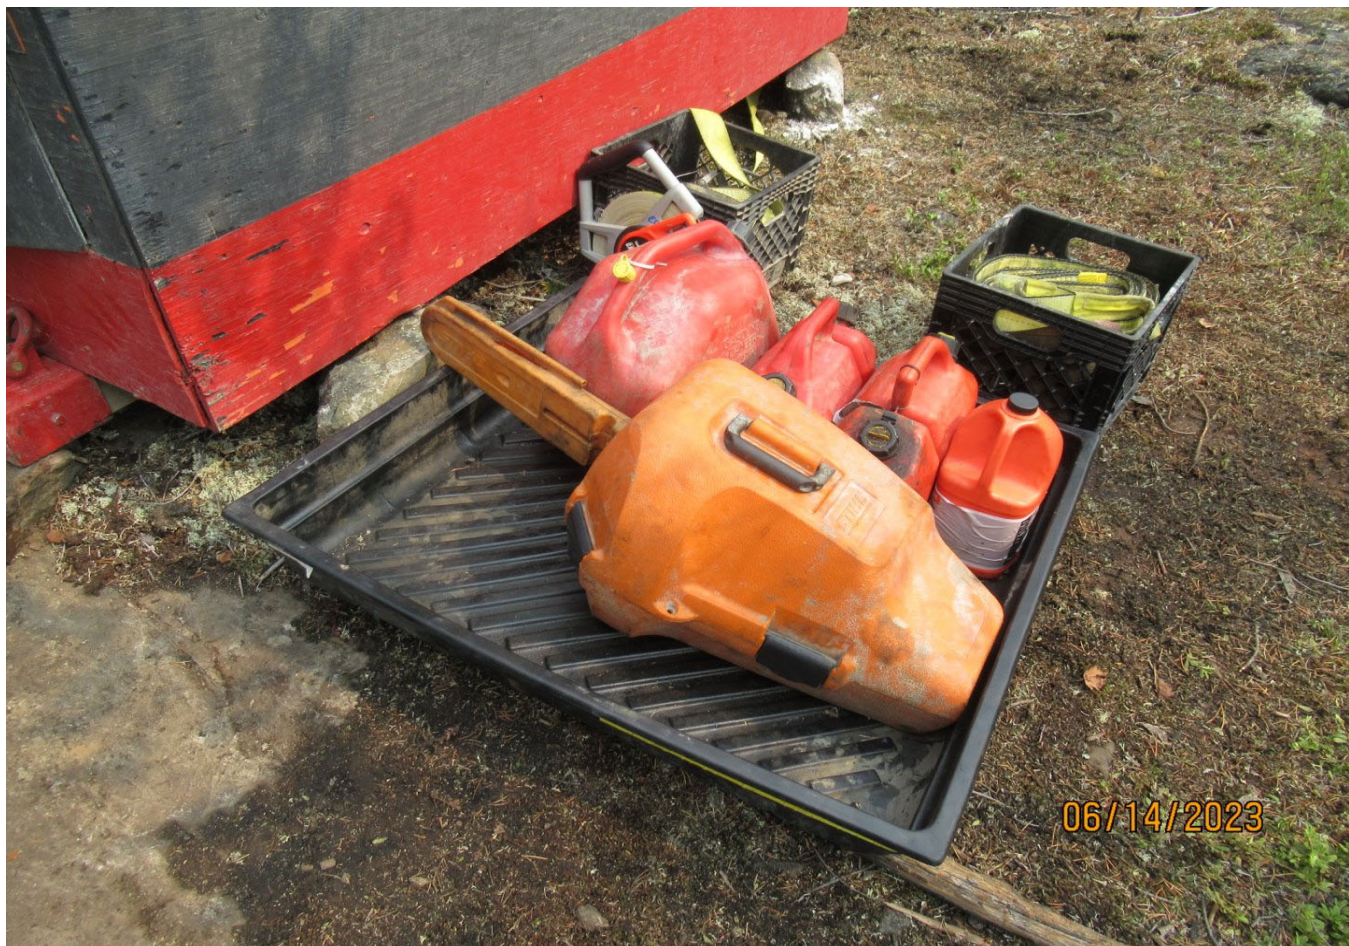
Figure 17
Small hydrocarbon containers at the Dorado survival shack are stored in containment. Spill response materials must be placed in a highly visible location.
