**Re: Land Use Permit MV2022C0021
Mineral Exploration
Yellowknife Lithium Project, NT**

ENVIRONMENTAL INSPECTION REPORT

Permittee:	EREX International Ltd.	Inspection Date – June 14 th , 2023
------------	-------------------------	--

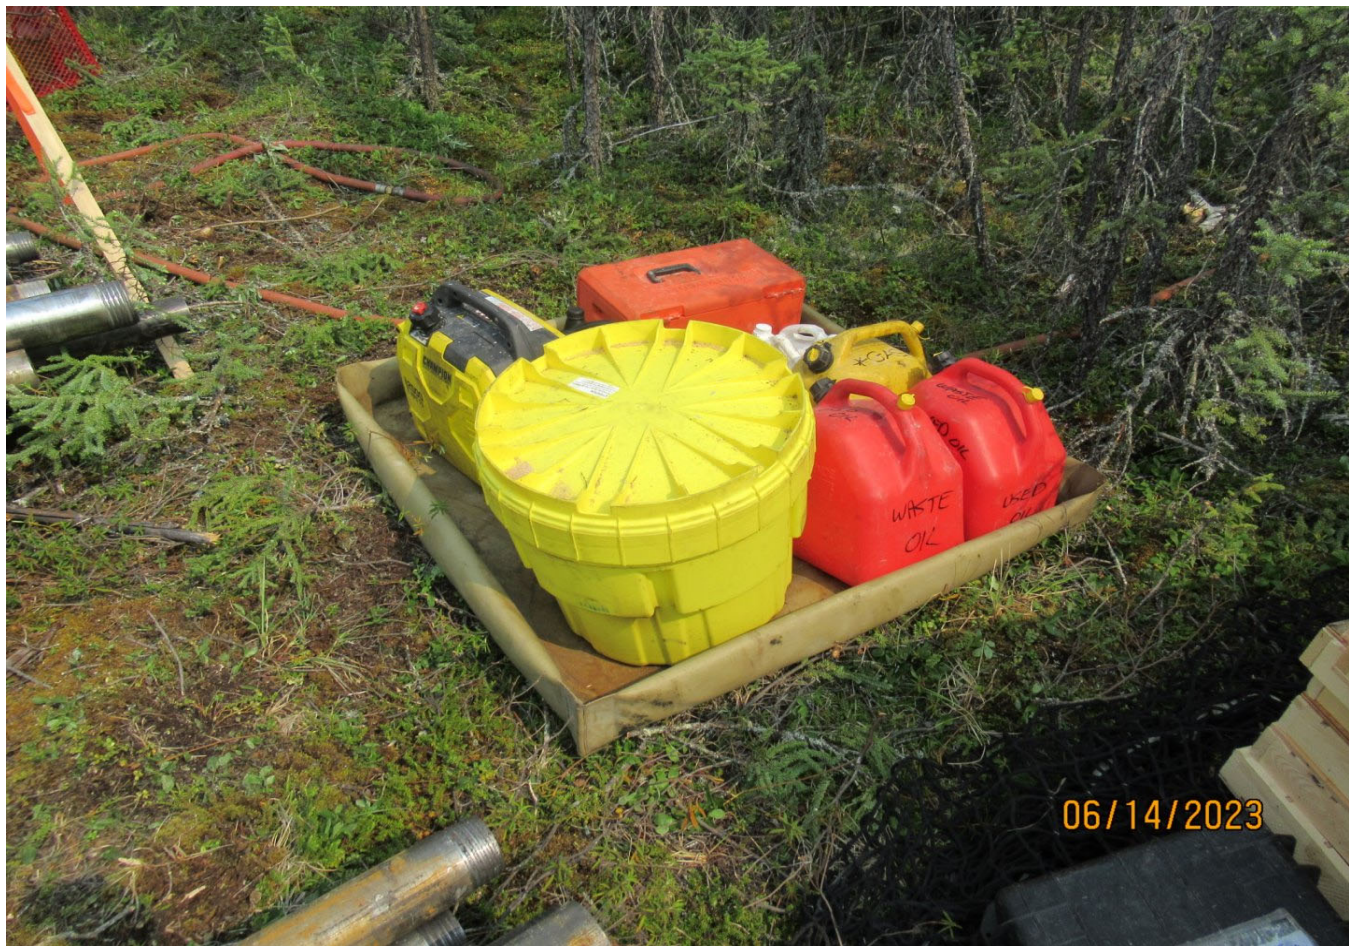
Figure 18
Hydrocarbon containers at the Northtech drill are stored in containment and spill response materials were present.

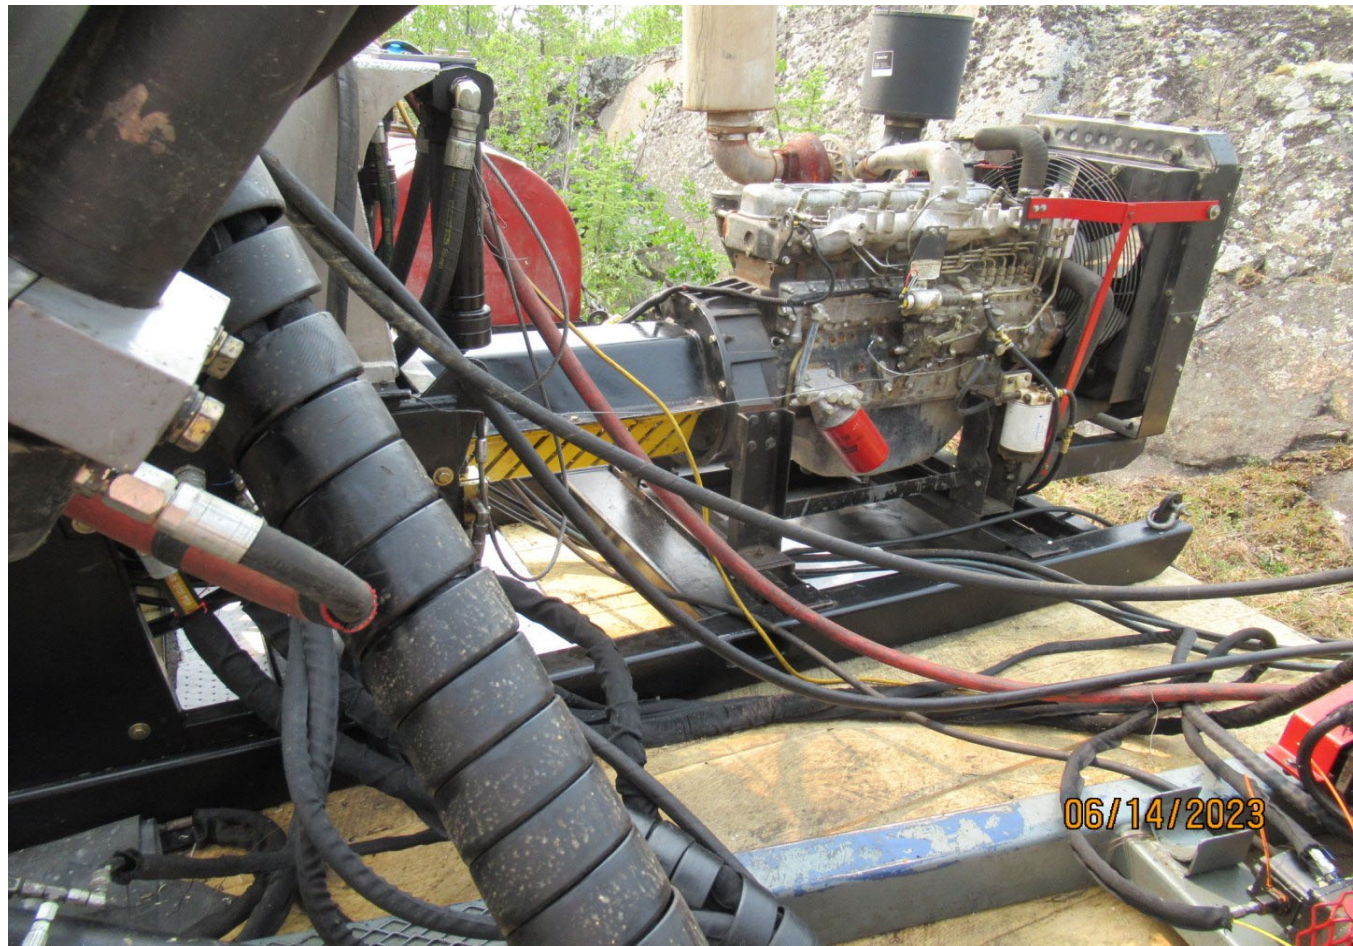
Figure 19

The power pack for the Dorado drill had a form of secondary containment beneath it.

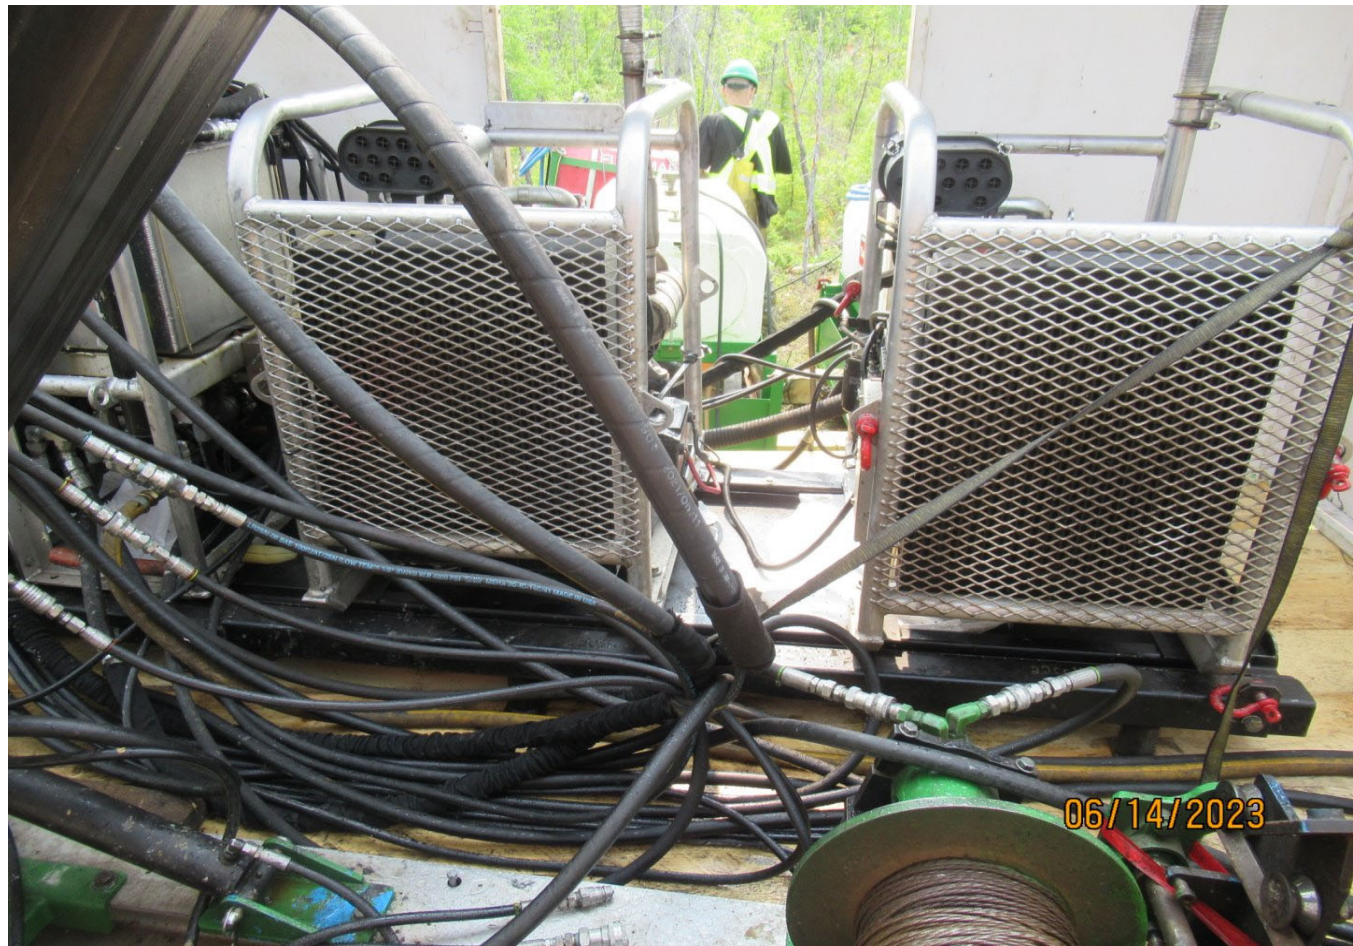
Figure 20

Secondary containment was present below the Northtech drill.

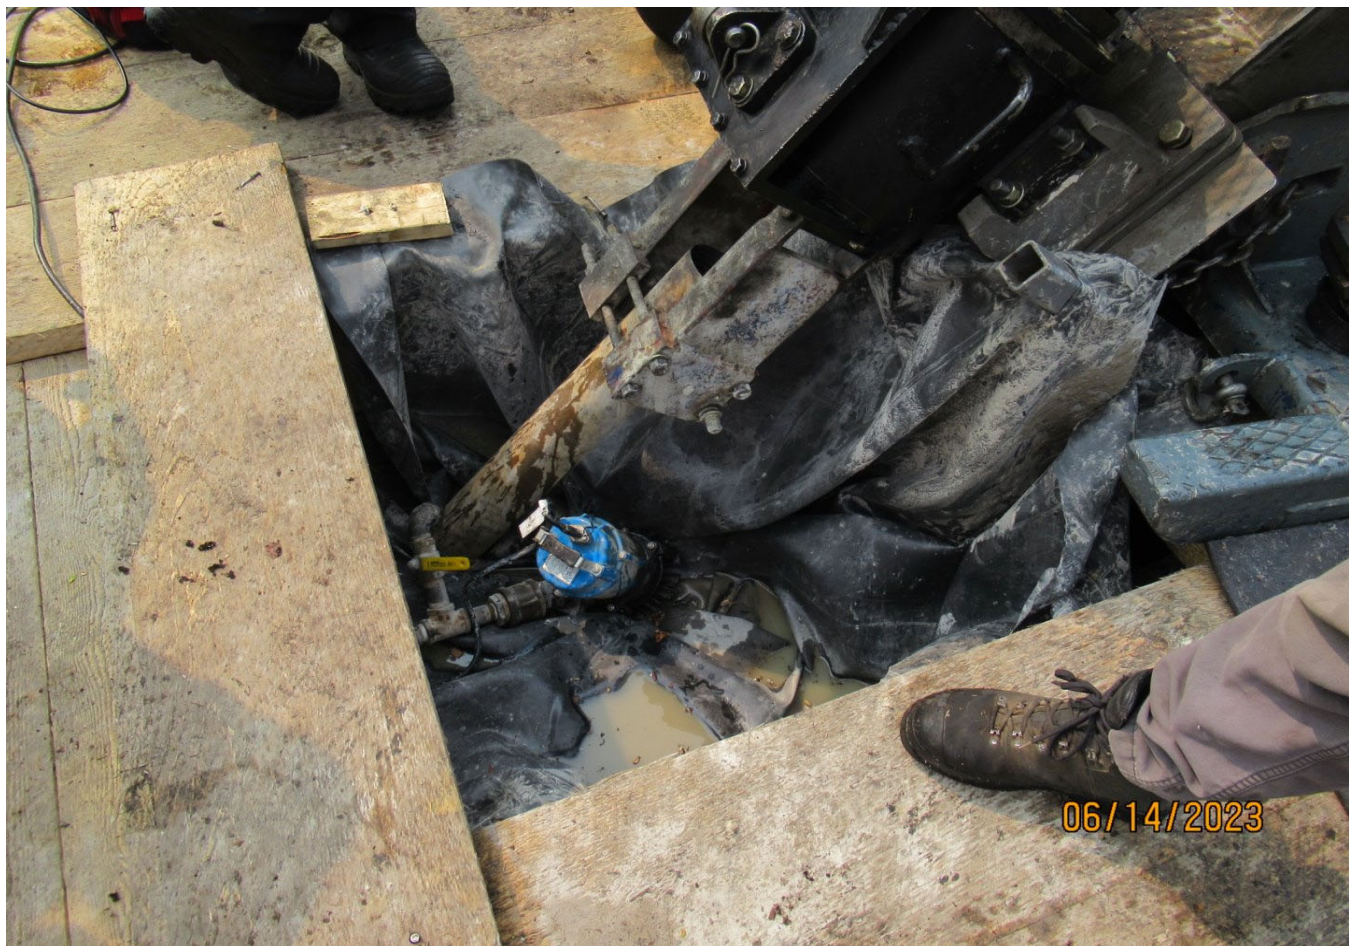
Figure 21

An impermeable tarp and submersible pump are being used to collect drill waste at the collar for the Dorado drill. Diligent monitoring of its effectiveness must remain a priority.

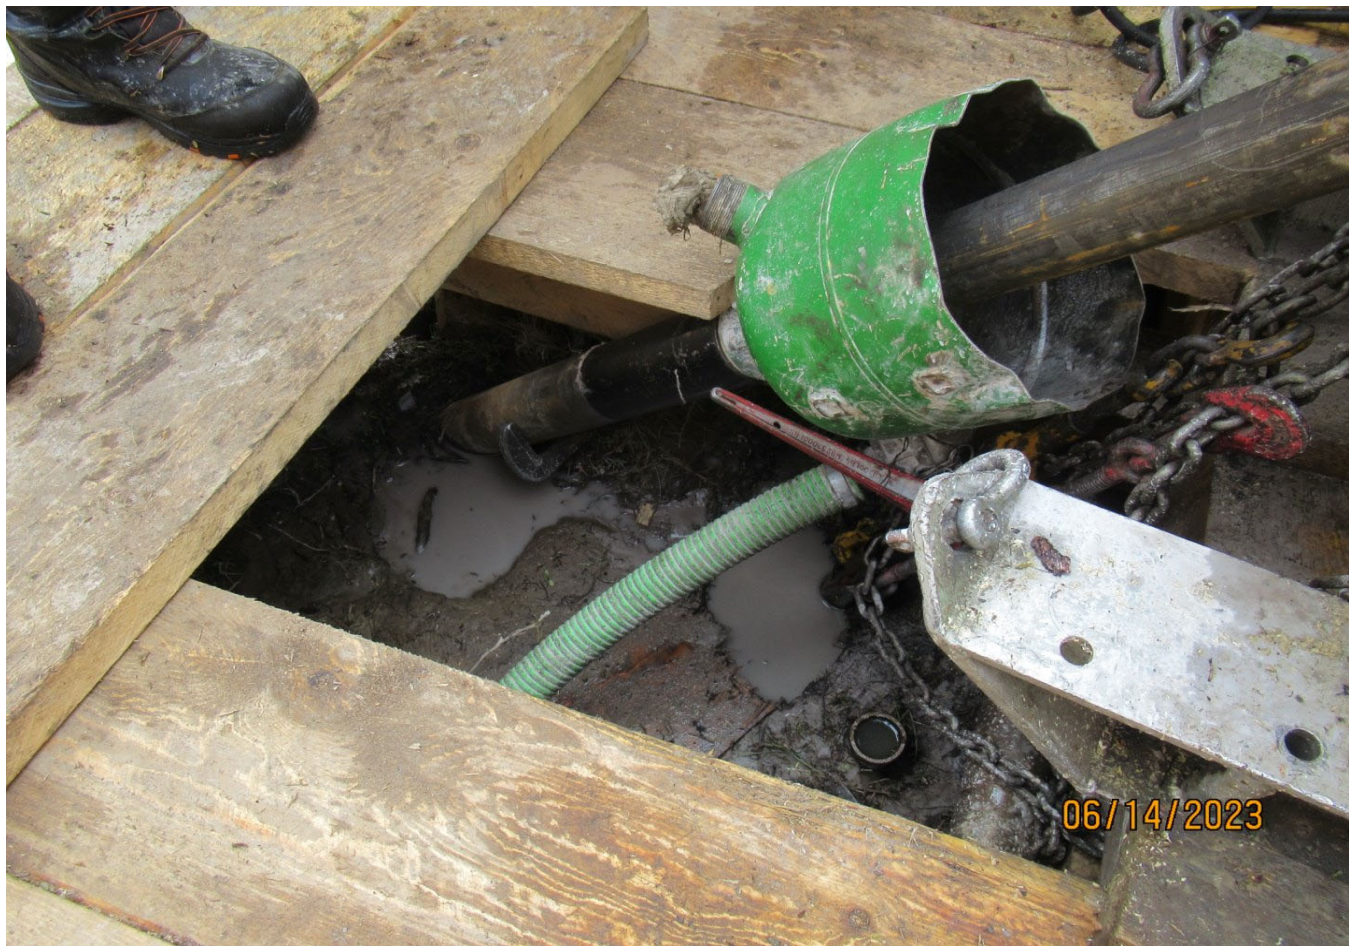
Figure 22

At the collar of the Northtech drill, drill waste was observed below the drill and discussions with personnel occurred. The Inspectors were informed that water is seeping up from around the casing and options to prevent/reduce volumes could be driving additional casing before drilling, using permaseals or using a drill additive (G-Stop). The Inspectors anticipate the best efforts of both drill contractors to mitigate the migration of water on the outside of the casing and this cooperation is anticipated.

Casing pot for the collection of drill waste at the Northtech drill. Small earthen sump is being used to collect waste that is seeping around the casing.

When the aforementioned methods do not rectify the seepage, a shallow earthen sump can be excavated at the collar. The size of the sump must be kept to a minimum and if possible, no larger than what is required for a submersible pump.

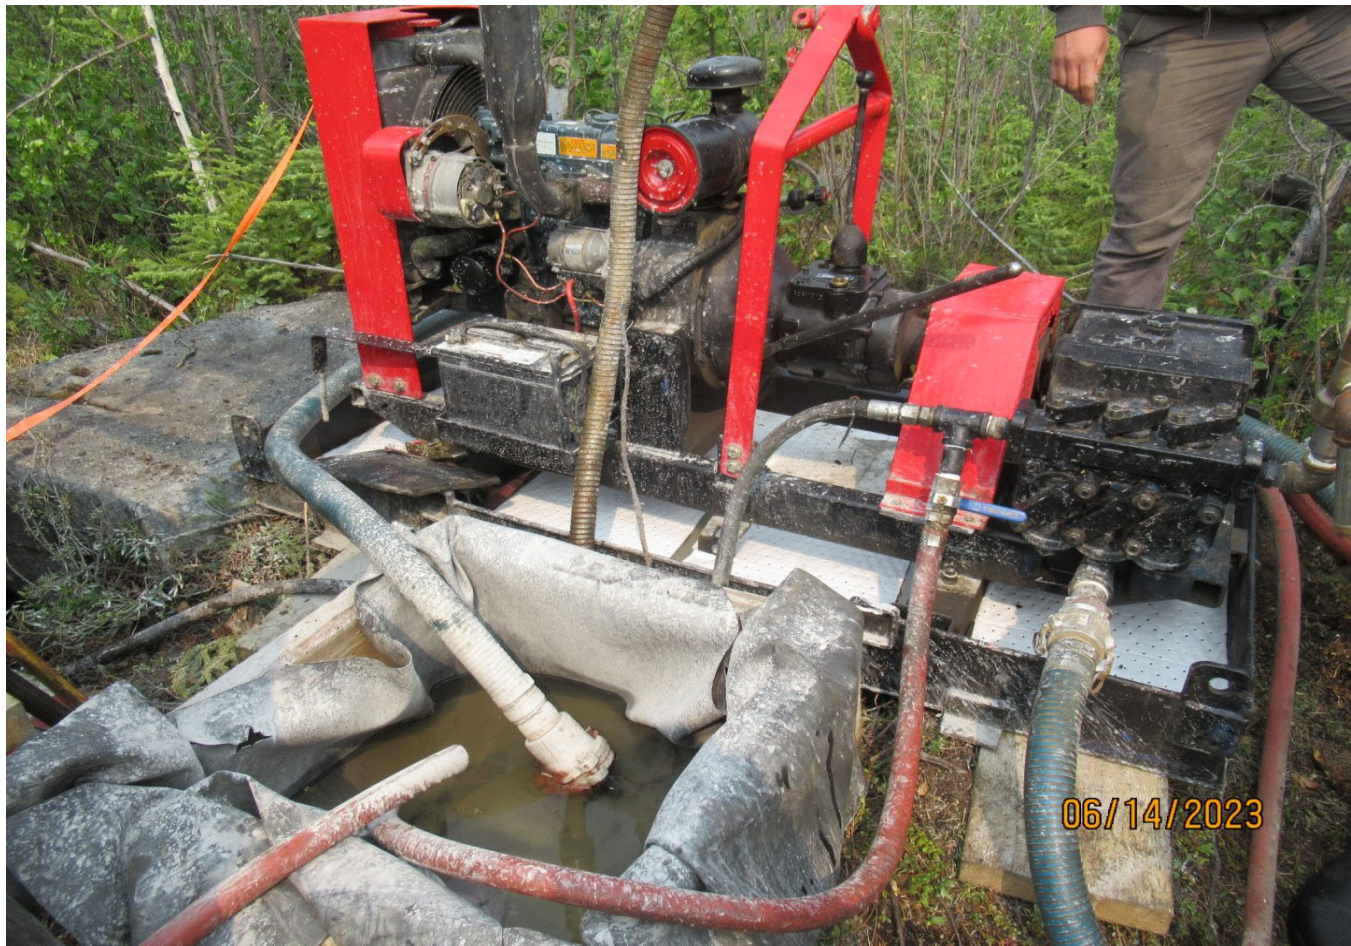
Figure 23

Drill waste is being directed to this collection bin for pumping to a natural depression.

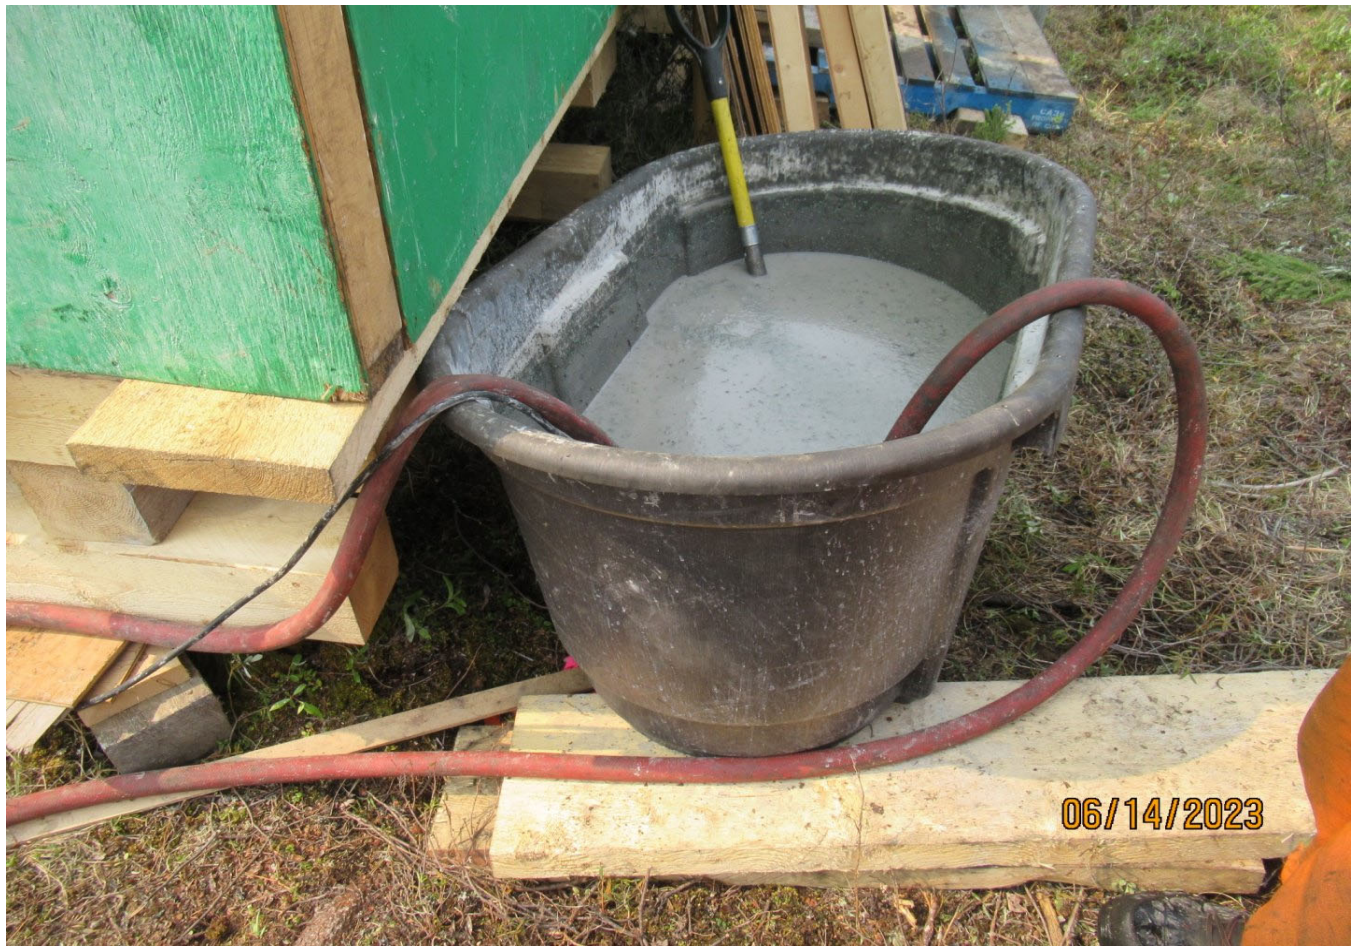
Figure 24

Drill waste collection tub at the Northtech drill. Continuous pumping to a disposal location is occurring.

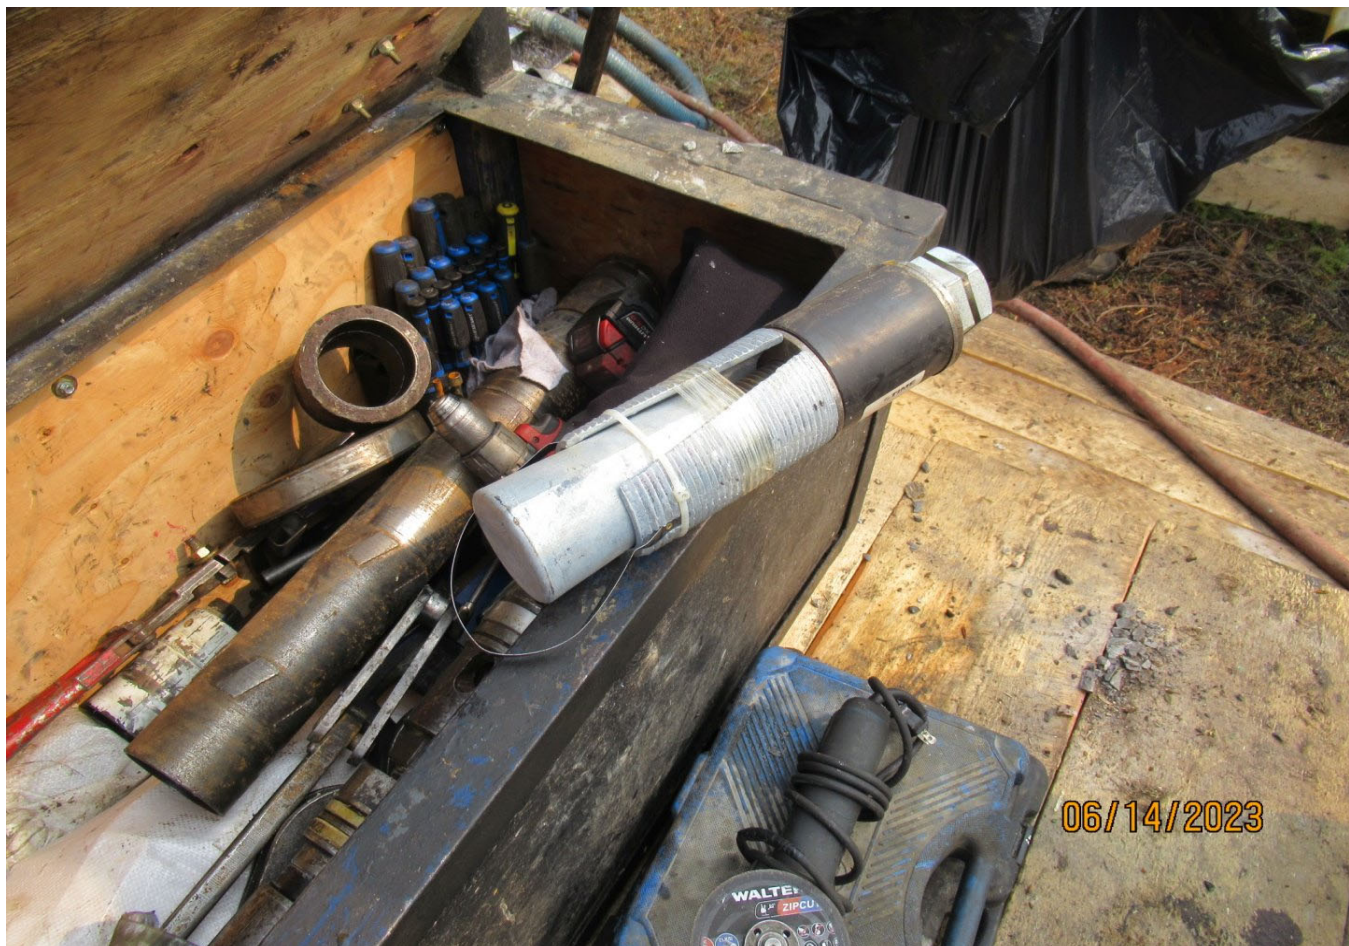
Figure 25

Drill hole plug is being used by Dorado for the sealing of holes upon completion of drilling a target. Northtech is using a Van Ruth Plug and cement.

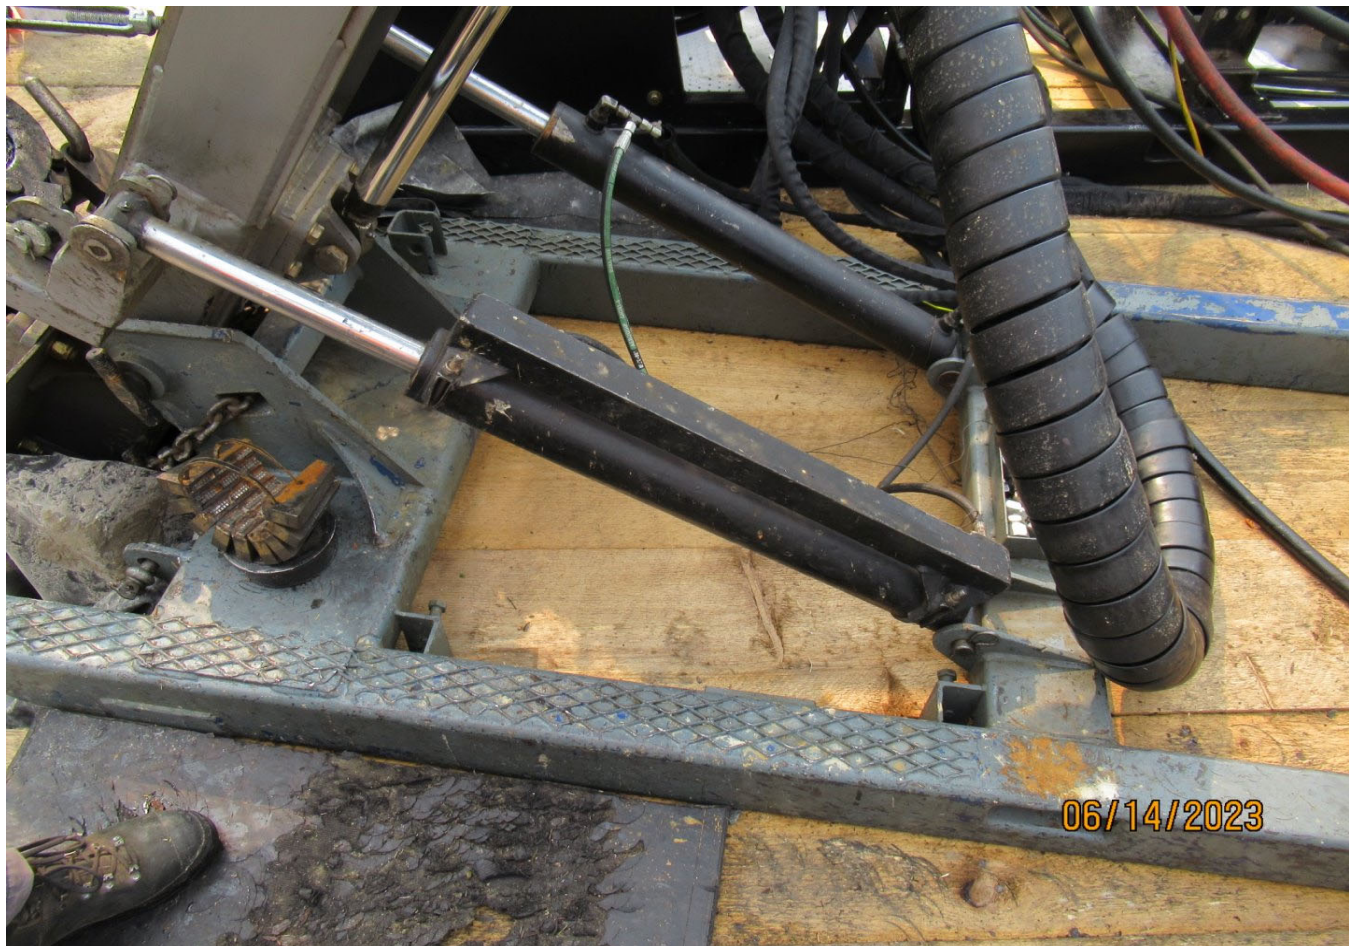
Figure 26

A form of secondary containment must be implemented below the feed frame of the Dorado Drill.

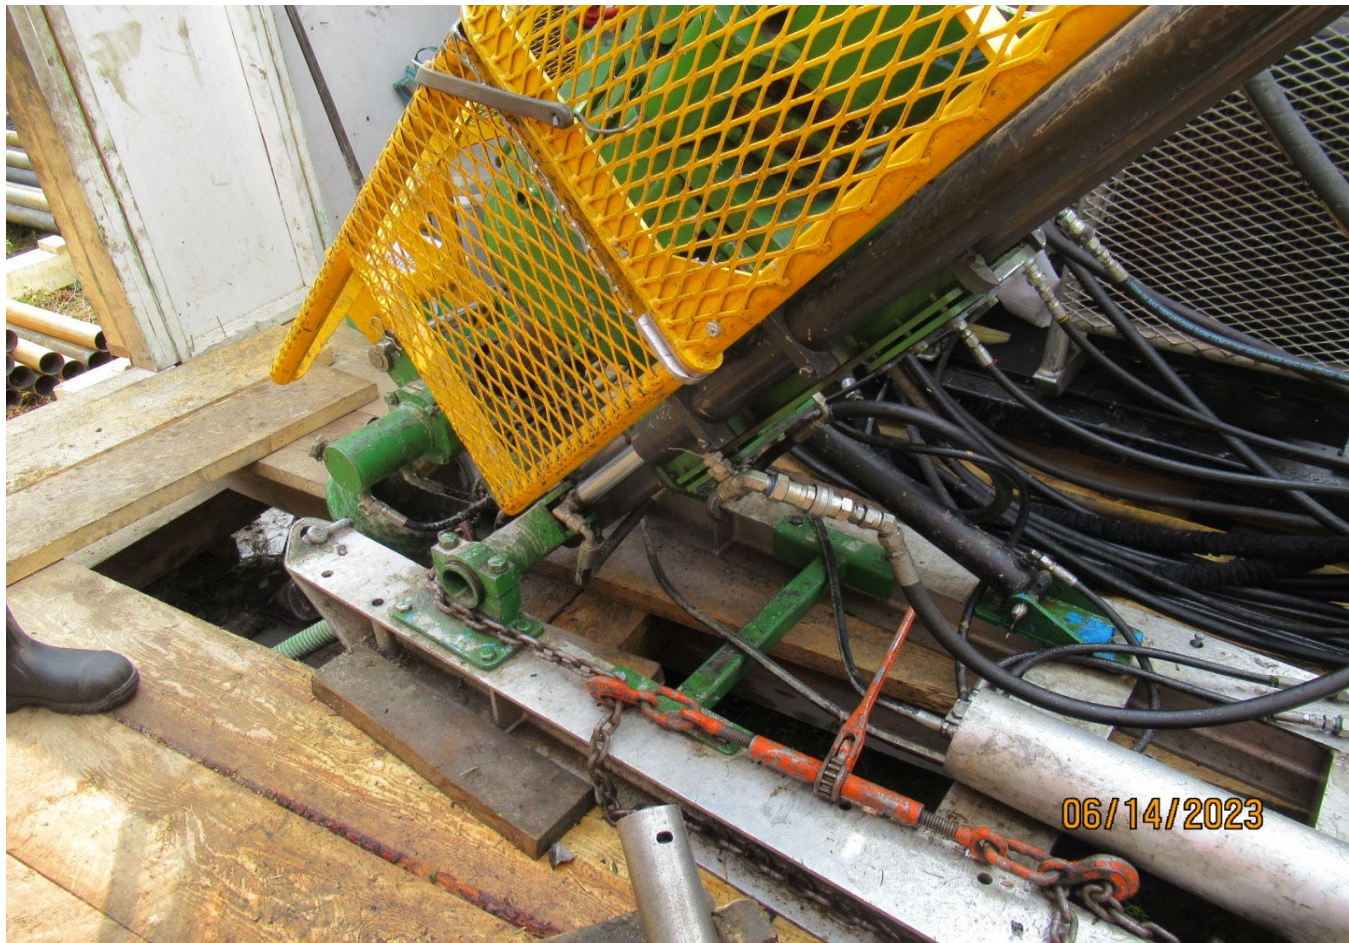
Figure 27

A form of secondary containment must be implemented below the feed frame of the Northtech drill.

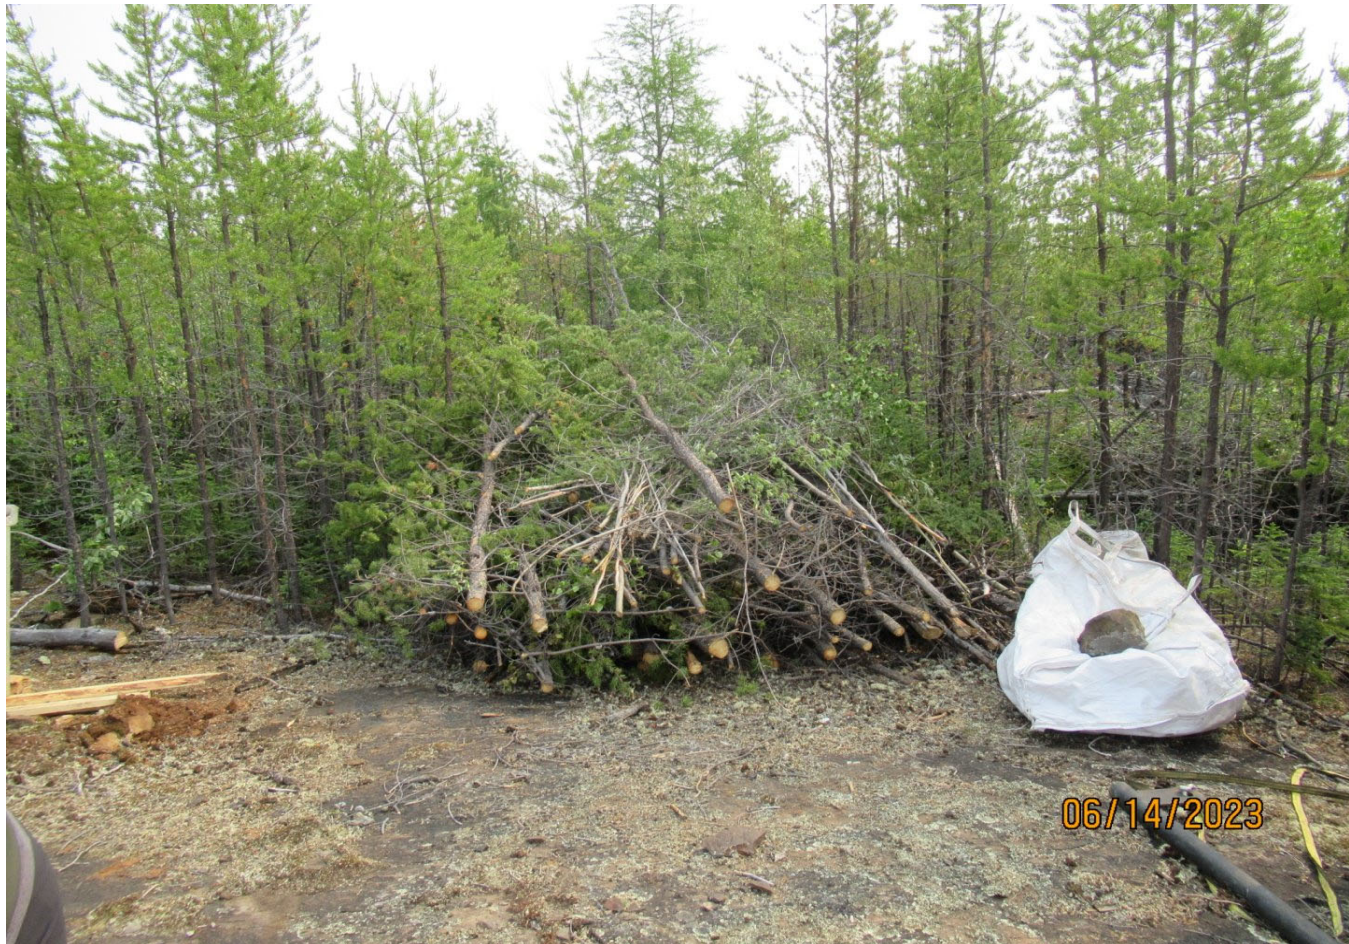
The current practice for tree disposal in laydowns and at drill sites is cut & pile like viewed in Figure 28 & 29. This practice is not required and acceptable methods to comply with Condition #78 were discussed with the Mr. Mike Leidl and both drill Contractors. Trees can be cut and bucked up into suitable lengths so all parts of the tree lie flat on the ground surface and spread in the adjacent forest, or over a completed drill site.

All cut trees must be bucked up and spread in the adjacent forest or over a completed drill site. Double handling of trees should be avoided.

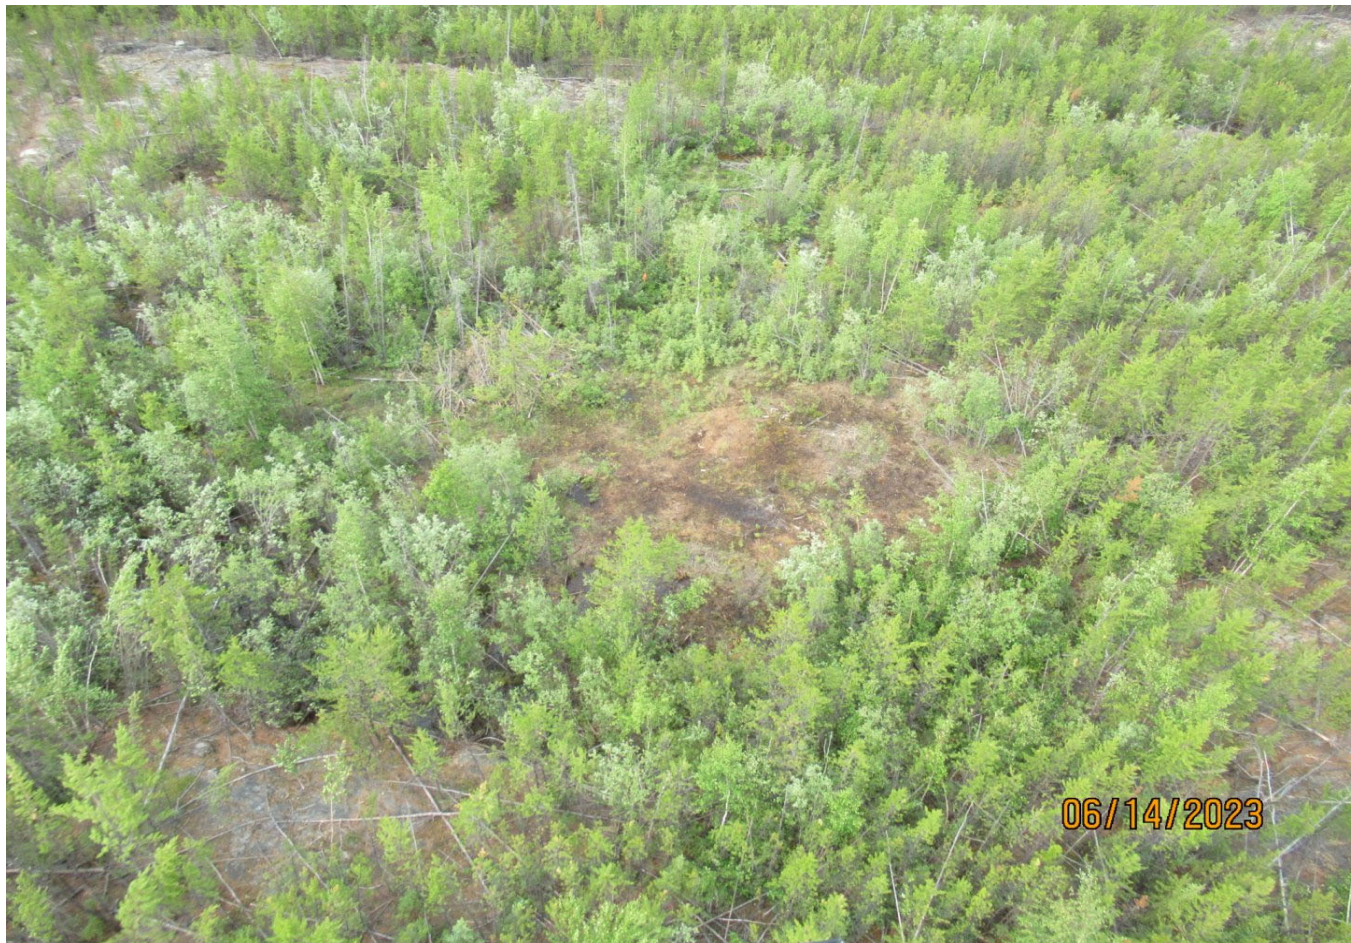
Figure 29
Completed drill target on Fi Southwest. Proper tree disposal must occur.

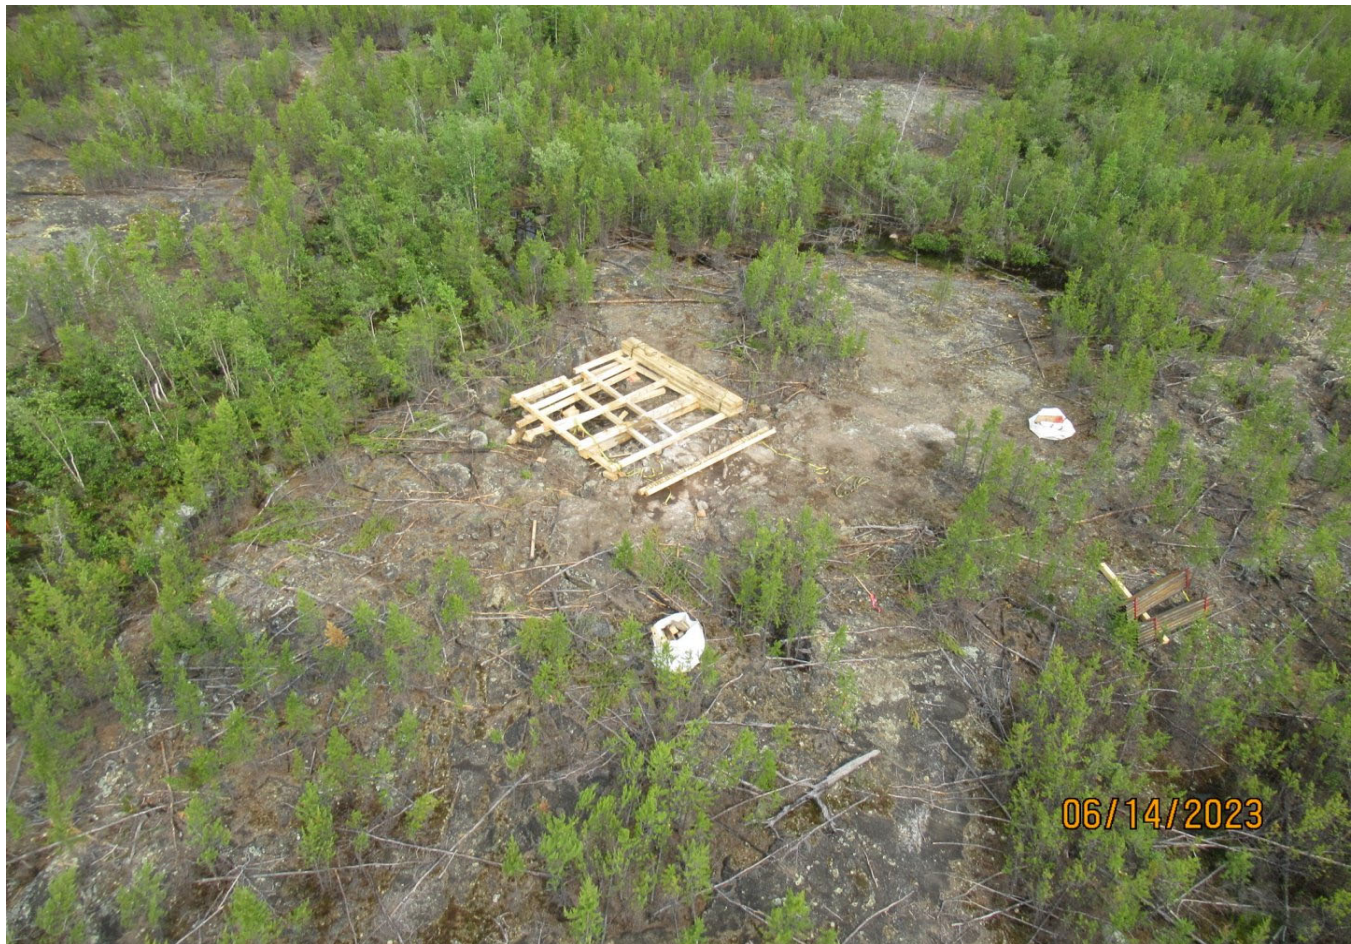
Figure 30
Another completed drill target on Fi Southwest. All items will be removed in due course.

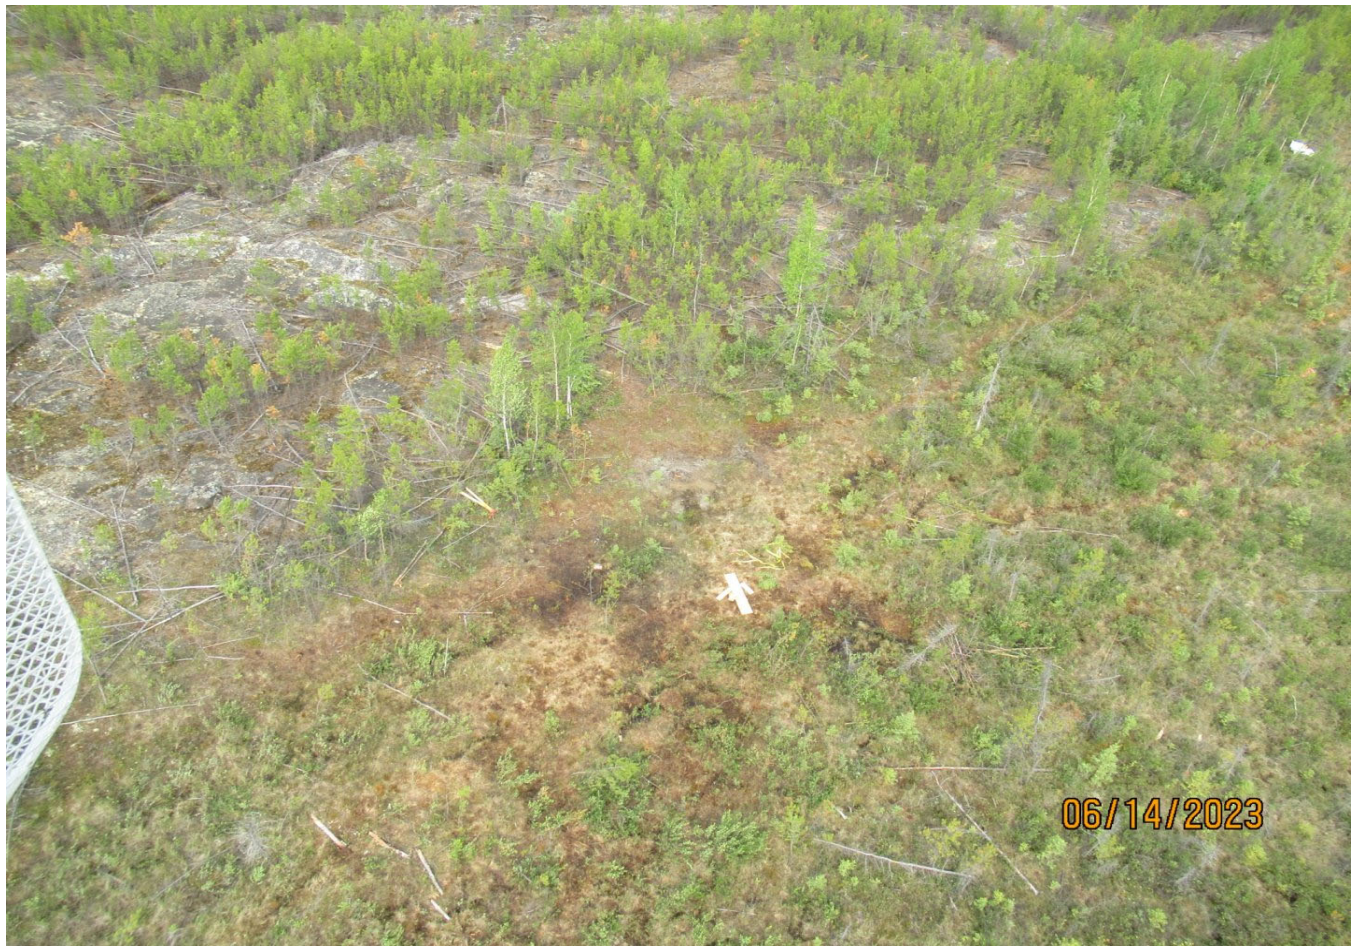
Figure 31
Minor amount of blocking to retrieve from a completed drill site.

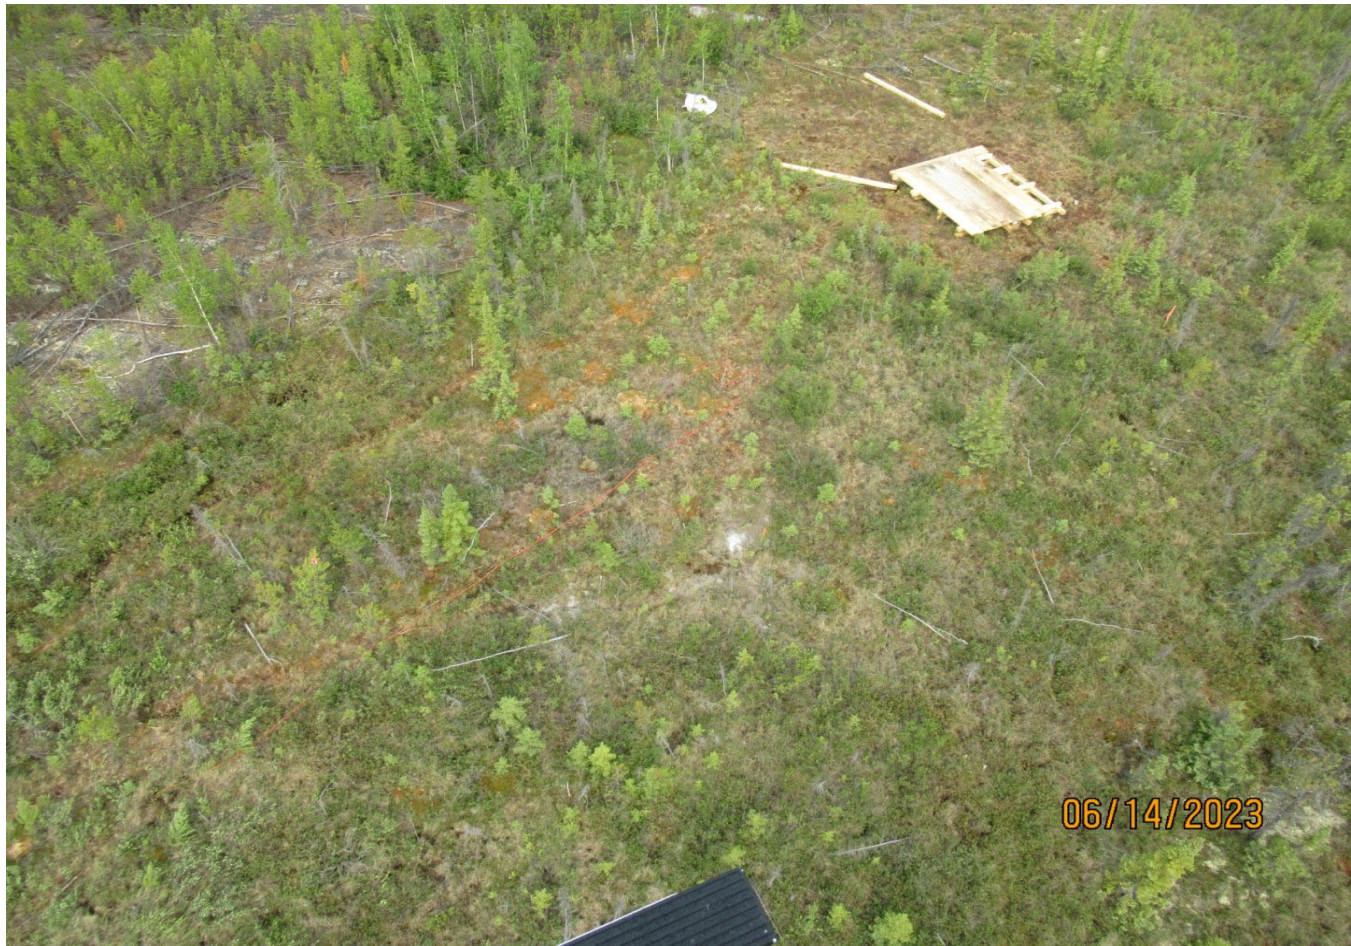
Figure 32
Completed drill site to the south of the timber pad. It appears cuttings management is occurring and drilling is being undertaken in the dry.

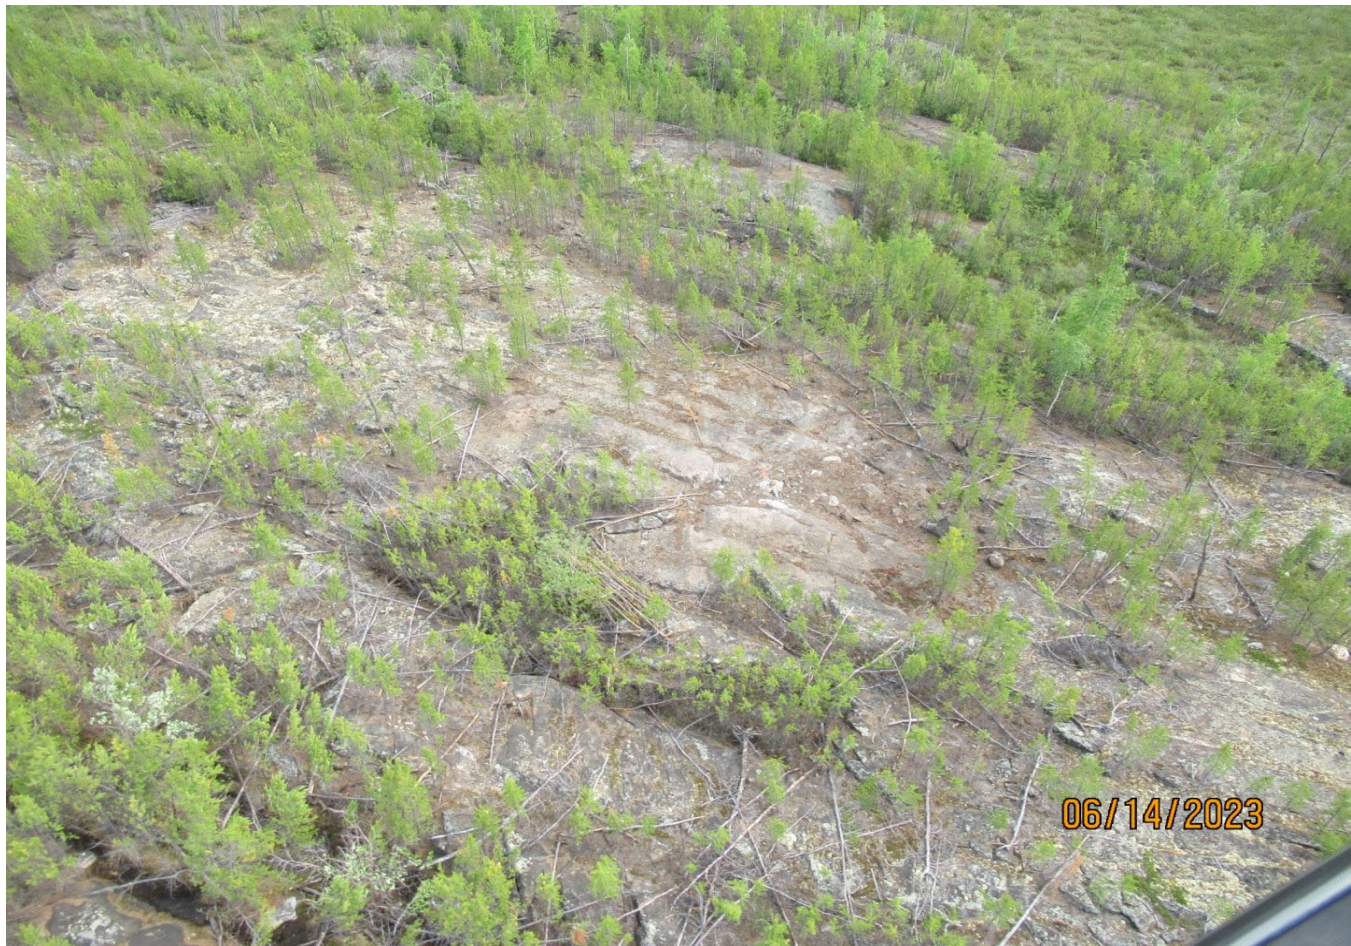
Figure 33
Completed target and no concerns noted with the exception of tree disposal.

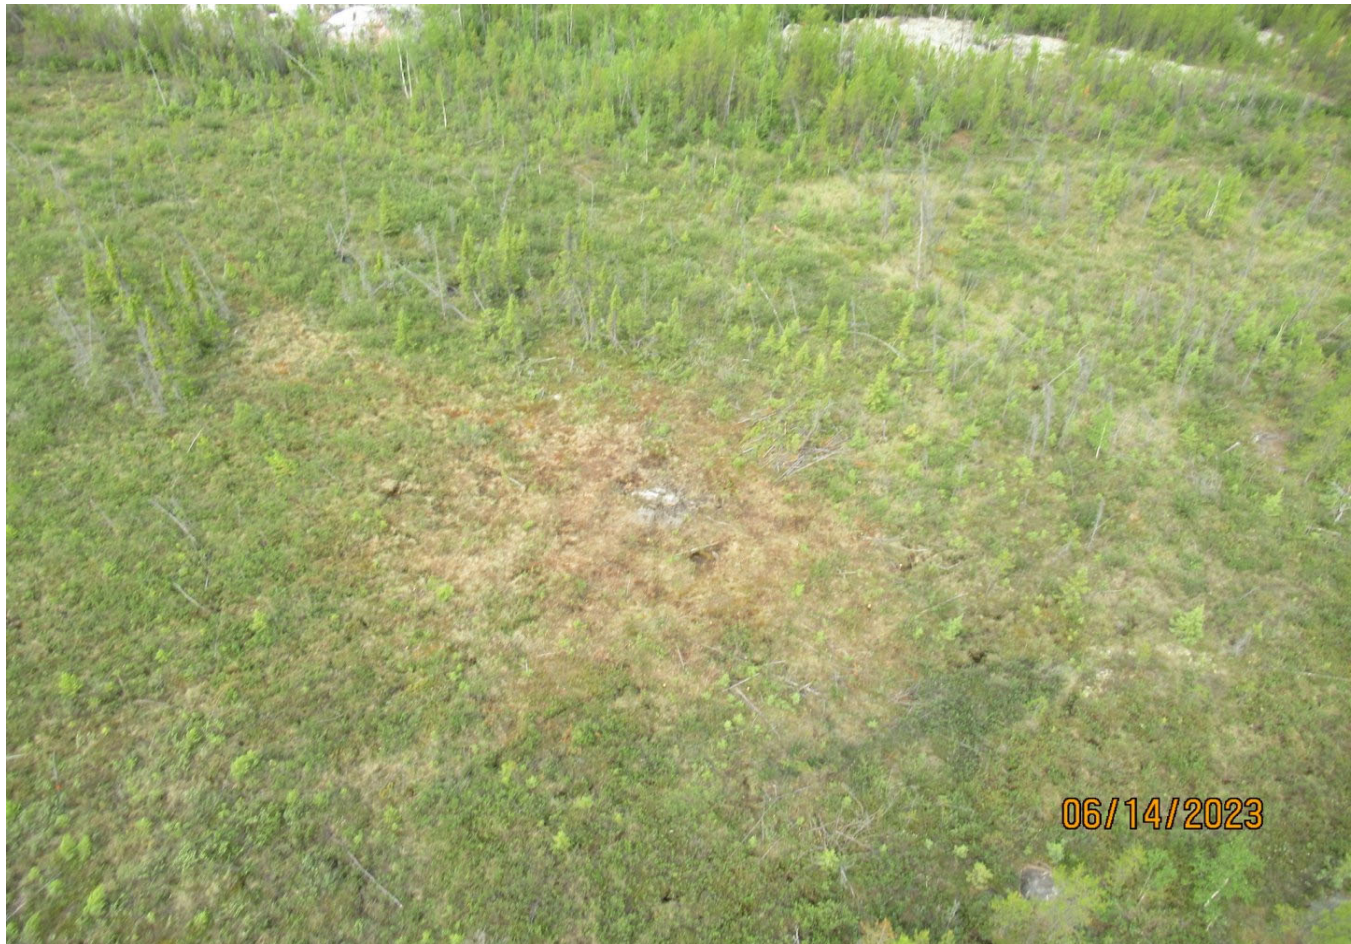
Figure 34
Another example of a completed drill site. Operations are being conducted in a manner that complies with operating conditions of the land use permit.
