**Re: Land Use Permit MV2022C0021
Mineral Exploration
Yellowknife Lithium Project, NT**

ENVIRONMENTAL INSPECTION REPORT

Permittee:	EREX International Ltd.	Inspection Date – June 14 th , 2023
------------	-------------------------	--

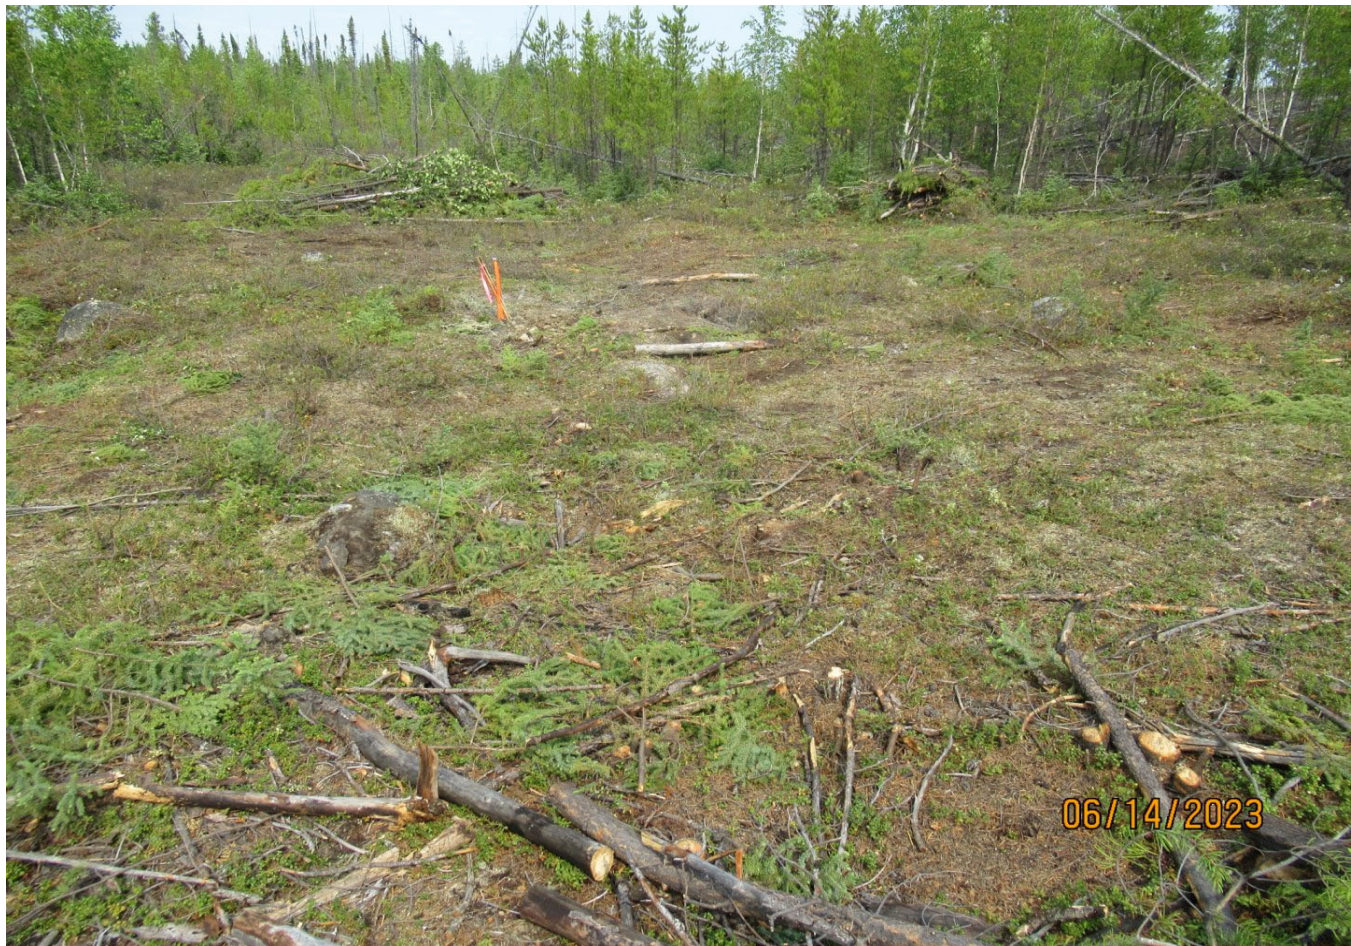
Figure 35
Completed drill site on Fi Main.

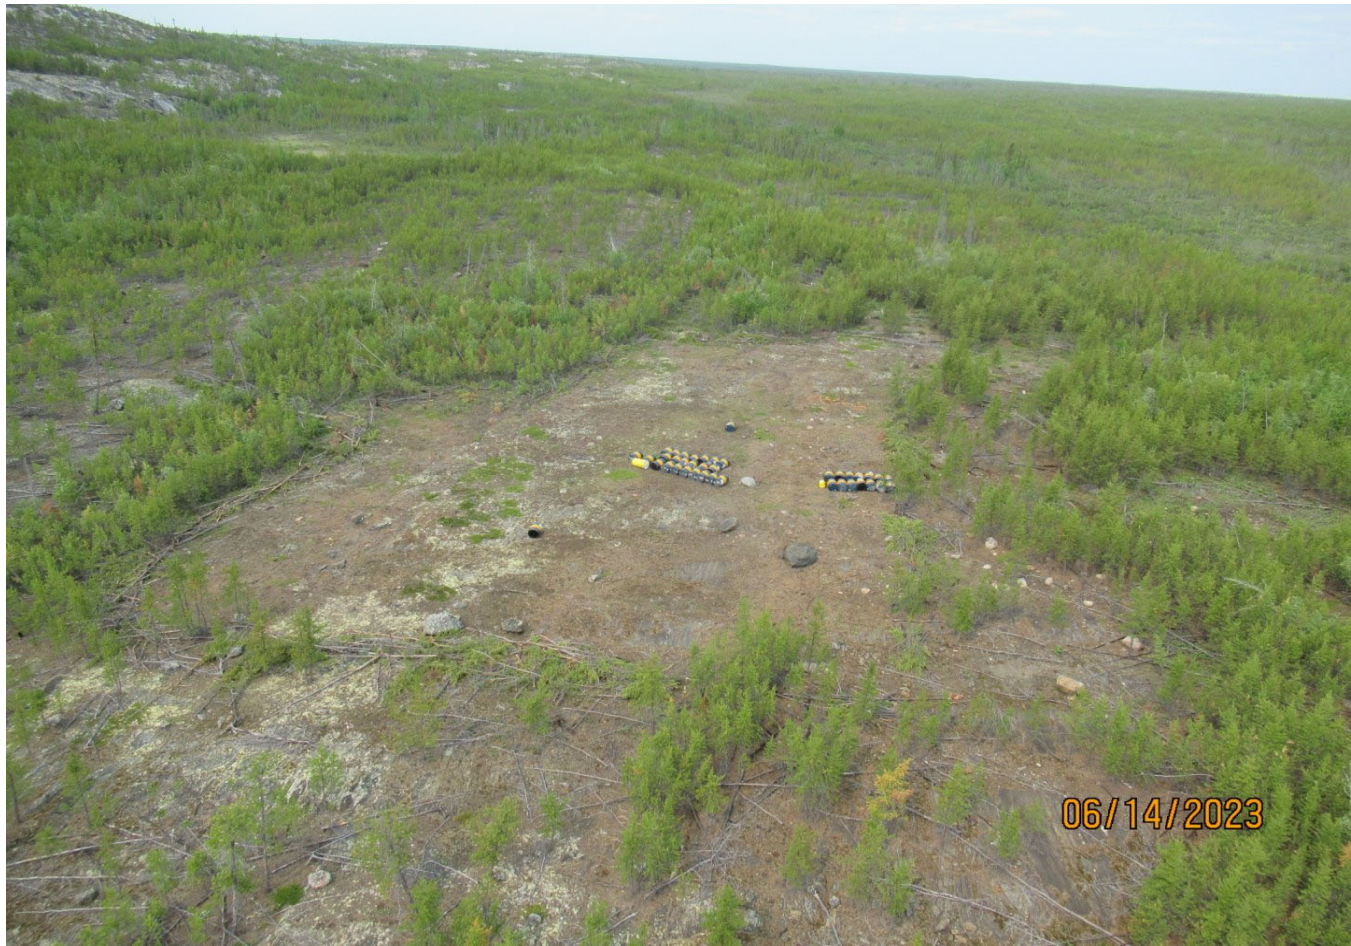
There is currently one fuel cache southwest of the Fi mineral lease and (Figure 36) only one improvement is required. Drums are being stored on their sides, the Permittee’s name has or will be stenciled on the drums, a spill kit was present and bungs are positioned at 3 and 9 o’clock. The improvement required is to better space the rows of drums so that walkways between rows can be created to allow for ease of inspection. This will ensure diligent compliance with Condition #62 of the land use permit.

Figure 36
Fuel cache southwest of where drilling is occurring. Only concern was the requirement to establish walkways between rows of drums.
