File Number	MV2022X0018
Type of Operation	Cameron Hills Oil and Gas Field Abandonment
Location	Cameron Hills, NT

ENVIRONMENTAL INSPECTION REPORT

Permittee:	Strategic Oil and Gas Ltd. c/o Alvarez & Marsal Canada Inc.	Permit Expiry Date:	January 02, 2028
Land Use Permit No.	MV2022X0018	Previous Inspection:	February 21, 2024
Quarrying Permit No.		Inspection Date:	September 17, 2024
Contractor:	ELM Inc.	Subcontractor:	
Location(s) Inspected:	Cameron Hills Oil and Gas Field		
Current Stage of Operation:	The abandonment of the H-03 Battery, forty-four (44) oil and gas wells was completed in the winter of 2023 and 2024.		
Program Modifications Approved:

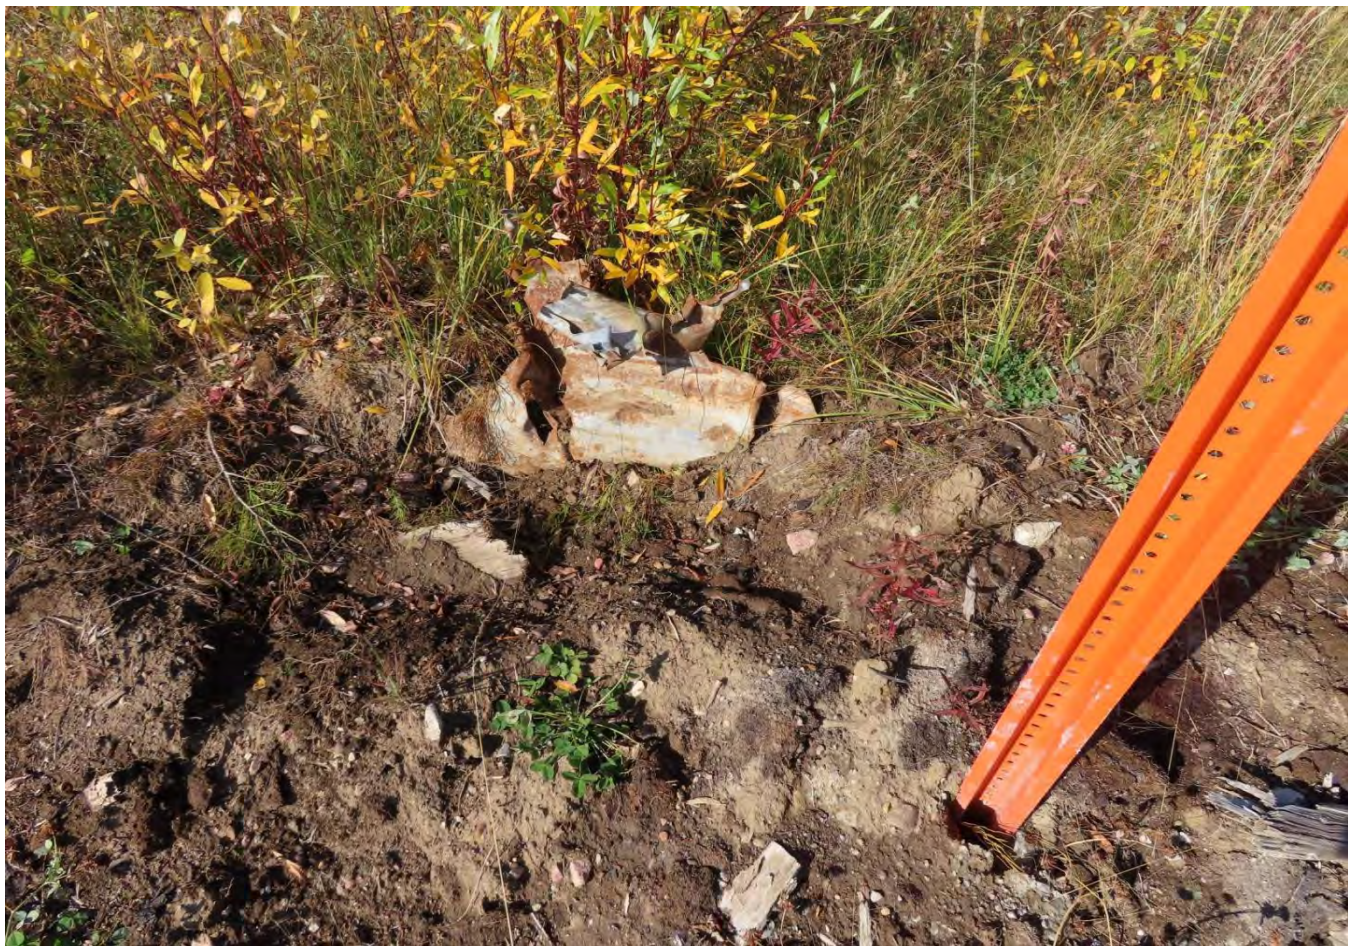
C-74: Piece of cellar with sharp metal sticking out of the ground poses hazard to wildlife.

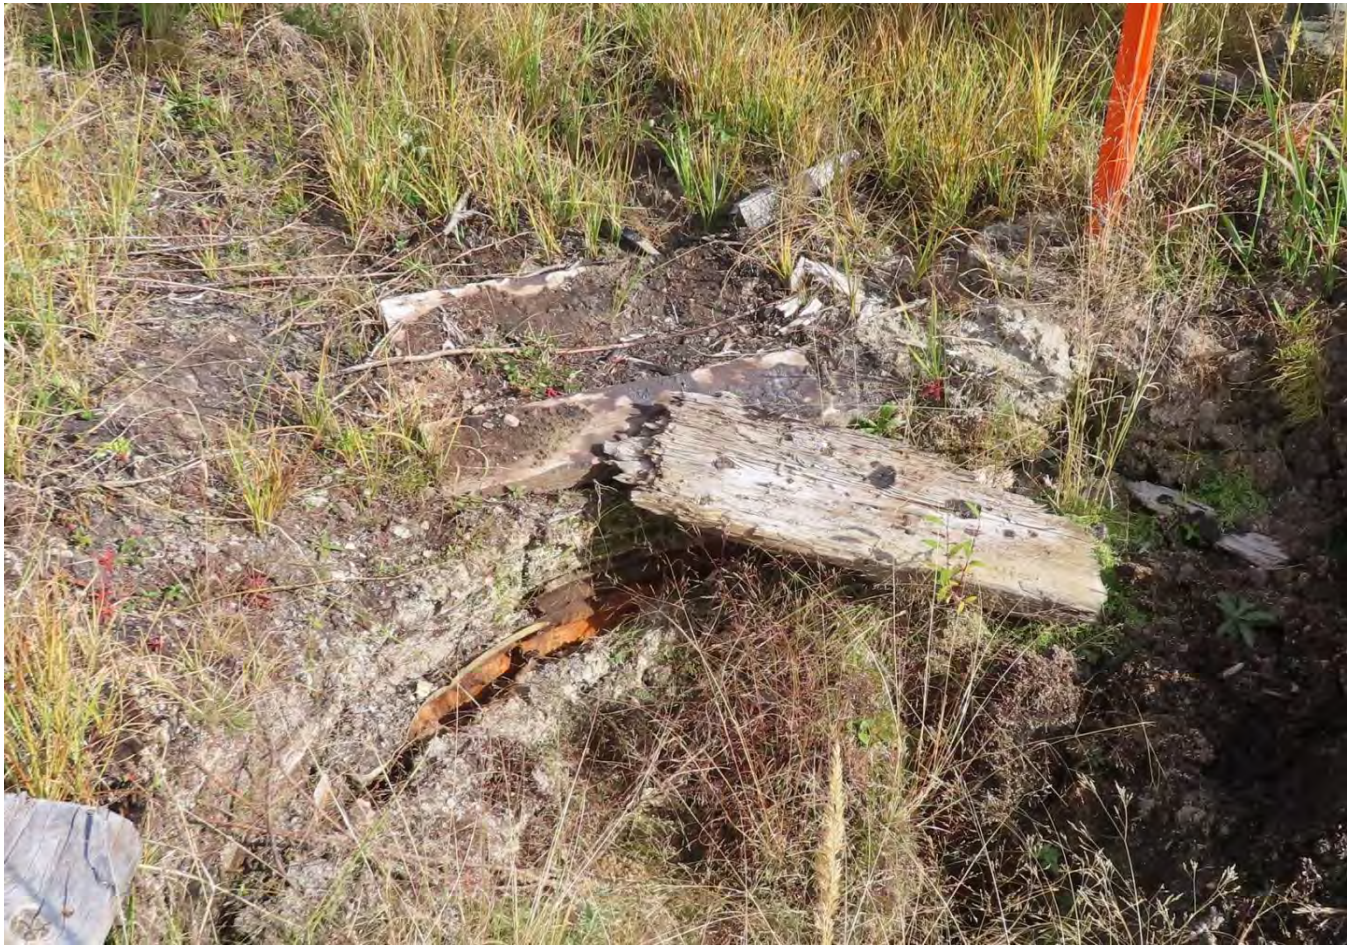
H-03: Cellar, oil stained lumber to be removed from well center.

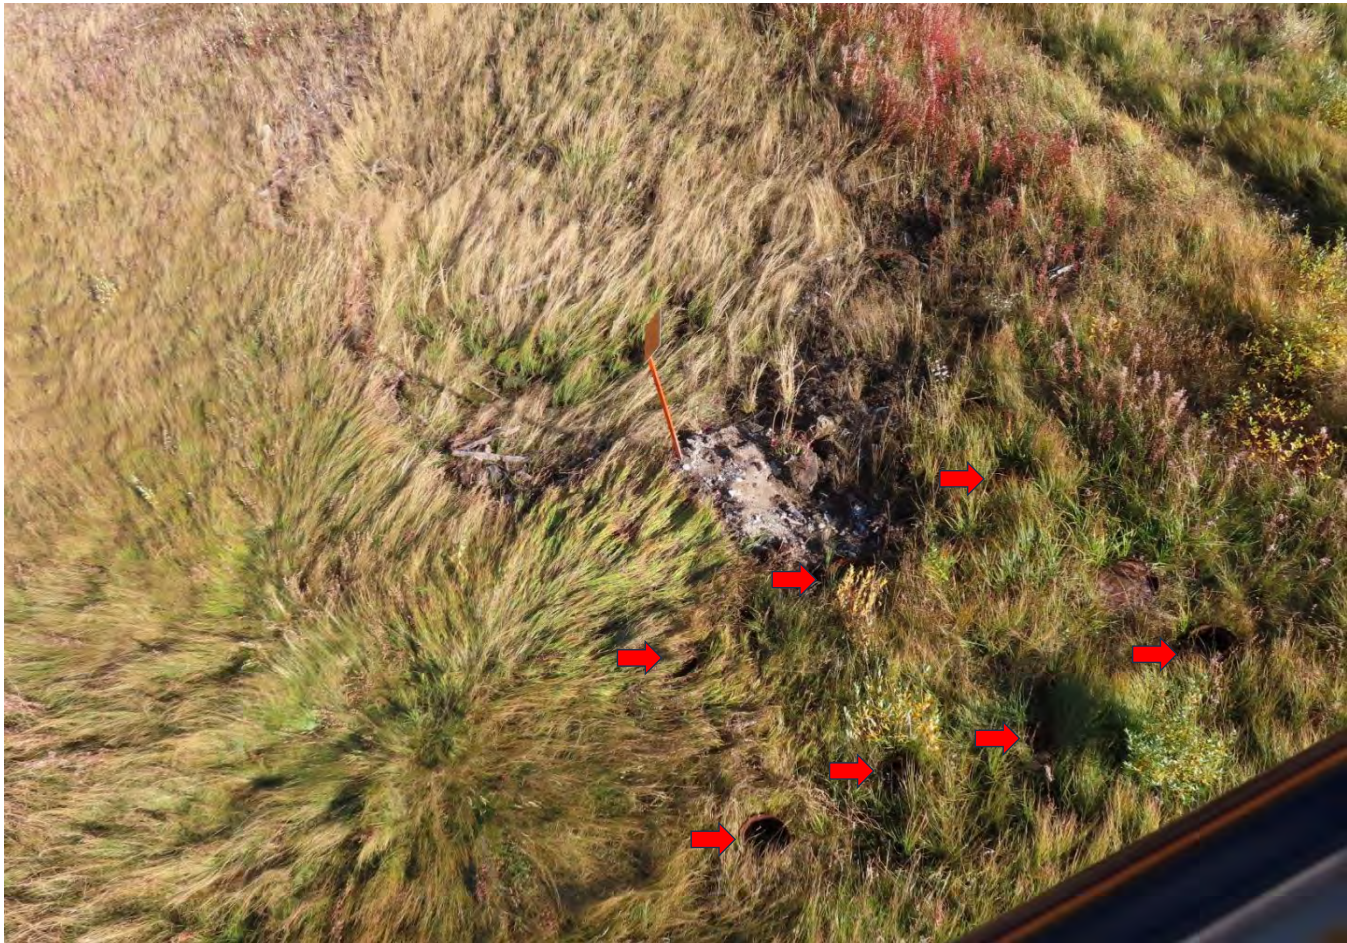
- 4. Eleven (11) pilings were observed to be cut off just above ground level. 2 pilings: 20” diameter; 8 pilings: 18” diameter; 1 piling: 6” diameter. All pilings were hollow, full of water and greater than 1.3 meters deep. Note that many of these pilings were obscured by vegetation making them difficult to see. These pilings pose a hazard to persons on site and wildlife. **ECC requires Alvarez and Marsal (A&M), the NWT receiver of Strategic Oil and Gas Ltd., to implement temporary mitigation of 2H-03 no later than October 31, 2024.**

2H-03: Eleven (11) pilings were observed to be cut off just above ground level. 2 pilings: 20” diameter; 8 pilings: 18” diameter; 1 piling 6” diameter.

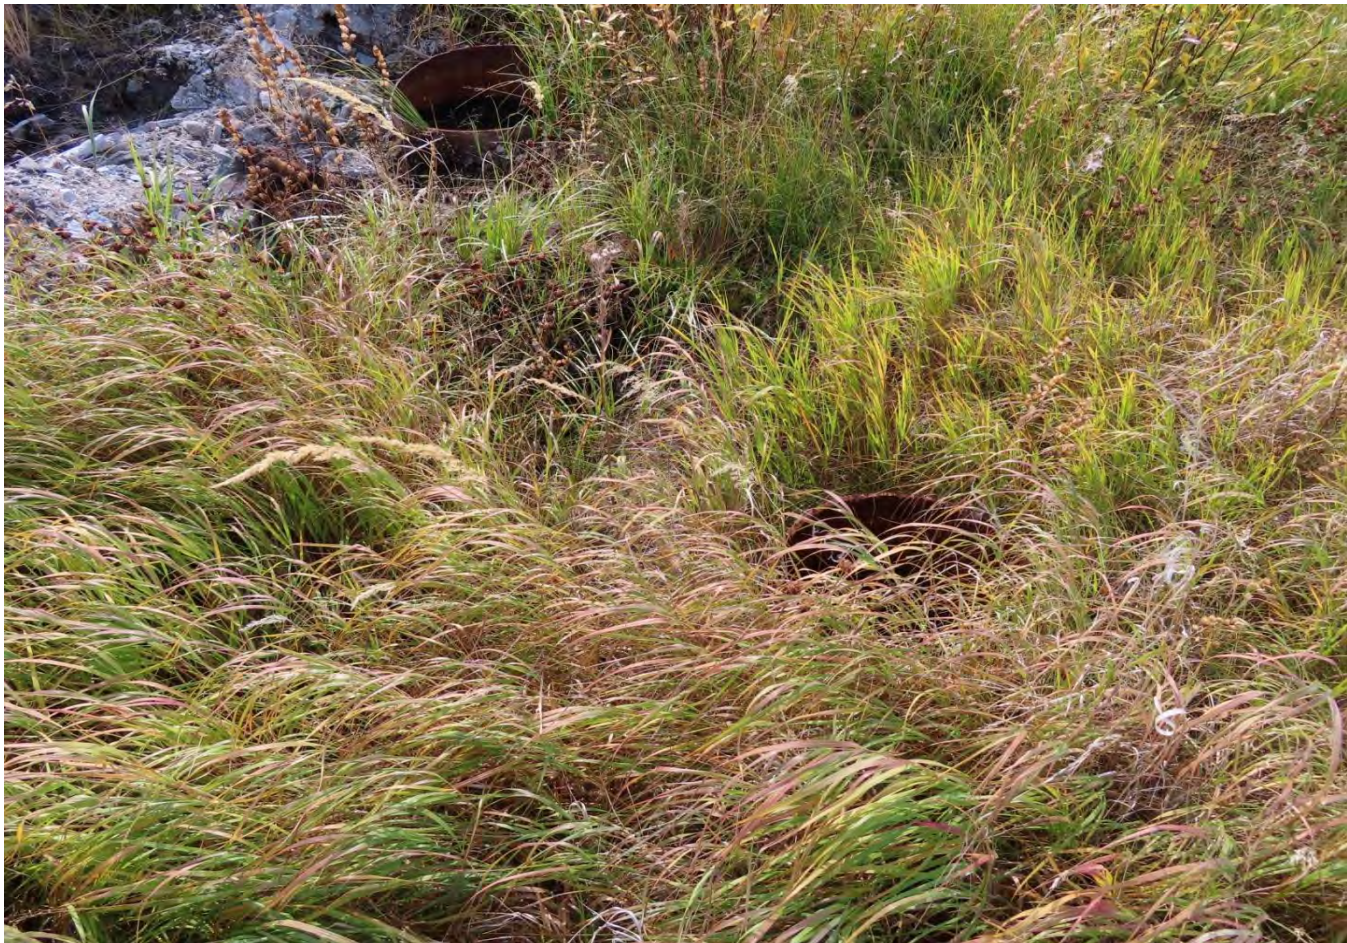
Figure 60

2H-03: Pilings were foundation for oil and gas infrastructure on the well. Pilings were note removed when the well was abandoned in 2023. Most pilings were difficult to see due to the high vegetation.

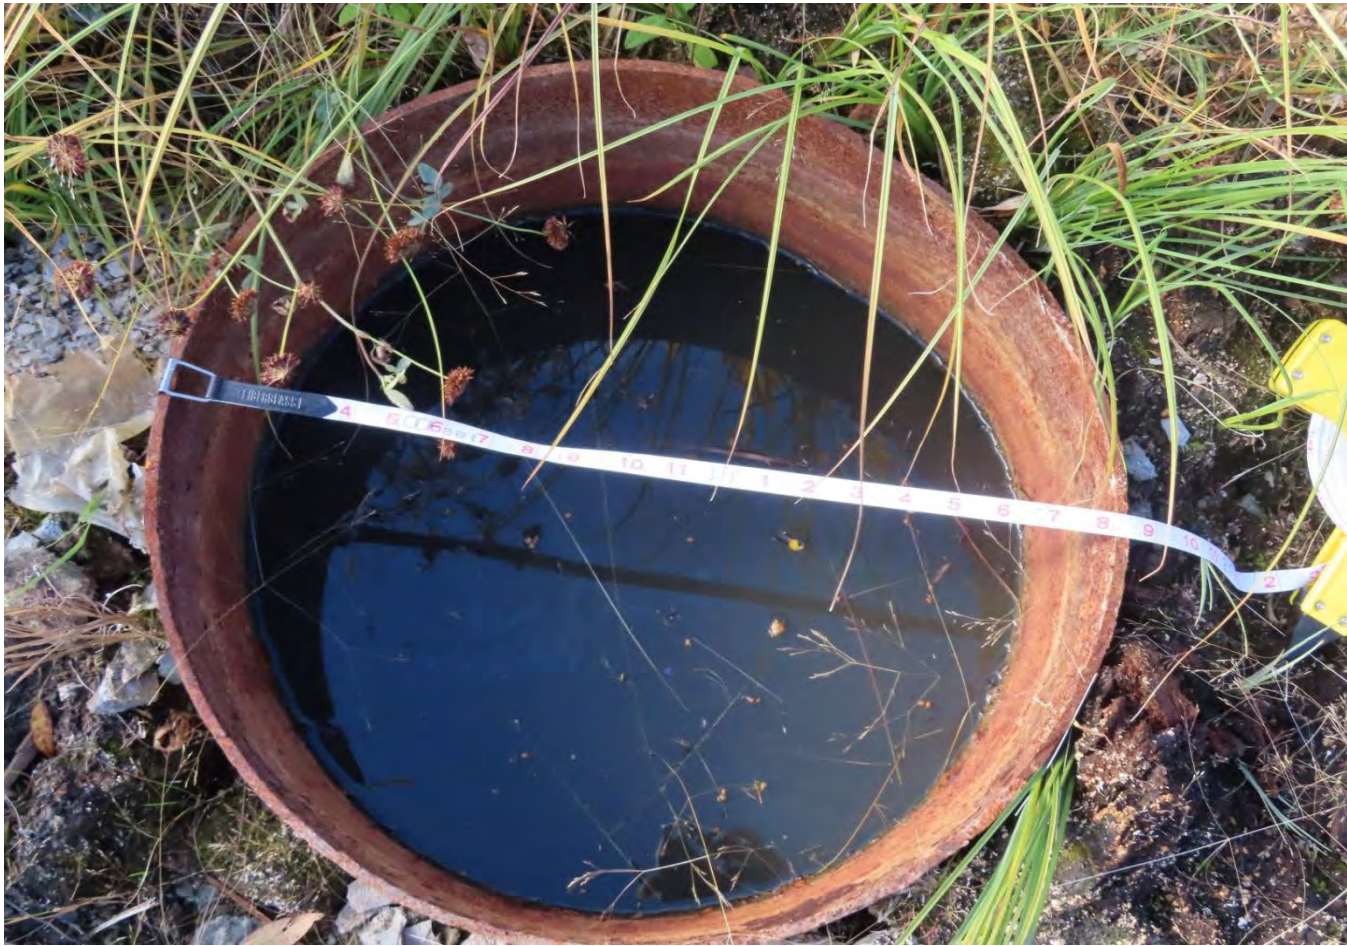
2H-03: Example of a 20” diameter piling left on the wellsite. These pilings are open and hollow posing a hazard to persons on site and wildlife.

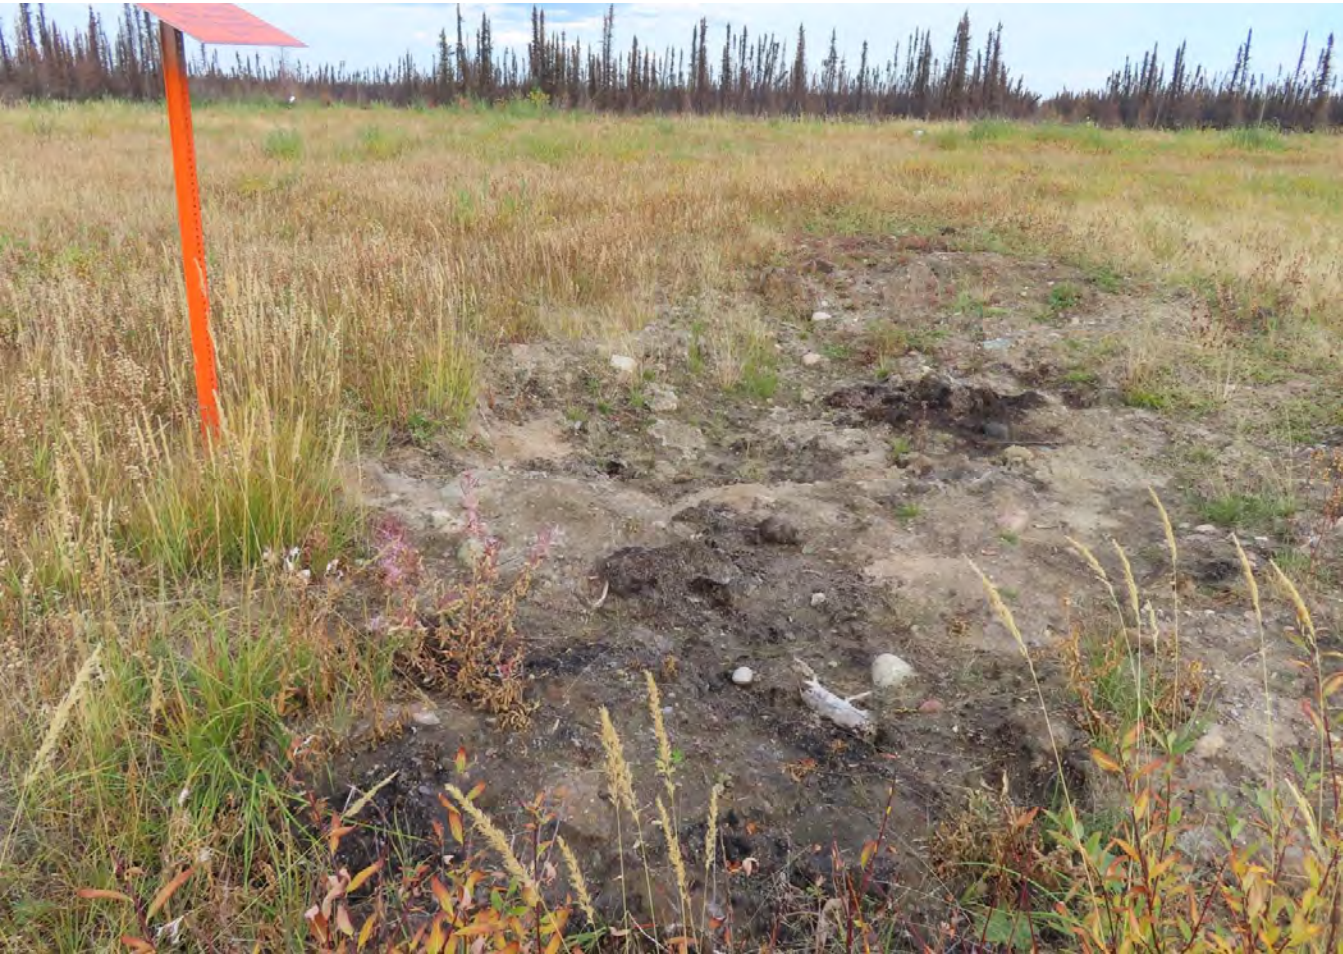
Figure 66

- 1. H-58 Well has been abandoned and cut/cap completed.
- 2. All production infrastructure was removed in 2023.
- 3. Backfill of well center satisfactory.
- 4. No debris or drill waste observed on the site.
- 5. Hydrocarbon impacted soils observed at well center (<3m³) requires cleanup.
- 6. All other aspects of wellsite satisfactory.

H-58: Backfill of well center appears satisfactory. Hydrocarbon impacted soils observed at well center (<3m³) requires cleanup.

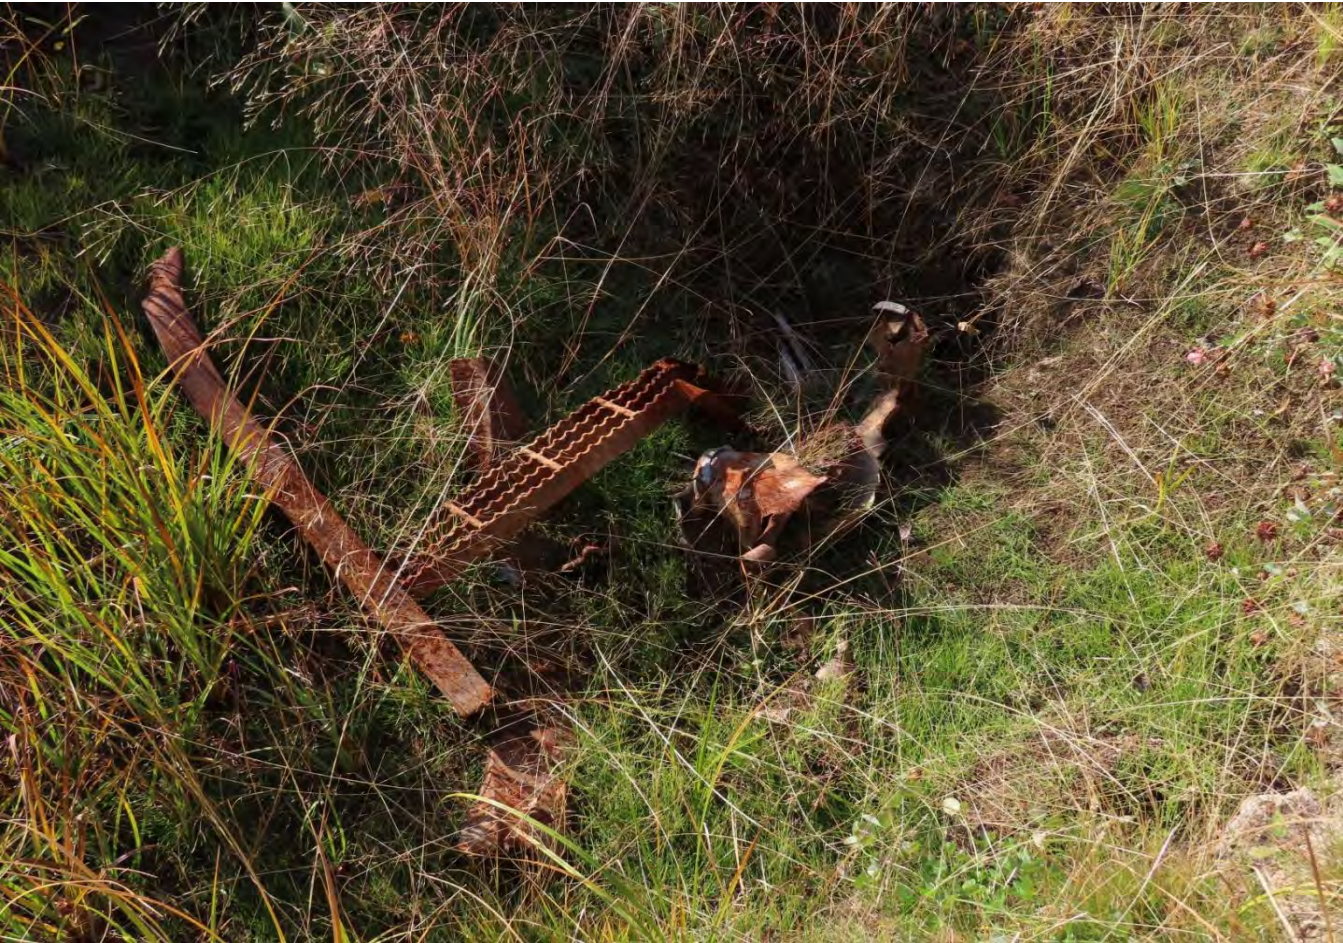
I-73: Portion of cellar with sharp metal is sticking out of the ground which poses hazard to wildlife. Metal debris at well center to be removed. Backfill of well center not completed.

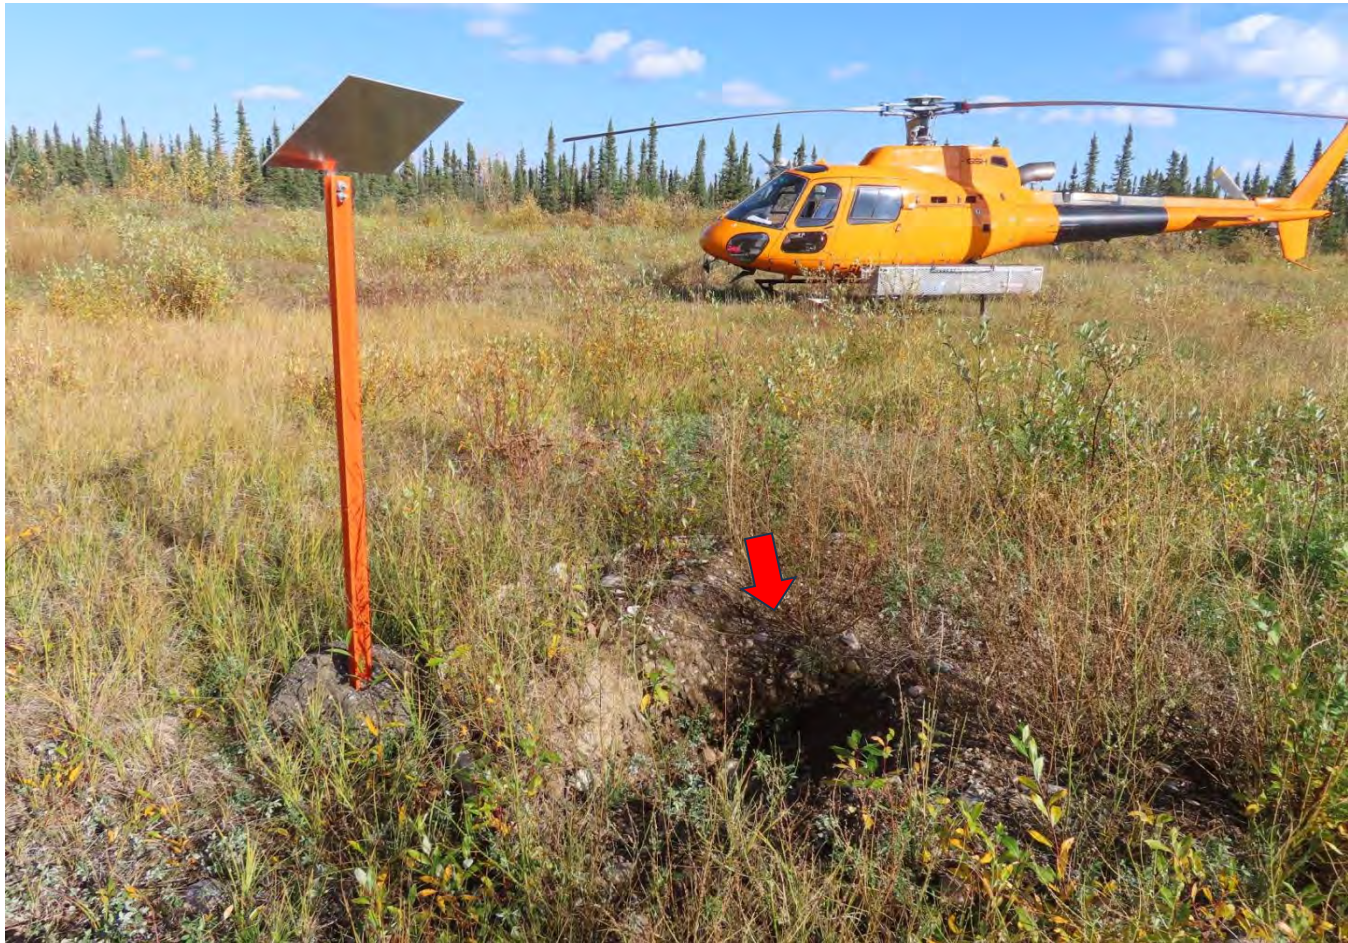
I-74: Well center not backfilled following abandonment operation.

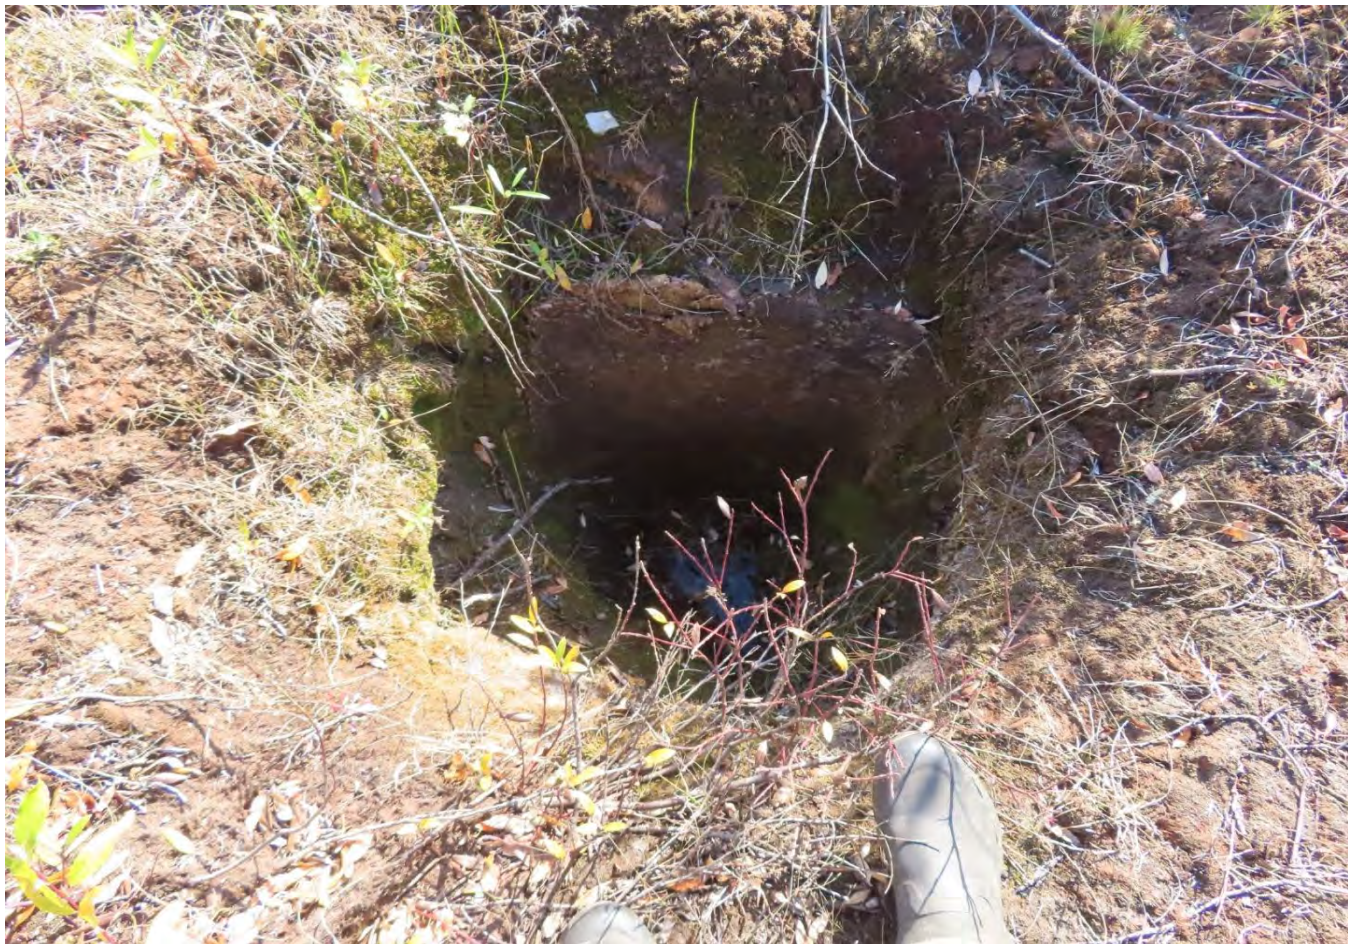
Figure 80

2I-74: Rathole not backfilled where proposed 2I-74 well was to be drilled. The rathole is a hazard to persons on site and wildlife.

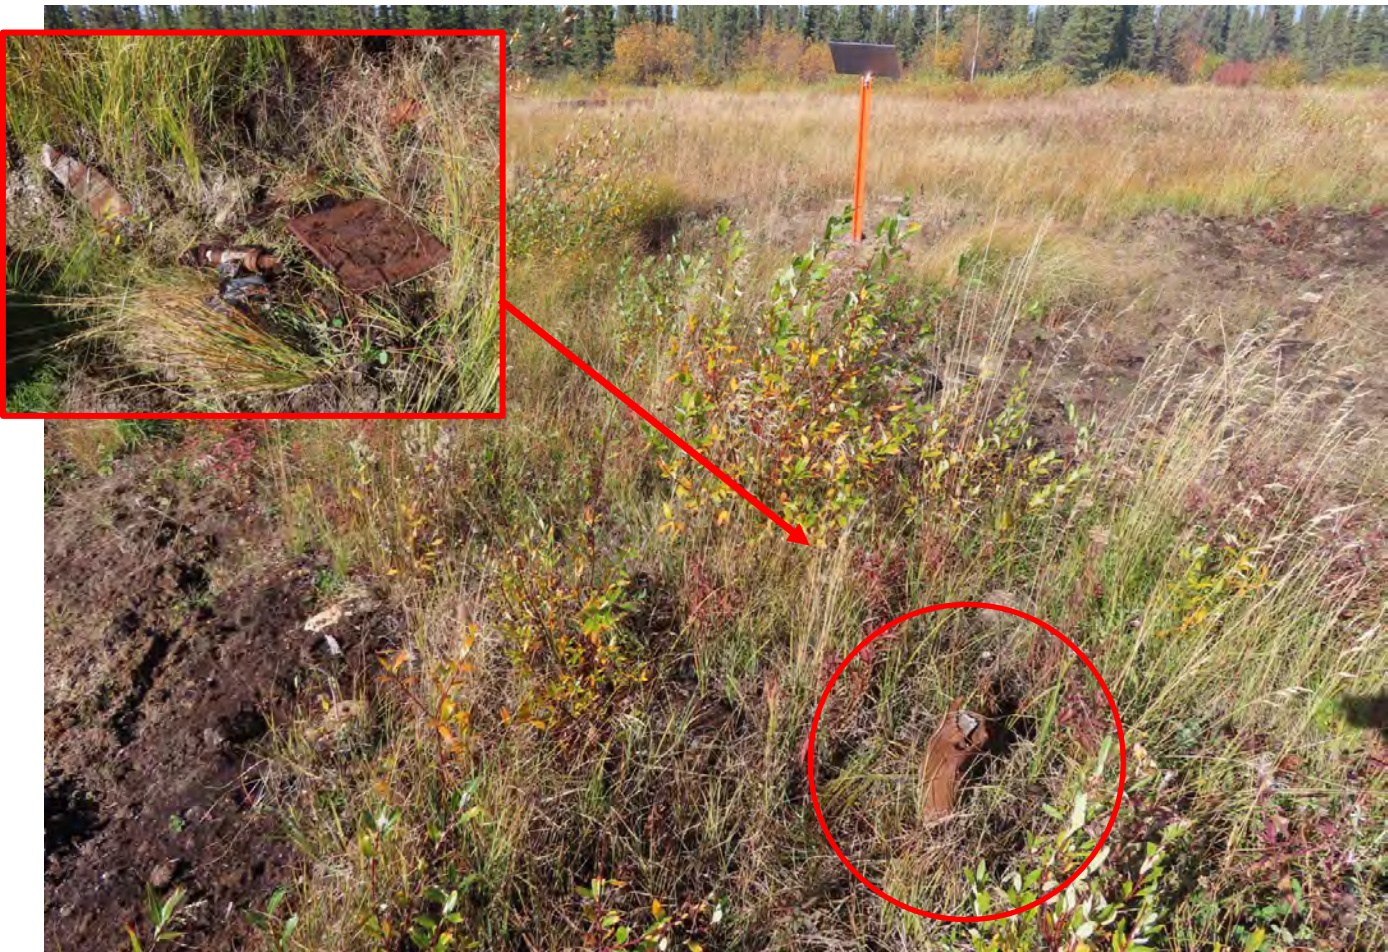
M-73/2M-73: Steel piling cut above ground level located between M-73 and 2M-73 well abandonment sign. *Insert:* A small amount of metal debris located on the wellsite to be removed.

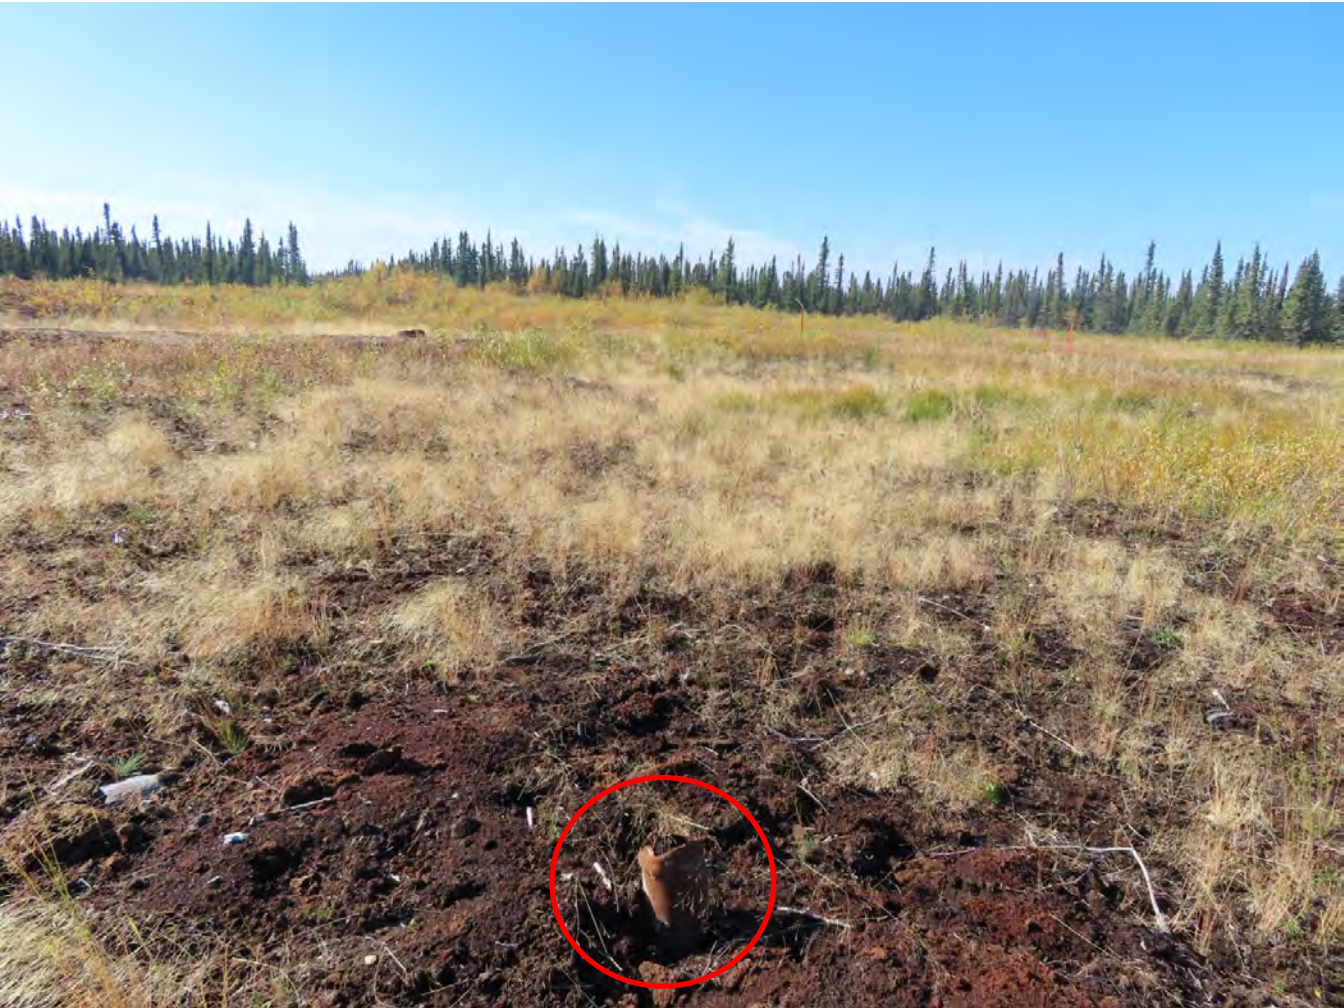
M-73/2M-73: Steel piling cut above ground level located on the wellsite to be removed.

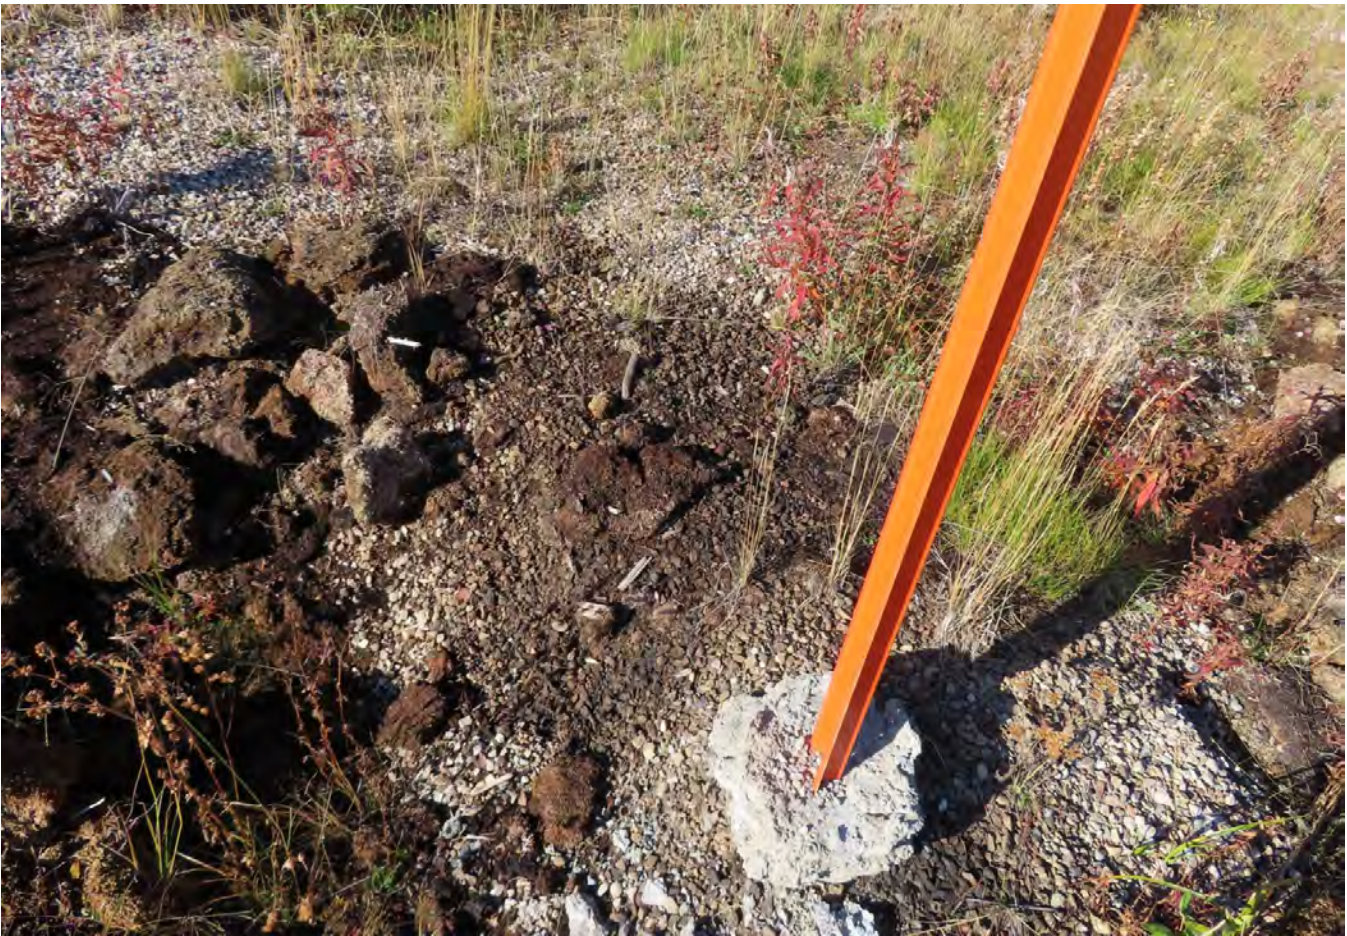
Figure 122

M-74: Hydrocarbon impacted soils observed at well center (<1m³) requires cleanup.

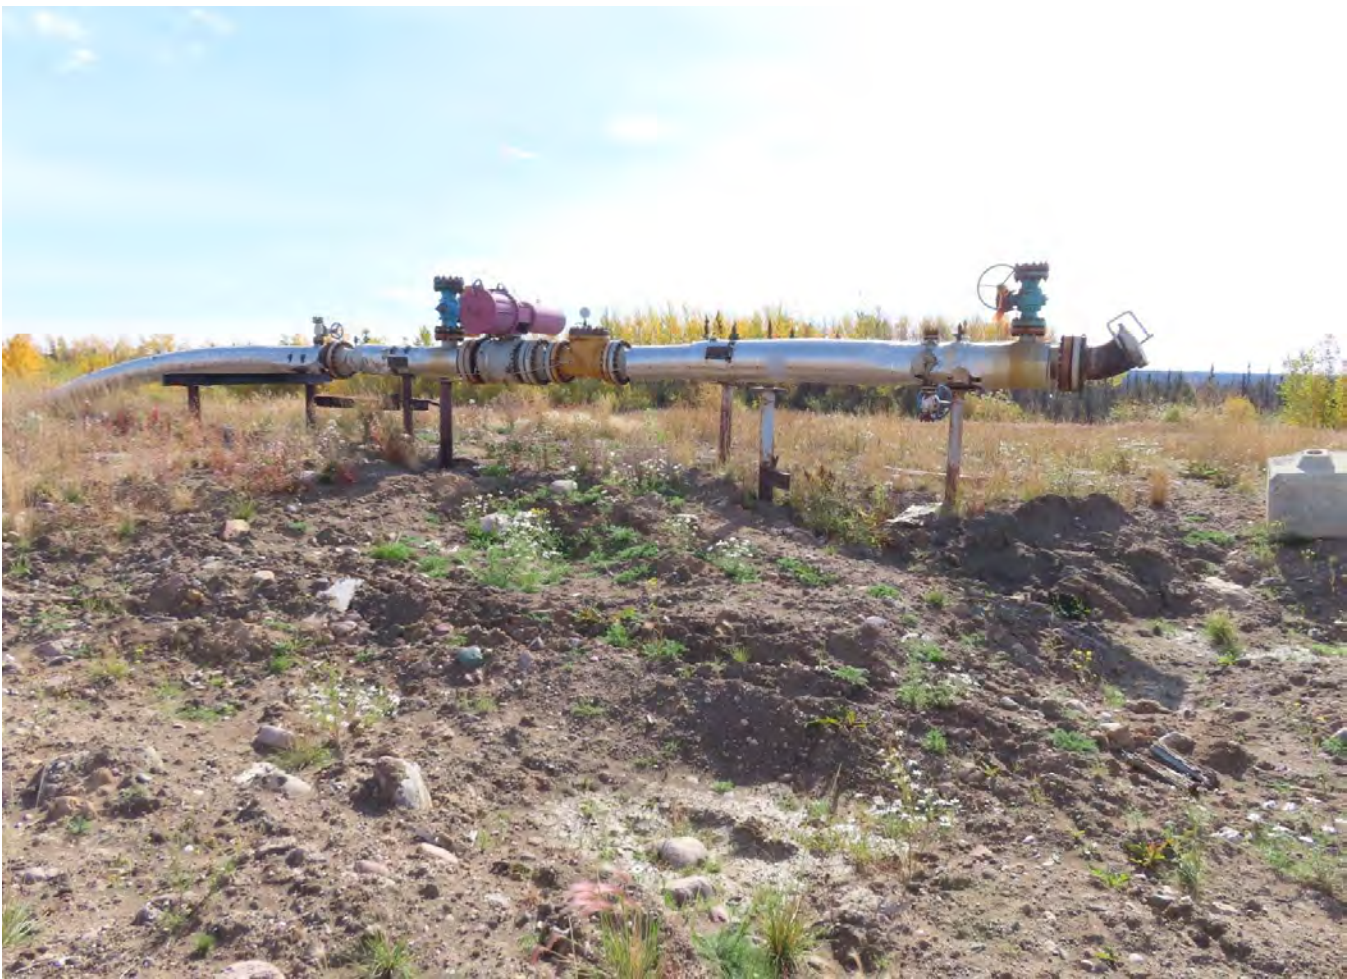
H-03 Battery: Transboundary pipeline riser located at the H-03 Battery site requires removal.

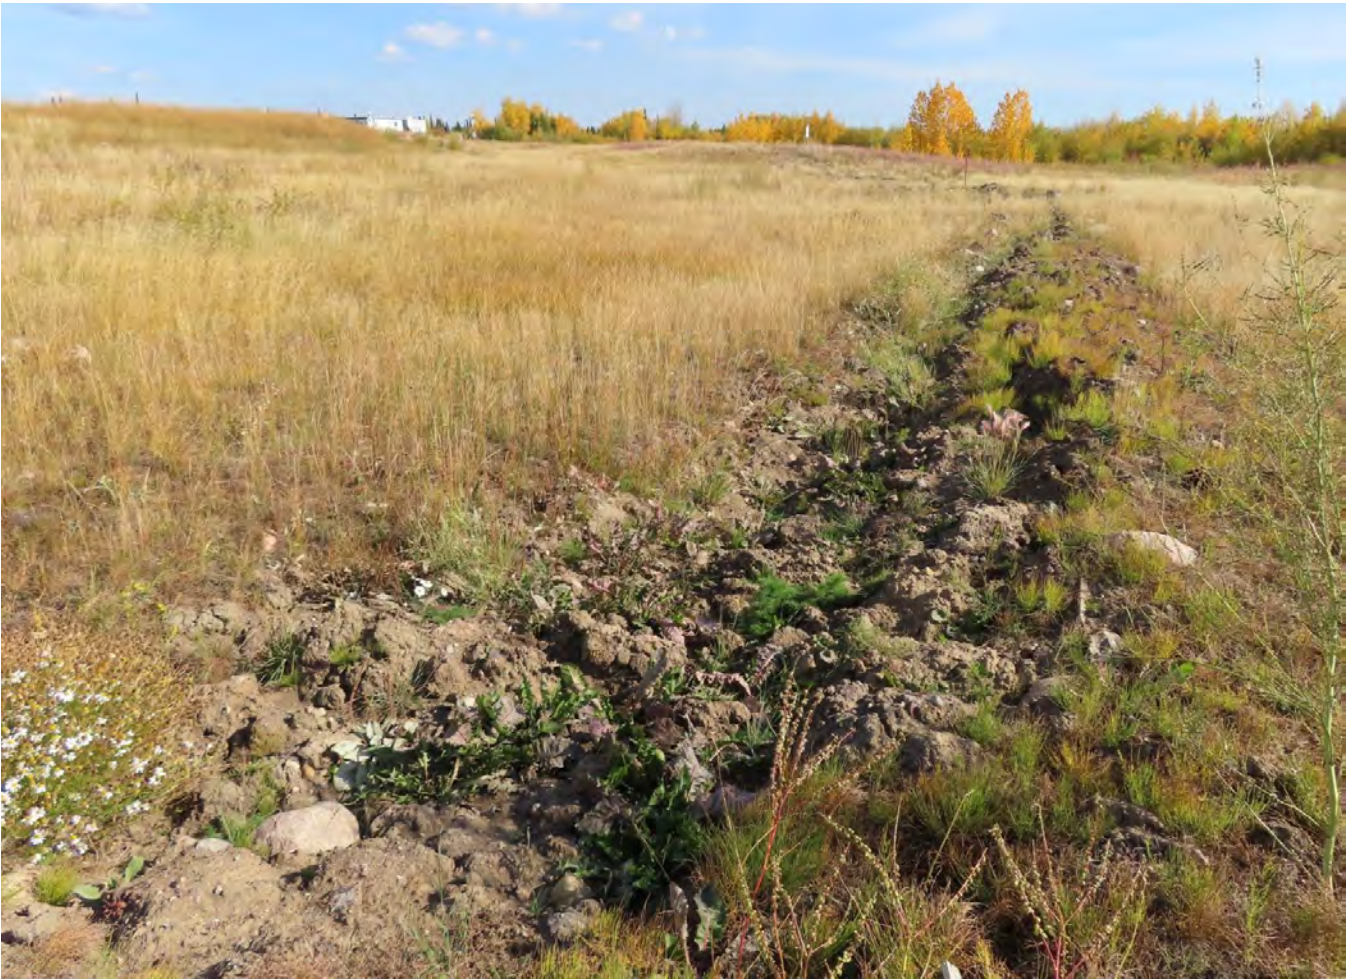
Figure 136

H-03 Battery: Pipeline trench from A-03 to the H-03 Battery requires recontouring.

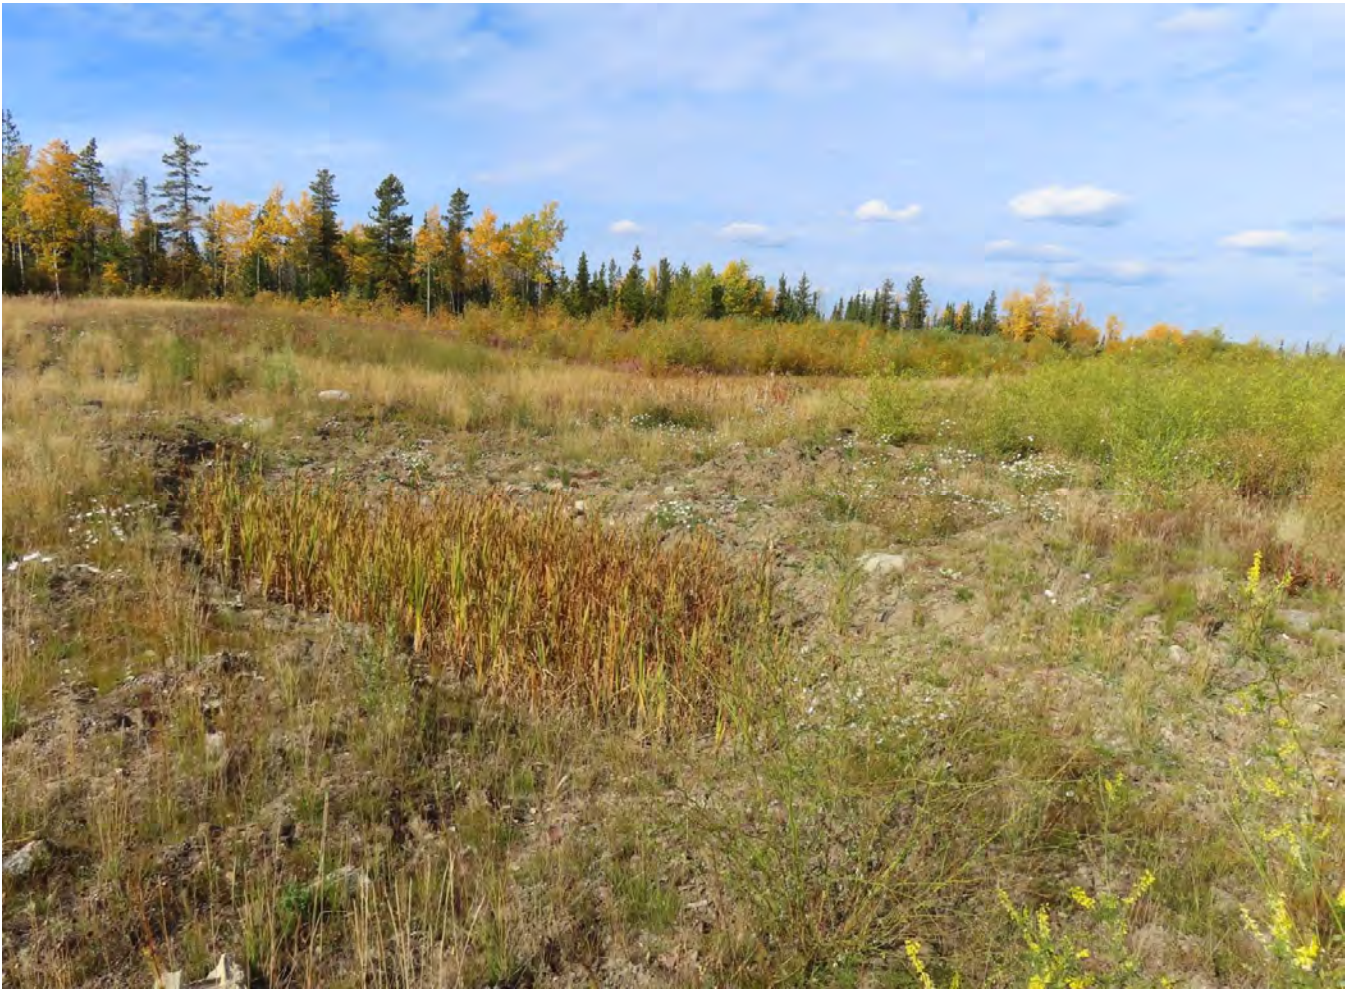
H-03 Battery: Disturbed area from the flarestack removal requires recontouring.

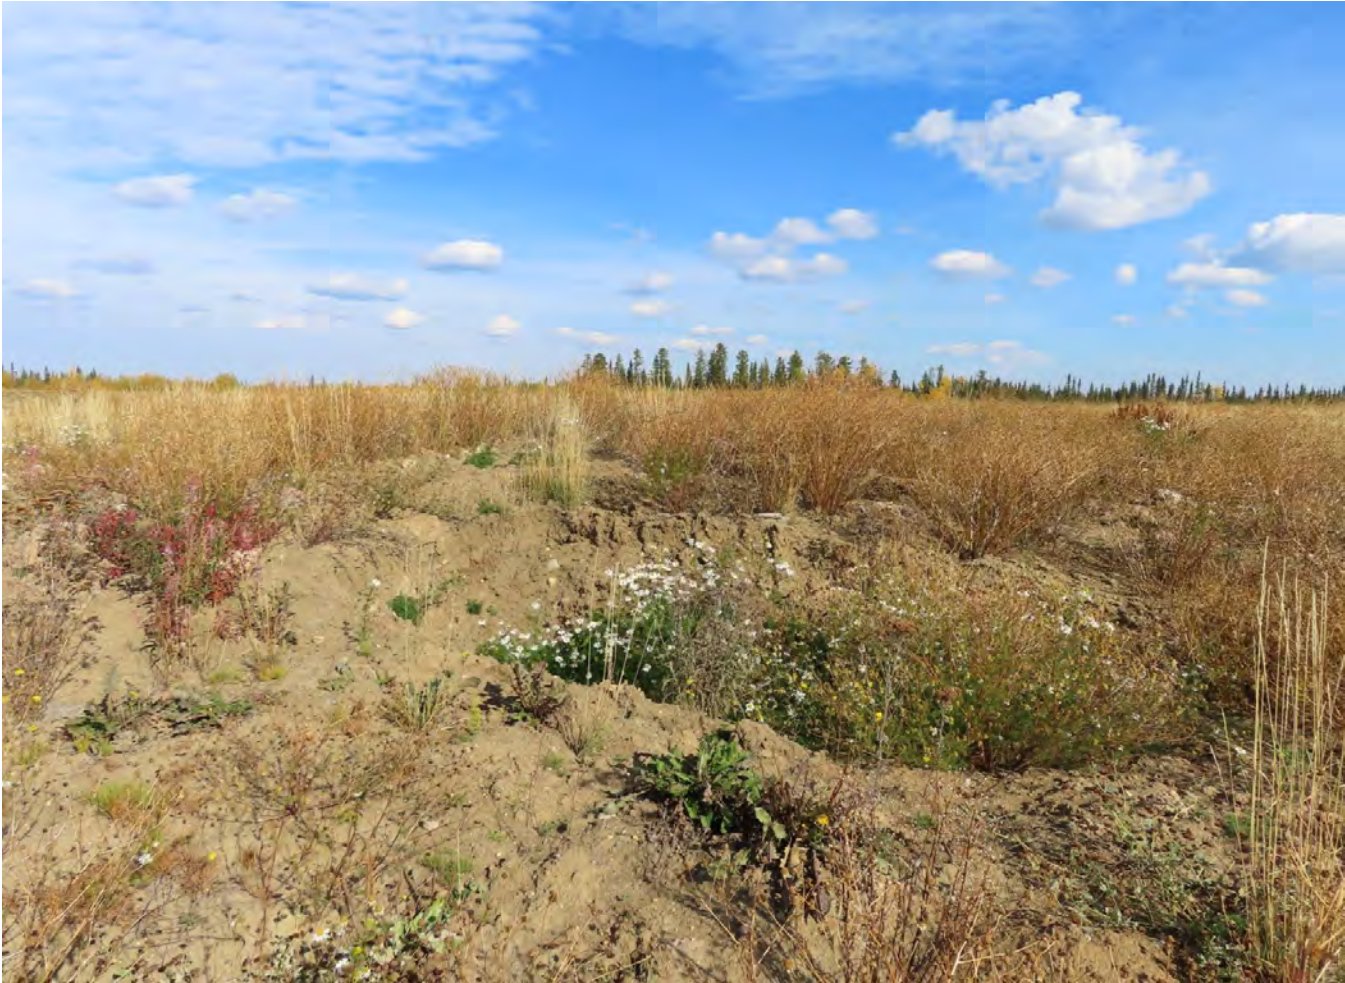
H-03 Battery: All areas affected by the removal activities at the H-03 Battery must be stabilized and landscaped to their pre-construction profiles.

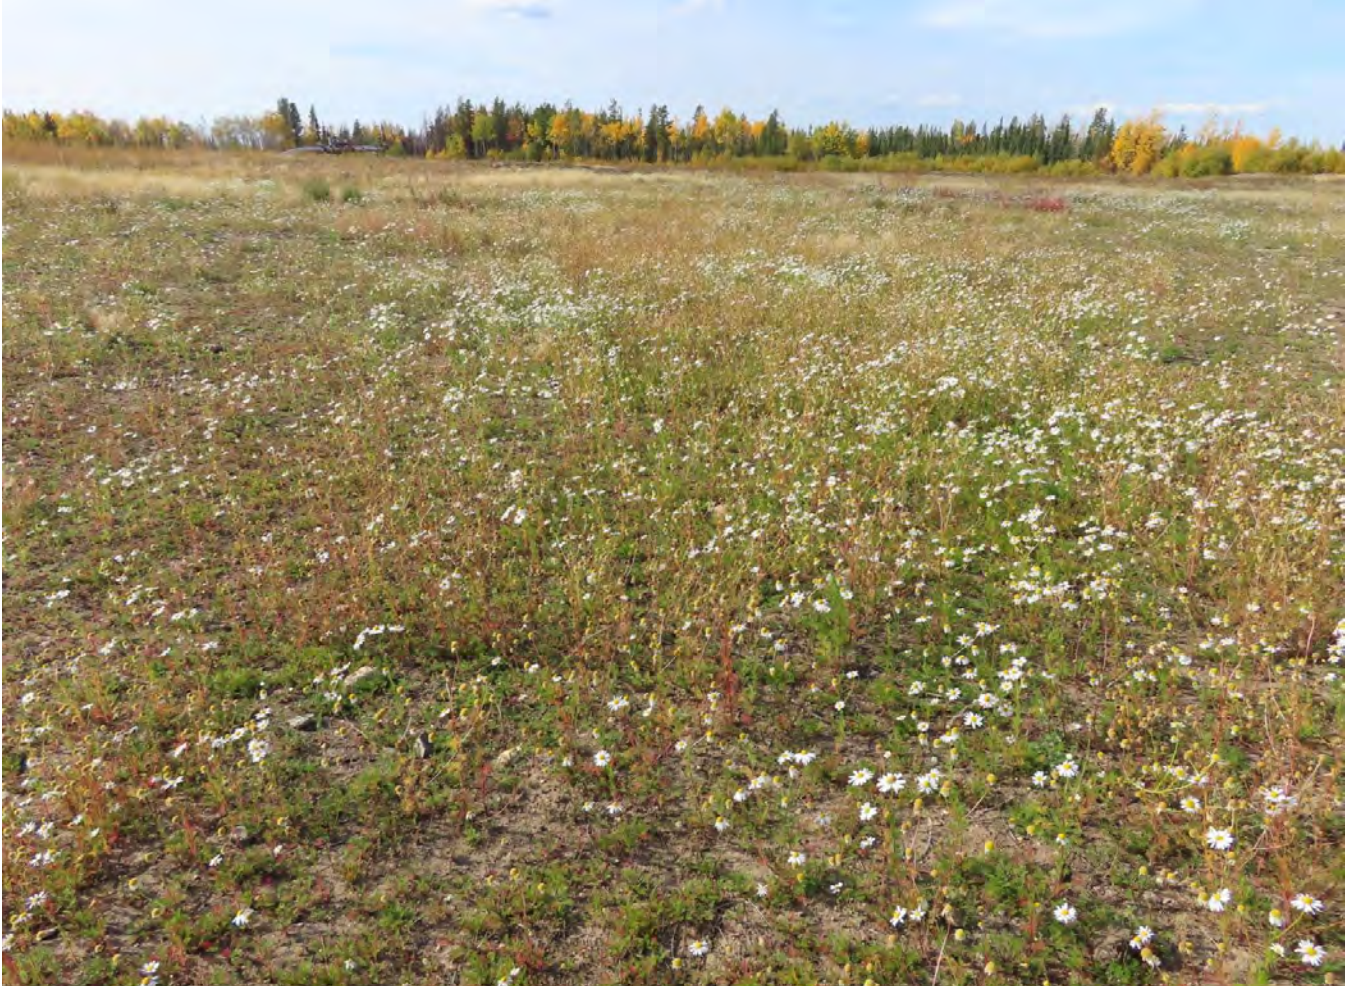
Figure 140

H-03 Battery: Invasive weed species Scentless Chamomile established on the H-03 Battery site.
