File Number	MV2022X0018
Type of Operation	Cameron Hills Oil and Gas Field Abandonment
Location	Cameron Hills, NT

ENVIRONMENTAL INSPECTION REPORT

Permittee:	Strategic Oil and Gas Ltd. c/o Alvarez & Marsal Canada Inc.	Permit Expiry Date:	January 02, 2028
Land Use Permit No.	MV2022X0018	Previous Inspection:	February 21, 2024
Quarrying Permit No.		Inspection Date:	September 17, 2024
Contractor:	ELM Inc.	Subcontractor:	
Location(s) Inspected:	Cameron Hills Oil and Gas Field		
Current Stage of Operation:	The abandonment of the H-03 Battery, forty-four (44) oil and gas wells was completed in the winter of 2023 and 2024.		
Program Modifications Approved:

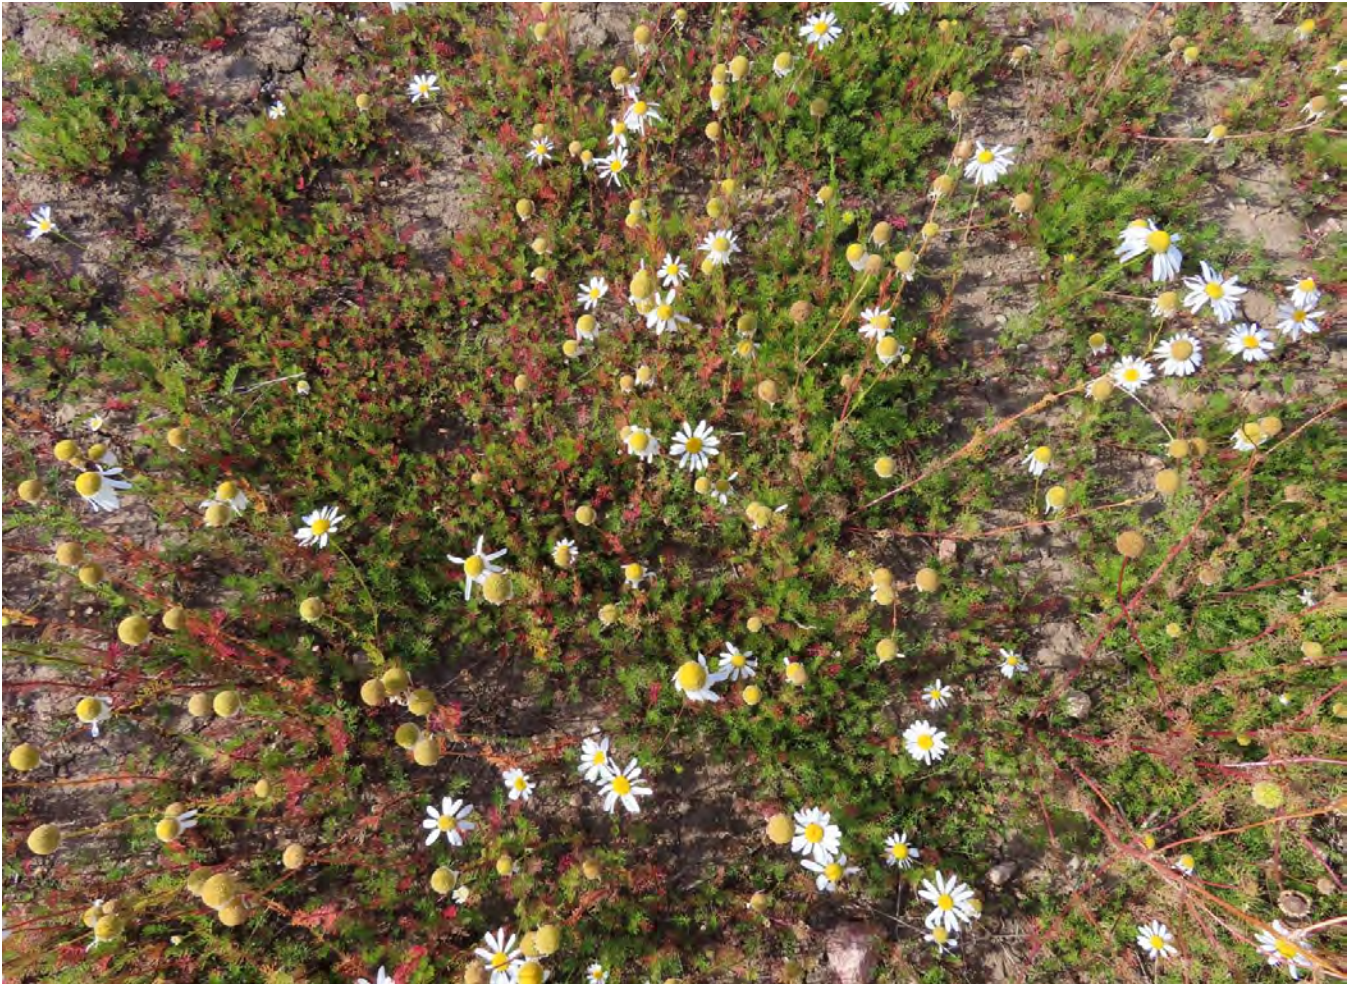
H-03 Battery: Close-up of the Scentless Chamomile. The invasive weed must be removed from the battery site.

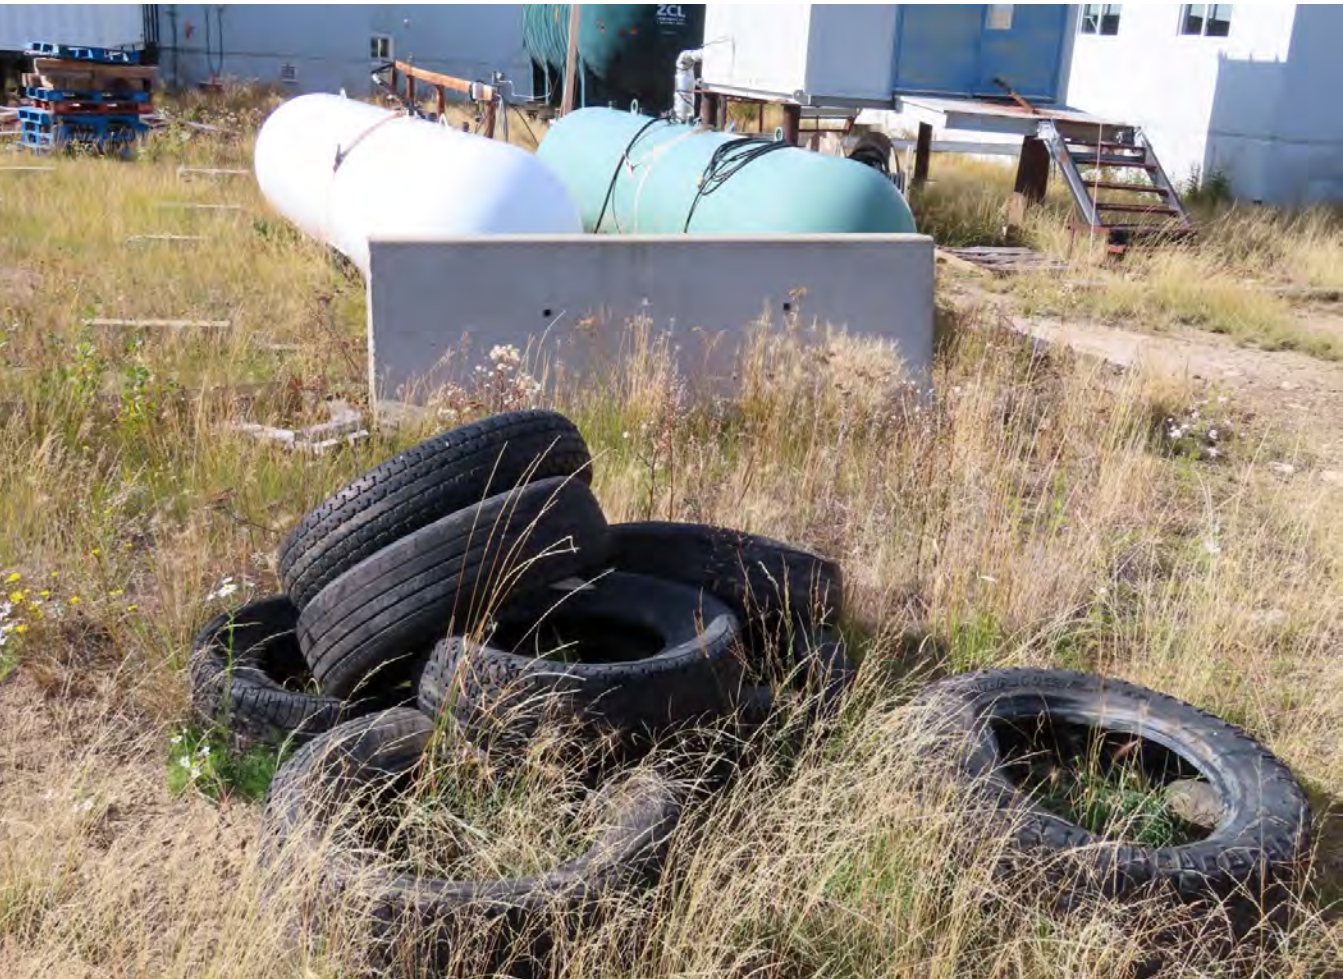
Figure 150

Main Camp: Rear view of main camp. Old tires and pallets to be removed from the site.

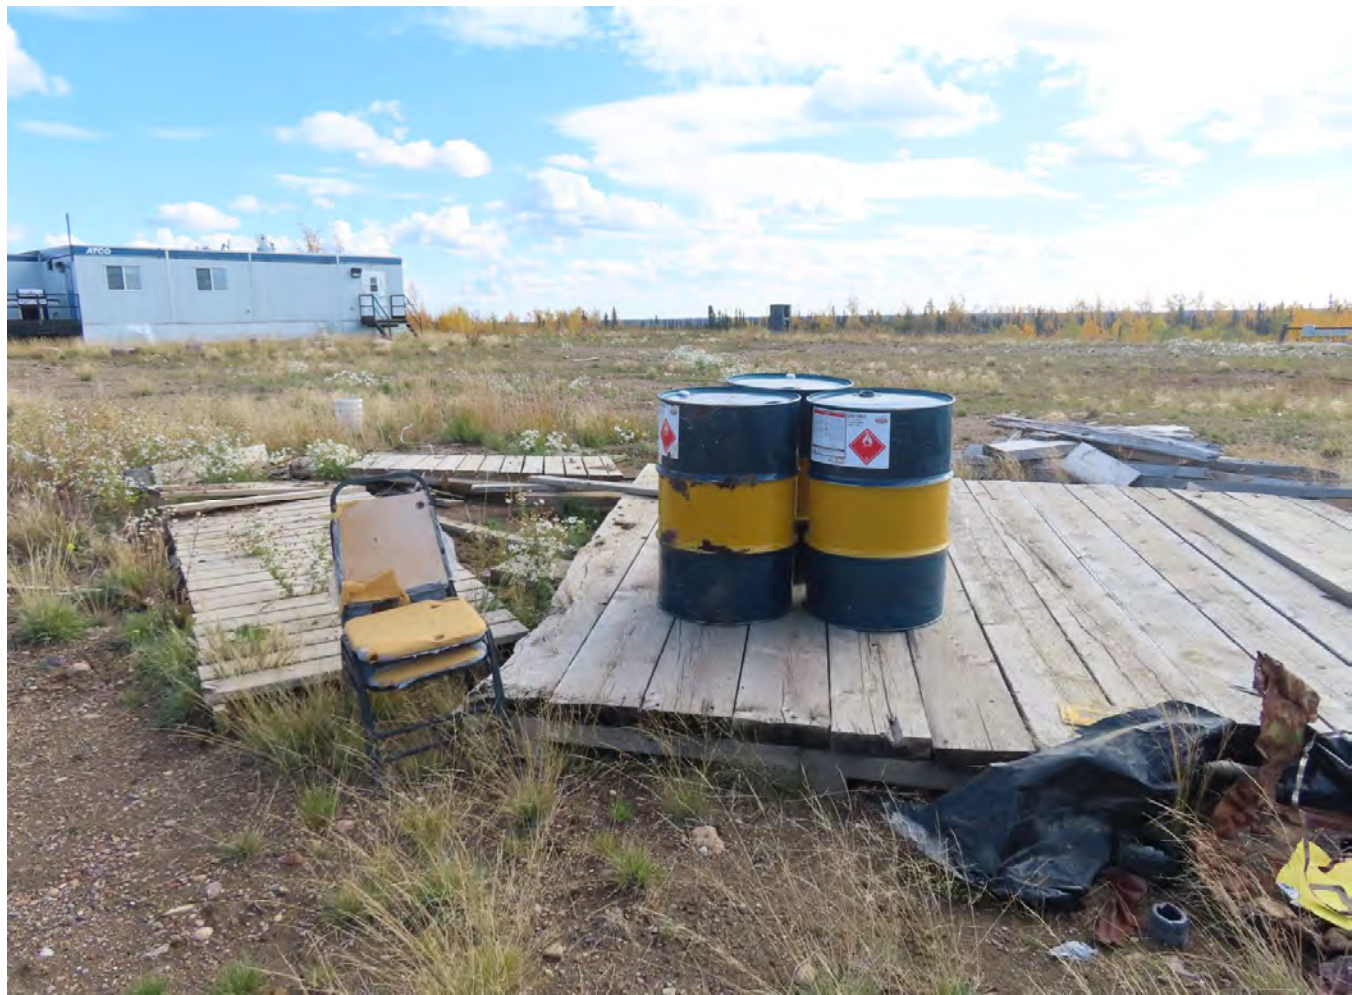
Main Camp: Debris stored on the west side of the main camp to be removed. ECC will remove the three 205 litre fuel drums (empty) used by the helicopter during the inspection.

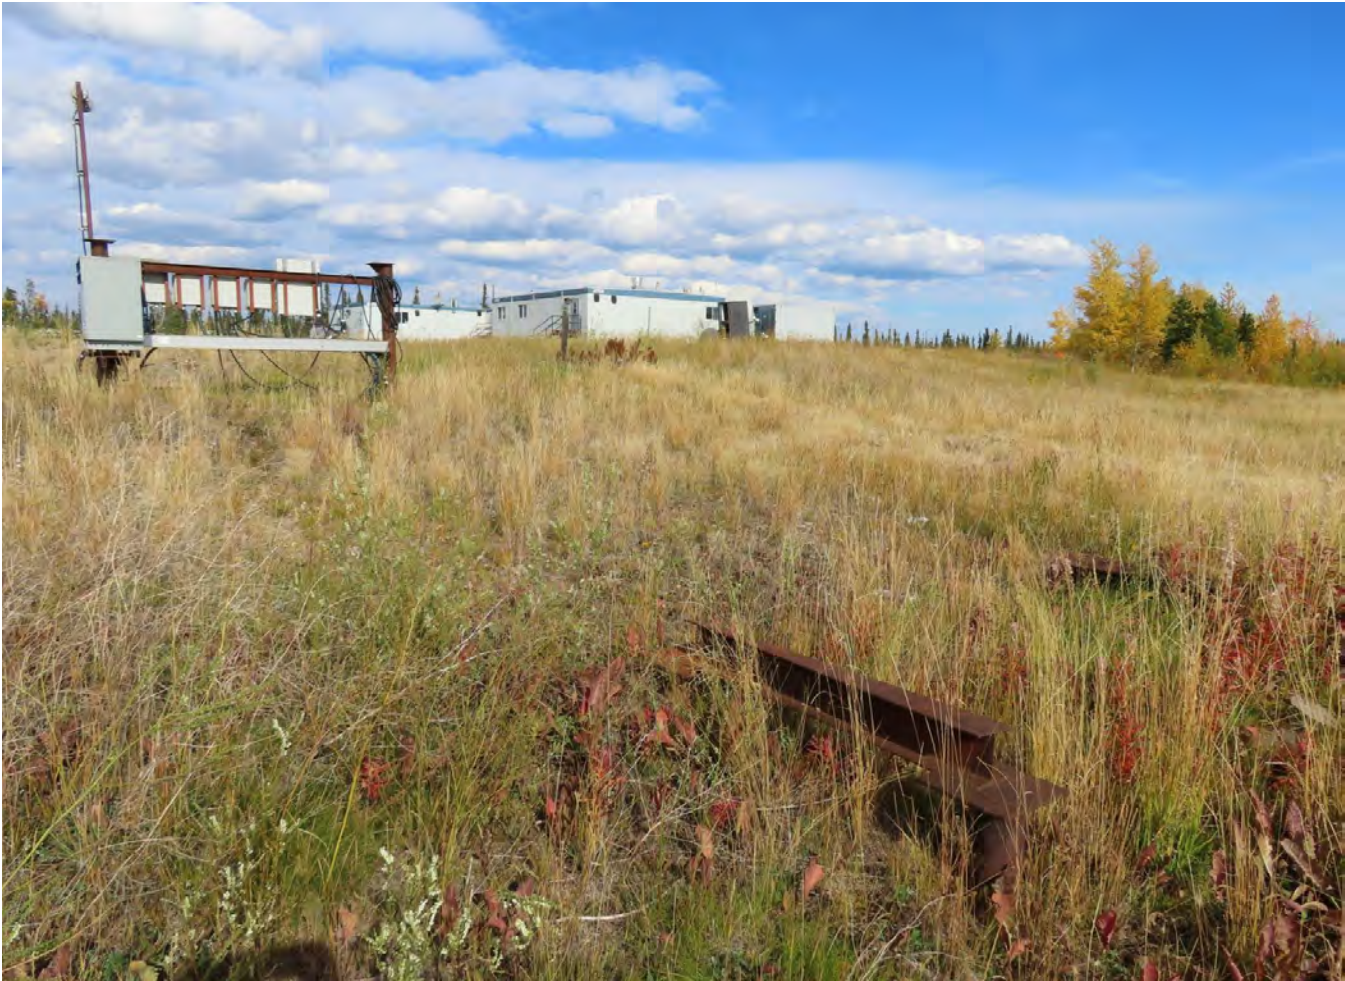
Main Camp: Metal supports on the south side of the site to be removed at camp abandonment.

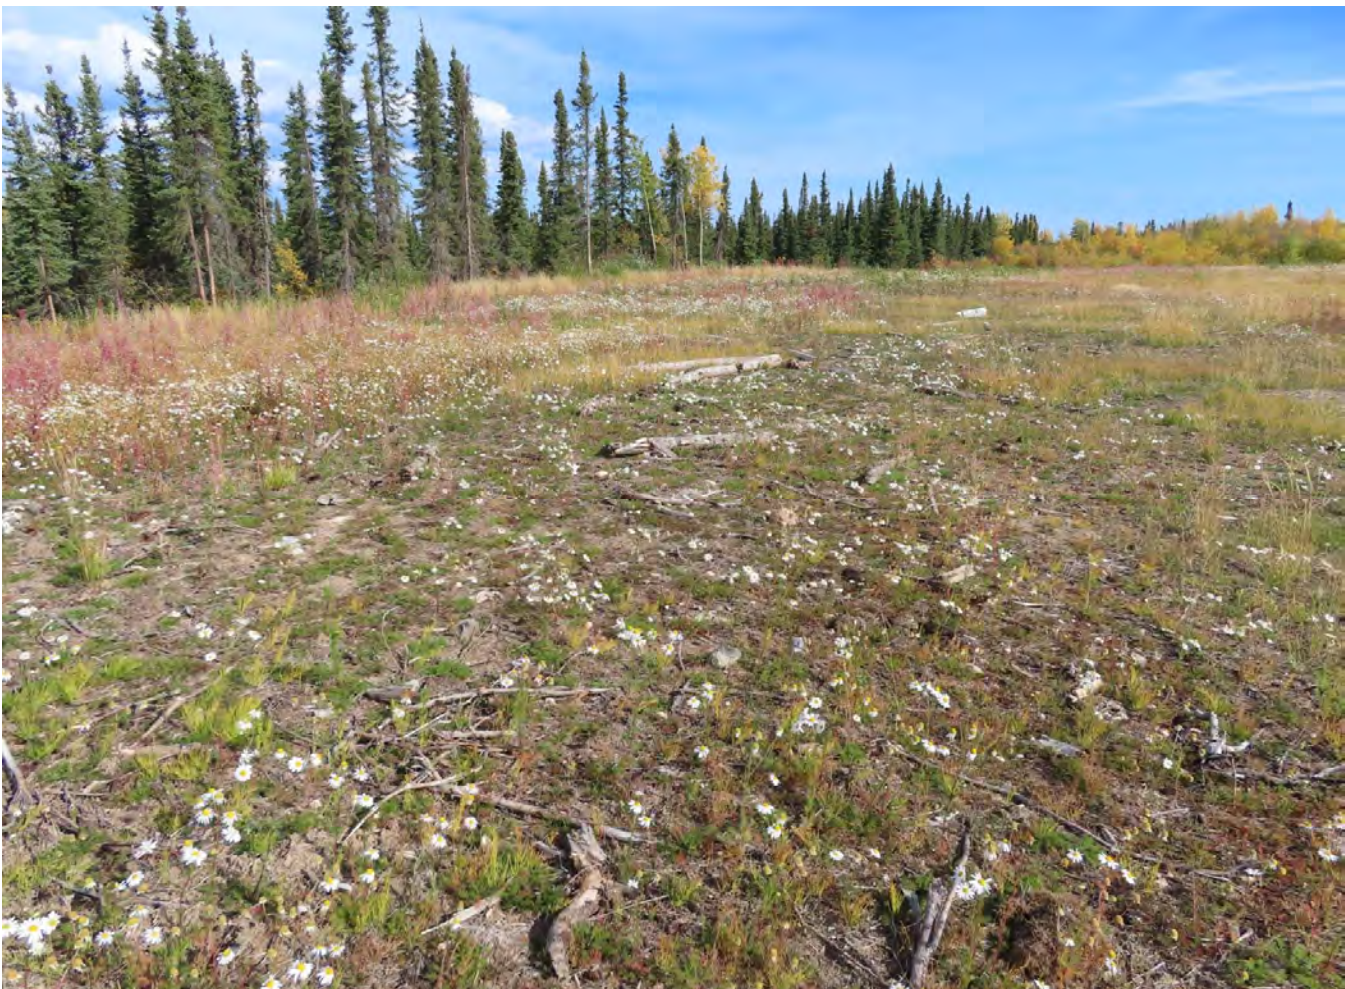
Figure 154

Main Camp: Invasive weed species Scentless Chamomile becoming established on north side of the main camp.

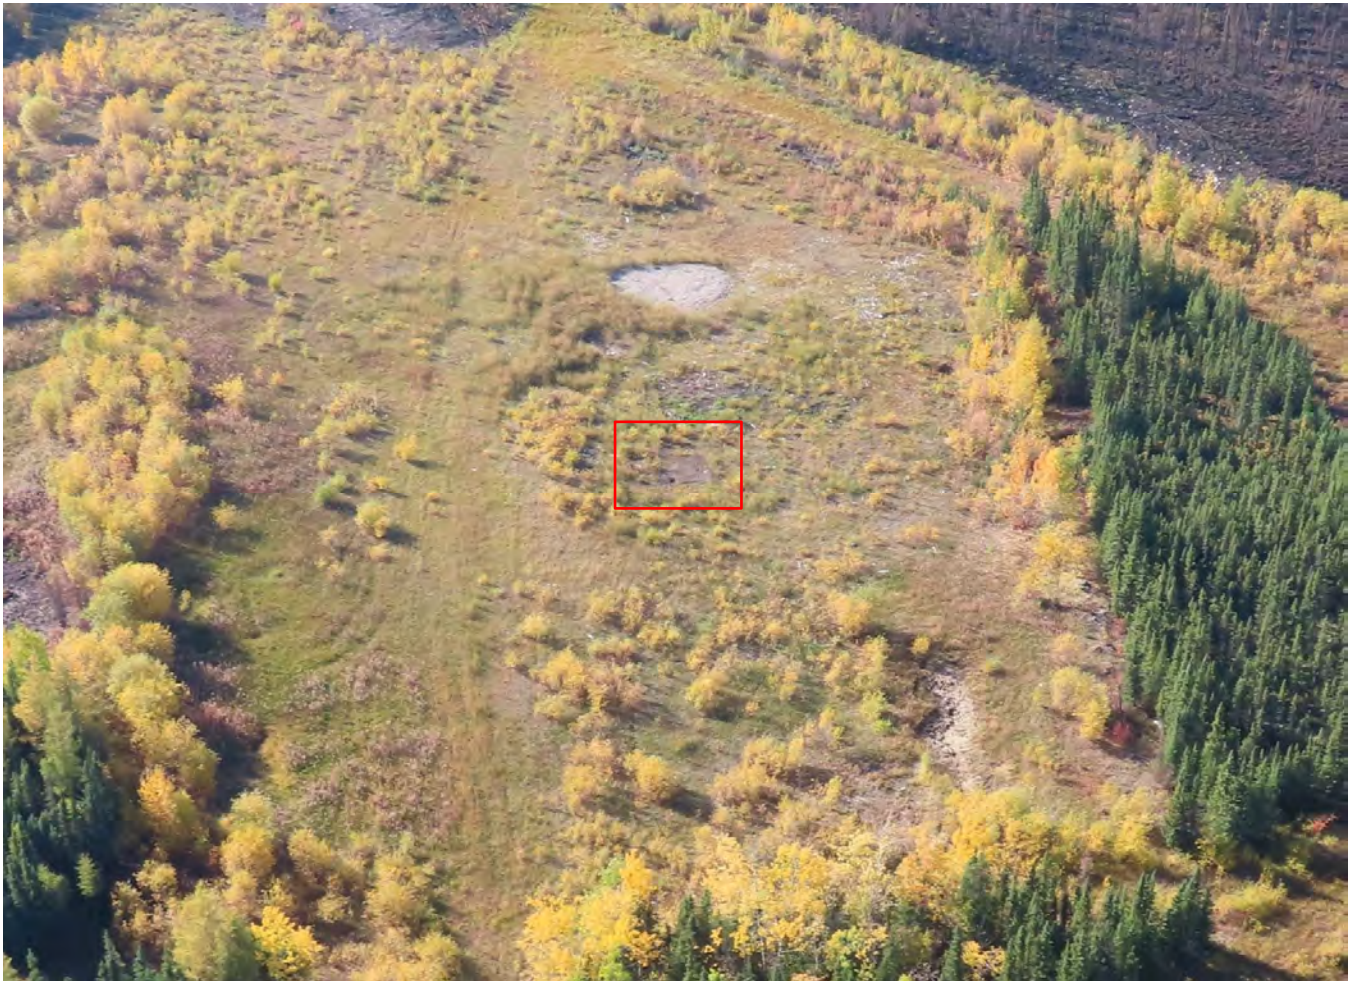
Camp: K-74 Campsite. Location of possible hydrocarbon impacted soils at the campsite.

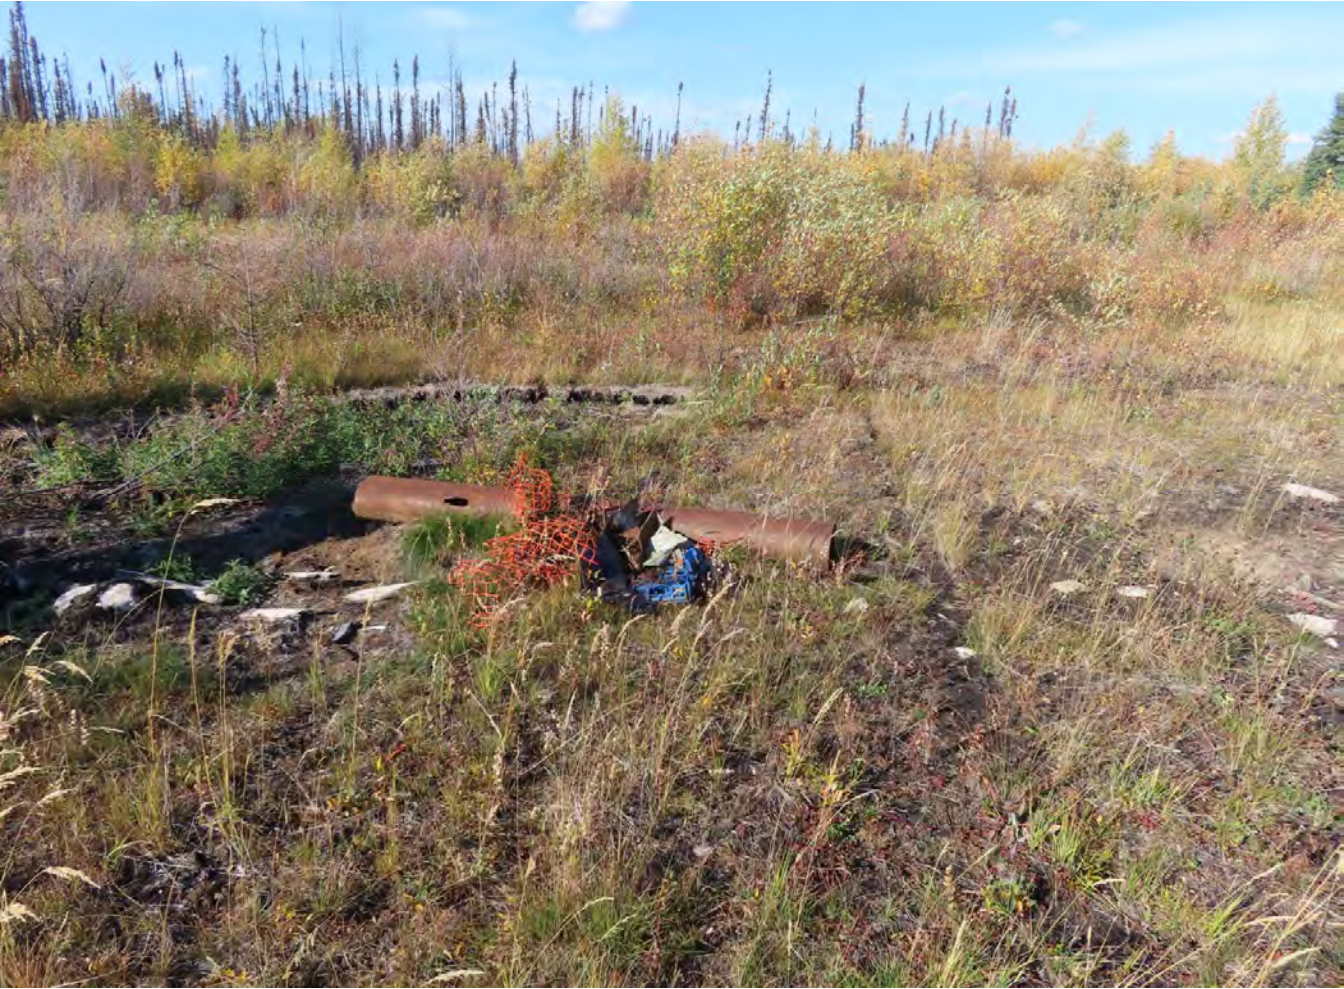
Camp: K-74 Campsite. Detached section of casing and other debris to be removed.

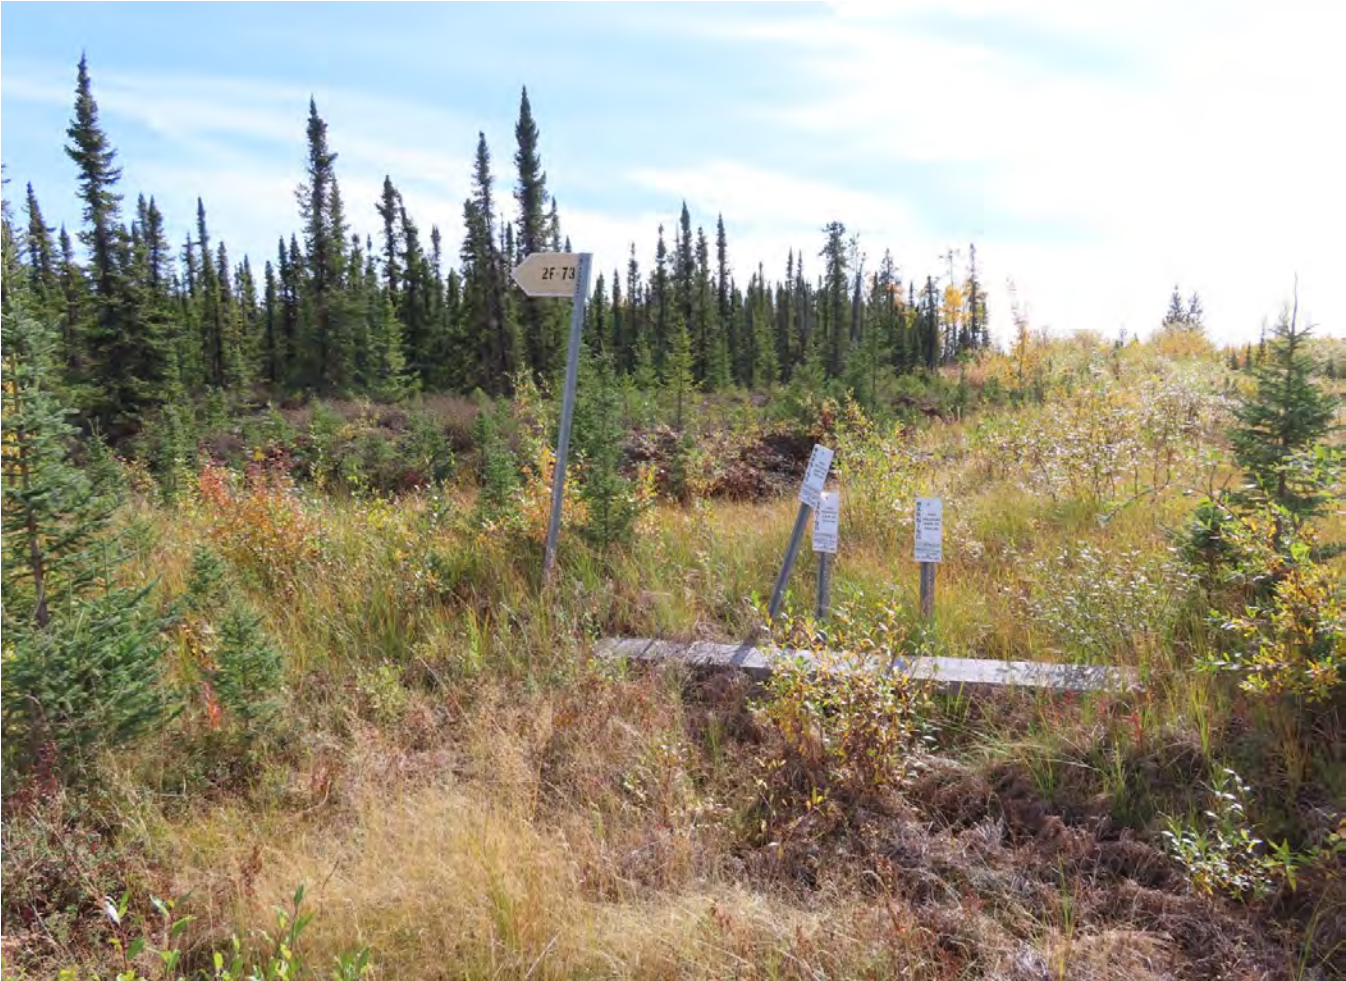
Access - Signage. Signs located on the pipeline right-of-way to be removed.

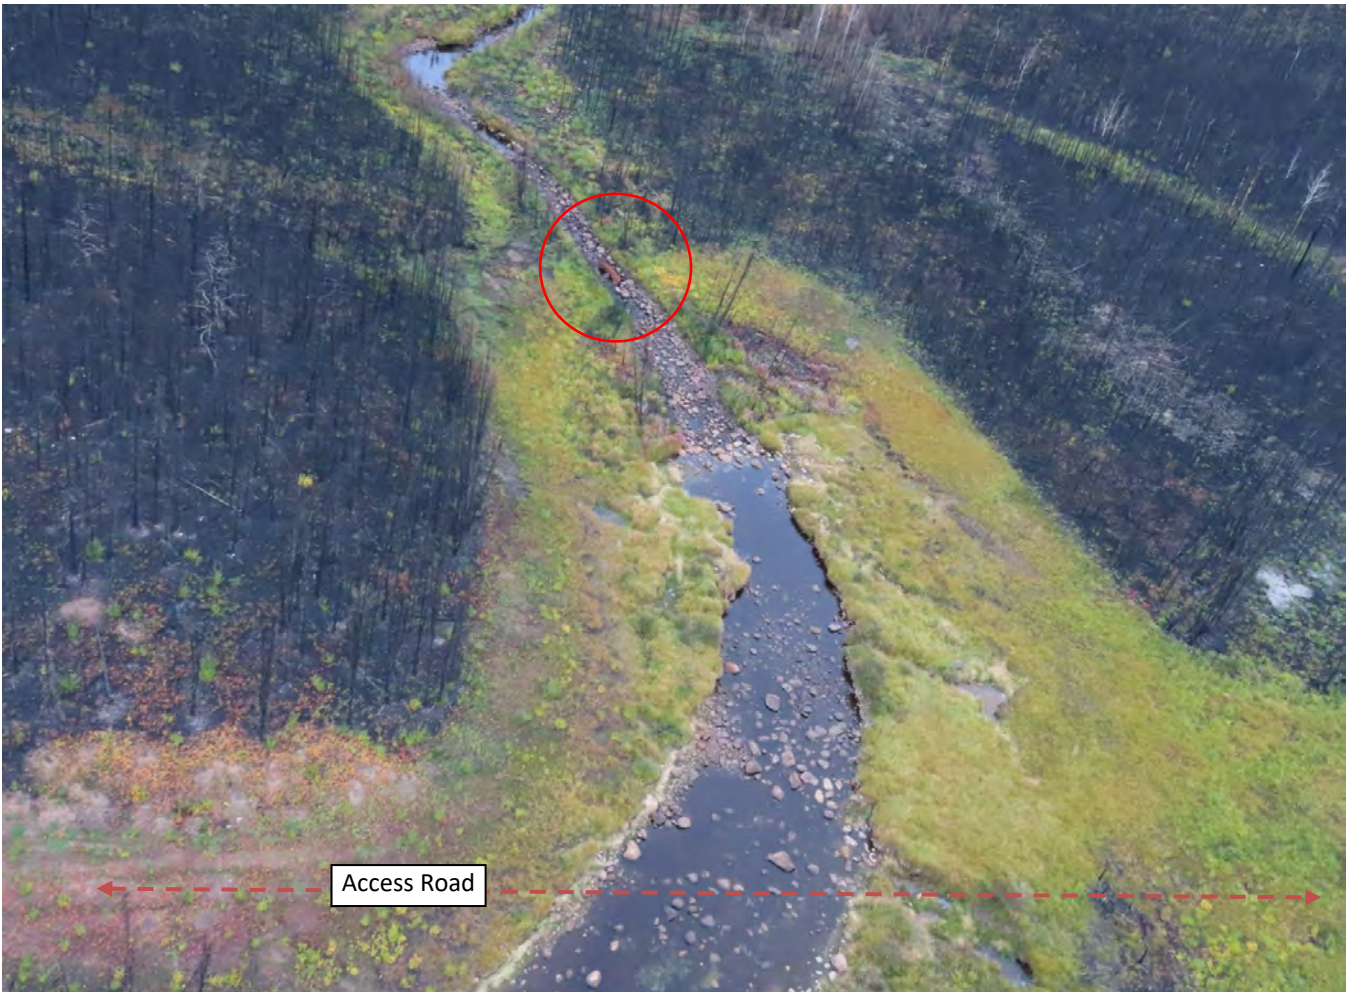
Access. Facing north, culvert located north of Creek Crossing #1 on the access to Wellsite L-47 to be removed.

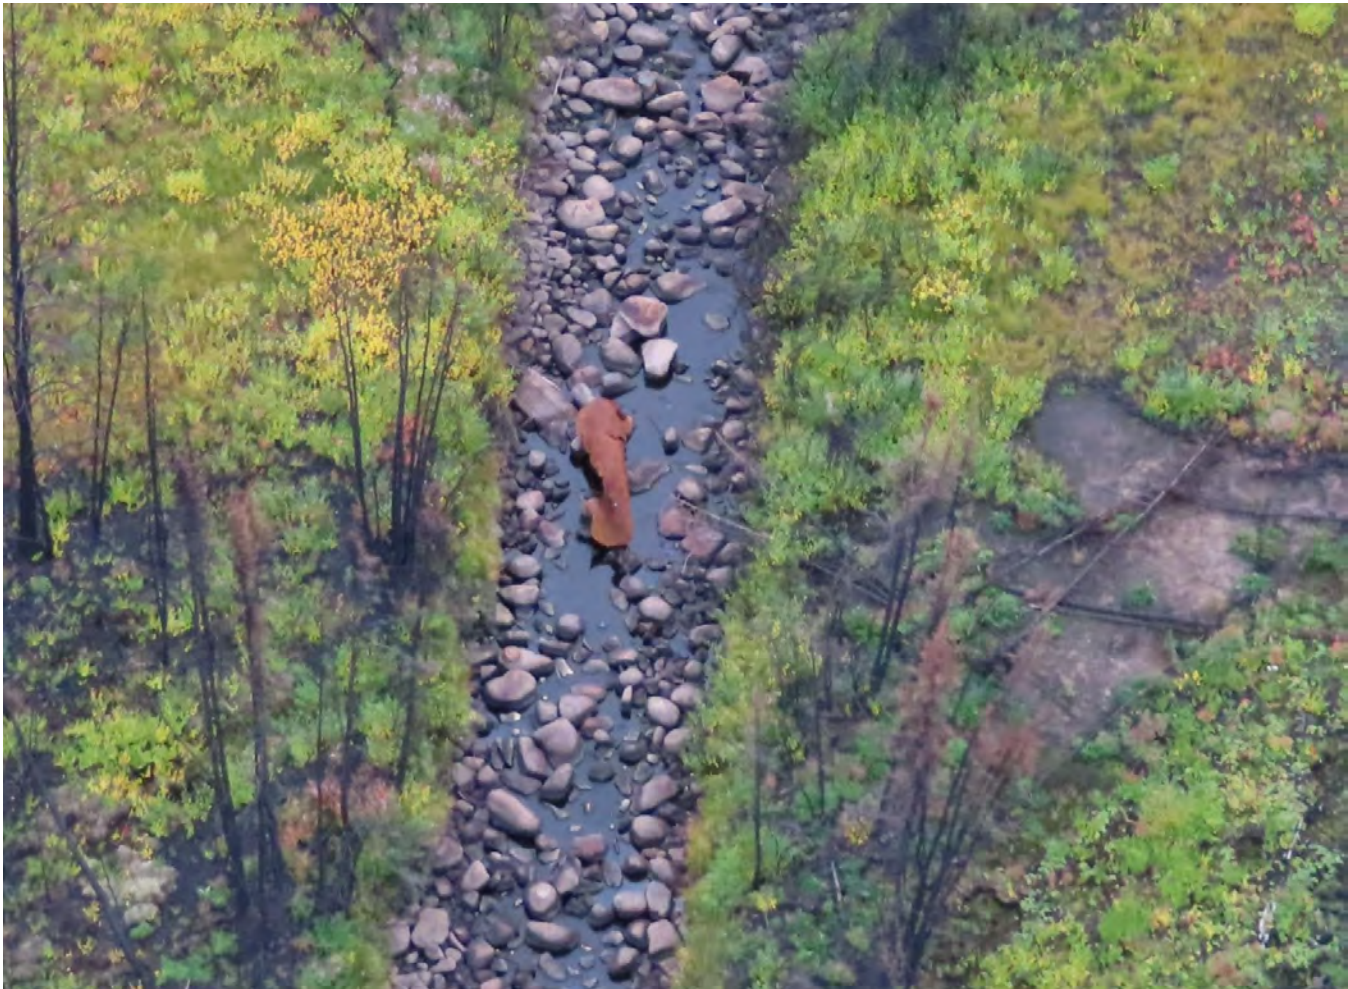
Figure 190

Access. Close-up of culvert to be removed from Creek Crossing #1.

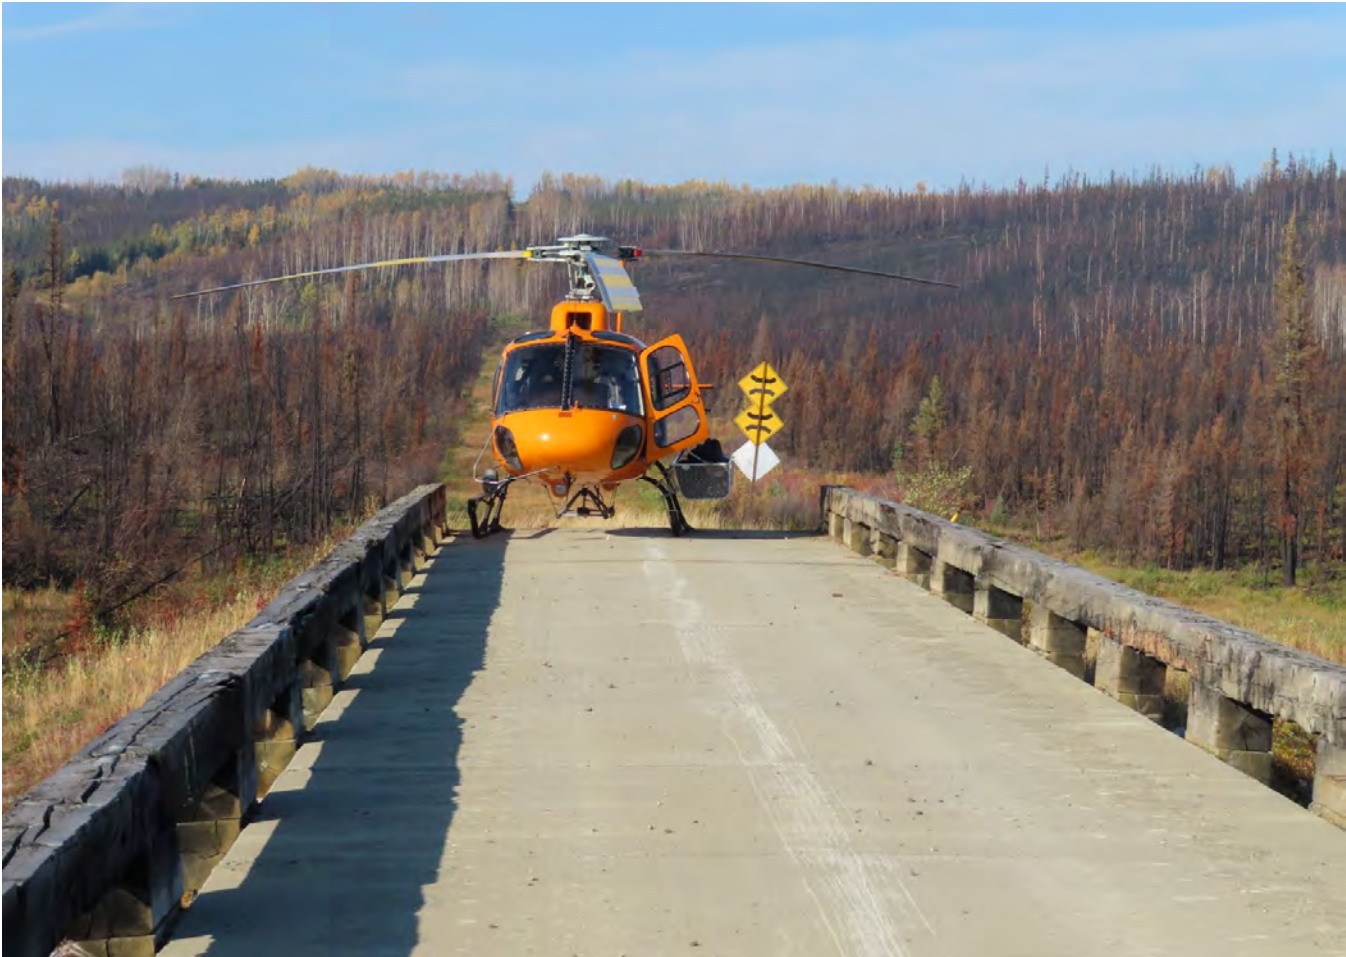
Access – Cameron River Bridge. Bridge with prefab concrete slabs. Bridge to be removed in accordance with Permit Condition #92 (FINAL CLEANUP AND RESTORATION).

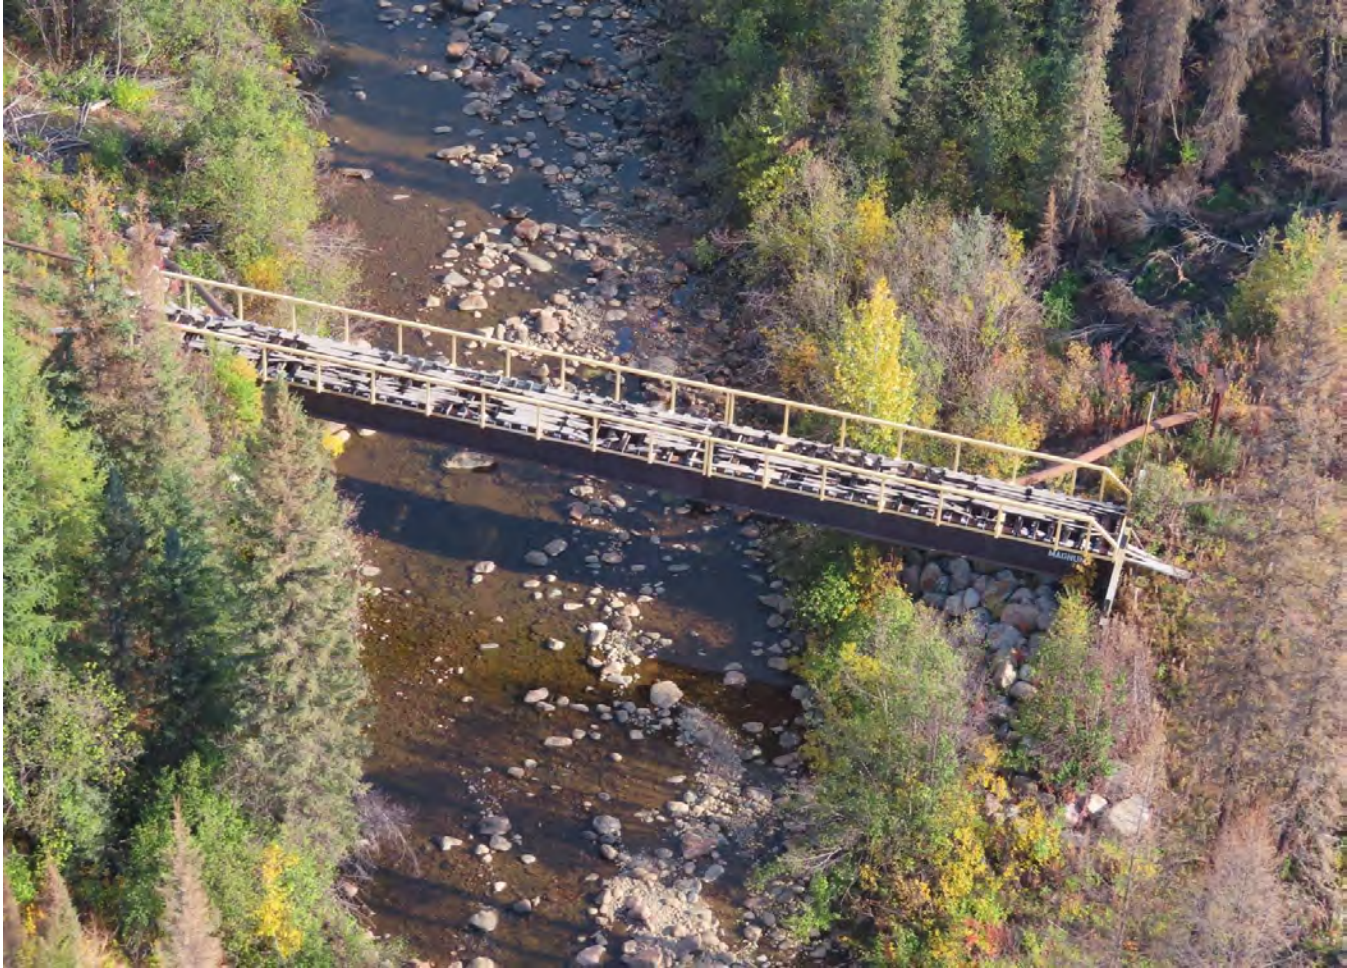
Figure 194

Access – A-73 Bridge. Bridge over Herbal Creek facing north. Bridge to be removed in accordance with Permit Condition #92 (FINAL CLEANUP AND RESTORATION).

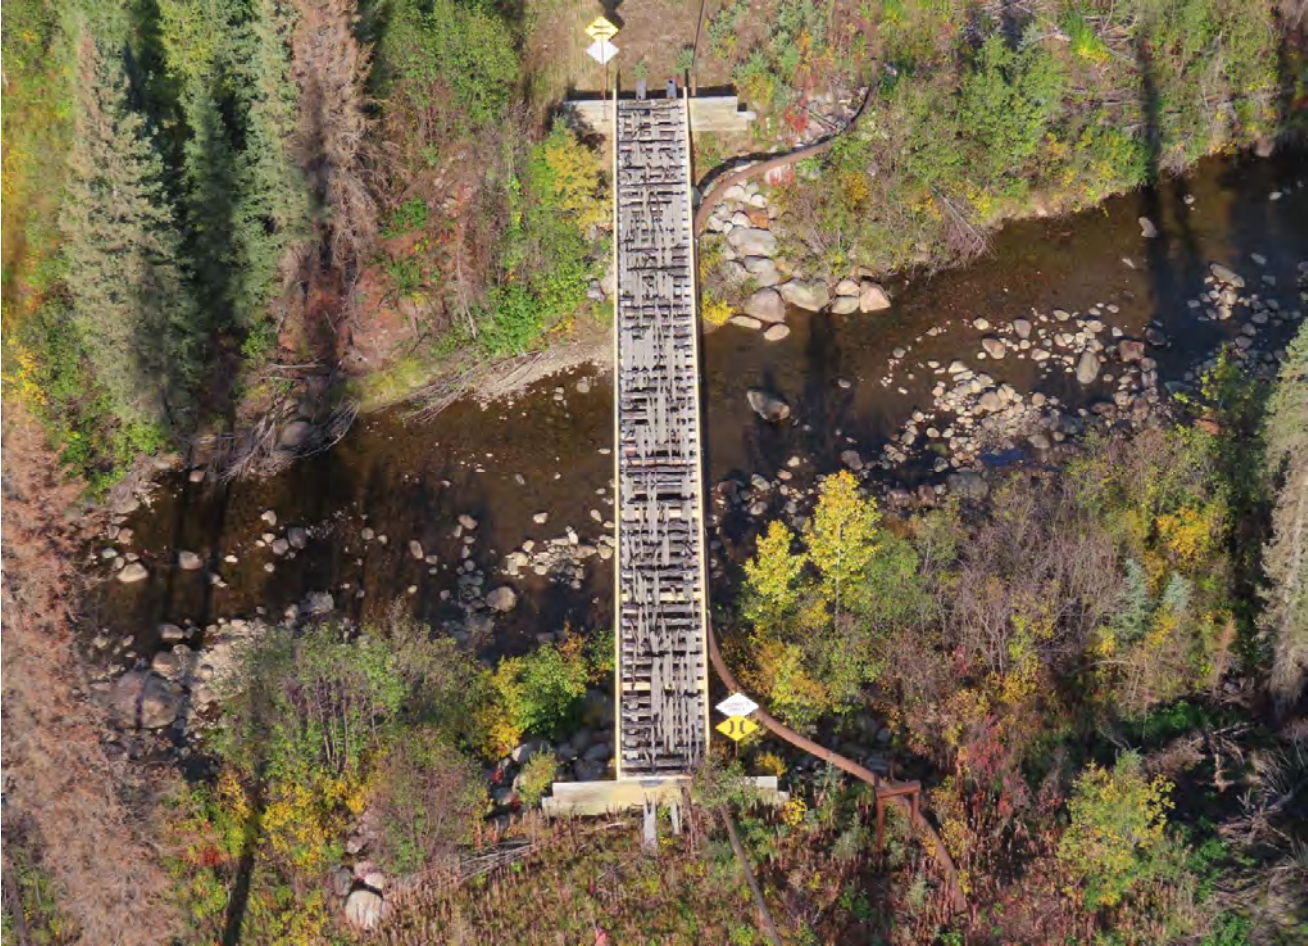
Access – A-73 Bridge. Aerial view of the A-73 Bridge with rotten wood decking and attached pipeline facing north.

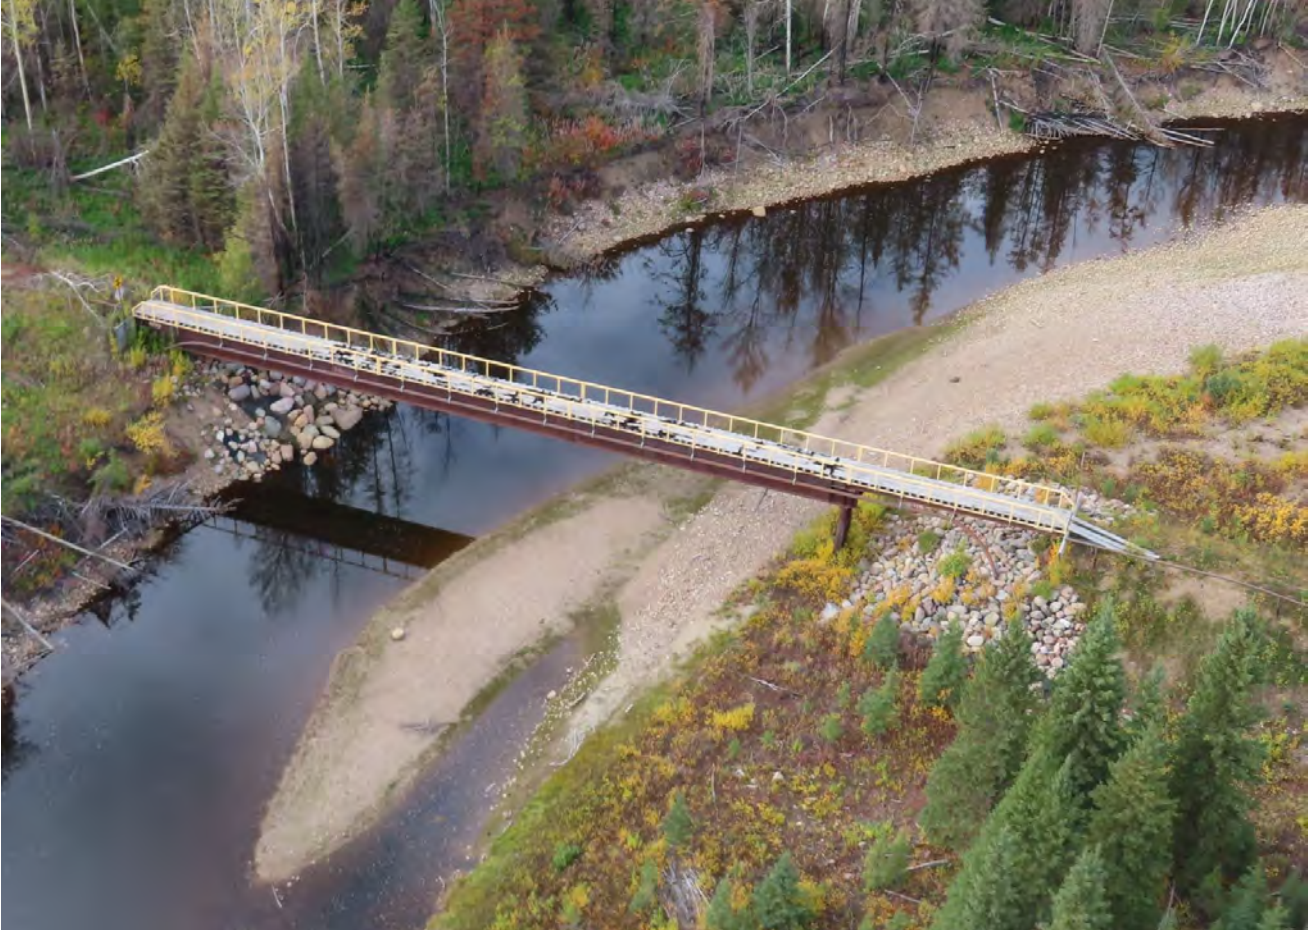
Figure 196

Access – C-50 Bridge. Bridge with attached pipeline over the Cameron River facing west. Bridge to be removed in accordance with Permit Condition #92 (FINAL CLEANUP AND RESTORATION).
