Cantung Mine Closure Geotechnical Stability Assessment

PRESENTED TO
North American Tungsten Corp. Ltd.
c/o Alvarez & Marsal LLC

JULY 2019
ISSUED FOR USE
FILE: 704-ENW.WENW03039-03.007

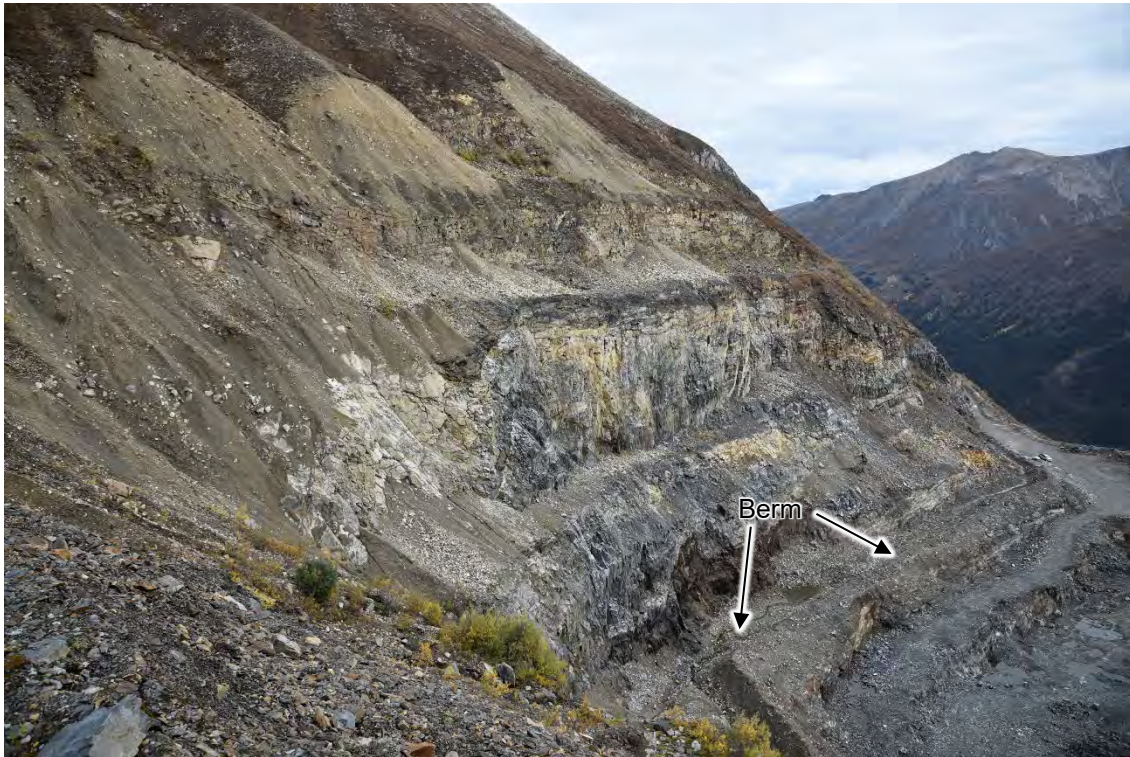
Photo 1: Northwest wall of the Open Pit showing benches filled with talus material, and rock fall berm on the second-lowest bench

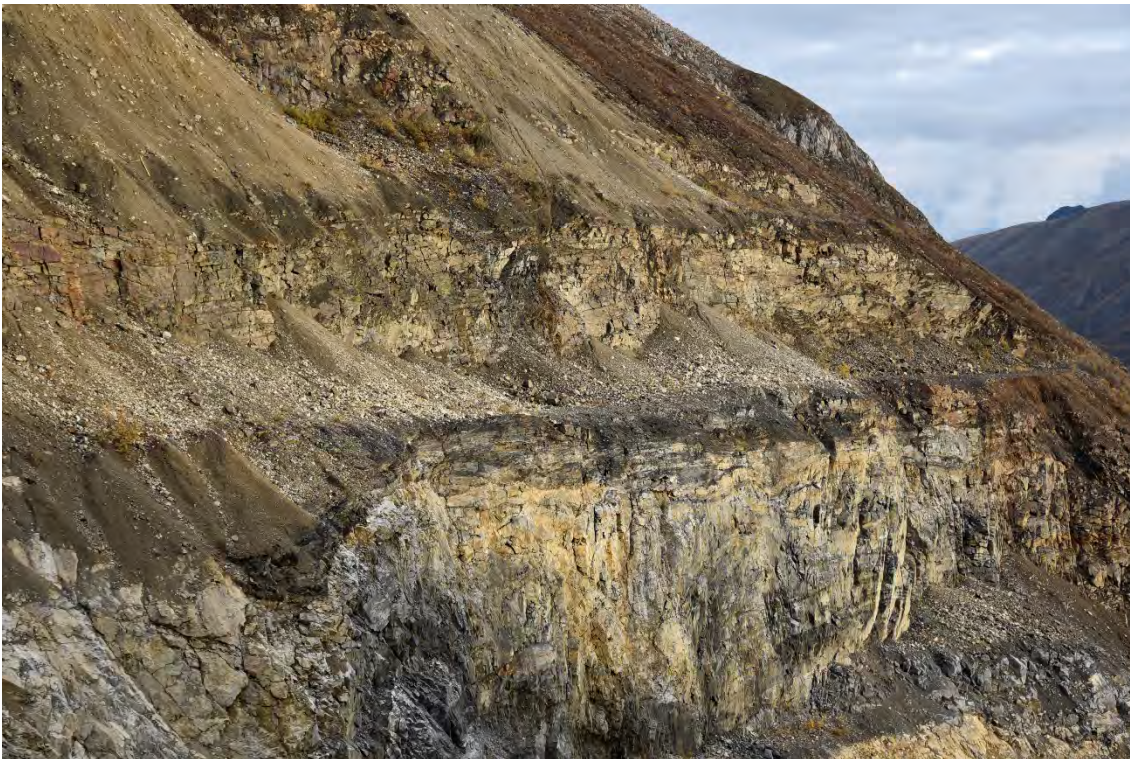
Photo 2: Upper benches of the NW wall of the Open Pit completely filled in with talus material

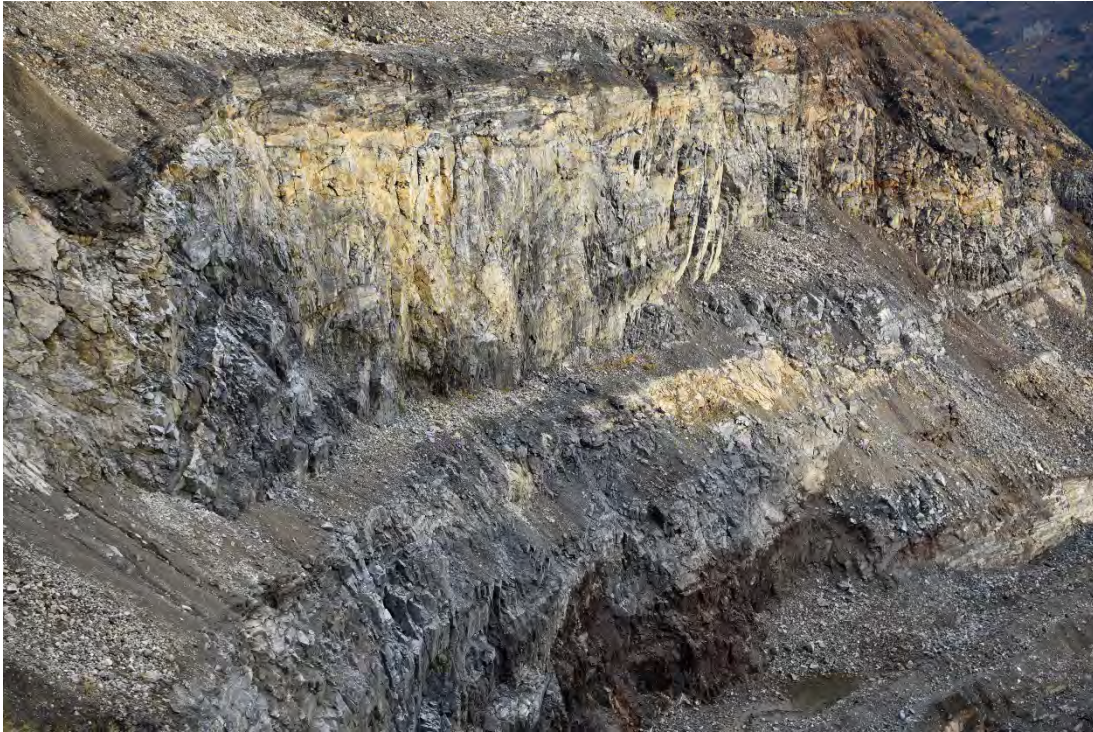
Water seepage was observed from Face 4 and the rock mass on this face is significantly more fractured than higher faces, most likely due to pronounced freeze-thaw action. This makes the bench between Faces 4 and 5 more susceptible to rock fall, although the large berm prevents this rock fall from reaching farther into the pit. This is an important observation as, with the berm and little evidence of rock fall on the bench between Faces 4 and 5, the base of the pit is considered to have a low rock fall risk.

Photo 3: Middle benches of the NW wall of the Open Pit showing erosion and iron staining; note seepage from the face in the lower-right of the photo.

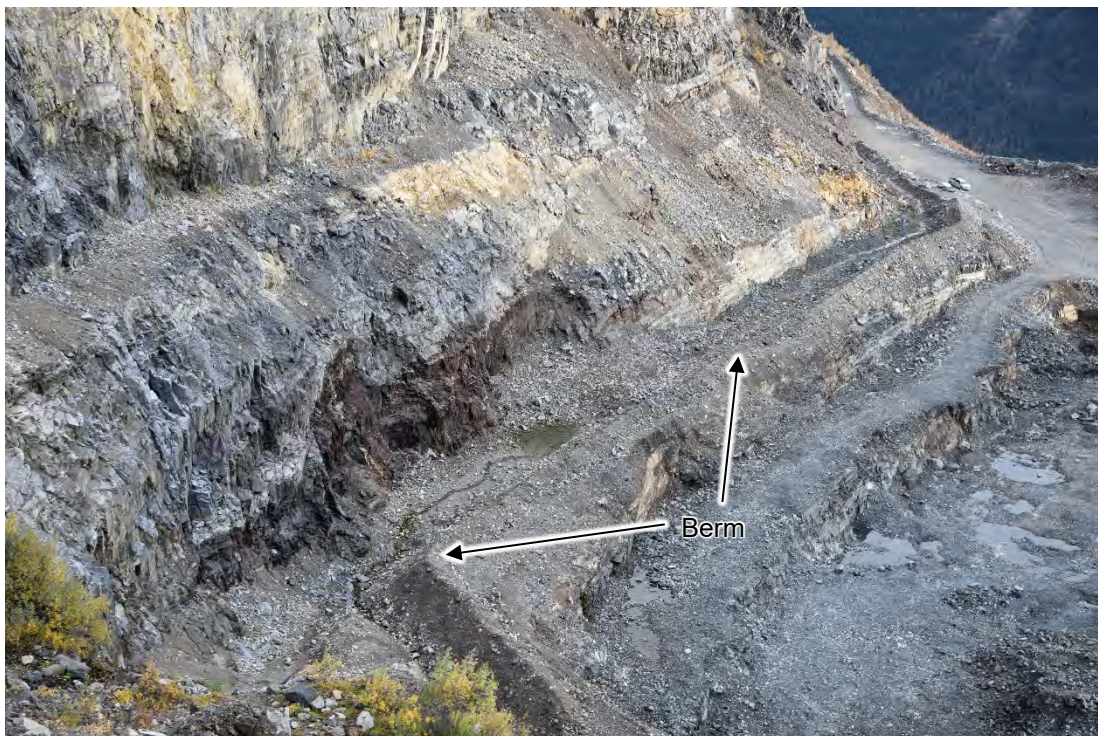
Photo 4: Lower benches of the NW wall of the Open Pit showing rock fall berm, providing effective catchment to benches below.

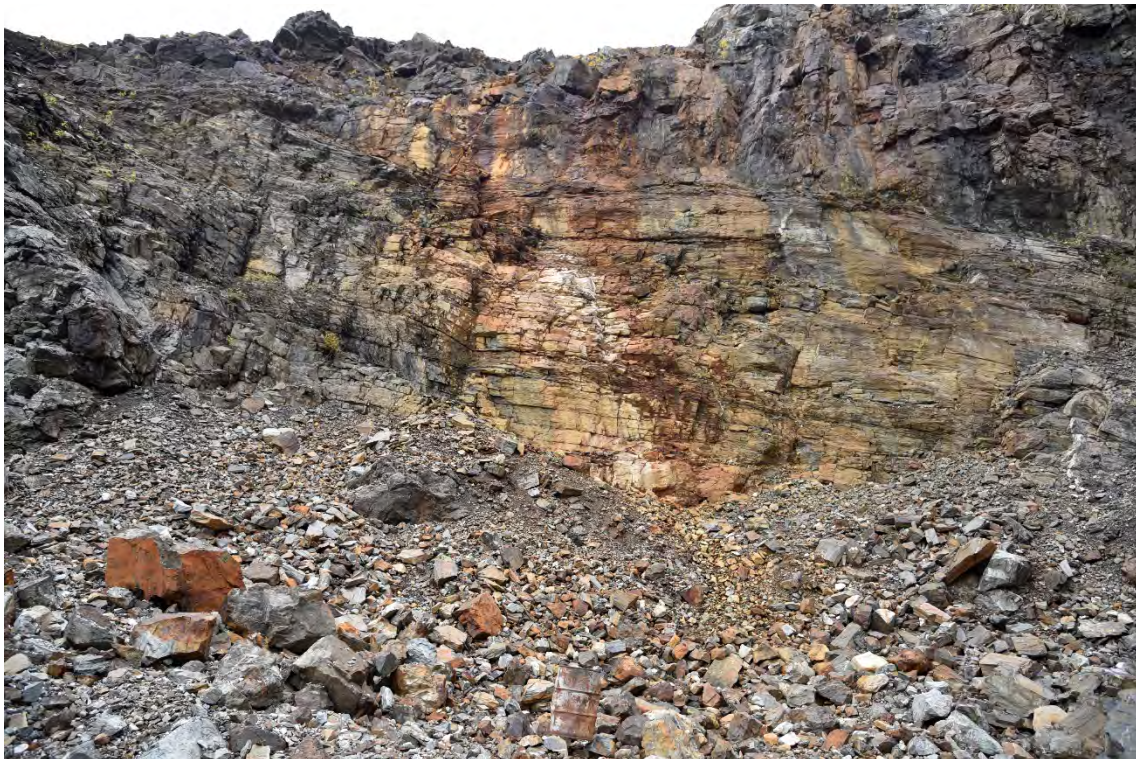
There is iron staining on virtually all the exposed rock surfaces, likely due to the amount of water inflow which occurs through the waterfall and groundwater seepage.

Photo 6: Significant iron staining from water inflow / seepage on the SW wall of the Open Pit.

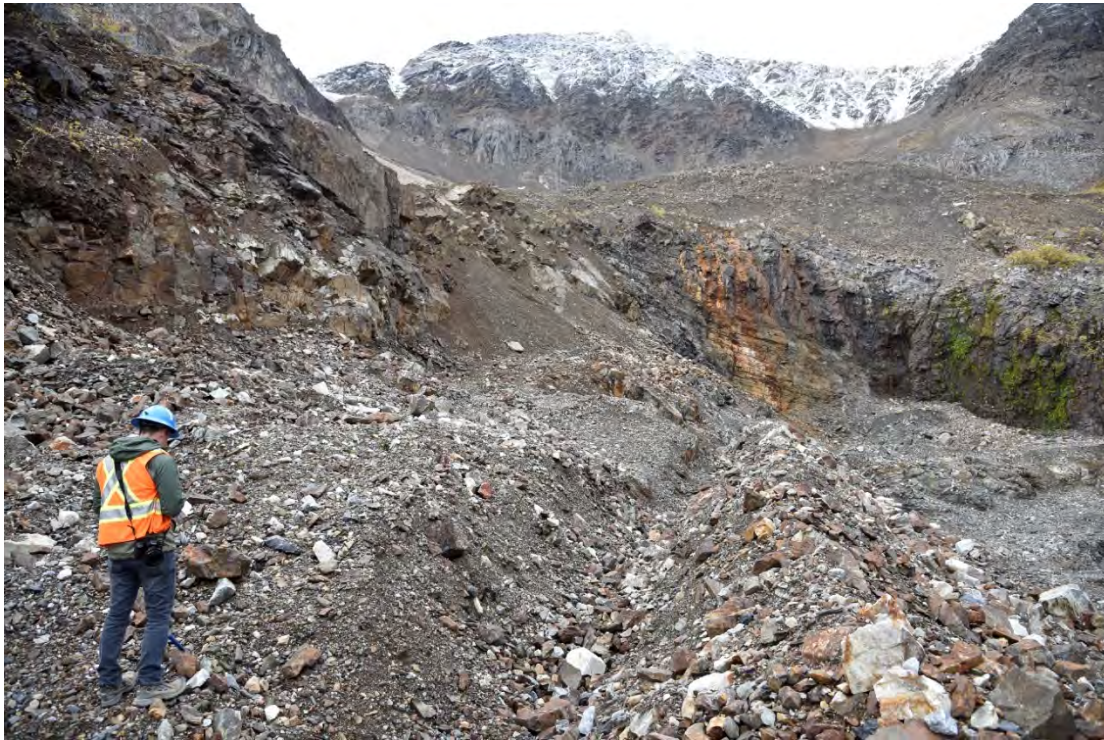
Photo 7: Rock fall berm below the upper bench-face of the Southeast Wall of the Open Pit, iron staining and seepage on the SW Wall is visible in the background.

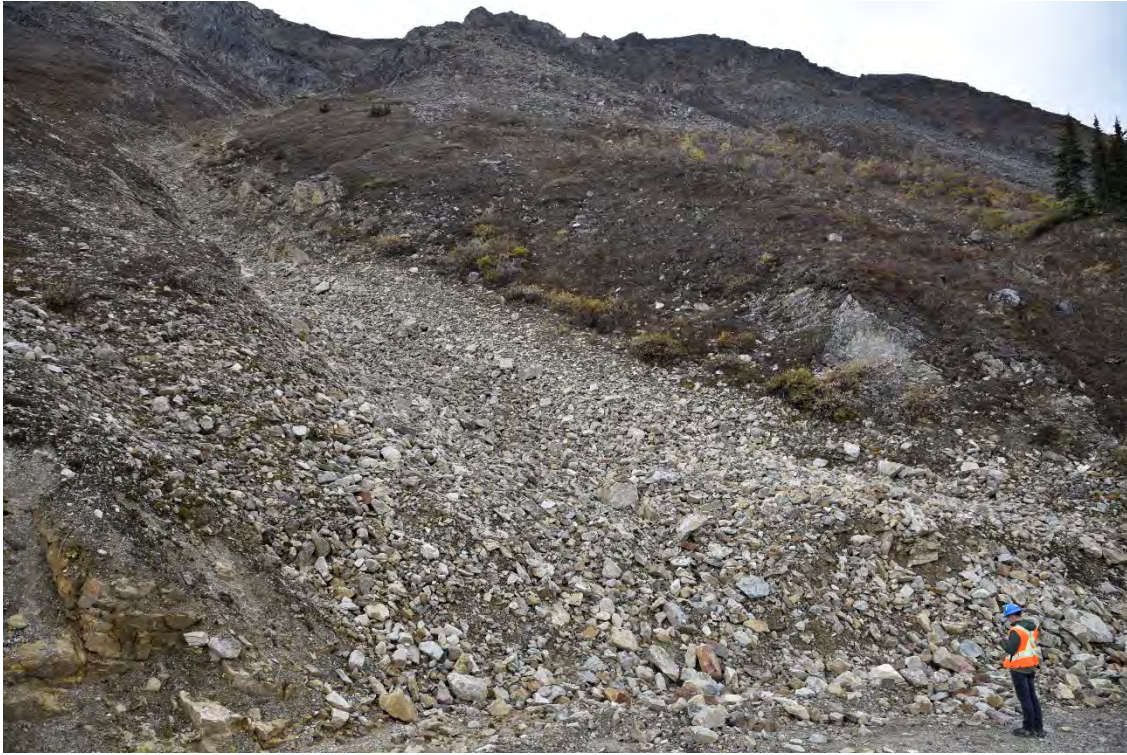
This is the most significant channel that crosses the road, and will likely have the most impact after abandonment. The channel continues below the road, into the base of the valley below. It is 15 m wide and 5 m deep, and has been incised by high flow events. Many large boulders line the channel, and debris from past flow events lines the road near the crossing. Minor levees and some diamicton were observed, further indicating debris flow potential.

Photo 9: Drainage Channel 2, which is the most significant channel that crosses the Open Pit Access Road; the person in the photo is 1.8 m tall, for scale.

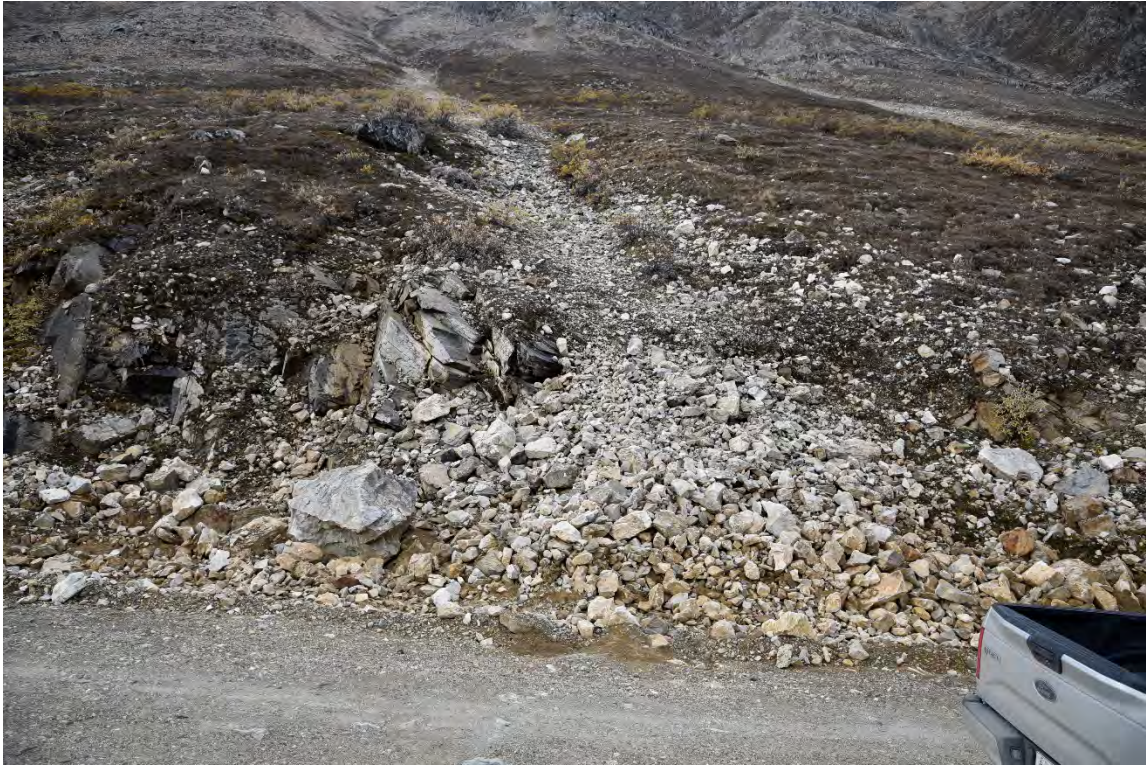
Photo 11: Drainage Channel 4 crossing the Open Pit Access Road.

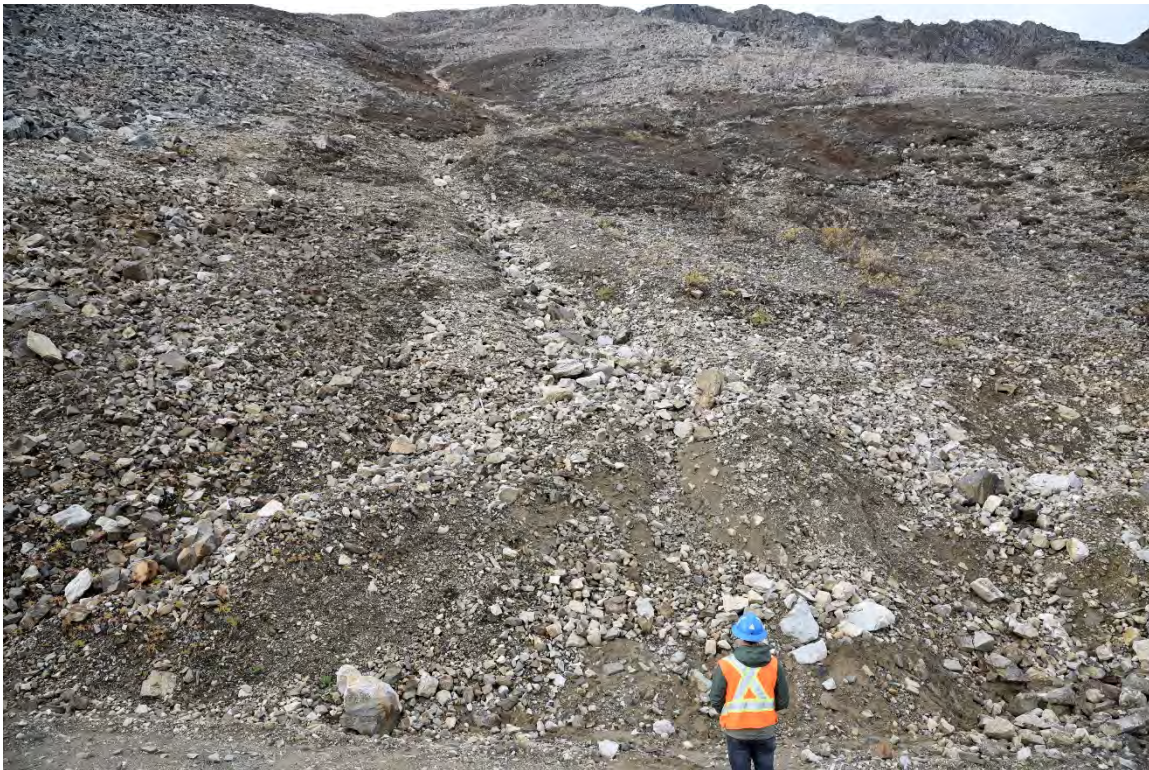
Photo 12: Drainage Channel 5 crossing the Open Pit Access Road.

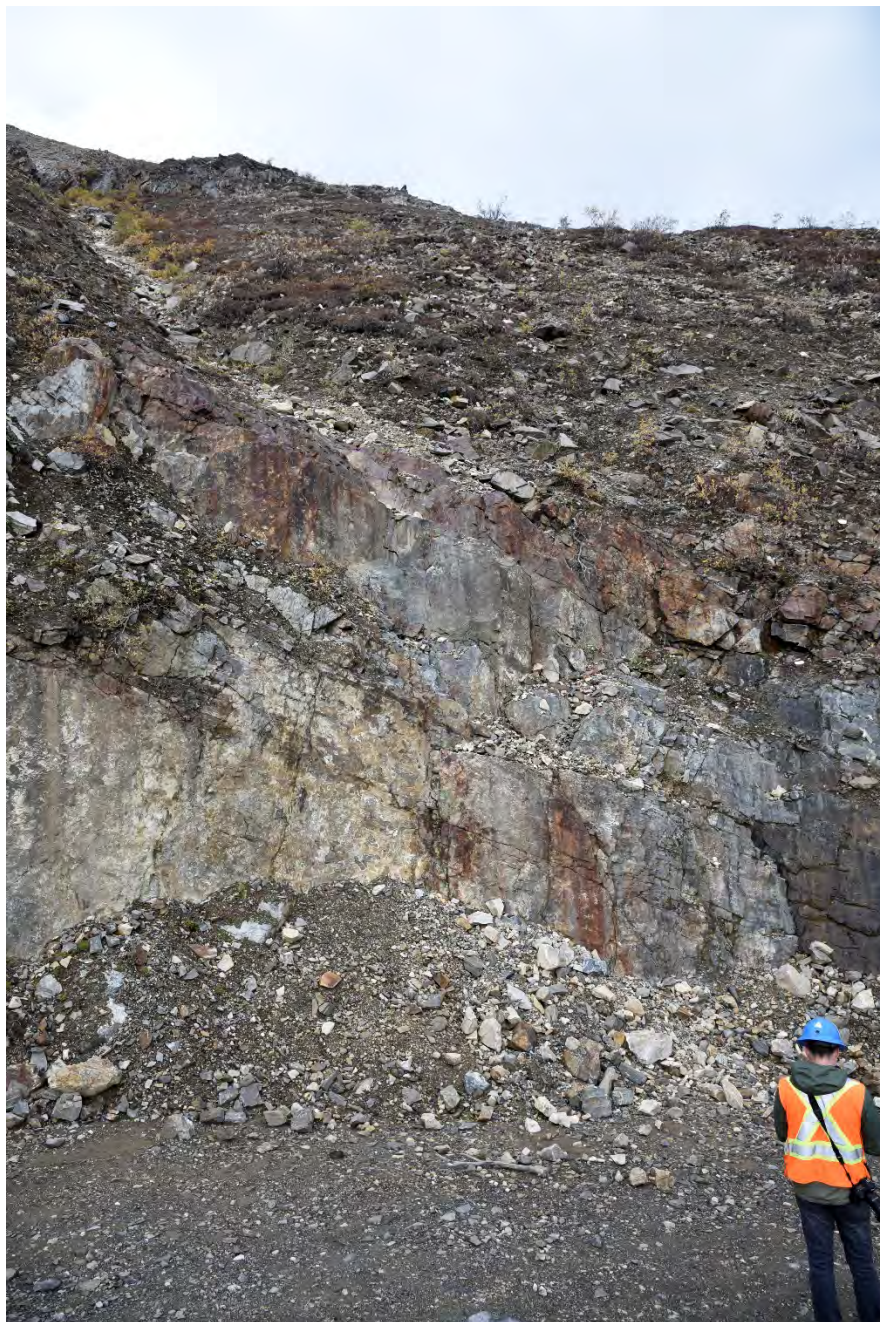
Photo 13: Drainage Channel 6 crossing the Open Pit Access Road.

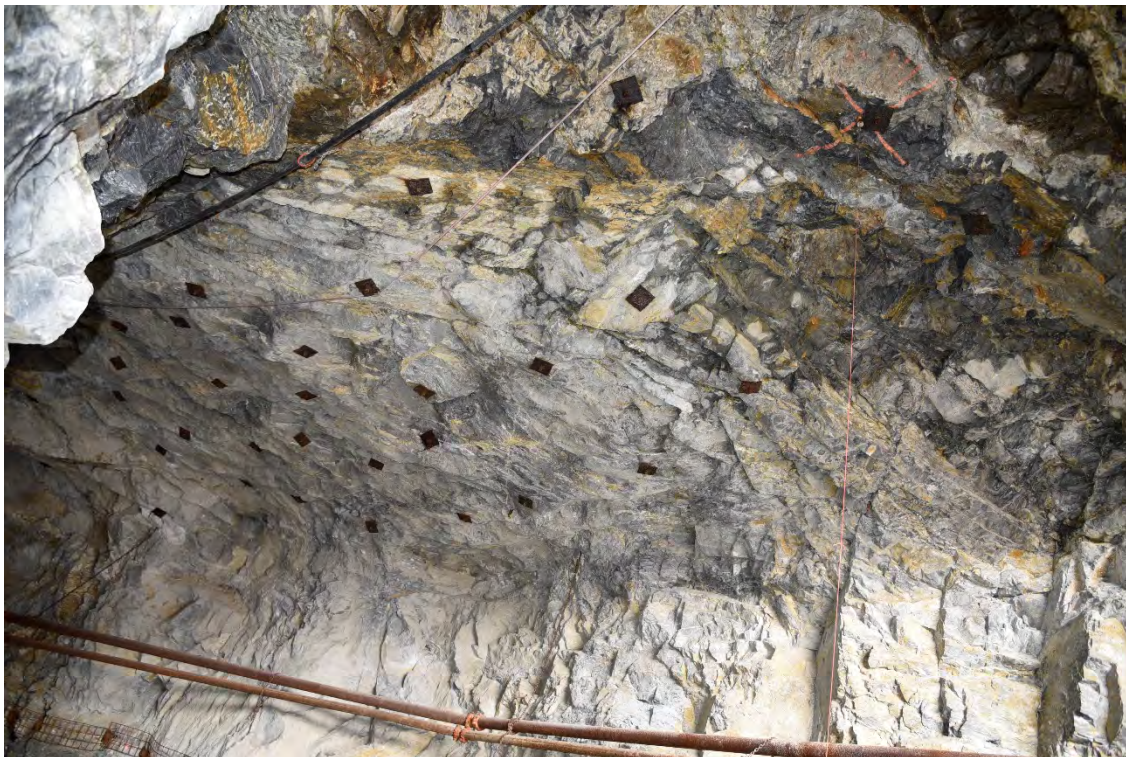
Inside the portal the crown is supported by pattern bolting with a spacing of approximately 1.5 m for the first 8 m of the tunnel, and intensifying to a spacing of approximately 1 m from a distance of 8 m, onwards. The sidewalls are largely unsupported. The Q-rating inside the portal is 4, indicating fair rock. This is a lower quality classification than what was given by the RMR and this is likely due to the Q-system's decreased rating for near-surface conditions at portals. The support recommended for this excavation is systematic bolting with 50-60 mm of shotcrete. The support appears to be performing adequately as-is and therefore we do not recommend additional measures be taken. The calculation of the Q-rating is shown in Table 3.2.1-2, below.

Photo 16: Pattern bolting in the crown of the PUG Adit.

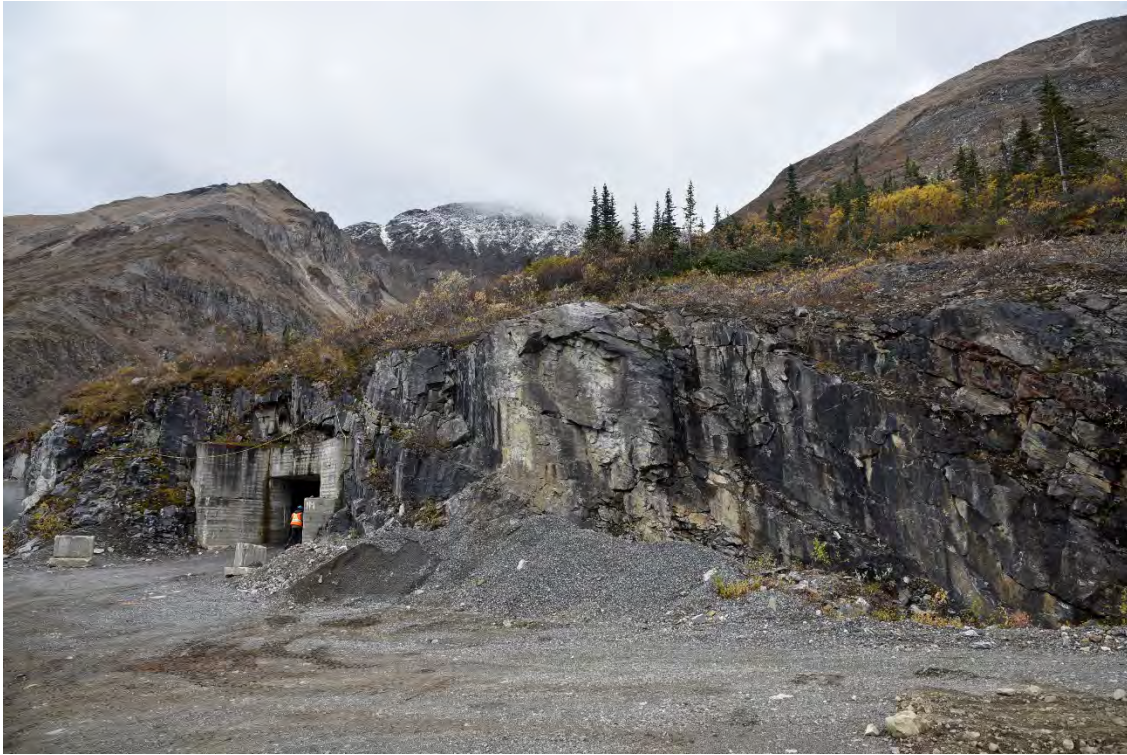
Photo 18: Northwest Slope of the Vent Adit manway.

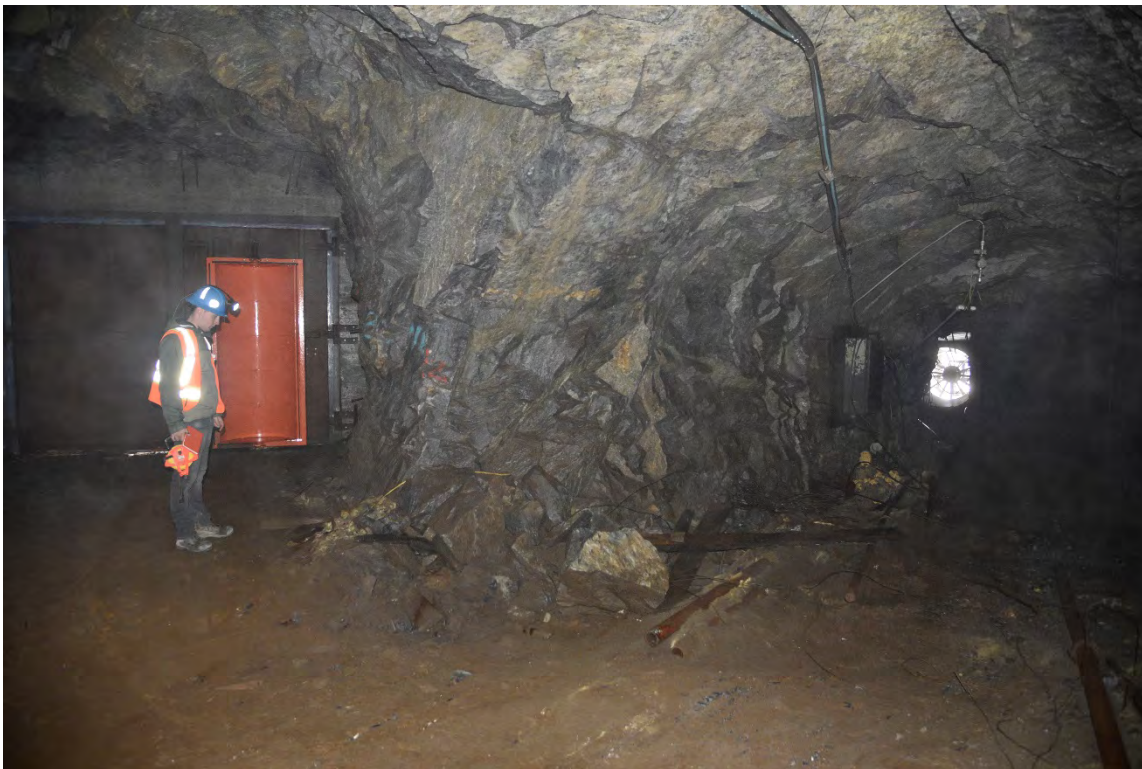
Photo 20: Stress release of the pillar at the intersection of the manway and vent portal of the Vent Adit.

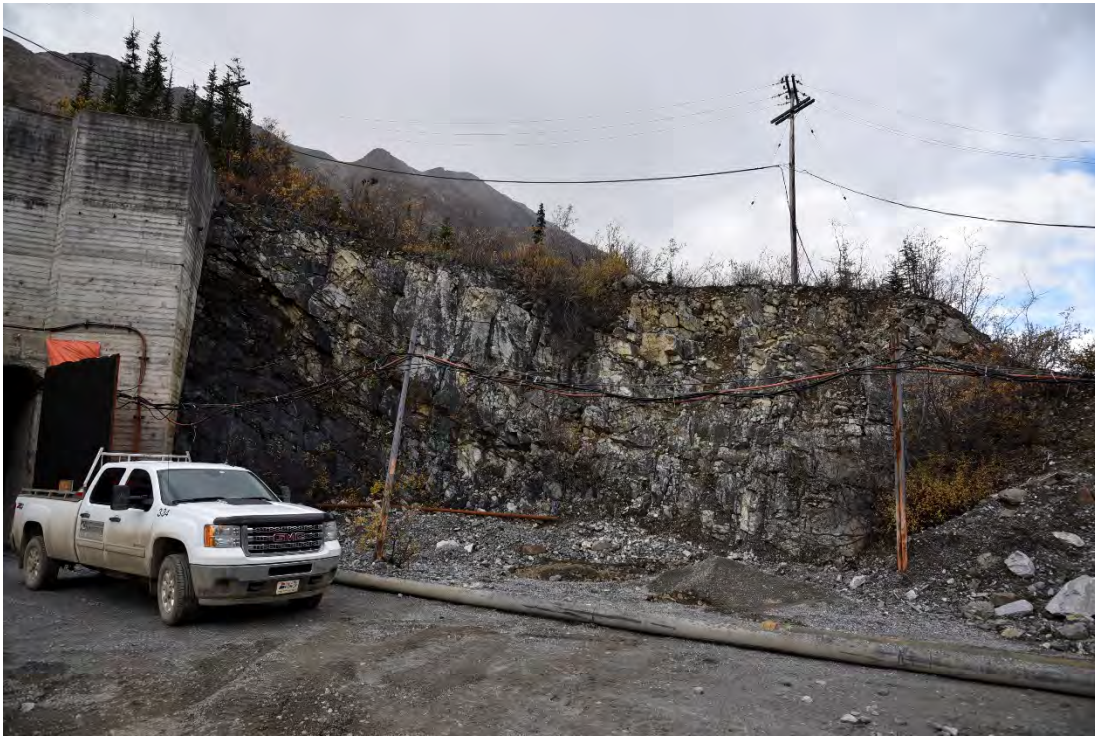
Photo 22: Northwest Slope of the Main Haulage portal. It is recommended that a 4 m setback distance be maintained for workers and equipment during closure and remediation work.

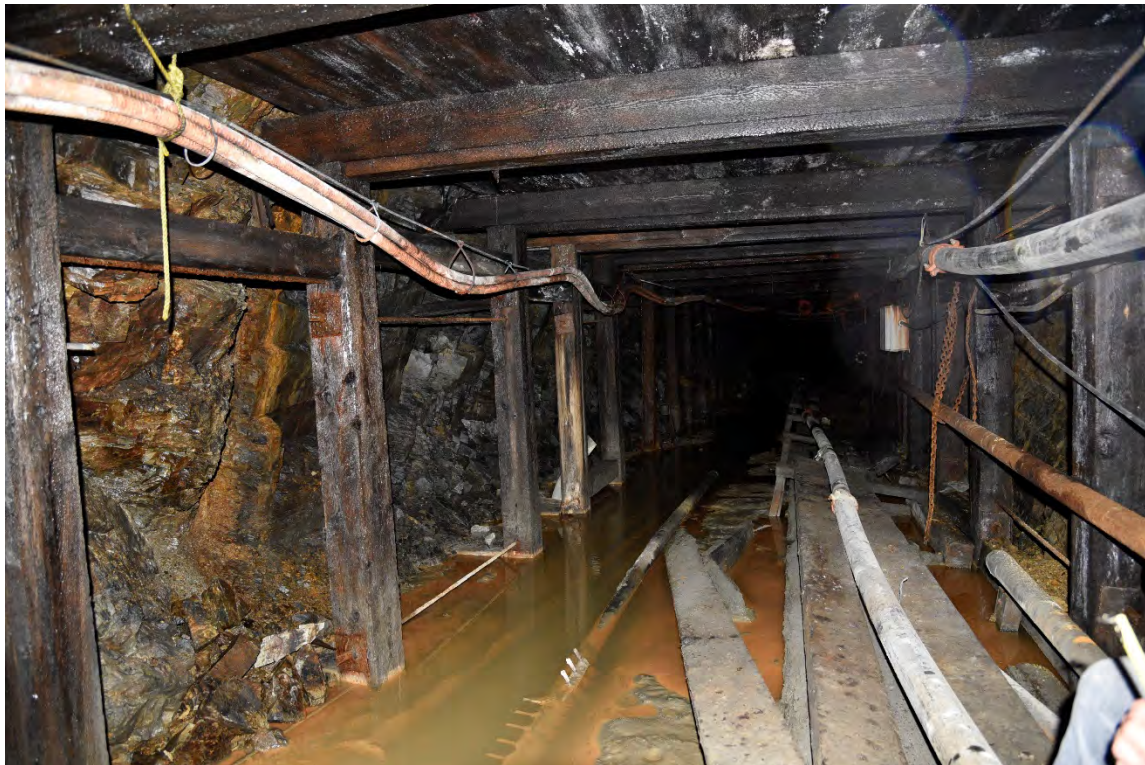
Photo 27: Conveyor Adit timber sets support, poor rock mass conditions (left), and iron staining of the rock mass and water.

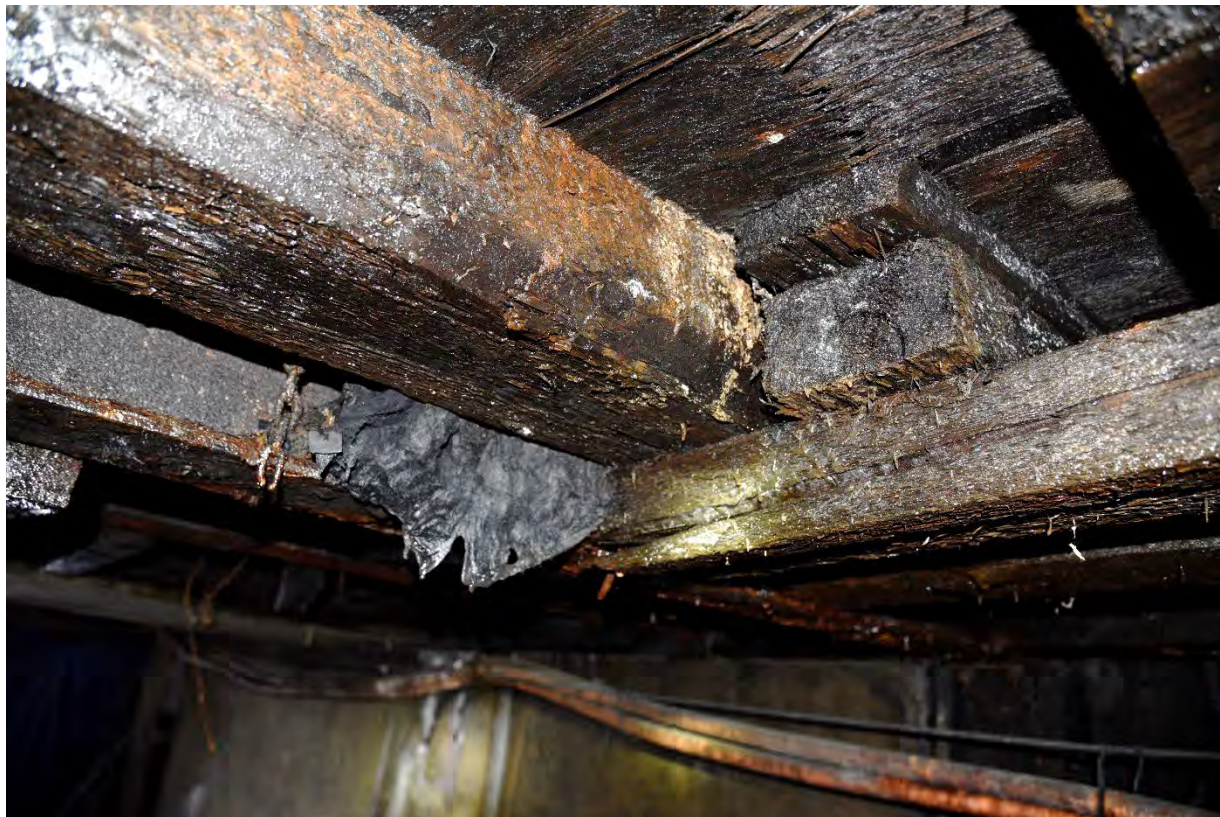
Photo 28: Cracked timber support in the crown of the Conveyor Adit.

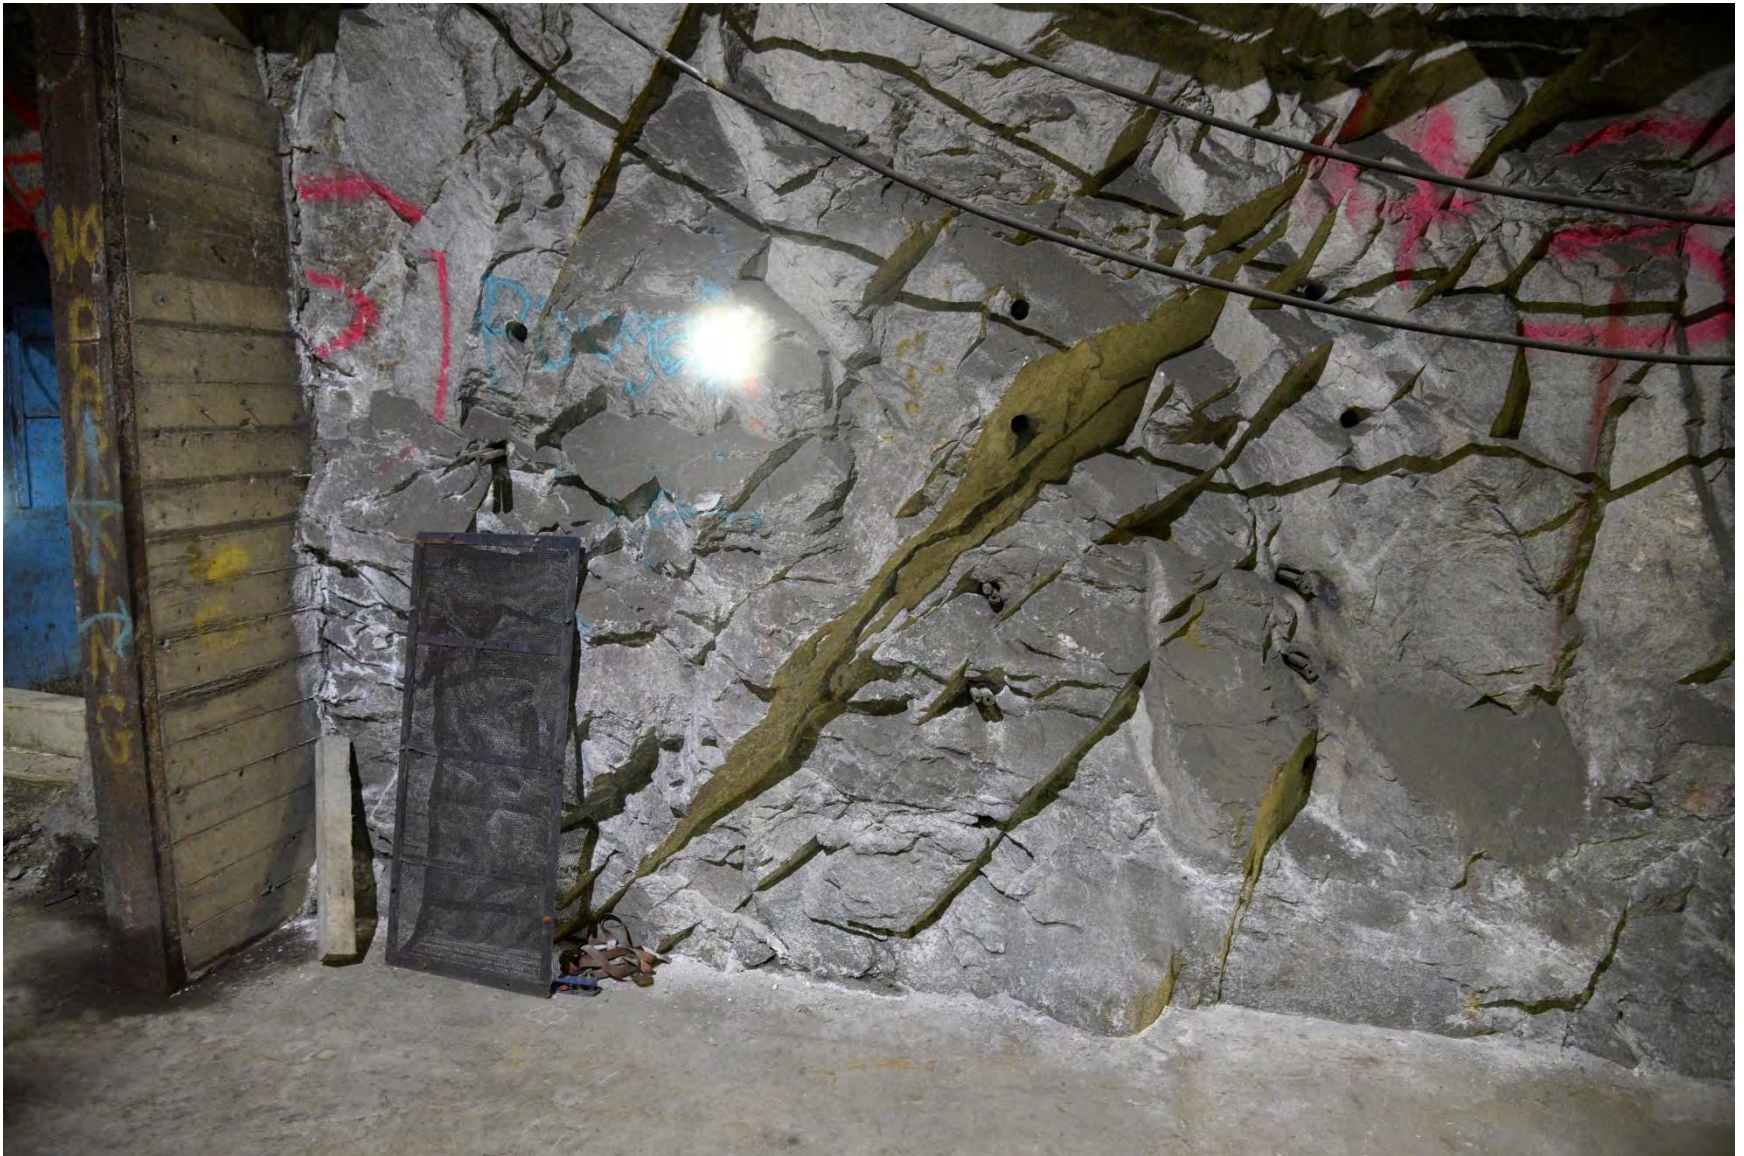
Photo 4: Jointing visible on workshop wall

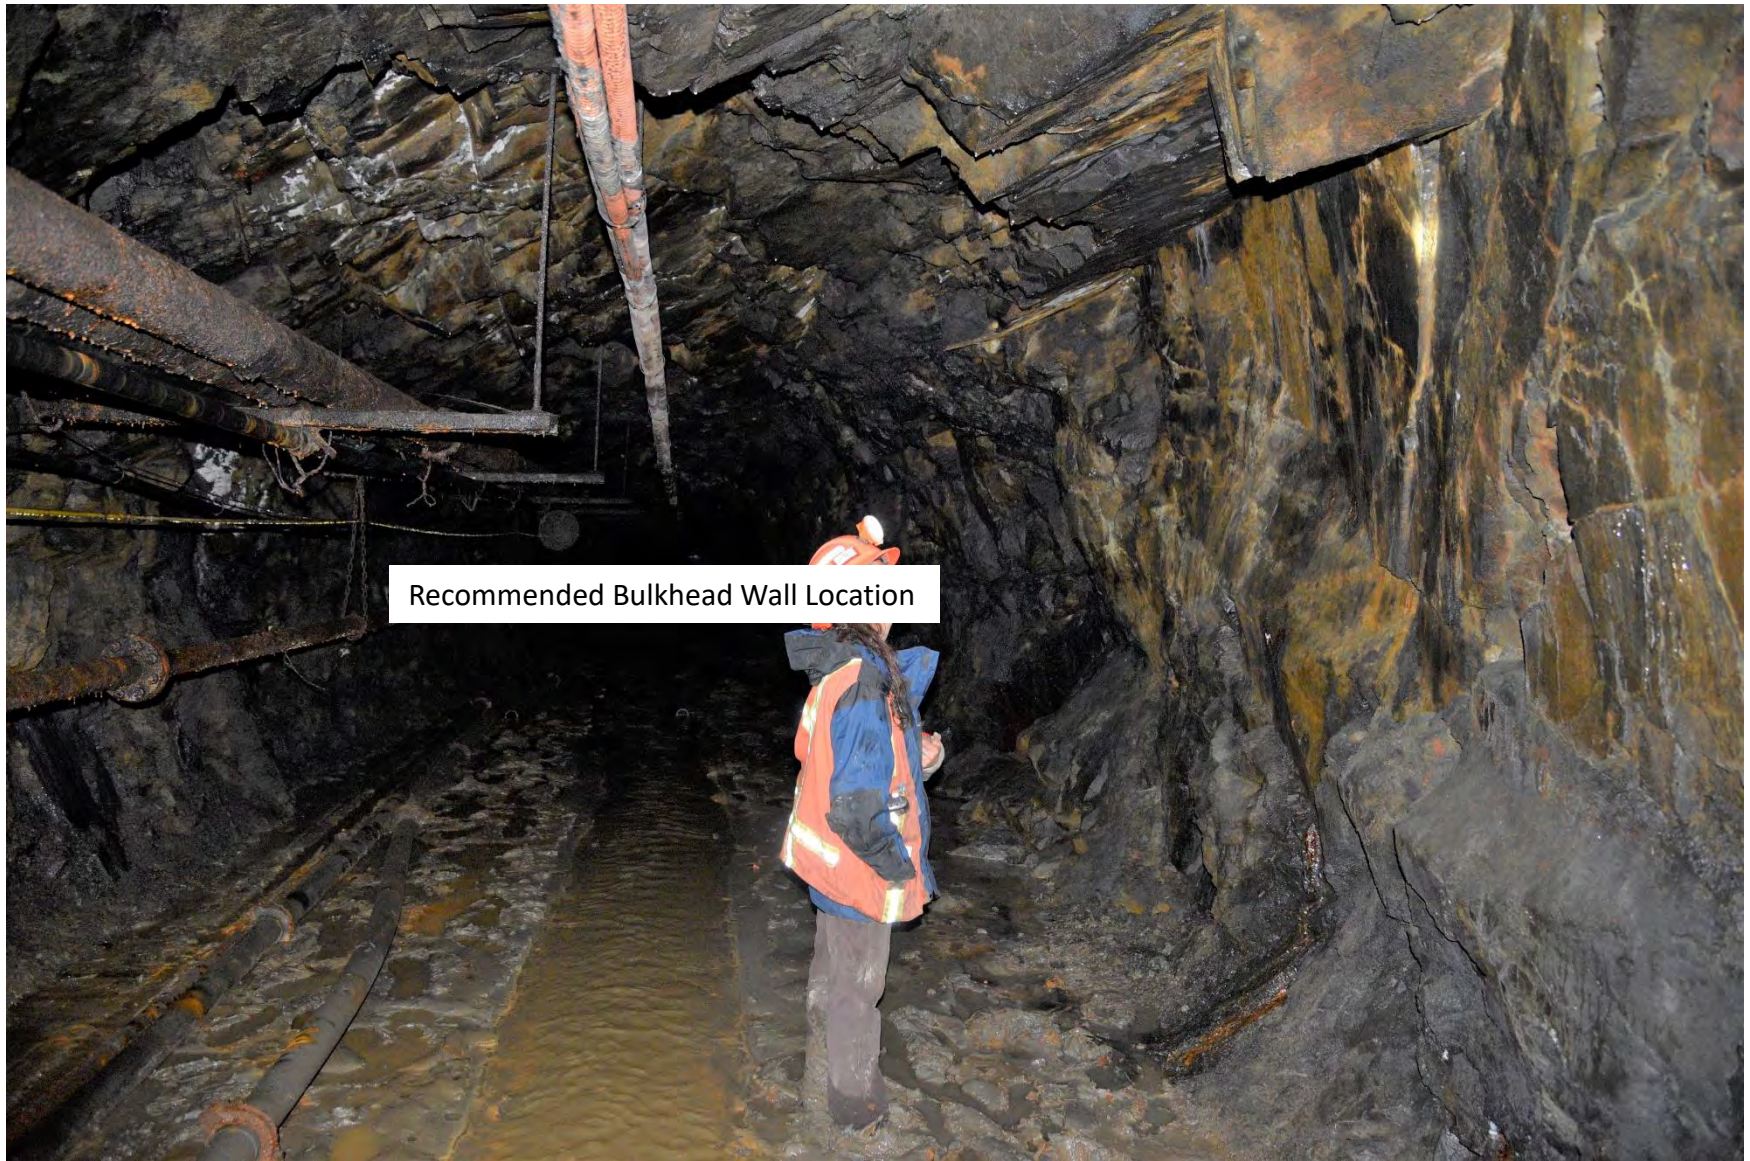
Photo 12: Recommended Bulkhead Location in Conveyor Adit (470 to 480 m)

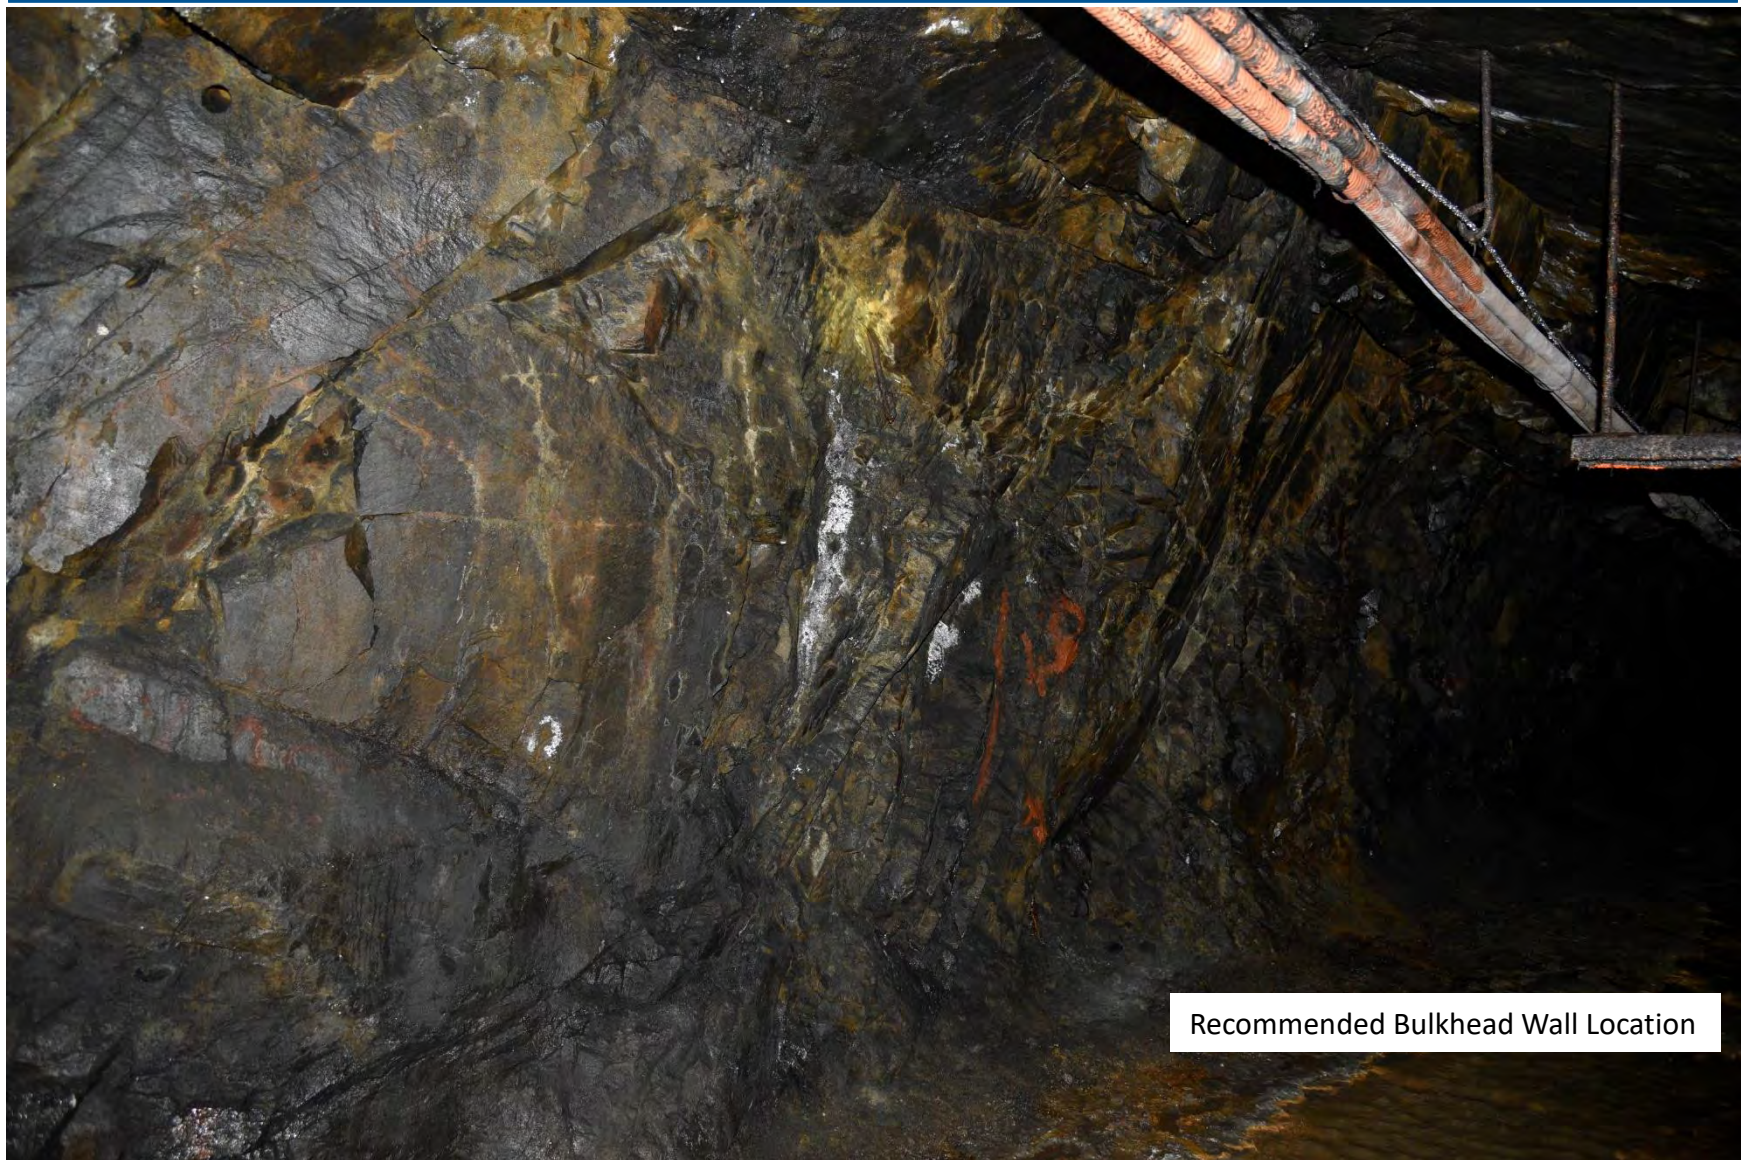
Photo 13: Rock mass at Recommended Bulkhead Location in Conveyor Adit (470 to 480 m)

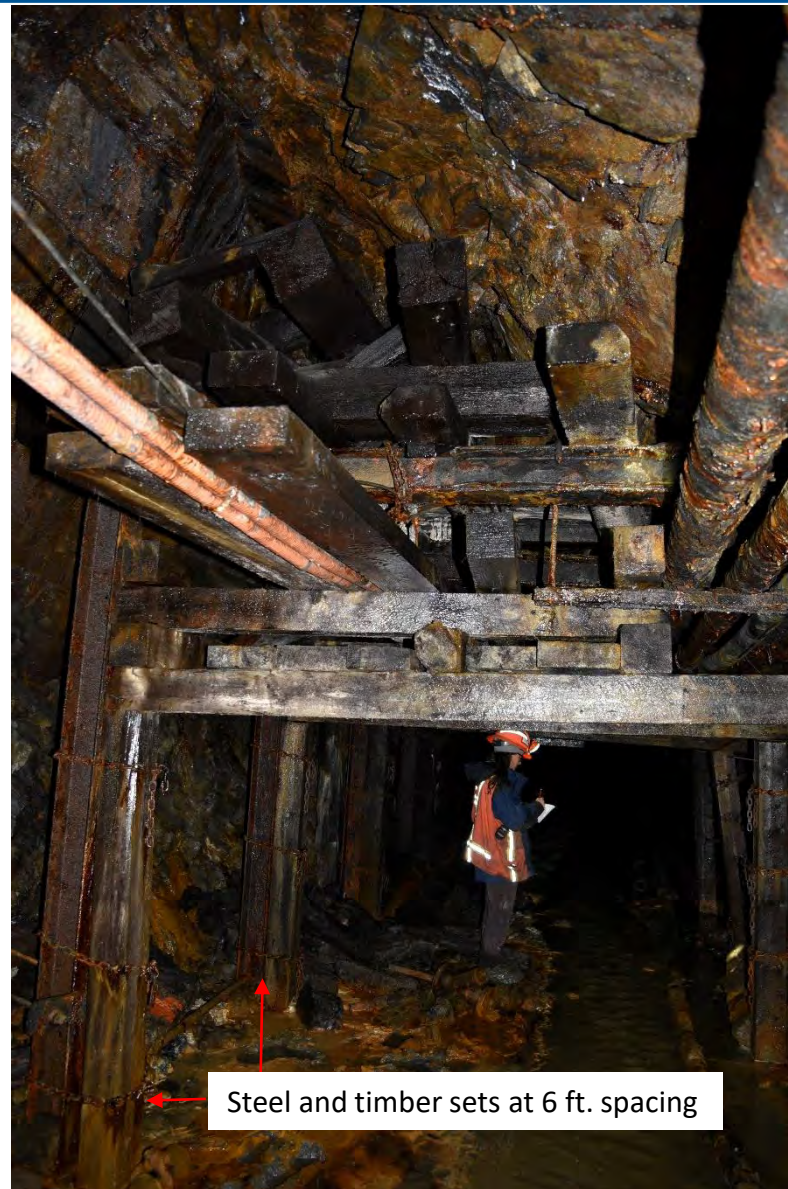
Photo 16: Deteriorating timber and steel sets
