Cantung Mine Closure Geotechnical Stability Assessment

PRESENTED TO
North American Tungsten Corp. Ltd.
c/o Alvarez & Marsal LLC

JULY 2019
ISSUED FOR USE
FILE: 704-ENW.WENW03039-03.007

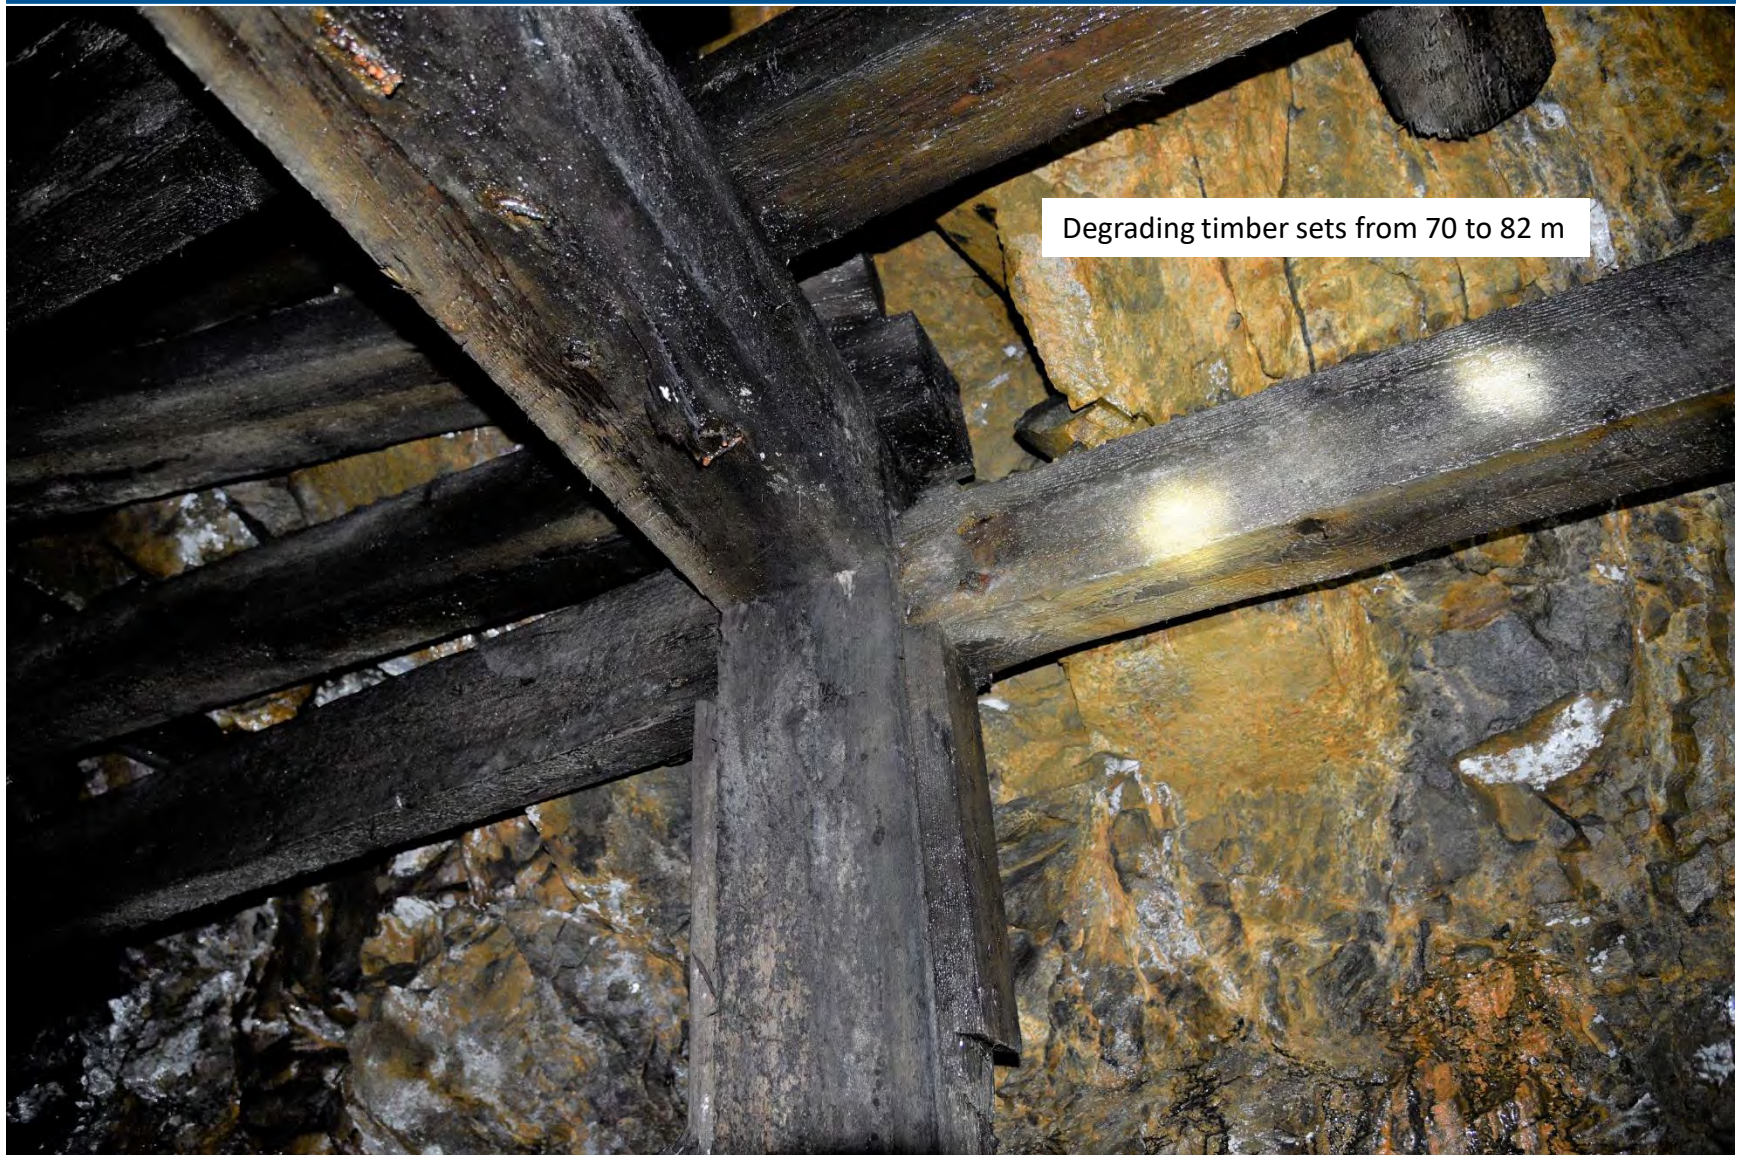
Photo 24: Degrading timber set connection

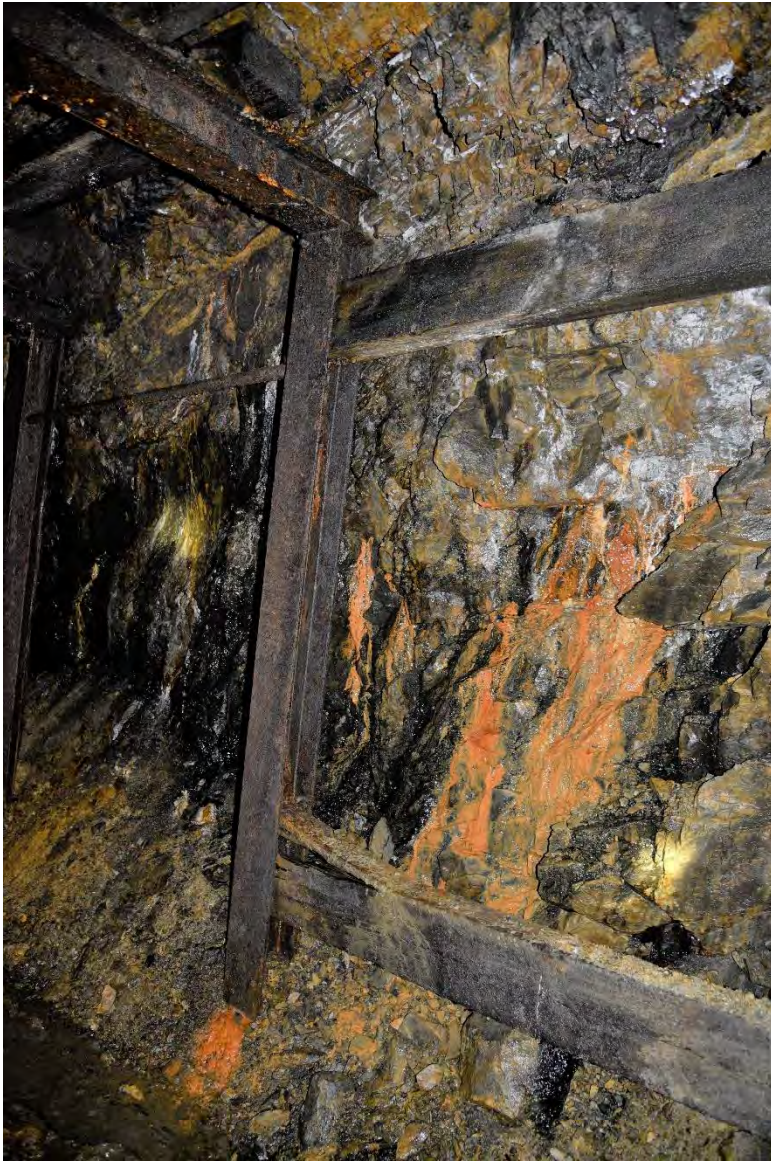
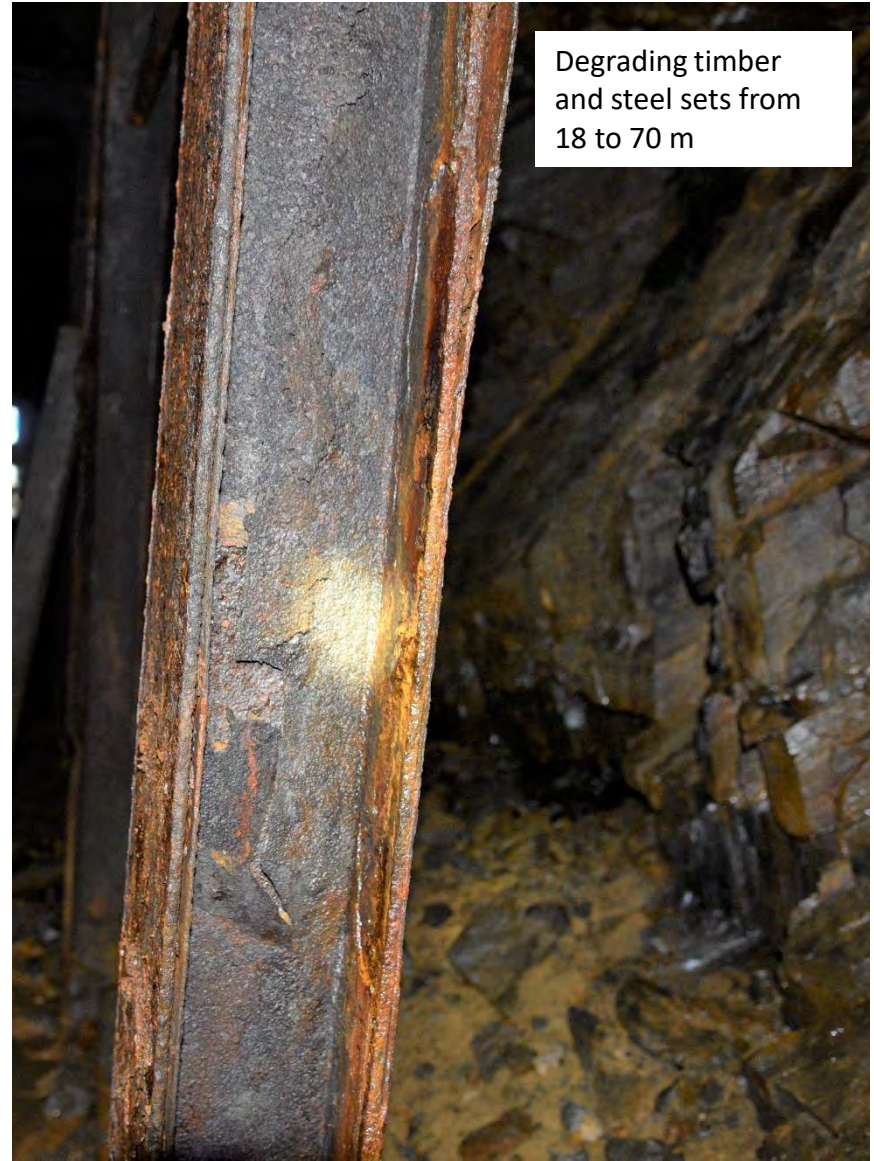
Degrading timber
and steel sets from
18 to 70 m

Photo 25: Current condition of timber and steel sets

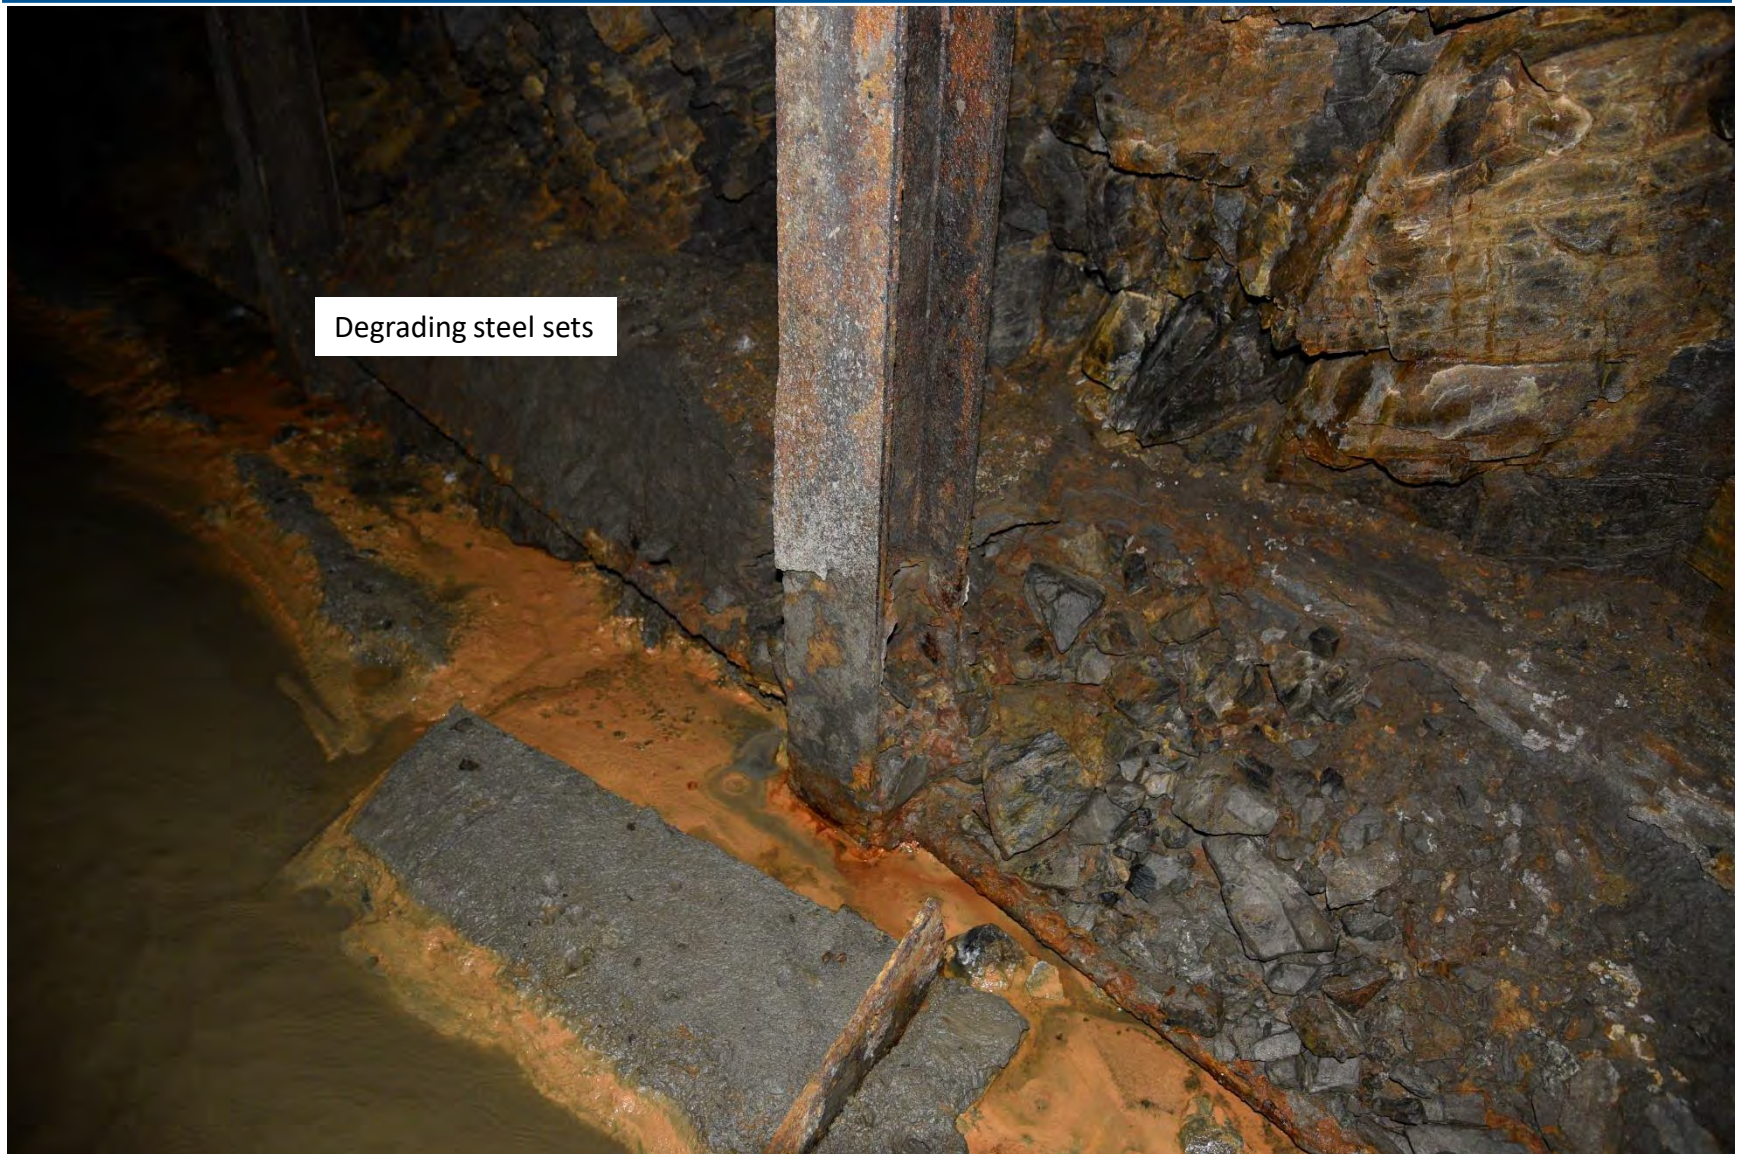
Photo 27: Highly corroded and deteriorated steel sets.

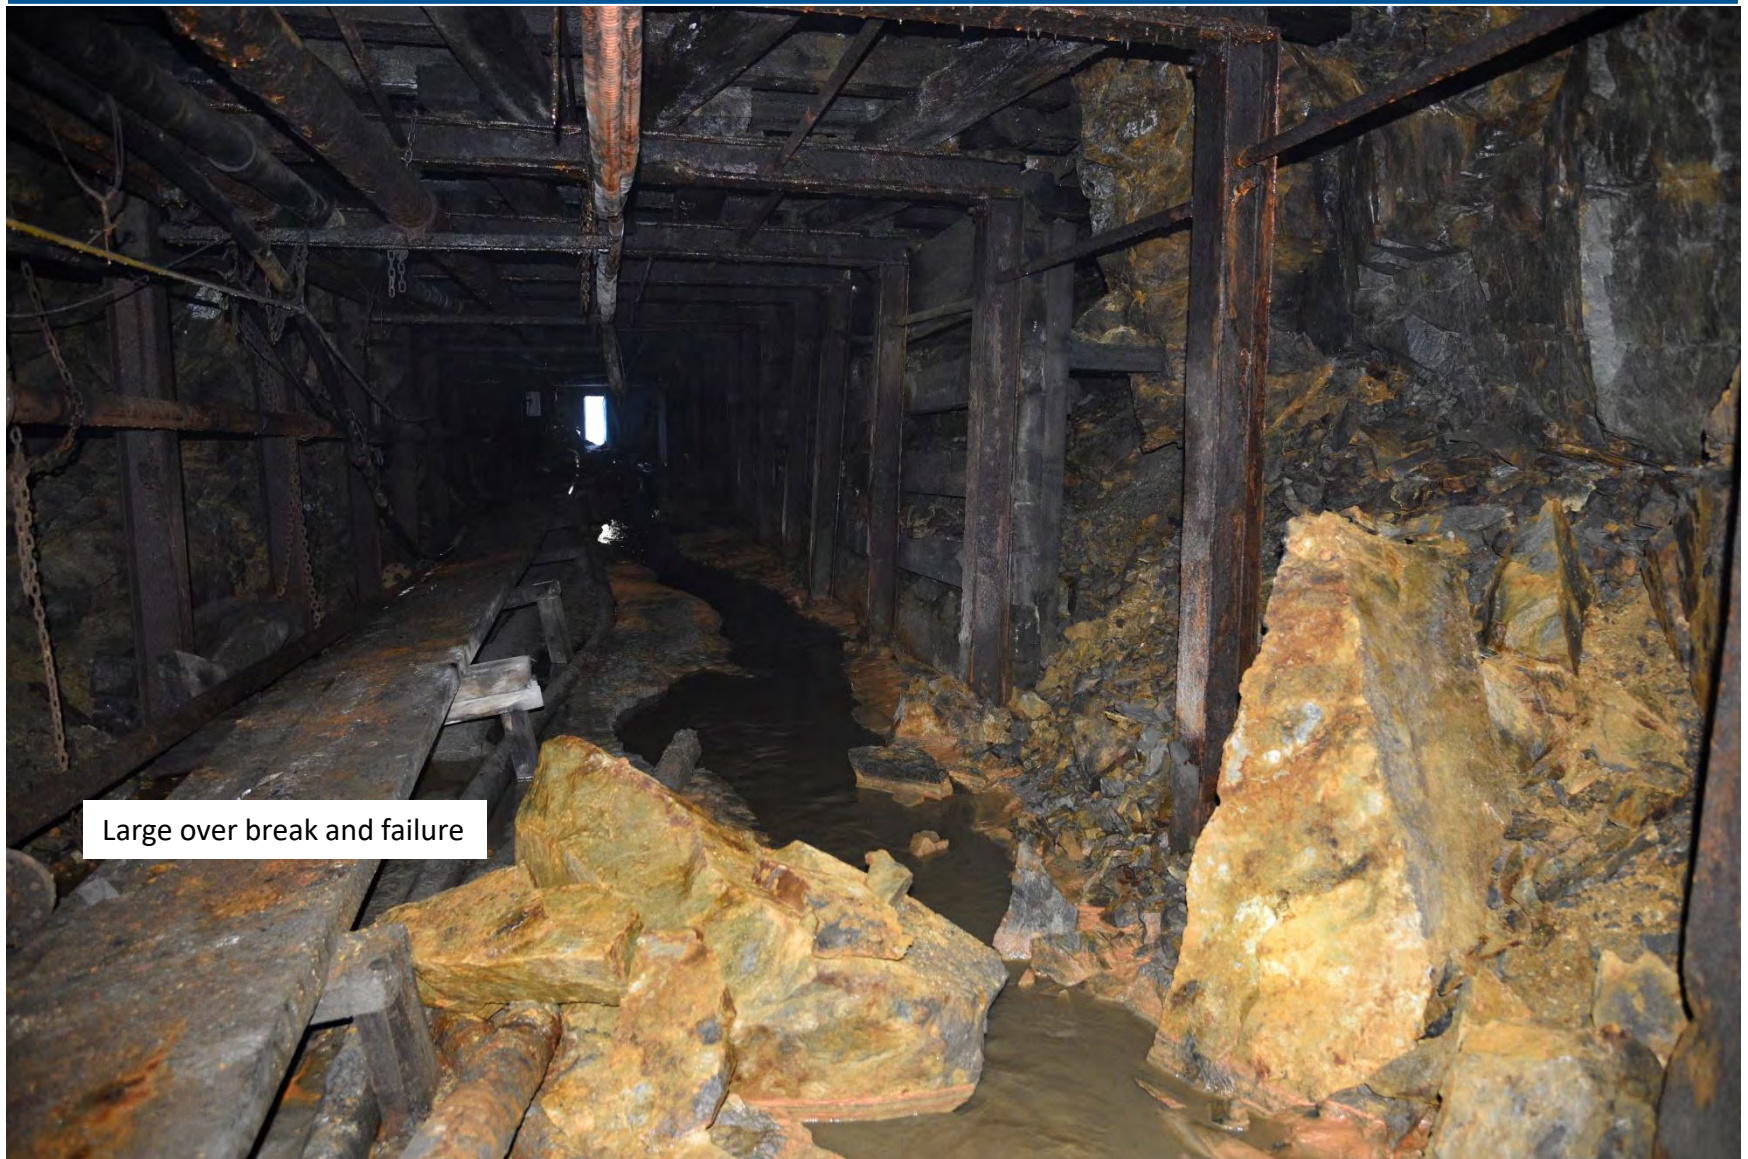
Large over break and failure

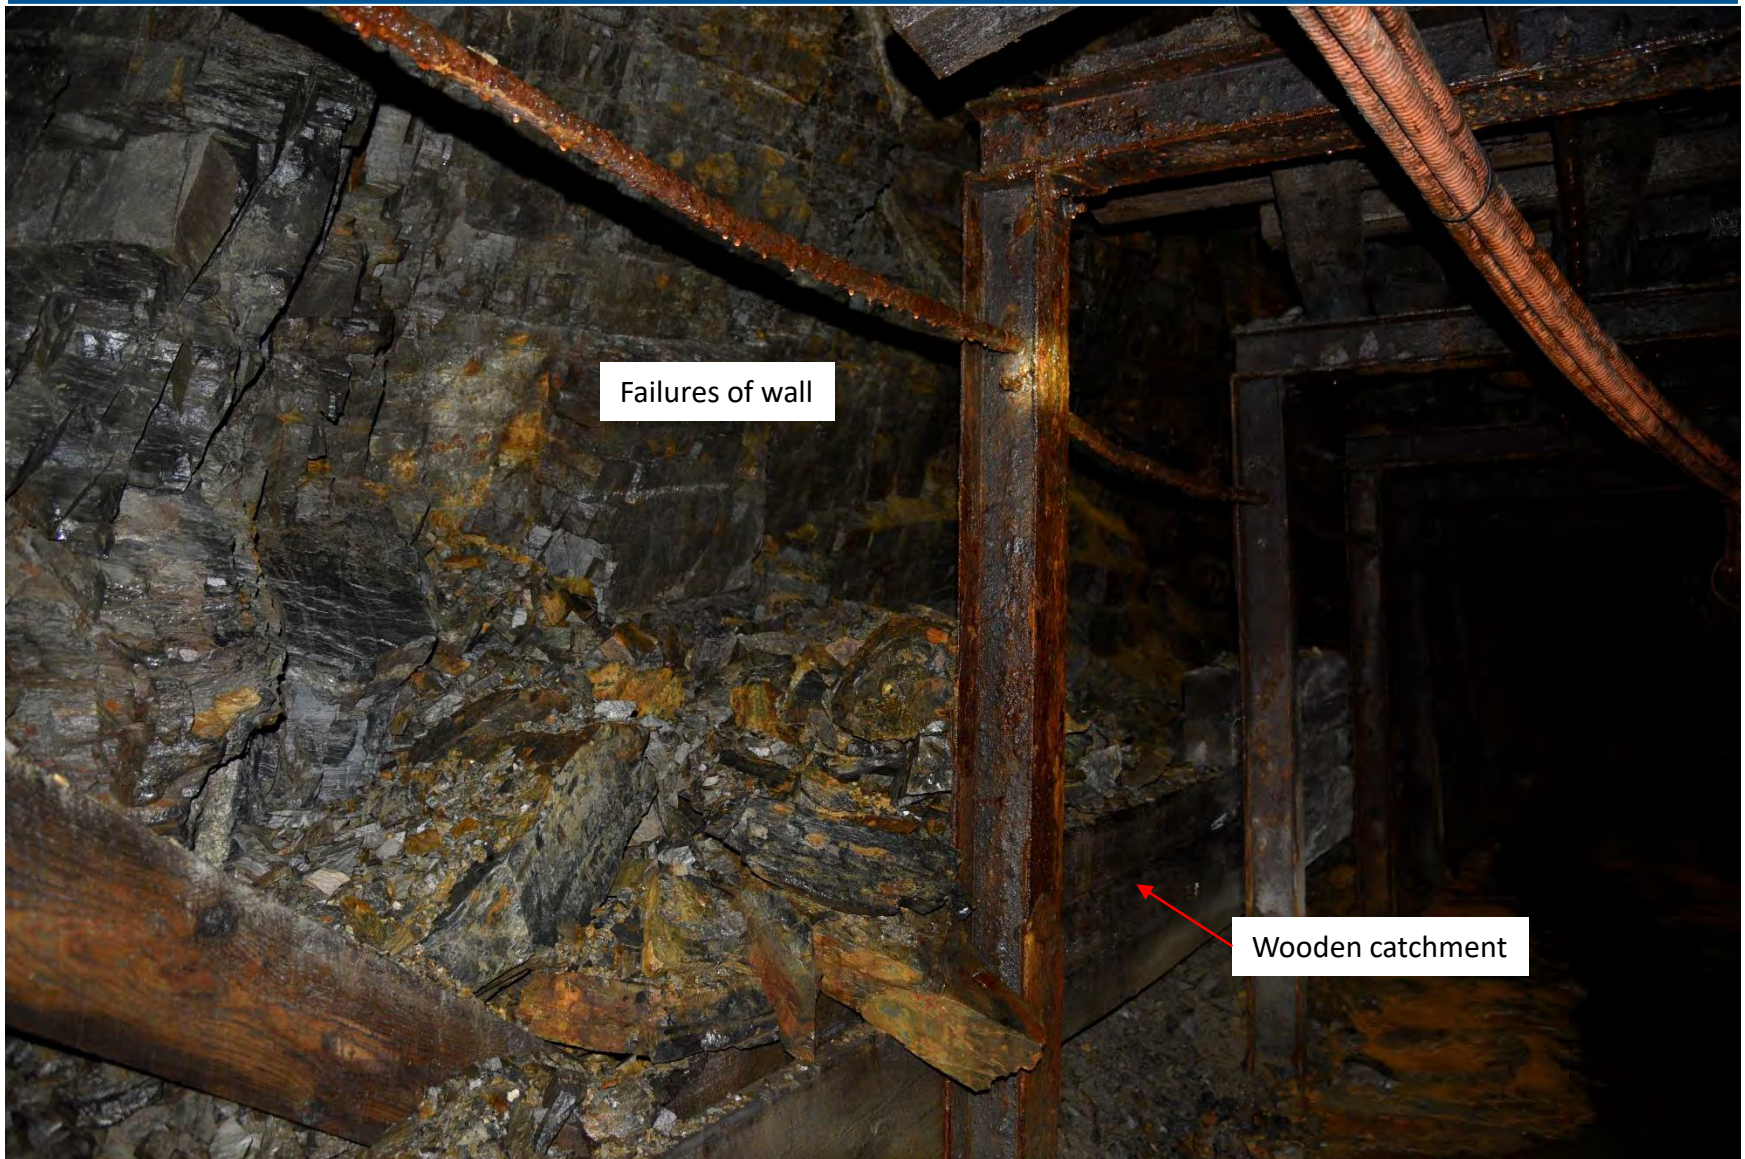
Photo 29: Failure from adit wall in wooden catchment from 20 to 30 m
