2024 ANNUAL REPORT

MV2023L2-0006

CANTUNG MINE, NT

PREPARED PARSONS INC.

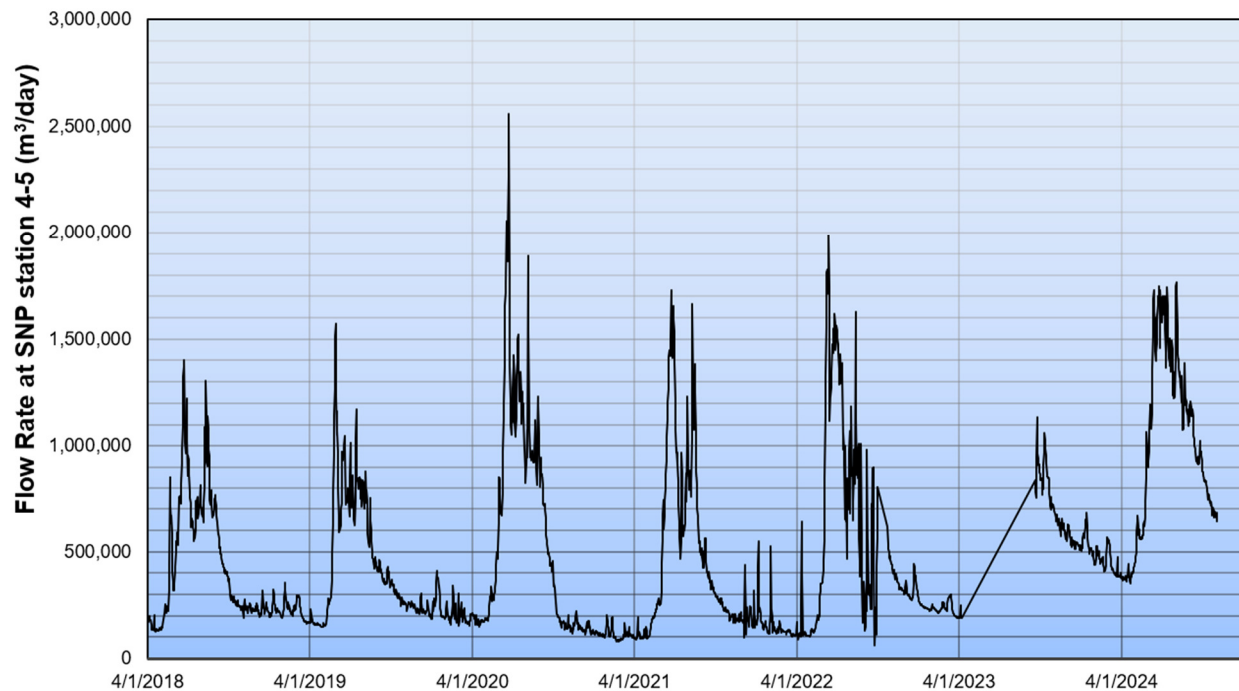
Figure 1. Historic Flow Data at SNP S4-5

Flow data for Station S4-5 over time is provided in Figure 1 below. As noted, some of the flow volumes calculated in 2024 were significantly higher (in some cases double) than historical levels. This could be reflective of inconsistency in the survey data or a technical issue with the logger data. Troubleshooting will be conducted during the 2025 field season any corrections to the data reported herein will be addressed as an Addendum, if applicable.
