DRAFT TECHNICAL MEMORANDUM

FROM: Independent Peer Review Panel
Review Team Participants: Ian Hutchison, Mike O’Kane

DATE: August 18, 2023

RE: **Comments and Recommendations – Gordon Lakes: Camlaren Tailings and Soil Containment Area (TSCA) Geotechnical Investigation**

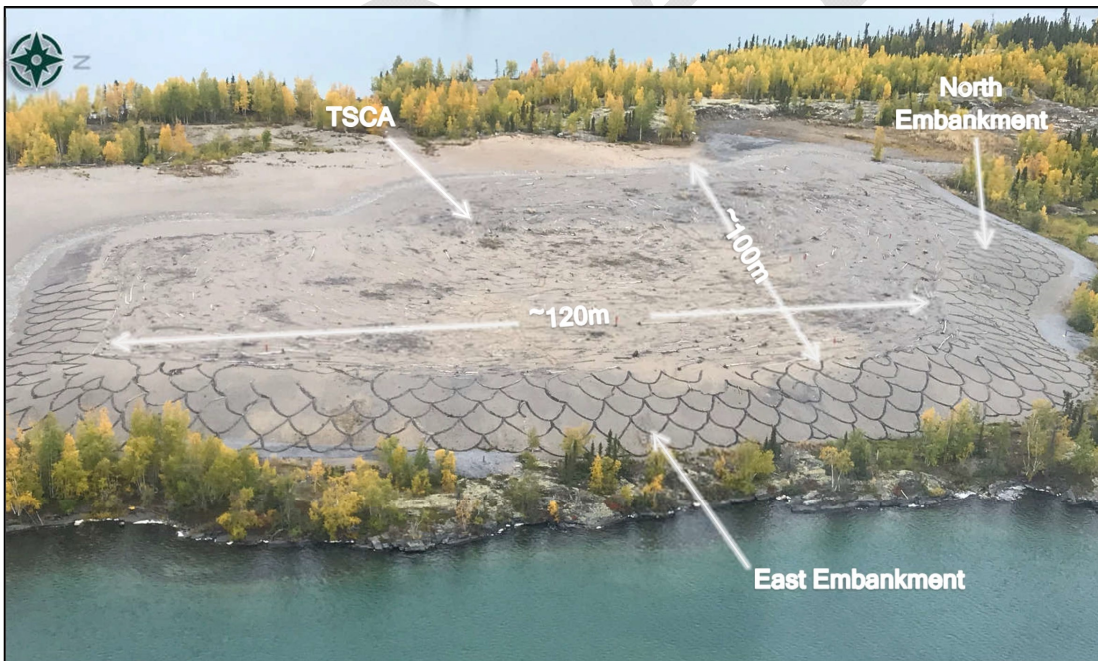
Figure 2 Camlaren Mine TSF

The TSCA was closed and covered in 2018. The outer dam slopes were stabilized, fill was placed to create a domed surface over the entire facility with slopes of approximately 4%. To limit water infiltration, a cover system was constructed consisting of a Bituminous Geomembrane (BGM) overlain with a 0.5 m thick sand layer. Erosion protection consisted of providing vegetation (willow branches) along the top of the TSCA and a coarse sand with rockfill and coco mats on the dam slopes (Figure 2).

The Panel considers features such as willow branches and coco mats are only suitable in the short term and should not be relied upon for the long-term, and questions whether sufficient vegetation can be established to provide for erosion protection in the long-term.

- *Consult with an experienced biologist / revegetation expert with experience in northern soils and vegetation to assist in establishing a plan to upgrade the cover system so it is more erosion resistant and conducive to the establishment of a vegetated cover.*

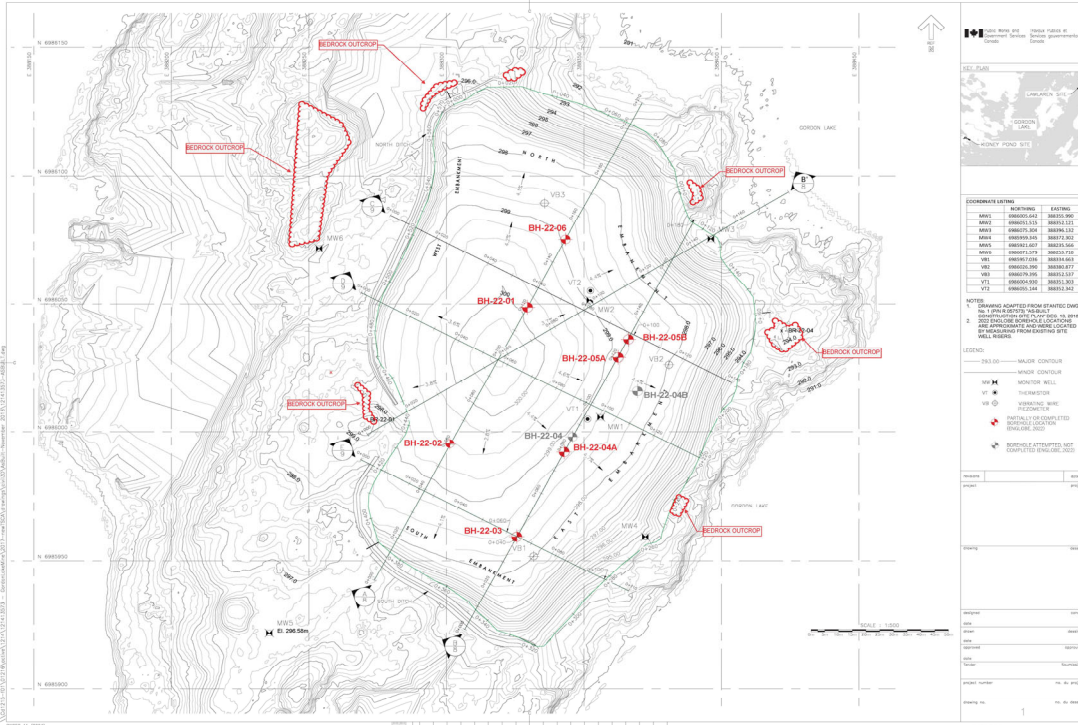
Figure 3 Plan View Showing Cross Section Boring Locations and Possible Extent of Liquefiable Tailings Based on Robertson 2021

The Panel notes there appear to be inconsistencies between the boring shown in plan view (Figure 3) and the cross-section B (not shown) of the report and some of the plot locations on Figure 7 appear to be incorrect.

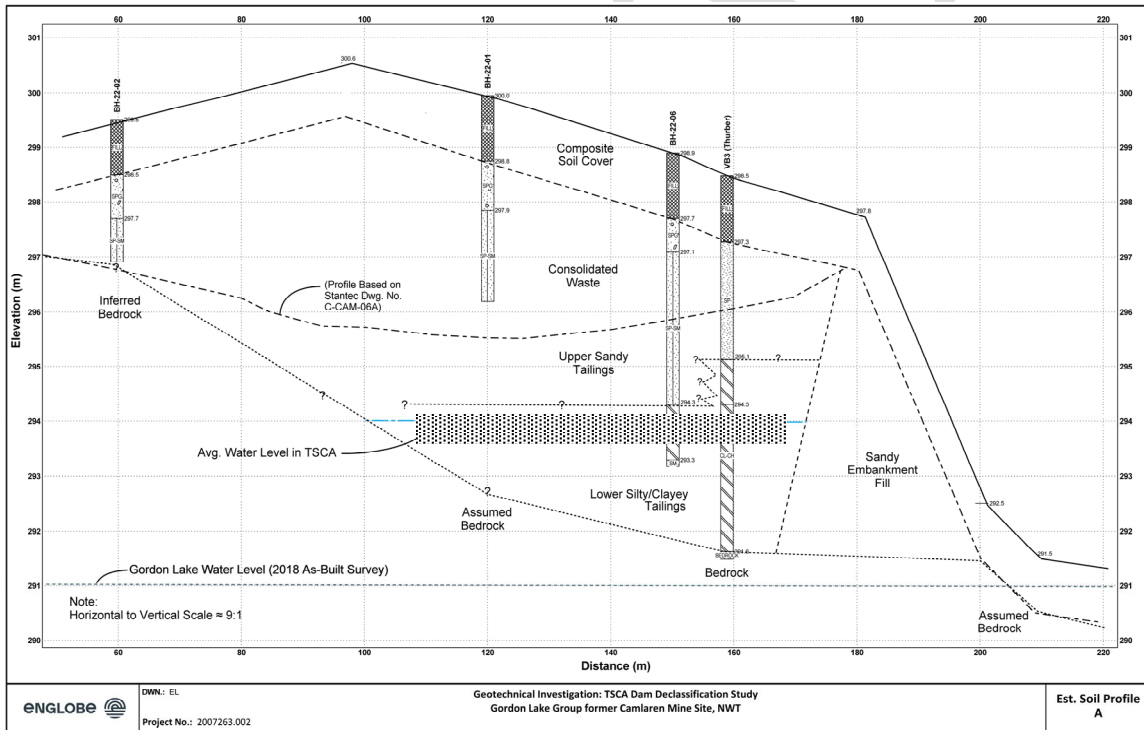
Figure 4 Cross Section View Showing Cross Section A Boring Locations and the Potential Liquefiable Zone Based on Robertson 2021

Based on the more recent 2021 chart, the layers that are potentially liquefiable include BH-22-06 (4.9-5.5m) and BH-22-05B (4.- 4.8 m), which would be considered contractive (see Figures 4, 5 and 8).

The Panel judges the total volume of tailings may be in the 20,000 to 40,000 m³ range based on the sections provided in the report. Furthermore, assuming worst case, the zones identified as potentially liquefiable represent continuous zones (Figures 4 and 5); the Panel’s rough estimates of the volume of potentially flowable tailings appear to be approximately 10% of this volume. The relevance of these small amounts of total and potentially liquefiable tailings is discussed further in Section 4. Overall, the capacity of the TSCA is cited as 80,000 m³ (Englobe 2022a).

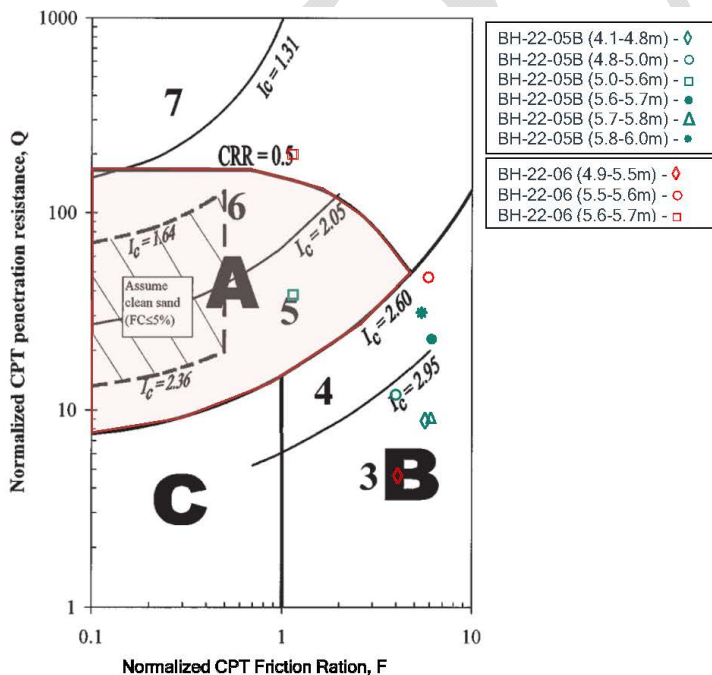
Figure 7 CPT Results Plotted by Englobe on Chart Developed by Robertson (1990)

Englobe (2022) using a chart generated by PK Robertson (1990), a recognized international expert in assessing liquefaction potential in granular materials, to assess the liquefaction potential of the tailings

in the TSCA. The results indicate only one 0.6 m thick layer of tailings, classified as “sand to silty sand”, could potentially be considered to be liquefiable.

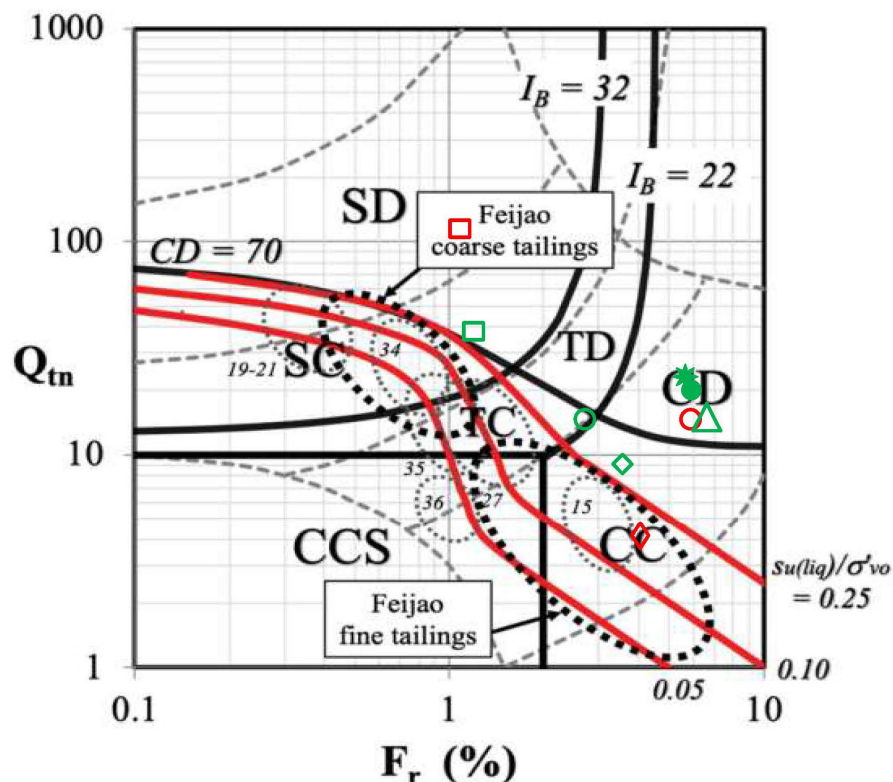
Figure 8 CPT Results Plotted by Panel on Updated Chart Developed by Robertson (2021)

The Panel notes that since the Robertson publication in 1990 significant advances have been made in establishing methods to assess liquefaction potential and there have been several major Tailings Storage Facility (TSF) failures that have provided valuable data against which the relationships have been calibrated. The current version of Figure 7 has evolved into that provided in Figure 8 with a more detailed interpretation of the condition of the assessed tailings. The indicated behavioral zones (Figure 8) include:

- *Elaborate on the characterization of the TSCA considering the following:*
 - *Update the liquefaction analyses considering the most recent developments in this field.*
 - *Refine and use the stratigraphic modeling of the TSCA to estimate the total and potentially liquifiable tailings volumes. Consider these in context with the CDA definition of a dam as discussed in Section 4.1.*
 - *Obtain geochemical data on the tailings, include acid-base accounting testing and both total and leachable mineral and metal content to address the chemical stability finding requirements.*
 - *Assess the filter compatibility between the tailings and the dam construction materials.*
