# 2024 Camlaren Tailings and Soil Containment Area Annual Geotechnical Inspection Report

Gordon Lake Group of Sites

**Public Services and Procurement Canada**

**K'alo-Stantec Limited**

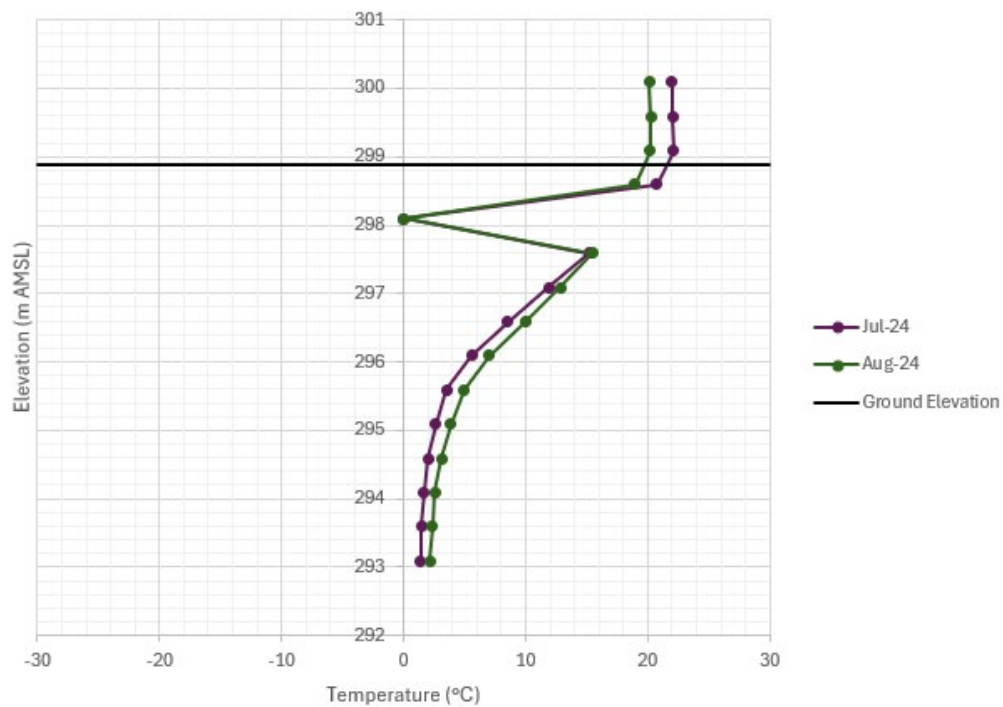
**Figure 5.4 VT1 Year 5 to Year 6 Monthly Average Temperature Profiles**

Thermistor VT1 had missing data from September 2022 to August 2024. This instrument has since been repaired, though node five appeared to be malfunctioning.

Temperature data downloaded from VT2 indicated a range of temperatures at surface level, ranging from approximately -25°C during the winter months and 22°C during the summer months. At VT1, a similar summer temperature of 22°C was recorded. Since the top node was located at/near ground level, these temperatures correlate closely with ambient air temperatures. Temperatures fluctuated seasonally. At depth, the active permafrost zone appeared to extend to approximately 4 m deep at VT2. At VT1, temperatures remained above 1.4°C, indicating thawed ground throughout the profile. Based on historical data, temperatures remaining above 1.4°C, and comparing these results to VT2, it appears that the data at VT1 is erroneous and requires further assessment.

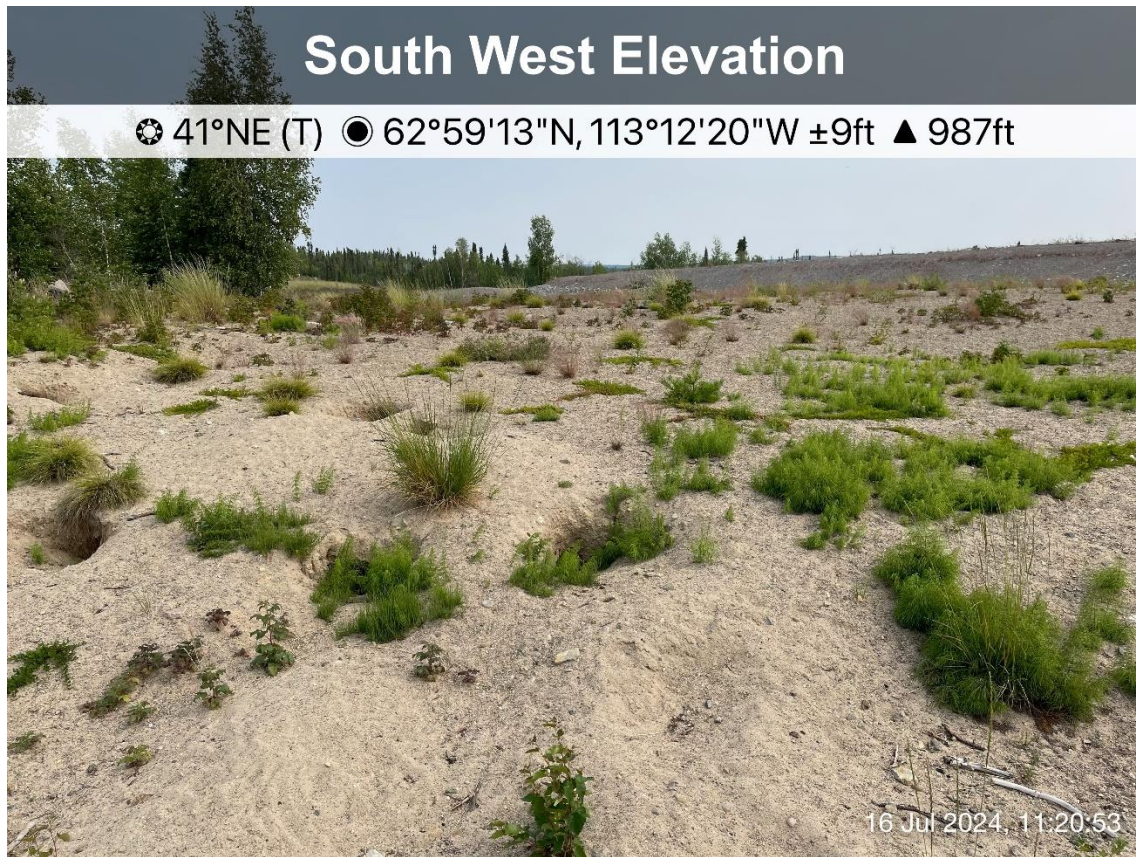
In 2024, a burrow was observed on the cover surface of the TSCA near the east crest of the facility. In addition, numerous fresh burrows were noted in 2024 in the sand to the west of the west perimeter ditch, located outside of the TSCA footprint. These burrows did not extend deeper than 0.5 m and the BGM liner appeared to be intact. Although these burrows did not trigger the LTM adaptive management as per the LTM Plan, they should be filled in with granular material. Monitoring of animal activity should be performed in subsequent LTM/DSI inspections.

**Photo 3: Animal borrows to the west of west drainage ditch.**

Two new dam safety deficiencies were identified during the 2024 DSI. These deficiencies included observation of fresh animal burrows and fresh, minor erosion. It is recommended that animal burrows are backfilled with granular material with continued monitoring for animal activity in subsequent DSIs. Minor erosion is recommended to be monitored for worsening conditions with consideration to implement a more permanent solution, such as flattening embankment slopes, providing additional coarse material, or removing material that contributes to channelized flow.

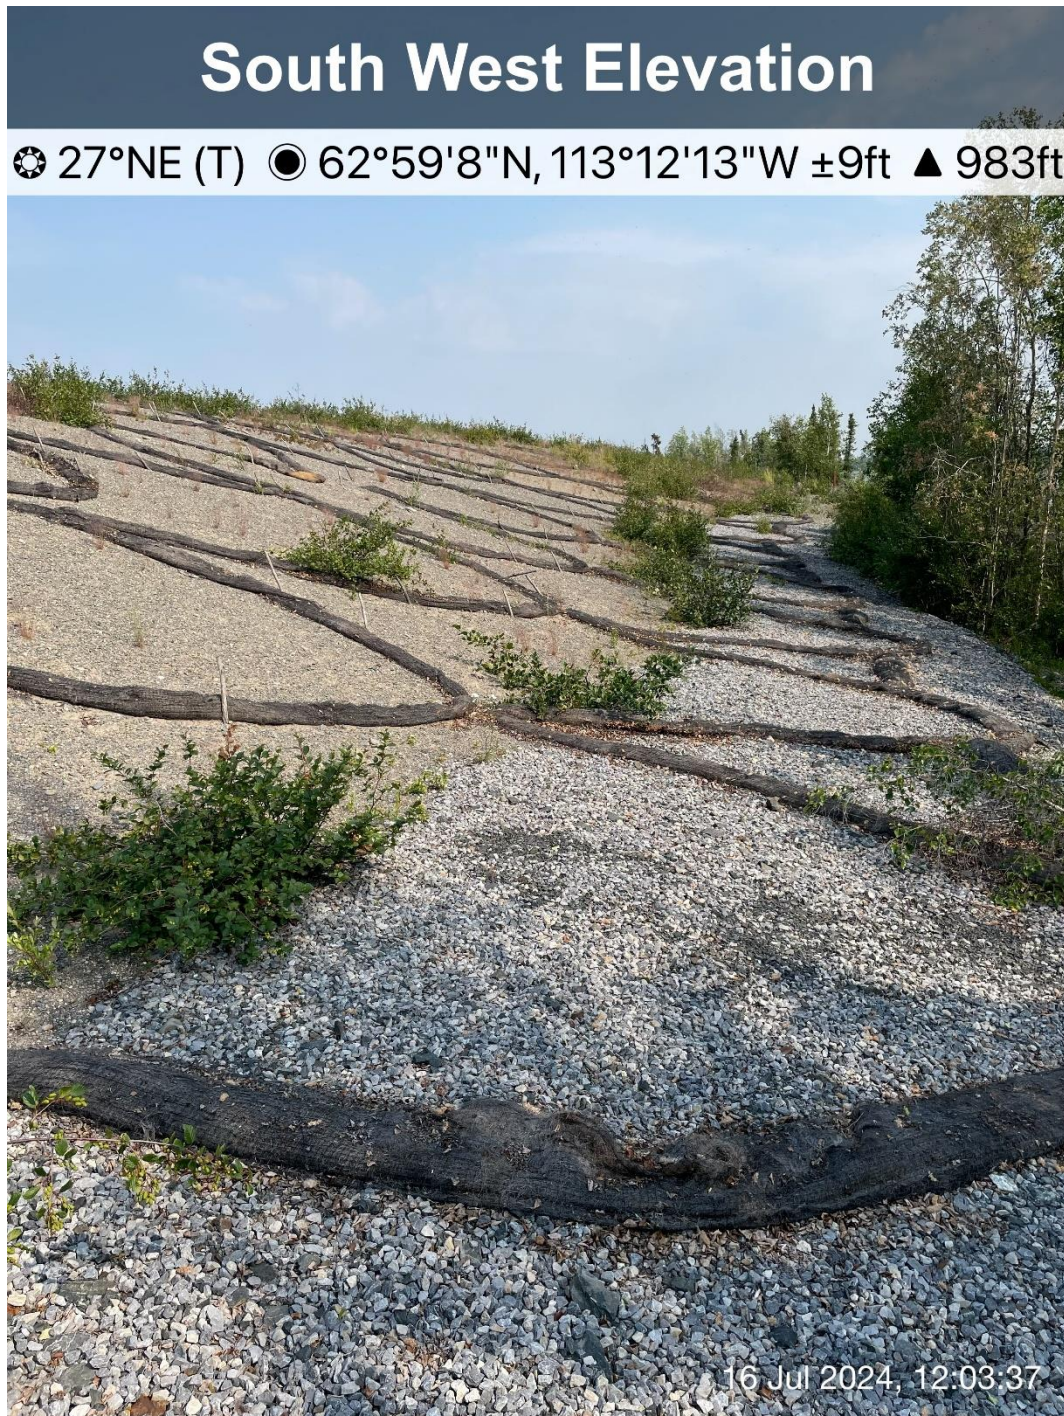
**Photo 4: East slope – Sporadic willows growing.**

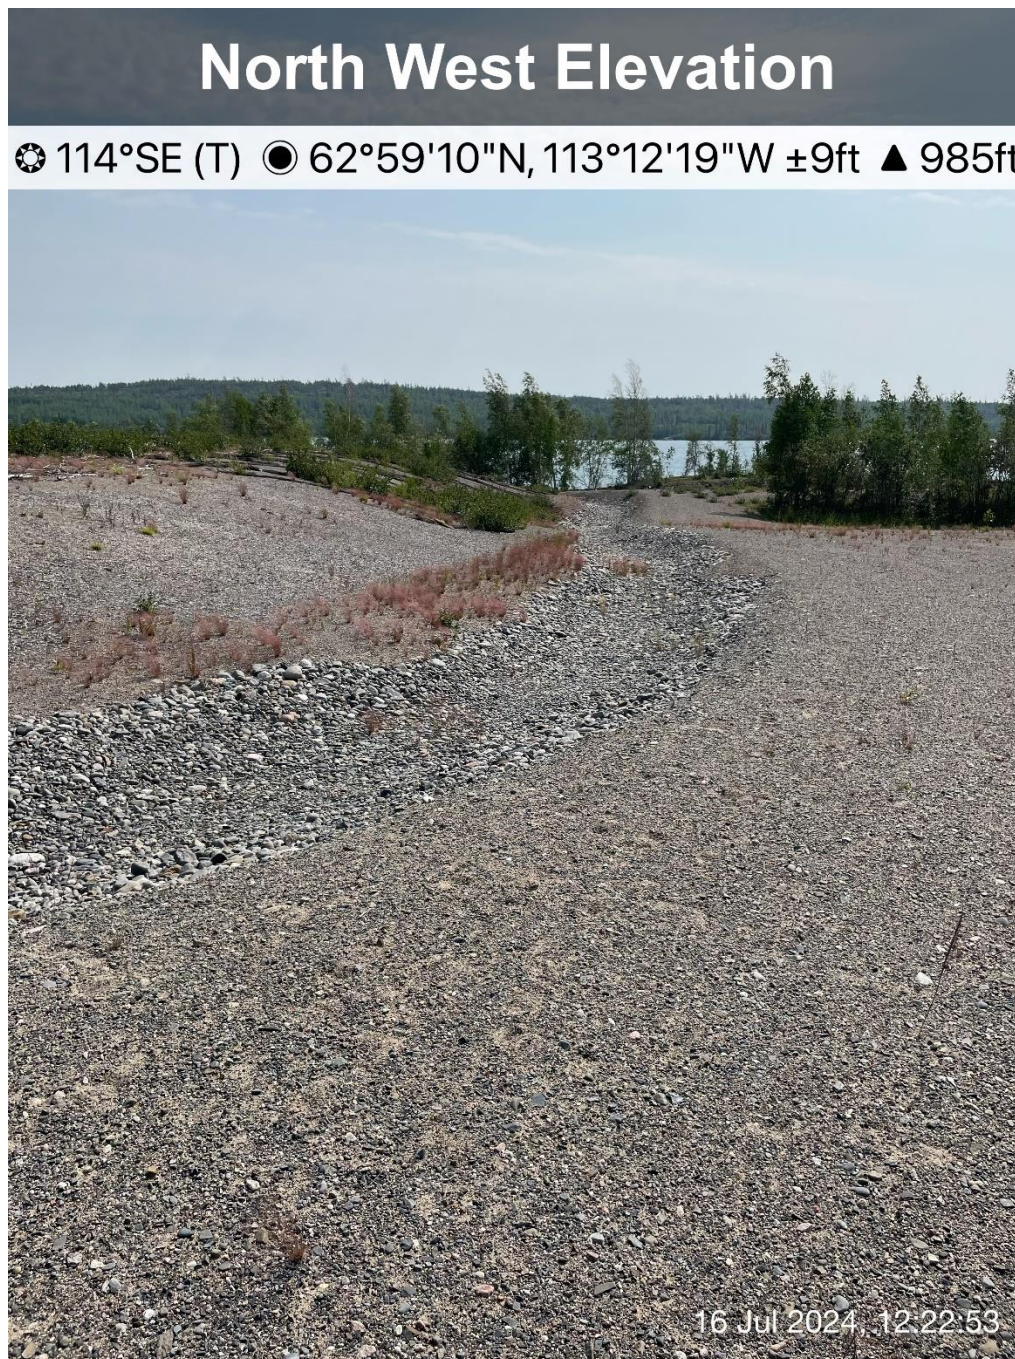
At the time of inspection, there was standing water in localized sections of the southern ditch due to an undulating ditch invert. Similar observations have been made in previous LTM/DSI inspections. It is recommended to continue monitoring the extent at which water pools in the ditches; if the situation worsens, it is recommended to fill the depressions with low permeability soil and to place a piece of BGM liner over the top and to seal it to the underlying BGM around the edges.

**Photo 7: South perimeter ditch and slope.**

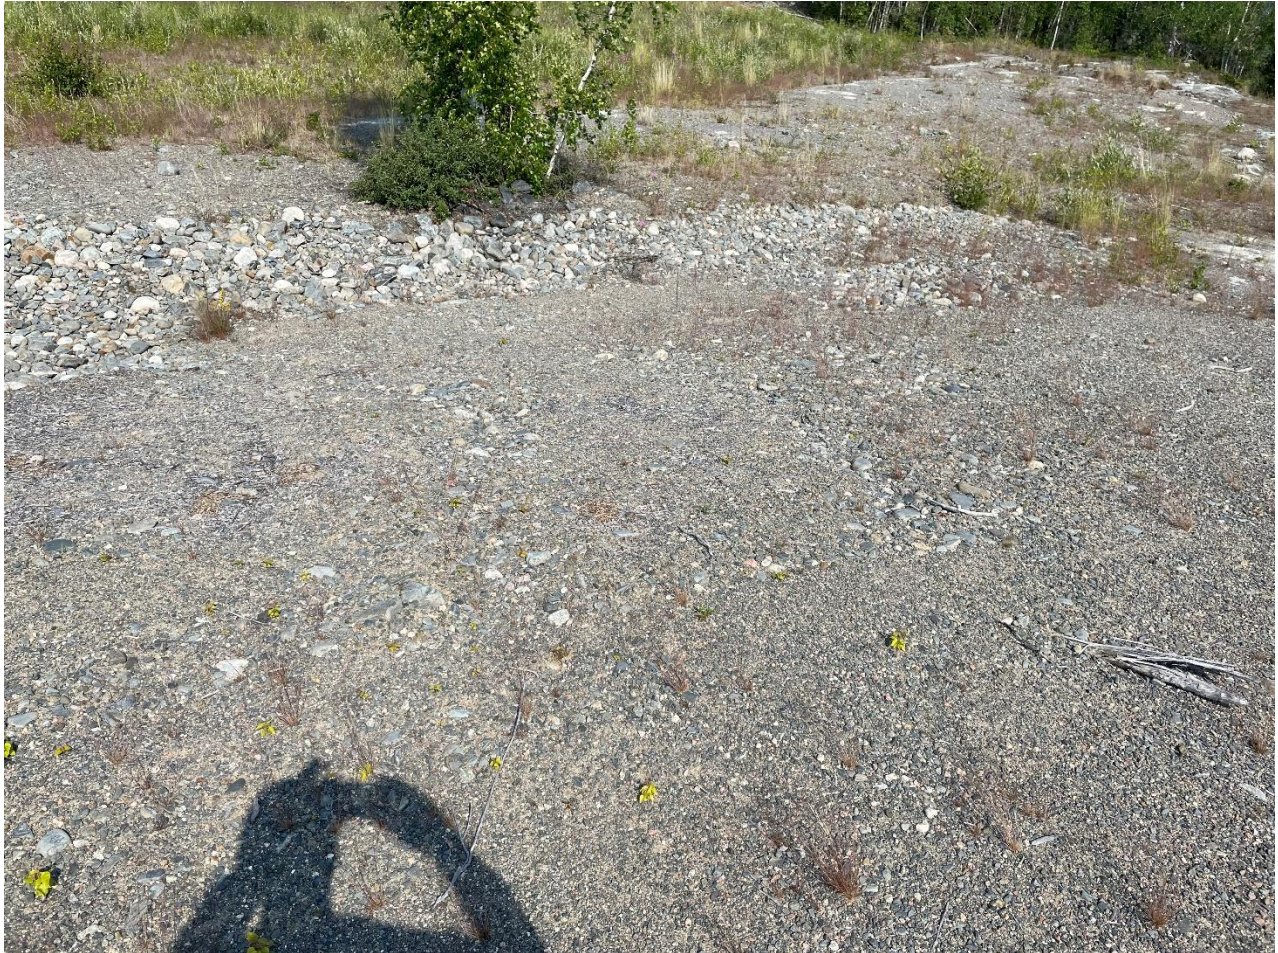
Observations collected in 2024 indicated that the historical erosion channels noted above appeared to be partially healed and that surficial erosion observed in 2024 was minor.

**Photo 8: TSCA north slope with partially healed erosion channels – looking toward perimeter ditch.**

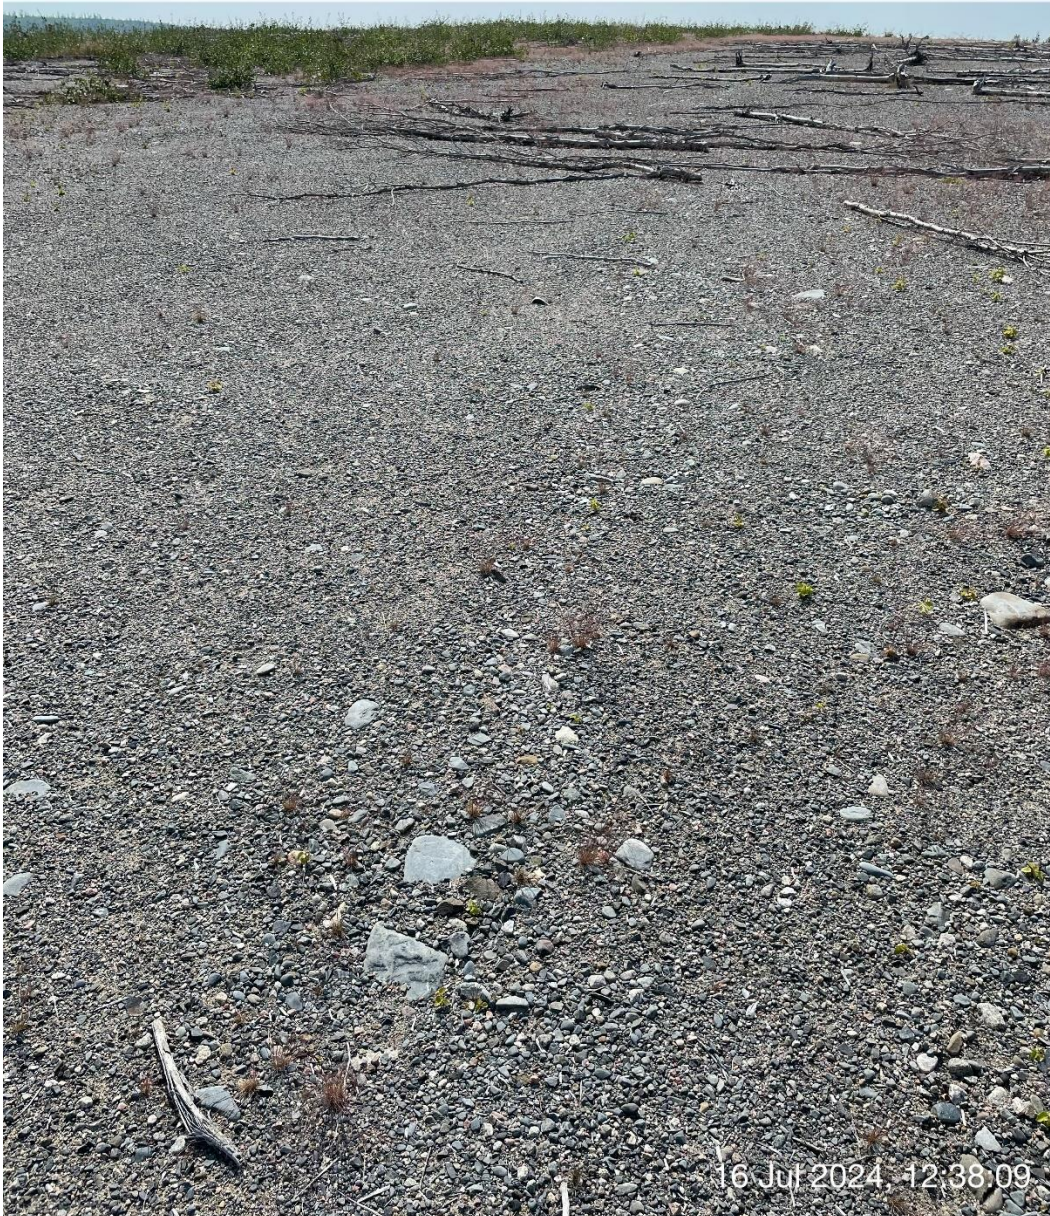
**Photo 9:** Willow branches cover the top of the TSCA to mitigate potential erosion – partially healed erosion channel visible.

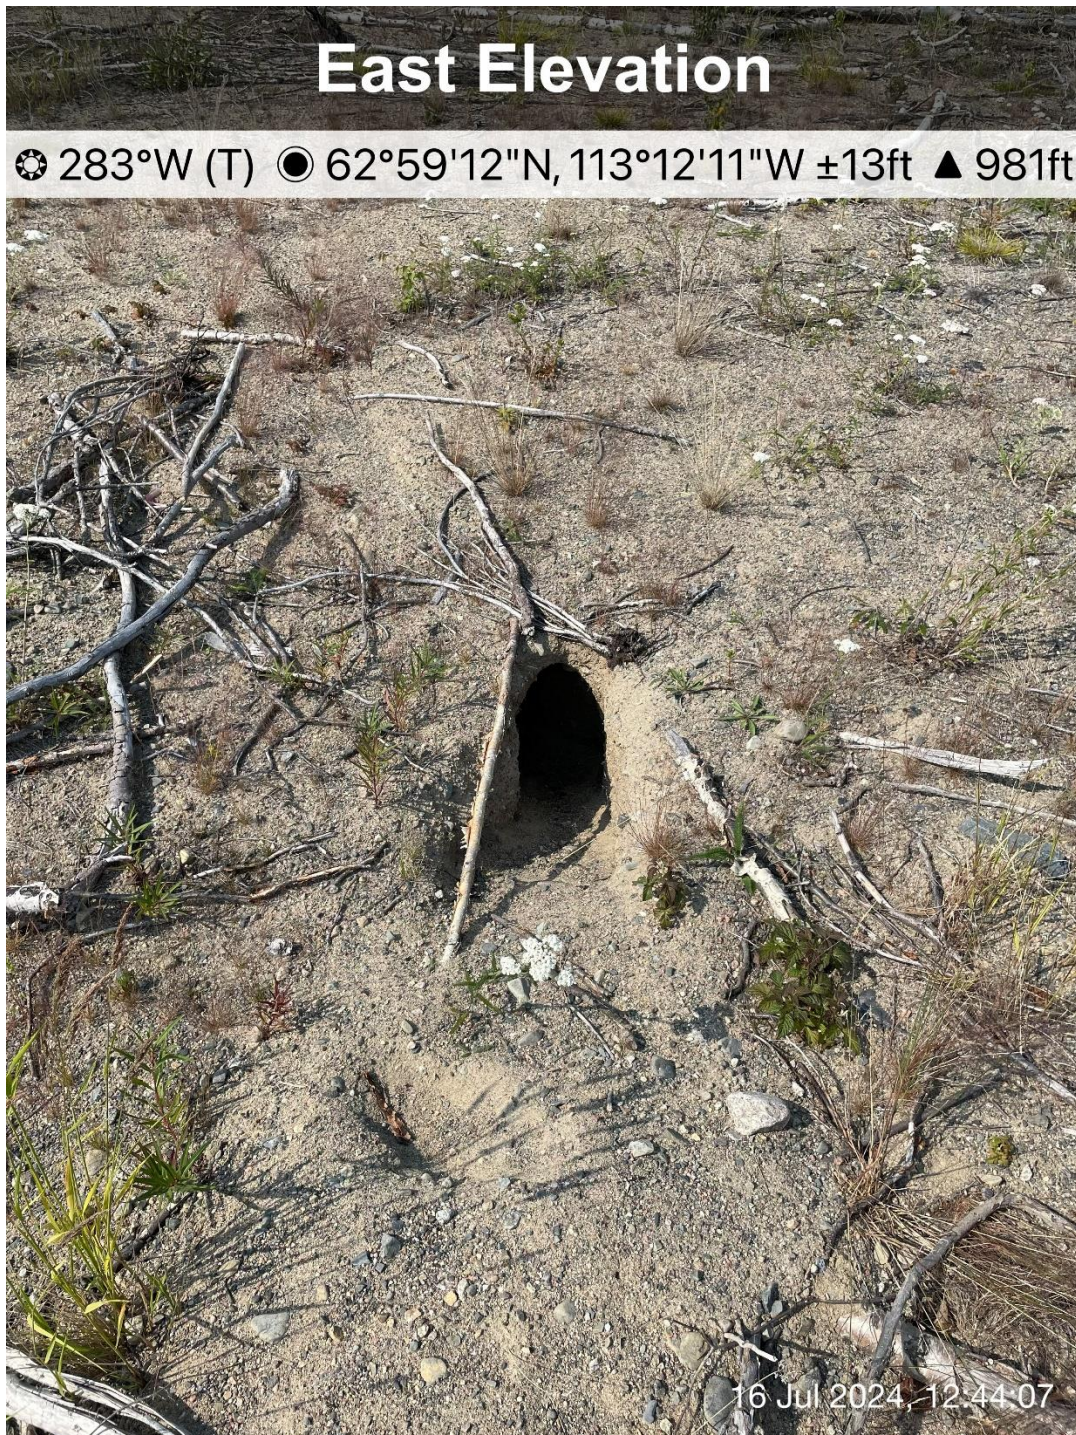
Animal burrows	One start of a partial den (potentially fox) was observed on the surface of the TSCA near the east crest. Burrow was not dug deeper than approximately 0.5 m.
----------------	---

**Photo 11: Start of partial animal burrow near east crest of TSCA.**

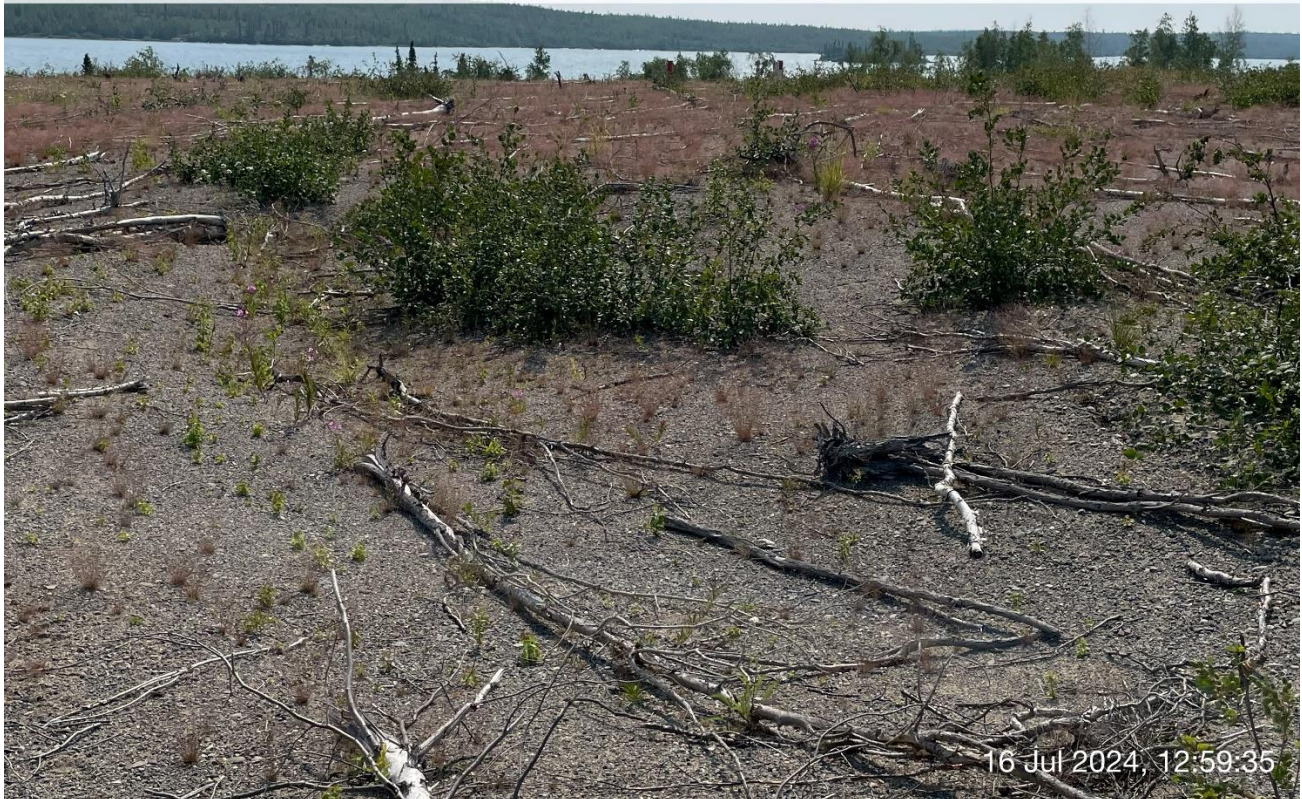
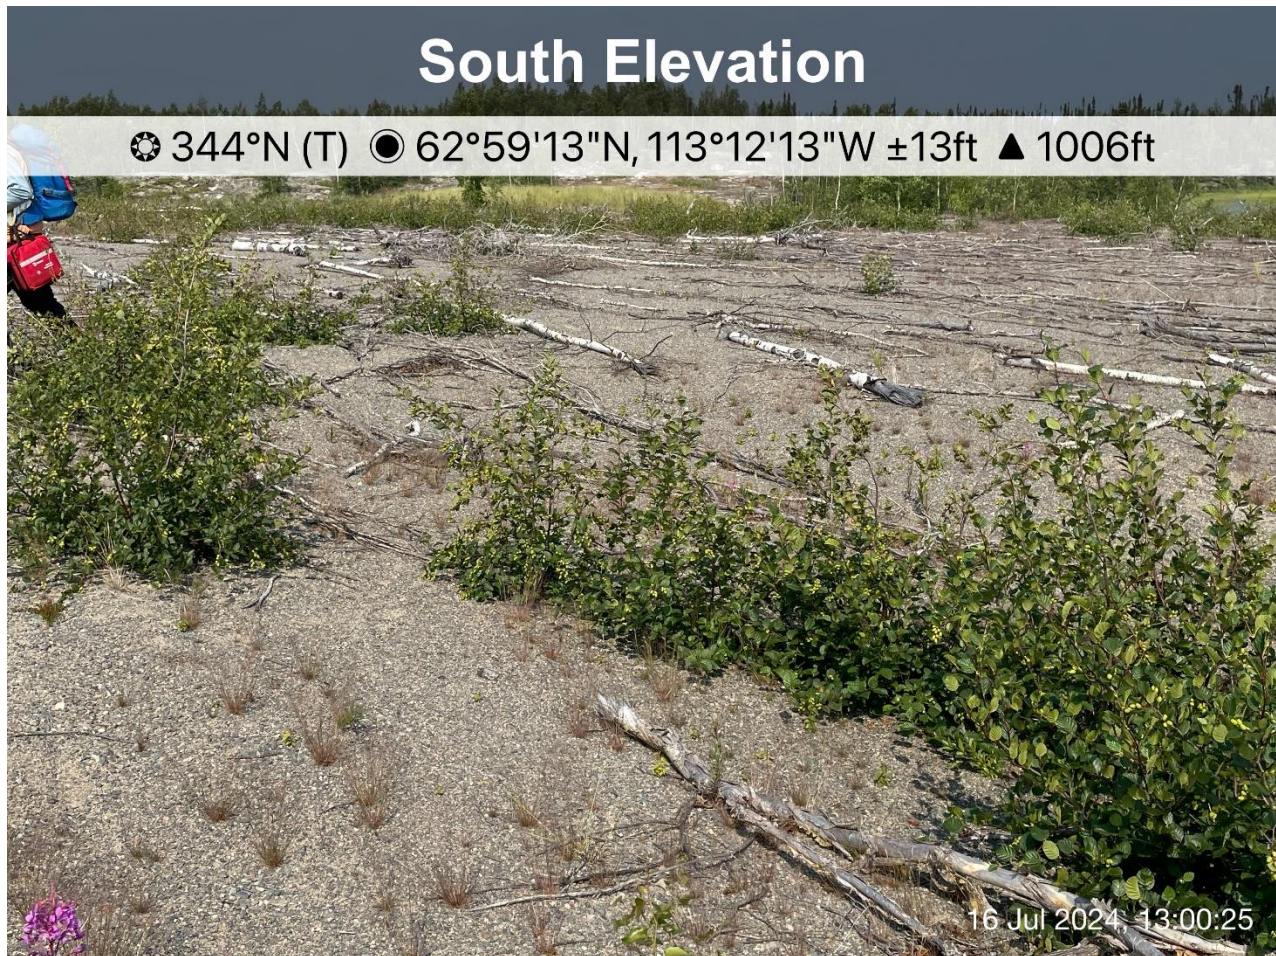
During the 2024 inspection, a surface depression up to 0.3 m deep, 12 m long (east to west), and 5 m wide (north to south) was observed at the top of cover of the TSCA near the northern perimeter. Two smaller depressions, roughly 0.15 m deep, were observed near this larger feature and near the location of VB2 in 2024. These features were initially observed in 2019 and there appeared to be no change in the dimension or depth in 2024. Surficial cracking in the vicinity of the ground depressions appeared to be partially healed in 2024.

The depressions could be caused by settlement related to the consolidation of tailings or as a result of ice melt within waste rock, presumed to be placed in 2018. As described in the design basis report (Stantec, 2018a), this type of settlement was anticipated. The identified settlement was not deep enough to prompt the trigger level identified in the OMS Manual.

**Photo 12: Surface depression near northern perimeter of TSCA.**

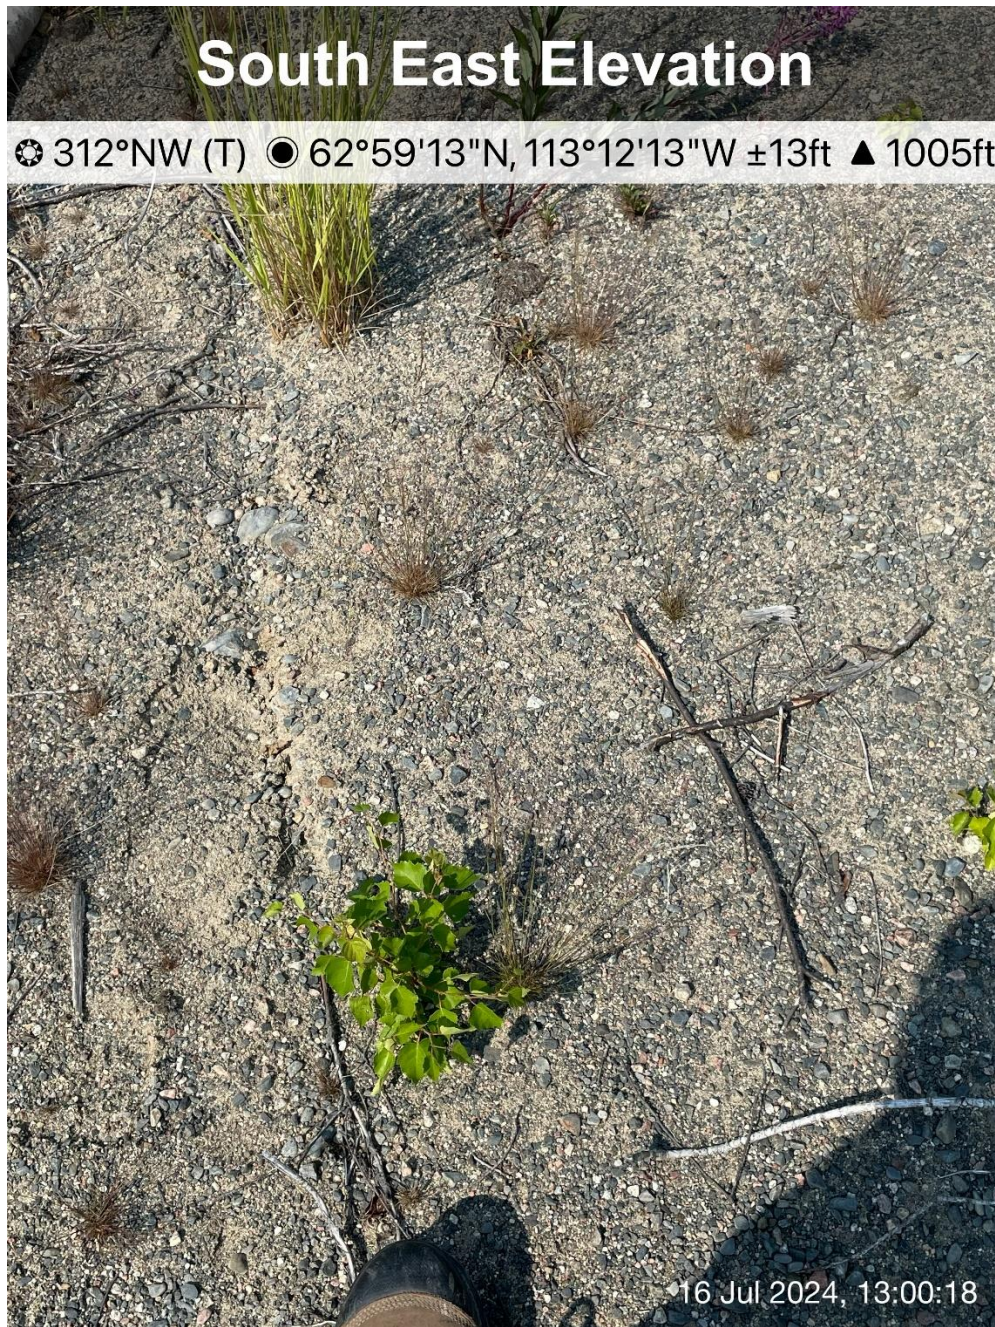
- The condition of the dam was consistent with that documented in the 2023 DSI (AECOM, 2024), with the exception that a historical, partially healed crack appeared to be fully healed, and a surface crack zone adjacent to a historical depression appeared to be partially healed.

**Photo 13: TSCA top towards North Perimeter, surface crack zone around depression area – partially healed.**
