Gordon Lake Group - Geotechnical Services Program - TSCA Geotechnical Investigation for Dam Declassification

Final Report | Version 00

Our reference no. 2207077.00

March 7, 2023

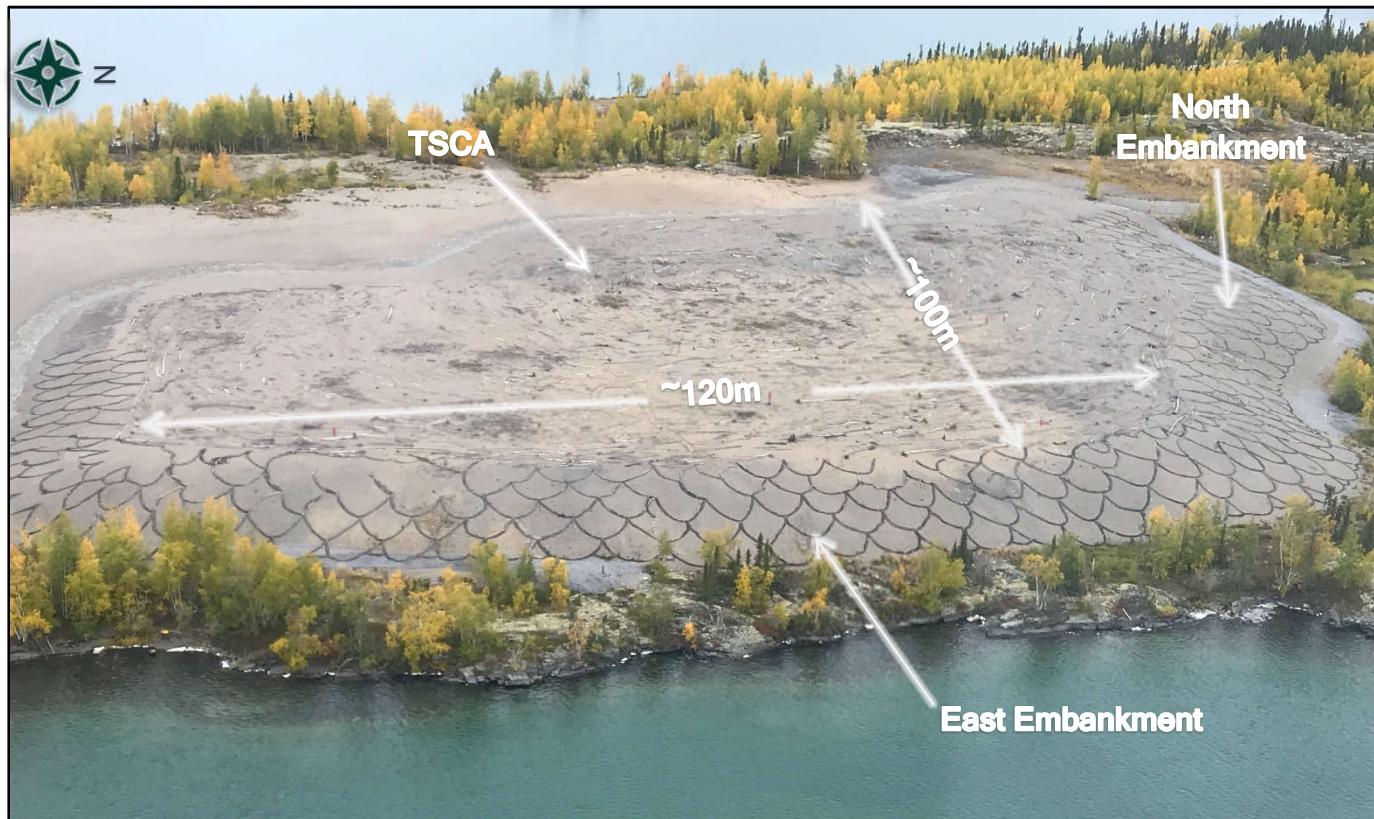
Figure 3.2: Site Aerial View From East to West (September 2021)

- The dam safety review indicated minor erosion of the soil liner cover material along the embankments as a recurring issue at the site. However, Englobe notes, as of our recent 2022 inspection, that the minor erosion appears to be self-healing and attributable to the establishment of significantly more plant growth observed at the site from prior years.

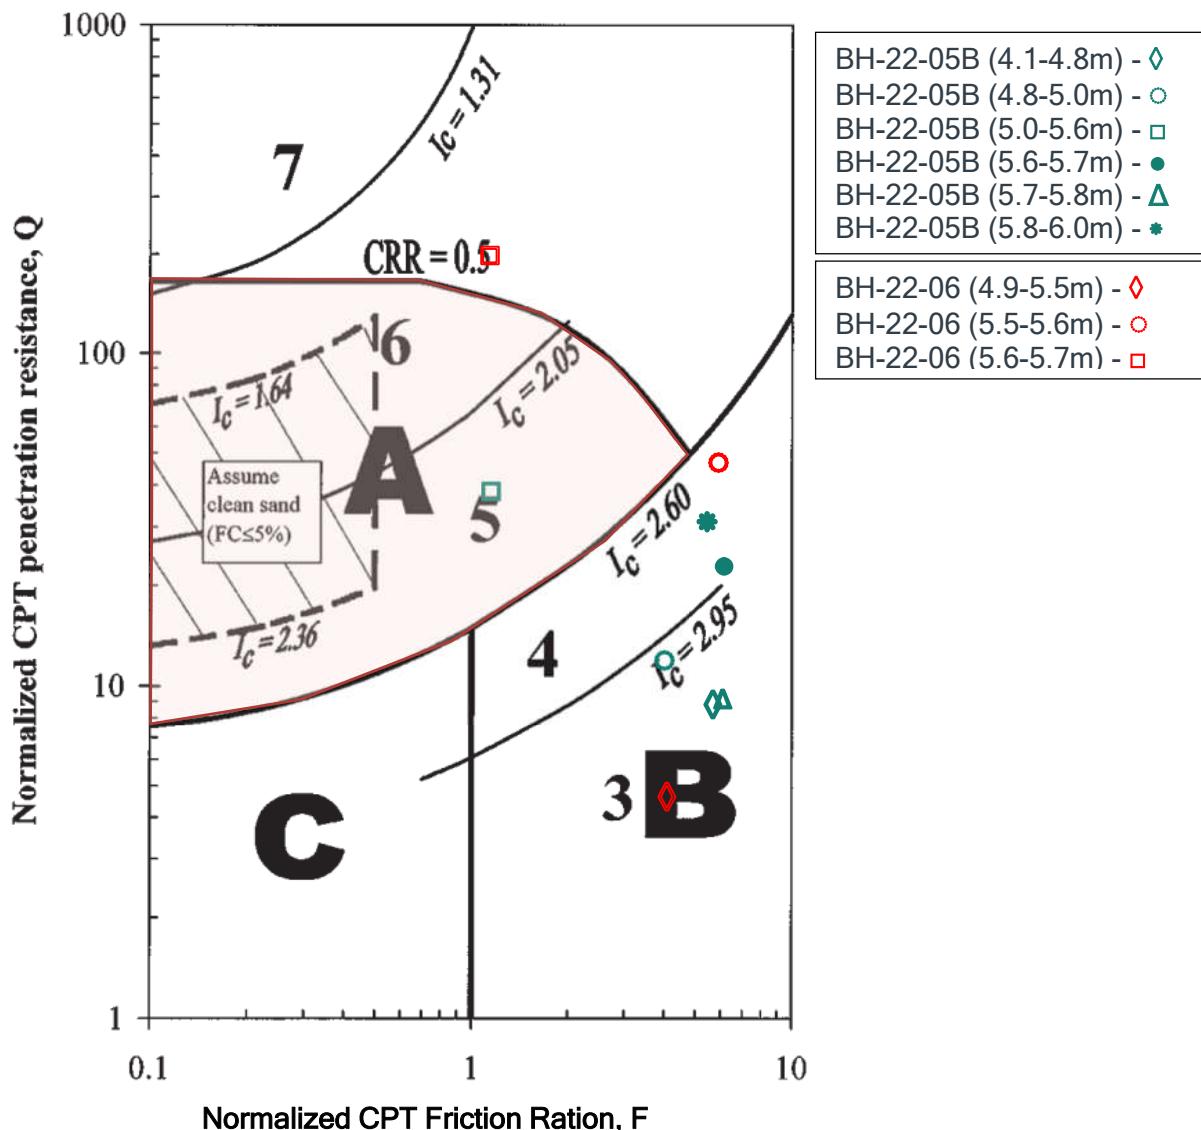
Figure 6.2: Summary of Liquefaction Potential Soil Classification Chart By Robertson (1990)

In summary, based on the nine (9) individual layers/values assessed with this methodology, a single isolated layer of 600 mm thickness was noted within borehole BH-22-05B that could be considered potentially liquefiable. Given the limited thickness of this layer within the overall soil profile and the lack of a significant seismic source, the overall liquefaction potential from this isolated occurrence would be negligible.

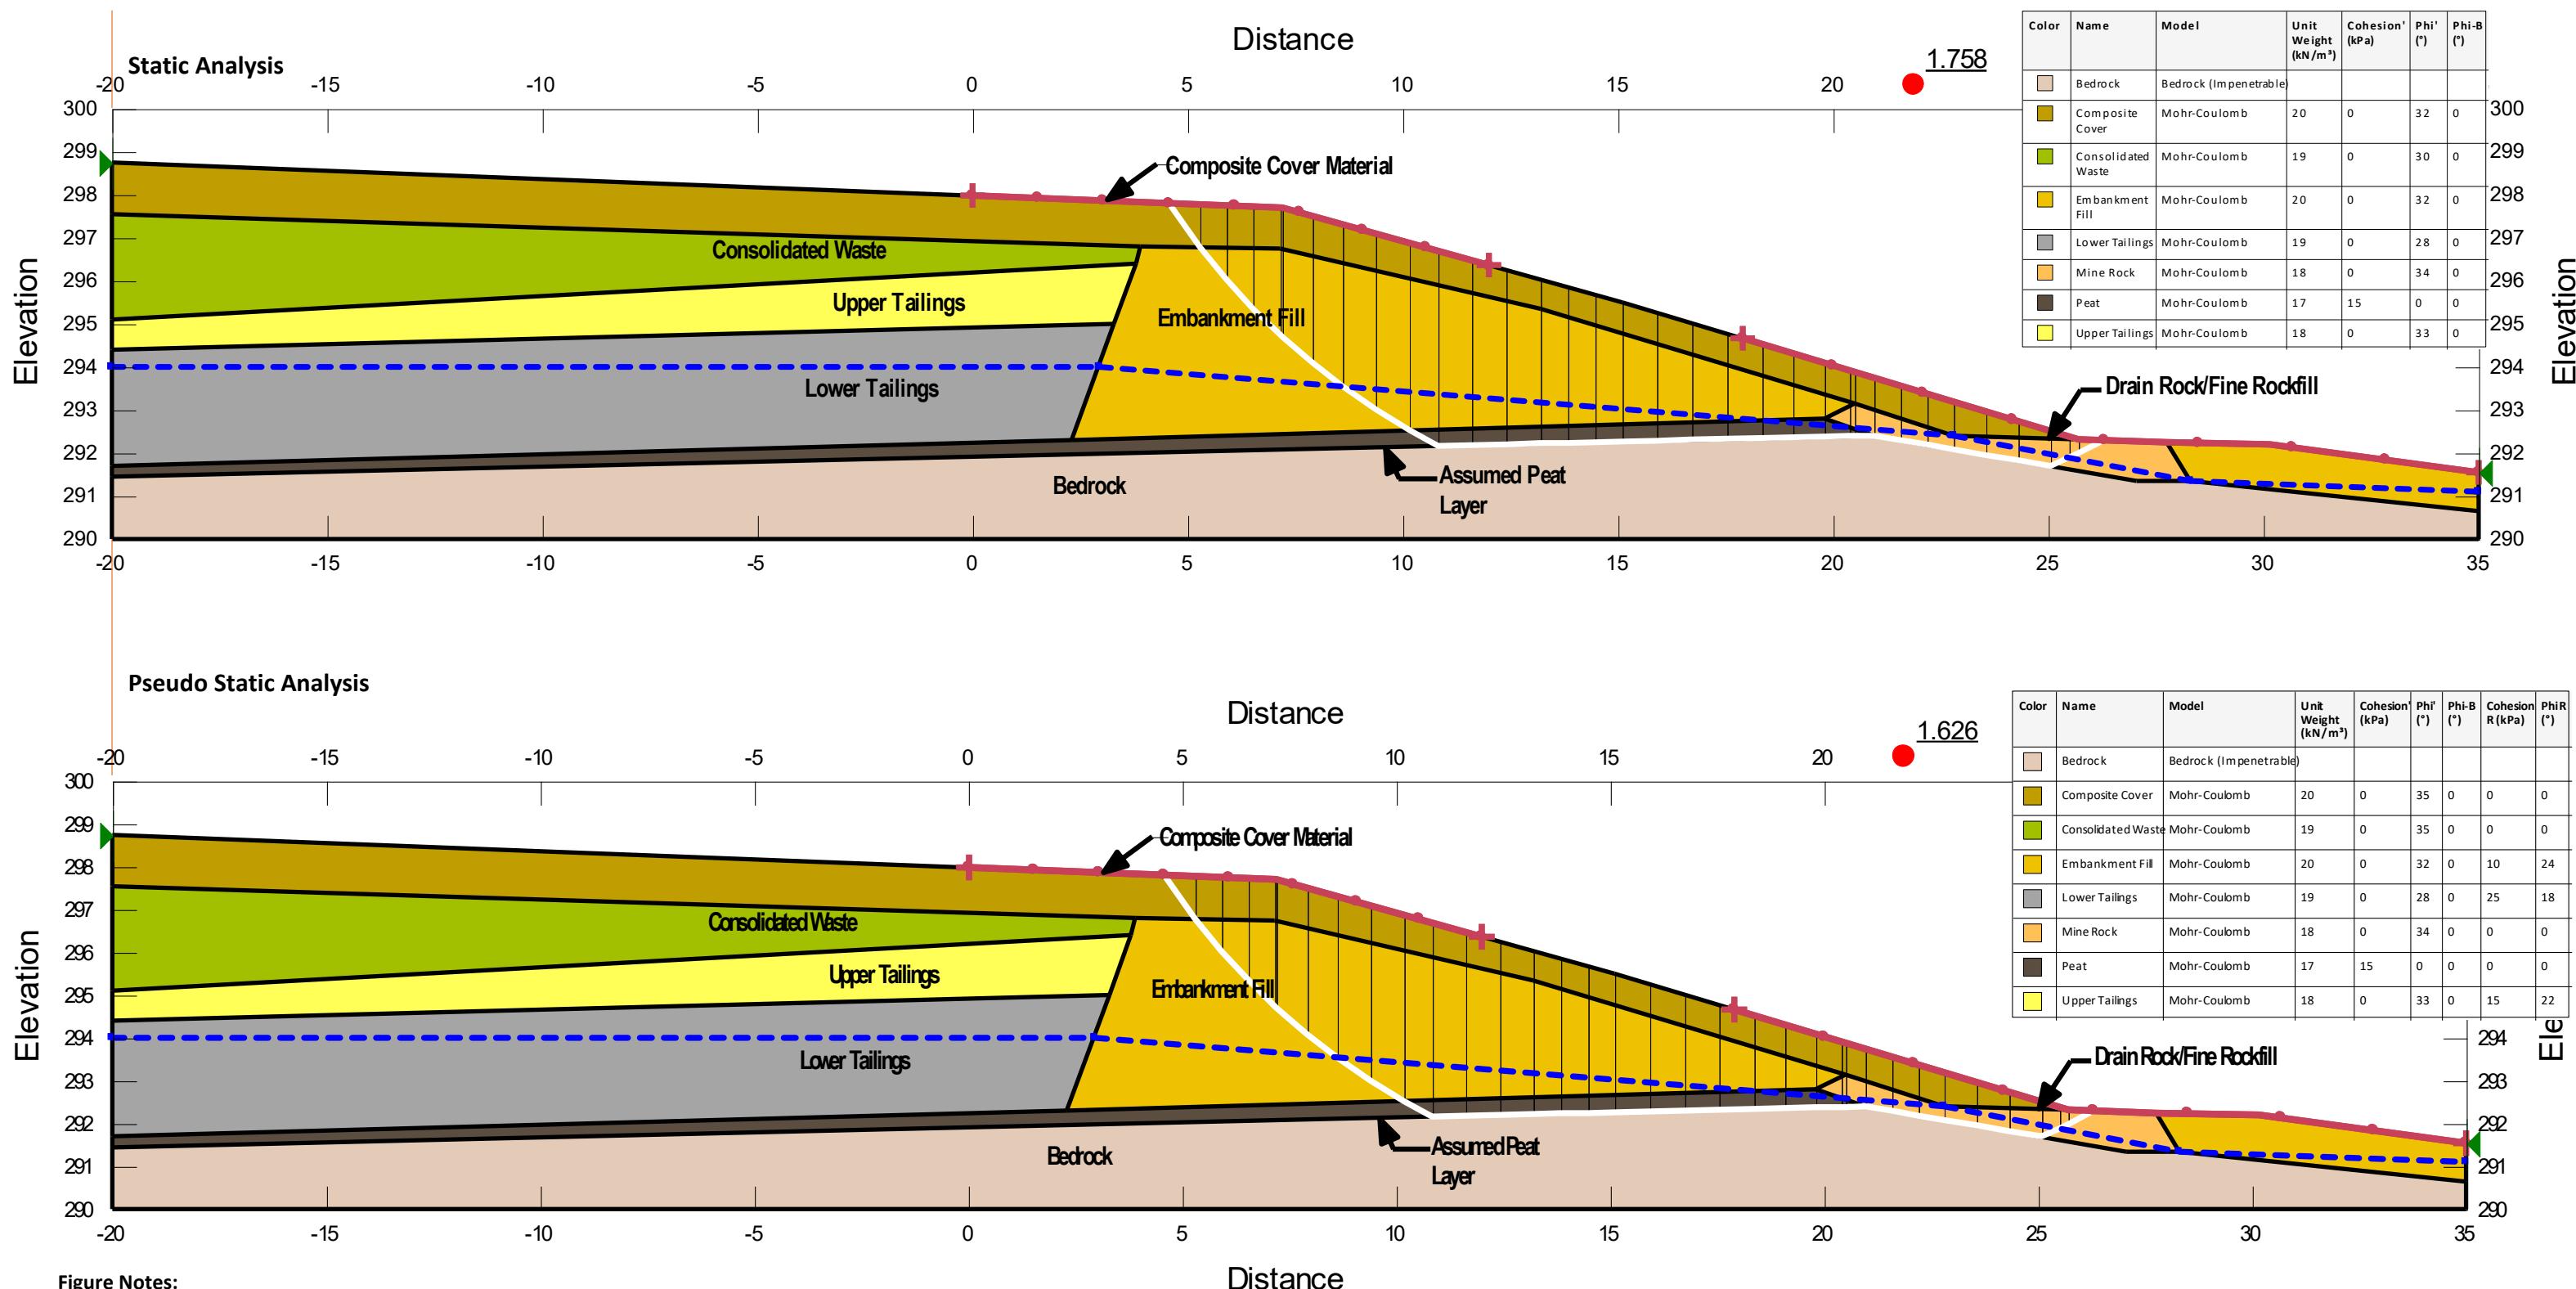
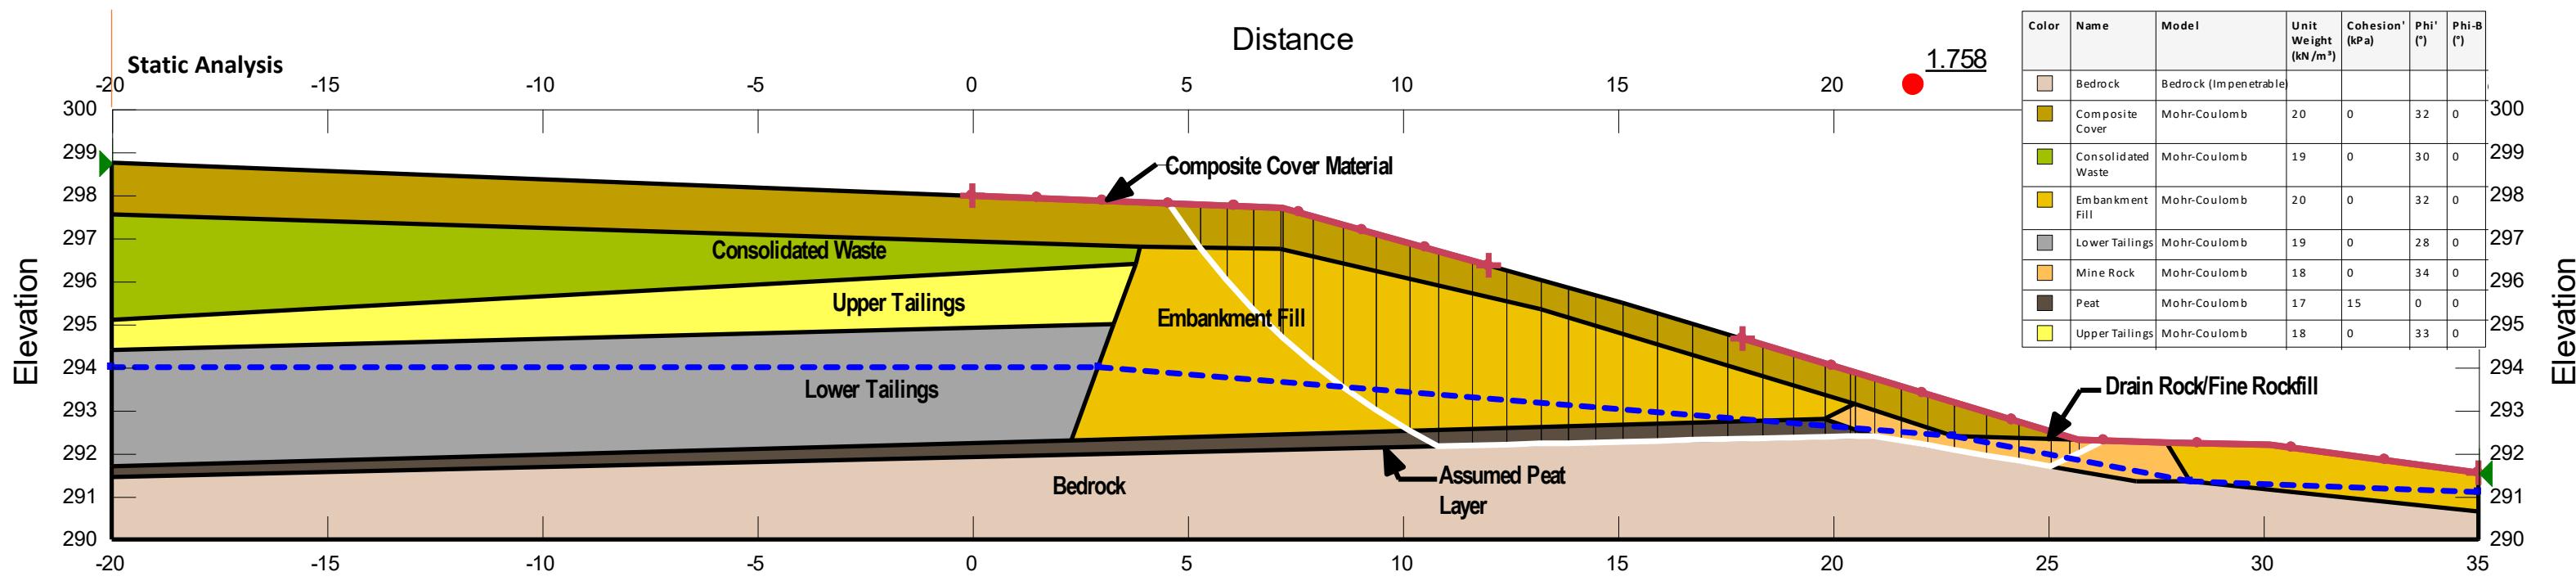
Figure D-1

Slope Stability Section (Analysis STA Section)	Static Slope Stability Factor of Safety, As-Built Conditions ¹	Pseudo-Static Slope Stability Factor of Safety, As-Built Conditions ²
Section A (@ STA 0+180)	1.76	1.63
Section B' (@ STA 0+120)	1.63	1.52
Section C (@ STA 0+120)	1.62	1.50

Section "A" - Slope Stability Results
Static & Pseudo Static Case

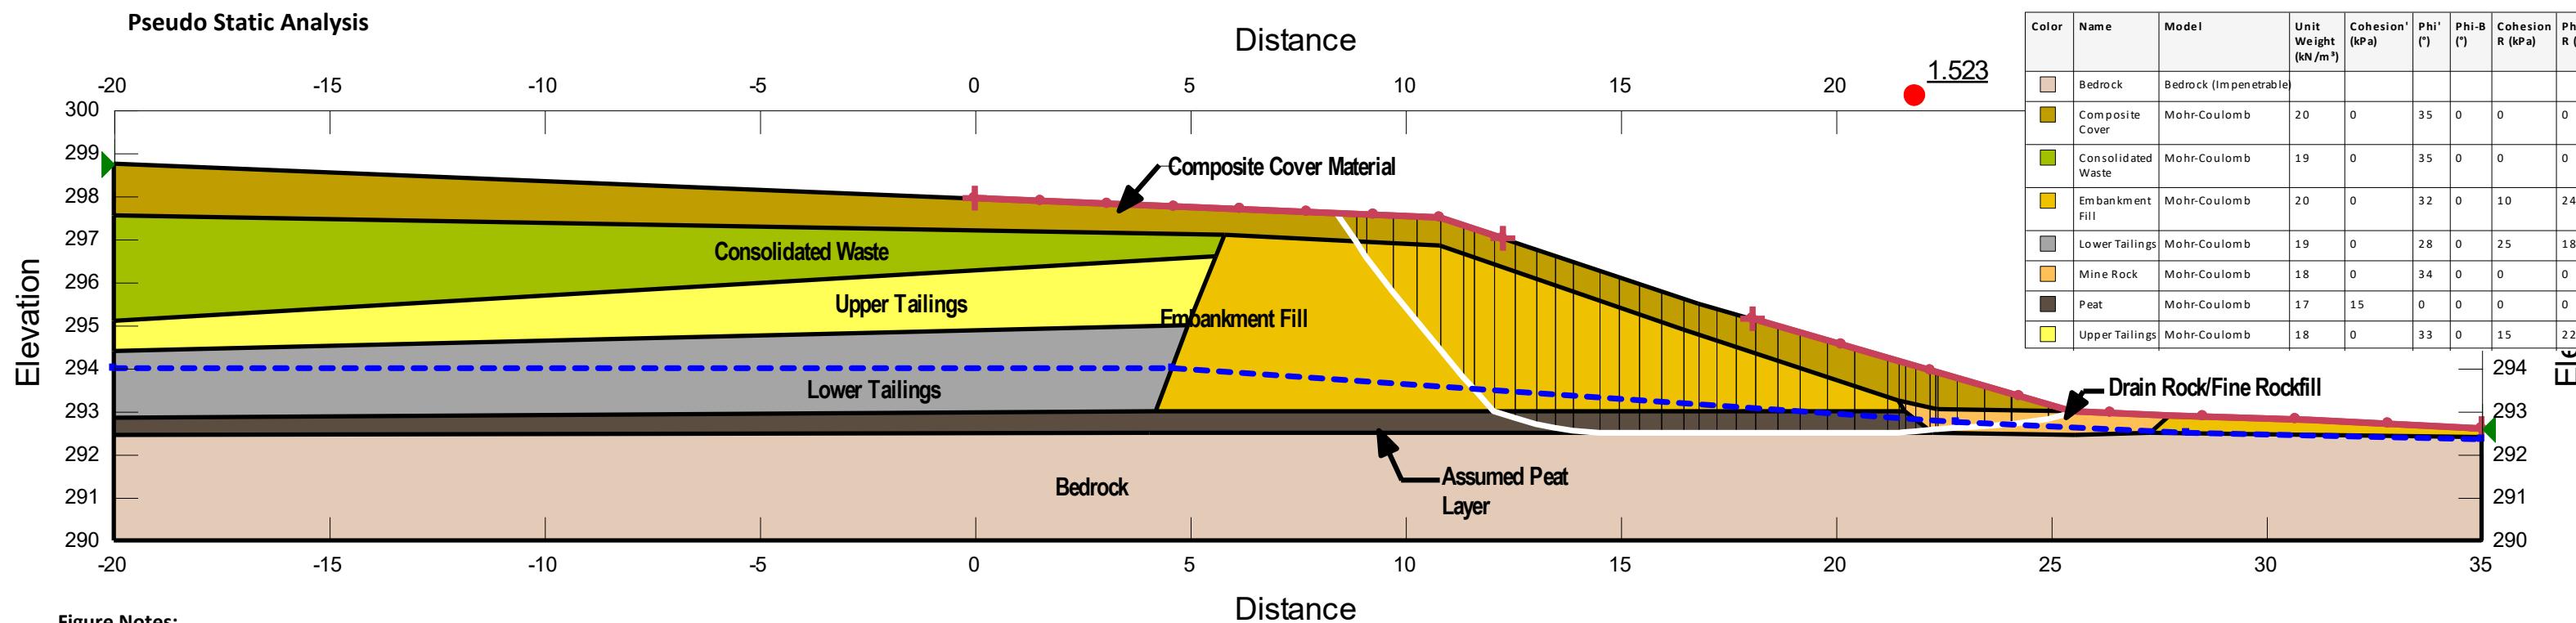
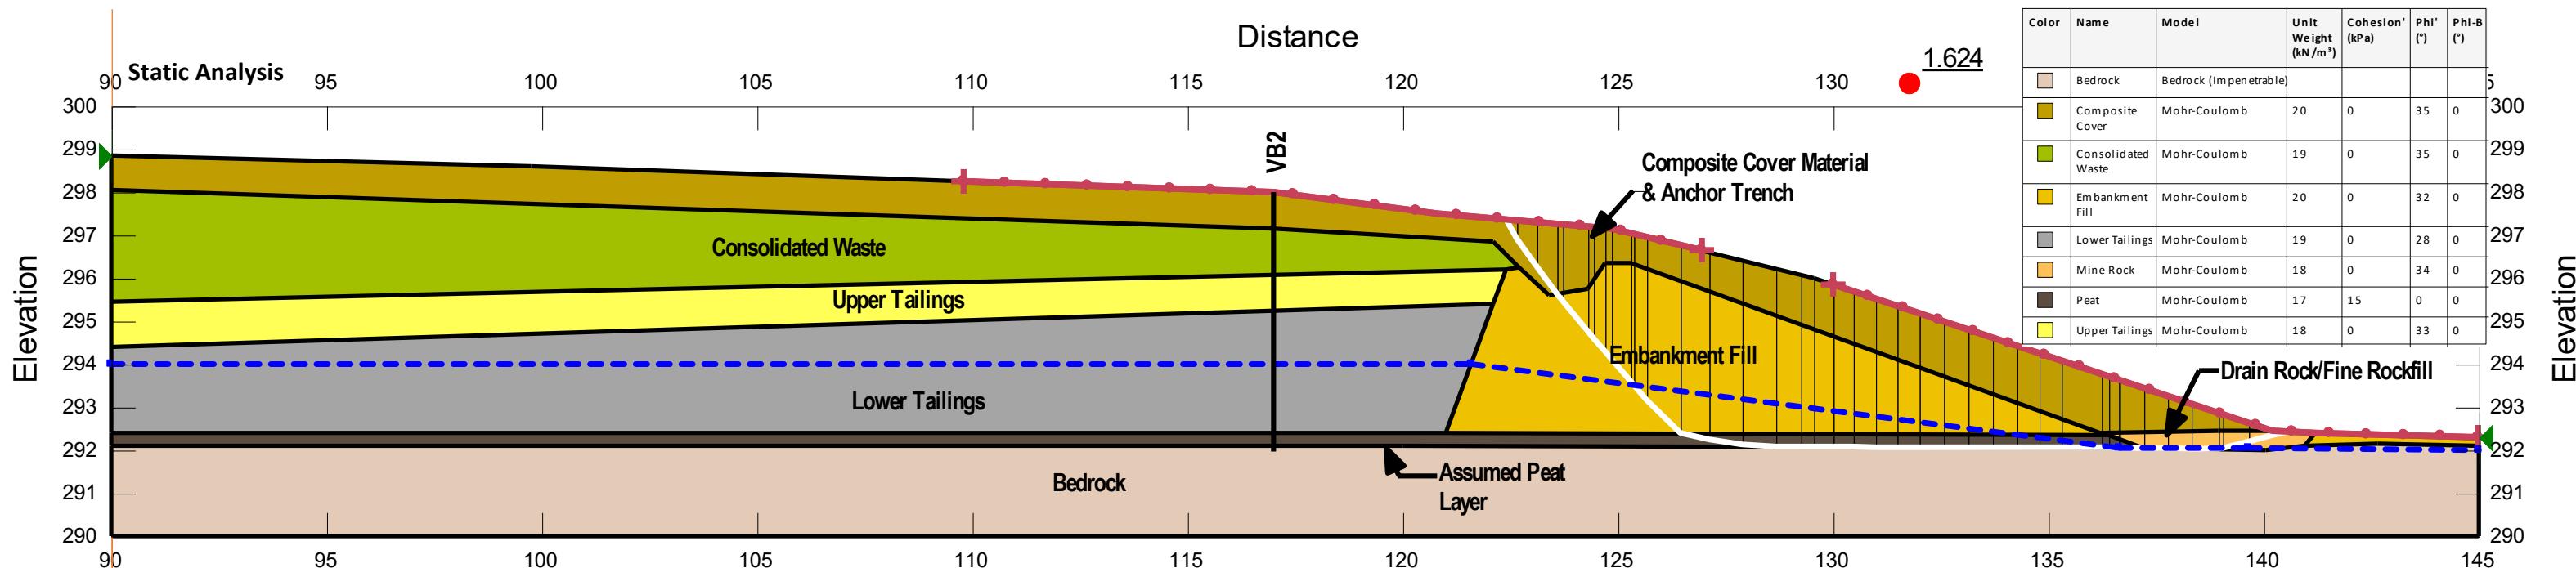
Figure D-2

Section "B" - Slope Stability Results
Static & Pseudo Static Case
