Crown-Indigenous Relations
and Northern Affairs Canada

Gordon Lake Group of Sites Closure Report

PROJECT ID: Gordon Lake Group Remediation Project

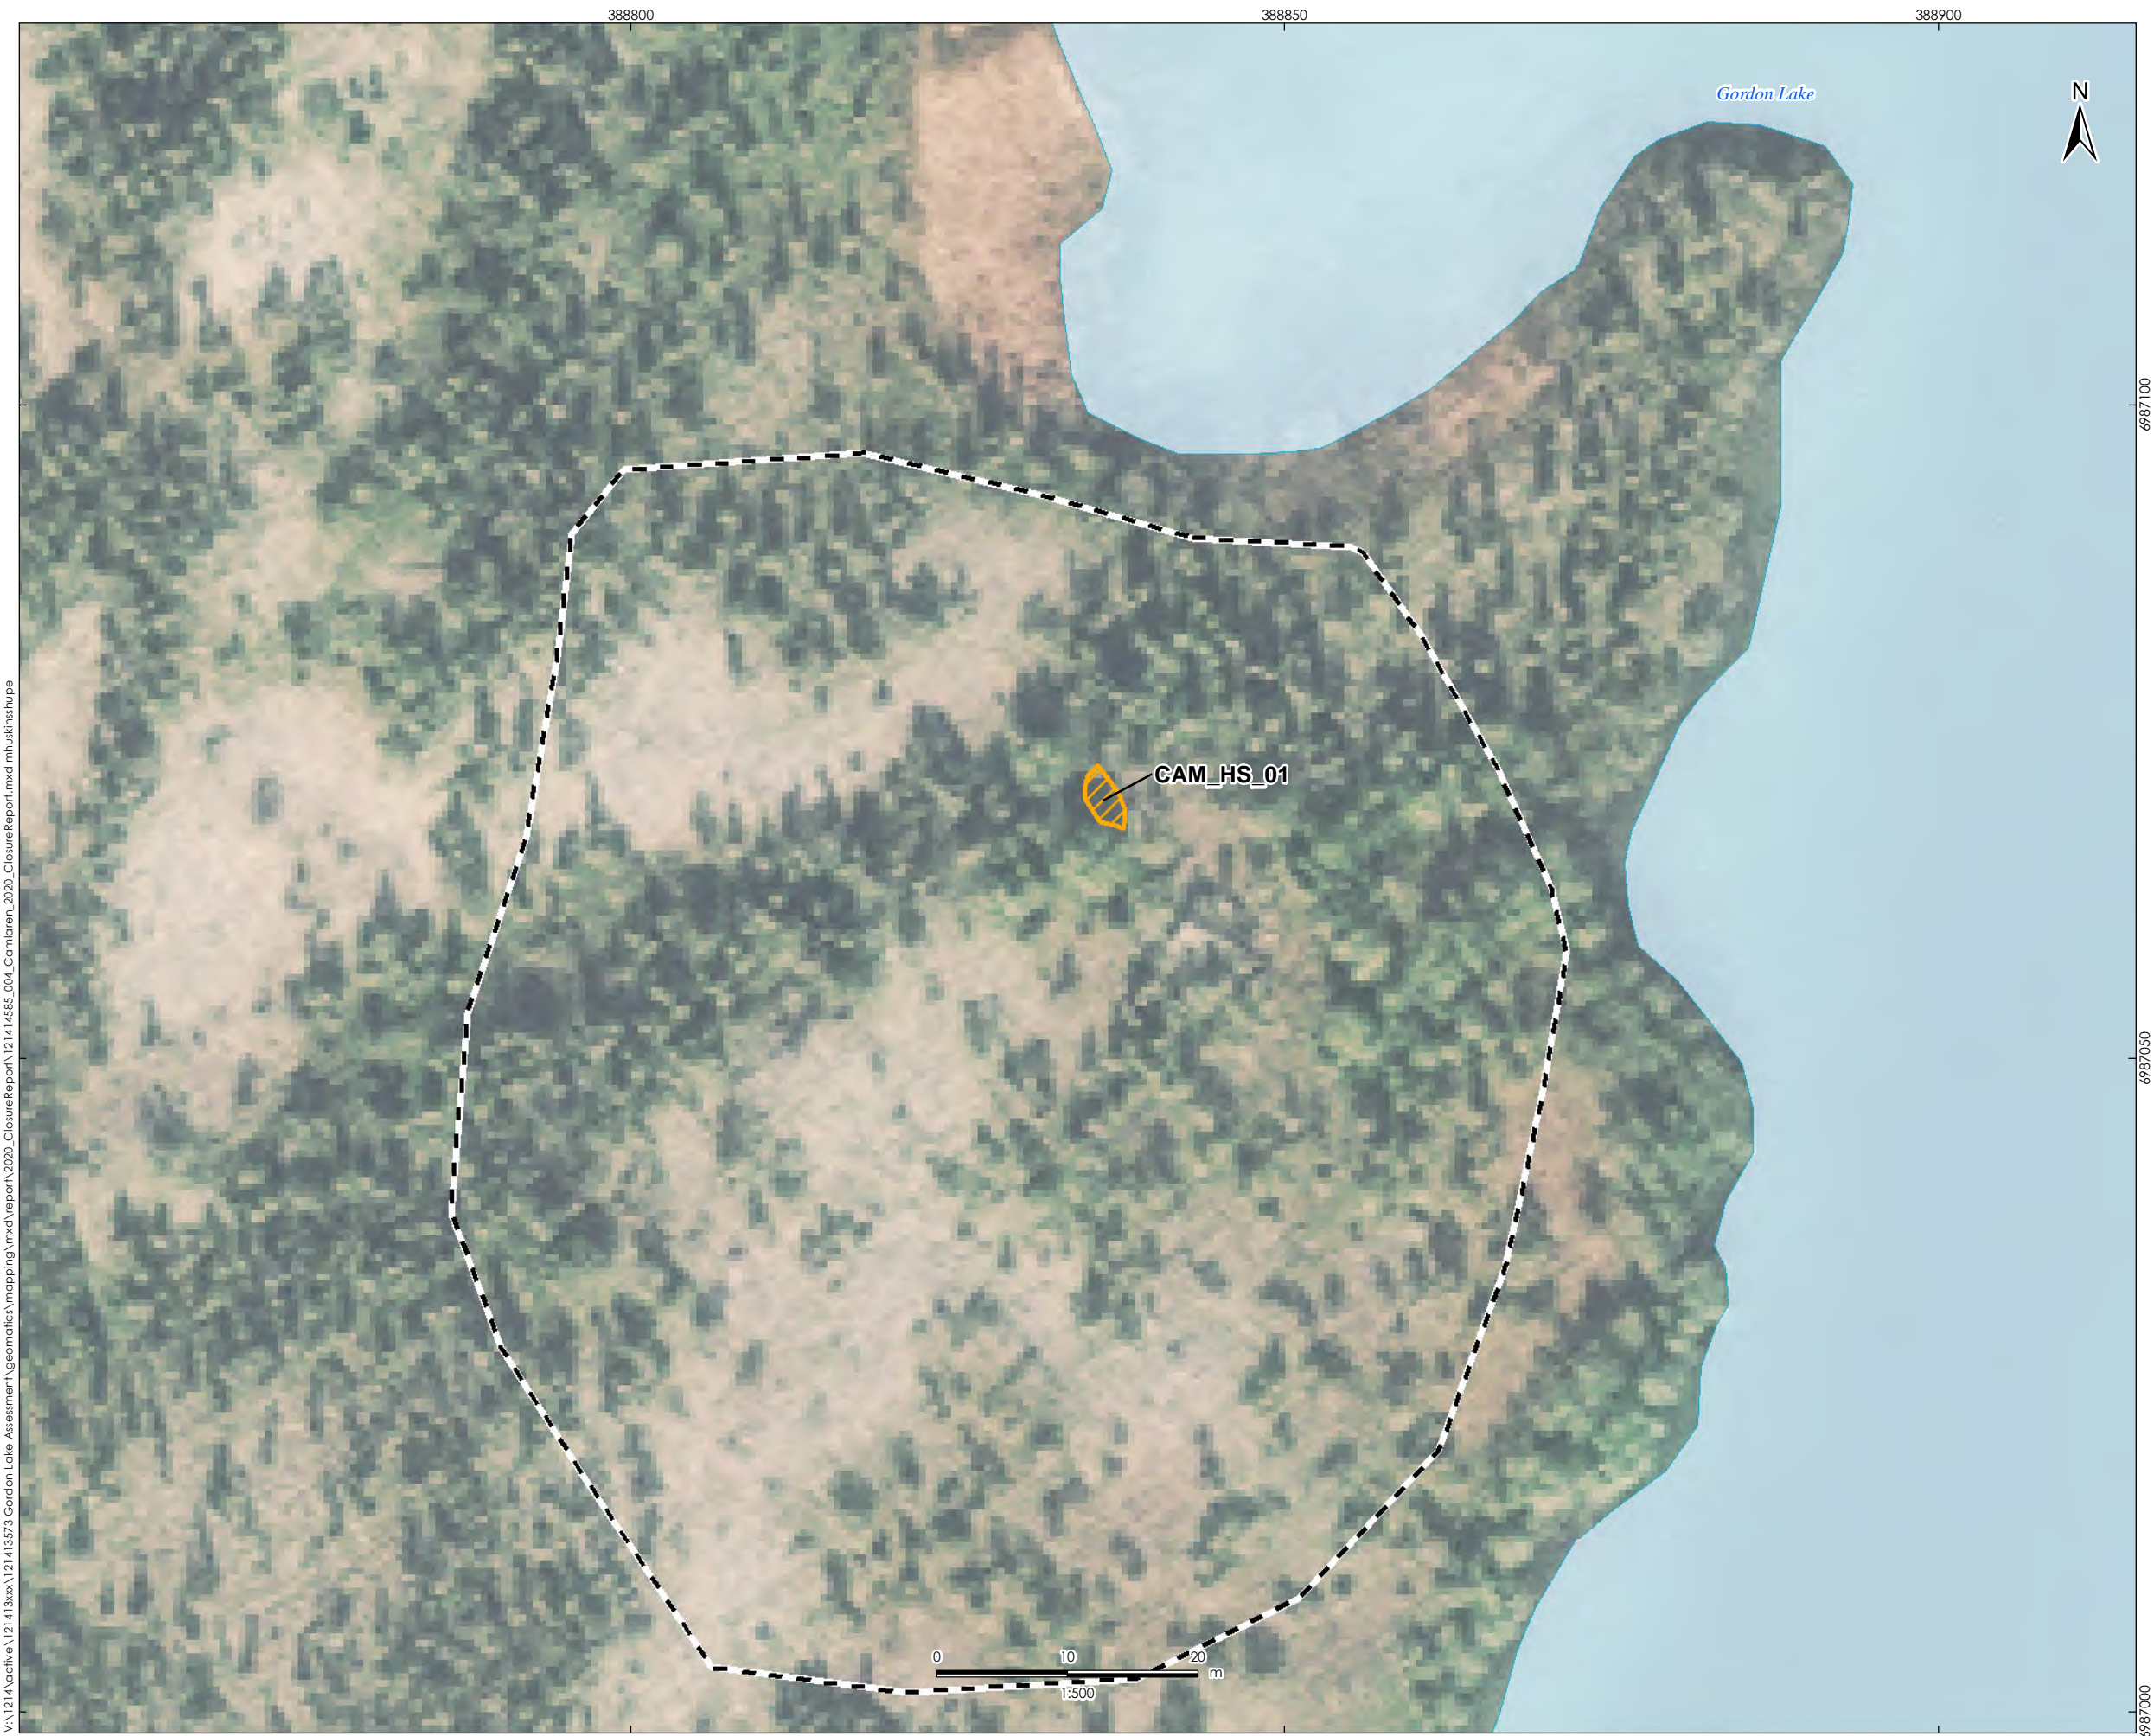
Figure No.
B2.4

Title
Camlaren - North Cabin
Remedial Components

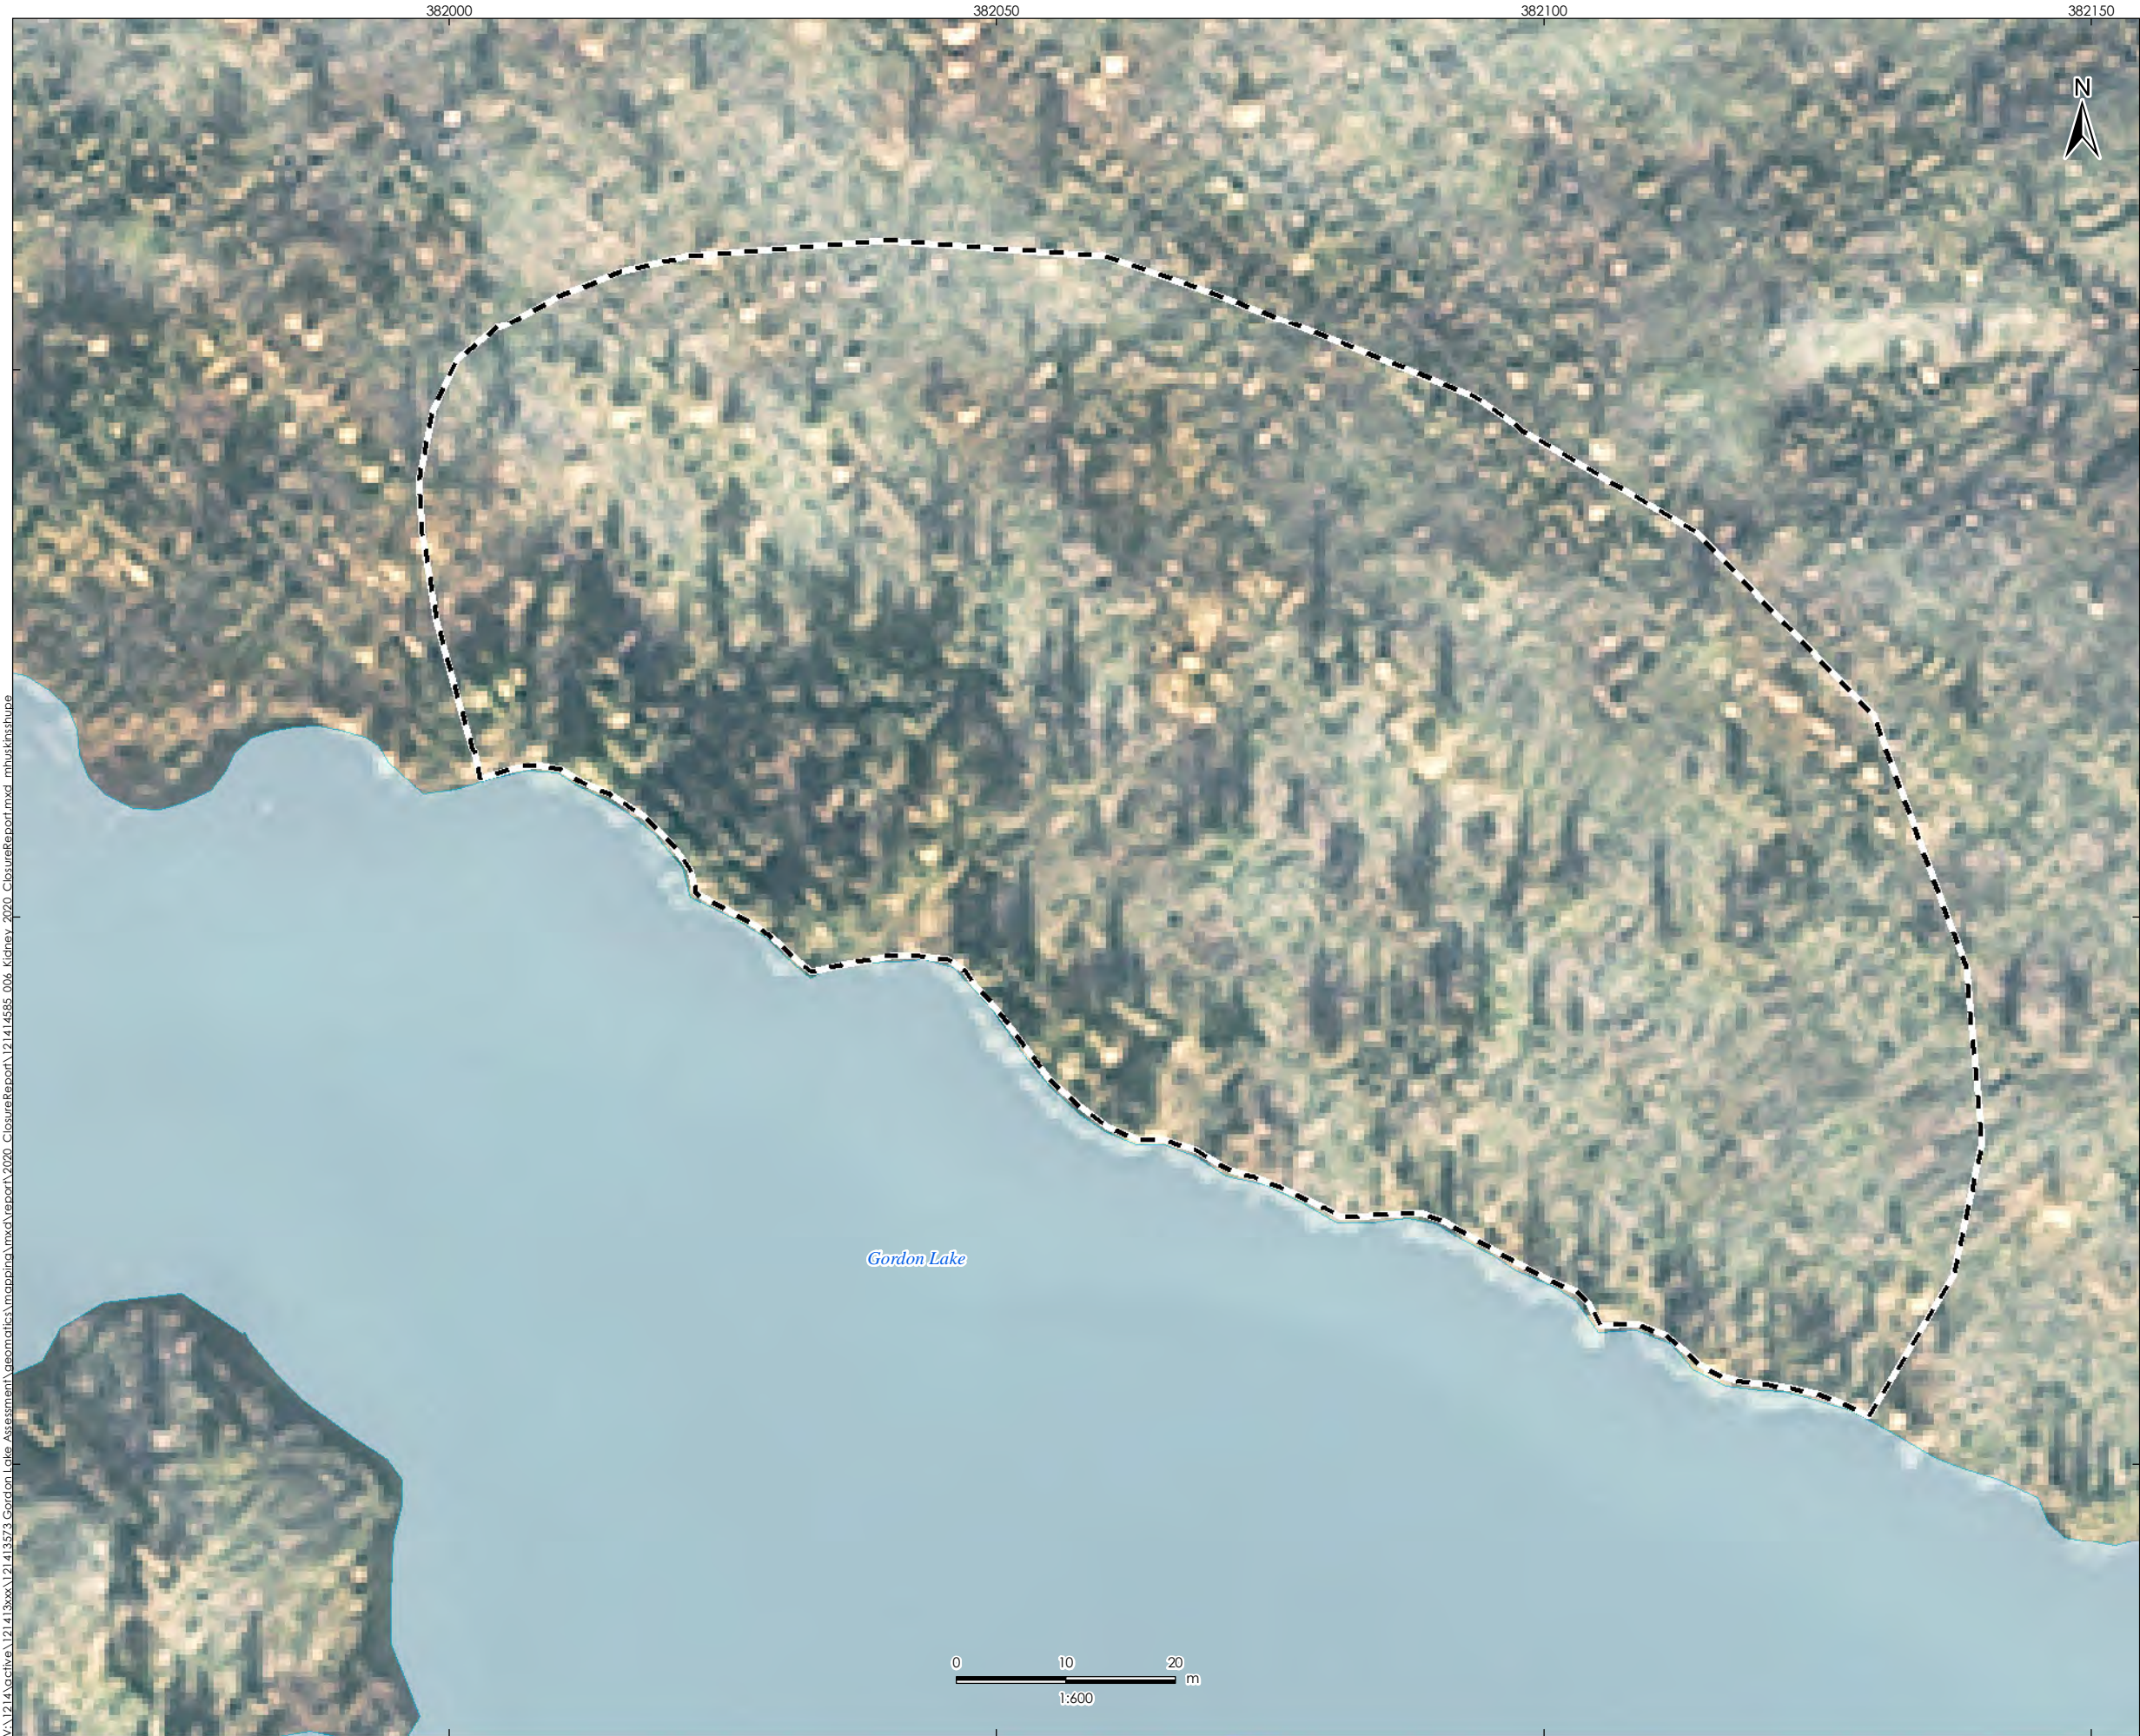
Figure No.
B4.4

Title
Kidney Pond - 1939 Camp
Remedial Components

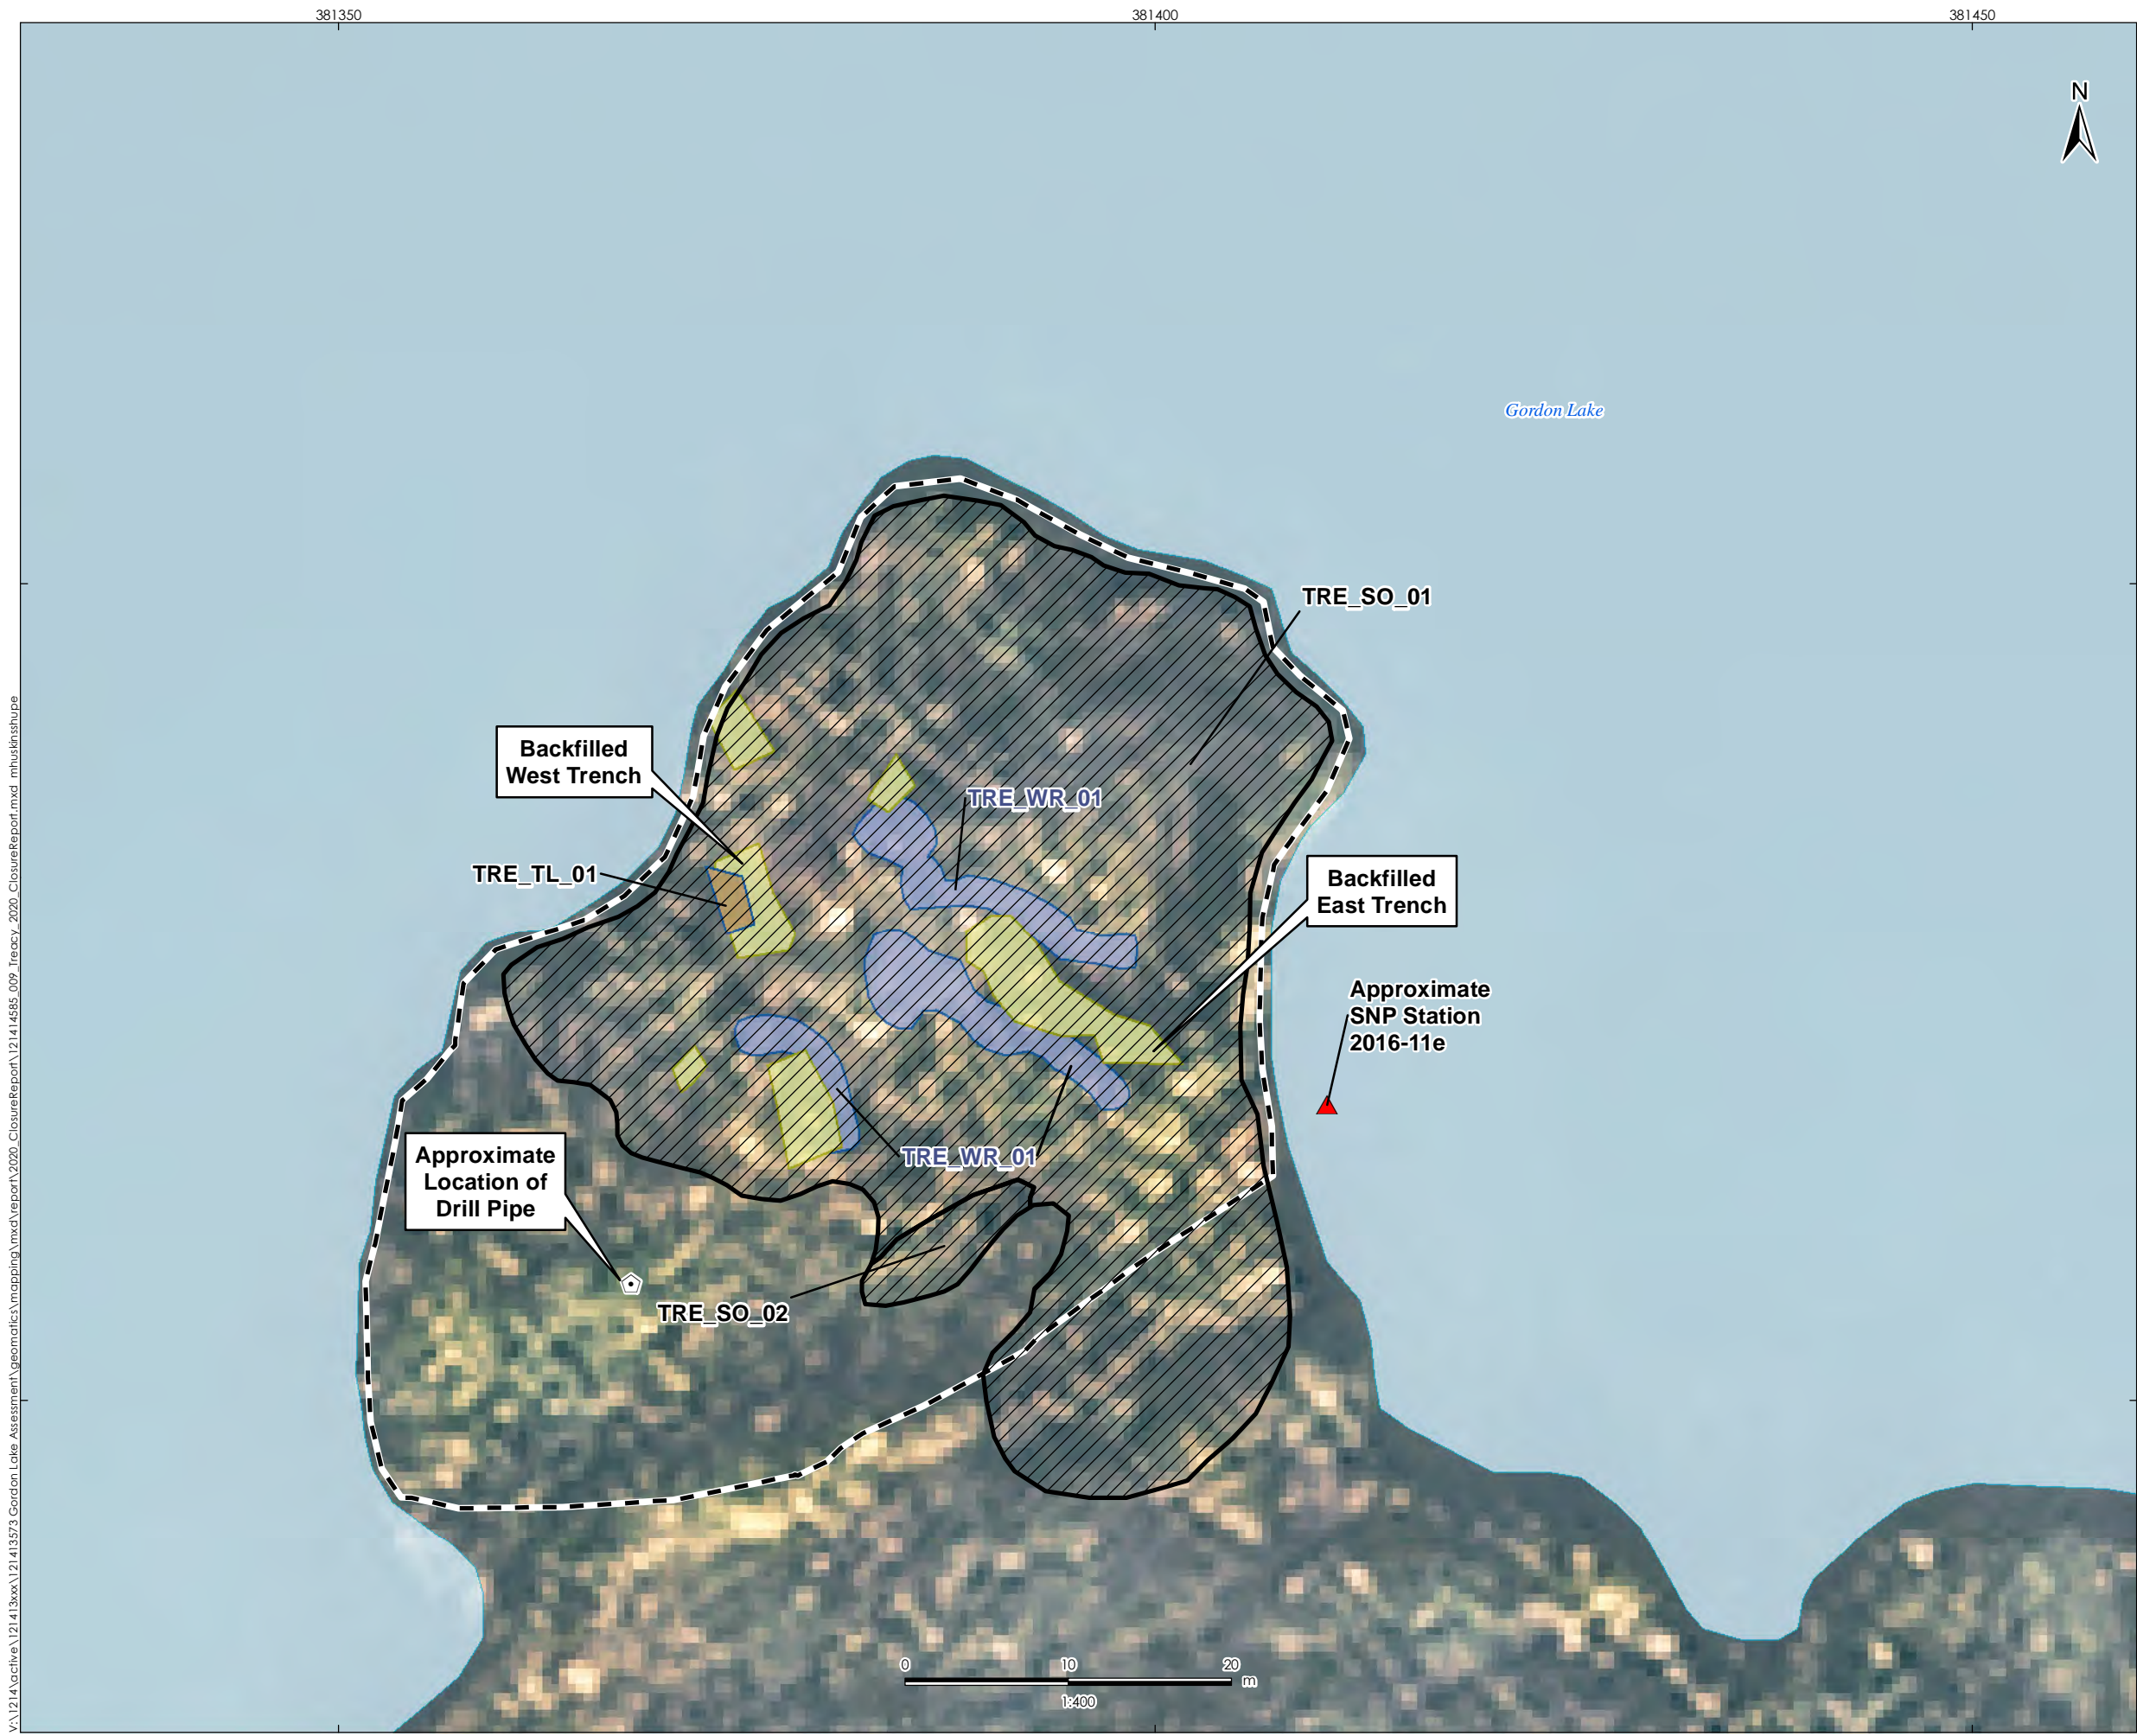
Figure No.
B7.2

Prior to remediation, the Mill Area (Figure B7.2, Appendix B) included non-hazardous waste (mill remains, a burn pit and garbage), hazardous waste (including lead-based paint on scattered wood debris), trenches (including East Trench and West Trench), tailings and waste rock. The Camp Area (Figure B7.3, Appendix B) contained non-hazardous waste (including structure remains, building pad, drums, can dumps and stove remnants).

Title
Treacy - Mill Area
Remedial Components
