**FINAL REPORT: LONG-TERM
MONITORING (YEAR 2) –
GORDON LAKE GROUP OF
SITES**

Prepared for:
Public Services and Procurement
Canada on behalf of
Crown-Indigenous Relations and
Northern Affairs Canada

Prepared by:
Stantec Consulting Ltd.
40 Highfield Park Drive, Suite 102
Dartmouth, NS B3A 0A3

March 31, 2021

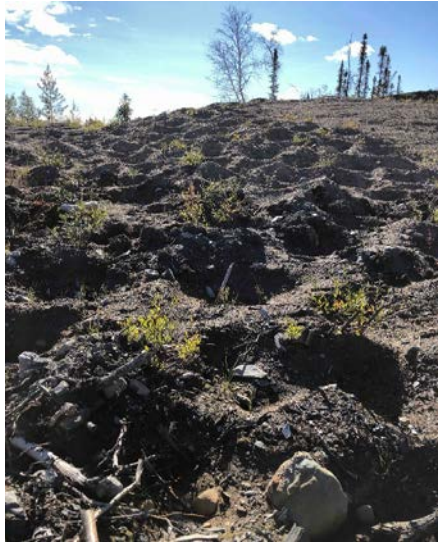
Photo 3

Rough and loose revegetation plot at Zenith. Facing southeast.

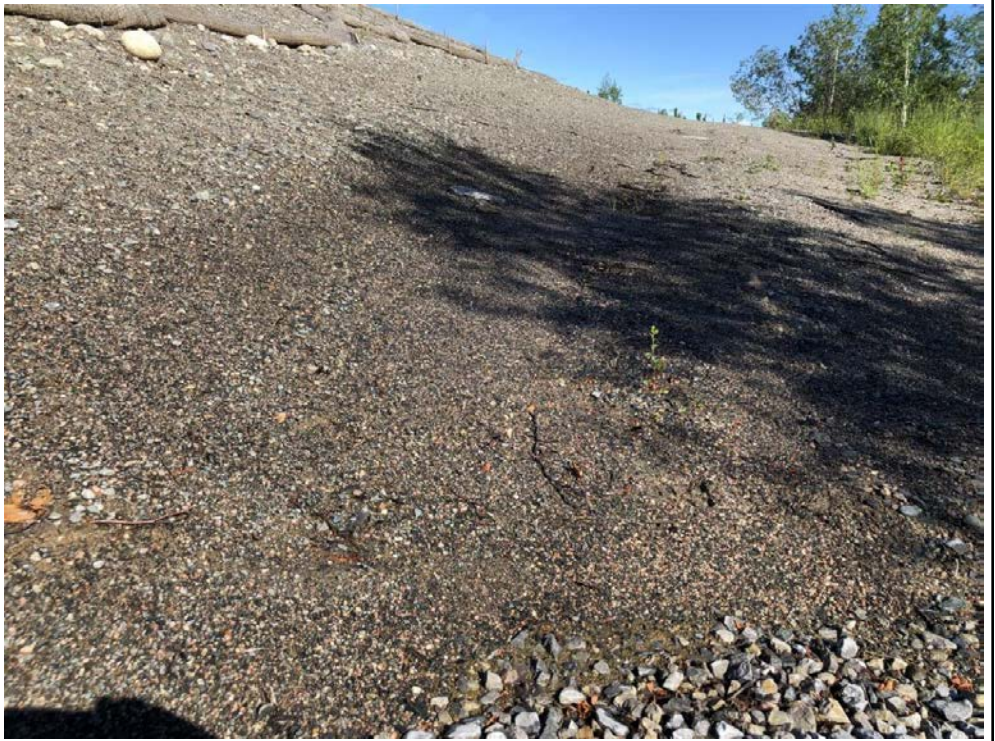
Photo Location: Wet sand identified as potential seepage point on north bank of TSCA			
Direction: Looking north			
Survey Date: 7/16/2020			
Comments: Viewpoint 5 (Figure A2.2, Appendix A)

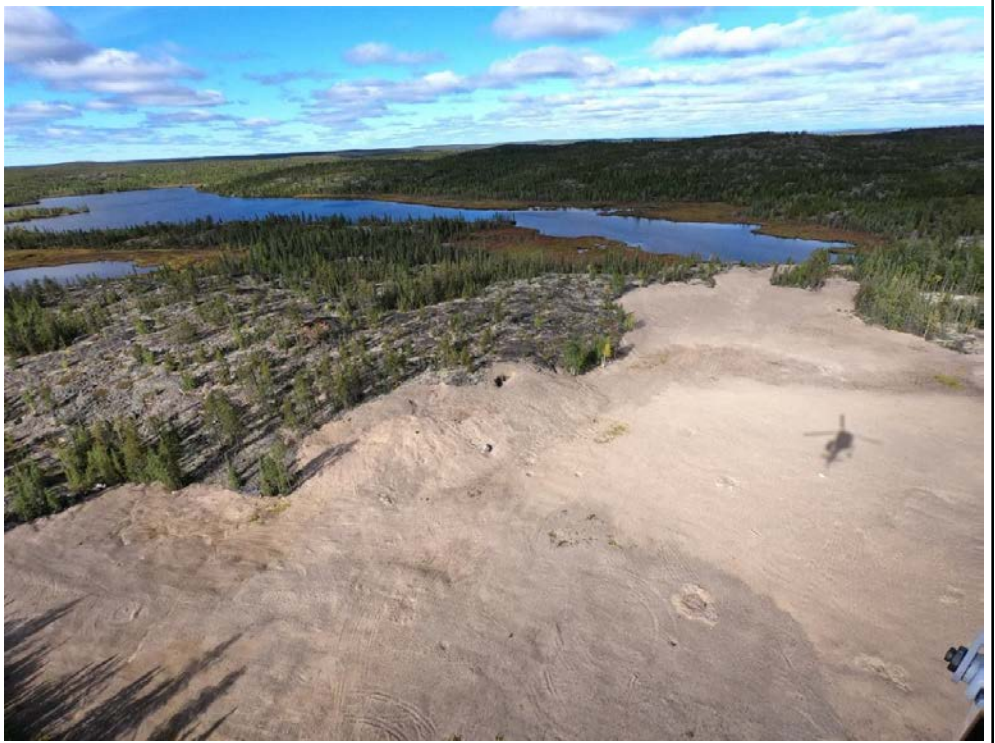
Photo Location: Kidney Portal at Kidney Pond			
Direction: Looking north			
Survey Date: 9/4/2020			
Comments: Viewpoint 2 (Figure A4.3, Appendix A)

- Additional work is required at the Kidney Pond Portal to rectify slumping and erosion concerns. This area should be monitored in Year 3 to confirm backfilling is stable and sufficient to eliminate the hazard and control erosion.

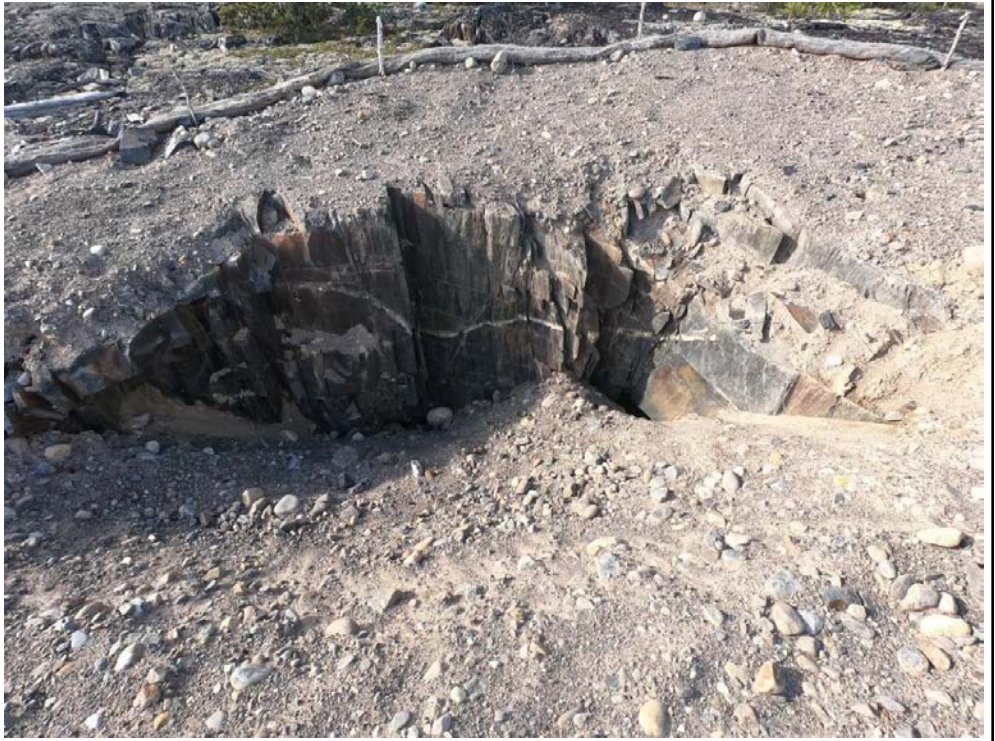
Photo Location: Kidney Portal slumping (note exposed portal entrance)			
Direction: Looking northwest			
Survey Date: 9/3/2020			
Comments: Viewpoint 3 (Figure A4.3, Appendix A)

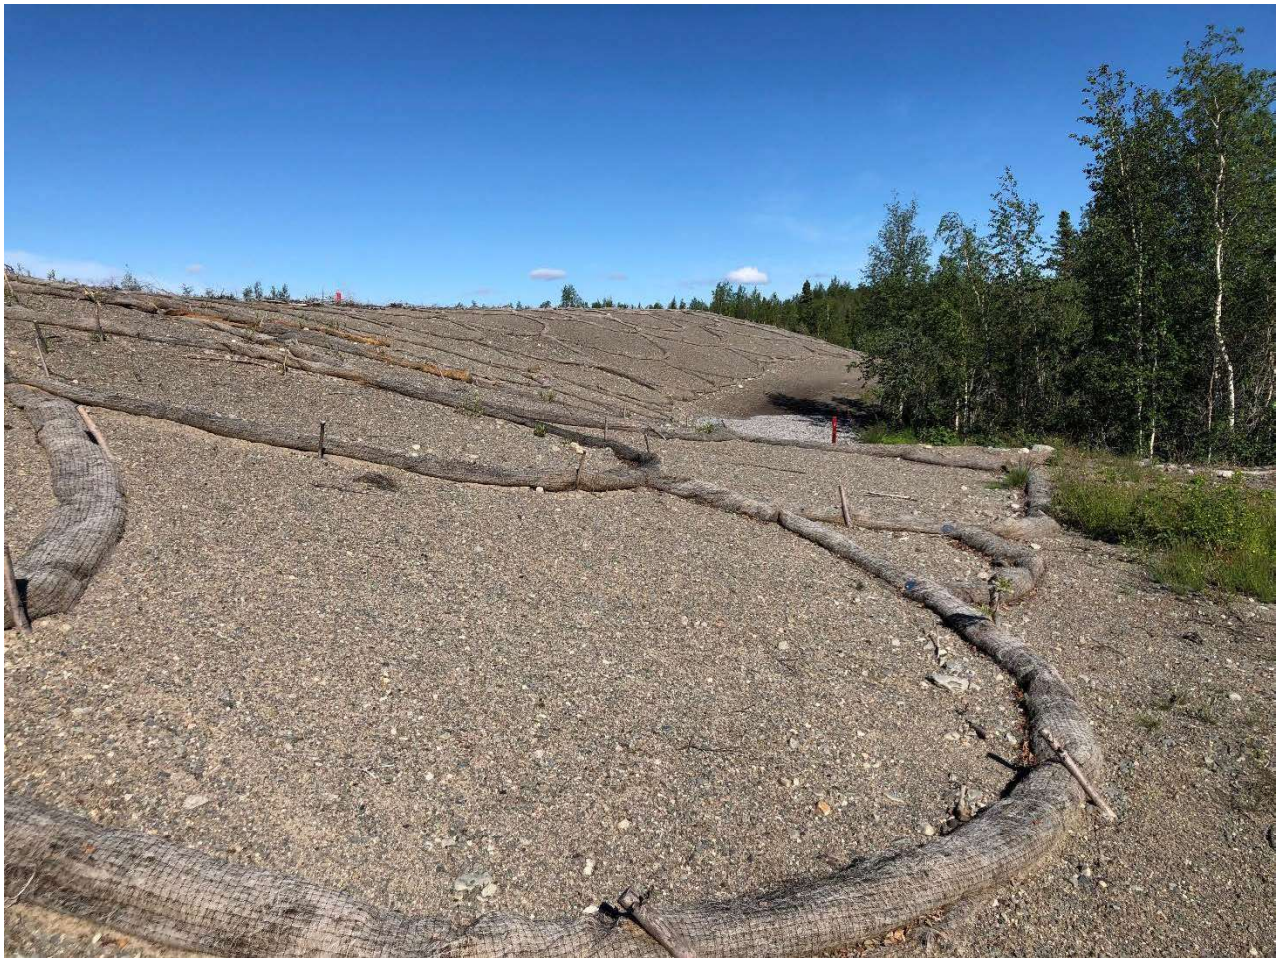
Photo 2: Northern slope of the TSCA, looking West, protected with coco-mats and willow branches in segments to mitigate potential erosion. MW3 in the far right. Photo taken in July 2020.

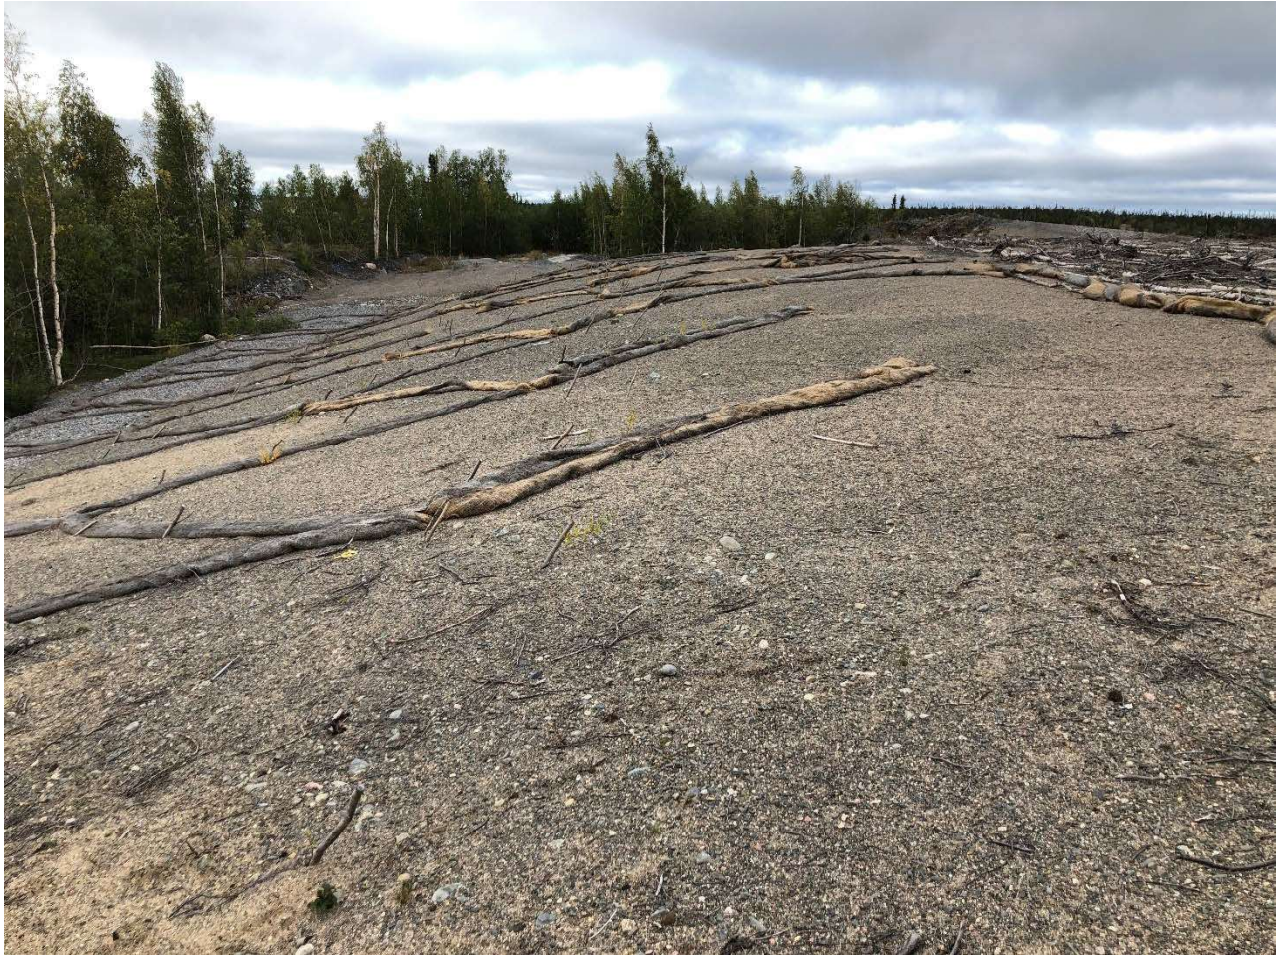
Photo 3: Eastern slope of the TSCA, looking south, protected with coco-mats and willow branches in segments to mitigate potential erosion.

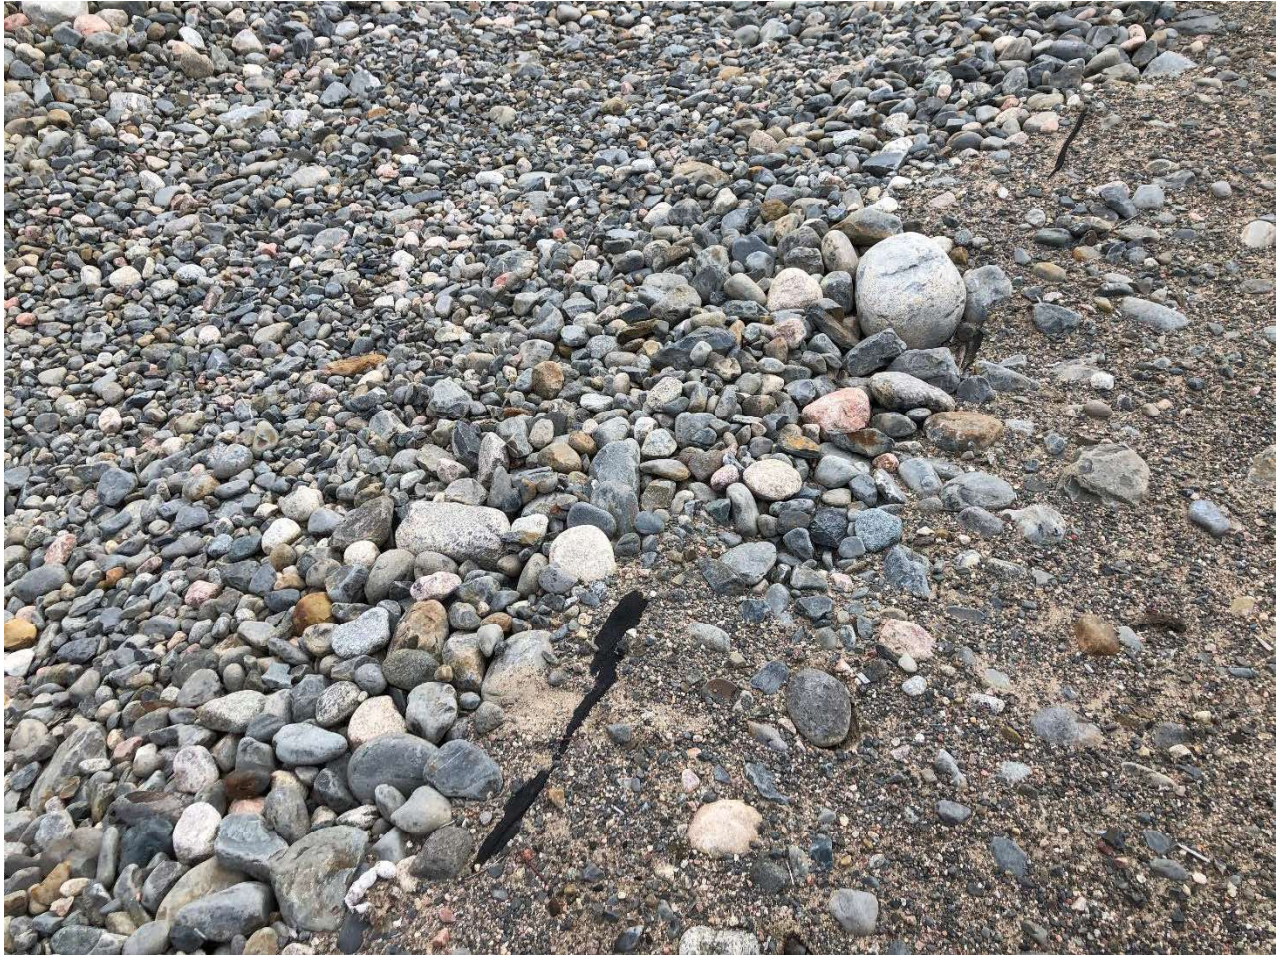
Photo 4: Exposed geofabric at TSCA toe.

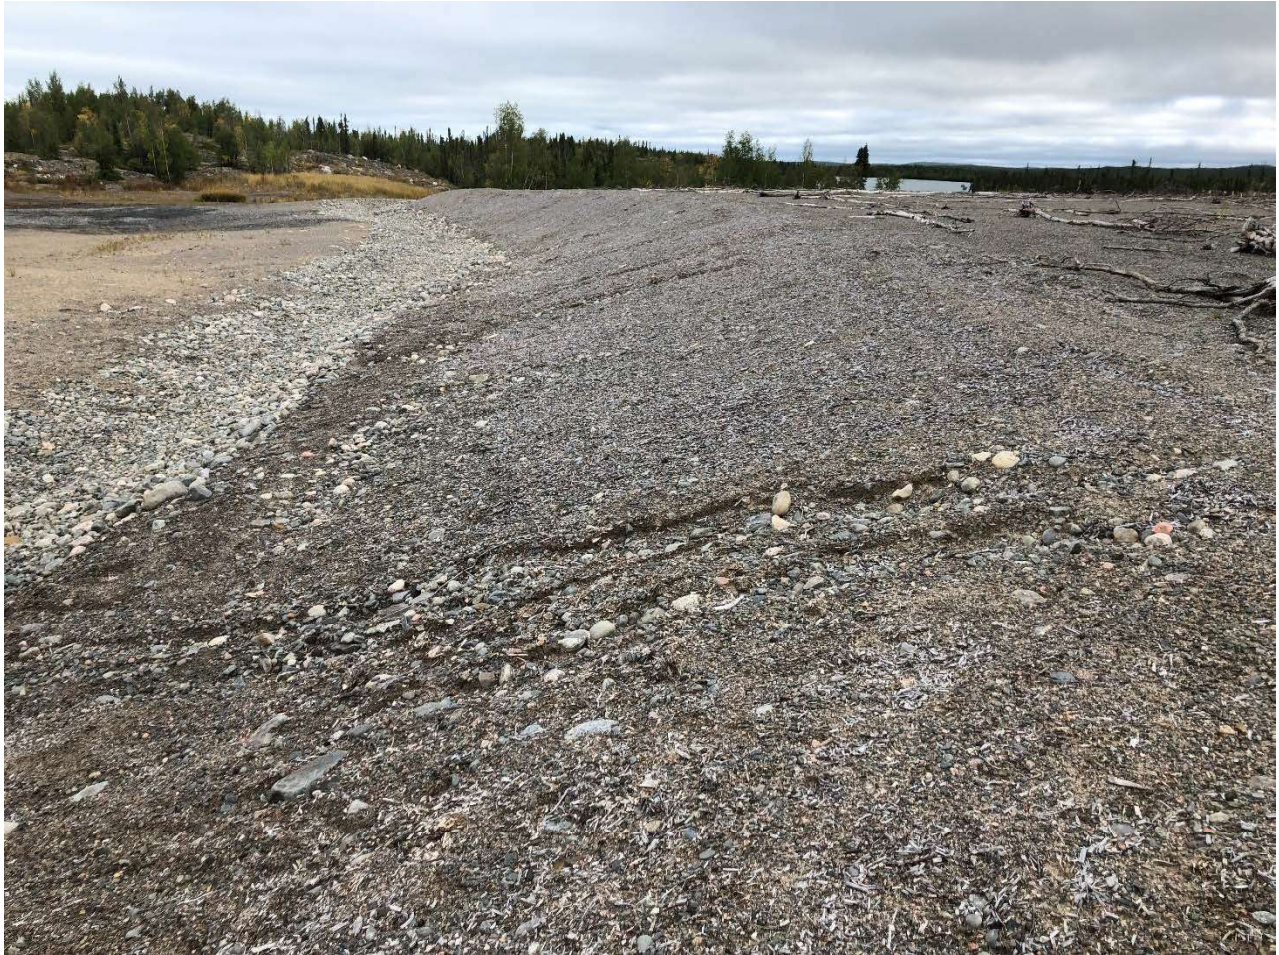
Photo 5: Ditch 1 – West Perimeter. Rip Rap stone lining ditch. Slope erosion.

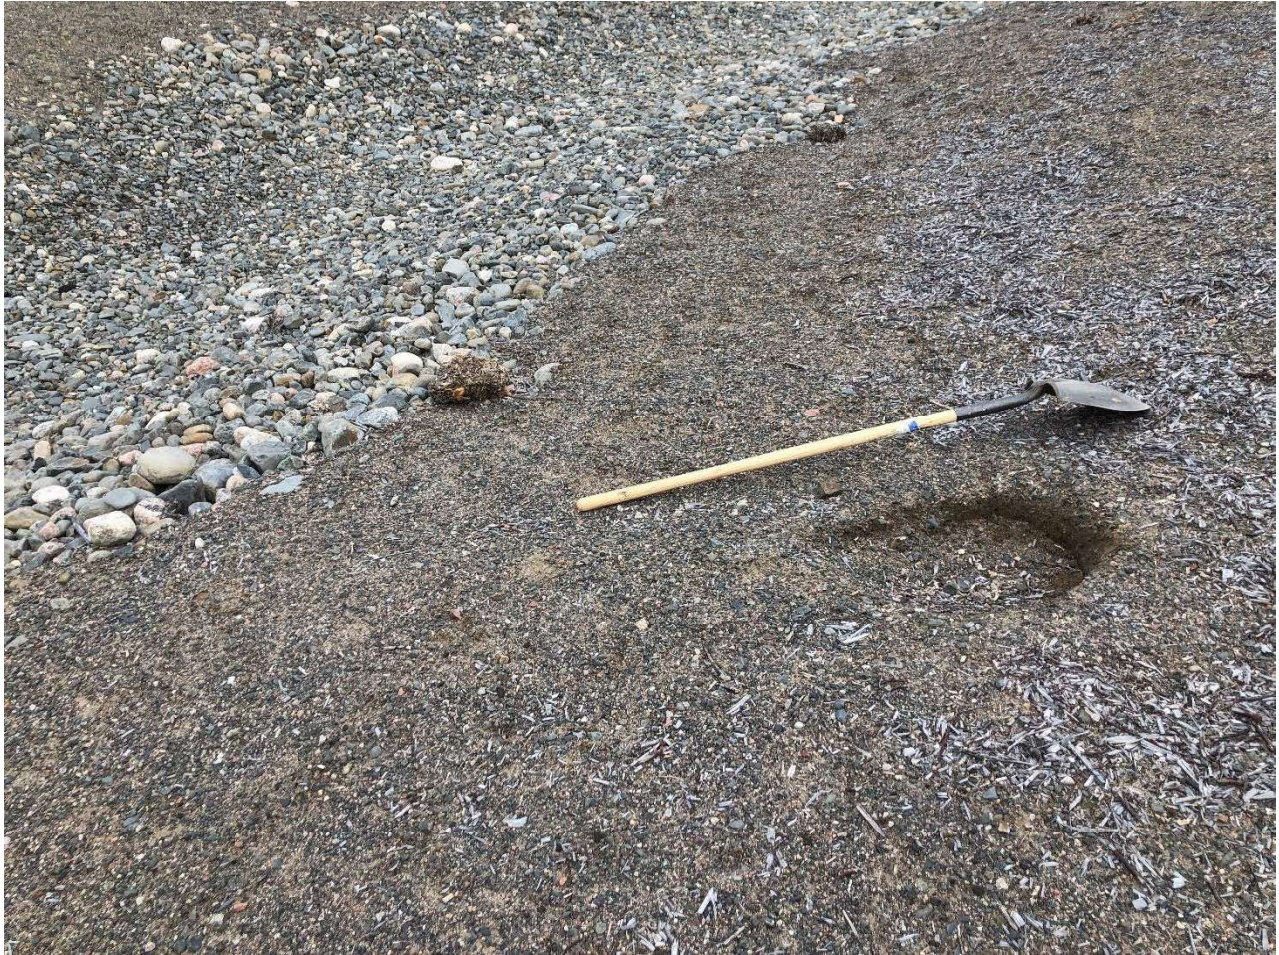
Photo 6: South Perimeter and south ditch. Animal burrow.

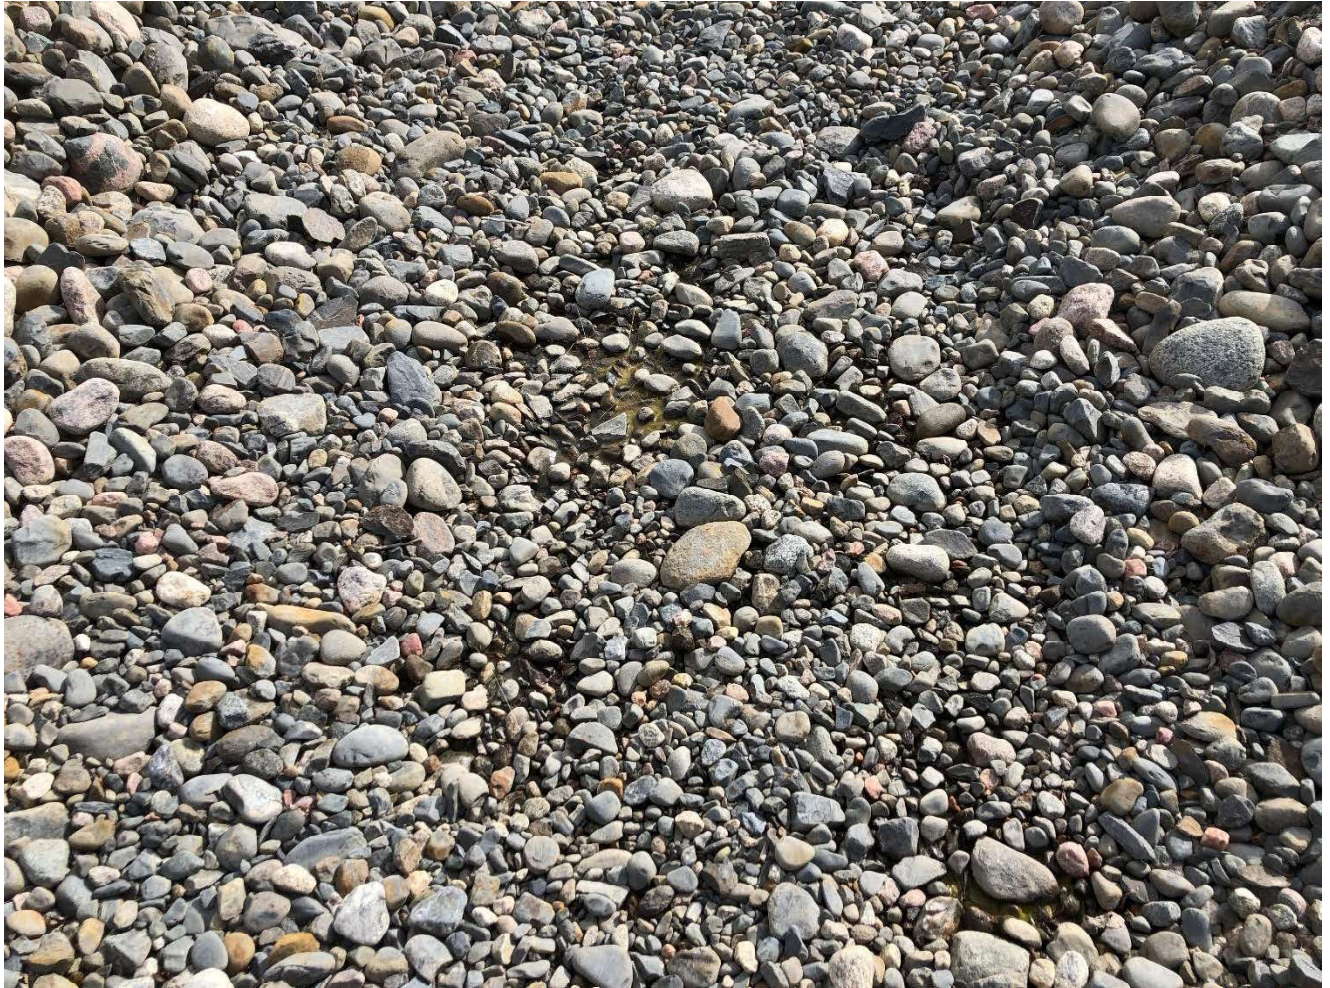
Photo 7: TSCA ponded water in South Ditch.

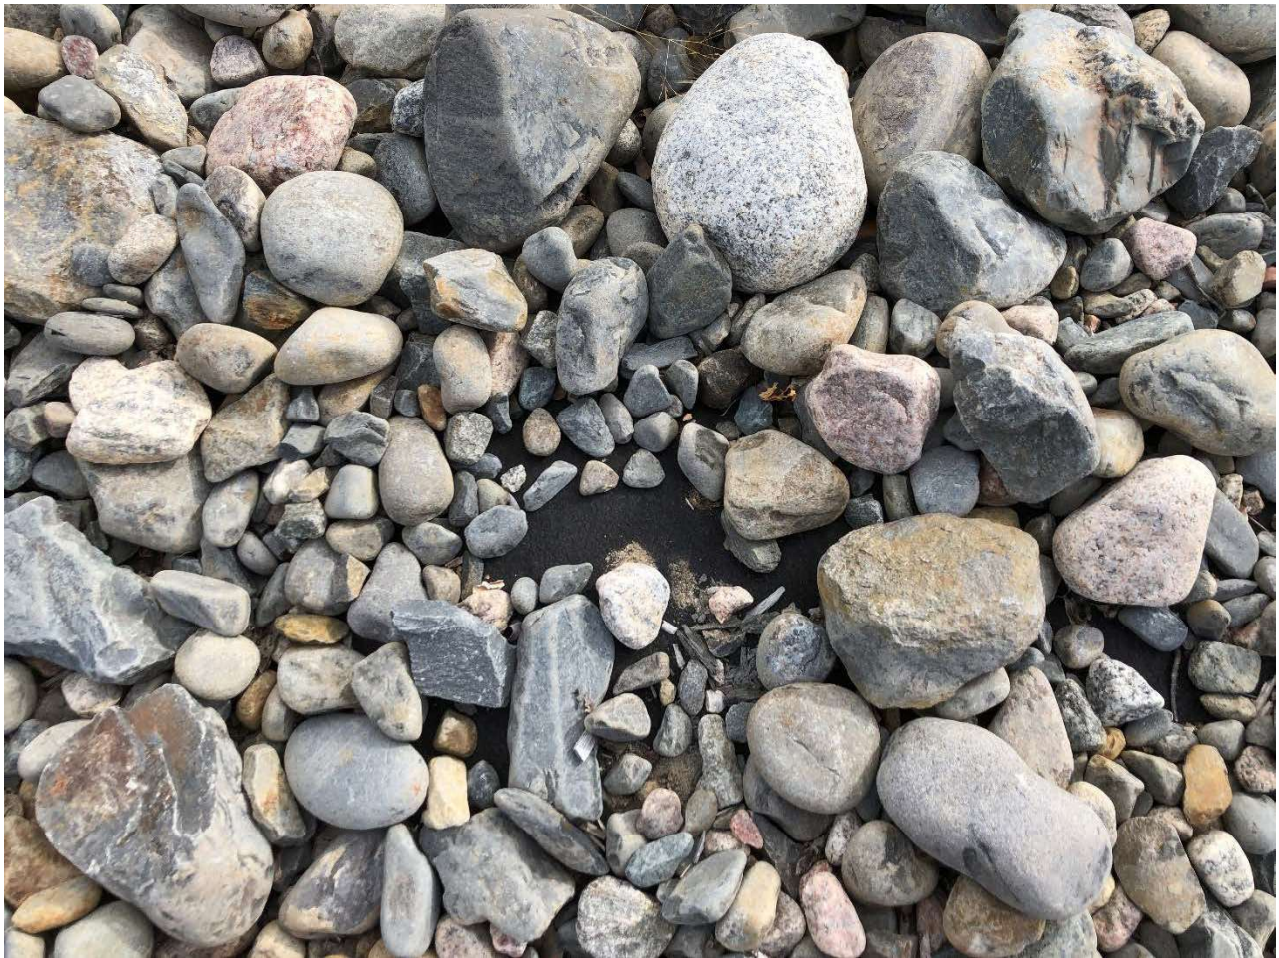
Photo 8: TSCA exposed liner at West Ditch.

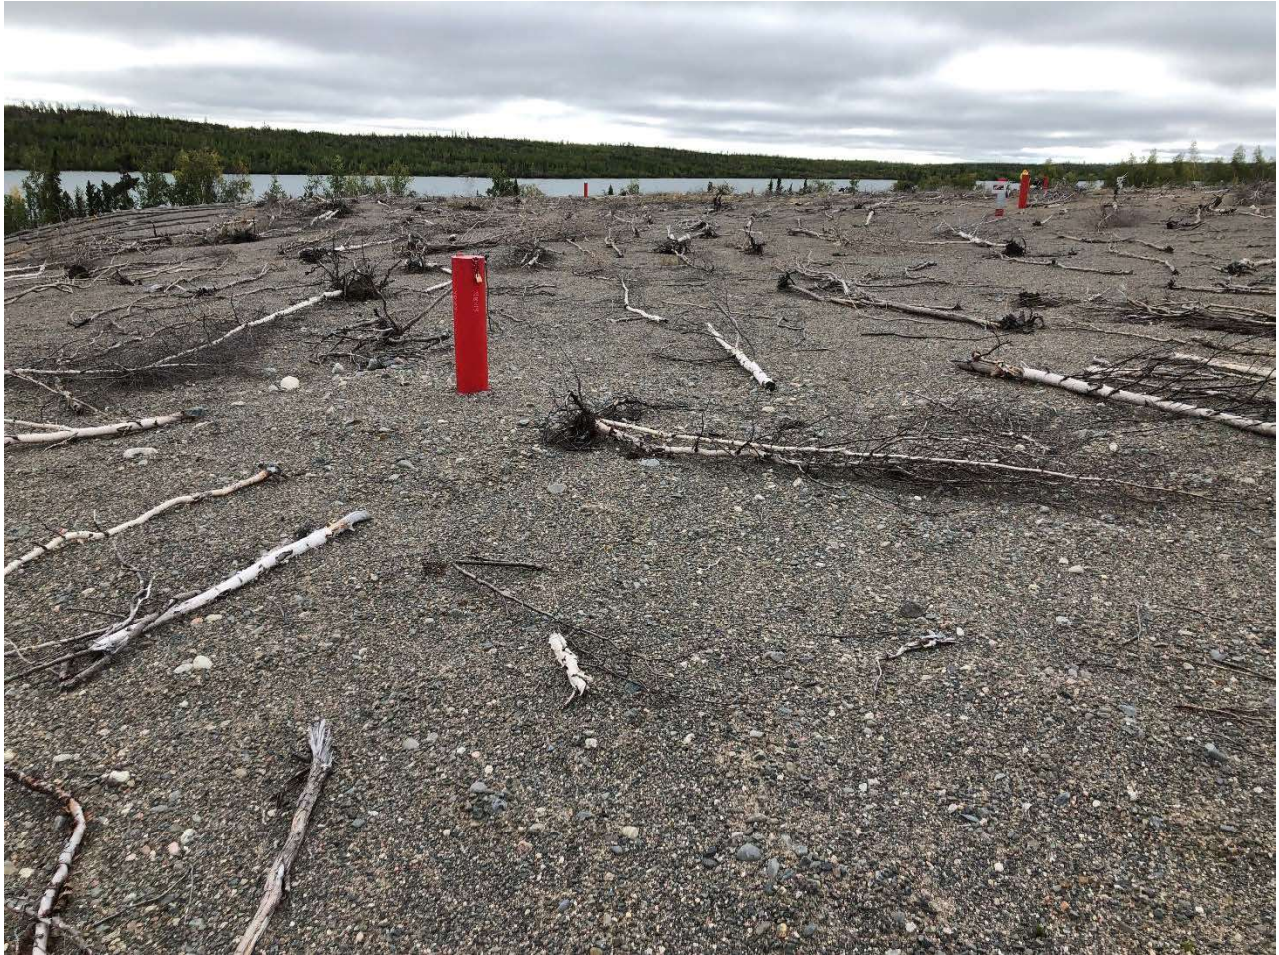
Photo 9: Willow branches cover the top of the TSCA to mitigate potential erosion.

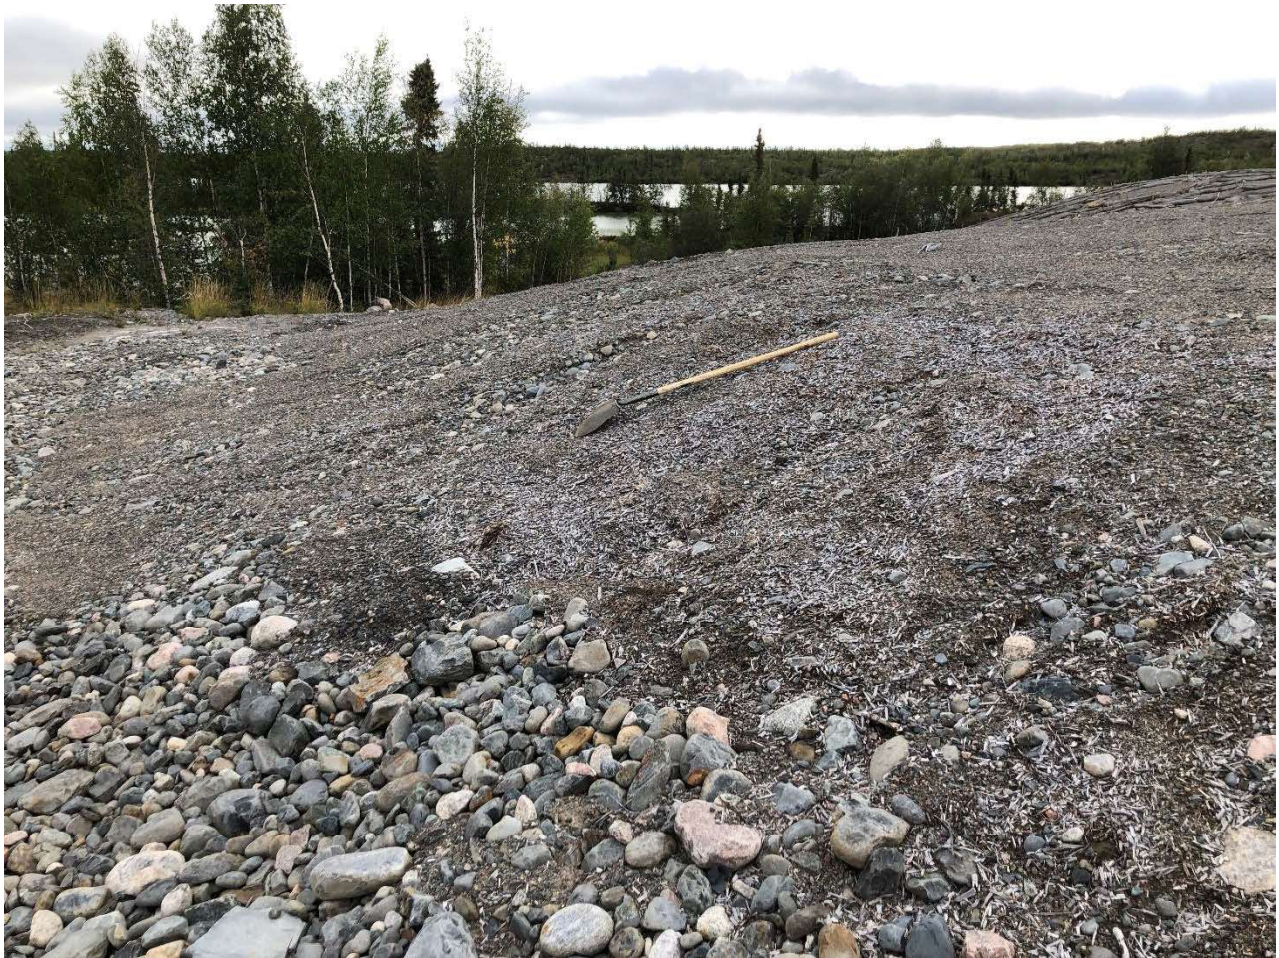
Photo 10: Northwest TSCA Perimeter Slope. Surface Erosion.

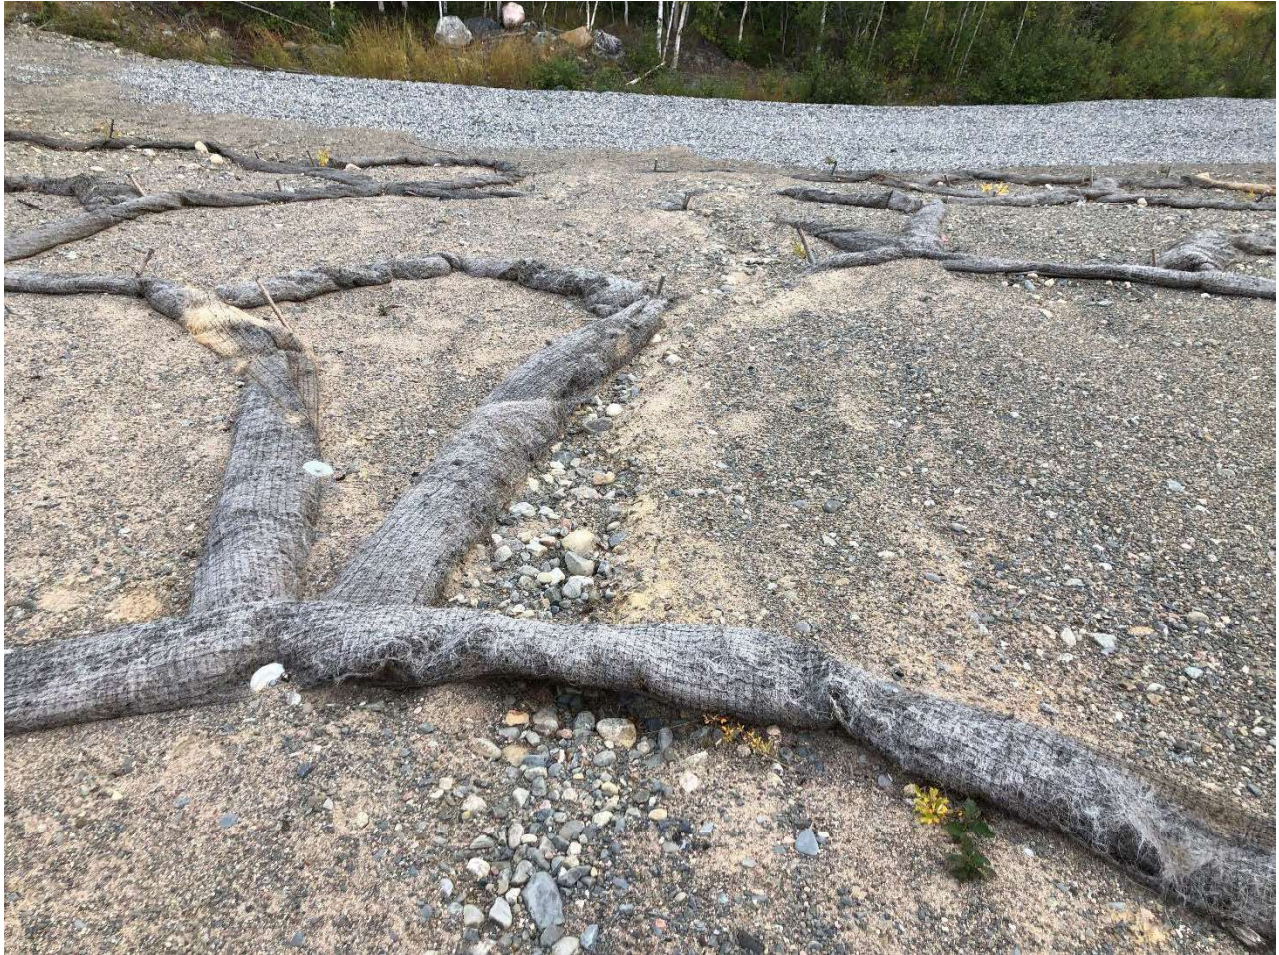
Photo 11: North TSCA Perimeter Slope. Surface Erosion.

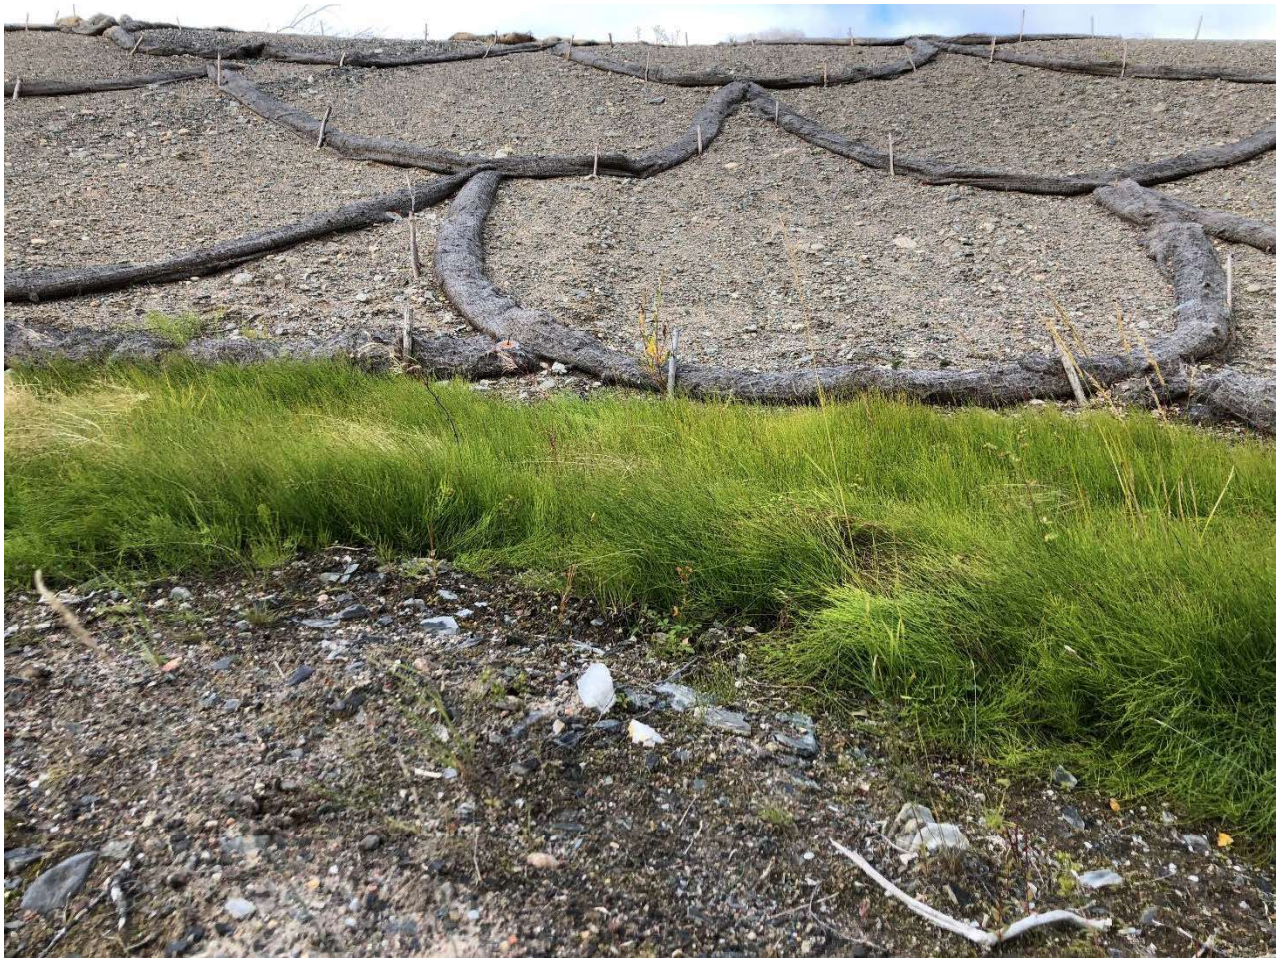
Photo 12: Northern TSCA Perimeter Slope. Vegetation growth.

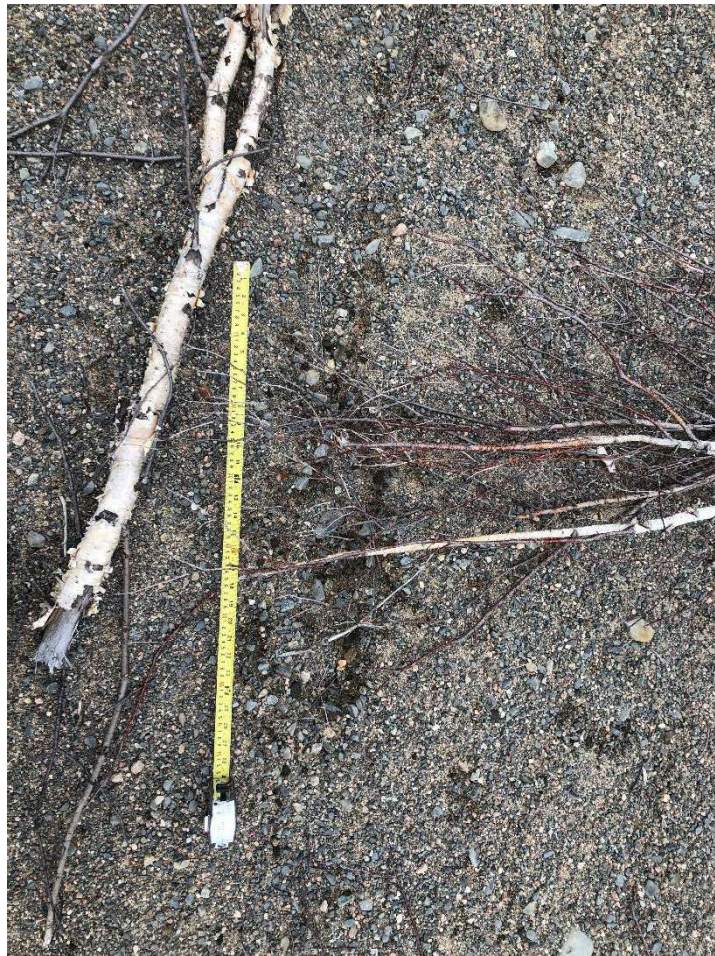
Photo 14: TSCA top towards North Perimeter, surface crack zone around depression area.

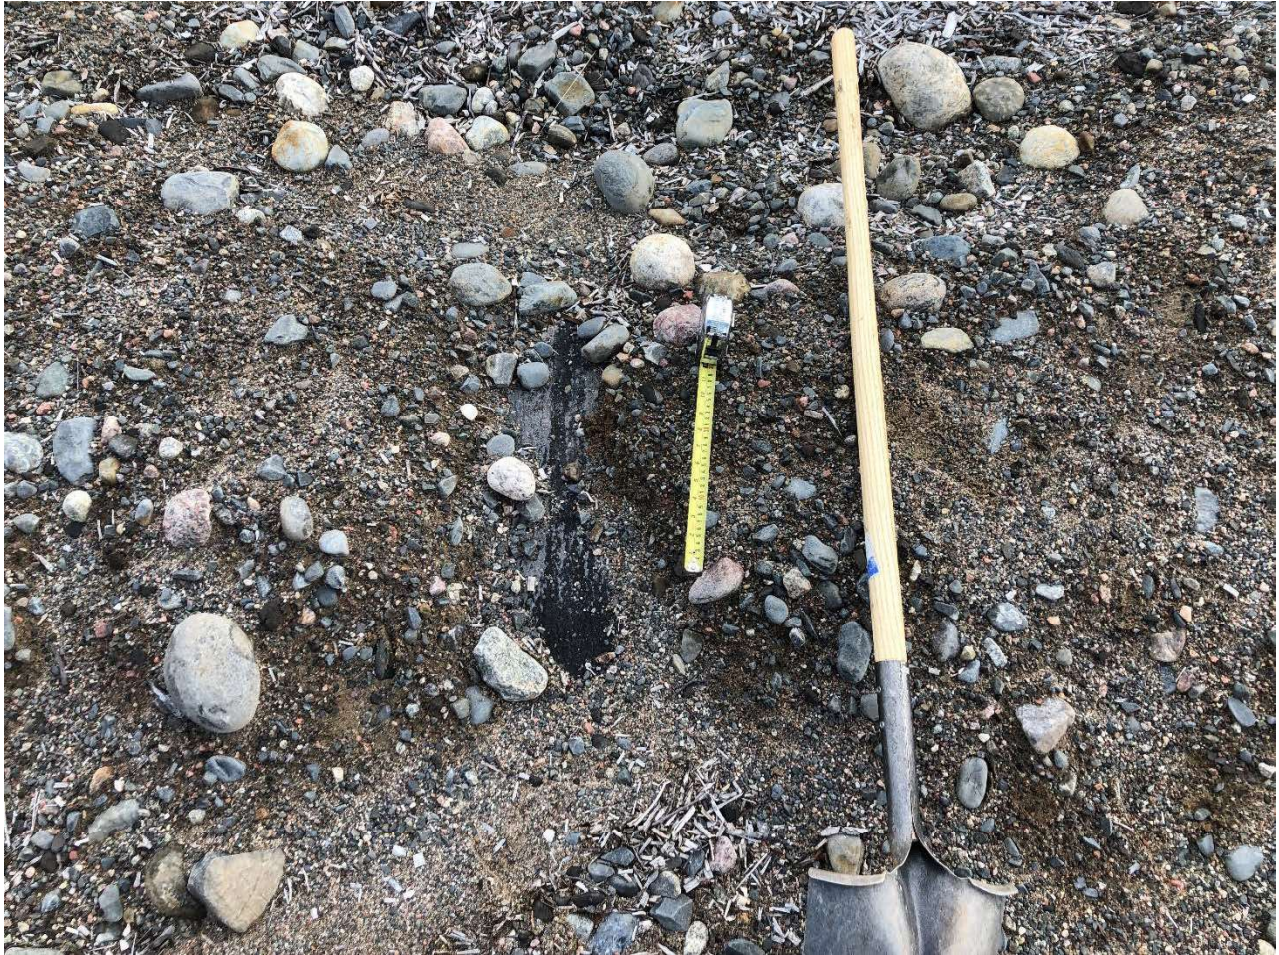
Photo 15: TSCA West Slope exposed liner.
