Attachment 2 Photographs

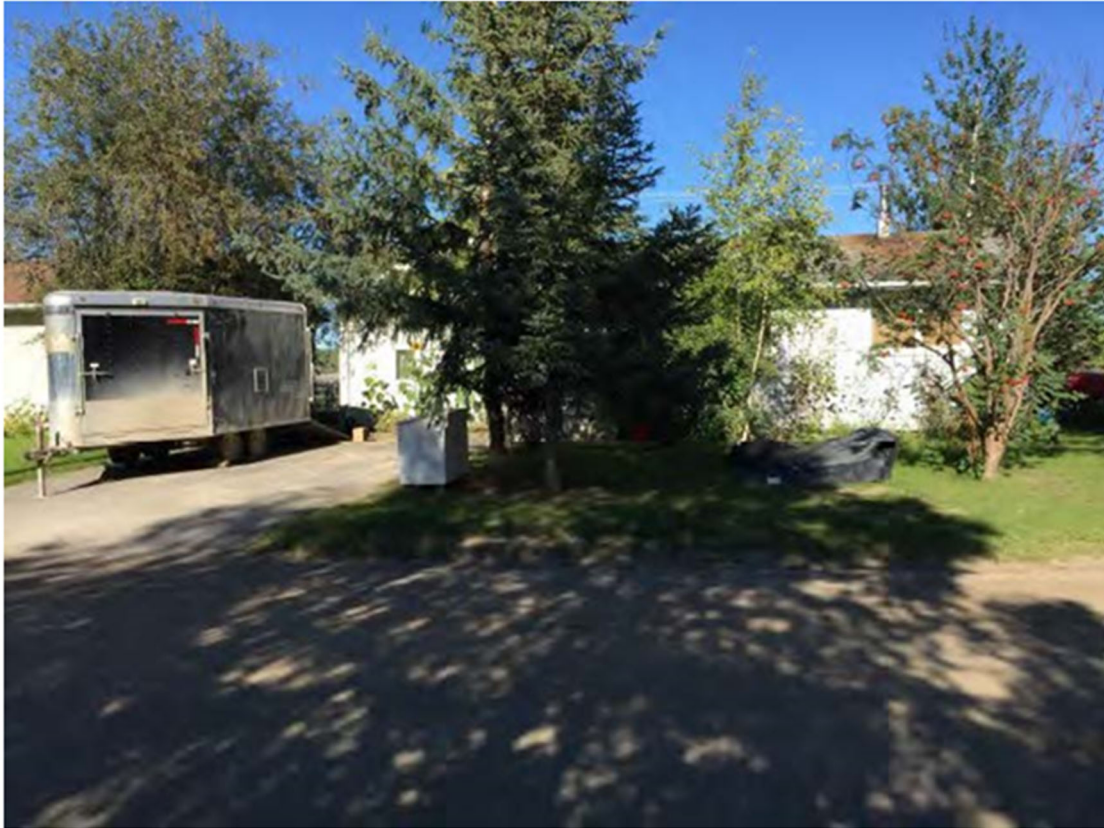
Photo 1: 9606 102nd Street. PSPC Residence

FRONT VIEW OF HOUSE

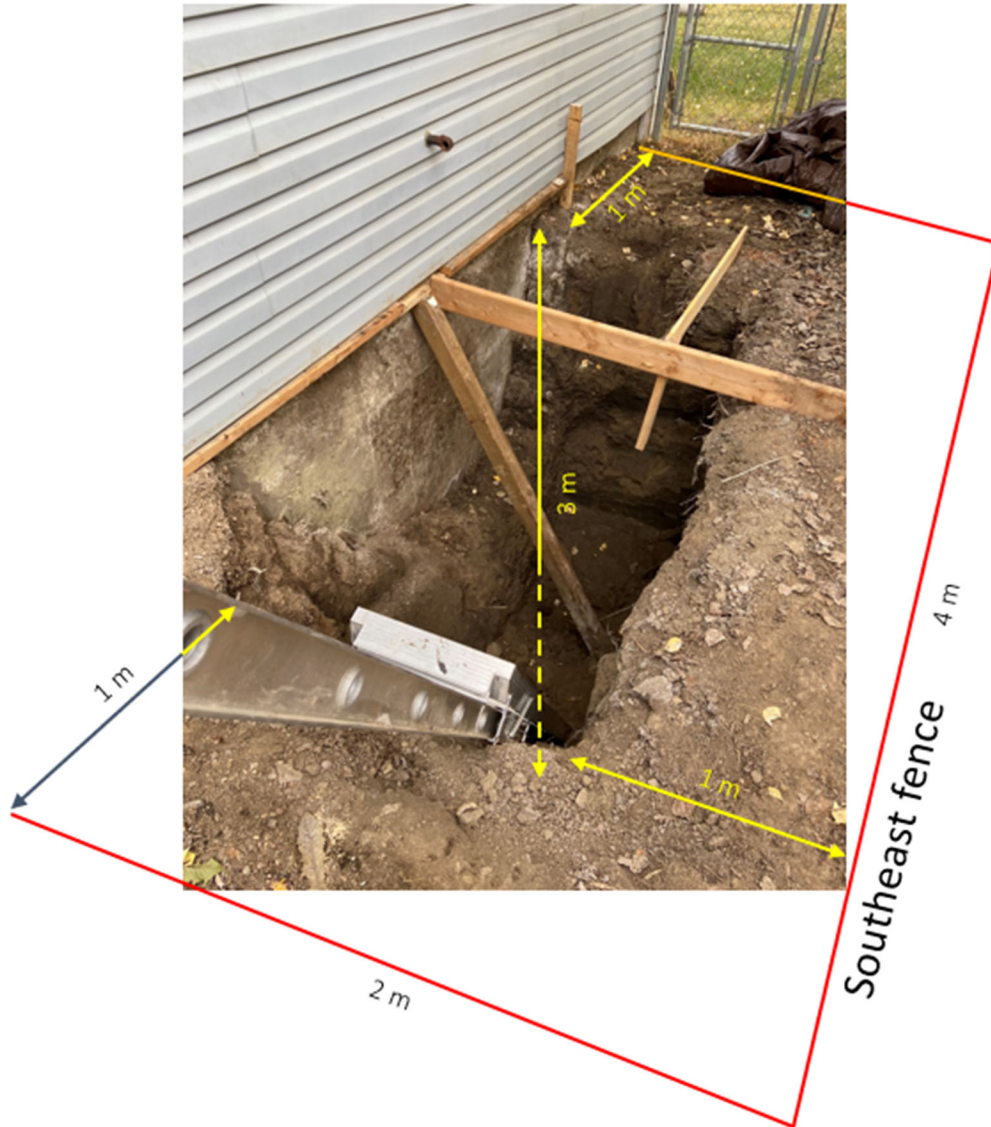
Photo 2: 9606 101st Street PSPC Residence Former Fuel Oil Tank

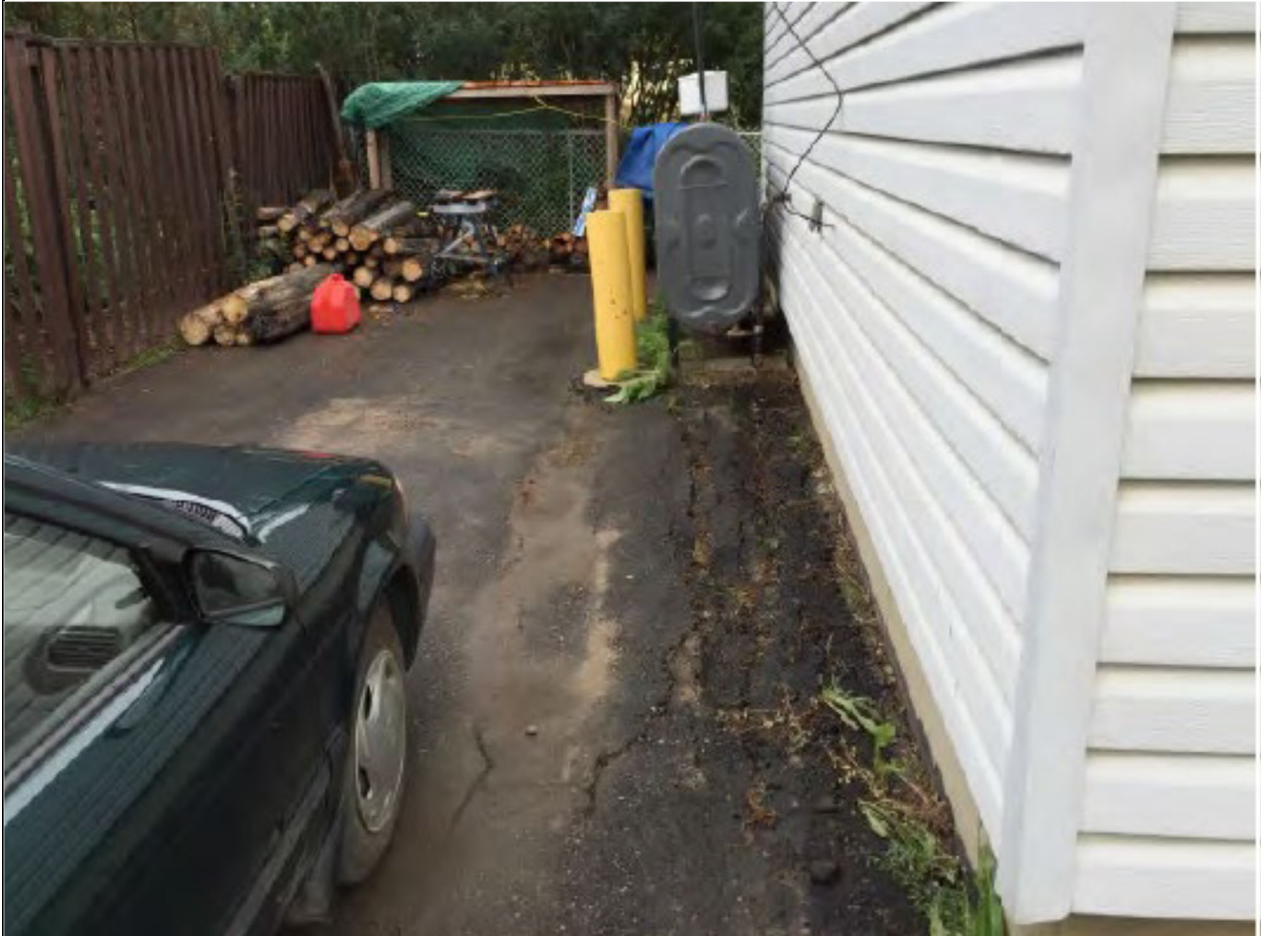
Photo 4: 9818 101st Residence – Historical Fuel Oil Tank Not In Service Minor Leak From Adapter

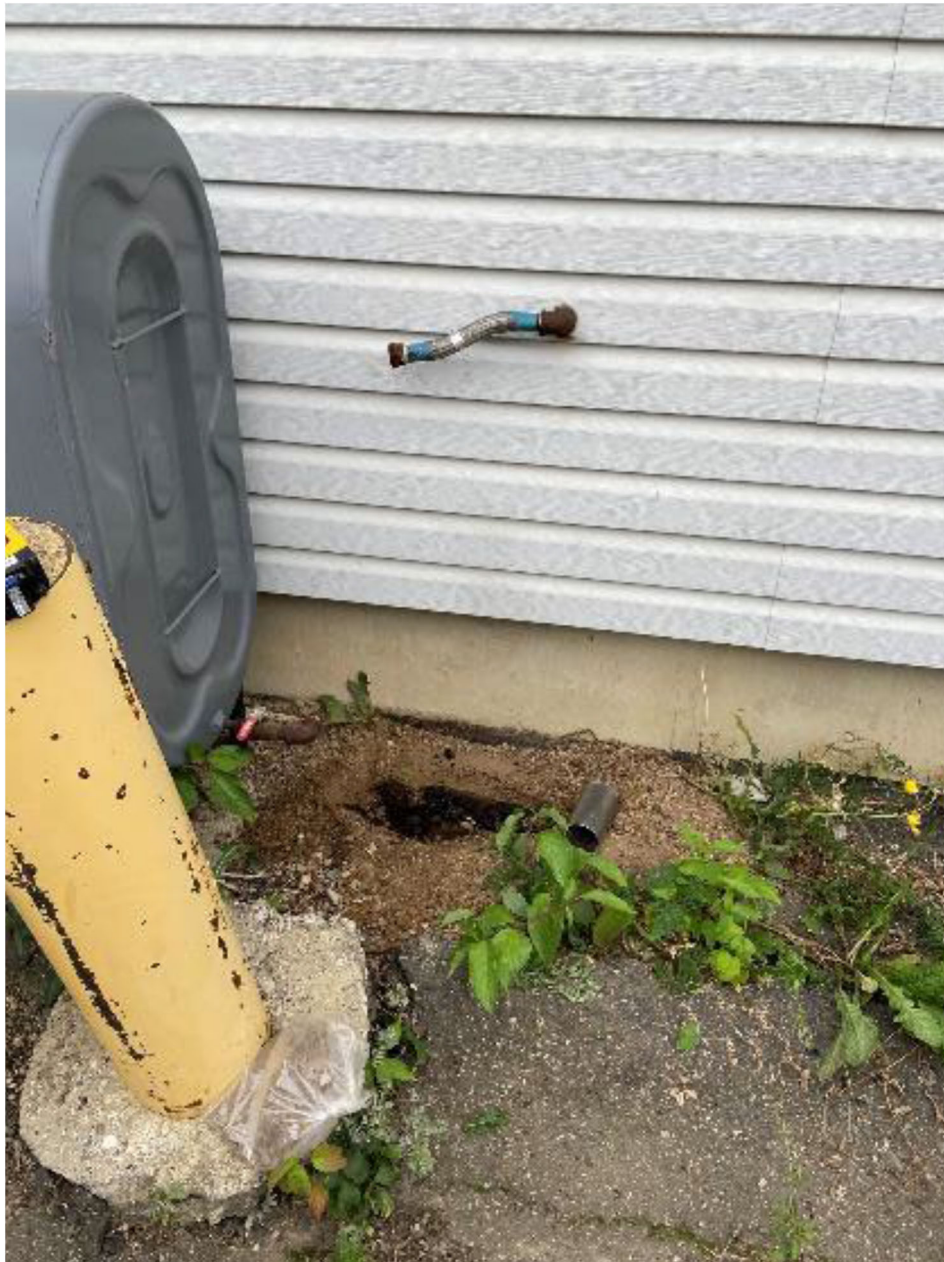
Photo 5: 9818 101st Residence – Historical fuel oil tank not in service minor leak from adapter. Soil staining is surficial and estimated to be no more than a cubic meter in volume and to be transported to KBL environmental, who accepted the original PHC impacted soil

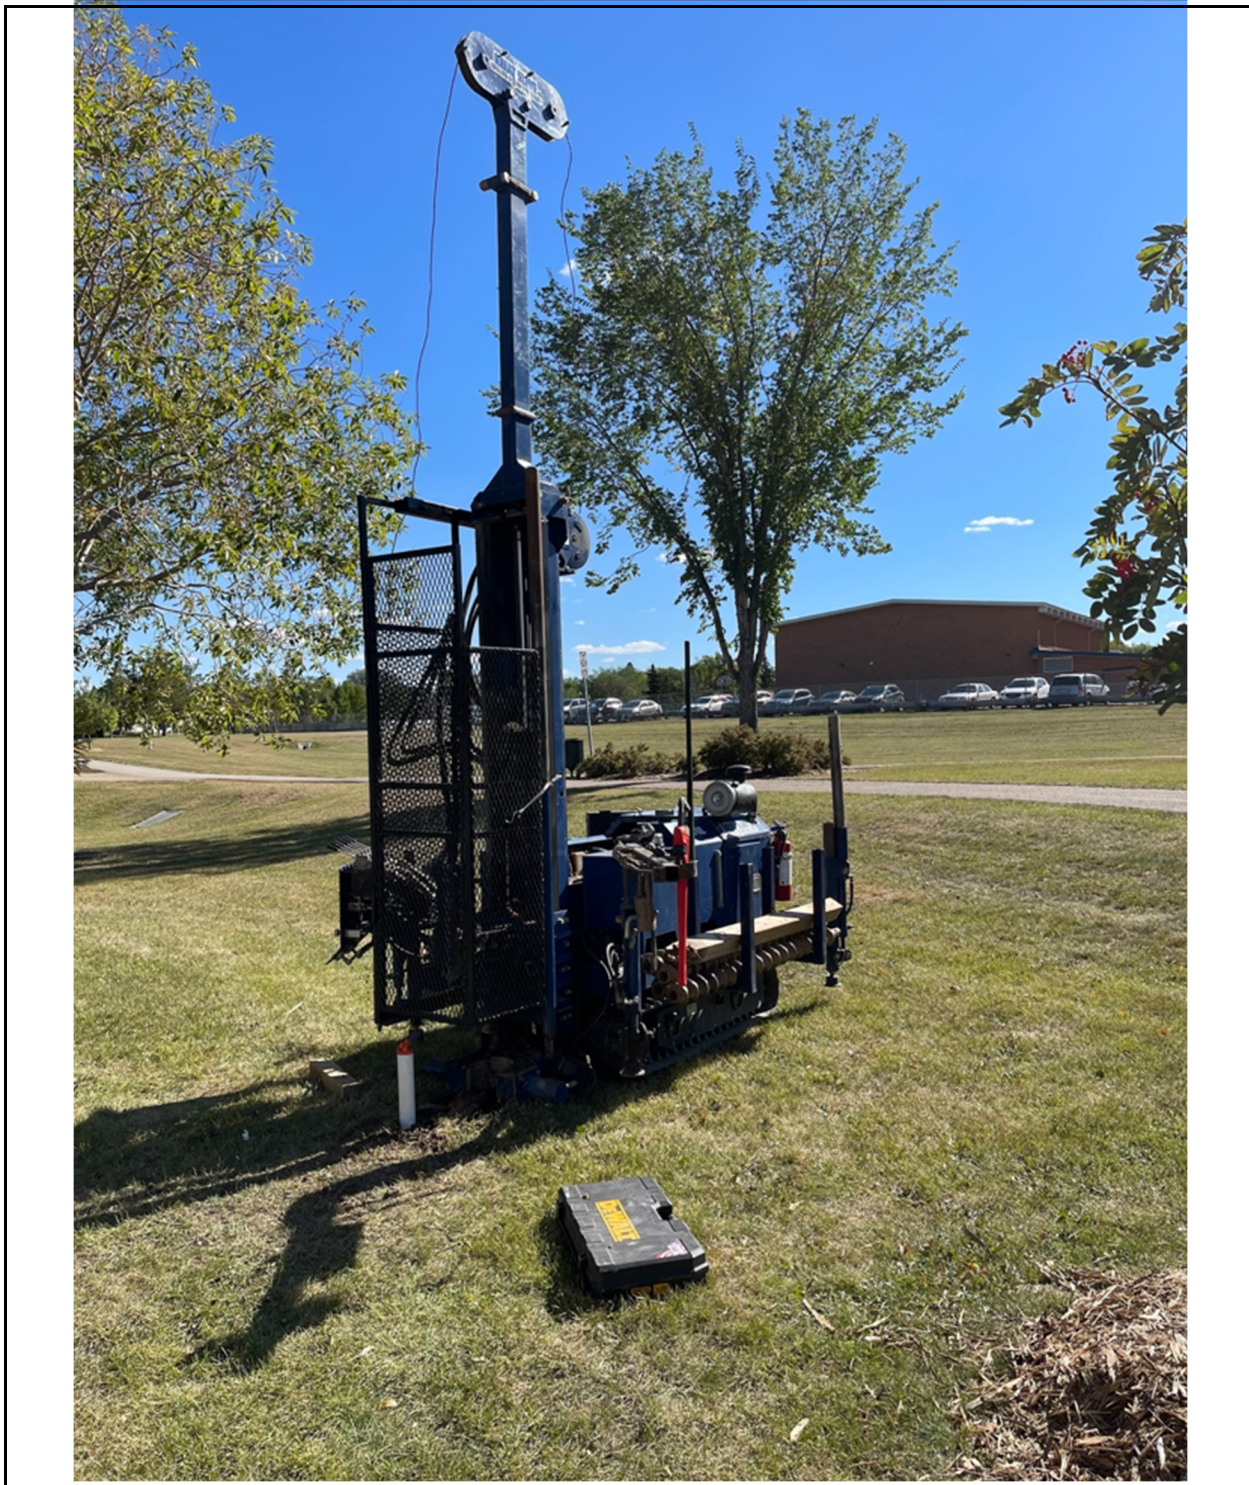
Photo 6: Drill Rig Used for Soil Sampling and Groundwater Well Installation
