SNARE HYDRO SYSTEM

2006 Comprehensive Dam Safety Review

FINAL

Kohn Crippen Berger

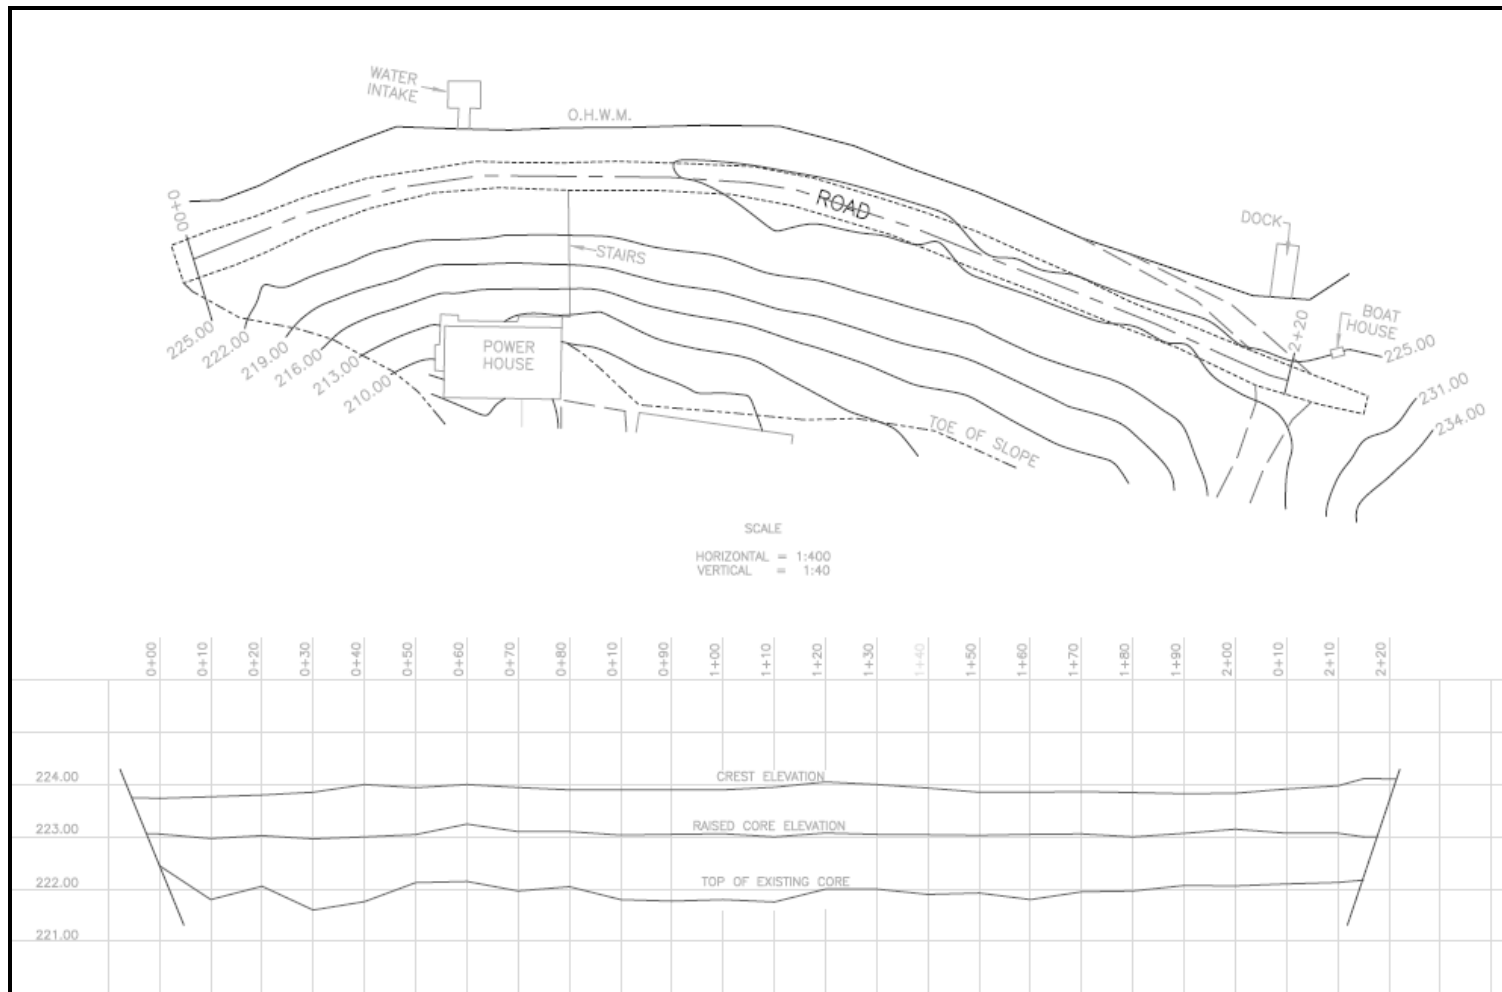
Figure 6-2: Snare Rapids Main Dam – Crest and Core Profile (2002 Survey)

The crest of the dam appears planar with no visible cracking or settled areas (Photo 1). At the time of inspection the crest had recently been graded, making observation of any older cracking or other signs of distress impossible, but NTPC staff reported that the discontinuous longitudinal cracking near the upstream crest noted in some winters since 1990, and which has been attributed to ice lens formation in the frost-susceptible silty sand (20% silt typically) filter covering the top of the core, has not re-occurred. Notwithstanding the appearance of the crest, it is noted that based on the crest survey undertaken following the core raising remedial works (see Figure 6-2) there are several

areas where the crest is below the design level either as a result of local settlement or lack of placing sufficient material following the core raising remedial works. The most deficient area is near the right abutment where the crest is locally up to 260 mm (0.85 ft) below the designed top of dam. Although the crest level is still above the minimum elevation of EL. 223.34 m (EL. 732.7 ft) required to satisfy the latest freeboard estimates (Agra Monenco, 2000) at all locations, it is recommended that the dam crest design level be reinstated over the full length of the dam and confirmed by a new crest survey.

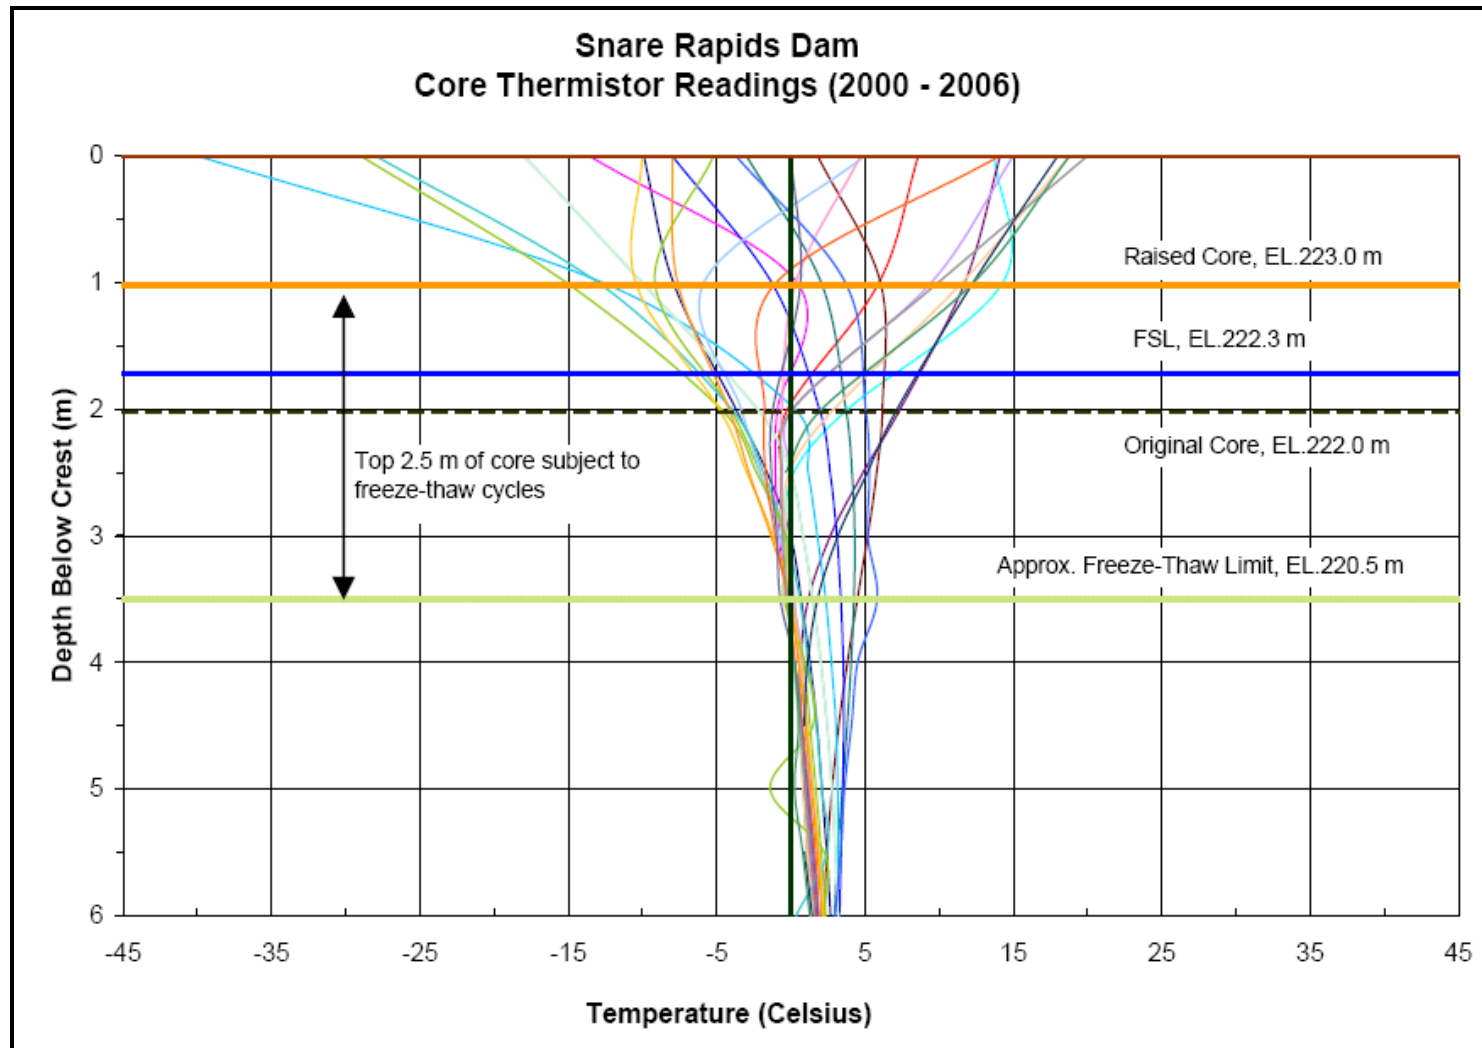
Figure 6-3: Snare Rapids Main Dam – Core Thermistor Readings (2000 to Present)

In 2000, a single multi-level thermistor was installed in the top 6 m of the main dam to record temperature fluctuations at 0.5 m intervals in the top of the dam and core. Figure 6-3 charts the data presented in Appendix IV. From Figure 6-3, frost penetration extends approximately 2 to 2.5 m (6.5 to 8 ft) into the upgraded core of the dam. However, laboratory testing and material assessments undertaken during the 2000 DSR concluded that the existing core material has low to negligible frost sensitivity due to its relatively high clay content (50 to 70% fines and 17% clay content) and consequent low permeability. Properties of the materials used to increase the height of the core were not available for review, but are assumed to have similar frost sensitivity properties. Although deterioration from freeze-thaw effects is unlikely based on the previous assessment, it is recommended that seasonal readings (4 per year) should be maintained as a minimum to confirm that no adverse conditions develop in the upper part of the dam and core which could potentially lead to deterioration. To this end it is noted that only 2 thermistor readings have been taken since June 2002.

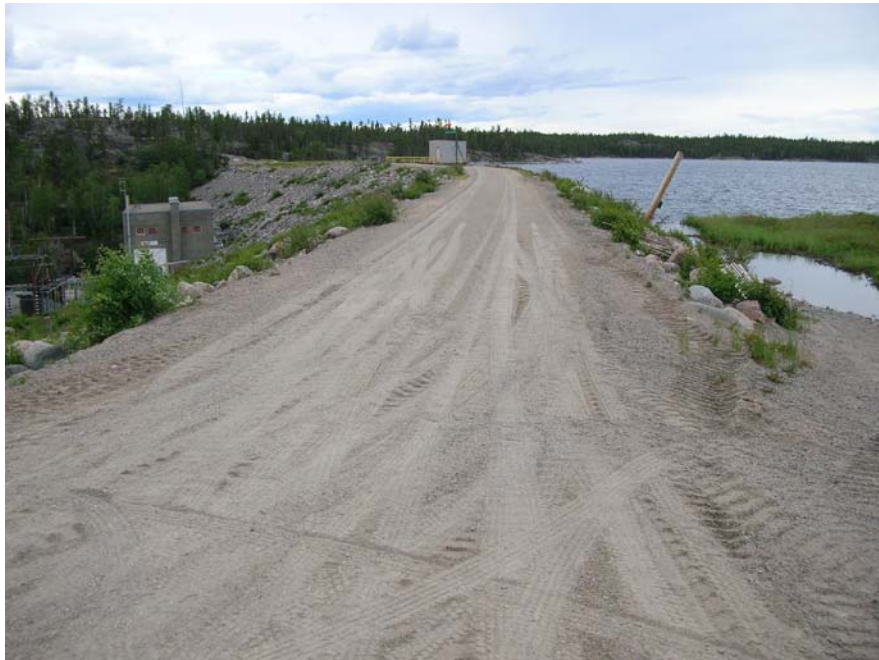
Photo 1 Snare Rapids Main Dam – typical crest condition.

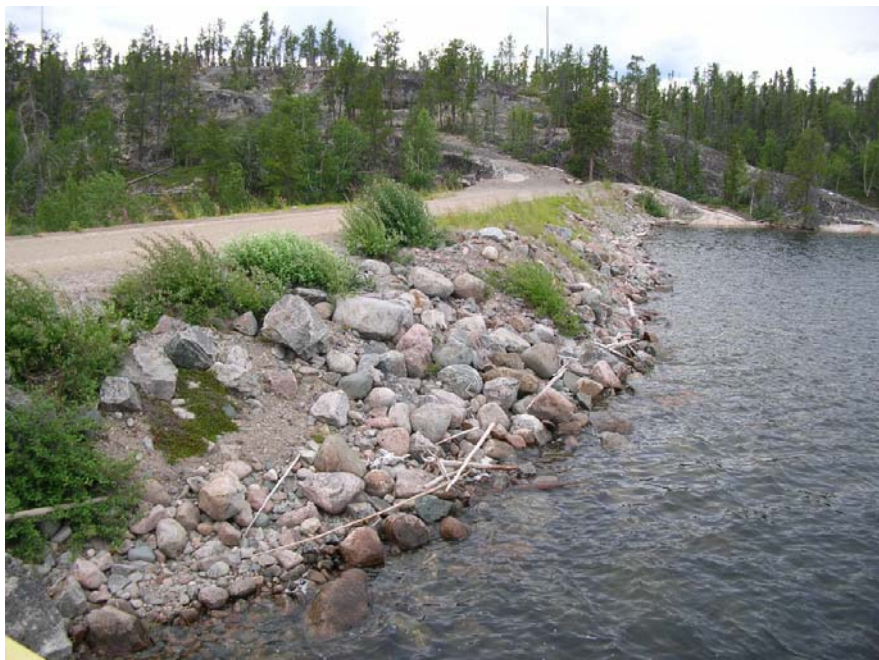
There are fairly regular accumulations of woody debris along the upstream face of the dam (Photo 2 and 3) which has the potential to dislodge the riprap during periods of high wind and waves. This material should be removed when brushing of the crest and slope is next undertaken to prevent deterioration of the riprap protection.

Photo 2 Snare Rapids Main Dam – vegetation along crest shoulder and upstream face to be removed

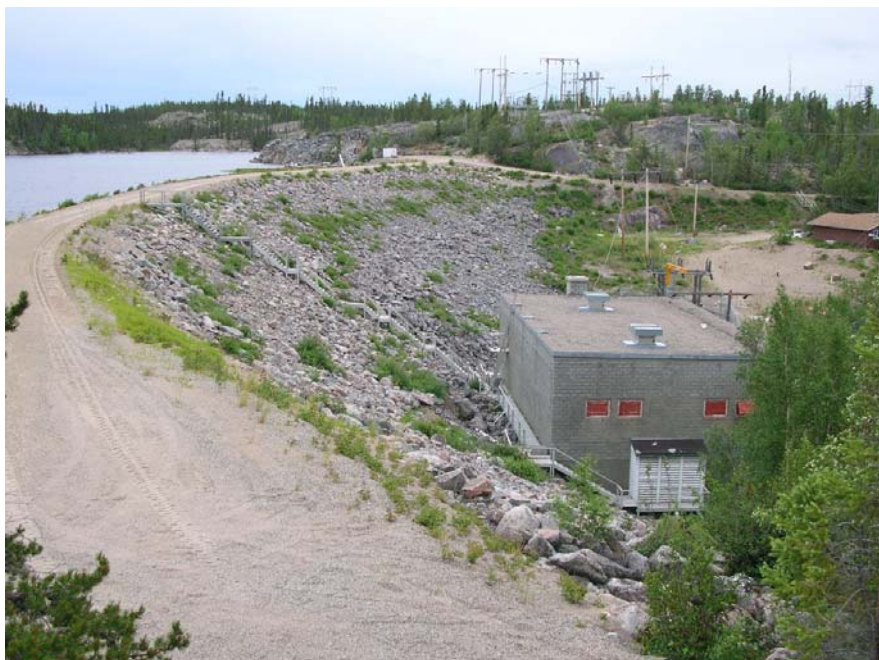
Photo 4 Snare Rapids Main Dam – downstream face in good condition, brushing recommended as part of regular maintenance.

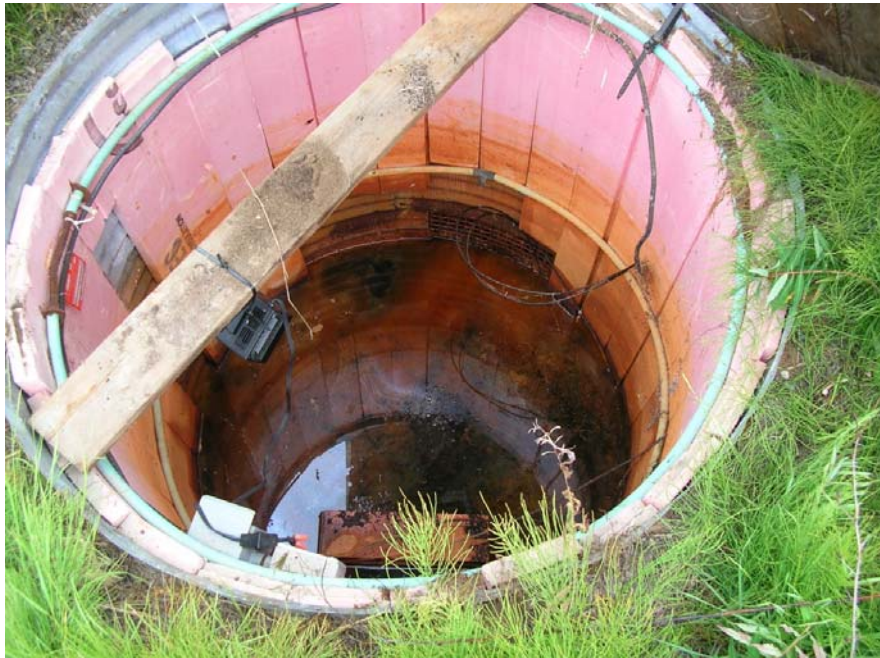
Photo 5 Snare Rapids Main Dam – heated sump collecting seepage from downstream left abutment. No inflows at time of inspection.

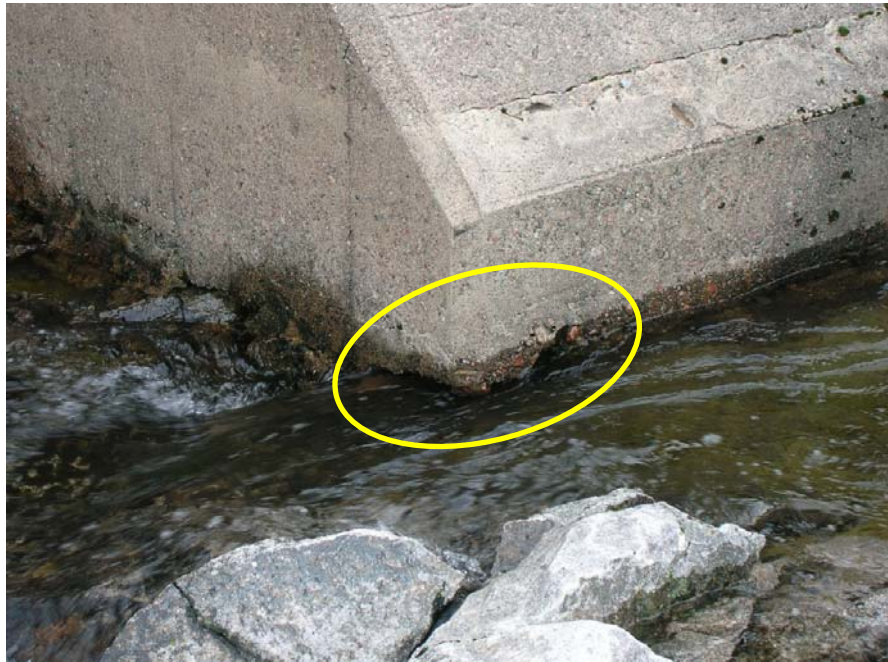
Photo 13 Spillway 5B – pier undercutting observed at other pier locations.

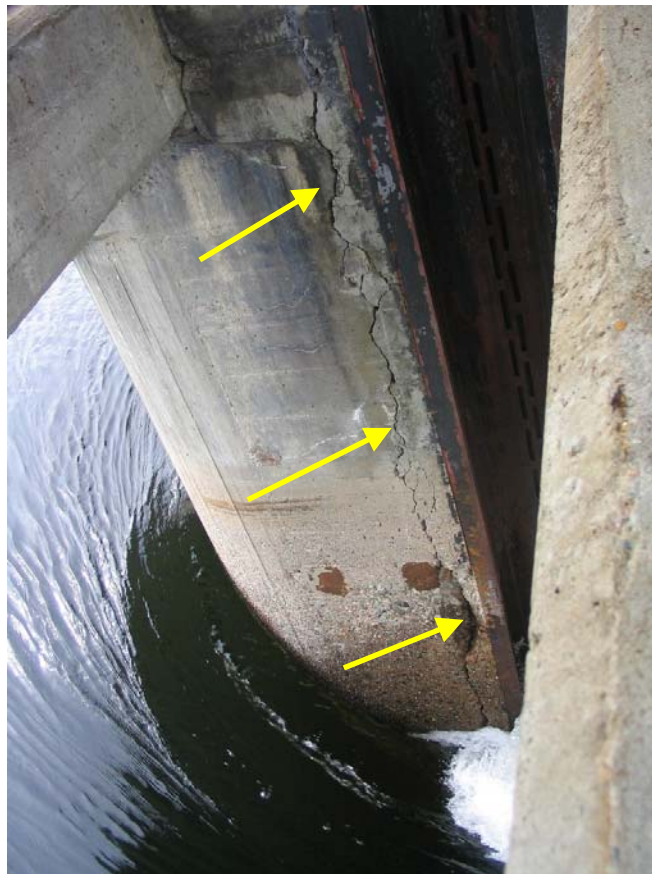
Photo 14 Spillway 5B - cracks in the second stage concrete around the heated gains in spillway Bay 3 and 4.

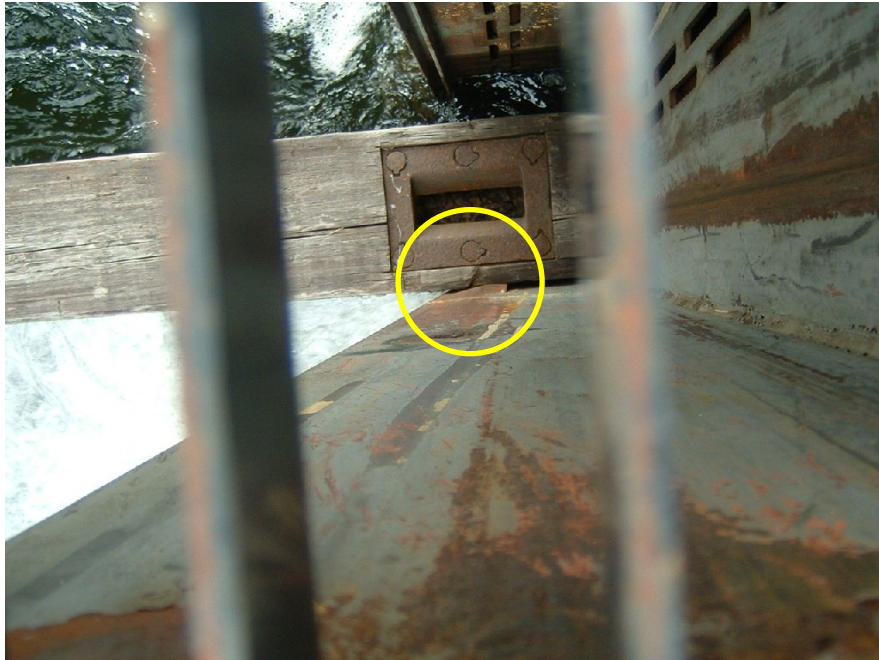
Photo 15 Spillway 5B - 1 cm bulge and corresponding tear in the left side steel embed of spillway Bay 4, approximately 2 m below deck level.

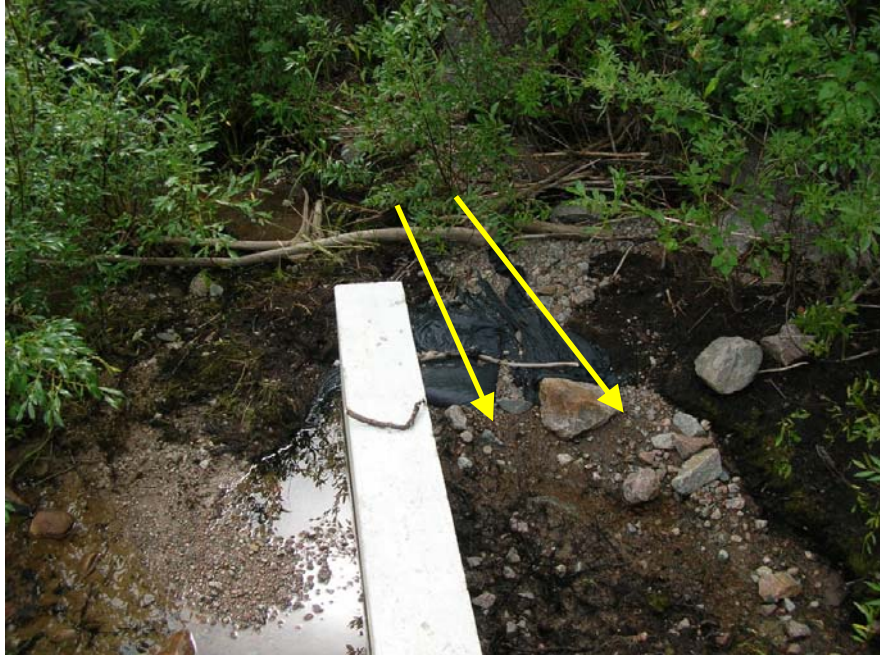
Photo 17 Side Dam 5B – area along left side of measuring weir structure where flow by-pass is observed to occur. Lateral extension of the wall is recommended to contain all future seepage flows.

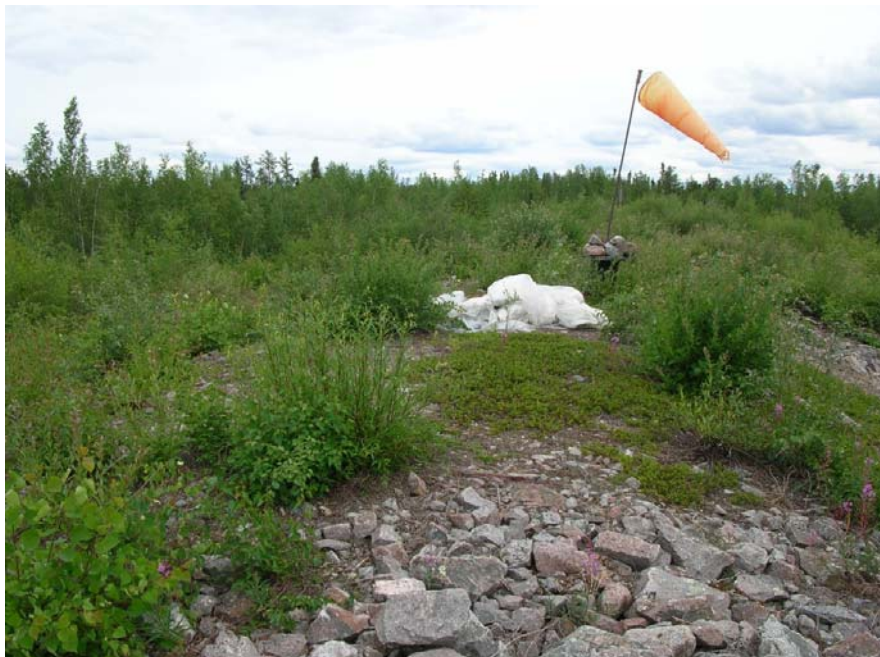
Photo 18 Side Dam 5B – typical crest condition. Brushing of crest and slopes required to permit proper inspection in the future.

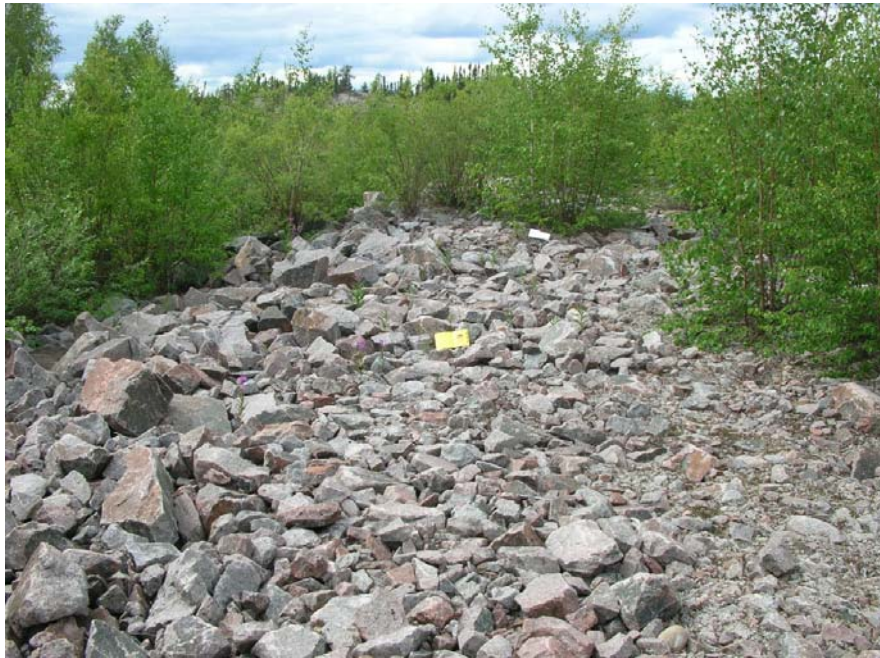
Photo 19 Side Dam 5B – apparent low point on crest near the right abutment.

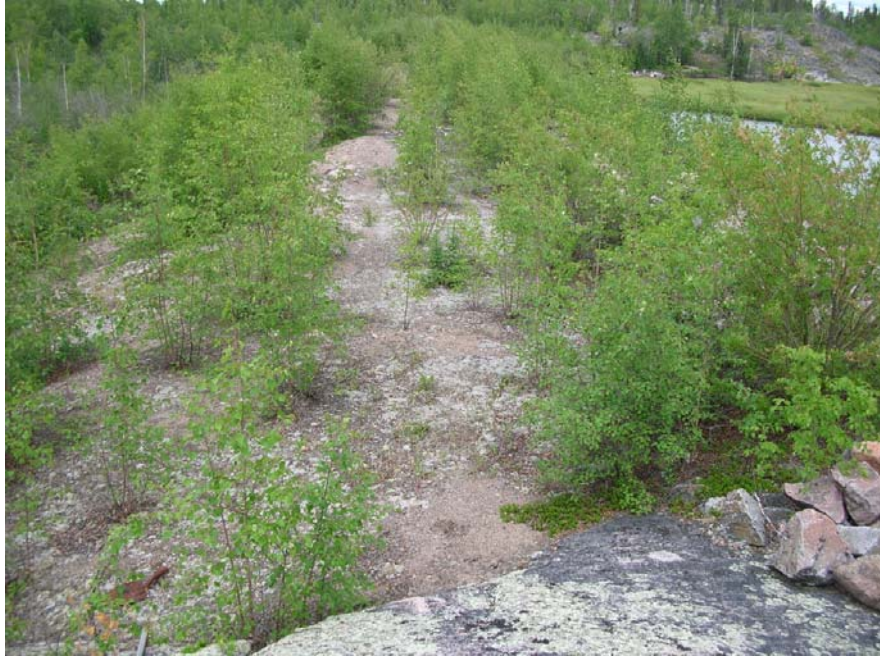
Photo 21 Side Dam 4 – typical crest condition. Some minor erosion and undulations in profile. Brushing of crest and slopes required to permit proper inspection in the future.

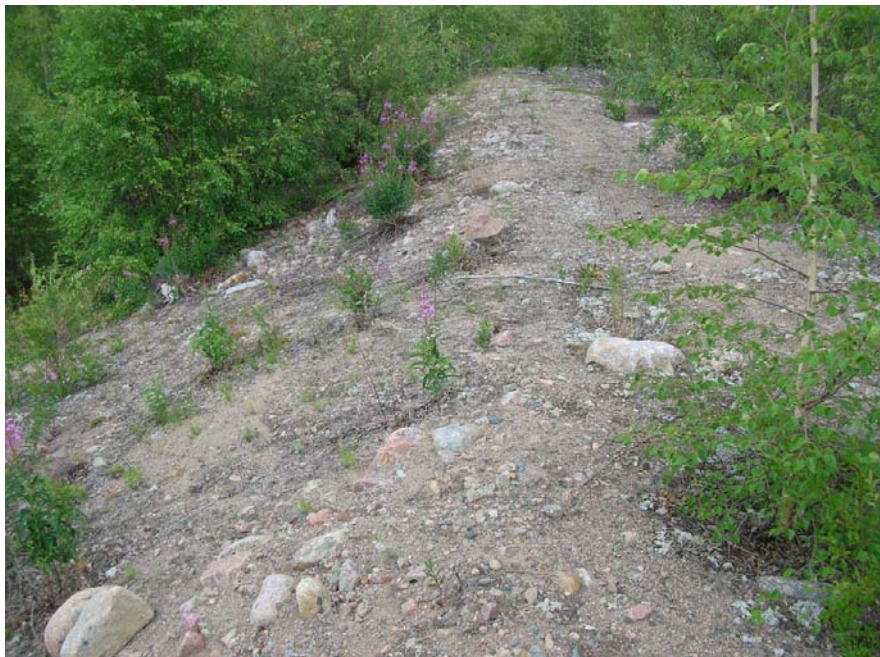
Photo 22 Side Dam 4 – some gullying on downstream face evident due to surface runoff.

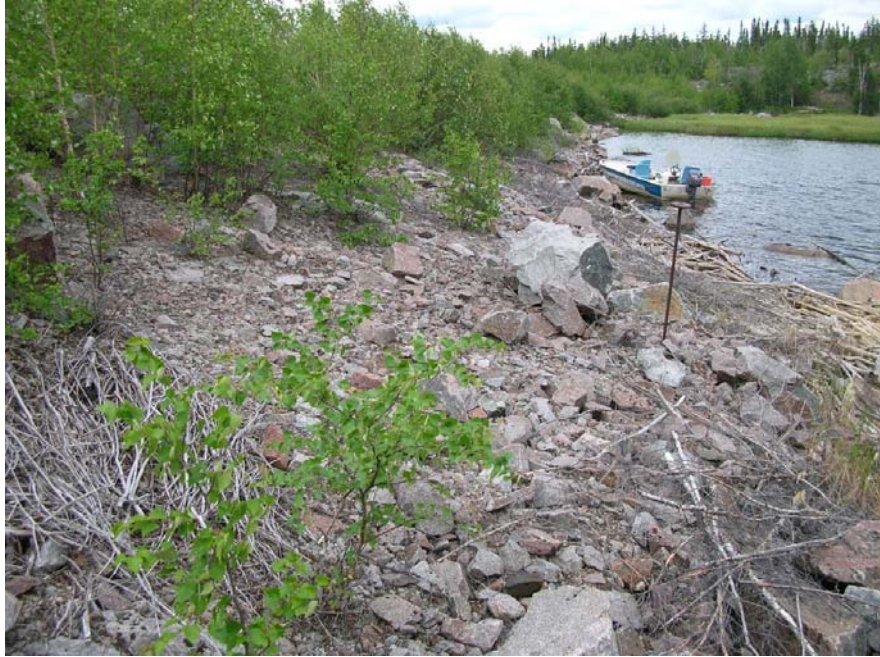
Photo 23 Side Dam 4 – upstream face riprap showing signs of deterioration towards the left abutment.

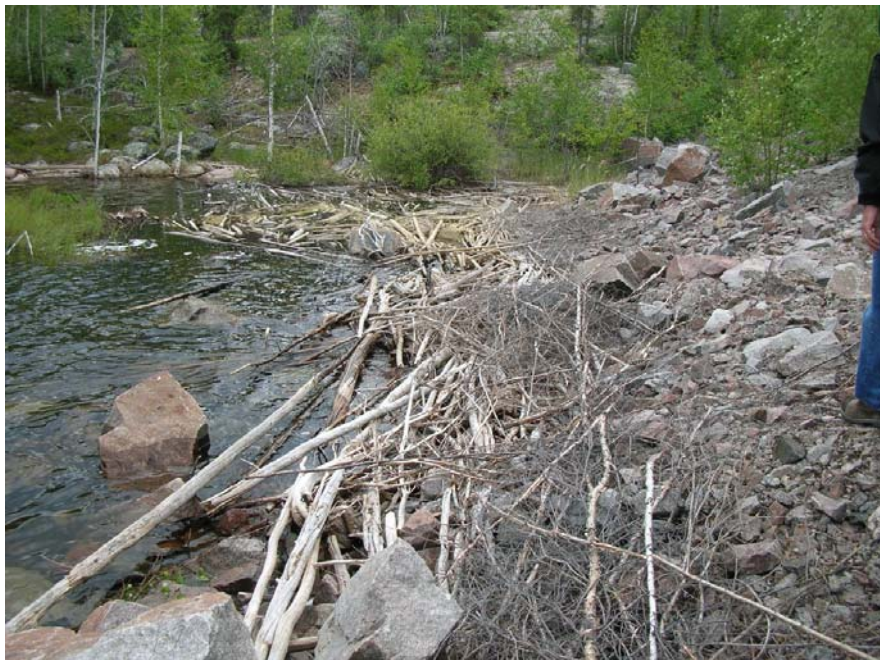
Photo 24 Side Dam 4 – accumulations of woody debris near left abutment.

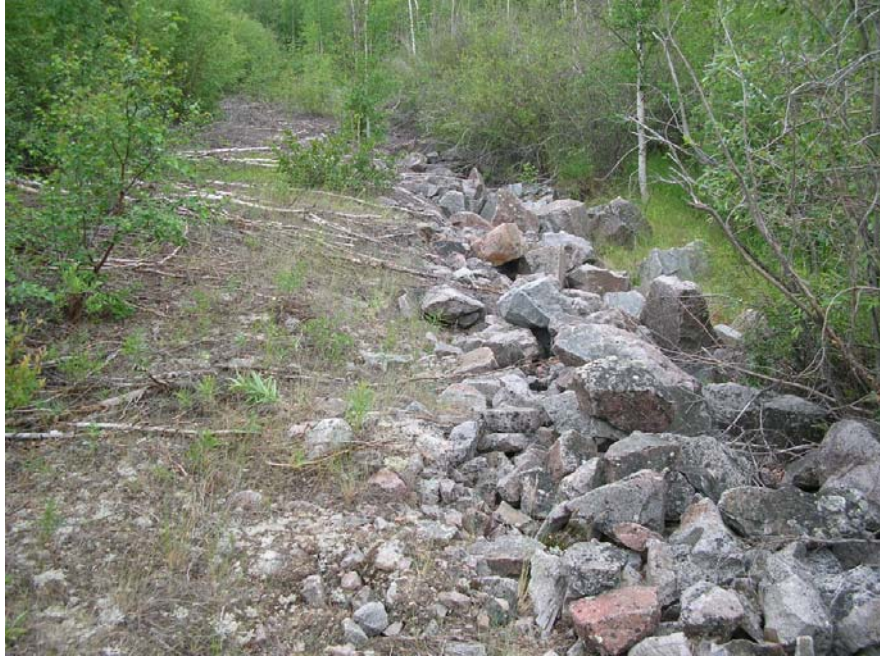
Photo 25 Side Dam 4 – rockfill toe berm shows no signs of cracking identified in earlier reports. Brushing of toe and slope required to permit proper inspection in the future.

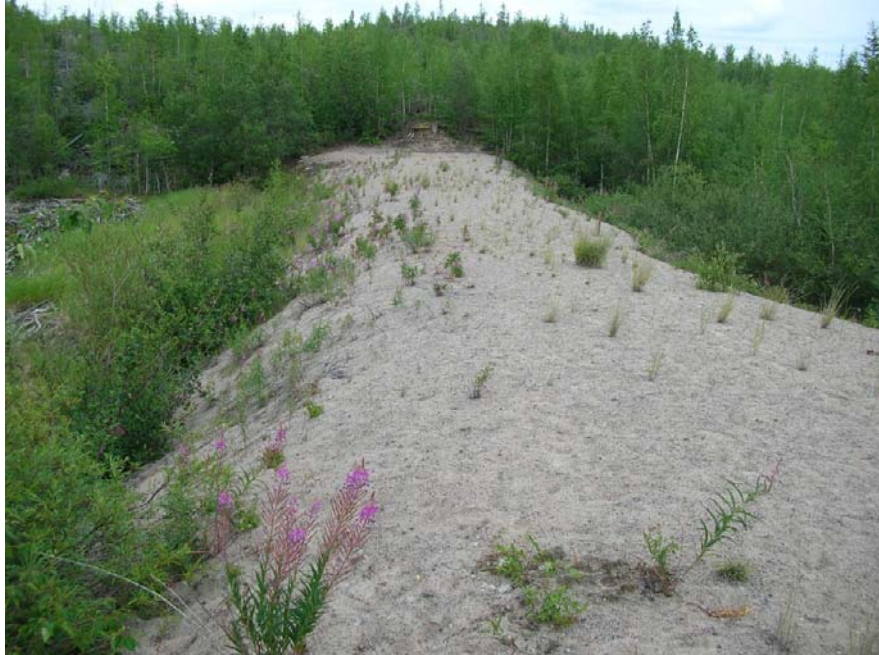
Photo 27 Side dam 9B – crest profile shows possible signs of minor settlement near centre – survey recommended to determine if topping-up is required to reinstate the crest design level.

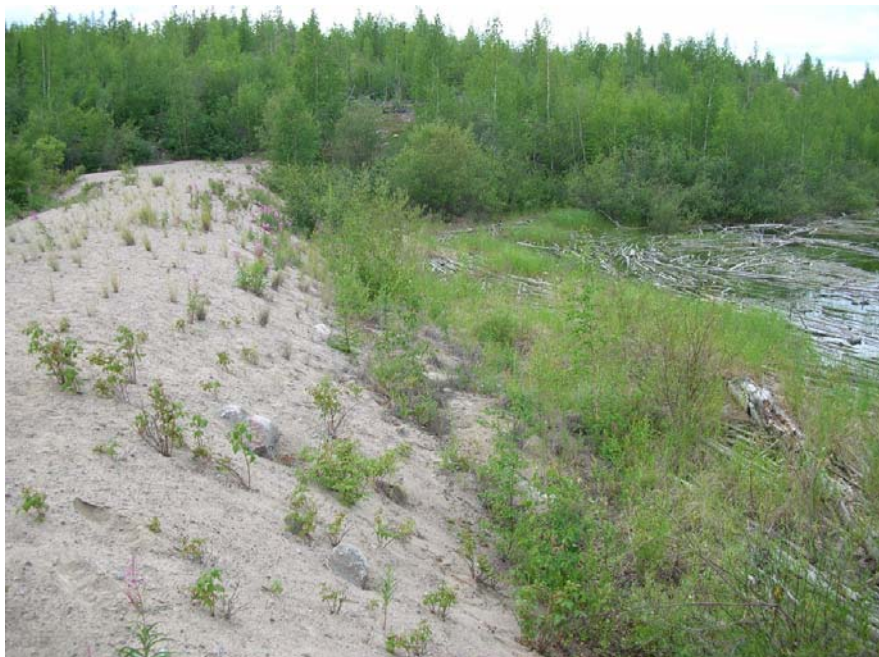
Photo 28 Side Dam 9B - upstream slope of the dam shows some signs of minor rutting in areas due to surface run-off. 30 cm layer of fine rockfill or crushed gravel recommended. Brushing required as part of on-going maintenance.

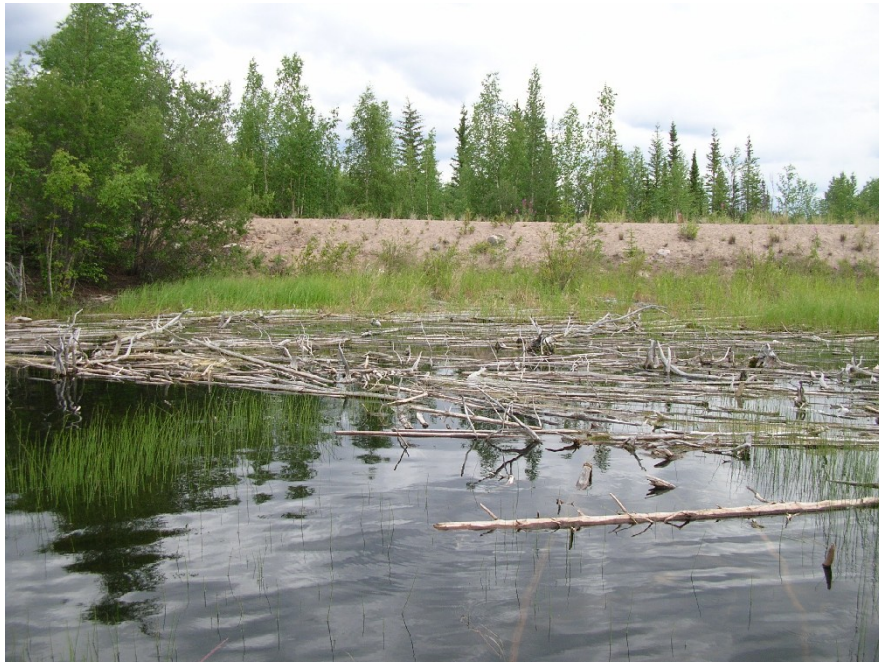
Photo 29 Side Dam 9B – woody debris mat accumulating near upstream face.

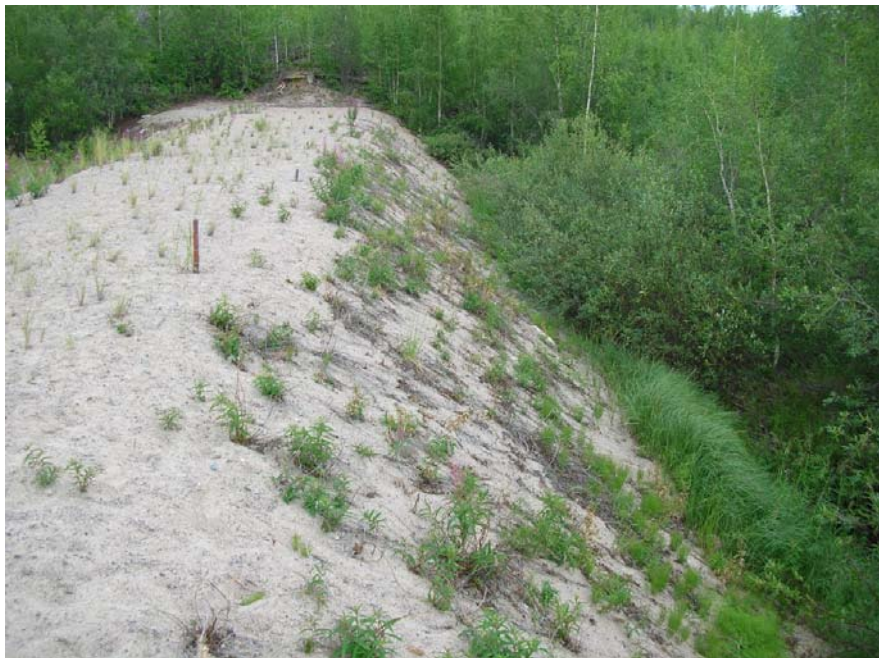
Photo 30 Side Dam 9B - downstream slope is in a satisfactory condition

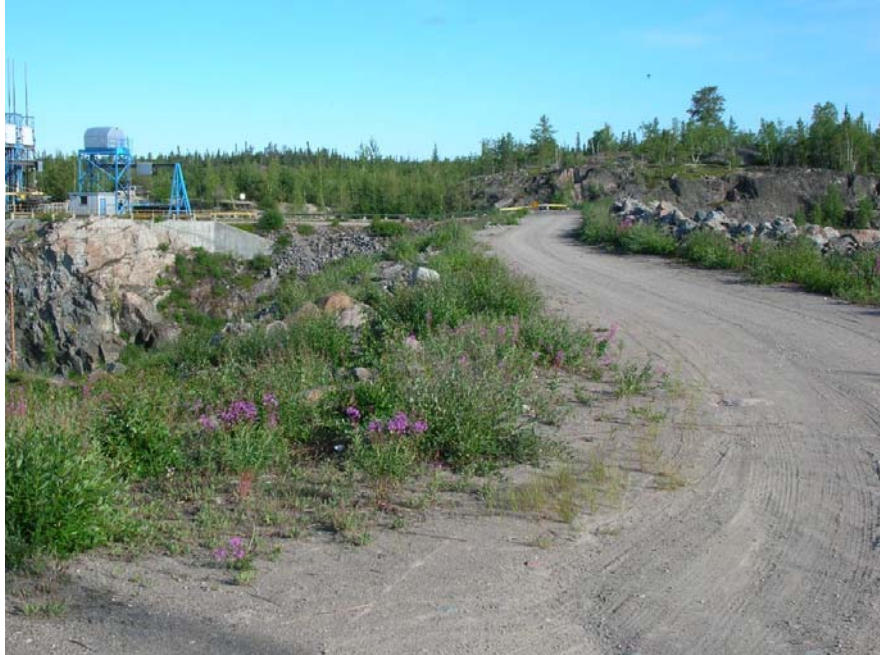
Photo 31 Snare Falls Main Dam – crest condition satisfactory. Brushing recommended as part of on-going maintenance.

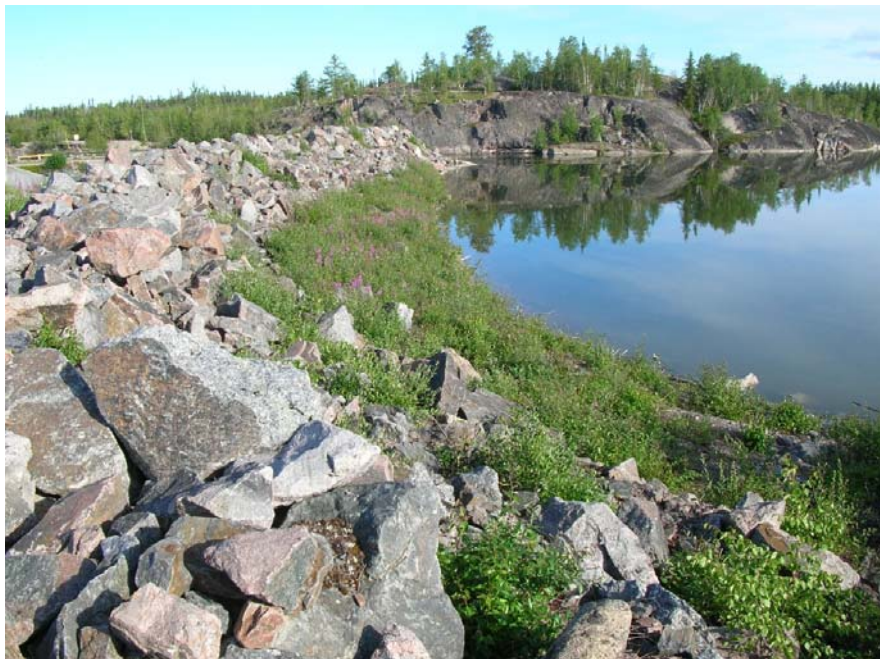
Photo 32 Snare Falls Dam – upstream riprap satisfactory. Brushing recommended as part of on-going maintenance.

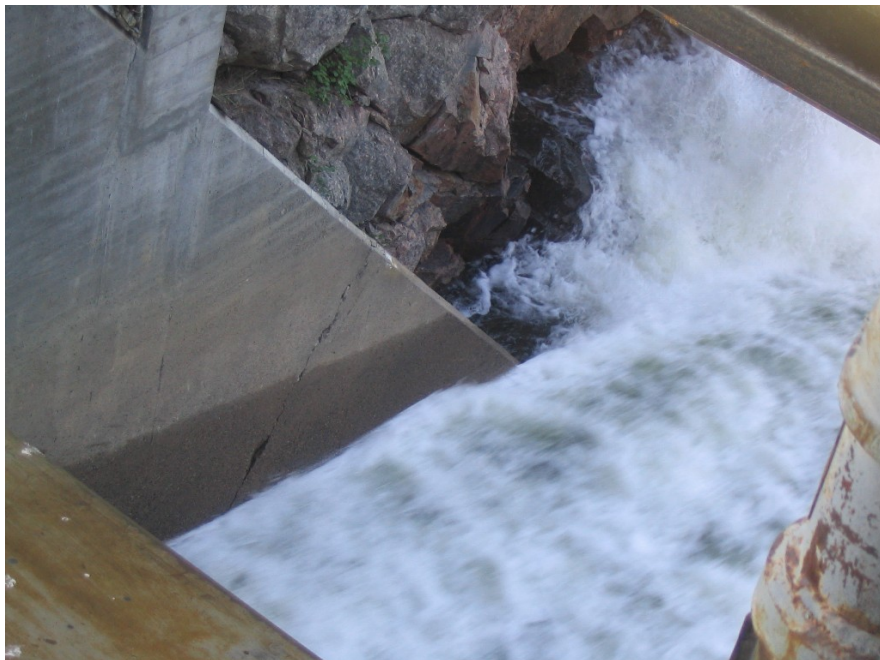
Photo 36 Snare Falls Spillway - diagonal cracks on the downstream end of both abutment piers unchanged from previous inspections.

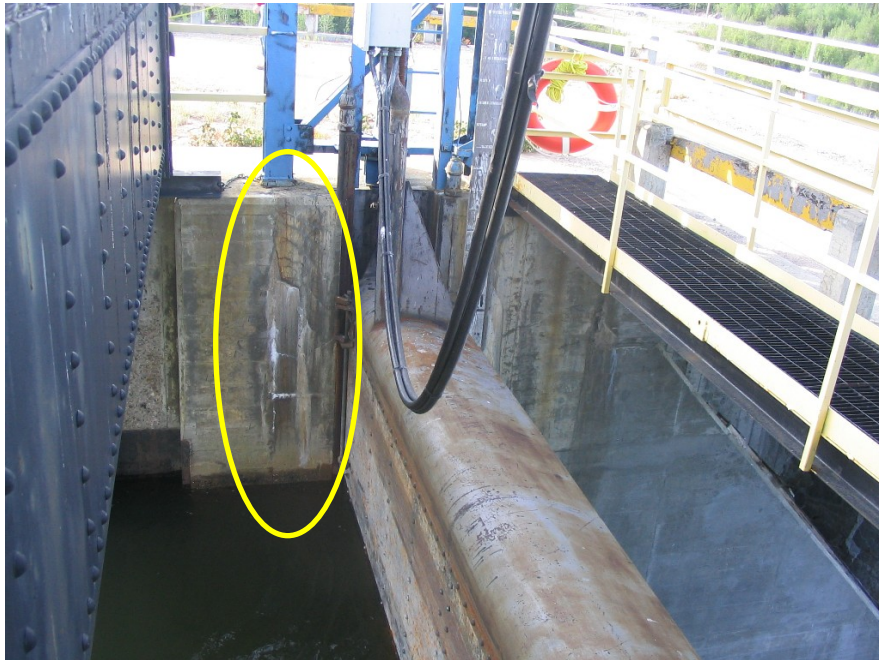
Photo 37 Snare Falls Spillway - vertical cracks in concrete adjacent to left gate guide (heated).

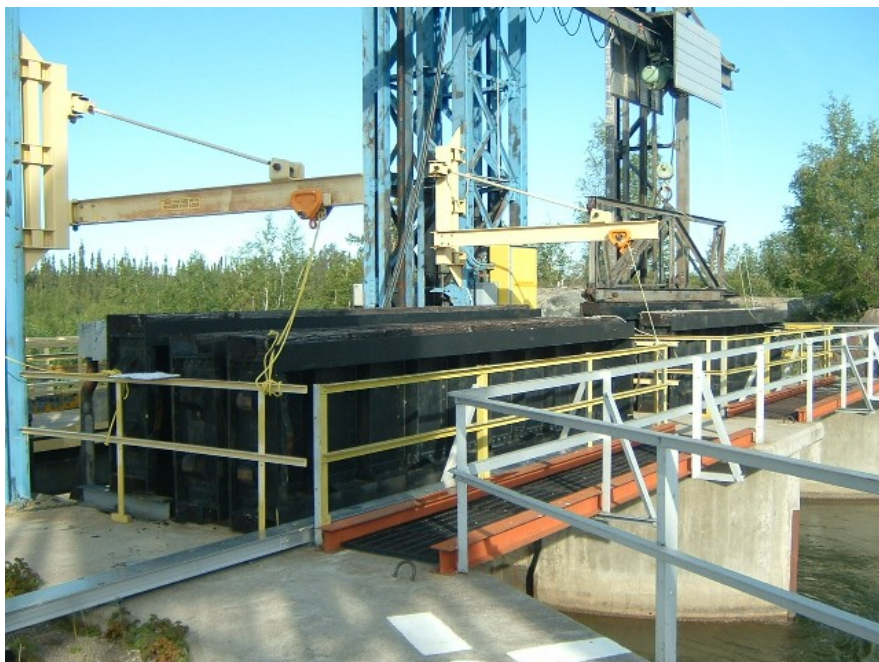
Photo 38 Snare Falls Spillway – stoplogs in satisfactory condition and in close proximity for quick installation.

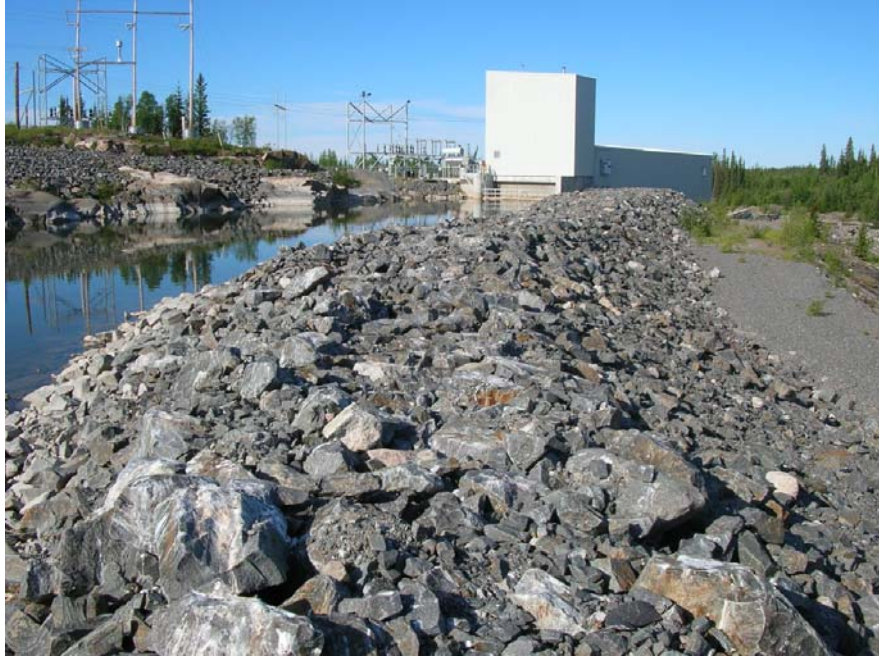
Photo 49 Snare Cascades Power Canal Dyke – slight narrowing of the crest at about mid-dyke in an area where additional rockfill has been added to cover the previously observed exposures of concrete cut-off wall.

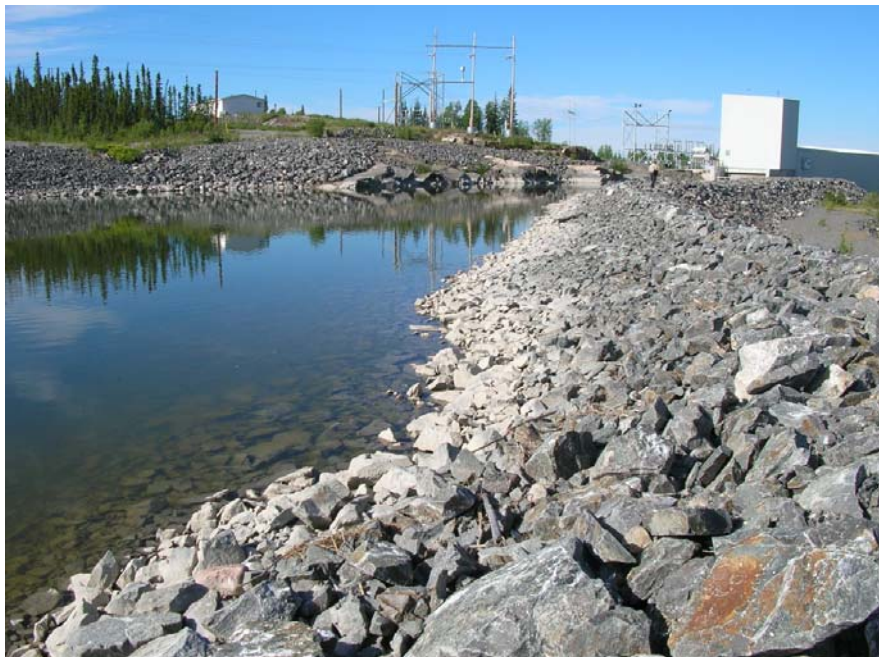
Photo 50 Snare Cascades Power Canal Dyke - upstream slope is typically planar with a slight distortion in the slope of the fill in the area where the new rockfill was added. The rockfill is in good condition.

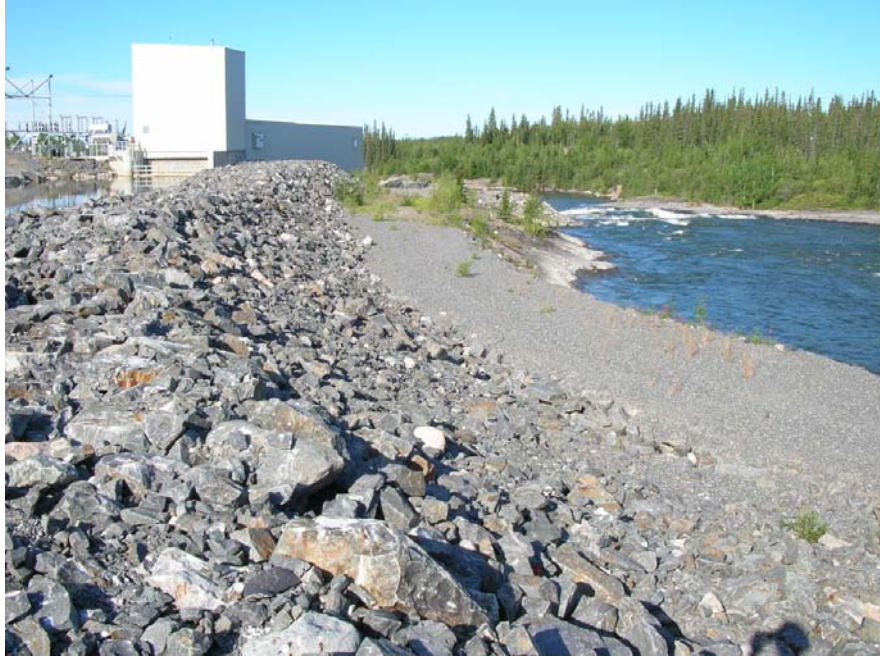
Photo 51 Snare Cascades Power Canal Dyke - downstream slope is planar with no signs of erosion, instability or seepage.

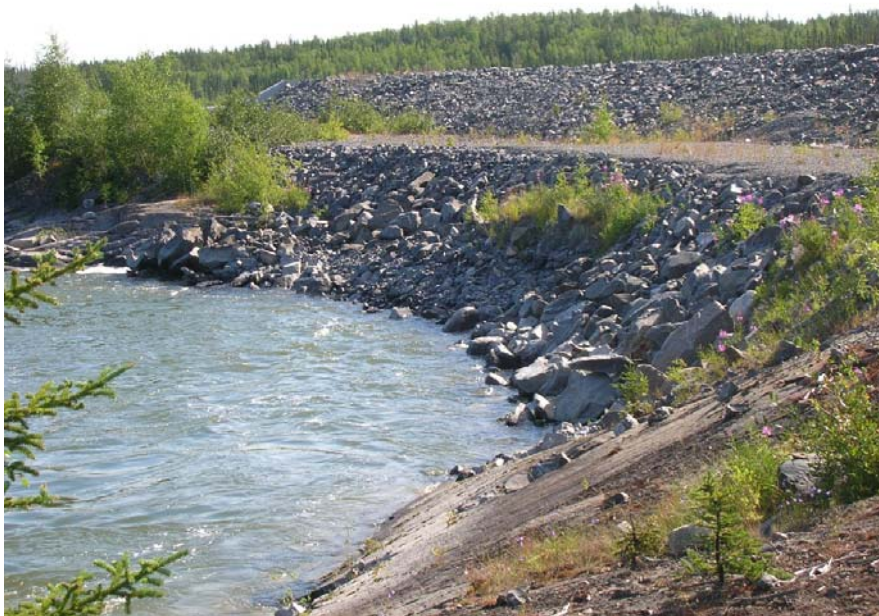
Photo 54 Snare Cascades Power Canal Dyke - downstream slope of the lower bench is planar, with no signs of instability or other distress. The rockfill protection appears sound and in good condition.

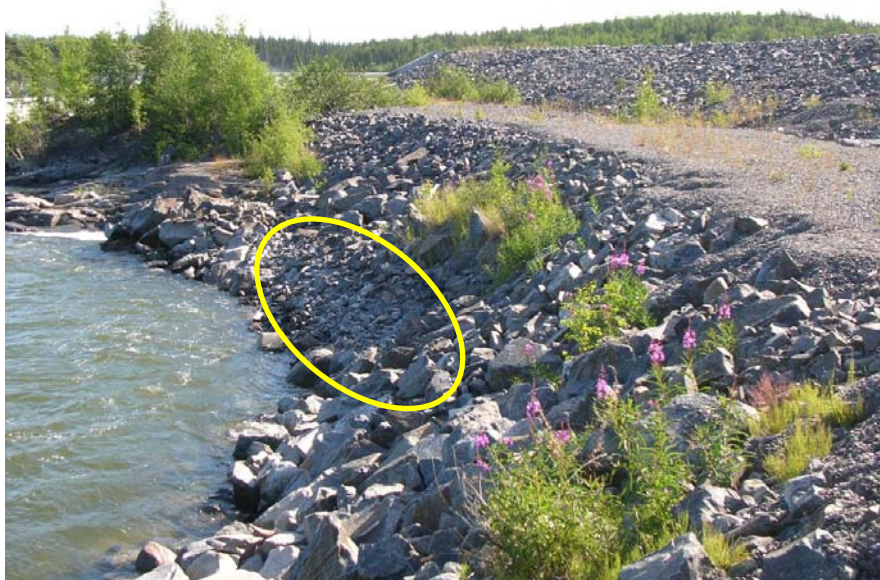
Photo 55 Snare Cascades Power Canal Dyke - localized area on the lower slope where the rockfill appears finer than the surrounding material, but there is currently no associated beaching or erosion. Brushing recommended..

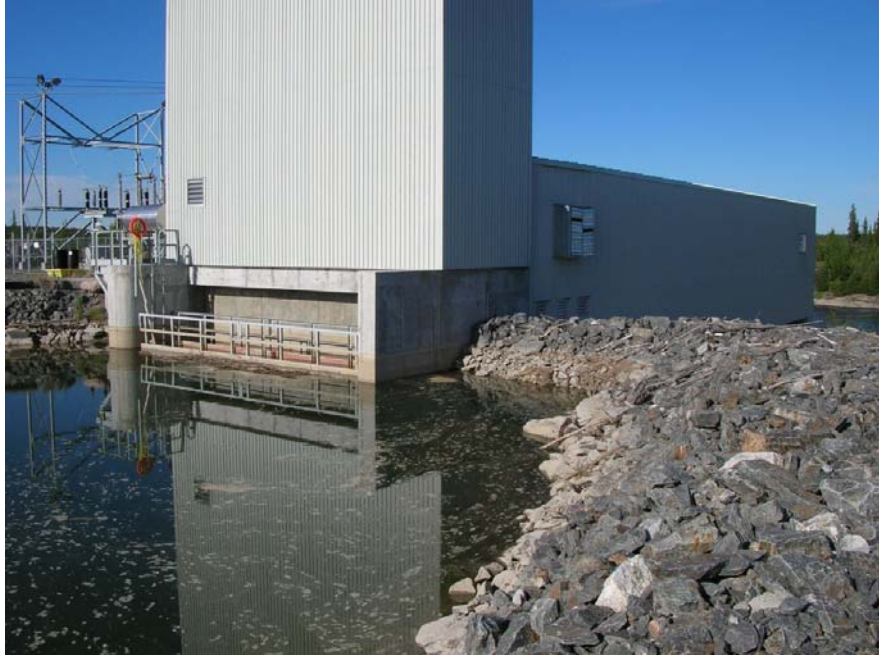
Photo 57 Snare Cascades Intake and Powerhouse - steel frame superstructure including the cladding appears in sound condition.

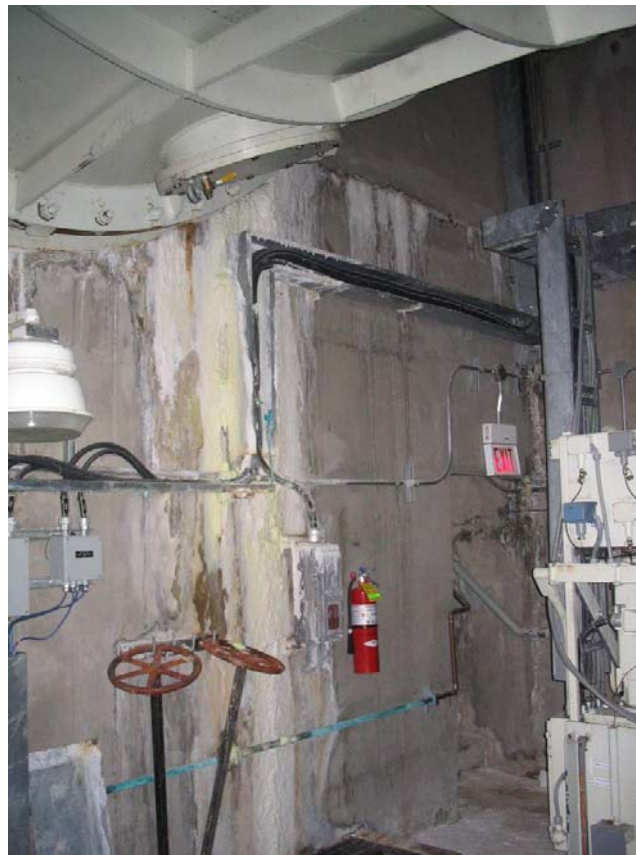
Photo 58 Snare Cascades Intake and Powerhouse - multiple zones of cracks, seepage and efflorescence.
